# SHORE EROSION STUDY Technical Report

SHORELINE EROSION AND BLUFF STABILITY ALONG LAKE MICHIGAN  
AND LAKE SUPERIOR SHORELINES OF WISCONSIN

DOUGLAS AND WESTERN BAYFIELD COUNTIES  
WISCONSIN POINT TO BARK BAY

July 1980

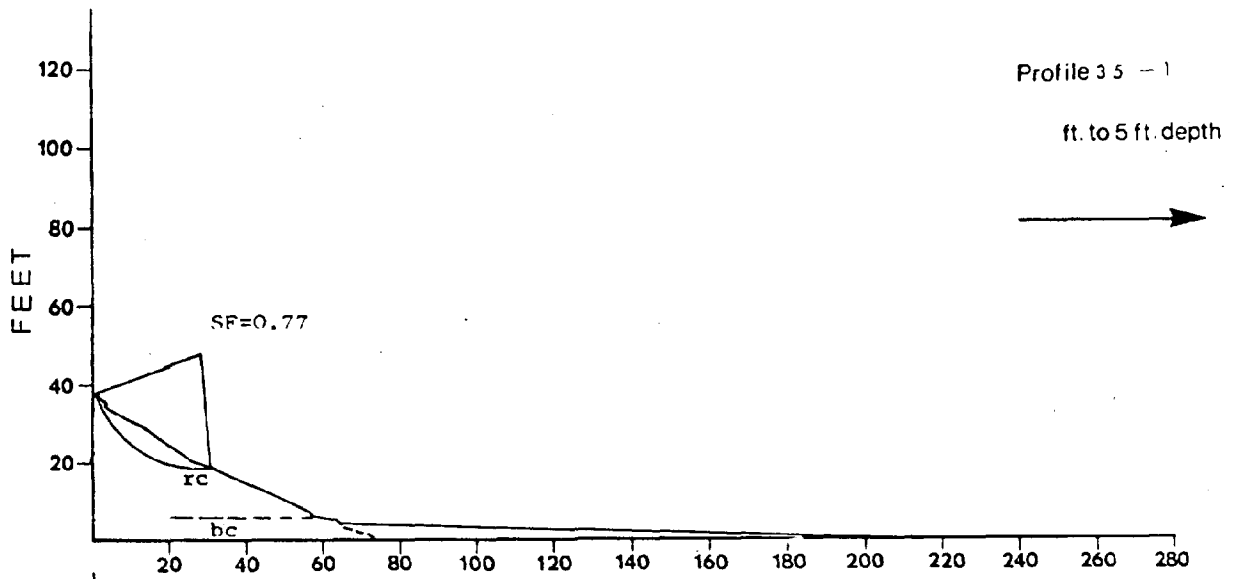
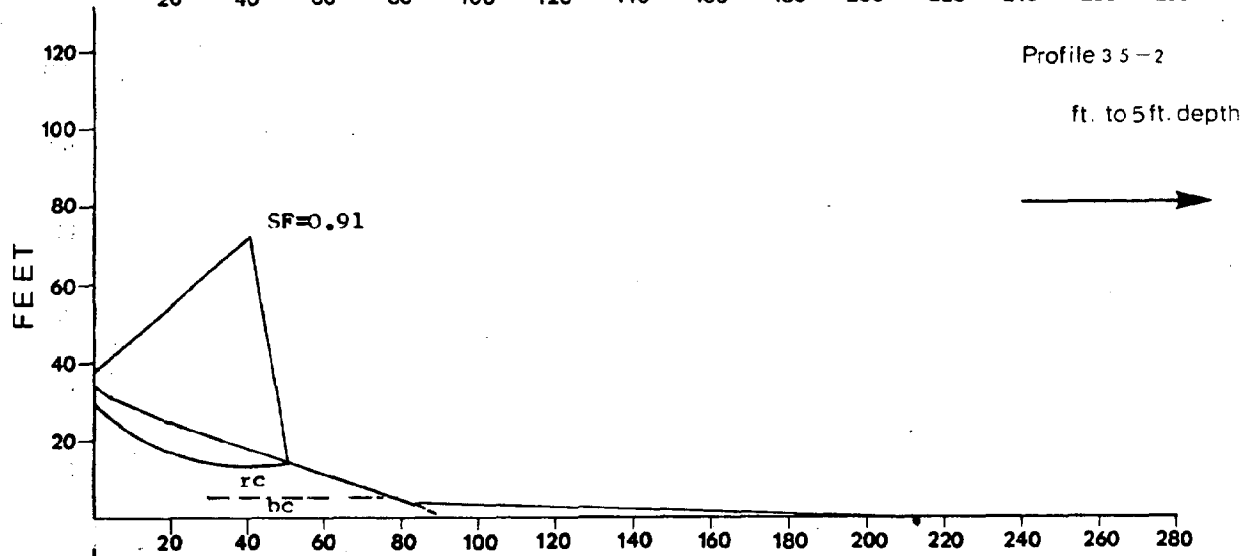
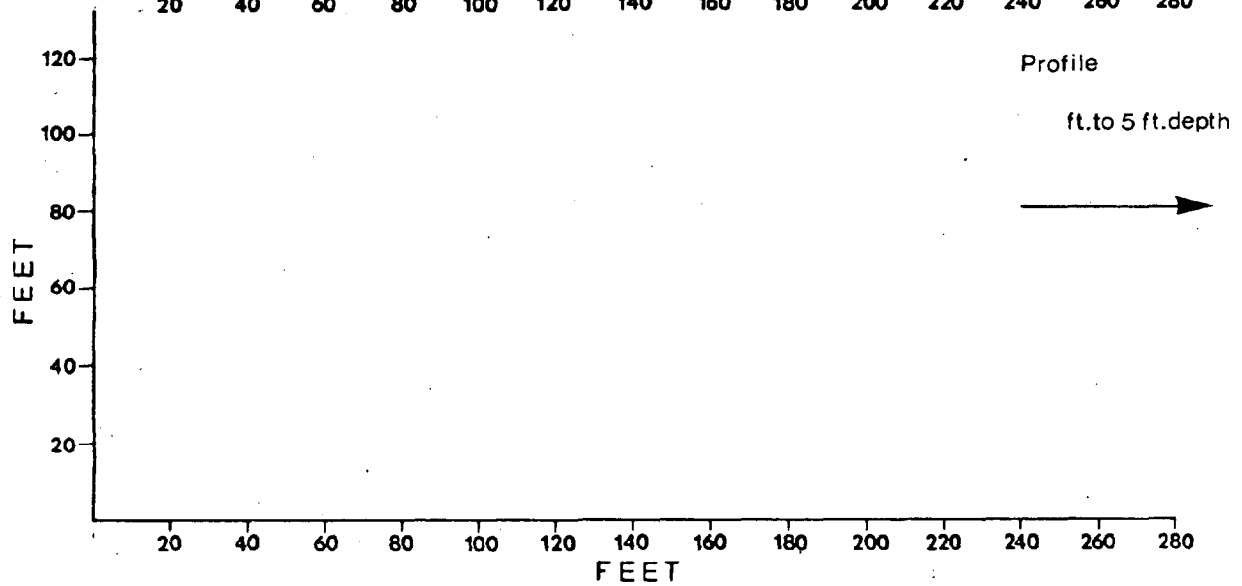
T. 49 N., R. 13 W., Sec. 35

- a) spit
- b) spit backed by lagoon
- c) 100-150 ft wide; coarse sand with scattered cobbles throughout width and with a concentration of pebbles and granules near the water's edge

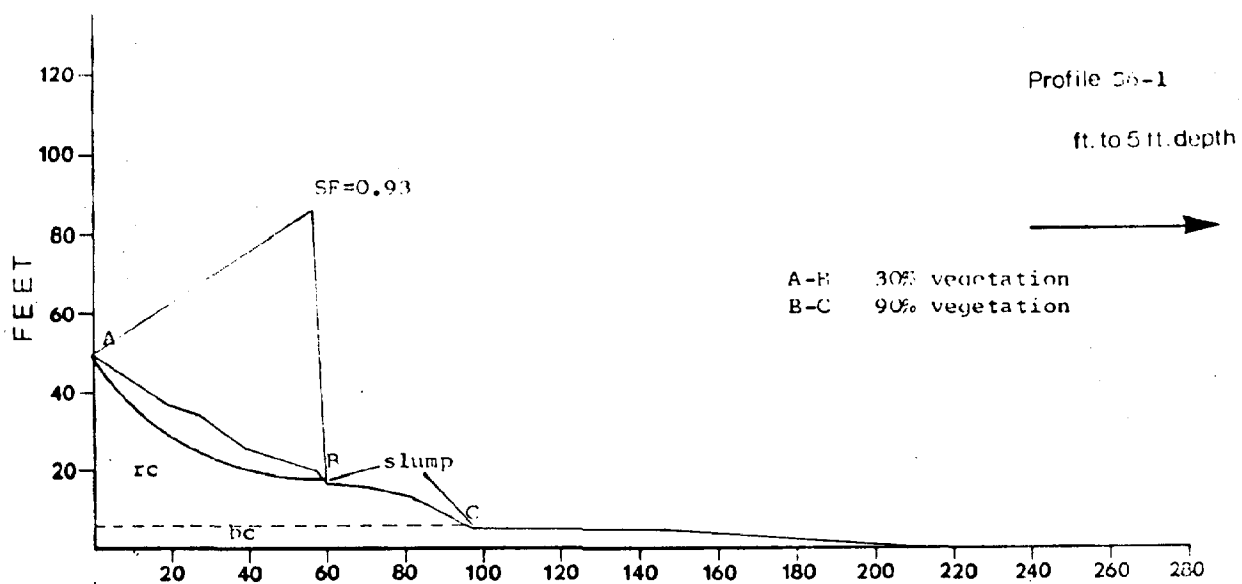
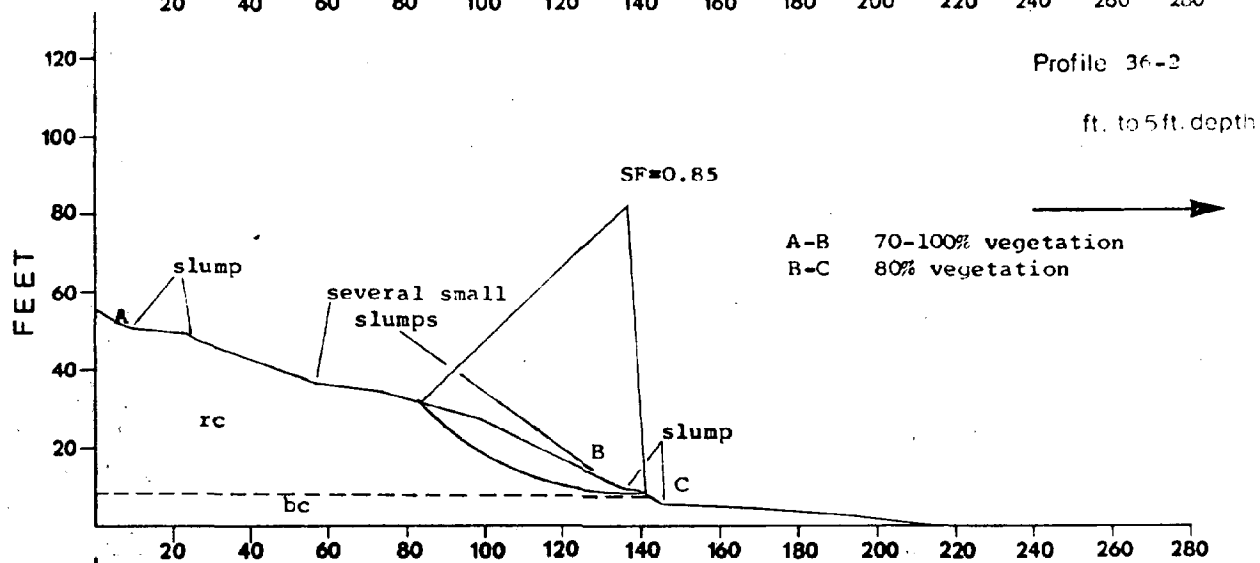
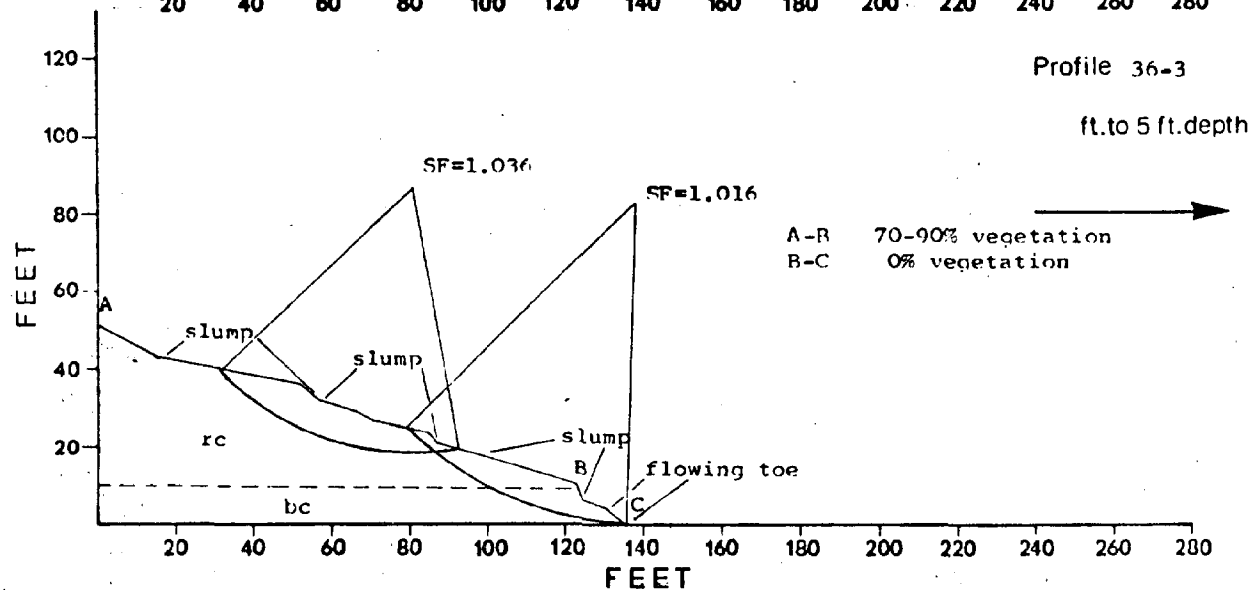
- a) red clay; slumped; protected by beach
- b) clay, slumped, protected, vegetated with alder and grass or scarped at large slump blocks
- c) clays, slumped, partially protected, failing for 10 ft vertically by shallow sliding with 2-3 ft scarps at base unvegetated
- d) clays, slumped, unprotected from waves, failing by shallow sliding and mudflows with 8-12 ft scarps at base, unvegetated
- e) clays, slumped, partially protected, failing for 10 ft vertically by shallow sliding with 2-3 ft scarps at base unvegetated

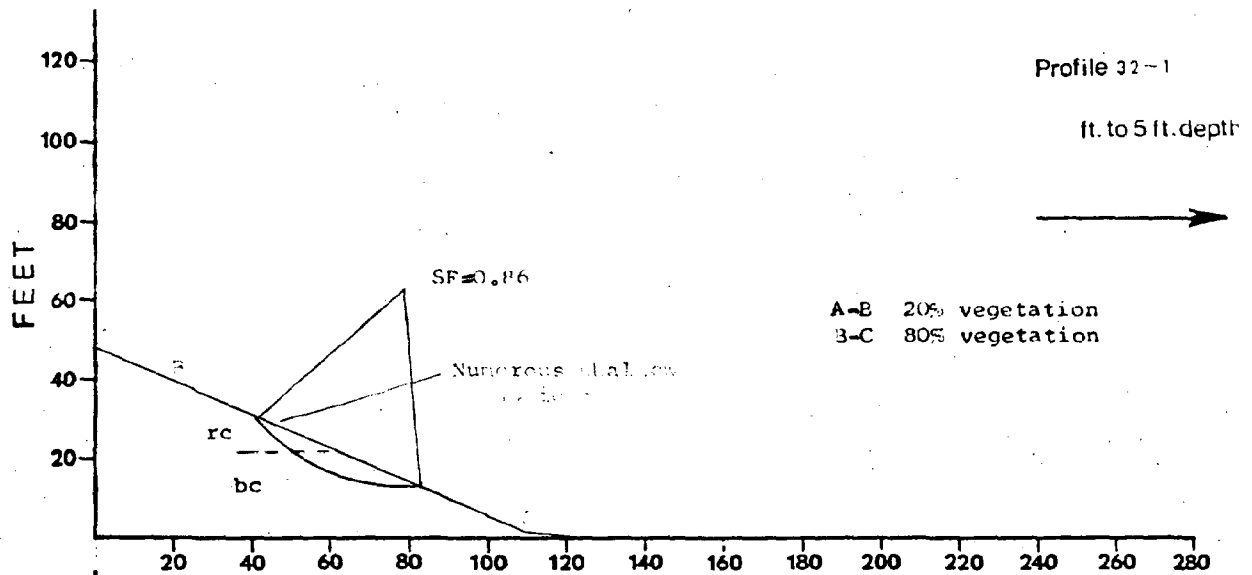
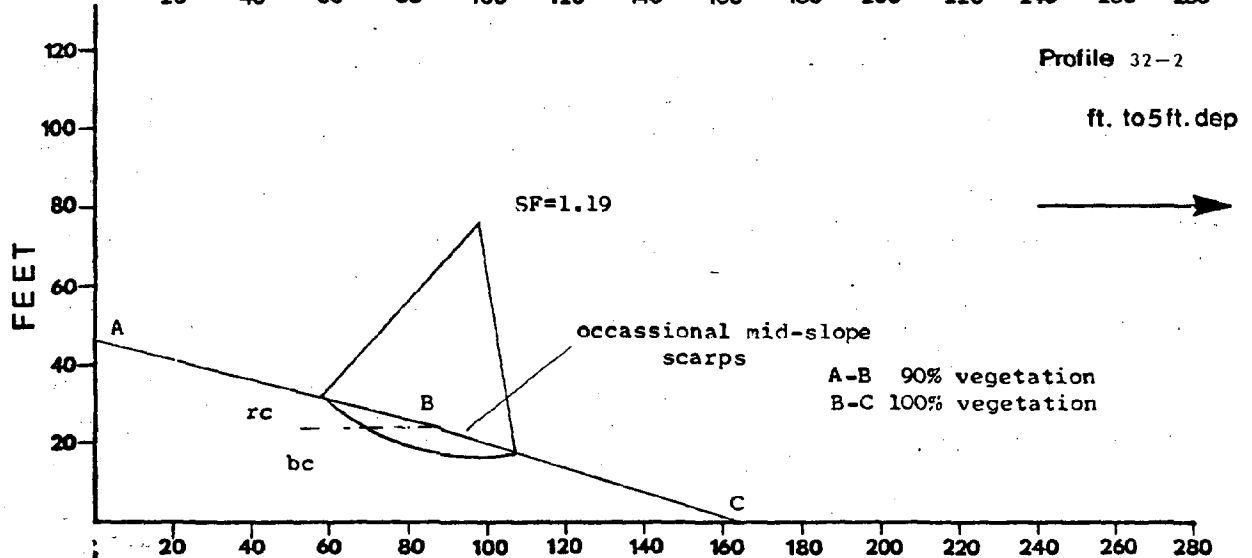
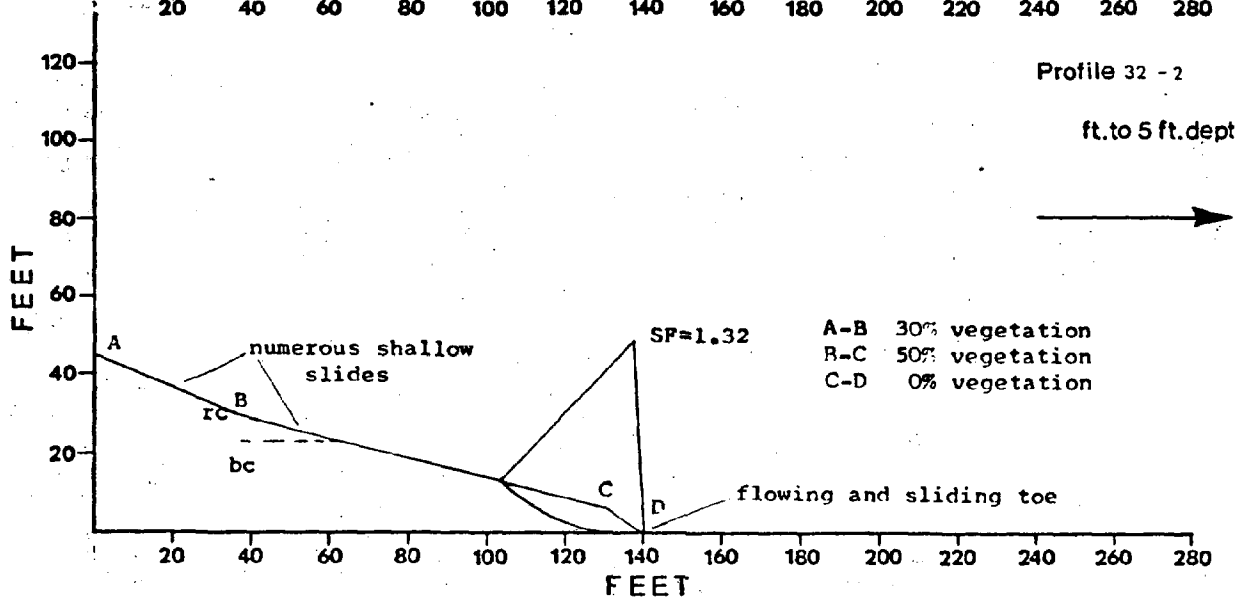
T. 49 N., R. 12 W., Sec. 32

- a) 45-50 ft high; crest scalloped; shallow slides; vegetation (50-60%) restricted to clump on actively moving slump blocks; clay
- b) 45-50 ft high; crest subdued; well-vegetated (80-90%) with alder, birch, some conifer, grass, moss, and horsetails toward the toe; fairly stable of late but fresher a-mid-slope scarp was often noted, clay
- c) 45-50 ft high, crest newly scalloped; vegetation being destroyed (0-10%); shallow slides, clay

- a) mixed-colored clay (red-brown-gray); slumped; generally protected from wave action
- b) red and brown clay; slumped; under wave attack; failing for 12 ft vertically by shallow slides and mudflows

- a) discontinuous (covered by slumped clay occasionally) 0-20 ft; coarse to medium sand with occasional large boulders and pebbles and cobbles at waterline; pebble and cobble concentration decreases to absent eastward
- b) mostly-absent 0-5 ft; wholly within wash-swash zone; sand with occasional large boulders

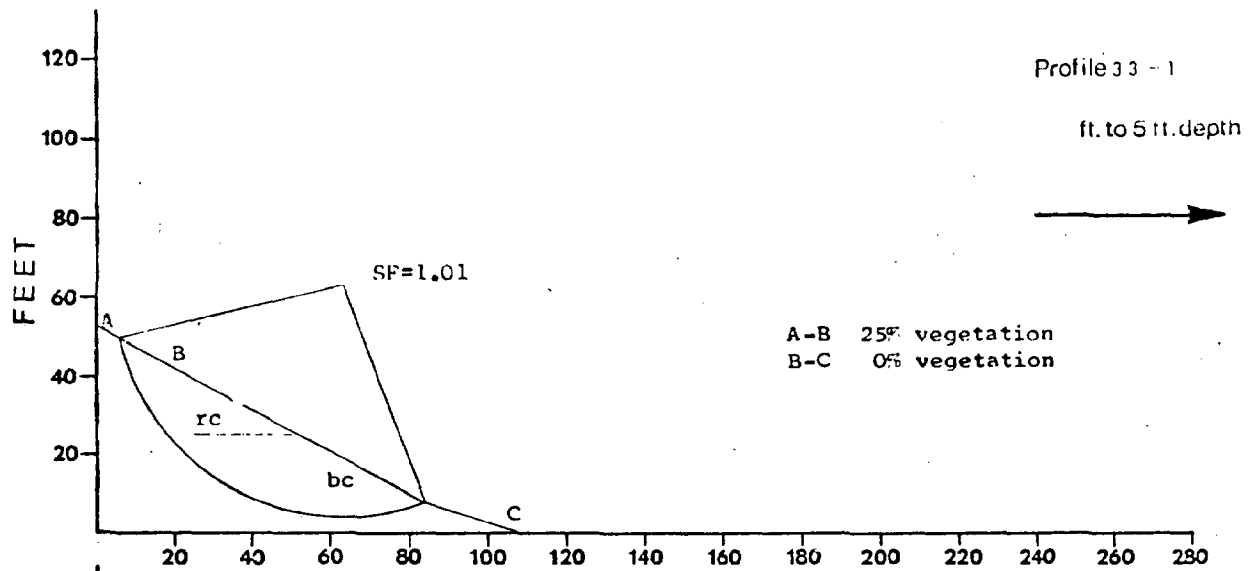
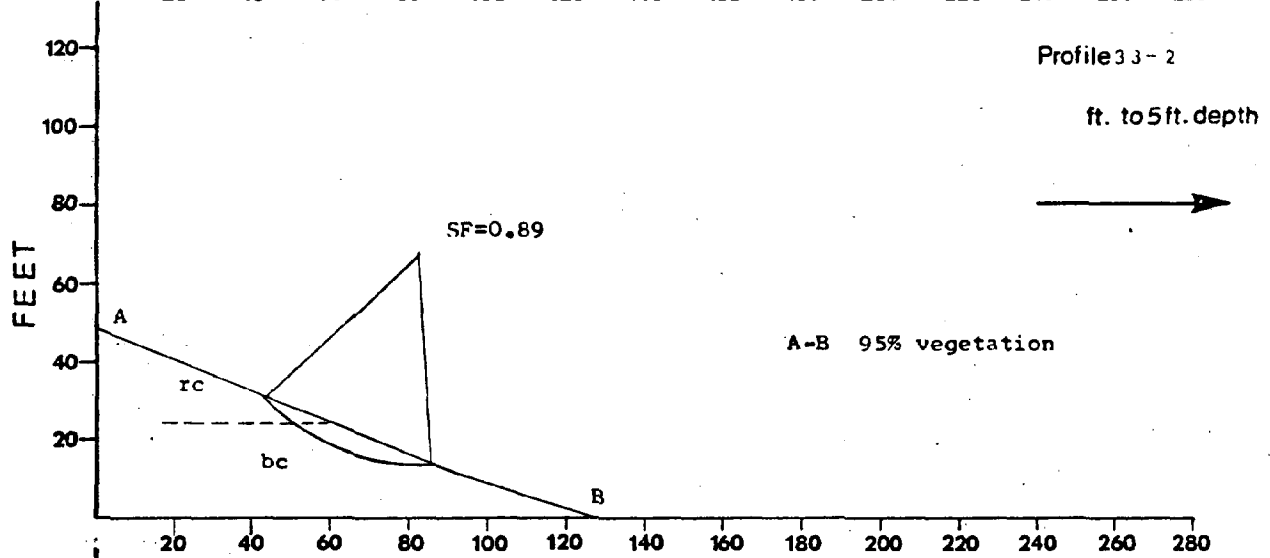
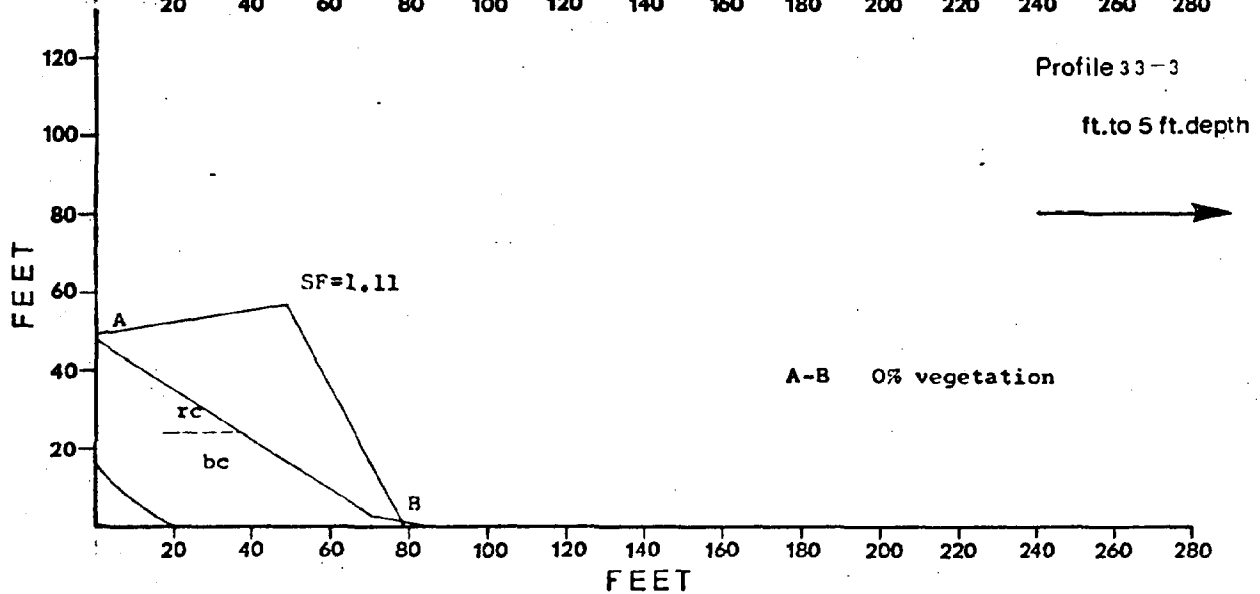
T.49 N., R. 12 W., Sec. 33

- a) discontinuous; mostly absent; if present up to 20 ft wide coarse sand with pebbles, cobbles and occasional boulders
- b) absent
- c) discontinuous, mostly absent; if present up to 20 ft wide coarse sand with pebbles, cobbles and occasional boulders

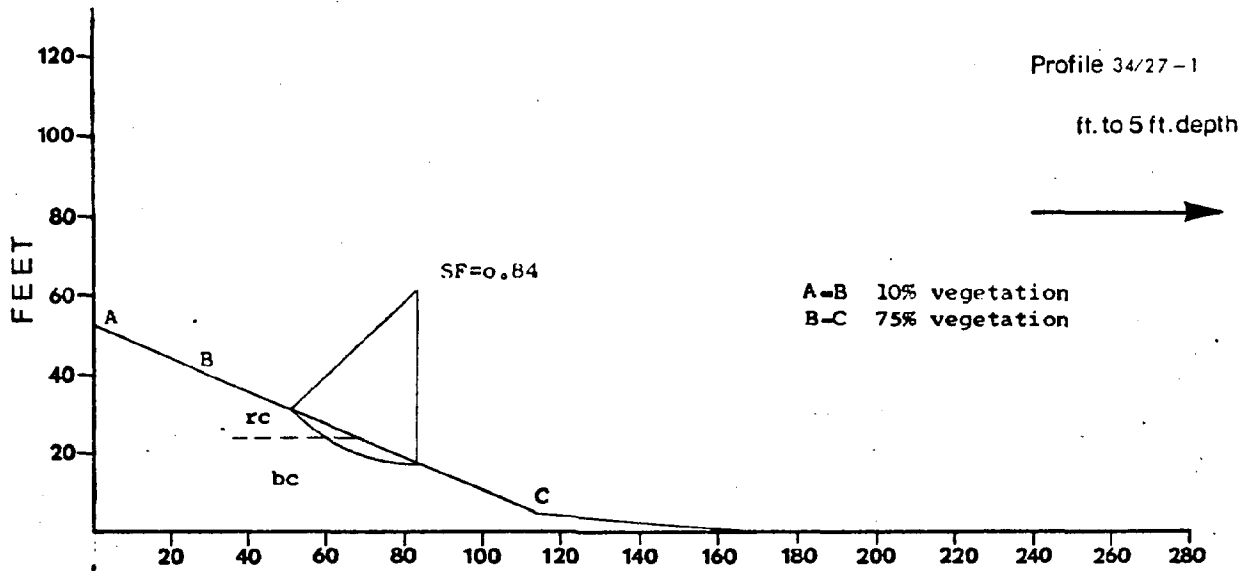
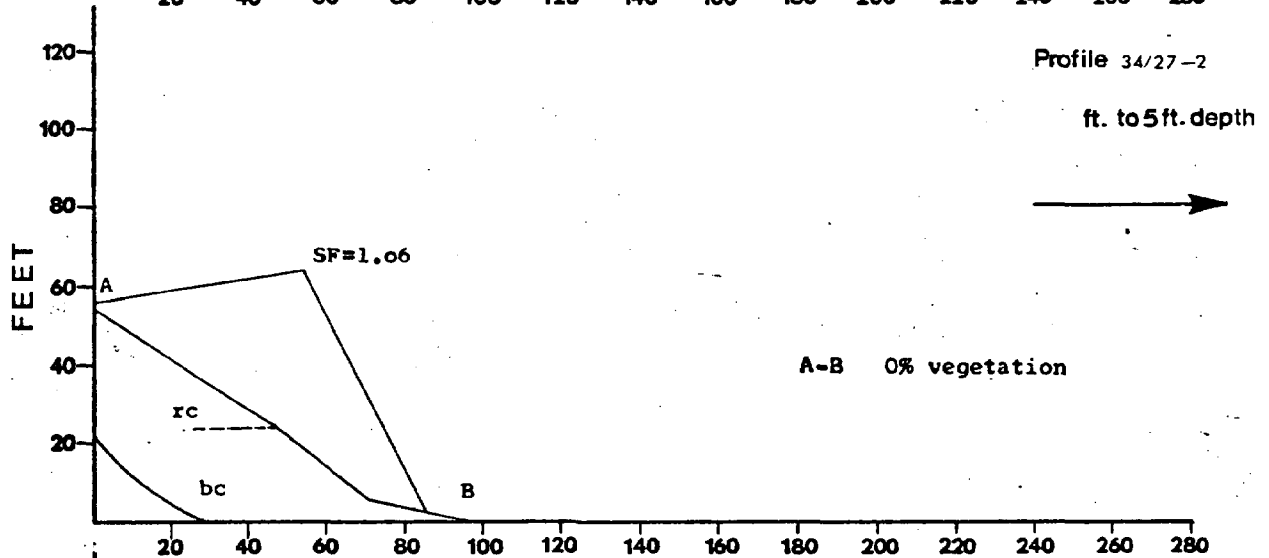
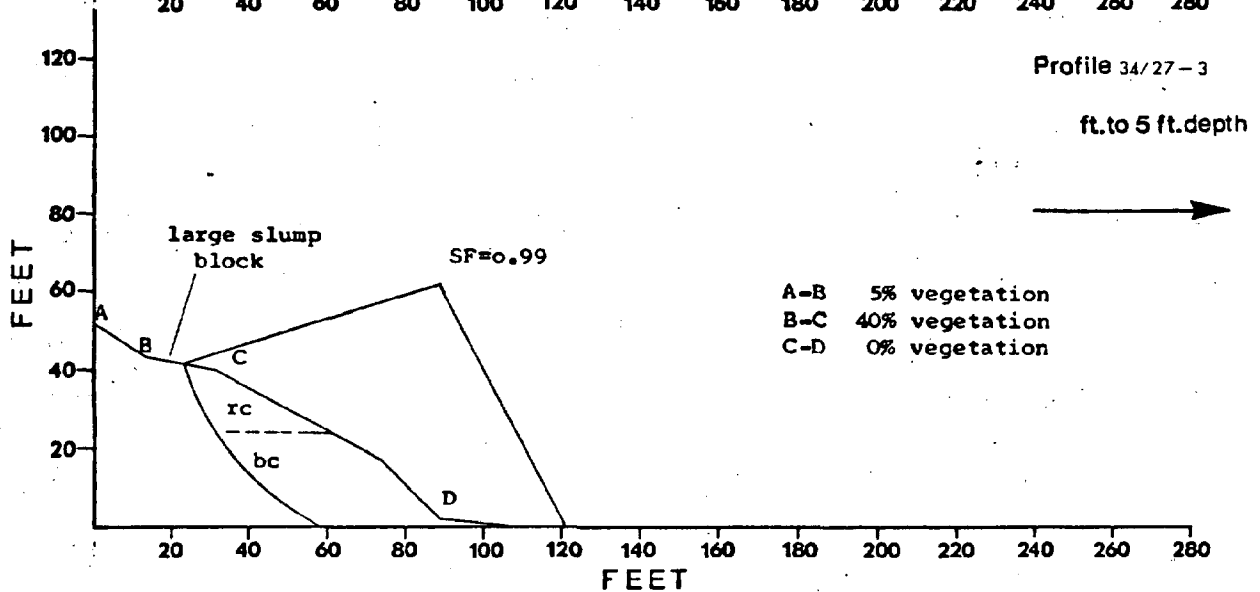
T.49 N., R. 12 W., Sec. 34/27

- a) absent- toe water
- b) maximum of 80 ft; 0 ft at both ends; coarse sand with cobbles scattered-pebbles concentrated near water
- c) absent
- d) 0-5 ft widening eastward to 50-60 ft at river coarse sand with pebbles and granules concluded near water
- e) spit and beach 80-100 ft wide; coarse sand with some boulders and cobbles at water
- f) 20-30 ft; coarse sand with scattered cobbles; occasional concentration of pebbles and granules at water
- g) 0-10 ft discontinuous; coarse sand, boulders frequent

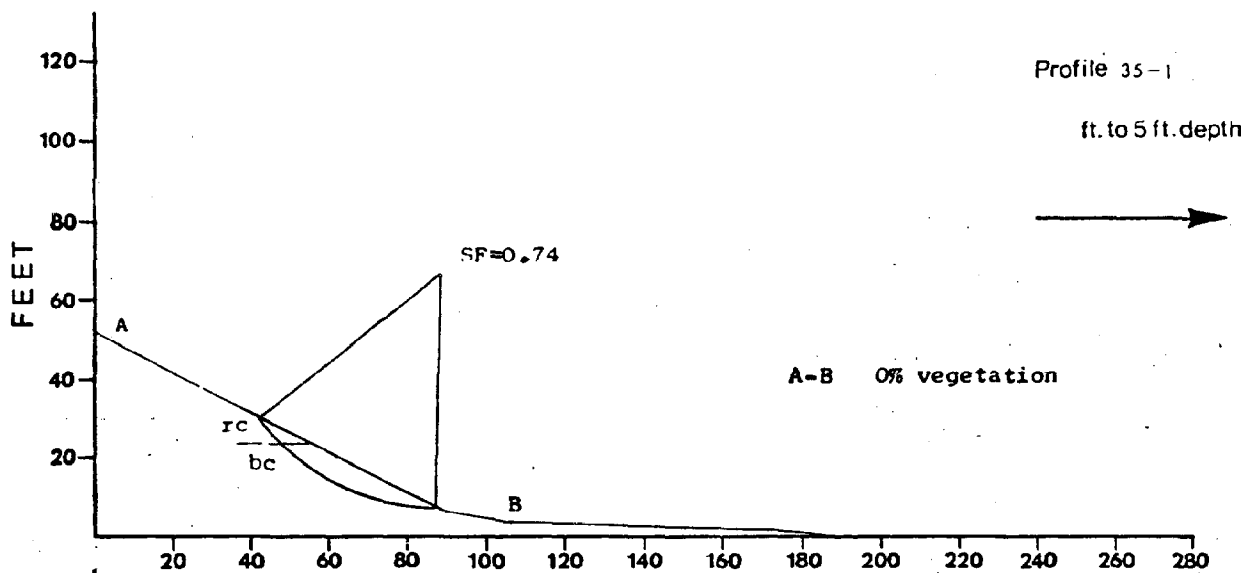
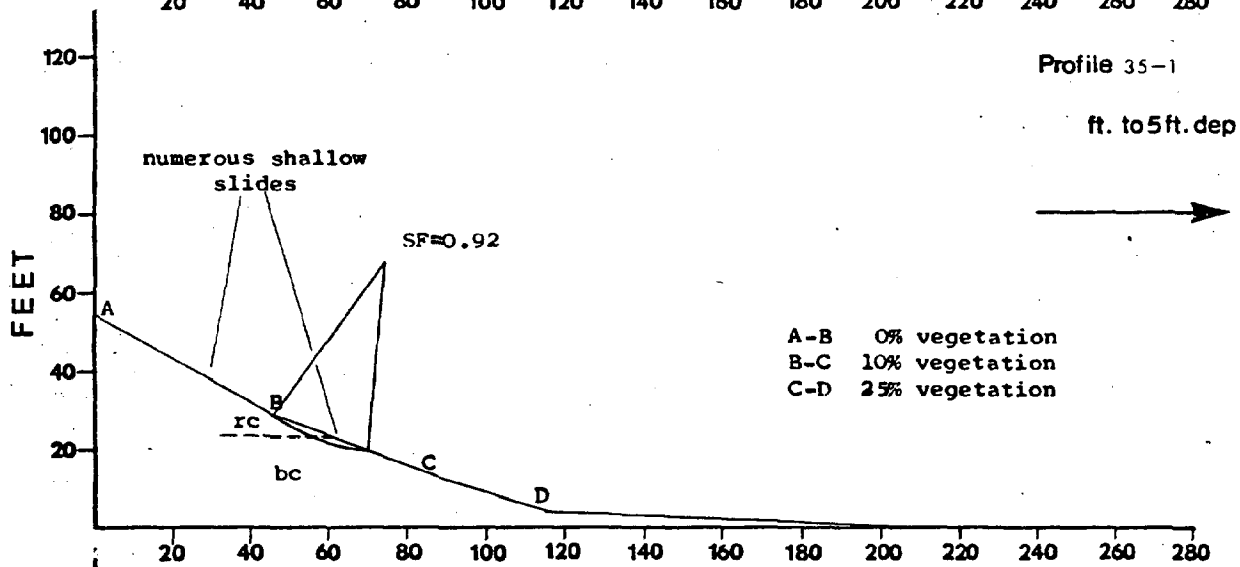
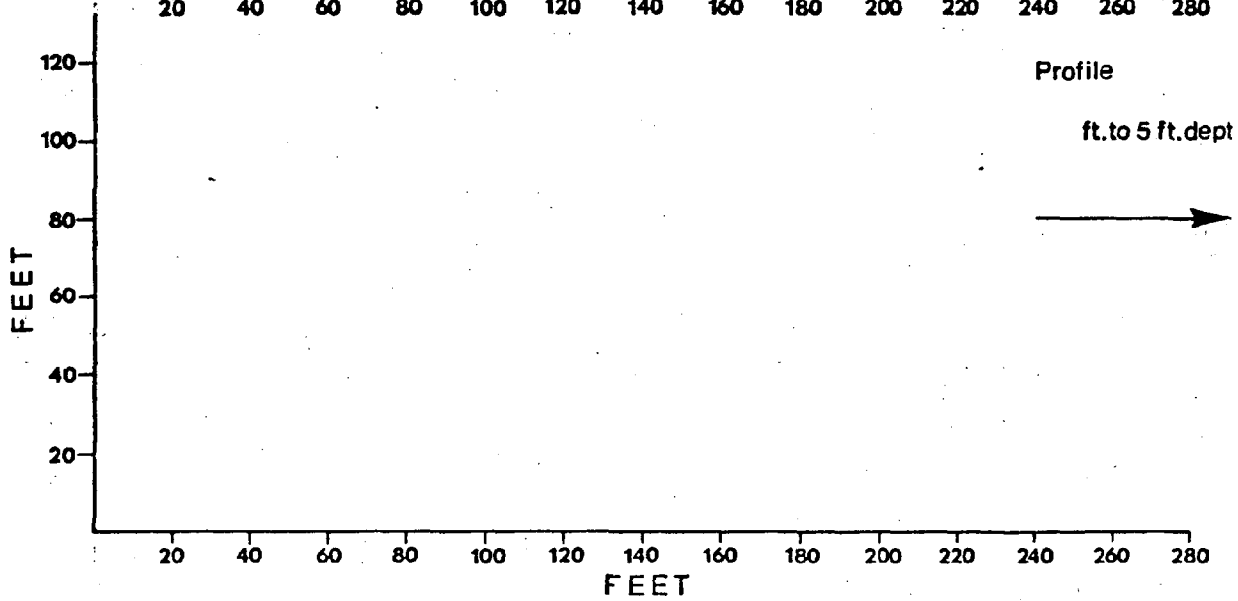
T.49 N., R.12 W., Sec.35

- a) 50 ft dropping to 0 ft; shallow slide and block fall; 0% vegetation, red and brown clay
- b) absent
- c) rising to 50 ft; eastward shallow slides; flows from top 0-5 to 40-50% alder and grass; two clay units
- d) 30 ft falling to 0 ft; no failure seen; vegetation 95-100%, birch, alder, grass, horsetails
- e) 50-55 ft; shallow sliding and flows from top; vegetation usually 0-20% alder grass slumped clay
- f) 30 ft falling to 0 ft; no failure seen; vegetation 95-100%, birch, alder, grass, horsetails
- g) absent gentle graded slope - well vegetated
- h) 0 ft rising to 30 ft; shallow slides and some block fall; 10-20% tree-clumps and horsetails, slumped clay

- a) mostly absent; interfingering with clay flows
- b) 40 ft coarse sand with pebbles concentrated near water
- c) 60 ft; coarse sand, pebbles near water
- d) absent Middle River
- e) 60-80 ft coarse sand; pebbles near water; includes spit

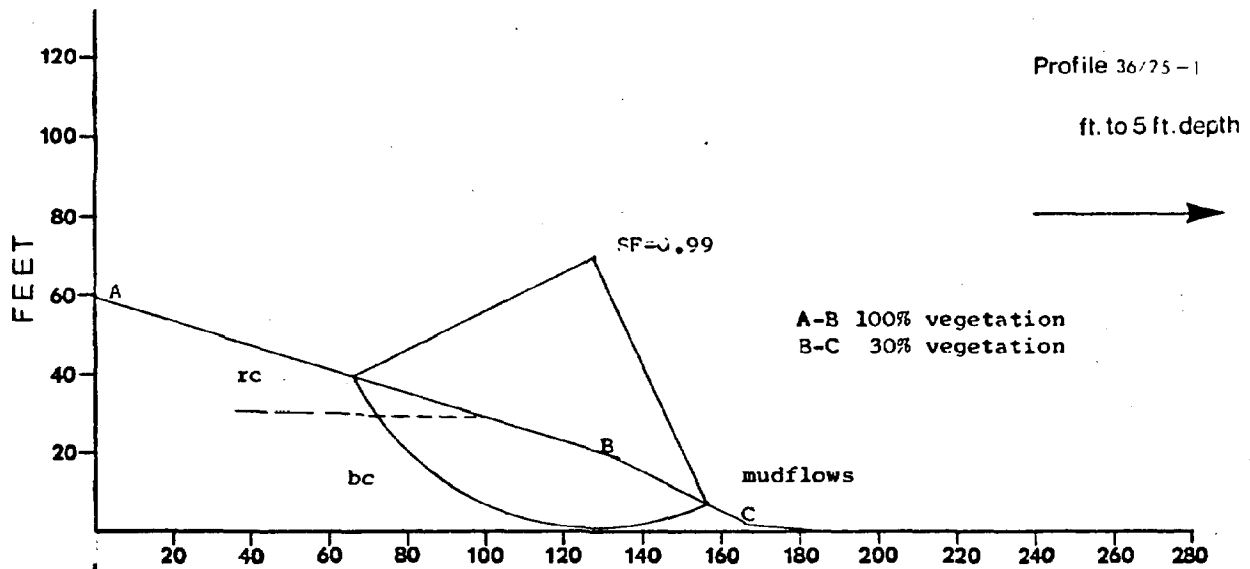
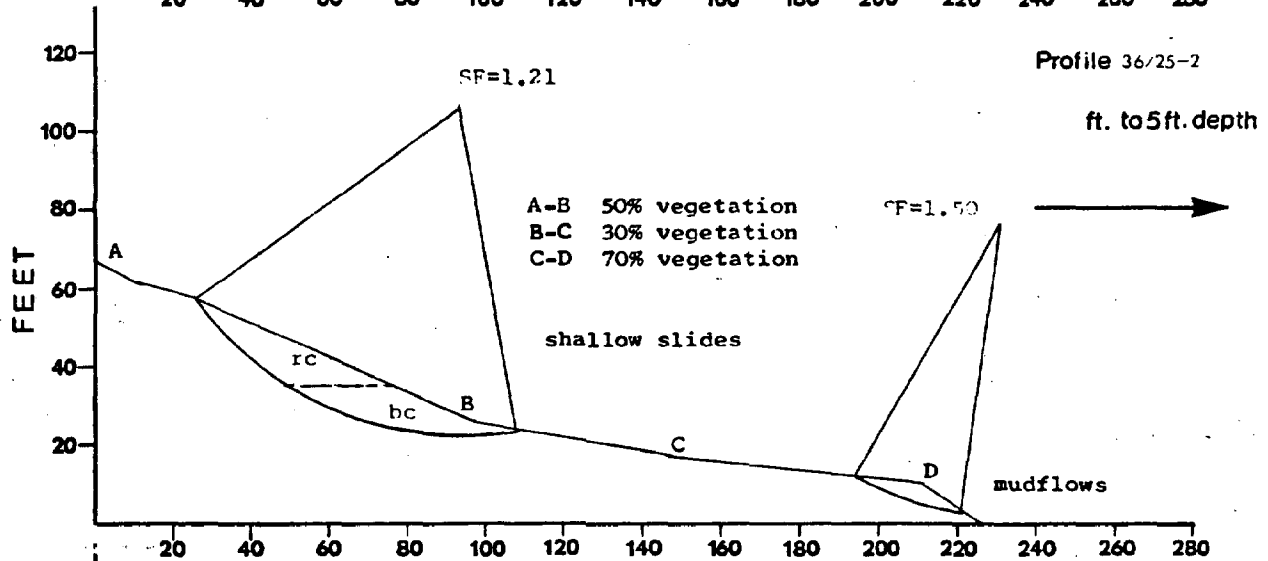
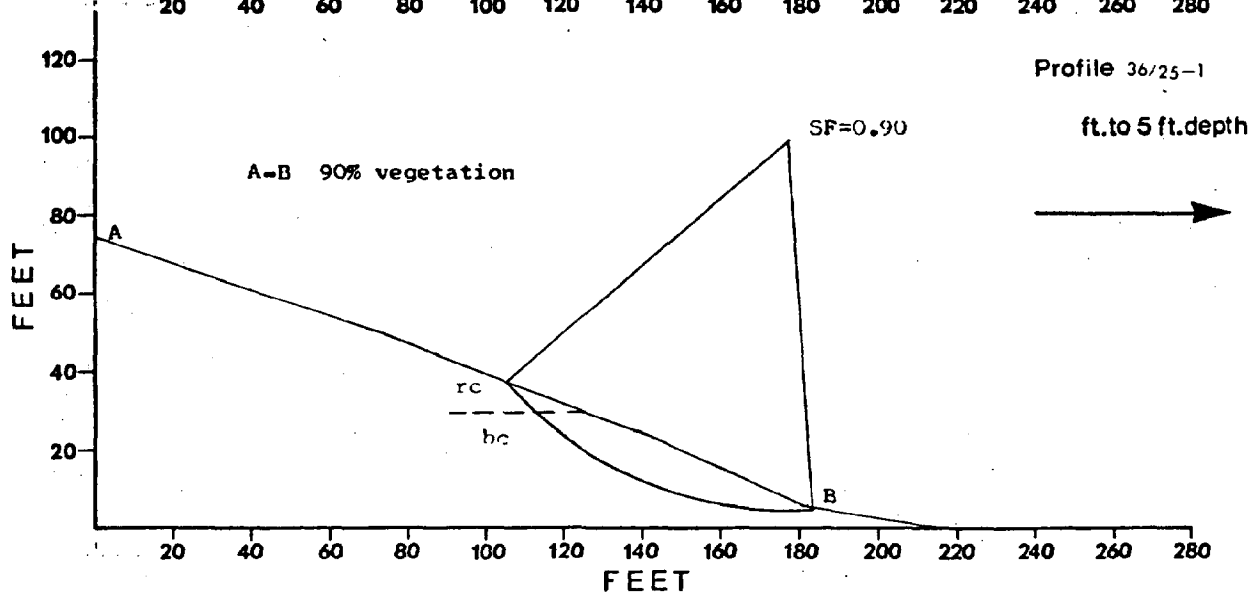
T.49 N., R.12 W., Sec. 36/25

- f) 30-60% vegetation with birch and alder with grass in clumps moving downslope, Horsetails on recent failures; red clay with brown and red clay towards base; shallow slides, bluff height 65-75 ft and constant except where it drops to meet a creek.

- a) narrows to the east from 50' to 15', sandy with concentration of pebbles and granules 10' from shore
- b) 3-15' wide; sandy with scattered pebbles; in places beach consists only of swash zone
- c) 20-50' wide; sandy with pebble concentration 10' from shore

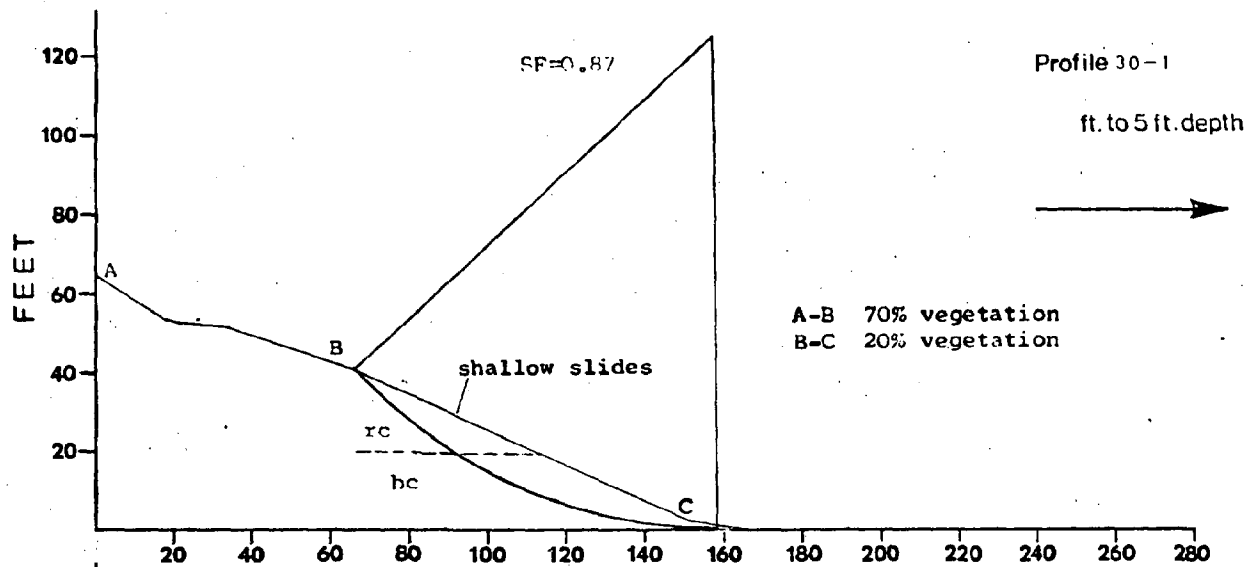
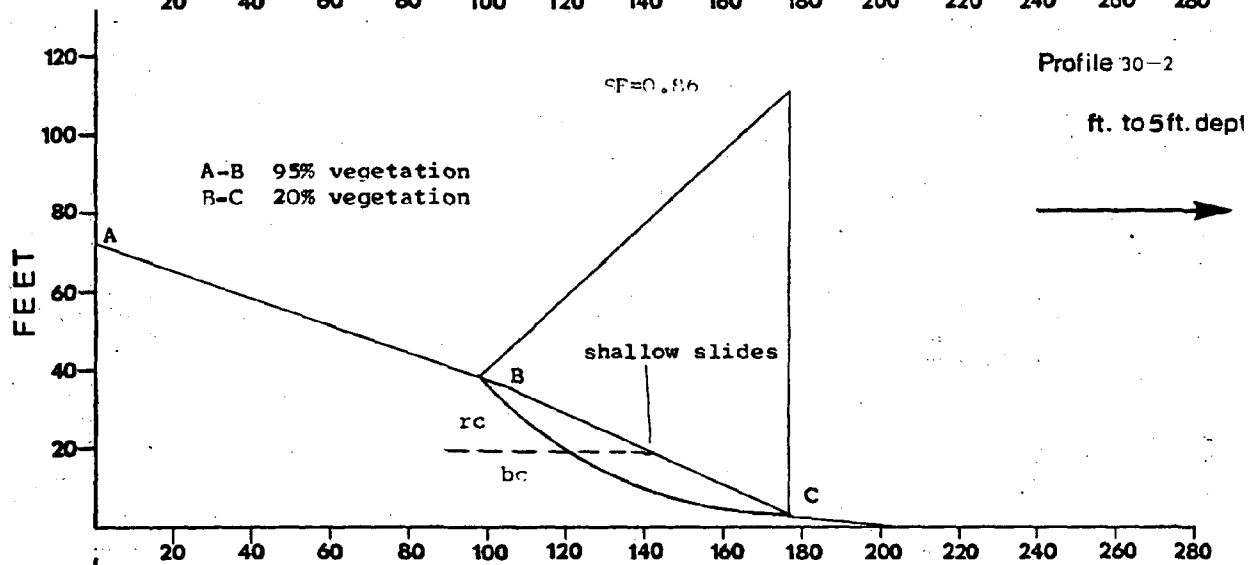
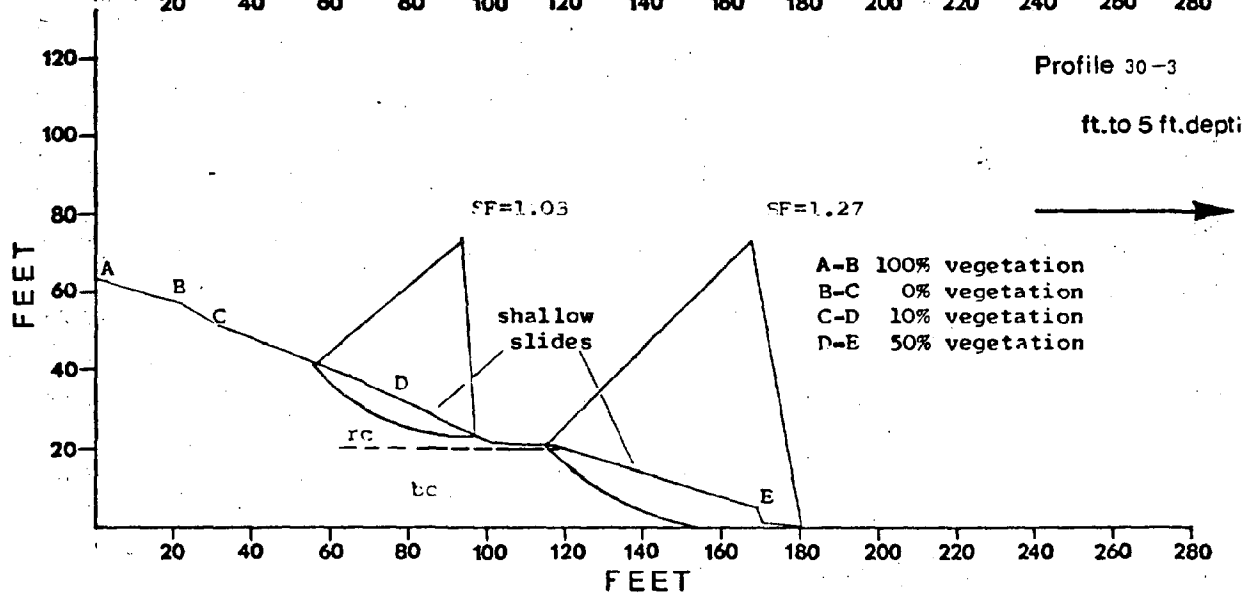
T. 49 N., R. 11 W., Sec. 30

- a) 30' wide; sand with pebbles at shore
- b) 3-15' wide; width variable; sandy with pebbles; beach occasionally consists only of swash zone
- c) 30-50' wide; sandy with pebbles at shore; extensive driftwood towards Poplar River
- d) 10-20' wide; width fairly even; sandy
- e) 0-15' wide; width variable; sandy with occasional cobbles and numerous slumped trunks

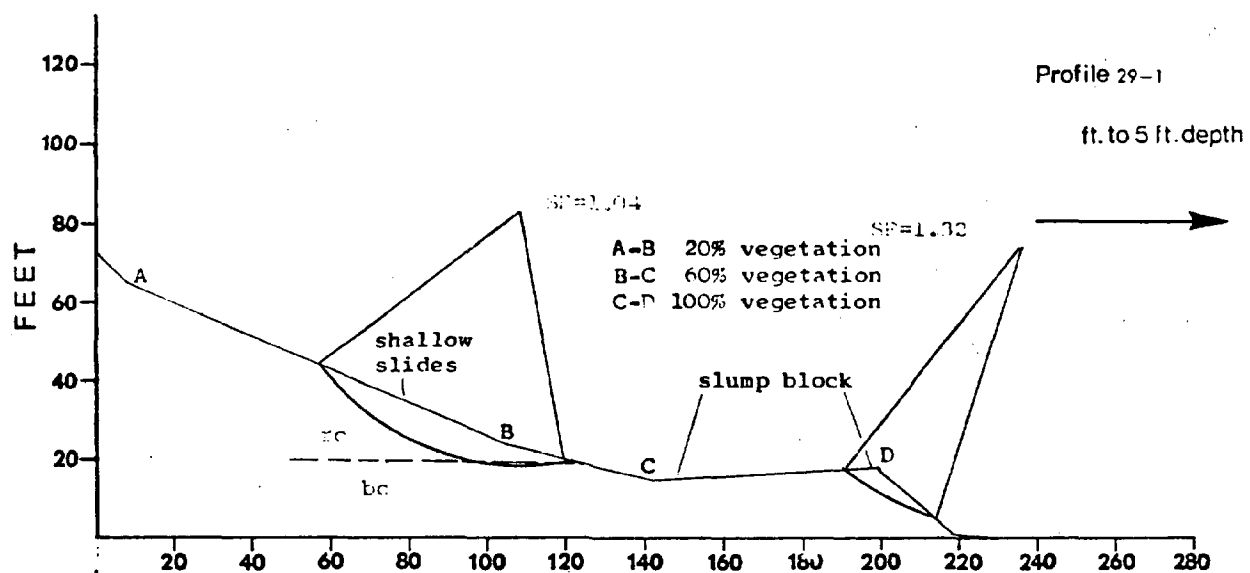
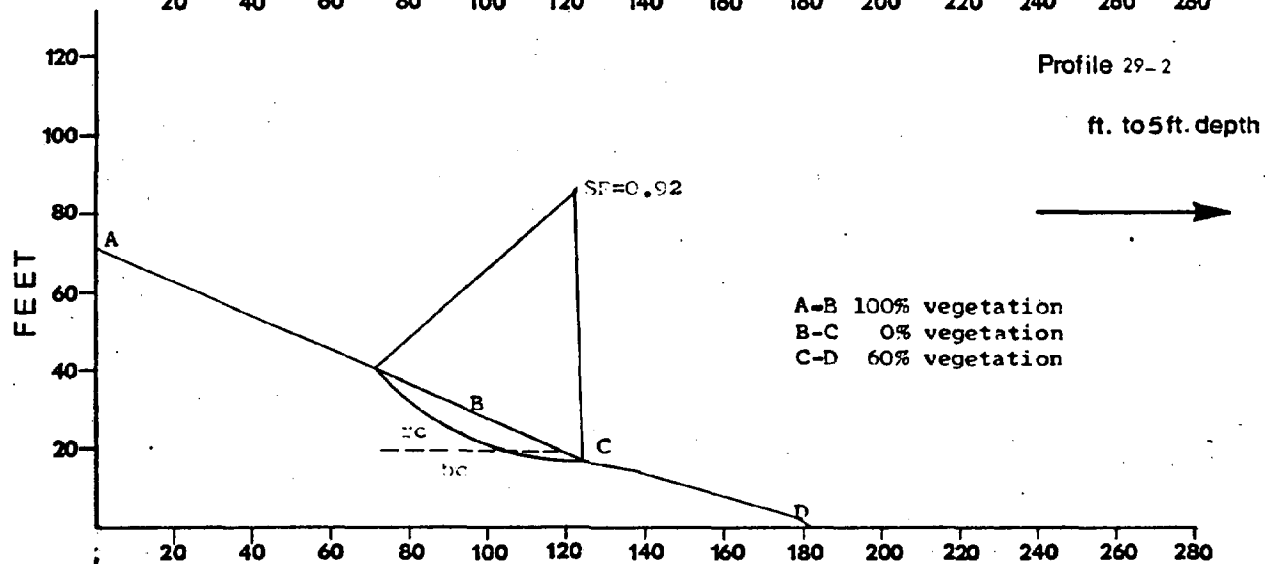
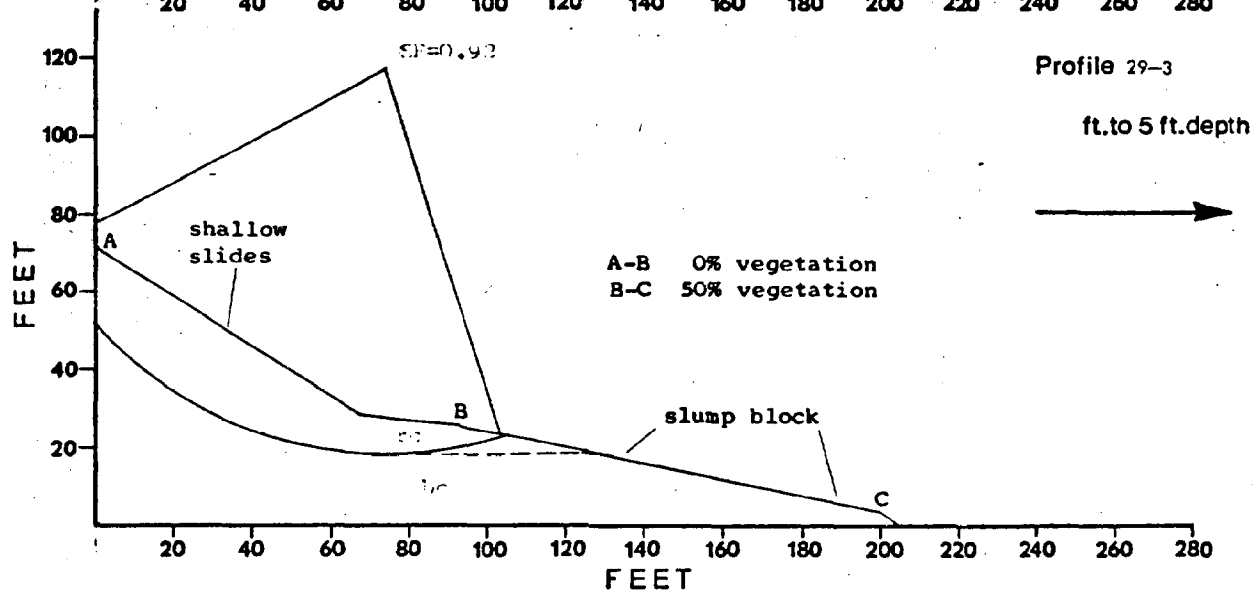
T. 49 N., R. 11 W., Sec. 29

- a) 0-10' wide; width variable; sandy few pebbles, patches of cobbles
- b) 15-20' wide; sandy with pebbles near shore
- c) 0-15' wide, width variable; sandy with pebbles near shore
- d) 15-20' wide; sandy with pebbles near shore

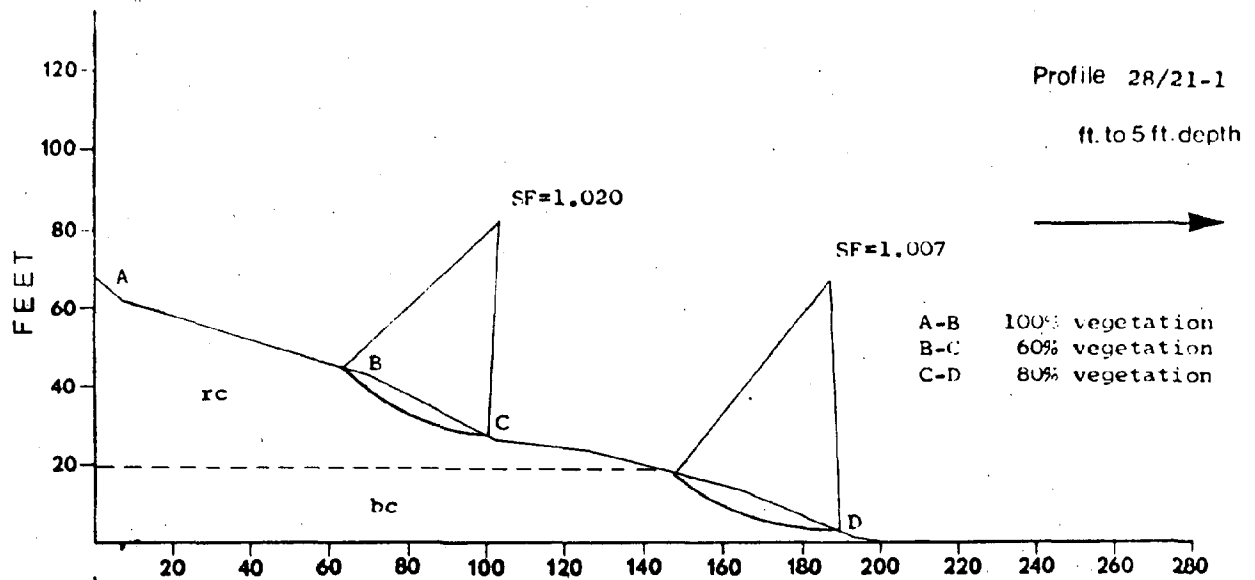
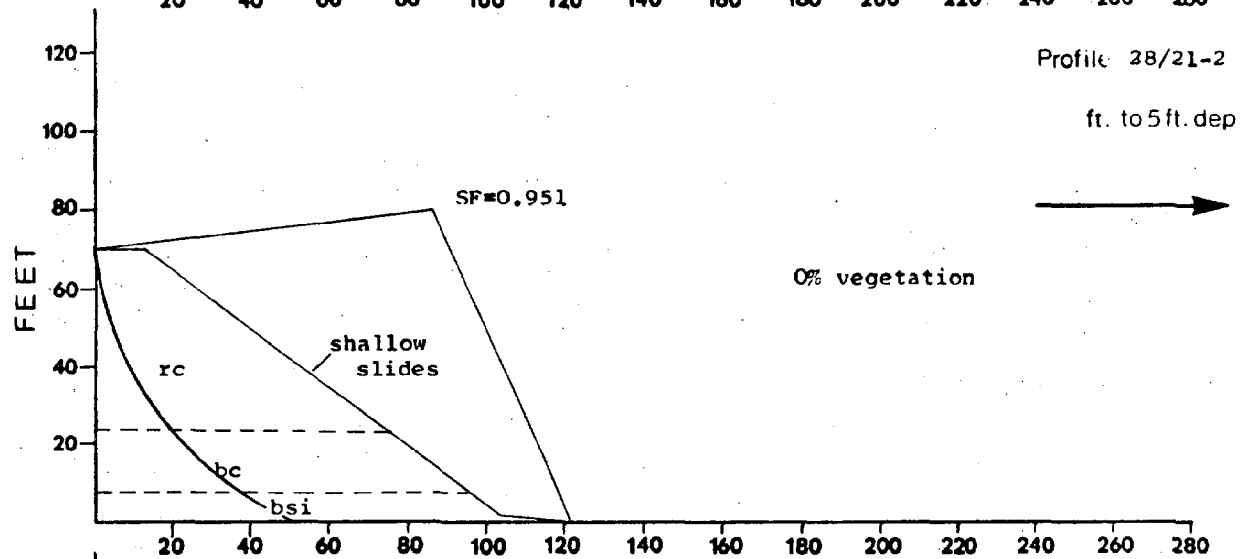
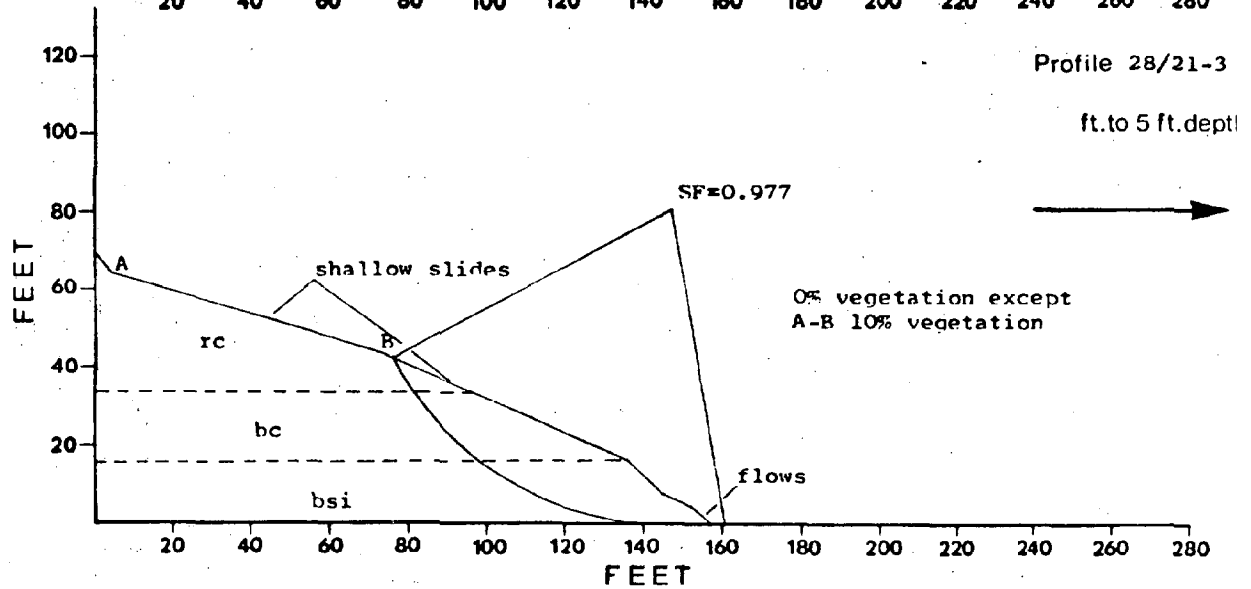
T. 49 N., R. 11 W., Sec. 28/21

- a) 20-25' wide; sand with scattered pebbles; width constant
- b) 8-15' wide; sand with scattered pebbles
- c) 0-8' wide; width variable; sandy with log litter and occasional boulders
- d) 8-50' wide; widens at mouth of Bardon Creek; sandy
- e) narrow sandy swash zone or beach absent: scattered driftwood
