# SHORE EROSION STUDY Technical Report

SHORELINE EROSION AND BLUFF STABILITY ALONG LAKE MICHIGAN  
AND LAKE SUPERIOR SHORELINES OF WISCONSIN

DOUGLAS AND WESTERN BAYFIELD COUNTIES  
WISCONSIN POINT TO BARK BAY

July 1980

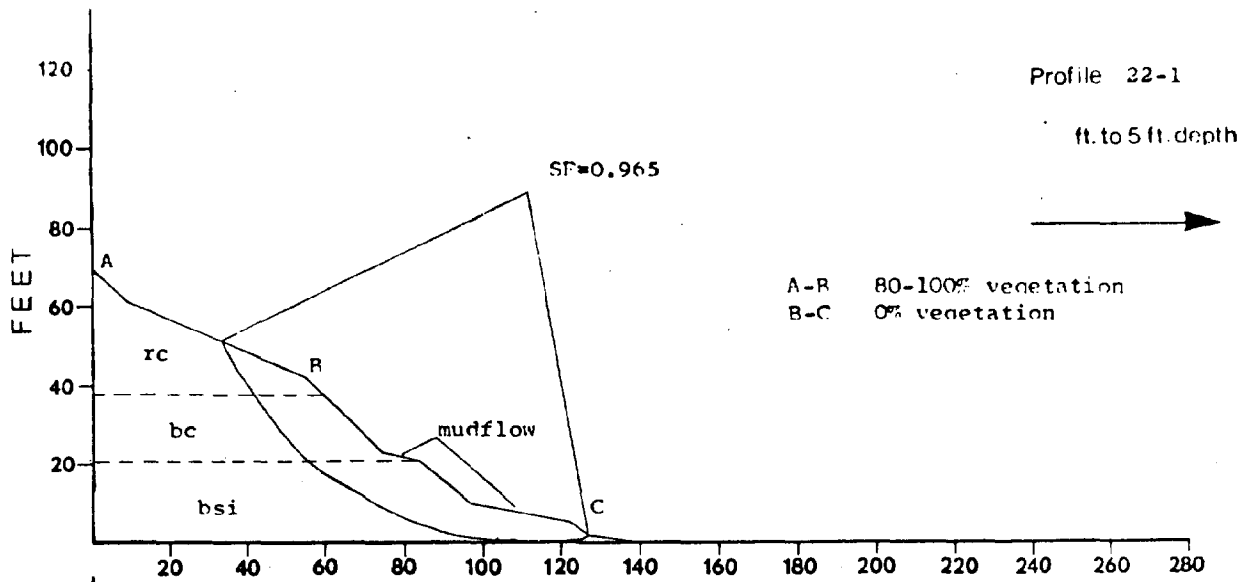
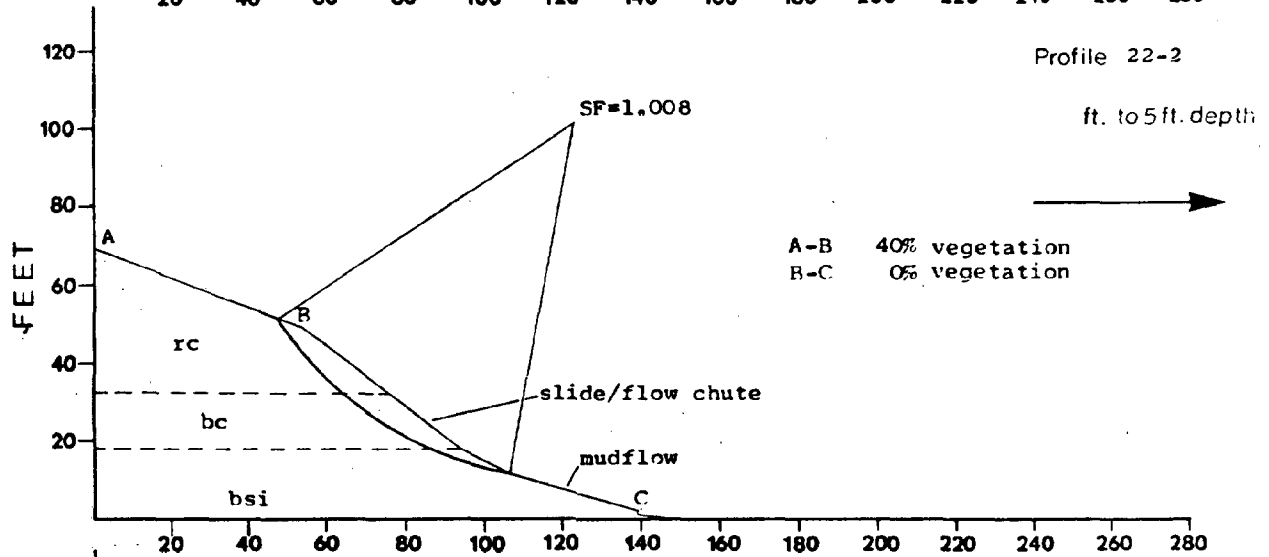
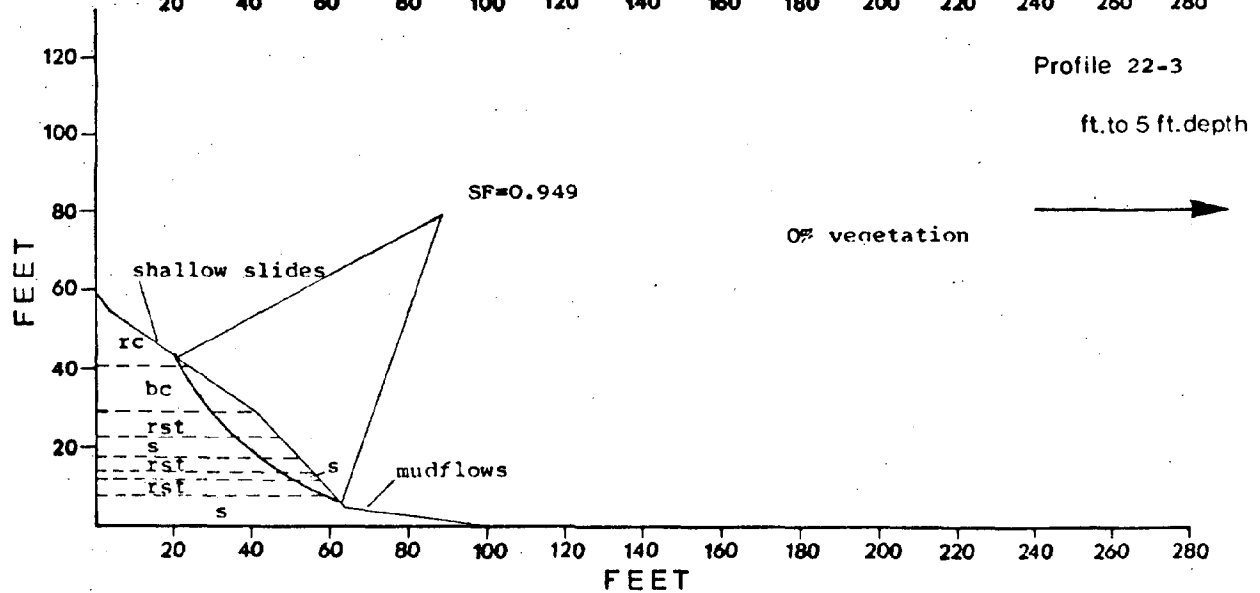
T.49 N., R.11 W., Sec. 22

- a) 10-25' wide, sandy with scattered pebbles; occasionally absent due to extensive flows
- b) 3-8' wide, width variable; sandy; occasionally absent due to slump blocks and mudflows
- c) 10-25' wide; sandy, with scattered pebbles
- d) 40-50' wide; sandy, cobbly in swash zone and 20' back

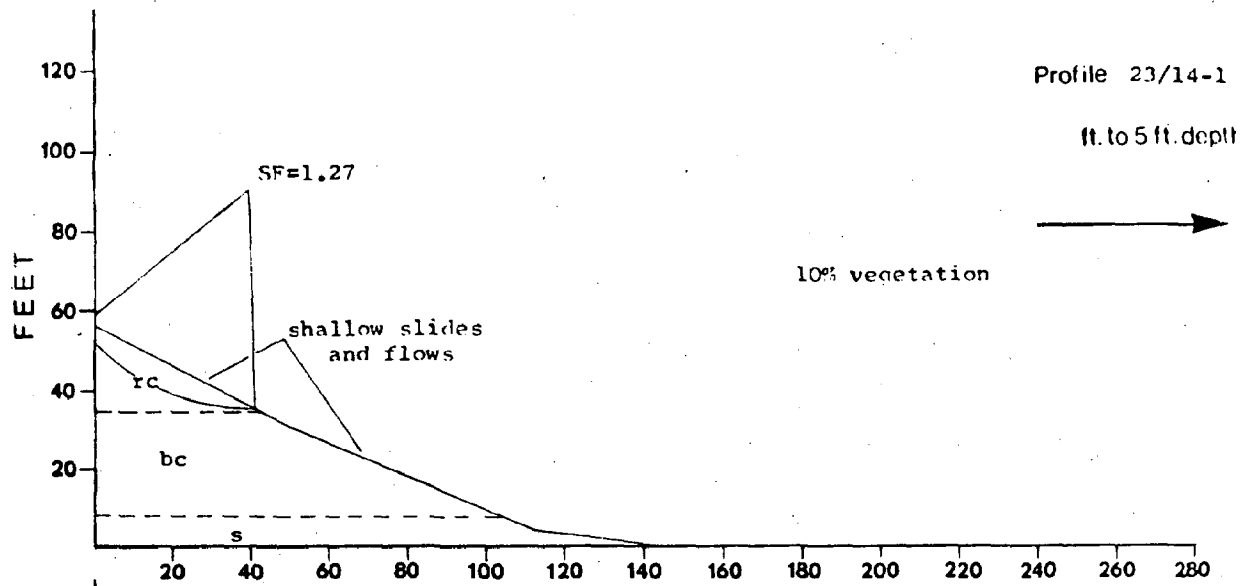
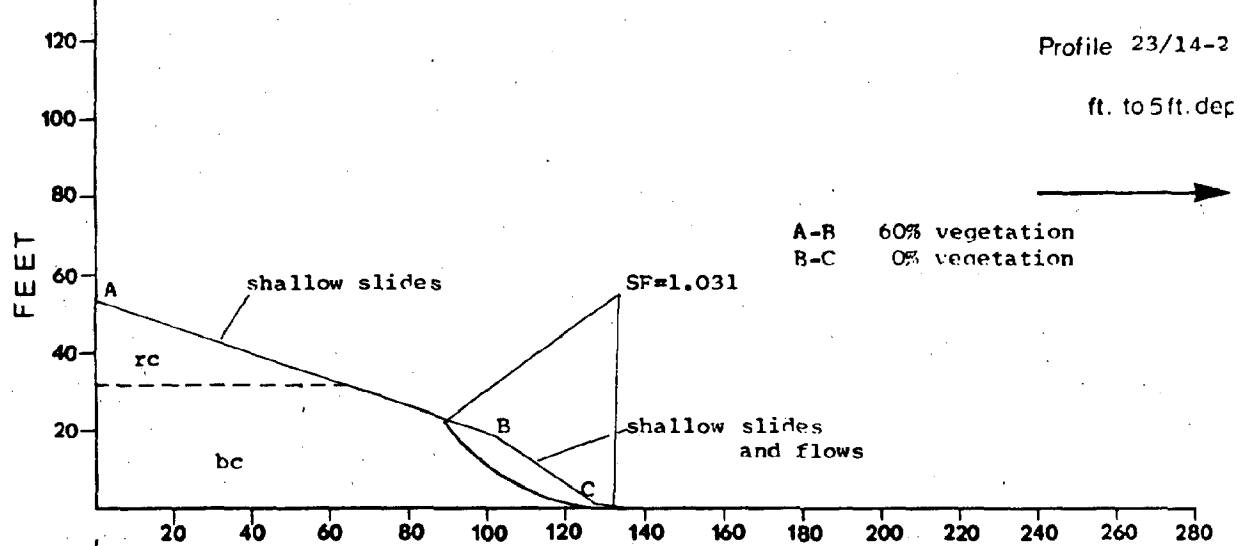
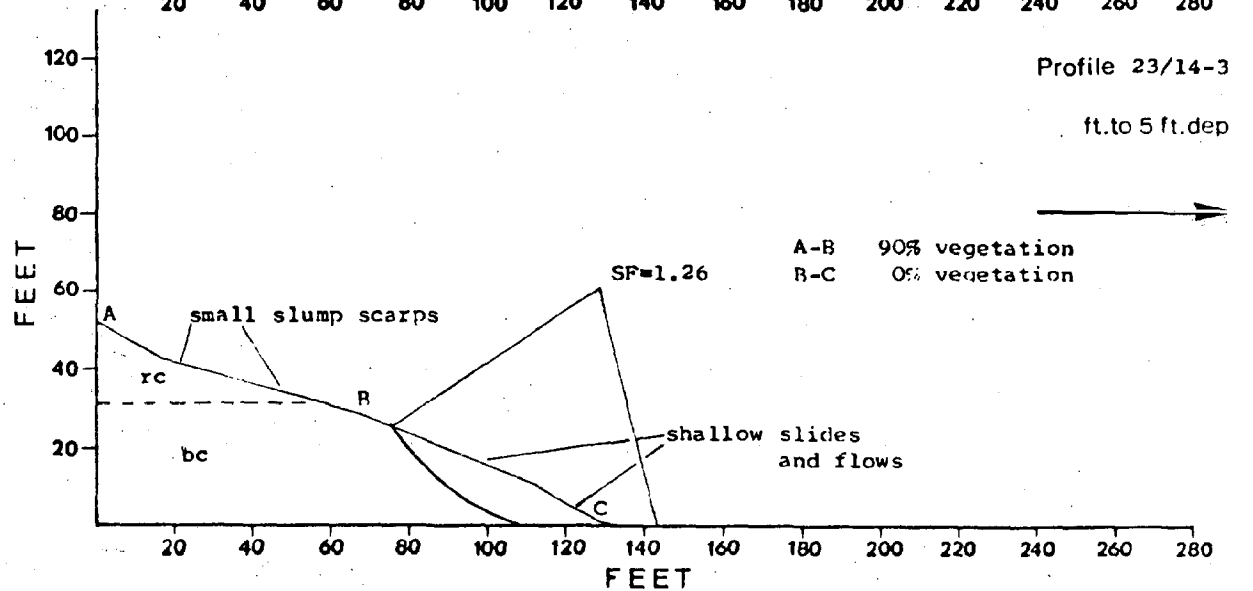
T.49 N., R. 11W, Sec. 23/14

- a) 10-20% vegetation with occasional alder or birch clump; red to brown clay over sand with till; shallow slides and mudflows; 55-60 ft high; crest fairly even; sand with till forms bench.
- b) 10% vegetation; with grass tufts and birch clump; steep failing slope; red to brown clay over sand with till; 60-65' high
- c) 80-90% vegetation; horsetails and alder; hummocky rounded bluff face; clay over sand with till (?); even crest 55-60'
- d) 50% vegetation with grass birch and alder, red over brown clay: shallow slides with scarps common: 50-55' with even crest

- a) 3-8 wide; sandy with cobbles and boulders; occasionally absent
- b) 20-30' wide; sandy with scattered pebbles; lots of driftwood
- c) 3-8' wide; sandy with occasional boulders; occasionally absent
- d) 20' wide; sandy with pebbles at shore
- e) 3-8' wide; sandy with occasional boulders, occasionally absent

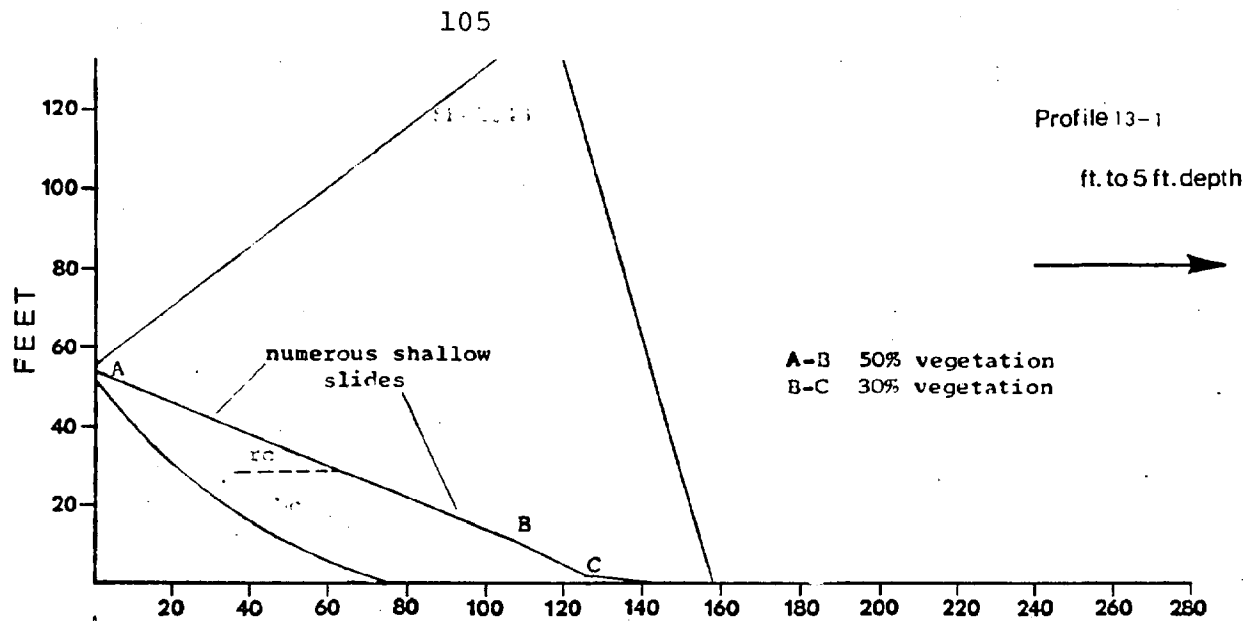
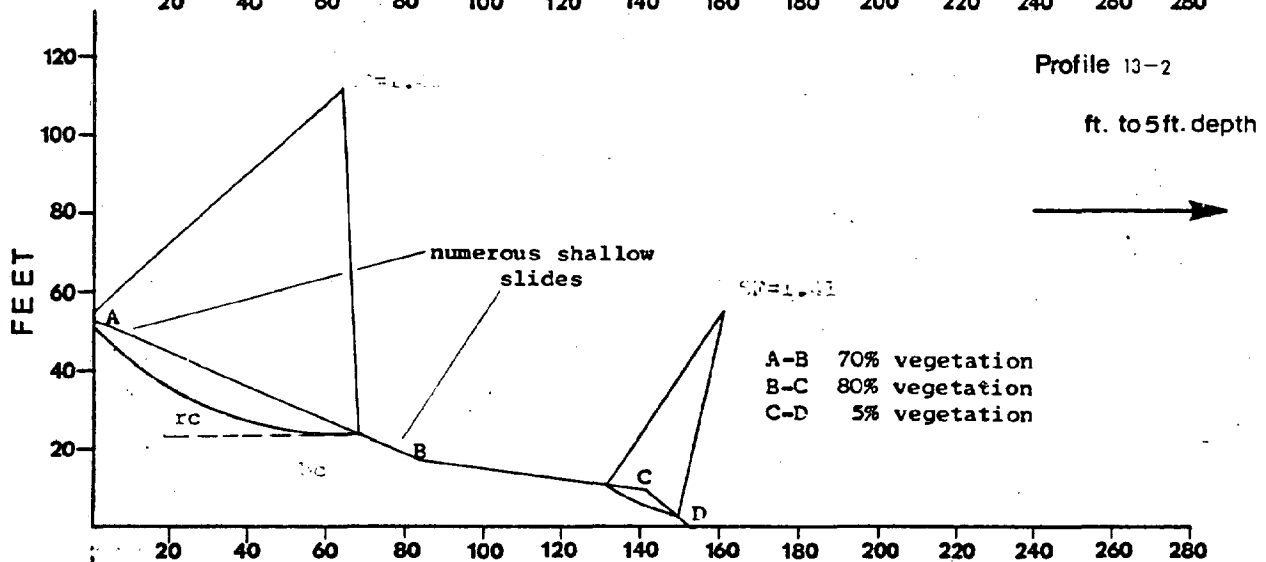
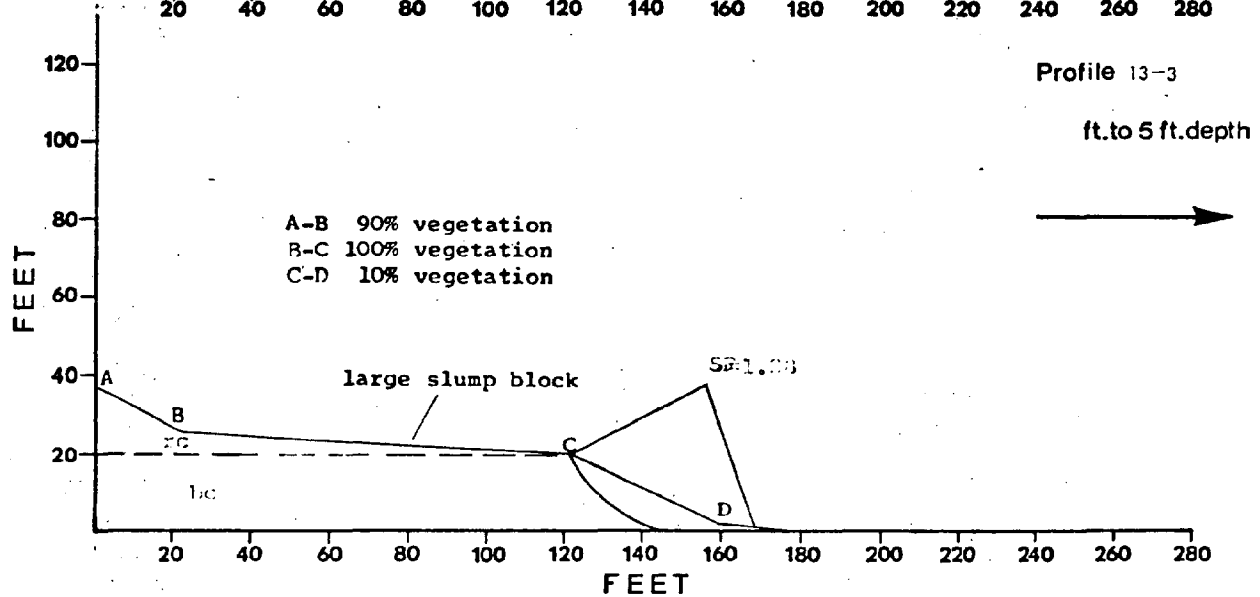
T.49 N., R. 11 W., Sec. 13

- a) 50-55 ft; crest scalloped and scarped; shallow sliding slumps; 70-90% alder and grass silty clay over clay
- b) absent-estuary
- c) 50-55 ft; single block slide with shallow failure above and below; 60% alder and grass; slumped silty clay over clay
- d) 40-50 ft. declining to east; crest scarped and scalloped; poorly expressed single block failure; numerous shallow failures - hummocky; vegetated 40-80% birch, alder and grass, horsetails; silty clay over clay
- e) 35-40 ft; broadly scalloped; single-block moderately-deep slide, shallow sliding on main and toe scarps; vegetated 70-90% alder and grass

- a) 15-20 ft; discontinuous, coarse sand with boulders offshore
- b) 40 ft; coarse sand with pebbles boulders at water
- c) 0-5 ft; coarse sand, boulders offshore under waves
- d) 15-20 ft, discontinuous; coarse sand, boulders offshore
- e) absent-boulders
- f) 10-15 ft; coarse sand boulders offshore

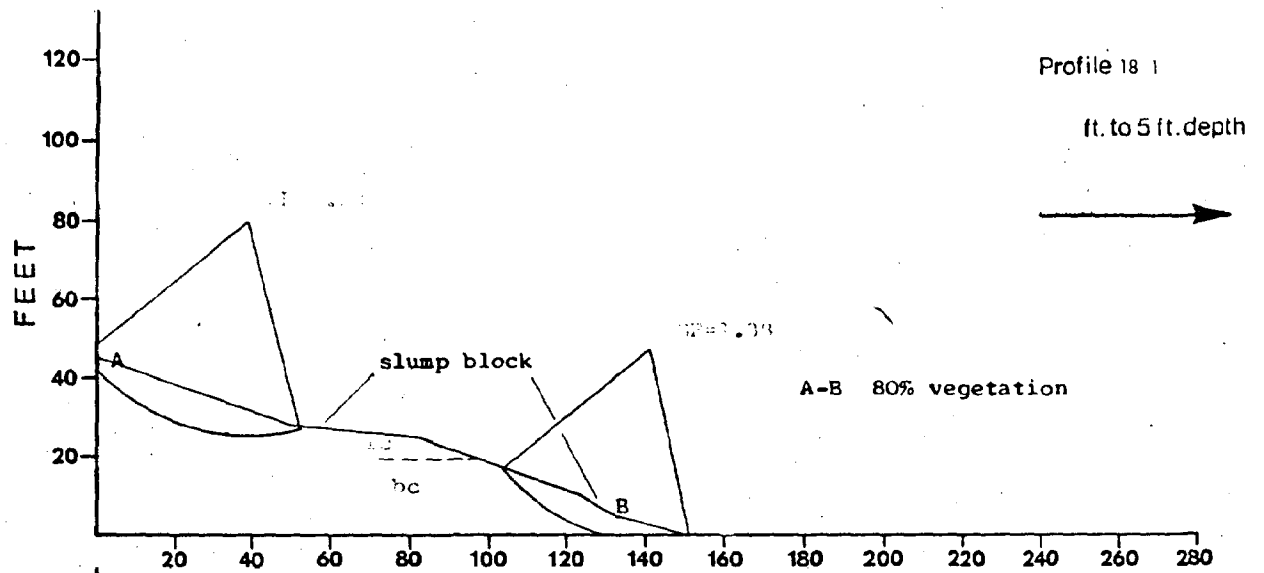
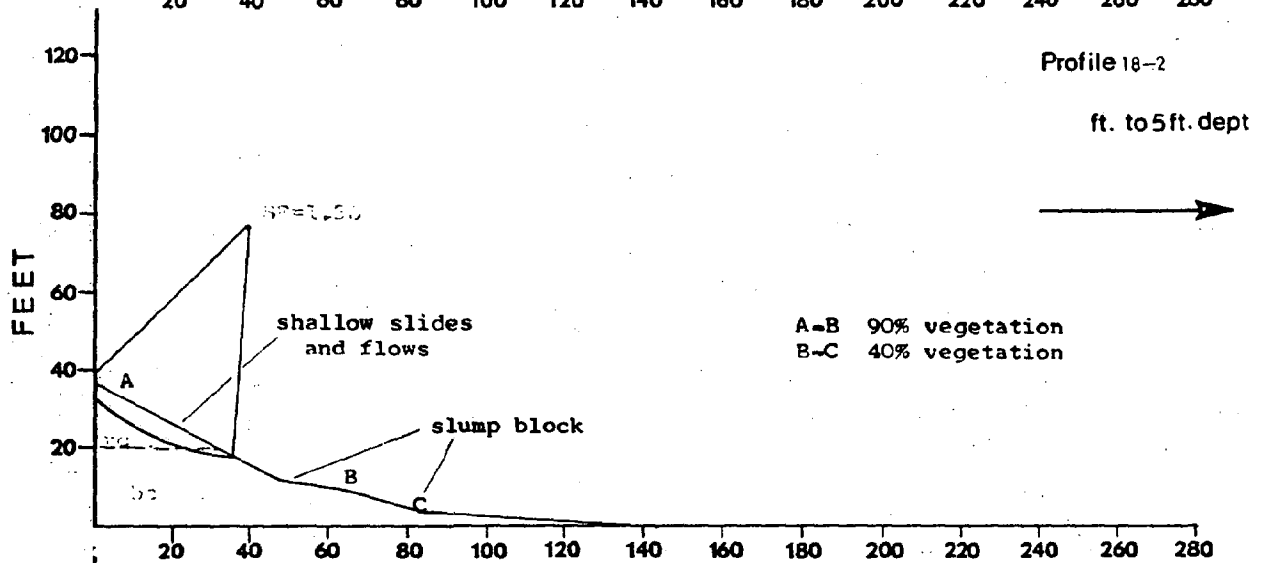
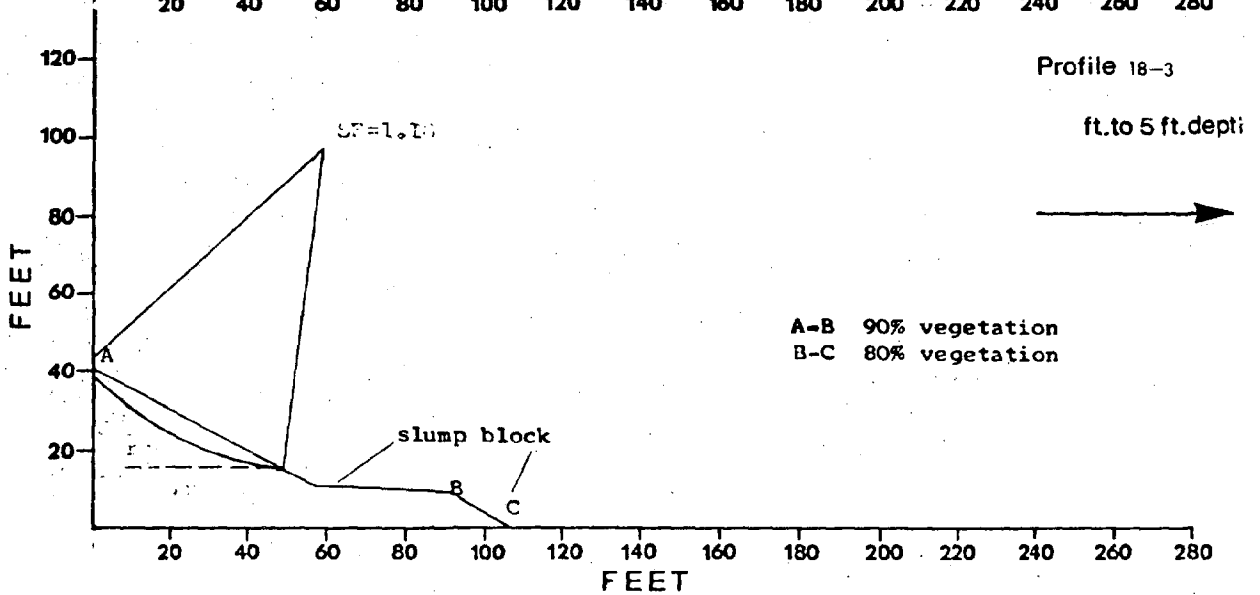
T. 49 N., R. 10 W., Sec. 18

- a) 50 ft at west, dropping to 35 in middle and rising back to 40 ft at east; crest broadly scalloped, both scarped and rounded; failure is by many processes and is quite varied spatially: large rotational slumps, slides and flows on slump scarp; brown silty clay; birch, alder, grass, moss and horsetails.

- a) 10-20 ft, discontinuous coarse sand with boulders frequent offshore
- b) 60-70 ft; coarse sand with boulders frequent offshore
- c) absent; boulders offshore

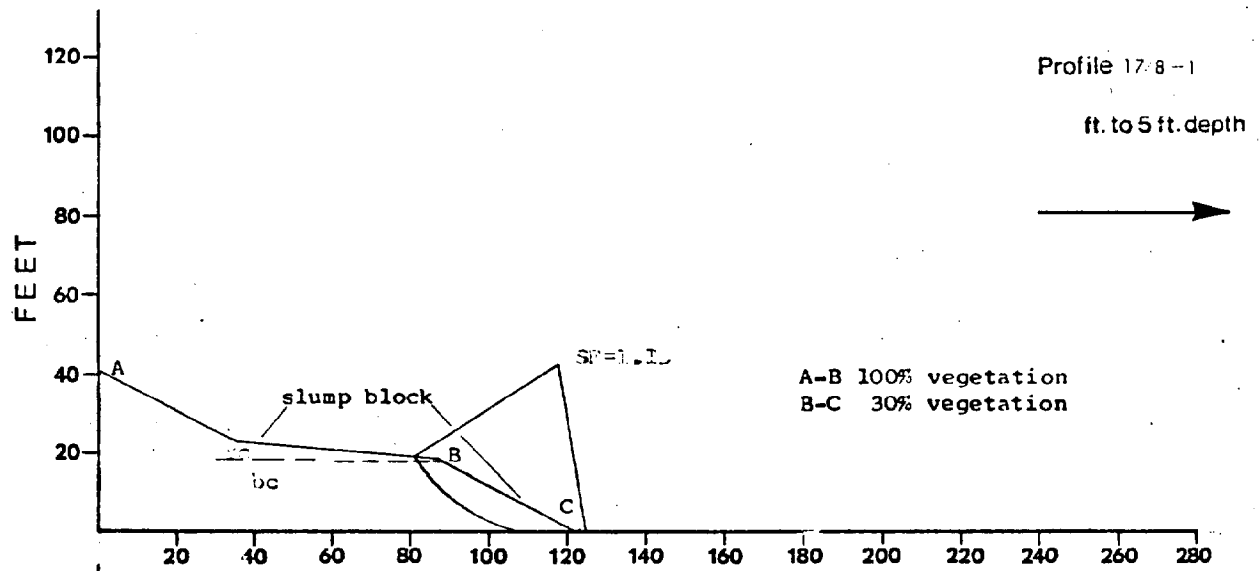
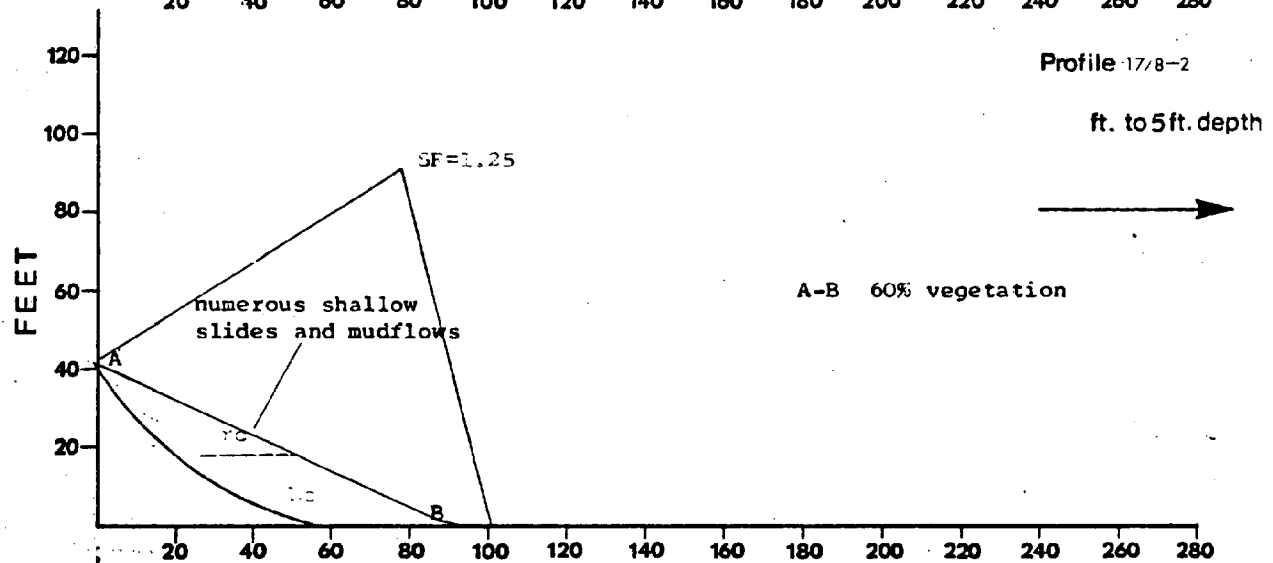
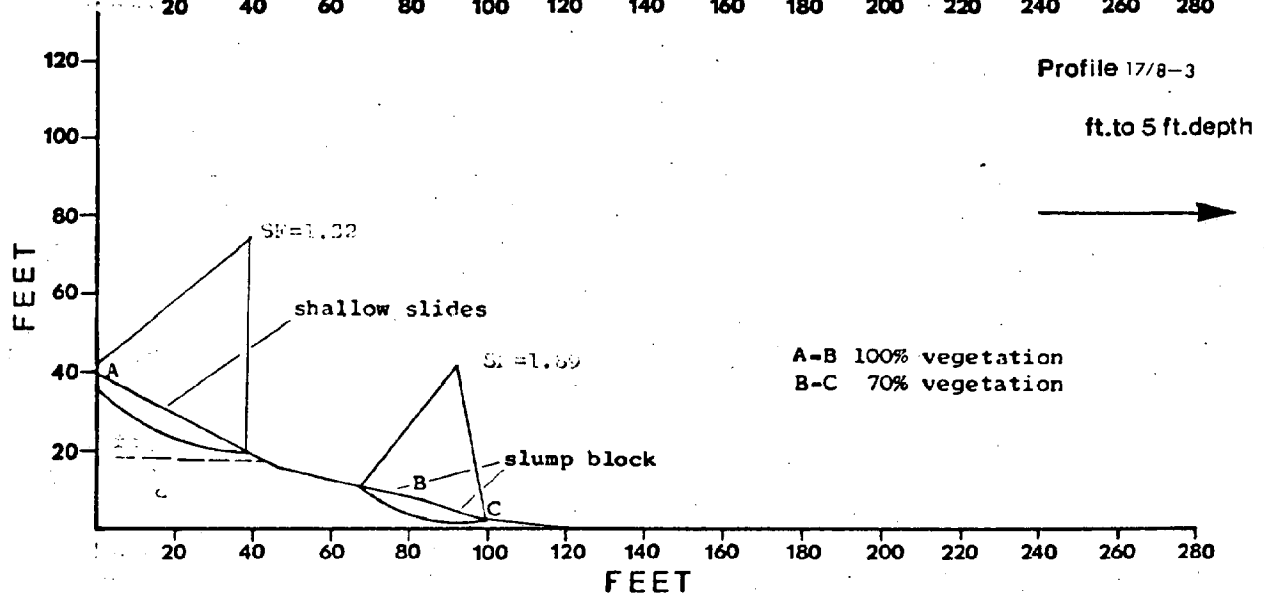
T. 49 N., R. 10 W., Sec. 17/8

- a) 35-40 ft; crest broadly scalloped, scarped or rounded; single moderately deep slide, shallow sliding and flowing on main scarp and toe; vegetation 70-90%, birch, alder, grass, horsetails; red-brown silty clay, mostly slumped
- b) 35-40 ft. crest scalloped and scarped; shallow sliding and flowing, lacks large single block failure; vegetation 40-60%, alder and grass moving down slope; silty clay
- c) absent - Smith Creek; boulders offshore
- d) 40 ft; crest scalloped, rounded; failing by single block, shallow slide, with sliding and flowing above; vegetation 80-90%, birch, alder, grass, silty clay

- a) absent, boulders offshore
- b) 10-20 ft; coarse sand often interrupted by toe-flows, boulders offshore
- c) absent - Smith Creek; boulders offshore
- d) 5-10 ft; coarse sand, 2-3 ft wave-cut face at water-line
- e) 40-60 ft. back half vegetated; 2-3 ft. wave-cut face 25 ft from water-line; coarse sand with concentration of pebbles near water, boulders
- f) 20-30 ft; coarse sand occasionally interrupted; concentration of pebbles near water: a .5ft wave-cut face 6-8 ft from toe, boulders

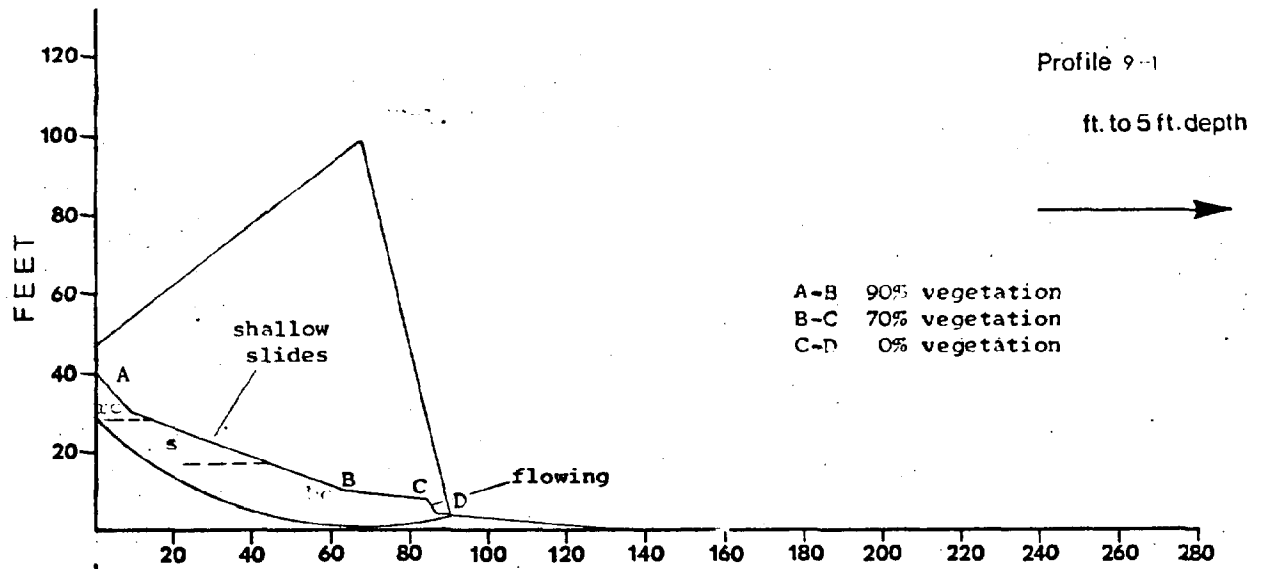
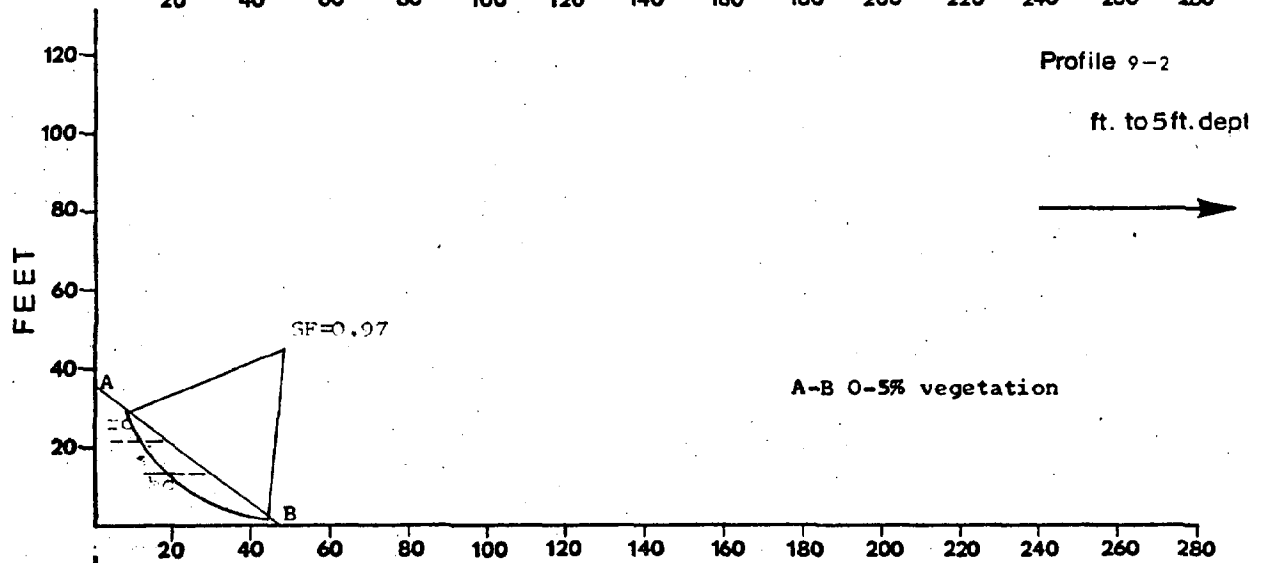
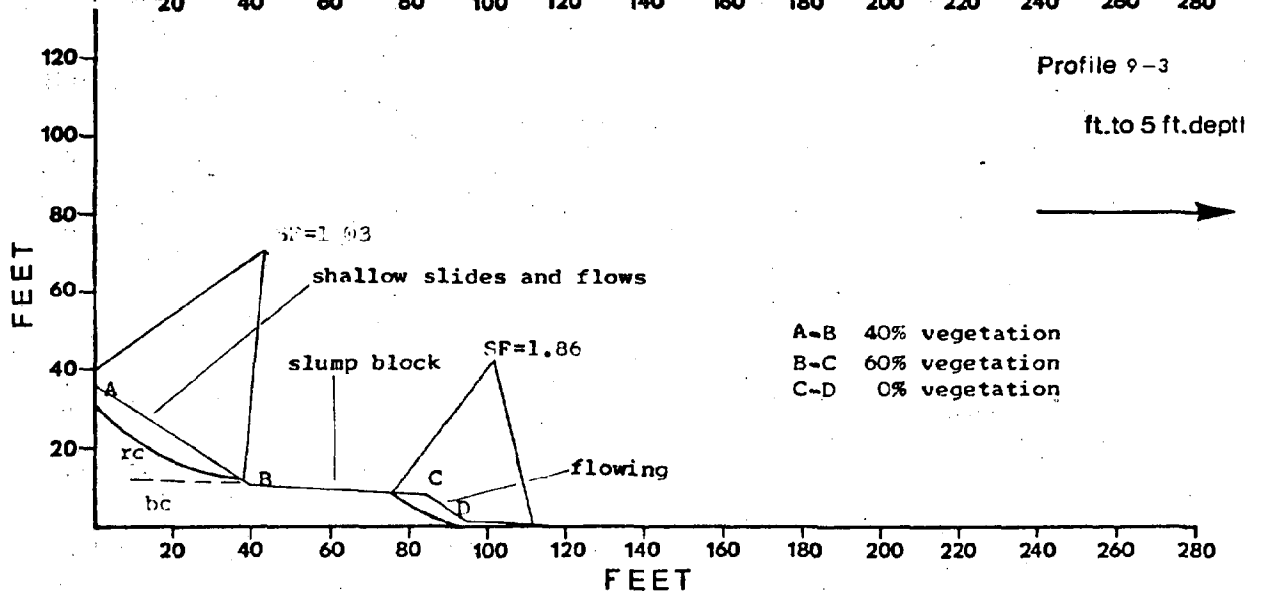
T.49 N., R. 10W., Sec. 9

- a) 30 ft; coarse sand with some pebbles at water; .5 ft. wave-cut face close to toe; boulders offshore
- b) discontinuous, interrupted frequently, 10-15 ft. coarse sand with boulders offshore
- c) 20-80 ft; broadest just west of stream and across estuary coarse sand with pebbles near water; 2-3 ft wave-cut face often present.

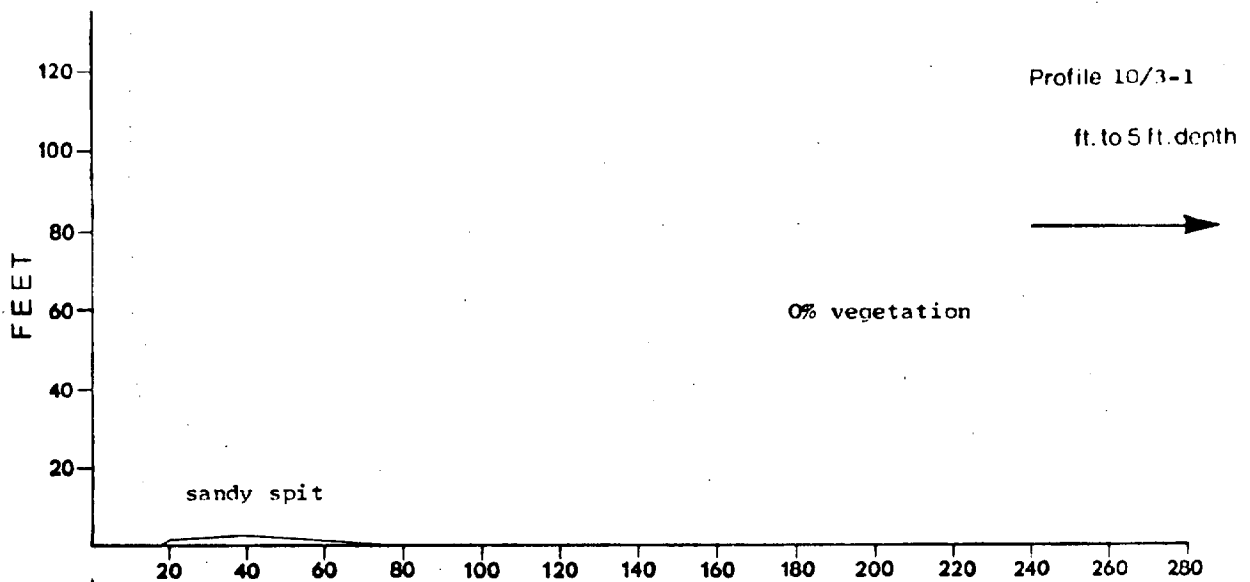
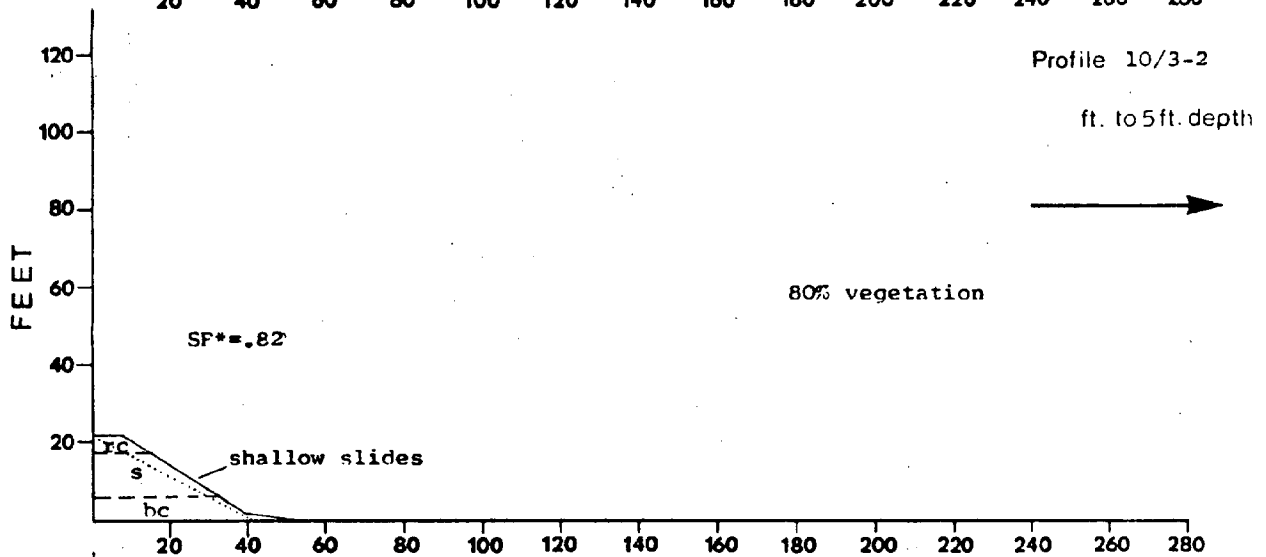
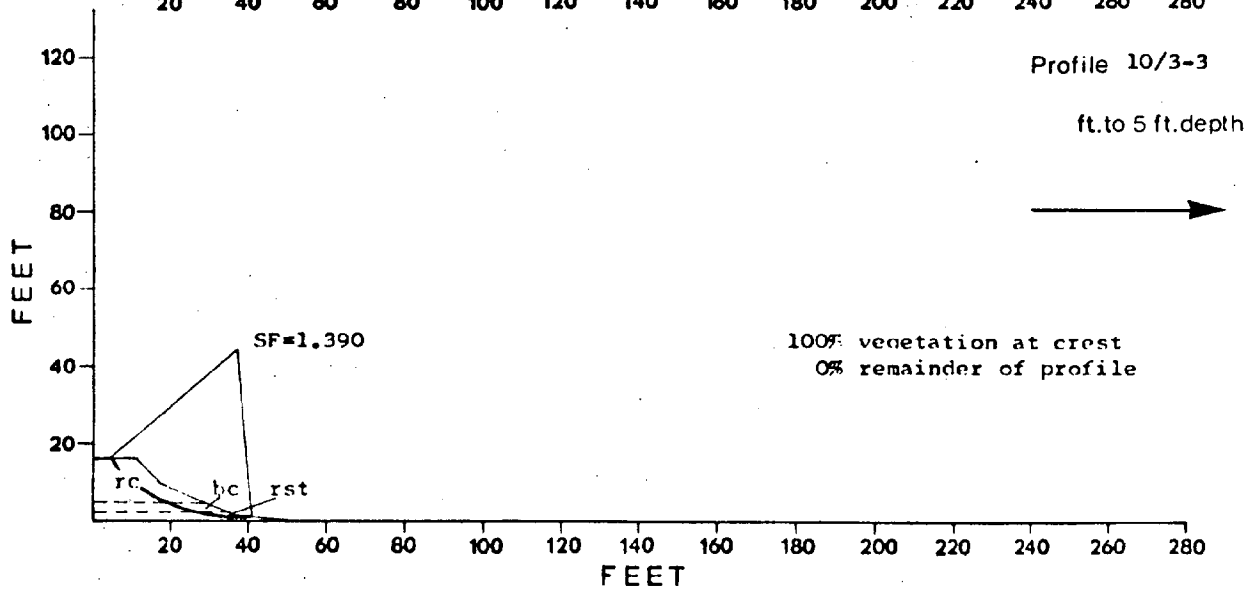
- a) sandy spits; pebble concentration along shore
- b) 3-8 ft. sandy with scattered boulders; locally beach is cobbly
- c) 20 ft.; sandy
- d) 3-8 ft.; sandy with scattered boulders
- e) 10-20 ft.; sand, boulders, cobbly in places, coarse sand along shore

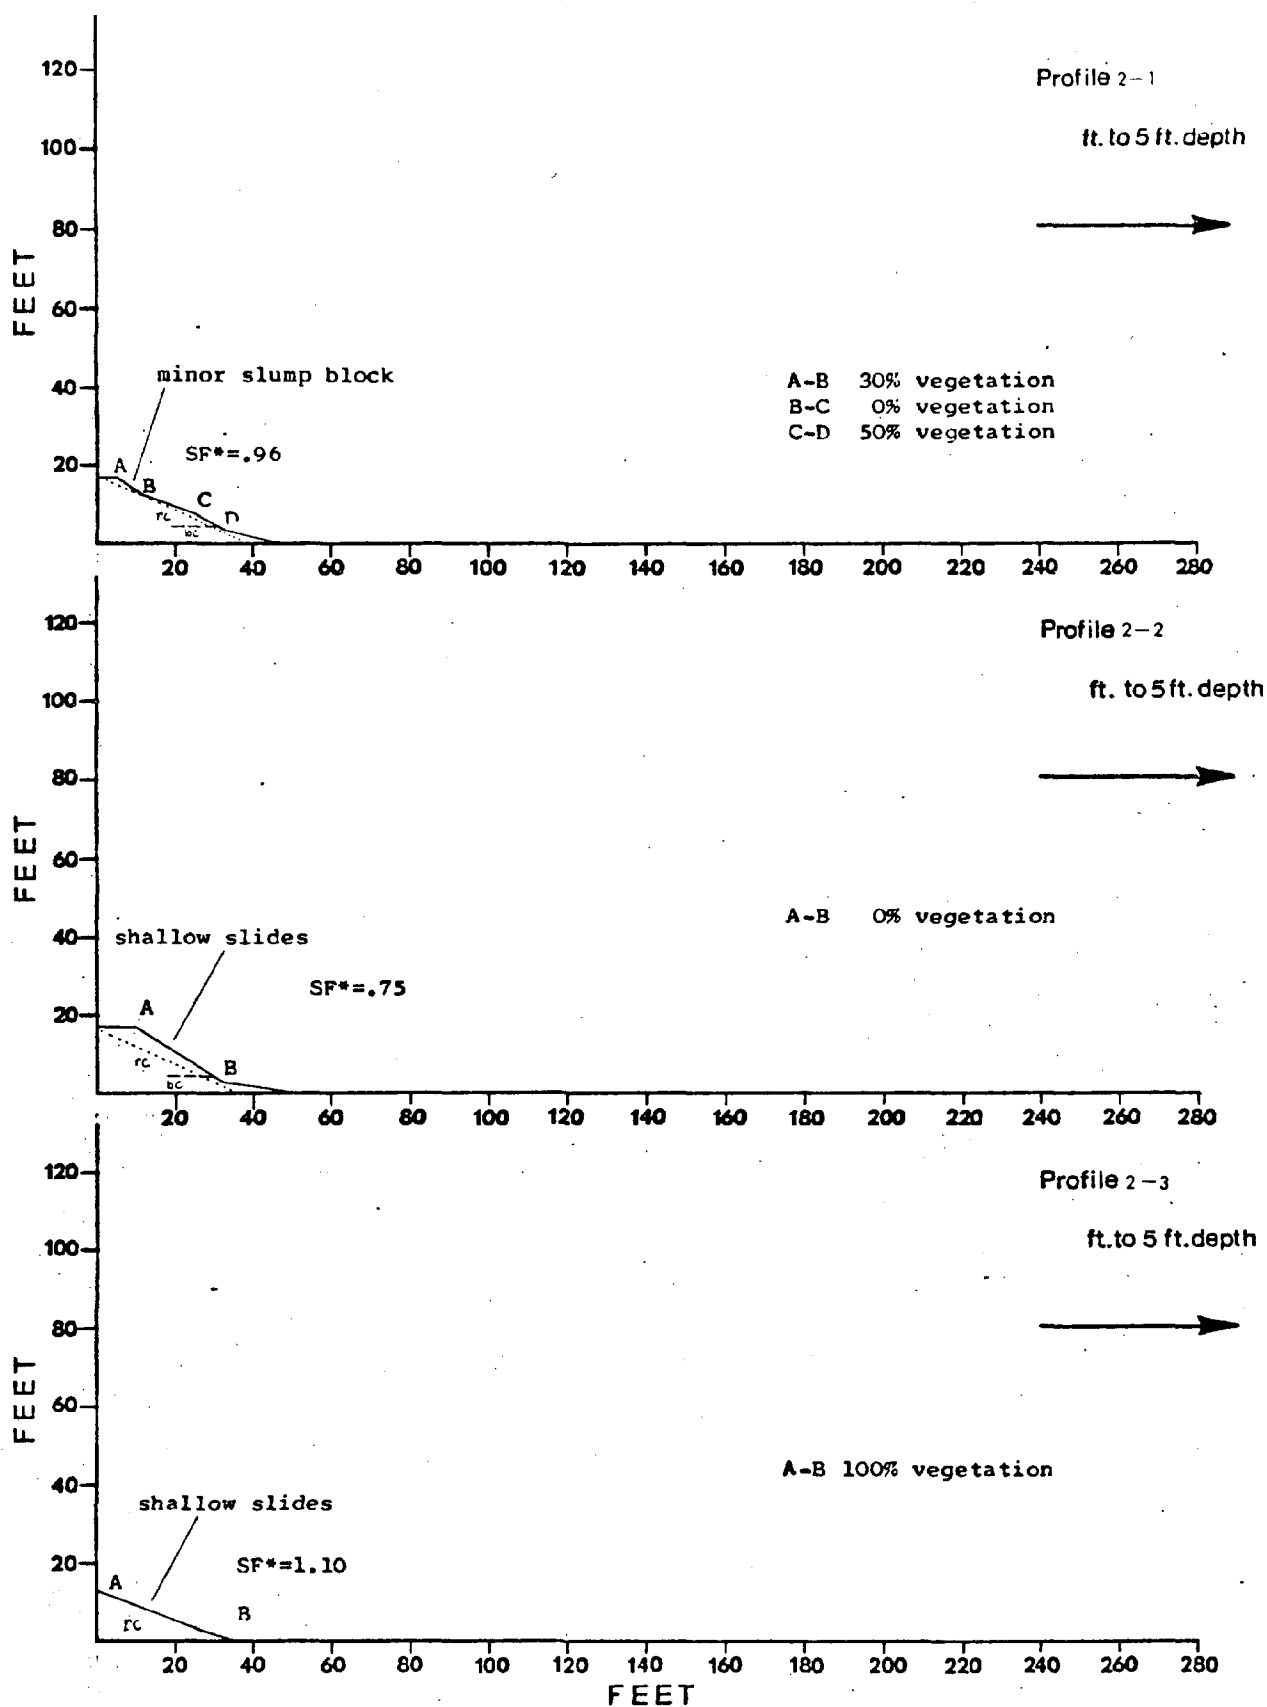
T.49 N., R. 10W., Sec. 2

- a) 15-20 ft; coarse and magnetite sand, pebbles at water
- b) absent
- c) 10-15 ft; coarse sand with cobbles and boulders scattered
- d) 0-5 ft; mostly absent, coarse sand
- e) 80 ft narrowing eastward to 10 ft; coarse sand with pebbles and cobbles at water
- f) 5-10 ft. often interrupted; coarse sand with many cobbles throughout

g) 0-5 ft. mostly absent; coarse sand with scattered pebbles

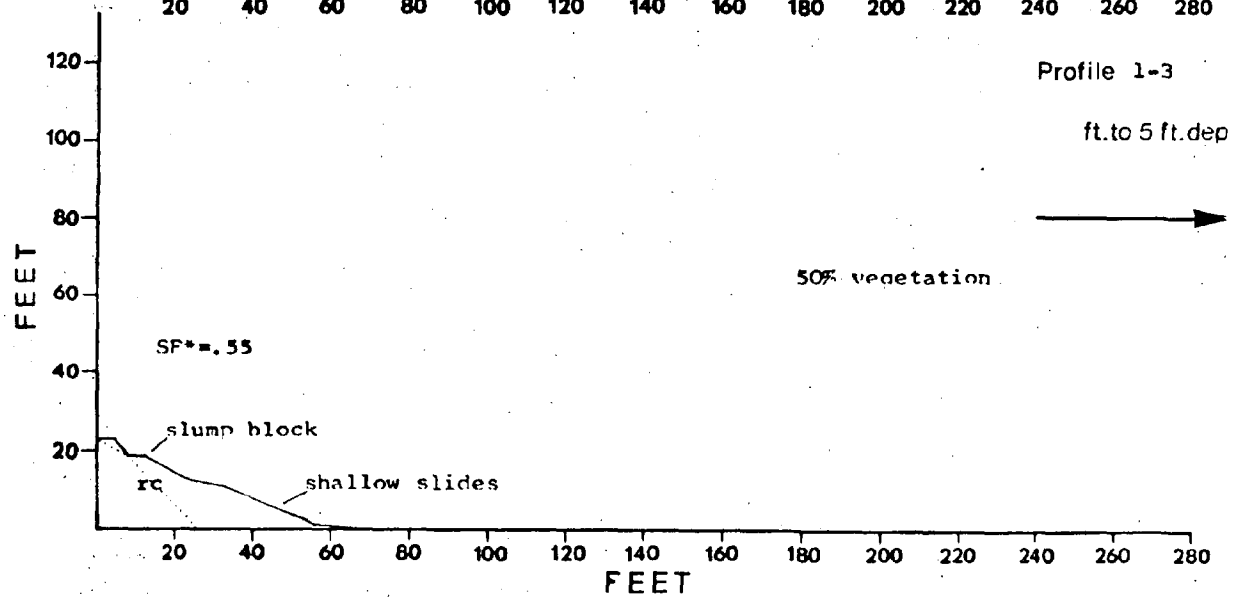
T. 49 N., R. 10 W., Sec. 1

- a) 10% vegetation, sod clumps; shallow slides in red clay; 18 ft. with root-bound crest
- b) 100% vegetation; grass sod with birches, smooth stable slope in red clay; 20' with even crest
- c) 10-40% vegetation with sod and birch in clumps; shallow slides with occasional rotational slump; 20-30' high rising steadily to the east
- d) 0-50%; well vegetated where small slumps predominate; no vegetation in near vertical scarps; red clay; 20-30' irregular crest.

- a) 3-10 ft.; sand
- b) 30 ft.; sandy, no pebbles
- c) 20 ft. sandy
- d) 0-5 ft, swash zone occasional; sandy
- e) 20-30 ft., sandy, no pebbles
- f) 0-10 ft, sandy with occasionally covering slumps

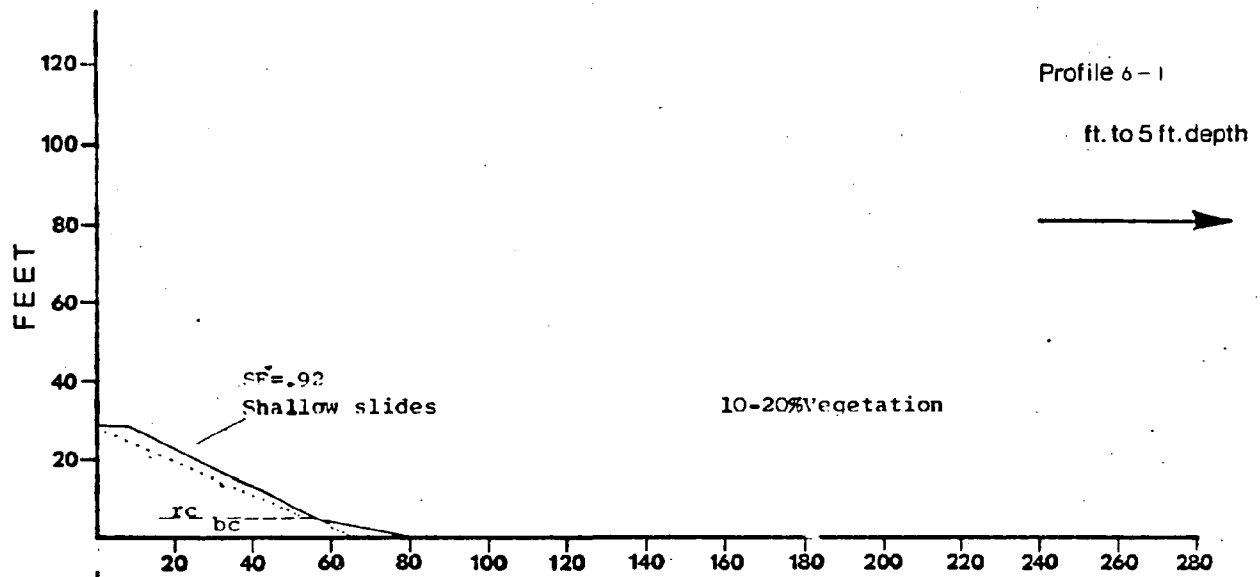
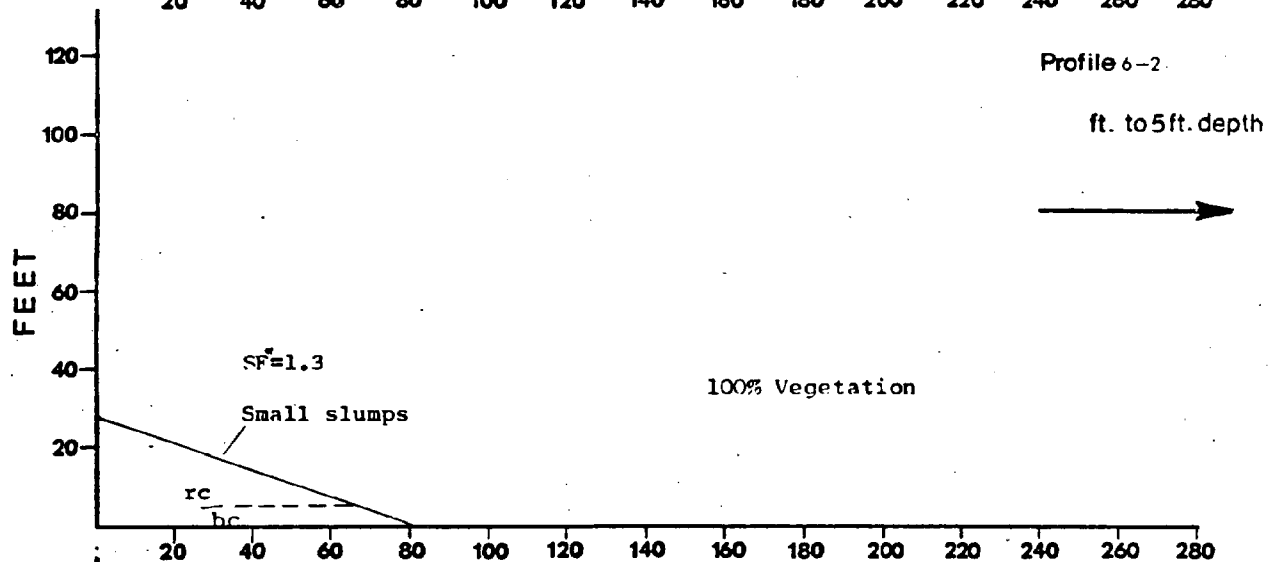
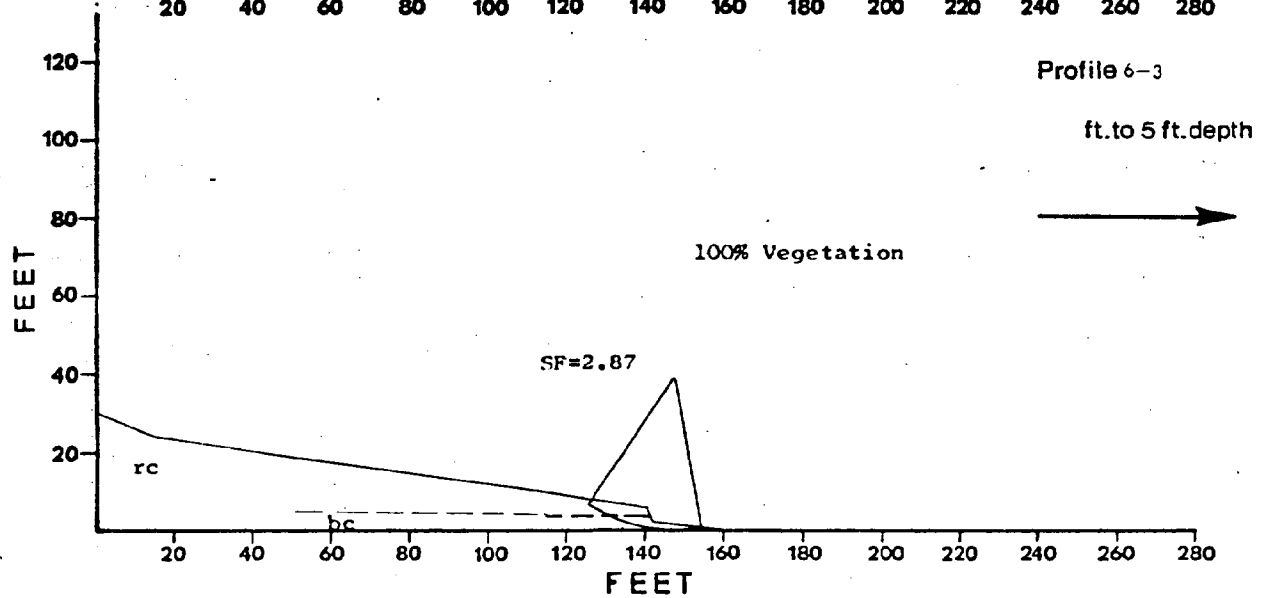
T.49 N., R. 9 W., Sec. 6

- a) 30' wide; sand with pebbles at shore
- b) 5-15' wide, width variable; sand
- c) 30-40' wide, sand with pebbles at shore
