# SHORE EROSION STUDY Technical Report

SHORELINE EROSION AND BLUFF STABILITY ALONG LAKE MICHIGAN  
AND LAKE SUPERIOR SHORELINES OF WISCONSIN

DOUGLAS AND WESTERN BAYFIELD COUNTIES  
WISCONSIN POINT TO BARK BAY

July 1980

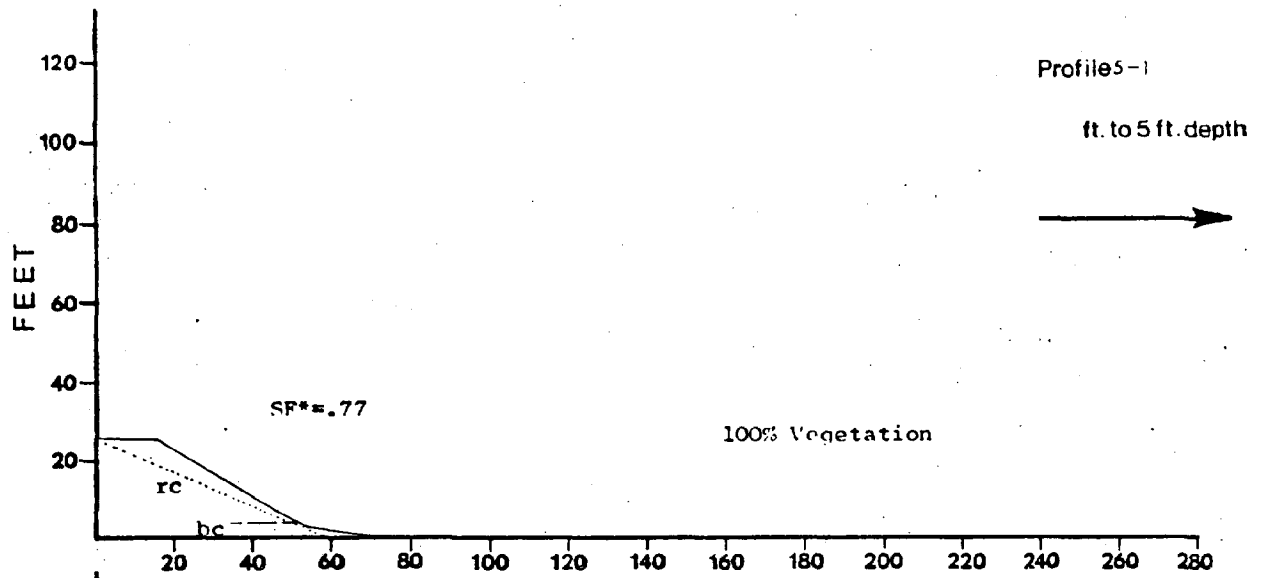
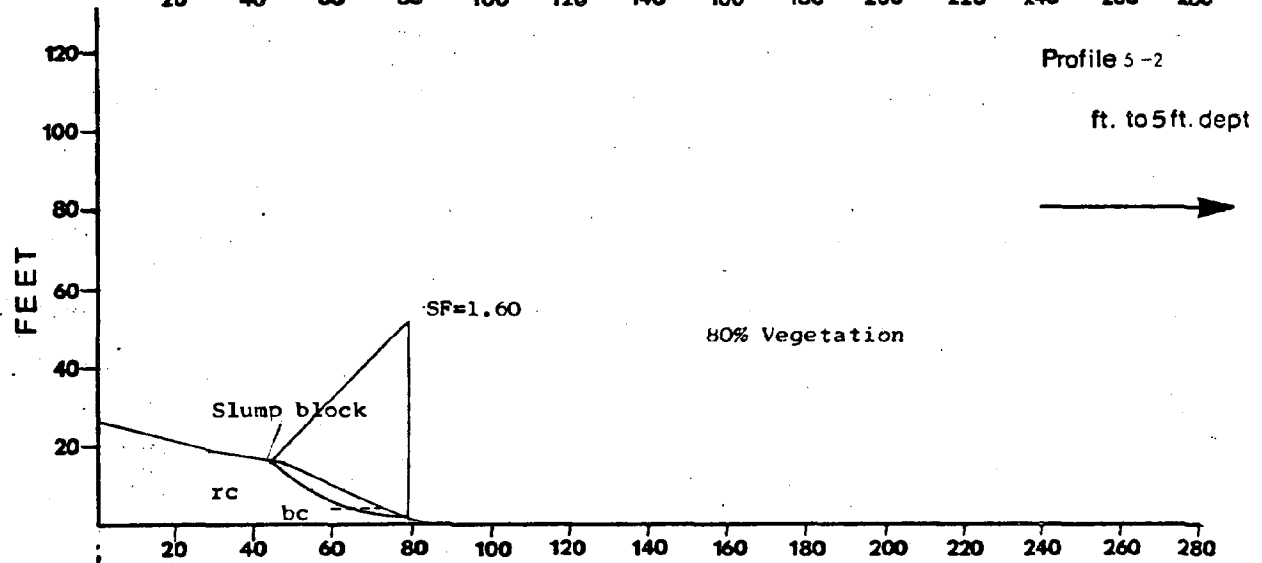
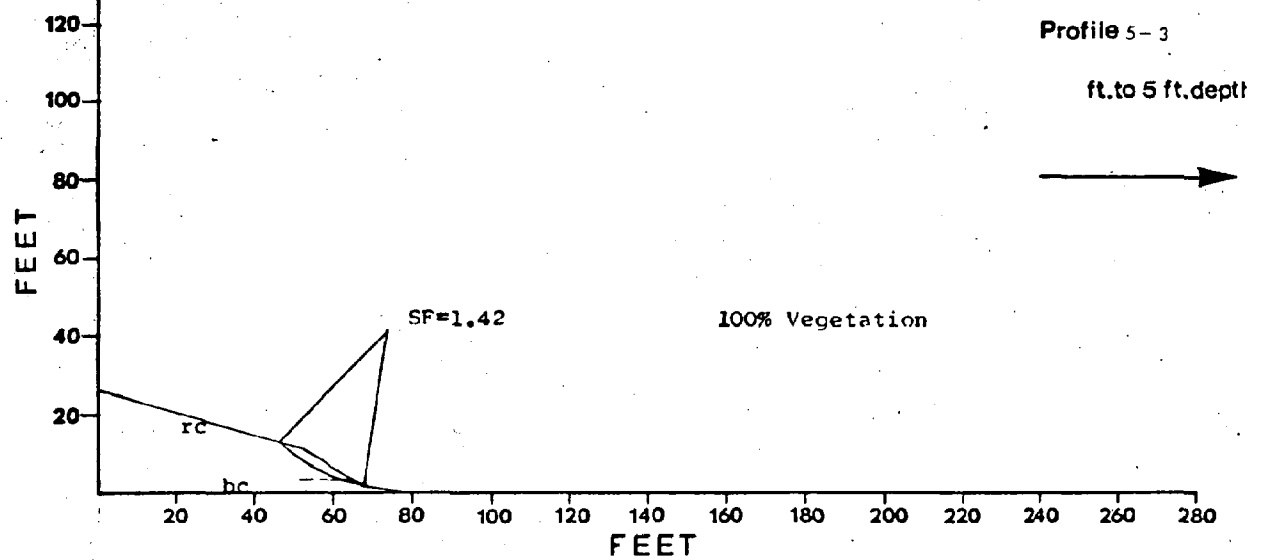
T.49 N., R. 9 W., Sec. 5

- a) 100% vegetated in alder and birch forest; smooth to slightly hummocky surface in red clay; fairly stable; 20-25' high of even crest
- b) no bluff, Fish Creek with low lying lateral terraces
- c) 100% vegetated in alder and birch forest; hummocky surface with occasional slumps, red clay, 30' high with even crest
- d) Corps of Engineers rip-rap study; 500' wide; bluff leveled at low slope and the following sequence of materials are found at toe (west to east)
  - Boulders
    - Concrete ribbed blocks
    - Boulders
      - Interlocking cinder blocks
      - Boulders
        - Interlocking cinder blocks
        - Boulders
          - Bolted automobile tires
          - Boulders
            - Fence of I-Beam frame and railroad ties

- a) 20-25' wide; sand with pebbles
- b) 15-20' wide sandy
- c) 15-20' wide sandy
- d) 10-15'; sandy, pebbly with cobbles and scattered boulders
- e) (see bluff subsection 'd')

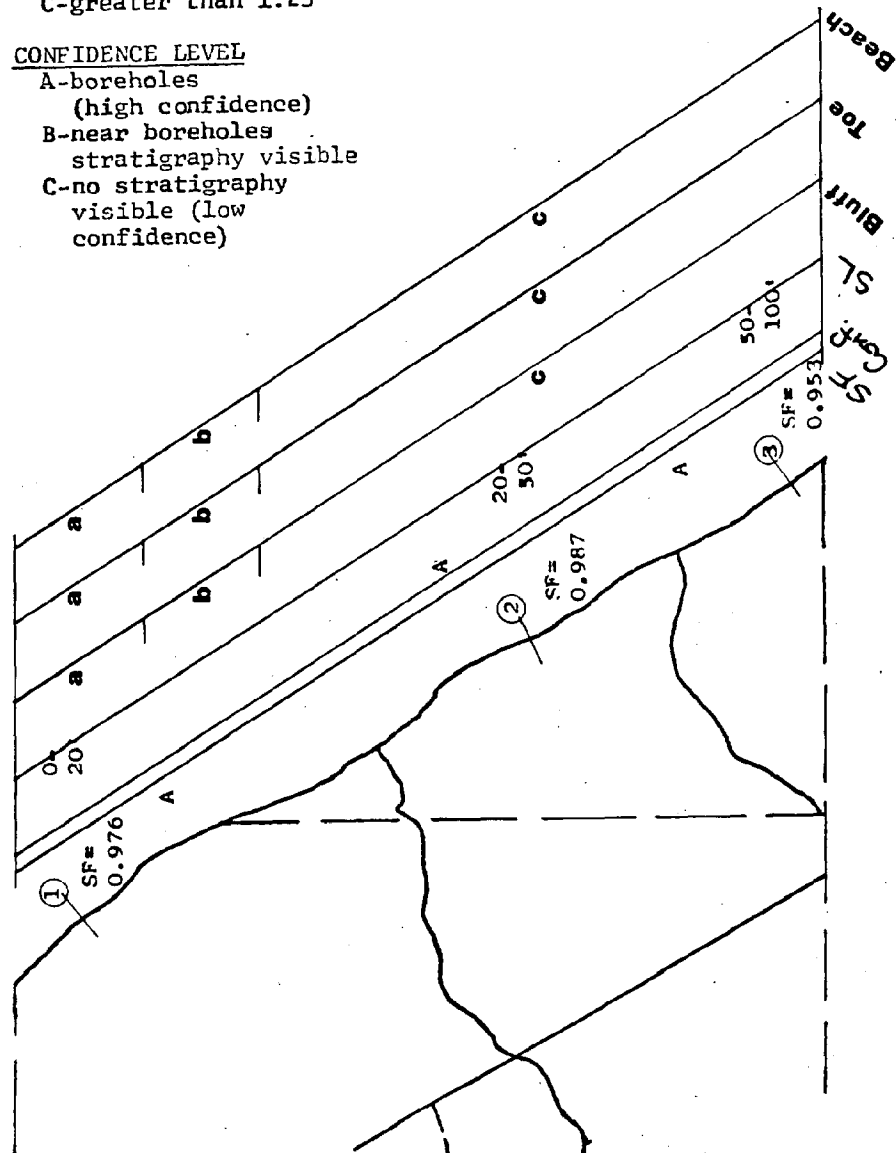
Sec. 14/11, T 50 N, R 8 W

- a) bluff mostly forested with scattered patches of non-vegetated bluff face; sand with discontinuous silty or clayey beds which are often indurated with seeps; shallow sand flows and rills on exposed face. Occasional seep failures producing long narrow gullies with fans at base; 75-80' high with irregular crest
- b) 100% Vegetated, forested; few scarps, smooth slope; sand with some gravel and occasional clay layers in upper slope which produces seeps, 100' high
- c) 0-100% vegetated sand with red clay at top of bluff and occasional gravel lenses; rilling, gulling and seep failures where non-vegetated; steep 125 -140 ft seeps where sand is silty or clayey

- a) sand fans below failures; vegetated, bedrock at extreme W end
- b) sand fans
- c) sand fans below failures; "talus" of slid sand; vegetated

- a) 5-10'; cobbles with sand; occasional covered by sand fan; numerous slumped trees
- b) 20-25; sand with cobbles; sand spits at creek
- c) 10-15 ft; sand and cobbles; sand at creeks

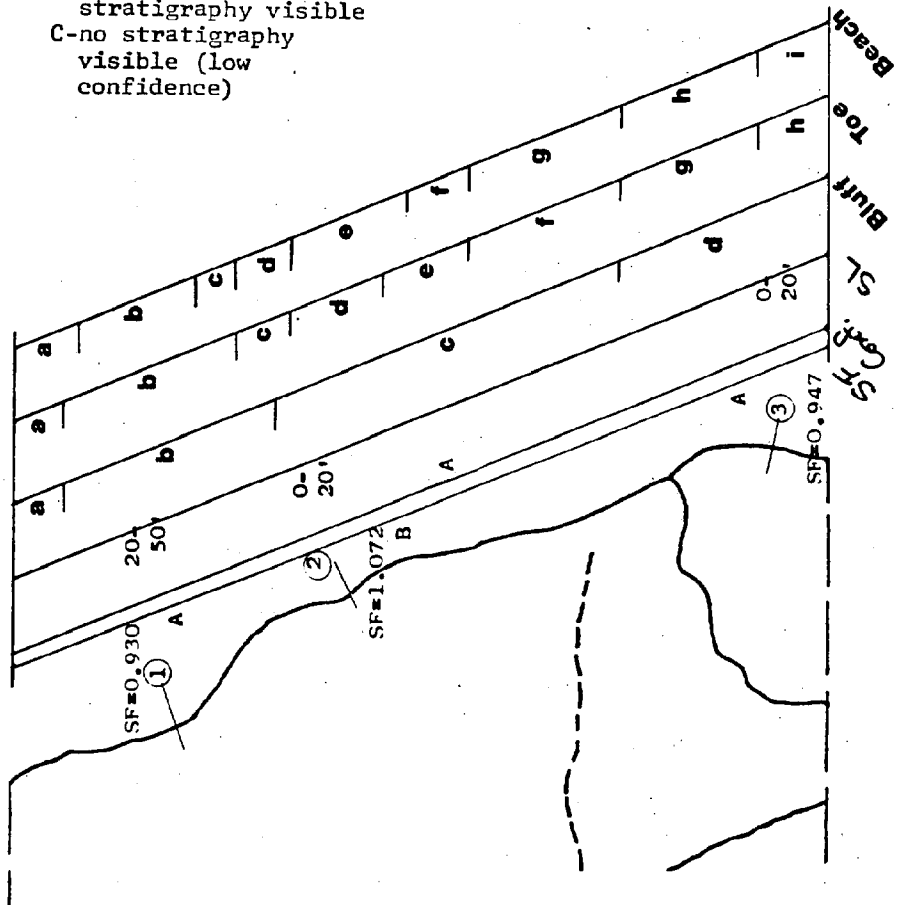
## Sec. 12, T 50 N, R 8 W

- a) 140-150 ft; sand and gravel; seeping and rilling/gulleying; vegetation variable 0-100%, tall birch, alder, fir and thick undergrowth
- b) 140-150 ft; sand with occasional gravel lenses; narrow seep failures which open up laterally at creast; vegetated 60-100% tall birch, fir and alder, thick undergrowth
- c) 120-130 ft; sand; seeping; rilling; dry flows; vegetation mostly 0% some 50-90% tall birch, cedar and fir with undergrowth
- d) 140 ft dropping at stream, then rising, as a series of ridges oblique to shoreline, to 120-140 ft.; sand with gravel lenses; gulleying and dry flows; vegetation mostly 100% tall birch, cedar and fir; some 10-20% vegetated slum blocks

- a) vegetated sand
- b) partially vegetated and partially failing sand
- c) 6-8 ft bedrock
- d) vegetated sand, partially failing
- e) 4-6 ft bedrock
- f) vegetated sand, partially failing
- g) 4-6 ft and up to 25 ft of bedrock
- h) vegetated sand, partially failing

i) 15-20 ft; coarse sand with cobbles at toe

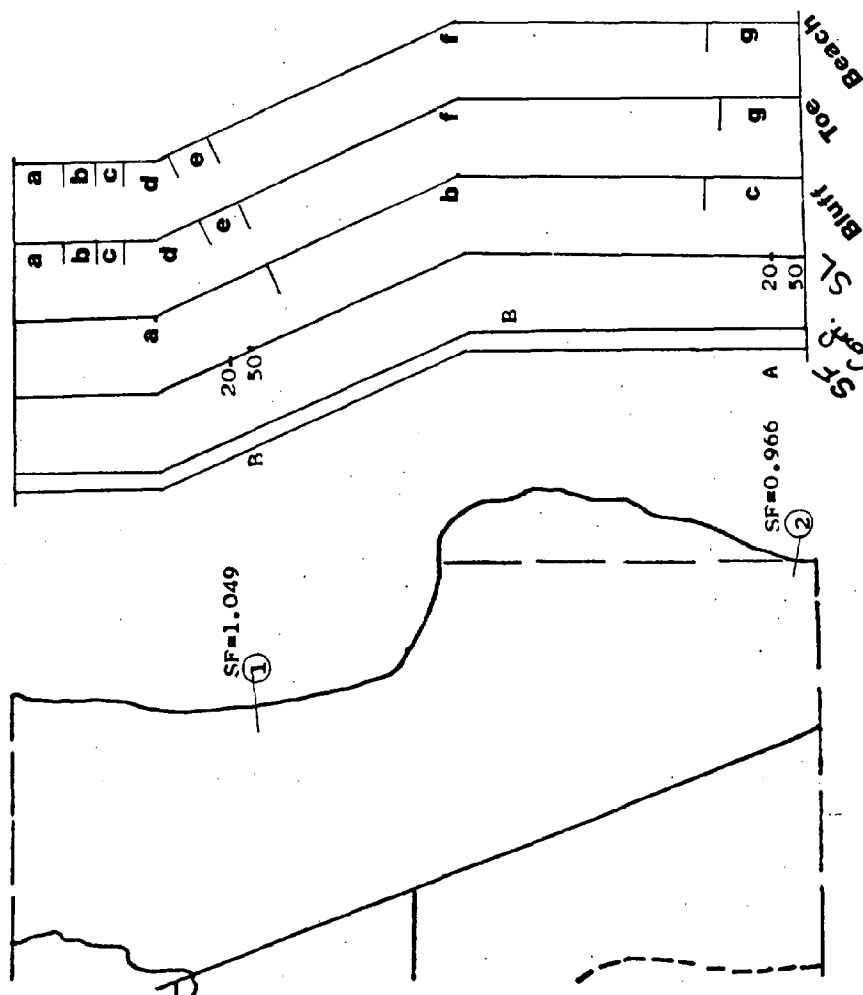
## Sec. 7/6, T 50 N, R 7 W

- a) 180 ft dropping to 100 after northward bend; sand with gravel lenses; rilling and gulleying; vegetation as little as 0-10%; half to two-thirds is 70-90% tall birch and cedar with undergrowth
- b) 100 then 70 ft after eastward bend; sand and gravel over bedrock the latter is 1/2 of bluff height; ~~there are~~ watercourses graded to rock lip; occasional failure by block fall; vegetation 100% birch, cedar, fir, alder along the top of the bluff.
- c) 70 ft; bedded sands and silts; shallow sliding and gulleying; 40-70% vegetated; clumps moving downslope, birch and alder

- a) bedrock
- b) 15-20 ft; coarse sand with occasional cobbles and pebbles
- c) bedrock
- d) 20-25 ft; coarse sand
- e) 1-2 ft; cobbles and boulders; bedrock just underwater
- f) bedrock
- g) 45-60 ft; coarse sand, pebbles at shore, granules in swash zone

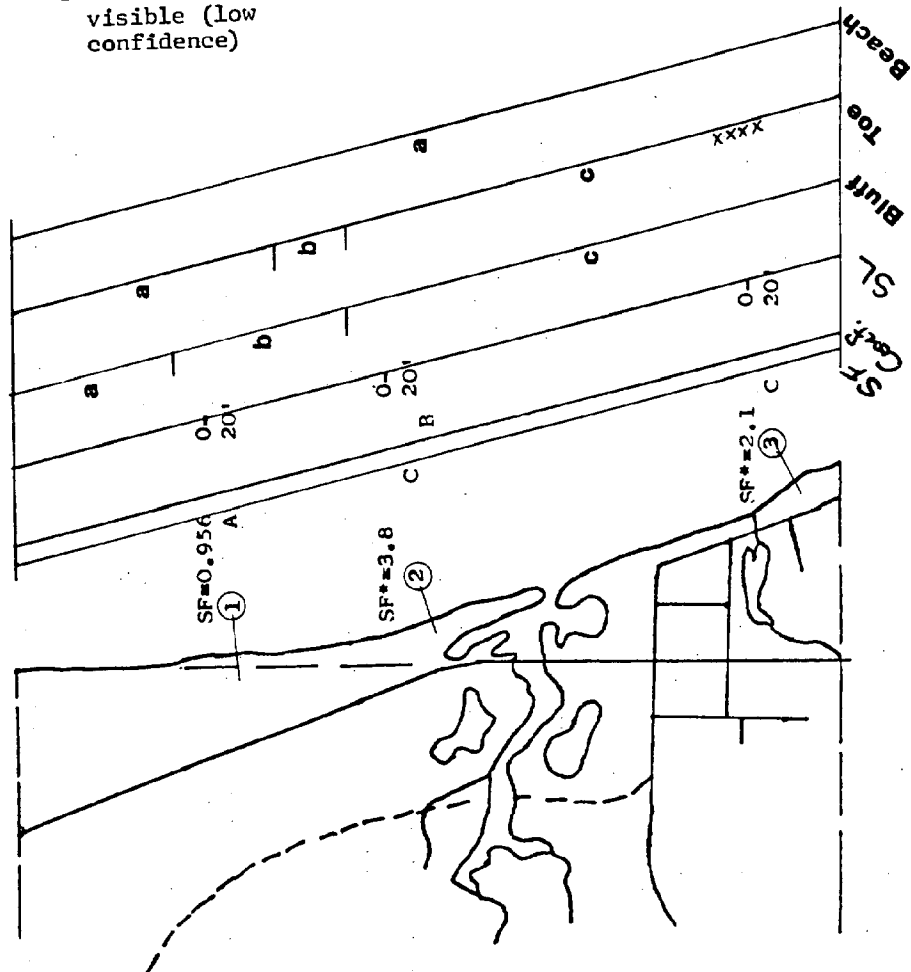
Sec. 8/5, T 50 N, R 7 W

- a) 20-30 ft; coarse sand; pebbles at shore, granules in swash zone

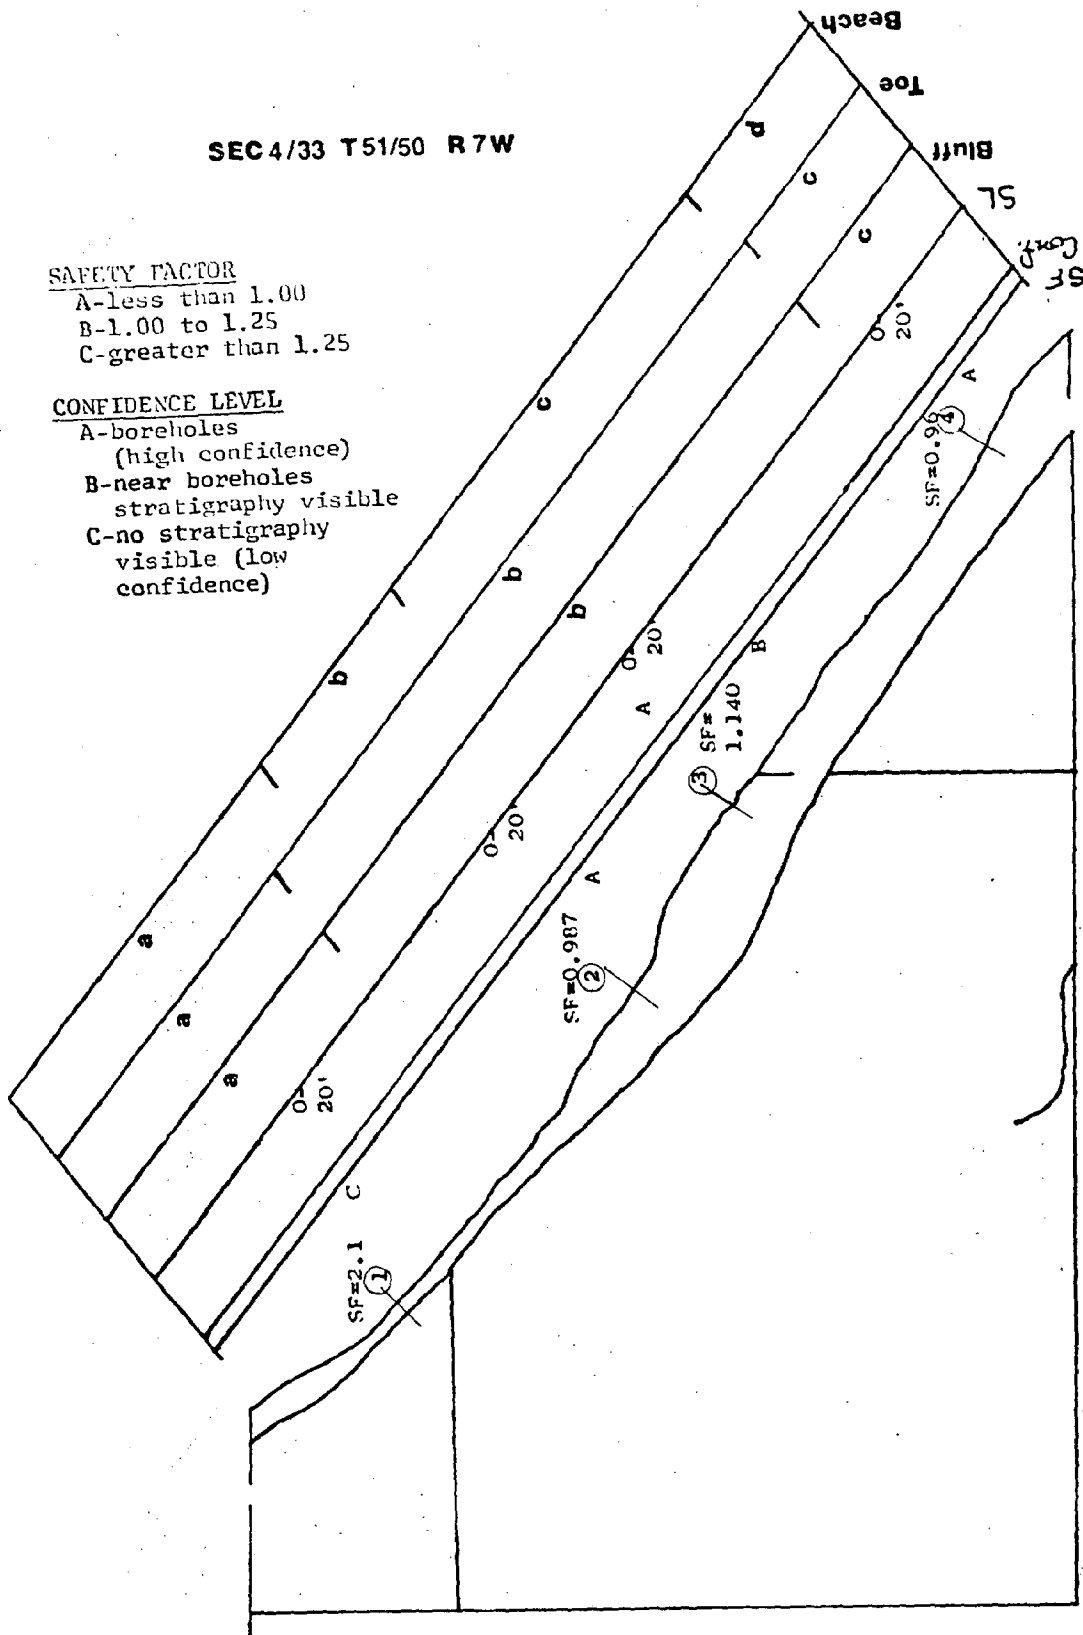
Sec. 4/33, T 50/51 N, R 7 W

- a) 20' wide; sandy with occasional culvert; two piers
- b) 15' wide; cobbles and pebbles with scattered boulders
- c) 5' wide; cobbles of scattered boulders
- d) 10-20' wide; cobbles and pebbles; occasional boulders

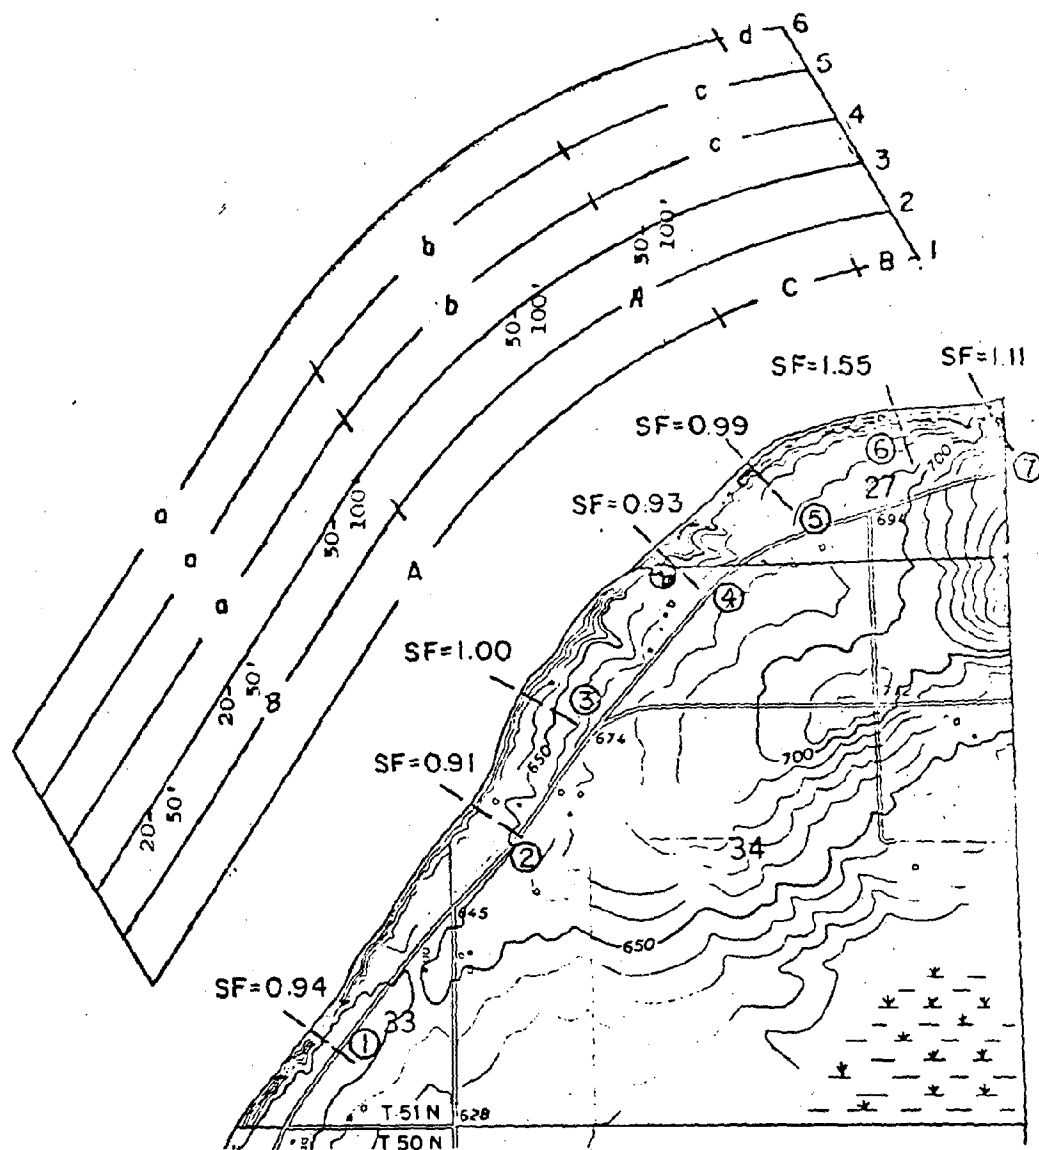
Bluff composition is similar to that of Site 4, mostly well sorted sand and gravel. Sand is well compacted and obtain slope angles in excess of  $50^{\circ}$  in many locations. Red-brown clay-loam is found overlying the sand discontinuously. In Profile 6, a stony silt-loam unit is exposed at the toe of the bluff. Sandstone is exposed at one location between Profiles 6 and 7 in Section 27.

Erosion along this coast occurs as the result of direct wave attack on the bluff toe. These slopes fail by translational slides and flows. A second form of coastal erosion at this site is gullying. Numerous ravines dissect the bluff face and are actively being enlarged by surface water drainage. One gully north of Profile 4 is being enlarged at a rapid rate as the result of land management practices. A roadside ditch is channeling large volumes of storm water into the gully which, in turn, erodes bluff soils. Without some corrective measures, the road may become endangered over the next three years.

- a) Covered with debris from slope failure.
- b) Steep faced wave cuts exposing bluff material.
- c) Covered with debris from slope failure.

- a) 10 to 20 feet, cobbles and boulders, wider near gullies.
- b) 20 to 30 feet, sand and gravel.

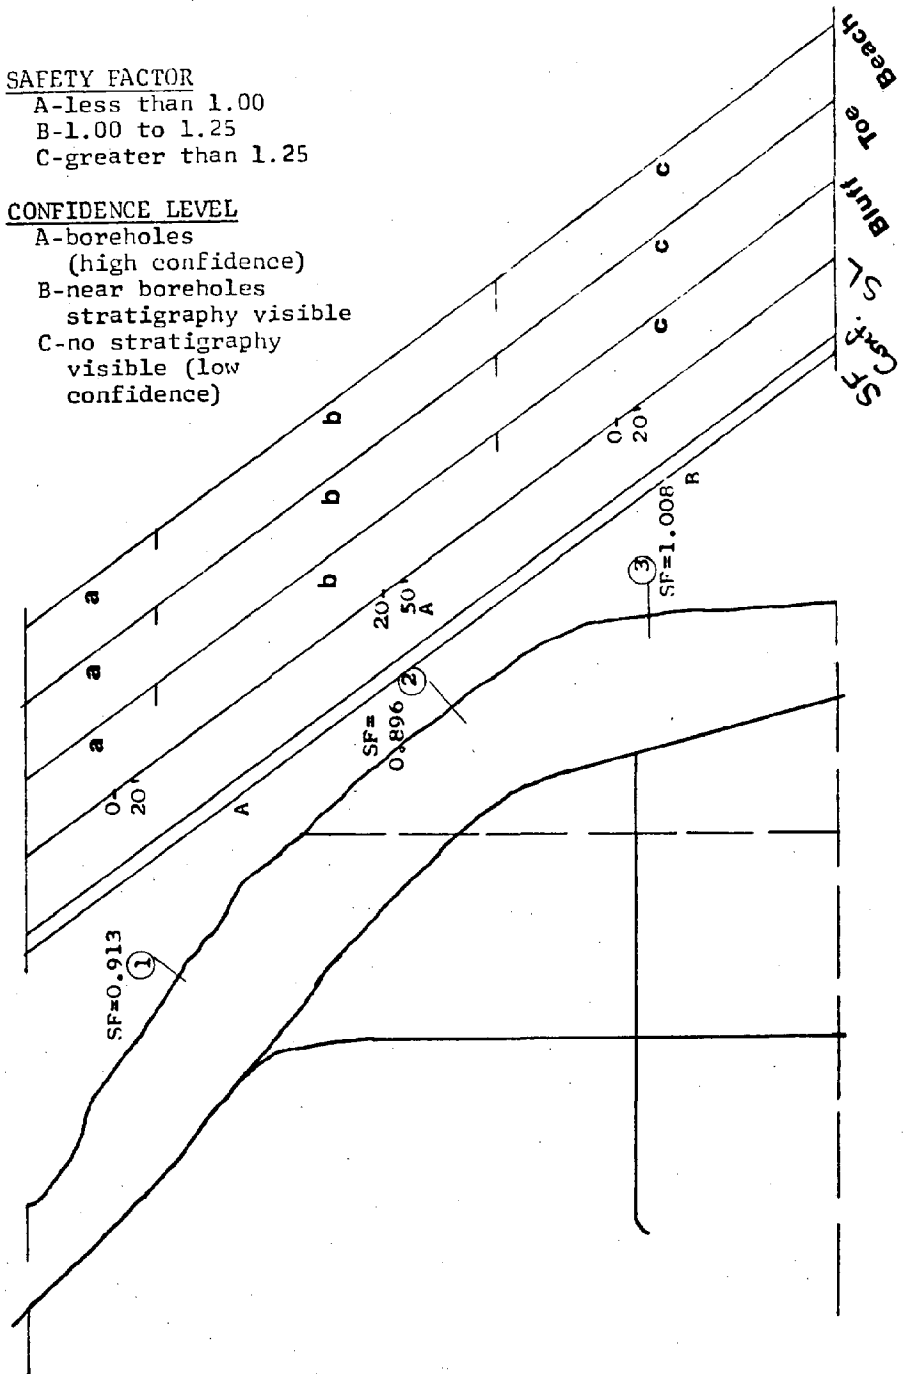
## Sec. 34/27, T 51 N, R 7 W

- a) 25-40' high bluff; red clayey sand with clay on top and occasional clean sand beds throughout; 60-80% in birch and shrubs; occasional shallow slides
- b) steep (45°-90°) slopes in hard dry poorly sorted sand; eroded by slope wash, occasional debris flow, and block falls; usually 3-4' of sandy clay at top with overhanging poor bound crest. Farther east, seep failures occur; 40-50' high
- c) steep high bluff in sand and clayey sand; sandy clay occasionally at crest; 60' high; Densely vegetated on scarp and in ravines but no vegetation on scarp faces; shallow sand flows and rilling

- a) 0-5 ft wide; sand over cobbles; numerous slumped trees; occasionally absent
- b) 10-20 ft; cobbles with sand and scattered boulders
- c) 3-10 ft; variable, sandy and cobbly; numerous fallen trees

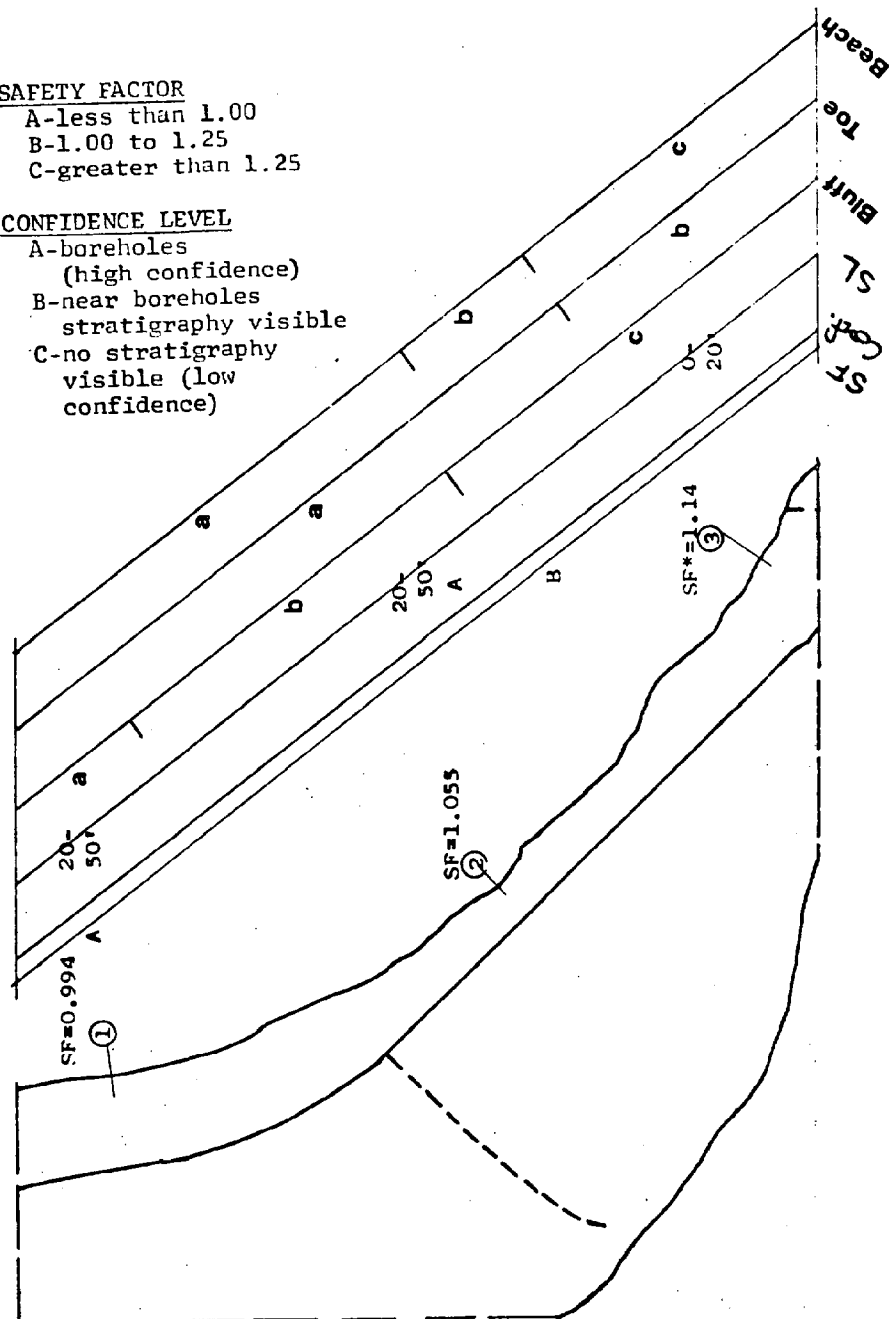
## Section 26/23, T 51 N, R 7 W. northwest-facing shoreline

- a) 125-140 ft. falling to 100 ft "eastward"; some shallow slump and surface flows, rilling and gulleying; vegetation - usually 90-100% alder fir and cedar; where failing, 0-20%; loose sand over silt loam
- b) 100 ft. falling to 15 ft steadily; shallow slides and surface flows and gulleying; vegetation usually 40-50% alder, birch, fir and cedar; often 100% or 0%; clay loam over sand
- c) 15-10 ft. even height; shallow slides; vegetation 30-40% as above; clay loam over discontinuous laminated clay over loamy sand

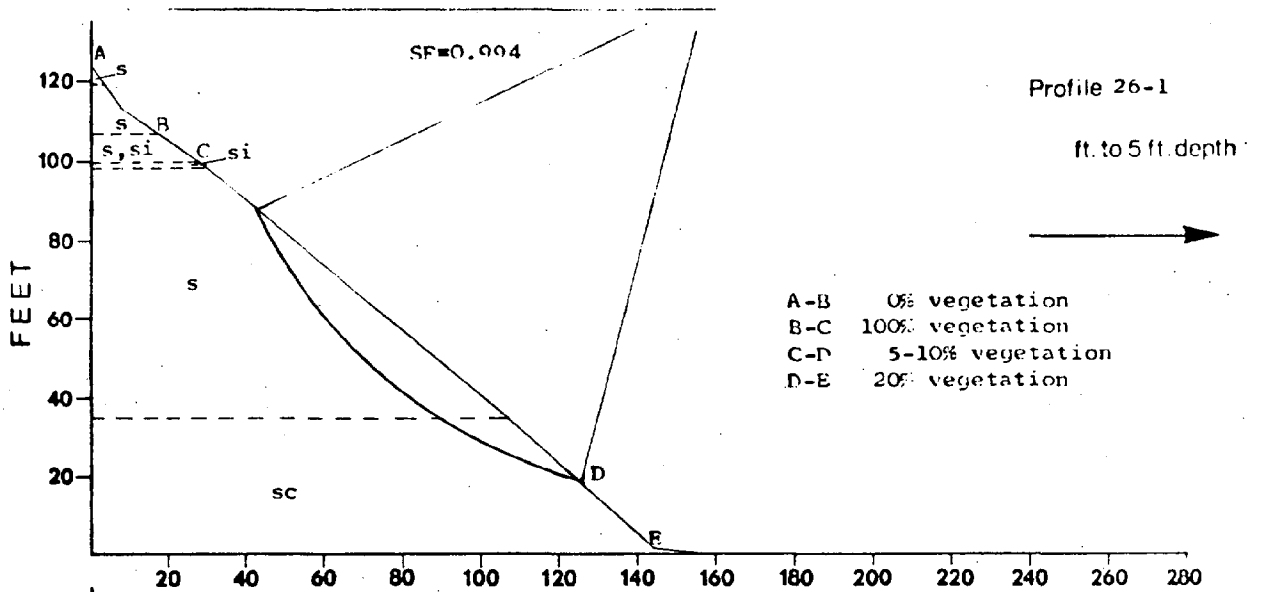
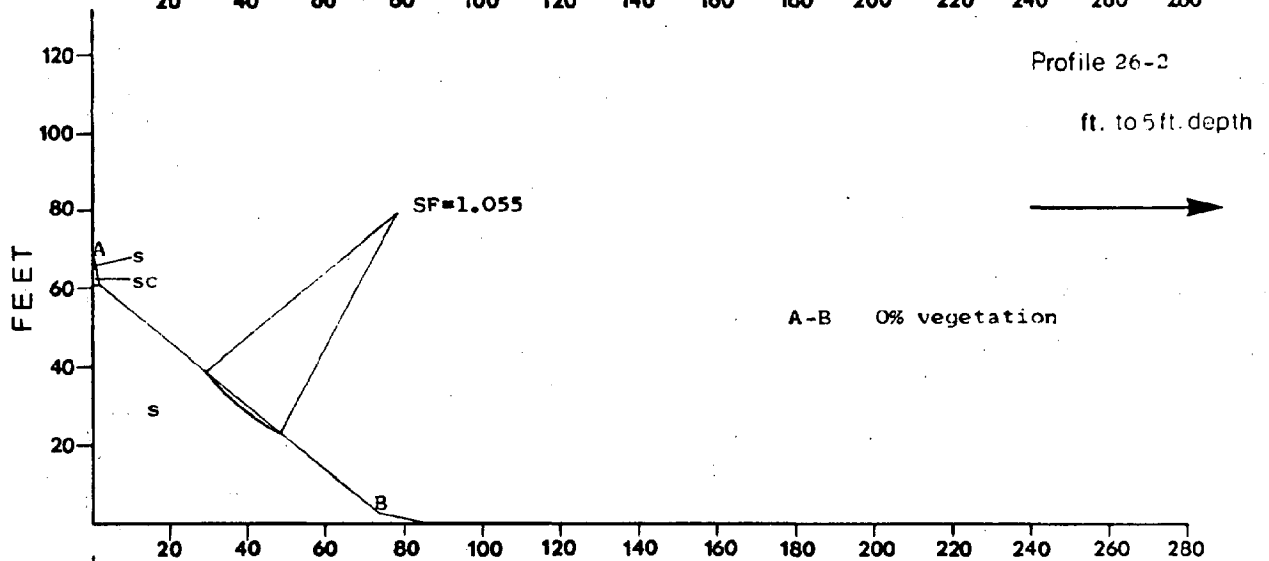
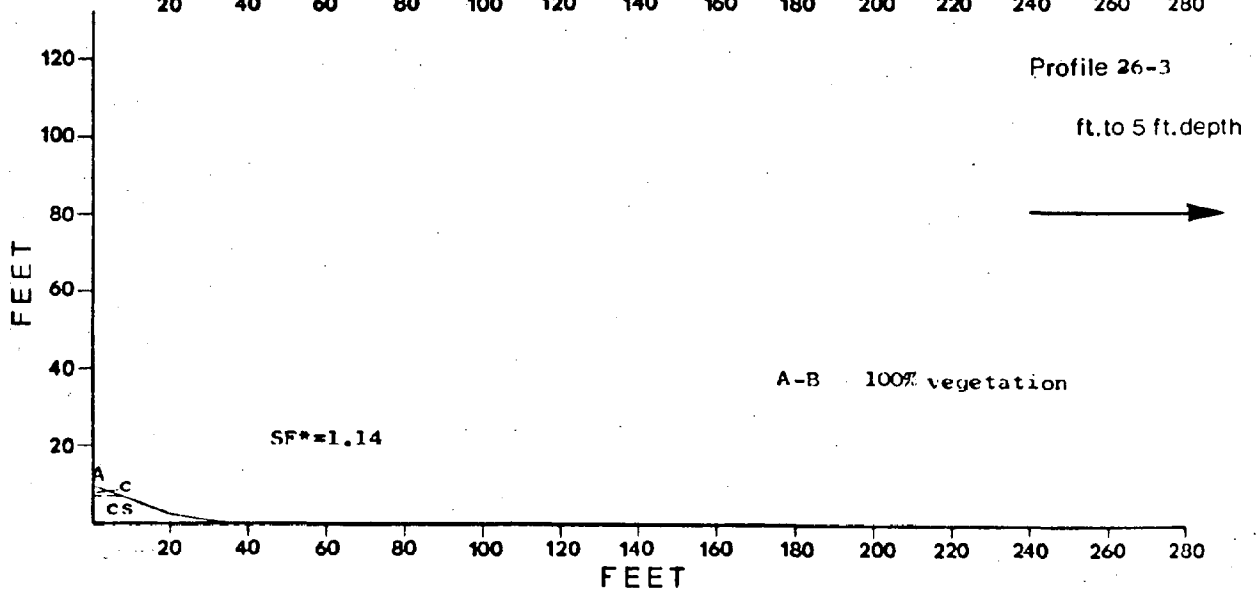
T.51 N., R. 7 W., Sec. 26

- a) 15-25 ft; coarse sand, with pebbles at water and cobbles at toe occasionally
- b) 15 ft cobbles and boulders with coarse sand at water occasionally
- c) 0-2 ft; cobbles and coarse sand; mostly absent

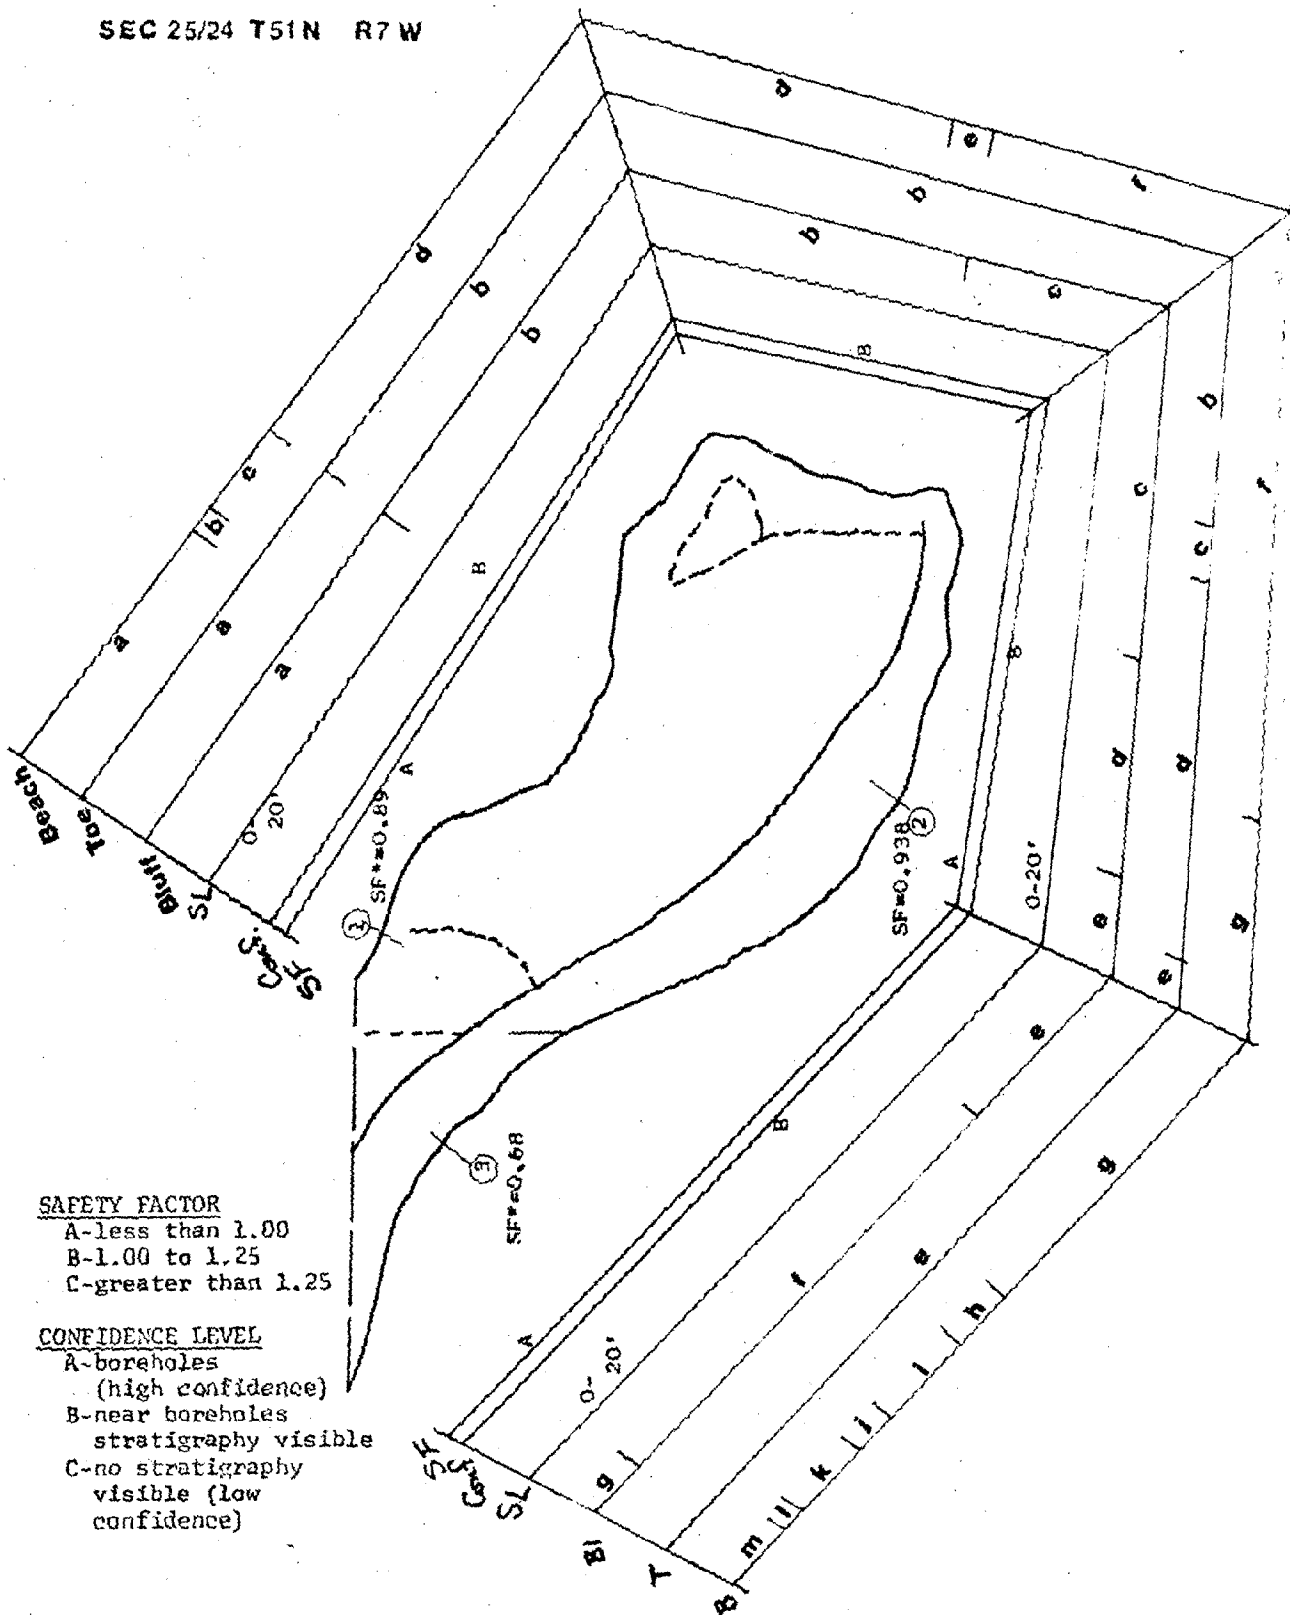
Sec. 24/25, T 51 N, R 7 W

- g) 3-5 ft. little failure noted; 80-100% birch, poplar, fir, cedar

- f) bedrock- no beach
- g) 5-15 ft cobbles with boulders; not as interrupted by slide blocks
- h) 10-20 ft coarse sand with cobbles and two concrete and wood piers
- i) 5-15 ft cobbles with boulders; less interrupted by slide blocks
- j) 10-20 ft coarse sand with cobbles and one pier at south end
- k) 5-15 ft cobbles with a short portion cribbed with wood and less interrupted by slide blocks
- l) 10-20 ft coarse sand with two piers, a retaining wall between and a wood crib at south end
- m) 5-15 ft cobbles with boulders; less interrupted by slide blocks

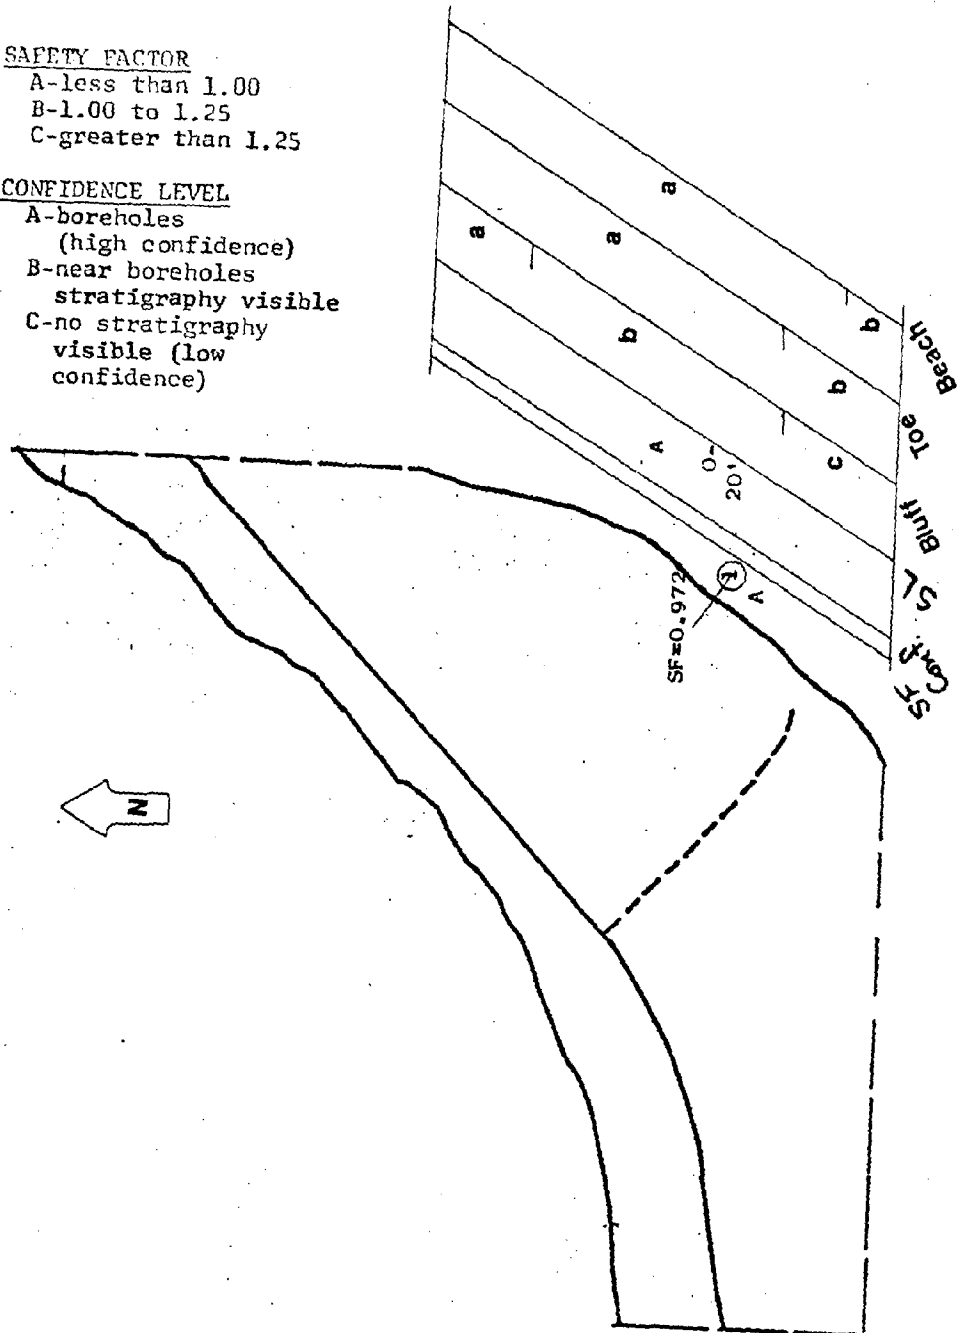
## Section 26/23, T 51 N, R 7 W southeast-facing shoreline

- a)  $\leq$  5 ft; mostly well-graded and vegetated (100%) with poplar and birch and cedar; clayey sand
- b) 10-15 ft rising to 25-30 ft southwest-ward; clay over clayey sand; shallow sliding and rilling; 0-10% large trees fallen over
- c) 30-40 ft; clay over sand over clayey sand: occasional shallow slides associated with seeps; vegetated mostly 100% birch, cedar, poplar, fir: 0% on failures

- a) 10-15 ft; cobbles with boulder and occasional coarse sand matrix
- b) 0-5 ft; cobbles; interrupted by blocks from failures

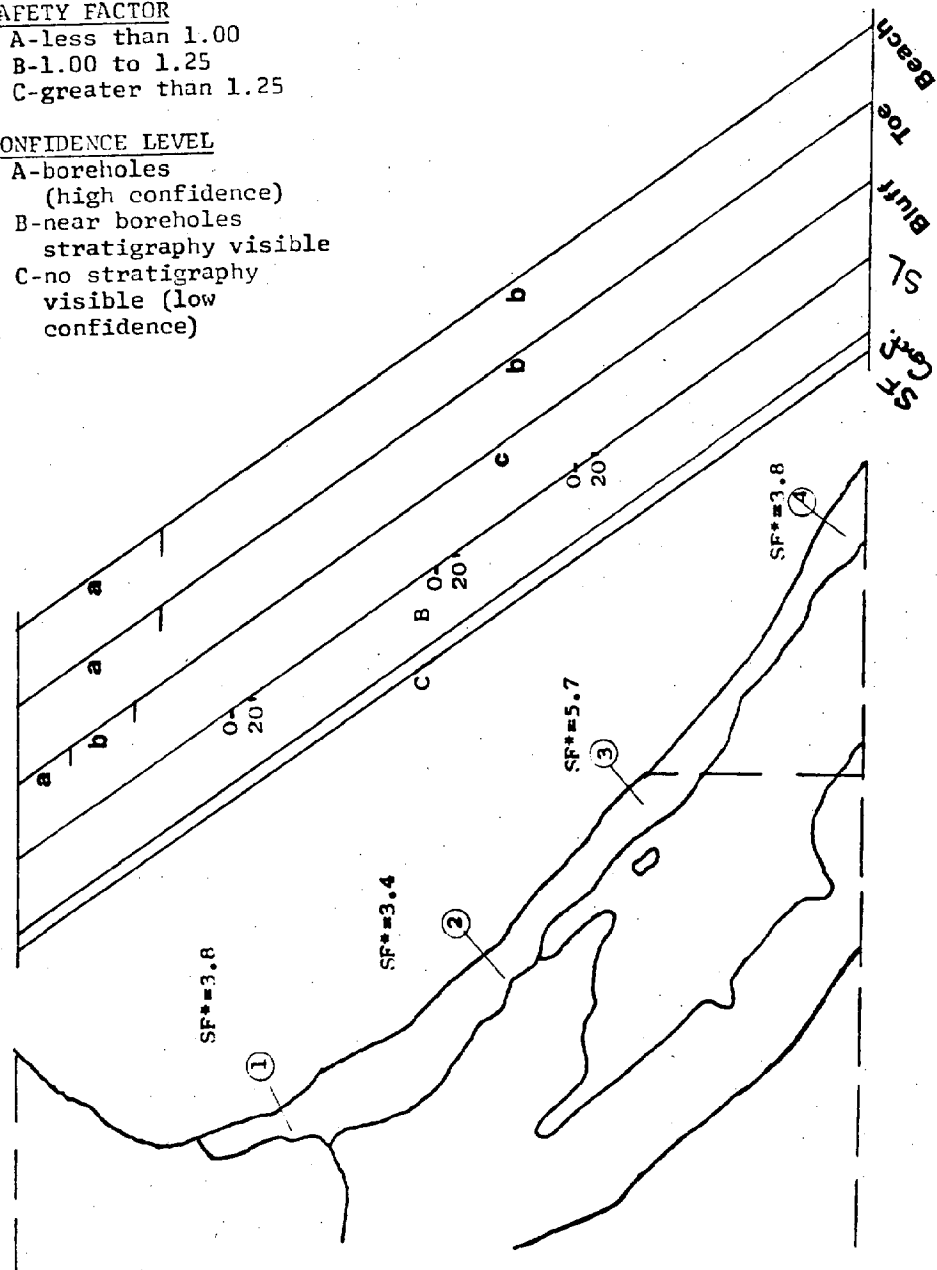
Sec. 35/36, T 51 N, R 7 W

- a) 30-40 ft.; clay, sand, clayey sand; occasional shallow sliding; mostly 100% vegetated birch, poplar, cedar
- b) falling to 0 ft; no failures; 100% vegetated
- c) absent; beach ridge

- a) 5-10 ft; cobbles with sand matrix
- b) 20-30 ft; medium sand

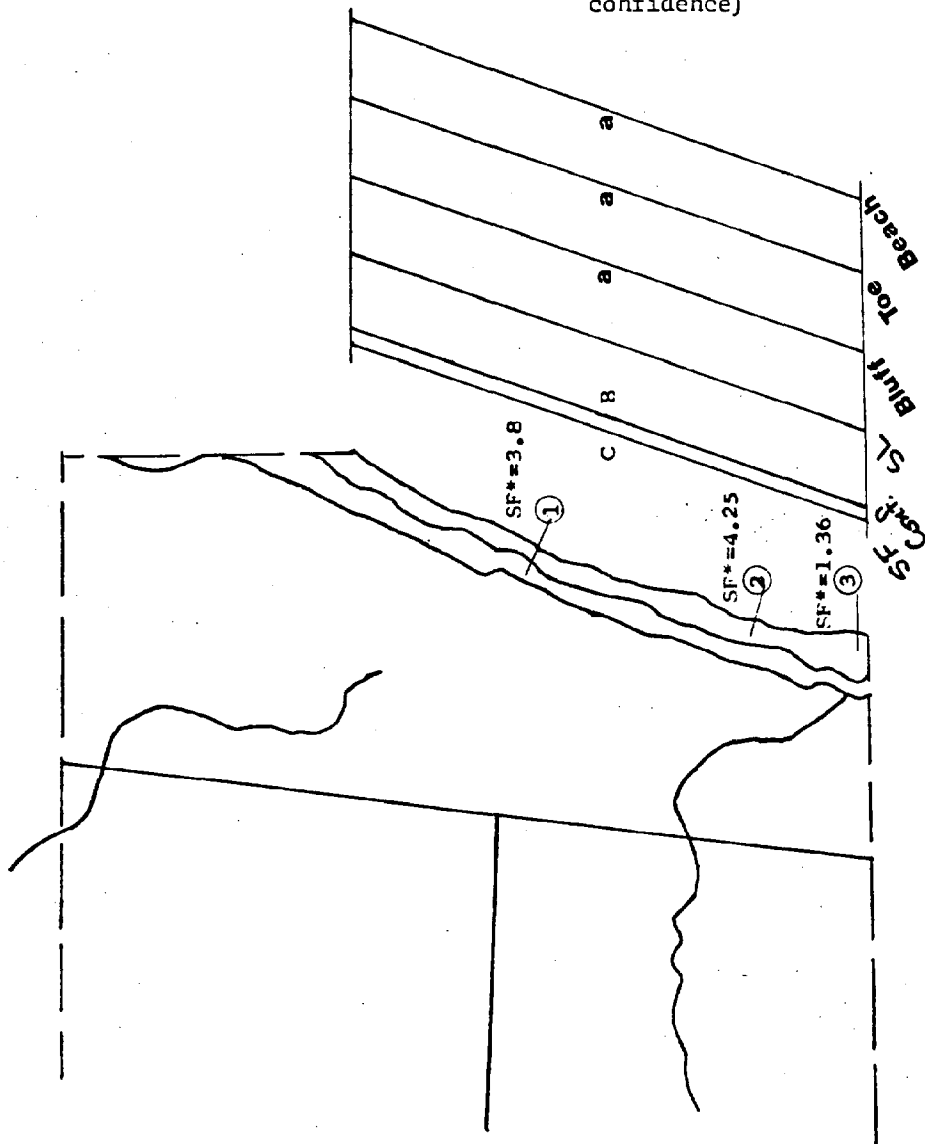
Sec. 1, T 50 N, R 7 W

- a) 20-30 ft; medium sand; some horsetails on backbeach
