Connecticut Embayments Study

Phase I Inventory & Problems Analysis

CONNECTICUT EMBAYMENTS STUDY

PHASE I - INVENTORY AND PROBLEMS ANALYSIS

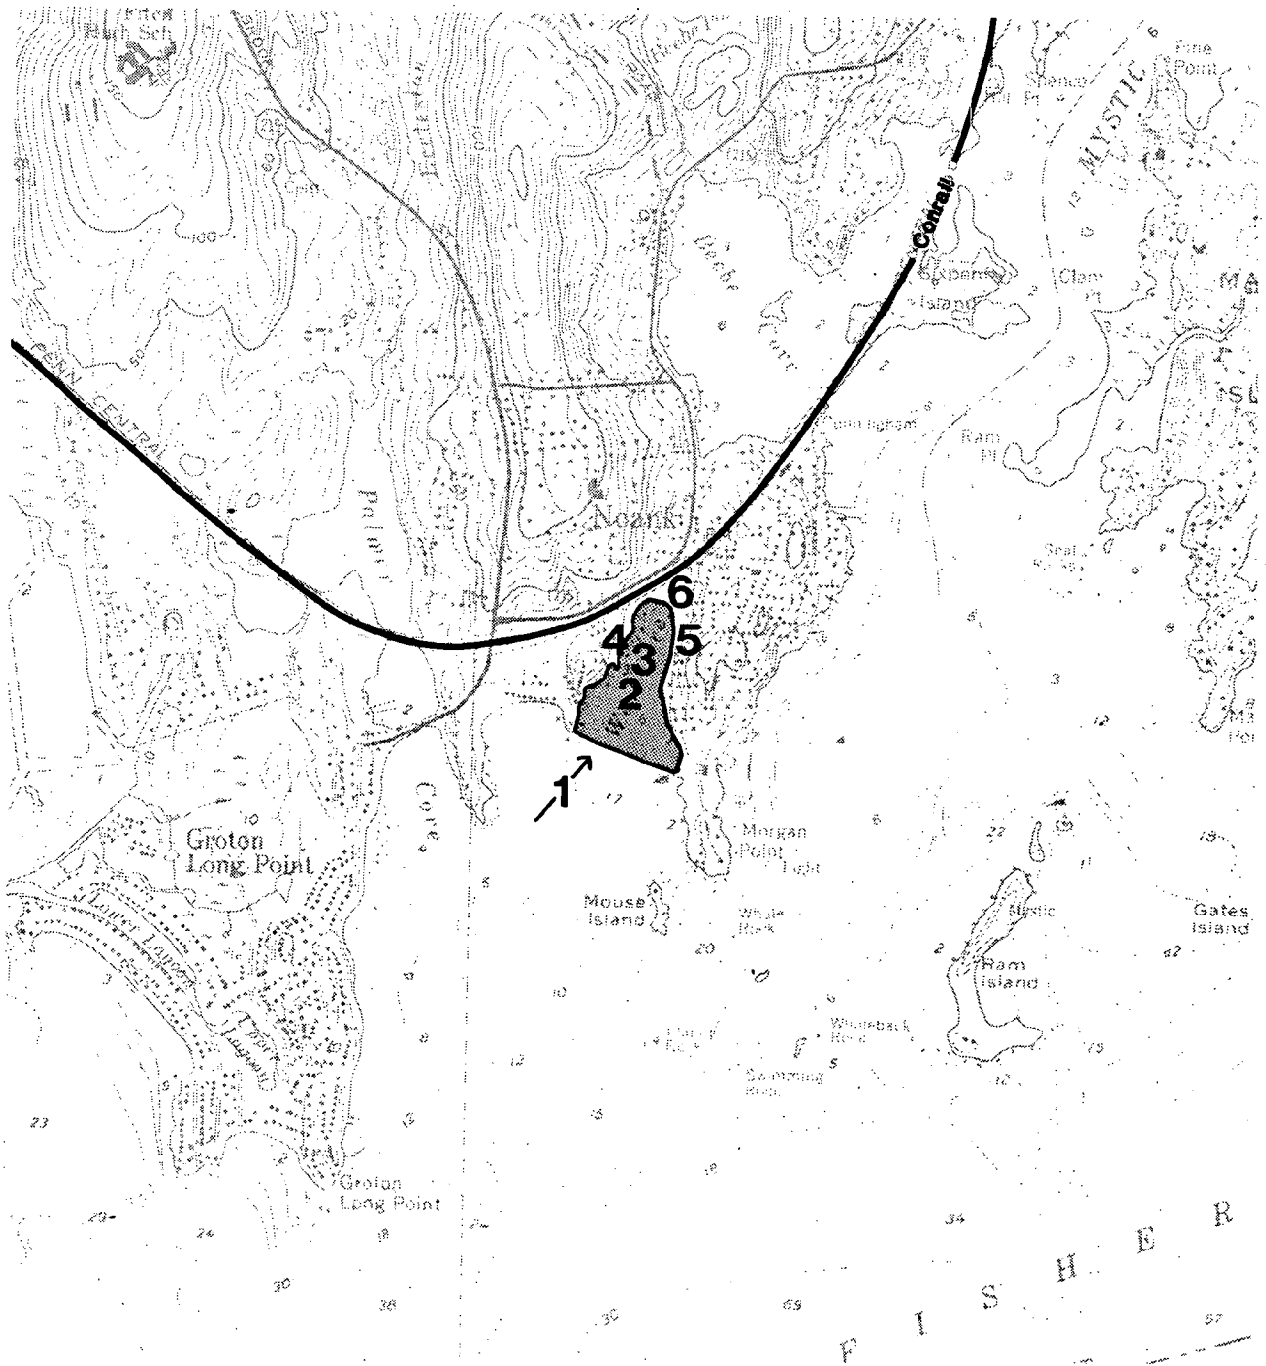
FIG 3.2 WEST COVE
ENVIRONMENTAL PROBLEMS

The siltation problem appears to be most severe along the Noank shoreline, as the residential docks are cut off from the water by tidal flats at low tide. Water access is restricted along in some segments of the shoreline even at high tide (See Figure 3.2).

It appears that the extended jetty may be shifting some of the sedimentation to the Noank shorefront, thus accelerating the deposition rate in the area (See Figure 3.2). It appears that the jetty extension has helped to focus wave energy on the bottom sediments, eroding them and carrying them towards the Noank shoreline, where they are redeposited and block boat access.

Though the embayment is not constricted by any causeways or bridges, free tidal circulation is impeded somewhat by the Spicer Marina jetty (See Figure 3.2). The jetty was designed to shelter marina boats from storm generated waves approaching from the southwest. An unintended side effect, however, has been the

One of the major factors affecting sedimentation is the configuration of the cove. The Noank Peninsula shelters the cove from prevailing summer winds and the hill at the head of the cove shelters it from the northwest winter winds (See Figure 3.2). The regular shoreline, small size, and gradually narrowing configuration of the embayment limit the opportunity for tidal and wave scouring of bottom sediment.

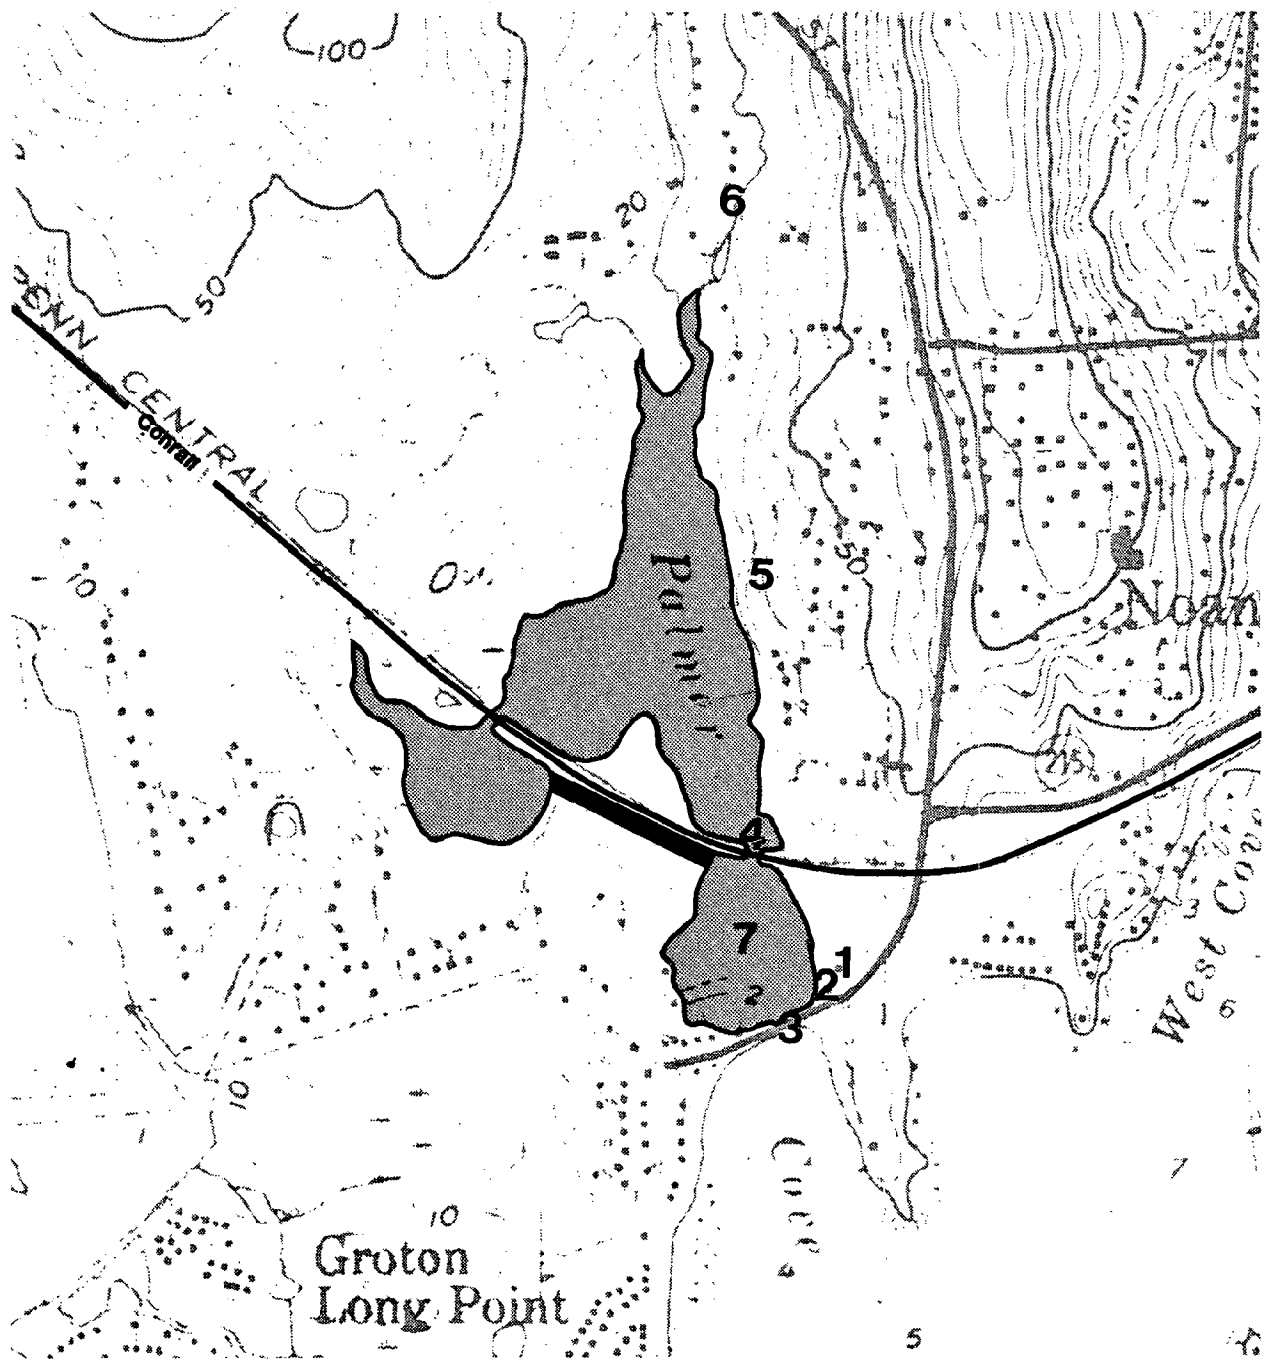
FIG 3.4 PALMER COVE
ENVIRONMENTAL PROBLEMS

The major problem identified throughout consultation with the town was siltation, primarily in the outer cove. Reduced circulation (caused by the railroad and highway bridge) and eutrophication were also indicated as additional problems (See Figure 3.4).

The constricted water circulation caused by the railroad and highway bridges is the single largest cause of the reported sedimentation and eutrophication within the cove. The highway bridge at the mouth of the cove has reduced the width of the embayment inlet by a factor of 10 (500 feet to 50 feet). This reduction has severely limited flow exchanges between Long Island Sound and the cove (See Figure 3.4).

The railroad bridge and causeway has reduced the embayment cross-section by nearly a factor of nine (420 feet to 49 feet) at the intersection of middle and outer coves. This severely limits flow exchange between the outer and middle coves (See Figure 3.4).

Tidal exchange to the inner cove would have been eliminated altogether were it not for the excavation of a hard-pan bottom channel connecting it to the outer cove.

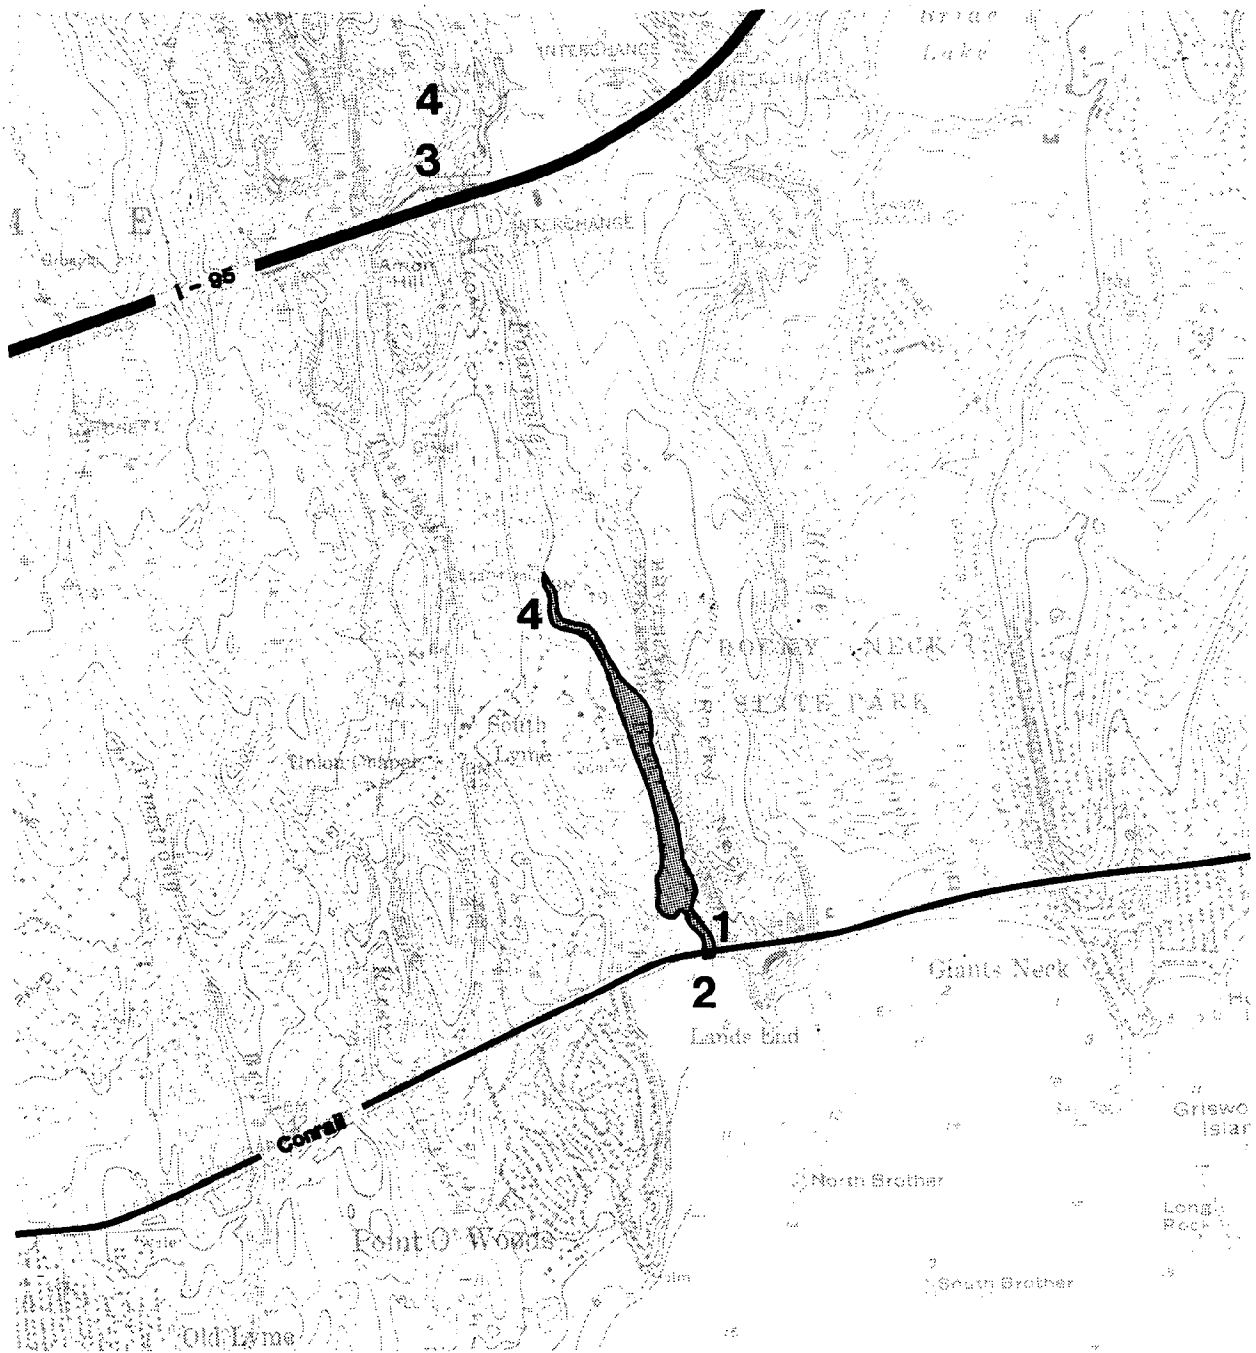
FIG 6.6 FOURMILE RIVER ENVIRONMENTAL PROBLEMS

Research and field work indicate the Fourmile River system to be a relatively healthy and unpolluted river with no significant environmental problems. Visual observations and review of a state feasibility study for dredging verify the occurrence of shoaling and sedimentation problems at the mouth of the river, west of Rocky Neck (Lands End) (see Figure 6.6).

South of the mouth of the Fourmile River is a horseshoe shaped embayment (see Figure 6.6). This embayment lies between Point o' Woods and Land's End. The natural shoaling pattern of Long Island Sound in the embayment acts to transport off-shore sediment material into this area where it settles out, creating near shore shoaling. Navigation charts for the area indicate depths of only 0.5 to 2 feet at Mean Low Water (see Figure 6.6).

The natural channel of the Fourmile River has been partially maintained due to tidal flow and flushing. The narrow mouth opening, created by the railroad causeway, slows tidal waters down considerably prior to entering the estuary. This acts to increase the rate of sediment settling out in the area inside of the river's mouth. This creates navigation problems in the area between the state boat ramp and the river's mouth. Upon leaving the constricted channel (at the railroad causeway), sediment in suspension is deposited, increasing bar size (see Figure 6.6).

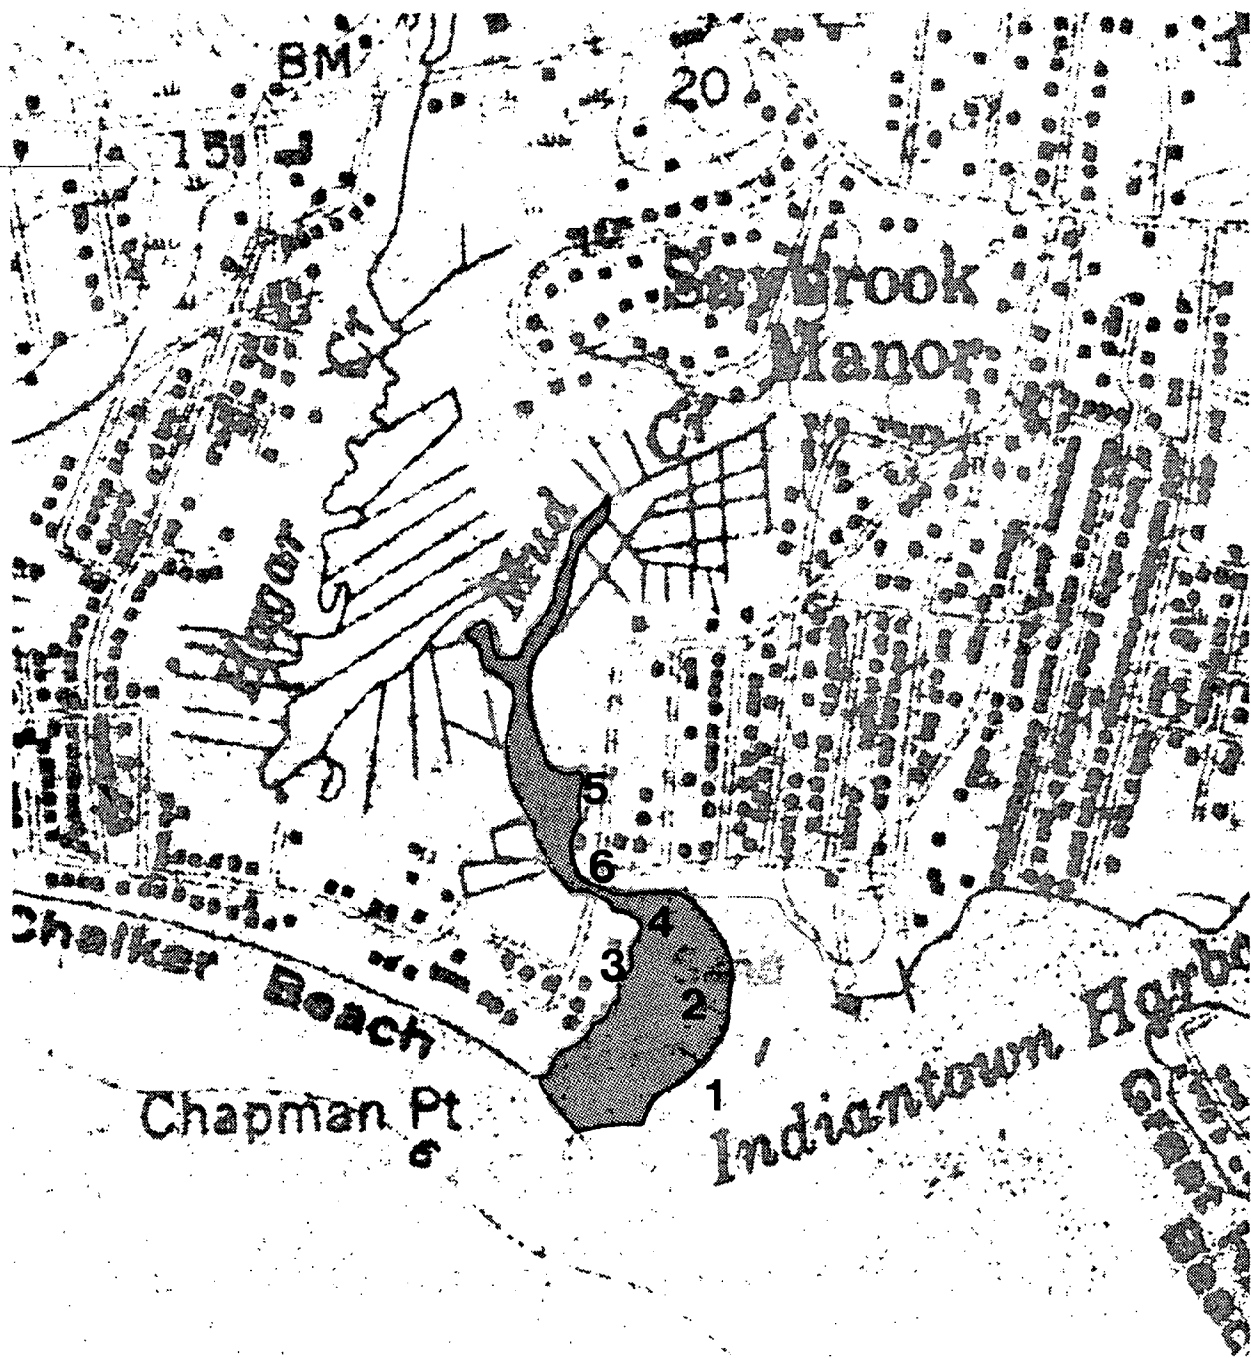
FIG. 9.2 INDIANTOWN HARBOR
ENVIRONMENTAL PROBLEMS

The field survey confirmed the shoaling problem at the mouth of the harbor, and two incidents of erosion (see Figure 9.2). One erosion site is a beach on the western shore inside the jetties. Several groins have been erected in an attempt to trap sand and stabilize the shoreline in this area. The second site of erosion is just north of the Mud Creek bridge and community boathouse on the eastern side of the creek (see Figure 9.2). At this point, the shoreline appears to have recently moved inland at least 10 feet.

The site visit also provided an opportunity to look at the new jetty construction. The jetty has been extended approximately 200 feet at an angle of about 20° east of its original alignment. This extension forms a slightly narrower inlet and places the end of the jetty at an angle to approaching storm waves, rather than facing them head on.

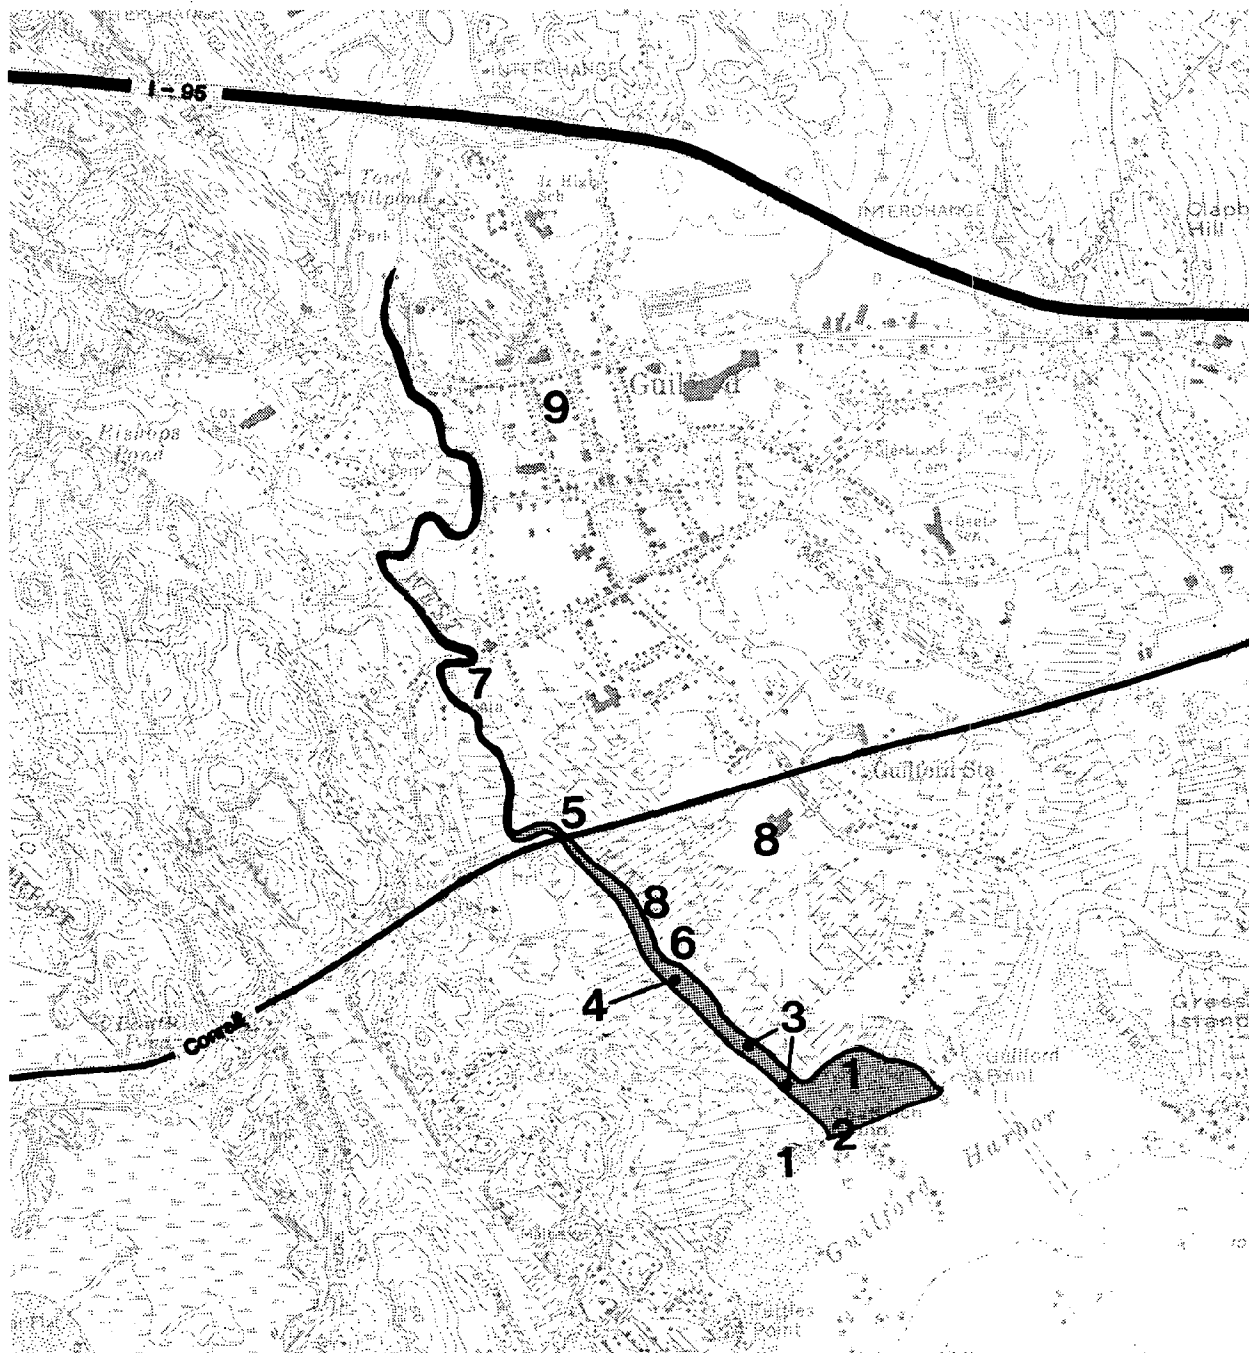
FIG 11.2 WEST RIVER
ENVIRONMENTAL PROBLEMS

The open marshlands of Chaffinch Island and Chittenden Beach have been exposed to the eroding forces of wave action for decades (See Figure 11.2). This has resulted in a retreating shoreline with an irregular shape. Historical air photos show a loss of over 200 feet of shoreline in these areas since 1934. Unless efforts are made to artificially stabilize these areas, erosion should continue unabated.

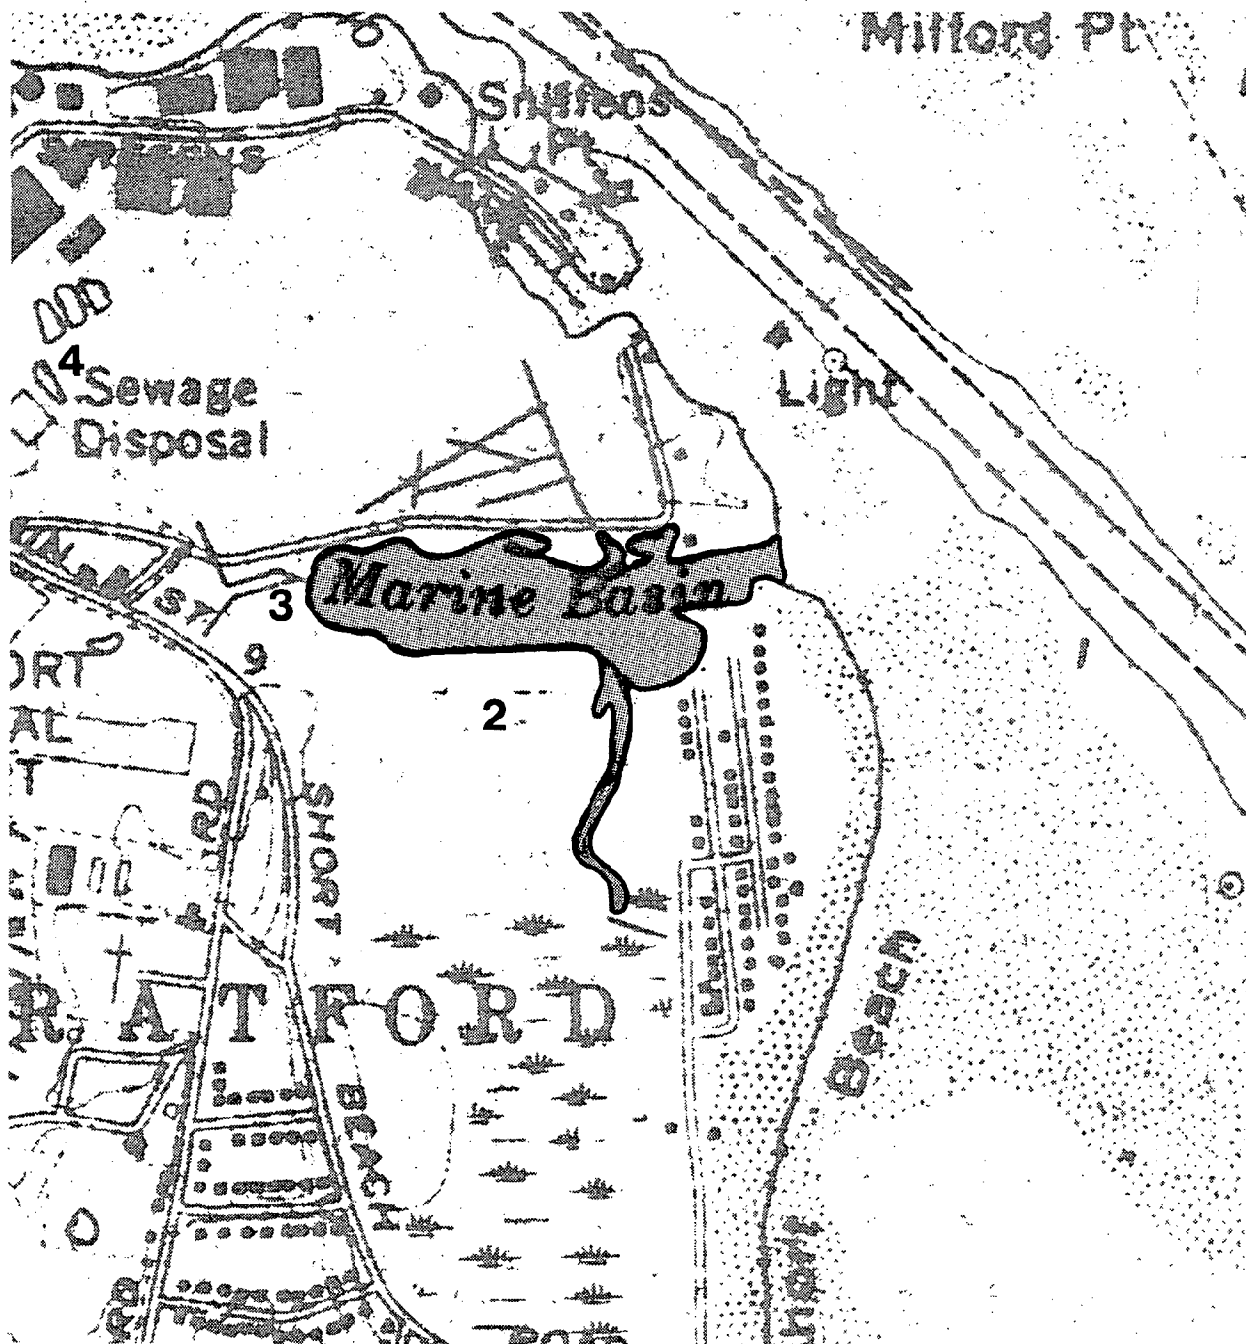
FIG 15.2 MARINE BASIN ENVIRONMENTAL PROBLEMS

The siltation of the basin is most severe in the western end and becomes less severe toward the mouth (See Figure 15.2). Two factors explain the gradient. First, tidal flow and circulation, though constricted by natural shoaling at the mouth, is more active in the eastern end of the basin. Particles are resuspended there and either flushed to the Housatonic River on an ebb tide or transported and deposited in the quieter environment of the west end. Second, the landfilled area most subject to erosion is located near the west end. As noted in Section C, part of the landfill at the western end of the basin extends right to the water's edge. This is a clear opportunity for erosion of silt into the embayment.

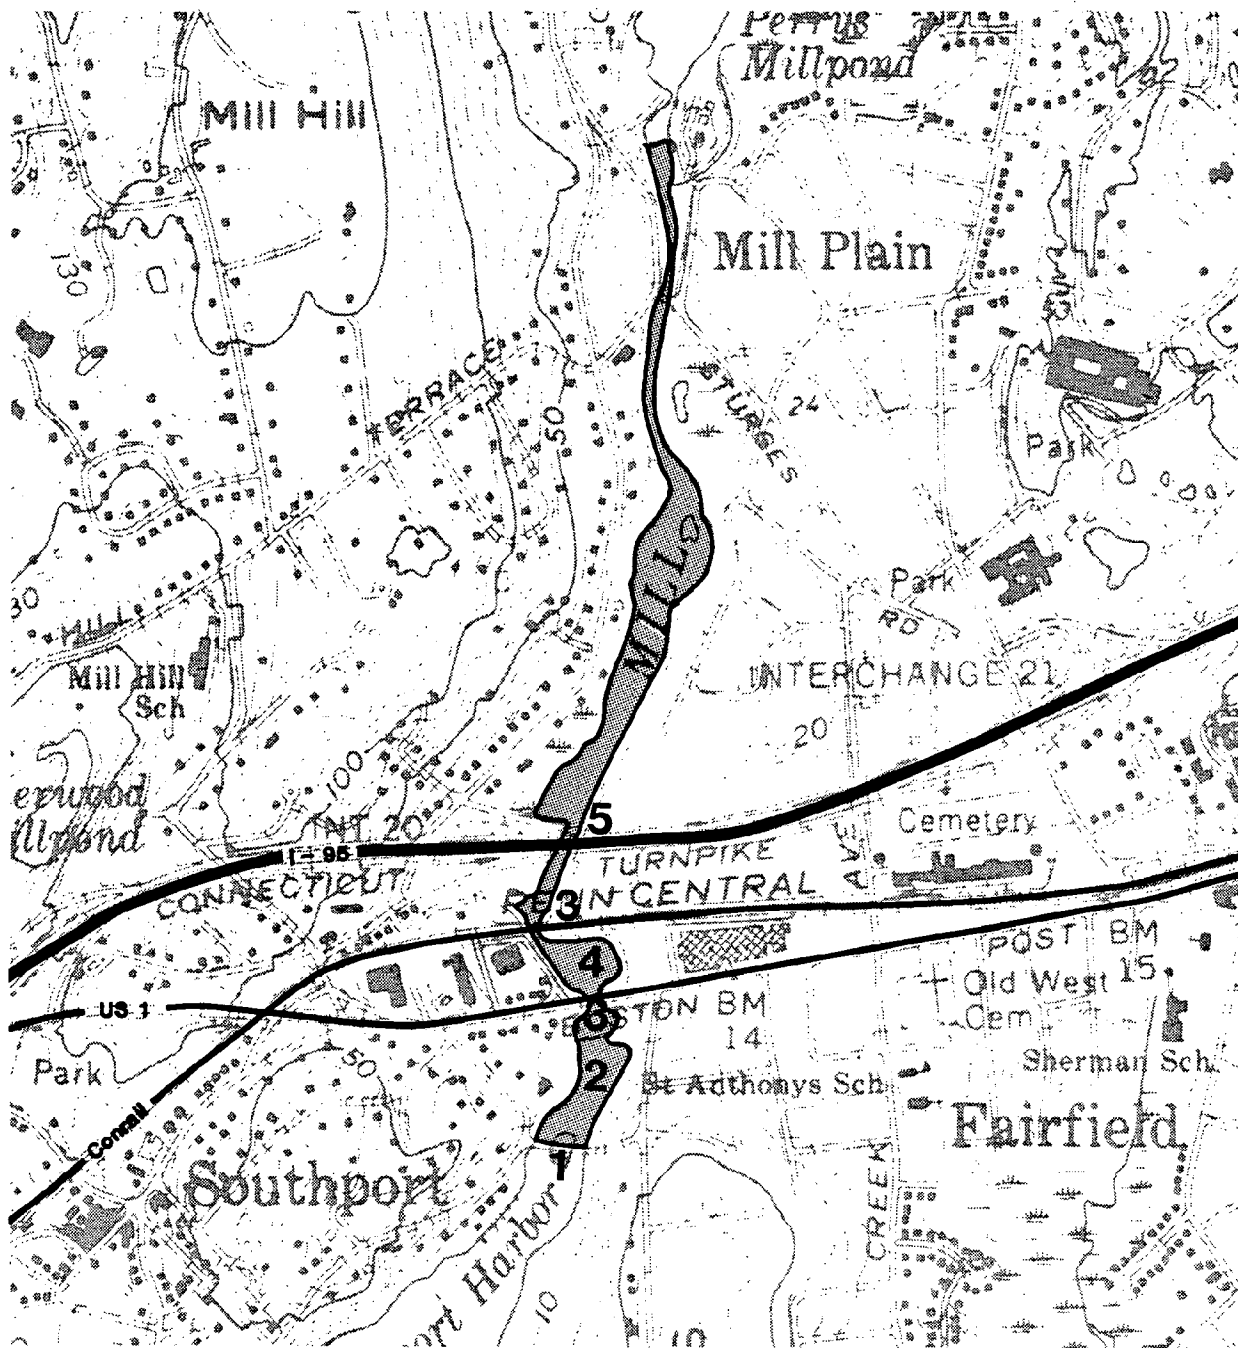
FIG 16.4 MILL RIVER/POND ENVIRONMENTAL PROBLEMS

Though no visible signs of lead contamination were present at the time of the site visit, the location of the ESB outfall pipe was confirmed (See Figure 16.4). Signs prohibiting clamming, crabbing and swimming were also noted in the vicinity. Water sampling on the Mill River since 1977 has documented the lead contamination from ESB wastes. The results of the sampling are summarized in the discussion in Subsection D-2 below. Pollutants in the ESB waste stream (in addition to lead) include oils, acids, and iron.

Tidal exchange on the Mill River is restricted above the Mill Pond dam and spillway at Harbor Road (See Figure 16.4). The spillway creates approximately a four to five foot rise in the riverbed elevation, and thus prevents most normal tides from penetrating further up the river on an incoming tide.

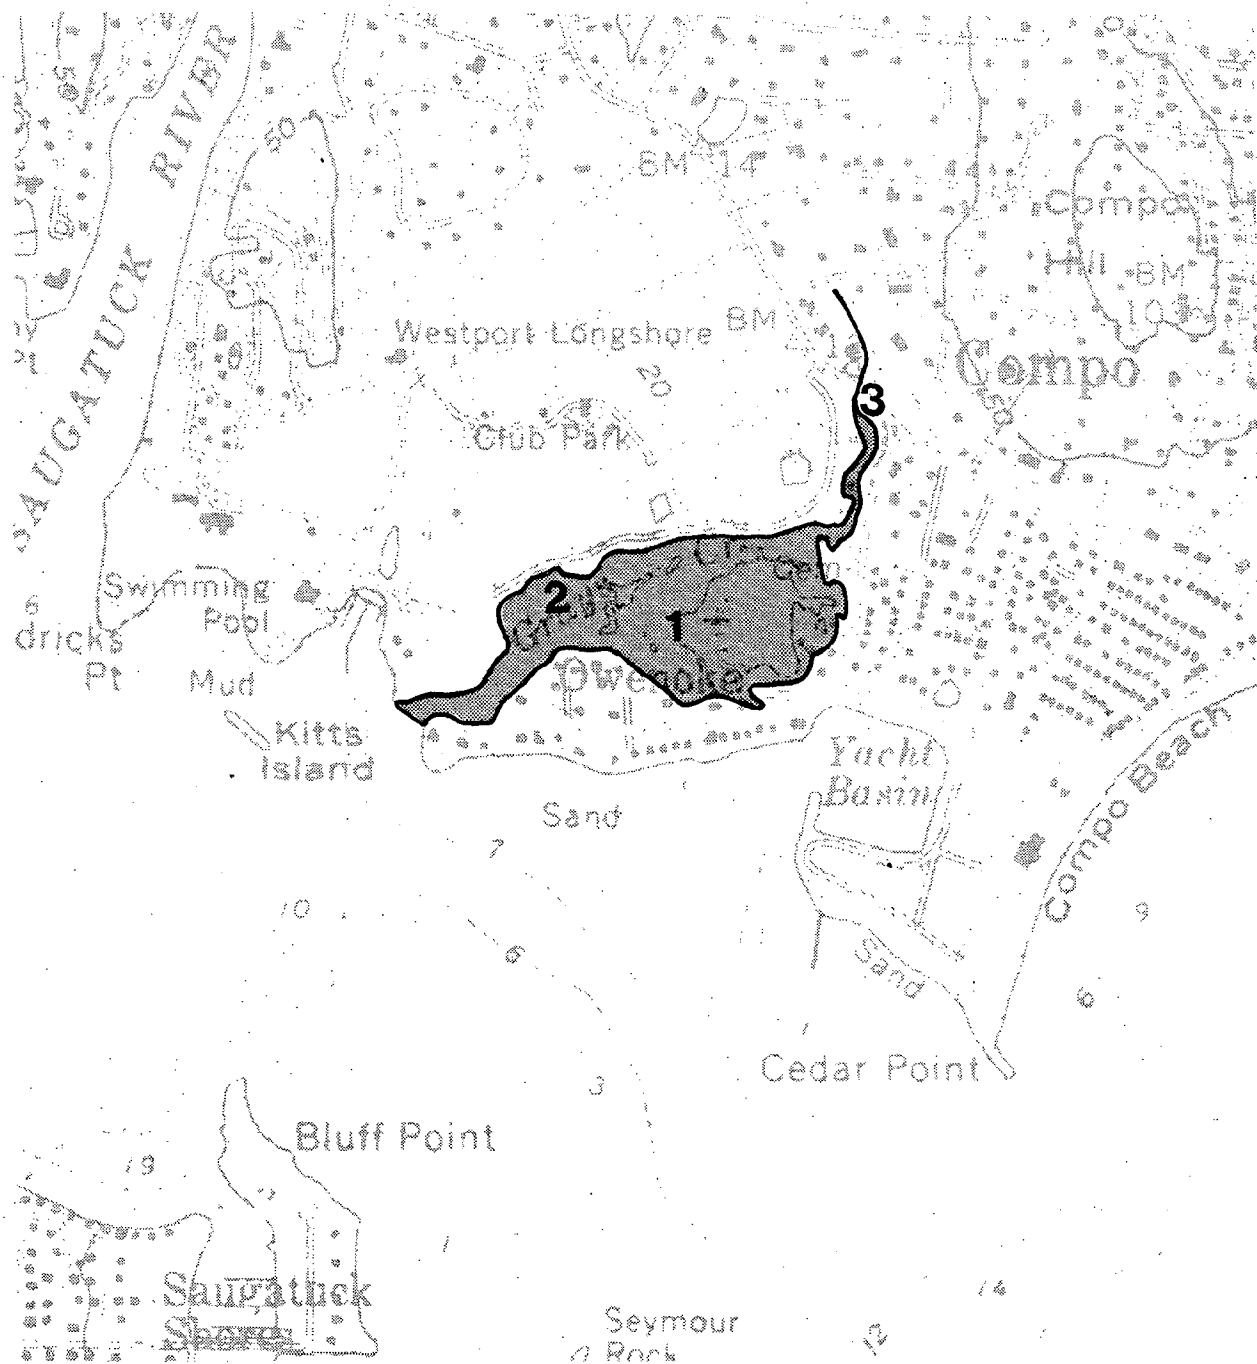
FIG 17.4 GRAY'S CREEK
ENVIRONMENTAL PROBLEMS

The embayment is experiencing some siltation (See Figure 17.4). Over two-thirds of the embayment becomes tidal flats at low tide and serves as an important feeding area for shorebirds and other wildlife. The sediment is almost black, very soft, and appears to have a high organic content. Composition of the sediment generally becomes more coarse as one approaches the mouth of the embayment or from the center of the creek bed to the shoreline.

There are three potential sources of the sediment. First, it is likely that some silt is discharged to the creek by the storm sewer outfall located at the head of the embayment (See Figure 17.4). Second, some sediment appears to be eroding from the service road embankment on the north side of the creek. Most of the embankment is composed of unconsolidated sediment and is subject to erosion by surface runoff from the golf course. Third, some of the silt may originate from the Saugatuck River and Long Island Sound in the form of resuspended bottom sediment. Waves and tidal currents could possibly resuspend the fine silt, which, once transported into the creek by a flood tide, may settle out in the quiet environment of the creek.
