Torpedo Plant Dock and Piers:

Technical Analysis and Design Recommendations

City of Alexandria, Virginia

July, 1979

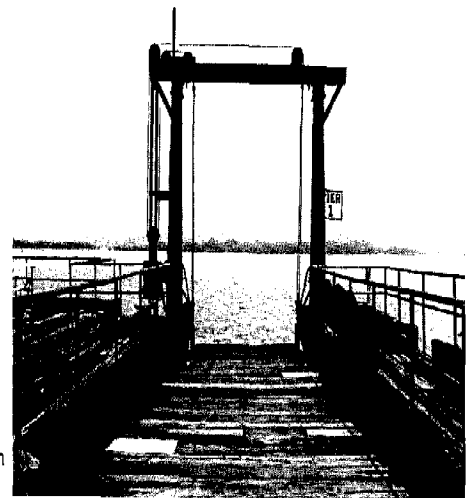
Figure 14 Pulley system on North Pier

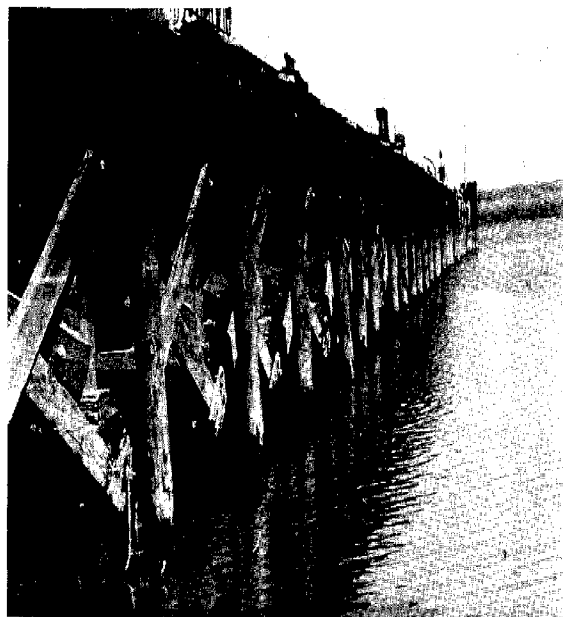
Figure 40 South Elevation View of South Pier

The timber deck and the backing log timbers are very badly deteriorated. The timber stringers and headers are in poor to fair condition. The 12-inch by 12-inch vertical timbers in each bent, and the related cross bracing are in poor condition. The longitudinal cross bracing between bents and the fender piles are in poor condition due to decay or mechanical damage. A major factor contributing to the deterioration of the vertical and bracing members is the decay which developed in the many bolt holes used for connection of the members.

In general, based on conclusions formed during the site inspections and from review of the reports of investigations conducted by others, it appears that the condition of the pier superstructure, from the deck to the top of the piles, does not warrant the expenditures for repairs. (Figure 40.) The foundation piles, while exhibiting some shallow surface deterioration, are believed to be reasonably sound and in good condition. This is not unexpected, since these members are exposed for very short periods of time during very low tides. In similar

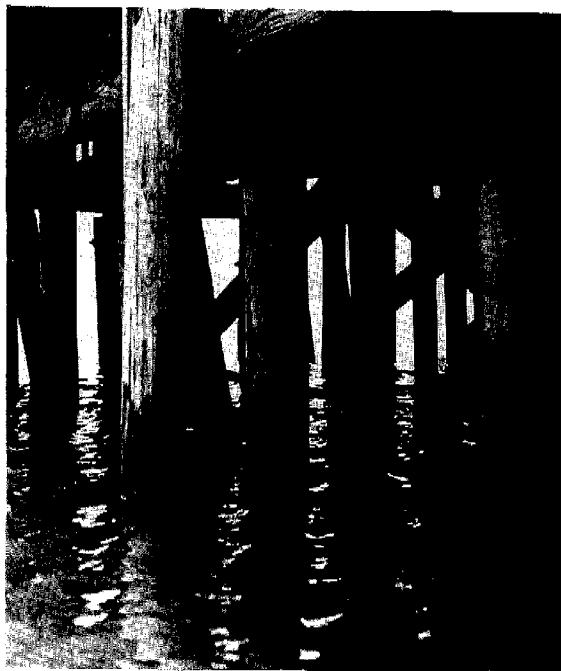
Figure 49 North Pier Piling

The timber foundation piles supporting the timber section of the pier are in generally good condition. Of the interior piles inspected, approximately 31 percent exhibited evidence of decay in the outer fibers, but beyond that depth, the piles appear to be sound.

The fender piles around the perimeter of the North Pier have suffered the greatest deterioration and damage due to past usage and exposure, particularly in the tidal zone. It is estimated that approximately 80 percent of these piles, including the clusters at the northeast and southeast corners and along the south side of both the timber and the concrete sections of the pier will require replacement.

For the timber section of the pier, rehabilitation can be accomplished by replacement of the pile bracing members, repair of the deteriorated or unsound decking, and replacement of the timber fender piles and pile clusters. The decay noted in the bearing piles can be arrested with the use of an internal fumigant. This action will prolong the expected life by approximately ten years.
