The following policies and rules, which require modifications of aircraft for the purpose of remedying defects affecting airworthiness, are hereby adopted. They shall become effective upon publication in the **FEDERAL REGISTER** unless otherwise indicated, in order to promote safety of the flying public. Compliance with the notice, procedures, and effective date provisions of section 4 of the Administrative Procedure Act would be impracticable and contrary to the public interest and, therefore is not required.

1. Introduction to airworthiness directives (CAA policies)—(a) General. (1) The Civil Aeronautics Act of 1938, as amended, empowers the Administrator of Civil Aeronautics to issue type certificates for aircraft after he determines that the aircraft is of proper design, material, specification, construction, and performance for safe operation, and that it meets the minimum standards prescribed by the Board. If the Administrator finds that the aircraft conforms to the type certificate therefor, and, after inspection, that the aircraft is in a condition for safe operation, upon application by the registered owner, he will issue an airworthiness certificate.

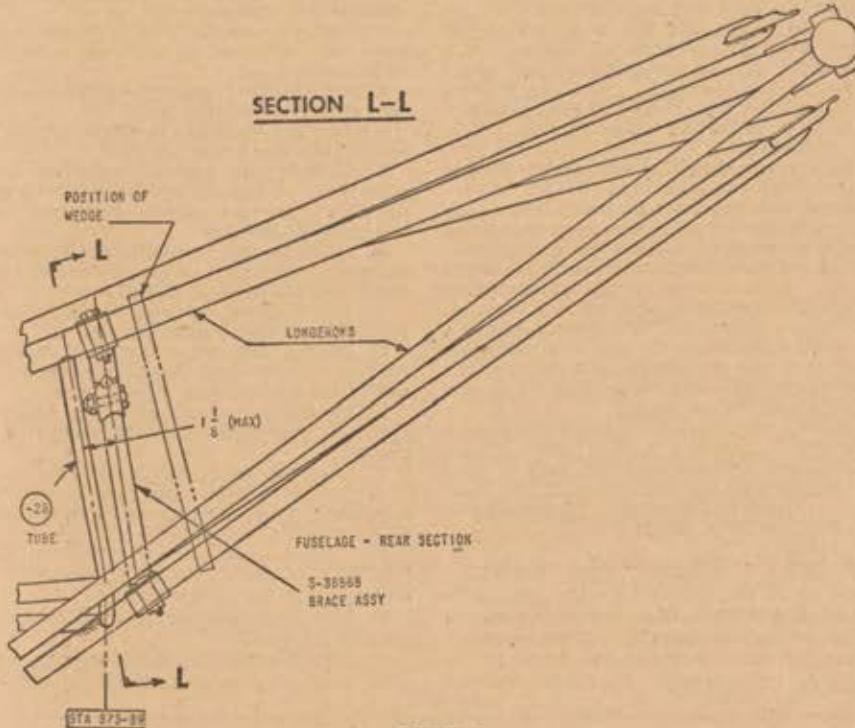
FIGURE 7.

c. Fashion a wedge, using a piece of wood $1 \times 3 \times 14$ inches, and V notch both ends. (See fig. 7.)
