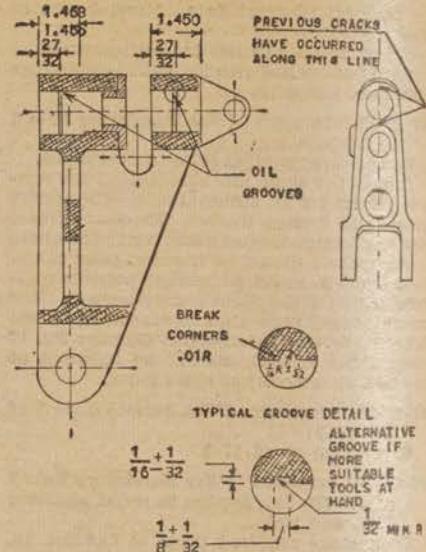
FIGURE 3.

2. Visually inspect main rotor links, part No. VS 36181 by one of the following methods for cracks around link pin hole and longitudinally along what was the flash line in original forging. (See Figure 3.) If cracks are present, links should be scrapped.

3. Machine oil grooves. (See Figure 3.)

(b) If bearings removed are part No. AT-16-OH and retainers washers are damaged or show evidence of foreign matter, they are to be replaced.
