Southern California Edison Company, et al.; San Onofre Nuclear Generating Station, Units 2 and 3; Issuance of Director's Decision Under 10 CFR 2.206

Director's Decision Under 10 CFR 2.206

A. Request for an Investigation to Determine if SONGS Unit 2 Has Experienced Eggcrate Degradation Similar to Unit 3

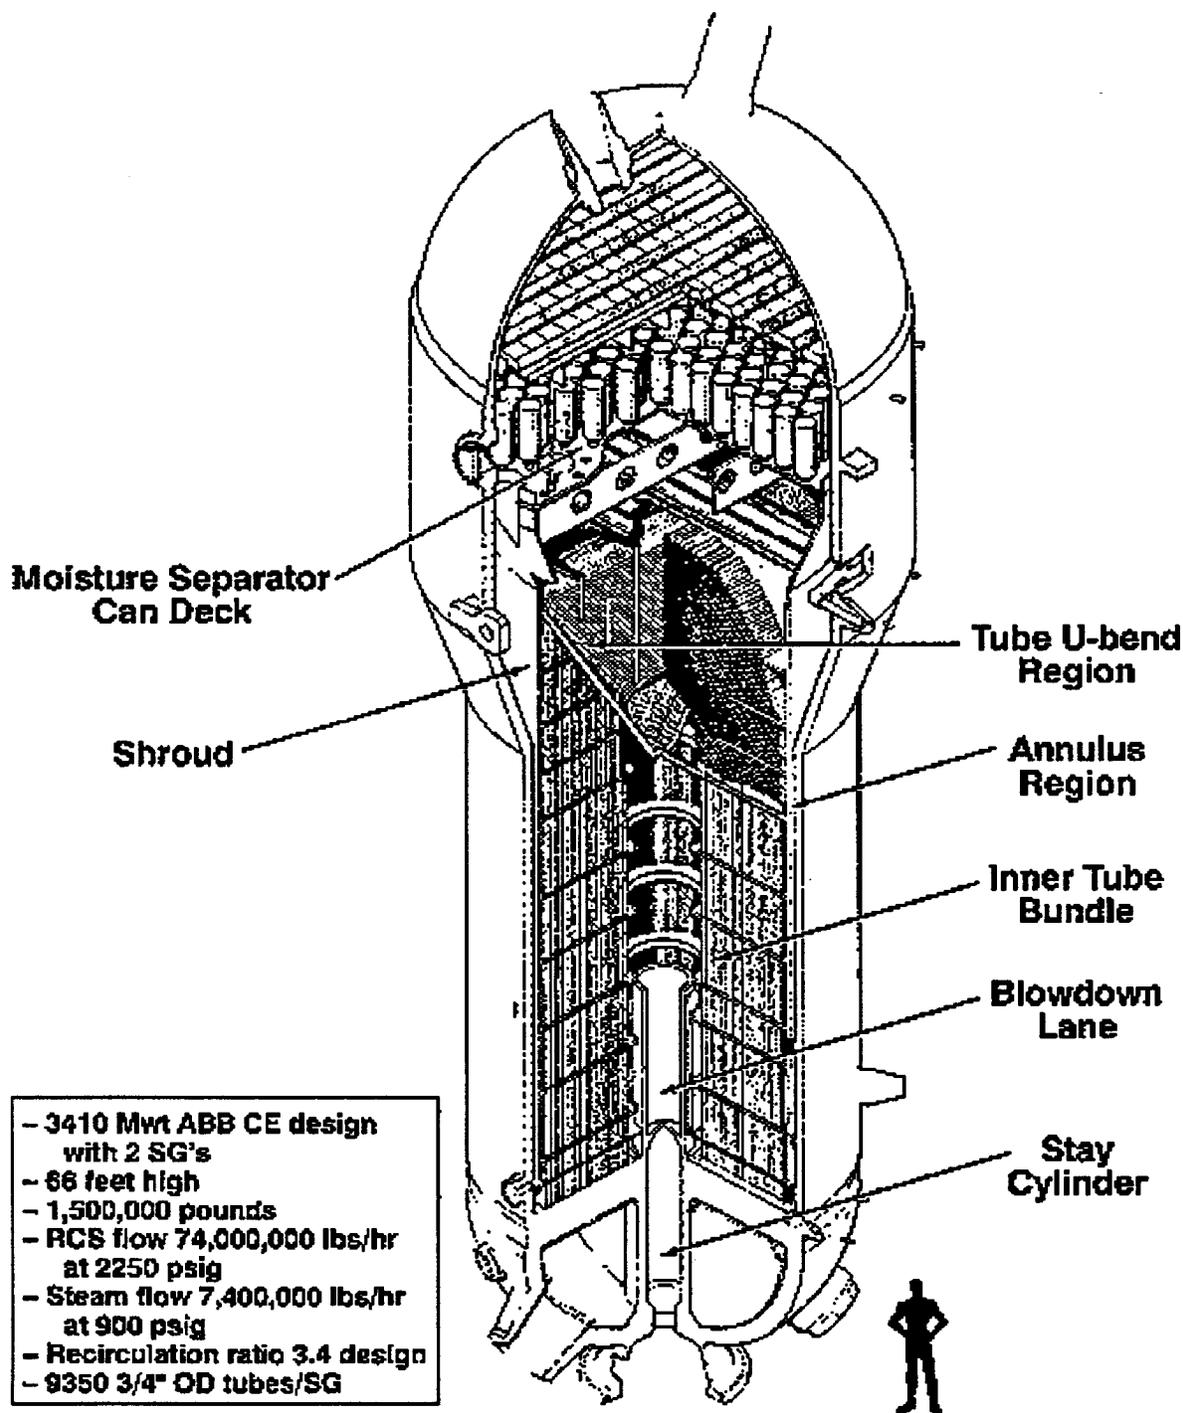
Figure 1

For the individual steam generator tube analysis, the licensee calculated the maximum loads that could occur assuming that adequate support was not available at two consecutive eggcrate levels (see Figure 1). The staff finds this assumption conservative and acceptable because the licensee has removed from service all tubes where two consecutive eggcrate levels were found degraded to the point where adequate support could not be assured.

Steam Generator
Eggcrate Locations
