Federal Register

Friday, October 21, 2016

[Docket No. FAA-2016-9254; Directorate Identifier 2015-CE-030-AD]

#### Airworthiness Directives; Piper Aircraft, Inc. Airplanes

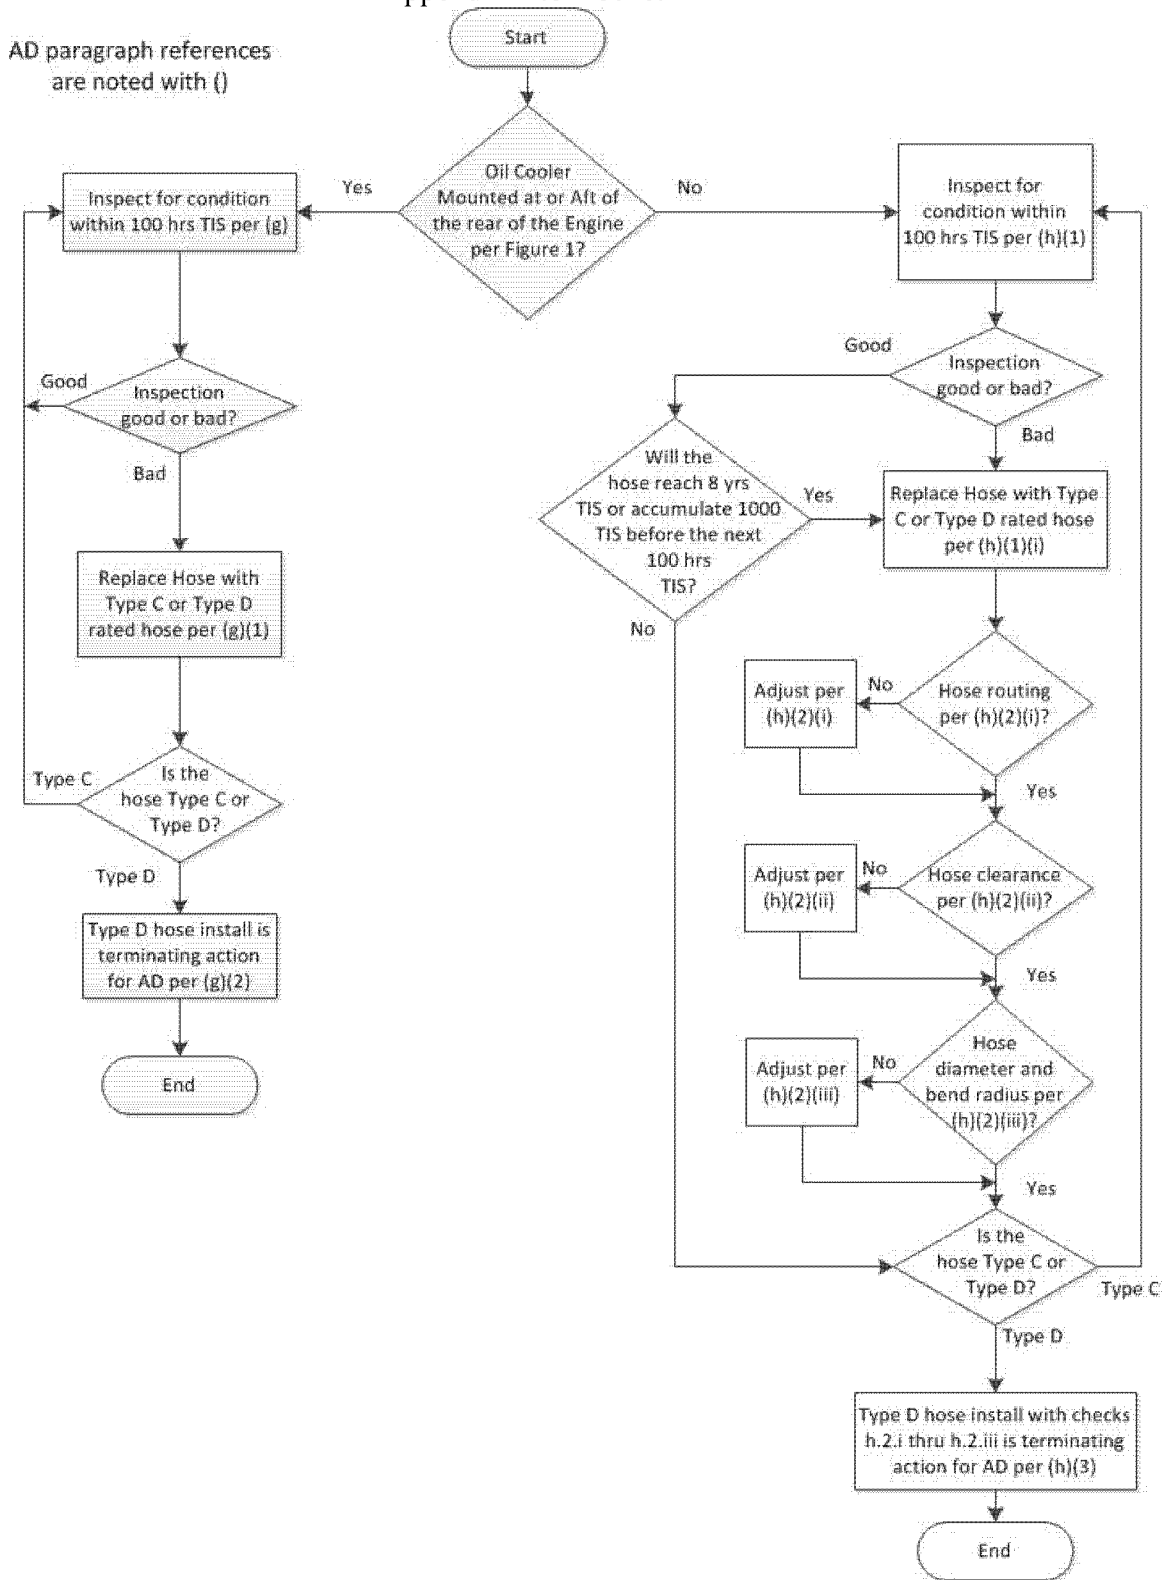
Appendix 1 to Docket FAA-2016-9254

(3) Within the next 100 hours TIS after February 5, 1996 (the effective date retained from AD 95-26-13) and each time the oil cooler hose assembly is replaced for any reason or inspected following paragraph (h)(1) of this AD, inspect to ensure the installation conditions in paragraphs (h)(3)(i) through (iii) of this AD are met. If the conditions listed in paragraphs (h)(3)(i) through (iii) of this AD are not met, before further flight, make any necessary adjustments. Please see figure 2 to paragraph (h) of this AD for additional information.
