# Investigation of L'Ambiance Plaza Building Collapse in Bridgeport, Connecticut

Center for Building Technology  
National Engineering Laboratory  
National Bureau of Standards  
Gaithersburg, MD 20899

Issued September 1987

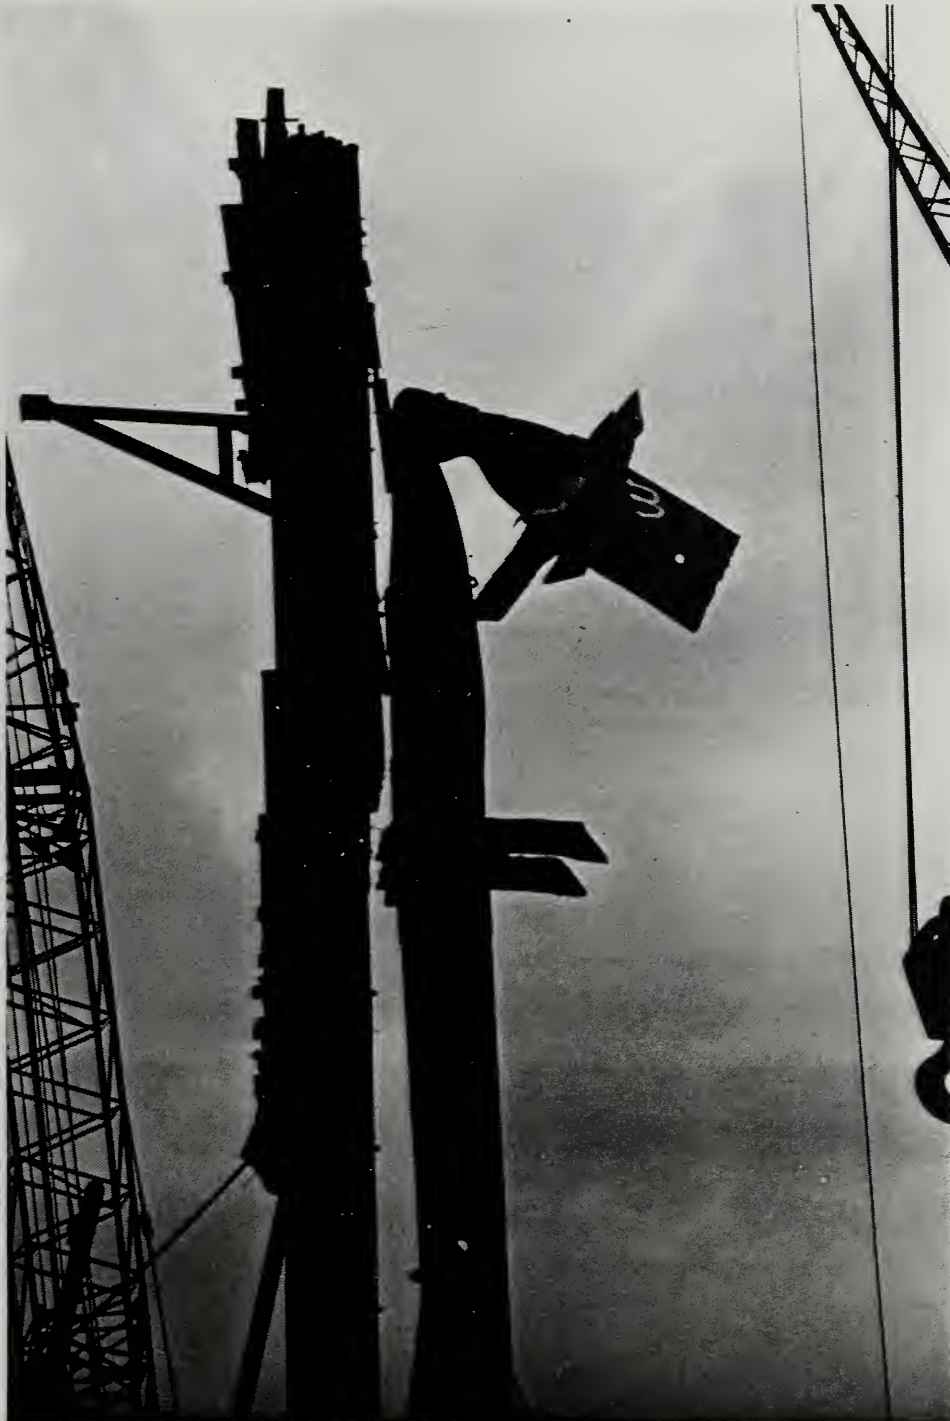
Figure 4.4.2 Column C3 bending about the strong axis -  
View to the East, shearwall on left

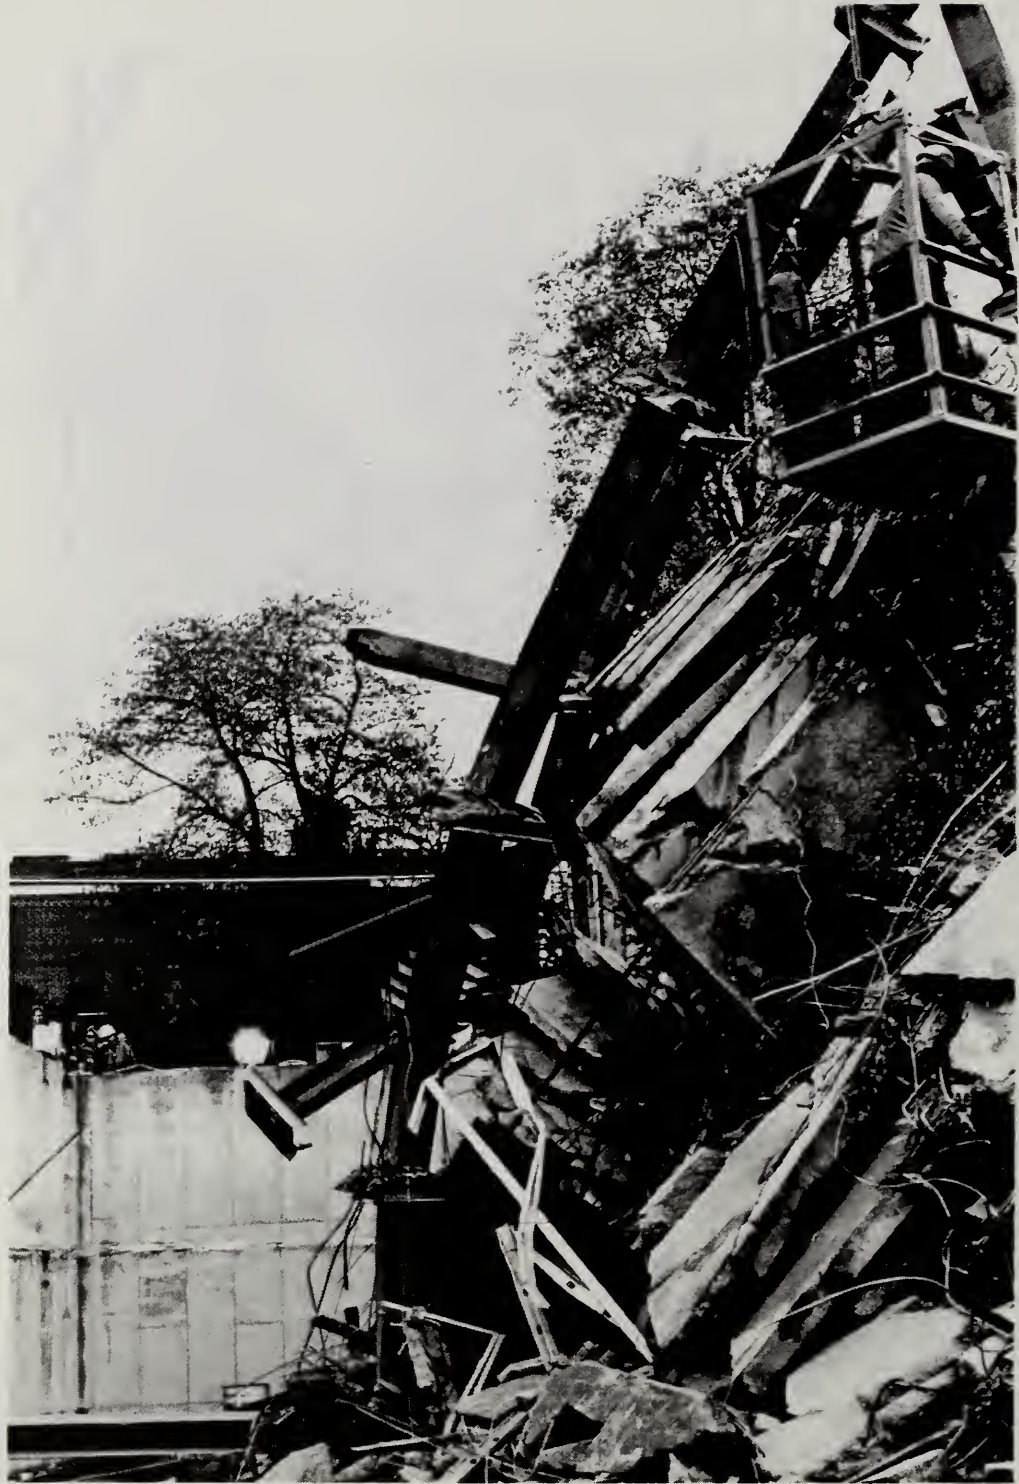
Figure 4.4.3 Deflected shape of column E1 –  
View to the North

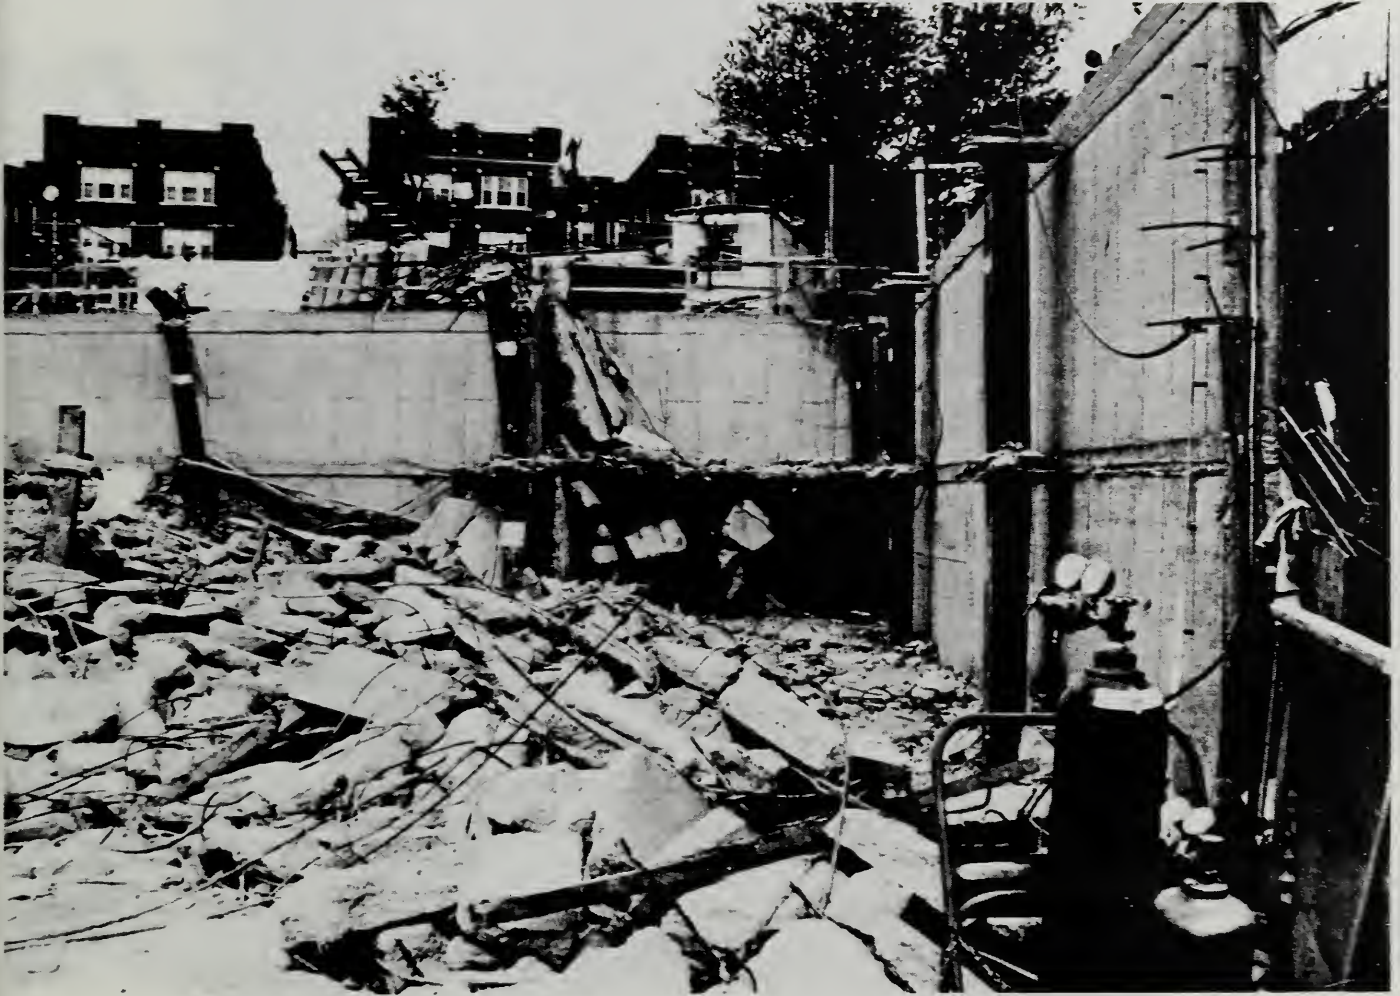
Figure 4.4.4 East perimeter columns at Levels E and D. East tower—  
View to the North; photo taken after rescue  
operations complete

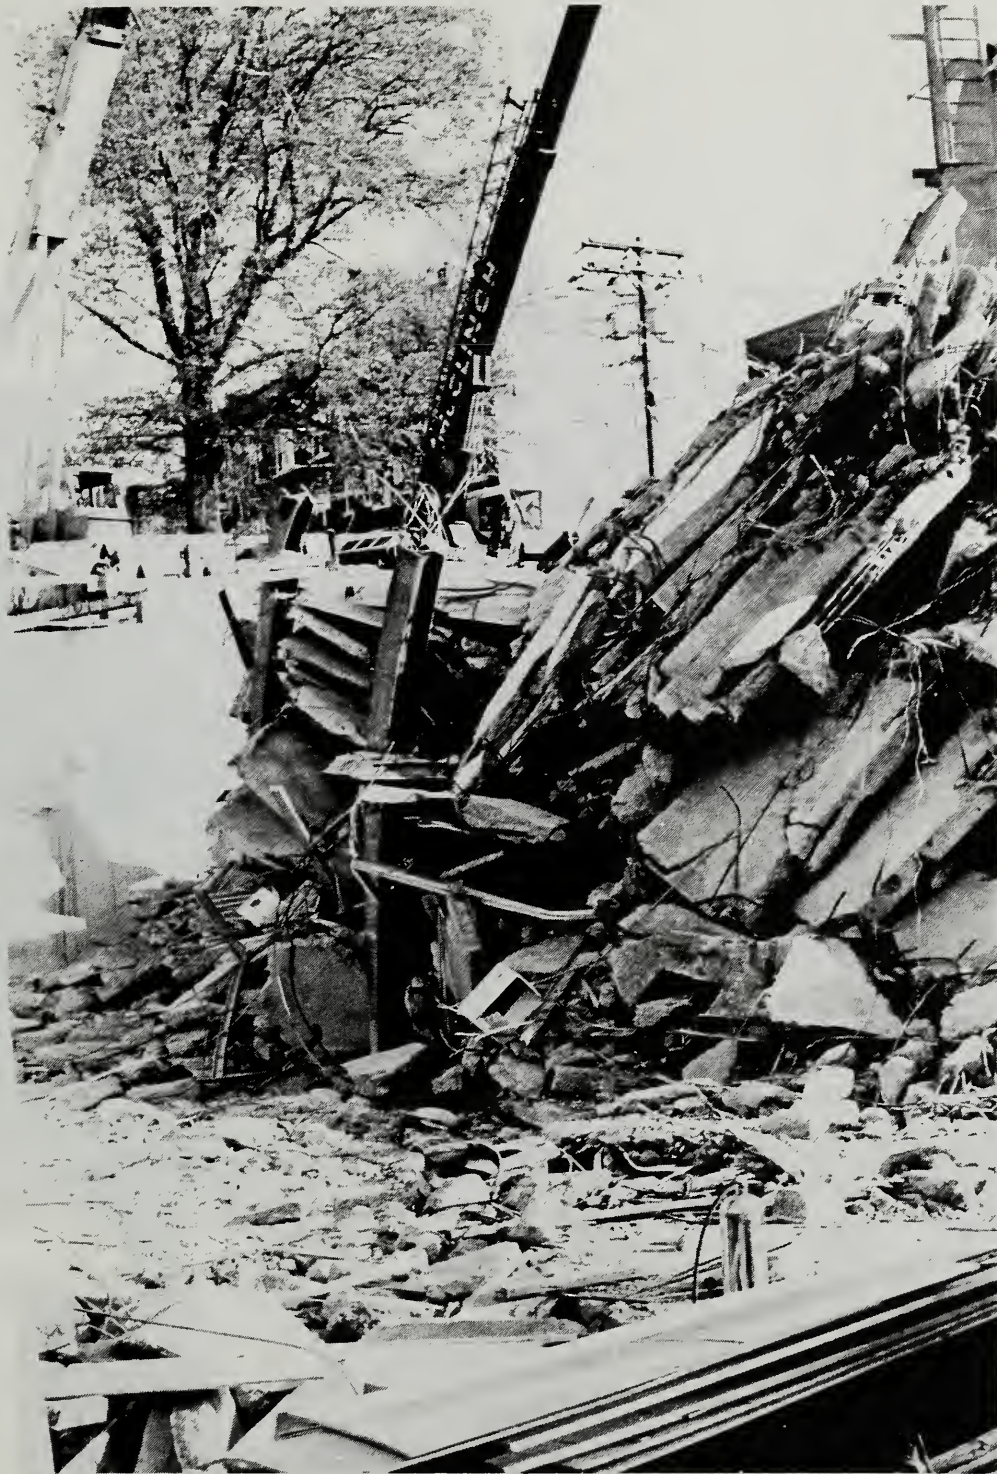
Figure 4.4.8 Lower level floor slabs at Northwest corner of West tower – View to the North; column E1

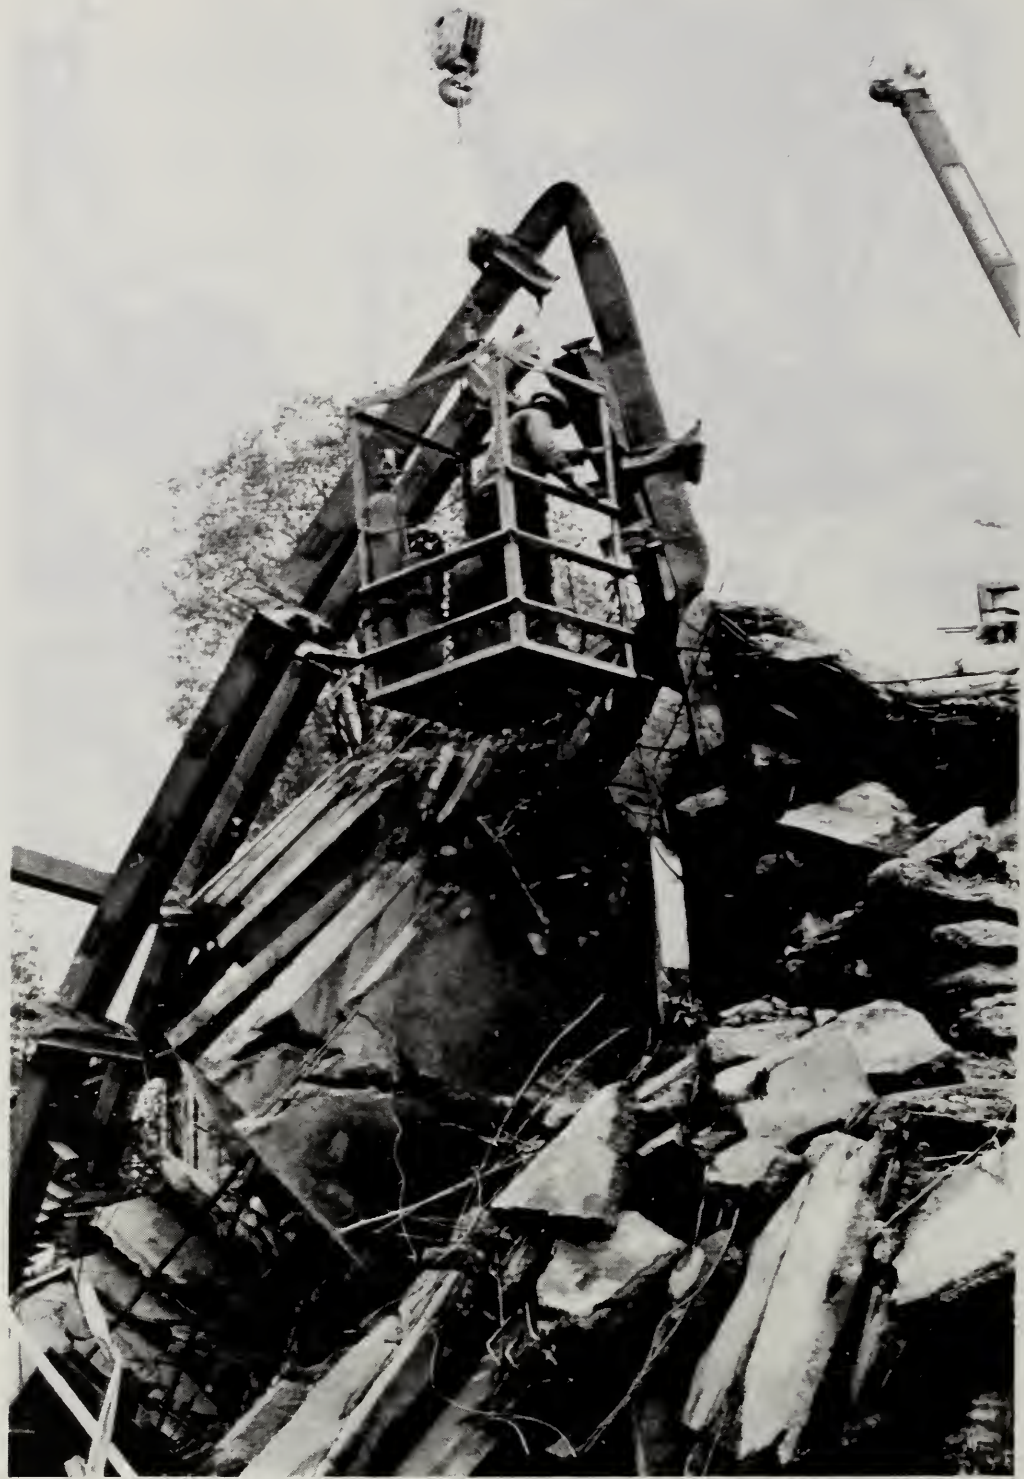
Figure 4.4.9 Upper floor slabs on Northwest corner of West tower - View to the North; column E1

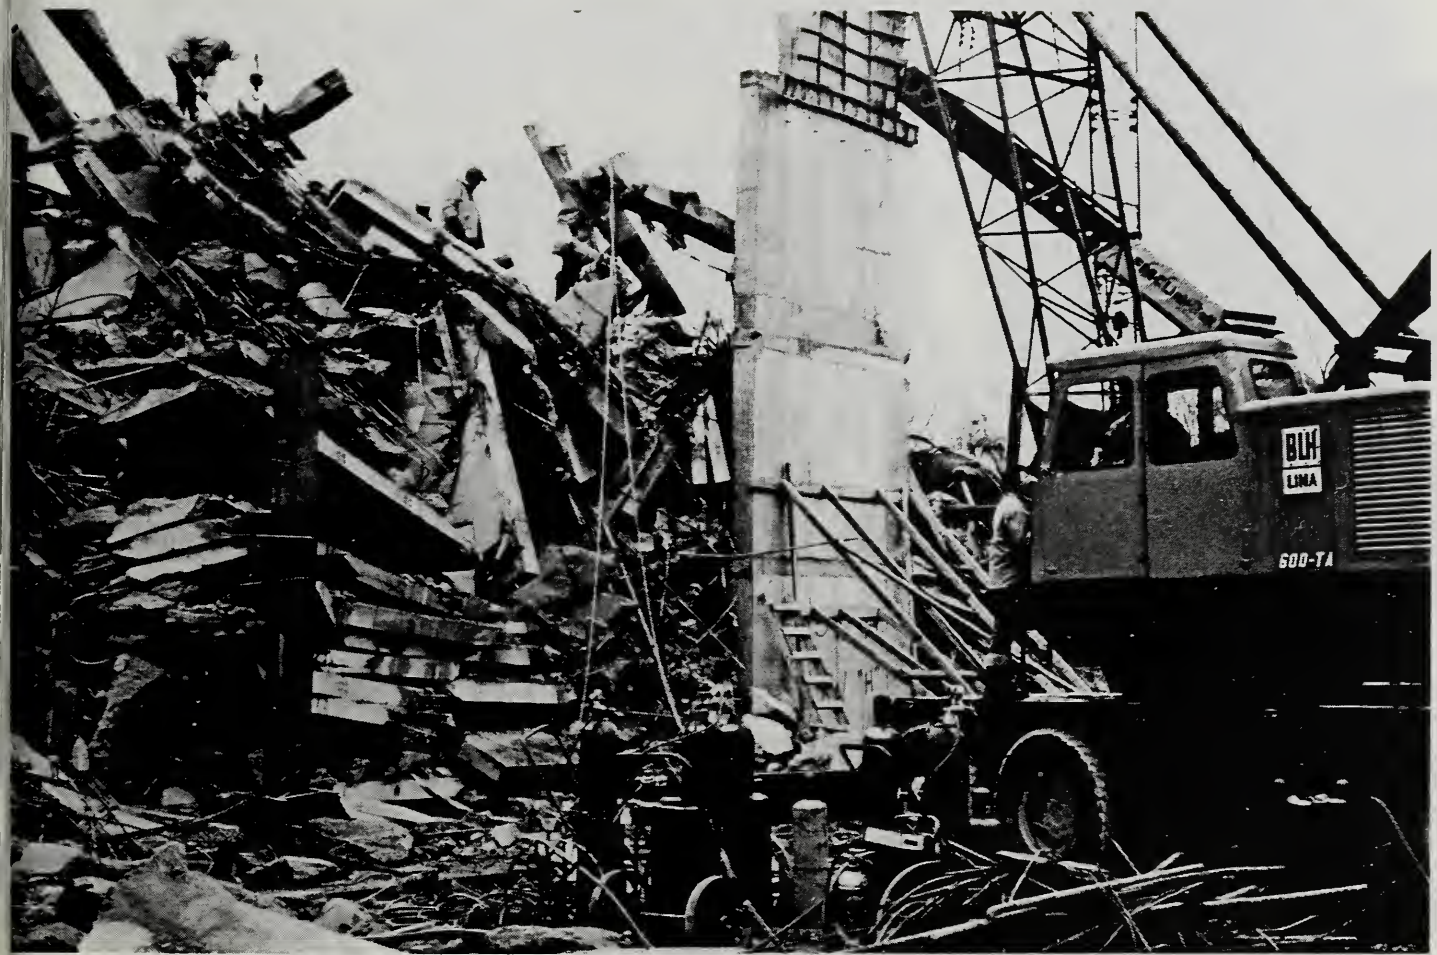
Figure 4.4.10 Lower level floor slabs in center portion of West tower – View to the Northeast

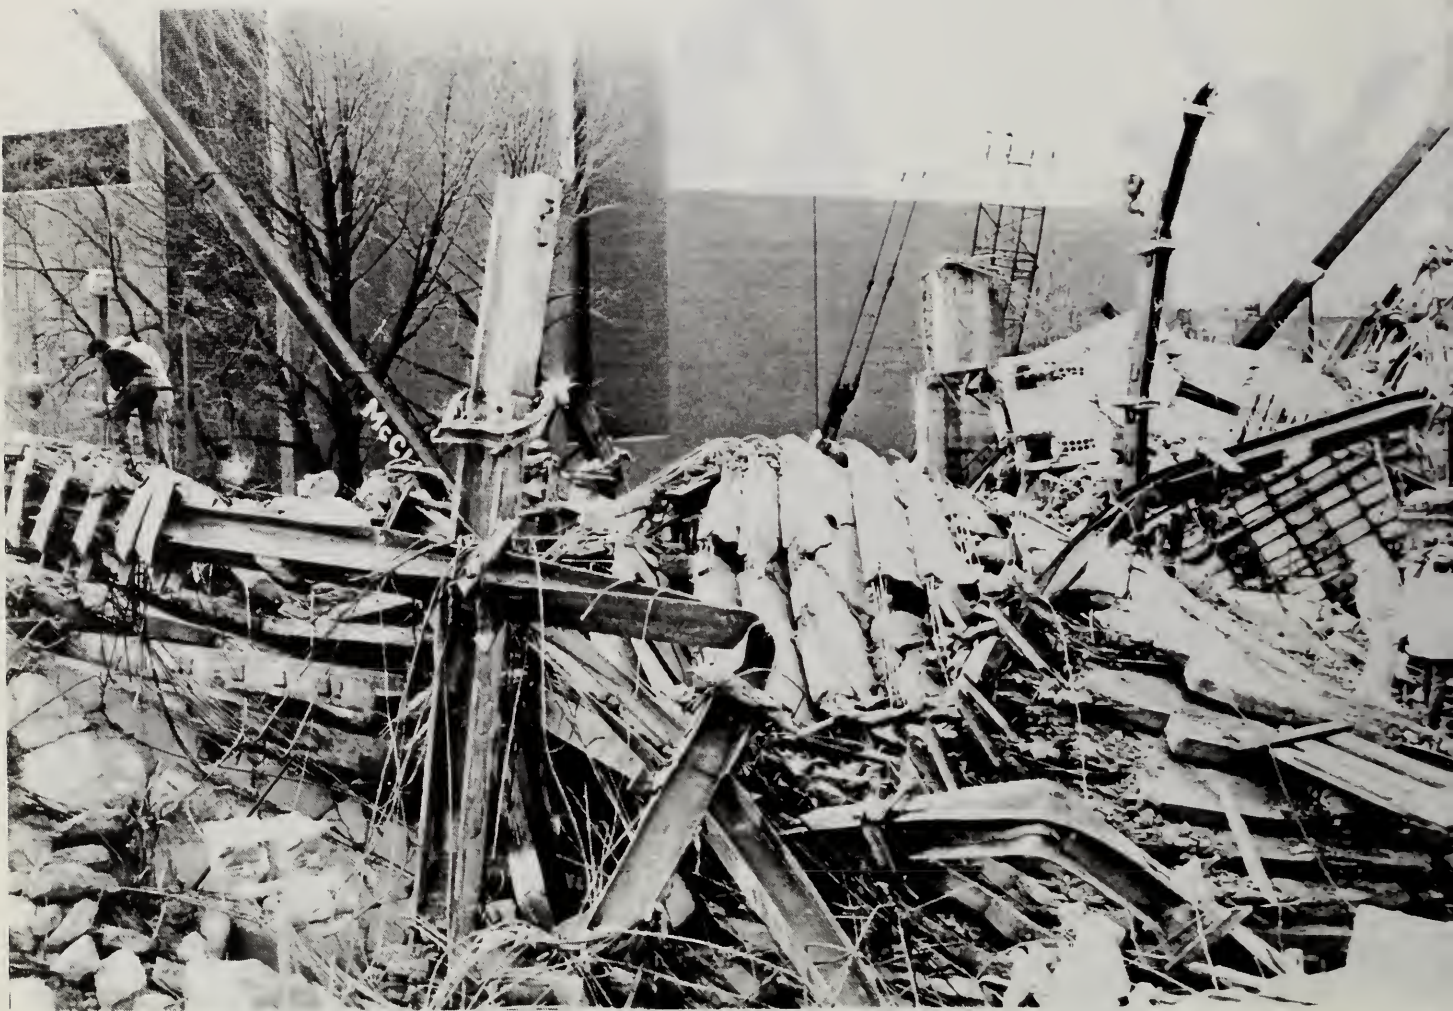
Figure 4.4.11 Floor slabs in the central portion of East tower – View to the Southwest

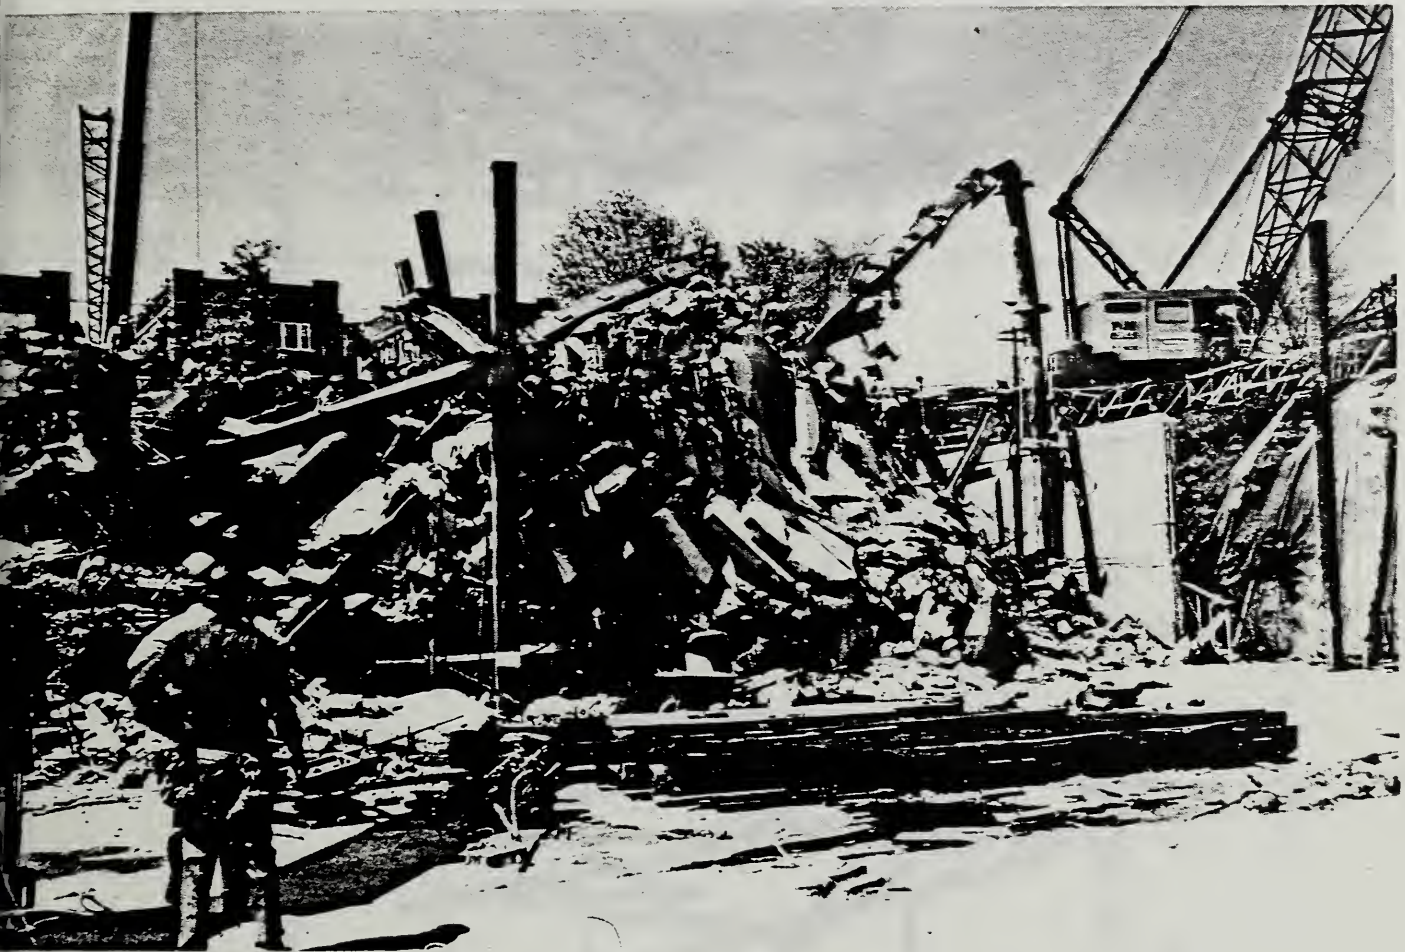
Figure 4.4.12 Floor slabs in Southeast corner of East tower -  
View to the Northeast

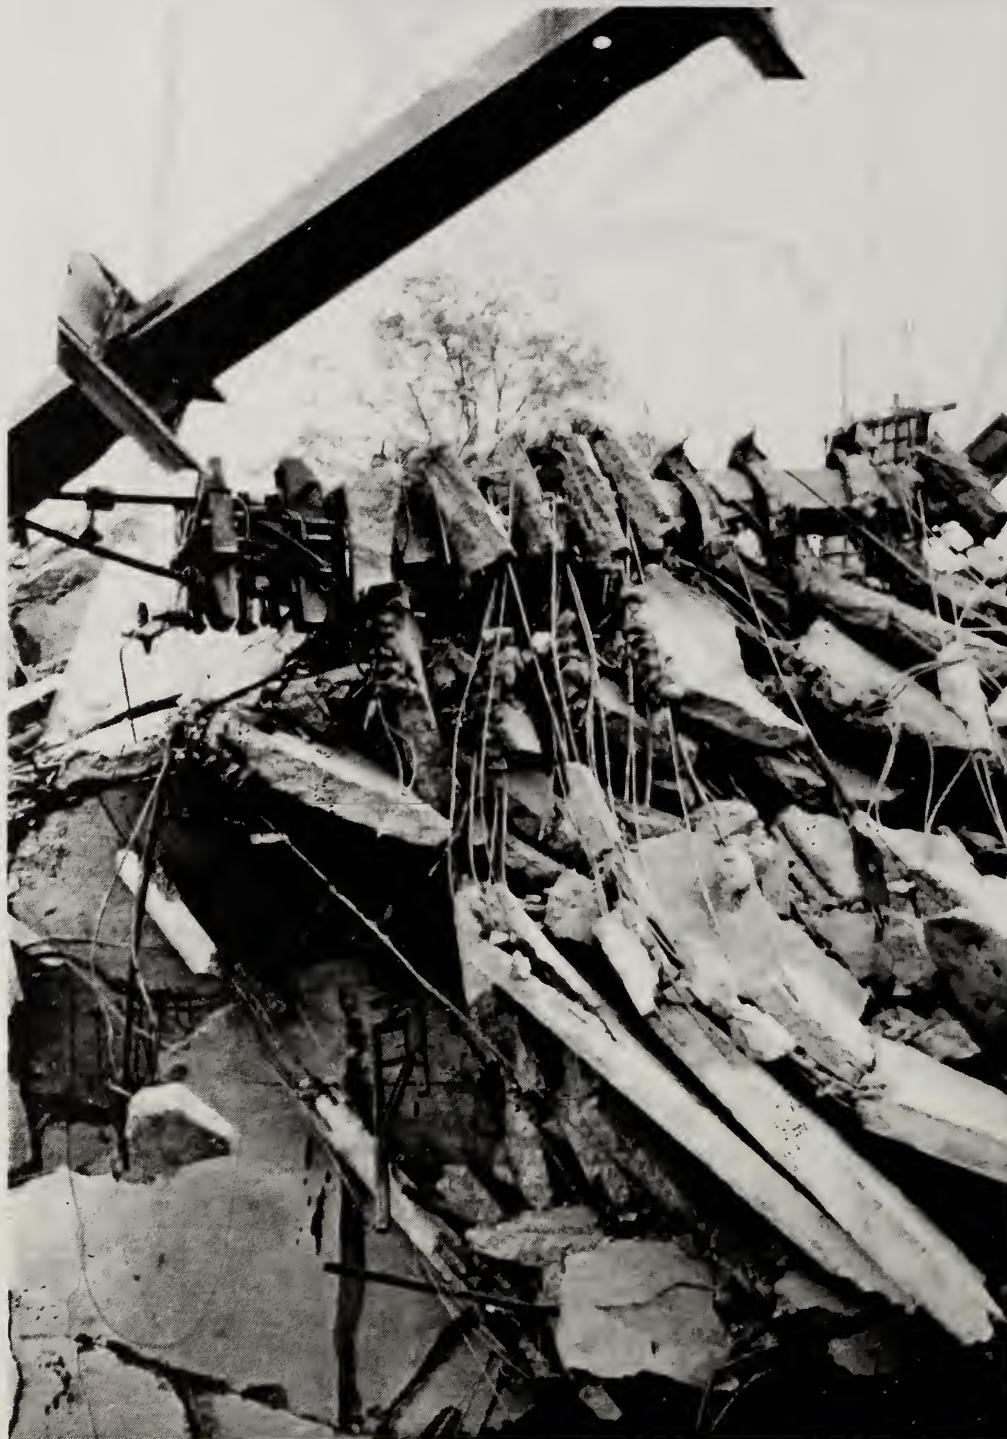
Figure 4.4.15 Separation of floor slabs from shearheads

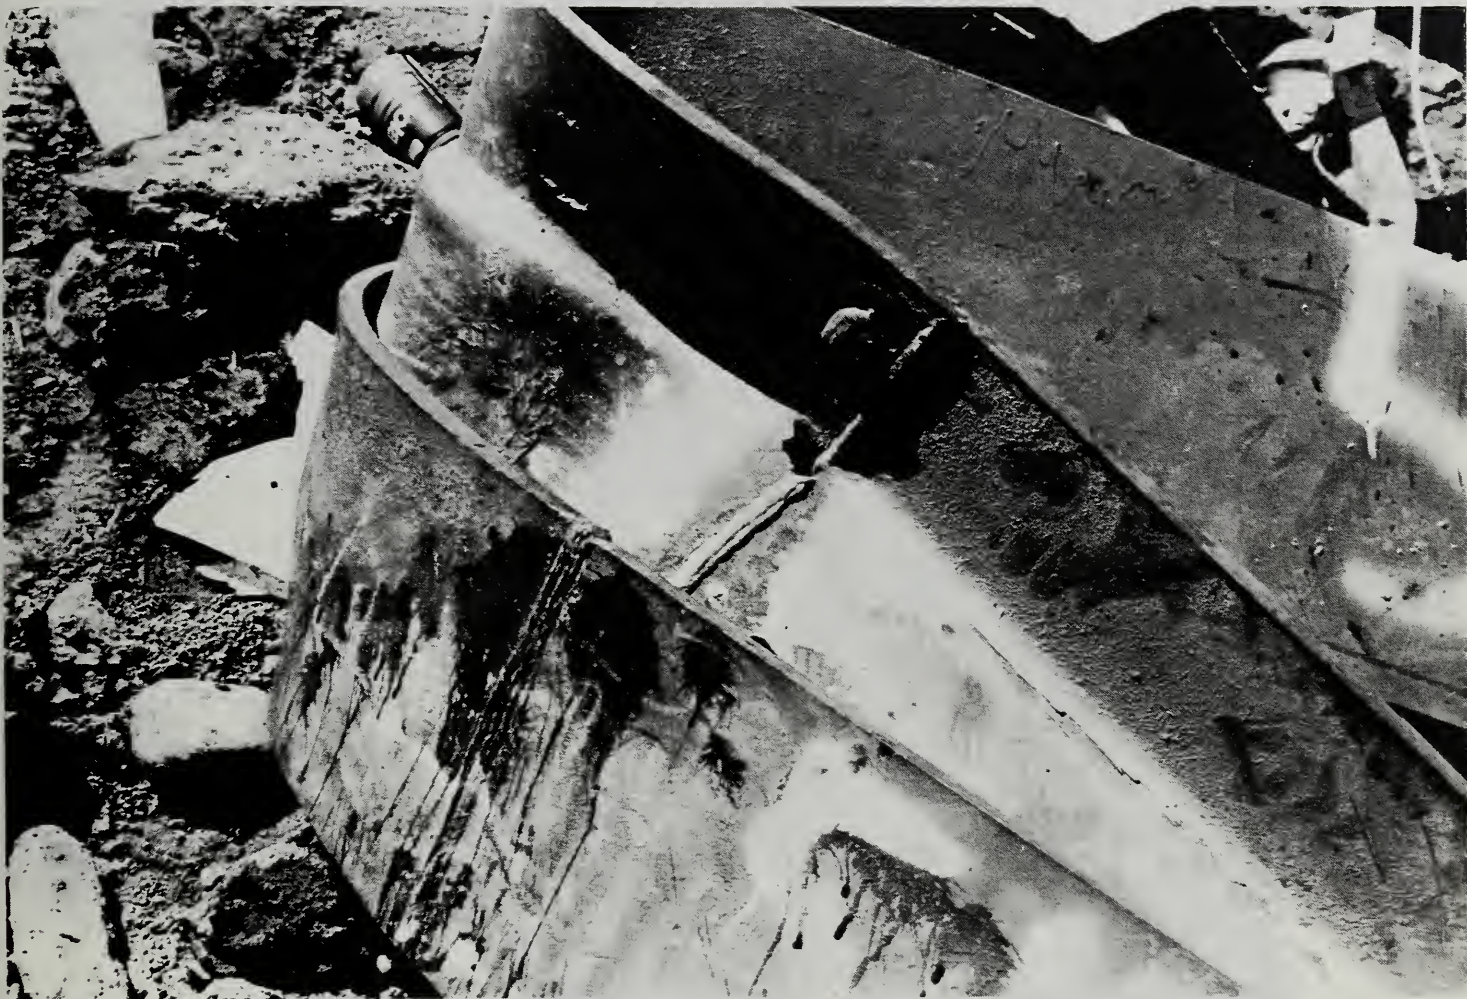
Figure 4.4.22 Deformation at column splice

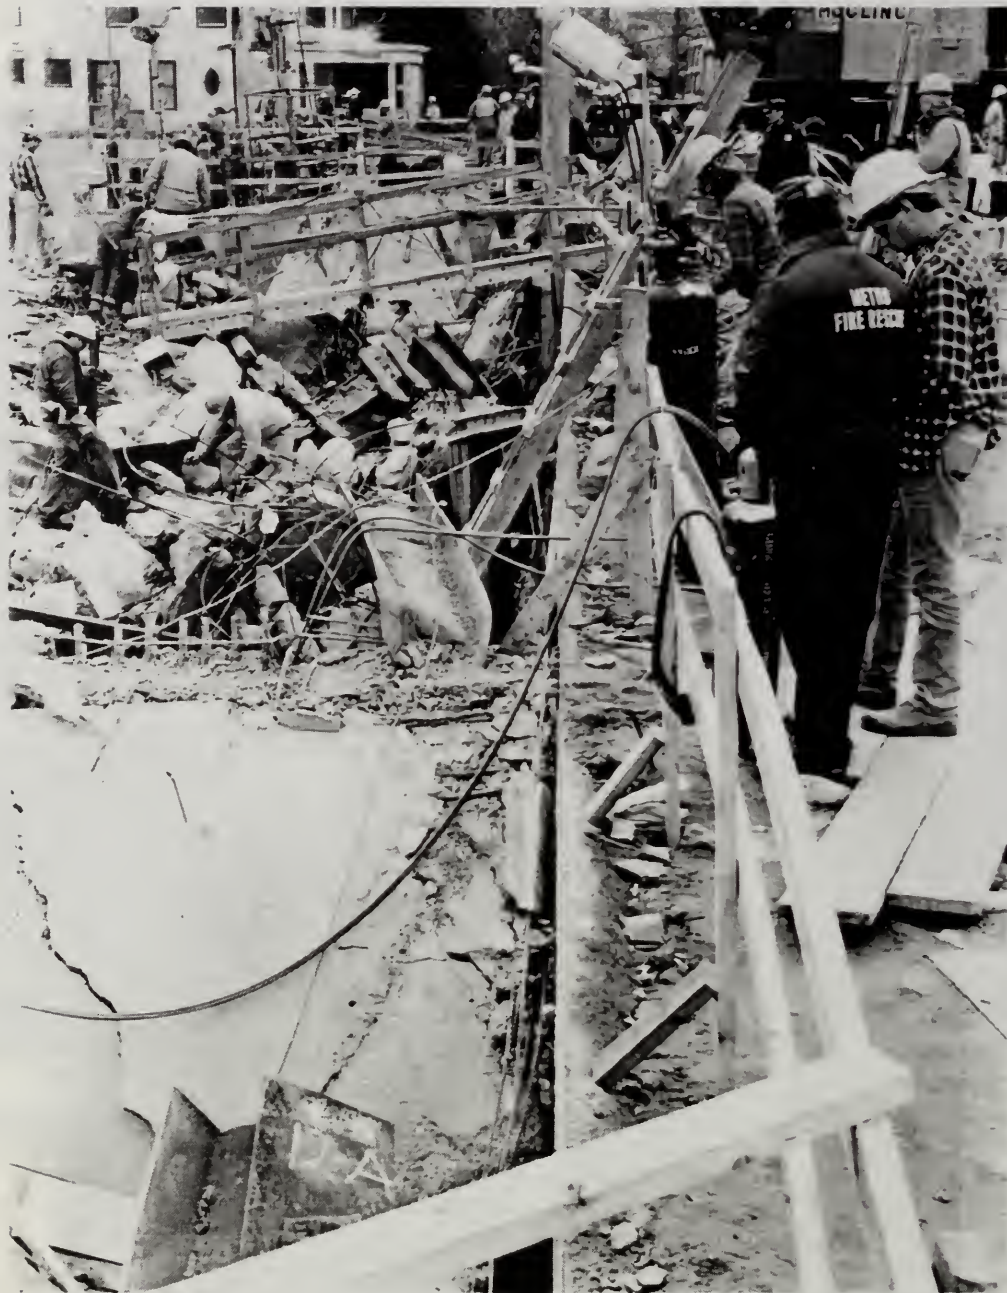
Figure 4.4.29 Basement wall on North side of East Tower – viewed from the East, May 1, 1987

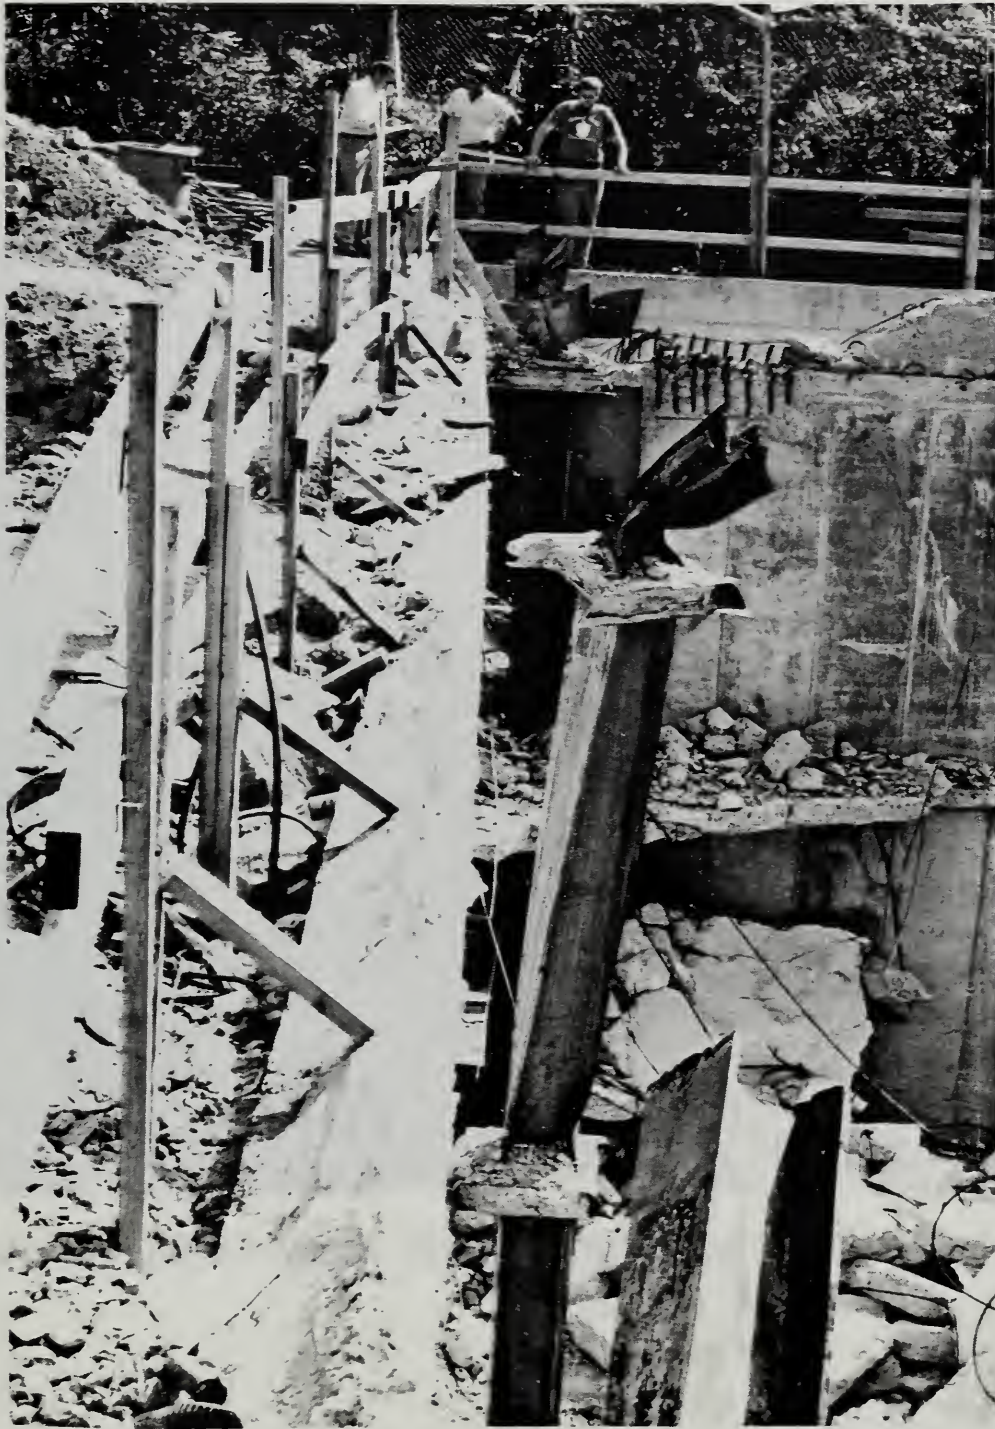
Figure 4.4.30 Basement wall on North side of East Tower – viewed from the West, July 22, 1987

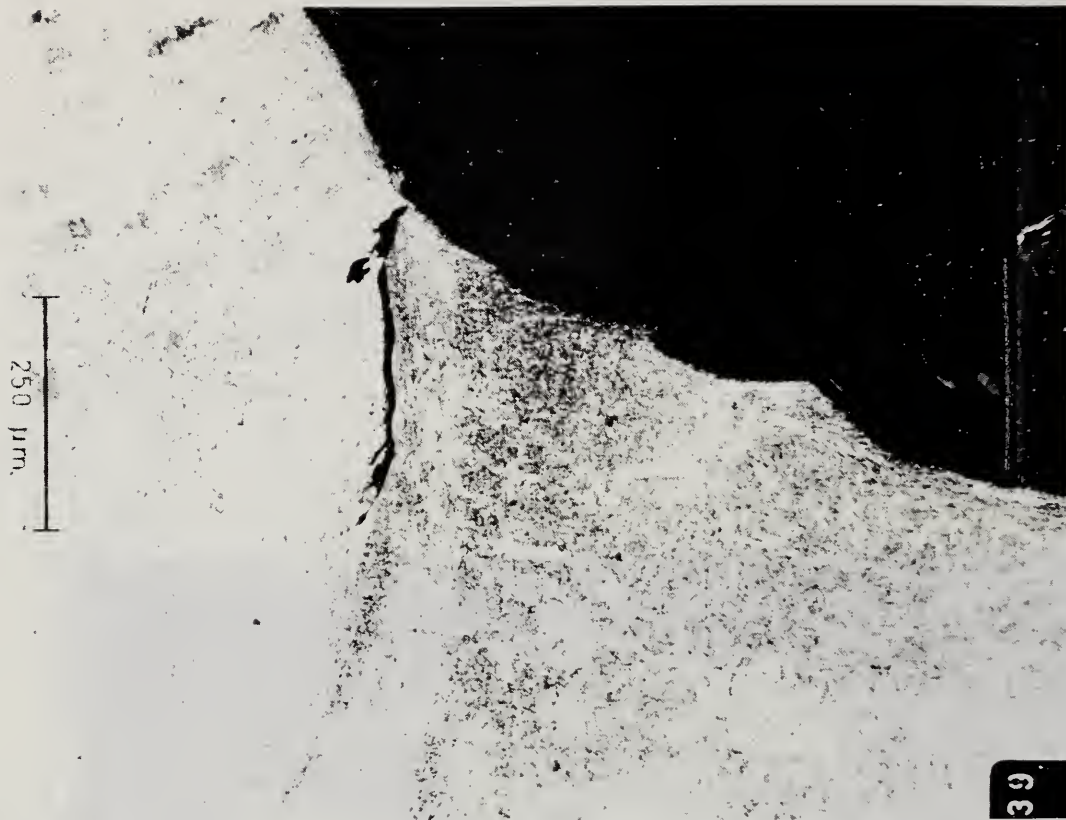
Figure 5.4.3 Cross section showing weld in sample NBS 21-3A-2 (x 100)

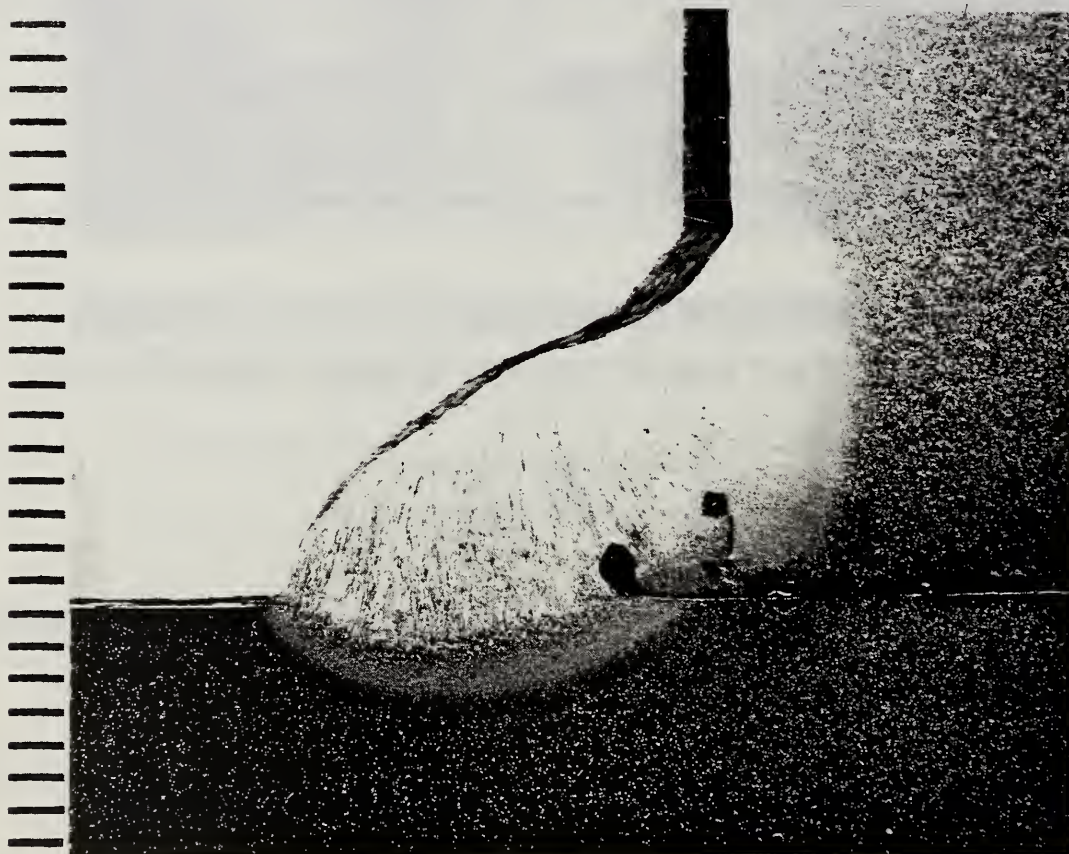
Figure 5.4.4 Cross section showing weld in sample NBS-3A-3 (x 4)

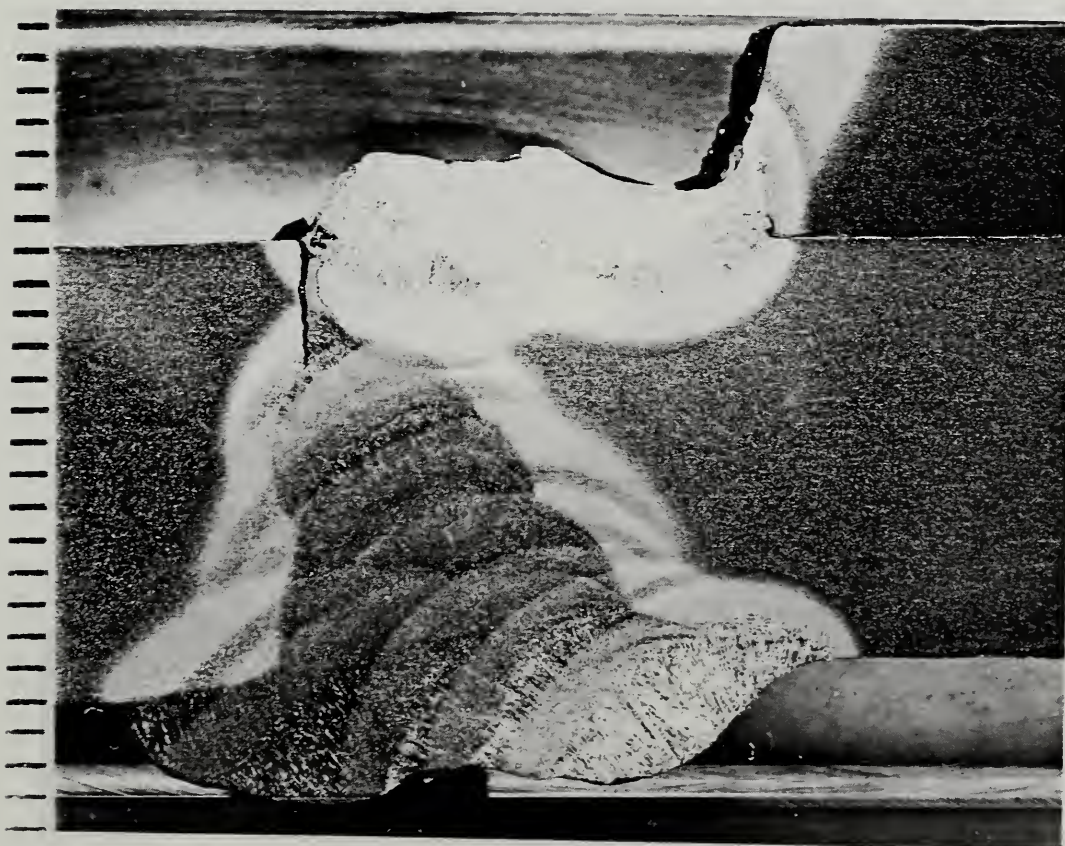
Figure 5.4.6 Cross section showing weld in specimen NBS 8-T1 (x 4)

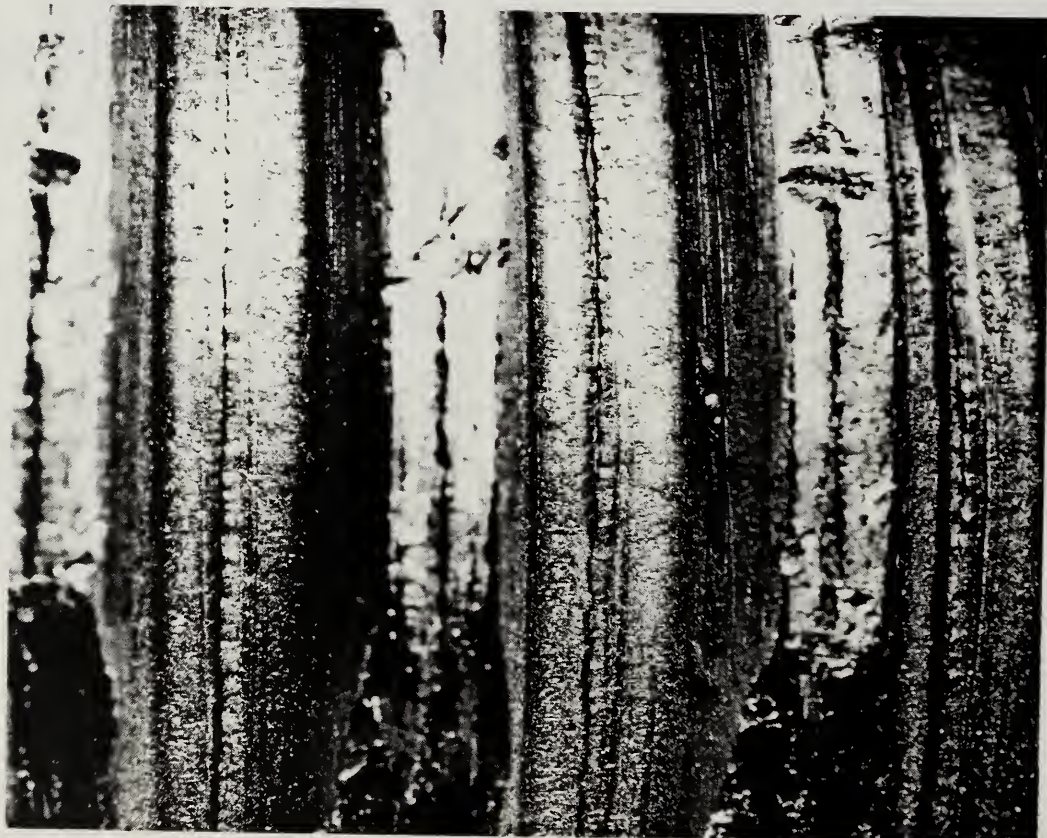
Figure 5.5.4 Jack rod on tension side showing lap seam from thread rolling operation (x 3)

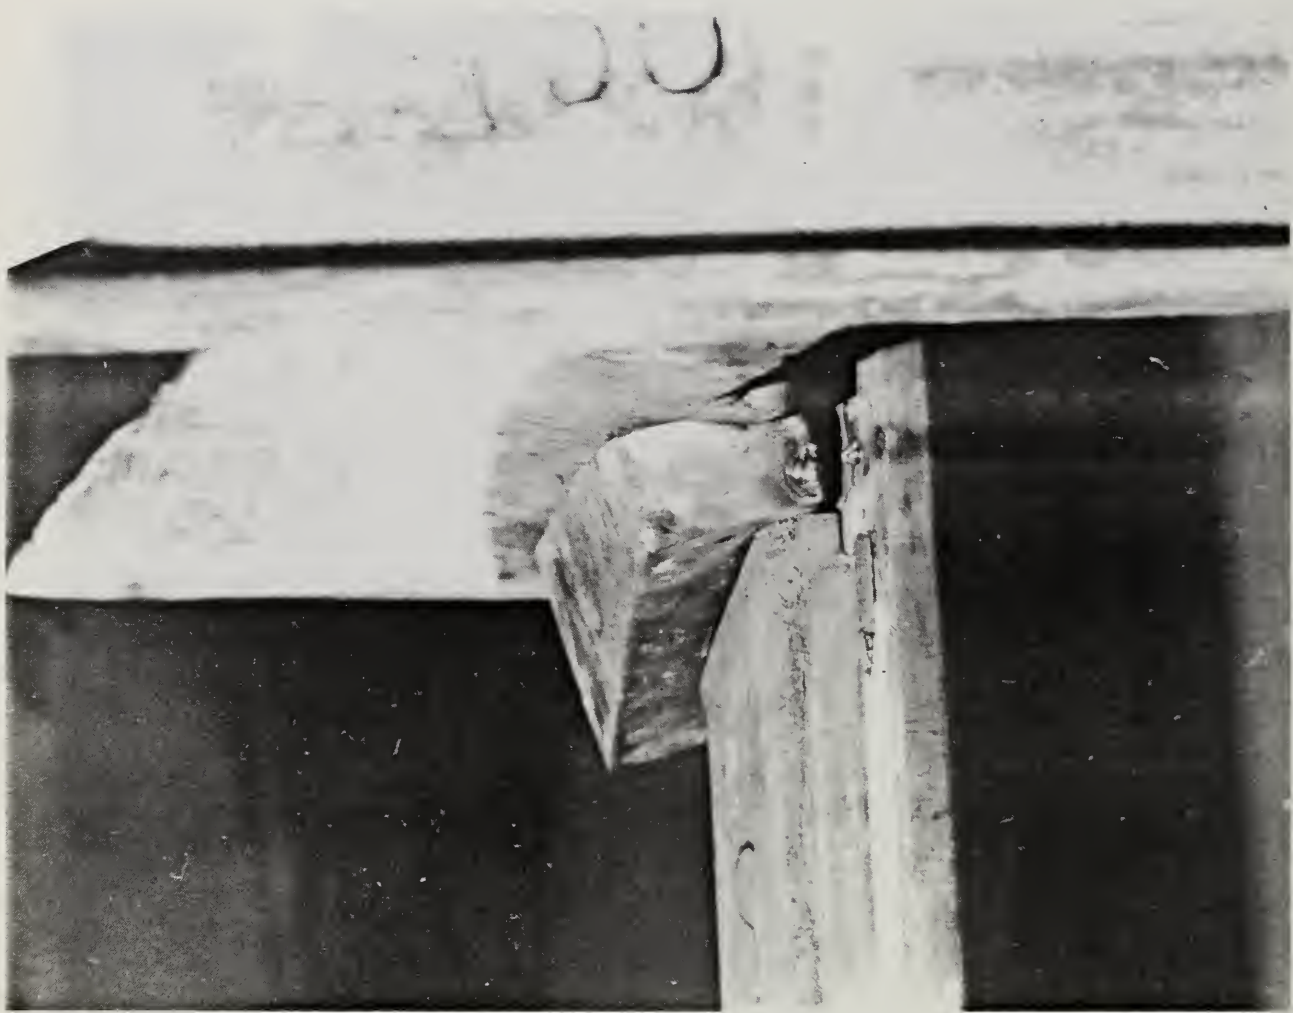
Figure 5.5.12 Deformation of shearhead channel in test of shearhead
