# Investigation of L'Ambiance Plaza Building Collapse in Bridgeport, Connecticut

Center for Building Technology  
National Engineering Laboratory  
National Bureau of Standards  
Gaithersburg, MD 20899

Issued September 1987

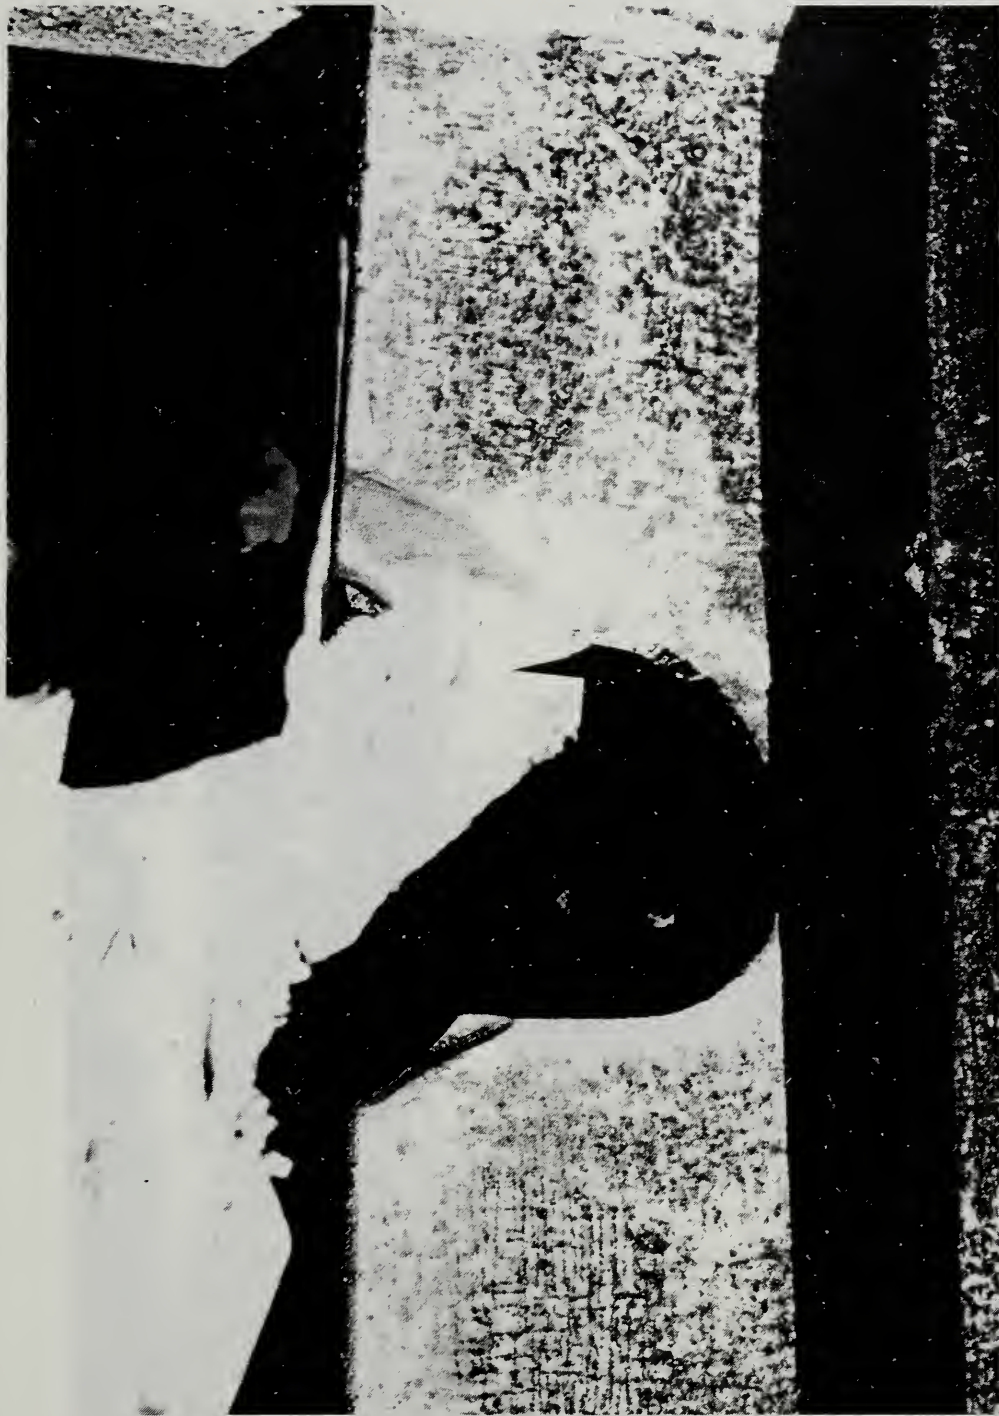
Figure 9.3.4 Indentation in underside of lifting angle, column E3.8, level 10

As has been noted in the discussion of test results in Section 5.5.5, a jack load of 190 kips (845 kN) acting on the type X51 shearheads of column E3.8 would produce very significant rotations of the lifting angles, possibly leading to kick out of one or both of the lifting nuts. The bottom surfaces of the lifting angles of the shearhead at slab 9, column E3.8, are shown in figure 9.3.3. The marks on these surfaces show that kick out did indeed occur. This sudden release of energy would be expected to raise dust from the surfaces of the concrete slabs and the noise associated with the kick out experienced in the lifting assembly tests described in Section 5.5.5 could readily be described as steel breaking under stress. This is consistent with the eyewitness accounts (#3 and #4 - figure 4.3.1). The surviving witness working at column E4.8 at the time of the collapse (#14 - figure 4.3.1) noted that the first indication of a problem was a loud noise either right above his head (E4.8) or more towards the center of the slab (E3.8). Due to load redistribution, loss of a jack at either E3.8 or E4.8 would lead to failure of the other jack. As floor slabs 9/10/11 moved downward, the shears and moments in the slabs adjusted to the new support conditions. Because the post-tensioning tendons now were located in the compression side of the slabs, the tendons adjacent to columns E3.8 and/or E4.8 became ineffective and flexural cracks developed in the bottom face of the slabs. This explains the sudden appearance of cracks in the slab directly above the workmen who were installing wedges at column E4.8. The underside of shearhead 10, column E3.8, is shown in figure 9.3.4 and that of shearhead 11 is shown in figure 9.3.5. It appears that one of the lifting nuts glanced off of the web and became partially lodged under shearhead 10. As the slabs moved downward due to loss of support at column E3.8, the lifting nut was again kicked out from under a lifting angle. The imprint on the underside of shearhead 11 suggests that this process was repeated for a third time. It was not possible to confirm this sequence of events with lifting nut impact points on the web because the top section of column E3.8 could not be positively identified. The likely progression of the collapse through the upper levels of the west tower is described in the following paragraphs.
