# 2011 Wildland Urban Interface Amarillo Fires Report #2 – Assessment of Fire Behavior and WUI Measurement Science

**NIST Technical Note 1909**

February 2016

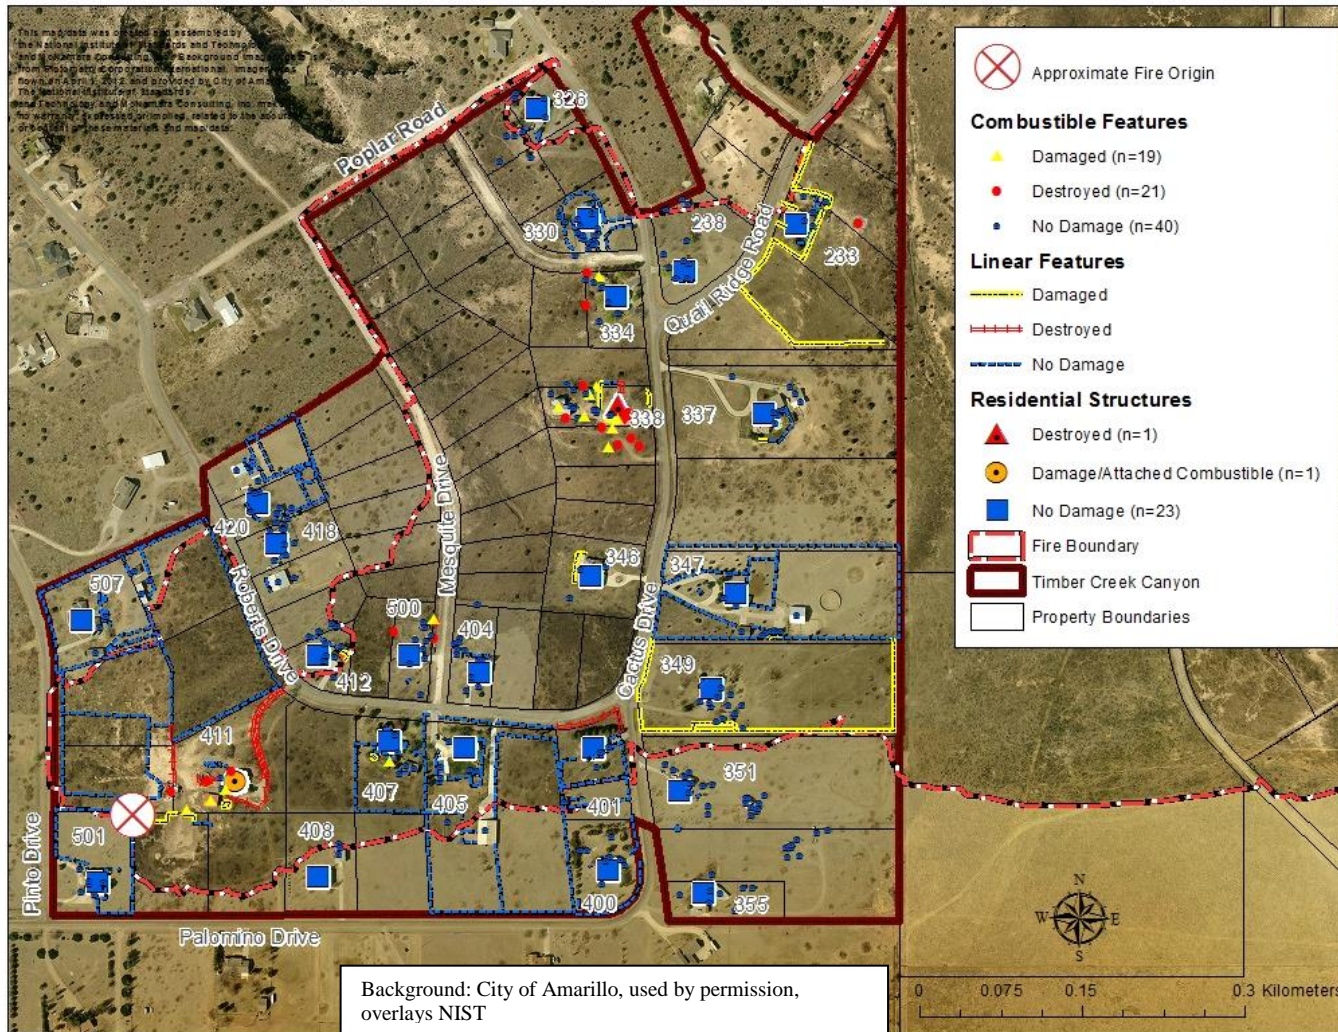
Figure 5 Damage to structural elements in Timber Creek Canyon.

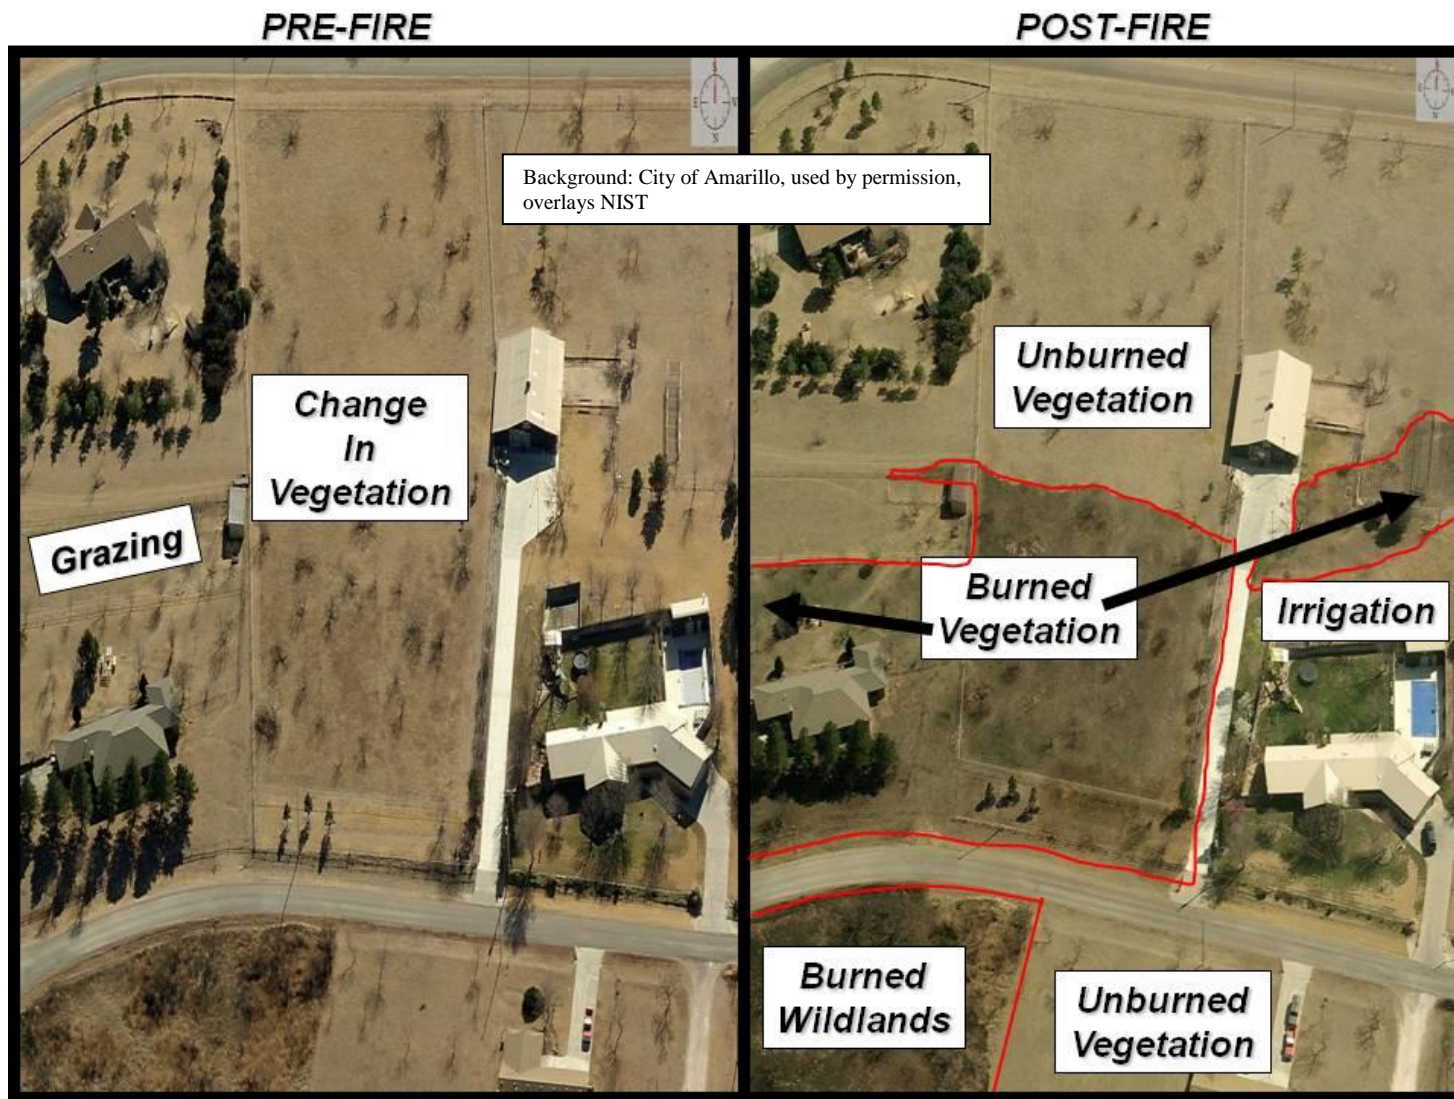
Figure 14 Pre-fire and post-fire imagery showing how vegetation treatments or landuse might have effected fire behavior. Approximate fire line is shown in red on image to the right.

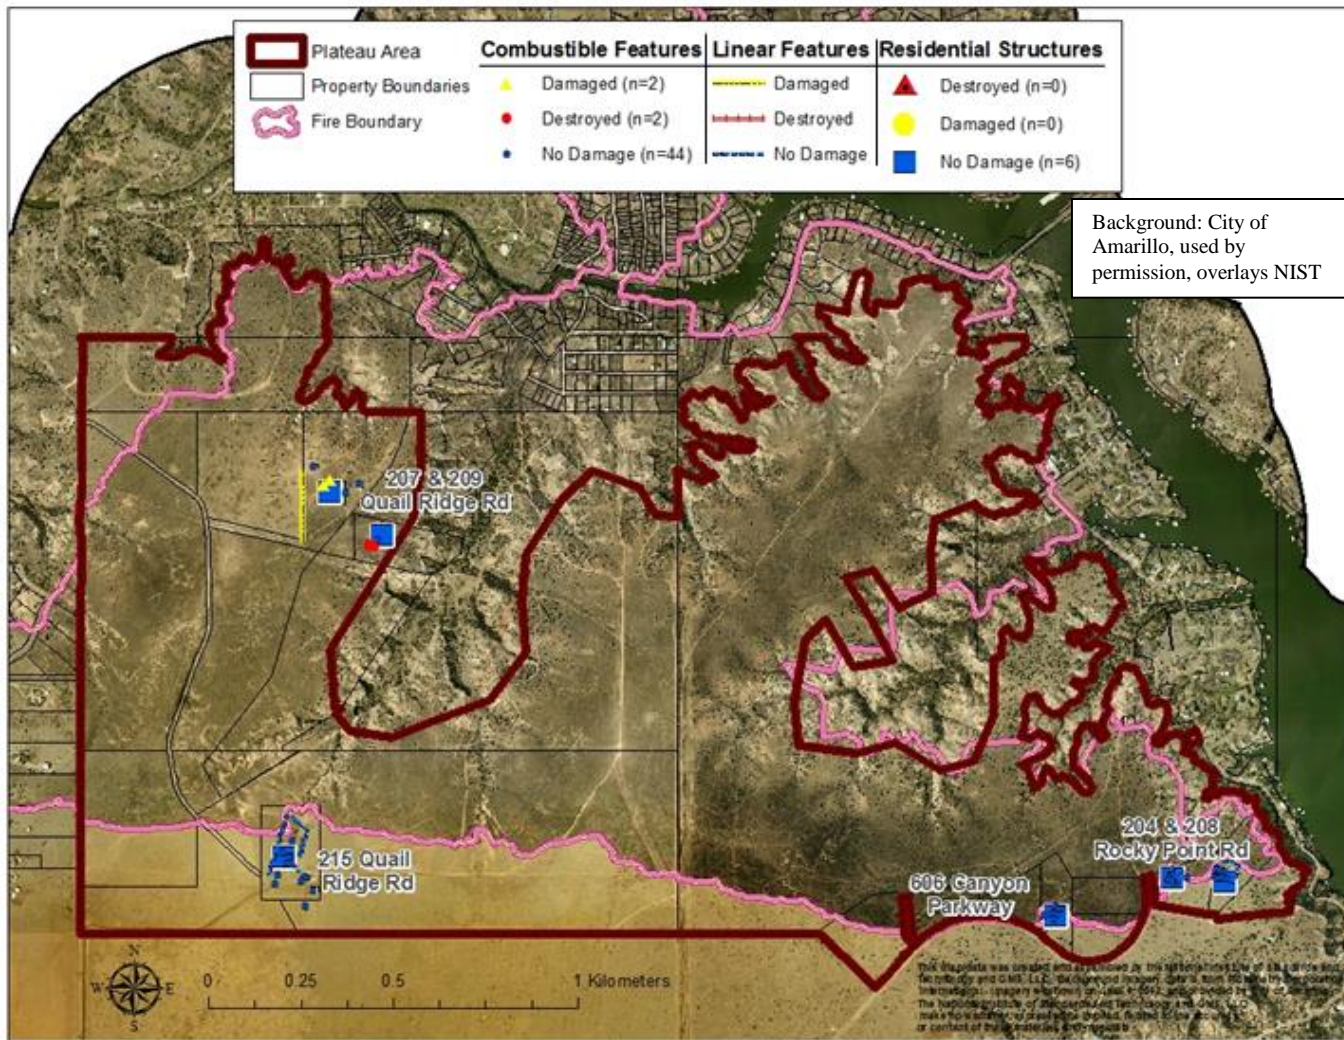
Figure 15 Damage to structural elements in the Plateau Community.

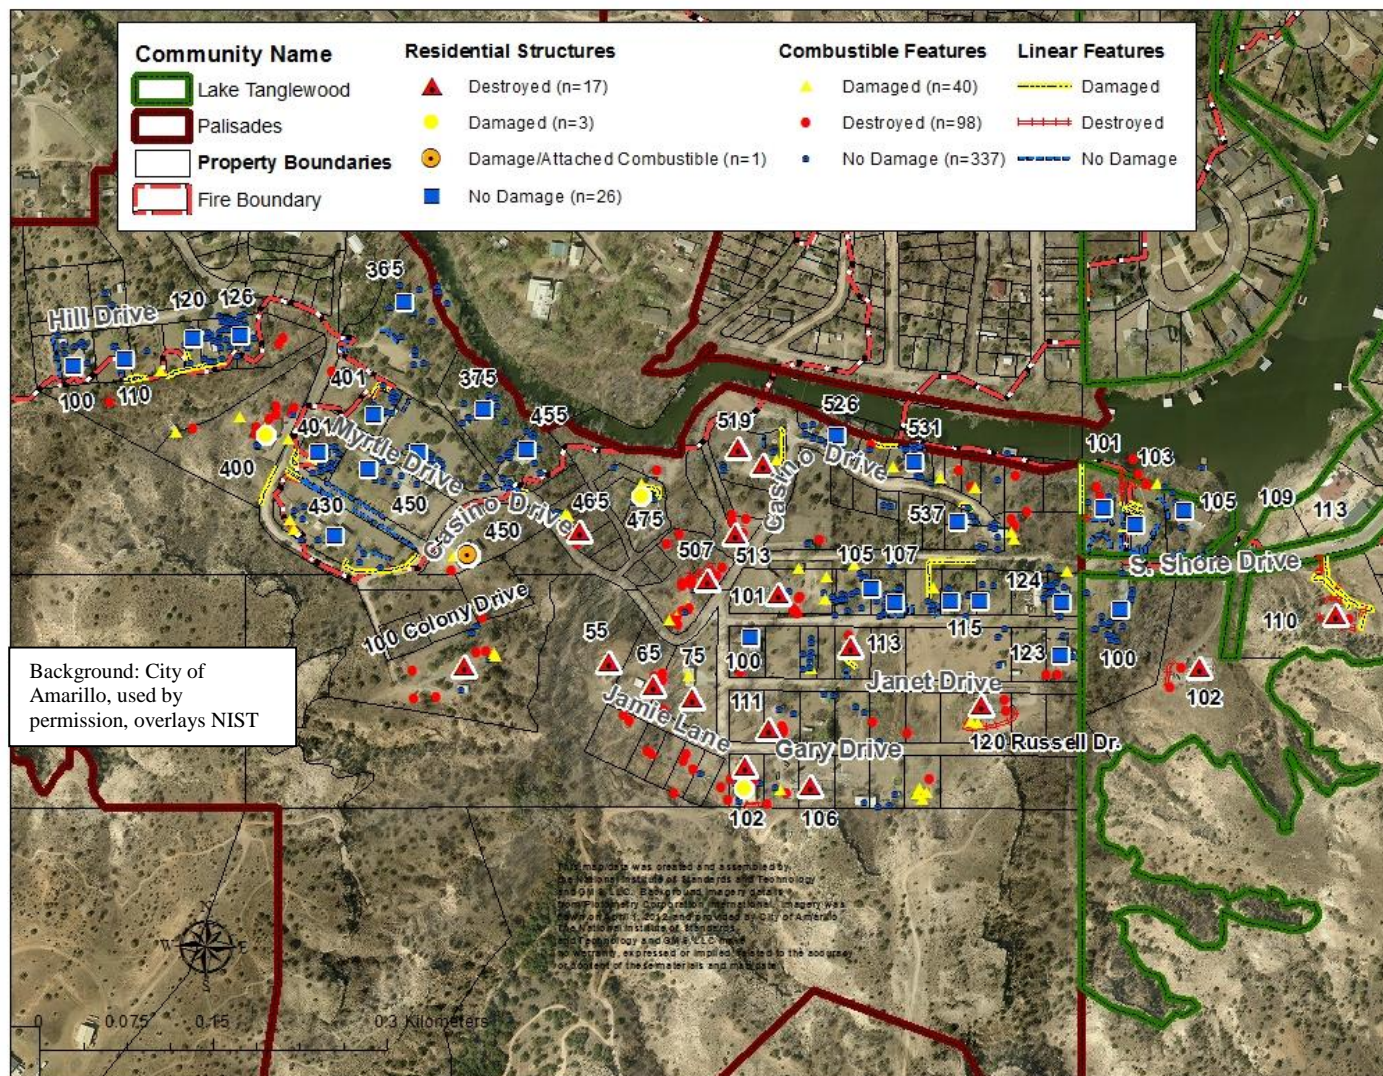
The primary damage close to homes found in this area was to a storage shed located on 110 Hill Drive and railroad tie retaining walls and borders located on the parcels at 110 and 120 Hill Drive and 401 and 430 Casino Drive. These damaged features were close to or directly adjacent to wildlands. The damaged storage shed was over 19 m (62 ft) from the closest primary structure. Damaged railroad tie retaining walls were 9 m (29 ft) away from the residential structure located at 110 Hill Drive and about 19 m (62 ft) away from the residential structure located at 120 Hill Drive.

The primary structure at 400 Casino Drive was also damaged. This was due to a pile of trash bags with unknown debris that burned and melted a vinyl soffit. The radiant heat or flames appeared to be sufficient to melt the vinyl soffit but no scorching to the underlying enclosed wood soffit was document by field observers. The brick siding was scorched.

Figure 22 Damage to structural elements in the southern Palisades Community and selected portions of the South Lake Tanglewood Community.

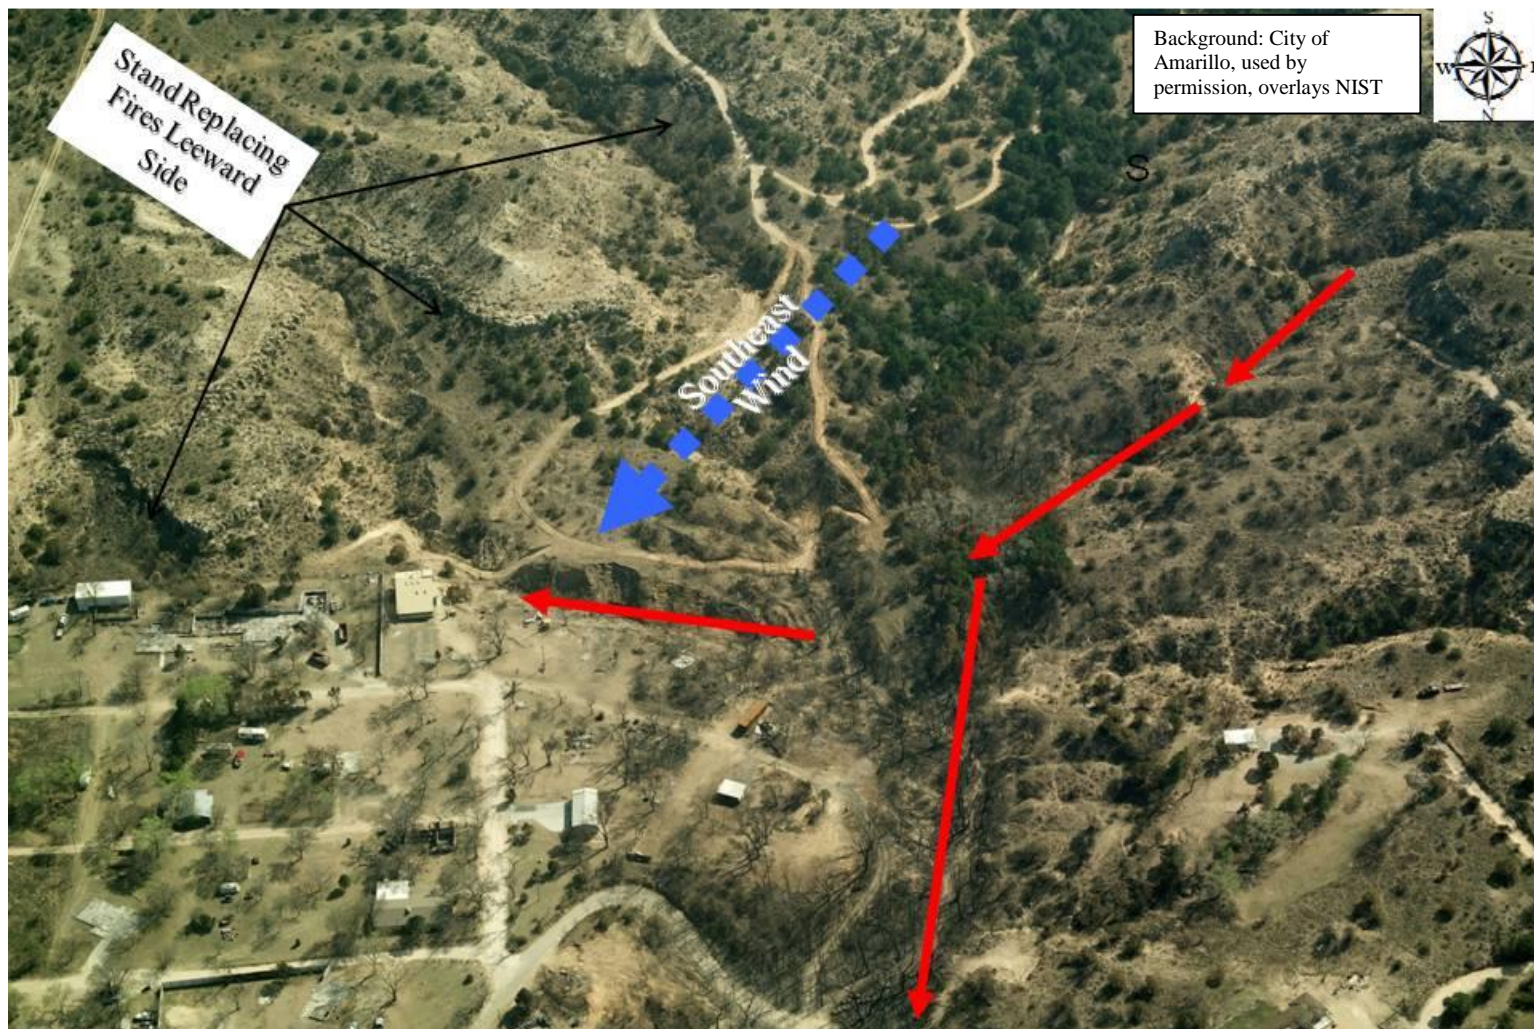
Figure 27 Post-fire south facing oblique imagery showing results of fire behavior in the upper portion of the middle canyon area of Southern Palisades Community.

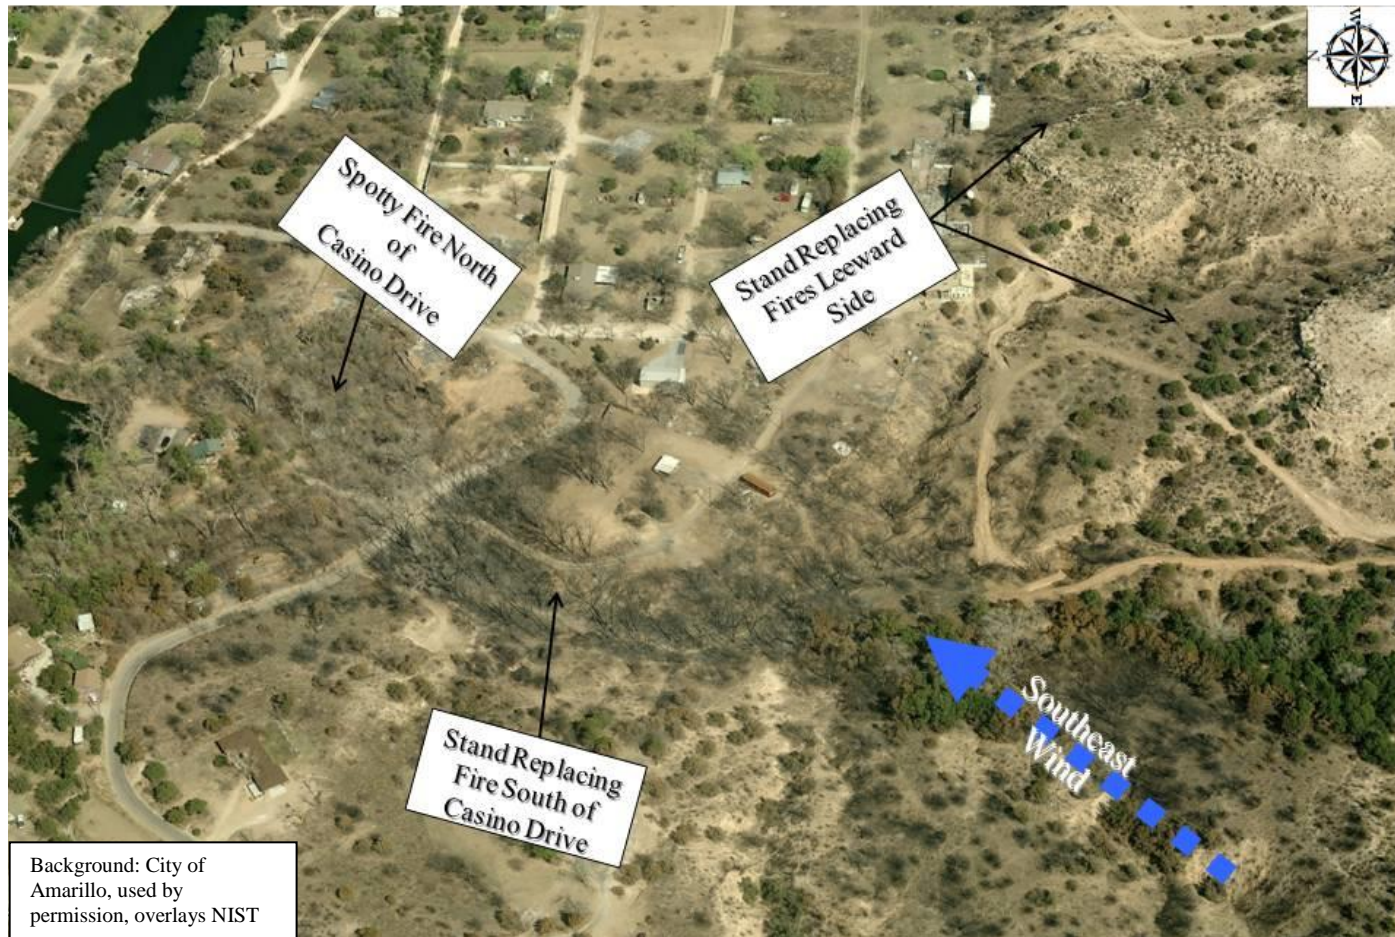
**Figure 28 Post-fire east facing oblique imagery showing results of fire behavior in the bottom of the middle canyon area of Southern Palisades Community.**

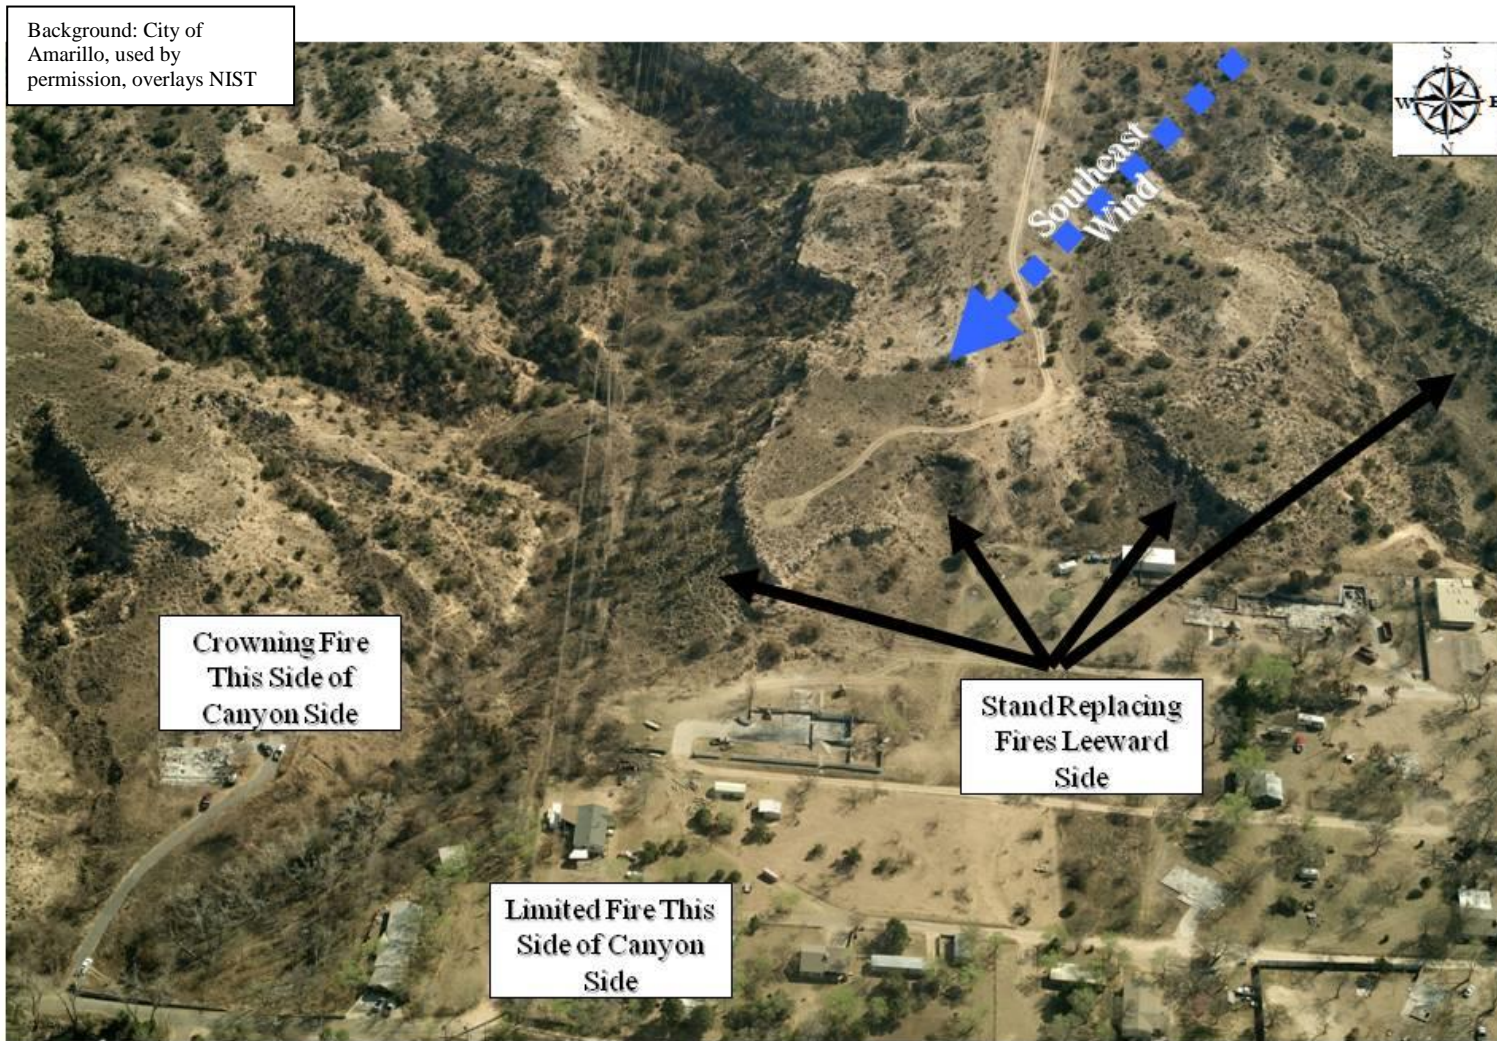
Figure 29 Post-fire south facing oblique imagery showing results of fire behavior in the eastern most canyon area of the Southern Palisades and South Lake Tanglewood Communities.

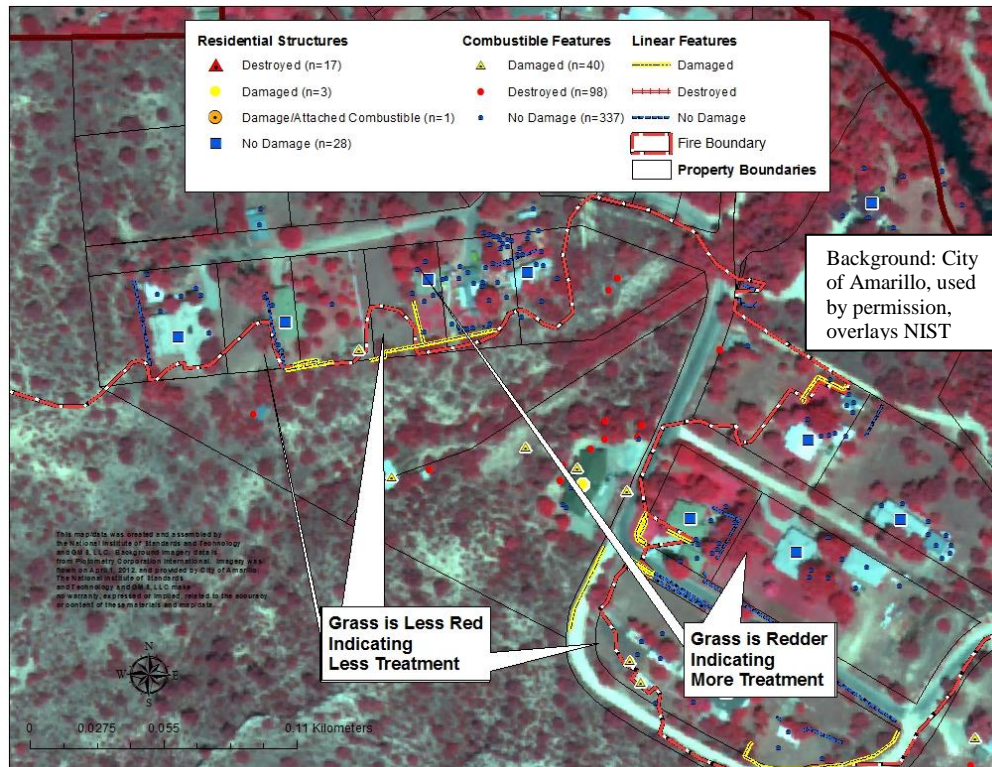
Nonetheless, the grass areas that are redder might have had more treatment (i.e., water and possibly nutrition) that could have helped prevent fire spread on these properties. It is also possible that first responders suppressed

the fire and treatments, either those present or lack thereof, on the yards did not affect fire behavior. Also, the properties on Hill Drive appeared to be located on a less exposed area due to topography and wind. Other areas along Janet Drive and Gary Drive also showed burn patterns that corresponded to possible vegetation treatment in pre-fire imagery.

**Figure 36** Portions of the fire perimeter overlaid on pre-fire (2009) color-infrared imagery. Fire did not travel into redder residential grass areas. This could be due to exposure conditions, defensive actions, pre-fire vegetation treatment or a combination of these factors.

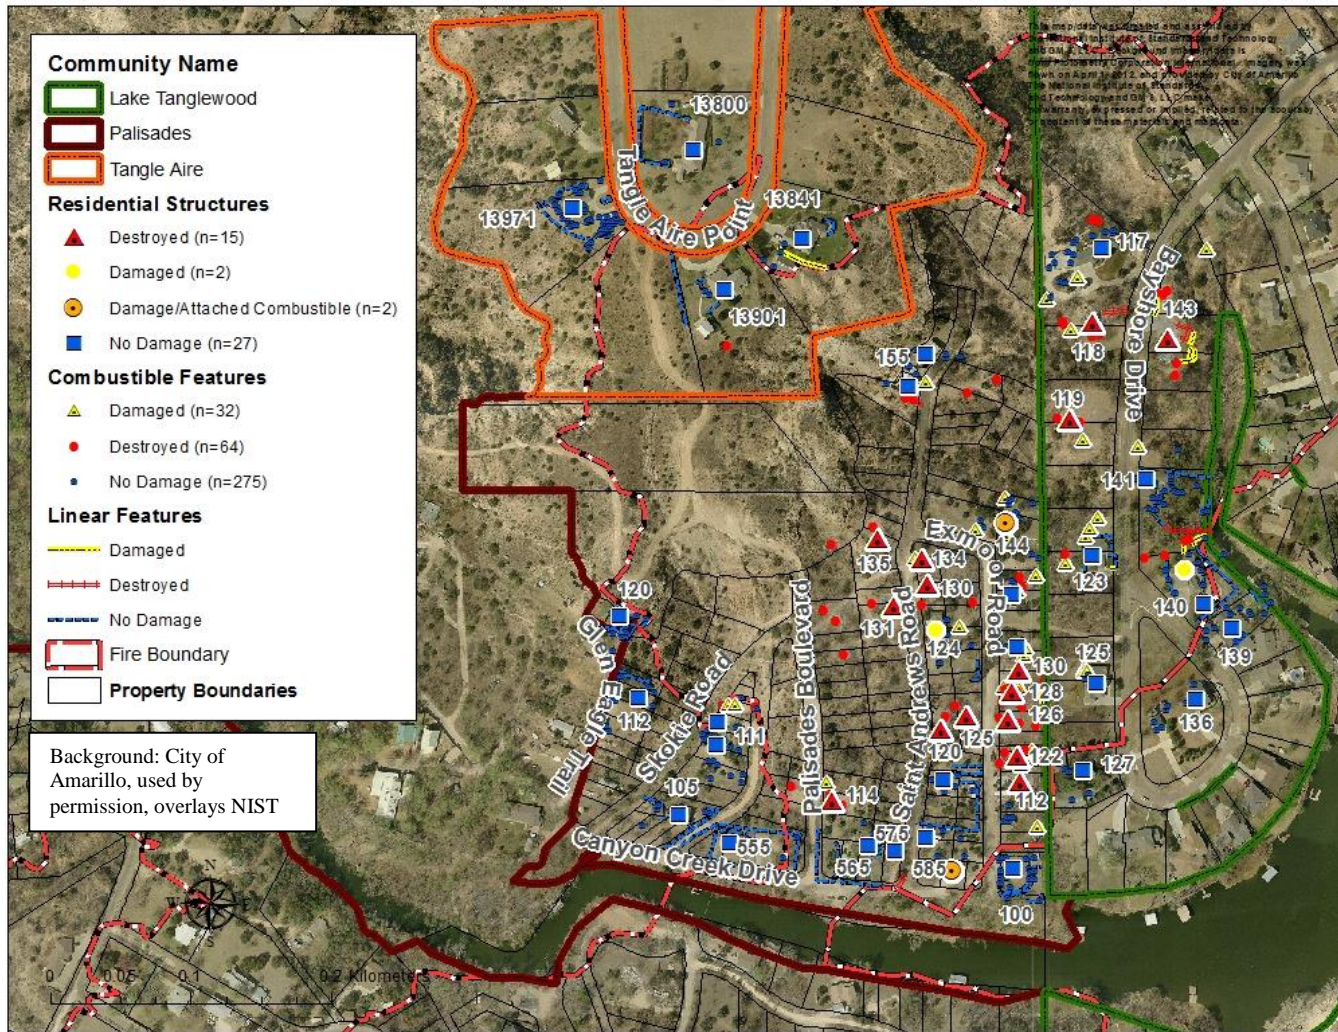
Fences, rail road ties and secondary structures were ignition mechanisms in the Northern Palisades, Tangle Aire and selected portions of Lake Tanglewood communities. As shown in Table 16, there were several fences extinguished by first responders. Additionally, railroad ties were identified as being damaged or destroyed with some identified as being defended, though these could not be linked to a specific feature. Also, a deck was ignited at one location by minor ember accumulation at 144 Exmoor Road and extinguished by homeowners, as shown in Figure 44. Figure 44 demonstrates the need for discussions with first responders and homeowners to determine defensive actions as no signs of actions were present at this home. This also demonstrates that when structural items are damaged, researchers should assume a defensive action as opposed to assuming no defensive action occurred, as stated in Quarles et al<sup>6</sup> and Foote et al.<sup>14</sup> Fire underneath mobiles homes was also identified as an ignition mechanism.

Figure 37 Damage to structural elements in the northern Palisades, Tangle Aire and selected portions of North Lake Tanglewood Communities.

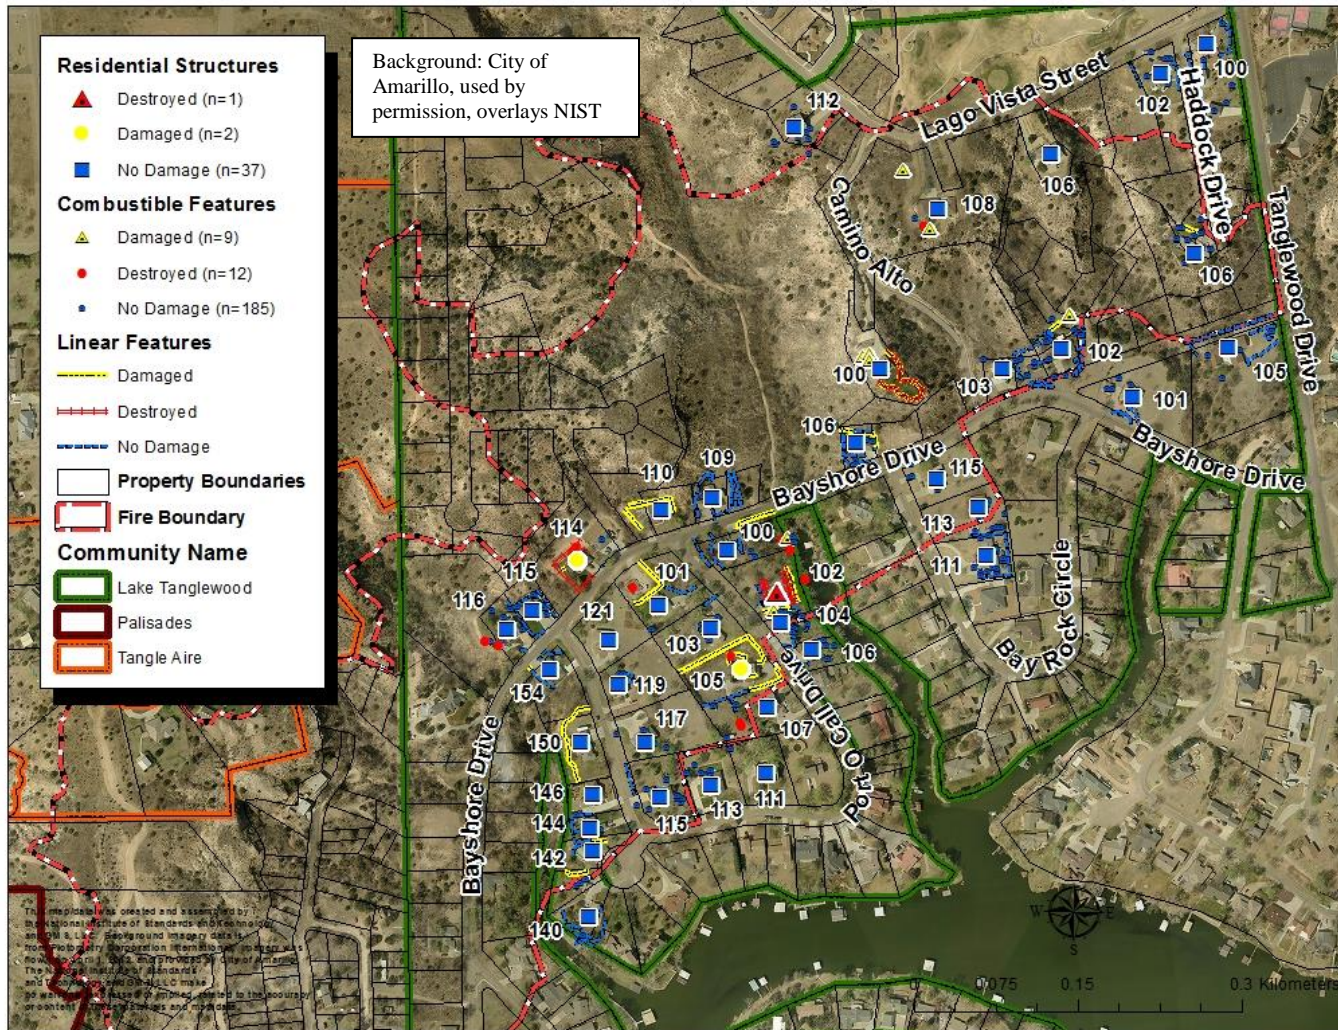
Figure 47 Damage to structural elements in the North Lake Tanglewood Community.

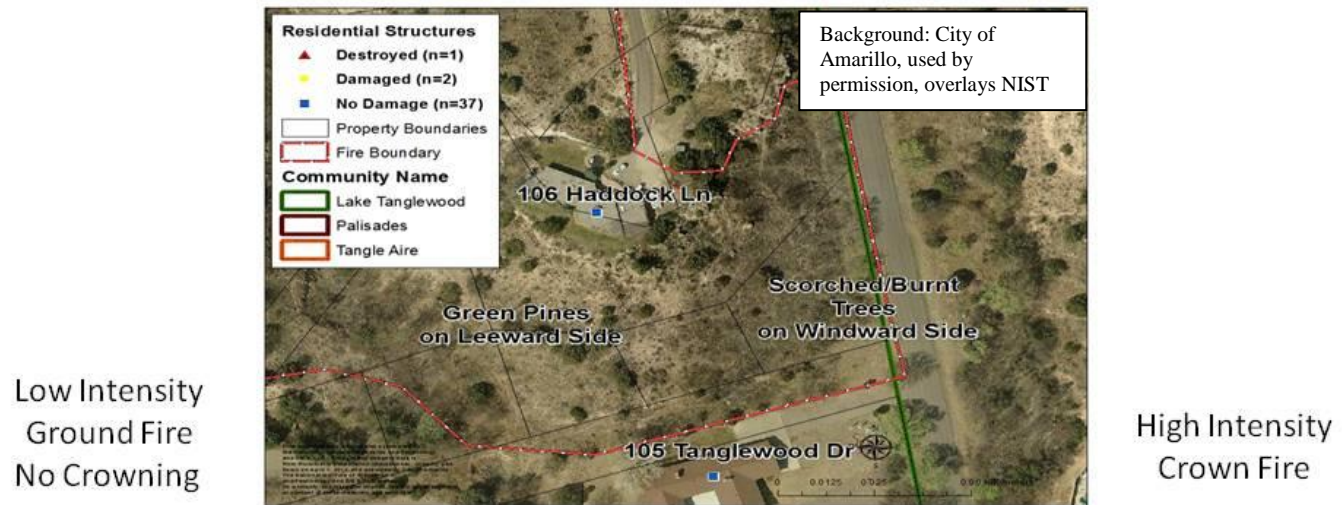
Figure 52 portrays radar derived percent slope for the North Lake Tanglewood Community. Figure 53 portrays radar derived aspect for the North Lake Tanglewood Community. As mentioned above, topography appeared to play an important role in fire behavior in the North Lake Tanglewood Community. The exact contribution of topography and fuels is not examined in this study. Nonetheless, the steepest slopes were found along the rim of the canyon and these steep slopes or cliffs appeared to prevent fire spread into the northern plateau area of the Lake Tanglewood Community. As with the fire entering the canyon area in the Southern Palisades Community, fire appeared to only enter the plateau area of the Lake Tanglewood Community in areas of moderate slopes.

Figure 50 Fire behavior changes coincident with topography. Side directly exposed to wind (left) saw limited scorching and no torching of trees in post-fire imagery, and a low intensity ground fire during Amarillo Sheriff Helicopter flight. Side not facing wind (right) exhibited scorching and torching of trees in post-fire imagery, and a high intensity crown fire during helicopter flight was observed.

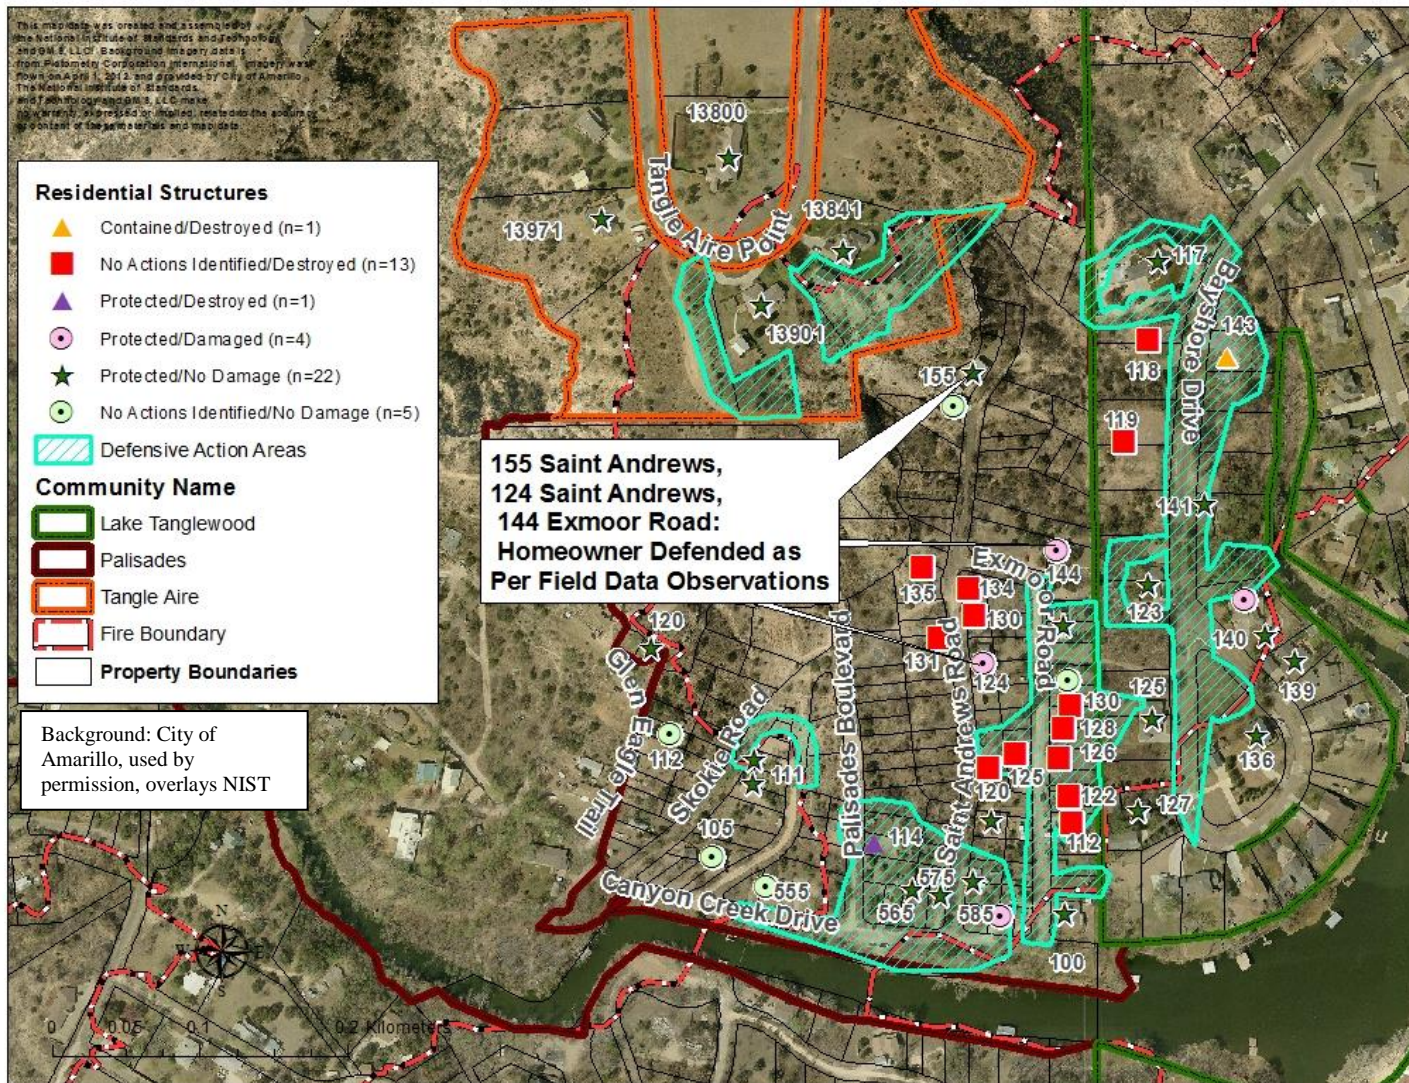
Figure 51 Defensive action locations and primary structure categorizations in North Lake Tanglewood Community.

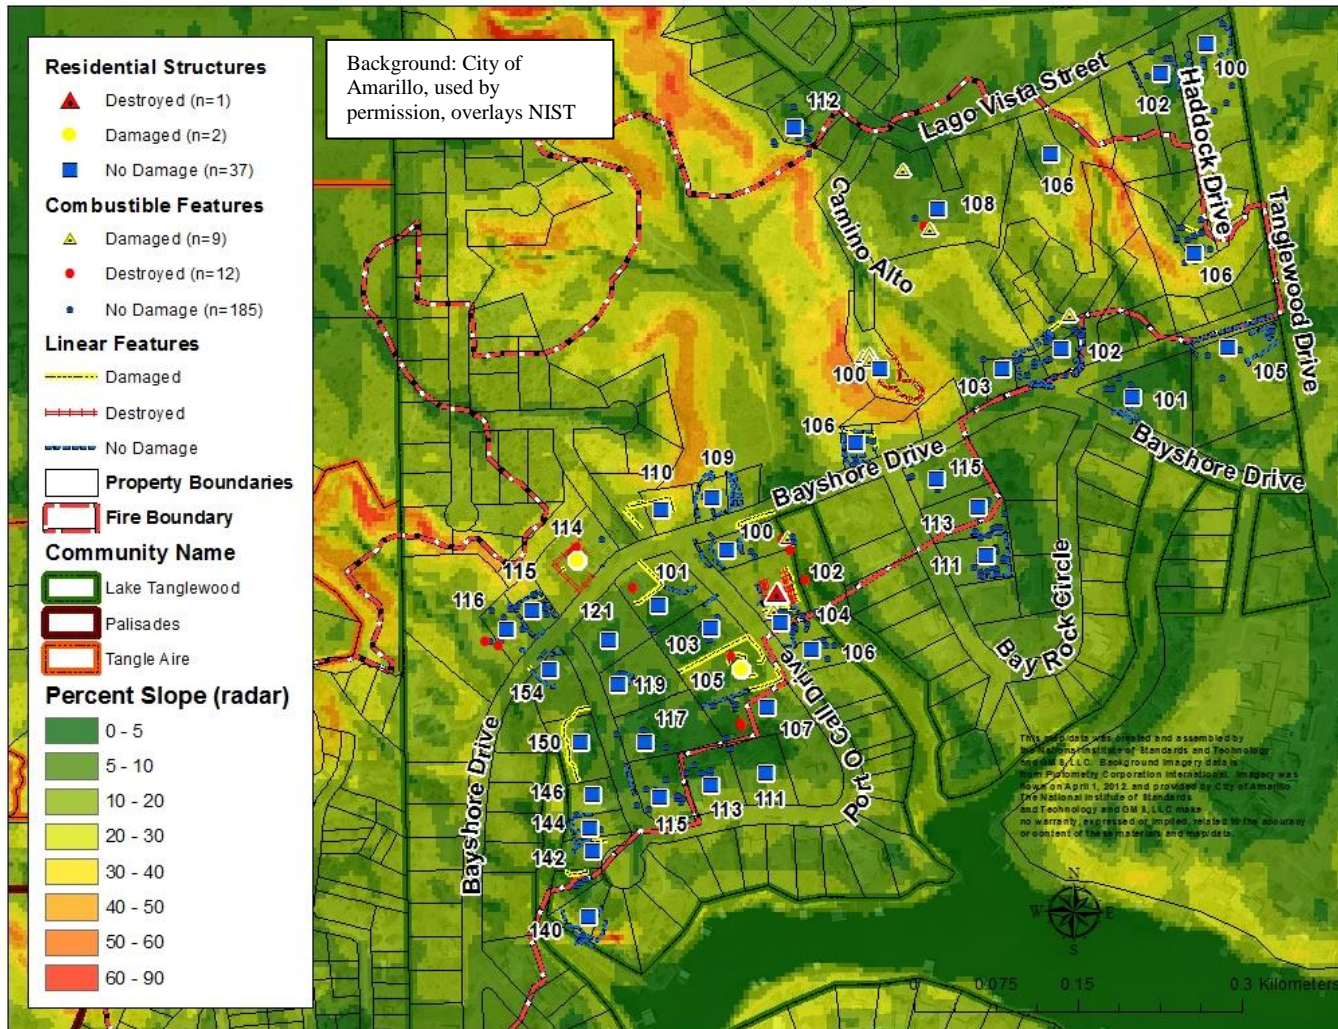
Figure 52 Radar derived percent slope in North Lake Tanglewood Community.

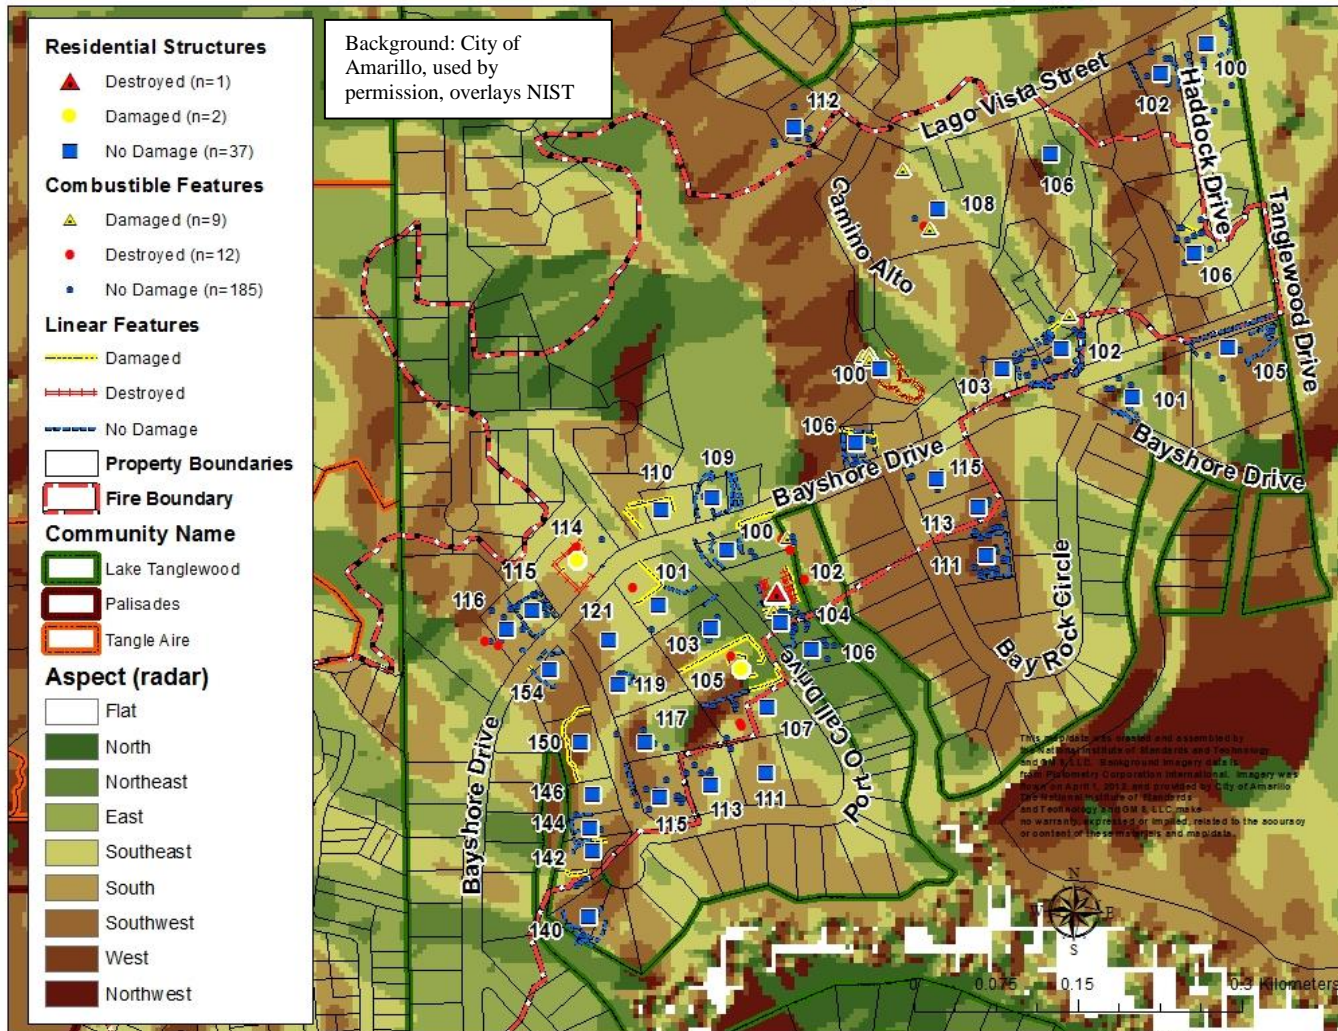
Figure 53 Radar derived aspect in North Lake Tanglewood Community.

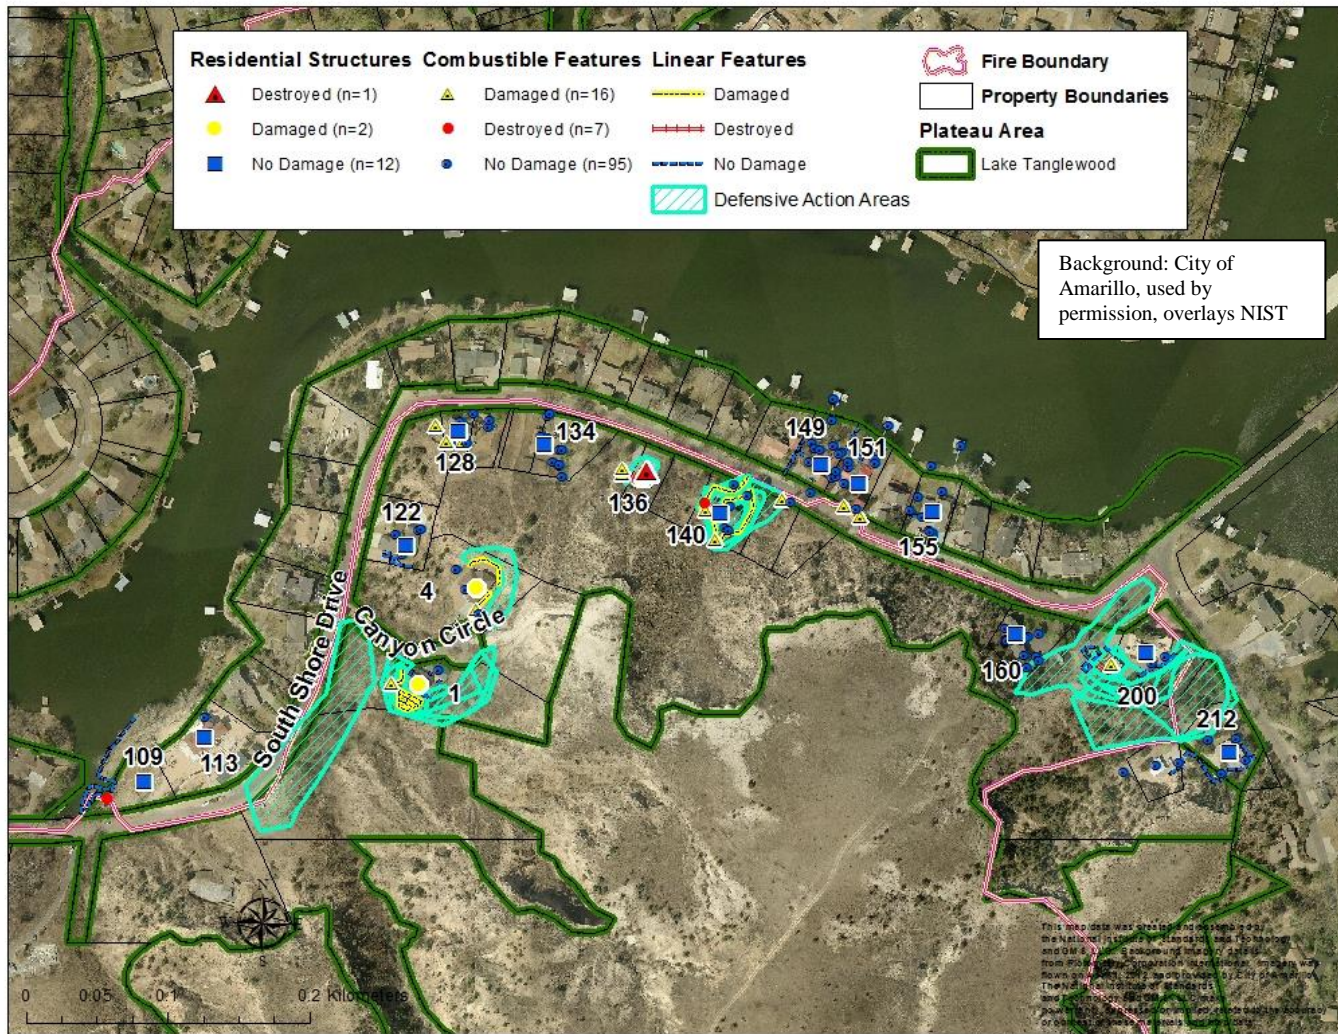
Figure 61 shows damage to structural elements from the Tanglewood Fire within the South Lake Tanglewood Community. There were two damaged residential structures, one

Figure 61 Damage to structural elements in the South Lake Tanglewood Community.
