# 2011 Wildland Urban Interface Amarillo Fires Report #2 – Assessment of Fire Behavior and WUI Measurement Science

**NIST Technical Note 1909**

February 2016

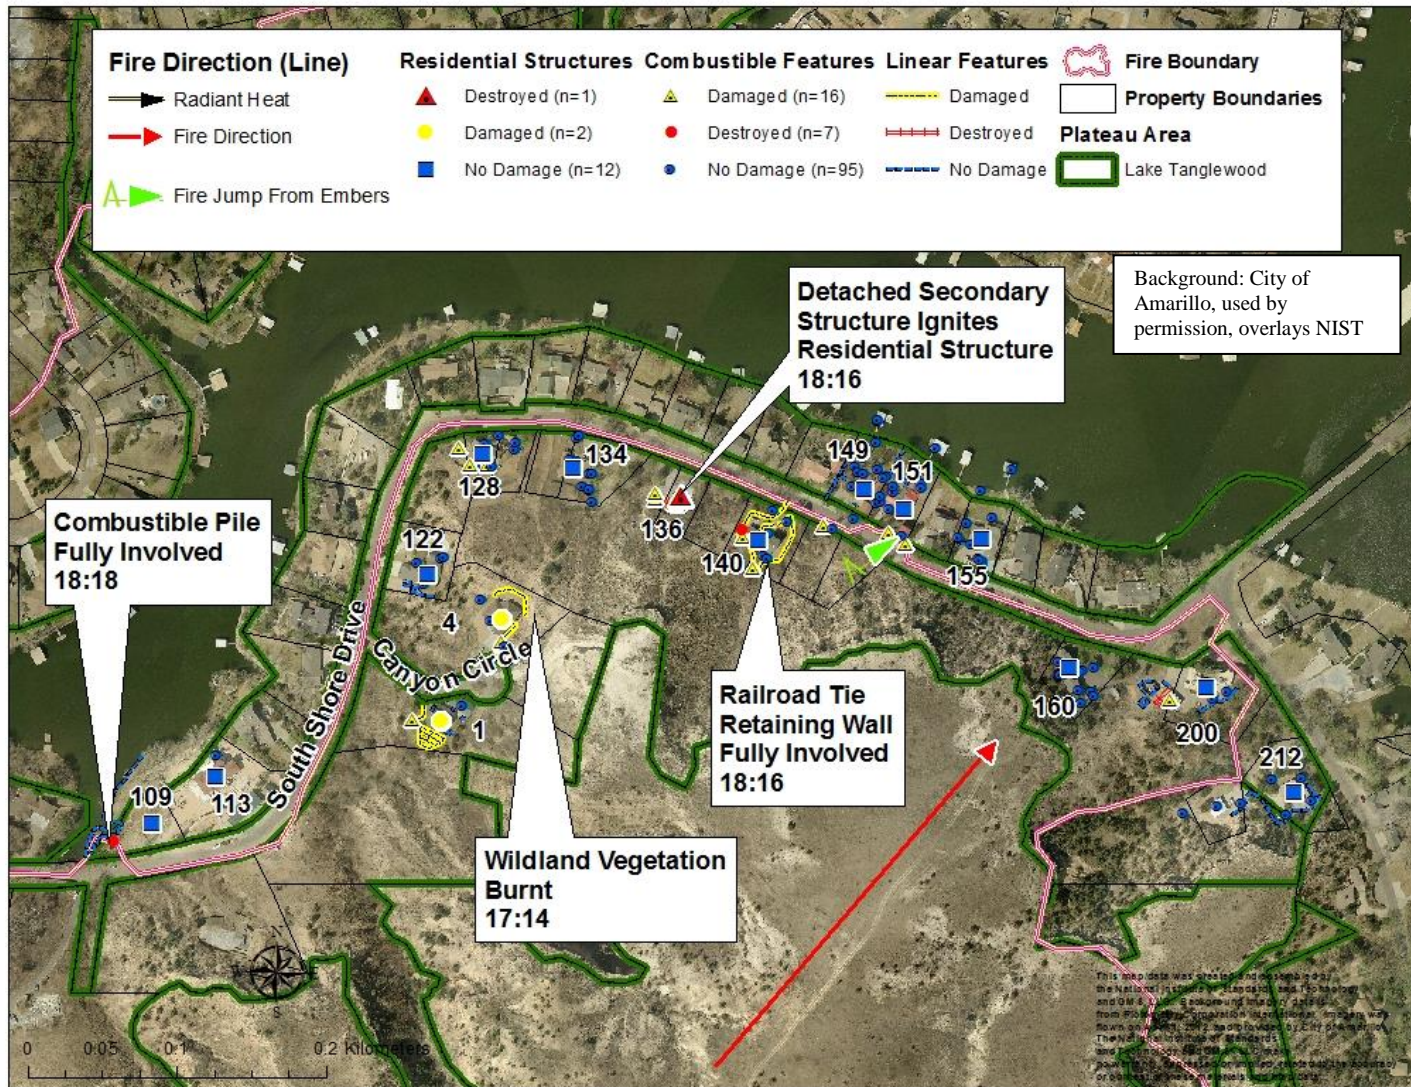
Figure 62 shows fire direction in the South Lake Tanglewood Community. Little is known about the behavior of the wildland fire in this area. The wildland fire front appeared to reach the wildlands behind 200 South Shore Drive sometime after 15:30. However, it is not known precisely when the wildland fire front reached the wildlands behind 122 to 140 South Shore Drive, but these areas were already burnt by 18:18, during the Amarillo Sheriff Helicopter flight. A ground image at 17:14 shows the wildlands around 4 Canyon Circle already burnt. Nonetheless, fire behavior in these wildlands continued into the night (February 27 to February 28), as described by first responders. Exact fire direction in these wildlands was difficult to determine in the field.

There was only one location where the fire jumped South Shore Drive, which was on the west side of 109 South Shore Drive, as shown in Figure 62, though other embers might have jumped South Shore Drive and been suppressed by first responders before any ignitions could occur. The time of this fire jump is not known, illustrating one of multiple gaps in the fire timeline. The destroyed secondary structure was shown as igniting the one destroyed residential structure at 136 South Shore Drive at 18:16 during the Amarillo Sheriff Helicopter flight when the secondary structure was fully involved. There was a pile of unknown combustibles at 109 South Shore that was shown as fully involved during this flight also. Finally, a railroad tie retaining wall at 140 South Shore Drive was also shown as fully involved at 18:16.

Figure 62 Fire direction and fire timeline in South Lake Tanglewood Community.

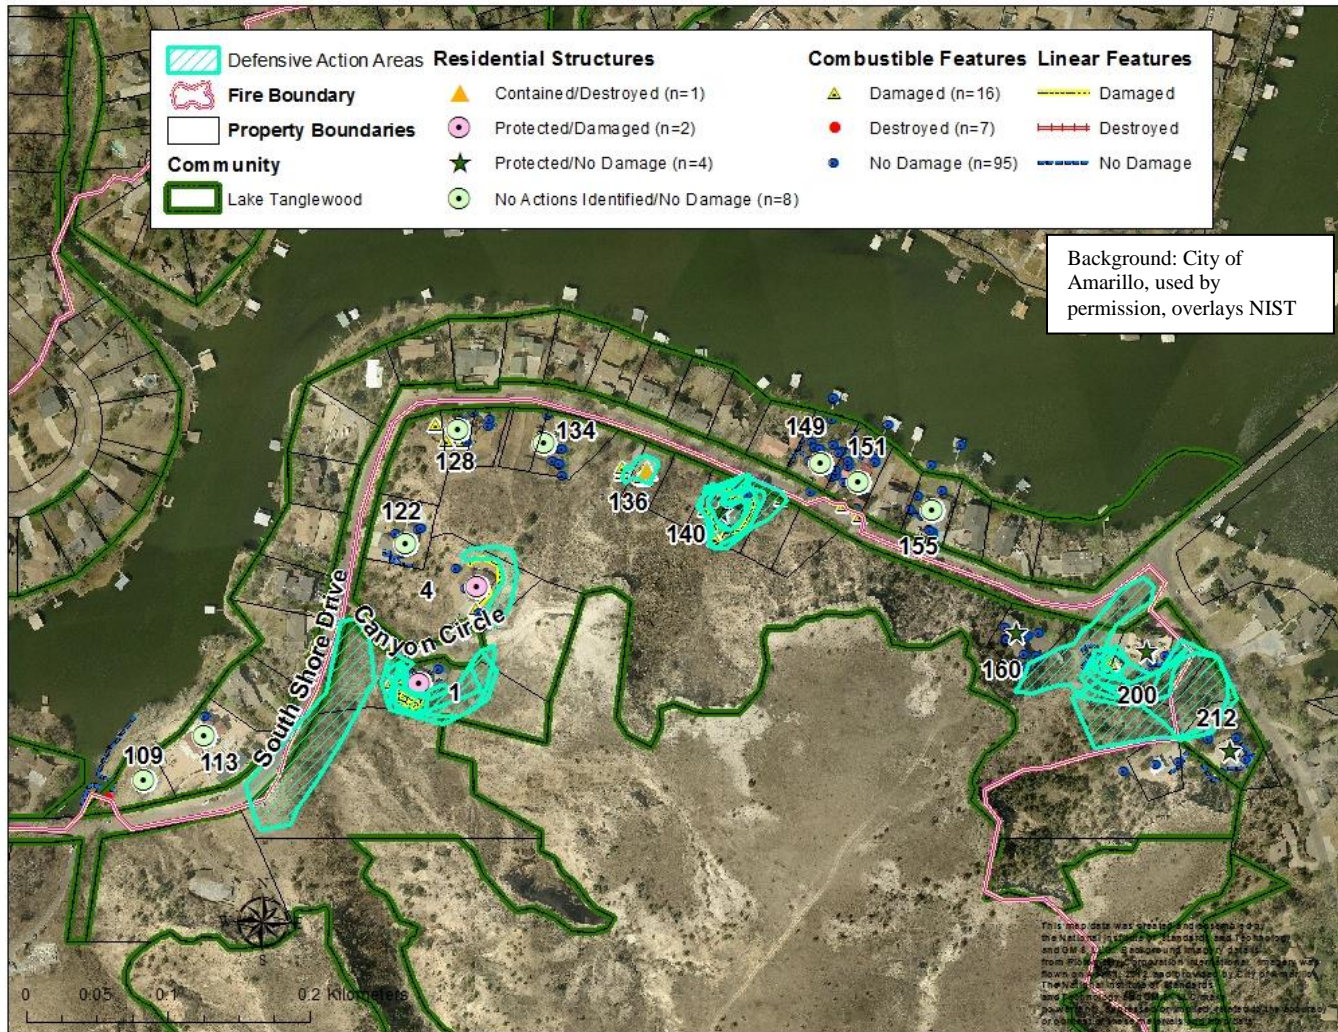
Figure 63 shows locations of identified defensive actions along with the resulting categorization of structures as to a defended category. First responders extinguished wood fences, railroad tie retaining walls, secondary structures, hot spots in the wildlands, residential grasses and various debris piles. Railroad tie retaining walls and secondary structures directly adjacent to wildlands were defended numerous times by different first responder teams due to multiple re-ignitions. There was a railroad tie retaining wall around treated vegetation at 140 South Shore Drive that was explicitly identified as being defended many times. The log home at 140 South Shore Drive was also explicitly identified as being defended, and it is assumed the home was defended against ember spread from the railroad ties. Finally, 212 South Shore Drive was explicitly identified as having water sprayed on it.

Figure 63 Defensive action locations and primary structure categorizations in South Lake Tanglewood Community.

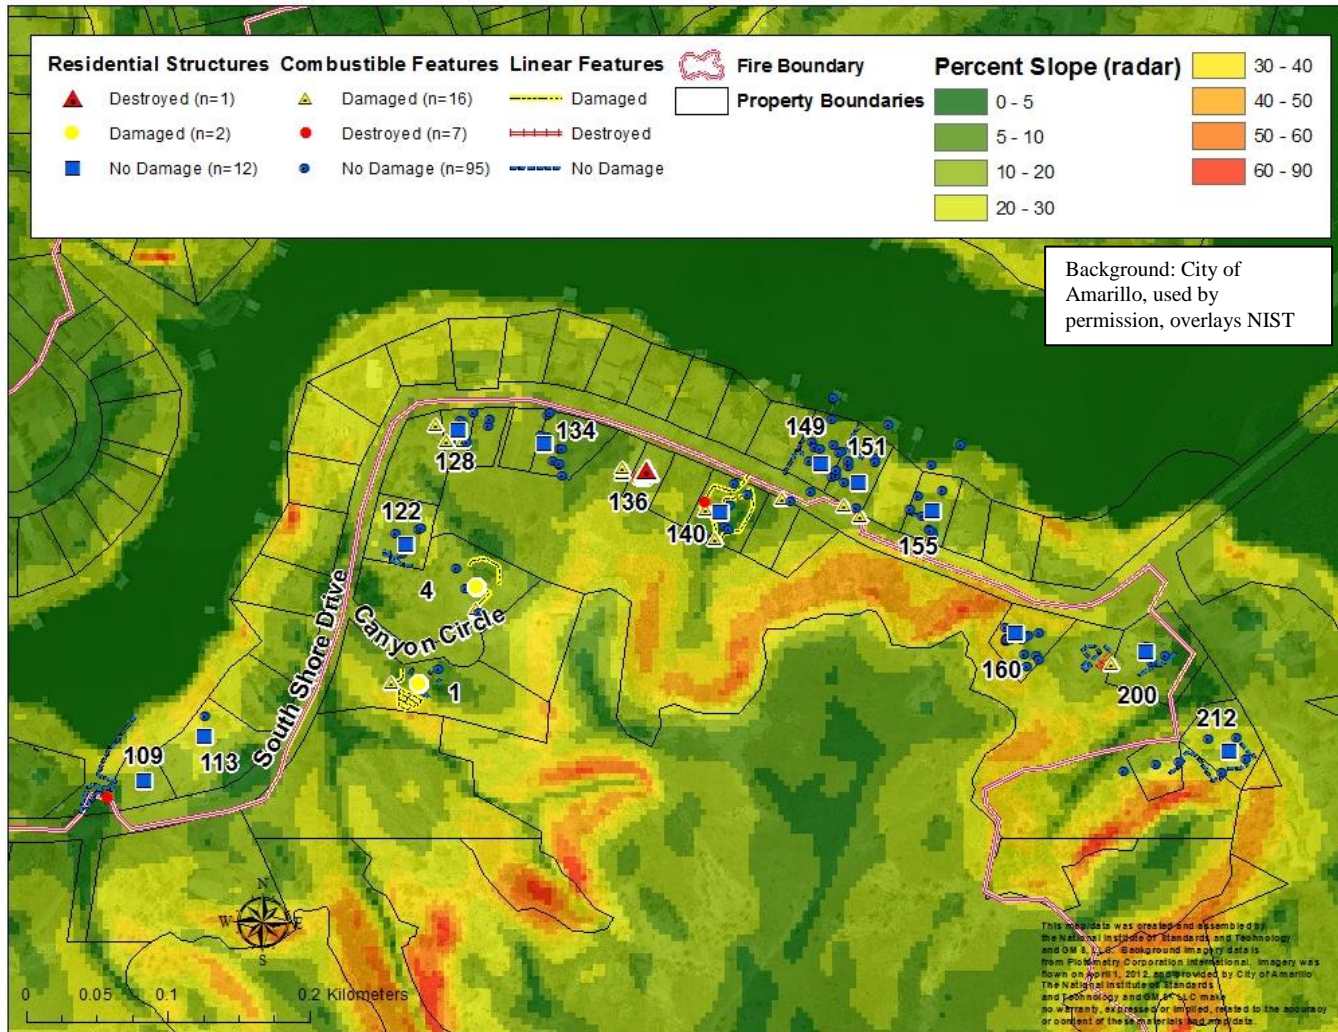
Figure 64 displays radar derived percent slope for the South Lake Tanglewood Community. Figure 65 portrays radar derived aspect for the South Lake Tanglewood Community. As with the Southern Palisades Community the fire appeared to enter some sections of the South Lake Tanglewood Community in areas lacking cliffs. The damaged secondary structure at 200 South Shore Drive appeared to be a result of direct flame contact from burning vegetation, and the topography shown in Figure 64 displays an area between 160 and 200 South Shore Drive of moderate slopes. This area had continuous burned vegetation from the plateau right to the secondary structure. Vegetation in the steeper areas (i.e., cliffs) directly behind 160 and 212 South Shore Drive was not burned.

Figure 64 Radar derived percent slope in South Lake Tanglewood Community.

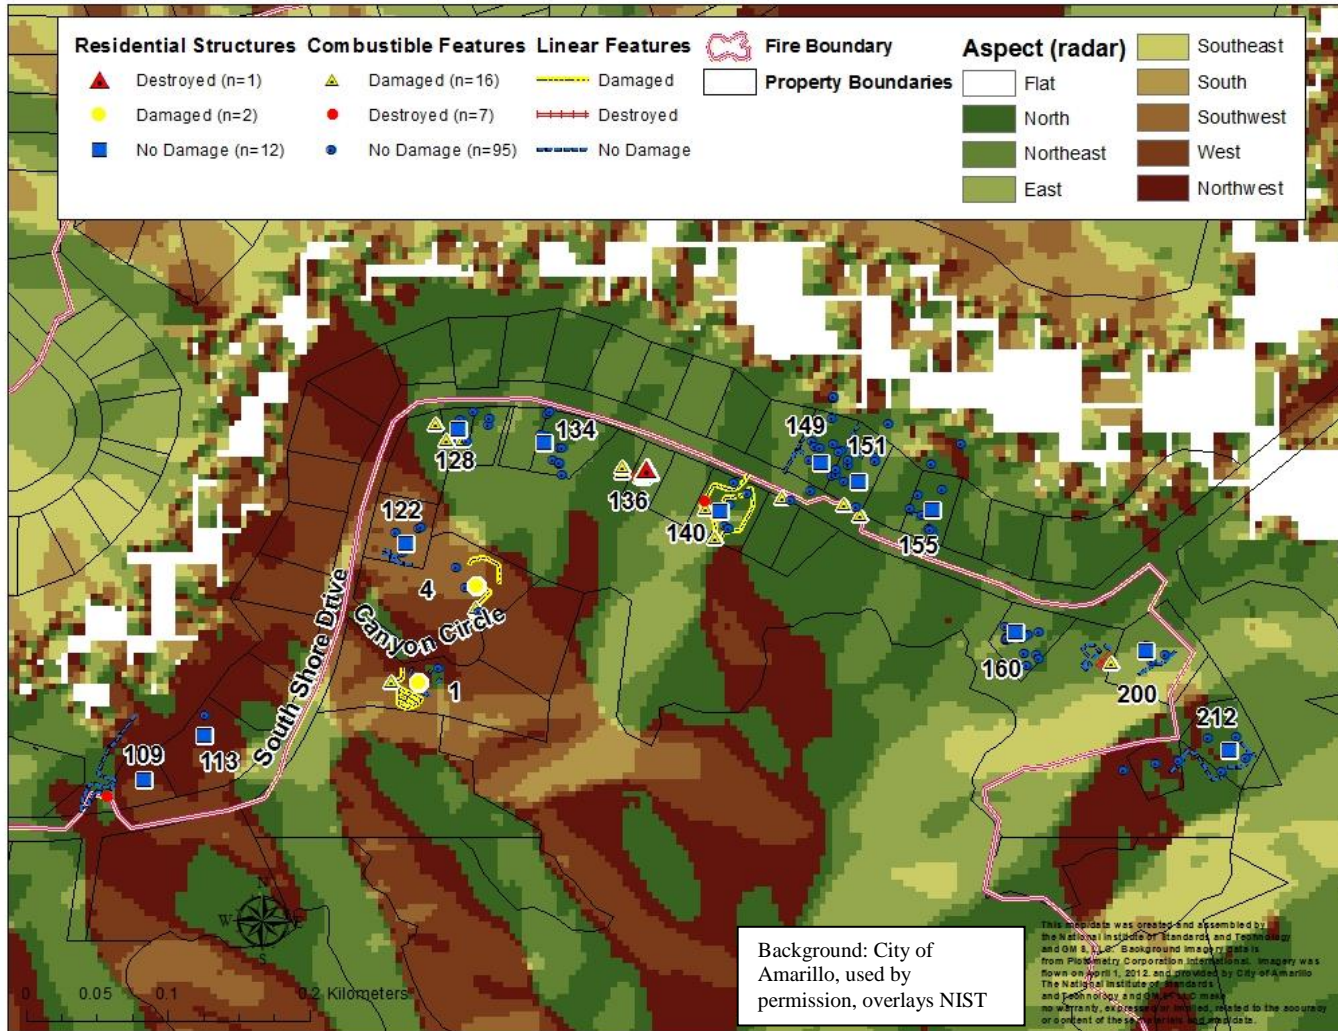
Figure 65 Radar derived aspect in South Lake Tanglewood Community.

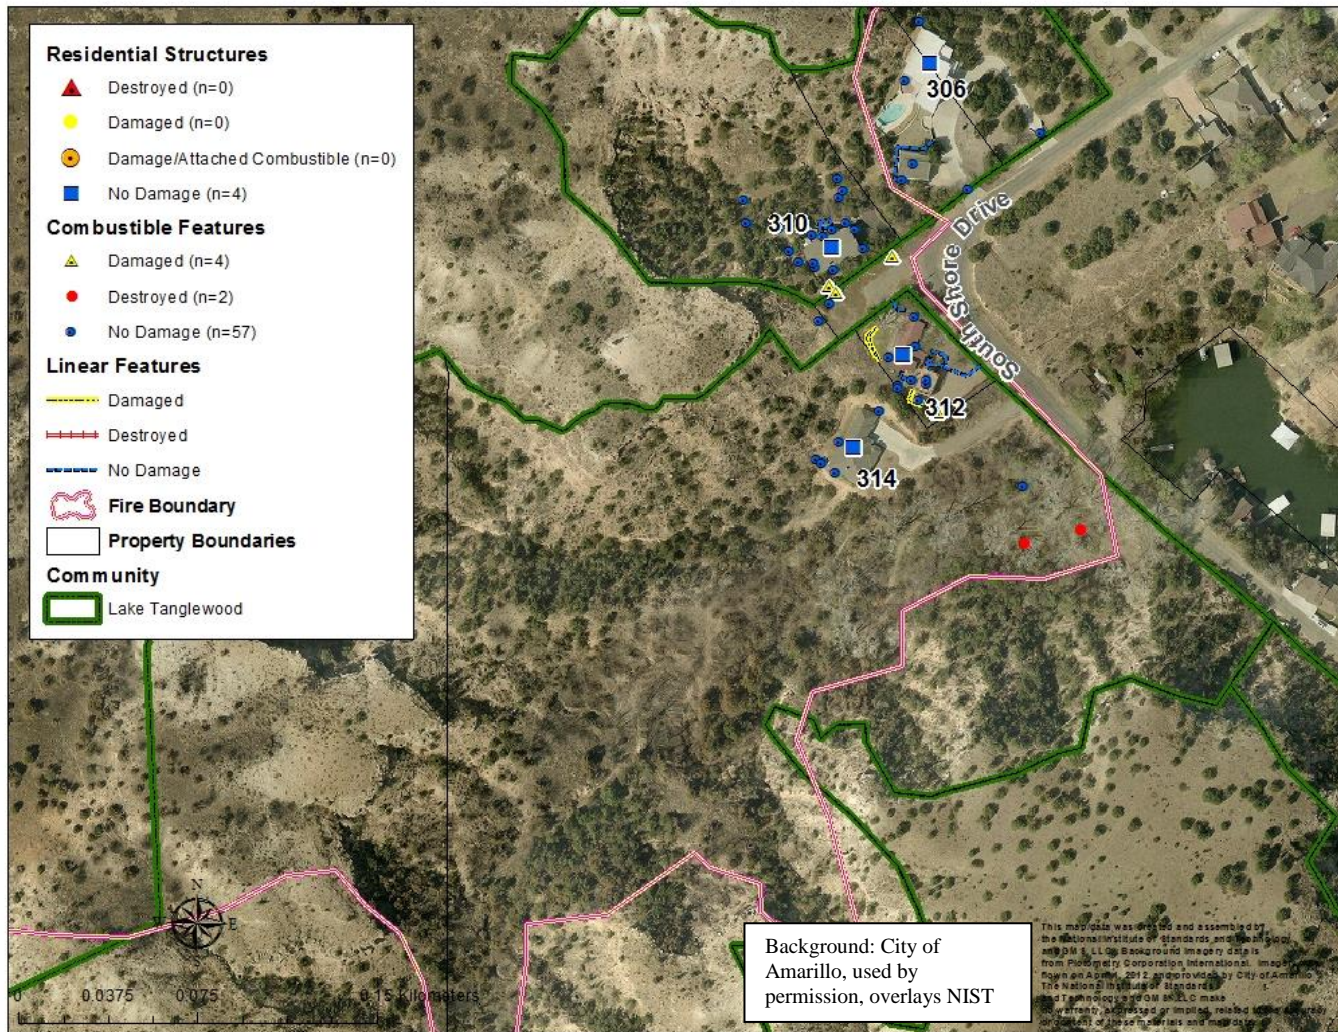
Figure 66 shows damage to structural elements from the Tanglewood Fire within the Southeast Lake Tanglewood Community. No residential structures were damaged or destroyed in this area. Damage and destruction did occur to some detached combustibles and linear features as shown in Table 23. Damage and destruction to linear features by length is shown in Table 24. The exact time of when most of the detached combustibles burned is not known. Figure 67 shows fire direction in the Southeast Lake Tanglewood Community. The fire jumped the circular driveway at 310 South Shore Drive in two locations. As listed in Figure 67, the fire in the wildlands moved through the area sometime prior to 18:21 on February 27.

Figure 66 Damage to structural elements in the Southeast Lake Tanglewood Community.

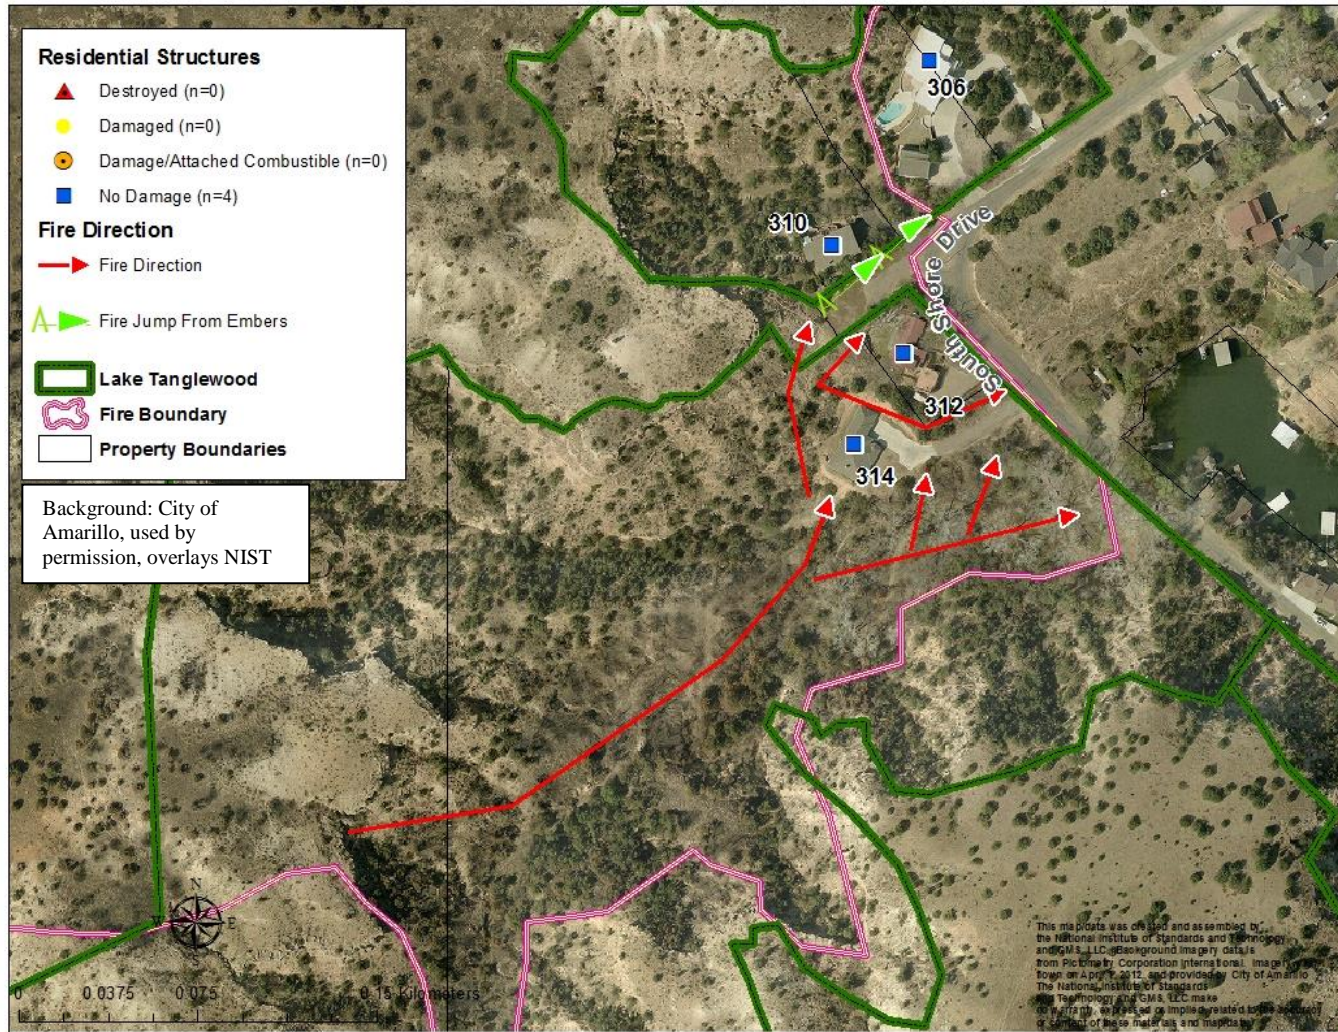
Figure 67 Fire direction in Southeast Lake Tanglewood Community. The main fire front moved through area by 18:21 on 2/27/2011 based on Amarillo Sheriff Helicopter flight.

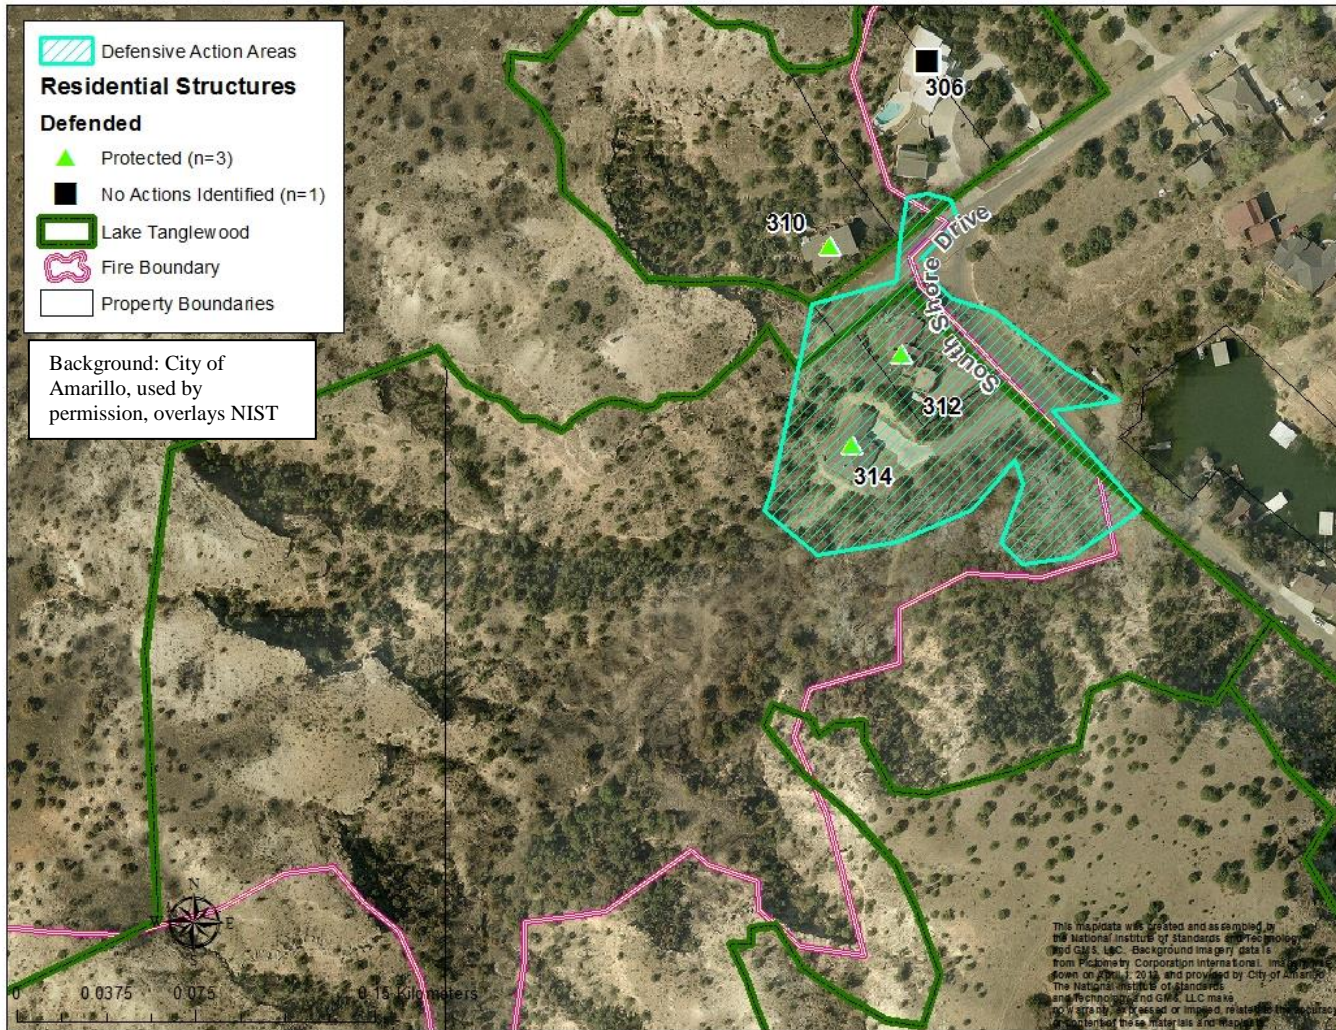
Figure 68 shows the locations of identified defensive actions along with the resulting categorization of structures as to a defended category. First responders extinguished railroad tie retaining walls, landscape borders, grass vegetation by South Shore Drive and also suppressed burning wildland vegetation to the west of the residential structures. The damaged combustibles by 310 South Shore Drive were not explicitly identified as defended, but the scorching of these features was minor and suppression of nearby burning vegetation by first responders might have alleviated some of the damage to these features. Table 25 identifies damaged and destroyed linear and combustible features by identified defensive actions.

Figure 68 Southeast Lake Tanglewood Community defensive action locations and primary structure categorizations.

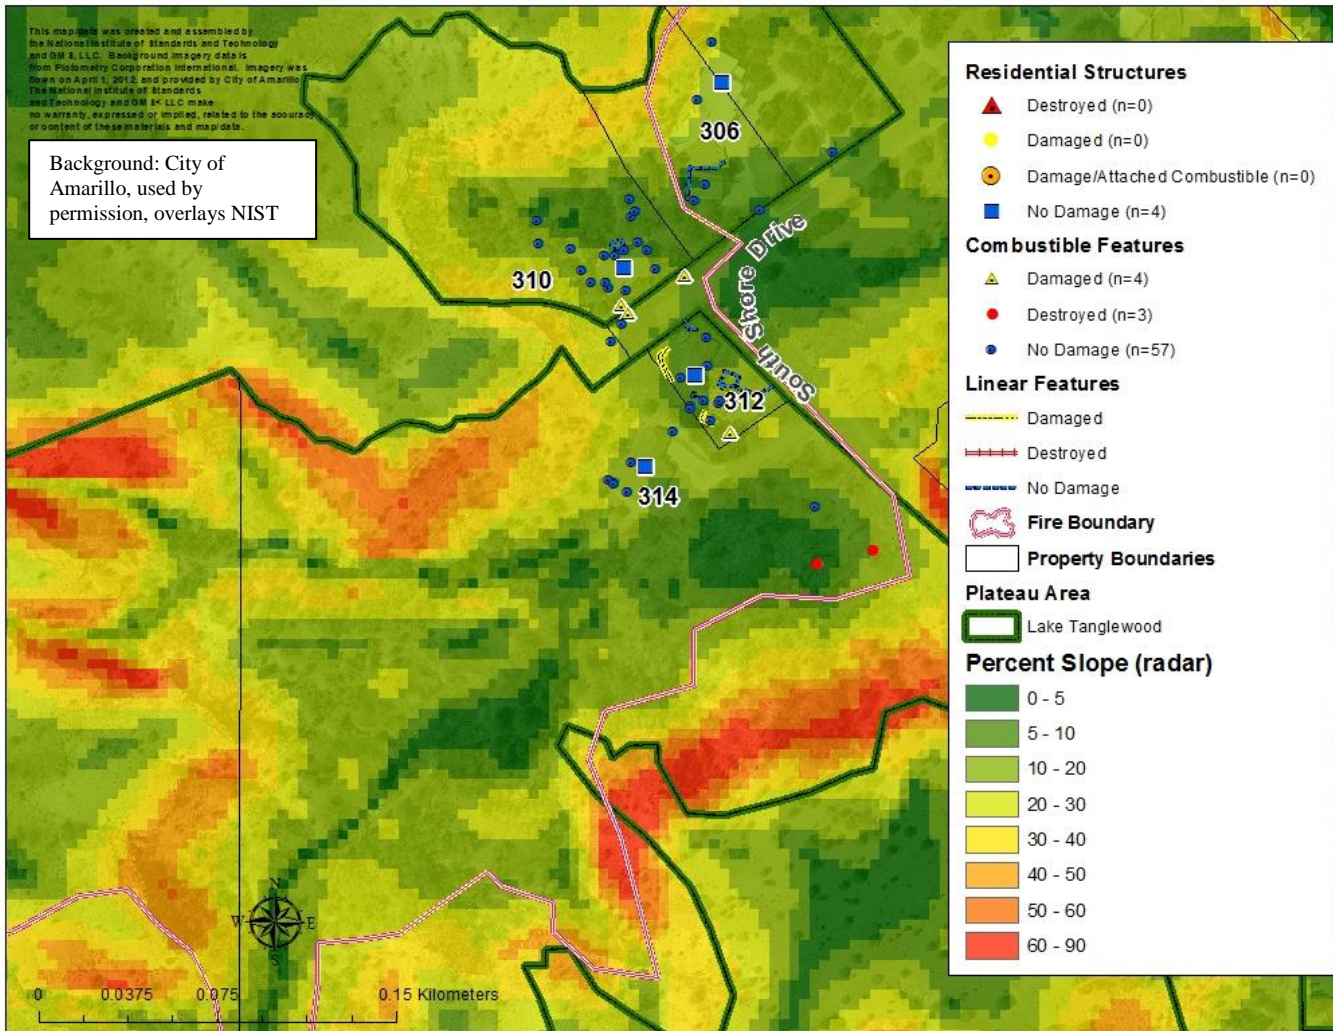
Figure 69 displays radar derived percent slope for the Southeast Lake Tanglewood Community. Figure 70 portrays radar derived aspect for the Southeast Lake Tanglewood Community. As with other areas described above fire behavior was more heavily concentrated on one side of the canyon than the other side. It was more difficult to discern the precise area where the fire traveled from the plateau to the canyon in this area. Nonetheless, steep areas with cliffs have burned vegetation up to the cliffs on the plateau side with green vegetation on the canyon side of the community not being burned.

Figure 69 Radar derived percent slope in Southeast Lake Tanglewood Community.

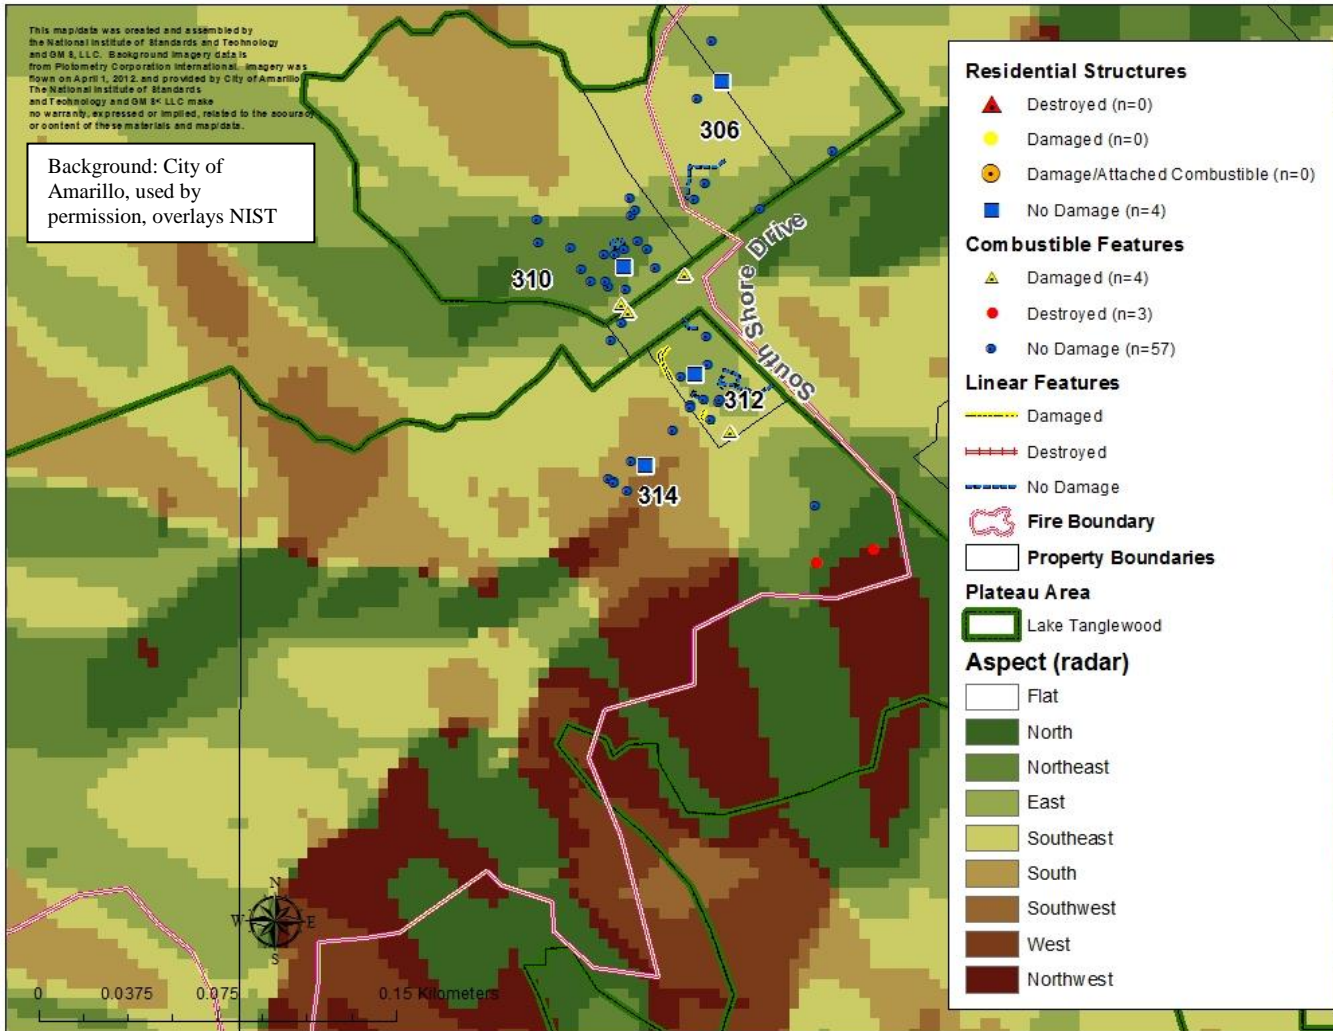
Figure 70 Radar derived aspect in Southeast Lake Tanglewood Community.

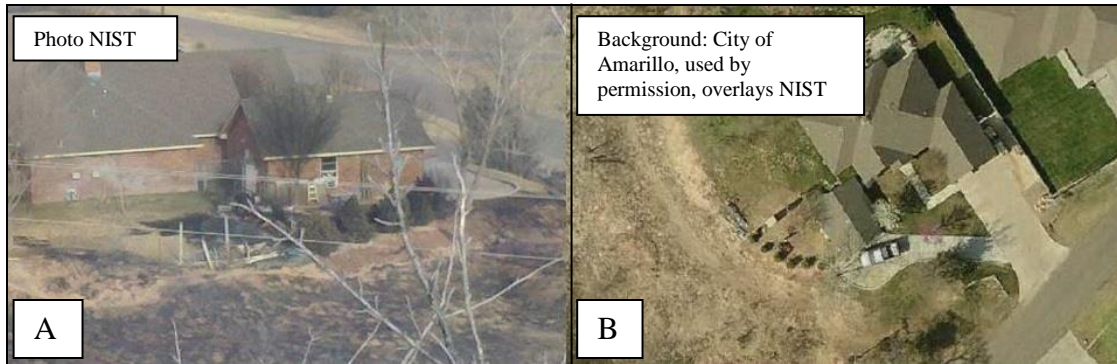
Field data collection of burned vegetation is a key component of post-fire assessments. This field data collection, however, must be coupled with timely acquisition of aerial imagery of sufficient spatial resolution, and focus on detailed ground imaging. The post-fire imagery provided by the City of Amarillo was essential to this assessment, but the temporal resolution after the fire (i.e., 30 days) resulted in some burned vegetation being

difficult to identify. For example, Figure 71A shows an image of burned vegetation right after the fire, while Figure 71B shows an image of the same area from the City of Amarillo provided post-fire imagery. As can be seen, the black marks, which clearly identify the burned area in the imagery right after the fire (Figure 71A), are not present in the aerial imagery taken a month later (Figure 71B).

**Figure 71 A: Image of burned vegetation right after the main fire front moved through the area. B: Aerial image of same area acquired one month after fire, lacking clear black demarcation of burned area.**

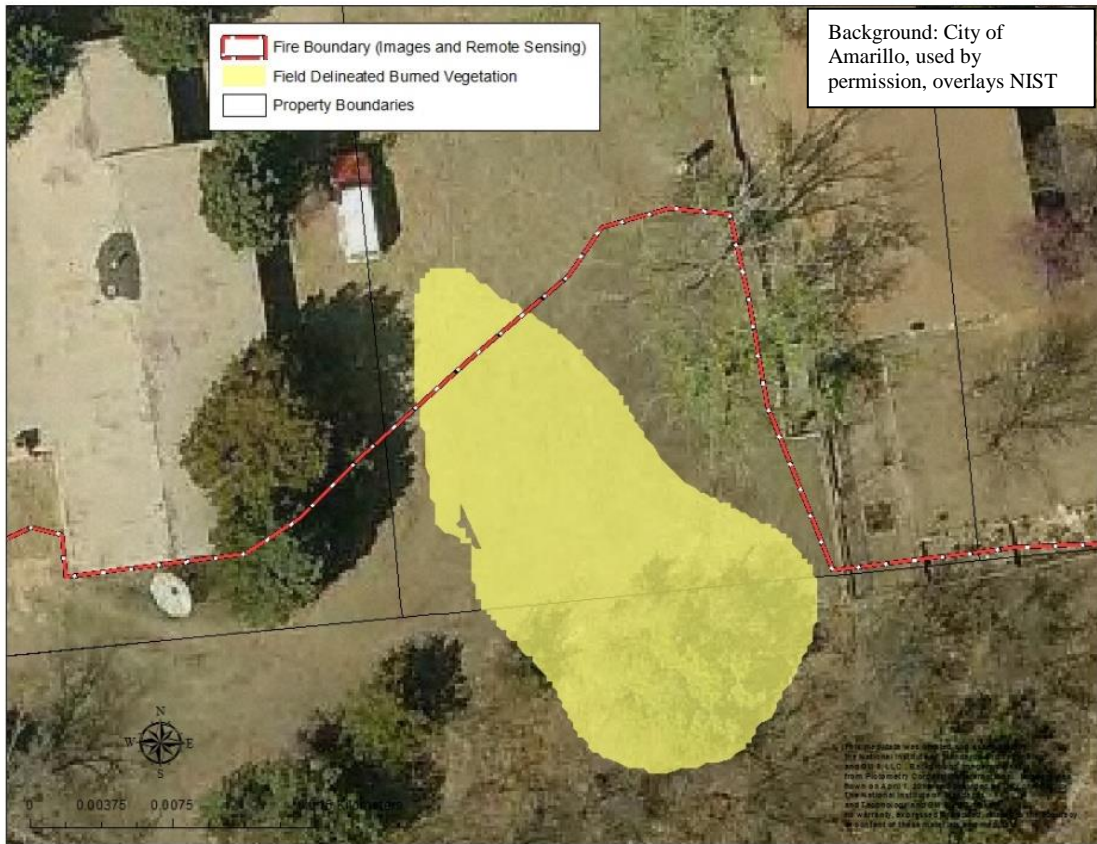
6. Collection of post-fire vegetation information in residential areas should be greatly simplified with a large emphasis on imaging of features. The onscreen digitizing of burned vegetation using pre-fire imagery did not result in a directly usable dataset in part due to varying skills in digitization as seen in Figure 74. In addition to varying degrees of digitizing expertise amongst data collectors, even an experienced digitizer often had errors such as flipping the orientation of burned vegetation, as shown in the figure below. The use of post-fire imagery as a base layer will aid in producing a more directly usable data set. However, being that data collectors are unlikely to be Geospatial professionals, it should be expected that the field data set will still require extensive post-processing.

**Figure 74 Erroneous field collected burn vegetation boundary**
