# NATIONAL BUREAU OF STANDARDS REPORT

REPORT  
OF  
EXPERIMENTS TO DETERMINE THE FIRE RESISTANCES  
OF  
TWO PREFABRICATED WOOD WALLS

J. V. Ryan  
Fire Protection Section  
Building Technology Division

U. S. DEPARTMENT OF THE AIR FORCE  
Headquarters U. S. Air Force  
Washington 25, D. C.

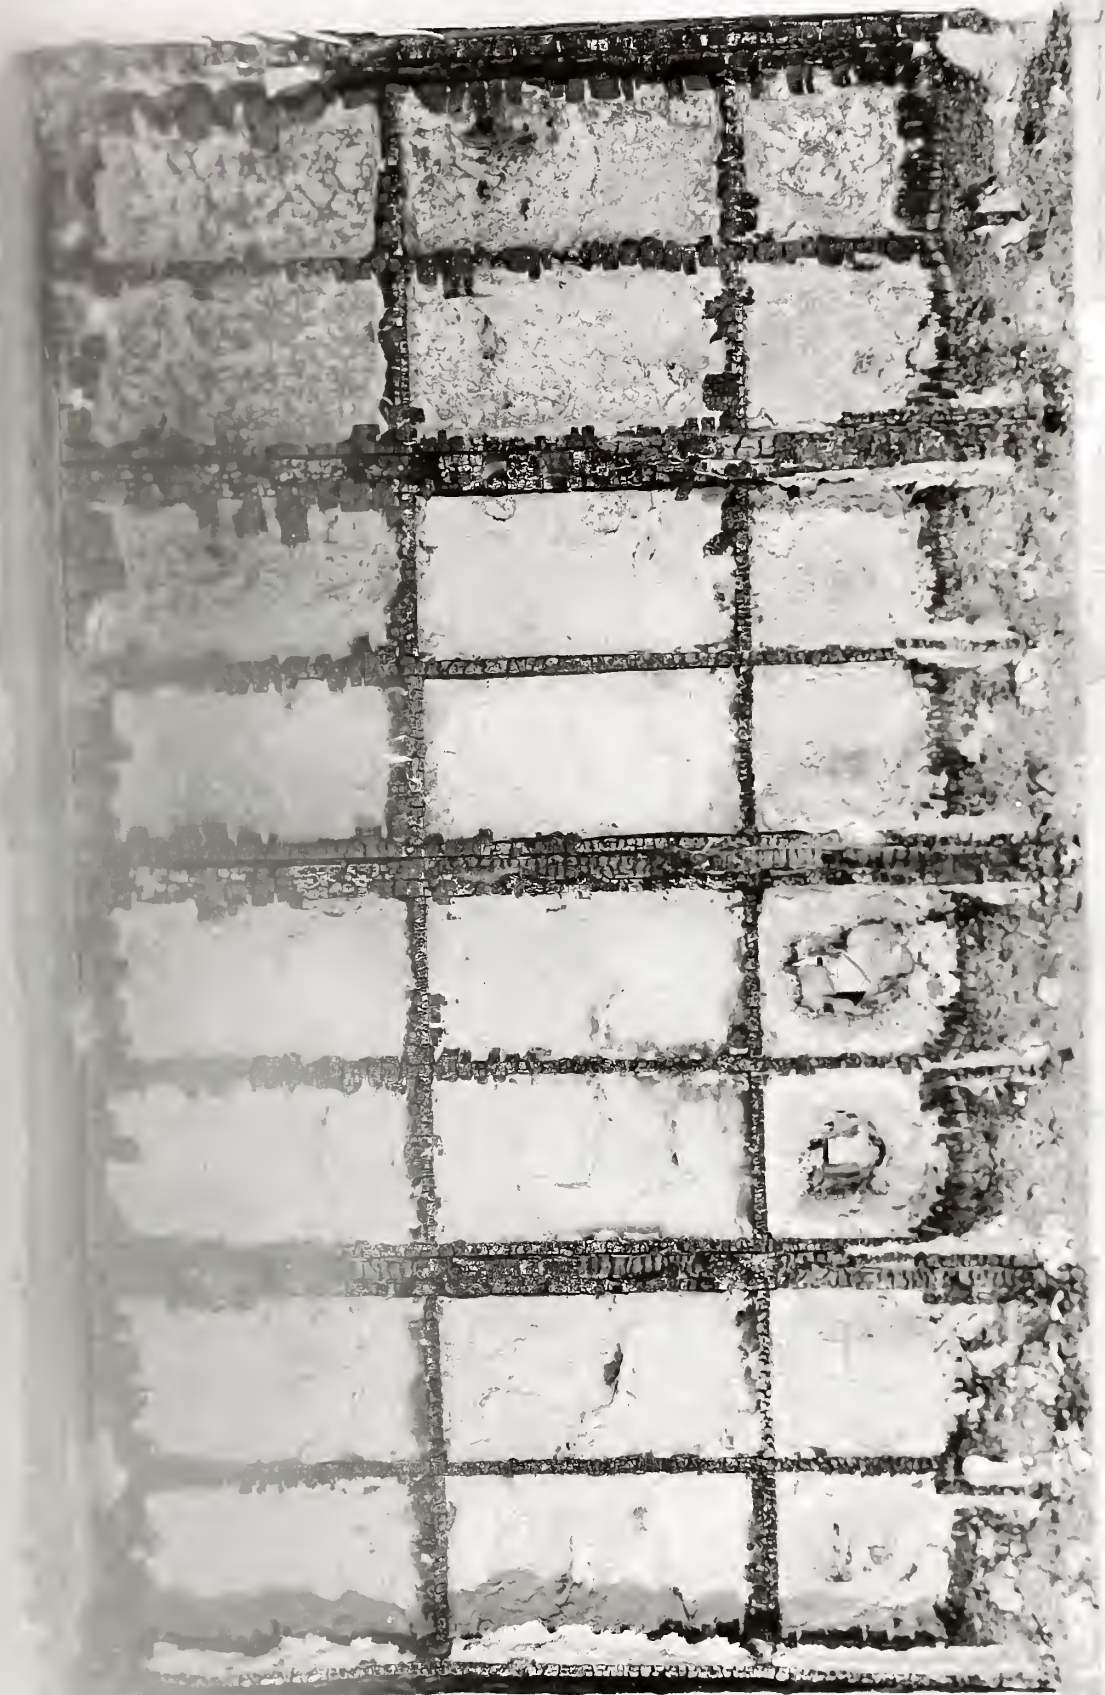
The specimen and flame were removed from before the furnace and a water stream played on from exposed side. The panels that had made up the exposed side of the wall were almost completely gone. The plywood was burned from the inner faces of the panels that made up the unexposed side of the wall and the glass fiber insulation was white and matted. Over some areas, it had a granular texture in place of the original fibrous texture.

Figure 5. Section of fire-break wall from fire  
side after test 11.
