# Investigation into the Ashland Oil Storage Tank Collapse on January 2, 1988

# **Investigation into the Ashland Oil Storage Tank Collapse on January 2, 1988**

Issued June 1988

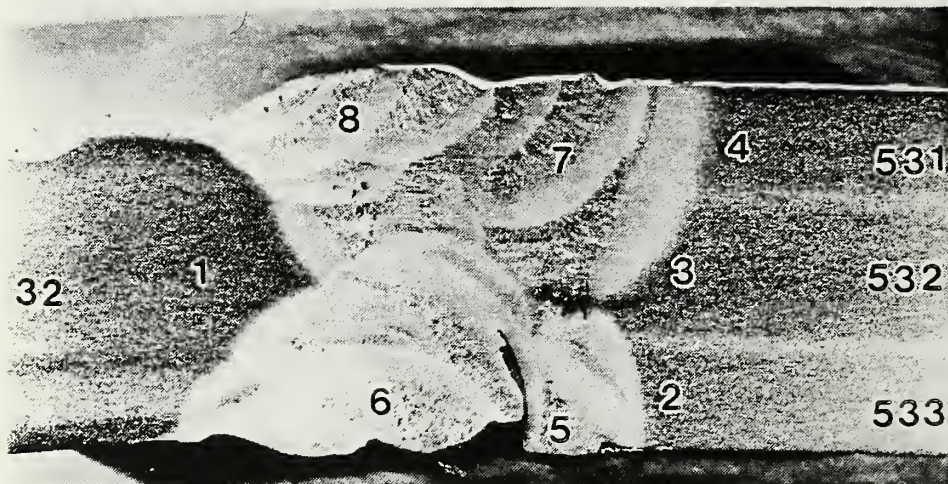
Figure 7.6 - Location of Samples for Chemical Analysis

the first shell course base metal showed substantial evidence of "banding" due to chemical segregation in the steel plate. Therefore, chemical analyses were taken in three locations as shown in Figure 7.6 to determine the extent of the chemical segregation. The chemical analyses were performed four times at each location. The results (average of four determinations) are shown in Table 7.1 as samples 5-3-1, 5-3-2, and 5-3-3 corresponding to the locations shown in the micrograph in Figure 7.6. Chemical analyses were performed on one location in the base metal specimen from the second shell course (sample 3-2). The sample was analyzed four times. The results of the chemical analyses are shown in Table 7.1 as sample 3-2.

Chemical analyses were performed at 8 locations within the specimen taken from a section of the horizontal weld (test sample 4E) as shown in Figure 7.6. The results of these chemical analyses are shown in Table 7.1 identified as samples 1 through 8. Sample location 1 was in the base metal from the second shell course. The chemical composition at this location is consistent, within the expected normal variability in composition, with the chemical composition of the same base metal plate (sample 3-2) at a different location. Sample locations 2, 3, and 4 are in the base metal from the first shell course. The chemical compositions at these three locations (2, 3, and 4) are consistent with the chemical compositions determined in corresponding locations in the base metal sample from the first shell course (test sample 5-3). Although the base metal from the first shell course showed significant banding in the microstructure (Figure 7.6), no evidence of significant segregation was shown by the chemical analyses.

Locations 6 and 8 in the weld metal sample (Figure 7.6) have been identified to be in the "new" weld metal (the weld made when the tank was reassembled at the Floreffe site). The chemical composition of the weld metal at locations 6 and 8 are considered to be equivalent within the expected range of variability for chemical composition of weld metal. Locations 5 and 7 in the weld metal sample (Figure 7.6) have been identified to be in the "old" weld metal that was deposited when the tank was originally fabricated at the site near Cleveland. The chemical composition at locations 5 and 7 are considered to be equivalent within the normally expected range of variability for chemical composition of weld metal.

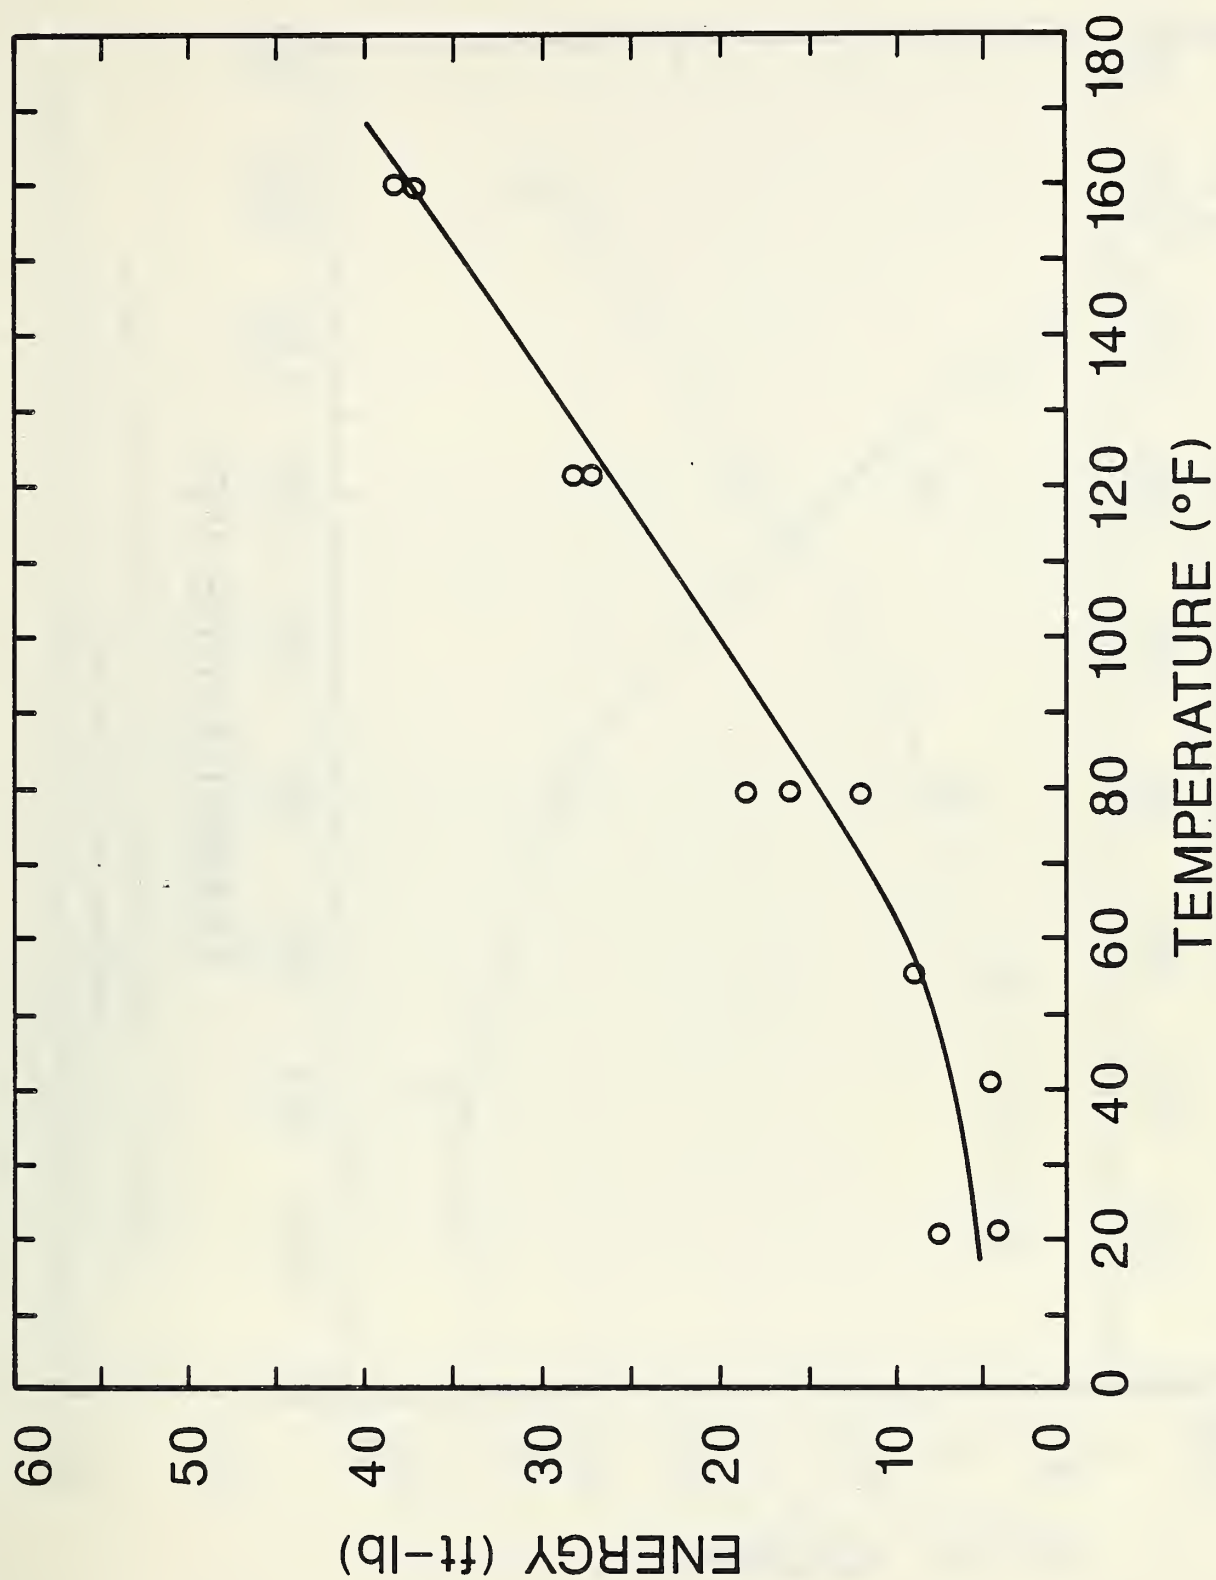
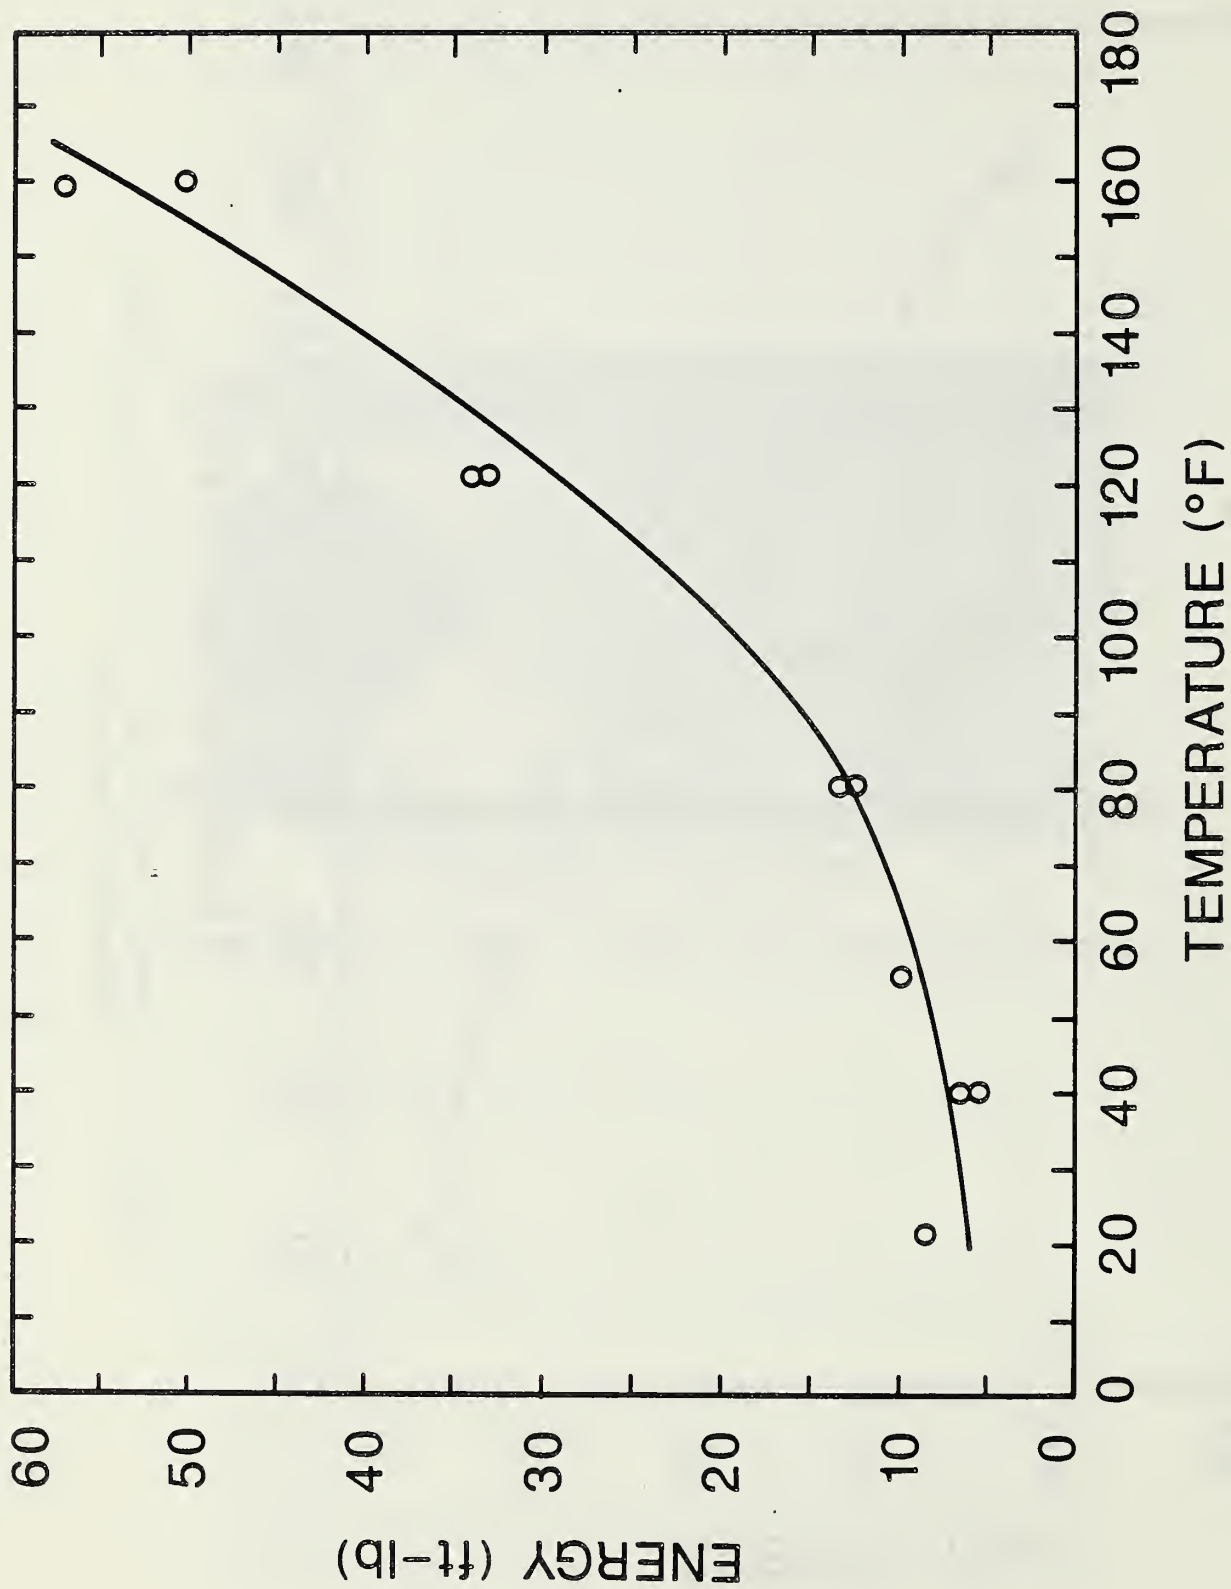
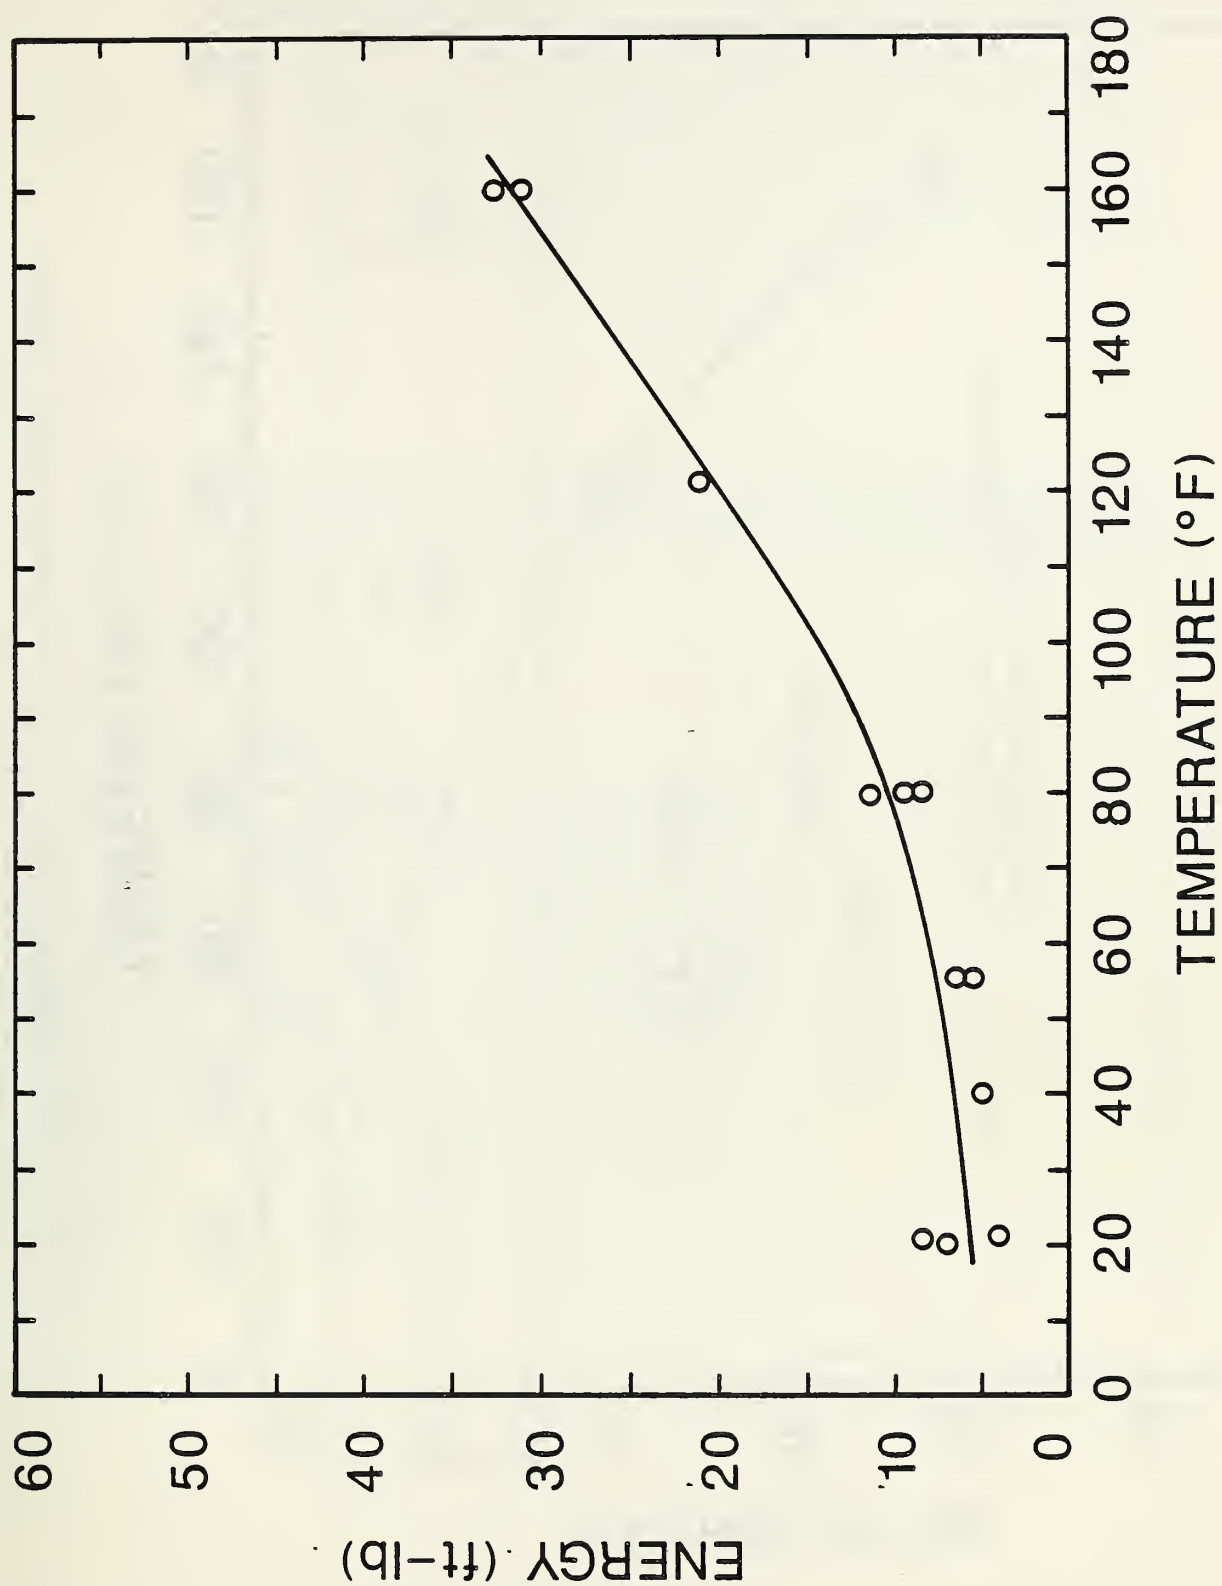
The results of the Charpy-V-notch tests for each plate and each orientation are summarized in Tables 7.3, 7.4, 7.5 and 7.6 and the values of the energy absorbed are shown Figures 7.7, 7.8, 7.9, and 7.10. For test temperature below 60° F all specimens exhibited low property values as determined by the Charpy-V-notch specimens. At all temperature of 55° F and below in each of the plates tested, the energy absorbed was less than 10 ft-lbs, the lateral expansion was 15 mils or less, and the amount of shear fracture was less than 30 per cent. This indicates substantial tendency for brittle fracture at temperatures of 55° F and below. The energy absorbed and lateral expansion were essentially the same at 20° F as at 40° F indicating that the steel was operating in the "lower shelf" region as determined by the Charpy-V-notch tests. The steel plates did not exhibit significant toughness, as measured by the Charpy-V-notch tests until temperatures of 100° F and above. Specimens exhibited greater than 50 per cent shear fracture appearance only above a temperature of 95° F.

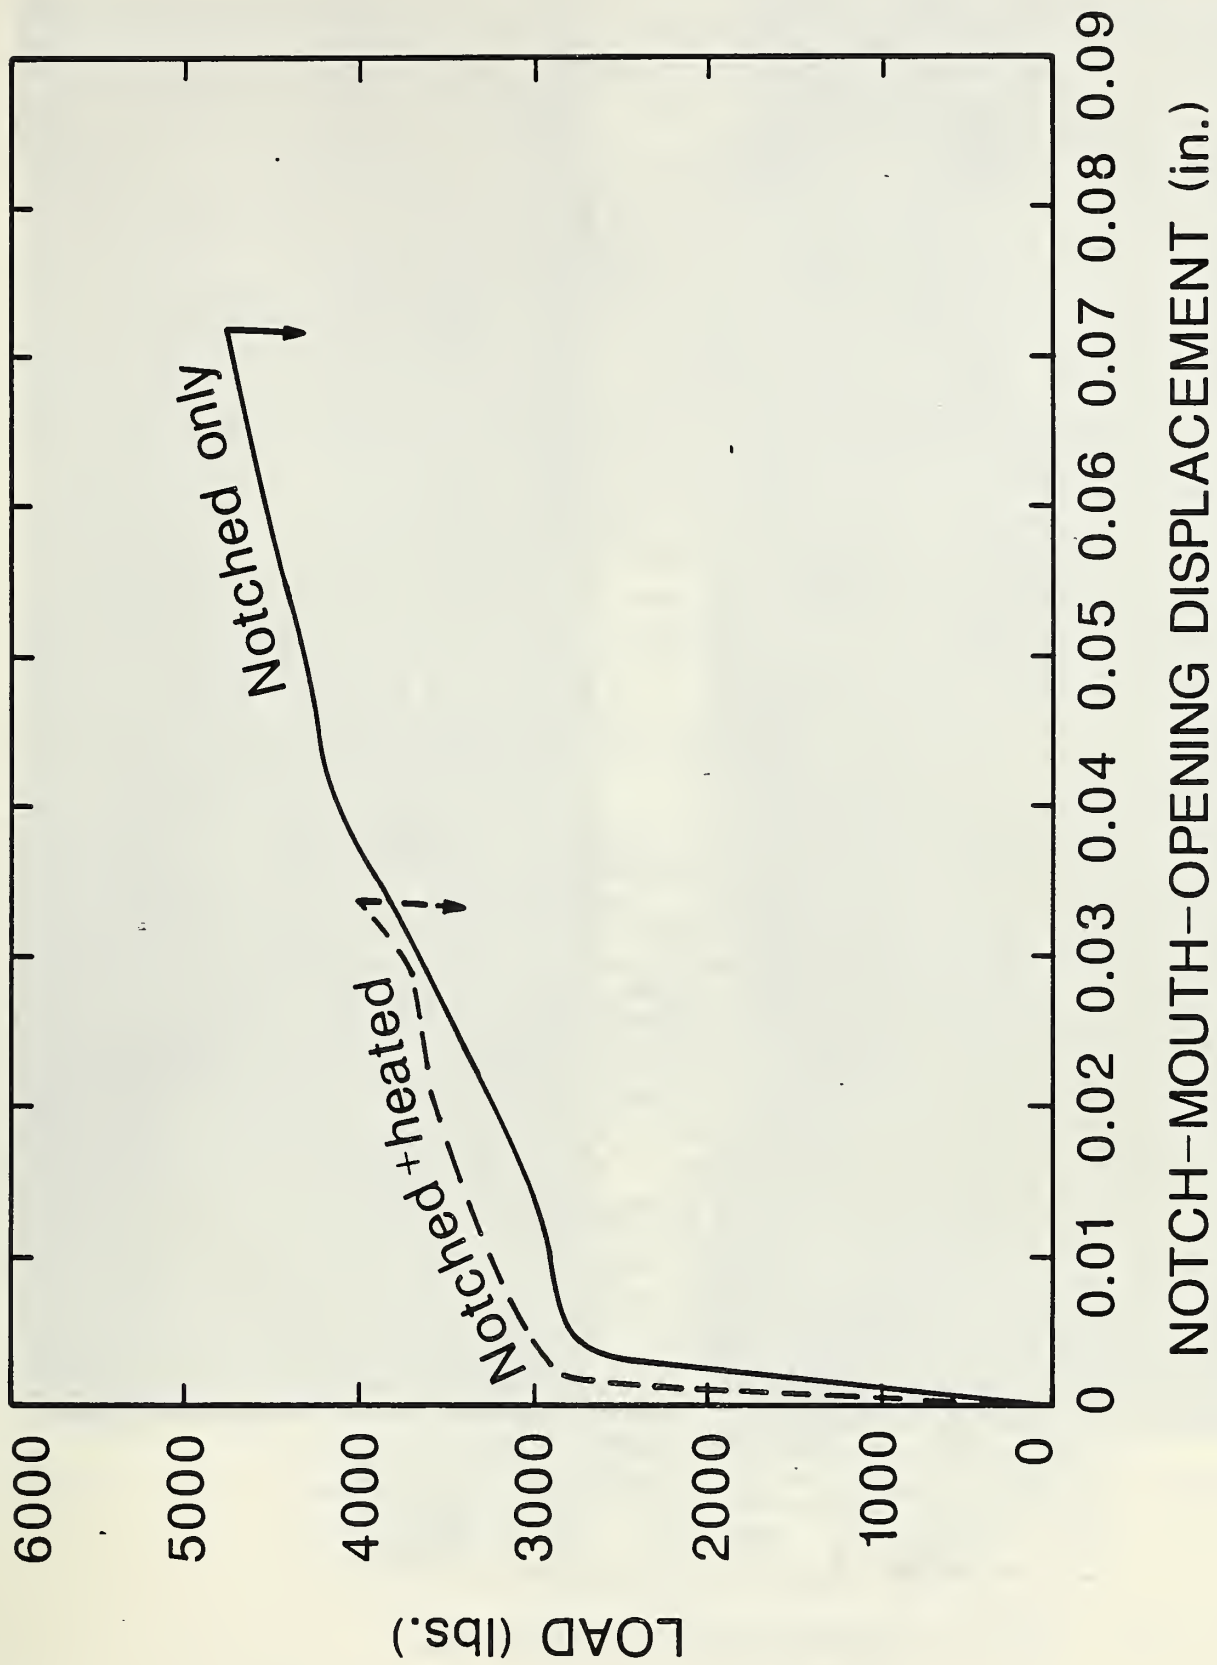
Figure 7.13 - Results of Notched-Bend Test

In this investigation, the effect of the heat-affected zone on the steel is determined from the load/displacement curve. It is seen in Figure 7.13 that the notch mouth-opening displacement at the maximum load (point of fracture initiation) for the heat affected (embrittled) specimen was 0.032-inch compared with a value of 0.072-inch for the notch mouth-opening displacement for the normal steel plate. The area under the load-displacement curve, (Figure 7.13) which can be expressed in terms of energy, can also be taken as a measure of the tendency to fracture. For example, two specimens that were tested at 40° F with just a notch in the base metal had energy values at maximum load equal to 21.4 and 21.7 foot-pounds. A similar specimen tested at 40° F, in which the metal had been embrittled by heating before cutting the notch had an energy at maximum load of 9.0 foot-pounds and a specimen that was heated after cutting the notch had an energy at maximum load of 9.7 foot-pounds. It was found that the energy to initiate fracture in the notched and heat embrittled specimens at 40° F was less than one half the energy to initiate fracture in the steel base metal that had not been embrittled by heating.

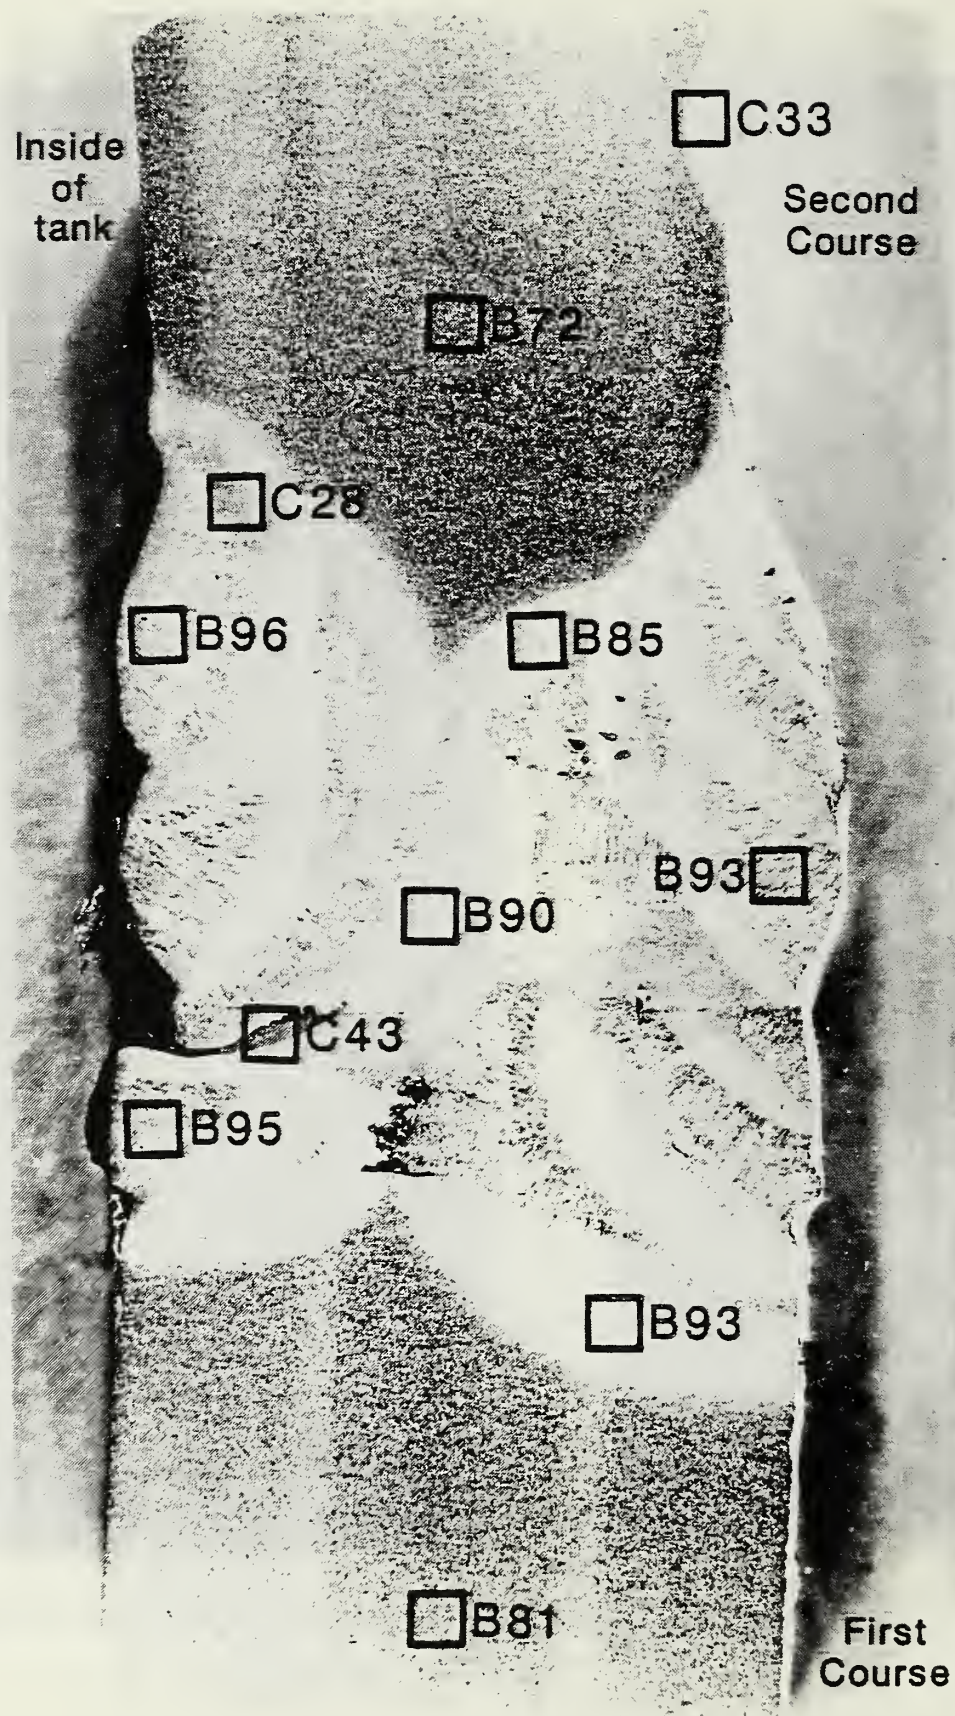
Figure 7.16 - Microstructure and Hardness of Horizontal Weld Metal

Rockwell B and C Scale Hardness Values are given for various Locations.

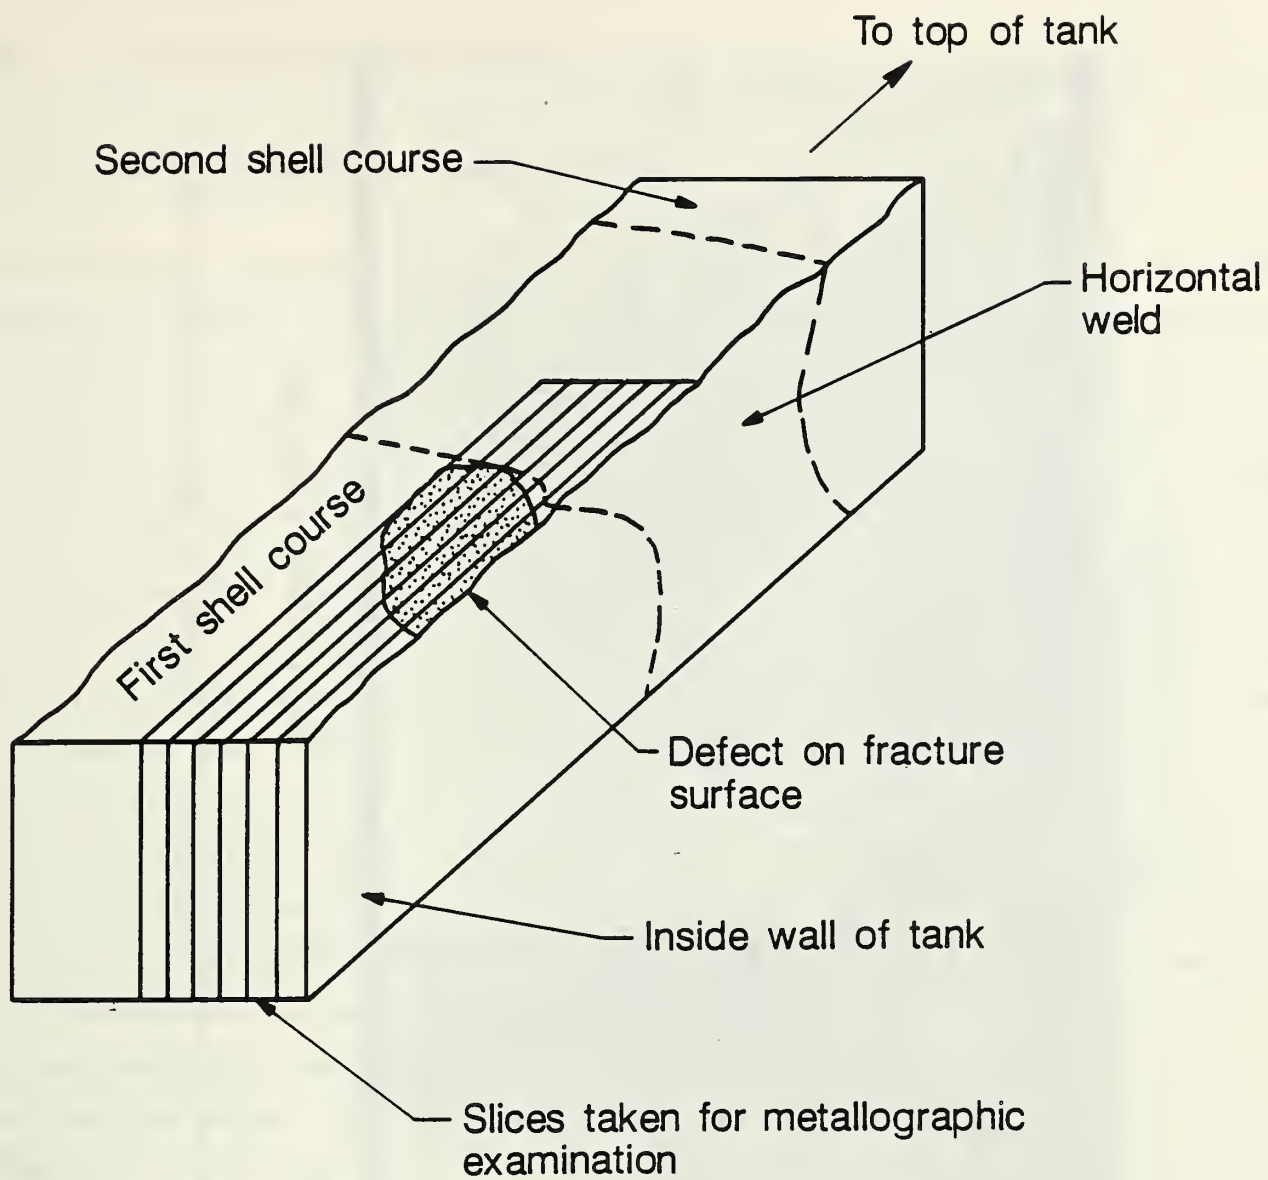
Figure 7.25 - Details of Sectioning to Determine Location of Defect

To determine the exact location of the defect with respect to the new weld metal, old weld metal, and first shell course plate, the sample shown in Figure 7.24 was sectioned as shown in Figure 7.25. The sections were cut using a fine wire electrodischarge machine. Eight specimens were cut at intervals of 0.080 in starting from the inner surface of the tank. These specimens were then examined metallographically to permit a 3-dimensional reconstruction of the defect to be made and to determine the exact location of the defect. An example of one of these sections is shown in Figure 7.26. This figure shows that the defect was located entirely in base metal from the first shell course. The edge of the defect extended just to the edge of the heat affected zone of the old weld metal.

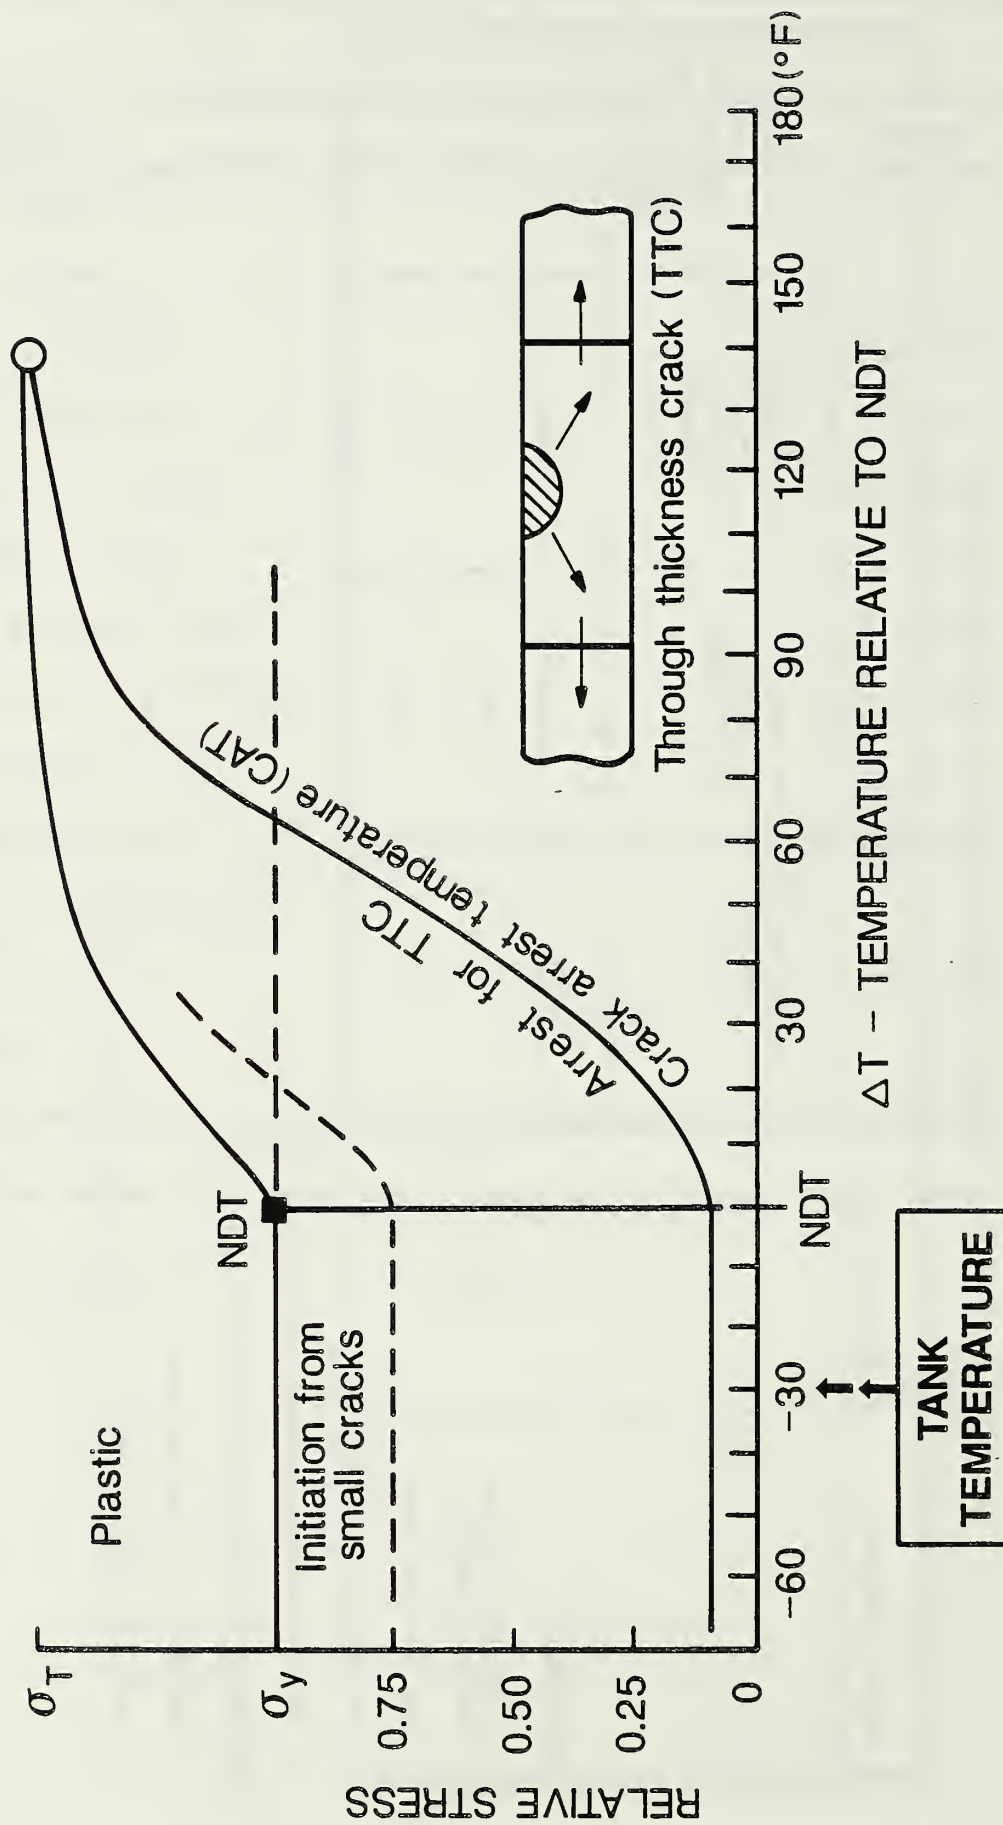
Figure 8.1 - Fracture Analysis Diagram (FAD)

A more exact, but still empirically based, procedure to assess the probability of fracture initiation and arrest is the determination of the drop-weight nil-ductility transition (NDT) temperature. This NDT temperature is used in conjunction with the generic Fracture Analysis Diagram (FAD), shown in Figure 8.1, to make an assessment of the probability of fracture initiation and arrest [8.4]. The Fracture Analysis Diagram provides a generalized description of the relationships between the crack size, relative stress, and operating temperature relative to the NDT. At temperatures below the NDT, the Fracture Analysis Diagram predicts that fracture will initiate from small defects (typically less than 1-inch in length) at stress levels below the yield strength of the steel and that the fracture will be brittle in nature. As seen in Table 7.8, the NDT for the first and second shell course steel plates was 20° F to 40° F above the operating temperature of the tank at the time of the failure. Based on the measured NDT and the Fracture Analysis Diagram, fracture initiation is predicted to be likely to occur in this tank at the operating temperature of 32° F.
