**NIST Technical Note 2203**

# **Fire Resilience of a Steel-Concrete Composite Floor System: Full-Scale Experimental Evaluation for Influence of Slab Reinforcement (Test #2)**

The National Institute of Standards and Technology is conducting a series of large compartment fire tests to investigate the behavior and fire-induced failure mechanisms of full-scale composite floor assemblies with a two-story steel gravity frame, two bays by three bays in plan. This report presents the experimental design and results from the second composite floor fire experiment (Test #2).

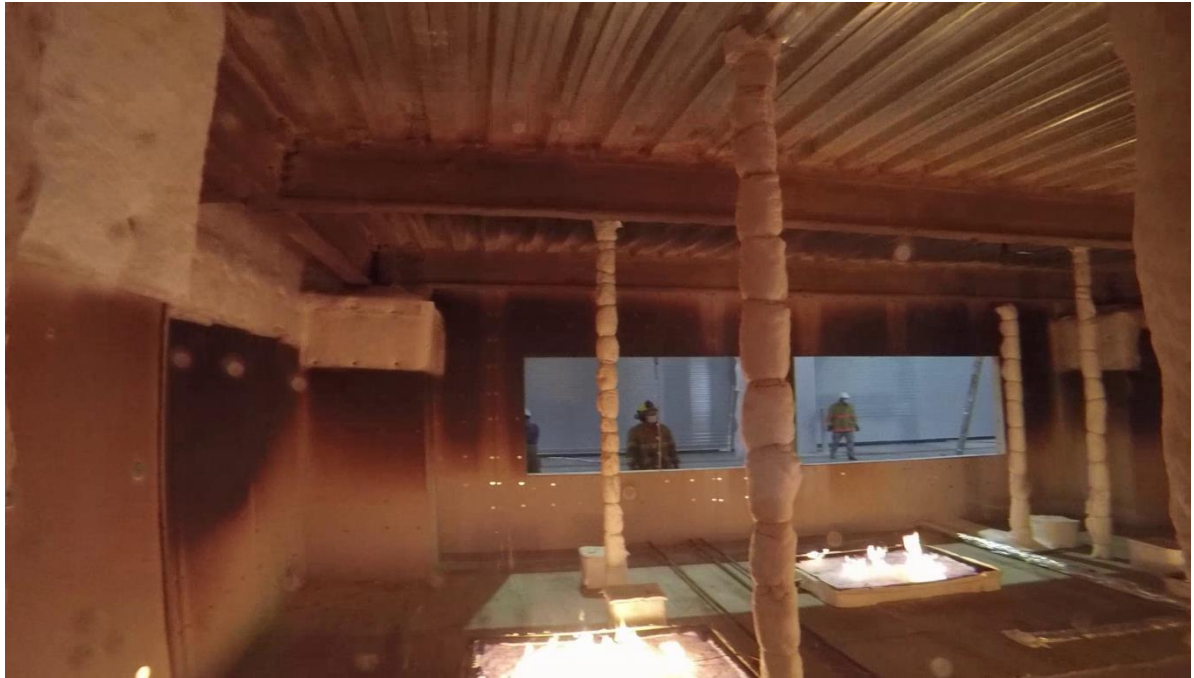
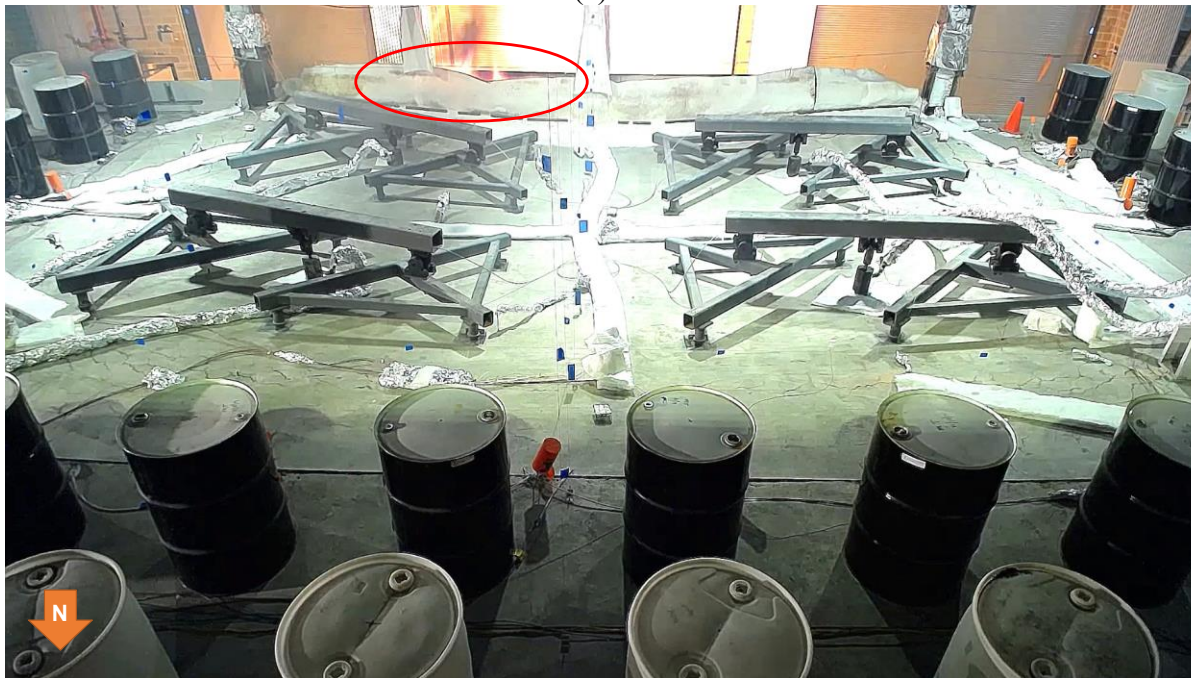
| Clock Time | Fire Exposure Time | Description |
|---|---|---|
| 12:45 PM | 100 min | A breach became visible along the south wall above the test floor level allowing flame extension; See red circle in Fig. 14b. |

**Fig. 14. Snapshots from the test video showing (a) inside the test compartment at ignition of the burners and (b) top of the test floor specimen at 120 min after the burner ignition.**

As shown in Fig. 28, the vertical displacement of the secondary beam at midspan (VD5) increased to 455 mm (equivalent to the ratio  $L/20$  where  $L = 9.1$  m) at 131 min, finally reaching its peak value of 475 mm at 145 min (i.e., about 14 min into cooling). The maximum displacements of the north beam (VD1), the east girder (VD7), and the west girder (VD11) were 200 mm, 115 mm, and 125 mm, respectively. The vertical displacements of the south edge beam at midspan (VD10) became invalid after 130 min because Kaowool strips placed along the south wall were flipped over a measurement string of this displacement sensor as the south wall significantly bent toward the south (Refer to Fig. 14b).

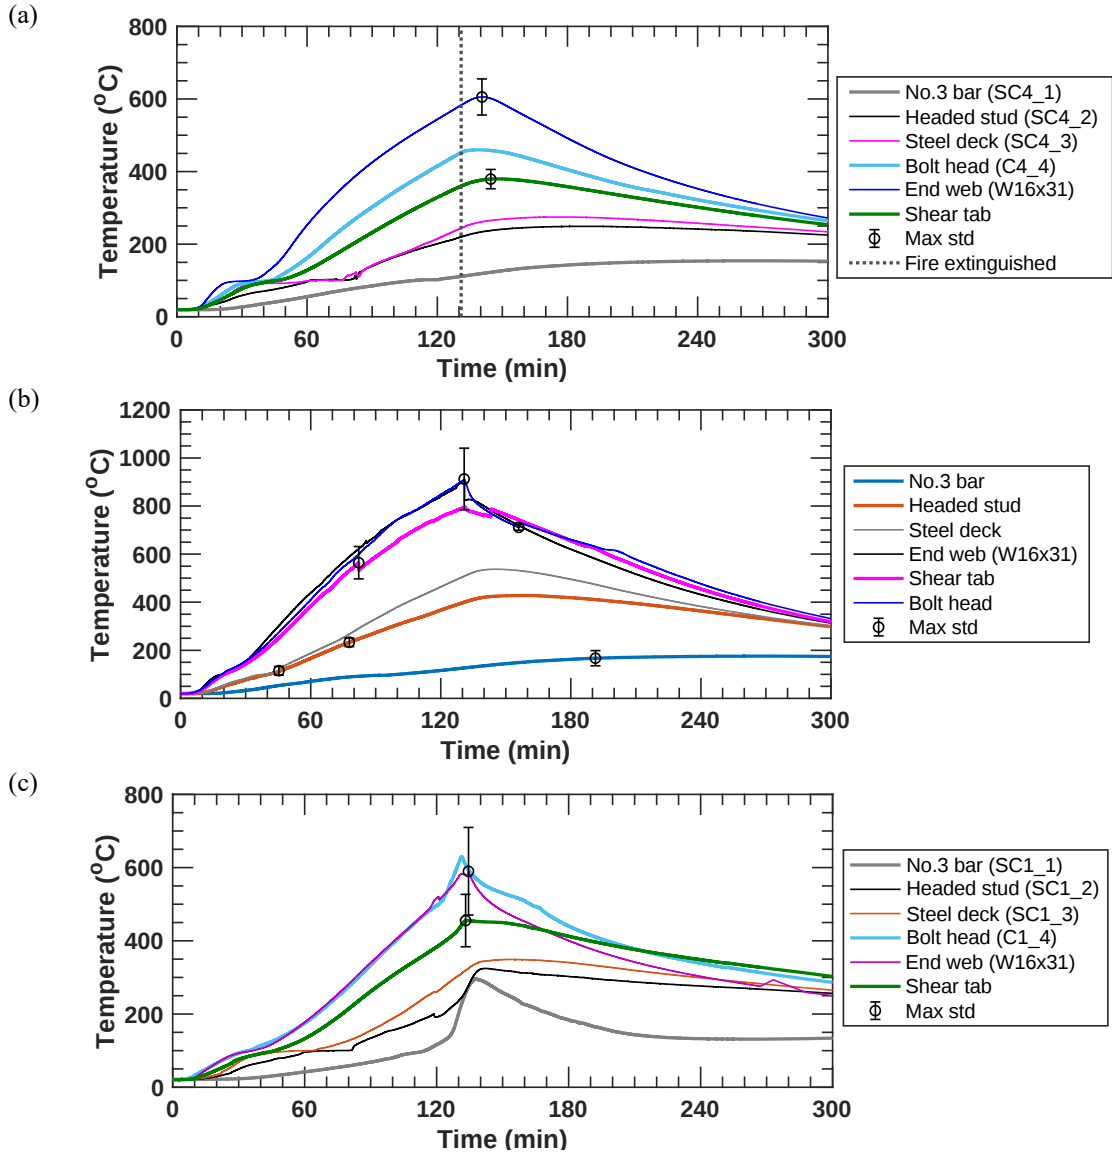
As shown in Fig. 25, the beam-to-girder connection region was heated more rapidly due to its proximity to the burners and a thinner layer of SFRM. The shear-tab connection temperature exceeded 800 °C on average during the fire exposure. Temperatures of the same connection at the north and south beam ends remained below 600 °C. The No.3 reinforcing bar over the connection remained below 200 °C for the north and secondary beams. However, the No. 3 bar temperature at the south beam ends sharply increased after 120 min, indicating concrete cracks.

**Fig. 25. Average temperatures of the beam-end connections of (a) north edge beam, (b) secondary beam, and (c) south edge beam with W16x31 shapes. Error bars indicate a maximum value of standard deviation of temperatures measured at multiple locations.**

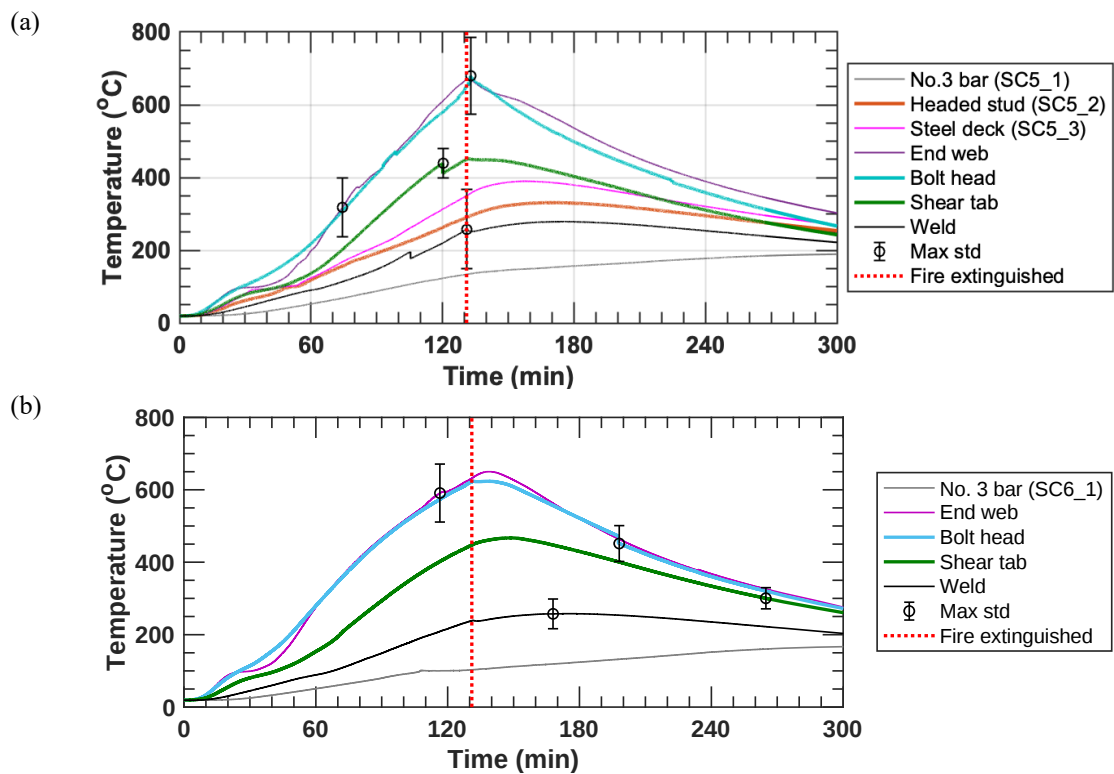
The girder end-connection regions indicated a similar change in temperatures (Fig. 26). The beam end web and bolt head reached over 600 °C on average. However, temperatures of the extended shear tabs and welded joints were approximately 200 °C and 400 °C lower, respectively, because thermocouples in those regions were shaded by the column flanges. The No.3 bar temperature was considerably low with a peak value of 200 °C during cooling.

The temperature variation in the beam or girder end webs as well as bolt heads was as large as 25 %. This might be caused by local buckling of the end web leading to physical damages (fissures, debonding, or both) to applied SFRM where thermocouples were installed.

**Fig. 26. Average temperature of (a) east girder end connection and (b) west girder end connection attached to W18x35 shapes. Error bars indicate a maximum value of standard deviation in temperatures measured at multiple locations.**

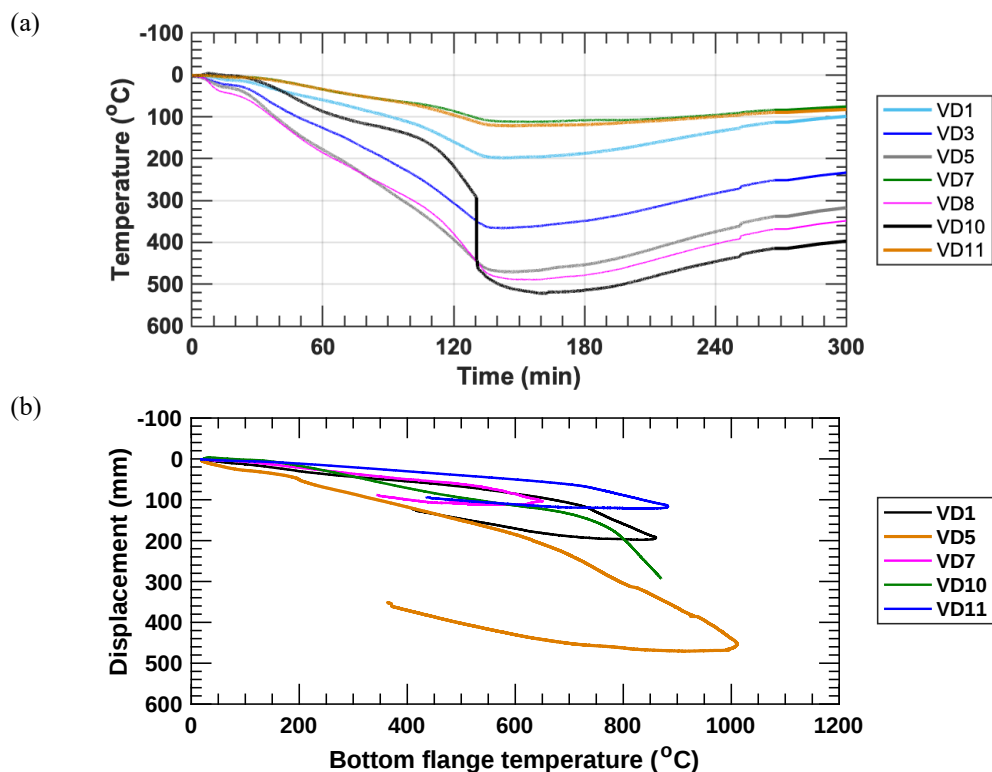
The mid-panel vertical displacement (VD5) increased at an approximate rate of  $0.4 \text{ mm}/^{\circ}\text{C}$  until the bottom flange temperature of the secondary beam reached  $700^{\circ}\text{C}$ . The increase in the VD5 value became approximately  $0.7 \text{ mm}/^{\circ}\text{C}$  afterward. The vertical displacement of the south (exterior) edge beam (VD10) increased more rapidly than other edge beams (VD1,

**Fig. 28. Measured vertical displacements as a function of (a) fire exposure time and (b) bottom flange temperatures of the floor beams.**

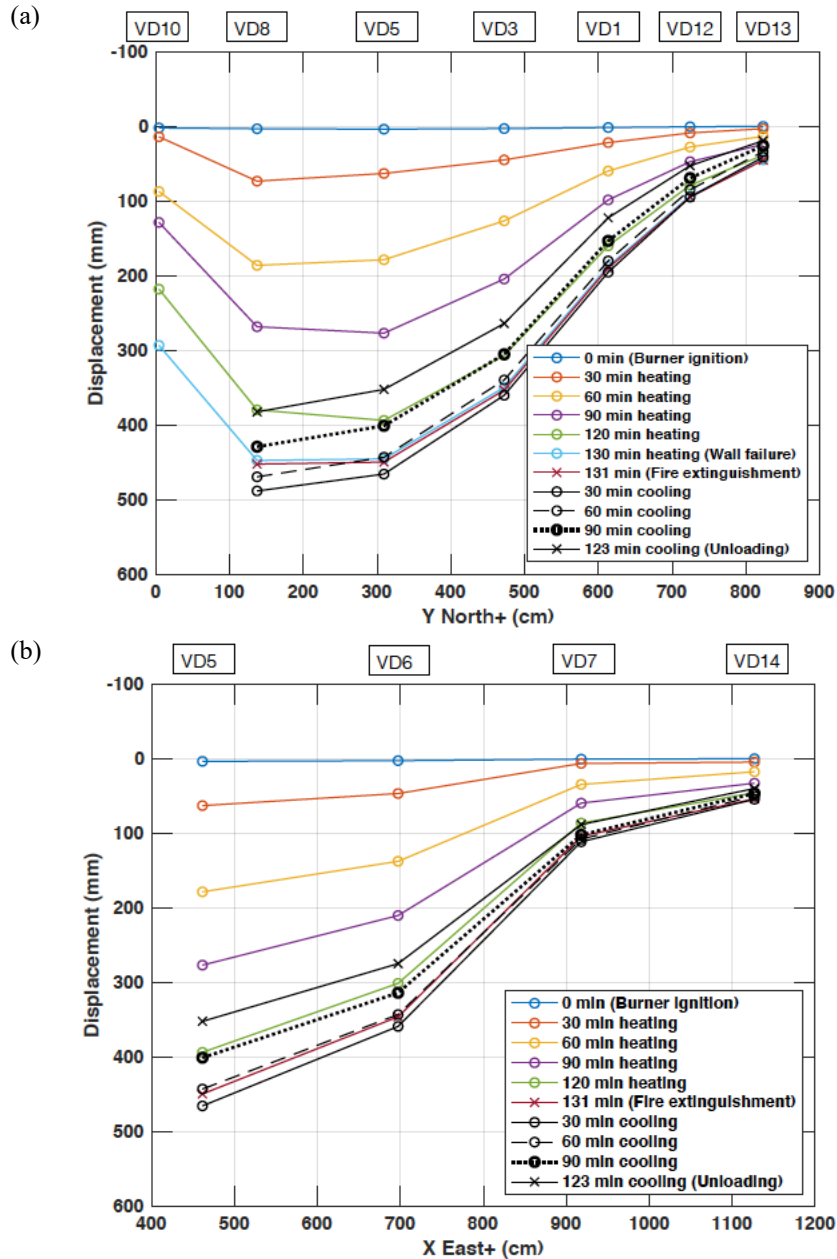
The temporal change in the vertical displacement measured along the centerlines of the test bay is illustrated in Fig. 30. The south half of the floor specimen deflected more than its north half since the No. 3 deformed bars placed perpendicular to the north edge beam provided some degree of rotational restraints, maintaining a good continuity with the steel reinforcement placed in the north surrounding bay which remained cool during fire loading.

**Fig. 30. Vertical displacement profile of the test floor assembly at (a) the north-south centerline and (b) the east-west centerline. The upper horizontal axes indicate the corresponding position of each vertical displacement sensors.**

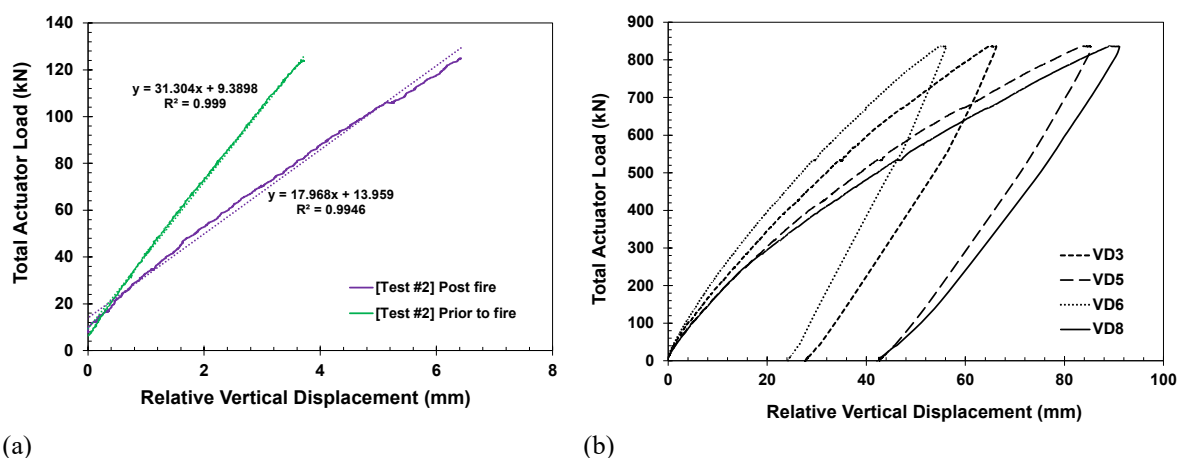
The total actuator load versus vertical displacement relationship is plotted in Fig. 34b. At a maximum load of 836 kN, the mid-span vertical displacement of the secondary beam (VD5) was about 85 mm, and the vertical displacement of the south middle slab (VD8) was about 91 mm, relative to the permanent displacement measured after cooldown from fire loading. The maximum gravity load was approximately 17.8 kPa (370 psf), which was estimated including self-weight of the test floor assembly prior to fire exposure and that of loading frames.

It is noteworthy that the test floor assembly still retained very large flexural strength (after cooldown) at least two times greater than the ASCE 7 load demand (9 kPa) for normal conditions determined from the load combination of 1.2 times dead load plus 1.6 times live load. A collapse mechanism was not developed even though the total floor load reached almost 90 % of the ambient-temperature moment capacity (21 kPa) of the as-designed secondary composite beam calculated in accordance with the AISC 360 specification [15] but with measured mechanical properties of steel and concrete at ambient temperature (Refer to Table 2 and Table 8, respectively).

Several factors might have influenced this high post-fire capacity of the test floor, including but not limited to (1) the rotational restraint provided by the steel reinforcement in the hogging moment region of the floor slab, (2) the negligible damage in headed stud anchors which developed the design composite action between the steel beams and concrete slabs under flexural loading, and (3) the concrete surrounding the headed studs appeared to be less affected by thermal degradation as temperatures were measured lower than 200 °C in those locations.

Fig. 34. (a) Initial bending stiffness and (b) load-displacement relationship during the post-fire loading test.

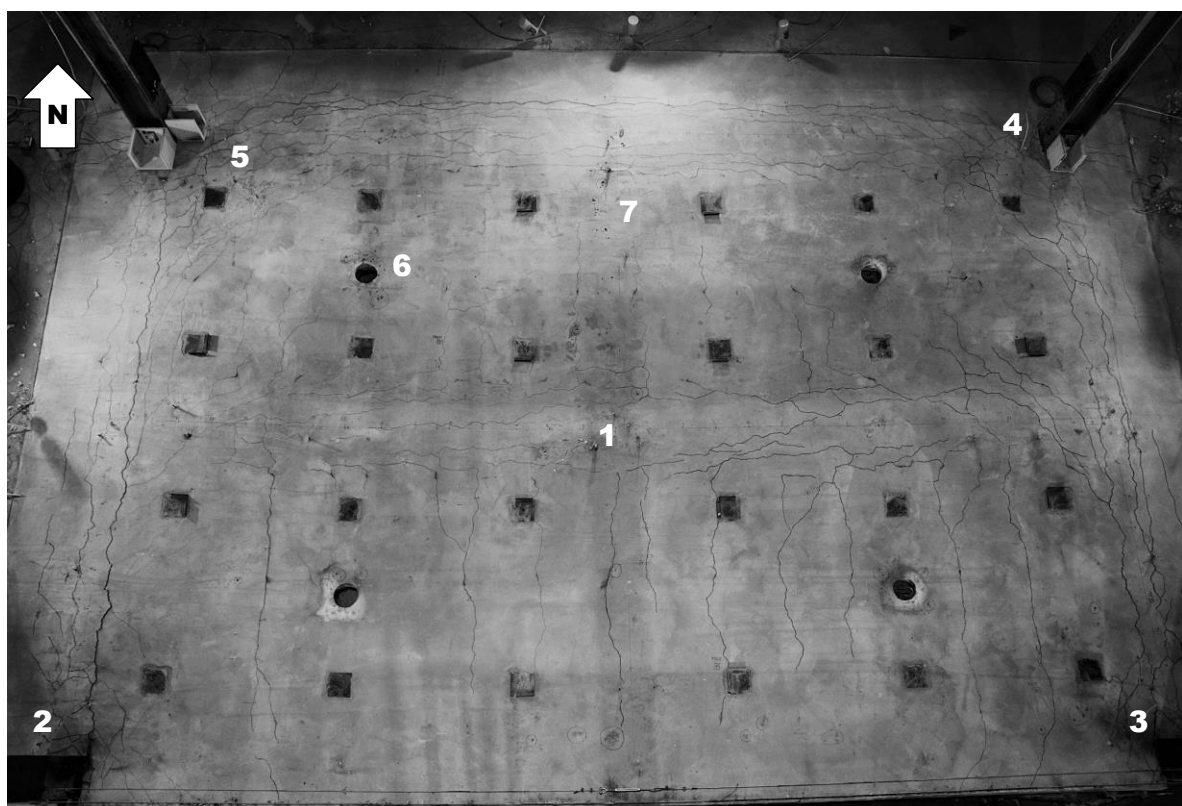
Top View

Fig. 35 shows a concrete crack pattern on top of the floor specimen. The concrete cracks were less than 5 mm wide and randomly distributed across the test bay. The south half of the floor specimen exhibited more transverse cracks that resulted from tensile forces induced in the longitudinal direction (location 1). Longitudinal cracks appeared around the north edge beam as well as around the secondary beam indicating flexural and tensile forces induced in the transverse direction, respectively. Wider cracks were visible along the centerlines of the east and west girders. These cracks were larger toward the south columns but became smaller around the north columns (locations 2 through 5). There were several spots indicating localized aggregate spalling across the test floor slab, e.g., the center of the north edge beam (location 6) and the slab penetration holes (location 7) used for loading tubes.

Some short cracks within the test-bay column grid appeared to be full-depth cracks with visible soot marks but fully closed during cooldown. Overall, the No.3 bars effectively controlled the development of large crack openings in the hogging moment region as well as within the mid-panel zone. Only one longitudinal bar next to the southwest column was found to be ruptured.

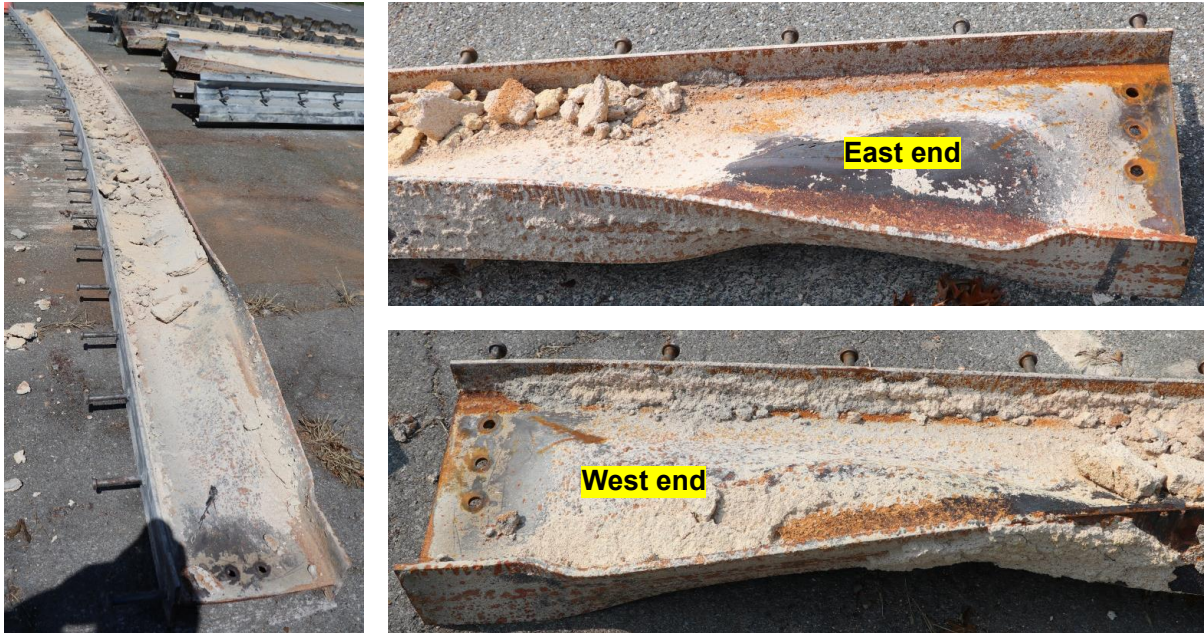
Post-test photographs of the support beams and girders are shown in Fig. 72 through Fig. 75. It is noteworthy that the west girder exhibited a local rupture of the bottom web toe at the north end because of web local buckling (Fig. 76).

**Fig. 73. Post-test photographs: South edge beam.**

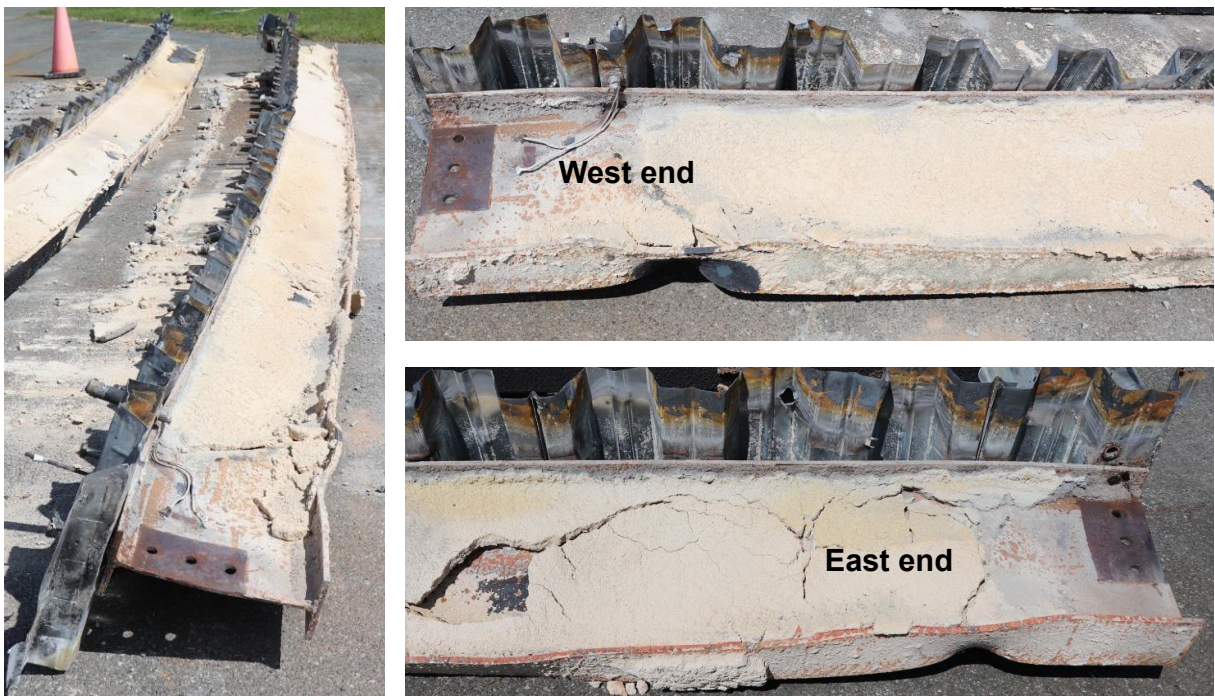
**Fig. 74. Post-test photographs: North edge beam.**

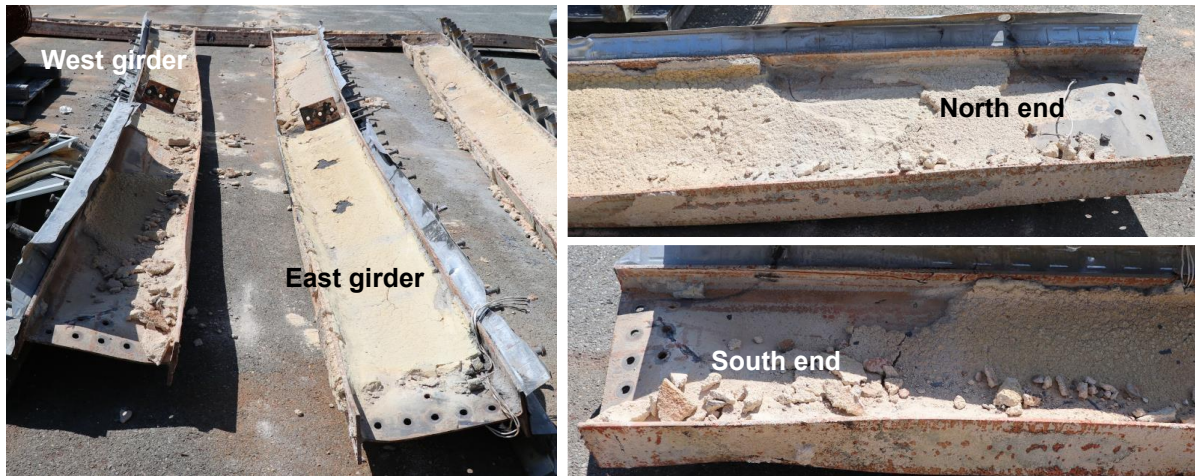
**Fig. 75. Post-test photographs: Test-bay girders (left) and north and south ends of the west girder (right).**

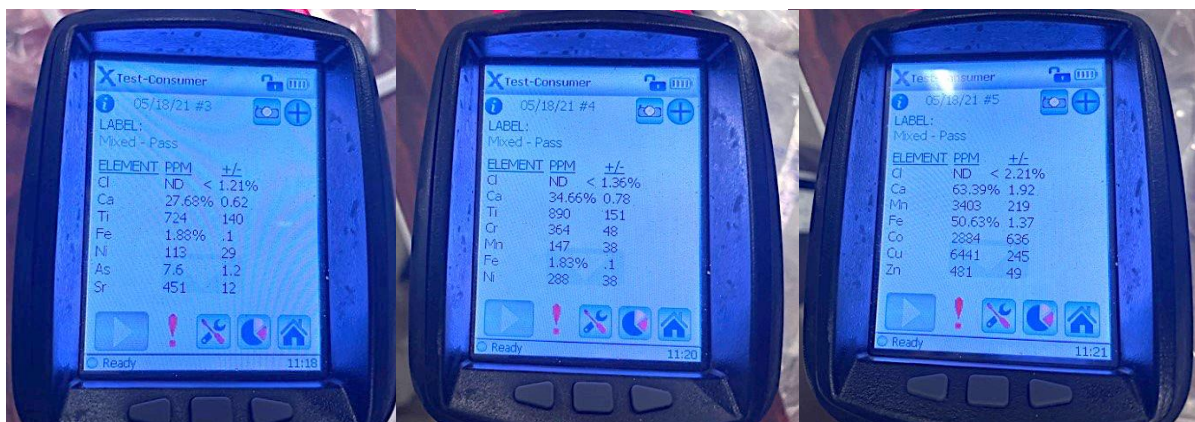
After the fire testing, there were two spots toward the ends of the secondary beam where the fire exposed SFRM turned black and charcoal color as shown in Fig. 77. Those locations were directly above the east and west burners. A handheld XRF (X-ray fluorescence) analyzer manufactured by Olympus [37] was utilized to measure chemical compositions of the samples collected from the secondary beam at two different locations (the west end and midspan) after cooling. A comparison of some scanned results is shown in Fig. 78, along with the unused SFRM powder. Although a further study is needed, this SFRM discoloration was likely caused by high-temperature oxidation or phase change of the steel heated beyond 1000 °C. Refer to TB5 and TB7 temperatures in Sect. A.6. The charcoal-colored sample contained about 51 % iron by mass, whereas the unused sample or other exposed sample contained about 2 %.

**Fig. 78. Chemical compositions of SFRM samples measured using a handheld XRF analyzer**
