# NATIONAL BUREAU OF STANDARDS REPORT

CONTROL OF LEAKAGE THROUGH JOINTS  
IN CAST-STONE MASONRY AT  
THE NATIONAL NAVAL MEDICAL CENTER

Progress Report No. 1  
by  
A. Hockman, E. J. McCamley and  
E. W. Krussell

To  
District Public Works Office  
Potomac River Naval Command  
Bureau of Yards & Docks  
Department of the Navy

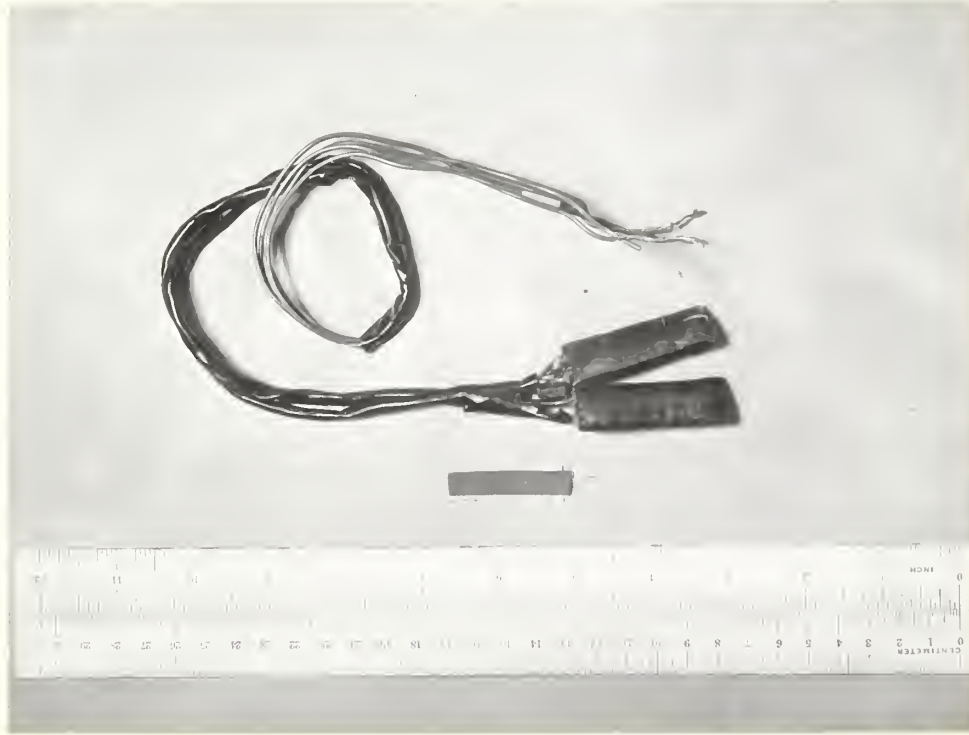
Fig. 3. Resistance strain gage used to measure thermal expansion of cast-stone. Left, gage with felt covering and exposed wires. Right, specimens with gages attached and waterproofed, ready for insertion into thermal chamber.

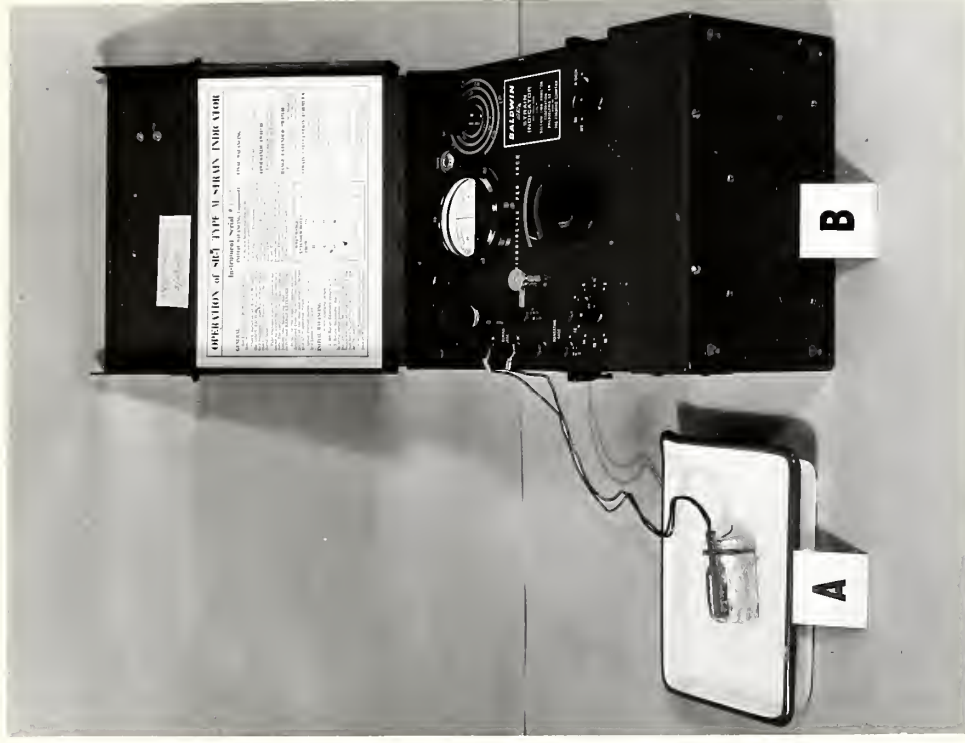
by a three junction thermocouple located close to the test specimen. A Baldwin strain indicator (figure 4-B) recorded the linear changes directly in microinches per inch.

Fig. 4. Moisture expansion test  
(A) Modified resistance strain gage cemented to cast-stone.  
(B) Strain indicator

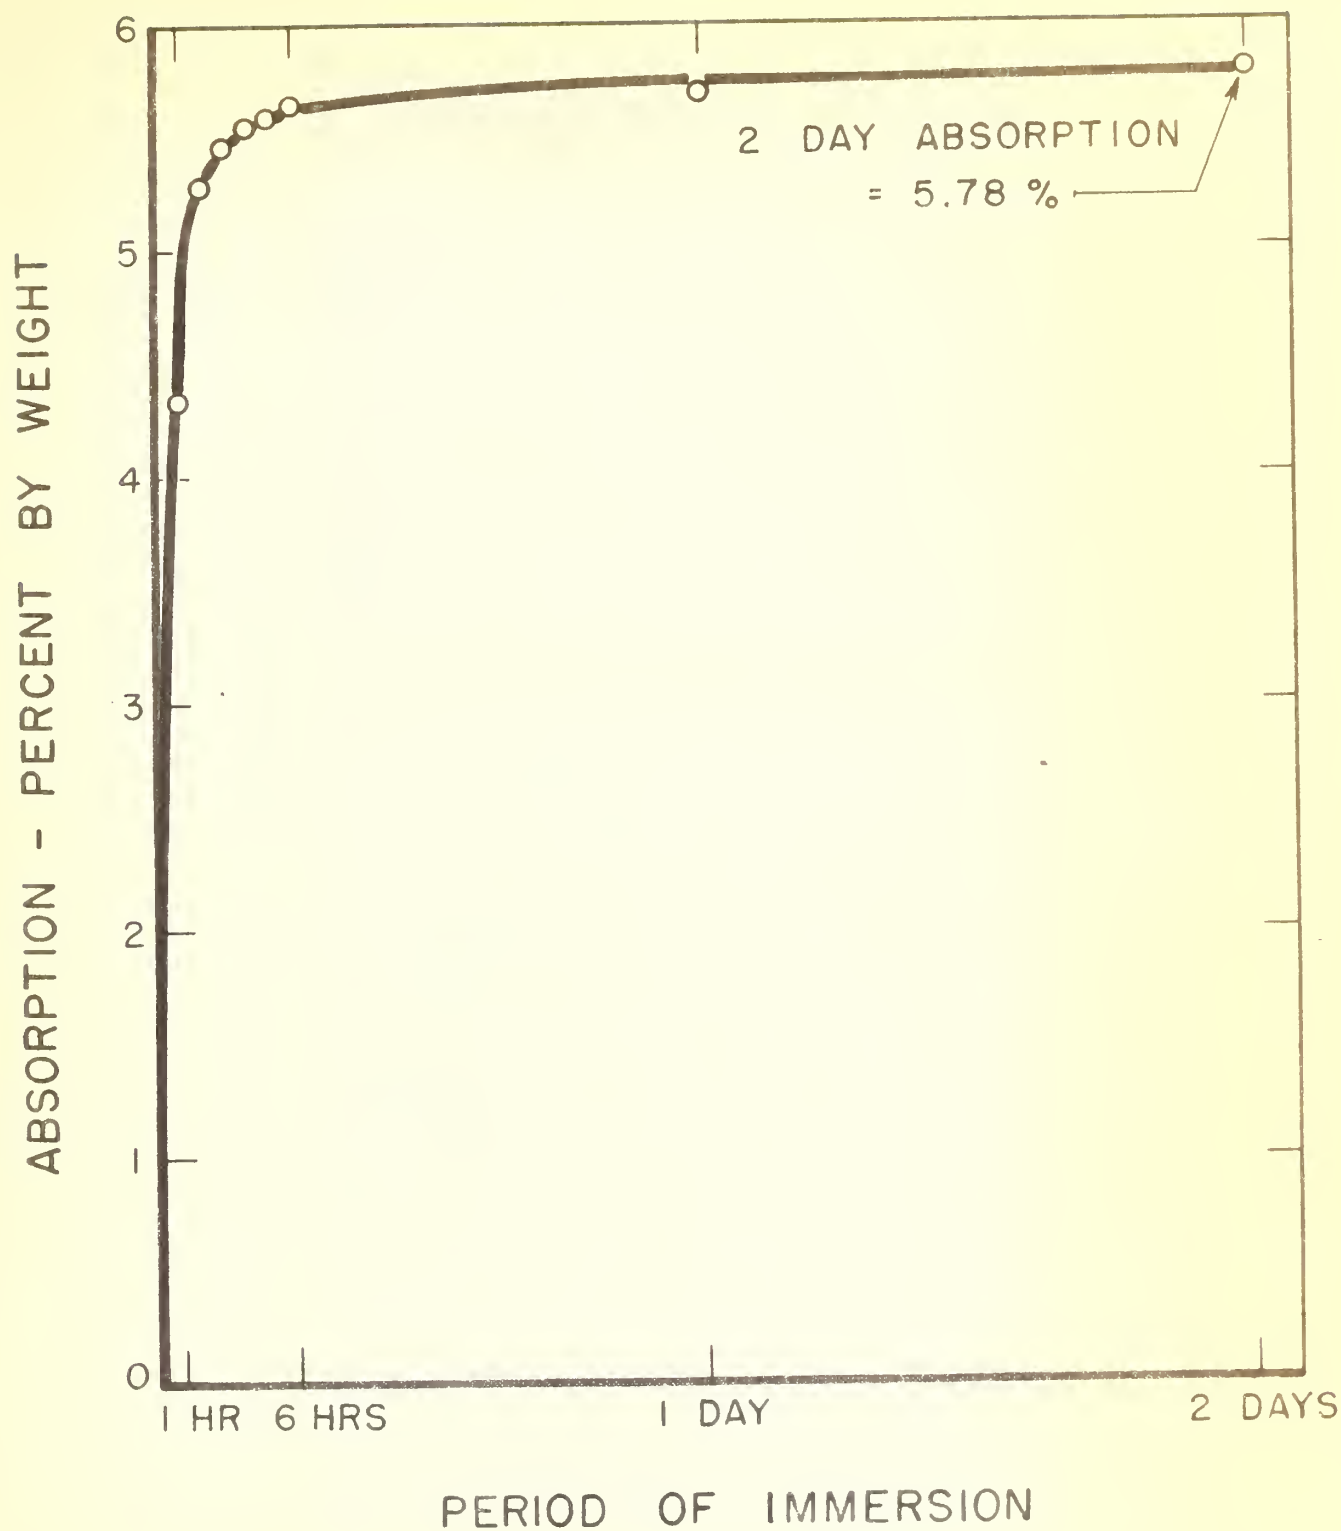
FIGURE NO. 7 WATER ABSORPTION CURVE OF SAMPLE OF CAST STONE USED AT THE NAVAL MEDICAL CENTER.

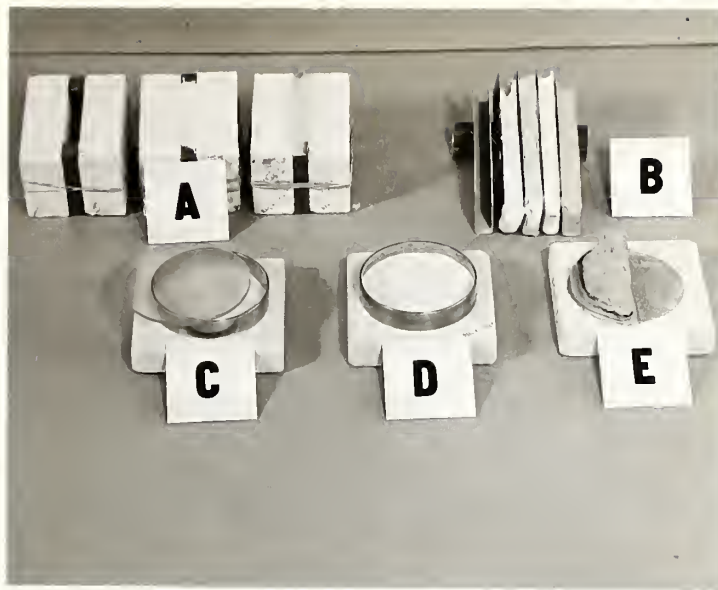
After the brass ring is removed from the shrinkage test specimen, half of the calking layer is loosened from the stone and is folded over the remaining part and creased six times along the same line (see figure 8-E). Embrittlement or lack of tenacity can be observed. This test is also being made at below freezing temperatures.

A metal trough 4 in. long, 1 in. deep and  $3/8$  in. wide is filled with the compound and suspended for 24 hours at room temperature, followed by a similar test at  $122^\circ\text{F}$  (figure 8-B). The material is observed for flow tendencies. Slump tests are also being made in cast-stone grooves.

Fig. 8. Calking test specimens  
 (A) Test specimens used for plasticity and bond studies at cold temperatures, (B) consistency test specimens, (C,D) shrinkage test specimens, (E) tenacity test specimen.

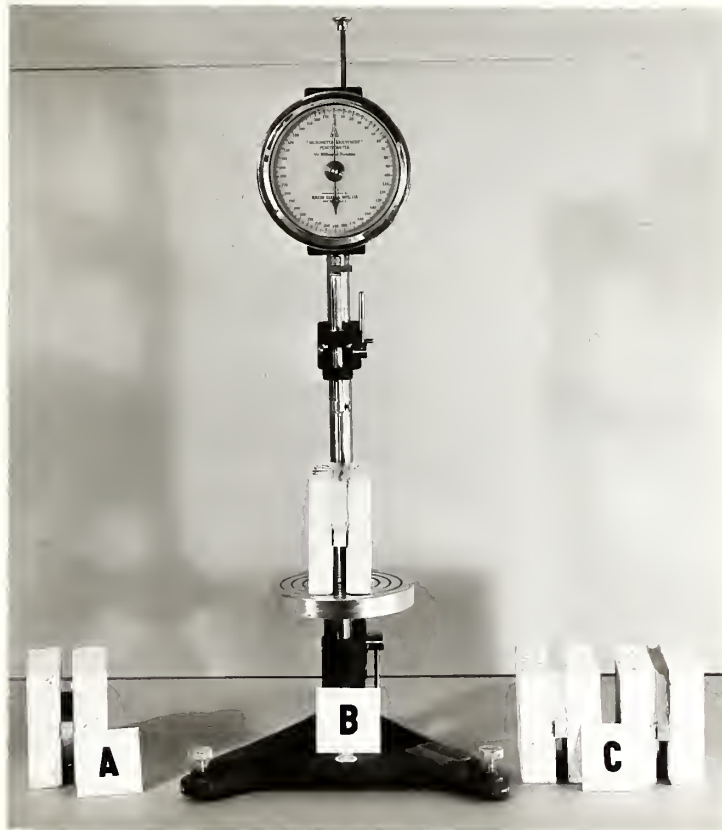
in which h is the rate of hardening, and  $P_1$  and  $P_2$  are the averages of the original and final penetrations, respectively. (See figure 9).

Fig. 9. Rate of hardening test of calking materials  
 (A) Cast-stone specimen before filling joint, (B) calking ready for test with penetrometer, (C) calking in cast-stone joints ready for exposure test.

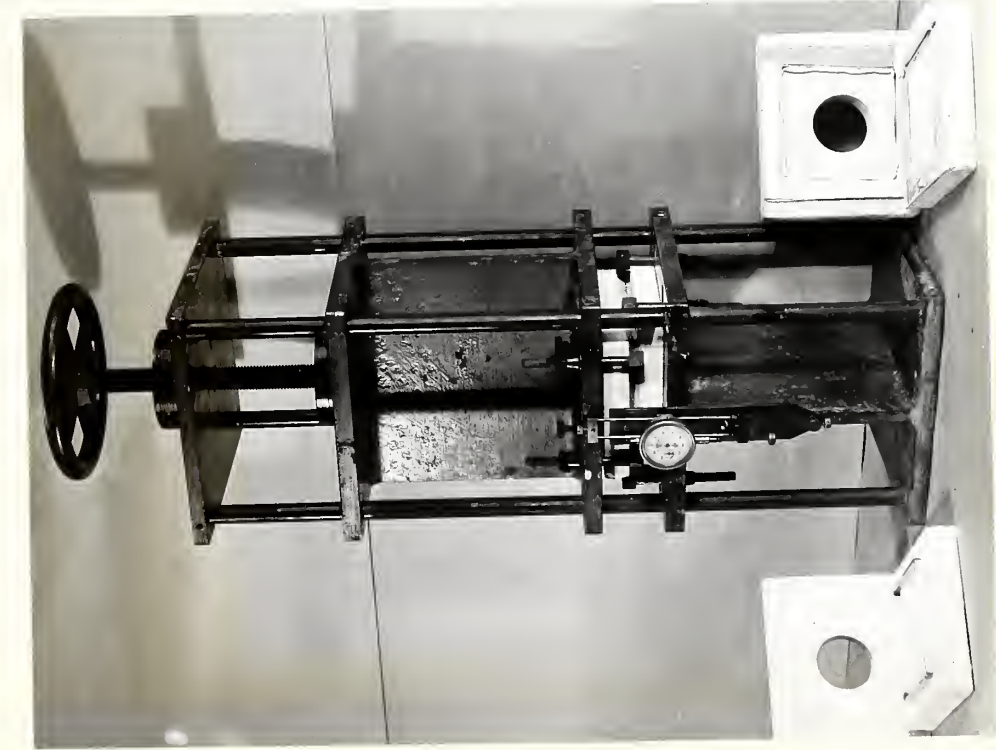
The apparatus used to make this test is described in Federal Specification SS-R-406c, No. 223.11, for testing asphalt joint sealers. Two cast-stone blocks, forming a joint 2 x 2 x 3/8 in. is filled with calking and allowed to cure for 30 days at room temperature. After the test specimen is placed in a cold box for at least 4 hours, it is clamped into place in the stretching machine, and the blocks drawn apart at the rate of 1/8 in. per hour until the joint is extended 1/10 in. (figure 11). During the test the temperature is maintained at 0°F. Observations are made of the bond and plasticity properties.

Fig. 11. Bond and plasticity test at 0° F. Calking test specimen is shown in place between two clamps ready for test.

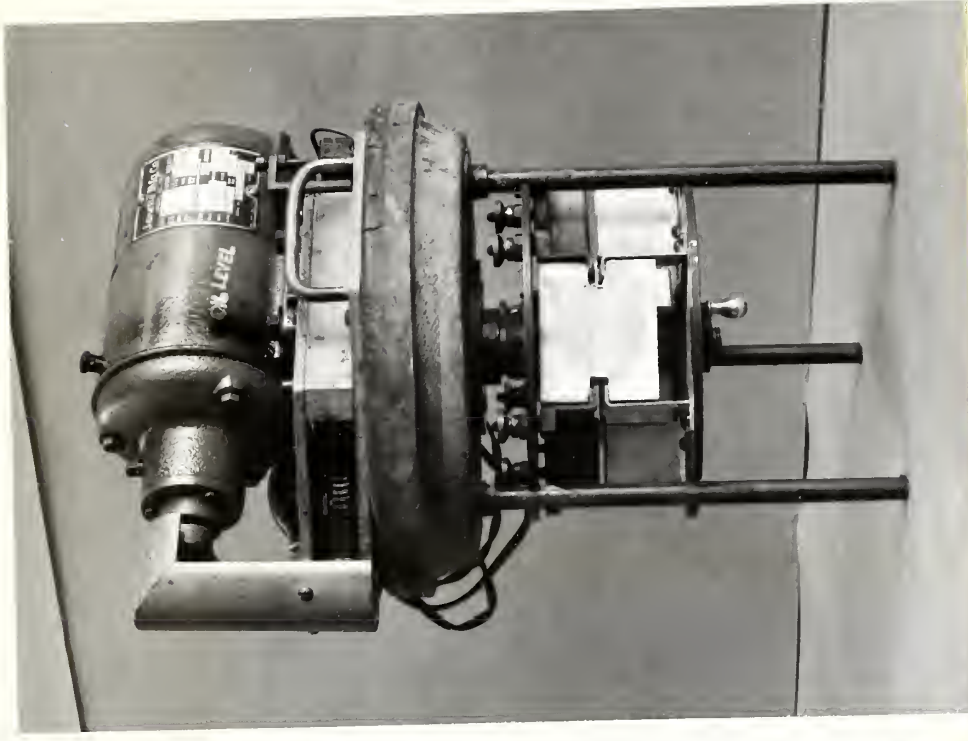
The joint tested is made between two slabs of cast-stone, 6 by 7 by 1 in., one of which has a 2 1/2 in. round hole. Calking is placed between slabs which are held apart by a 1/4 in. brass spacer, making a joint 1/4 in. thick and 3/4 in. deep on all four sides of the stone. (Figure 10). After 30 days of curing at room temperature, the slabs are drawn apart by a special apparatus (figure 10), the amount of separation being measured by a 0.001 in. micrometer dial gage. At the start of the test, water is poured into the hole of the top block and the joint is watched for leakage as the blocks are drawn apart. Figure 10, right, shows a compound after test in which premature failure was caused by lack of bond.

Fig. 10. Bond and plasticity test at room temperature. Left, cast-stone blocks before calking is applied. Center, calking under test. Right, example of failure of calking due to lack of bond.

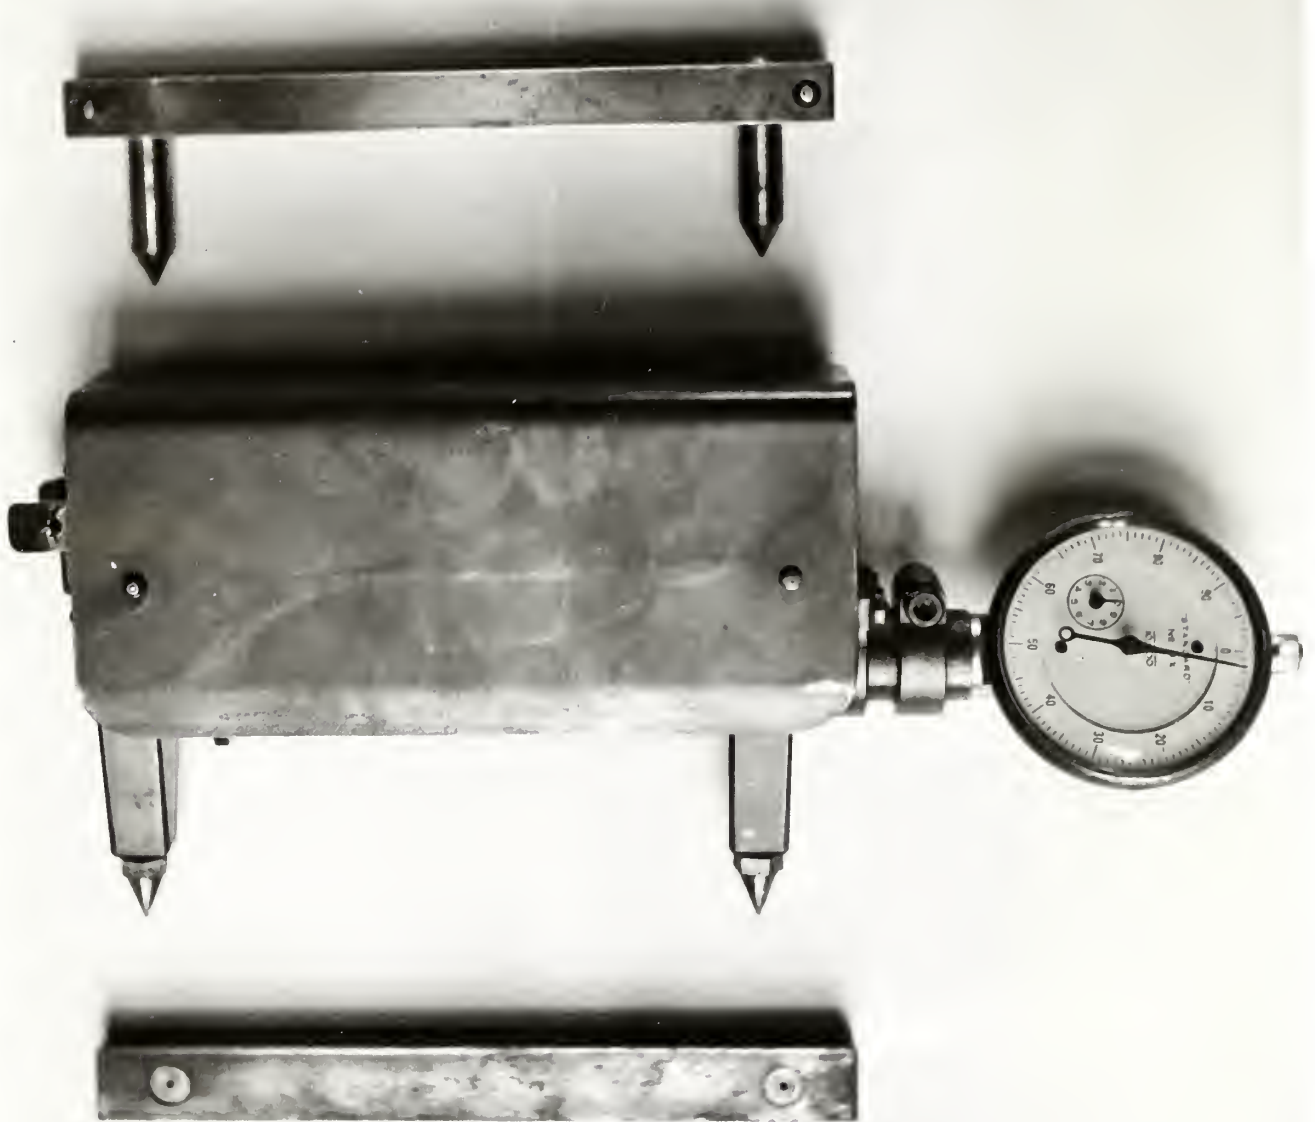
case) with a 0.0001 in. micrometer dial gage. The frame of the improved gage consists of two coaxial tubes (the innertube made of invar), connected near the ends by fulcrum plates of thin spring steel which constrain the tubes to move axially. A point is rigidly attached to one end of each tube. When the points are seated in small holes in the material to be measured the position of one tube with respect to the other is indicated on the micrometer dial clamped in the inner tube. Figure 12 shows the gage, standard bar and double pointed punch for spotting holes.

Fig. 12. Whittemore strain gage and accessories  
Top, double pointed punch to spot holes on 5-in. span.  
Center, measuring instrument with dial.  
Bottom, standard bar for correction of reading.

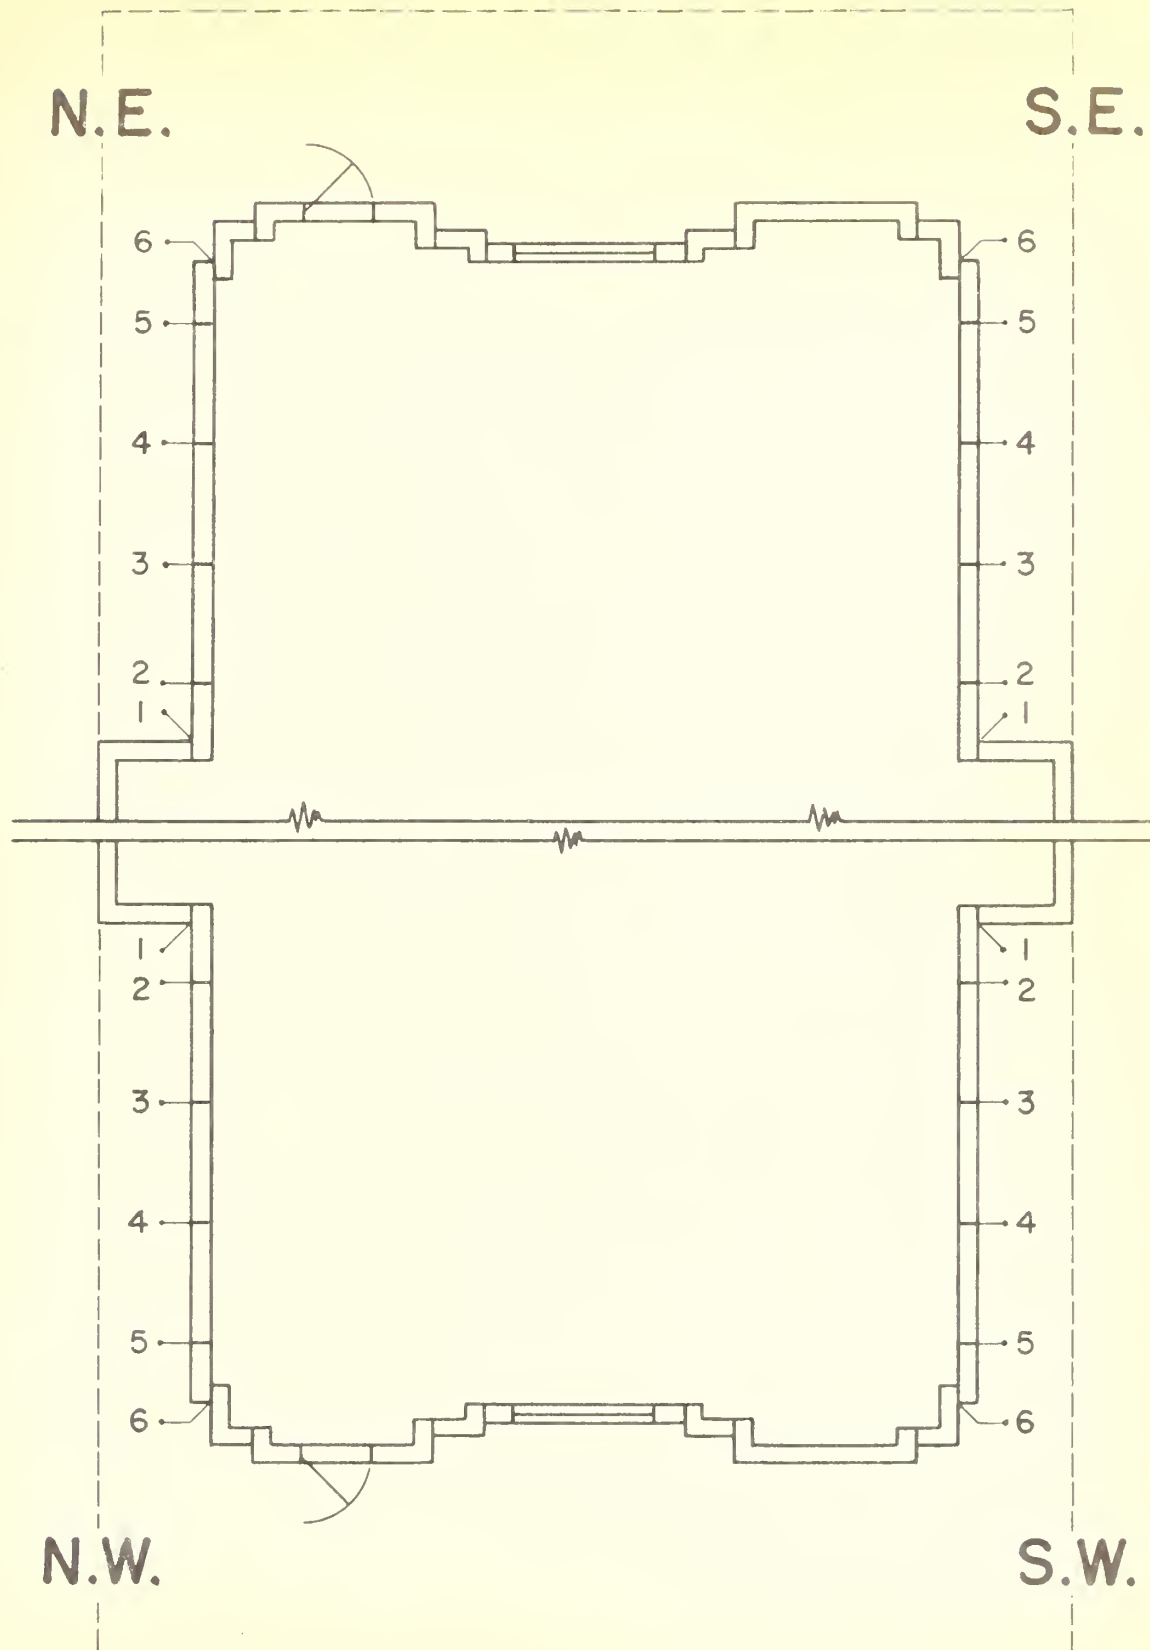
Figures 13 and 14 give the exact locations of the gage stations installed in the cast-stone panels on the northeast, northwest, se and sw elevations. At the start of the investigation, six stations were installed at each elevation in such manner that each station straddled a vertical joint at the 4 1/2 ft. level. Stations Nos. 1 and 6 were installed for measurement of panel movements in corners. After many unsuccessful attempts were made to obtain dependable and accurate measurements of the corner joint movements, it was decided to abandon the corner stations and restrict the measurements to stations 2, 3, 4, and 5, on all four sides of the building.

FIGURE NO. 13 PLAN VIEW SHOWING LOCATION OF ALL GAGE STATIONS USED IN MEASUREMENT OF JOINT MOVEMENTS. (19<sup>TH</sup> FLOOR LEVEL, BUILDING NO. 1, NAVAL MEDICAL CENTER.)

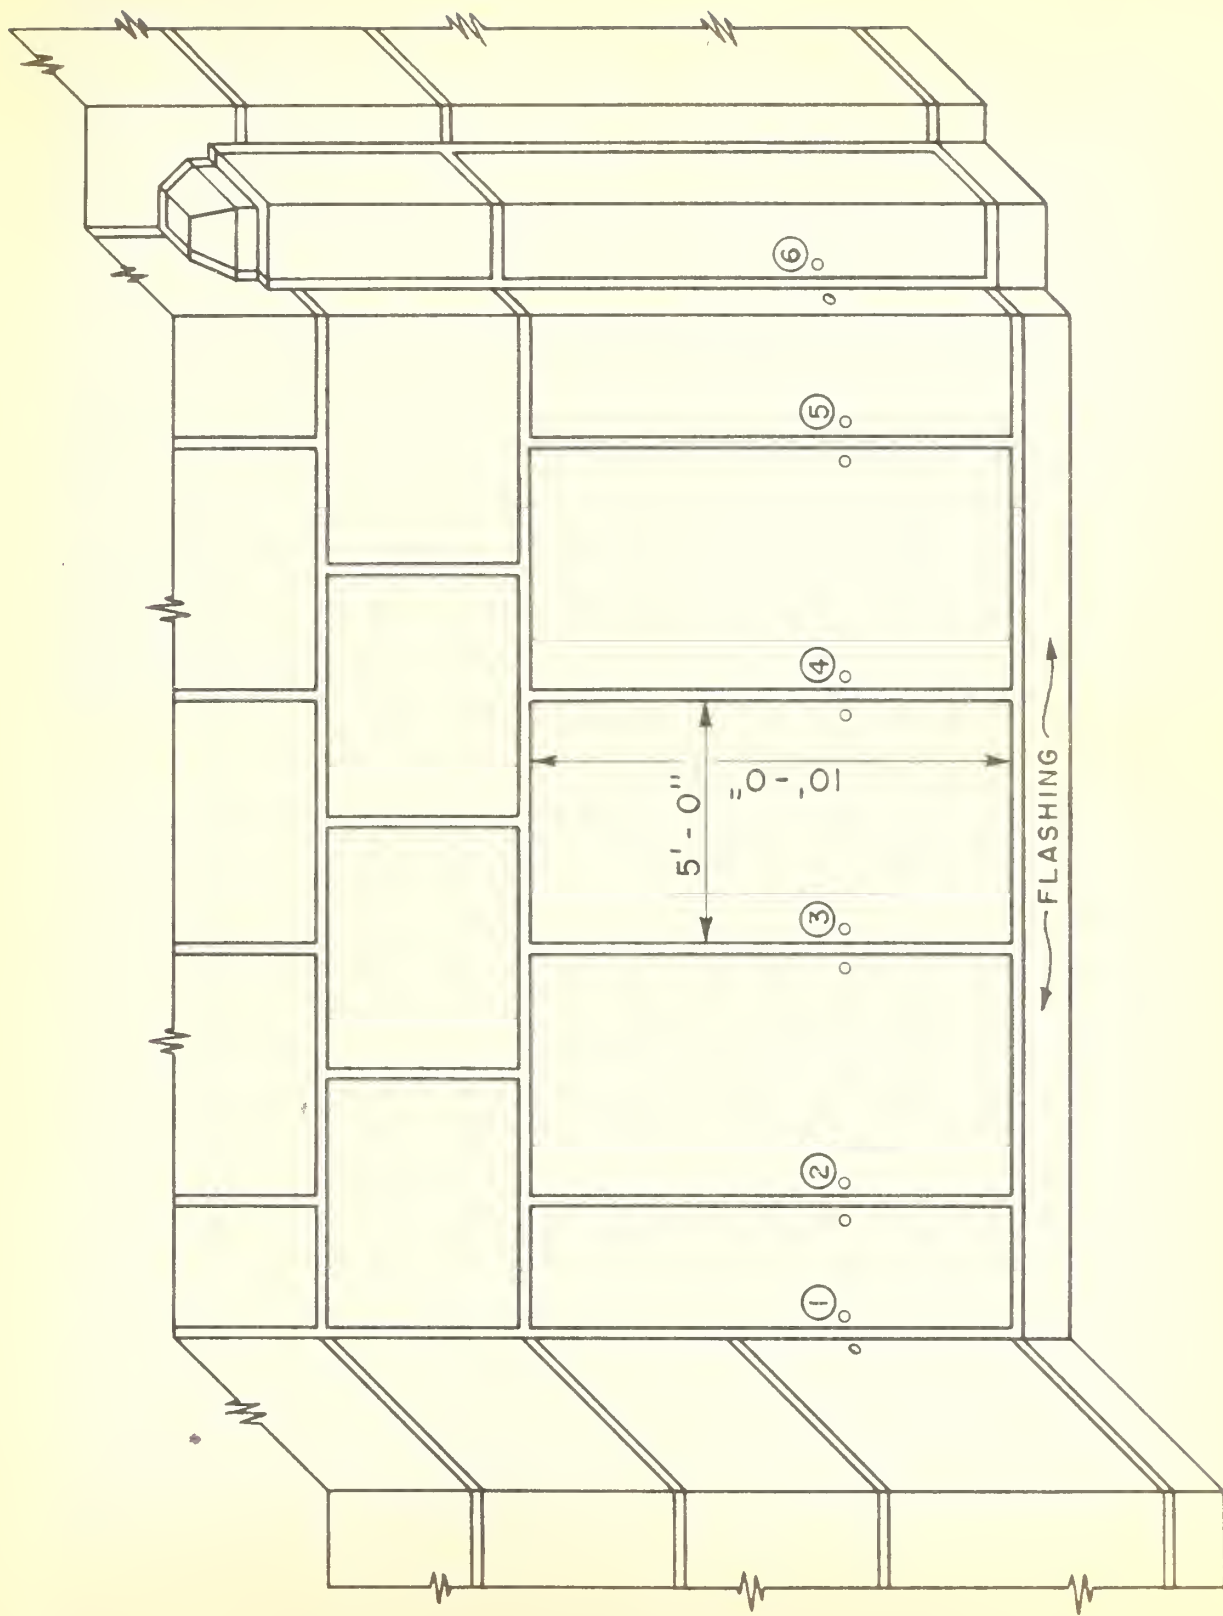
FIGURE NO. 14 TYPICAL WALL ELEVATION SHOWING LOCATION OF ONE SET OF GAGE STATIONS USED IN MEASUREMENT OF JOINT MOVEMENTS. (19<sup>TH</sup> FLOOR LEVEL, BUILDING NO. 1, NAVAL MEDICAL CENTER.)

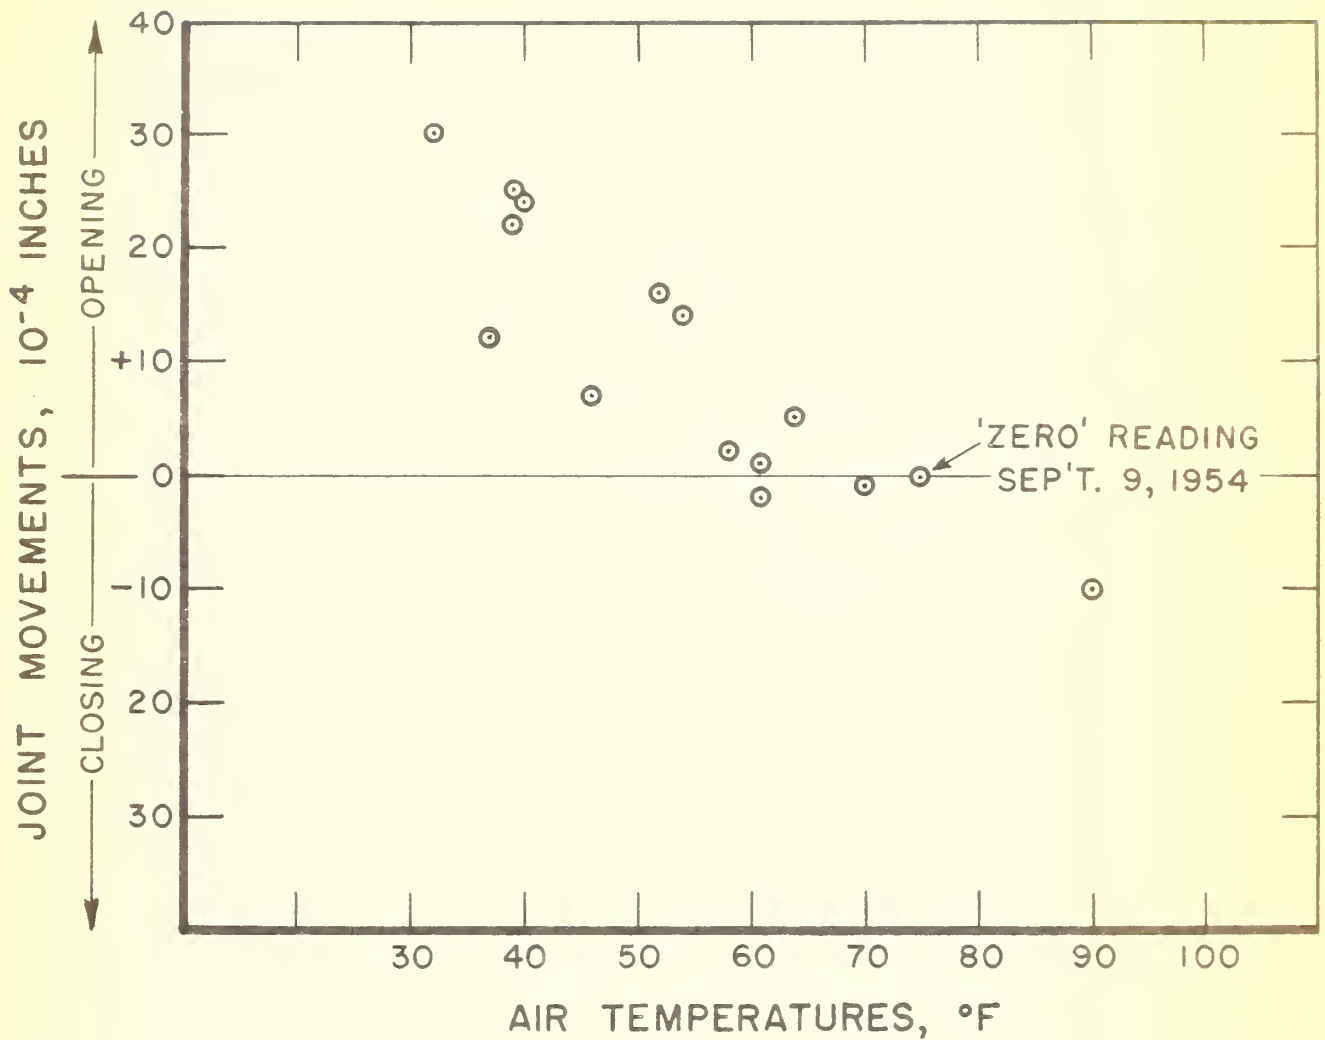
Figure 16 and table 3 give the complete record of joint movements as measured at all 16 gage stations on 15 separate occasions from September 9 to April 27, 1955. In general, the joint movements were directly related to the changes in temperature. A rise in temperature caused the cast-stone panels to expand which resulted in a closing or contraction of the joints. This is illustrated by the September 29 readings, when the temperature rose to 90°F and the joints contracted in most instances (cast-stone panels expanded). Similarly, a drop in temperature to 39°F on December 4, 1954, caused most of the joints to open or expand (cast-stone panels contracted). Figure 17 shows the correlation between the joint movements and the air temperature recorded at the time of gage readings.

FIGURE NO. 17 RELATIONSHIP BETWEEN JOINT MOVEMENTS AND AIR TEMPERATURES RECORDED AT THE TIME GAGE READINGS WERE TAKEN. EACH POINT REPRESENTS THE AVERAGE DATA OBTAINED ON EACH OF THE 15 DAYS THAT MEASUREMENTS WERE MADE FROM SEP'T. '54 THROUGH APRIL '55. (19<sup>TH</sup> FLOOR LEVEL, BUILDING NO. 1, NAVAL MEDICAL CENTER.)

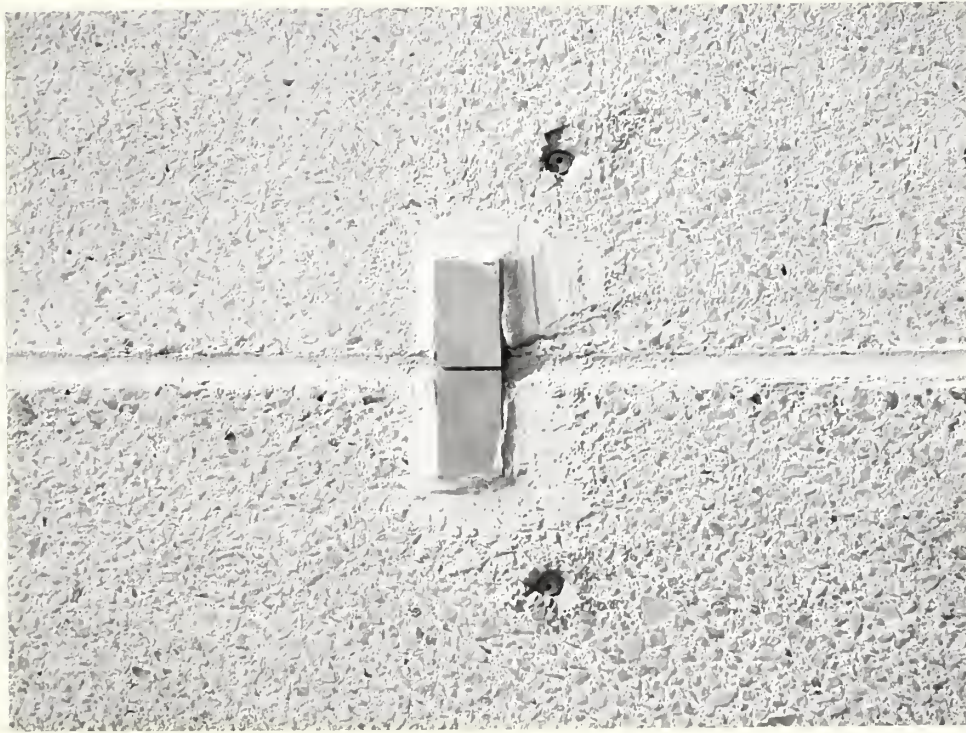
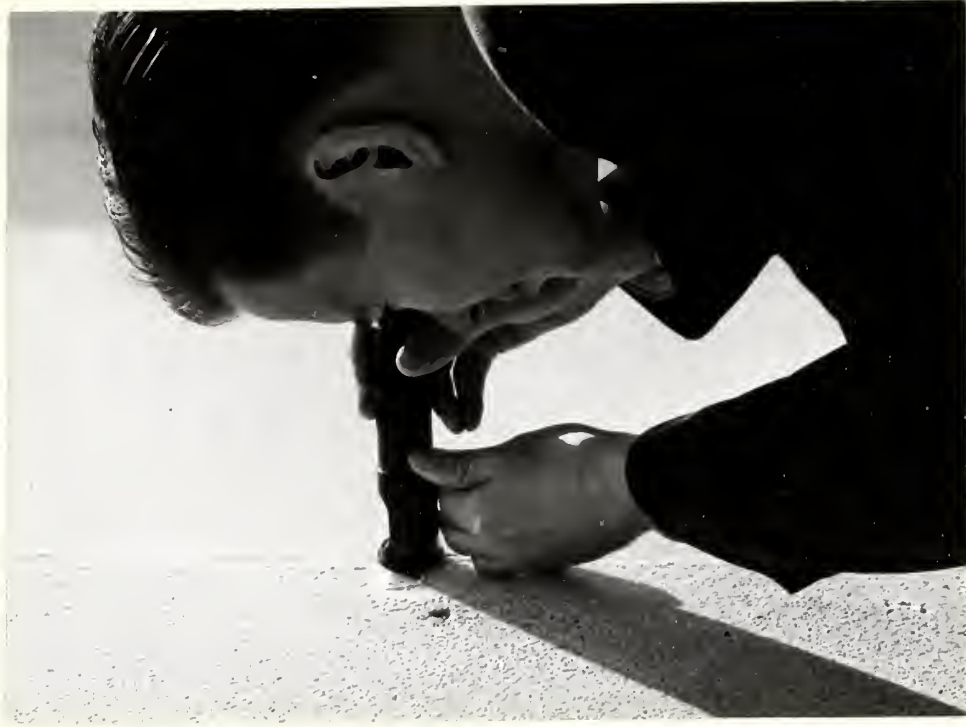
1. The method of measuring the joint movements will be changed with the hope of obtaining more accurate data. The Brinell microscope, reading directly in hundredths of millimeters will replace the Whittemore strain gage. Figure 19 illustrates the microscope and the type of gage station that will be installed for its use. Joint movements will be measured at more frequent intervals and especially after long periods of extreme hot and cold weather.

Fig. 19. (A) Type of gage station, (rectangular stainless steel strips), being used at the present time for measurement of joint movements.  
(B) Operator measuring the distance between steel strips with a Brinell microscope.
