NIST Special Publication 1164

Preliminary Reconnaissance of the May 20, 2013, Newcastle-Moore Tornado in Oklahoma

December 2013

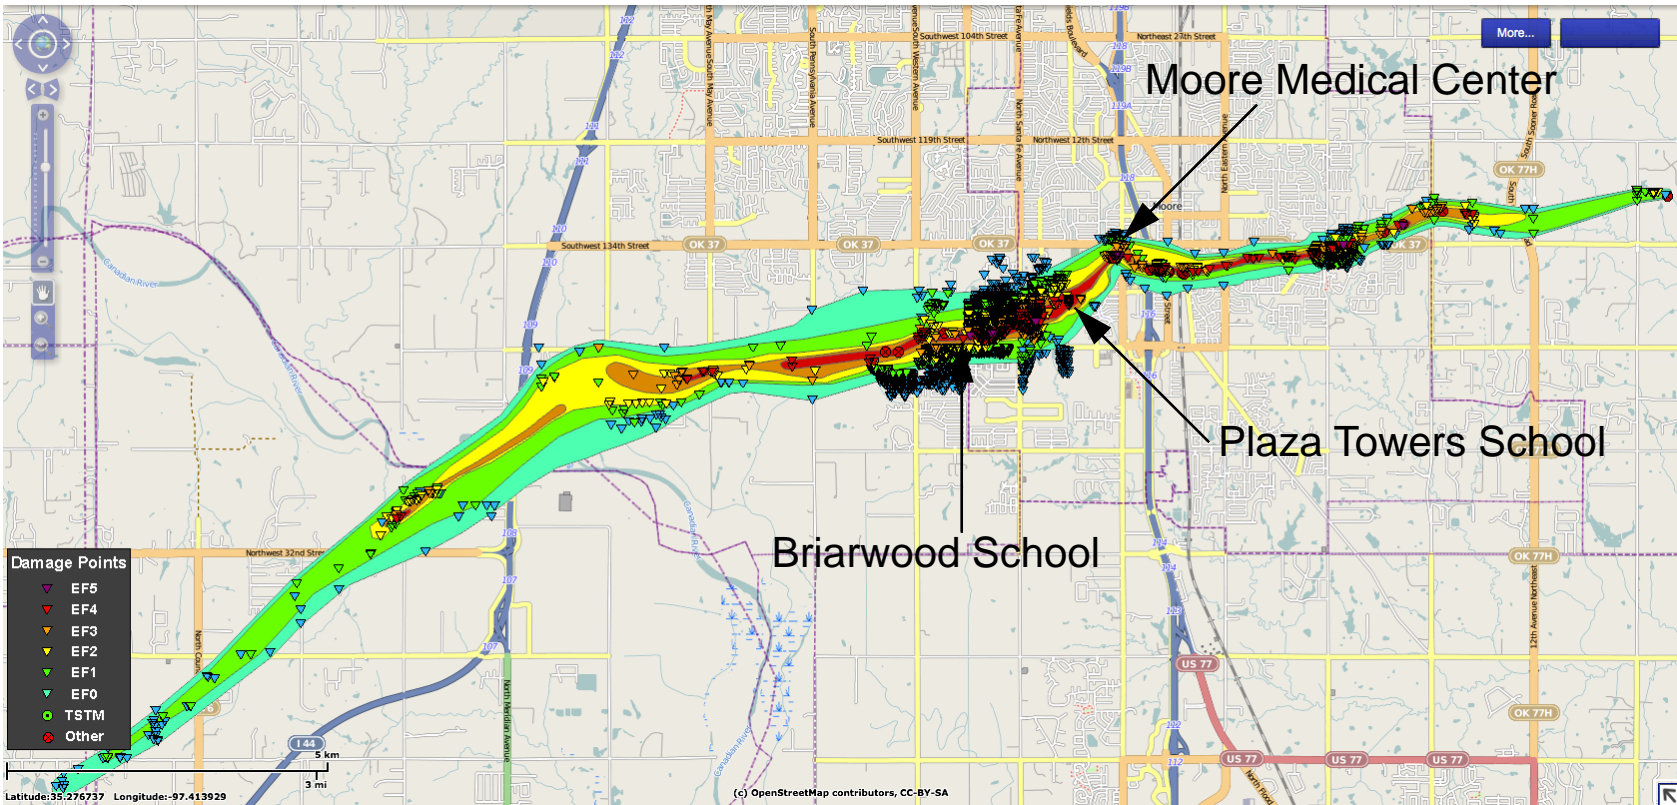
Figure 2-4. Tornado damage path map showing point estimates of EF damage at specific locations (triangles) and swaths for EF-0 (turquoise), EF-1 (green), EF-2 (yellow), EF-3 (brown), EF-4 (red) and EF-5 (purple) intensity damage (data source NOAA/NWS). The locations where damage was evaluated represents only a small percentage of the number of buildings damaged or destroyed by the tornado.

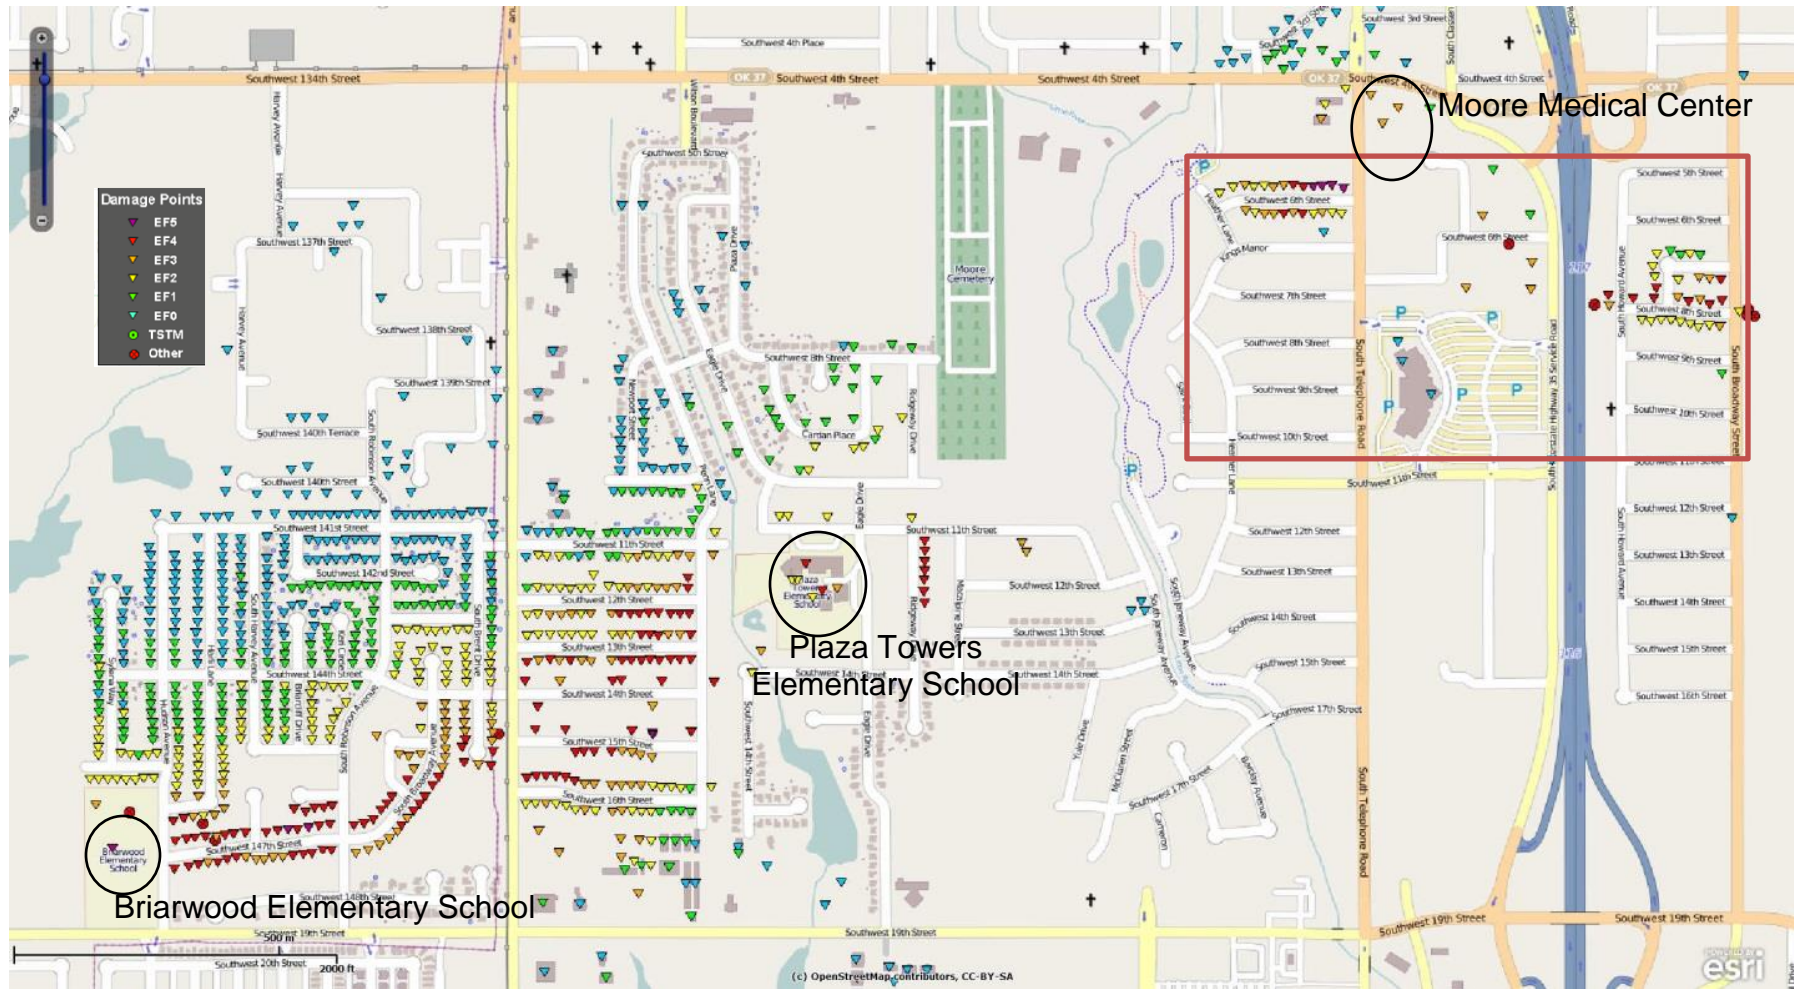
Figure 2-7. EF-rated damage by NWS west of Interstate 35 in the vicinity of Briarwood and Plaza Tower Elementary Schools and the Moore Medical Center. The triangles indicate locations where damage was assessed and the triangle color indicates the EF number assigned to each assessment. The red rectangle shows the approximate field of view of the aerial photo in Figure 2-6.

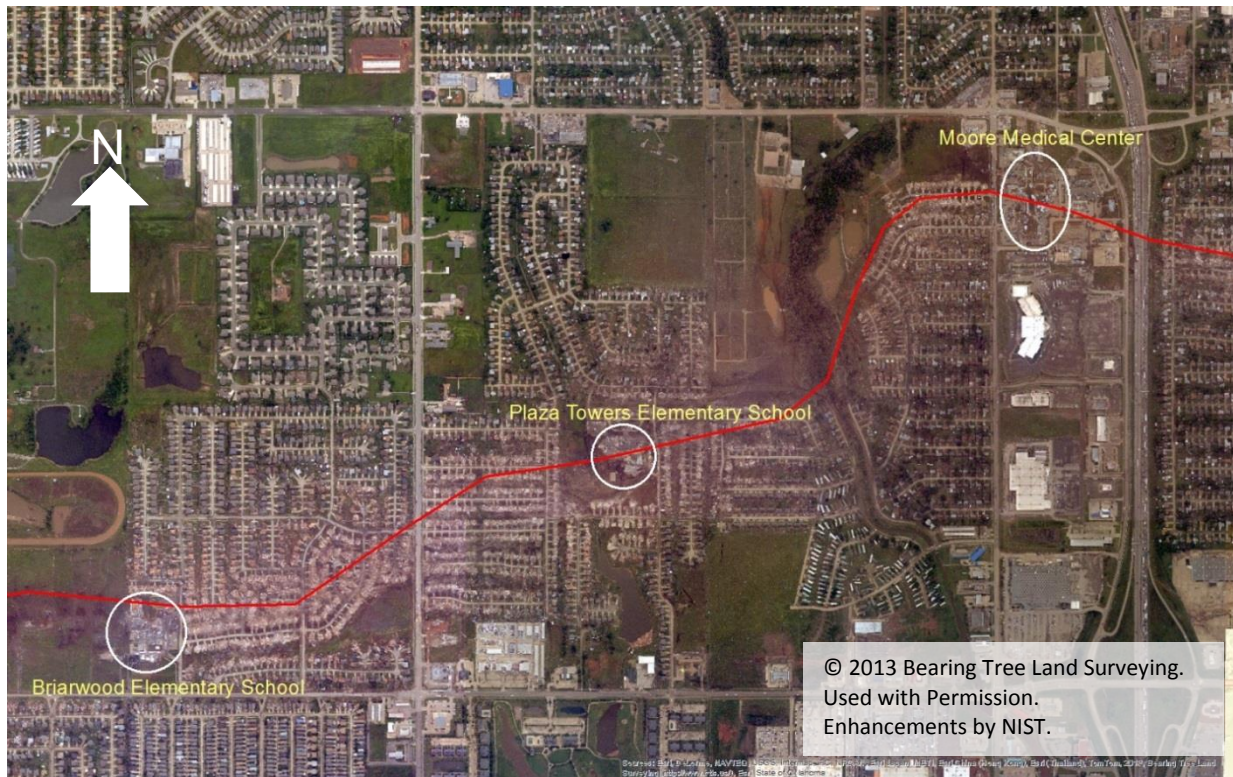
Three facilities were surveyed by the NIST Preliminary Reconnaissance team, two elementary schools (Briarwood and Plaza Towers) and the Moore Medical Center. Figure 4-1 shows an aerial photograph of these facilities and surroundings shortly after the tornado. All three were in close proximity to the estimated center of the tornado damage path (shown by the red line) in Figure 4-1. Briarwood Elementary was located in Oklahoma City, while Plaza Towers Elementary and Moore Medical Center were located in Moore, Oklahoma. Both elementary schools are part of the Moore Public School District. All three facilities were comprised of several individual low-rise buildings. The buildings at the two elementary schools were one-story in height, while the Moore Medical Center was a combination of adjoining one- and two-story structures.

Figure 4-1. Aerial overview, after the tornado, showing NIST-surveyed facilities relative to the estimated center of the tornado damage path (red line).

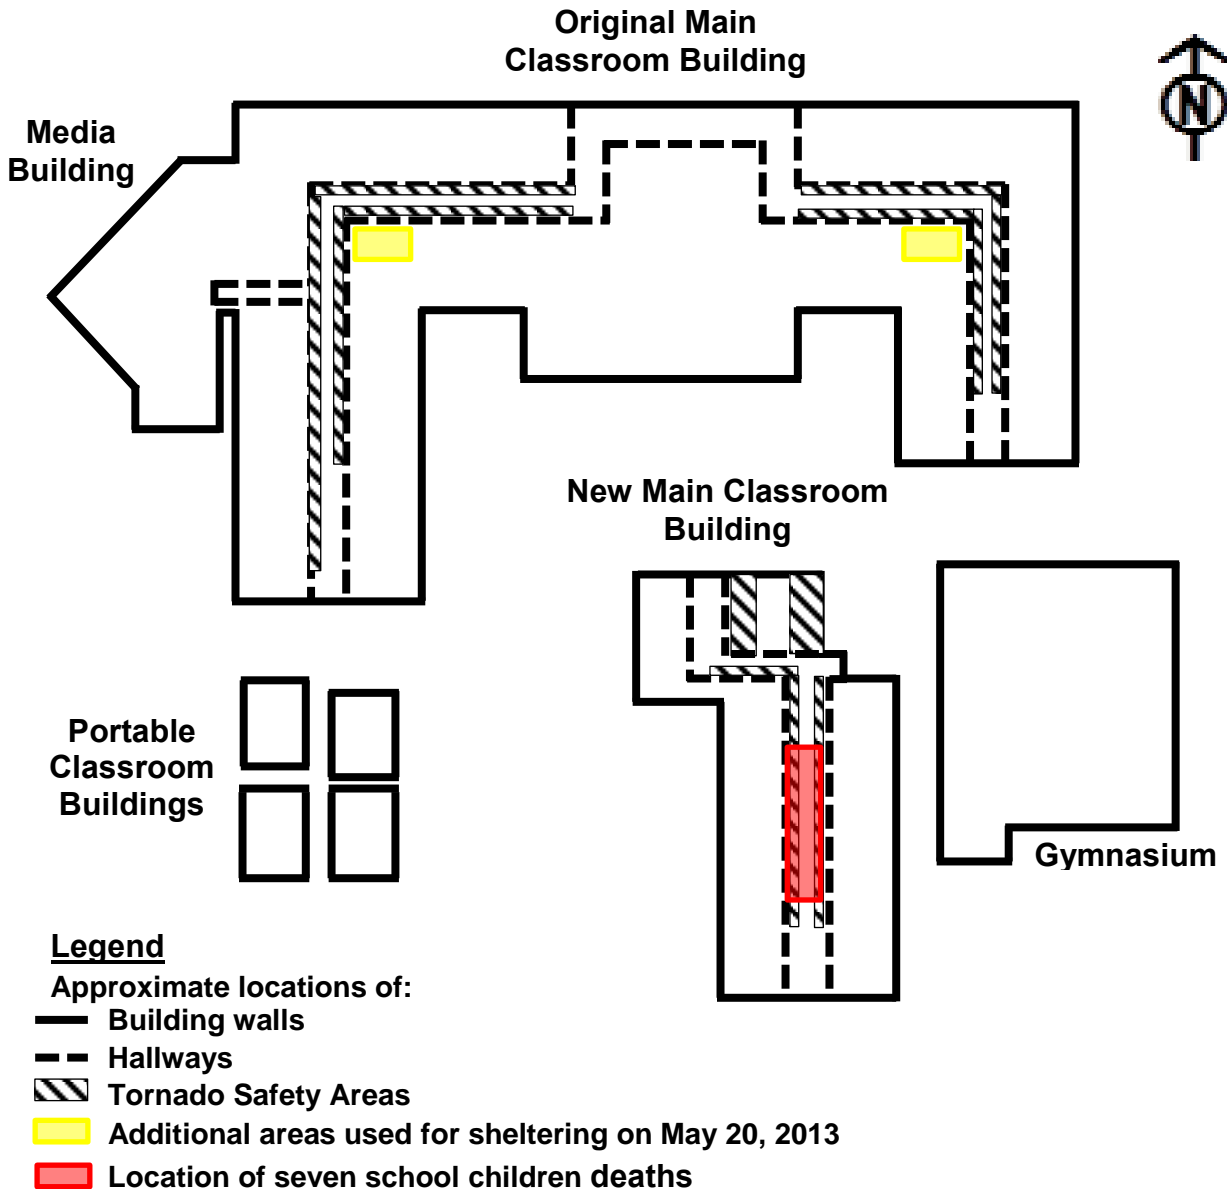
Figure 4-3. Designated areas of safety for tornadoes for the Plaza Towers Elementary School. The yellow shaded areas indicate the locations of bathrooms also used for shelter on May 20, 2013. The area shaded in red indicates where seven school children died.

- This area was a “designated area of safety” according to the school’s tornado emergency procedures (location shown on Figure 4-3). Five of the seven children died after the west masonry hallway wall collapsed on them. The east hallway wall also collapsed into the hall, but in such a manner as to leave an area of void space. Two fatalities occurred along the eastern wall, and seven or eight students and one teacher were rescued from under the rubble in that area as well.³⁸ According to the school principal,³⁹ injuries suffered in this building included a head injury to a staff person, a sternum fracture to a teacher, and a puncture wound in the back to a student; and at least one of the three injured was reported to be located in the “designated area of safety”.

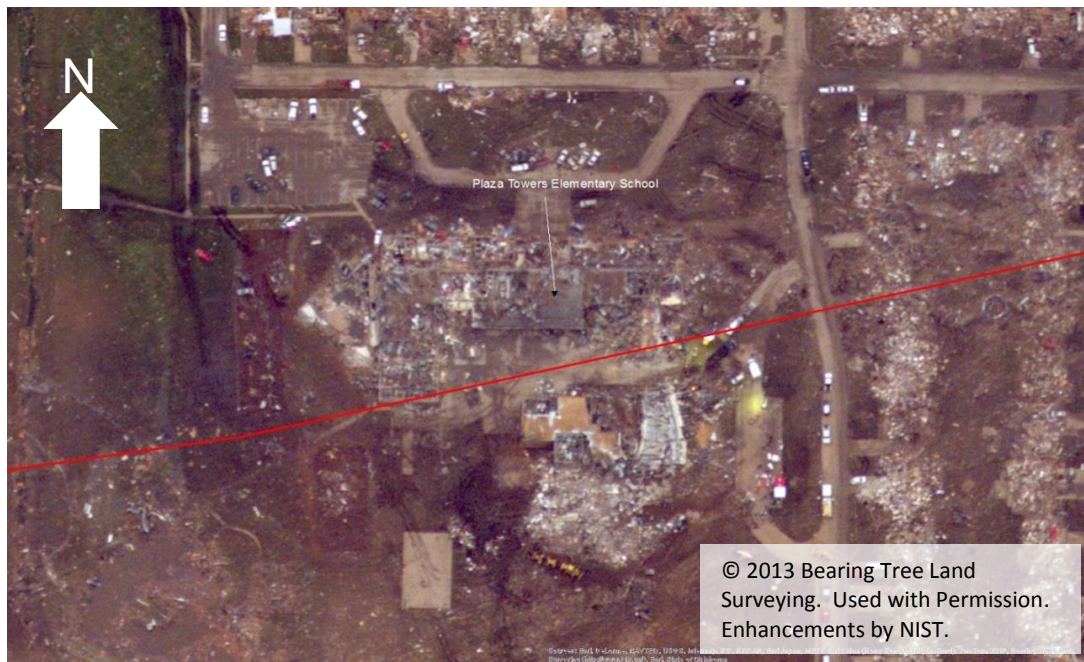
The buildings of Plaza Towers Elementary School sustained significant structural damage due to strong wind and debris impact loadings. Figures 4-4 and 4-5 show aerial views of Plaza Towers Elementary School shortly after the tornado hit. Following is a summary of the damage observed at this facility and related fatalities and injuries.

Figure 4-4. Aerial photograph of Plaza Towers Elementary School and proximity to estimated center of tornado damage path.

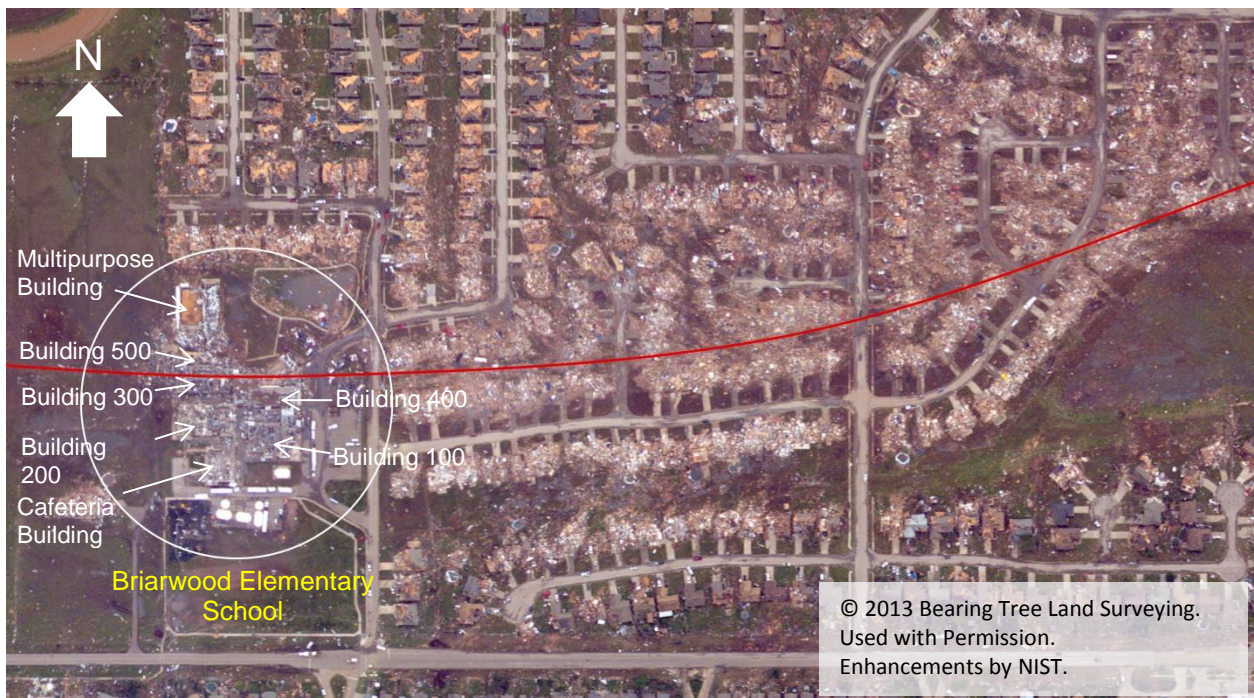
Figure 4- 13. Aerial photograph of Briarwood Elementary School and proximity to estimated center of tornado damage path (red line).

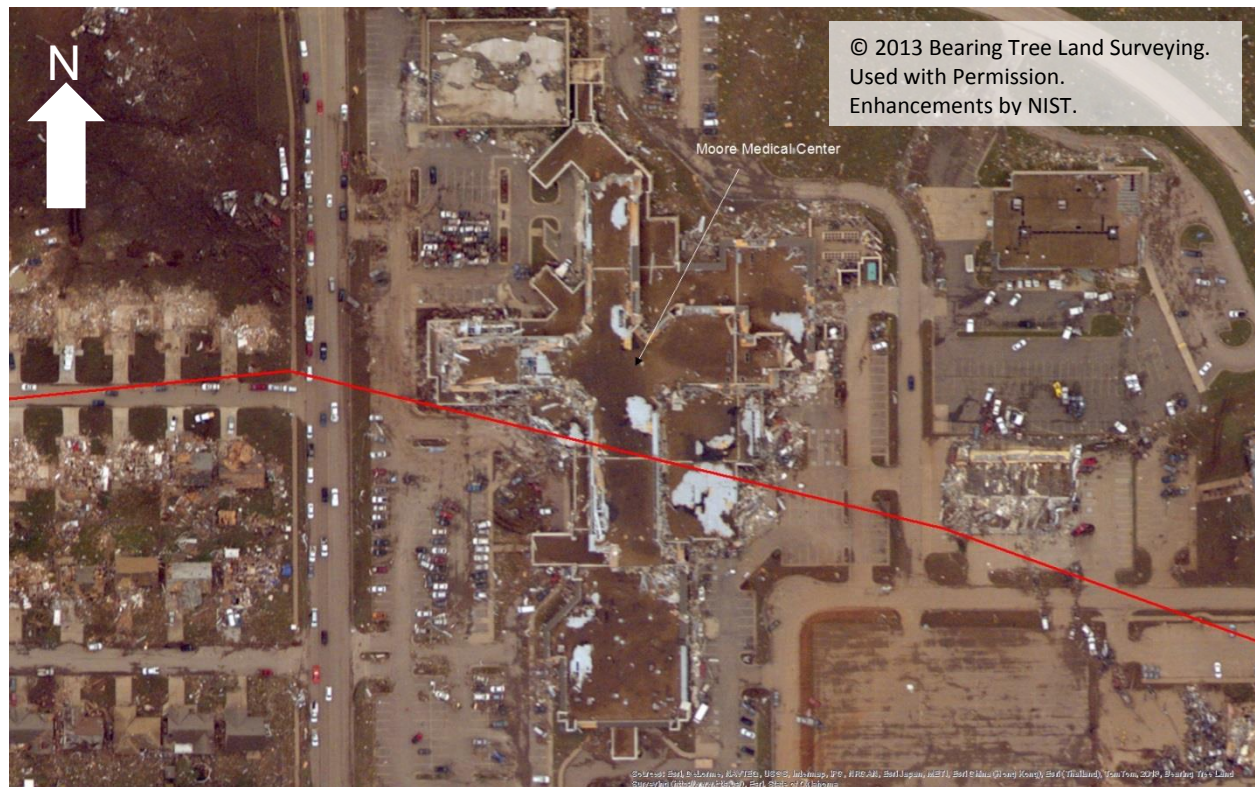
The estimated centerline of the tornado damage path passed close to the center of the facility (Figure 4- 23). The damage across the entirety of the exterior of the Moore Medical Center is shown in Figs. 4-24 through Figure 4-26. The figures show severe damage to much of the interior of the hospital and the medical office buildings. Similar to the two elementary schools discussed earlier in the report, the Moore Medical Center was also subjected to both wind and wind-borne debris impact loading; however, the structural damage to the Medical Center was minimal compared to the schools. Debris hazards included automobiles (and automobile parts) tossed against, into, and onto the building, and a large steel trash dumpster that landed on top of the second story of the west nursing wing of the hospital, damaging the roof deck and supporting bar joists (Figure 4-28).

Figure 4-23. Aerial photograph of Moore Medical Center shortly after the tornado struck, showing estimated centerline of the tornado damage path (in red).
