PERFORMANCE OF ROOFING IN PUERTO RICO

20 April 1962

Organic Building Materials Section  
Building Research Division

Office of the Chief of Engineers  
Department of the Air Force  
Bureau of Yards and Docks

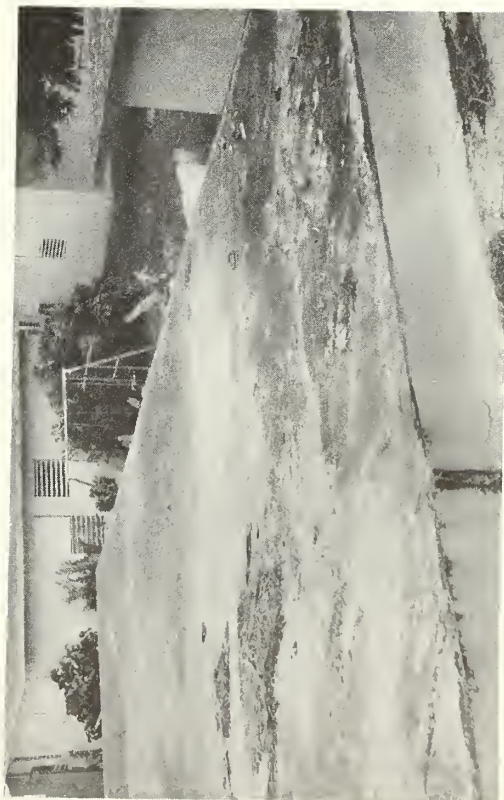
In cases where multiple roof levels were employed, some trouble was encountered at the junction of the deck with the vertical surface. A grout coating of concrete was unsuccessfully employed to remedy this condition. Cracking, as illustrated in Figures 11 and 12, soon developed and, in addition, the adhesion between the grout and the dense concrete was poor and water was invariably found in that area. Interior examinations generally revealed leakage in these areas.

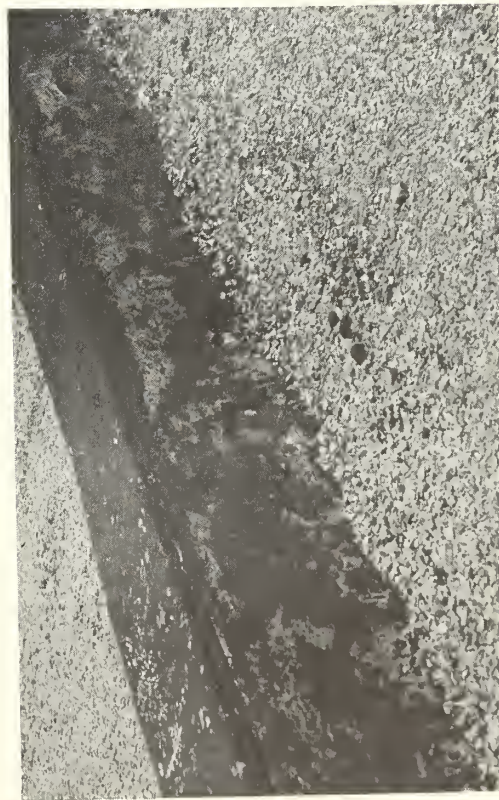
19

The appearance of this roof was good after about 20 years exposure, as shown in Figure 18. An examination of the asphalt showed it to be very hard and brittle even at the high temperature of the roof. However, there were no other signs of deterioration and it was apparently performing its basic function. The only defects observed were a number of bare areas where the felts were exposed. Some 41 leaks were reported in this roof. However, our observations indicated that most, if not all, of the leaks resulted from defective flashings, as shown in Figure 19. Obviously such deficiencies could be prevented by adequate and timely maintenance.
