# Fire Resistance of Shutters for Moving-Stairway Openings

United States Department of Commerce  
National Bureau of Standards  
Building Materials and Structures Report 129

Building Materials and Structures Report 129

Issued March 1, 1952

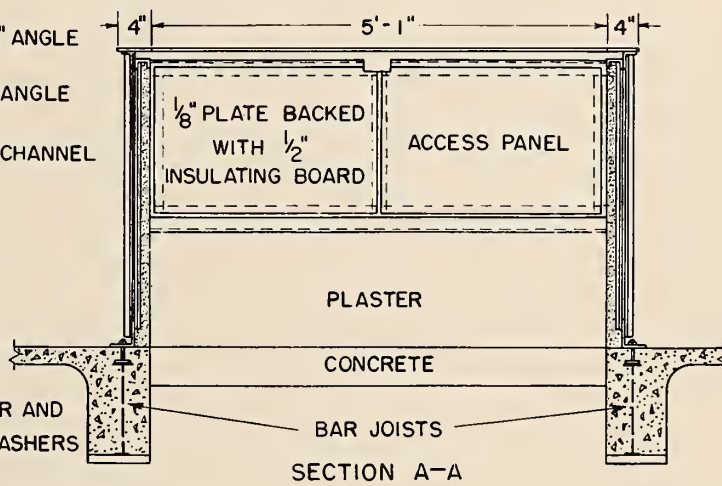
FIGURE 2. Construction details for test A.

The shutter for test A was actuated normally by push-button controls. Its closure could be arrested by a sensitive leading edge. Automatic closure was demonstrated by the use of three devices mounted in parallel and actuated independently, one by smoke, one by rate of rise of temperature, and one by heat (fusible link). The shutter for test B was equipped for operation by hand crank only (fig. 4).

The lubricants in the shutter started burning and smoke was observed at 5 min. At 7 min the shutter guide rails were observed to be spreading apart at the curved portion. At 20 min the curved portion of the rails had spread so much that the shutter rollers had come out of the guide slots. At 1 hr the shutter was out of the slot 1 in. on one side and  $\frac{1}{2}$  in. on the other. It had pulled clear of the slot for a length of 6 ft on one edge and 3 ft on the other and had sagged, causing the shutter to bow out beyond the front end about 6 in. The bottom chords of the balustrades had expanded over  $\frac{3}{8}$  in. longitudinally, notwithstanding the restraint of the floor slab. The test was ended at 3 hr 1 min, at which time a portion of the shutter had sagged 3 to  $3\frac{1}{2}$  in. at its center line, although the rollers were still held in the side-rail slots. The condition of the specimen after the test is shown in figure 7.

The primary source of trouble in test A was the spreading of the side rails, or balustrades. The shutter guide rail was rigidly attached as a part of the top chord of the truss, the inner portions being directly exposed to the furnace fire, whereas the outer portions were cooled by the air outside the furnace, a condition which resulted in a considerable difference in the thermal expansions along the inner and outer edges. This difference in expansion caused bowing of the chord members and consequent spreading of the guide rail, thus allowing the shutter rollers to drop out of the guide slots. The transverse members of the housing for the operating mechanism fixed the rear ends of the guides, and outside braces set at  $2\frac{1}{2}$  ft from the beginning point of curvature of the rail resulted in the spreading of the relatively free curved portion of the guides. In test B this effect was partly obviated by providing an expansion joint in the guide rail and placing the top chord of the balustrade framework below the guide rail, where it was somewhat protected from the fire by plaster. Another means of neutralizing unequal expansion was introduced by making saw cuts in the inner edges of the top chord and the guide rail. In spite of these provisions, some spreading of the guide rails was observed. This should be overcome by increased allowance for expansion. Any provisions that make adequate allowances for expansion effects might be substituted for those employed in test B.

The shutters for both tests A and B were of the same design. The failure of the structure in test A could therefore be laid to the warping of the balustrade framework rather than to any deficiency of the shutter itself. It is doubtful whether the use of the bolted rather than a welded balustrade assembly in test B made any difference in the fire resistance. Either method should provide an acceptable structure.

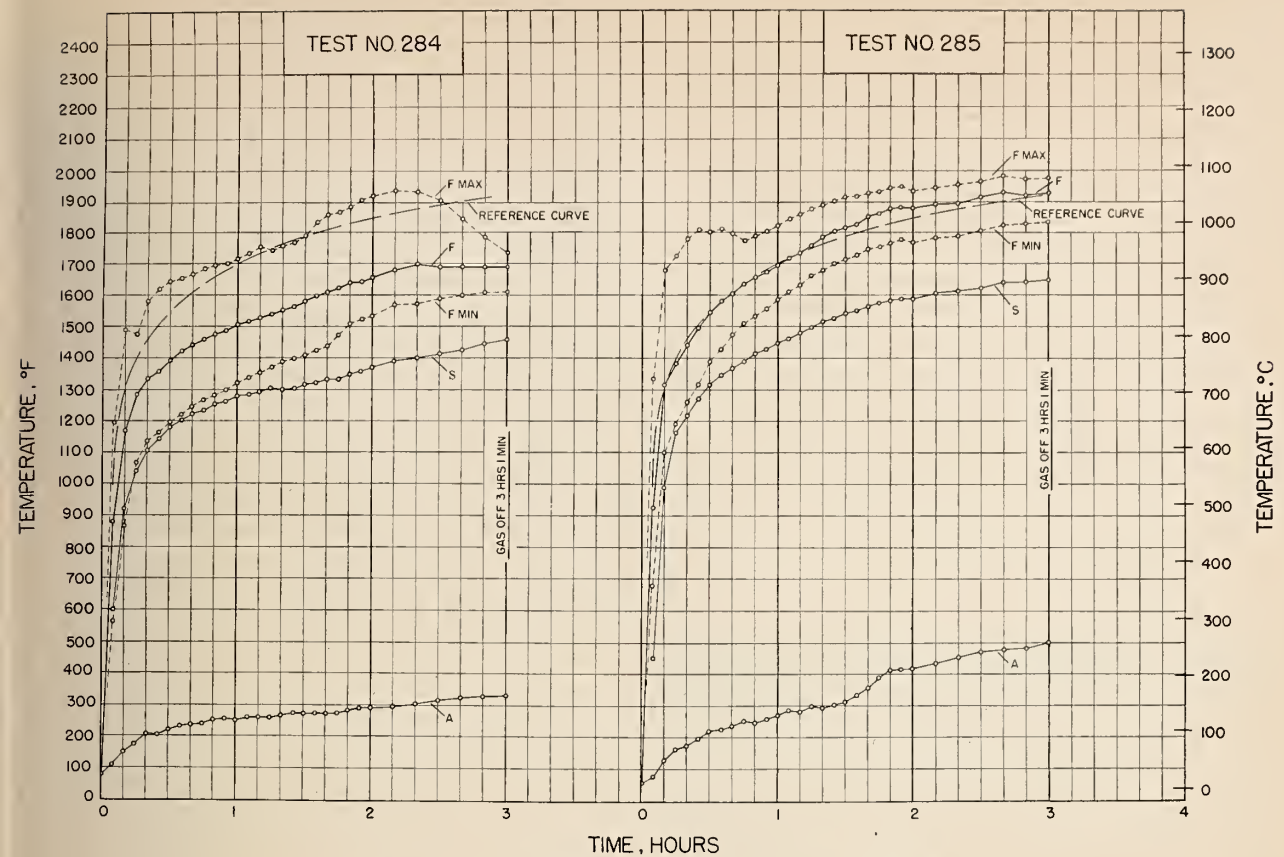
The severity of the fire exposure, as measured by the ratio of the area under the curve of average furnace temperatures to the area under the reference curve was 92.8 percent. These curves are shown in figure 8. The large openings that devel-

Smoke, indicating the burning of the shutter lubricants and a slight spreading of the side rails, was observed with the ends of the shutter slats showing at 3 min. At 23 min the expansion joints in the shutter guides were closed, and the shutter was sagging  $1\frac{1}{2}$  in. By 39 min the zinc coating on the surface of the shutter was largely oxidized, the guide rail was twisted upward slightly, and the restraining lip was bent outward. The shutter was sagging 3 in., and the base chord had expanded to push the end footing out  $\frac{1}{2}$  to 1 in. The spread of the side rails at the front left a  $\frac{1}{4}$ -in. opening on each side between the guides and the ends of the sheet-metal slats for a length of  $1\frac{1}{2}$  ft. At 2 hr the shutter was sagging 4 in., and the end footing had been pushed out and down to leave a  $\frac{1}{4}$ -in. gap between the end bar of the shutter and the floor. When the test was ended at 3 hr 1 min, the shutter sag was at least 6 in., but the rollers were still in the guides, the shutter showed a dull red glow over most of its surface, and the footing had been forced out 1 to 2 in. at the front end. The severity of the fire exposure was 103 percent.

FIGURE 8. Time-temperature curves from tests A and B.

The "reference curve" is the standard time-temperature curve defined in ASTM E119-47; "F", "F max", and "F min" are the average, maximum, and minimum furnace temperatures, respectively. S and A are the averages of the temperatures on the unexposed surface of the shutter and in air above the edges of the shutter, respectively.
