NIST Special Publication 862

1994 Northridge Earthquake Performance of Structures, Lifelines, and Fire Protection Systems

*Diana Todd, Nicholas Carino, Riley M. Chung, H. S. Lew, Andrew W. Taylor,
William D. Walton, James D. Cooper, and Roland Nimis*

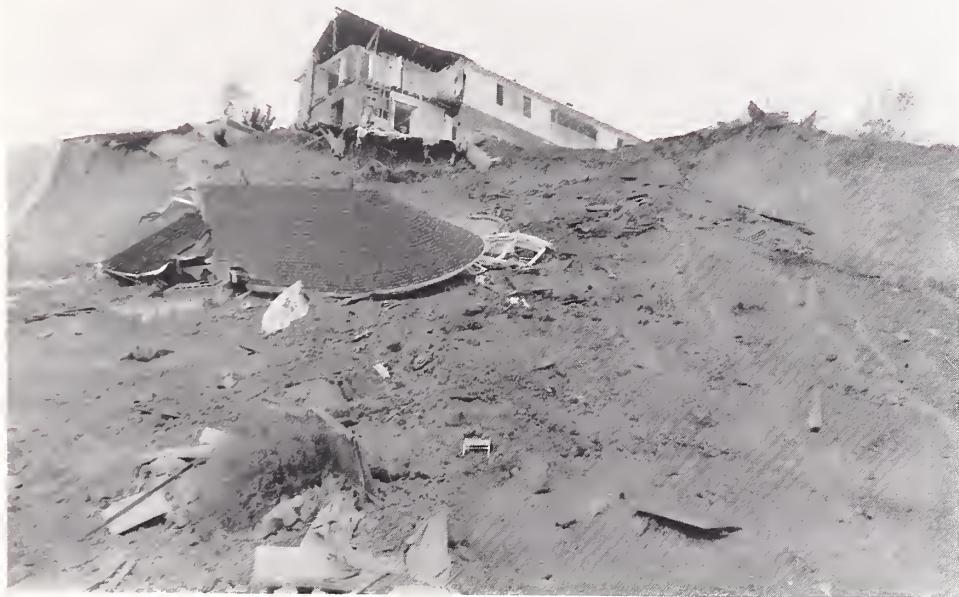
Landslides, rock slides and slope failures were the most visible geotechnical effect caused by the earthquake. Landslides along the Pacific coast in Santa Monica and Malibu damaged several buildings (fig. 2.8). Rockfalls in the Santa Monica, Santa Susana, and San Gabriel Mountains closed roads. Mulholland Drive in Sherman Oaks was temporarily closed because of the threat of slope failure.

Figure 2.8. A landslide along the Pacific Coast Highway north of Santa Monica undermined the foundation of a house at the crest of the slope, bringing a portion of the house down.

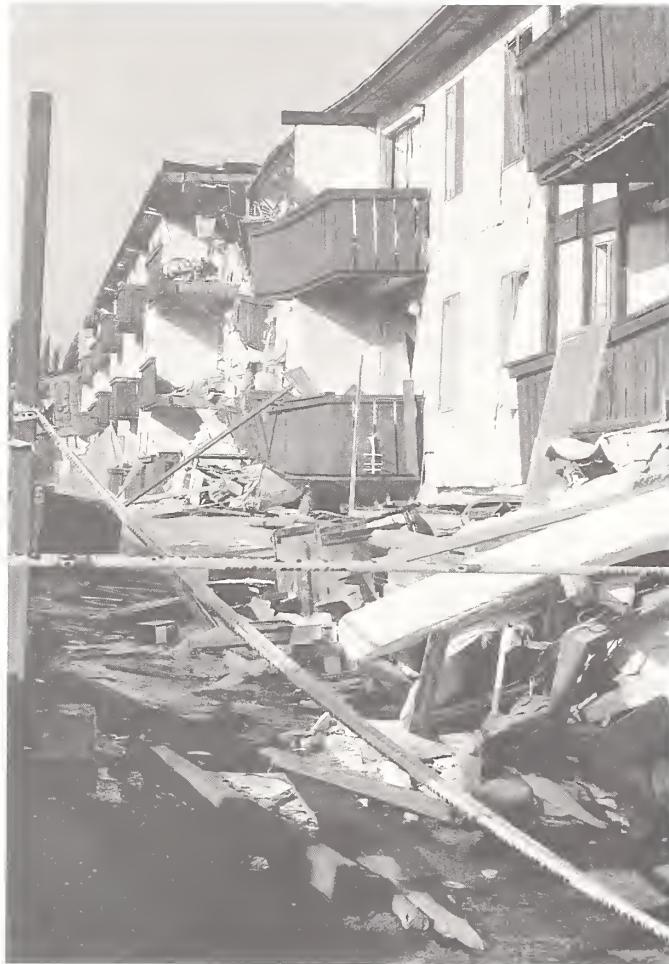
Collapses in a single apartment complex caused sixteen of the twenty-two deaths related to building failures [12]. The Northridge Meadows complex, constructed in 1972 (Los Angeles Times, January 19, 1994), consisted of several three-story wood-frame buildings, arrayed around courtyards on two sides of a mid-block alley. About half of the units had open spaces for parking on the street level. Typically these were around the perimeter of the complex. Most of the interior courtyard-facing units had living space at the ground level rather than parking. About half of the buildings in the complex collapsed. In all of the collapses, the first story gave way while the second and third stories remained largely intact. The 16 people killed were in first story apartments. All the buildings in the complex suffered some damage (figs. 3.3 and 3.4).

Figure 3.4. At the Northridge Meadows apartment complex near the epicenter the first story in several of the buildings collapsed, killing sixteen people. The second and third stories remained essentially intact. Large portions of the first story in these buildings were open space for parking. This type of collapse occurred in a significant number of similar apartment buildings throughout the affected area.

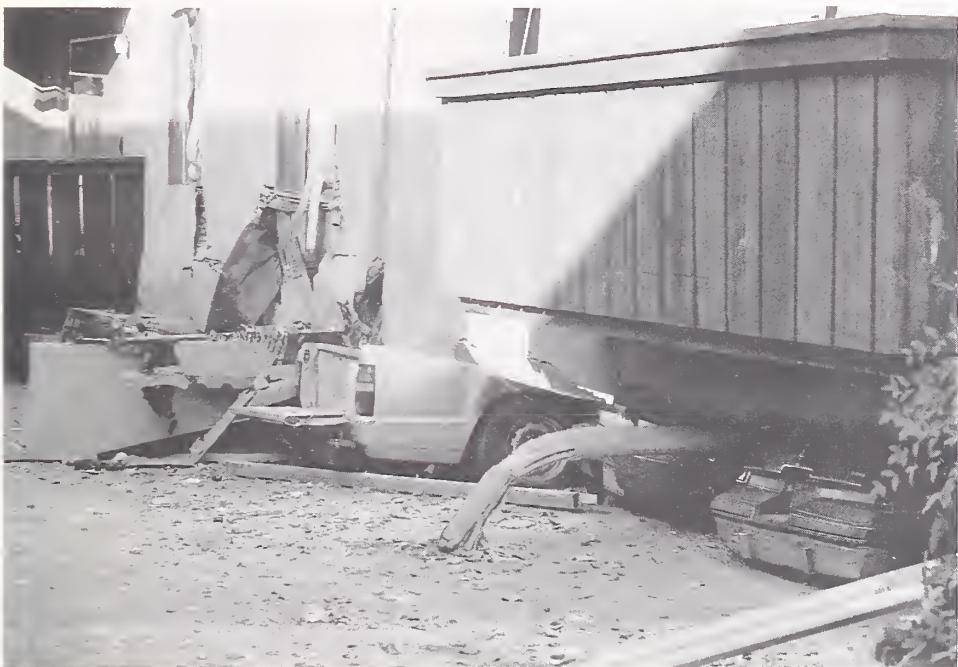
The upper stories of the collapsed buildings were displaced laterally and in some cases came to rest offset by as much as three meters from their original locations. The steel pipe columns, which hinged at their bases, apparently controlled the distance of the offset as they bent to the ground under the load of the building above (fig. 3.6). Collapses occurred in buildings aligned longitudinally east-west as well as those aligned north-south. At the southeast end of the complex, some building portions collapsed to the north, and other portions collapsed to the south, which indicates that no one extreme pulse of energy brought all the buildings down.

Figure 3.6. At Northridge Meadows, the first story steel pipe columns generally hinged near their bases but retained their length, controlling the displacement of the upper stories.

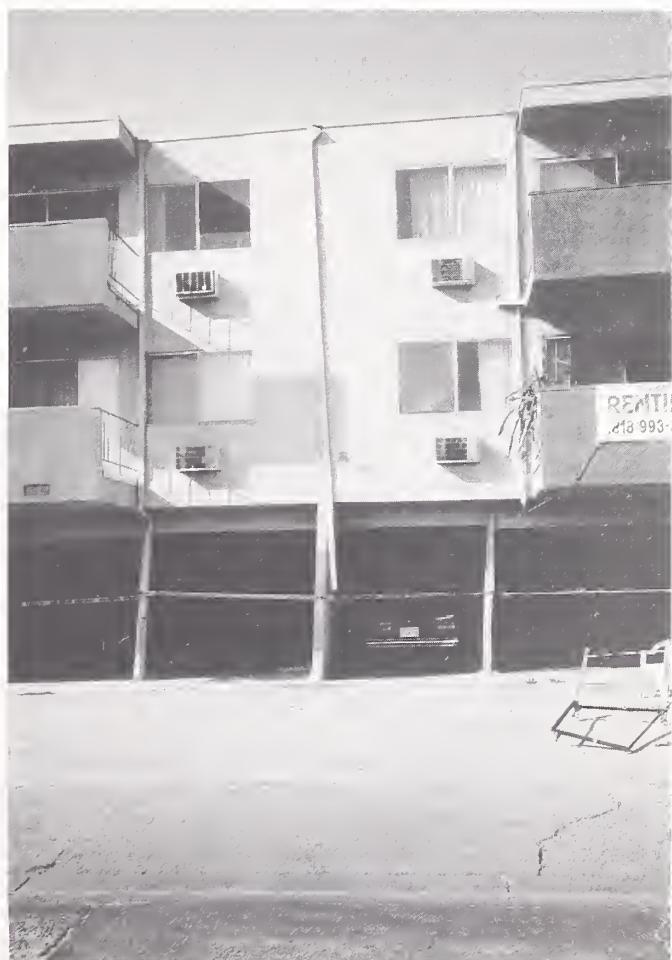
Figure 3.7. Racking, or leaning, of open first story parking areas was a common feature of damaged two and three-story apartment buildings.

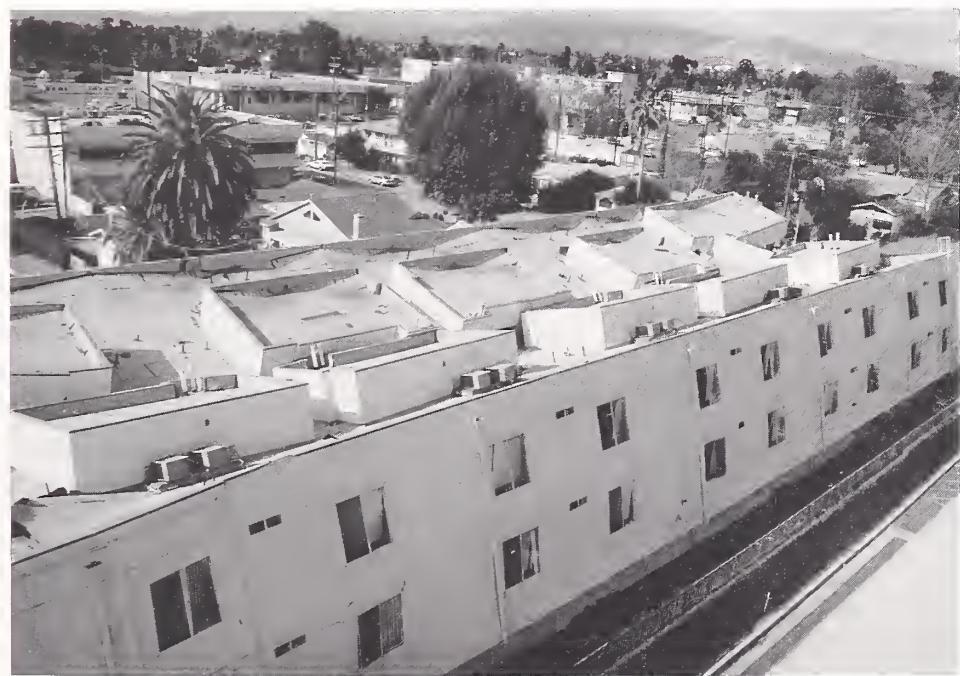
entire first story used for parking, located on Sherman Way in Sepulveda. In this building, the first story parking area was open only on the transverse ends. Concrete block walls formed the longitudinal walls at the first story and a row of concrete columns supported the mid-span of the flat plate concrete floor slab above. The two stories of living space over the parking level were wood-framed with a stucco facade. The entire line of mid-span concrete columns failed. The two halves of the upper stories settled in towards the middle (figs. 3.10 and 3.11), essentially destroying the structure.

Figure 3.11. This overhead view of the partially-collapsed apartment building on Sherman Way shows the solid concrete masonry block perimeter walls along the longitudinal axis of the building. Access to the first story parking was limited to the transverse ends of the building. When the row of interior columns failed, both sides of the building settled in towards the middle.

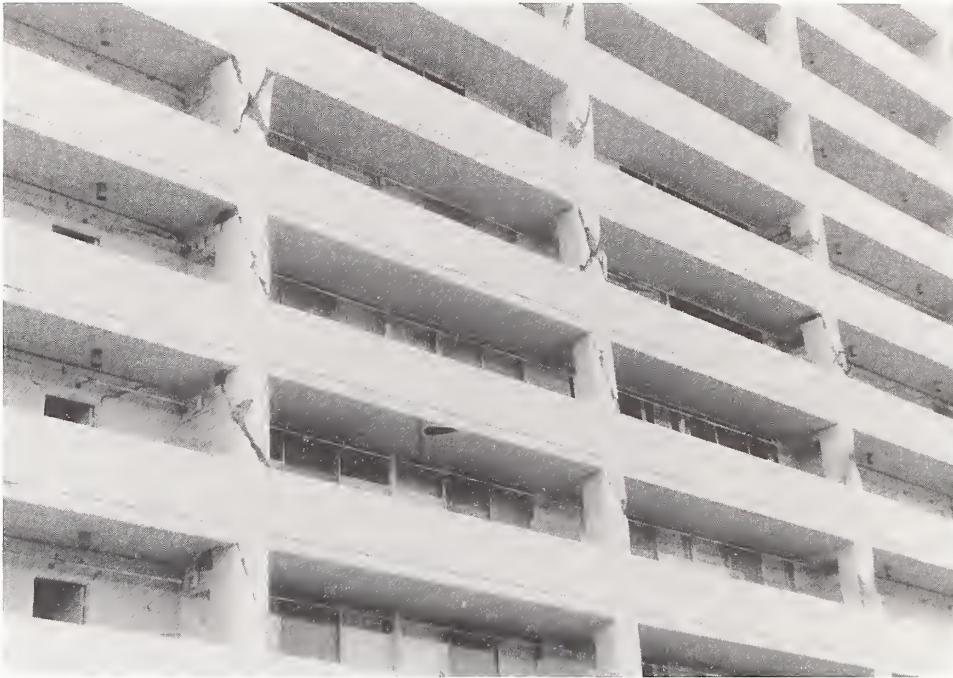
Figure 3.14. The back of the Champagne Towers building was badly damaged. The railings here are solid infill, which effectively stiffen the lower half of the columns. The shortened upper half of the columns were forced to accommodate all the displacement, and they failed in shear.

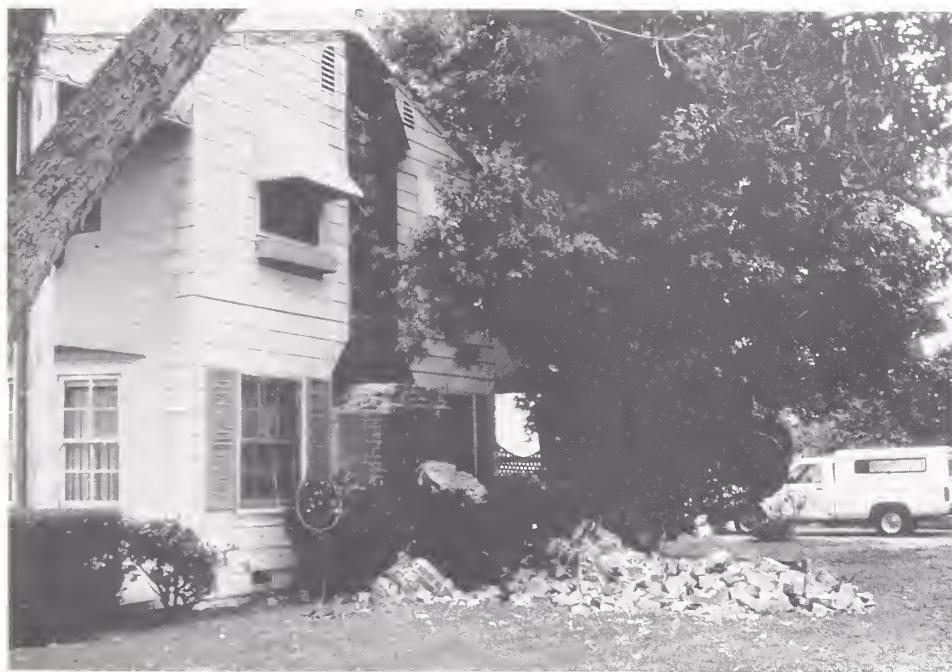
Figure 3.17. Failure of masonry chimneys was common.

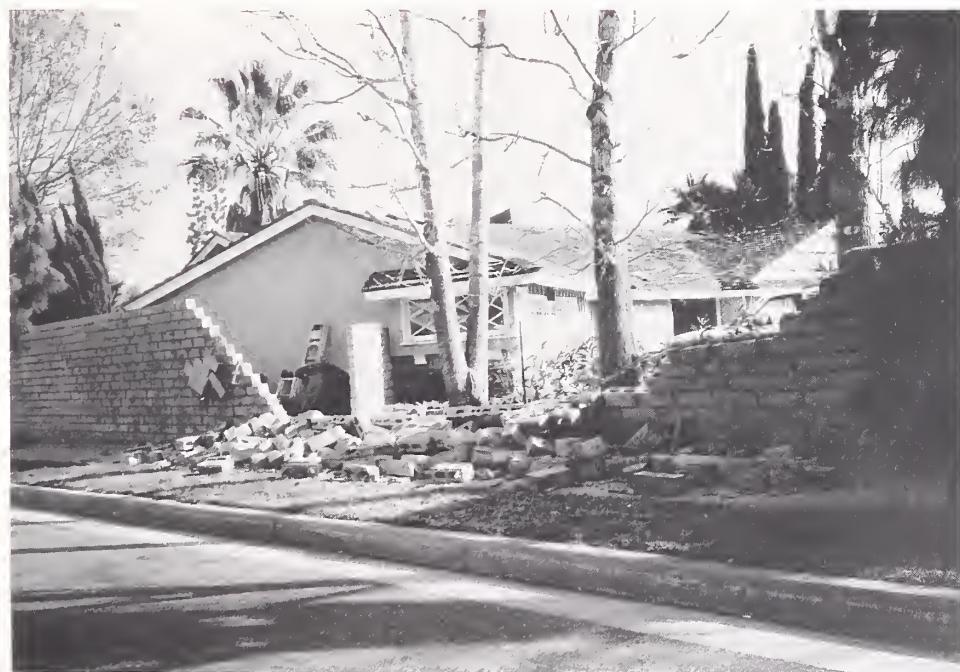
Figure 3.18. Damage to masonry privacy fences was ubiquitous. Many of these fences were tall enough to have been a serious threat to passersby when they failed. Luckily, due to the early morning hour of the quake, yards and sidewalks were essentially deserted.

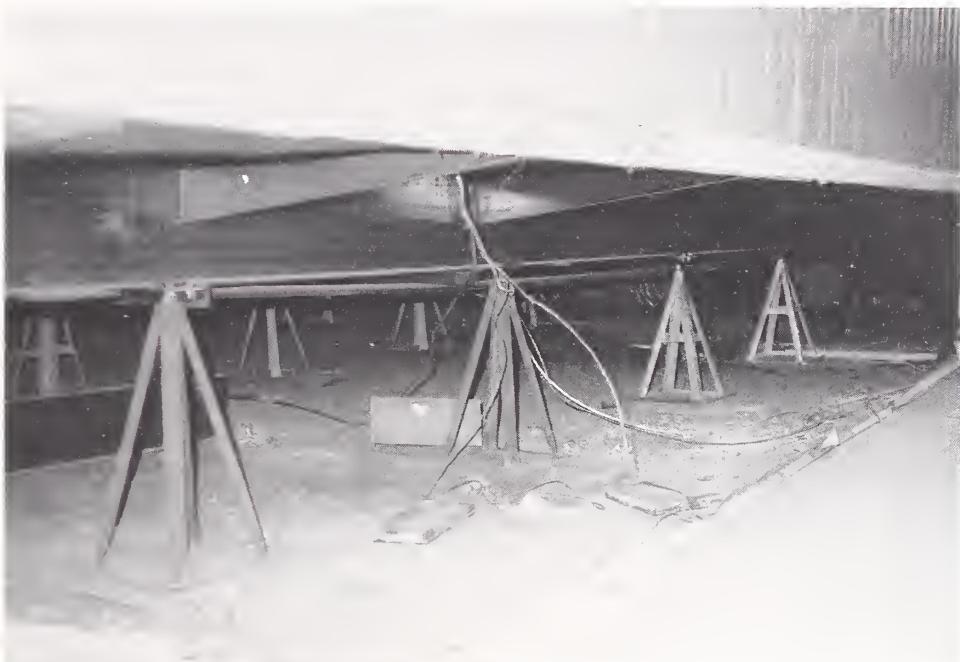
In some cases, the metal base supports were braced with small steel angle members. However, they were not adequately fastened to the supports and did not prevent the supports from rocking.

Figure 3.21. Another foundation system used for manufactured housing consists of supports constructed of small metal angles.

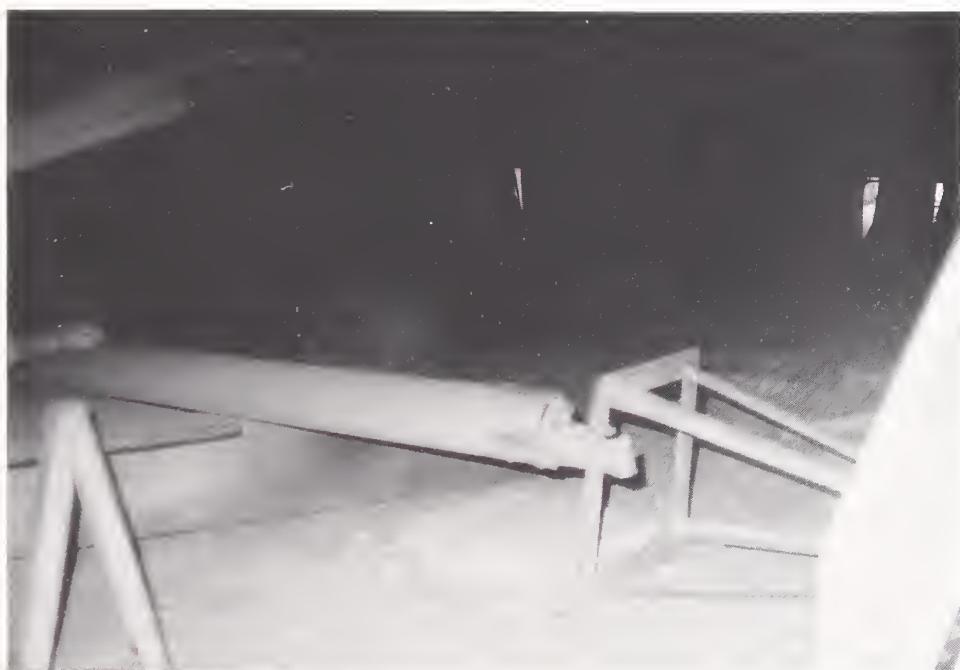
Figure 3.22. The metal supports under many homes tipped over, bringing down the houses above.

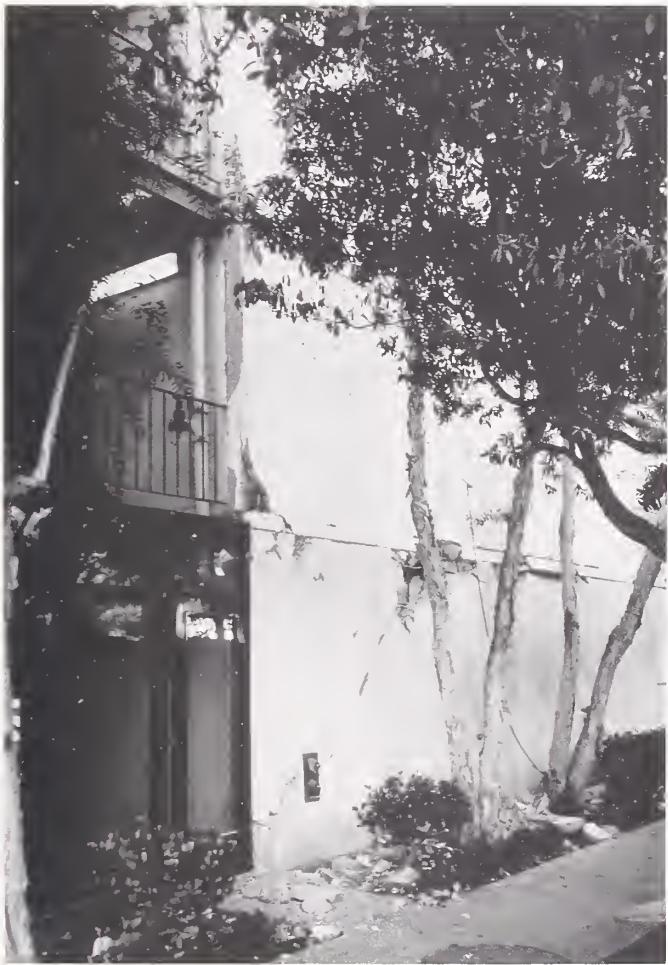
Figure 3.25. The concrete facade panels of the St. John's hospital parking garage had diagonal cracks and crushed toes.

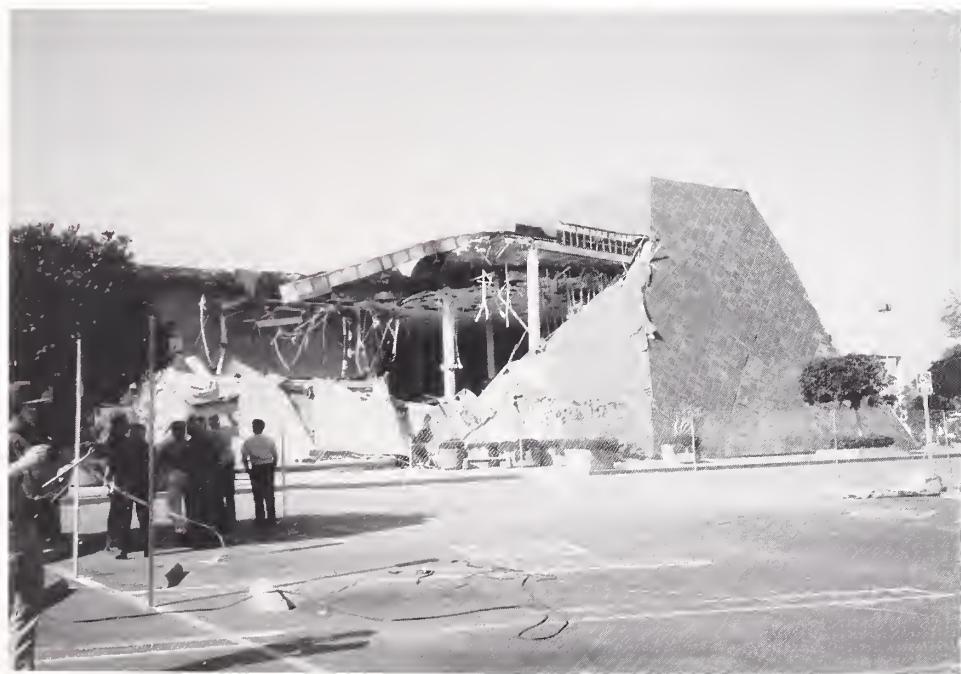
Figure 3.31. The Broadway department store at the Northridge Fashion Center had horizontal cracks in the facade and spalled corners at each floor level, and cracks in the soffit.

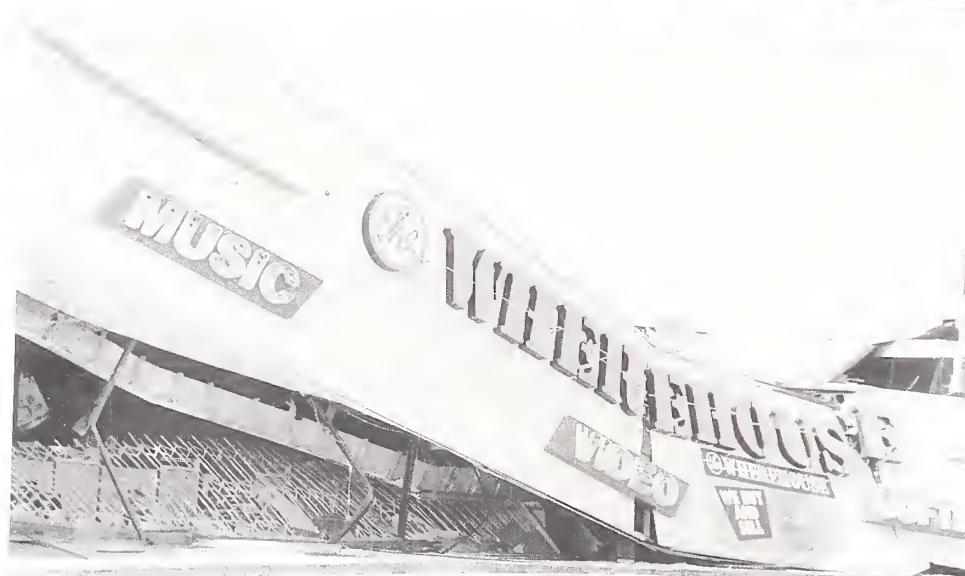
The area around the Northridge Fashion Center showed evidence of having been severely shaken. Significant damage of many types occurred. South of the Northridge Fashion Center, several single story retail structures were damaged; at least one, the Wherehouse, collapsed (fig. 3.32).

Figure 3.32. Many commercial buildings were damaged in the blocks south of the Northridge Fashion Center. The single-story Wherehouse collapsed completely.

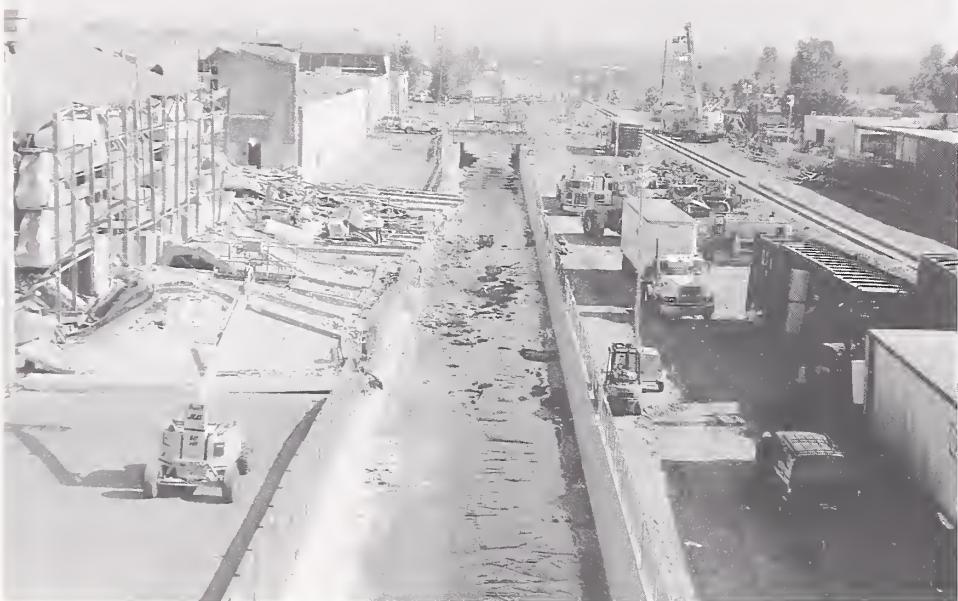
In the same area, the entire south wall of the concrete tilt-up Levitz furniture store fell away from the building to the south (fig. 3.33). In tilt-up construction, the concrete walls are formed and poured on the ground and, after the concrete cures, rotated into their final erect position. The remains of the damaged roof of the Levitz store, a plywood diaphragm, appeared to be supported by the top of the racks holding furniture.

Figure 3.33. The south wall of the concrete tilt-up Levitz furniture store/warehouse south of the Northridge Fashion Center fell away from the building into the alley and stream channel. The damaged roof was being supported by the racks of furniture. On the south side of the stream channel a freight train derailed during the earthquake. That clean-up effort was still underway three days after the quake.

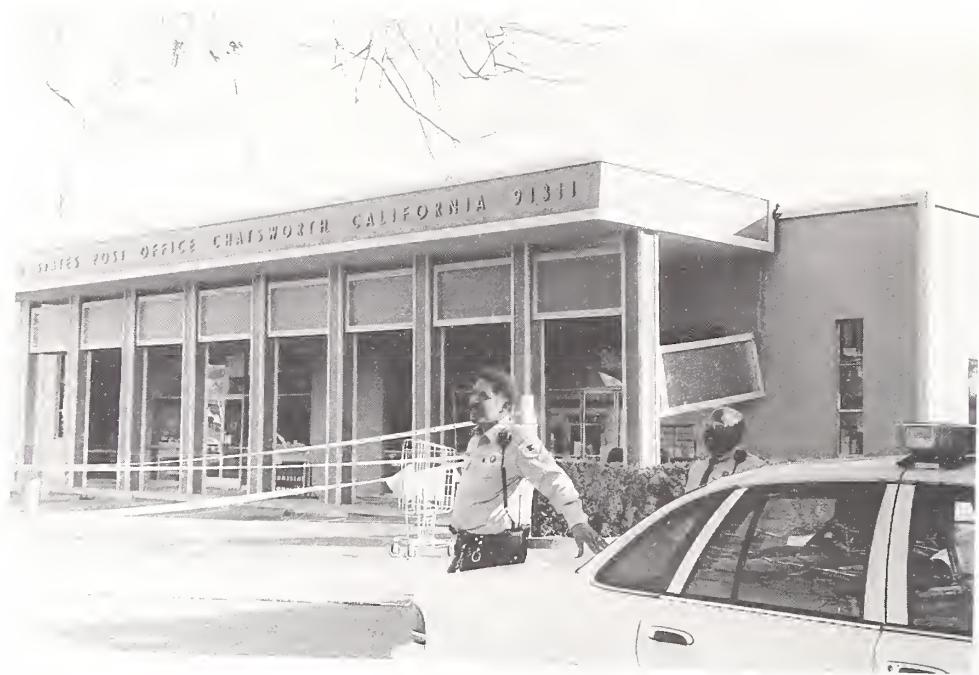
facade panel had become detached and interior ceiling panels had fallen (fig. 3.35). Mail was being collected in the parking lot.

Figure 3.35. The Chatsworth Post Office was closed due to damage. Mail was being collected in the parking lot.

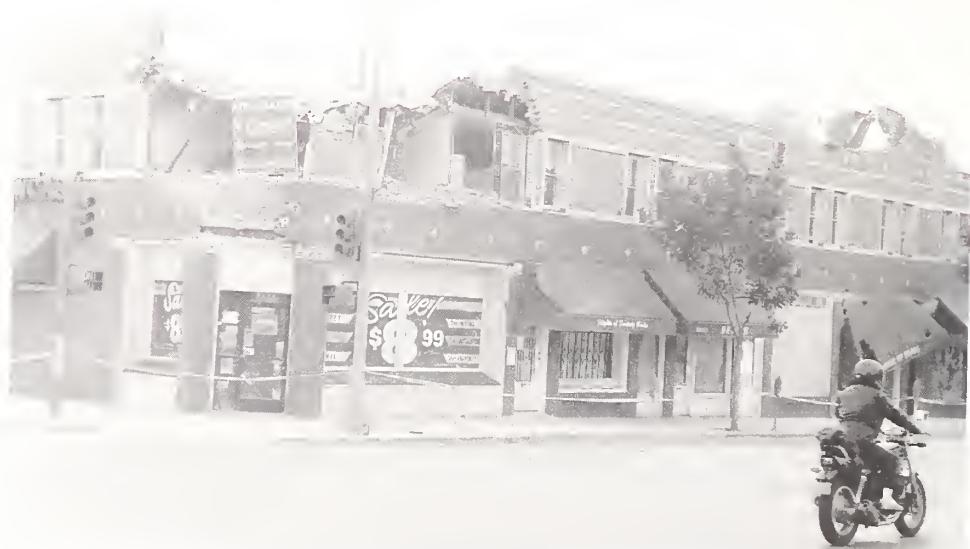
Figure 3.36. Damage to unreinforced masonry buildings, even those that had been rehabilitated, was common. Upper stories and corners were particularly vulnerable to damage. The rows of light-colored diamonds on the face of this building are the end plates of through-bolts used to connect the wall to the floor joists, a typical rehabilitation technique. The remains of parapet braces can be seen on the roof.

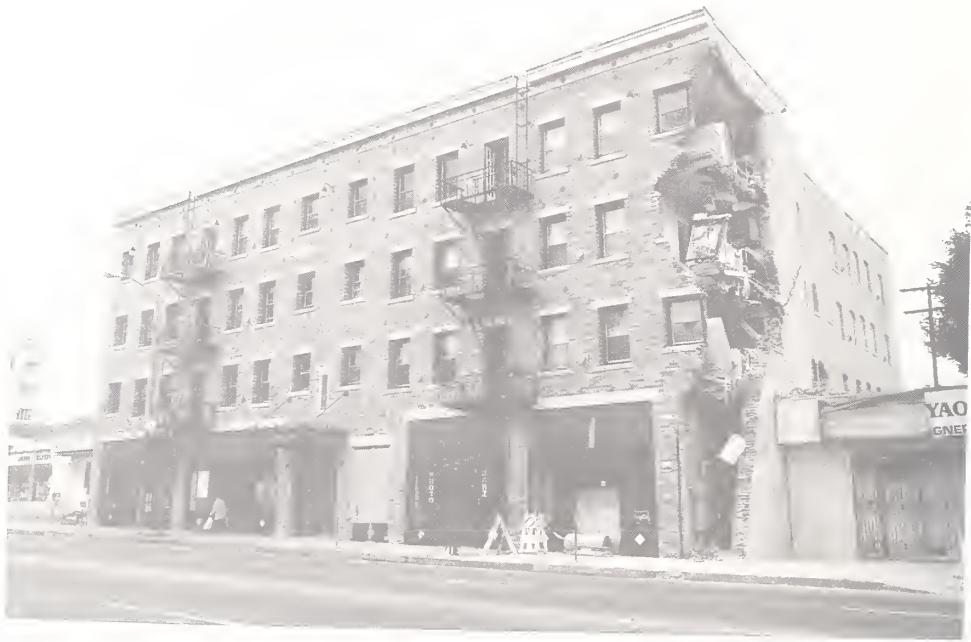
Figure 3.37. The corner of this rehabilitated unreinforced masonry apartment building in East Hollywood crumbled on all four stories.

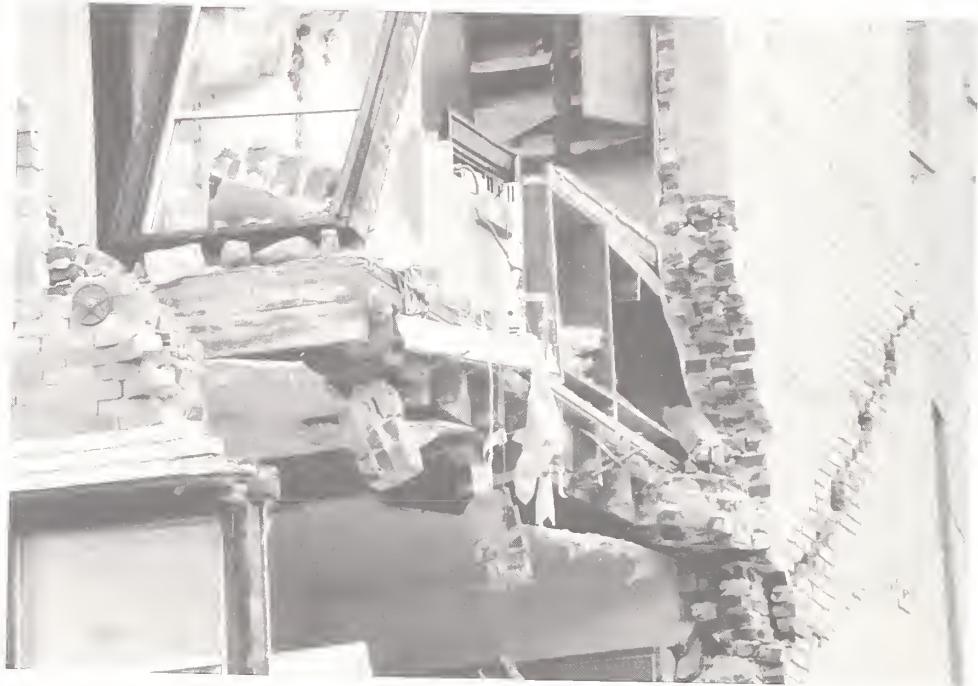
Figure 3.38. A close-up view of the third-story floor diaphragm of the building picture above shows (lower right) a rehabilitation bolt still holding a few bricks to the floor joists, after all the walls on three out of four sides of the bolts had disintegrated.

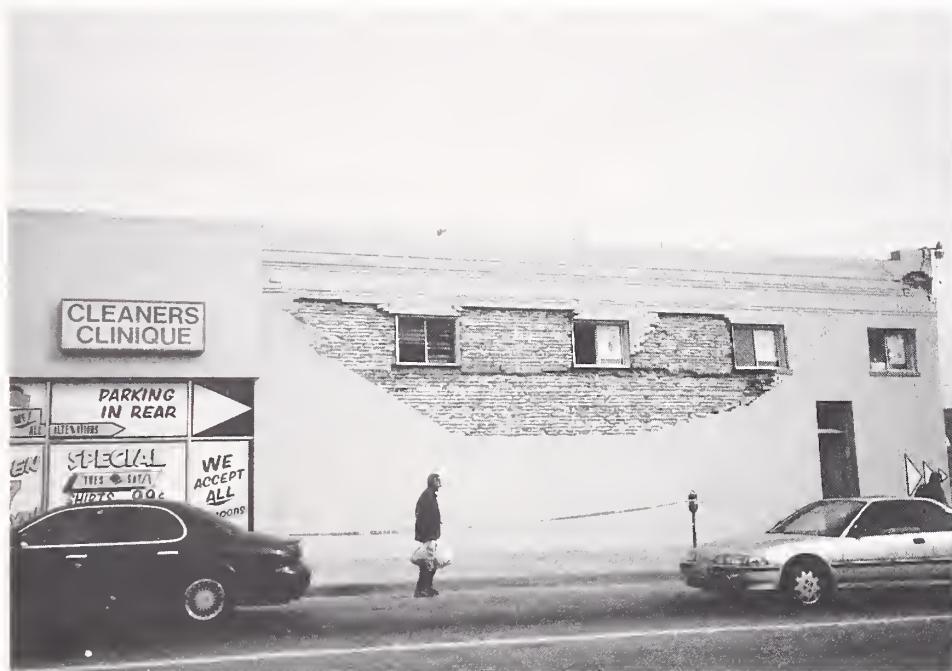
Figure 3.39. Only the exterior wythe of brick peeled off of this rehabilitated unreinforced masonry building in Santa Monica.

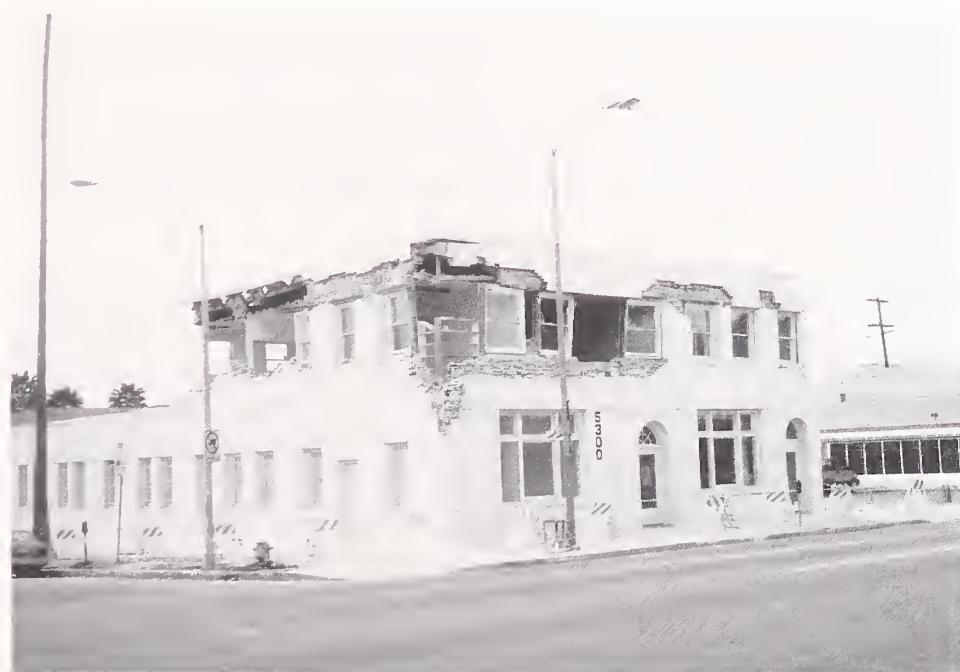
Figure 3.40. In other rehabilitated unreinforced masonry buildings, such as this two story structure in Hollywood, entire wall thicknesses were lost between rows of through-bolts.

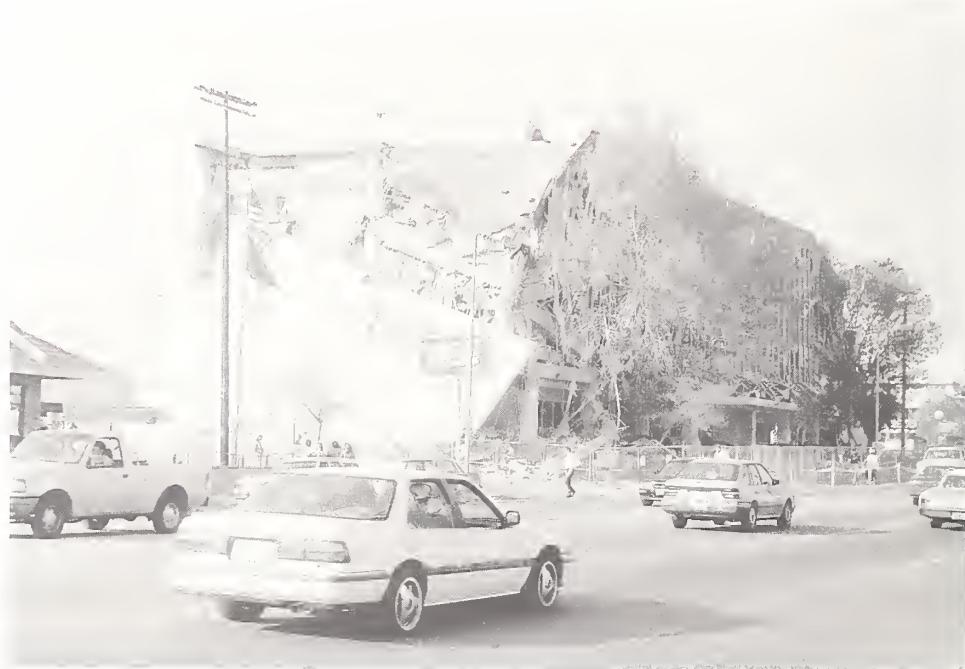
The concrete frame Kaiser Permanente office building on Balboa Boulevard in Granada Hills was badly damaged. The second story columns disintegrated, causing the upper stories to collapse onto the first story, which remained intact (fig. 3.41). At the ends of the building, damage to the frame caused partial collapses, but the mid-section of the building remained intact. The apparently nonstructural end walls became detached at both ends of the building and slid to the ground (figs. 3.42 and 3.43). The failure of these end walls may have contributed to the damage to the frame at the ends of the building.

Figure 3.42. Both end walls of the Kaiser Permanente building slid, partially intact, to the ground. The south wall is pictured here. Both ends of the building suffered damage to the concrete frame at all story levels, while the middle half of the building, except for the second story, remained intact.

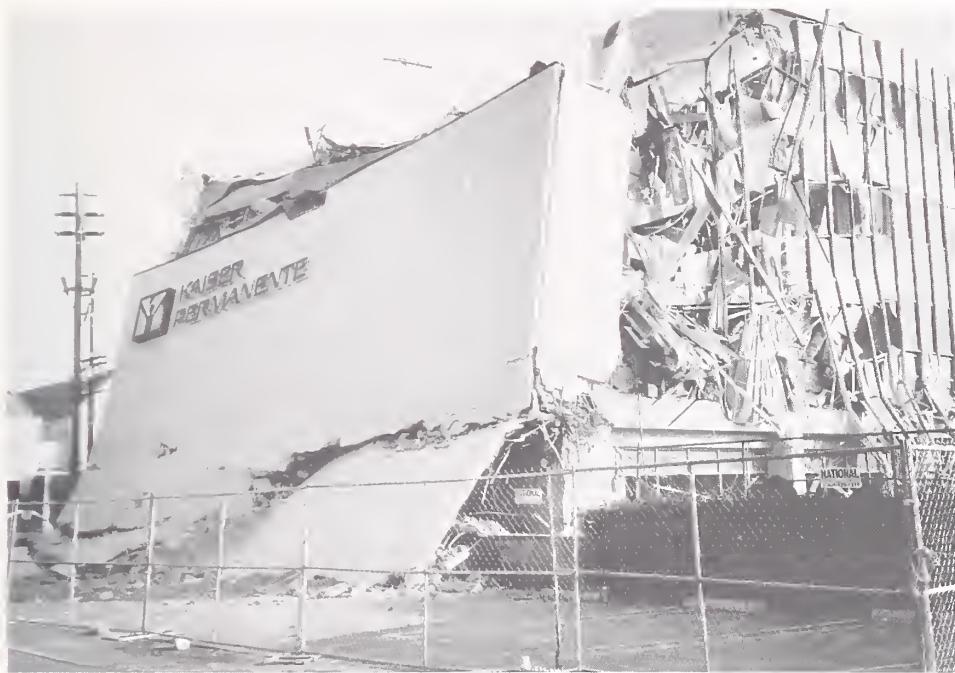
Figure 3.43.
Damage at the
north end of the
building was similar
to damage at the
south.

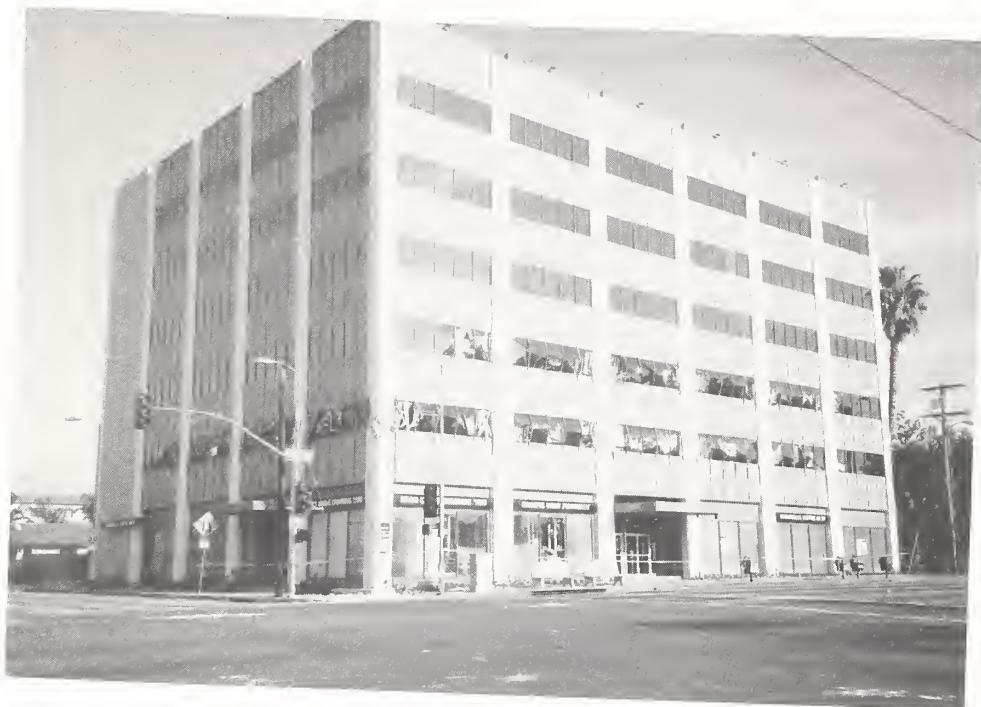
The L-shaped concrete frame Barrington Building in West Los Angeles also had damage concentrated in the second story columns (fig. 3.45). In this building, the horizontal architectural panels stiffened the lower half of the columns at each story, creating a short-column effect. The effectively shortened columns failed in shear between the windows, creating a pattern of X-cracking in the columns that diminished in severity towards the top (fig. 3.46). At the second story, the cracking was severe enough to cause a loss of vertical-load-carrying capacity; the bulging window frames indicate about a 50 to 100 mm reduction in height (fig. 3.47). The building was demolished within a few days of the quake.

Figure 3.45. The six-story L-shaped concrete-frame Barrington Building on Olympic Boulevard in West Los Angeles lost its vertical-load carrying capacity at the second story.

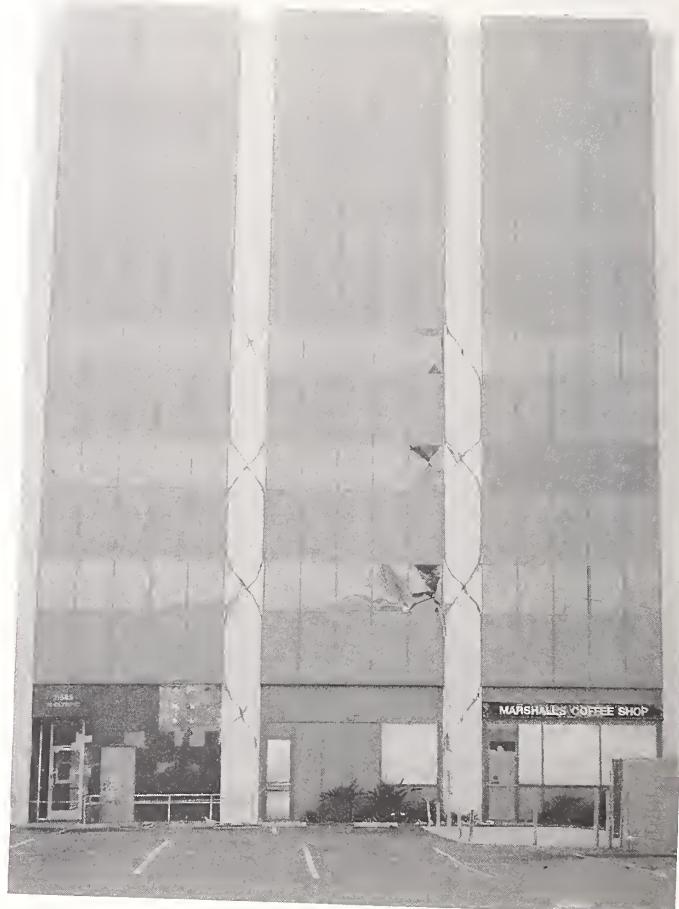
The column-shortening effect of the infill panels was apparently not considered in the design. Where column reinforcing was exposed, transverse bars of undeformed steel spaced at about 300 mm on center could be seen (fig. 3.48), not sufficient to provide confinement of the concrete in a region of high shear.

Figure 3.46. The stiff infill panels of the Barrington Building effectively shortened the concrete columns, forcing all the displacement into the column sections bounded by windows. Diagonal X-cracking decreased in severity towards the top of the building.

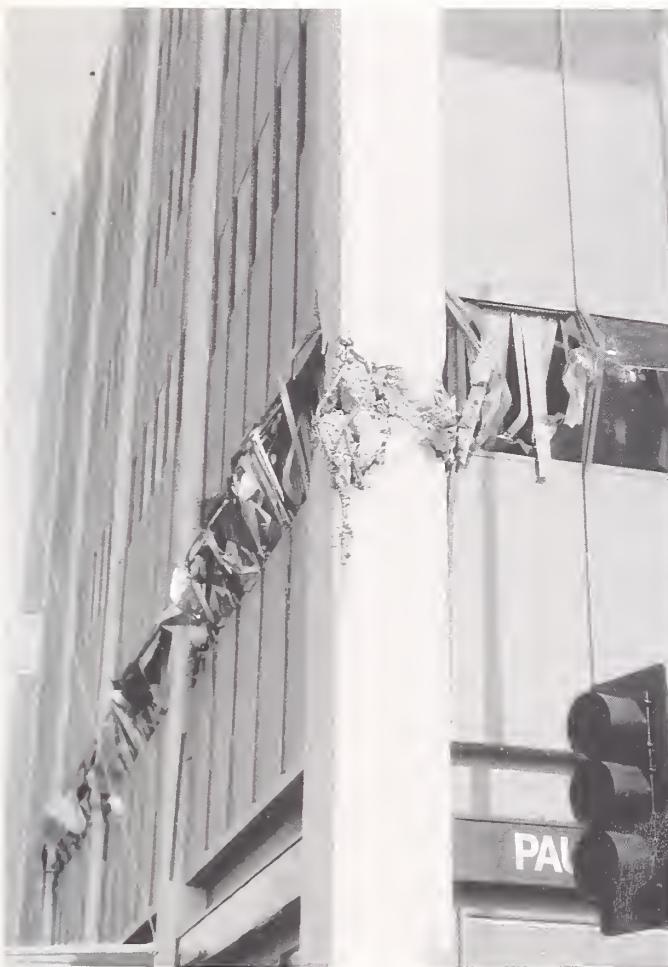
Figure 3.47. The cracking in the concrete columns at the second story was so extensive that the vertical-load carrying capacity of the building was affected. The building settled 50-100 mm at the second story, as these bulging window frames attest. The worst damage was at the southeast corner, the outside corner of the L-shape, pictured here. The building, which developed a slight list, was demolished within days of the quake.

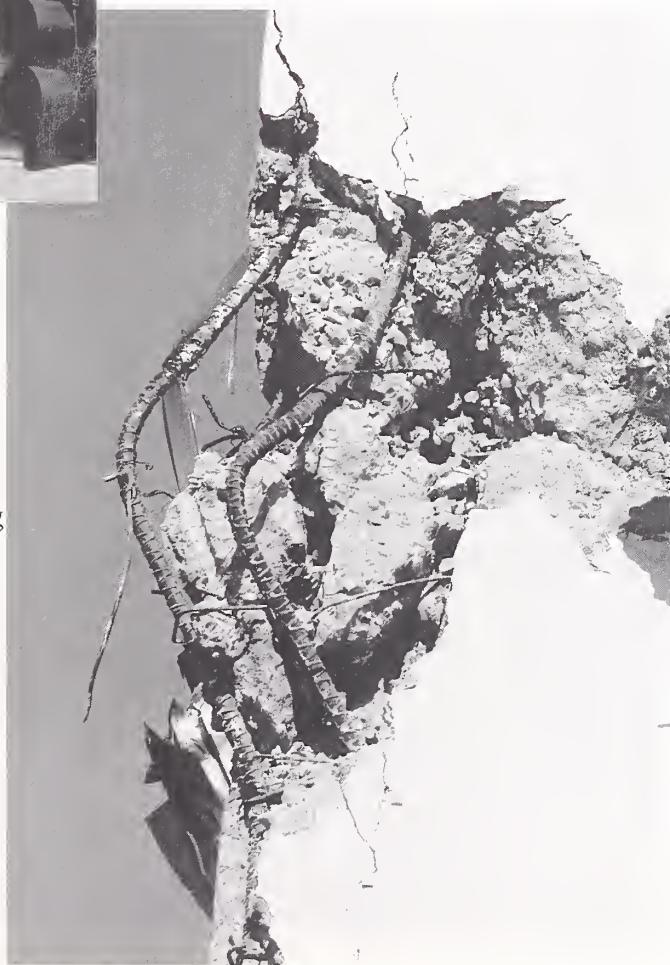
Figure 3.48. A close up of the damaged southeast corner of the Barrington Building shows the widely spaced, undeformed bars used for transverse reinforcement.

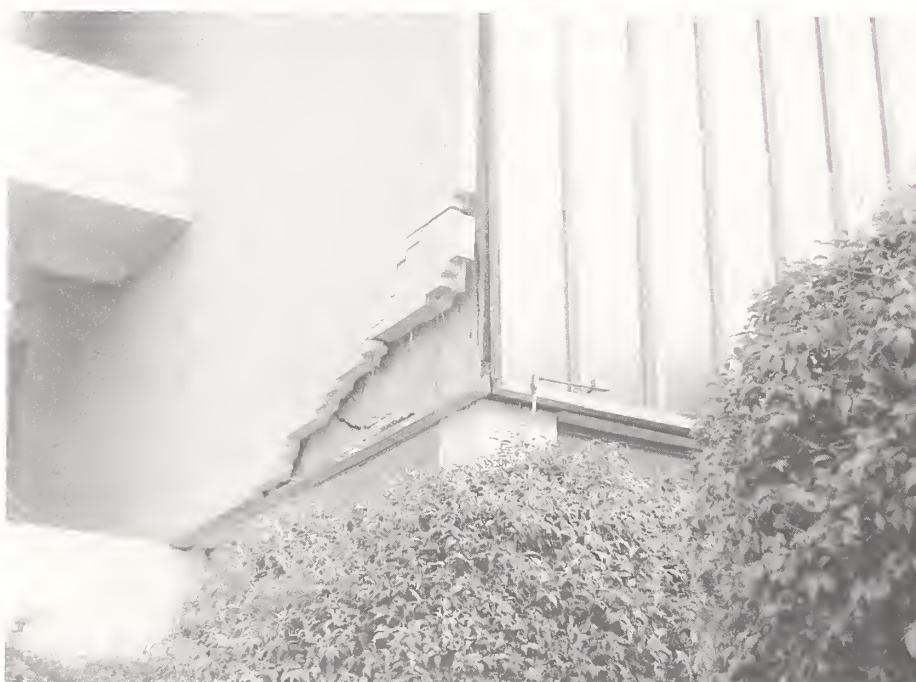
Figure 3.50. The similar west wall of was damaged, but did not peel away from the structure. This close up of the interface between the first and second stories shows that the masonry facade is supported on a steel angle. At the west end of the building, the facade was crushed at the toe where it is supported by the angle.

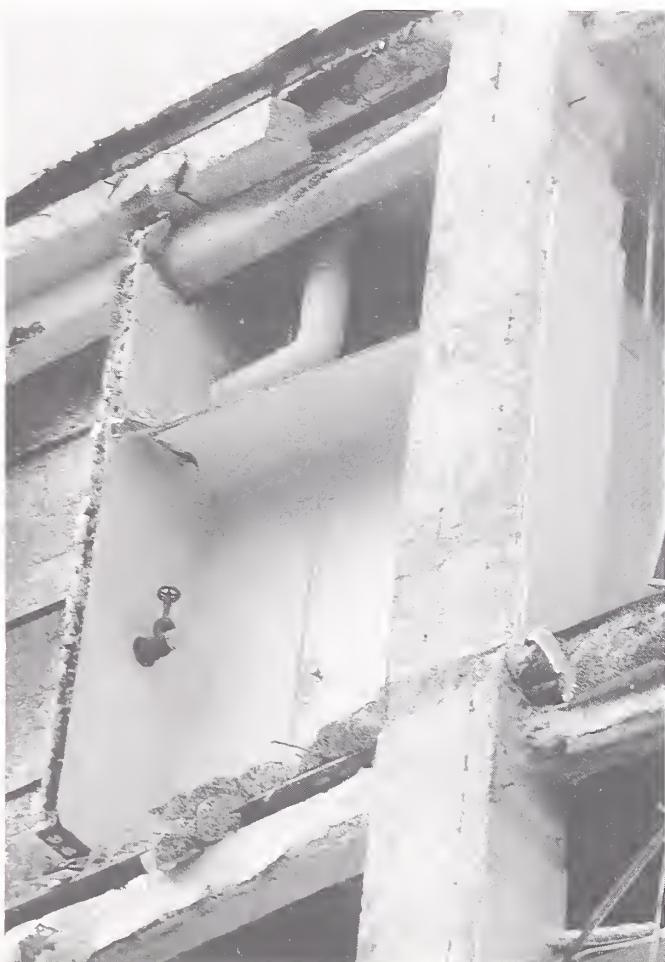
A steel-frame office building on the west side of Topanga Canyon Boulevard in Canoga Park, housing the American Savings Bank, experienced significant movement in its first story columns, apparently swaying in a north-south direction during the quake. It did not return to its original position, but suffered a permanent offset to the north (fig. 3.52). A nearly identical building on the same site, oriented at right angles to the first, had only minor damage to glass at the first

story. The first-story column heights of the two building differed significantly: the columns in the undamaged building were noticeably shorter than the columns in the damaged structure. The damaged building illustrates the classic problem of a "soft" first story. It is interesting to note that several glass-clad high-rise buildings in the vicinity showed no evidence of damage.

Figure 3.52. The first-story columns of the steel-framed building housing the American Savings Bank on Topanga Canyon Road in Canoga Park flexed during the quake and ended up slightly displaced from their original positions.

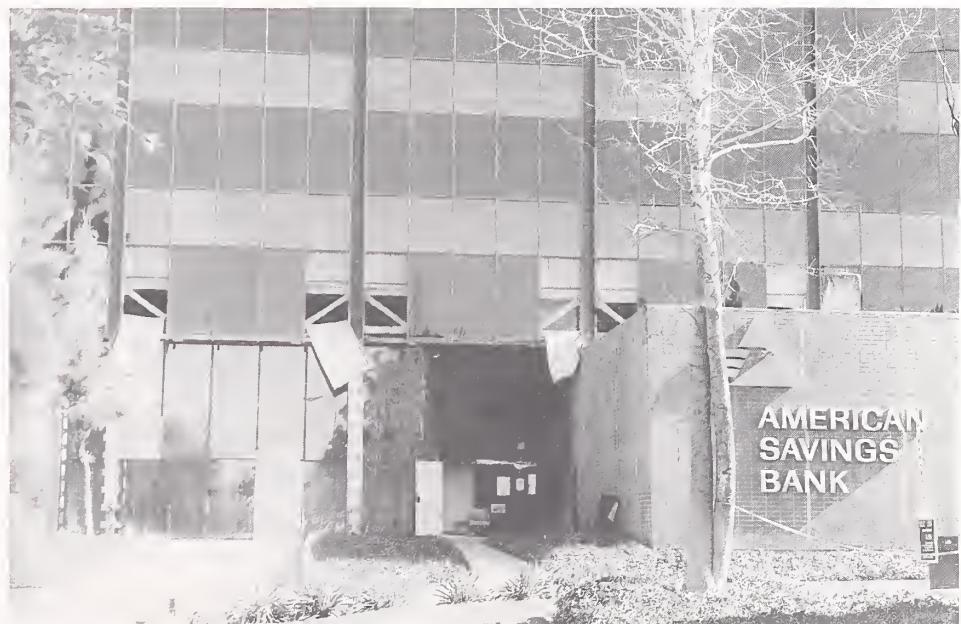
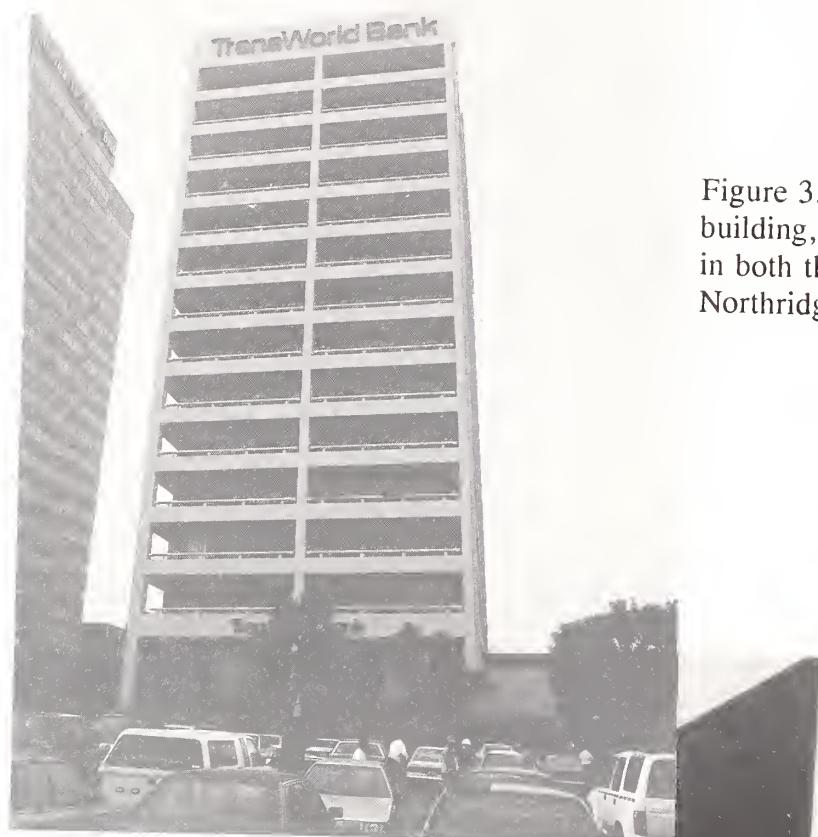
The business district along Ventura Boulevard in Sherman Oaks was another area with significant numbers of badly damaged buildings. The 13-story Trans World Bank Building is located at 15233 Ventura Boulevard (fig. 3.53). There is a two-level underground garage below the building and a mechanical penthouse on the roof. This reinforced concrete frame building was designed under the 1964 Los Angeles City code. Structural damage was in the first-story columns, primarily at the second-floor beam-column joints. Identical failures occurred during the 1971 San Fernando earthquake. The damaged joints were repaired with epoxy shortly after the 1994 earthquake (fig. 3.54).

Figure 3.53. The Trans World Bank building, in Sherman Oaks, was damaged in both the 1971 San Fernando and 1994 Northridge earthquakes.
