NIST Special Publication 862

1994 Northridge Earthquake Performance of Structures, Lifelines, and Fire Protection Systems

*Diana Todd, Nicholas Carino, Riley M. Chung, H. S. Lew, Andrew W. Taylor,
William D. Walton, James D. Cooper, and Roland Nimis*

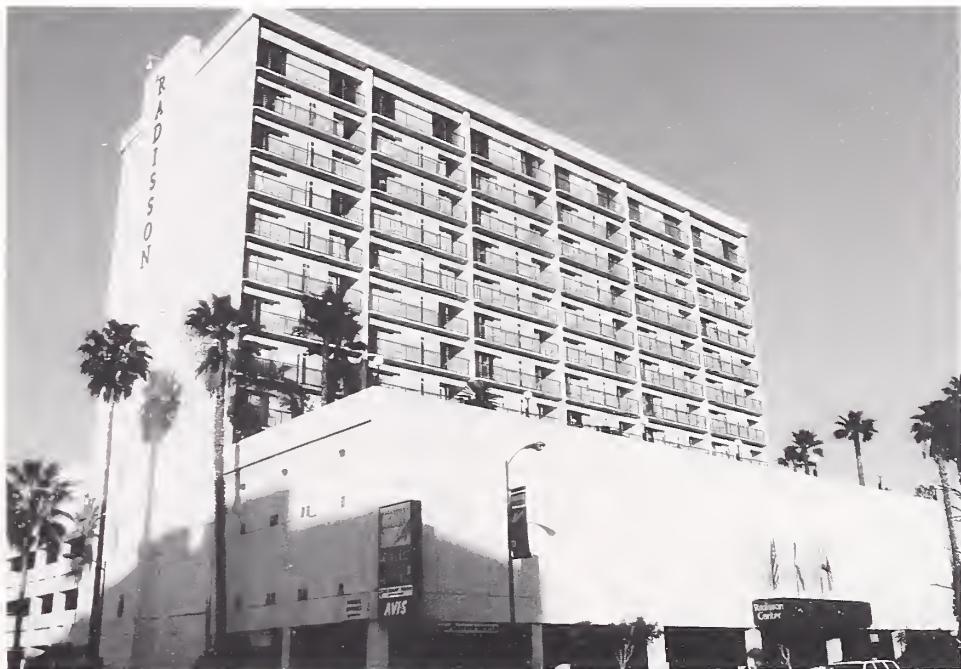
The Radisson Valley Center Hotel is located at 15433 Ventura Boulevard in Sherman Oaks (fig. 3.55). This 13-story concrete structure sustained serious damage to columns located at the first and fifth stories. Exterior columns which support the three-story appendage at the front of the hotel were also damaged (fig. 3.56)

Figure 3.55. The concrete Radisson Valley Center Hotel in Sherman Oaks had serious damage to the columns at the first and fifth stories.

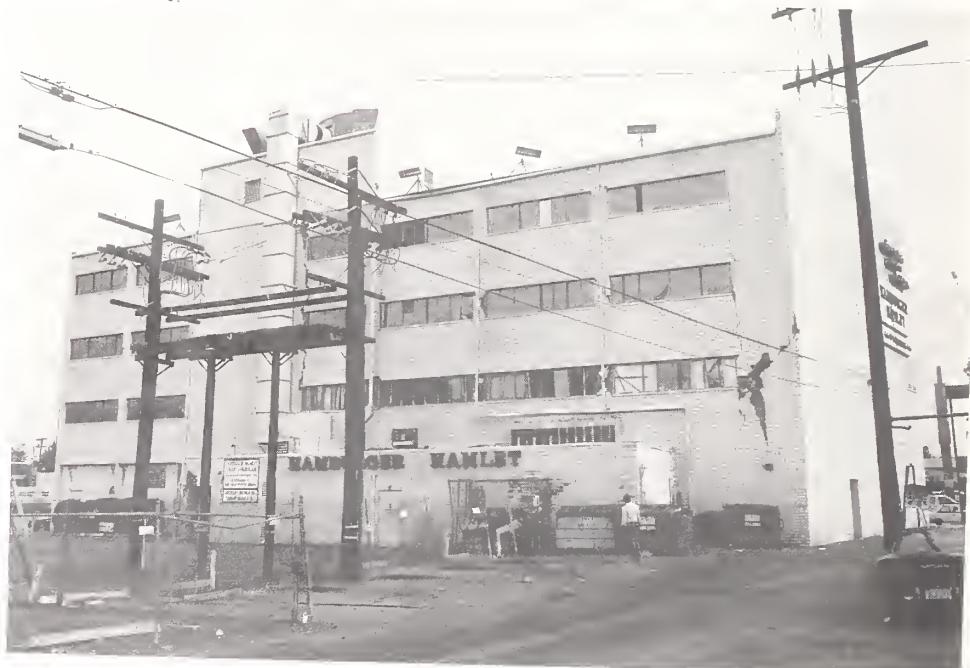
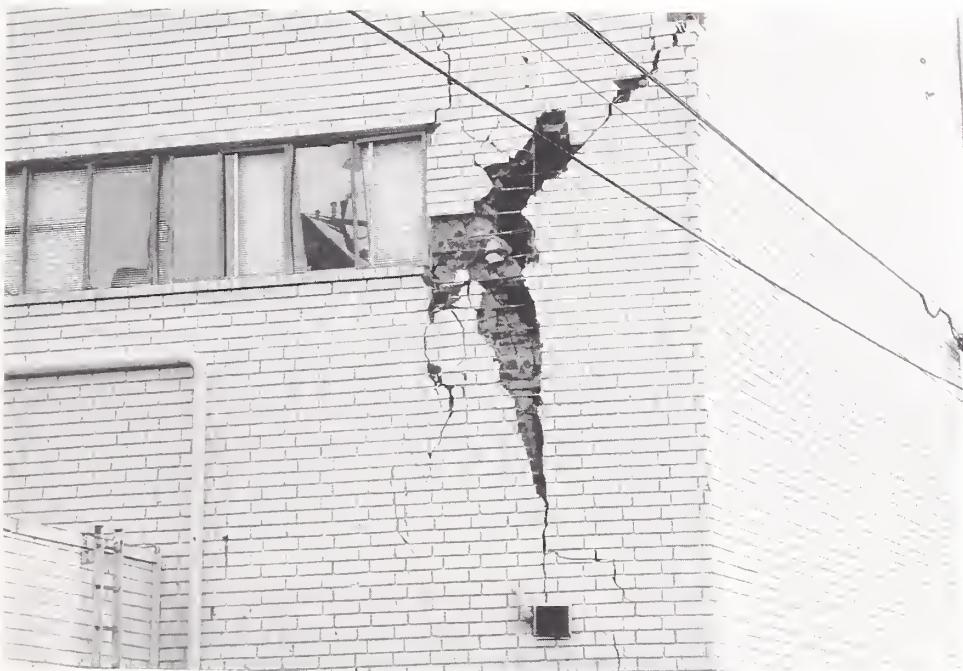
A four-story steel frame structure located at the intersection of Moorpark Street and Cedros Avenue in Sherman Oaks was shaken seriously during the earthquake (fig. 3.58). The exterior reinforced masonry wall was cracked in many places, particularly at the second floor level (fig. 3.59). The evidence of large ground shaking in the Sherman Oaks area was also seen by serious lateral displacements of single family houses and three-story apartment buildings from their foundation. In fact, a strong-motion instrument station in Tarzana located only a few kilometers away from this general area recorded the largest acceleration in this earthquake (1.82g horizontal, 1.18g vertical).

Figure 3.59. A close-up view of the damage shows the pattern of reinforcing used in the masonry facade.

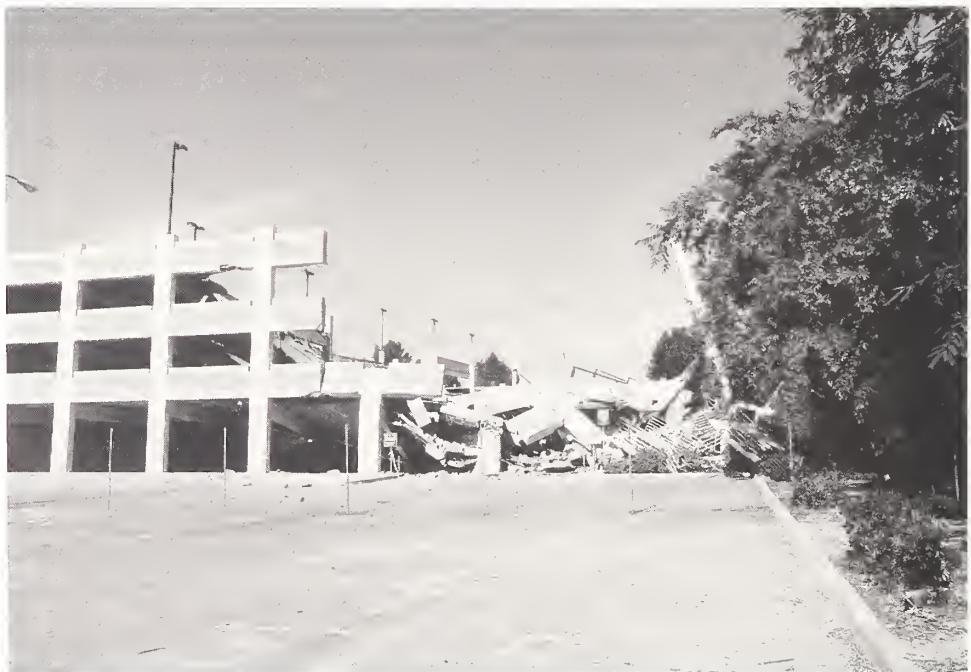
The collapse apparently started at the interior of the building. The exterior perimeter frame was pulled over towards the center of the structure (fig. 3.60), suggesting that interior beams had lost their vertical support, causing the floor plates to collapse and pull the exterior walls in with them. While some interior columns had collapsed, others were left intact, jutting up above the fallen floor slabs (fig. 3.61).

Figure 3.61. Some interior columns of the Northridge campus parking garage remained standing.

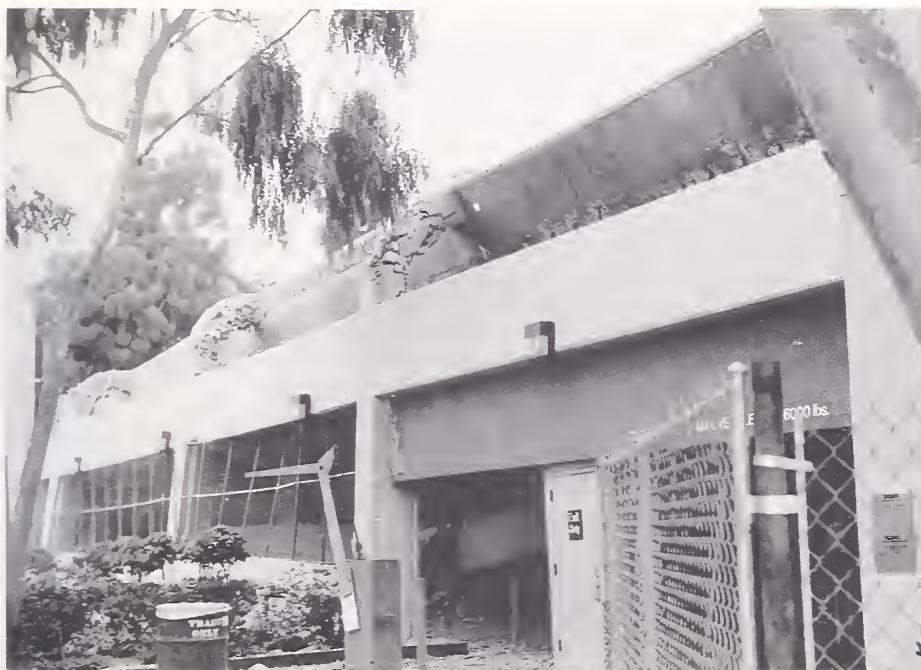
The five-level parking garage at the Kaiser Permanente medical complex on Cadillac Avenue in West Los Angeles experienced a similar collapse. All four facades were pulled inward, suggesting that an interior failure precipitated the damage (fig. 3.62). This garage was a post-tensioned cast-in-place concrete structure with shear walls providing the lateral-force resisting system at the east and west ends, and moment frames at the north and south perimeter. The shear walls were cracked horizontally throughout their height due to the out-of-plane bending (fig. 3.63). There was minor diagonal cracking, suggesting that the lateral load was not fully transmitted to the shear walls. The stair towers remained standing. Typically, these towers are structurally isolated from the post-tensioned slab to minimize potential deformations in the towers due to creep and shrinkage in the post-tensioned slabs.

Figure 3.62. The cast-in-place concrete parking garage at the Kaiser Permanente Hospital complex in West Los Angeles collapsed in on itself. The moment frame that provided lateral resistance on the south face of the structure could not resist the out-of-plane forces apparently caused by the collapse of interior elements.

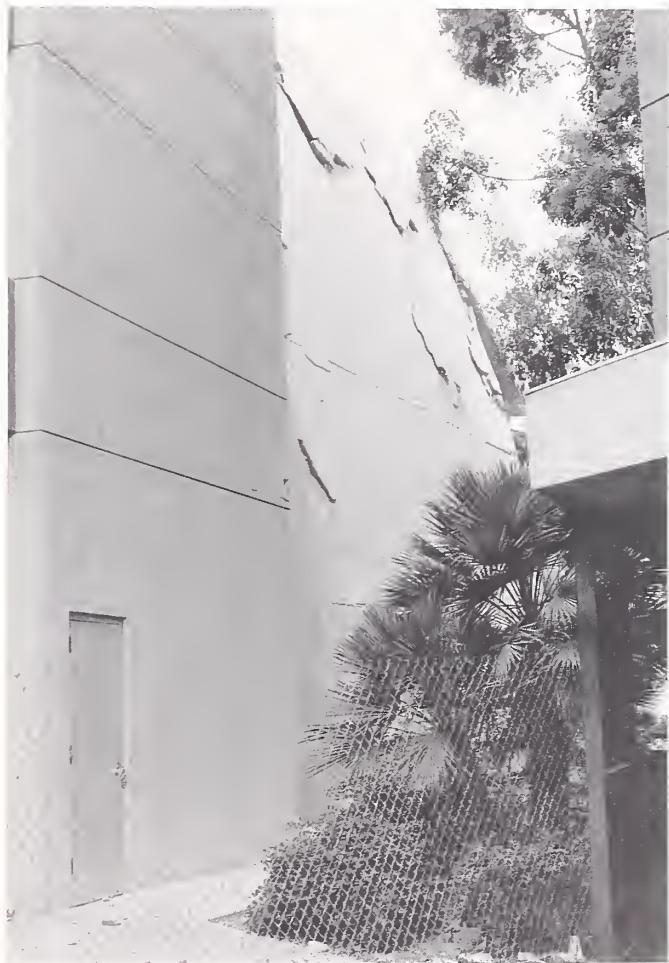
Figure 3.63. At the east and west faces of the Kaiser Permanente Hospital parking garage, shear walls made up the lateral force resisting system. Both walls had horizontal cracks caused by the out-of-plane bending when the walls were pulled inward. Neither wall had major diagonal cracking, suggesting that the lateral load was never fully delivered to the walls. The stair towers remained erect. The east wall and stair tower are shown here.

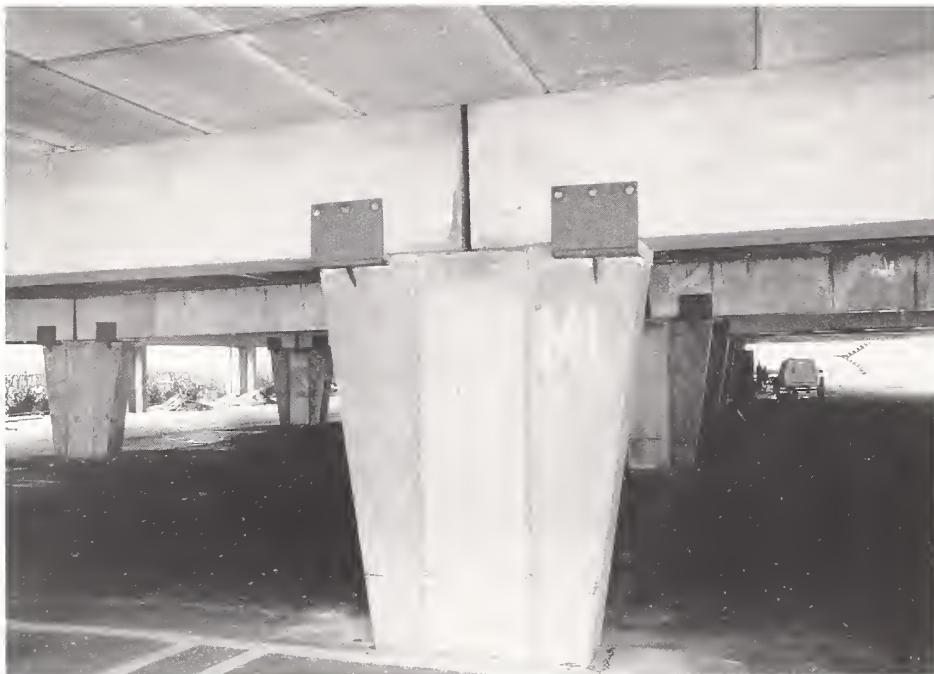
The two-level concrete parking structure adjacent to the Trans World Bank in Sherman Oaks had been seismically strengthened after suffering serious damage in the 1971 San Fernando quake. Flared extensions were cast next to the interior columns along their north-south axes (fig. 3.64), creating short wing walls supporting the precast beams. During the 1994 quake, the unrehabilitated exterior columns were badly cracked (fig. 3.65). The ramp was also heavily damaged. The interior columns were relatively undamaged.

Figure 3.64. The interior columns of the two-level parking garage at the Trans World Bank in Sherman Oaks had been seismically strengthened after it suffered damage in the 1971 San Fernando quake. The interior columns fared well in the 1994 Northridge quake.

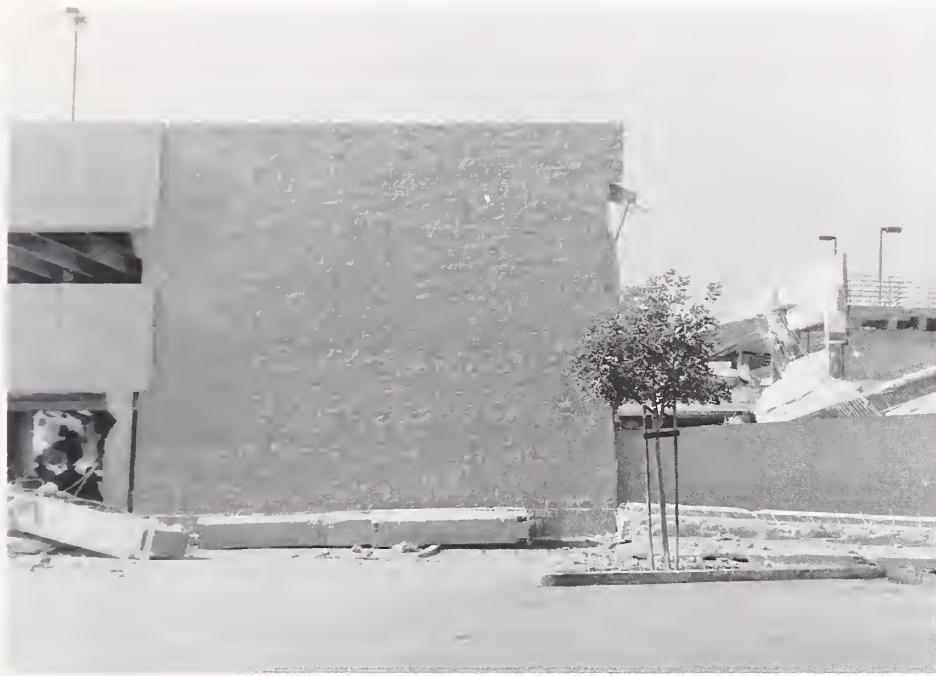
At the Northridge Fashion Center, three parking structures suffered damage. A large three-level concrete garage at the south end of the site, approximately 10 years old, suffered an almost complete collapse. The largely pre-cast concrete structure had intermittent shear walls which remained standing (fig. 3.66). The lack of diagonal cracks in these walls suggests that, like the walls at the Kaiser Permanente garage, they were never fully loaded. A similar, but smaller, precast garage at the north end of the Northridge Fashion Center also partially collapsed (fig. 3.68). At the east end of the site, an older two-level cast-in-place concrete garage showed

Figure 3.66. At the Northridge Fashion Center, major portions of the three-level south parking garage collapsed. The garage was precast concrete with intermittent shear walls. Most of the shear walls remained standing, largely undamaged, indicating that the lateral load was not adequately transmitted to these walls.

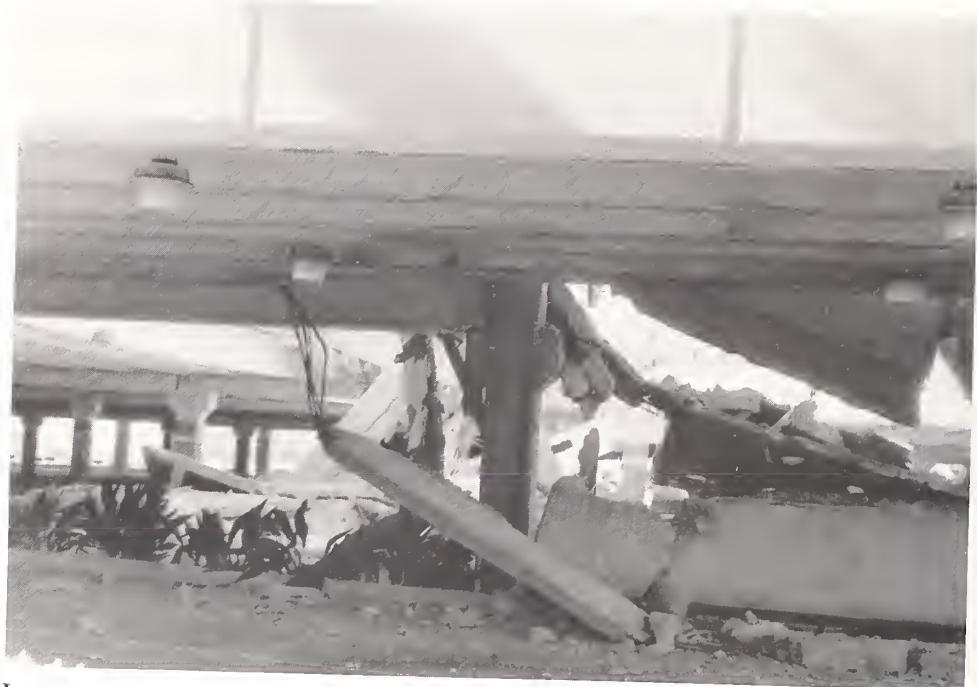
Figure 3.68.

Common types of damage in other parking garages included shear-failure in unintentional short columns created by ramps or split-level decks (fig. 3.67) and collapsed decks caused by inverted-T's or concrete planks pulling off supports (fig. 3.68).

In precast parking garages, the support of the double-tees that comprise the floors is a vulnerable link in the system. This garage, at the north end of the Northridge Fashion Center, illustrates a common failure: the double-tees pulled off their supports, leaving the supporting elements essentially intact.

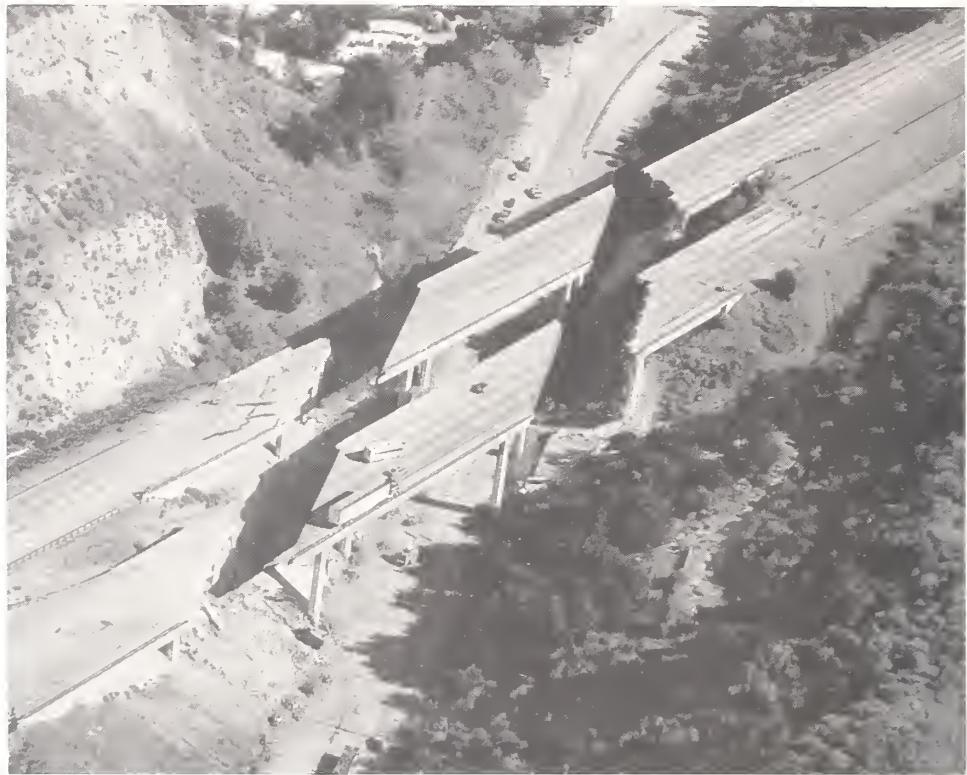
This bridge was designed in 1964 and constructed in 1967. It carries Interstate 5 over Gavin Canyon, about 3 km (2 mi) north of the intersection of Interstate 5 and State Route 14. An aerial photograph of the damaged bridge, after demolition had begun, is shown in figure 4.2, and a ground level view is shown in figure 4.3. Schematic structural drawings are shown in figures 4.4 and 4.5. The structure consists of two parallel bridges, with about a 66 degree skew alignment. Each bridge is composed of five spans. Each bridge has four two-pier bents, and there is a structural hinge near each of the two center bents (figs. 4.3 and 4.4). The superstructure consists of reinforced concrete box girders, and the central portion (between hinges) is post-tensioned. The bridge survived the 1971 San Fernando earthquake with virtually no damage. In 1974, the hinges were retrofitted with cable restrainers, as shown in figure 4.5. The seat length at the hinges is 200 mm (8 in), which by current design standards would be considered inadequate, especially for a structure of this size and flexibility.

Despite the presence of cable restrainers at the hinges, failure of three of the four end spans of the bridge was apparently initiated by the spans falling off the hinge seats. The fourth end span, at the far western corner of the bridge, partially came off its hinge seat but did not collapse, as indicated in figure 4.4. After support was lost at the hinges, a triangular portion of three of the end spans collapsed, as shown in figure 4.4. Demolition of the remaining portions of the end spans was carried out very soon after the earthquake, as shown in figure 4.2. It is likely that the skewed alignment of the bridge was an important contributing factor in this failure. The skewed alignment permitted rotation of the superstructure in a counter-clockwise direction, when viewed from above. The tall, flexible piers of the two center bents would have offered relatively little resistance to rotation in a horizontal plane. (EERC reconnaissance team members noted cracking patterns at the bases of the piers, which may have been evidence of such rotation [5]). Rotation of the superstructure would have resulted in differential displacements at the hinges, and eventually unseating of the end spans at the hinges. Demolition of the bridge was completed a few days after the earthquake.

Figure 4.2. Aerial view of the bridges at Gavin Canyon, looking to the east, showing appearance of the four end spans shortly after demolition had begun.

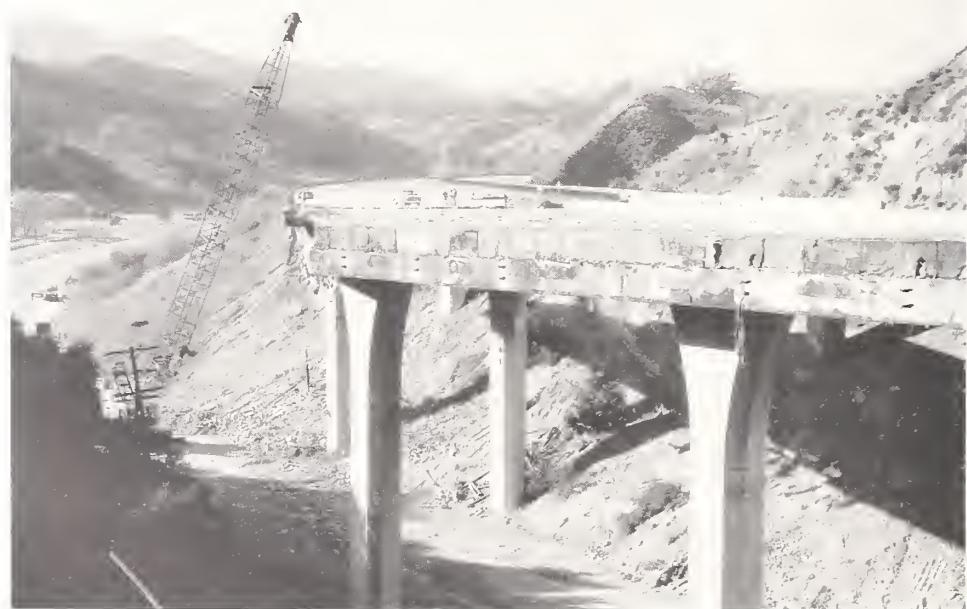
Figure 4.3. Ground level view of the southbound bridge at Gavin Canyon, looking to the northwest, showing the hinge bearing seat near Bent 3.

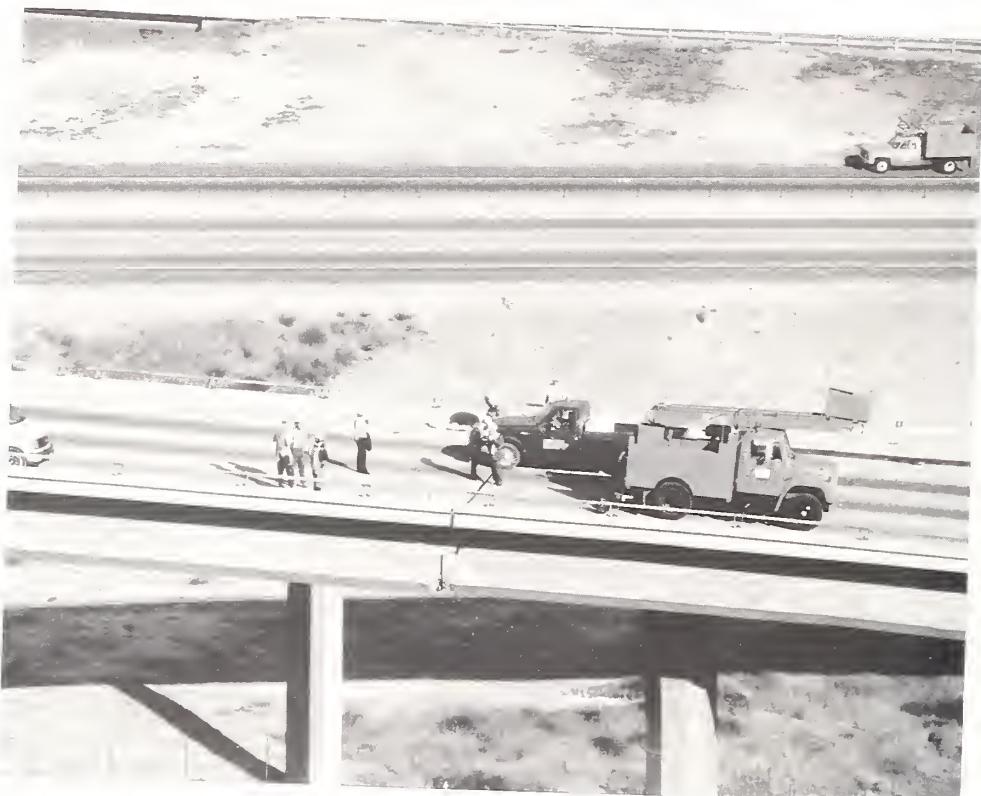
Figure 4.7. Example of pounding and offset at a hinge in the SR14/I5 interchange.

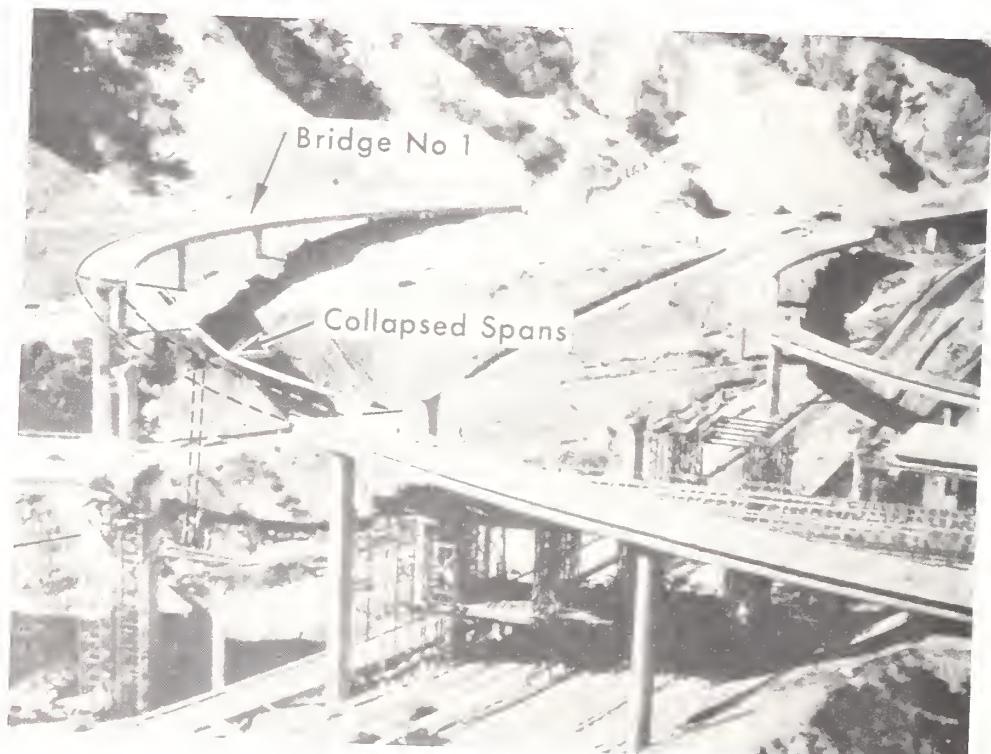
This interchange was designed in 1968 and was under construction in 1971 when portions were damaged by the San Fernando earthquake. At that time, one of the completed ramps in the interchange collapsed, and two ramps which were under construction were damaged. The portion which collapsed in 1971 was the South Connector Overcrossing, connecting southbound I5 with eastbound SR14. A photograph of the collapsed ramp, taken in 1971, is shown in figure 4.8. This ramp was later rebuilt, with improved pier reinforcement, and it suffered no significant damage in the Northridge earthquake. The damaged portions of the other two ramps under construction in 1971 were repaired in place, but not strengthened; the portions not yet constructed were completed with limited seismic upgrading. Both of the ramps which partially collapsed in the Northridge earthquake were under construction at the time of the 1971 earthquake.

Figure 4.8. SR14/I5 interchange after the 1971 San Fernando earthquake. View looking to the west, showing collapsed South Connector Overcrossing.

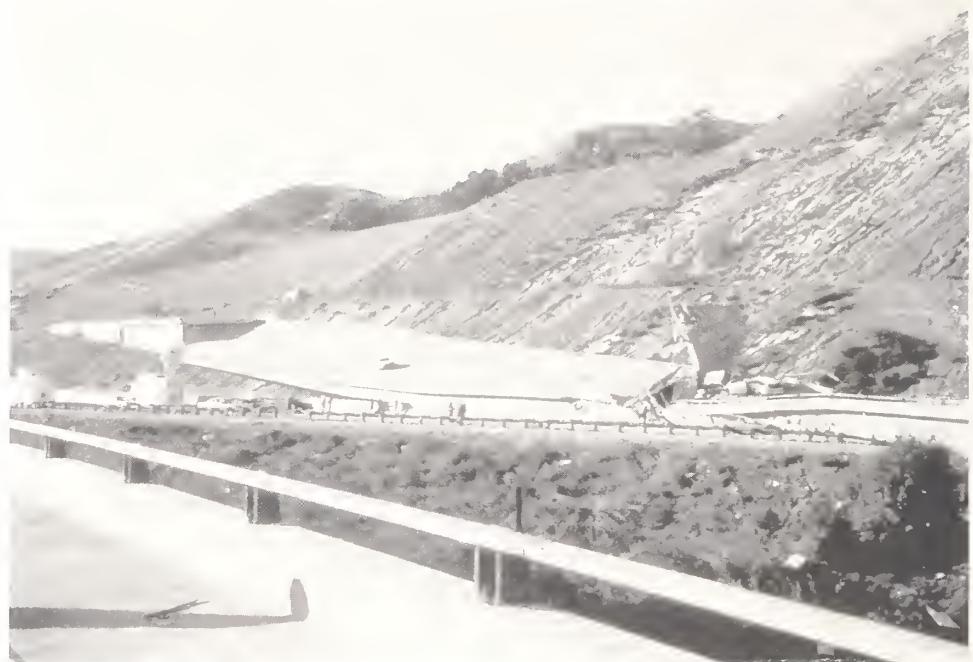
Figure 4.11. Overview of the collapse of the SR14/I5 Separation and Overhead, Ramp C, looking to the south at Abutment 1. Pier 3 can be seen at the right of the photograph (Photo courtesy of EERC).

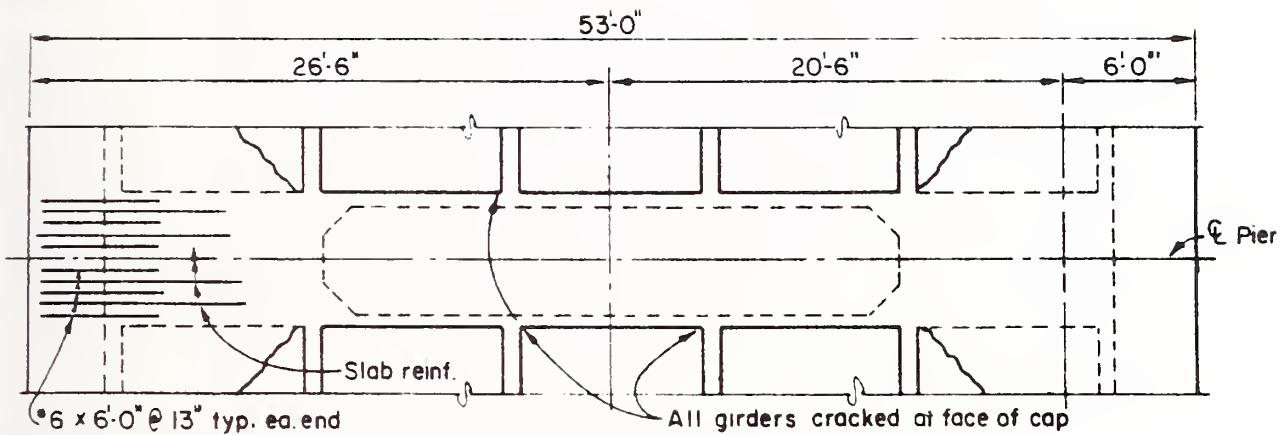
Figure 4.13. Cracking reported at Piers 2 and 3 following the 1971 San Fernando earthquake (reproduced from "The San Fernando Earthquake: Field Investigation of Bridge Damage," State of California, 1971).

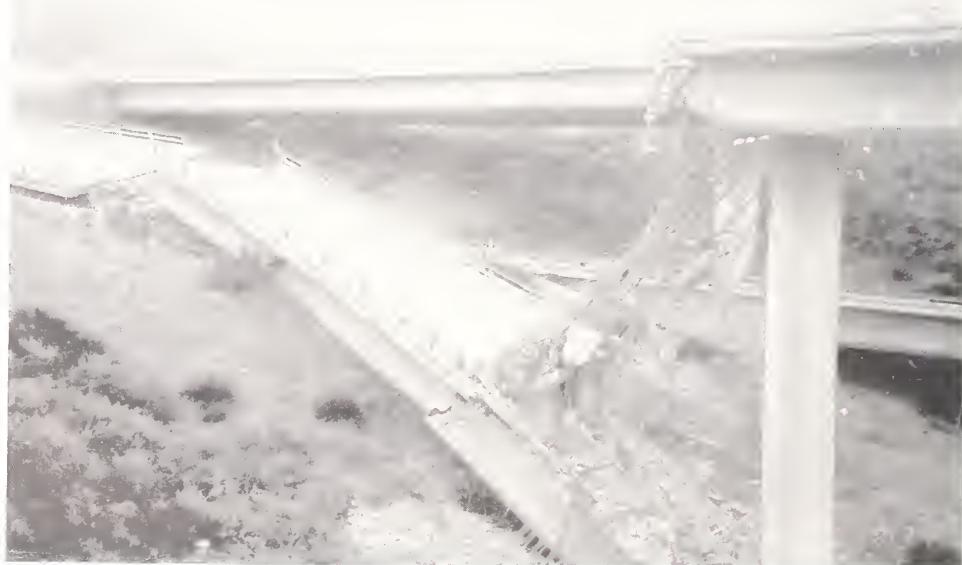
This ramp was designed in 1968 and constructed in 1971. Photographs of the collapsed portion of the ramp are shown in figures 4.14 and 4.15. Plan and elevation views of this ramp are shown in figure 4.17. The portion of the ramp which collapsed was located between Abutment 1 and Pier 3. As with the Separation and Overhead Ramp C, described above, this ramp was under construction in 1971. However, unlike Ramp C, this ramp was nearly completed when the San Fernando earthquake occurred. Only the portion from the hinge near Pier 8 to Abutment 11 remained to be constructed. The portion which collapsed in the Northridge earthquake, between Abutment 1 and Pier 3, was already constructed when the San Fernando earthquake occurred. Only minor damage to this ramp was reported following the 1971 earthquake [23]. This damage consisted of permanent offsets at the hinges near Piers 4 and 6.

The collapse in the Northridge earthquake appears to have been initiated by the failure of Pier 2. After Pier 2 failed, the simply supported span between Abutment 1 and the hinge near Pier 2 collapsed, and, as shown in figure 4.15, the superstructure failed near Pier 3 due to a large negative moment. Pier 2 completely disintegrated, as shown in figure 4.16. This is the shortest pier in the structure, so it is likely that it attracted a high level of lateral force, was damaged in shear, and finally collapsed in compression. Pier 10 is similar in height to Pier 1, but the quantities of lateral reinforcement in Pier 10 are greater than those in Pier 1, as shown in figure 4.18. This is because Pier 2 had already been completed, but Pier 10 had not yet been constructed, when the 1971 earthquake occurred. Following the 1971 earthquake the plans for Pier 10 were revised to provide increased lateral reinforcement, as shown in figure 4.18.

Figure 4.14. Collapsed portion of the SR14/I5 North Connector Overcrossing, looking east. Pier 2 was at the left, near the broken hinge on the ground (Photo courtesy of EERC).

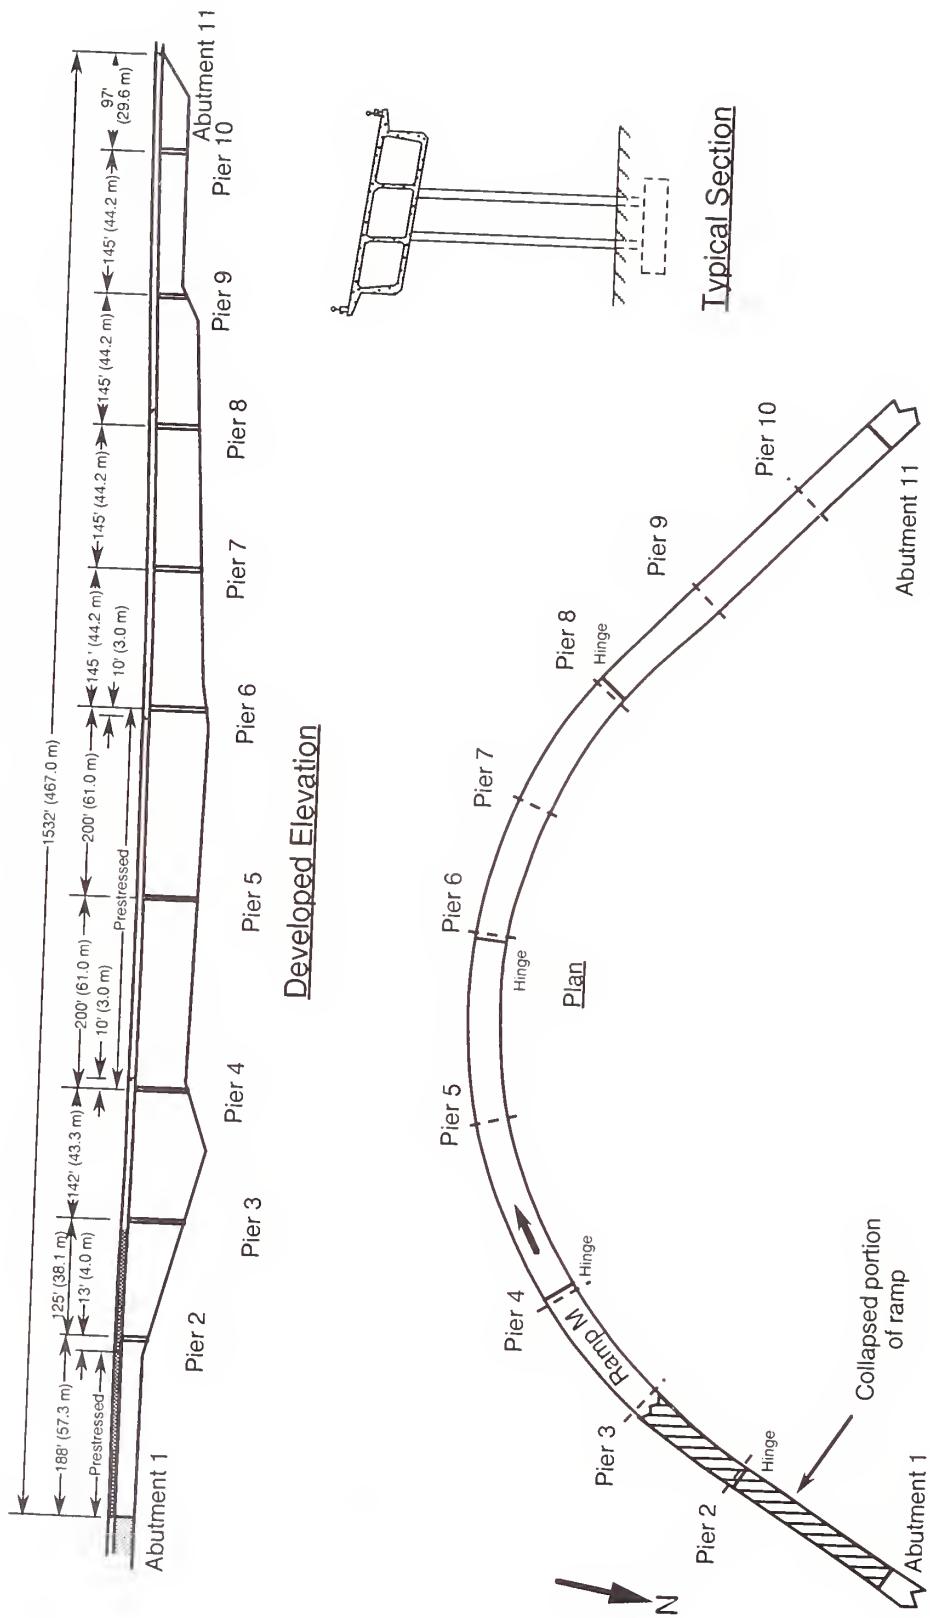
North Connector Overcrossing, Ramp M - SR14/I5 Interchange

Figure 4.17. Plan and elevation view of the SR14/I5 North Connector Overcrossing.

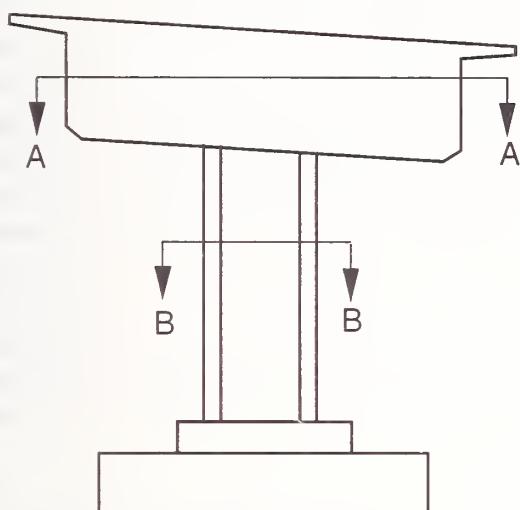
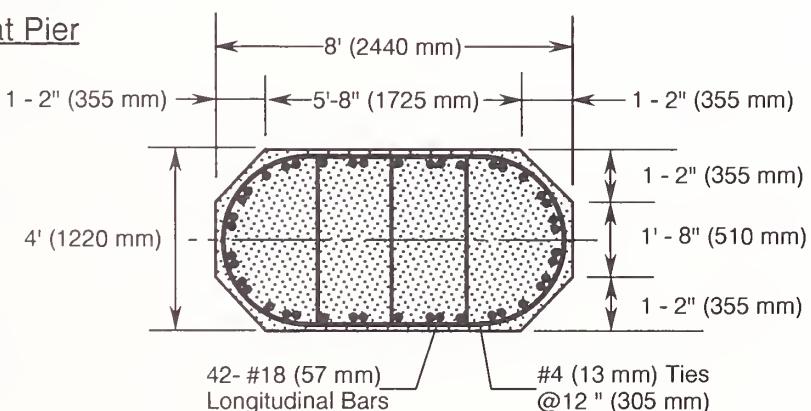
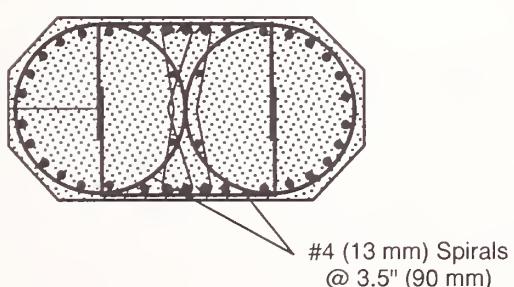
SR14/I5 North Connctor O C Ramp M - Pier 2

Figure 4.18. Reinforcement details for Pier 2 of the SR14/I5 North Connector Overcrossing, Ramp M.

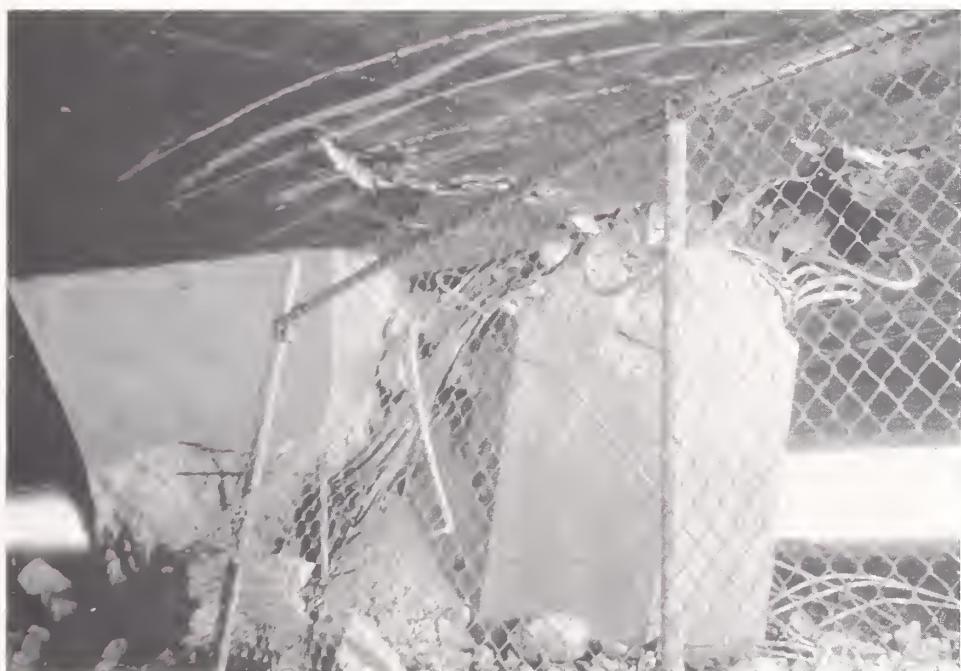
The likely failure mode of the bridge was that the piers initially suffered severe shear damage, followed by crushing of a number of piers in compression. The structure may also have shifted to the southwest, as constrained by the geometry of the abutments. Although unseating at Abutment 5 did occur, this was probably a secondary effect, as the seat lengths were generous by current standards. Rather, failure was probably initiated by damage to the piers. In this case the failure of piers has important theoretical implications, as the piers of this bridge contained quantities of lateral reinforcement similar to those required by current seismic design standards. Therefore, further research will be required to determine why the pier reinforcement was inadequate in this case.

Figure 4.22. Damage to a pier of the SR118 Mission-gothic Undercrossing, looking to the west at Bent 4 of the eastbound bridge, which collapsed (Photo courtesy of EERC).

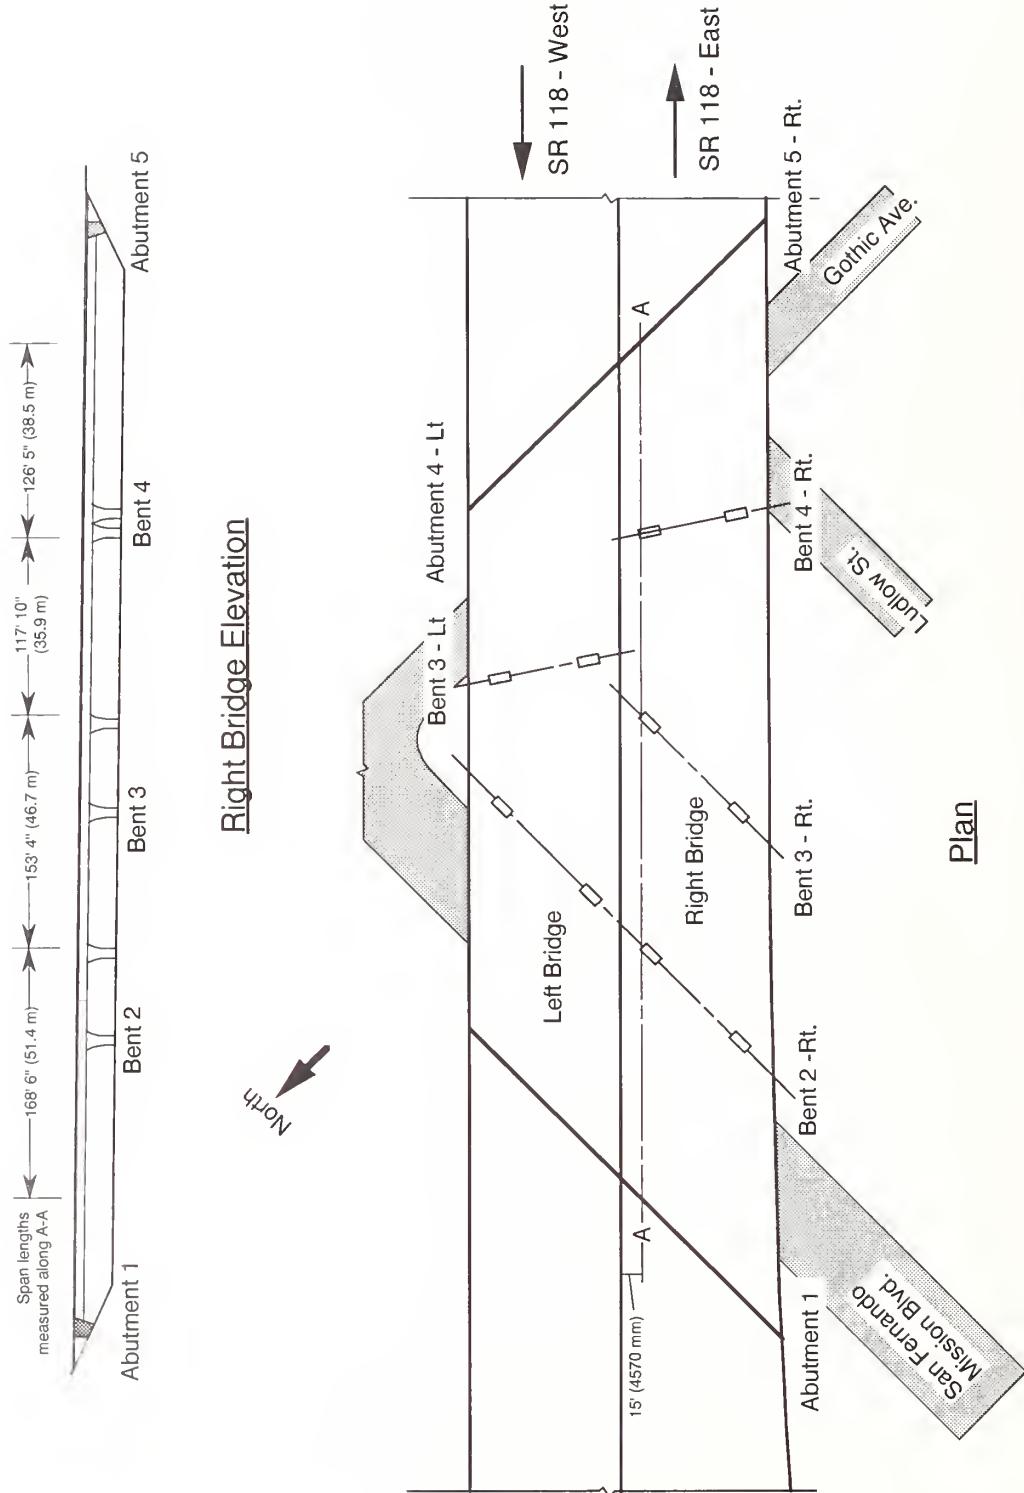
SR 118 - Mission-Gothic Undercrossing

The first important feature of the bridge is its irregular geometry. Figure 4.23 shows that the plan shape of the bridge is a trapezoid. Thus, because of the orientations of the abutments, the structure was constrained to move in only one lateral direction during the earthquake, roughly to the southwest. Indeed, figures 4.21 and 4.22 show that the superstructure moved in this direction, creating a diagonal shear failures in many of the piers. There is also a highly irregular placement of piers, dictated in part by the trapezoidal plan shape of the bridge, and in part by right-of-way restrictions. The irregular plan shape and placement of piers created asymmetric stiffness and mass distributions, which undoubtedly lead to some piers being more heavily loaded than others during the earthquake. Detailed analyses will be required to determine how lateral earthquake loads were distributed among the piers.

Figure 4.23. Plan and elevation views of the SR118 Mission-Gothic Undercrossing.

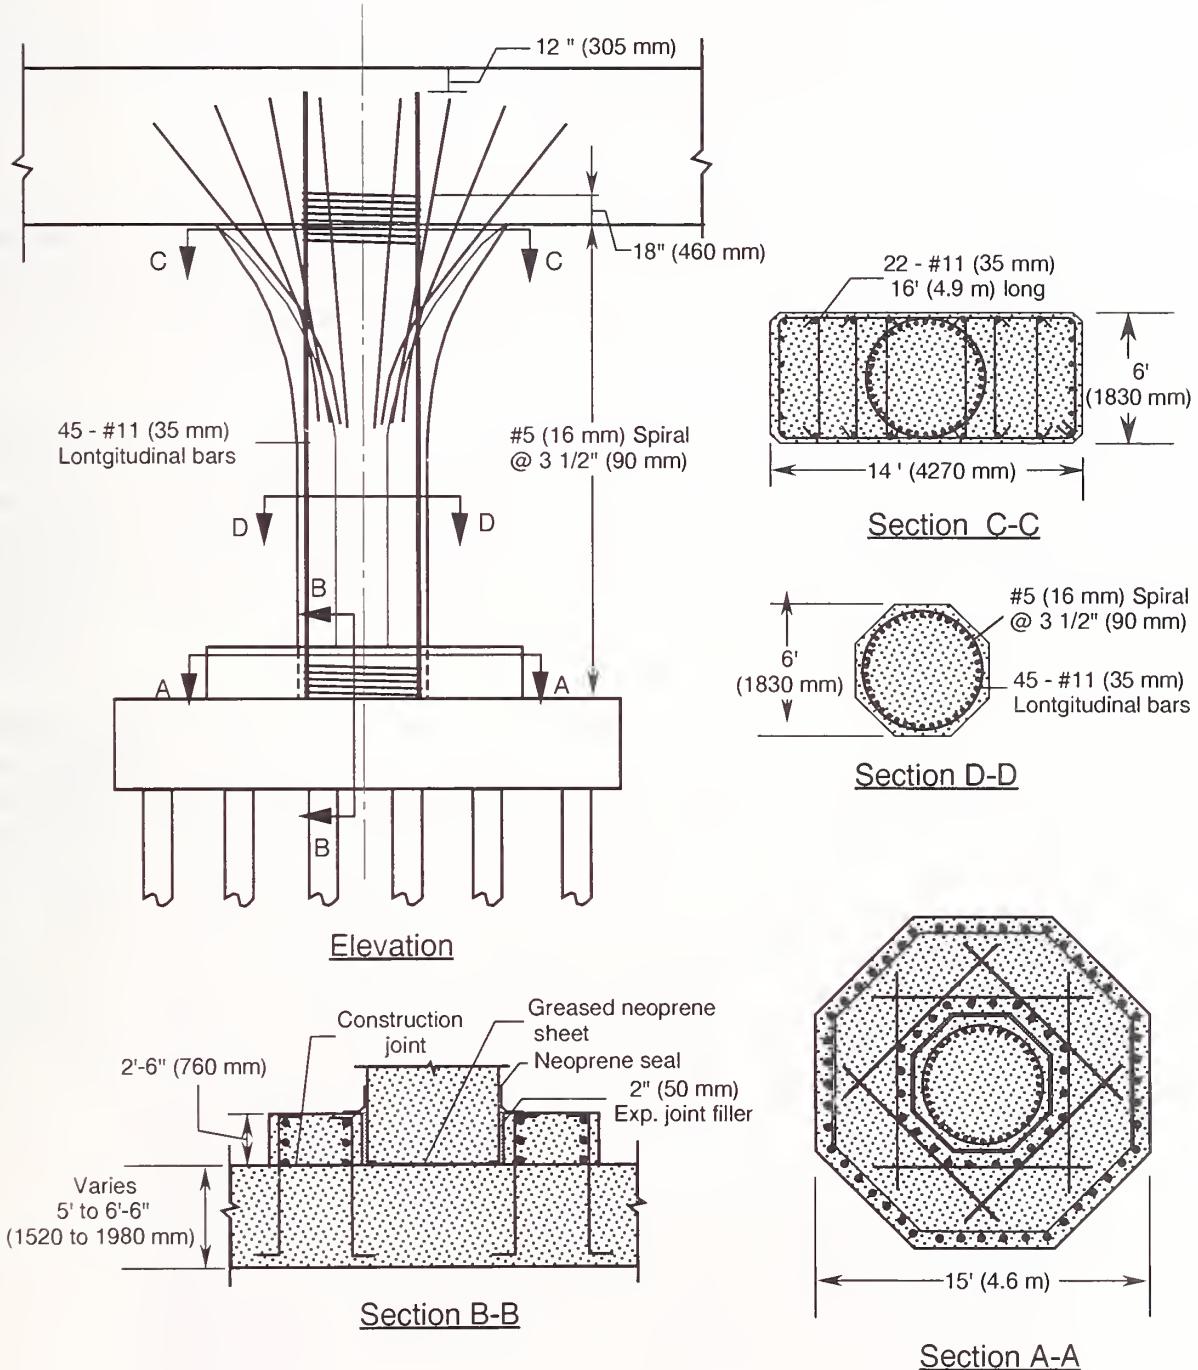
SR 118 - Mission-Gothic Undercrossing Pier Details

The second, and perhaps more important, feature of this bridge is the geometry of the bridge piers. Pier details are shown in figure 4.24. The piers were all relatively short, roughly 7200 mm (24 ft) tall by 1800 mm (6 ft) across, making an aspect ratio of only 4:1. However the piers also featured architectural flares at the tops, roughly 3600 mm (12 ft) tall. These flares were intended to be non-structural features of the piers . It was believed that the flares would spall or otherwise deteriorate during earthquake loading so that they would not contribute to the bending stiffness of the piers. However, it is clear that in actual performance the flares created a zone of added stiffness, reducing the aspect ratio of the piers to approximately 3:1. Thus the piers were very stiff laterally, and were dominated by shear rather than bending. The detail at the footing/pier interface was also somewhat unusual for this bridge. Figure 4.24, section B-B, shows that the base of the pier rested inside a collar at the top of the pier footing. This detail was intended to permit free translation of the pier base during post-tensioning operations of the superstructure, before the collar was cast. The detail also had the effect of creating a hinge at the pier base. It is not immediately apparent whether this hinge improved or worsened the seismic performance of the bridge, although for a given lateral force the bending moments at the tops of the piers were greater than if the hinges at the bases of the piers had not been present.

Figure 4.24. Pier details for the SR118 Mission-Gothic Undercrossing.

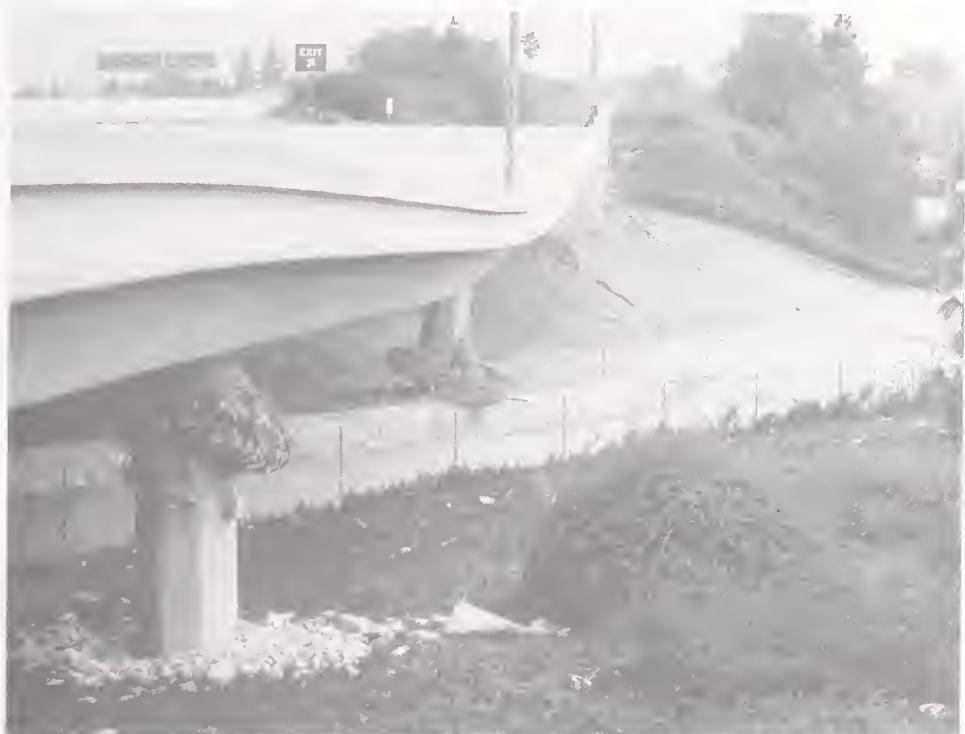
All ten of the piers in Bent 3 failed in combined shear and compression near their bases, as shown by figures 4.27 and 4.28. In Bent 2, Piers on the south side of the span failed near their top end, as shown in the left foreground of figure 4.26, and the damage became progressively less for piers to the north in Bent 2. The farthest north piers in Bent 2 showed relatively little damage - only diagonal shear cracks near the base, with no spalled concrete. This uneven distribution of damage to piers was probably caused by the asymmetric plan geometry of the bridge, as shown in figure 4.29.

Figure 4.26. Ground-level view of State Route 118 at Bull Creek Canyon Channel, looking along the south edge, towards the east.

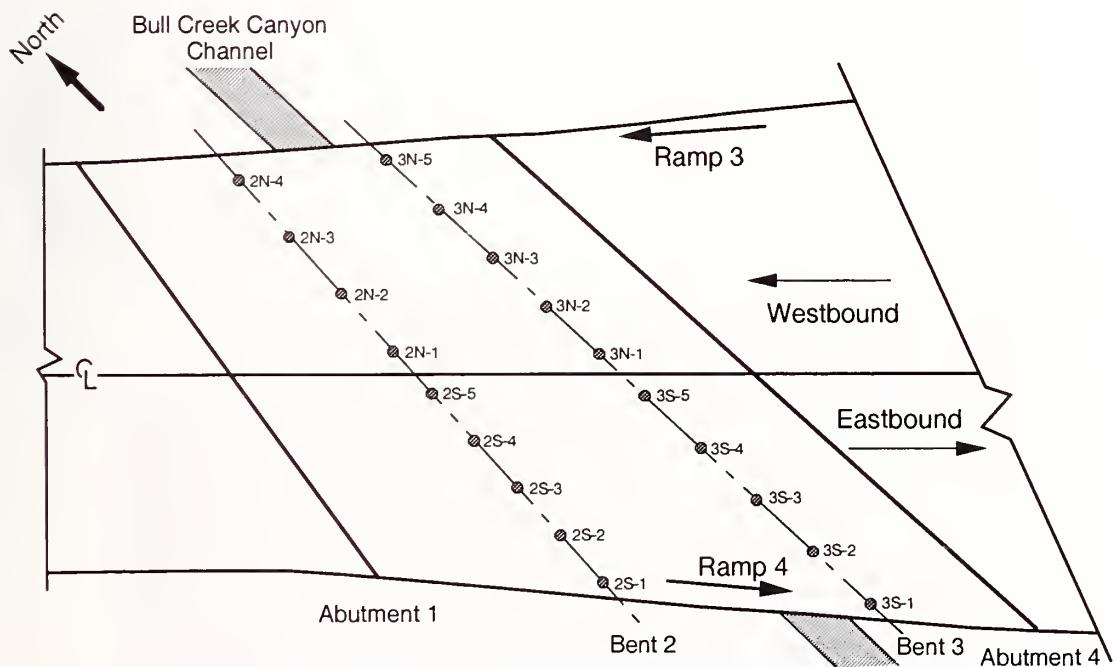
Figure 4.29. Plan and elevation views of State Route 118 at Bull Creek Canyon Channel.
