NIST Special Publication 862

1994 Northridge Earthquake Performance of Structures, Lifelines, and Fire Protection Systems

*Diana Todd, Nicholas Carino, Riley M. Chung, H. S. Lew, Andrew W. Taylor,
William D. Walton, James D. Cooper, and Roland Nimis*

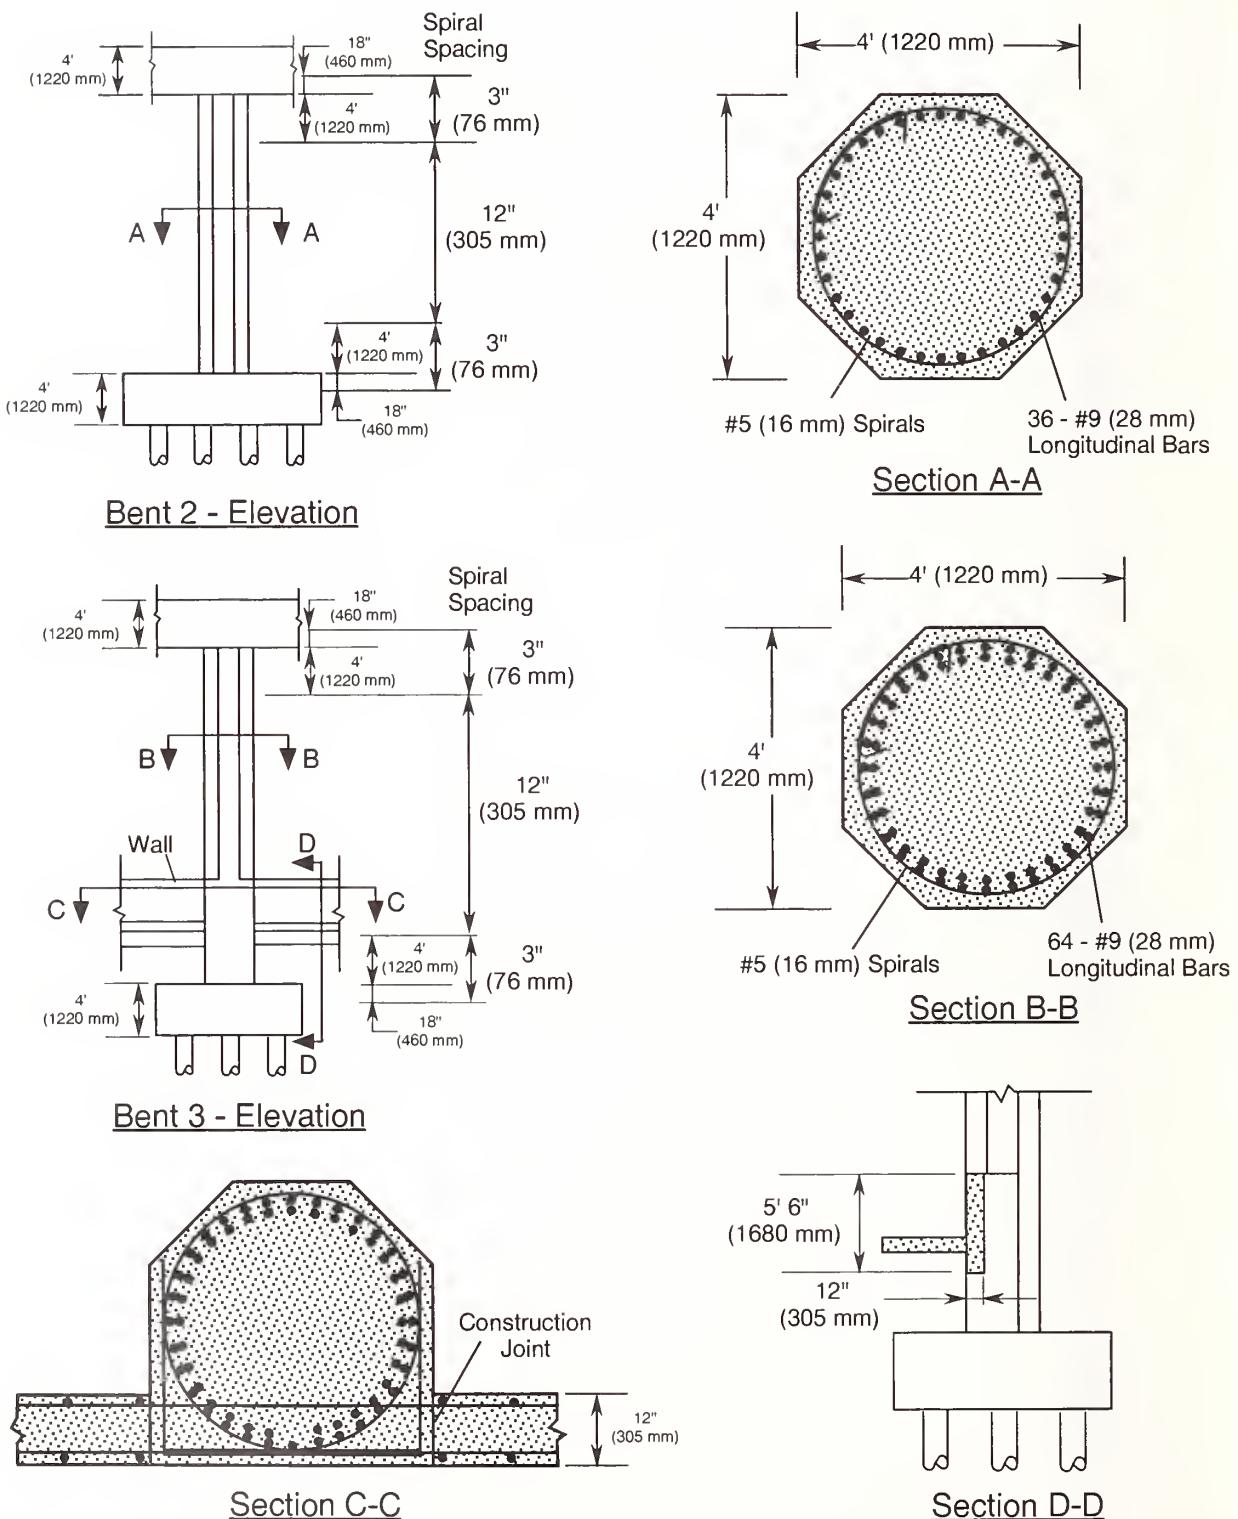
SR 118 Bull Creek Canyon Channel Bridge Piers

The confining reinforcement in the piers, shown in figure 4.30, is inadequate by current standards. Spiral confining hoops were spaced at 76 mm (3 in) near the top and bottom of each pier (presumably to provide confinement in potential plastic hinge regions), but the spacing was 305 mm (12 in) over most of the pier height. All pier failures occurred in the zone of wide spiral spacing. Another factor contributing to pier failure was that the effective lengths of the piers were much shorter than the distance between the footings and the girder soffit. The lengths of piers varied between roughly 6000 and 9100 mm (20 and 30 ft). In Bent 2, the effective pier lengths were decreased roughly one-third by compacted backfill soil above the pier footings. In Bent 3, the pier lengths were also decreased roughly one-third, but by a reinforced concrete channel liner wall, which was cast abutting the piers (fig. 4.30, section C-C). The shortened effective pier length resulted in stiffer piers, which were more susceptible to shear-dominated failure than bending-dominated failure.

Figure 4.30. Pier details for State Route 118 at Bull Creek Canyon Channel.

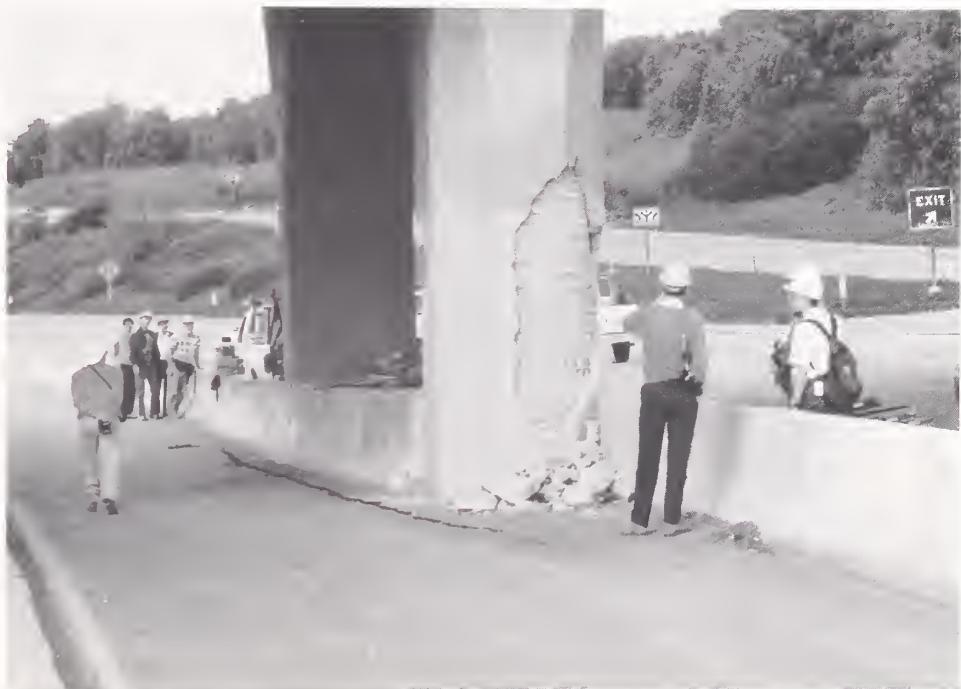
The good seismic performance of this bridge can probably be attributed to two factors. First, the central piers performed well because they contained adequate confining reinforcement and they were slender enough that they were not prone to a shear-dominated failure mode. Second, the overall geometry of the bridge is fairly compact, so that much of the lateral forces were carried by the abutments rather than the central piers. It is not common to see extensive seismic damage to short-span overpasses of this type.

Figure 4.31. SR118 Ruffner Ave. Overcrossing, easternmost central pier, looking to the west.

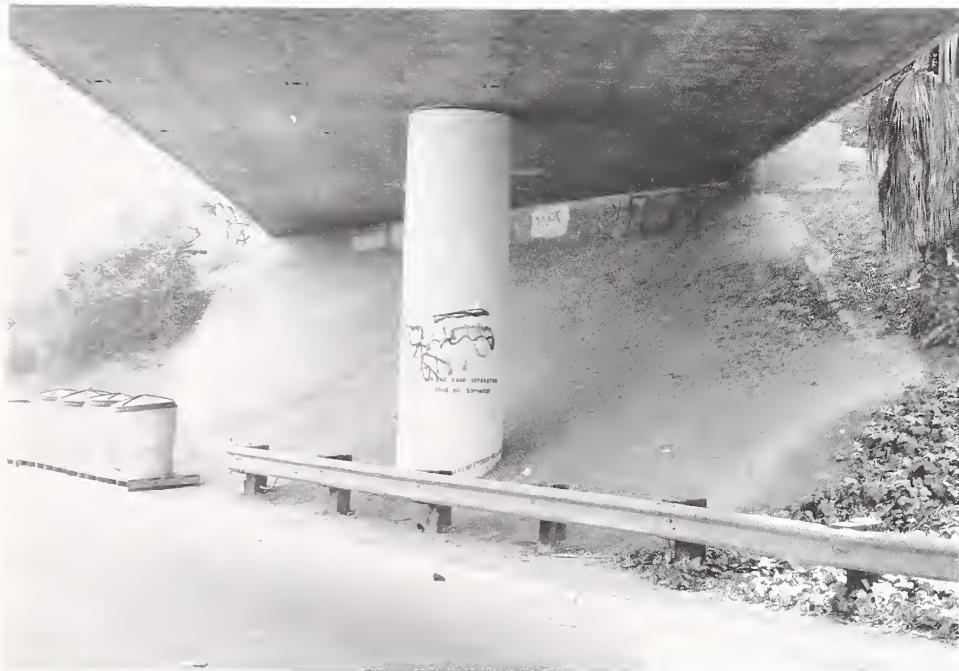
Figure 4.34. Cadillac Ave. ramp; view to east showing jacketed pier.

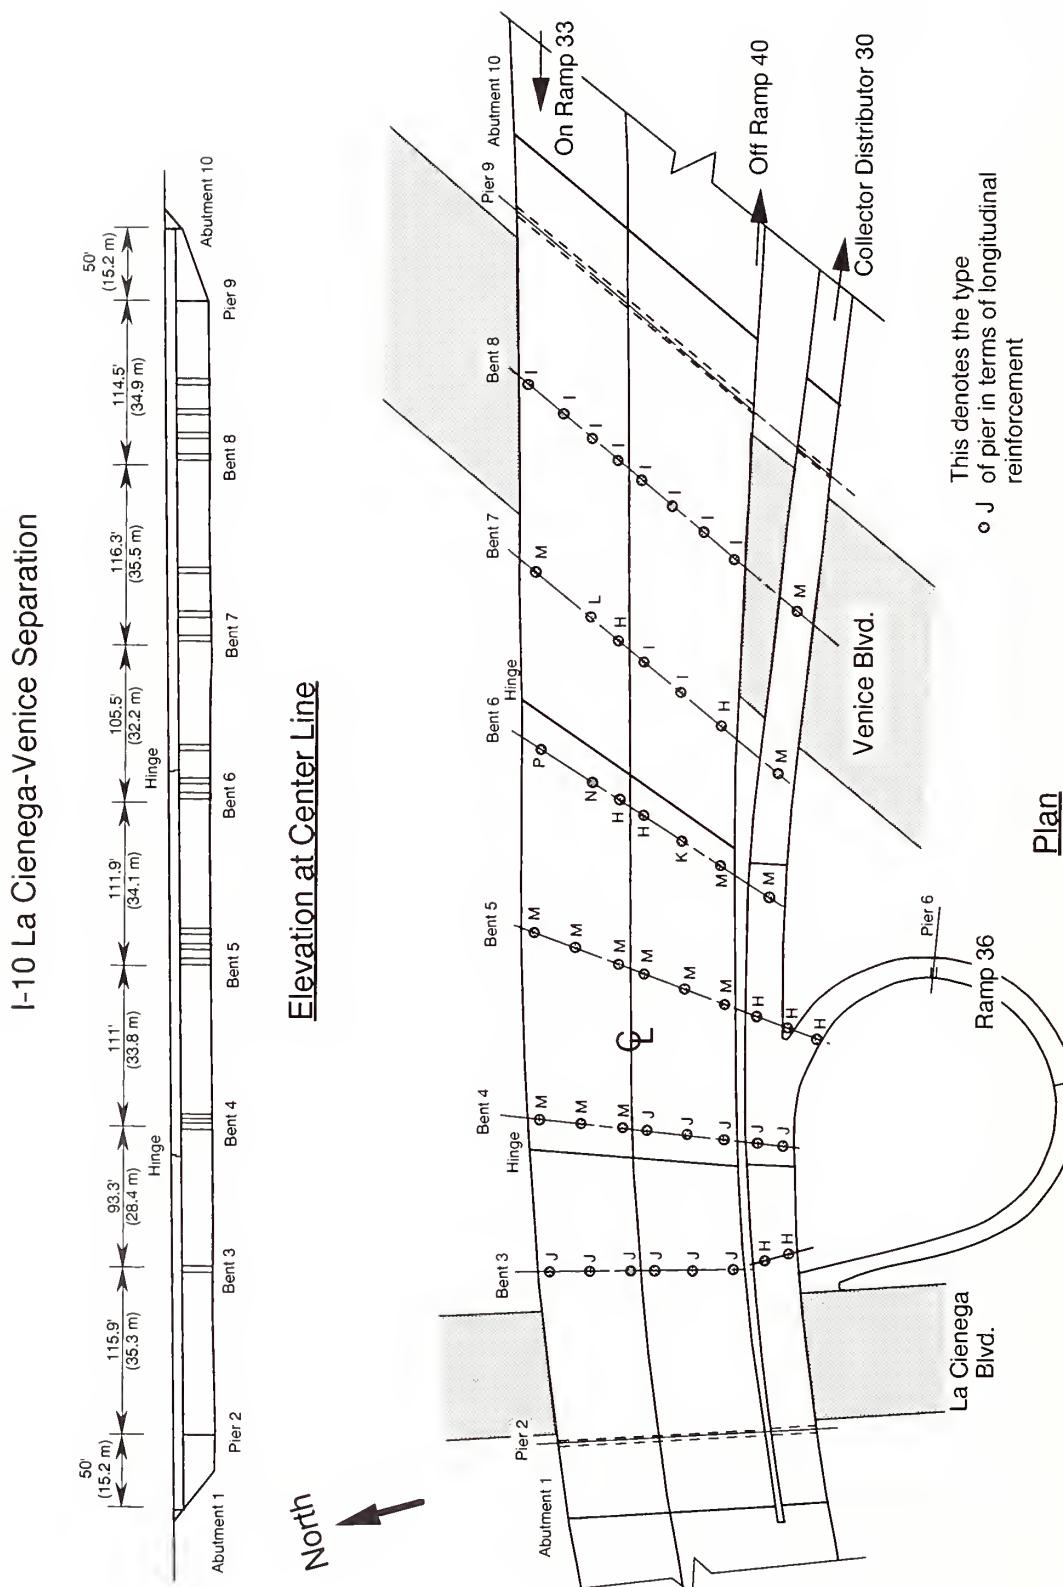
Figure 4.36 shows elevation and plan views of the nine-span bridge structure. Solid wall piers provided support adjacent to the abutments, and the remainder of the supports were multiple-pier bents. Two expansion joints (hinges) were provided as shown. Bents 3 to 7 included three supporting piers for each lane, while Bent 8 had four piers per lane. The exit ramp to La Cienega Blvd. and the eastbound collector-distributor did not collapse. Figure 4.37 shows the pier details. The piers had circular cross sections with a diameter of 1220 mm (4 ft), and the longitudinal reinforcement consisted of #11 (35 mm) or #18 (57 mm) deformed bars. The different pier reinforcement configurations were identified by pier "types" as shown in figure 4.37. These pier types are indicated in the plan shown in figure 4.36. The lateral reinforcement consisted of #4 bars (13 mm) at 305 mm (12 in) vertical spacing.

Figure 4.36. Elevation and plan of 110 Separation at La Cienega Blvd. and Venice Blvd.

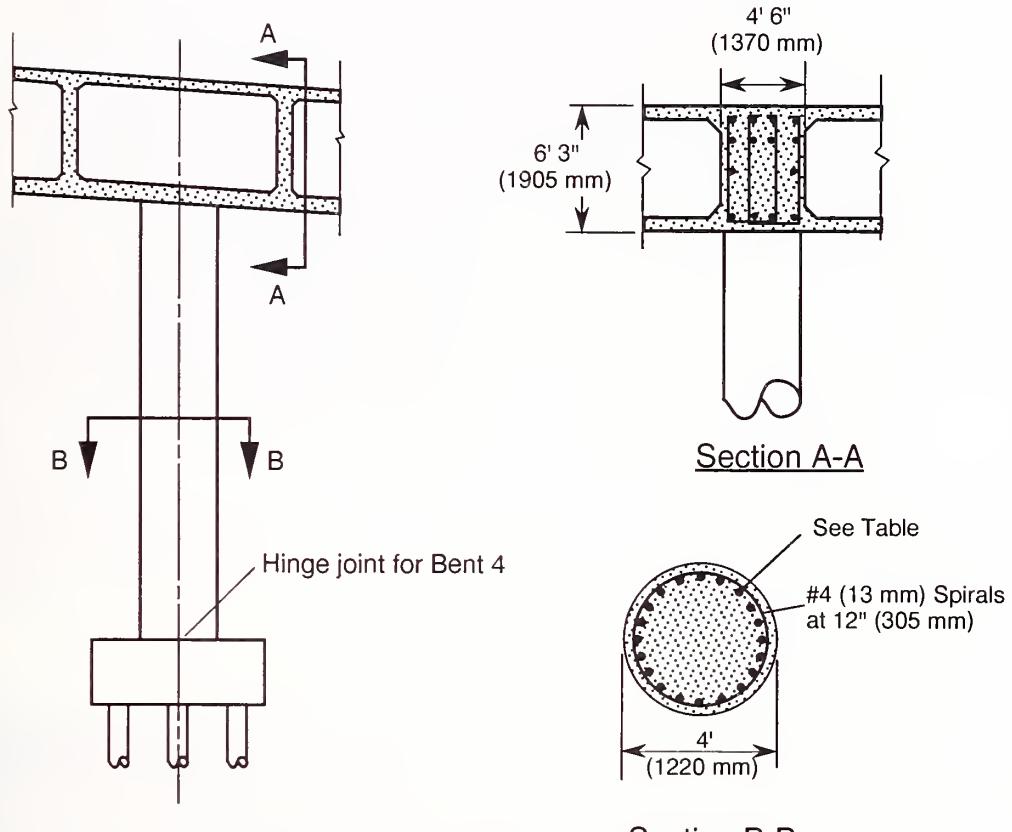
I-10 La Cienega-Venice Separation Pier Details

In summary, the bridge structure spanning La Cienega Blvd. and Venice Blvd. was extensively damaged. The failure is attributed to the small amount of lateral pier reinforcement. As the piers cracked due to the lateral loading, the lack of adequate confinement resulted in a reduction of the vertical load capacity because of core concrete loss and buckling of the longitudinal bars. Had it not been for the storage building located beneath the bridge, it is likely that more spans would have collapsed to the ground.

Figure 4.37. Pier details for I10 Separation at La Cienega Blvd. and Venice Blvd.

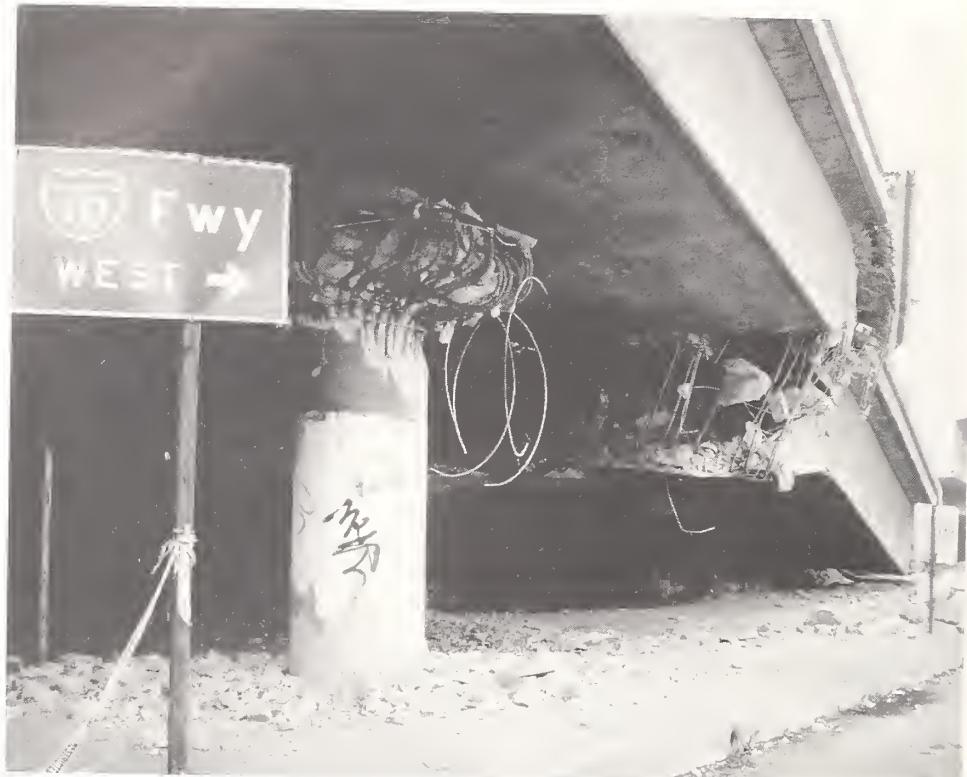
Figure 4.38 is a ground-level view of the portion of the westbound lane that collapsed to the ground at the hinge located between Bents 7 and 6. The pier in the foreground is the northernmost pier of Bent 7. It is seen that there was extensive column shortening due to the failure of the lateral reinforcement to provide adequate confinement of the core concrete. Fractured lateral reinforcement can be seen to the right of the failed portion of the pier. Figure 4.39 shows the other two piers of Bent 7 which supported the westbound lane. Extensive failure and column shortening is evident. The concrete block wall behind the piers is part of a storage building that was constructed beneath the bridge structure. The storage building extended from

Figure 4.38. Collapsed westbound lane of I10 at Venice Blvd.; pier of Bent 7 in foreground.

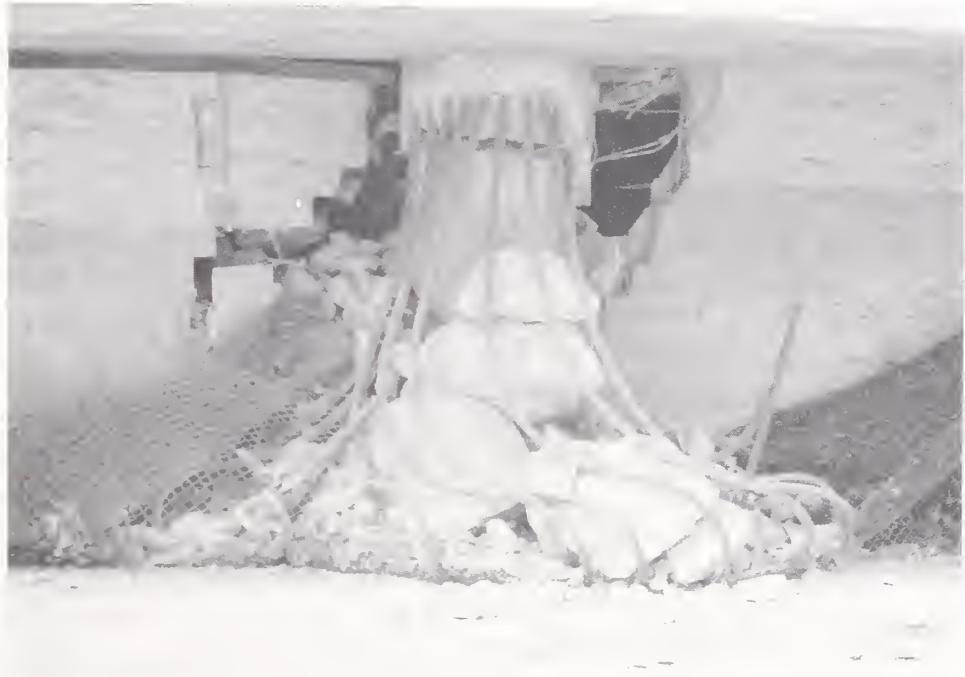
Figure 4.40 shows the northernmost pier of Bent 6, located just to the west of the hinge. This pier totally disintegrated, but the storage building prevented the roadway from collapsing to the ground. Figure 4.41 shows the southernmost pier supporting the eastbound lane at Bent 3. The top of the pier is severely damaged and it is likely that the storage building prevented the total collapse of the roadway.

Figure 4.40. Northernmost pier of Bent 6 supporting westbound lane of I10 (west of Venice Blvd.).

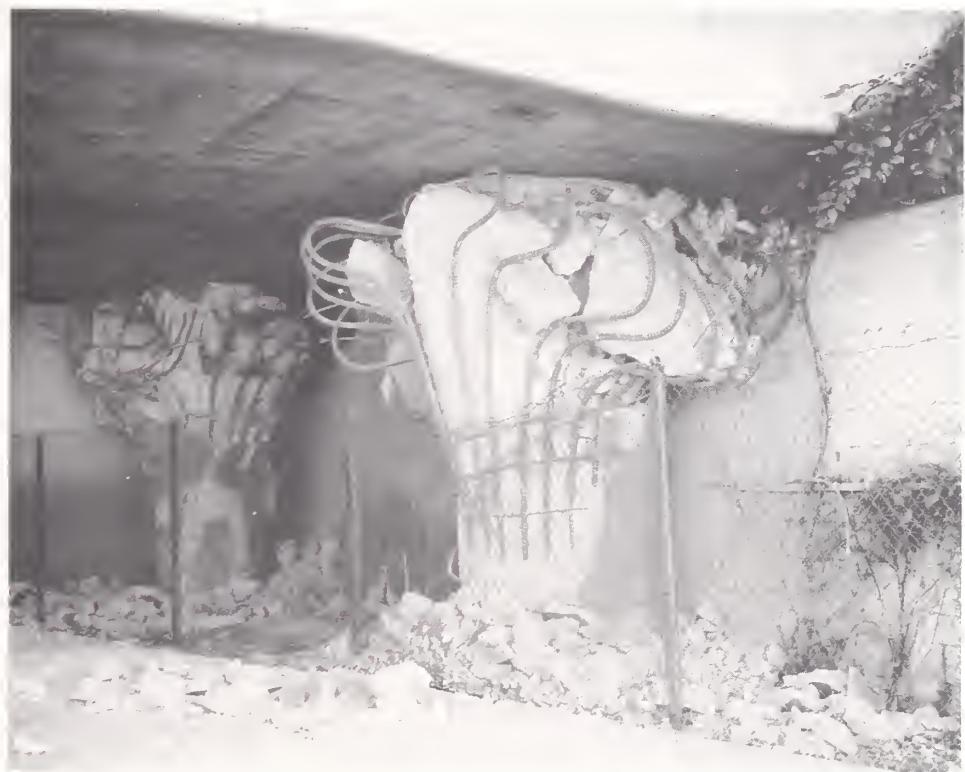
Figure 4.41. Piers of Bent 3 supporting eastbound lane of I10 at La Cienega Blvd.

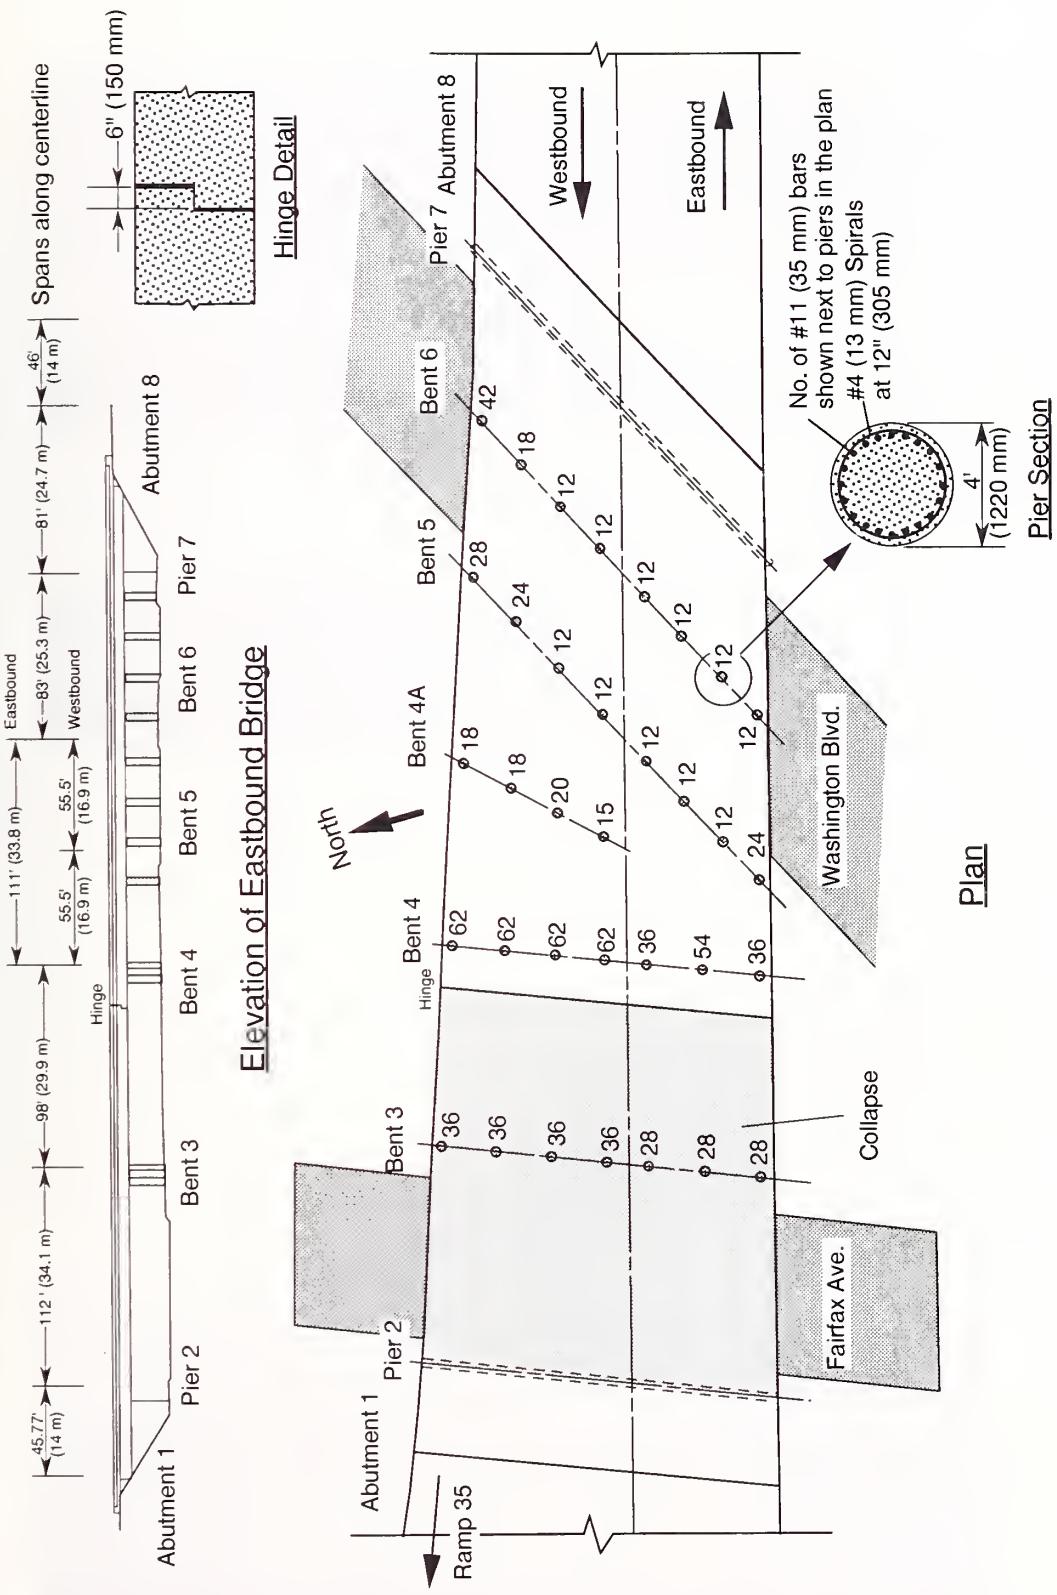
I-10 Fairfax-Washington Undercrossing

The earthquake caused partial collapse of two spans of the eastbound and westbound lanes on either side of Bent 3 (fig. 4.42). When the reconnaissance team arrived at the site, the collapsed spans had been completely removed and workmen were preparing to open up traffic on Fairfax Ave. Hence it was not possible to examine the collapsed structure. Conversations with Caltrans engineers at the site revealed that the piers in Bent 3 had failed and caused the girders to sag at this location. However, cable restrainers at the hinge west of Bent 4 prevented the girders from falling off of the hinge seats (fig. 4.43). Figure 4.44 is a photograph provided by EERC which shows the westbound lane of I10 over Fairfax Ave. It can be seen that the piers in Bent 3 shortened and caused the girder to sag. It can also be seen that the span to the west of Pier 2 lifted off of the abutment. Figure 4.45 is a close up view of one of the piers in Bent 3. The failure mode is similar to that observed at Venice Blvd. and La Cienega Blvd. When the piers were subjected to lateral ground motions, the lateral reinforcement was not able to adequately confine the core concrete. As a result of lateral load damage, there was a loss of axial load capacity and the piers shortened under the action of the vertical loads. As mentioned, the piers at Bent 4 had considerably more longitudinal reinforcement than the other piers. Examination of the piers in Bent 4 revealed varying degrees of diagonal cracking and spalling of the concrete cover. At the time of the site visit, these piers were surrounded with wooden shoring as a precautionary measure during the demolition of the collapsed spans.

Figure 4.42. Elevation and plan of I10 at the Fairfax Ave./Washington Blvd. Undercrossing.

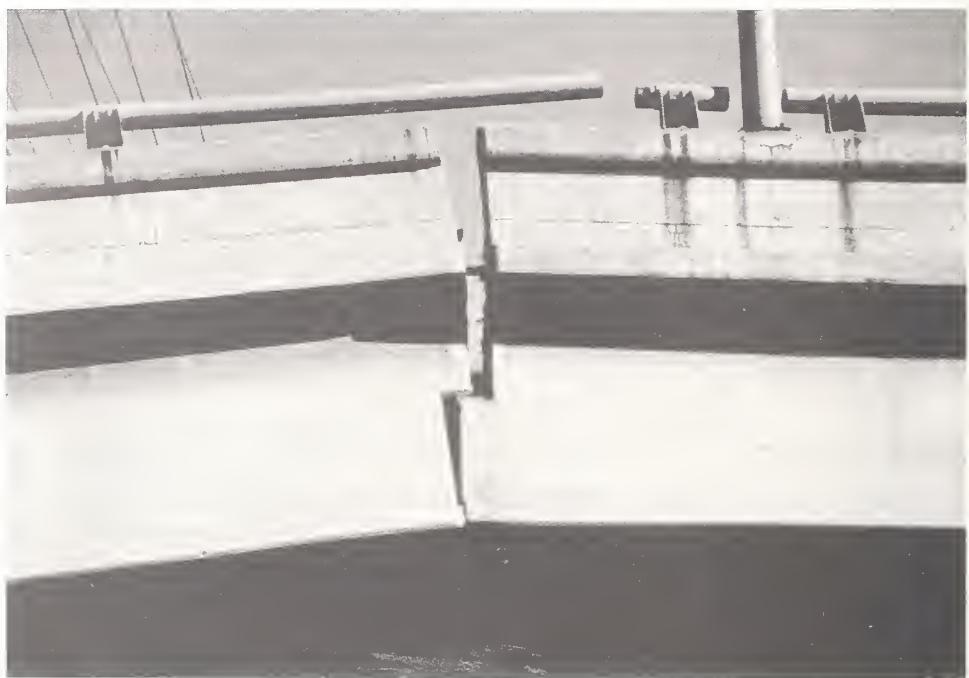
Figure 4.43. Hinge adjacent to Bent 4 of I 10 at Fairfax Ave.; cable restrainers prevented loss of support (Photo courtesy of EERC).

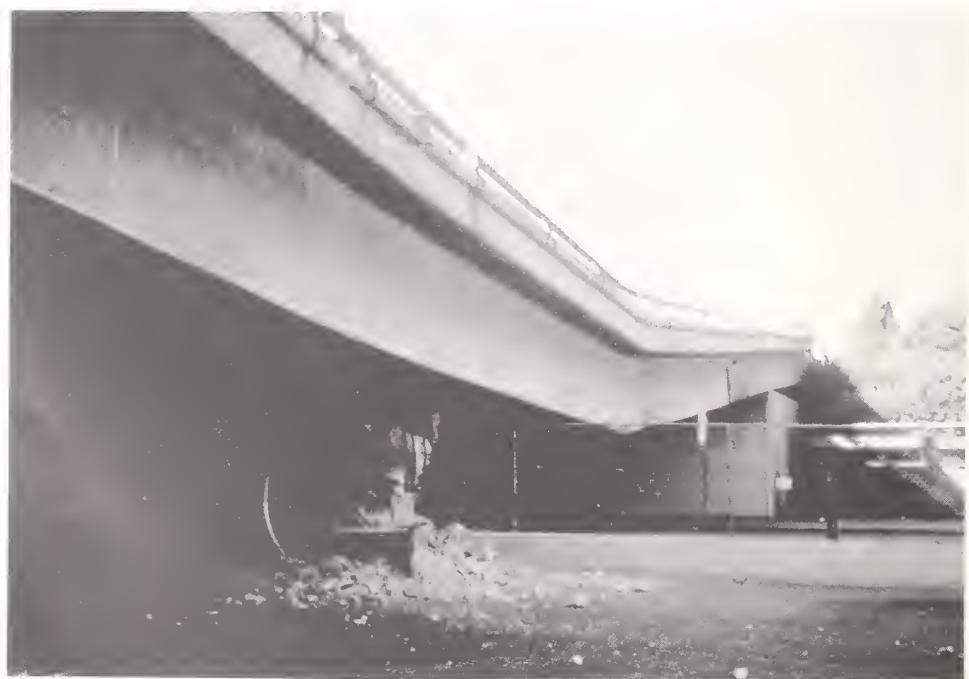
Figure 4.44. View of collapsed span of I10 over Fairfax Ave.; note rotation of girder over Pier 2 (Photo courtesy of EERC).

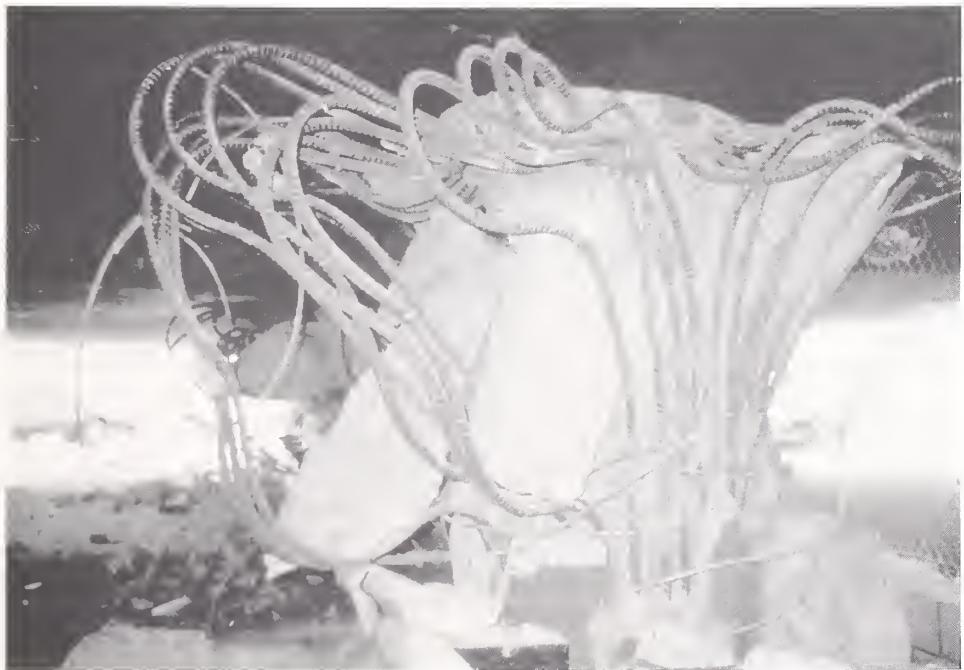
Figure 4.45. Failed column in Bent 3 of I10 at Fairfax Ave. (Photo courtesy of EERC).

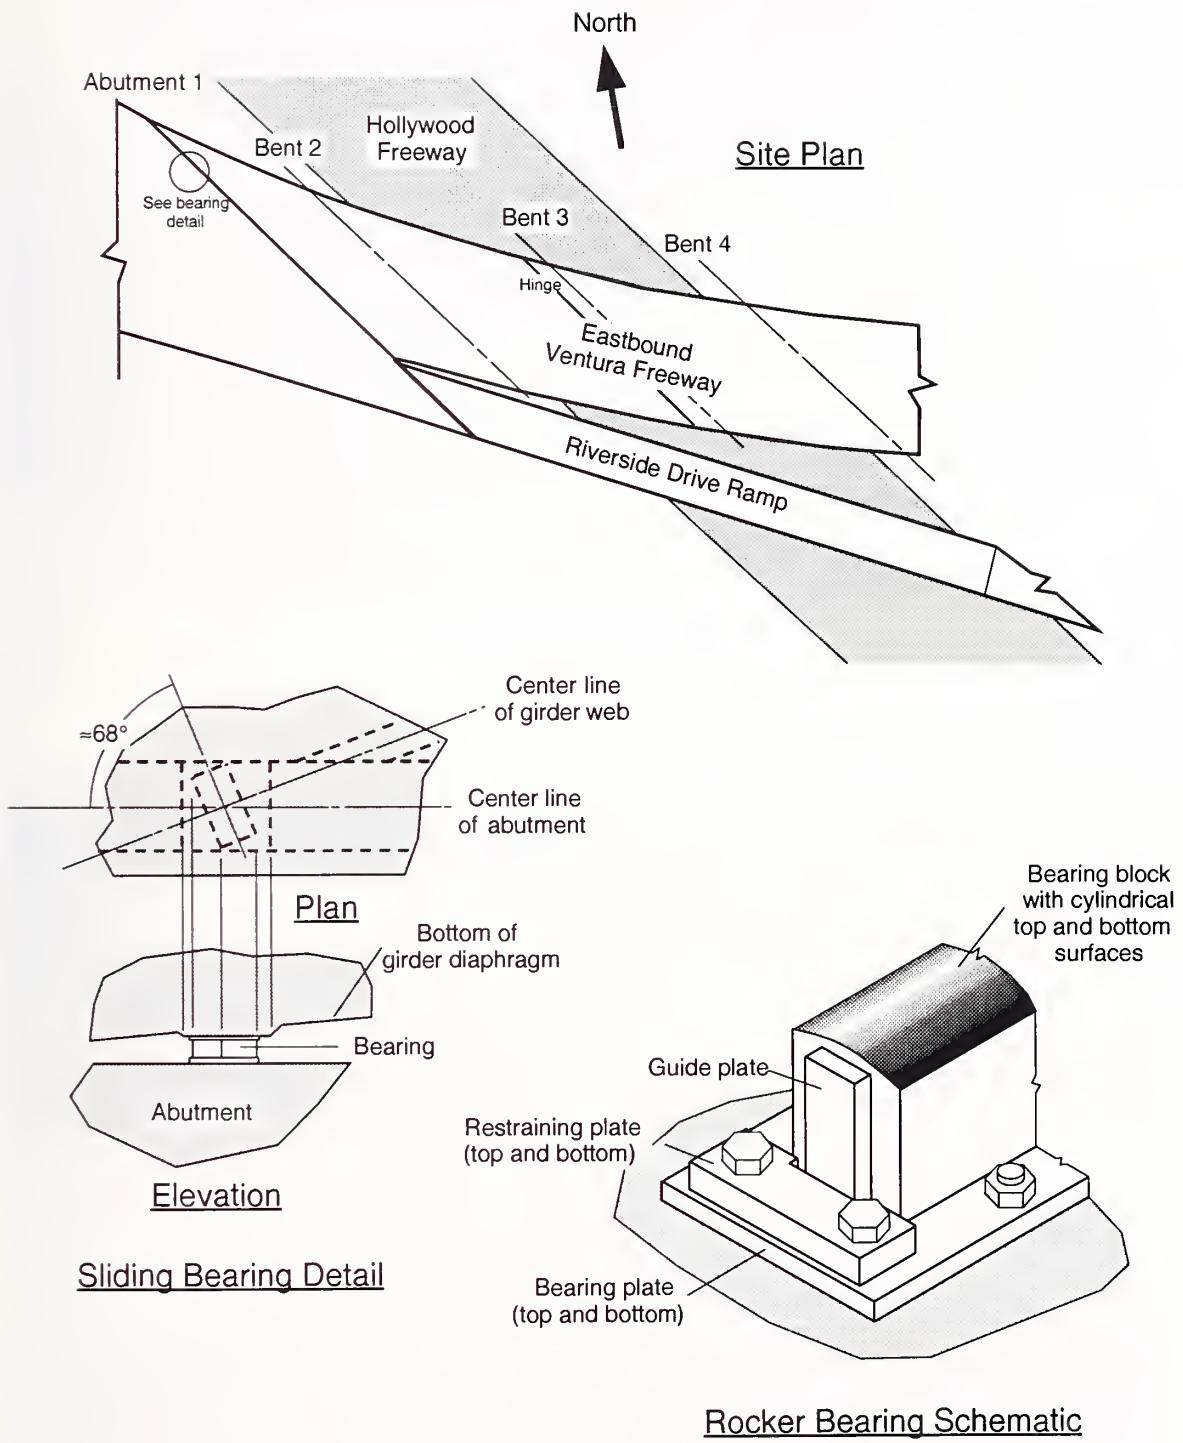
Figure 4.46 shows a simplified plan of the eastbound lane of the Ventura Freeway and the Riverside Drive ramp. Figure 4.47 is a ground level view of the eastbound lane as seen from the northbound lane of the Hollywood Freeway. At Abutment 1 (fig. 4.46), bearing supports are provided at the locations of the webs in the box girder. As shown in figure 4.46, the longitudinal axes of the bearings are aligned at right angles to the longitudinal axes of the girder webs. The four bearings on the north side of the eastbound lane of Ventura Freeway are of the sliding-type. Figure 4.48 shows the type of damage that was observed at these locations. Apparently, the dynamic frictional resistance of the bearing resulted in forces sufficient to spall off the shell of the abutment. The remainder of the bearings supporting the eastbound lane and the Riverside Drive ramp are of the rocker type. Figure 4.46 shows a schematic of this type of bearing. A steel bearing block with cylindrical surfaces is located between steel plates set into the abutment and girder end diaphragm. The blocks are kept in position with a system of guide plates and restraining plates as shown in figure 4.46. All of the rocker bearings showed some type of earthquake damage. The bolts for the restraining plates were sheared off at many locations, and the sheared bolt heads were found at distances of up to several meters from their original position. Some of the bearing blocks were skewed from their original positions (fig. 4.49). In one case, the bearing block had tipped over resulting in a complete loss of support at that location (fig. 4.50).

Figure 4.46. Eastbound lane of Ventura Freeway crossing over Hollywood Freeway; site plan and bearing details.

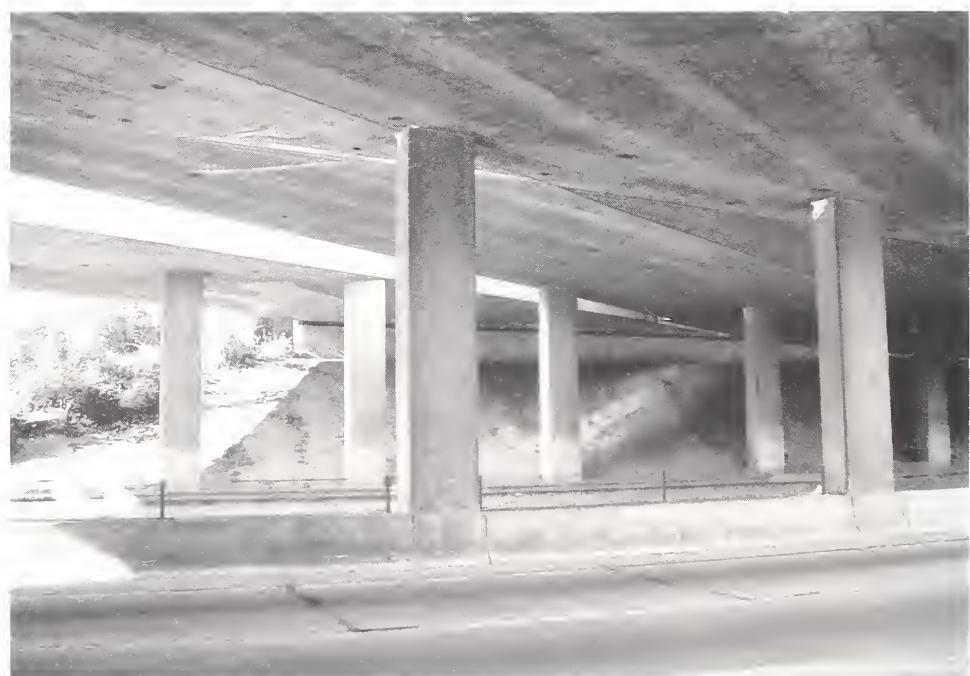
Figure 4.47. Eastbound lane of Ventura Freeway as seen from the northbound lane of Hollywood Freeway.

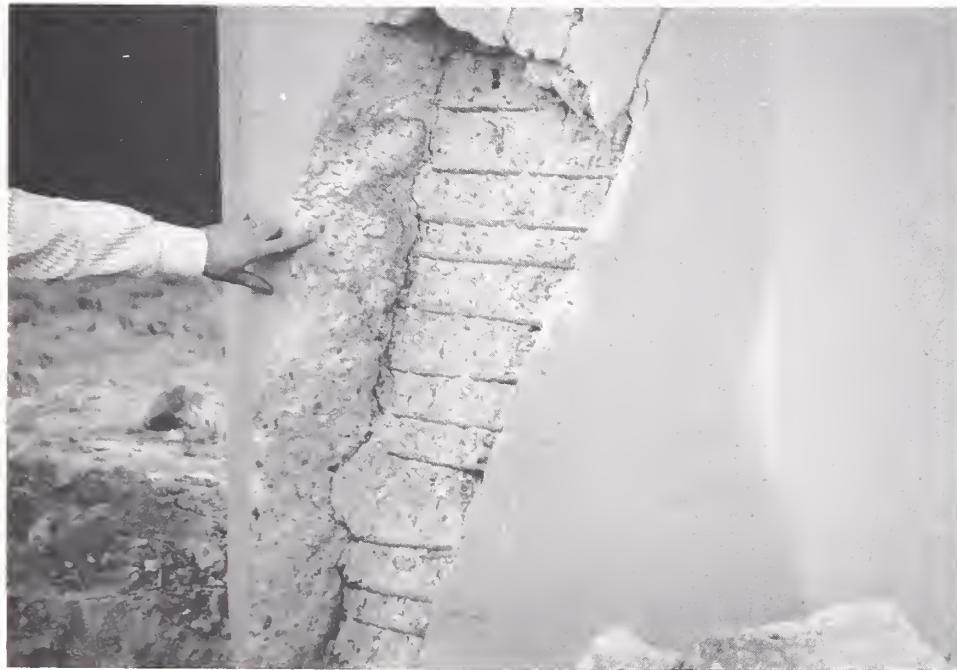
This is a long, curved ramp structure with piers of varying height. The last pier before the west abutment, adjacent to Sharp Avenue, exhibited severe shear cracking. This was one of the shortest and stiffest piers in the structure, so it probably attracted large lateral forces. Damage to the pier is shown in figures 4.51 and 4.52. Note that when the photos in figures 4.51 and 4.52 were taken the loose cover concrete had been removed by Caltrans workers to inspect damage to the core. It appeared that cracks extended into the core of the pier. The pier is octagonal in cross section, measuring 2440 mm (8 ft) across, and has a flared section at the top. Longitudinal reinforcement consists of 64 #11 (36 mm) bars (EERC 1994). This pier contains high levels of shear reinforcement: #4 (13 mm) spirals spaced at 89 mm (3.5 in). Damage to the abutment just to the west of this pier was also observed. This damage was apparently due to pounding between the superstructure and the abutment.

Figure 4.52. Close-up view of the westernmost pier at the Interstate 5, State Route 118, Southwest Connector, looking to the southeast. Loose cover concrete has been removed by Caltrans.

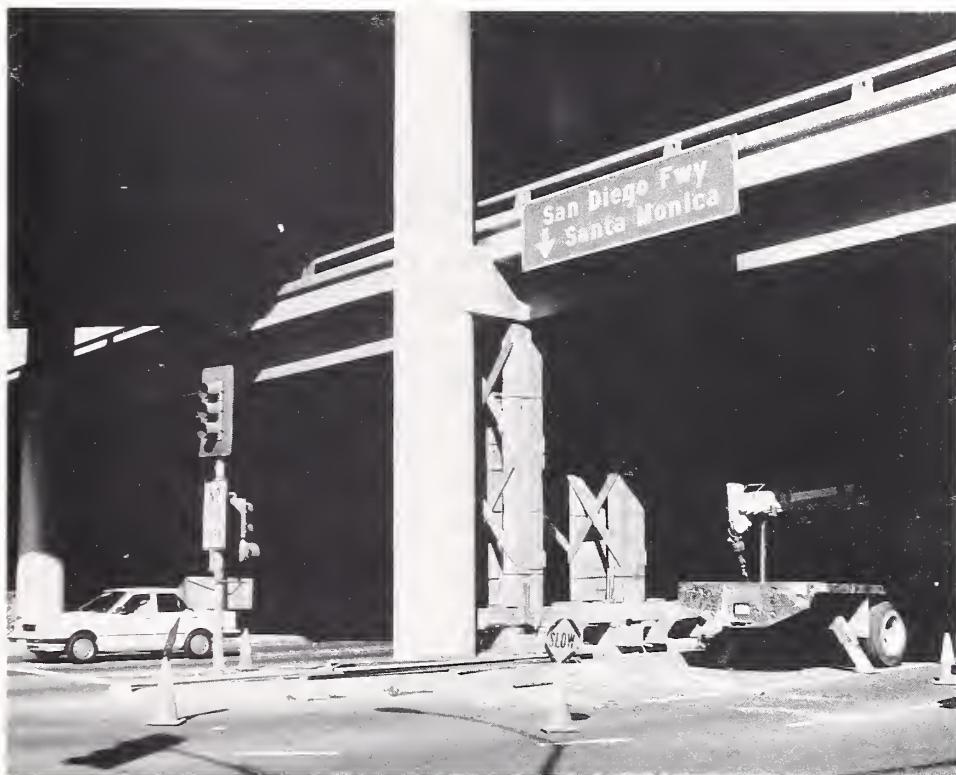
The damage observed in the Northridge earthquake possibly arose from three factors. First, the joint regions where cracking occurred are not as heavily reinforced as they would be under current design standards. Second, the structural hinges at the bases of most outrigger piers tended to increase the moments imposed on the outrigger joints. Third, the Jefferson Blvd. Undercrossing shares piers with the SR90 ramp above, as shown schematically in figure 4.55. The upper SR90 structure is more flexible than the lower Jefferson Blvd. Undercrossing, possibly resulting in further concentrations of moments at the outrigger joints.

Figure 4.53. Overview of the outrigger joint at the SR90/I405 interchange, Jefferson Boulevard Undercrossing, center bent, west side, looking to the north.

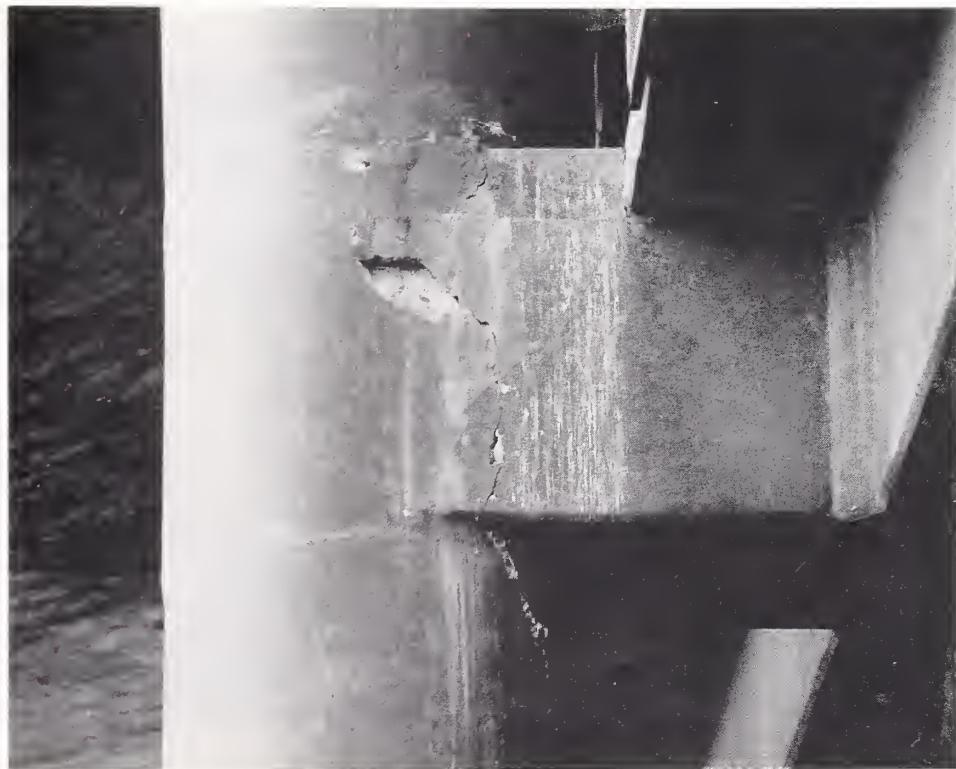
This is a cast-in-place reinforced concrete bridge which carries Interstate 405 over Jefferson Blvd. The bridge consists of four spans: two 8.5 m (28 ft) long end spans and two 16.0 m (52.5 ft) long center spans. The bridge is supported on three six-pier bents, making a total of 18 piers. The piers are circular and 1220 mm (4 ft) in diameter. All but two of the eighteen piers have structural hinges at the top of the pier footing. The outer piers of each bent are located outside the bridge girders, creating an "outrigger" configuration, as shown in figure 4.53. After the Northridge earthquake, diagonal cracks were observed in all six outrigger joints at the ends of the three bents. The cracking was most serious on the east end of the center bent. A close-up photograph at that location are shown in figure 4.54.

Figure 4.54. Close-up of the outrigger joint at the SR90/I405 interchange, Jefferson Boulevard Undercrossing, center bent, east side, looking to the south.

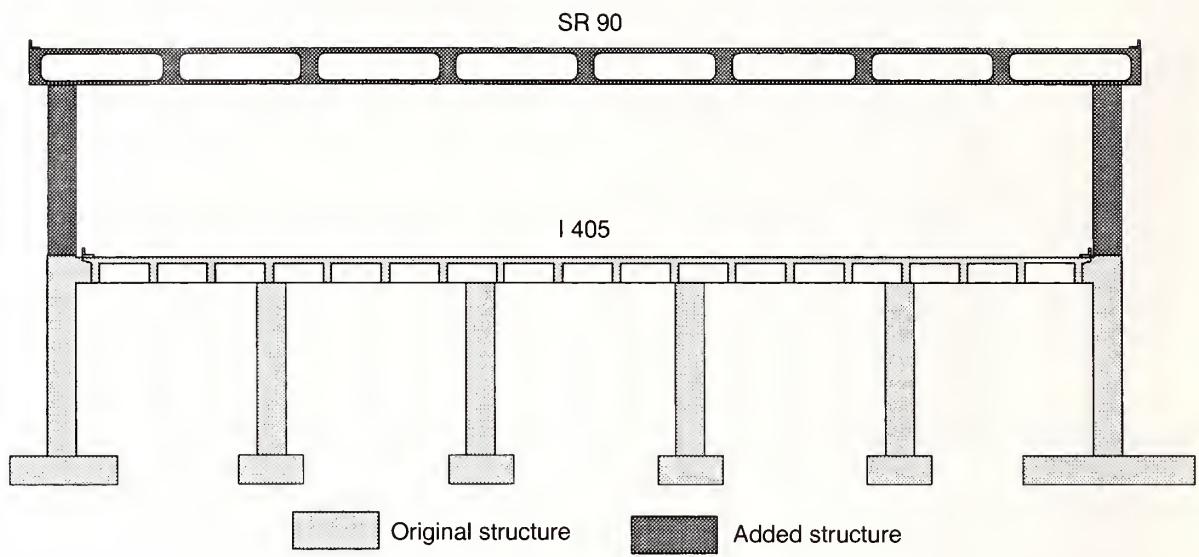
This bridge was constructed in about 1961, so generally speaking it does not meet current seismic design standards. The bridge is somewhat unusual because in the original design allowances were made for future construction of the ramps of the SR90/I405 interchange passing overhead: the outermost piers of the bridge were more heavily reinforced to allow for later extensions of the height of those piers. The reinforcement in the exterior piers consisted of 22 #18 bars (57 mm) longitudinally, and #5 bar (16 mm) spiral hoops spaced at 114 mm (4.5 in); the inner piers were reinforced with 14 #9 bars (29 mm) longitudinally, and #4 (13 mm) spirals spaced at 305 mm (12 in). The exterior piers were later extended in height, as can be seen in figure 4.53. It is not clear how structural continuity was achieved between the original exterior piers and the pier extensions, since no explicit provisions were made in the original design for extending the longitudinal reinforcement.

Figure 4.55. Schematic cross section, showing columns shared by SR90 and the Jefferson Boulevard Undercrossing.

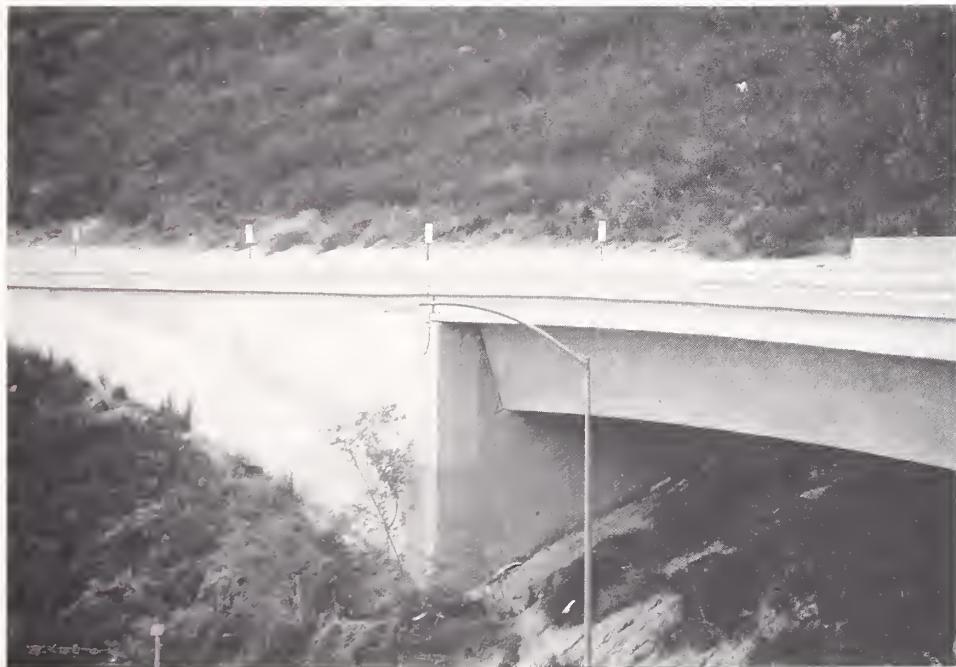
In the Northridge earthquake, bridge abutment damage ranged from minor settlement of backfill soil at the approaches, to cracking of wing walls, to permanent displacement of the entire abutment. For example, at the intersection of State Route 118 and Interstate 210, there was damage to the abutment at the east end of the long elevated structure connecting eastbound SR118 with northbound I210. An overview of the abutment is shown in figure 4.56, and a close-up of some of the abutment sidewall cracking is shown in figure 4.57. At the interchange of US101, SR134 and SR170, at the Riverside Drive Offramp Overcrossing (Caltrans bridge No. 53-1493S, described above) the abutments at both ends of the offramp exhibited severe cracking in the wing walls. Damage to concrete abutment piles was reported [5] at the Las Virgenes Overcrossing on US101 (Caltrans bridge No. 53-1442). There were many other cases of bridge abutment damage observed by the reconnaissance team, and reported by other investigators, which are too numerous to list here.

Figure 4.56. Overview of abutment at the east end of the ramp connecting eastbound SR118 with northbound I210.

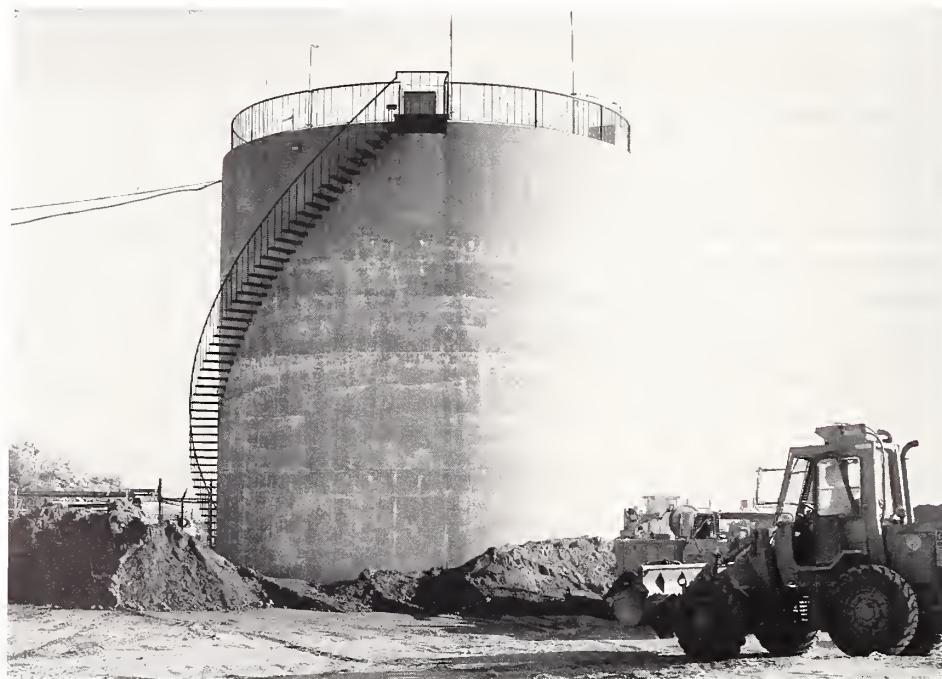
The reinforced concrete relief tank (surge chamber) on top of the hill appeared to perform well through the earthquake--no damage was observed (fig. 5.2). A steel pipe brings water up from the canyon below (fig. 5.3). The pipe is supported on concrete saddles built along the mountain slope. At a few places, the pipe separated from the saddles creating 50 to 80 mm (2 to 3 in) gaps. In at least one location, the pipe crashed vertically into the saddle. At two other locations, the pipe sections bulged 80 mm and 150 mm (3 and 6 in), however, no rupture or leakage was noticed. The ruptured section of the 2.1-m pipe is located near the hilltop. The two sections where the rupture occurred were connected using a mechanical coupling system (fig. 5.4). The pipe sections were connected by eight pairs of restrainer rods 35 mm (1-3/8 in) in diameter and 2.2 m (7 ft) long. The rods were attached to brackets, which were welded to the pipes. These welds broke during the earthquake (fig. 5.5) and resulted in the separation of the two pipe sections.

Figure 5.2. The reinforced concrete surge tank at Terminal Hill performed well during the earthquake--no damage was observed.
