NIST Special Publication 862

1994 Northridge Earthquake Performance of Structures, Lifelines, and Fire Protection Systems

*Diana Todd, Nicholas Carino, Riley M. Chung, H. S. Lew, Andrew W. Taylor,
William D. Walton, James D. Cooper, and Roland Nimis*

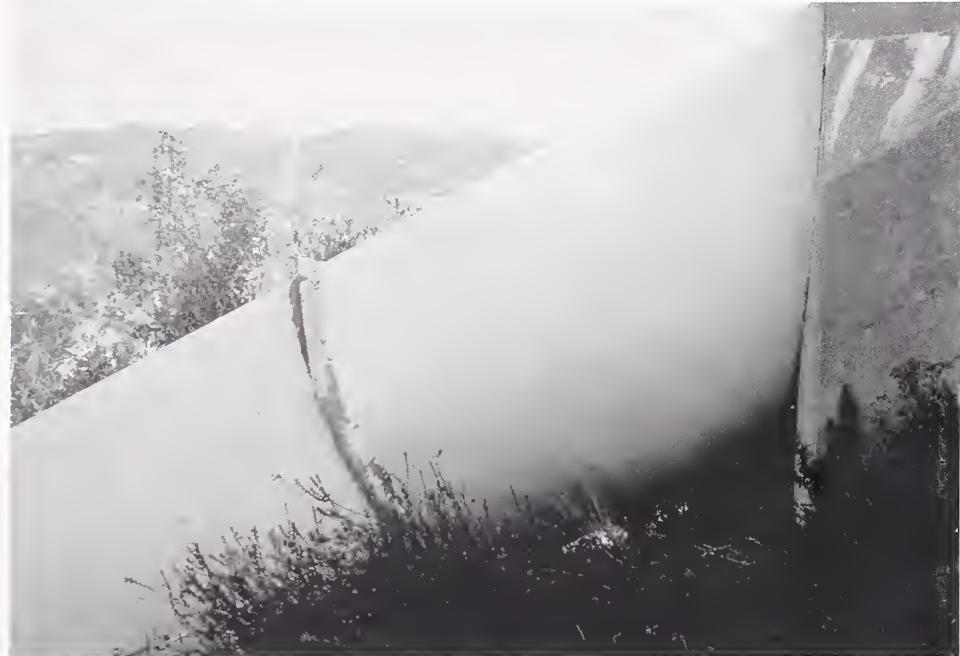
The reinforced concrete relief tank (surge chamber) on top of the hill appeared to perform well through the earthquake--no damage was observed (fig. 5.2). A steel pipe brings water up from the canyon below (fig. 5.3). The pipe is supported on concrete saddles built along the mountain slope. At a few places, the pipe separated from the saddles creating 50 to 80 mm (2 to 3 in) gaps. In at least one location, the pipe crashed vertically into the saddle. At two other locations, the pipe sections bulged 80 mm and 150 mm (3 and 6 in), however, no rupture or leakage was noticed. The ruptured section of the 2.1-m pipe is located near the hilltop. The two sections where the rupture occurred were connected using a mechanical coupling system (fig. 5.4). The pipe sections were connected by eight pairs of restrainer rods 35 mm (1-3/8 in) in diameter and 2.2 m (7 ft) long. The rods were attached to brackets, which were welded to the pipes. These welds broke during the earthquake (fig. 5.5) and resulted in the separation of the two pipe sections.

Figure 5.3. The steel pipeline at Terminal Hill separated from its supporting saddle at several places and pipe sections bulged at other locations along the alignment.

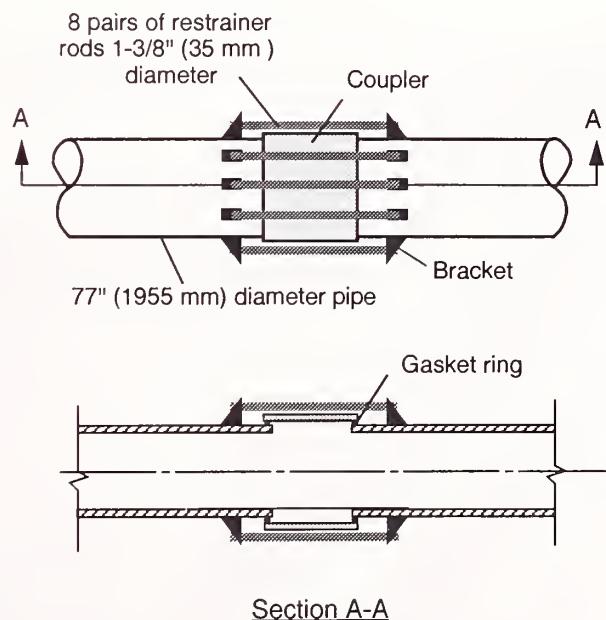
Figure 5.4. Schematic drawing of connection of the two steel pipe sections which were pulled apart during the earthquake.

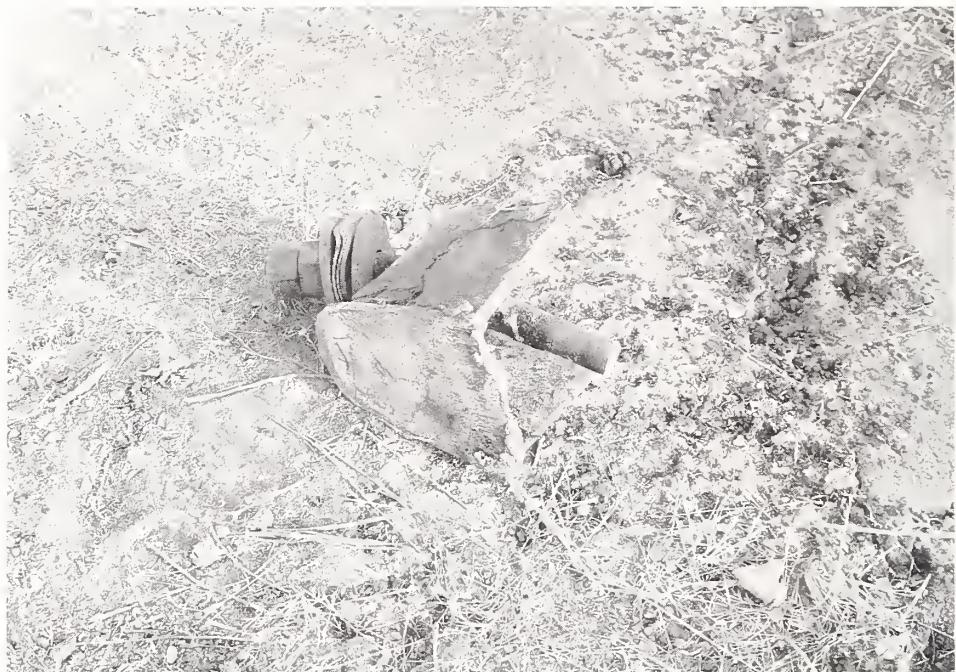
Figure 5.5. Welds of the restrainer brackets broke as the result of strong shaking.

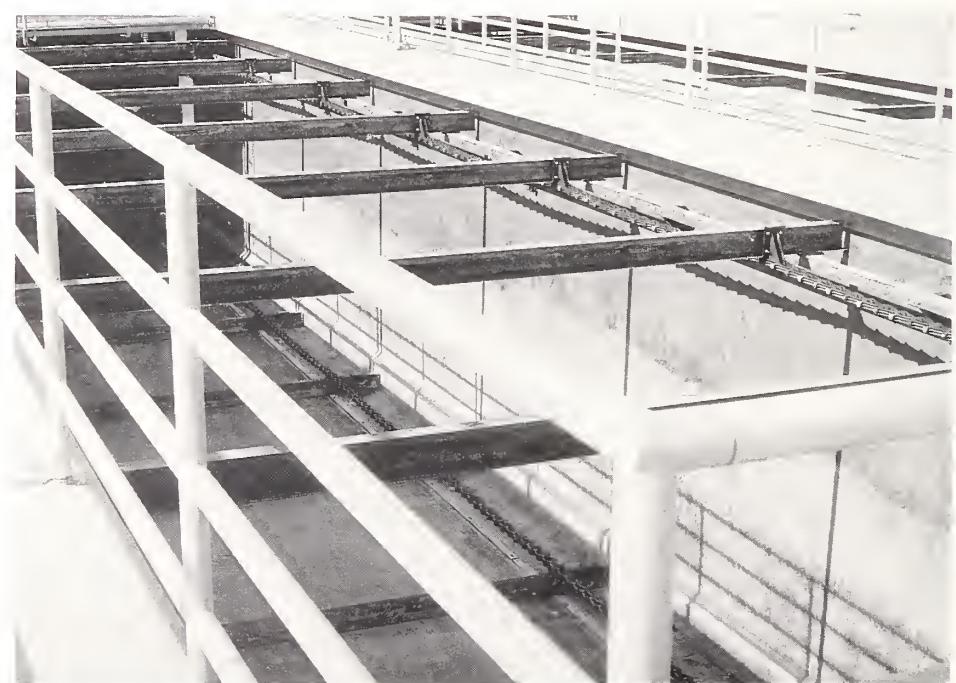
The earthquake resulted in damage to five out of twenty-two final clarifier tanks built in 1991 as part of the Phase II expansion. Twenty-two Phase I tanks built in 1983 were not damaged. Figure 5.6 shows a typical undamaged final clarifier tank. The scrapers are supported by railings attached to the walls with brackets. Chains are used to move the scrapers. All these components were made of plastic in the Phase II construction, whereas the brackets were made of metal and railings and sludge scrapers were made of redwood in the Phase I construction. Pins about 10 mm (3/8 in) in diameter and 19 mm (3/4 in) long connected the brackets to the railings. In the tanks where there was damage, it is suspected that the pins dislodged due to wave action in the tank and the railing became displaced. This caused jamming of the chain movement, which disabled the system (fig. 5.7).

Figure 5.6. Undamaged clarifier tank at the Tillman Water Reclamation Plant.

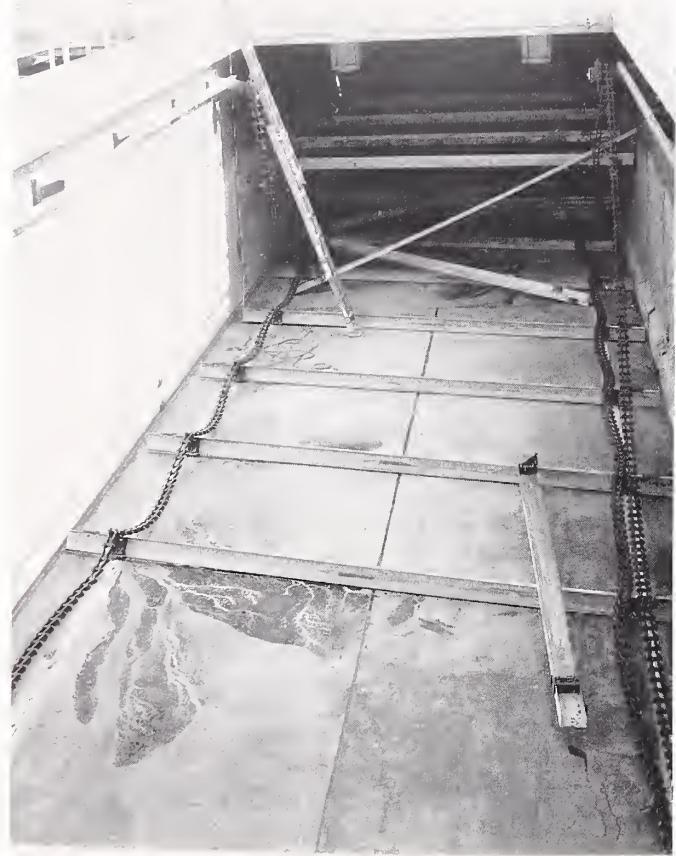
Figure 5.7. A damaged sludge scraper in a clarifier tank at the Tillman Water Reclamation Plant.

- Repair of water and gas lines is a very time-consuming process. Repairs should be thoroughly checked against leakage before backfilling pits.
- Repair of the Tillman Plant clarifiers was delayed due to nonstructural damage to the maintenance building that prevented operators for retrieving needed parts and tools. This delay could have been avoided if the building contents had been secured against earthquake motions.

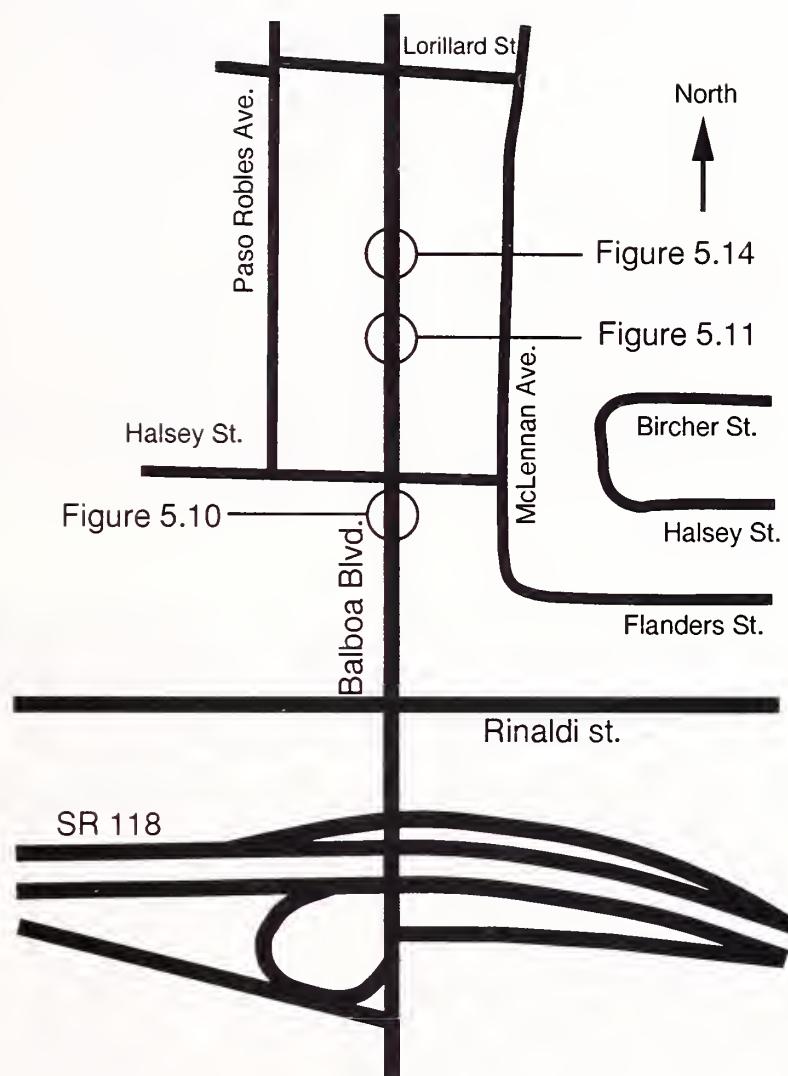
The rupture of a 0.6-m (22-in) gas main occurred along Balboa Boulevard between Rinaldi Street to the south and Lorillard Street to the north (fig. 5.8). Along this stretch, compressional ground failures occurred between Rinaldi Street and Halsey Street, and extensional ground failures occurred between Bircher Street and Halsey Street. Ground extension at this location is prominently exhibited by the transverse cracks in the pavement as shown in figure 5.9. Further, lateral spreading of 25 to 100 mm (1 to 4 in) toward the west was observed along the sidewalk on the west side of Balboa Boulevard north of Halsey Street, whereas no lateral spreading was observed on the east side of Balboa Boulevard.

Figure 5.8. Location of the 0.6-m gas main rupture on Balboa Boulevard.

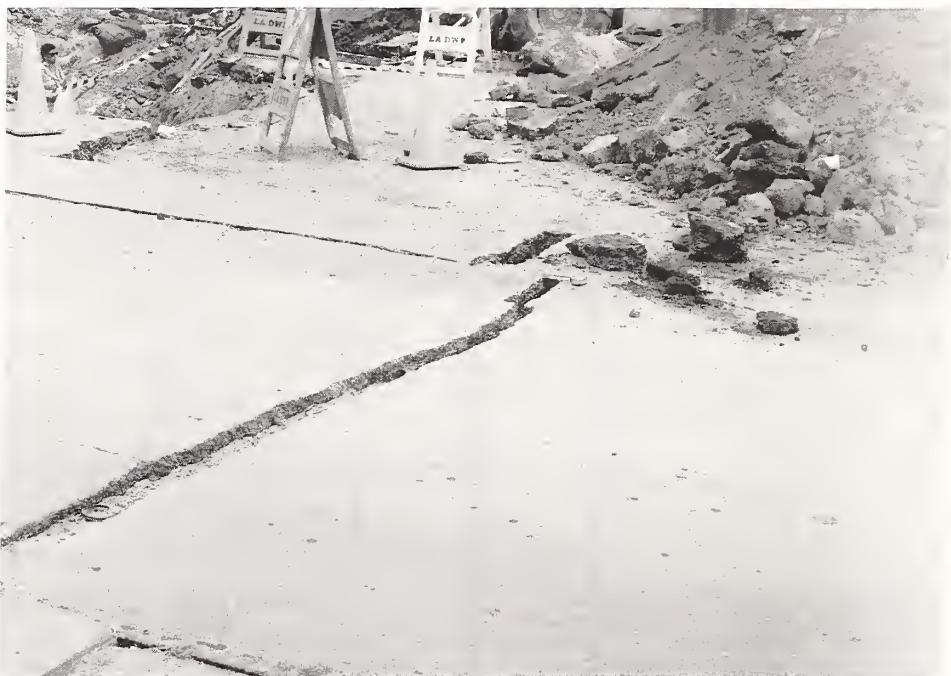
Figure 5.9. Ground extension at the gas fire site on Balboa Boulevard can be seen by the transverse cracks in the pavement.

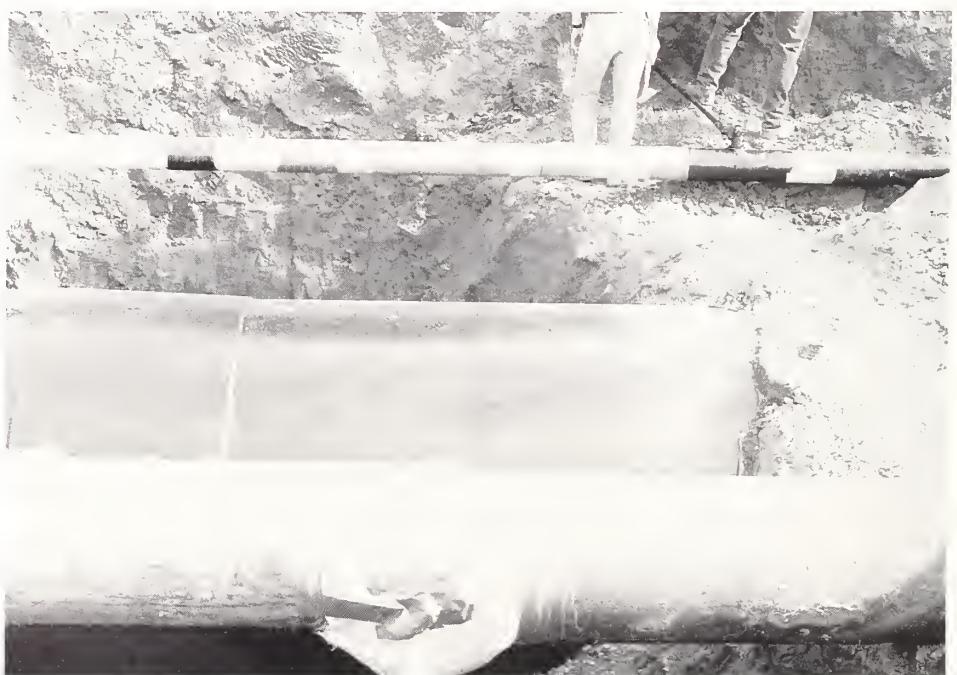
Three pipelines ruptured as the result of ground contraction; a 150-mm (6-in) gas distribution line, the 1.8-m (68-in) Rinaldi trunk water line, and a 0.6-m (22-in) gas main (fig. 5.10). The Rinaldi trunk line was of post-1971 construction, and the gas main was of 1930 vintage. These pipes showed a shortening of 125 to 150 mm (5 to 6 in).

Figure 5.10. Ground contraction along Balboa Boulevard caused the rupture of a gas distribution line (top), the Rinaldi trunk 1.8-m (68 in) water main (center), and a gas main (bottom). The pipes were being repaired at the time this photograph was taken.

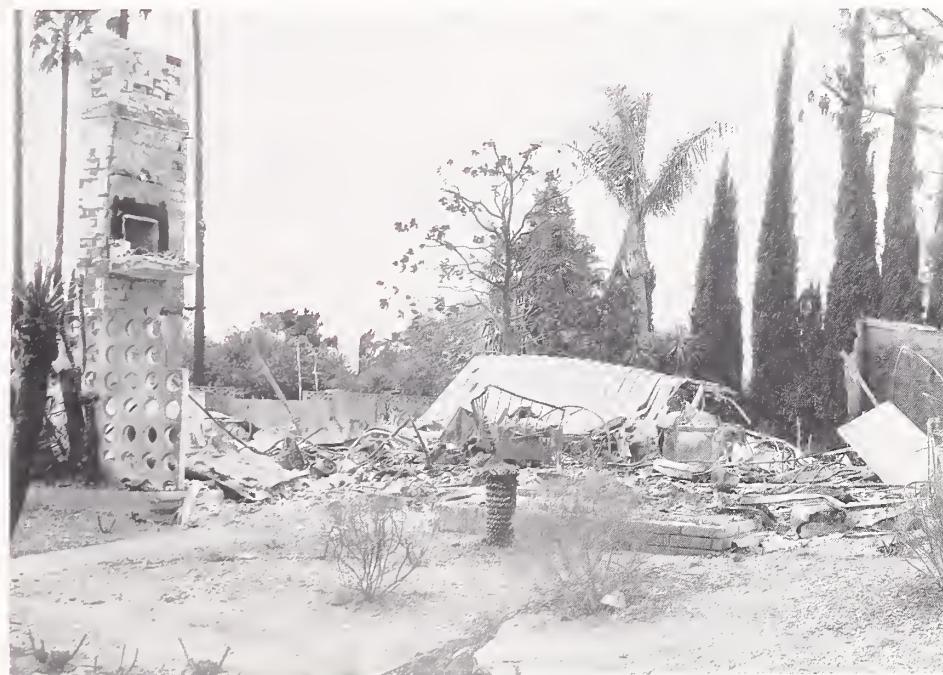
Figure 5.12. Houses destroyed by a fire resulting from the rupture of the 0.6-m gas main along Balboa Boulevard.

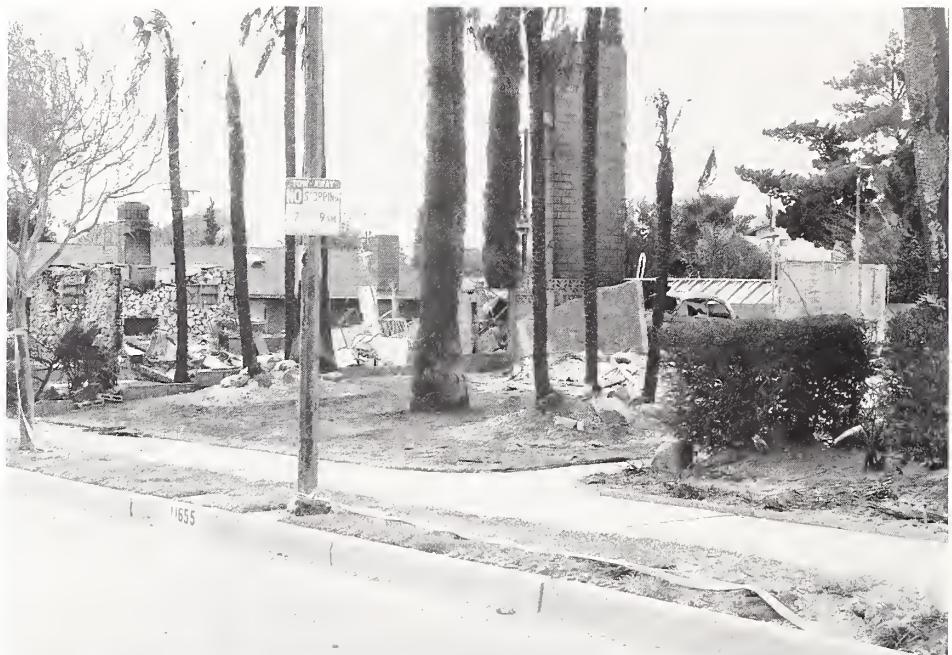
Figure 5.13. Houses destroyed by a fire resulting from the rupture of the 0.6-m gas main along Balboa Boulevard.

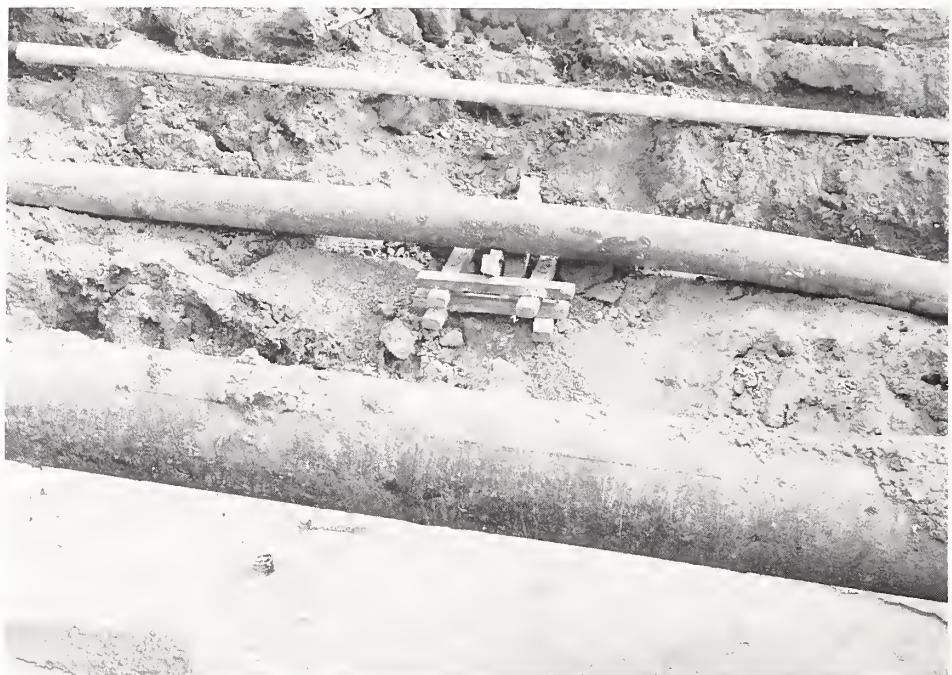
An excavated section just north of the fire site revealed some additional underground lines (fig. 5.14). The 460-mm (18-in) crude oil line in the middle of the photo performed well. The 150-mm (6-in) gas distribution line shown at the top of the photo is a replaced section.

Figure 5.14. Some of the buried pipelines located near the intersection of Balboa Boulevard and Bircher Street showing the potential hazard of co-location of lifeline systems. At this site are three water lines (two of them main lines); three gas lines; two sewers; one crude oil line; overhead power, telephone, and cable TV lines; the street lighting system; and the street itself.

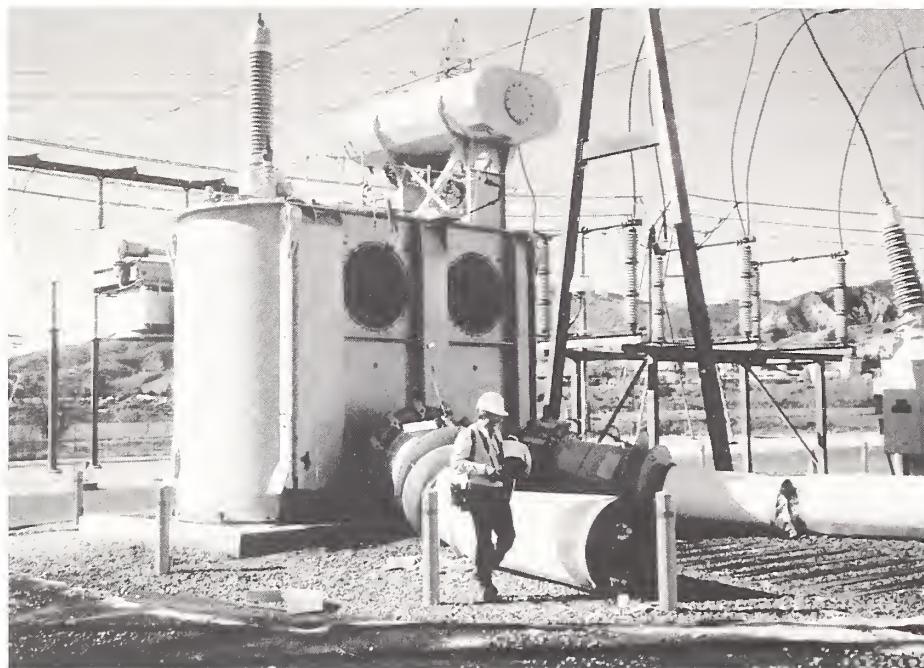
Some transmission towers suffered significant damage, many as the result of foundation failure. Damage to several high voltage substations near the epicenter, such as Sylmar, Pardee, and Rinaldi, led to the widespread power outage in the Los Angeles basin, as well as isolated outages throughout seven western states (fig. 5.15). As happened during the 1971 San Fernando earthquake, porcelain elements of 230-kV and 500-kV equipment suffered the most damage (fig. 5.16). This highlights the urgent need for developing new earthquake-resistant materials to replace porcelain, which is very brittle. Furthermore, most of the 230-kV circuit switchers, similar to those at the Sylmar substation shown in figure 5.17, were damaged. However, none were damaged during the 1971 earthquake, a possible indication of much stronger ground shaking by the Northridge earthquake. Most of the capacitor banks, similar to those in the background in figure 5.17, performed well in this earthquake, whereas most collapsed during the 1971 quake. Better performance of the capacitor banks is the result of stricter seismic requirements in equipment qualification and in installation practices.

Figure 5.15.
Damage to DC equipment at several high voltage substations, such as this one at Sylmar, led to widespread power outages in the Los Angeles area as well as isolated outages throughout seven western states. (Photo courtesy of Edward Matsuda, Pacific Gas and Electric Company.)

- Improved methods for avoiding damage to high voltage substations should be developed. New materials are needed to replace the brittle porcelain insulators. Better switch systems should be developed and installed to prevent blackouts. Failures of foundations for transmission towers should be thoroughly investigated.

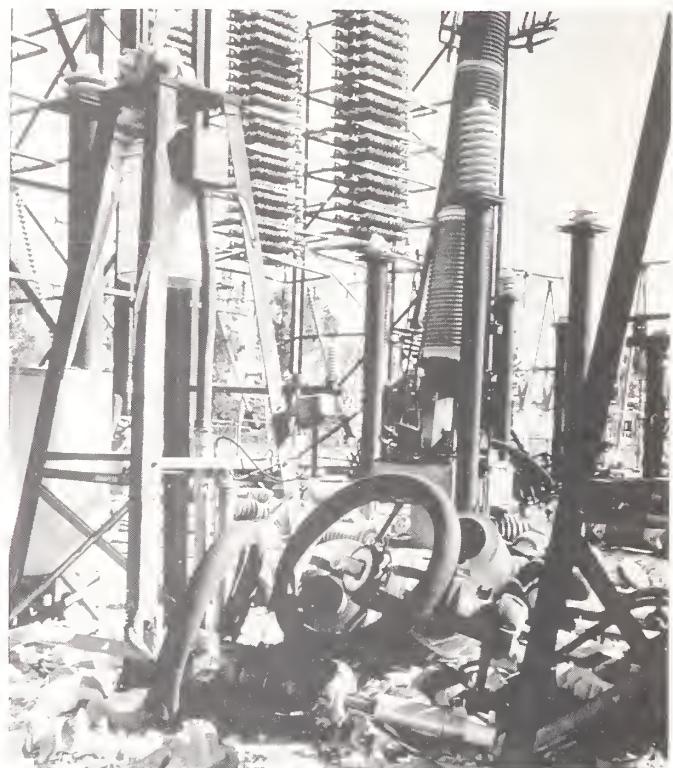
Figure 5.16. Porcelain is an integral part of high voltage electrical equipment due to insulation requirements and is also the most vulnerable to damage during strong earthquake shaking. (Photo courtesy of Edward Matsuda, Pacific Gas and Electric Company.)

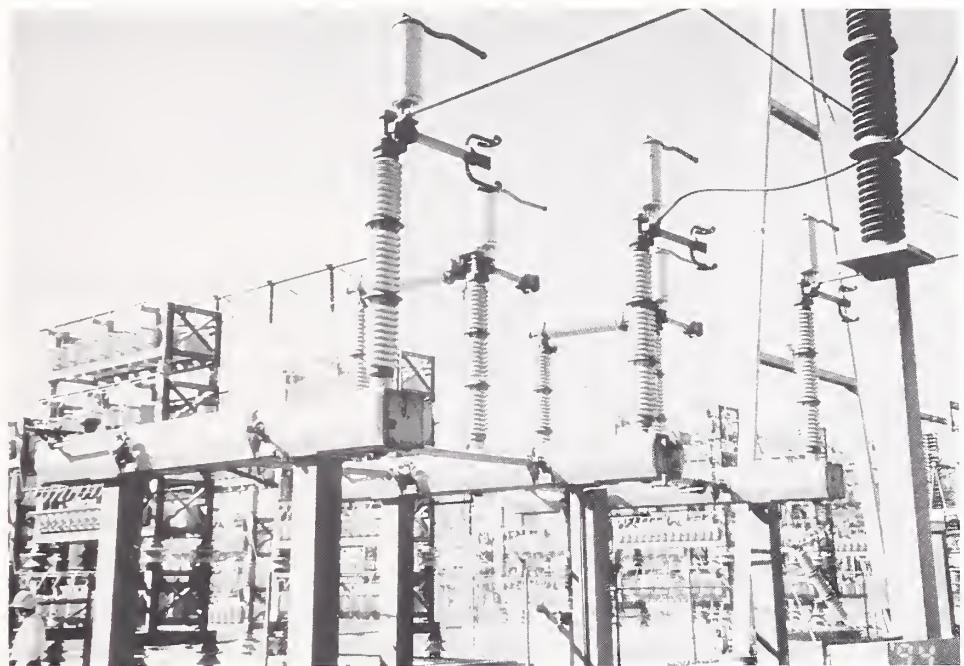
Figure 5.17. Most of the 230-kV circuit switchers (in the forefront) at the Sylmar substation were damaged. Most of the capacitor banks (in the background) performed well in this earthquake, whereas most collapsed during the 1971 quake. (Photo courtesy of Edward Matsuda of Pacific Gas and Electric Company.)

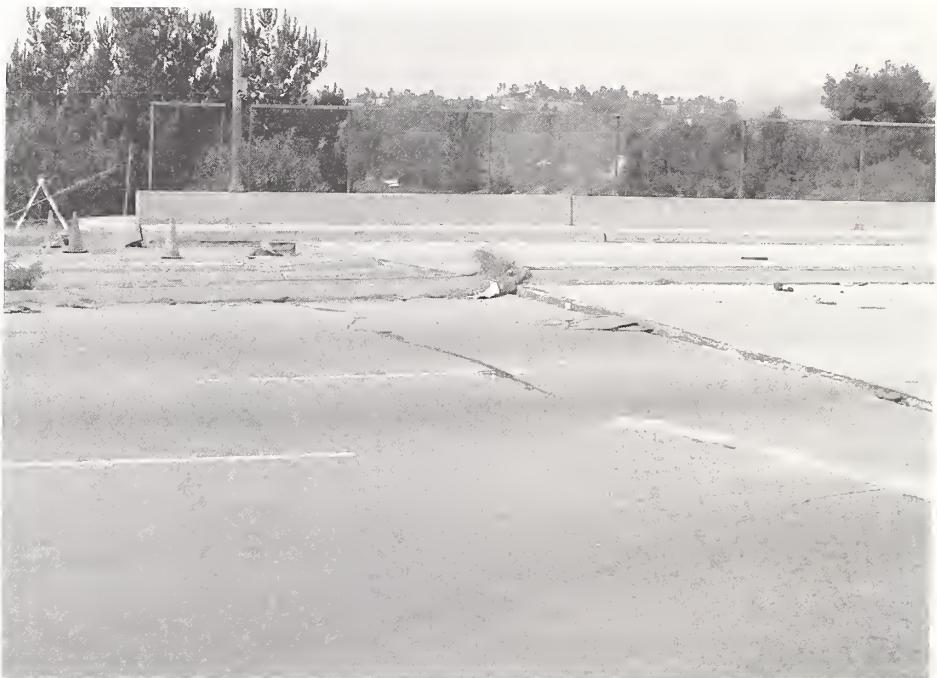
Strong ground shaking and lateral movement of subgrade materials resulted in numerous ruptures of asphalt pavement and concrete sidewalks in the epicentral area (figs. 5.19 and 5.20). In some instances, local traffic was interrupted temporarily until these cracks were repaired. In most cases, damage was minor and local traffic was not interrupted. The south approach of Balboa Boulevard at SR118 caved in because of loss of abutment fill due to a water main break (fig. 5.21). This bridge was closed for traffic due to some structural damage to the piers and the loss of the south abutment fill, as described in chapter 4.

Figure 5.20. Transverse cracks in pavement near the intersection of Balboa Boulevard and SR118.

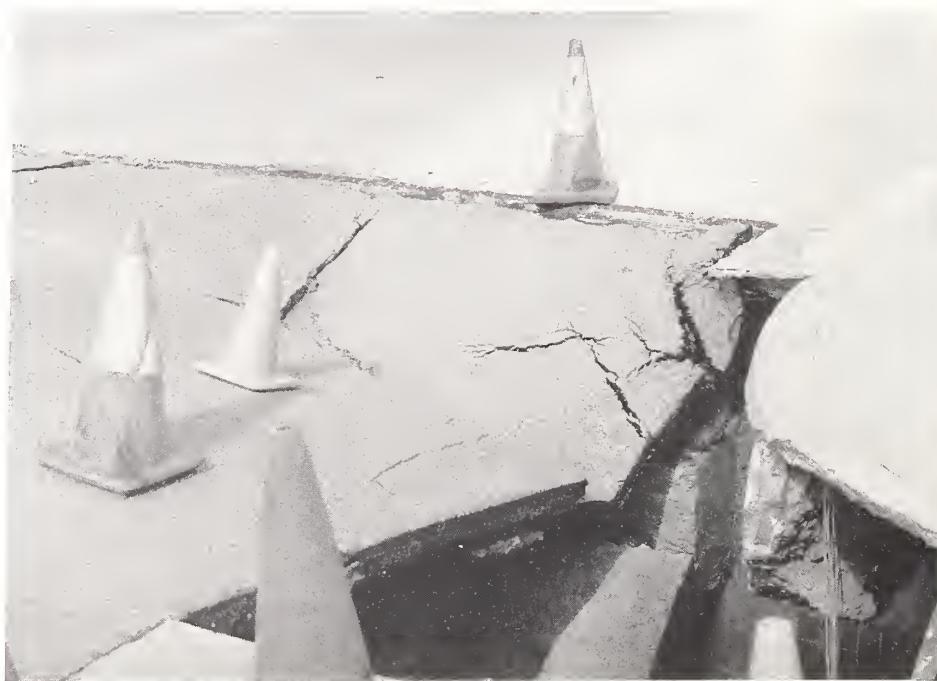
Figure 5.21. The approach of Balboa Boulevard at SR118 caved in due to the loss of the abutment fill because of a water main break.

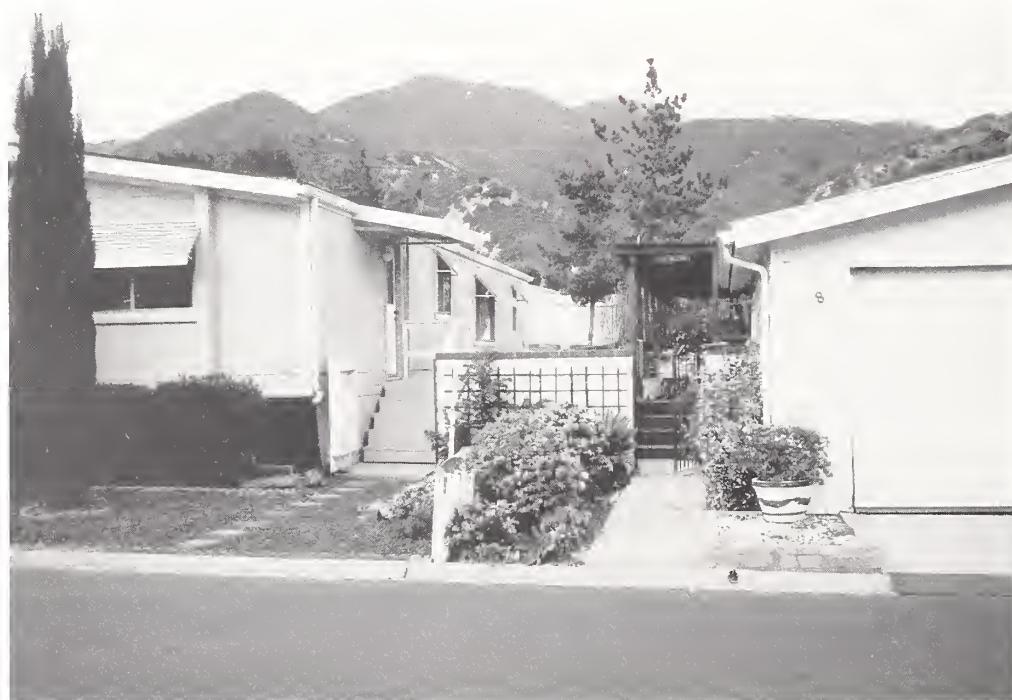
Building-to-building fire spread was limited to three manufactured housing developments (mobile home parks). Figure 6.8 shows the typical spacing between units in one of these developments. Figure 6.9 shows an area of the development destroyed by fire. Observations made at this development indicate that the method of unit-to-unit fire spread was primarily through windows. Once a unit became completely involved in fire, the thermal radiation was sufficient to cause the breakage of windows in an adjacent unit or to ignite combustibles within the unit directly through the windows. The fire department reported low water pressure in the area which combined with multiple independent fires and limited resources hindered fire fighting operations. The fire spread was stopped either by separation such as roads and open areas or by fire fighting operations.

Figure 6.8. Typical unit spacing in a manufactured housing development.

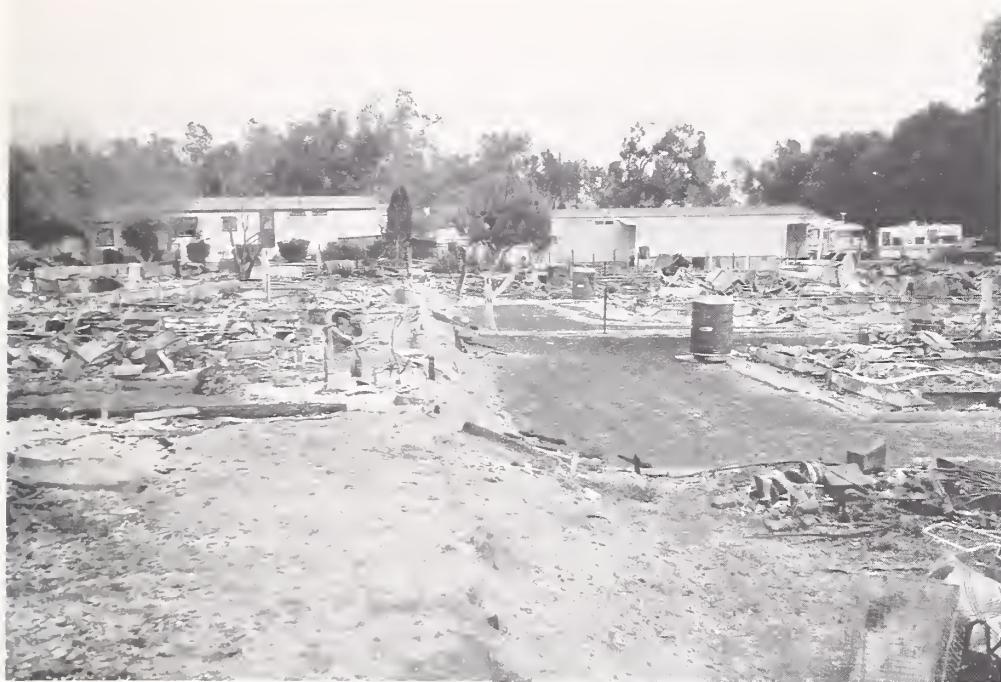
Figure 6.9. Impact of a multiple unit fire in a manufactured housing development.

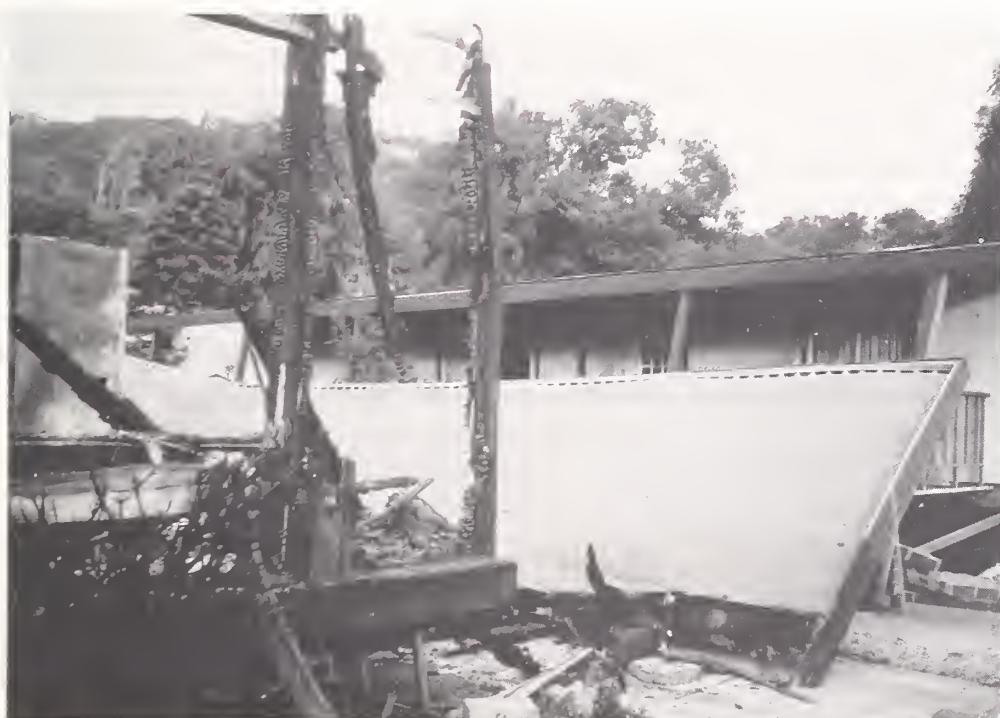
A unique aspect of the construction of these manufactured units played a role in limiting fire spread and assisting fire department actions. As the units burned from the inside, the carport roofs collapsed from the building side, coming to rest on the outside supporting columns. In this way the carport roofs formed fire breaks as shown in figure 6.10. Although these roofs would not necessarily have survived the fire by themselves, they reduced the fire exposure on adjacent units and thus enhanced fire fighting operations.

Figure 6.10. Collapsed roof which acted as a fire break in a manufactured housing development.
