Investigation of the Skyline Plaza Collapse in Fairfax County, Virginia

E. V. Leyendecker and S. G. Fattal

Final Report

The collapse of the Skyline Plaza apartment building A-4 has been studied by using information contained in case records of the Occupational Safety and Health Administration (OSHA), U.S. Department of Labor and obtained from on-site inspections by investigators from the National Bureau of Standards.

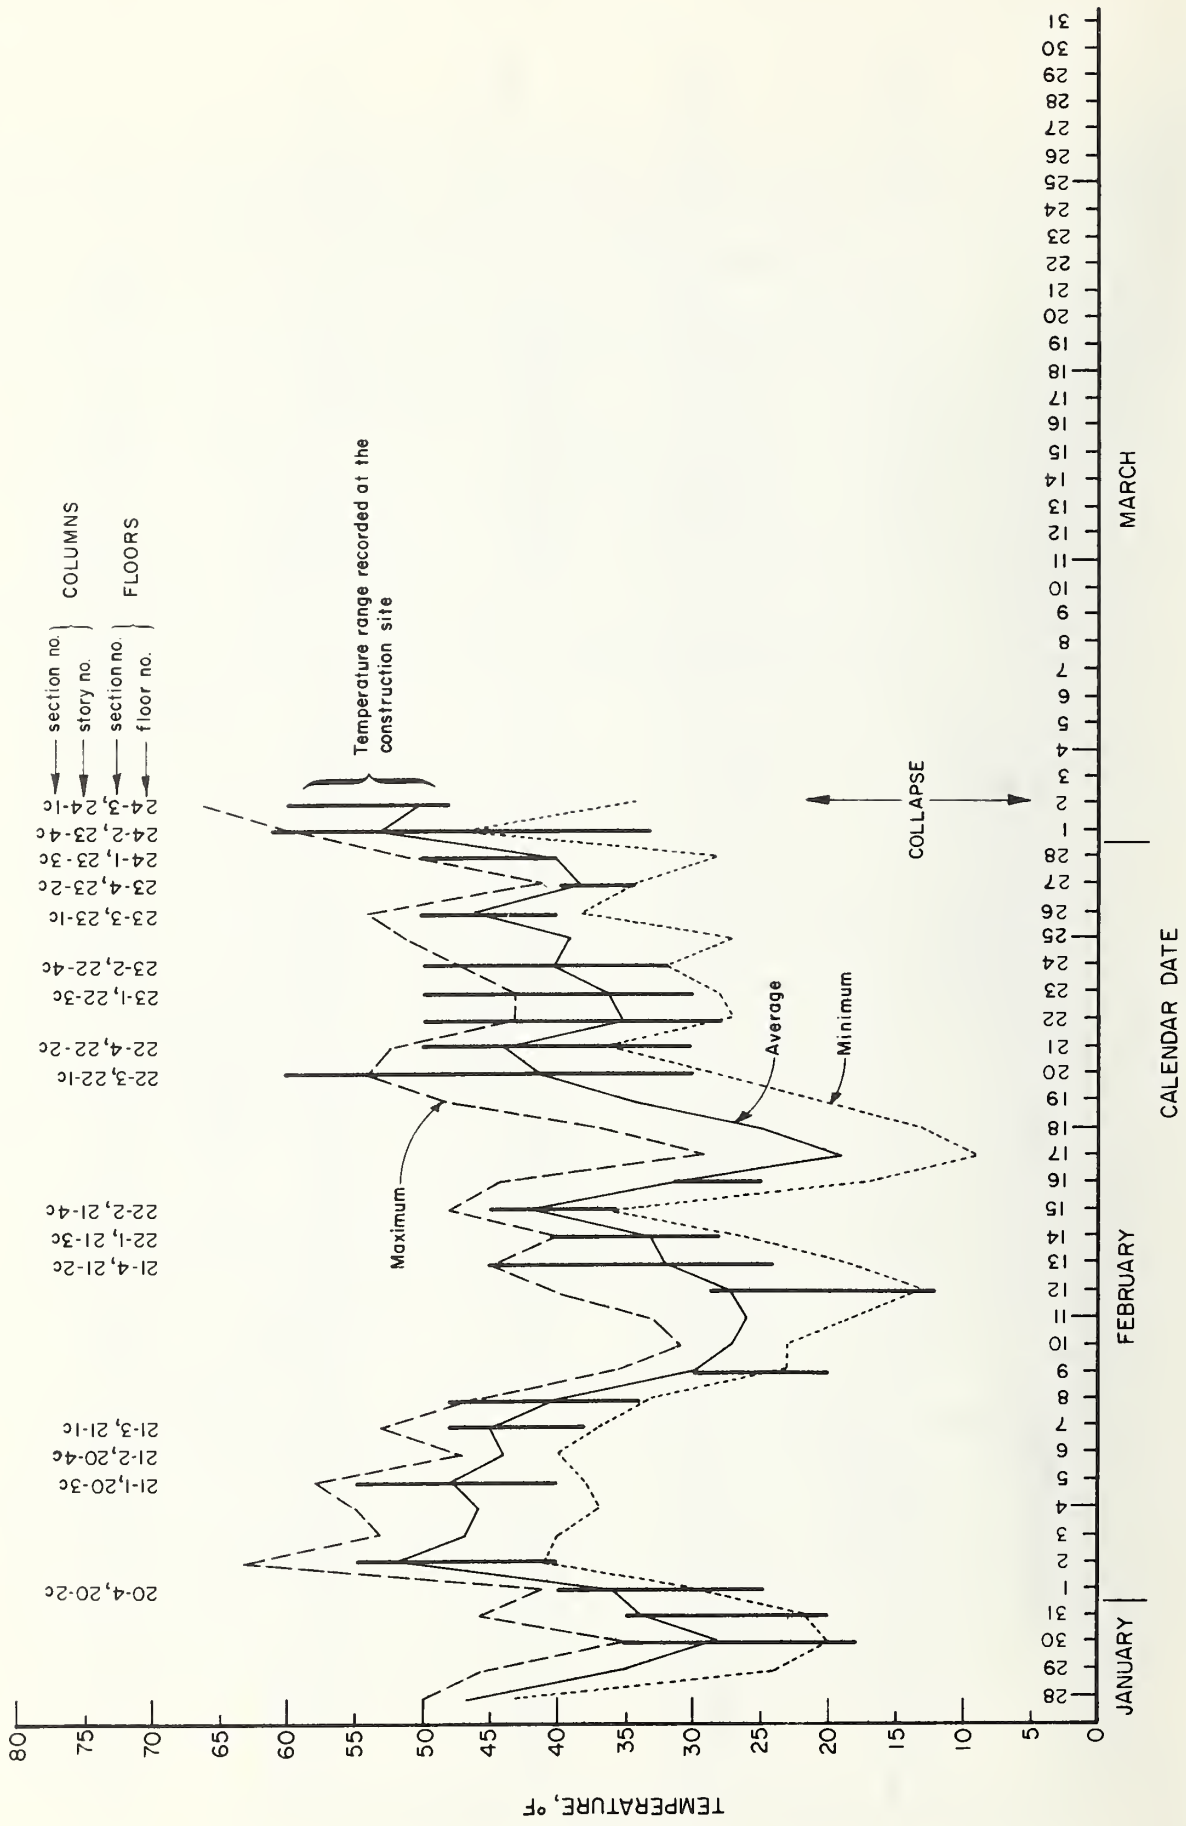
Figure 2.3 TEMPERATURE AND CASTING HISTORY FOR 21st STORY AND UP

In order to convert these strengths into estimates at the time of collapse the curing temperature should be considered. The average temperature history has been shown in figure 3.5 (enlarged from figure 2.3). The average air temperature was 42°F for the 22nd floor and 45° for the 23rd floor (temperatures as recorded at National Airport). Estimates of strength using the Klieger data for 2 percent calcium chloride in figure 3.4 (and interpolating between temperature curves) yields the following results rounded to the nearest 10 psi:

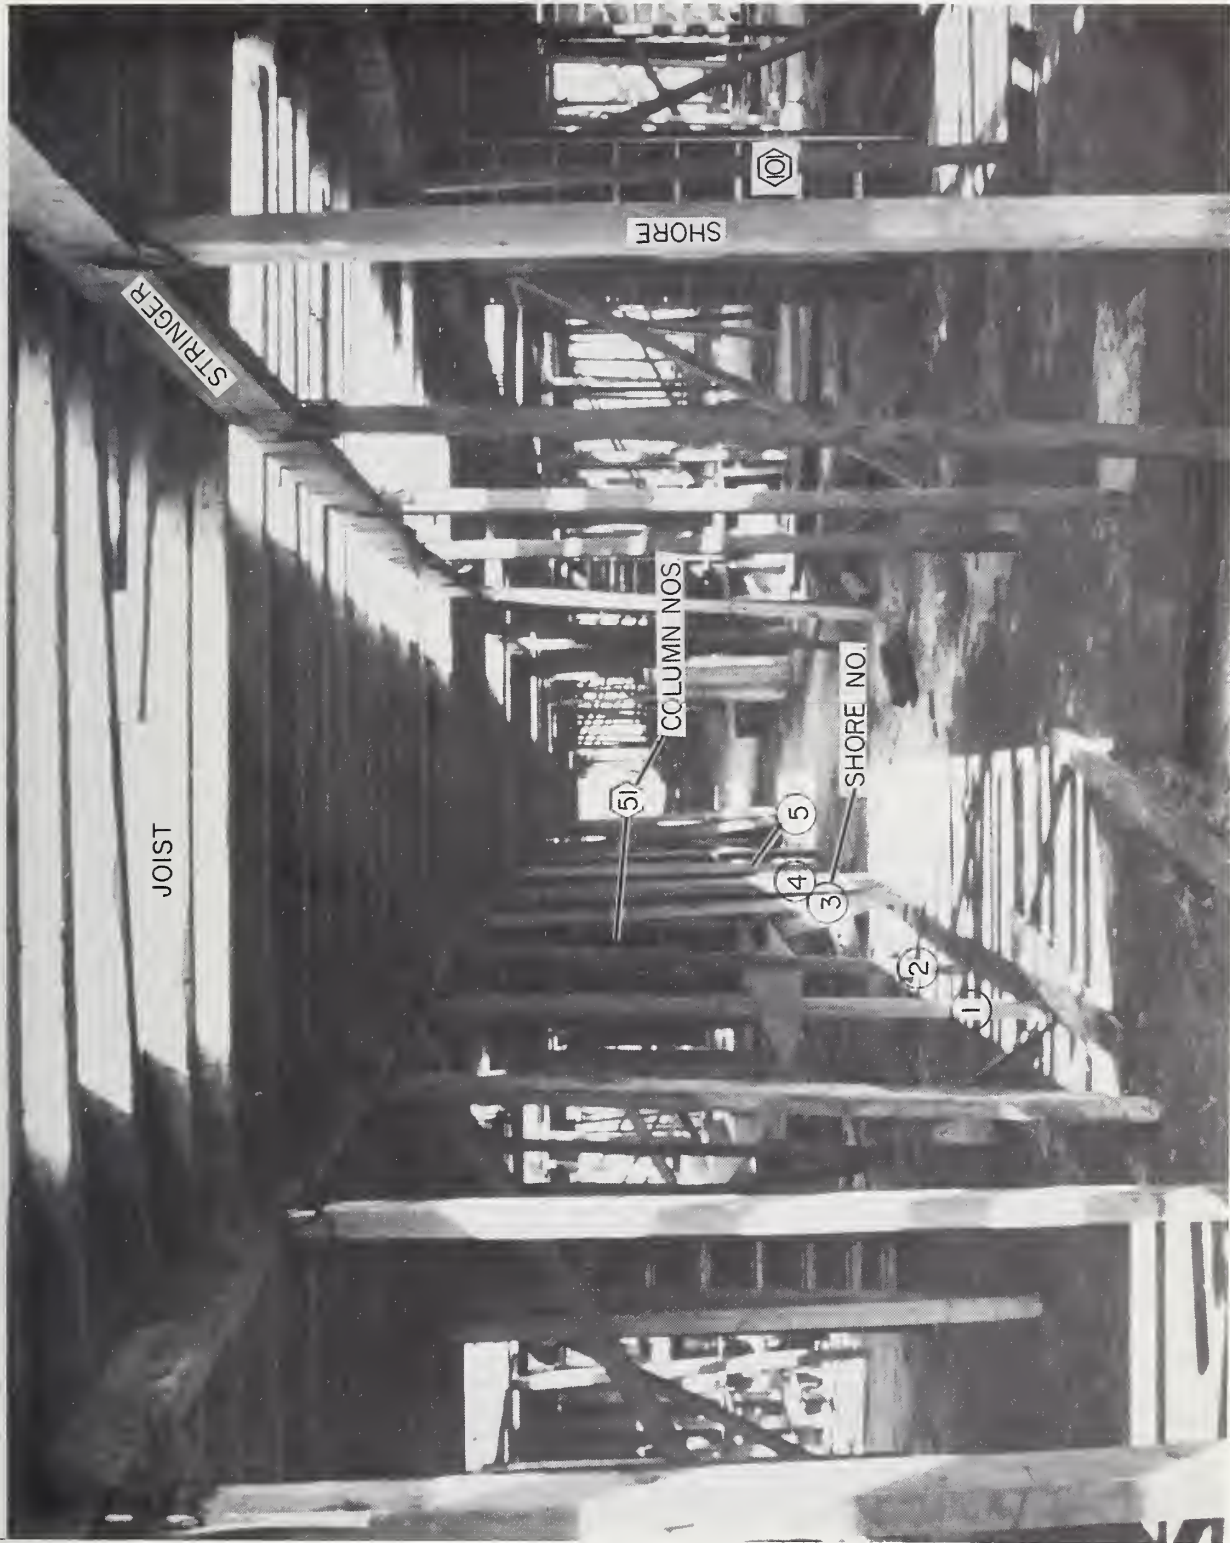
Figure 2.16 Formwork in sections 1 and 2 of 24th story, looking east.

OSHA regulations (ANSI-A10.9, section 8.1.24) allow a maximum deviation of 1/8 in per 3 ft out of plumb. Deviations of shoring exceeding these limits were found on the 23rd (figure 2.20) and 24th (figure 2.16) stories.

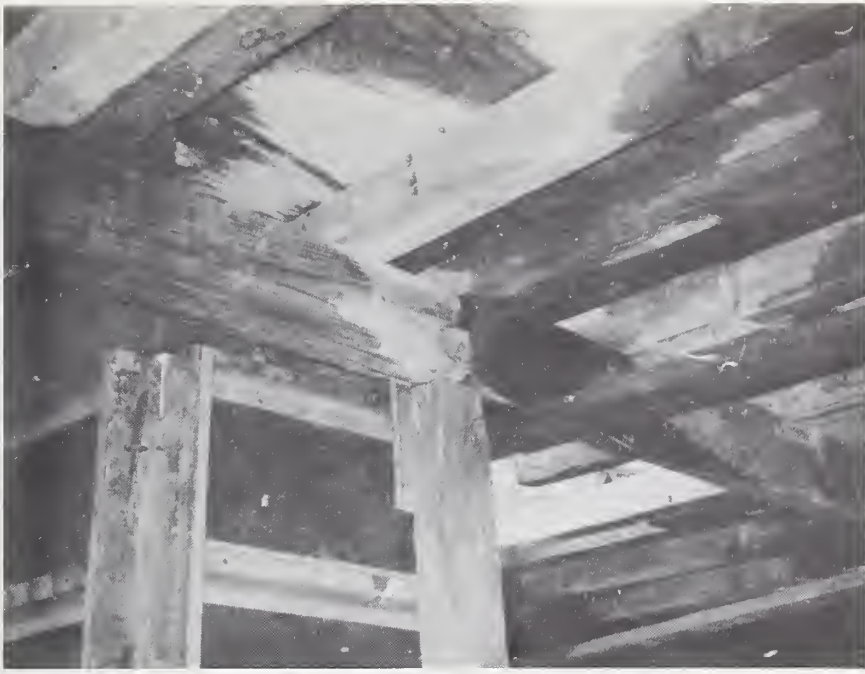
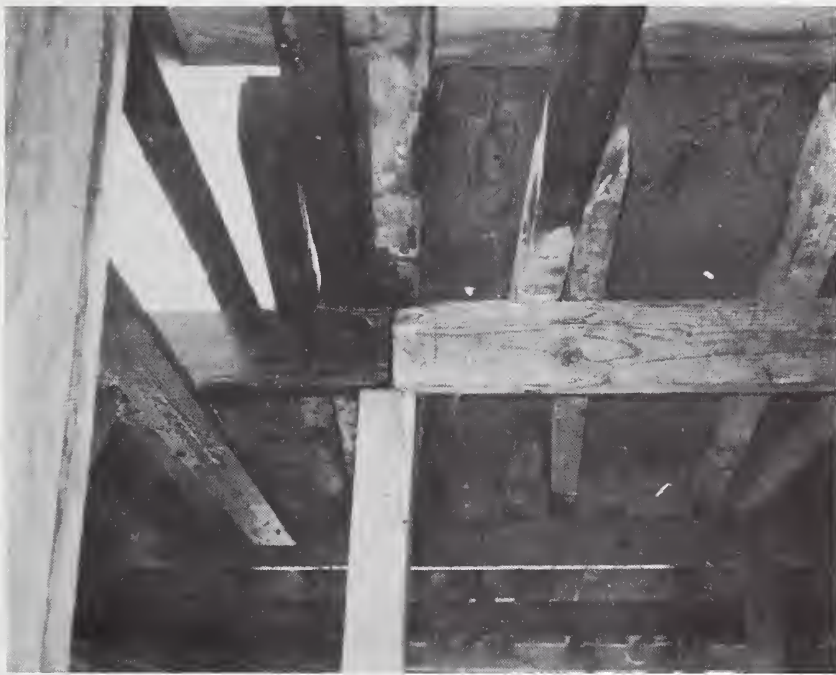
Figure 2.18 Selected details of 24th story forms.

OSHA regulations (ANSI-A10.9, section 8.1.25) require removal of damaged or weakened shoring. On-site inspection after the incident indicates this was not done on the 23rd (figure 2.22) and 24th (figure 2.18) stories.

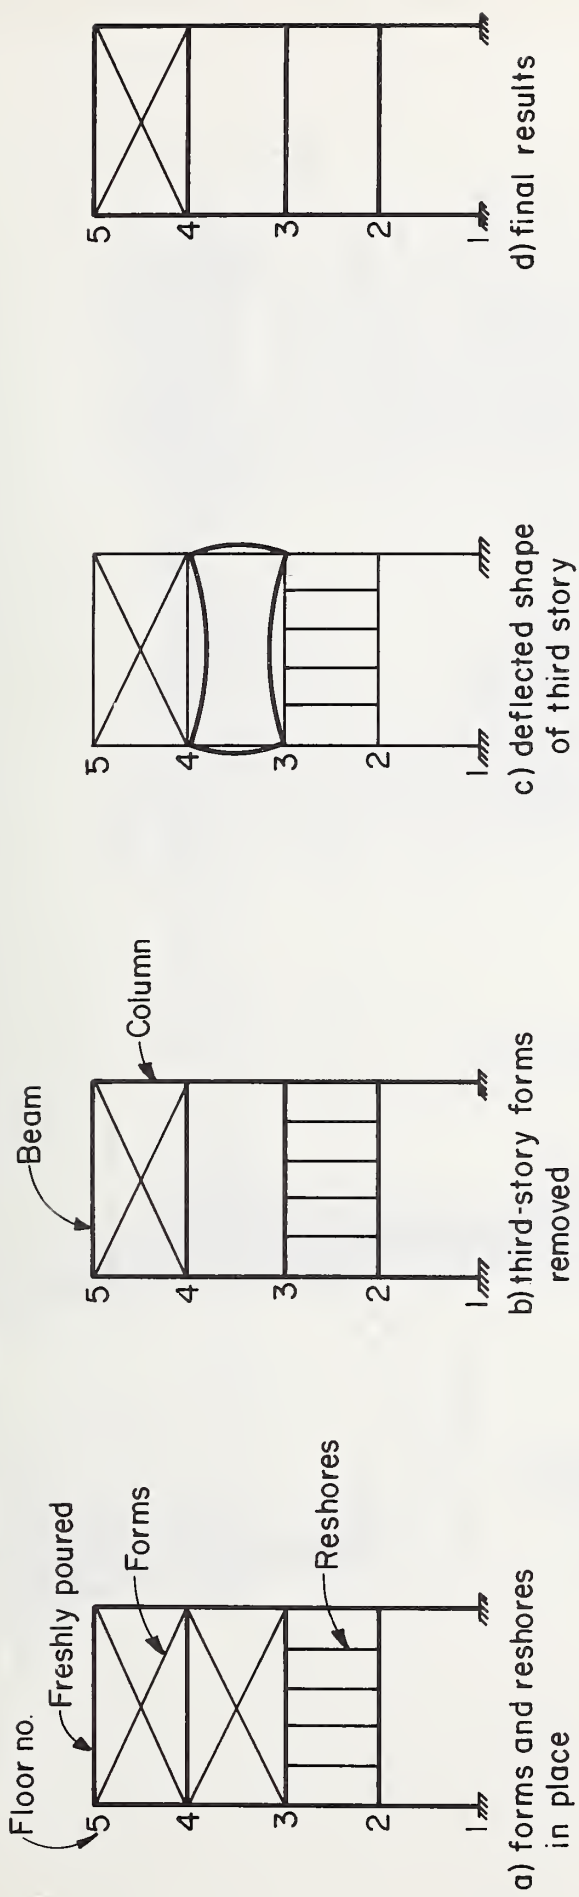
Figure 2.28 Effect of removal of forms.

The effect of these two factors on the load distribution cannot be quantified because of insufficient information. However, the load distribution which would simultaneously mobilize both floors towards their respective shear capacities can be examined; a condition under which the combined resistance of both floors is a maximum. In this case, the total weight of three floors plus shoring in two stories would be distributed between the 22nd and 23rd floors in proportion to the square roots of their respective compressive strengths. The results indicated required compressive strengths of 1030 psi and 1115 psi for the 23rd and 22nd floors, respectively. These compare with 1200 psi and 1340 psi respective average values estimated for these floors. Consequently, failure under Case 4 loading cannot be precluded. However, the following evidence is taken as an indication that the collapse did not initiate in the 22nd floor slab: (a) employee statements did not indicate sagging of the 22nd floor slab at the time of collapse and (b) one employee statement indicating the loss of the 21st story reshores prior to the incident was interpreted as a decrease in the 22nd floor deflection (section 2.2.2 and figure 2.28).

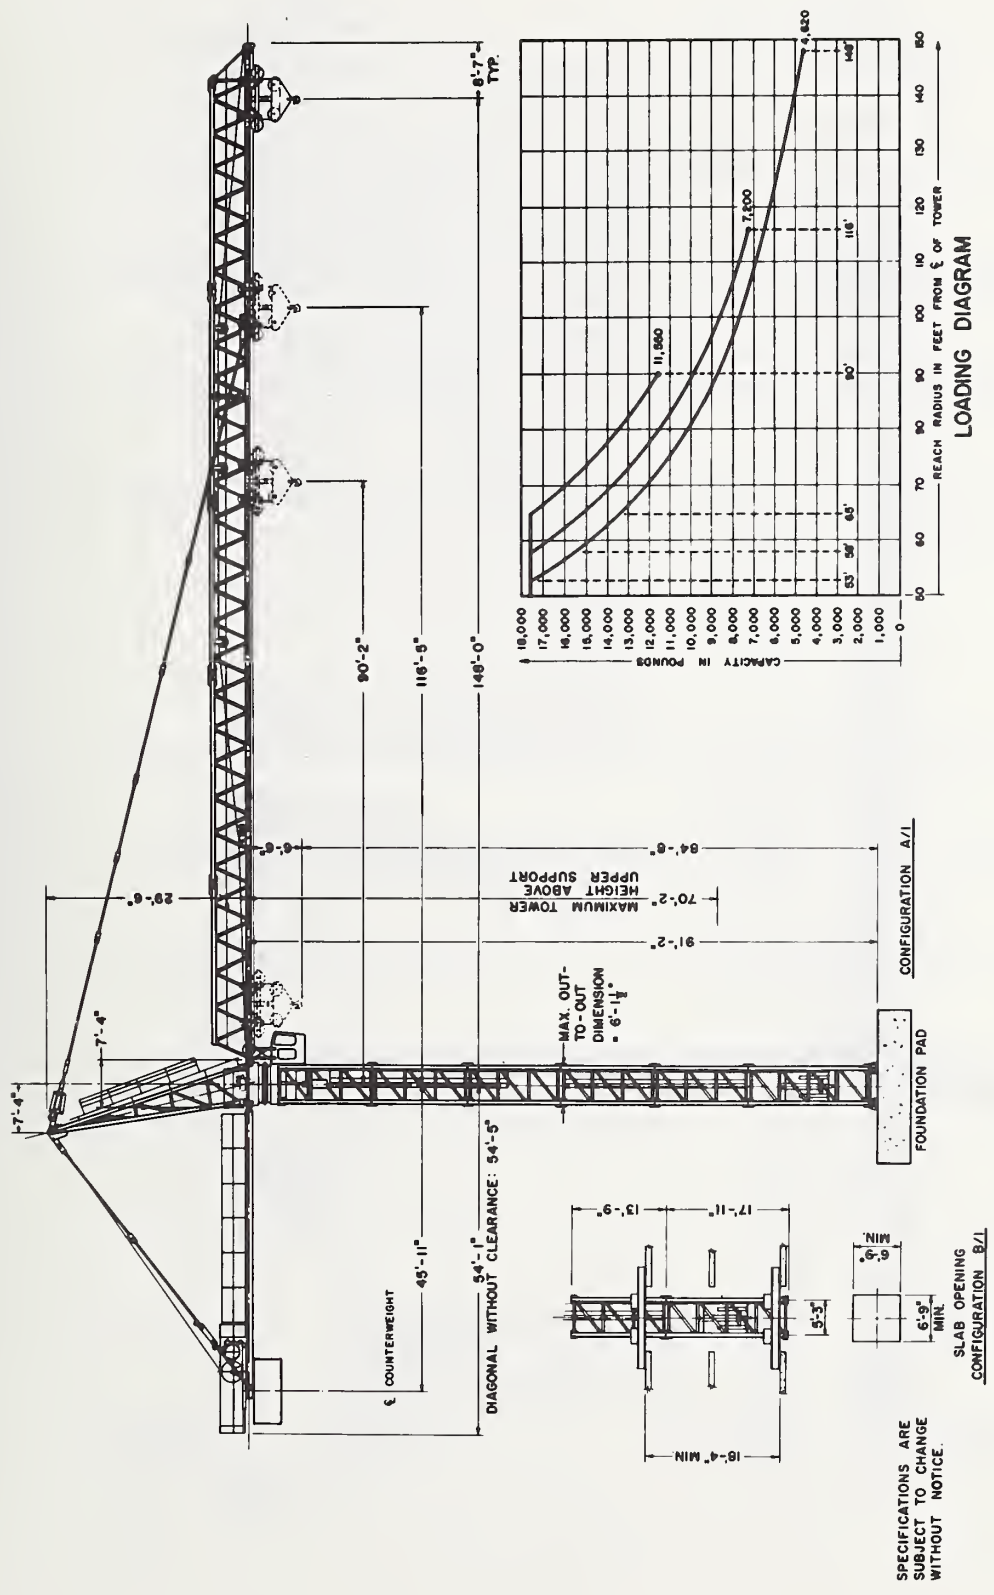
Figure 2.30 Crane no. 1 specifications.

- (1) Crane no. 1 (in section 1, away from the collapse area) - distance between top and bottom supports was less than the required 18 ft 4 in (figure 2.30) (18 ft was used).
- (2) Crane no. 2 (in section 4, in the collapse area)- distance between top and bottom supports was less than the required 21 ft 4 in (18 ft was used).
- (3) Crane no. 2 (in section 4, in the collapse area) - The number of standard tower sections used was one more than the four recommended by the manufacturer (figure 2.41 and section 2.2.3).
- (4) Crane no. 2 (in section 4, in the collapse area) - The maximum tower height exceeded (by approximately one standard tower section) the 81 ft-0 in recommended (figure 2.31 and section 2.2.3).

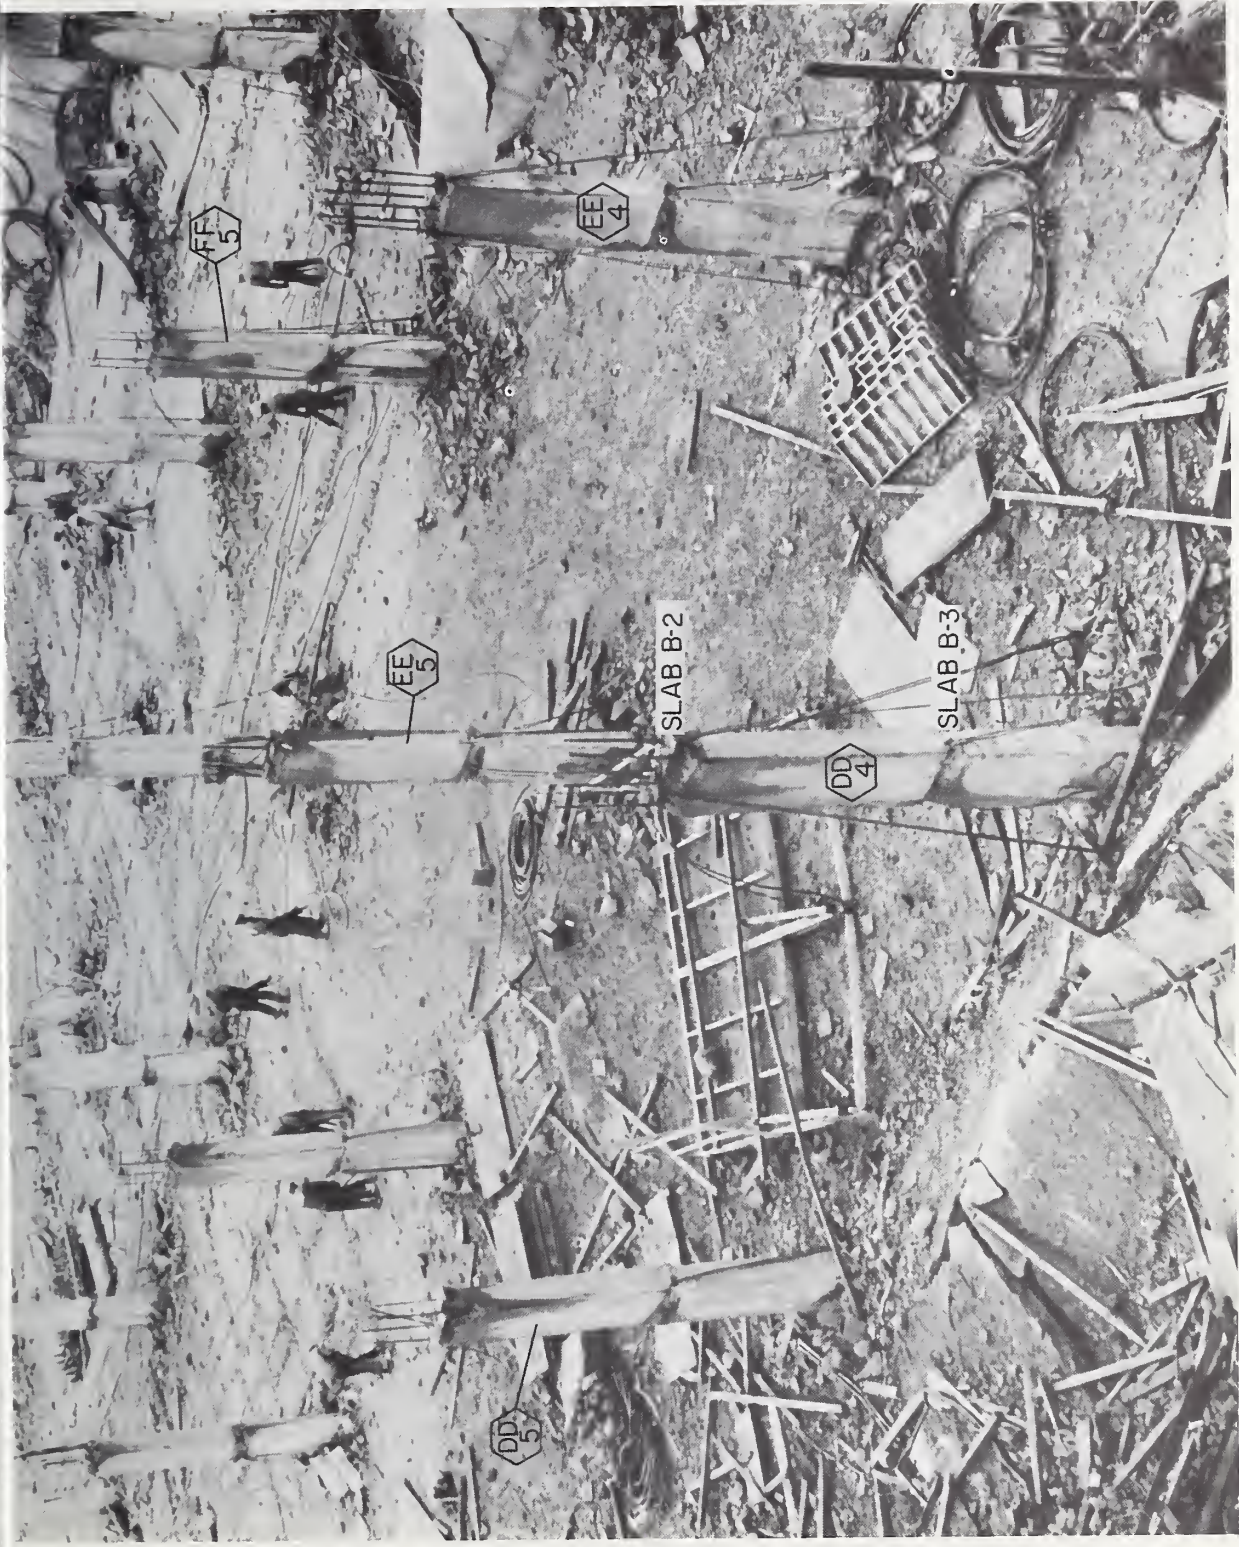
Figure 2.44 Closeup view of columns in figure 2.43.

The locations of slabs B-3 and B-2 are shown in figure 2.44 on column DD-4. Note the virtual lack of shear cones at the slab levels on most of the columns in that figure.

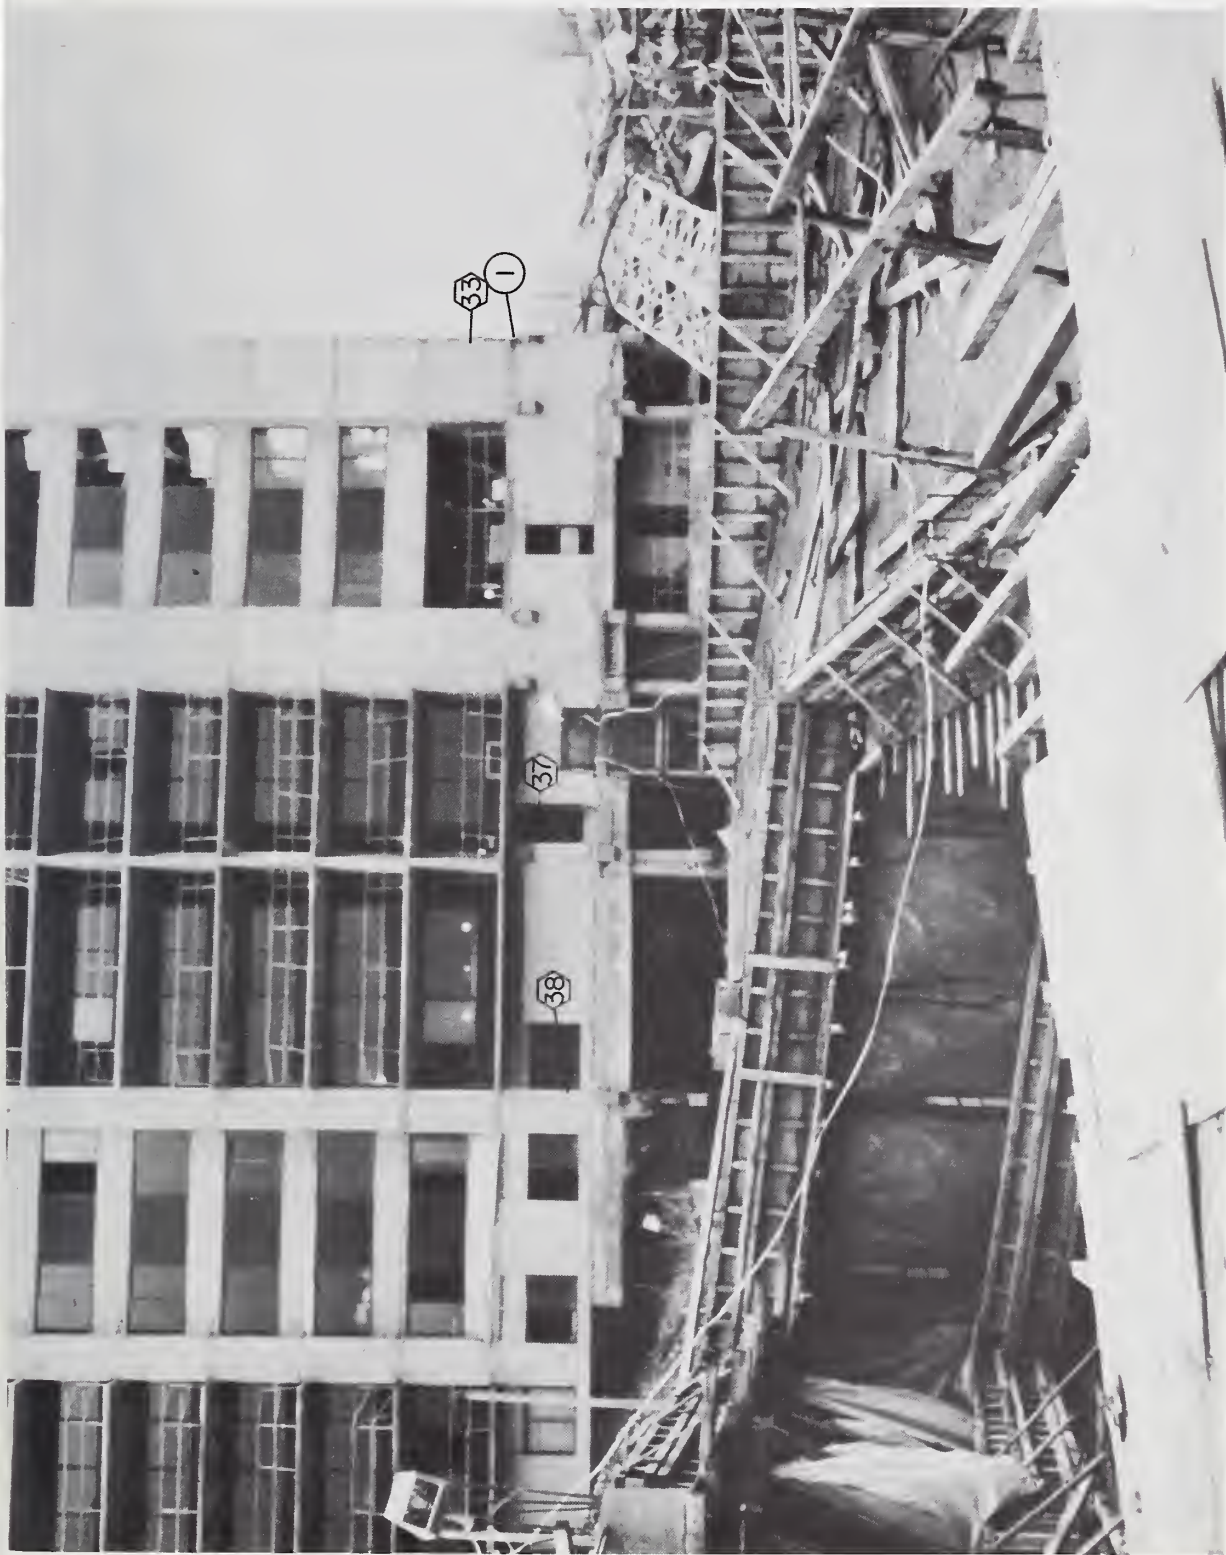
Figure 2.50 View looking north of ramp area and column corbels on building A-4.

The east edge of the garage was supported by columns as shown in figure 2.49. The northern edge was simply supported by corbels on the columns. These corbels are visible in figures 2.49 and 2.50. The pool deck level (corresponding with the first floor of building A-4) was to rest on corbels on columns 25, 26, 27 and 33-37. Slab B-1 was to rest on corbels on columns 25, 26, 27, 29, 31-38, and shear wall H. Slab B-2 was supported by corbels on columns 25, 26, 27, 29, 31-38, and shear wall H. Slab B-3 was supported by corbels on columns 25, 26, 27, 29, 31-36, and shear wall H.

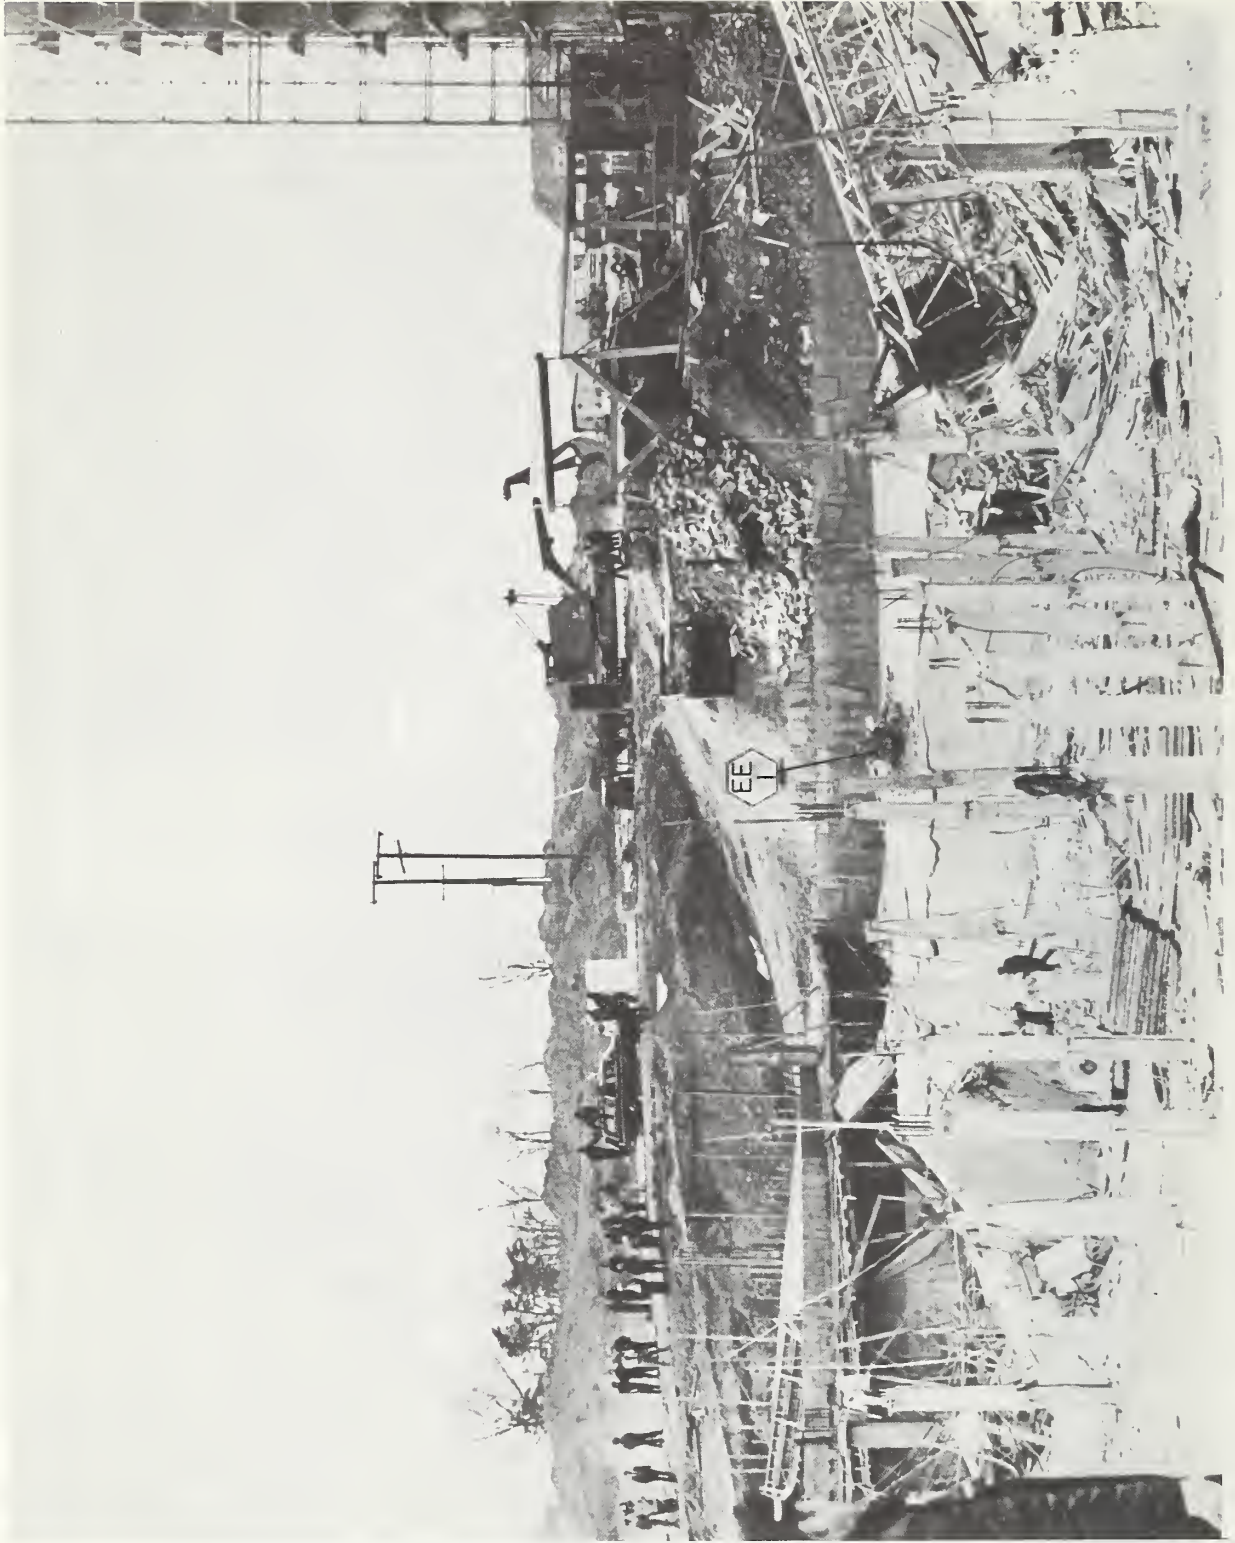
Figure 2.51 View looking west of area between the ramp and building A-4.

The west edge of the garage was supported by bearing on a wall and framing into a ramp as shown in figure 2.51. Slab B-2 may be seen resting on the portion of B-3 cast on a slab-on-grade (vicinity of column EE-1). More detail of the ramp framing can be seen in figure 2.52. The ramp was of reinforced concrete construction. The west wall south of the ramp can be seen in figure 2.53 and with more detail in figure 2.54. The formwork and strand which had been positioned for slab B-2 can be seen in figure 2.53. A portion of a shear cone is visible on column KK-3 in the same figure.

At the time of the collapse, crane No. 2 was reported idle with the jib pointed towards the garage. The exact orientation is not known. A distant view of the tower sections of the crane after the collapse may be seen in figures 2.49 and 2.51 (also 2.5). The tower top and hoist machinery (see figure 2.29) may be seen near column DD-2 in figure 2.55 (Note the partial shear cones on column DD-2). Based on an examination of the photographs it appears (refer to figure 2.1) that the crane tower lines up with the original position of the crane base (in plan view) and passes almost over columns 32 and DD-3, ending up with the top as shown in figures 2.55 and 2.56. This is a total distance of 125 to 130 ft. This distance compares to a total tower height (base section, 5 standard sections, and 1 slipping section) of about 125 ft. The implication here is that the tower fell while rotating about its original plan position. However, careful inspection of figures 2.54, 2.55, and 2.5 shows the jib is lying alongside the tower sections. The sequence of

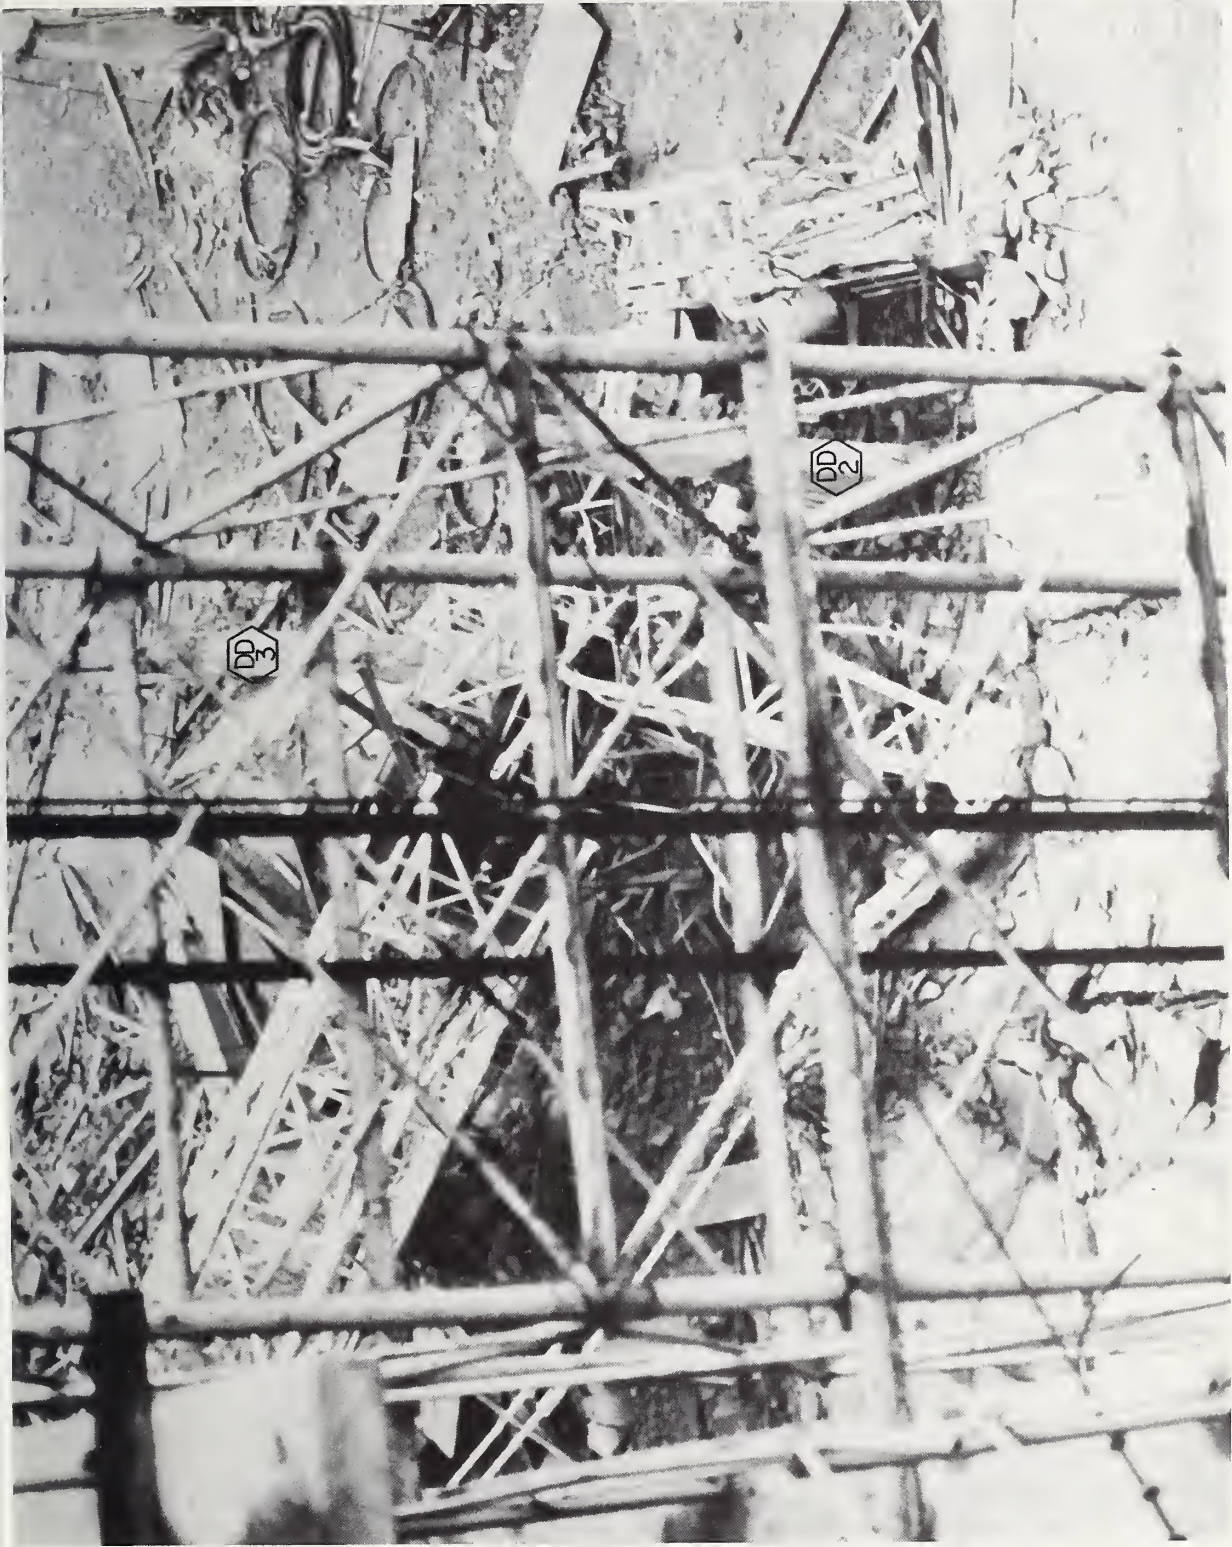
Figure 2.56 Position of fallen crane near column DD-2 looking east.

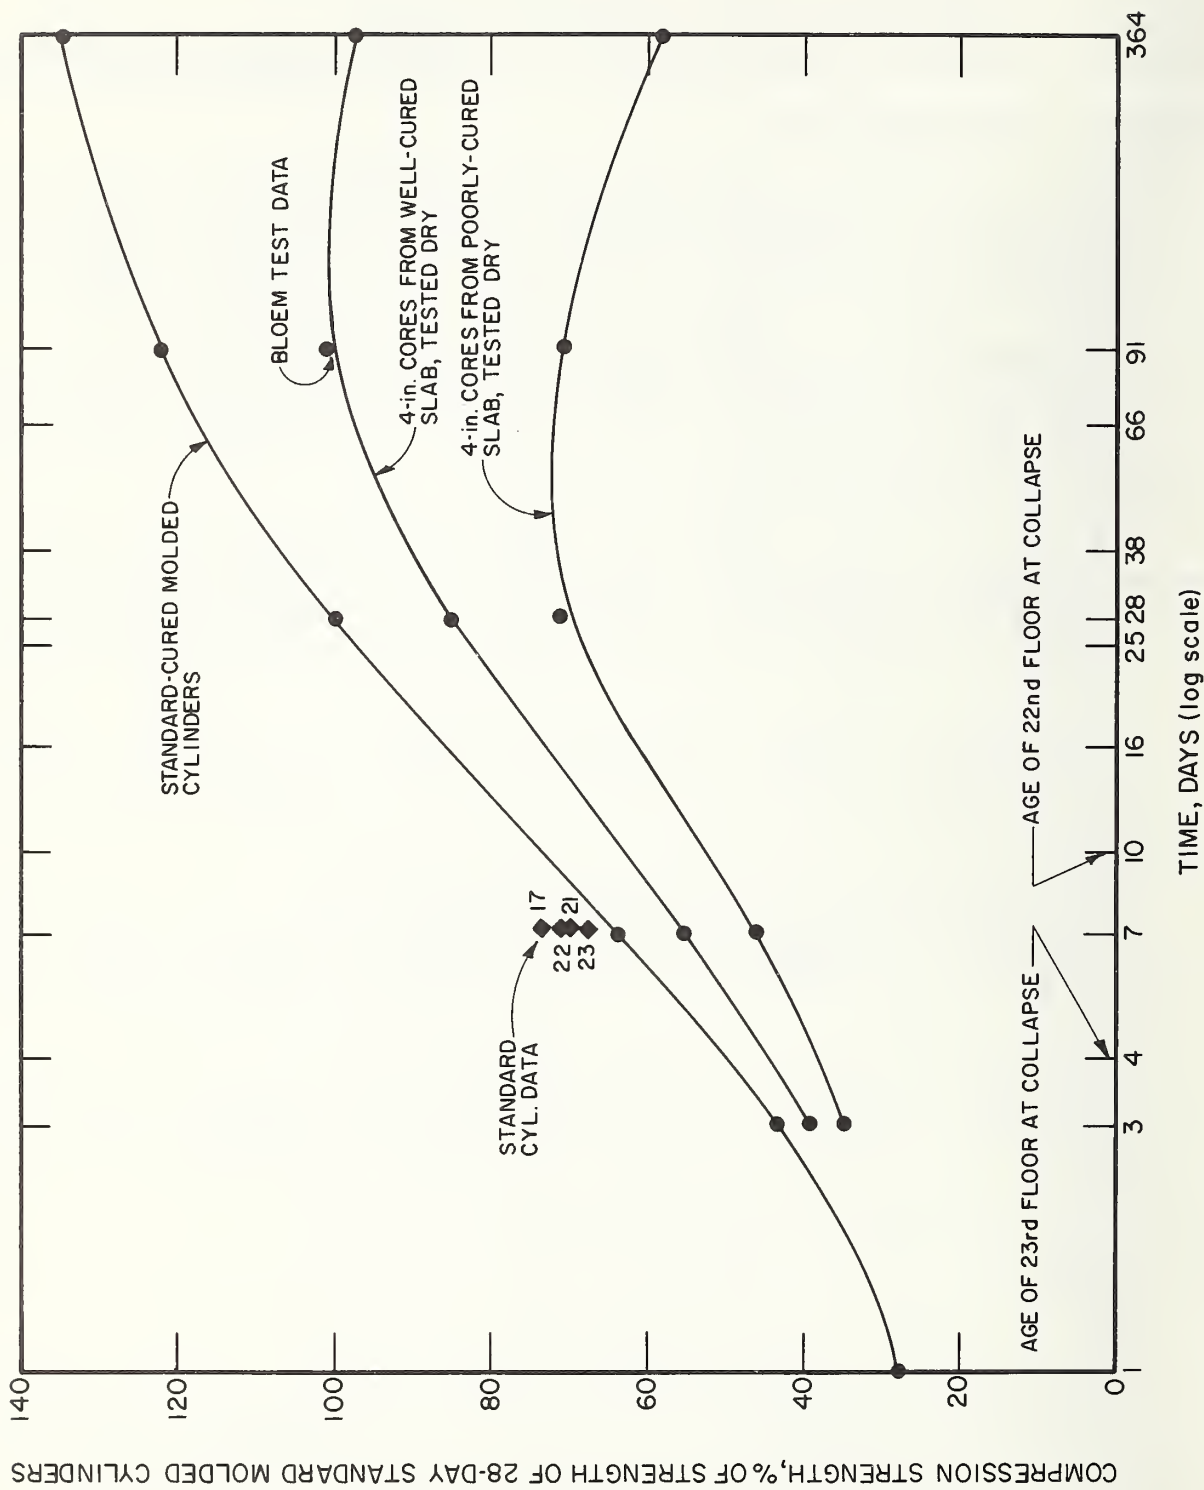
Figure 3.3 Strength measures for concrete cores and cylinders.

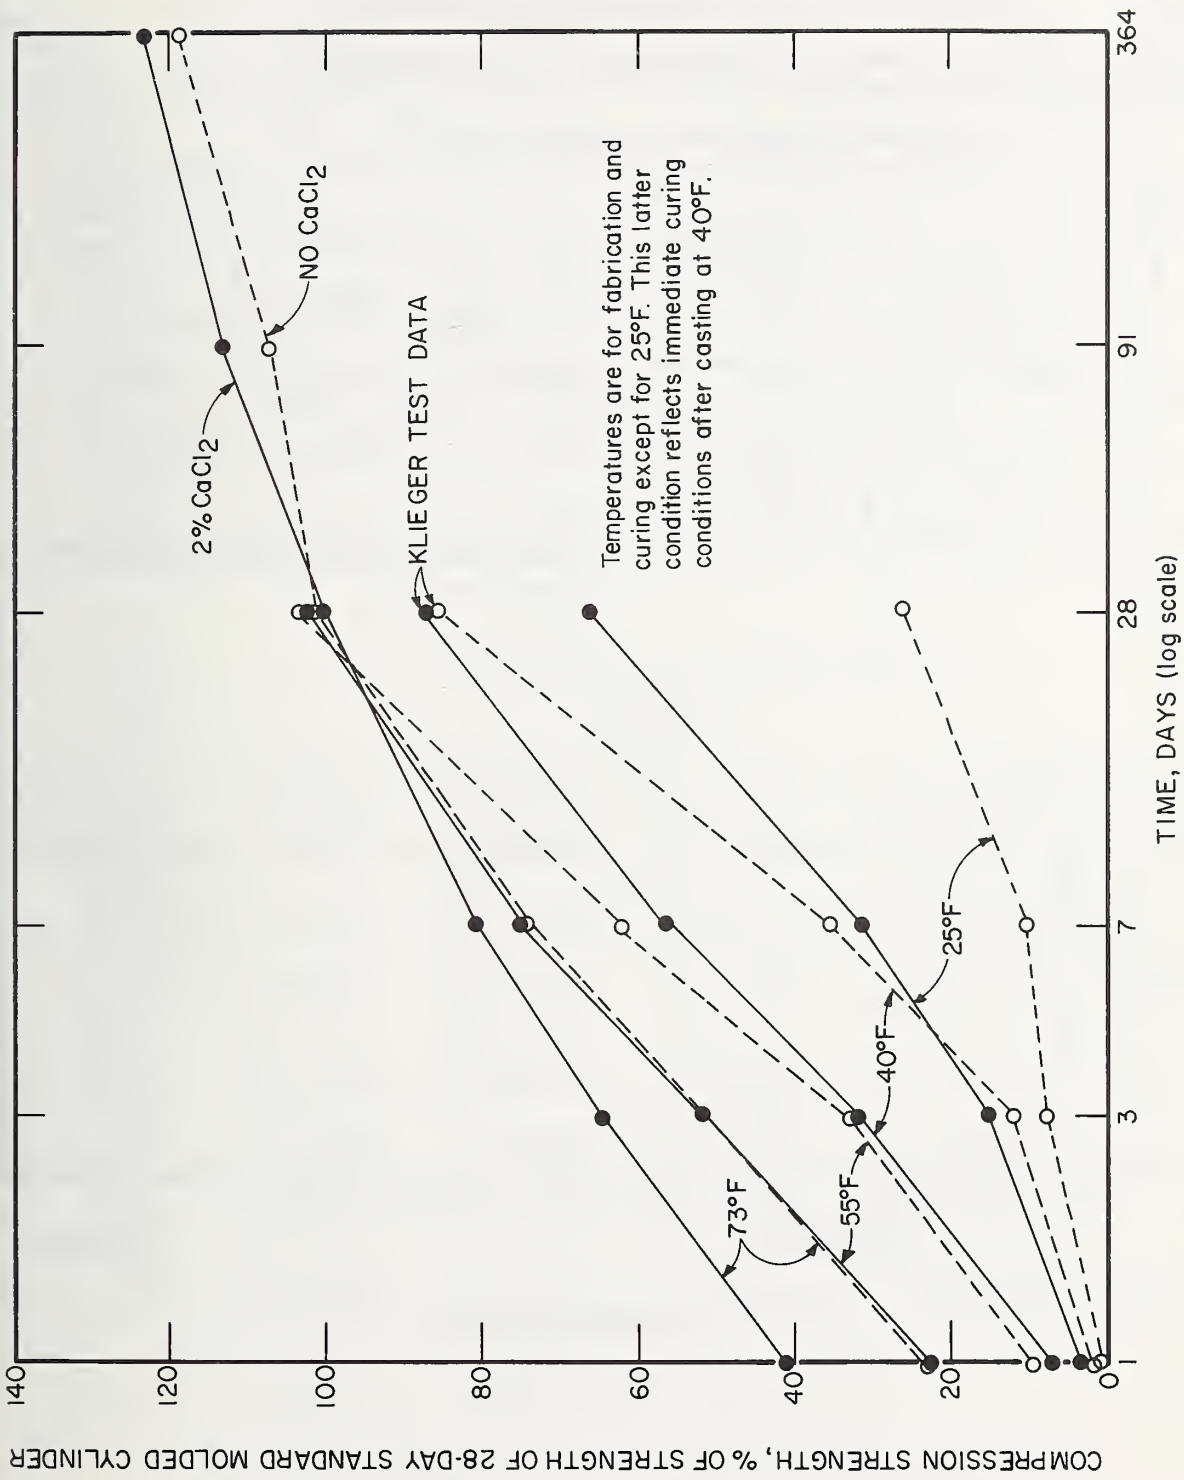
Figure 3.4 Development of concrete strength under various curing temperatures.

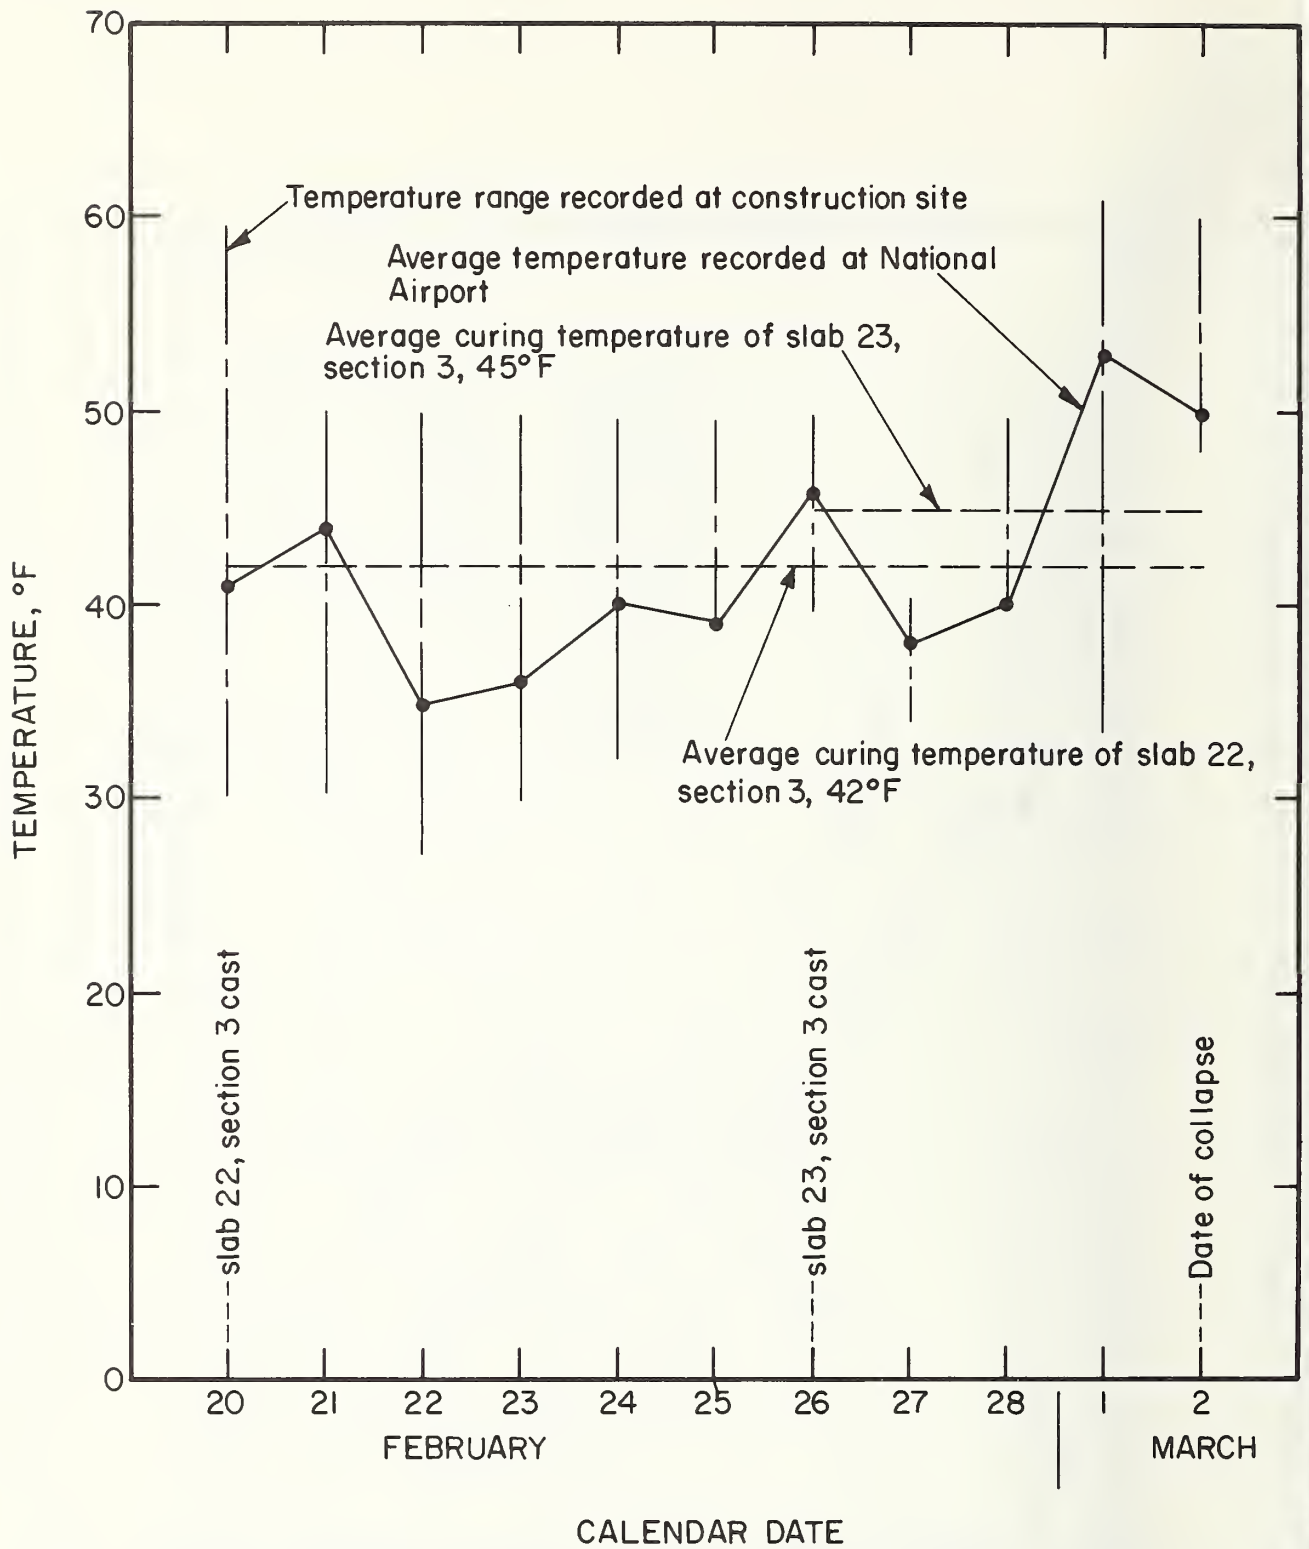
Figure 3.5 Temperature history for section 3 of 22nd and 23rd floor slabs.
