Investigation of the Skyline Plaza Collapse in Fairfax County, Virginia

E. V. Leyendecker and S. G. Fattal

Final Report

The collapse of the Skyline Plaza apartment building A-4 has been studied by using information contained in case records of the Occupational Safety and Health Administration (OSHA), U.S. Department of Labor and obtained from on-site inspections by investigators from the National Bureau of Standards.

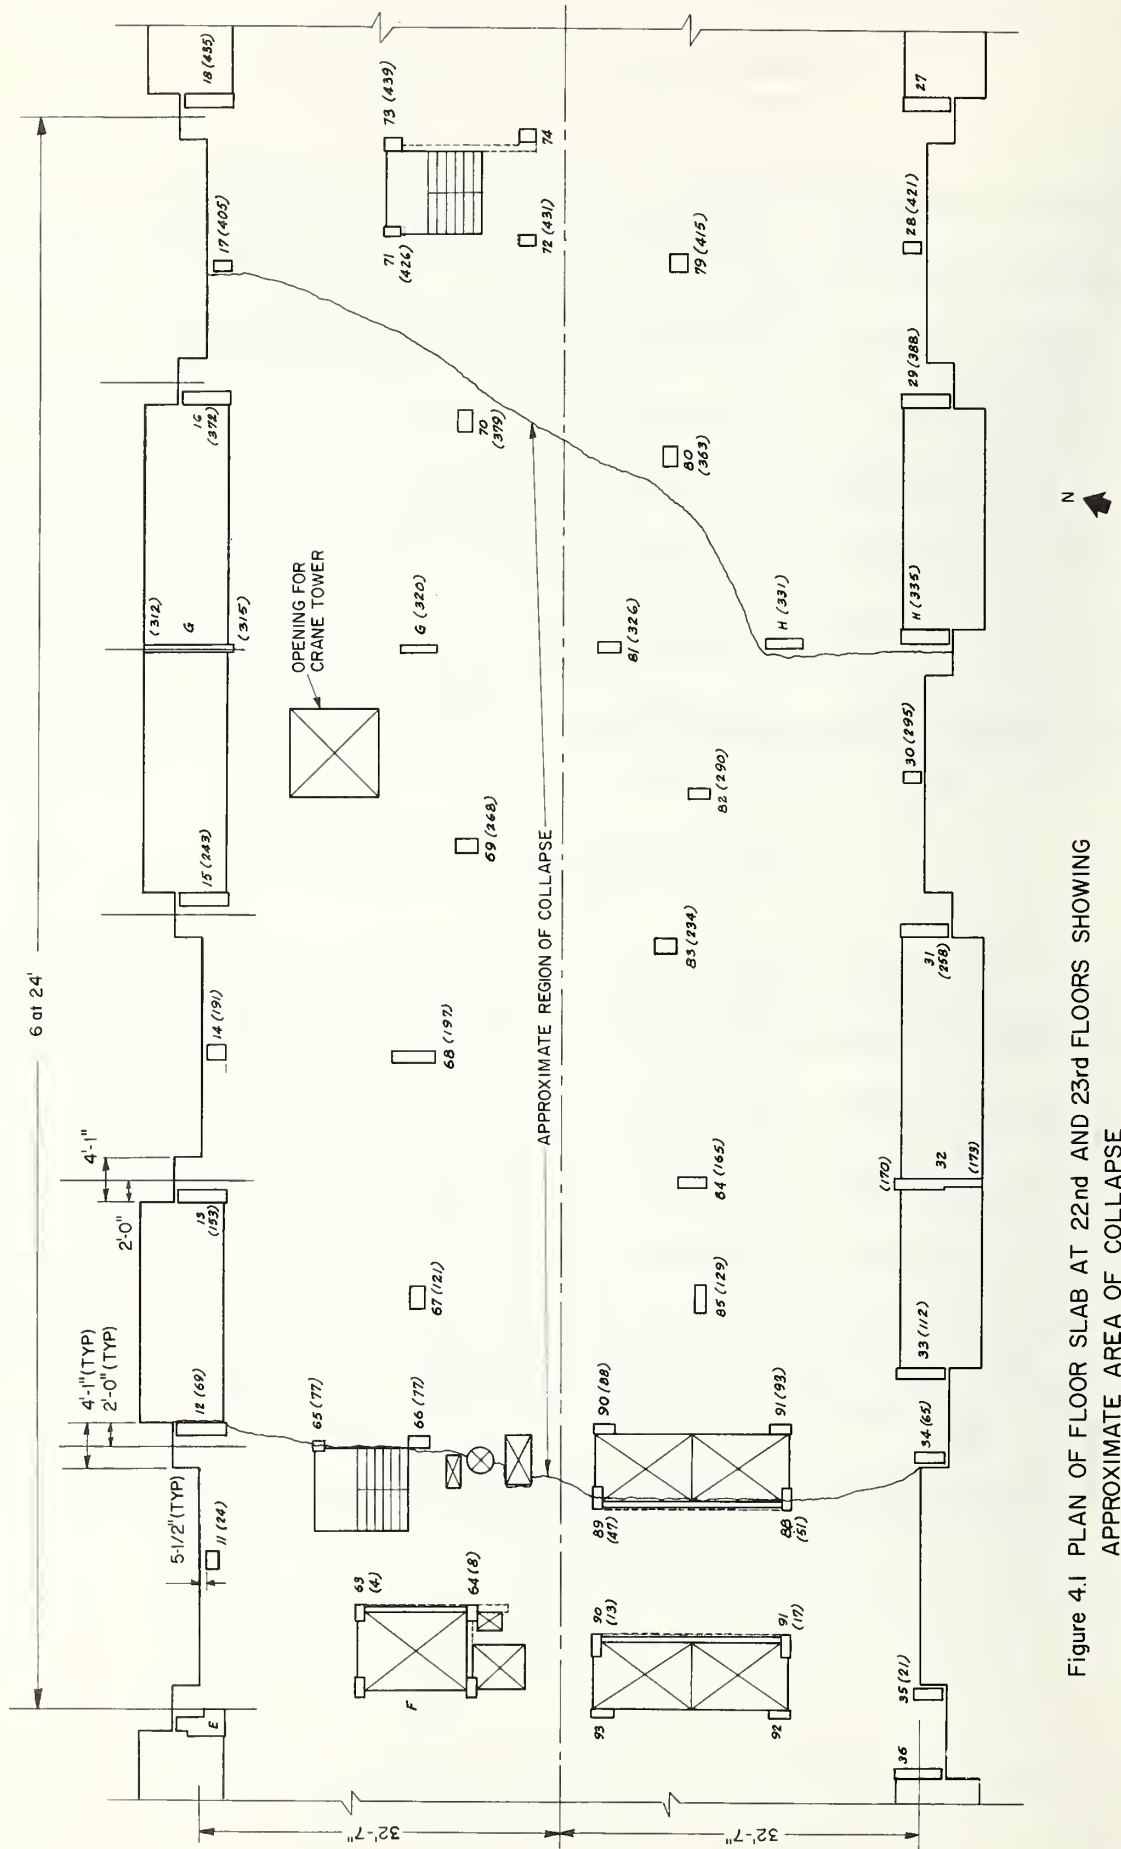
Figure 4.1 PLAN OF FLOOR SLAB AT 22nd AND 23rd FLOORS SHOWING APPROXIMATE AREA OF COLLAPSE

Three finite element analyses were made for the slab assembly in the region of collapse. The approximate area of collapse is shown in figure 4.1. All three analyses were based on the grid model shown in figure 4.2.

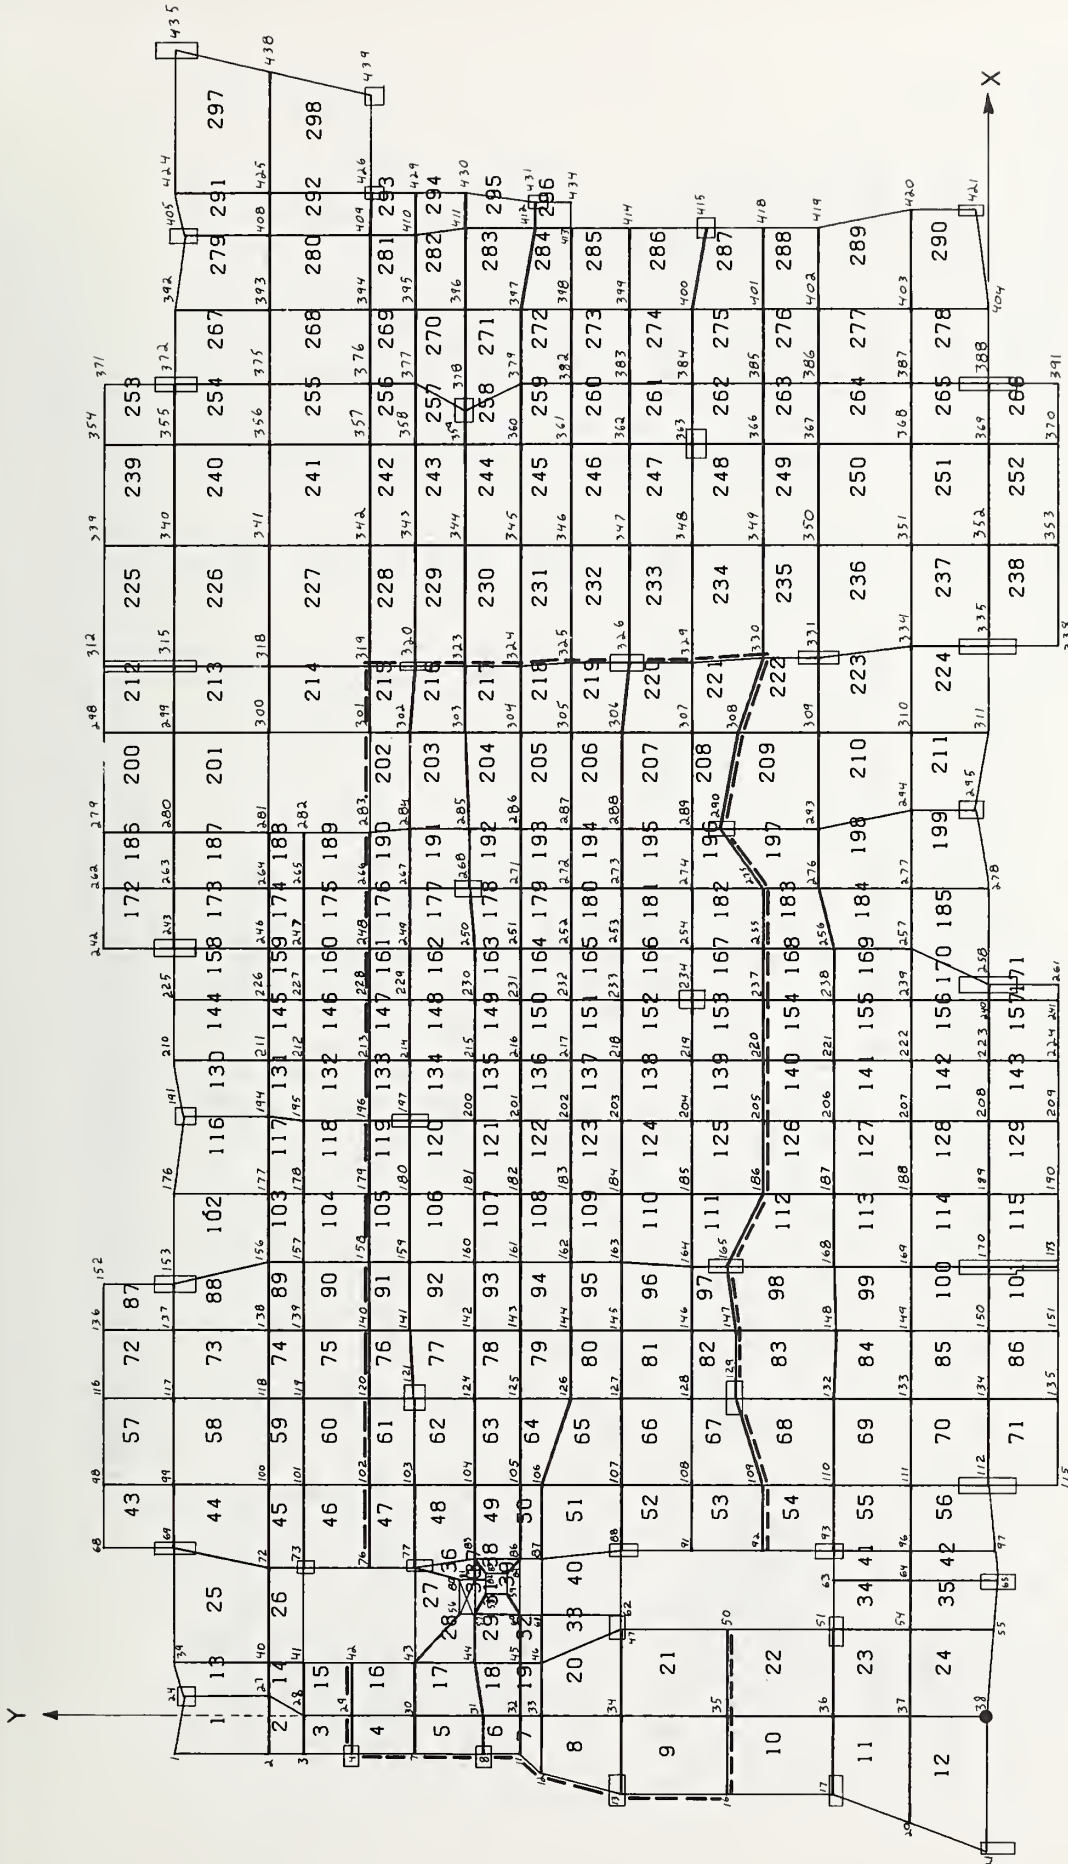
Figure 4.2 FINITE ELEMENT GRID FOR SLAB ANALYSIS

The grid layout in figure 4.2 is different from the slab in the contract drawings in certain aspects. The balcony slabs were assumed extending to the centerlines of the end columns. Likewise the boundary of the slab at north and south fascias between balconies was assumed extending to the centerlines of the flanking columns, eliminating, in effect, the stepped portion of the slab between a balcony and an adjacent fascia. Wherever possible, rectangular or square plate elements were used to construct the grid. In order to make column centroids coincident with nodal points of the grid a few trapezoidal plate elements were also introduced. By using a finer mesh one could develop a model which would more precisely represent the actual assembly. However, such a refinement is not justified because it would not significantly affect the results [7A].

the collapse (see section 2.2.2). A loading simulating the condition of partial removal of shoring was used. This Case is similar to Case 1 except the loads on the 23rd floor slab were reduced outside the region bounded by grid lines 7-320, 320-330, 330-16, and 16-7 as indicated in figure 4.2. To obtain these reduced loads, the loads from case 1 were multiplied by a factor which was based on the assumption that 22nd and 23rd floor slabs shared the loads on the 23rd floor in proportion to their respective elastic moduli. The modulus of elasticity of the 23rd floor slab was the same as was used in Case 1. The modulus of elasticity of the 22nd floor slab was calculated on the same basis as described in Case 1 using the average estimated concrete strength at the time of collapse of 1340 psi for the 22nd floor slab (see section 3.1.4).

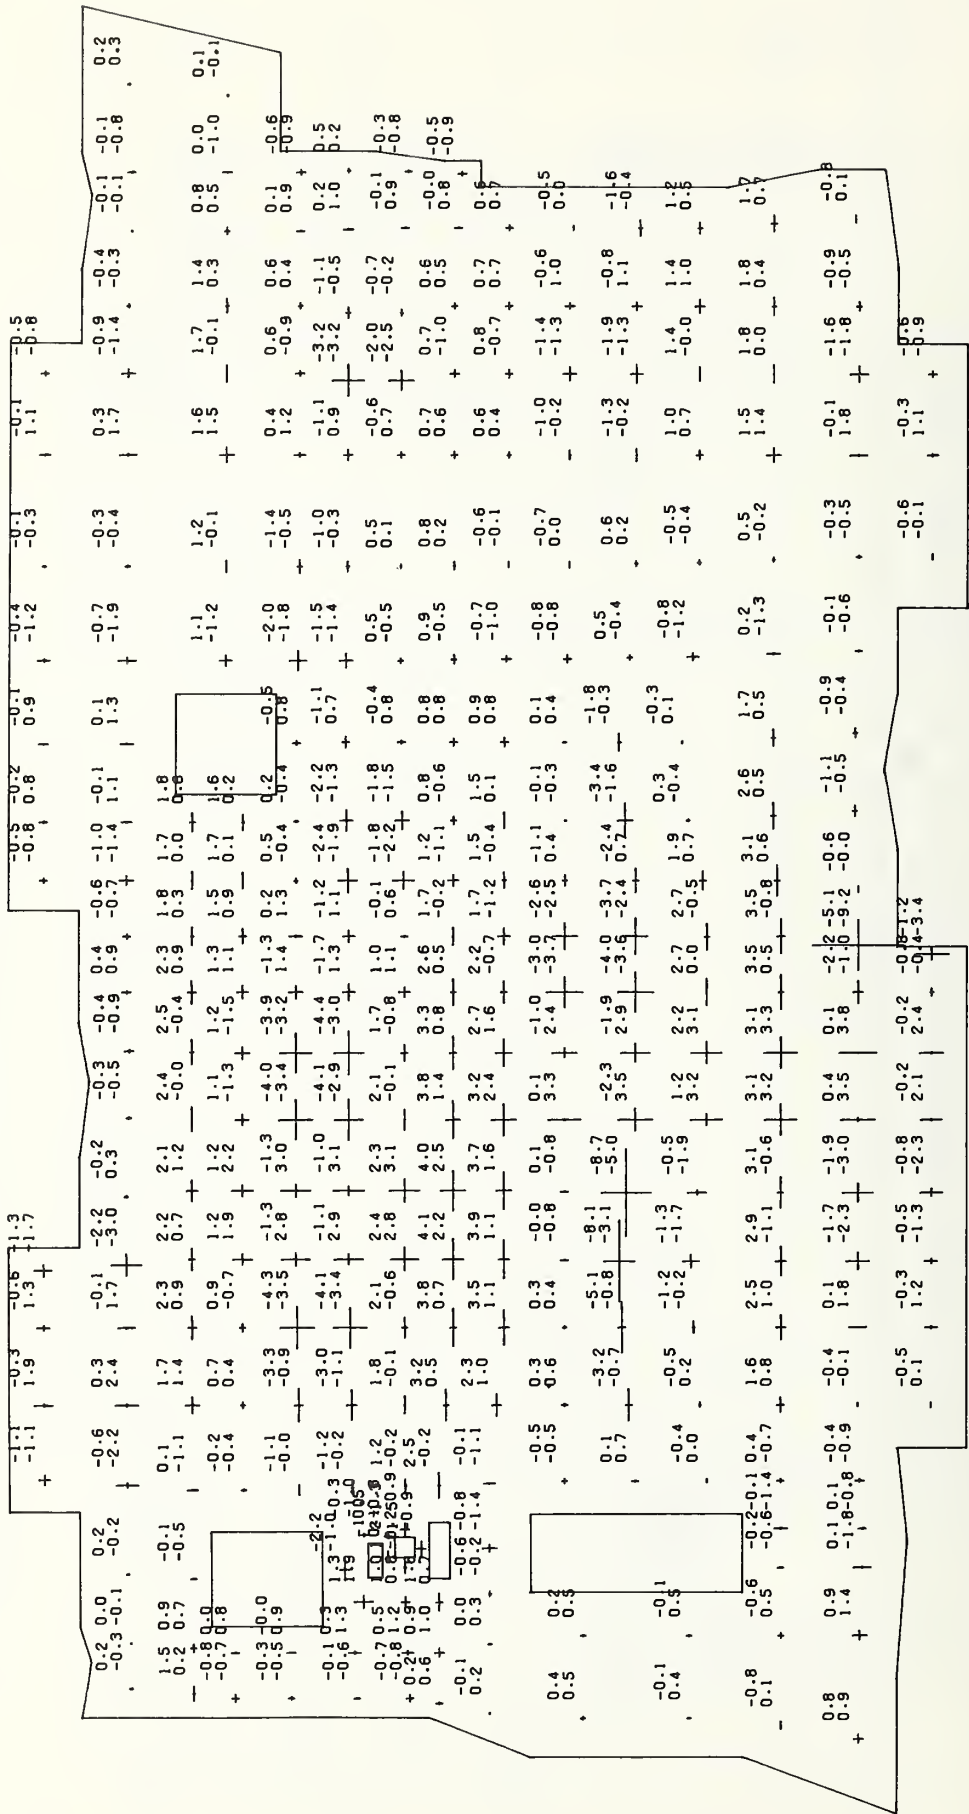
Figure 4.3 INTERNAL MOMENTS IN SLAB-CASE I

Figures 4.3 through 4.5 show the analytical results for cases 1 through 3. Moments M_x (rotation about x-axis) and M_y (rotation about y-axis) are designated by horizontal and vertical lines, respectively. They are shown plotted in pairs (and approximately to scale) at the centroids of slab elements. The numerical entries are moment magnitudes at the centroids and are expressed in units of foot-kips per linear foot of slab. Moments producing compression in the top of the slab are positive.

A comparison of results shown in figures 4.3 and 4.4 reveals the internal moments in the slab from the analyses of Cases 1 and 2 to be virtually identical. This indicates that the accuracy of predicted concrete strength will not have a significant influence on the results of flexural investigations.

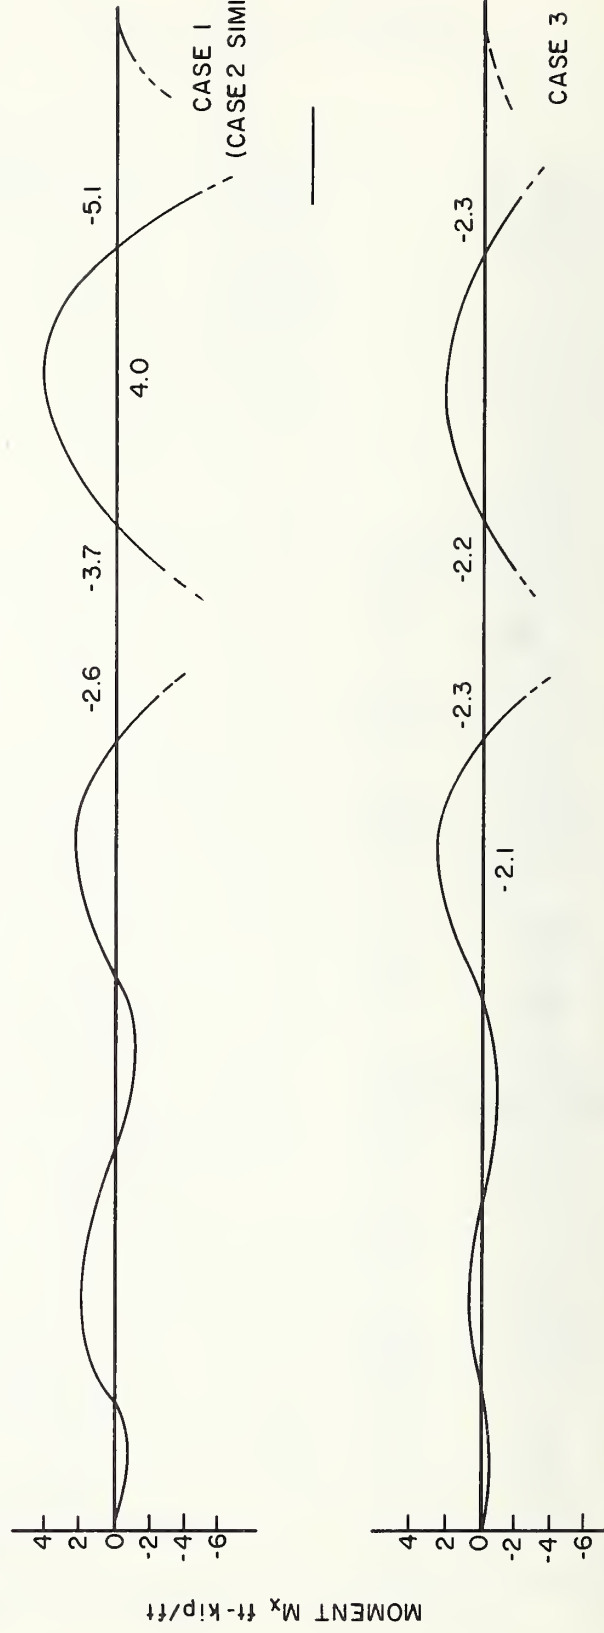
Figure 4.7 MOMENTS IN COLUMN STRIP 15-83-31

Figures 4.6 through 4.9 show moment diagrams developed for column strips taken from the grid of figure 4.2. These strips were investigated for their adequacy to resist moments obtained by analysis. Negative moments were investigated at the face of the columns according to ACI 318-71.

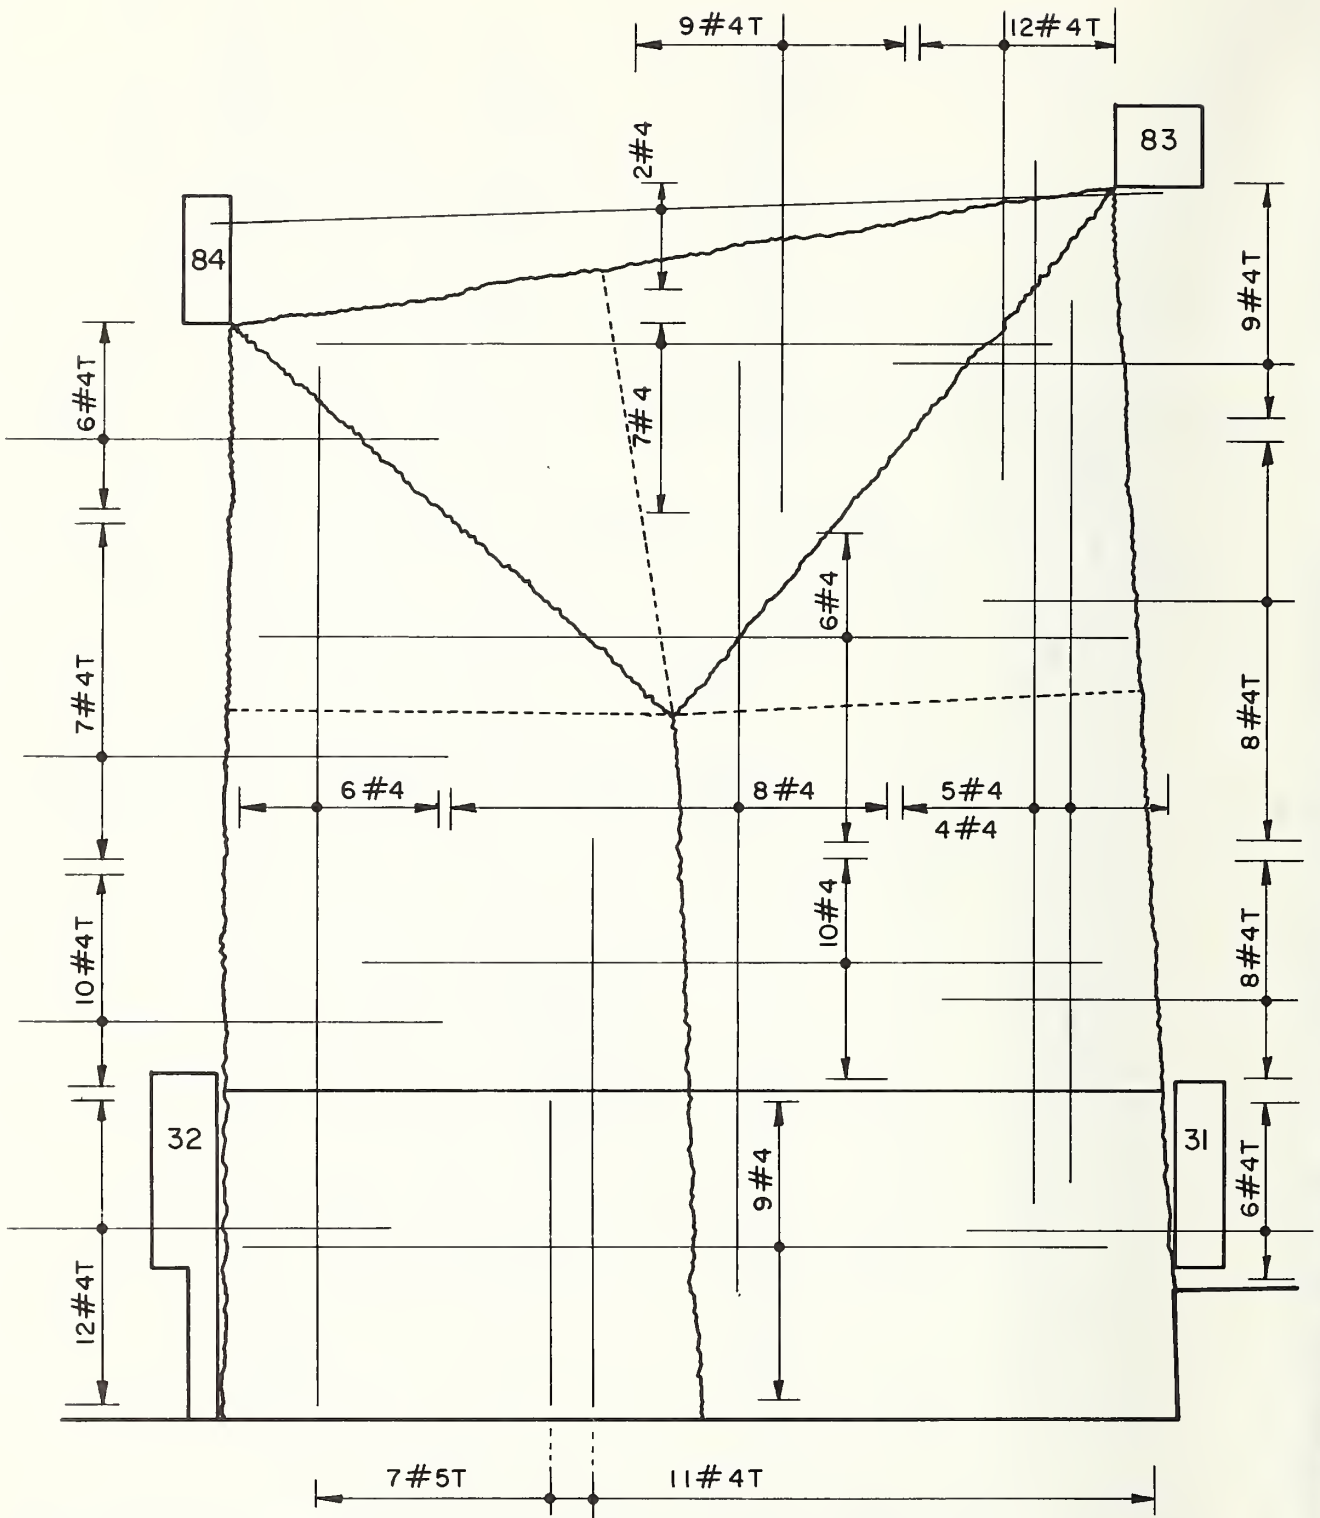
Figure 4.11 YIELDLINE PATTERN IN BALCONY PANEL

To further check the ultimate flexural capacity of the floor slab a selected critical area was investigated using yield line analysis. The yield line pattern assumed for the balcony panel bounded by columns 32, 84, 83 and 31 is shown in figure 4.11. Top and bottom reinforcement taken from the contract documents is indicated in the same figure. This particular analysis gave an ultimate load capacity of about 300 pounds per square foot indicating 80 percent excess capacity over construction loads. Other yield line analyses performed at selected interior panels gave consistently similar results. It should be noted that unless the assumed yield line pattern happens to be the same as would actually develop in the slab, the approach used will overestimate the slab capacity. However, the margin of approximation involved would be much less than the excess capacity indicated by these analyses.

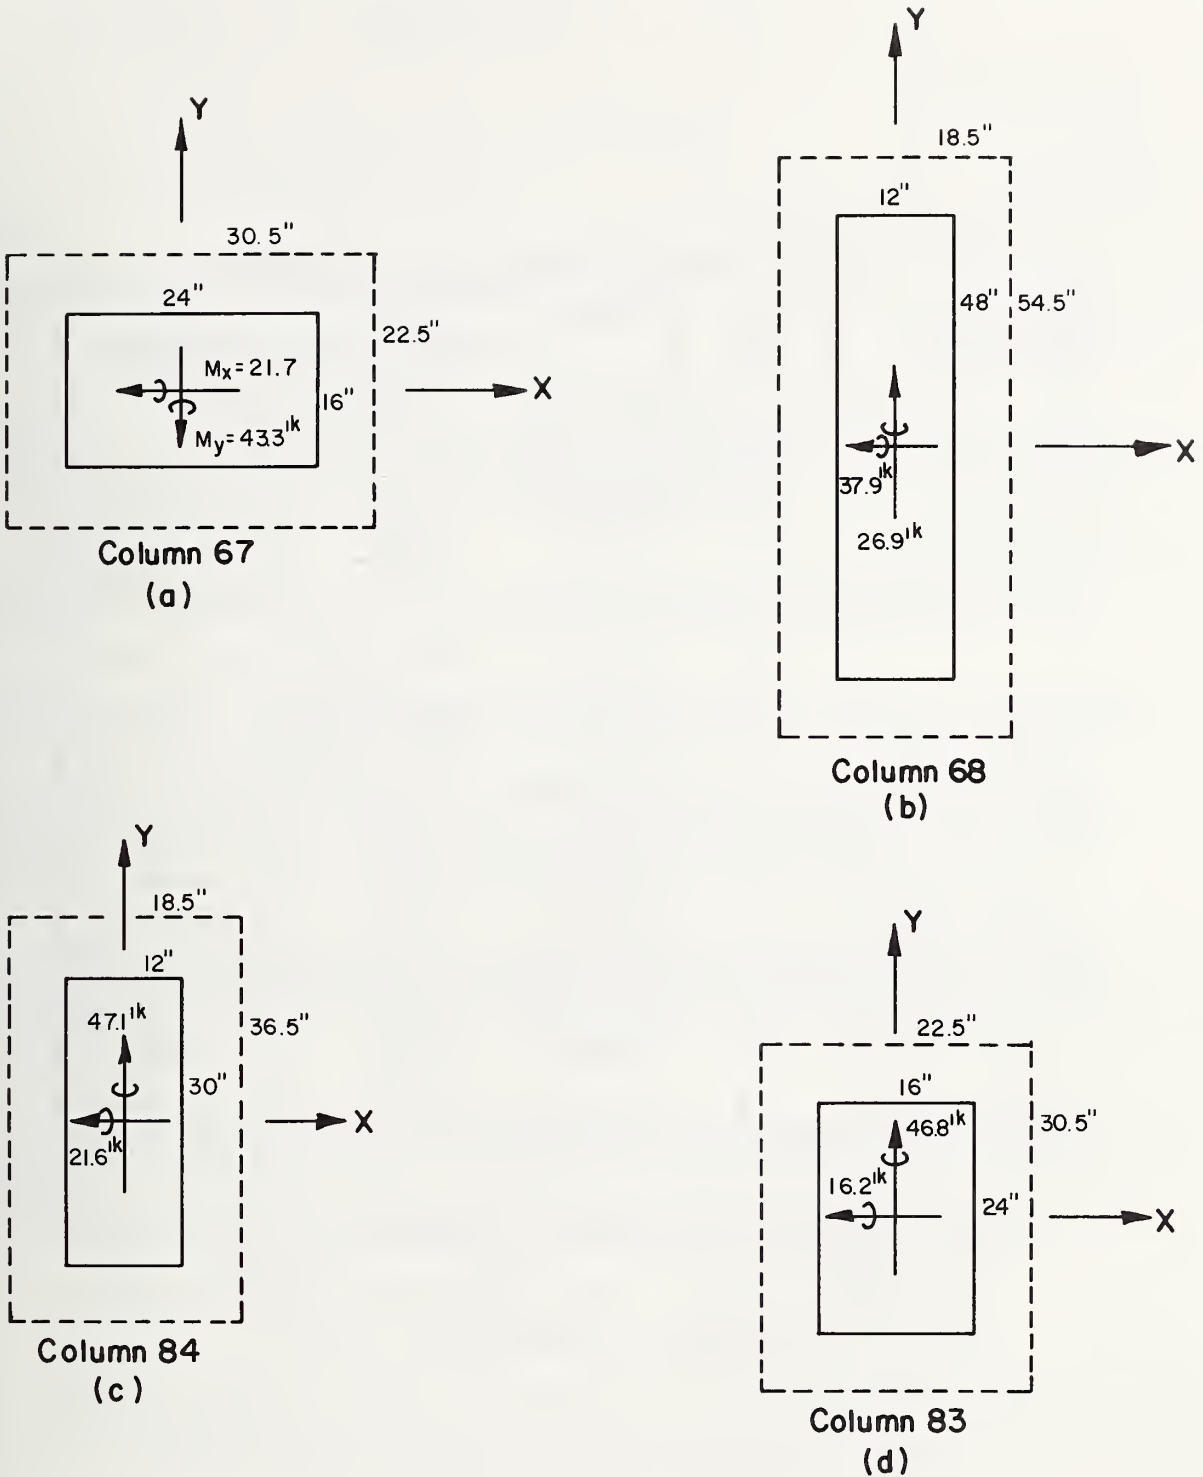
Figure 4.12 CRITICAL SECTION FOR SHEAR IN THE SLAB AROUND COLUMNS 67, 68, 83, 84

From the analytical results, axial loads and moments transmitted to column elements from the floor system were assessed in relation to peripheral column dimensions in order to establish which of the columns would be expected to create a severe shear condition in the slab. Figure 4.12 shows the four most critical regions identified at columns 67, 68, 83 and 84.

Figure 4.13 tabulates the results of the analysis of shear stresses in the 23rd-story floor slab for cases 1 through 3, based on the critical sections shown in figure 4.12.

Column No.	Case	v_{\max} psi	f'_c ^{1/} required psi	f'_c estimated psi
67 (16 x 24)	1	147	1870	960-1440
	2	147	1870	3000
	3	128	1417	960-1440
68 (48 x 12)	1	113	1104 (1724)	960-1440
	2	113	1104 (1724)	3000
	3	116	1164 (1816)	960-1440
83 (24 x 16)	1	148	1894	960-1440
	2	148	1894	3000
	3	130	1462	960-1440
84 (30 x 12)	1	149	1920	960-1440
	2	149	1920	3000
	3	145	1819	960-1440
