# Fire Tests of Wood-Framed Walls and Partitions With Asbestos-Cement Facings

United States Department of Commerce  
National Bureau of Standards  
Building Materials and Structures Report 123

Nolan D. Mitchell

Issued May 10, 1951

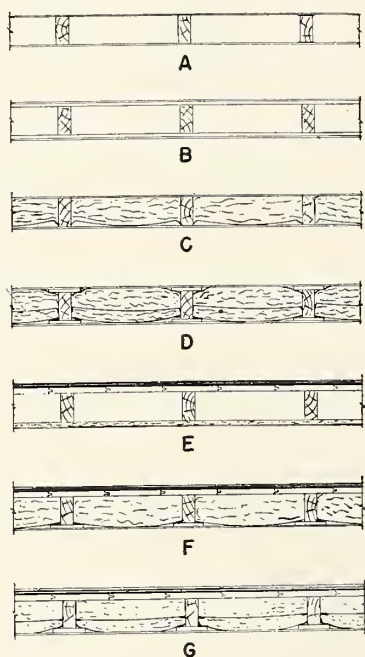
FIGURE 4. Designs of partitions A to D, table 1, and walls E to G, table 2.

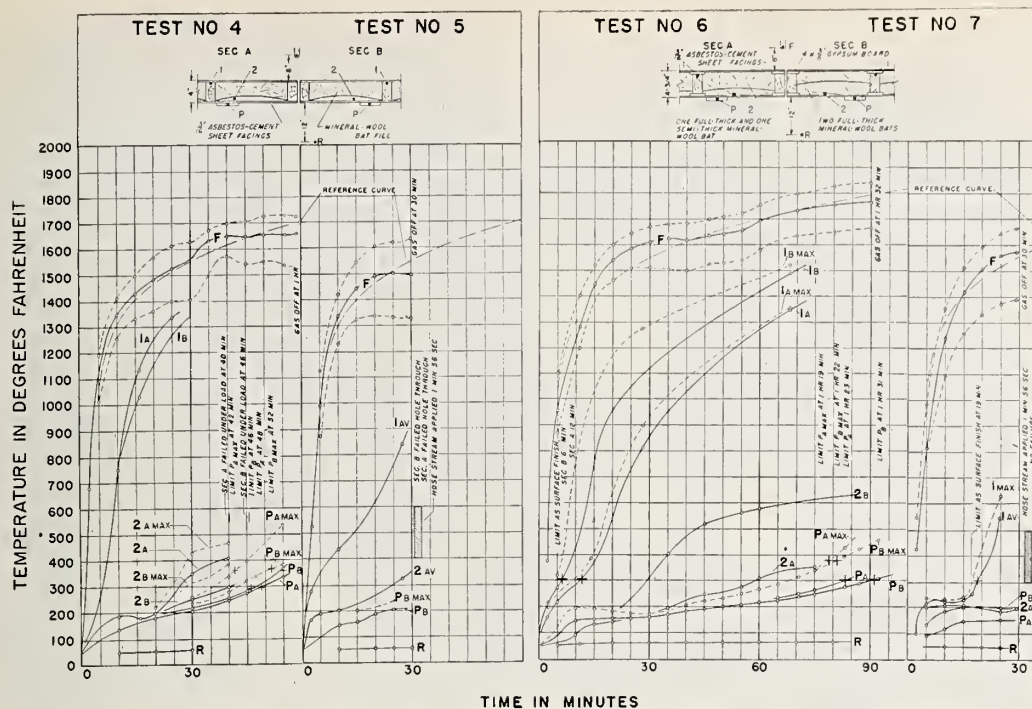
Failure by a temperature rise of 325 deg F (181 deg C) at one point of section A of the partition of test 6 occurred at 1 hr 19 min and on section B at 1 hr 22 min. The limiting rise of 250 deg F (139 deg C) as the average of five locations was reached at 1 hr 23 min on section A and at 1 hr 31 min on section B. Deflections of the midpoints of sections A and B toward the fire at 1 hr 25 min were 0.6 and 0.7 in., respectively. There was only minor cracking of the facing sheets on the unexposed surface. Figure 8 shows the face of the partition after 1-hr 32-min exposure to fire.

Data for the partitions with mineral-wool fill between the studs, tests 4, 5, 6, and 7, are shown in figure 9.

FIGURE 9. Furnace and partition temperatures for partition with mineral-wool fill between studs. Tests 4, 5, 6, and 7.

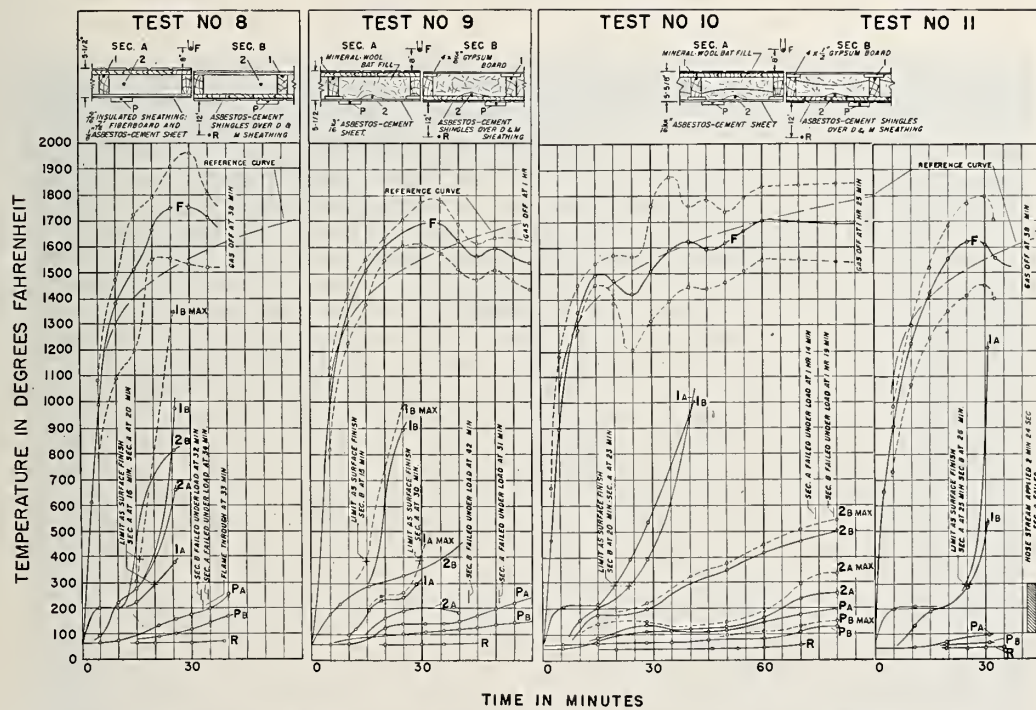
Three walls with asbestos-cement shingles on one side and asbestos-cement sheets on the other were subjected to fire-endurance tests, and one wall to a fire and hose-stream test. Each wall was divided into two equal sections, section A having the shingled face exposed to the fire, and section B with the sheet-faced side so exposed. All three walls subjected to the fire-endurance test failed by buckling of the studs under load. The limiting rise of temperature as measured by thermocouples under asbestos pads on the unexposed surface was not attained during the fire exposure in any of the three tests, the fires of which were continued for periods of 38 min, 1 hr, and 1 hr 25 min for tests 8, 9, and 10, respectively. Data for the walls (tests 8, 9, 10, and 11) are shown in figure 10.

FIGURE 10. Furnace and wall temperatures for walls with asbestos-cement shingles. Tests 8, 9, 10, and 11.
