Investigations of Near-Edge Ballistic Impacts on Law Enforcement Body Armor

Kirk D. Rice, Amanda L. Forster, Michael A. Riley,
and Nicholas G. Paulter, Jr.

September 2014

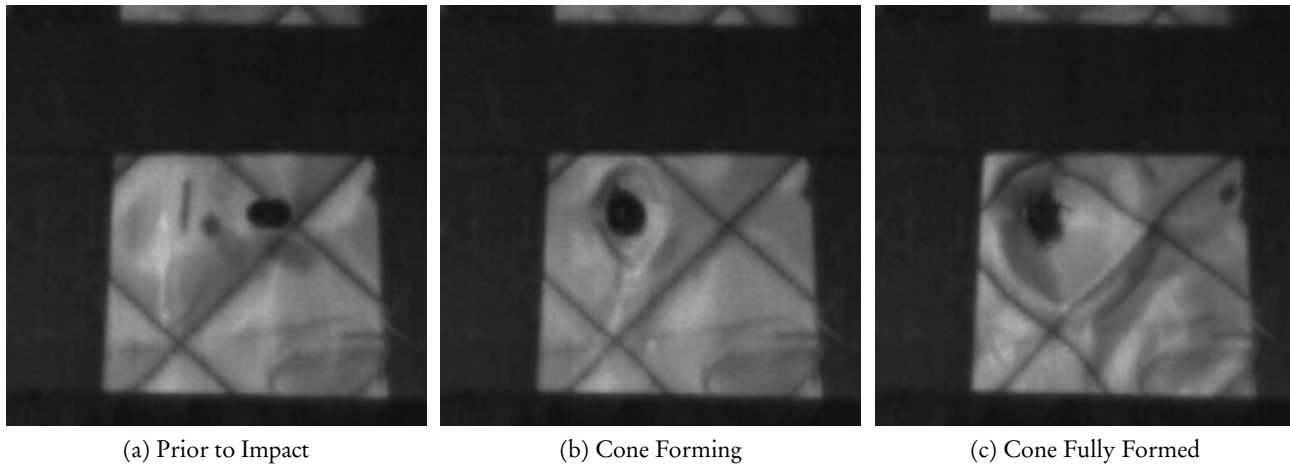
Figure 1.1: Example of Armor Deformation During Ballistic Impact.

Ideally, when a bullet strikes a fabric body armor the force from the bullet deforms the armor in the shape of a cone, as can be seen in the photographs in Figure 1.1. This cone will grow until either the bullet is stopped or the armor fails. When a bullet impacts fabric body armor close to the edge, a number of undesirable responses may occur. If the growing cone reaches the edge of the ballistic-resistant material, the edge of the cone may collapse and allow the bullet to slide off of the armor. If the bullet remains in the armor, the deformation may be much greater than for a similar impact that occurs at standard test distances from the edge. In addition, fabric armor relies on material away from the point of impact to constrain the relative movement of individual yarns. When the impact occurs close to the edge of the woven fabric there may not be sufficient material to keep the weave intact; yarns will separate from the weave, allowing the projectile to pass through layers without breaking the yarns. This can effectively reduce the number of layers of material involved in stopping the projectile and allow it to perforate the remaining layers.

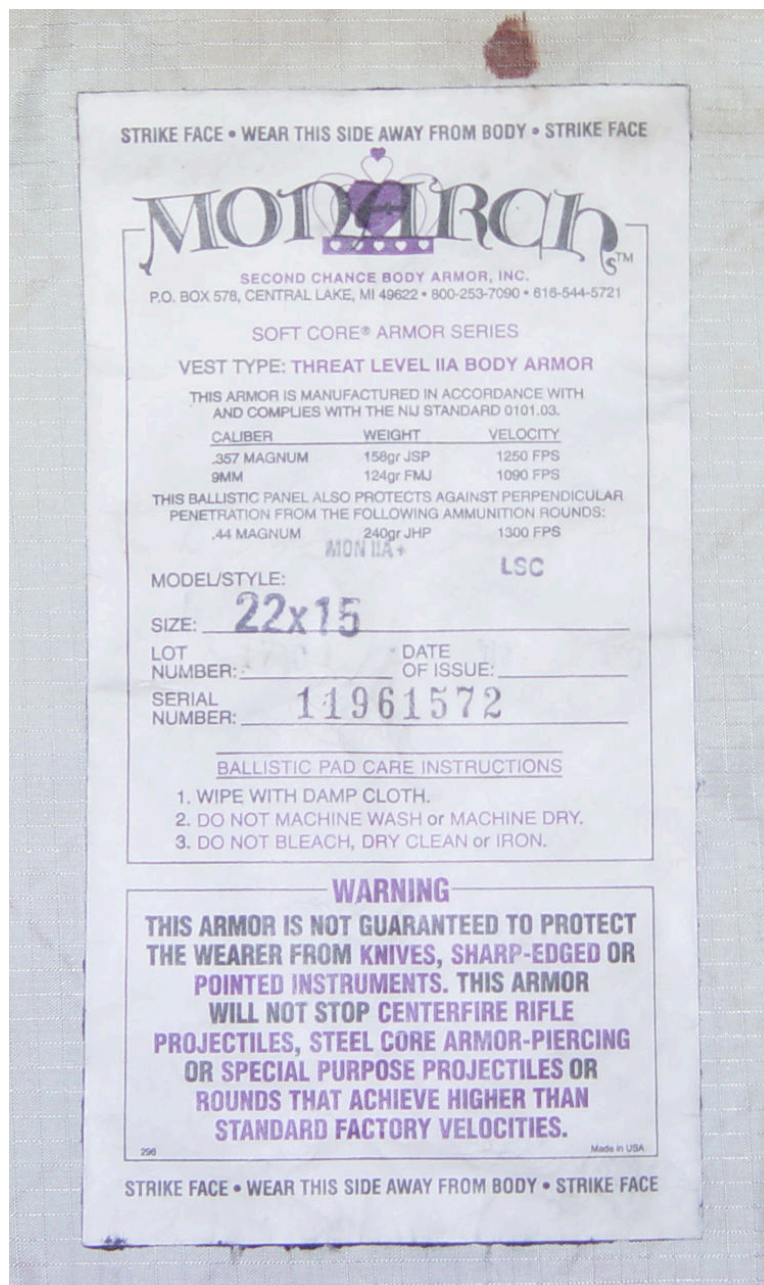
Figure 2.2: Panama City Beach Armor Ballistic Panel Label.

The ballistic panel was removed from the armor carrier, and it was noted that the ballistic panel was inserted into the carrier in the correct orientation. This was verified by the manufacturer's label, shown in Figure 2.2, which was affixed to the ballistic panel and mostly legible. The label on the incident panel clearly indicated that the labeled side was intended to be worn as the *Strike Face*, facing away from the body, and the visual inspection verified that the bullets struck this side of the panel covering. For some armor types, the orientation of the panel is critical, because the order of the layers of ballistic-resistant material leads to different ballistic resistance depending on which side of the ballistic panel a bullet strikes.

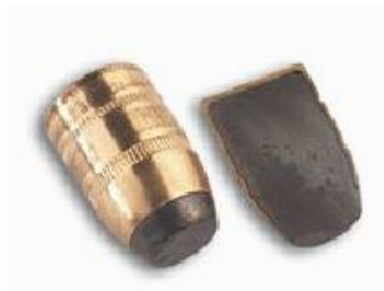
The incident bullet type is very similar to that used in the NIJ standard test for type II armor, which is a .357 Magnum, 10.2 g (158 gr), jacketed soft point bullet with a flat nose [18], and manufactured by Remington. The NIJ standard specifies the measured bullet speed for this type of bullet to be 436 m/s \pm 9.1 m/s (1430 ft/s \pm 30 ft/s), so the body armor should have had a large safety margin for the similar incident bullet, which, based on the Tampa Police Department's investigation, would have impacted the body armor at a speed approximately 90 m/s (300 ft/s) slower than the speed specified in the NIJ standard.

Figure 2.4: Bullet of the Type Used in the Tampa Shooting.
From Magtech Product Specification [30]

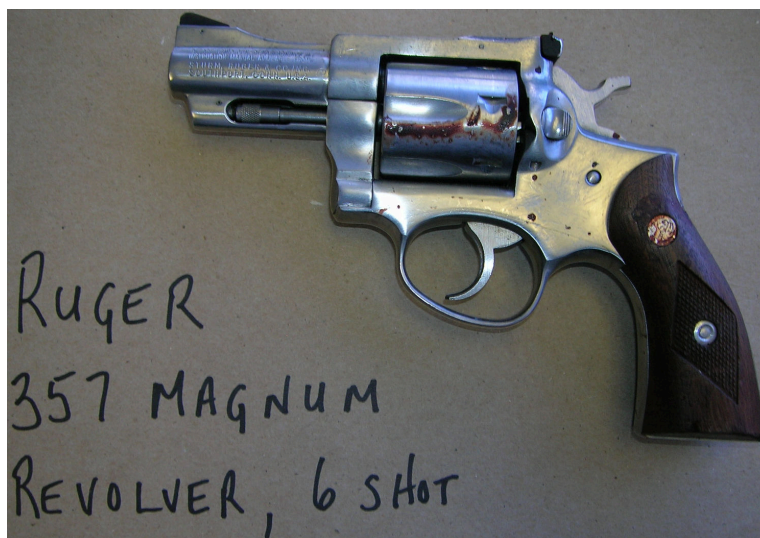
The firearm used in this incident was a Ruger Security-Six, a six-shot revolver [31], having a 70 mm (2 ¾ in) barrel. A photograph of the incident firearm, provided by the Tampa Police Department, is shown in Figure 2.5. The serial number of the revolver was 155-39321, which indicates that the firearm was likely manufactured in 1979 [32]. Since the barrel length of this revolver is significantly less than the standard velocity barrel length used by Magtech to determine the typical muzzle velocity, it is likely that the actual bullet speed from this revolver was less than the manufacturer specified 376 m/s (1235 ft/s) [30]. The Tampa Police Department, as described in Section 4.1.2, reported to NIST that the estimated incident bullet speed was 344 m/s (1130 ft/s), based on tests performed at their crime laboratory.

Figure 2.5: Firearm used in the Tampa Shooting.
Photograph provided by Tampa Police Department

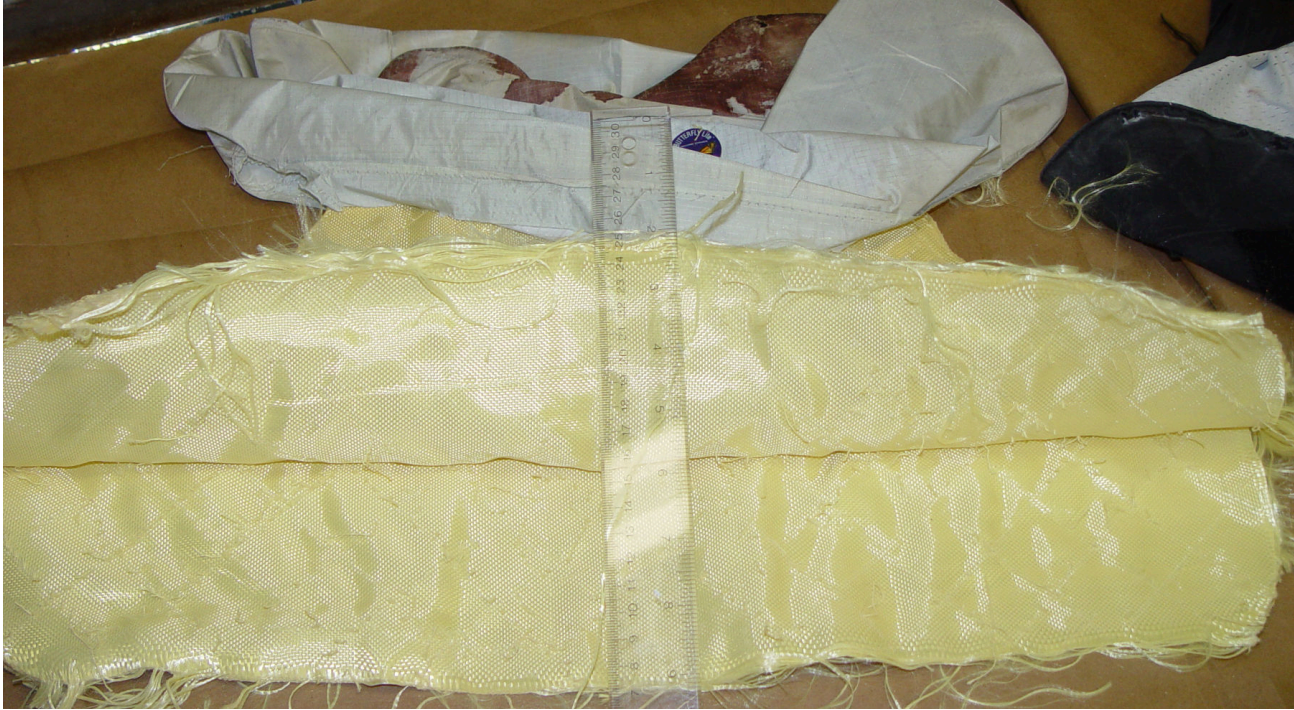
The incident panel was deconstructed by removing the quilt stitching and through-stitching (the vertical stitching holding the two 11-layer packs together) from the lower 100 mm to 125 mm (4 in to 5 in) of the armor panel. The partially deconstructed panel is shown in the photograph in Figure 3.6. Full-length pieces of fabric, approximately 100 mm (4 in) wide, were cut from layers 1, 6, 11, 12, 17, and 22, where the strike face was designated layer 1 and the body-side layer was designated layer 22. The ballistic panel with sample material removed is shown in the photograph in Figure 3.7 and an example of one of the material samples being prepared for storage is shown in the photograph in Figure 3.8. Once the fabric samples were taken, individual yarns were extracted from the fabric samples. Material property tests performed on these yarns are described in Section 5.

Figure 3.6: Panama City Beach Incident Panel with Stitching Removed.

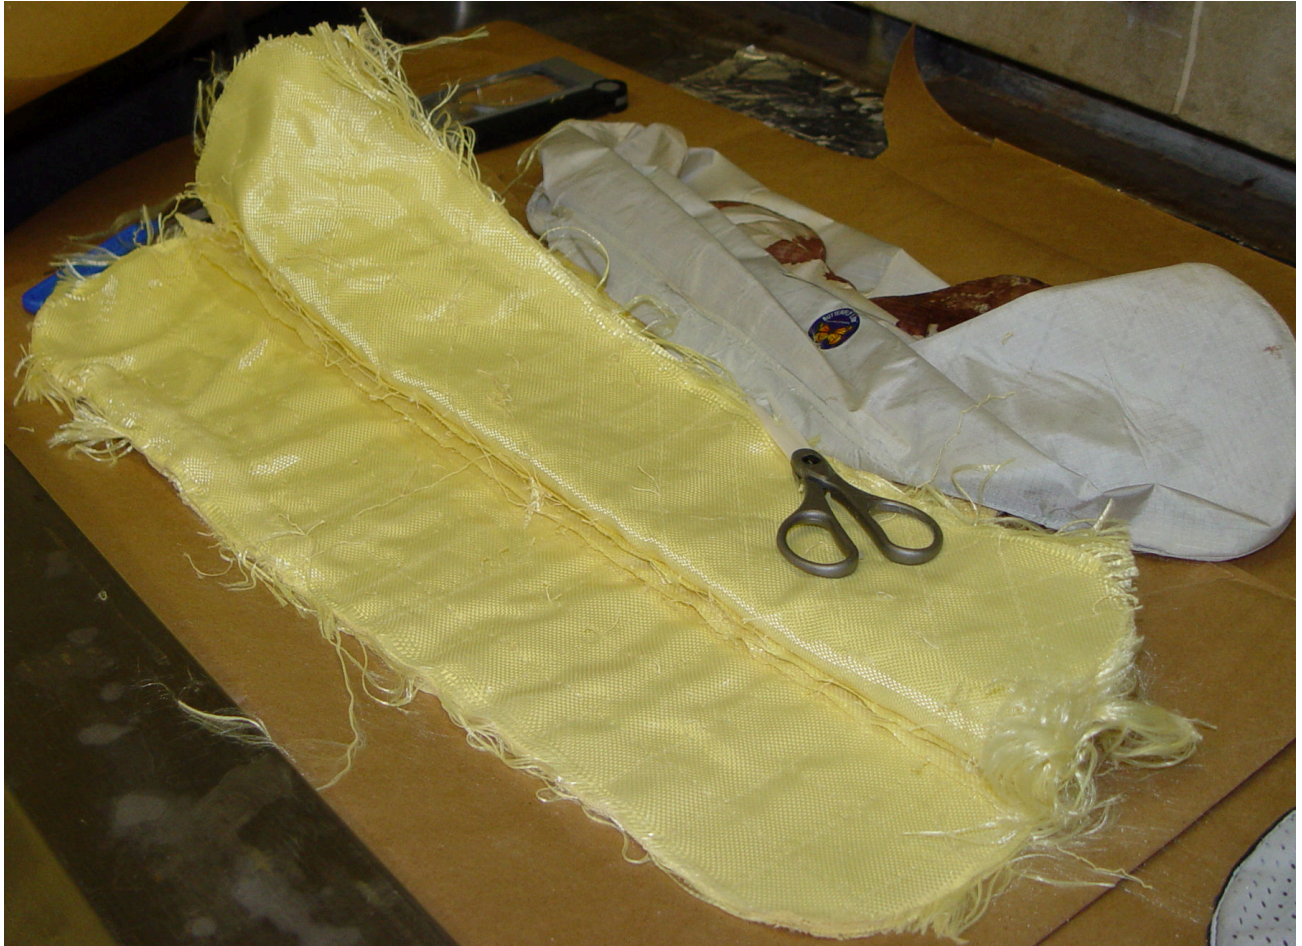
Figure 3.7: Panama City Beach Incident Panel with Sample Material Extracted.

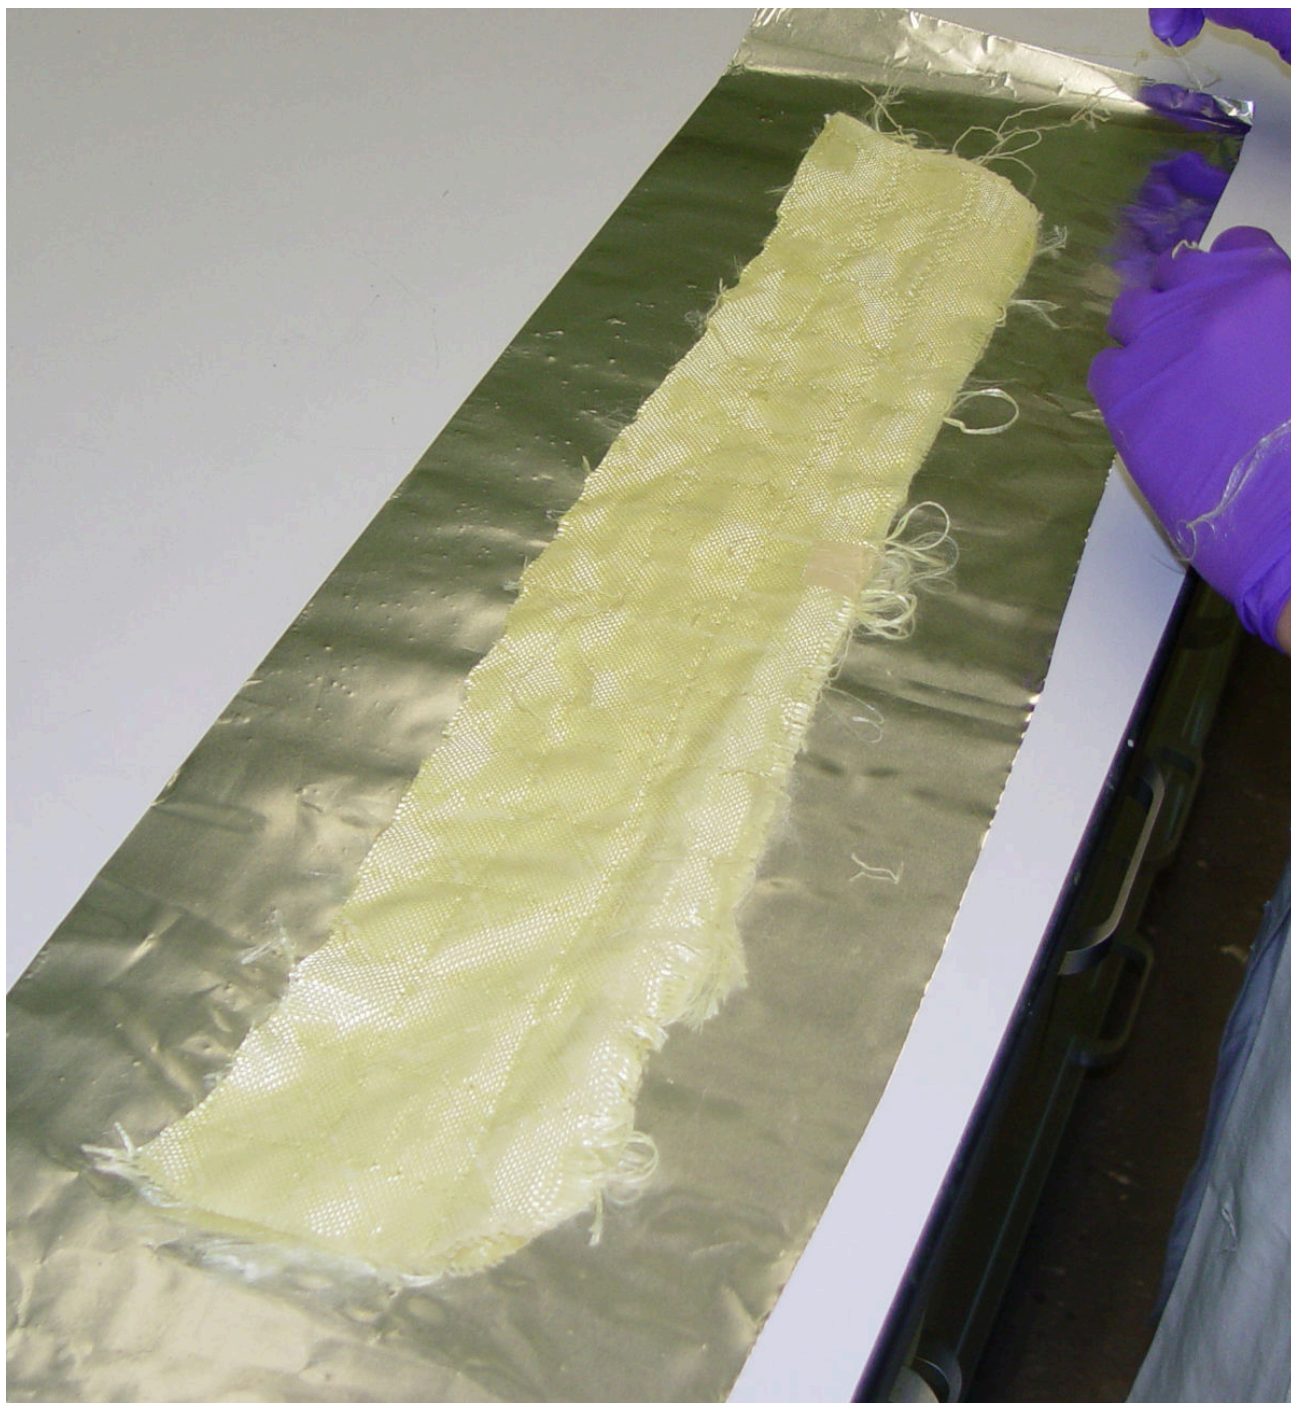
Figure 3.8: Example of Sample Material from Panama City Beach Armor.

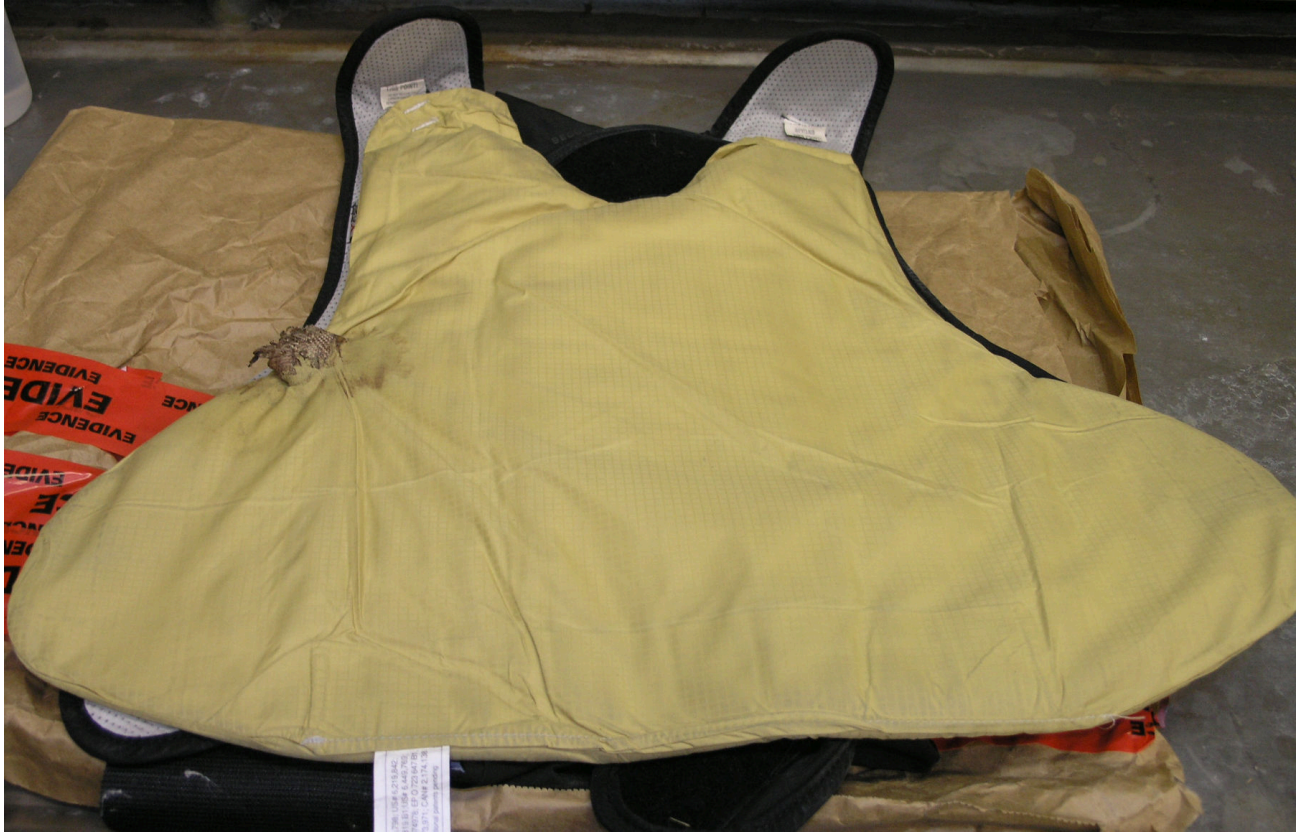
Figure 3.9: Body Side of Tampa Incident Panel with Bullet Exit Hole on Left Edge.

A photograph of the ballistic panel, removed from its carrier, but still encased in the panel covering, is shown in Figure 3.9. The body side is facing up in this picture, so the bullet impact location is on the left side in the photograph. After this photograph was taken, the armor panel covering was cut open to remove the armor panel from the armor panel covering for further examination of the bullet impact location.

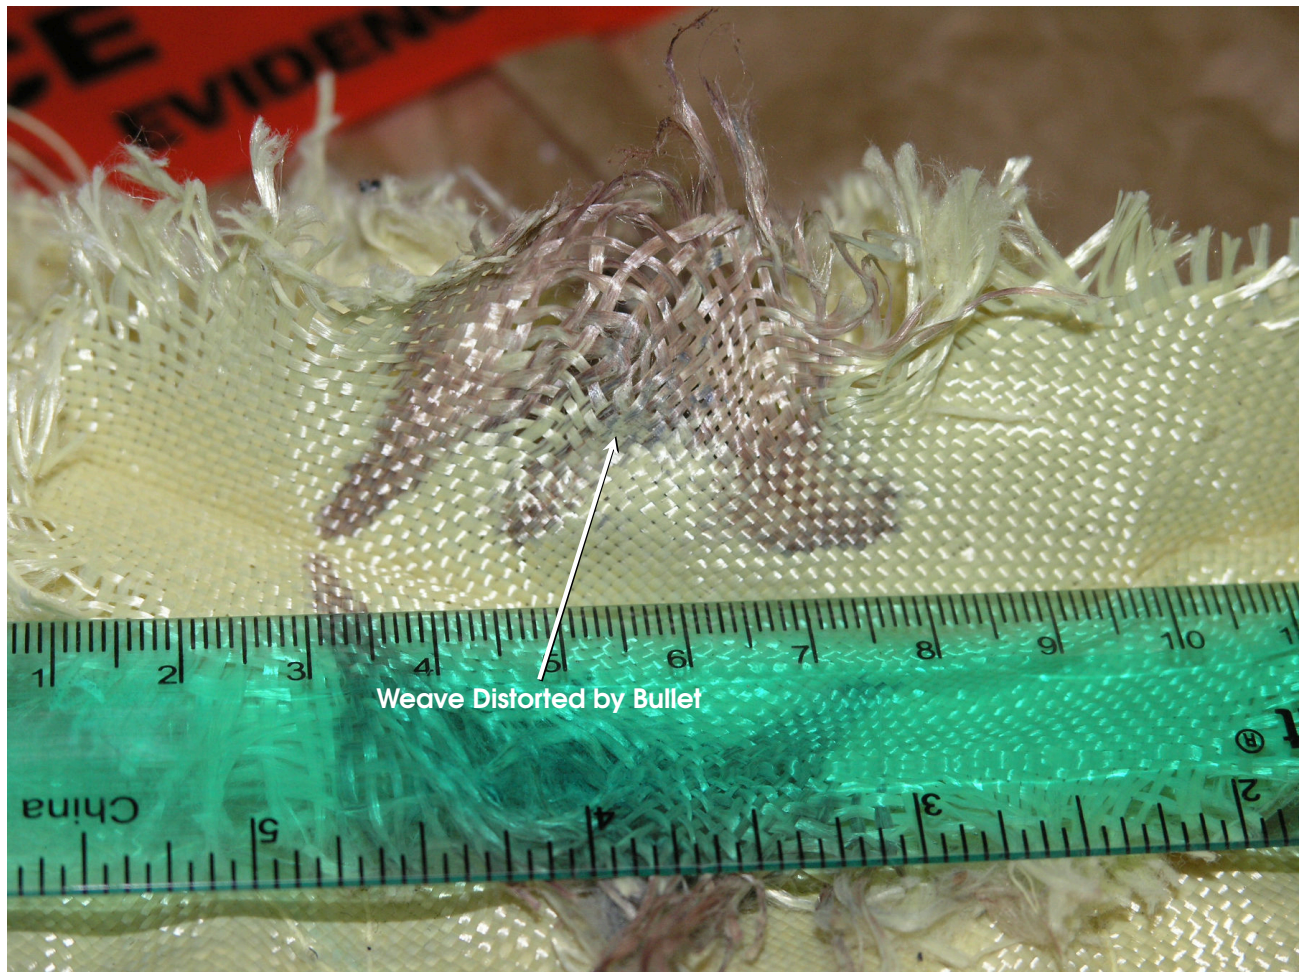
Figure 3.15: Incidence Location on Layer 3 of the Tampa Ballistic Material.

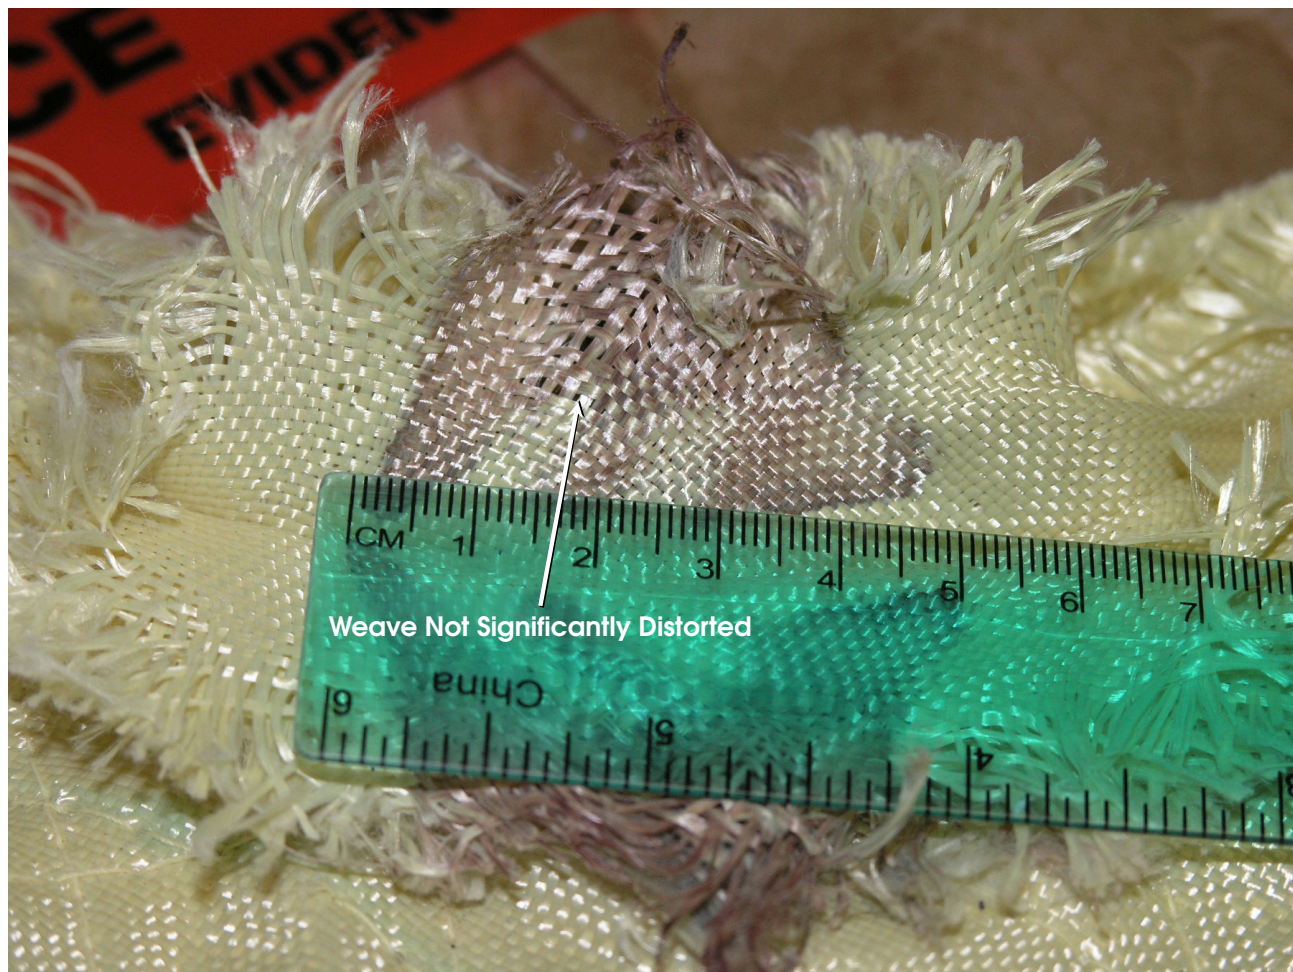
Figure 3.16: Incidence Location on Layer 4 of the Tampa Ballistic Material.

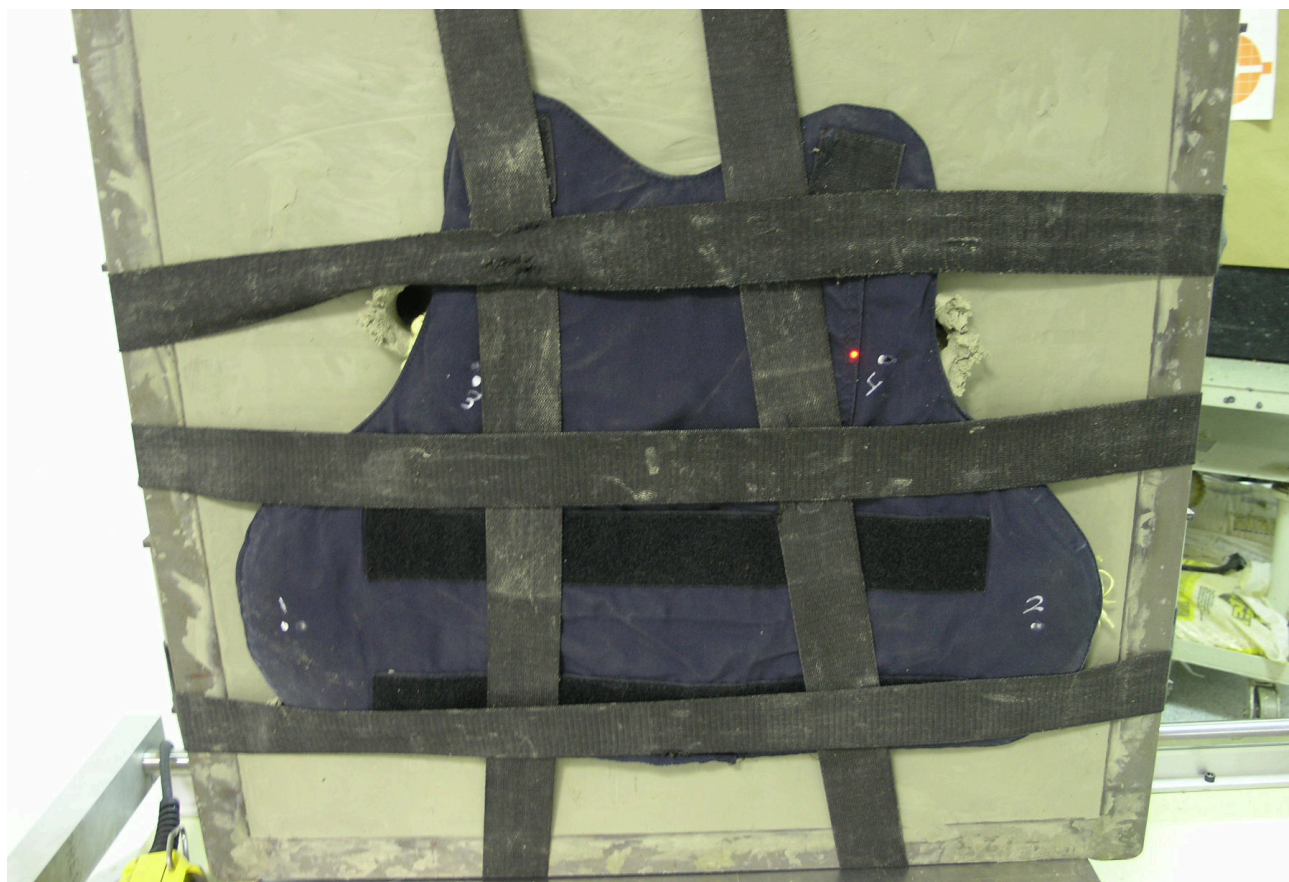
Four test shots were fired at this armor, which was mounted on a clay block that had been prepared according to the requirements of NIJ Standard-0101.04 [18]. All four shots were targeted at locations 25.4 mm (1.0 in) from the edge of the armor. Two shots were fired perpendicular to the armor surface (0° angle of incidence), and two were fired at 30° angles from perpendicular. The 30° angle shots were intended to reproduce the incident shot; therefore, the shots were angled outward, away from the center of the armor, instead of inward as they would be angled during a standard test. The shot locations can be seen in the photograph in Figure 4.1, which shows the armor panel mounted on the clay block immediately after the fourth shot.

The first two shots were fired at the edge of the *wings*, the portion of the armor that wraps around the wearer's waist. Both of those shots were fired at 0° angles; the first at the left edge of the panel, the second at the right edge. Both bullets were successfully stopped, but the impacts produced backface signatures (BFS) of 48 mm and 58 mm, respectively, which exceeded the NIJ Standard-

Figure 4.1: Near-edge Impact Test Armor Mounted on Clay Block.

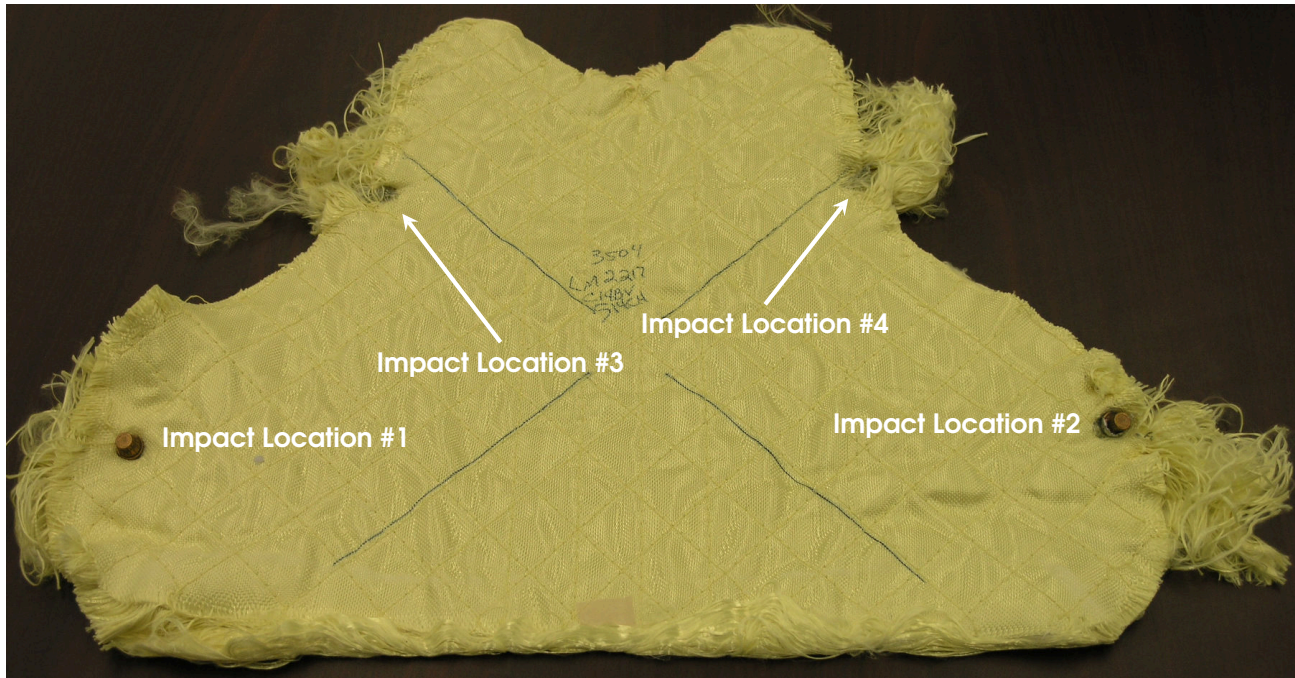
Figure 4.2: Ballistic Resistant Material from Near-edge Impact Test Armor.

0101.04 limit of 44 mm [18]. The ballistic panel, after completion of all four shots, is shown with the cover removed in the photograph in Figure 4.2. The two bullets from shots 1 and 2 are visible, having been captured by the first few layers of the ballistic-resistant material. The excessive BFS results are not surprising, because BFS tend to increase as the distance to the nearest edge of the ballistic-resistant material decreases. Prior research has proposed that impacts nearer to the edge engage less of the mass of the ballistic-resistant material, which, due to the conservation of momentum, results in a greater kinetic energy in the armor immediately after impact [36]. This larger initial kinetic energy translates to greater armor deformation and deeper indentations in the clay backing material. Since both of the impact locations were at approximately one-third the minimum shot-to-edge distance specified in the NIJ Standard-0101.04 test [18], it is not reasonable to expect that the armor would meet the standard performance requirements at these locations.

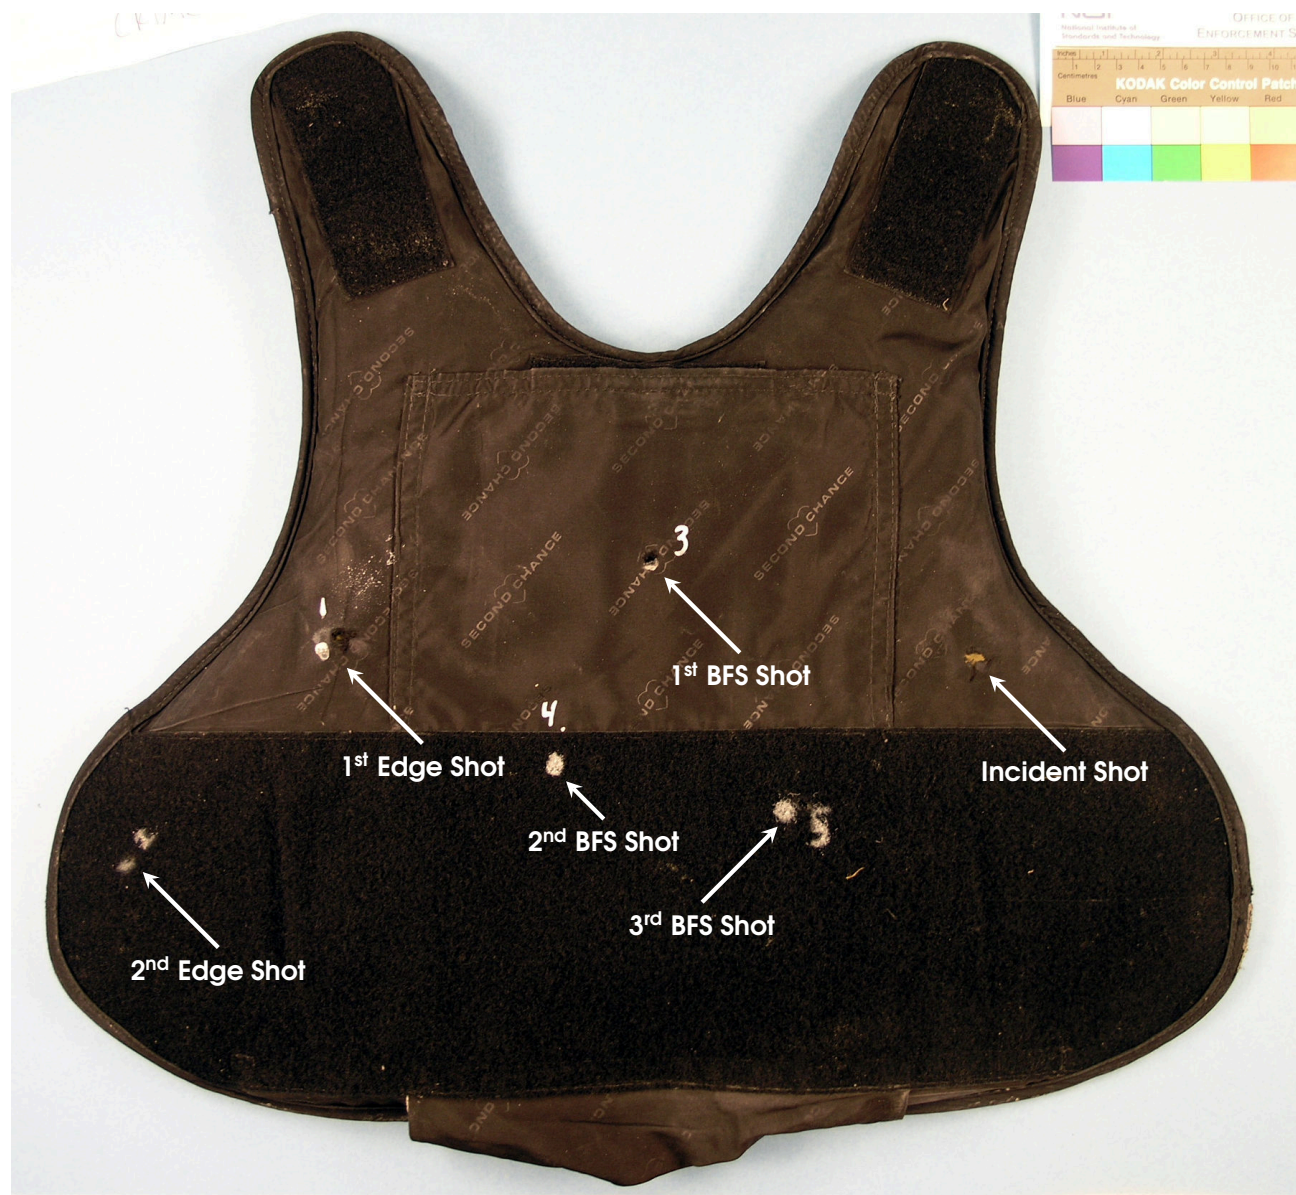
The next step of the testing was intended to determine if the front panel of the incident armor was capable of reliably stopping threats similar to the incident shot when the point of impact was consistent with the locations normally tested during the NIJ standard tests. Since the incident armor panel was smaller than the standard test specimen size and three bullet impacts had already damaged the edges of the panel, the testing was limited to three additional impacts. These shots were placed at approximately the #1, #4, and #6 locations described in NIJ Standard-0101.04 [18]. These locations correspond to the center of the upper chest, the right side of the lower chest, and the left center of the abdomen, respectively. These target locations can be seen in the photograph in Figure 4.4, where they are labeled “3” through “5” (indicated as the 1st through 3rd BFS shots). All shots were placed at least three inches from the edge of the armor

Figure 4.4: Tampa Incident Armor, Strike Face, Post Testing.

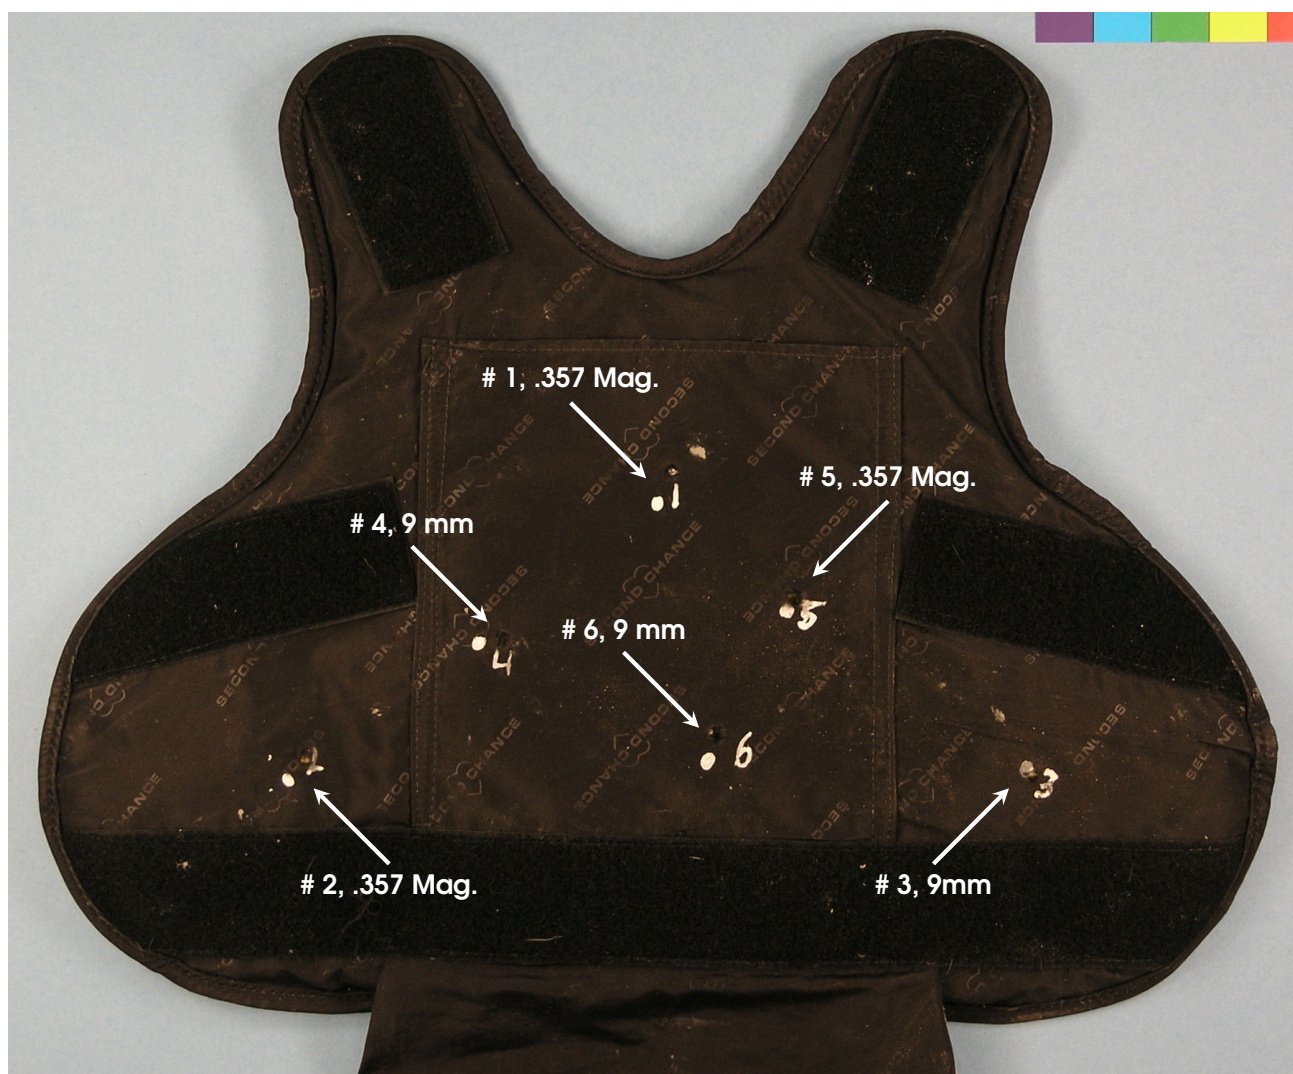
The front panel of the spare armor was tested with an abbreviated version of the NIJ Standard-0101.04 [18] P-BFS test. During a complete compliance test of a Type II armor model to the requirements of NIJ Standard-0101.04, eight armor panels are tested, each with six shots from one of two test bullet types at a specified speed. Four panels are tested with one of the test bullet types and four are tested with the other. Since only a single armor panel was available for this test, three shots of each of the two bullet types were used to test the panel. The shot locations can be seen in the photograph in Figure 4.7.

Figure 4.7: Tampa Spare Armor, Strike Face, Post Testing.

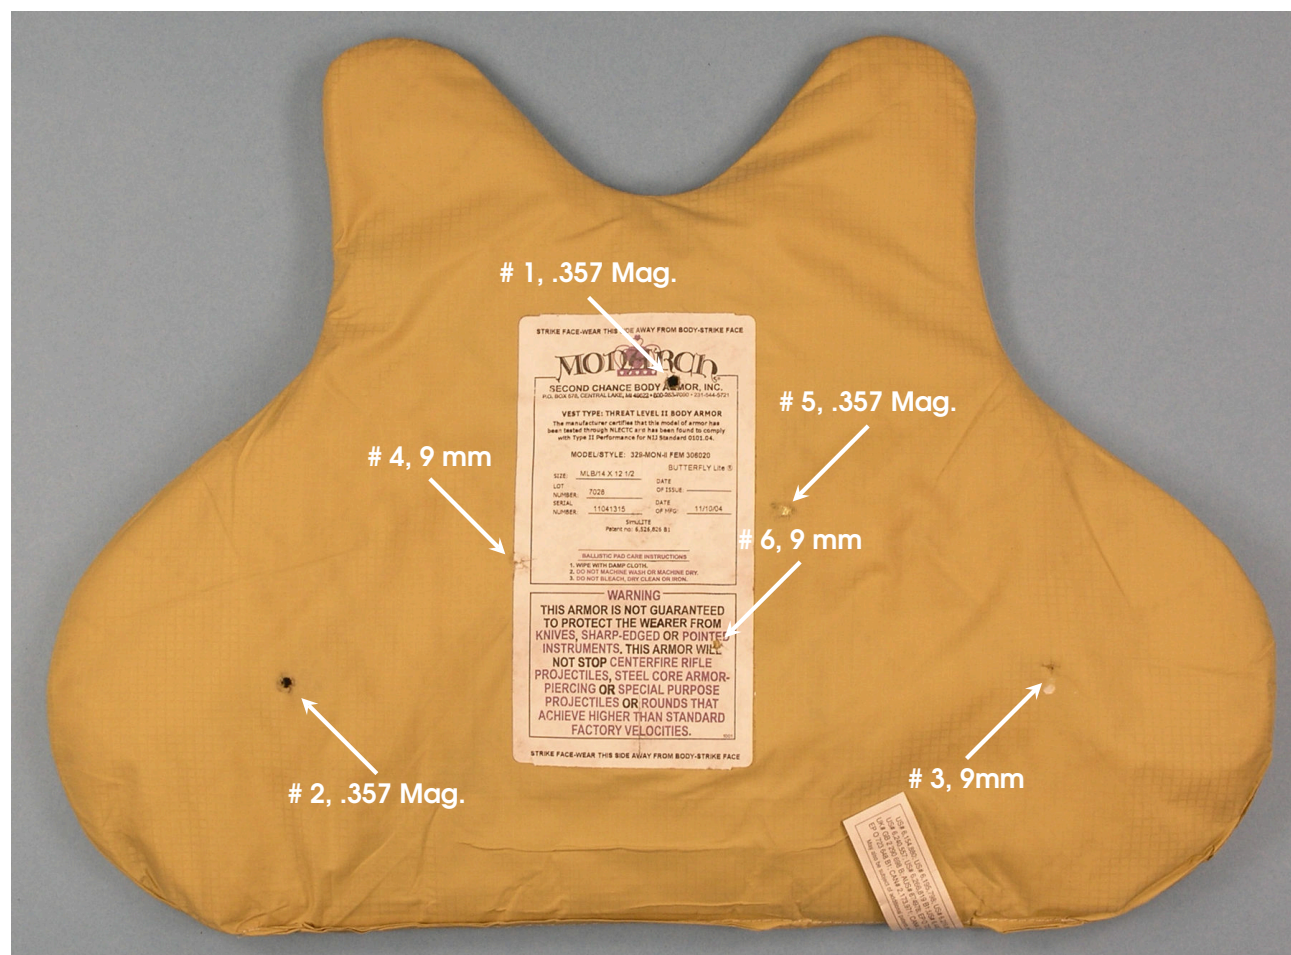
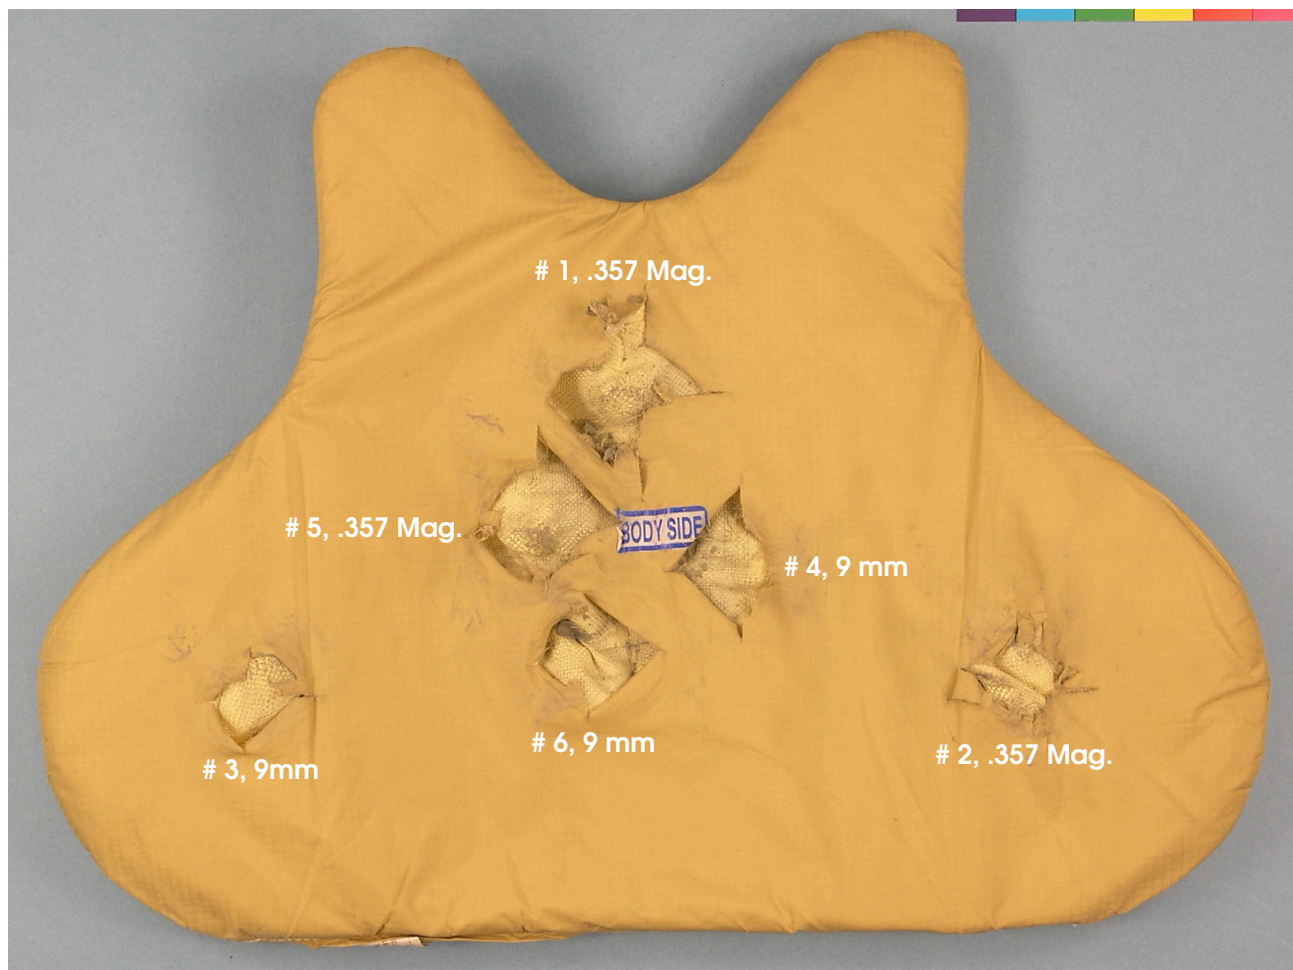
The panel was first tested with three shots of the NIJ Standard-0101.04 Type II .357 Magnum test cartridge – a Remington 10.2 g (158 gr) JSP bullet with a measured speed of $436 \text{ m/s} \pm 9.1 \text{ m/s}$ ($1430 \text{ ft/s} \pm 30 \text{ ft/s}$). These shots were fired at the #1, #2, and #5 locations, as described in NIJ Standard-0101.04 [18]. As in the standard test, the shots at the #1 and #2 locations were fired perpendicular (0° angle) to the armor, while the shot at the #5 location was fired at a 30° angle. As listed in Table 4.2, the armor successfully stopped all three shots; however, the measured BFS depths of the perpendicular shots were 53 mm and 45 mm, respectively. The results of these shots can be viewed in the photographs in Figures 4.8 and 4.9.

The panel was then tested with three shots of the NIJ Standard-0101.04 Type II 9 mm Luger test cartridge – a Remington 8.0 g (124 gr) FMJ bullet with a measured speed of $367 \text{ m/s} \pm 9.1 \text{ m/s}$ ($1205 \text{ ft/s} \pm 30 \text{ ft/s}$). These shots were fired at the #3, #4, and #6 locations. The shots at the #3 and #6 locations were fired perpendicular (0° angle) to the armor, while the shot at the #4 location was fired at a 30° angle. The armor successfully stopped all three bullets, and the BFS depths of the perpendicular shots were 40 mm and 35 mm, respectively. Again, the results of these shots can be viewed in the photographs in Figures 4.8 and 4.9.

Figure 4.8: Tampa Spare Panel, Strike Face, Post Testing.

Figure 4.9: Tampa Spare Panel, Body Side, Post Testing.

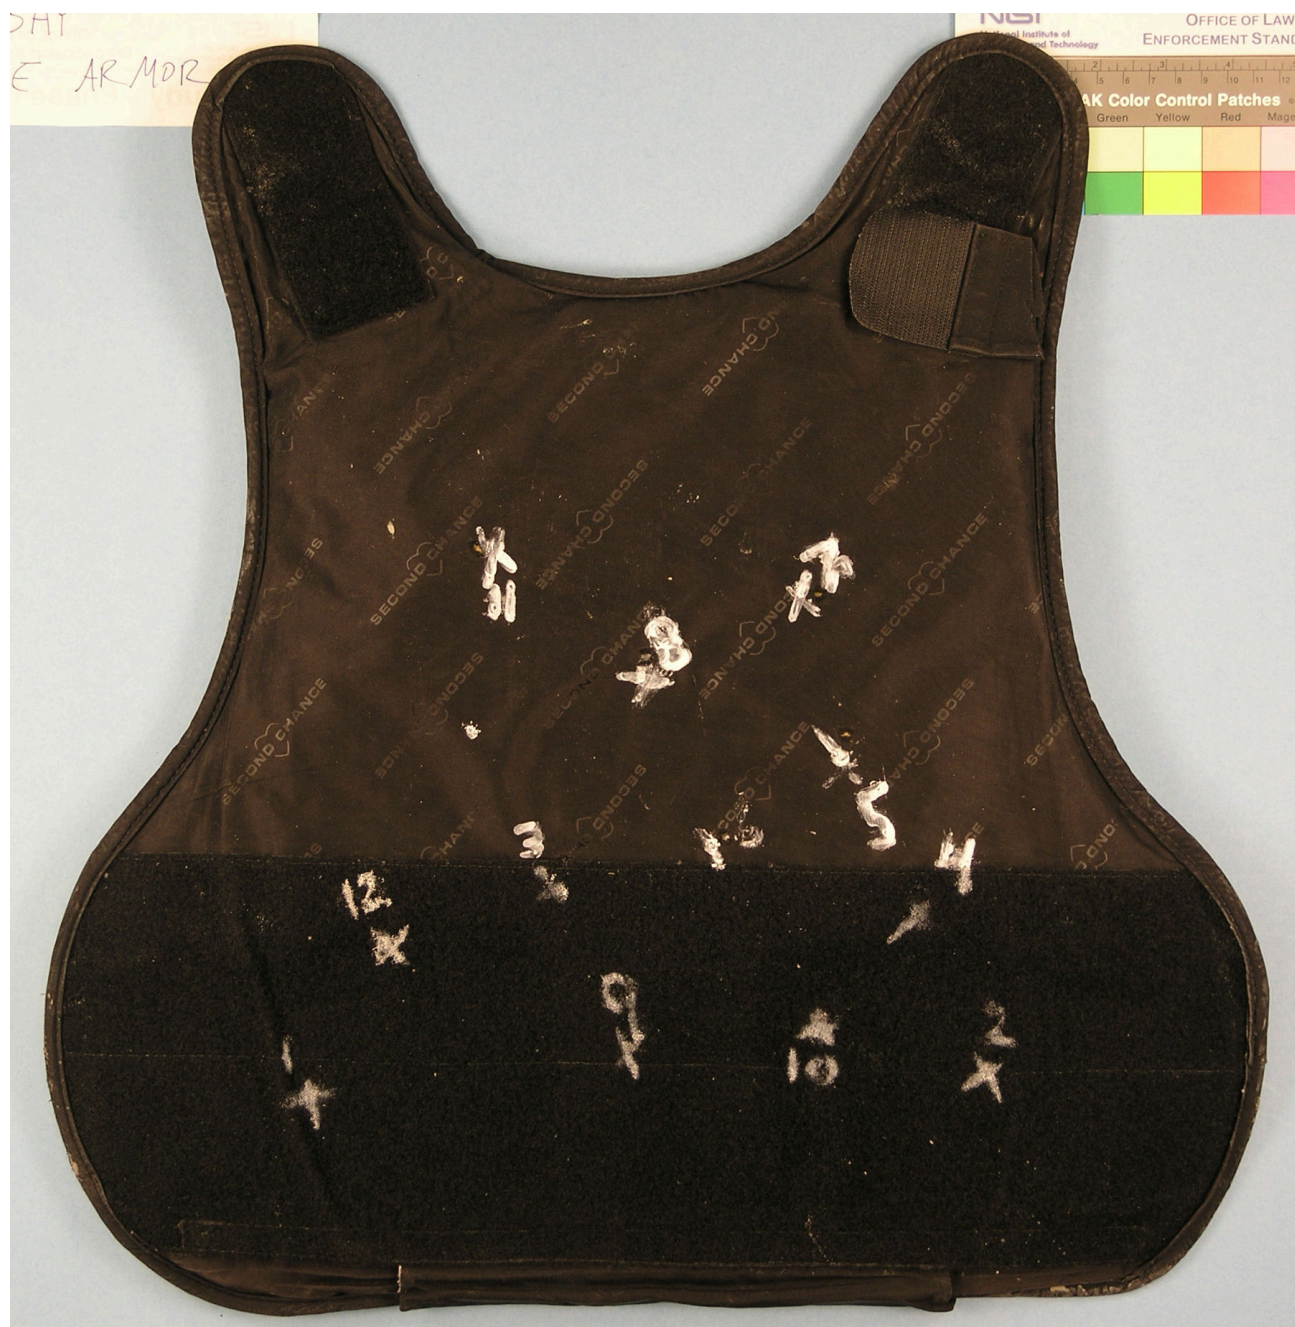
The V_{50} ballistic limit test on the back panel of the incident armor, shown in the photograph in Figure 4.10, was conducted according to the methods and requirements of NIJ Standard-0101.04 [18]. All cartridges were hand loaded using new Remington .357 Magnum cartridge cases, Accurate Arms #2 propellant, and Remington 9 mm Luger, 8.0 g (124 gr) FMJ bullets. The cartridges were fired out of a special universal receiver barrel that has a .357 Magnum chamber and a 254 mm (10 in) barrel with SAAMI standard 9 mm Luger rifling [22]. This configuration with the .357 Magnum chamber and 9 mm barrel allows the 9 mm bullets to be fired at much higher speeds than can normally be achieved with a standard 9 mm Luger cartridge, while maintaining the other standard flight characteristics for the bullet.

Figure 4.10: Incident Armor Back Panel used for Ballistic Limit Test.
