Investigations of Near-Edge Ballistic Impacts on Law Enforcement Body Armor

Kirk D. Rice, Amanda L. Forster, Michael A. Riley,
and Nicholas G. Paulter, Jr.

September 2014

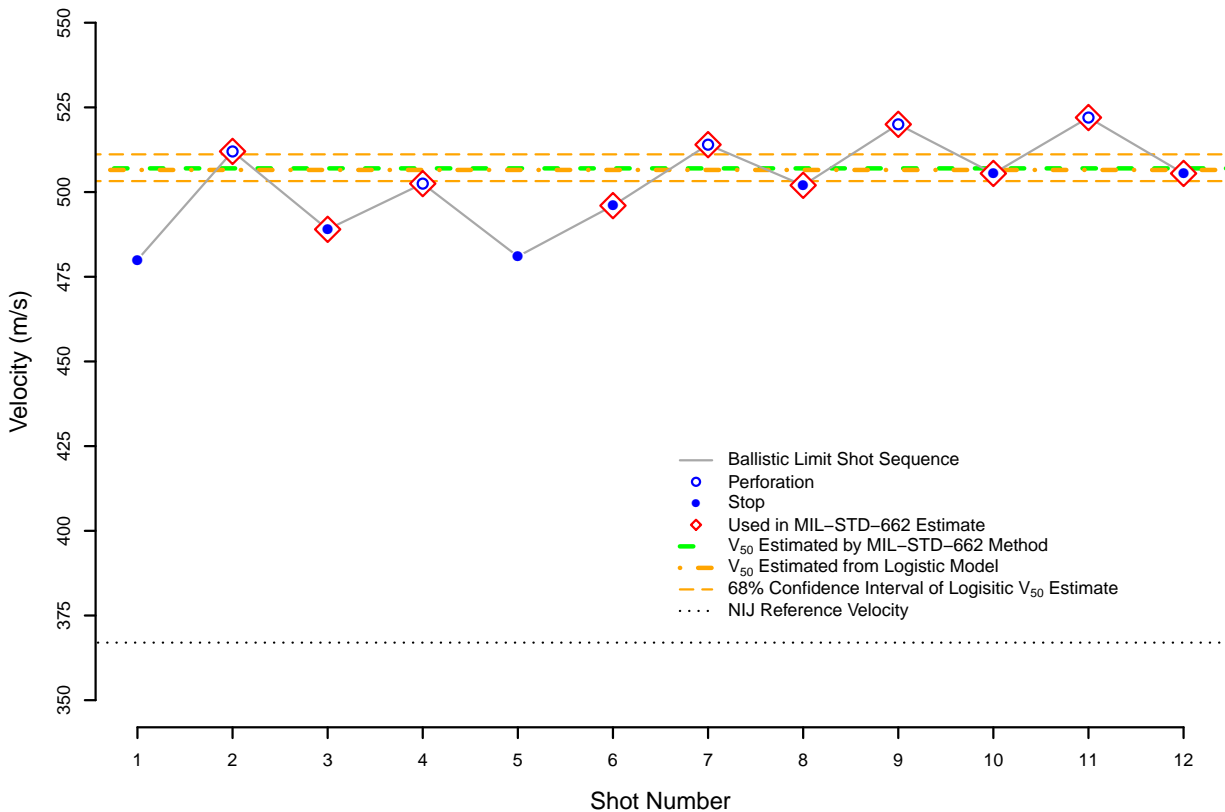
The V_{50} ballistic limit test consisted of twelve shots, listed in Table 4.3, ranging in speed from 480 m/s (1575 ft/s) to 522 m/s (1713 ft/s). Of these, the speeds of ten impacts (five stops and five perforations) were within 38 m/s (125 ft/s) of each other, between 489 m/s (1604 ft/s) and 522 m/s (1713 ft/s), and these ten impacts were used to calculate an estimated V_{50} value of 507 m/s (1663 ft/s) according to the requirements of NIJ Standard-0101.04 [18] and MIL-STD-662F [42]. The high stop speed was 506 m/s (1658 ft/s) and the low perforation speed was 502 m/s (1649 ft/s). A plot of the ballistic limit test series is shown in Figure 4.11.

The V_{50} ballistic limit test results were also analyzed by using the maximum likelihood method to fit the complete set of results to a logistic model [43, 44]. This analysis estimated the V_{50} to be 507 m/s (1662 ft/s). This method also allowed the goodness of the results to be estimated through an analysis of confidence intervals on the model fit. The 68.3 % confidence levels for the V_{50} were estimated to be 503 m/s (1651 ft/s) and 511 m/s (1677 ft/s), and these are shown in Figure 4.11. The twelve test shots were insufficient to allow the confidence intervals to be estimated at the 95 % level, which is to be expected, since the twelve shots represent a relatively small set of data for this type of analysis.

Figure 4.11: Ballistic Limit Shot Sequence and Test Results.

which is slightly less than the estimated V_{50} of 507 m/s (1663 ft/s) for the incident armor back panel. This result provides evidence that the ballistic resistance of the incident armor had not degraded while in use.

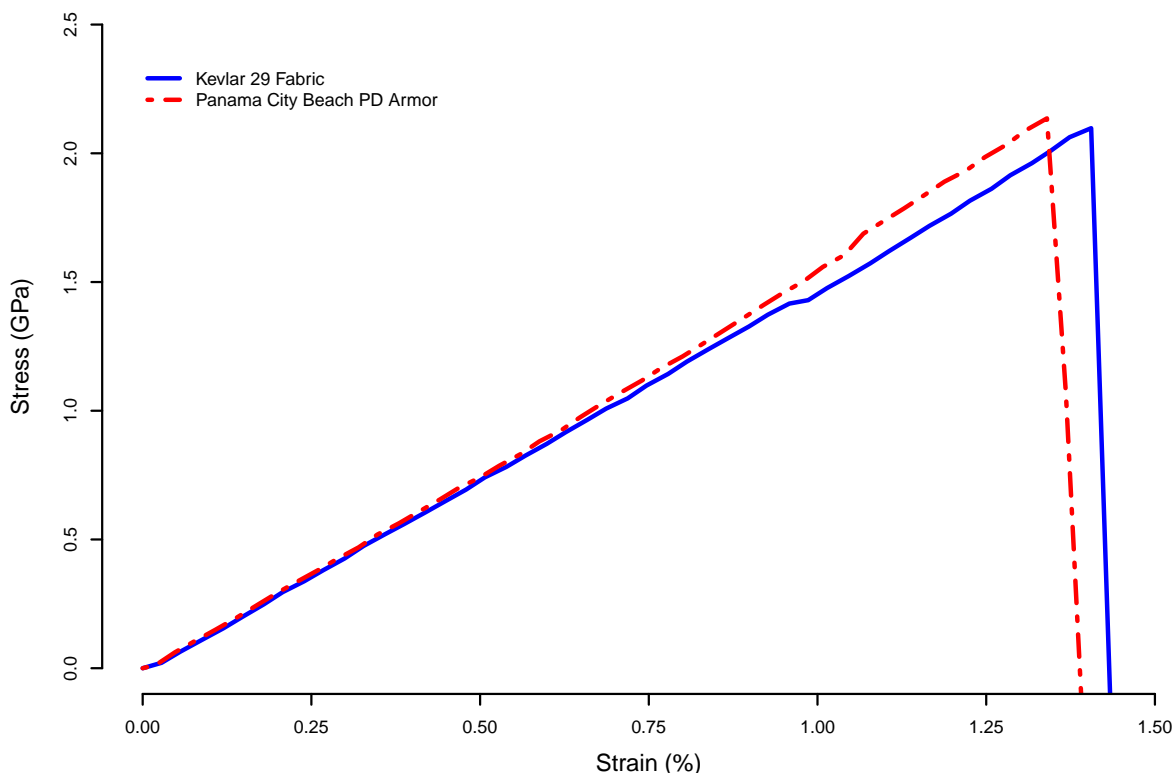
Figure 5.1: Stress-Strain Response of Representative Material Samples from PCB Armor.

from layers 6 and 12 had a significantly lower mean stress at break ($P = 0.05$). If the body armor were significantly degraded, the yarns extracted from the armor would be markedly weaker than those extracted from the woven Kevlar 29 fabric. The differences found between the two samples, however, are not large enough to conclude that there was any significant degradation in the tensile properties of the yarns in the incident armor.

The profiles of the breaking strength curves were also compared, and there did not appear to be any significant differences between the two. An example comparison can be seen in Figure 5.1.

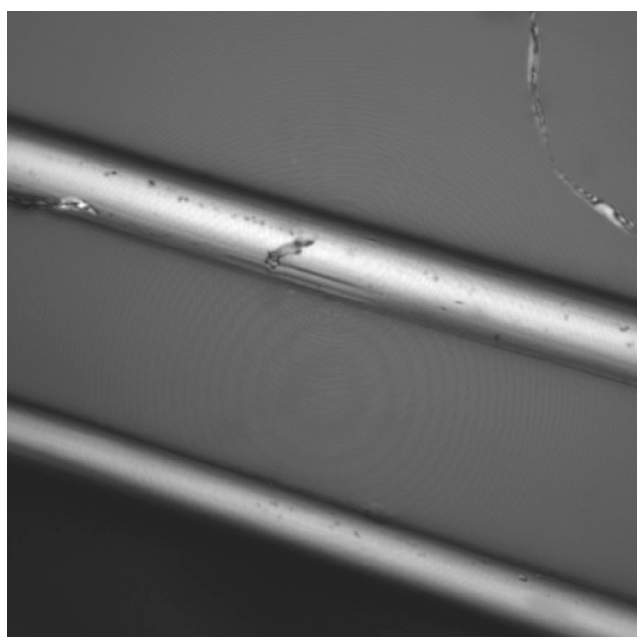
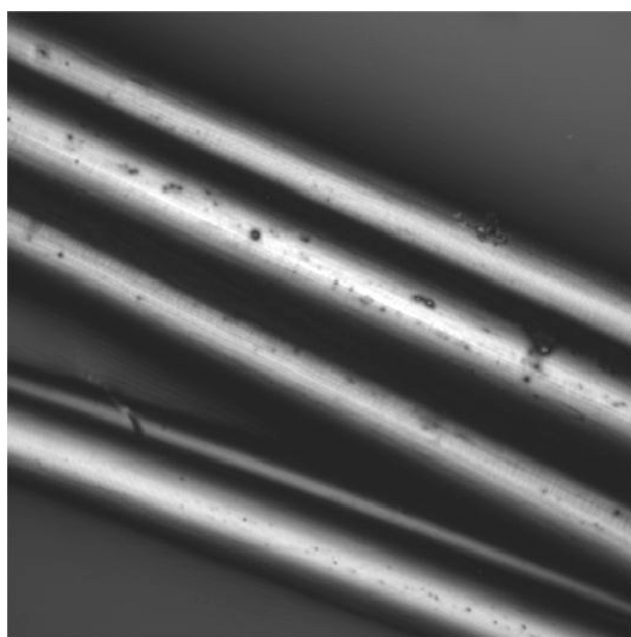
Figure 5.2: Confocal Micrographs of Control Armor Fibers, 150x Magnification.

Confocal microscopy was used to characterize the surface morphology of fibers taken from both the incident armor panel and the control armor, which is described in Section 5.2. Figures 5.2 and 5.3 show some representative micrographs
