# **1994 Northridge Earthquake Performance of Structures, Lifelines, and Fire Protection Systems**

Diana Todd  
Nicholas Carino  
Riley M. Chung  
H. S. Lew  
Andrew W. Taylor  
William D. Walton  
James D. Cooper  
Roland Nimis

Building and Fire Research Laboratory  
National Institute of Standards and Technology  
Gaithersburg, MD 20899-0001

May 1994

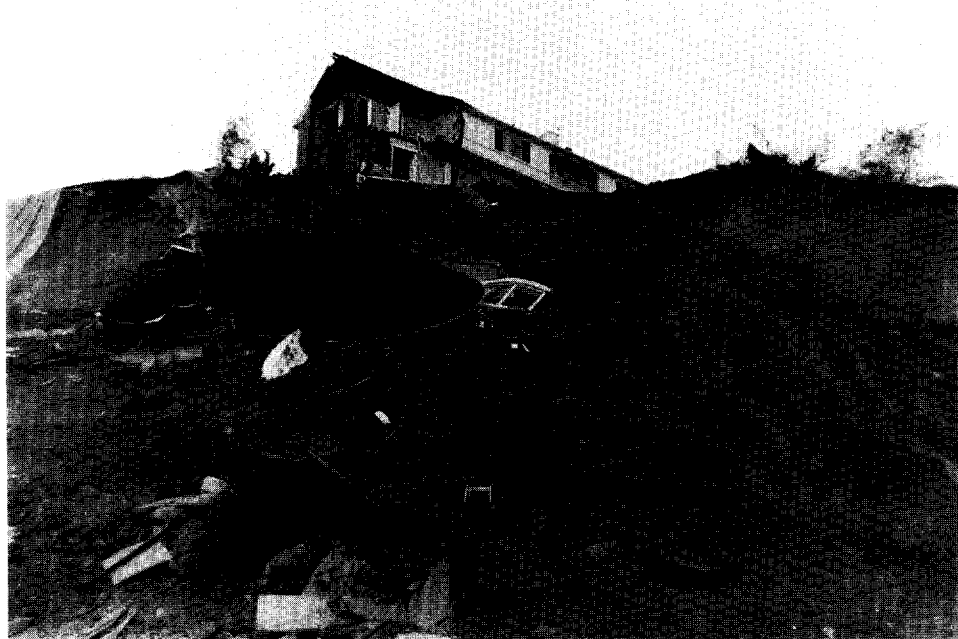
Landslides, rock slides and slope failures were the most visible geotechnical effect caused by the earthquake. Landslides along the Pacific coast in Santa Monica and Malibu damaged several buildings (fig. 2.8). Rockfalls in the Santa Monica, Santa Susana, and San Gabriel Mountains closed roads. Mulholland Drive in Sherman Oaks was temporarily closed because of the threat of slope failure.

Figure 2.8. A landslide along the Pacific Coast Highway north of Santa Monica undermined the foundation of a house at the crest of the slope, bringing a portion of the house down.

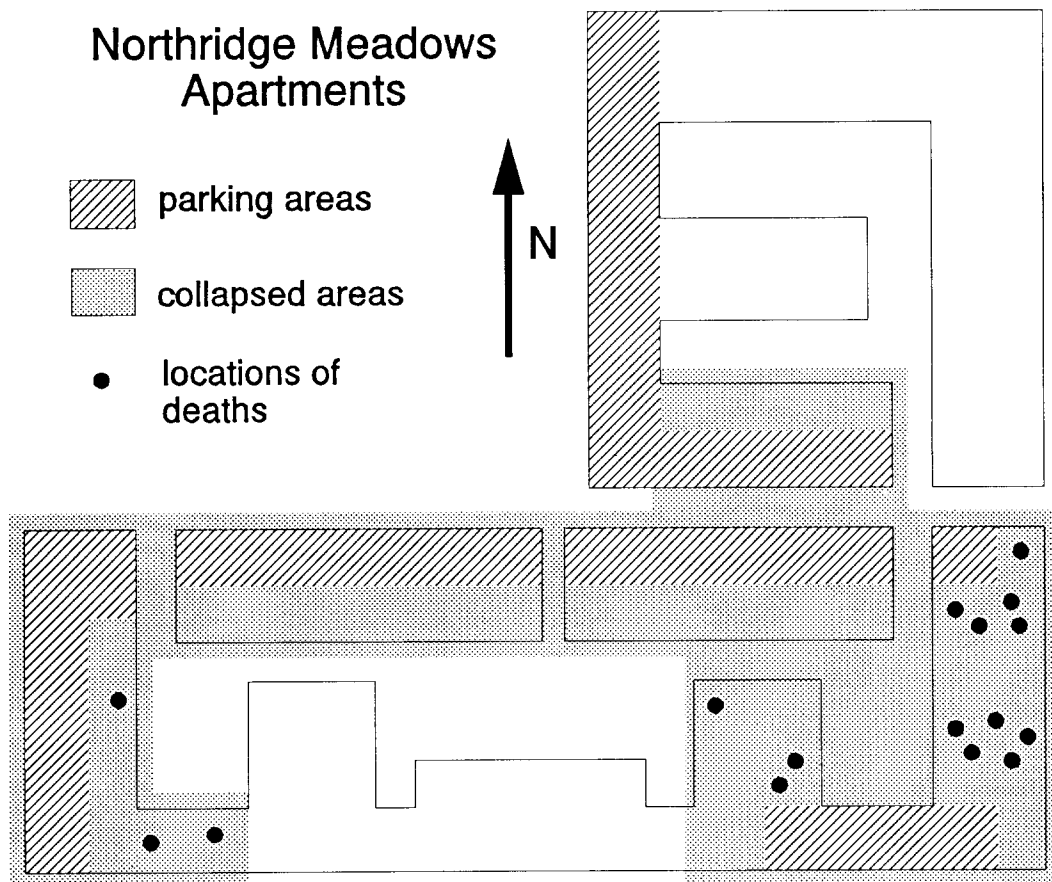
Figure 3.3. This plan of the Northridge Meadows apartment complex shows the distribution of parking and living spaces at the first level, and locations of deaths (source: Los Angeles Times, January 24, 1994). The shaded areas indicate the portions of the complex which collapsed.

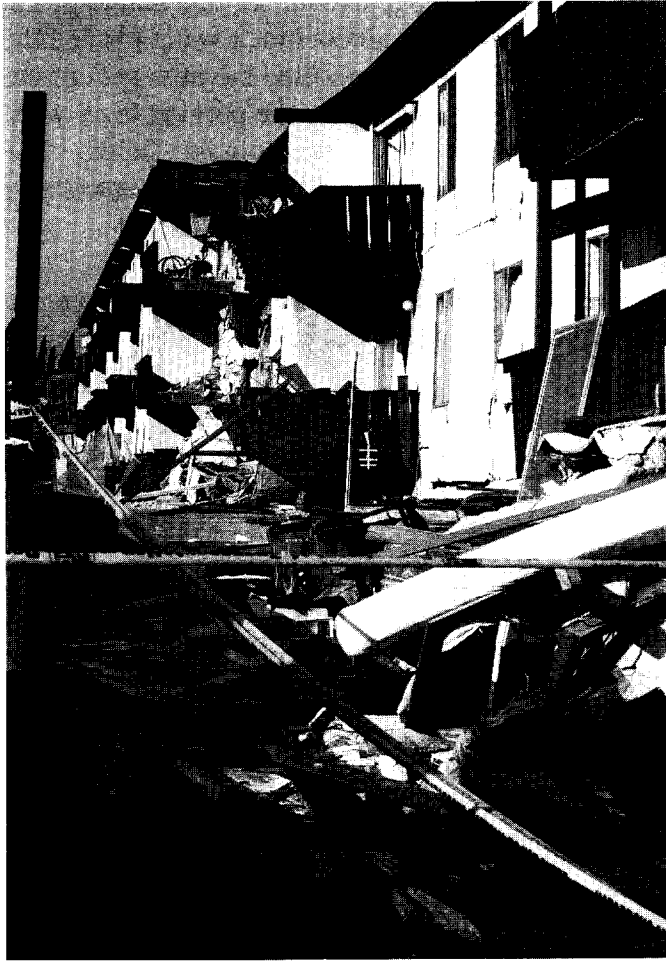
Figure 3.4. At the Northridge Meadows apartment complex near the epicenter the first story in several of the buildings collapsed, killing sixteen people. The second and third stories remained essentially intact. Large portions of the first story in these buildings were open space for parking. This type of collapse occurred in a significant number of similar apartment buildings throughout the affected area.

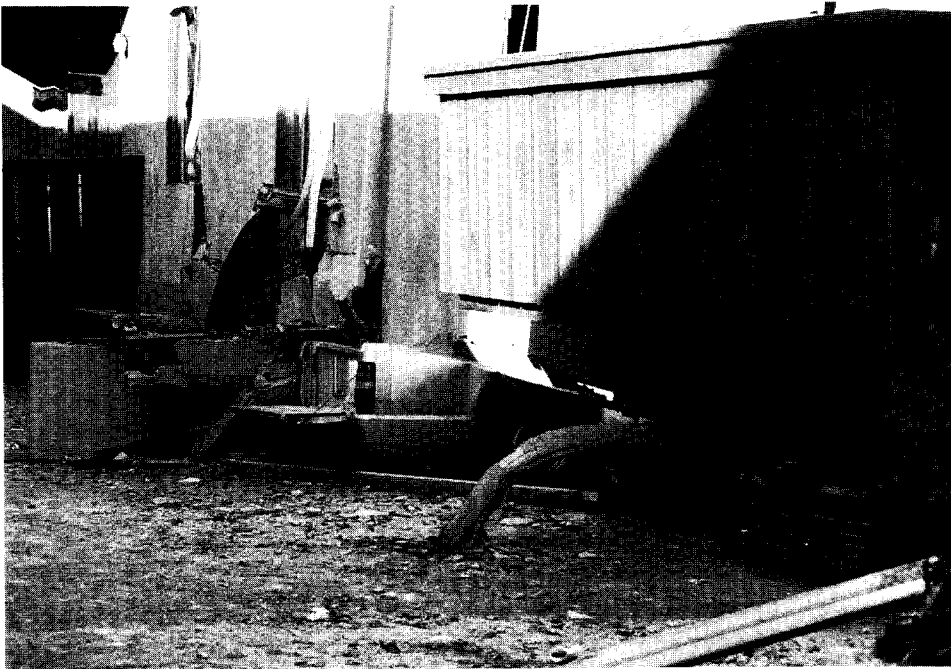
Figure 3.6. At Northridge Meadows, the first story steel pipe columns generally hinged near their bases but retained their length, controlling the displacement of the upper stories.

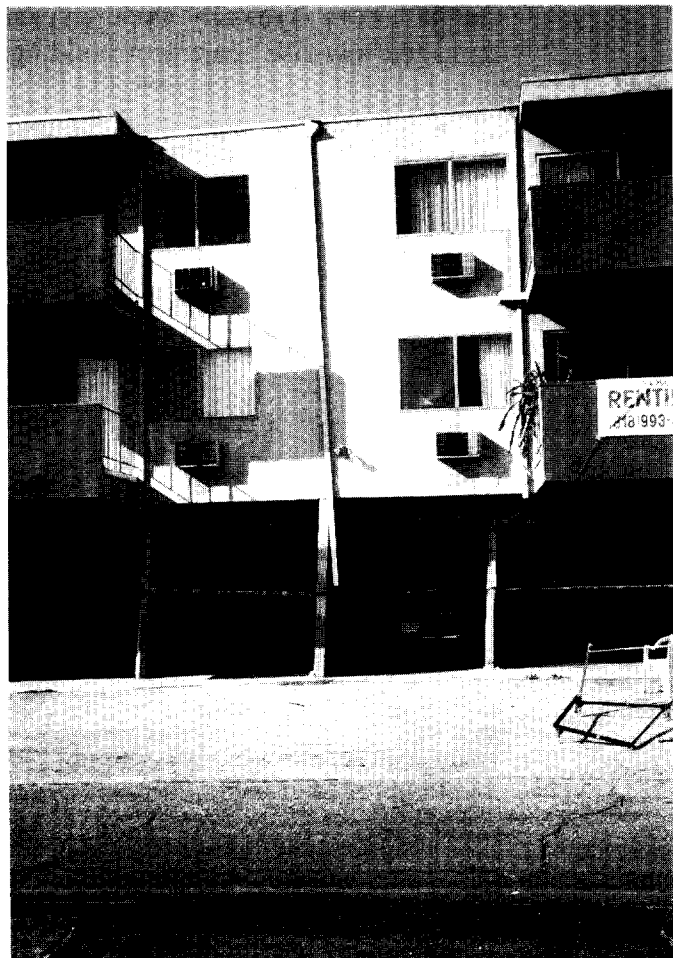
Figure 3.7. Racking, or leaning, of open first story parking areas was a common feature of damaged two and three-story apartment buildings.

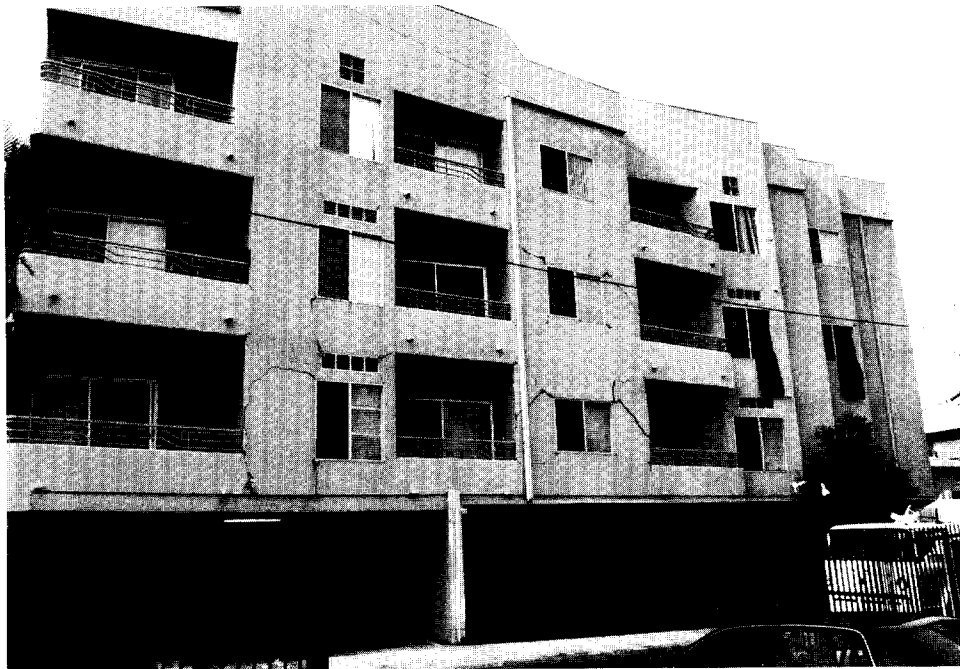
Figure 3.9. Typical damage in to low-rise apartment buildings included diagonal cracks in the stucco facade at the corners of windows and other openings.

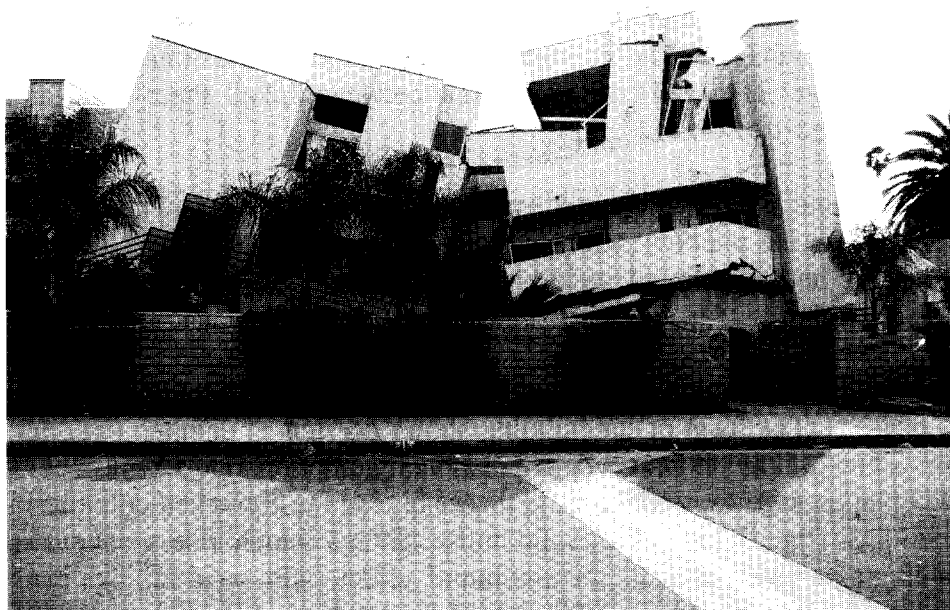
entire first story used for parking, located on Sherman Way in Sepulveda. In this building, the first story parking area was open only on the transverse ends. Concrete block walls formed the longitudinal walls at the first story and a row of concrete columns supported the mid-span of the flat plate concrete floor slab above. The two stories of living space over the parking level were wood-framed with a stucco facade. The entire line of mid-span concrete columns failed. The two halves of the upper stories settled in towards the middle (figs. 3.10 and 3.11), essentially destroying the structure.

Figure 3.10. The central row of concrete first-story columns in a three story apartment building on Sherman Way in Van Nuys collapsed, causing the wood-framed upper stories to settle inward.

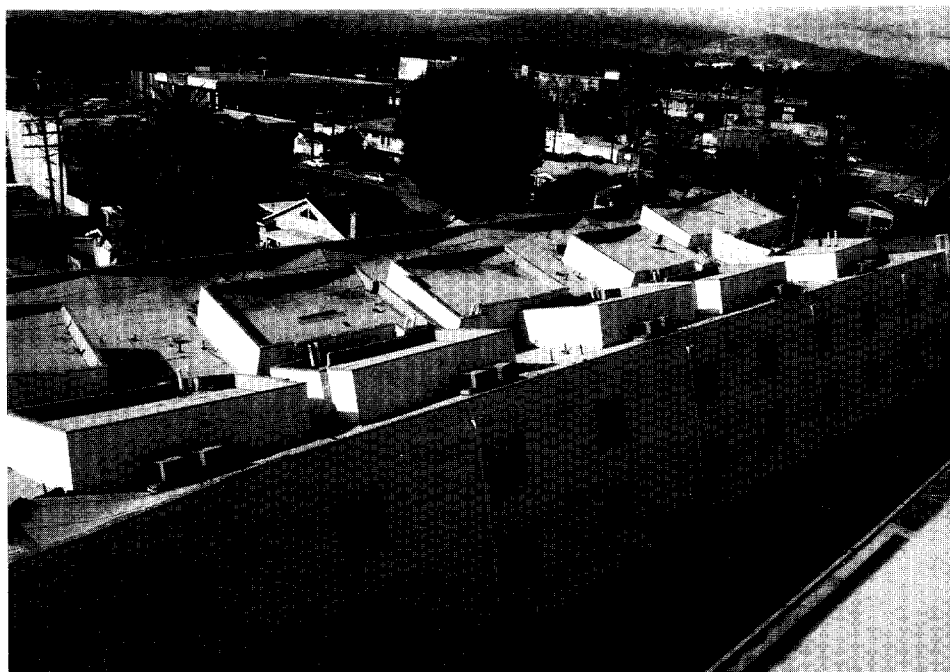
Figure 3.11. This overhead view of the partially-collapsed apartment building on Sherman Way shows the solid concrete masonry block perimeter walls along the longitudinal axis of the building. Access to the first story parking was limited to the transverse ends of the building. When the row of interior columns failed, both sides of the building settled in towards the middle.

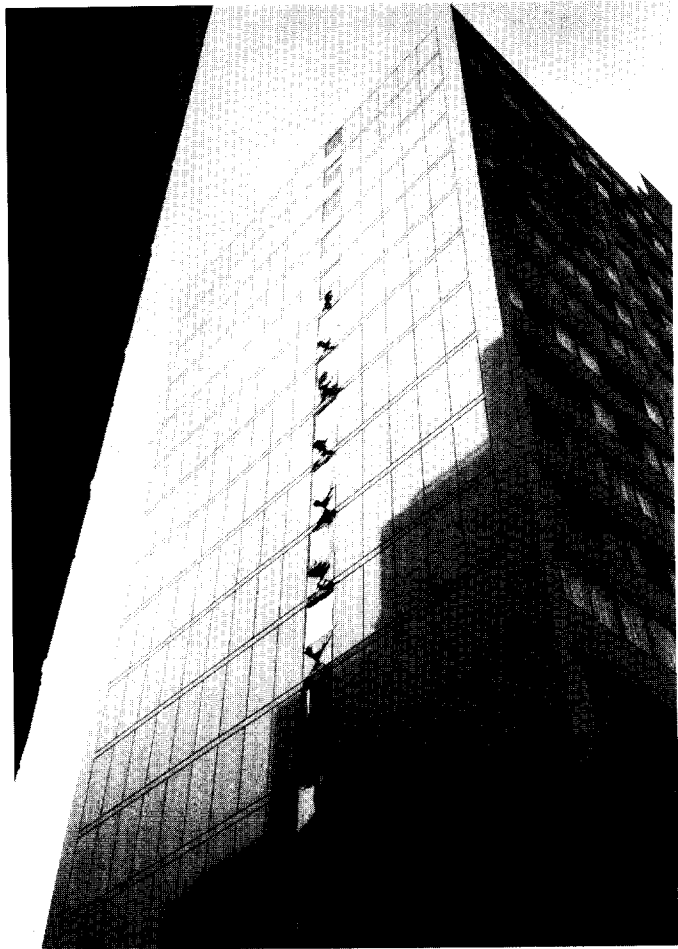
Figure 3.12. Champagne Towers apartment building in Santa Monica suffered a classic form of earthquake damage: shear failure of the coupling beams between linked shear walls at the transverse end of the building.

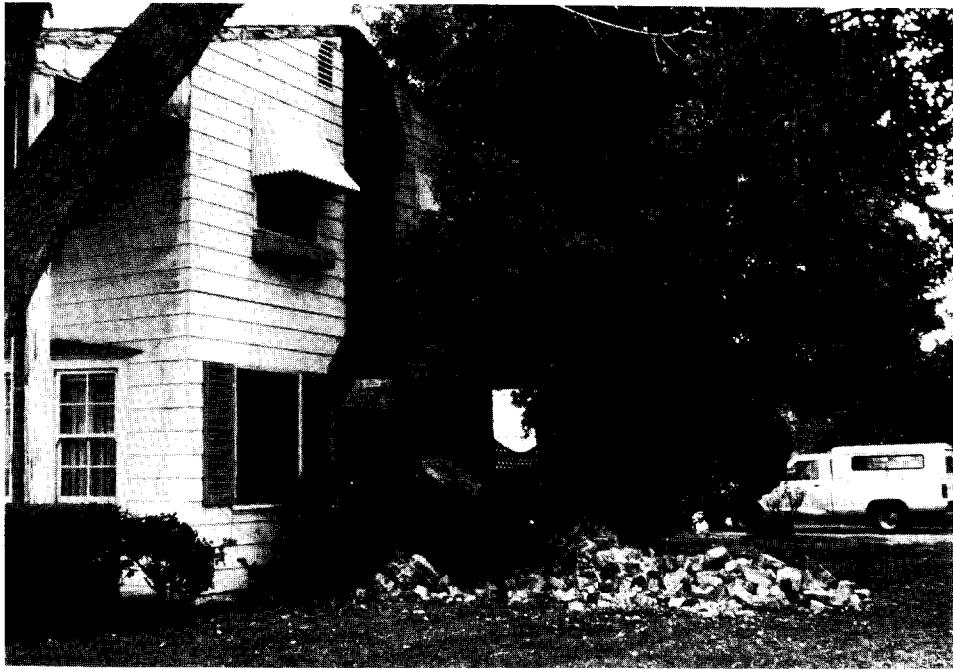
The most common and easily visible damage to single family homes was damaged and collapsed masonry chimneys (fig. 3.17). In some cases, the chimney fell onto and through the roof. Cracked stucco, fallen roof tiles, and racked garage door openings were visible throughout the affected area. Some houses shifted on their foundations. In the epicentral area, damage to concrete masonry fences at the edges of lots was almost universal (fig. 3.18). Piles of debris outside many homes attested to widespread interior nonstructural and contents damage.

Figure 3.17. Failure of masonry chimneys was common.

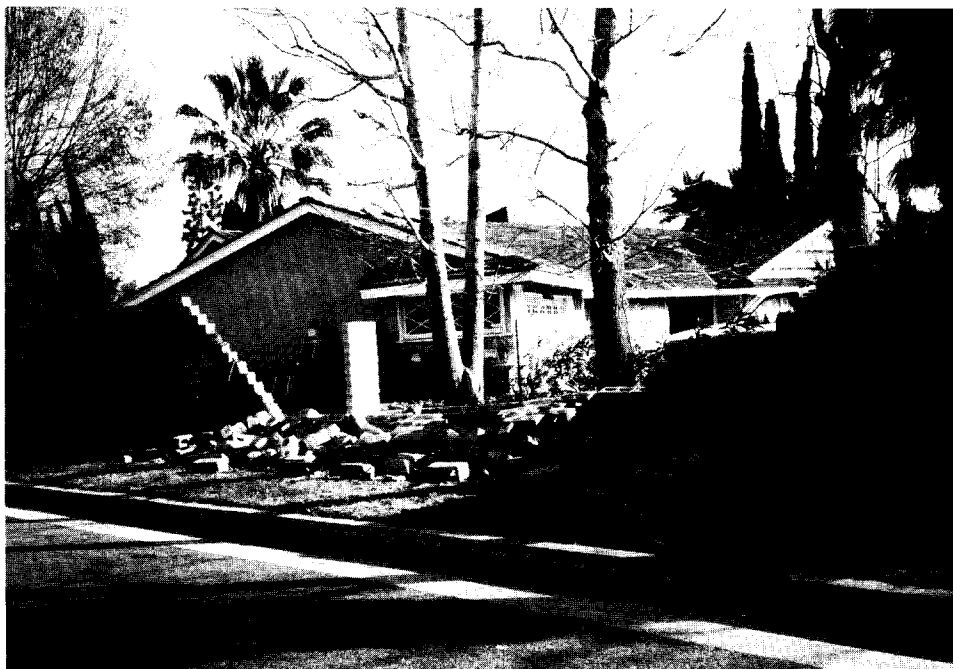
Figure 3.18. Damage to masonry privacy fences was ubiquitous. Many of these fences were tall enough to have been a serious threat to passersby when they failed. Luckily, due to the early morning hour of the quake, yards and sidewalks were essentially deserted.

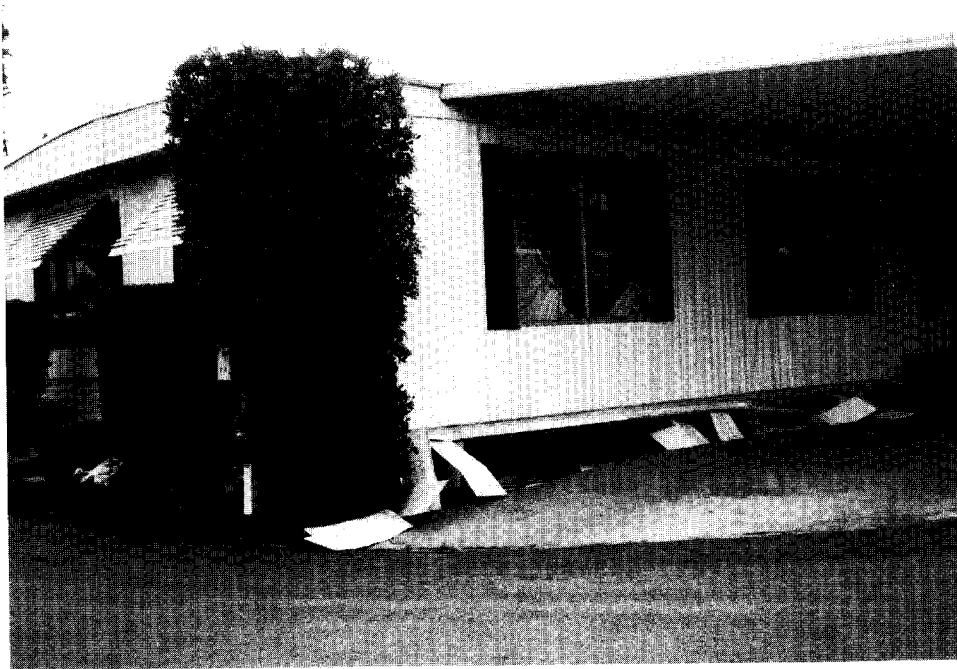
The vulnerability of mobile homes to earthquake ground shaking was demonstrated once again by the Northridge earthquake. For example, in a trailer park near the epicenter, at the intersection of Nordhoff Street and Tampa Avenue, nearly every home had moved on its supports. These types of homes are usually supported on small concrete and metal base supports (figs. 3.19, 3.20, and 3.21). These supports provide little resistance to lateral movements, and toppled during the quake (fig. 3.22). The identical failure was observed in the 1971 San Fernando earthquake. It is clear that no improvements in the practice of supporting manufactured homes adequately against lateral loads have been made during the past twenty-three years.

Figure 3.19. Damage to manufactured homes caused by collapsed supports was common.

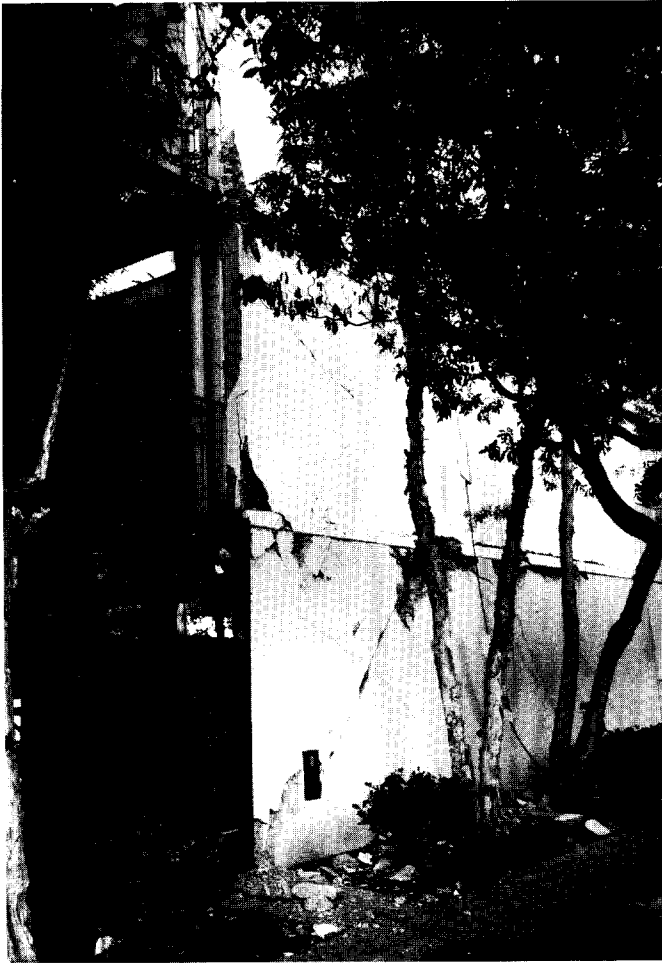
Many buildings had significant amounts of damage in the few blocks surrounding the St. John's Hospital complex. The concrete parking garage at the northwest end of the complex was damaged; the exterior facade panels had diagonal cracks across each panel, and crushed toes (fig. 3.25). To the southeast, a six-story concrete office building had cracked shear walls and broken glass. Several of the columns in this building were also cracked.

Figure 3.25. The concrete facade panels of the St. John's hospital parking garage had diagonal cracks and crushed toes.

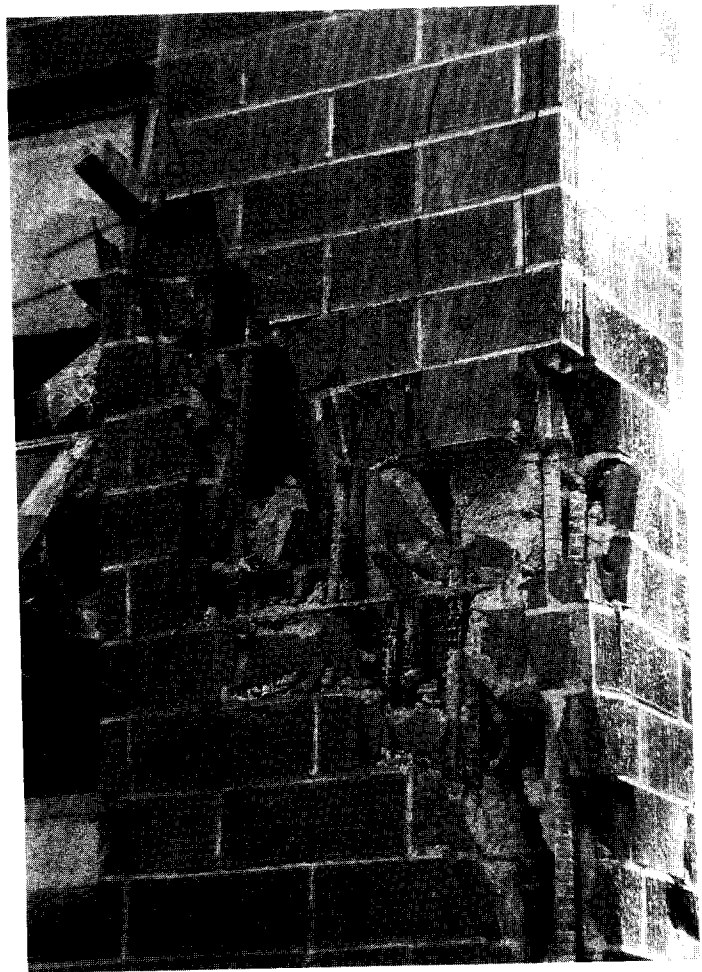
Figure 3.28. Two faces of the Berkley Convalescent Hospital had wing walls separating balconies. The ends of these wing walls spalled at the lower stories.

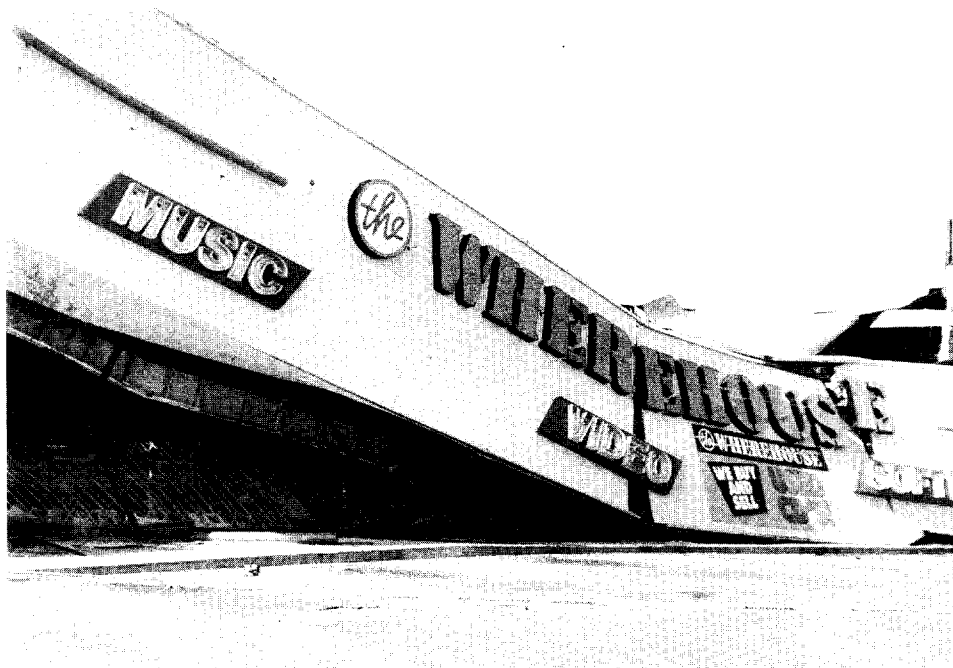
The area around the Northridge Fashion Center showed evidence of having been severely shaken. Significant damage of many types occurred. South of the Northridge Fashion Center, several single story retail structures were damaged; at least one, the Wherehouse, collapsed (fig. 3.32).

Figure 3.32. Many commercial buildings were damaged in the blocks south of the Northridge Fashion Center. The single-story Wherehouse collapsed completely.

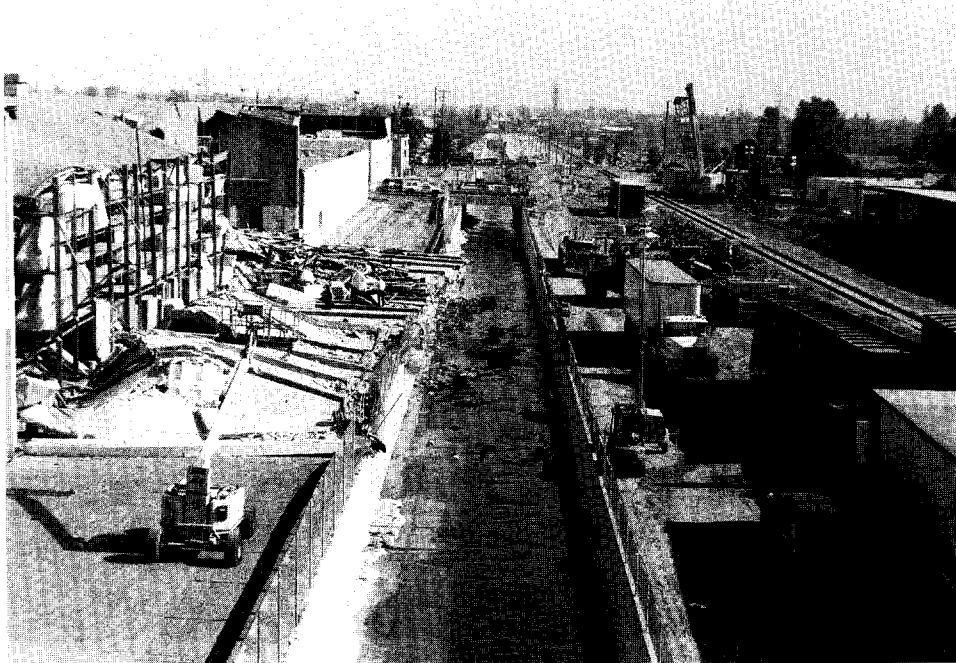
Figure 3.33. The south wall of the concrete tilt-up Levitz furniture store/warehouse south of the Northridge Fashion Center fell away from the building into the alley and stream channel. The damaged roof was being supported by the racks of furniture. On the south side of the stream channel a freight train derailed during the earthquake. That clean-up effort was still underway three days after the quake.

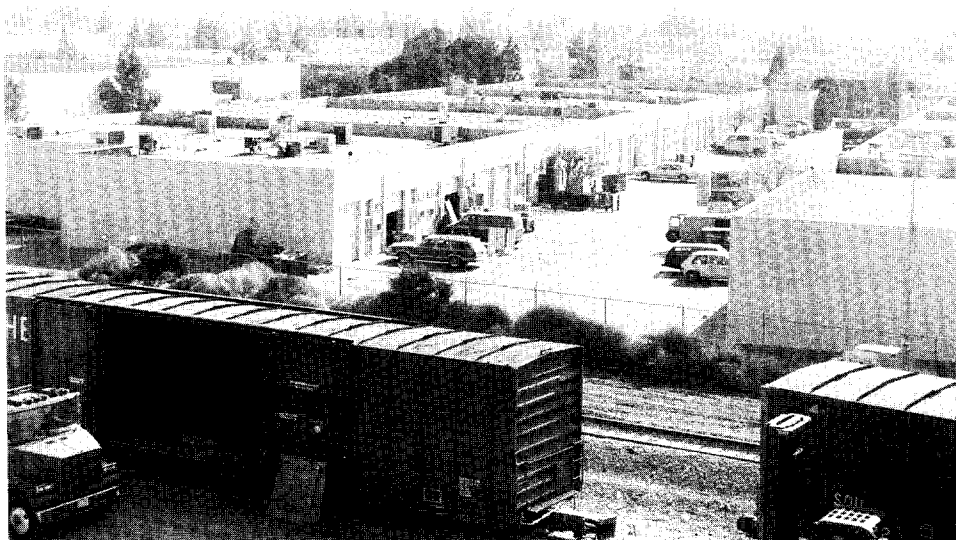
Figure 3.34. The single-story modern masonry commercial buildings directly south of the damaged Levitz furniture store and train derailment were apparently undamaged. All parapets and piers between garage openings appeared intact.

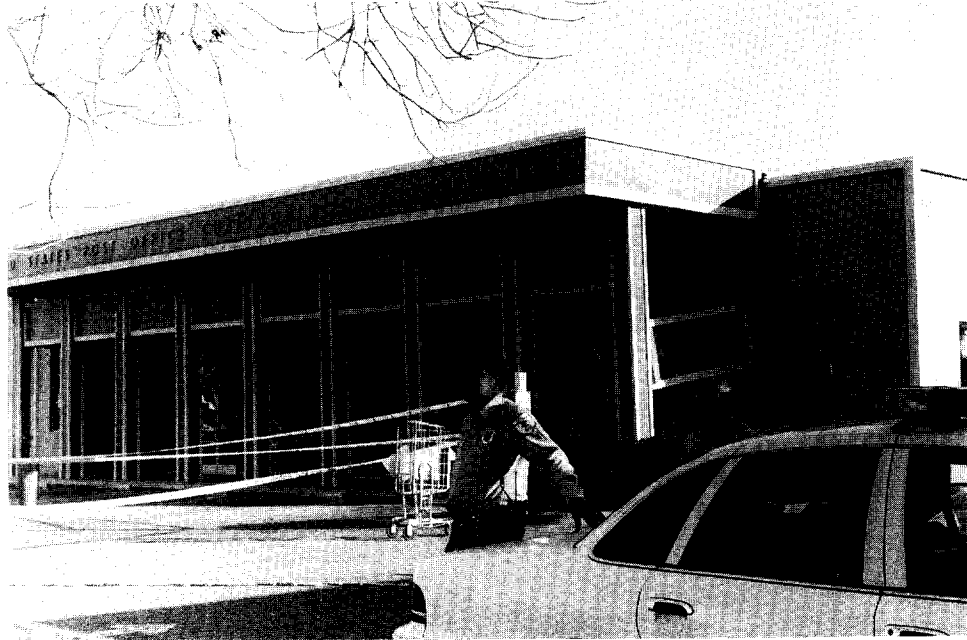
facade panel had become detached and interior ceiling panels had fallen (fig. 3.35). Mail was being collected in the parking lot.

Figure 3.35. The Chatsworth Post Office was closed due to damage. Mail was being collected in the parking lot.

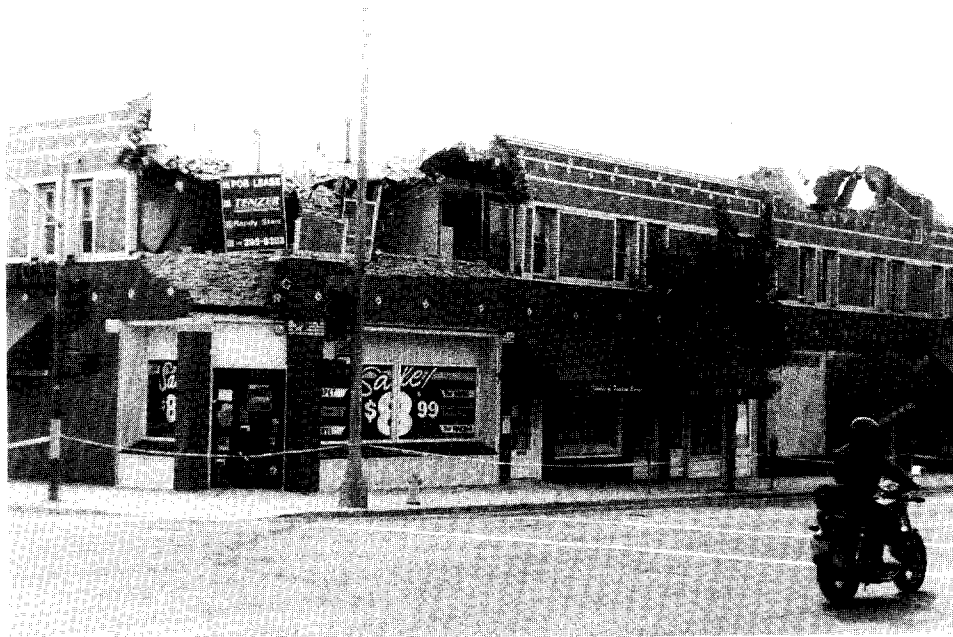
Figure 3.36. Damage to unreinforced masonry buildings, even those that had been rehabilitated, was common. Upper stories and corners were particularly vulnerable to damage. The rows of light-colored diamonds on the face of this building are the end plates of through-bolts used to connect the wall to the floor joists, a typical rehabilitation technique. The remains of parapet braces can be seen on the roof.

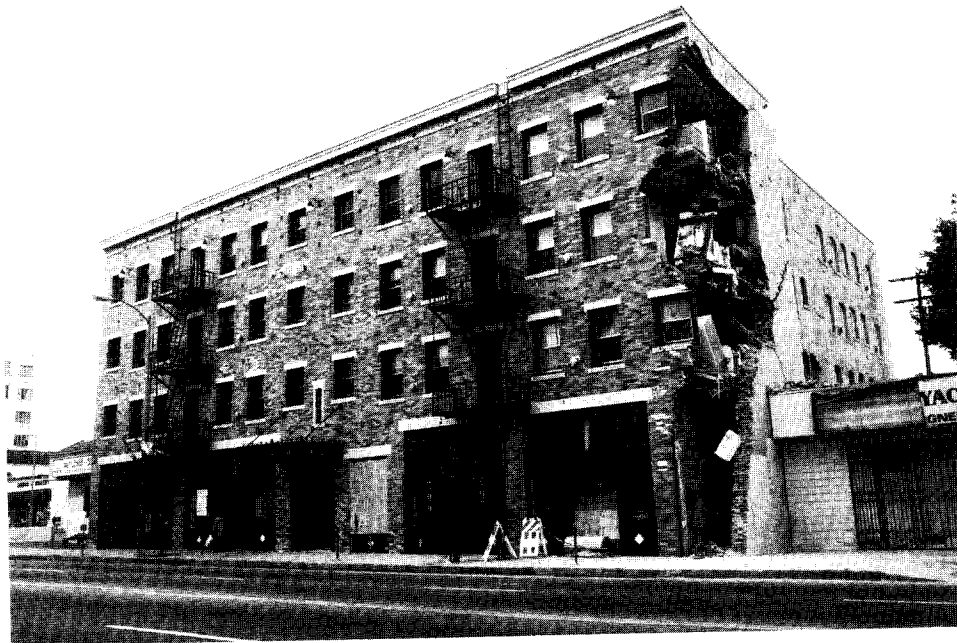
Figure 3.37. The corner of this rehabilitated unreinforced masonry apartment building in East Hollywood crumbled on all four stories.

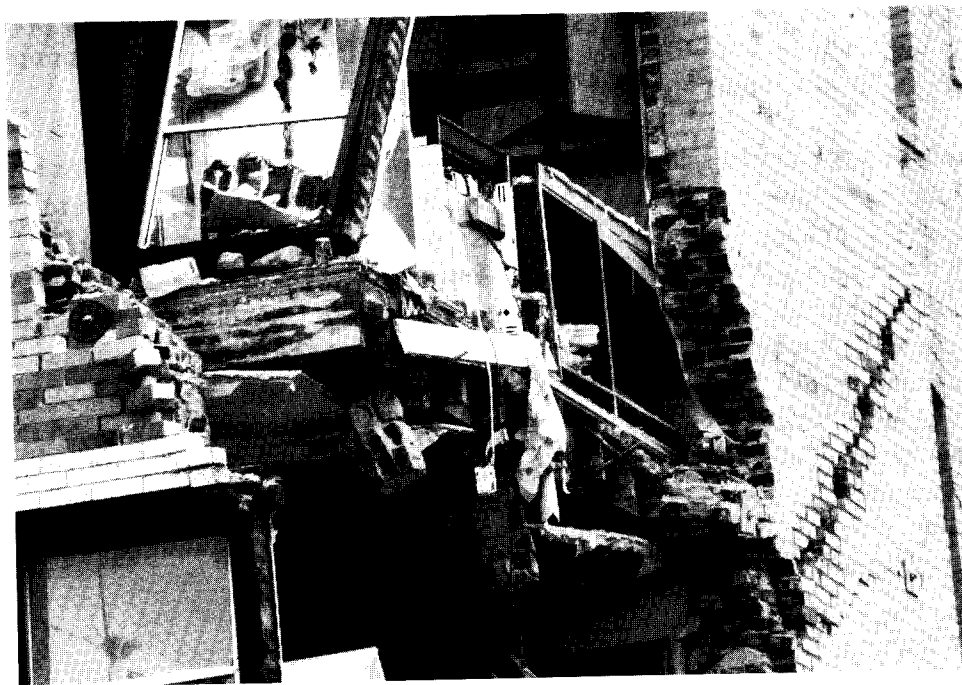
Figure 3.38. A close-up view of the third-story floor diaphragm of the building picture above shows (lower right) a rehabilitation bolt still holding a few bricks to the floor joists, after all the walls on three out of four sides of the bolts had disintegrated.

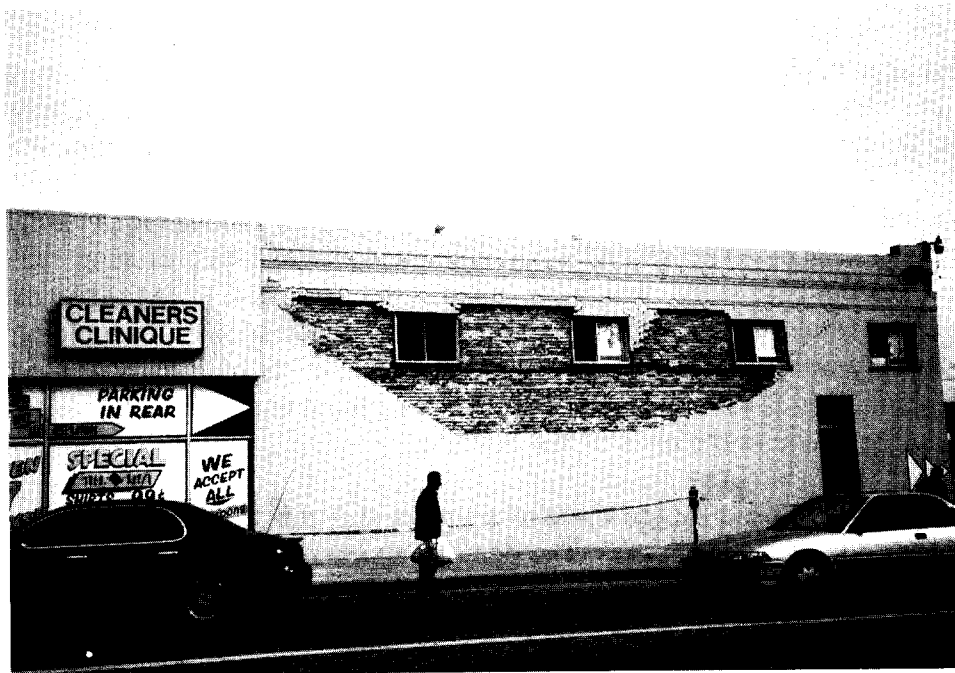
Figure 3.39. Only the exterior wythe of brick peeled off of this rehabilitated unreinforced masonry building in Santa Monica.

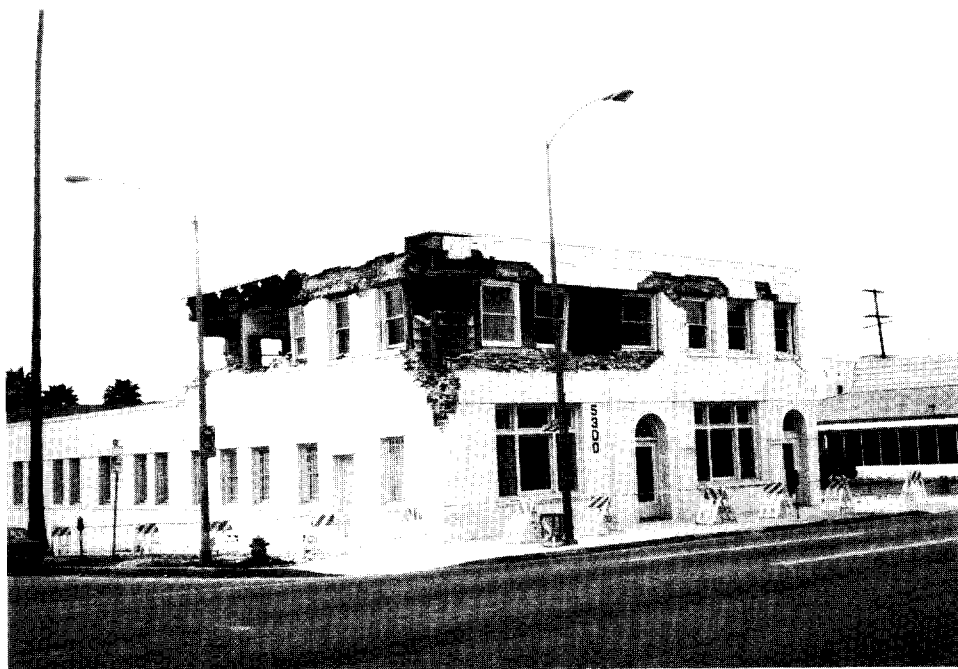
Figure 3.40. In other rehabilitated unreinforced masonry buildings, such as this two story structure in Hollywood, entire wall thicknesses were lost between rows of through-bolts.

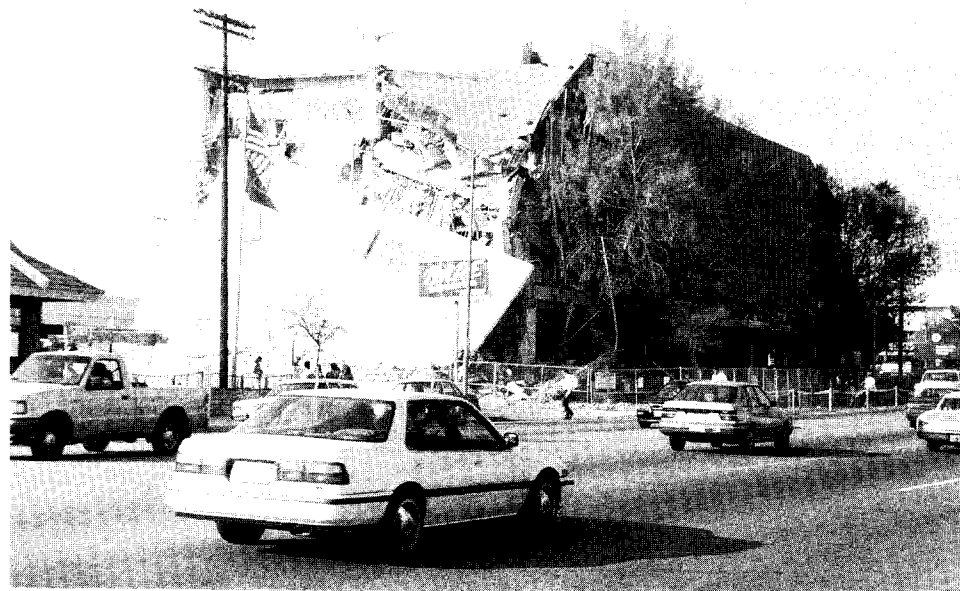
The concrete frame Kaiser Permanente office building on Balboa Boulevard in Granada Hills was badly damaged. The second story columns disintegrated, causing the upper stories to collapse onto the first story, which remained intact (fig. 3.41). At the ends of the building, damage to the frame caused partial collapses, but the mid-section of the building remained intact. The apparently nonstructural end walls became detached at both ends of the building and slid to the ground (figs. 3.42 and 3.43). The failure of these end walls may have contributed to the damage to the frame at the ends of the building.

Figure 3.42. Both end walls of the Kaiser Permanente building slid, partially intact, to the ground. The south wall is pictured here. Both ends of the building suffered damage to the concrete frame at all story levels, while the middle half of the building, except for the second story, remained intact.

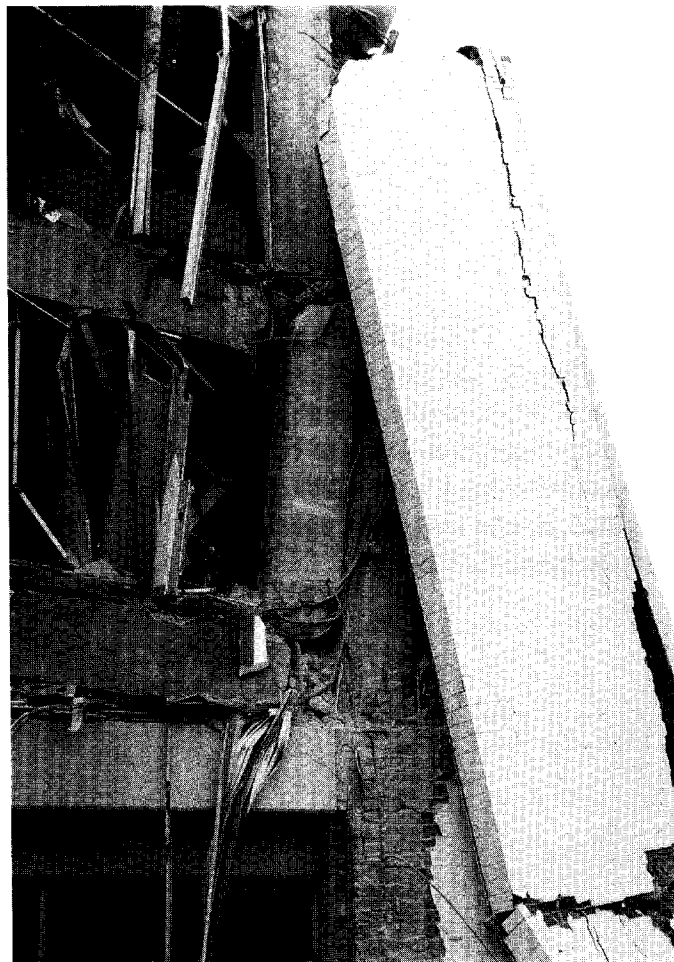
The bare frame exposed by the damage suggests that the buildings had a strong-beam/weak-column configuration (fig. 3.44). The damage appears to have initiated at the joints. At the damaged ends, the beams and columns remained essentially intact, but the joints disintegrated.

Figure 3.44. The exposed concrete frame of the Kaiser Permanente building, revealing deep beams, suggests that the building had a strong-beam, weak-column configuration. Except for the second story columns, the columns and beams remained intact while the joints disintegrated.

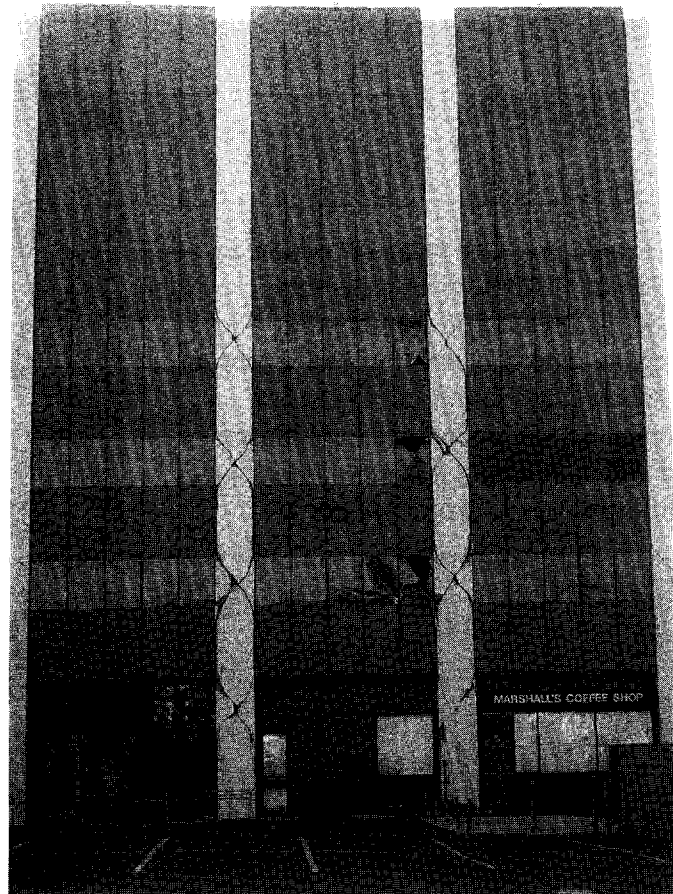
The L-shaped concrete frame Barrington Building in West Los Angeles also had damage concentrated in the second story columns (fig. 3.45). In this building, the horizontal architectural panels stiffened the lower half of the columns at each story, creating a short-column effect. The effectively shortened columns failed in shear between the windows, creating a pattern of X-cracking in the columns that diminished in severity towards the top (fig. 3.46). At the second story, the cracking was severe enough to cause a loss of vertical-load-carrying capacity; the bulging window frames indicate about a 50 to 100 mm reduction in height (fig. 3.47). The building was demolished within a few days of the quake.

Figure 3.46. The stiff infill panels of the Barrington Building effectively shortened the concrete columns, forcing all the displacement into the column sections bounded by windows. Diagonal X-cracking decreased in severity towards the top of the building.

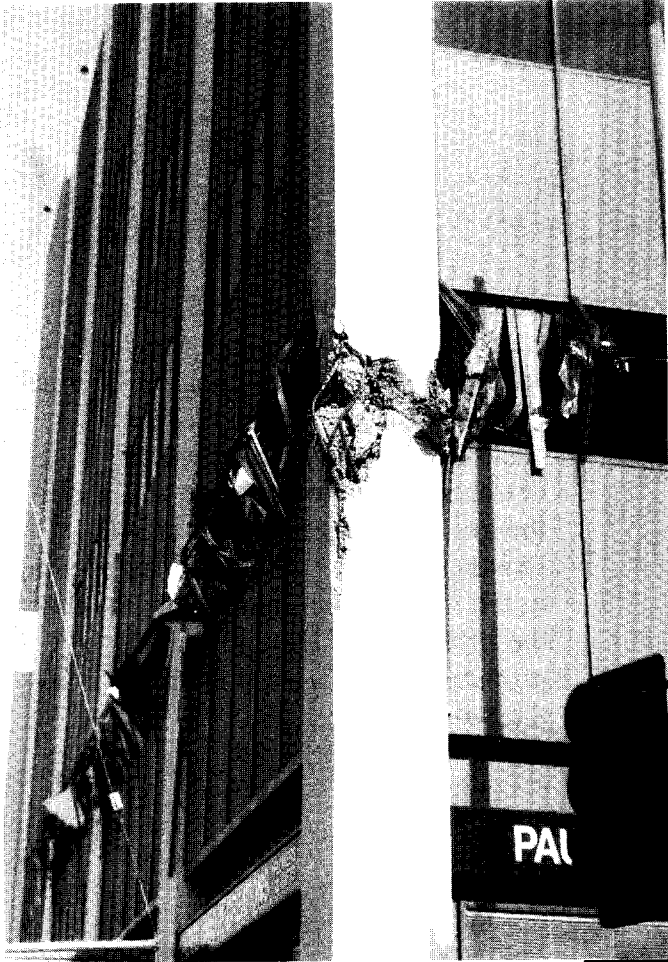
Figure 3.47. The cracking in the concrete columns at the second story was so extensive that the vertical-load carrying capacity of the building was affected. The building settled 50-100 mm at the second story, as these bulging window frames attest. The worst damage was at the southeast corner, the outside corner of the L-shape, pictured here. The building, which developed a slight list, was demolished within days of the quake.

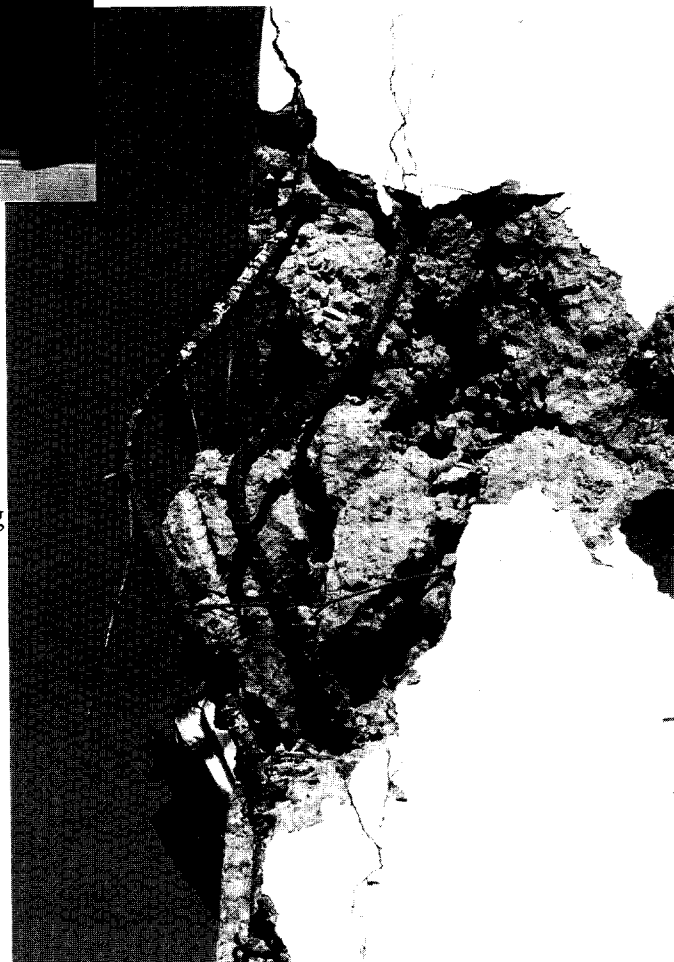
Figure 3.48. A close up of the damaged southeast corner of the Barrington Building shows the widely spaced, undeformed bars used for transverse reinforcement.

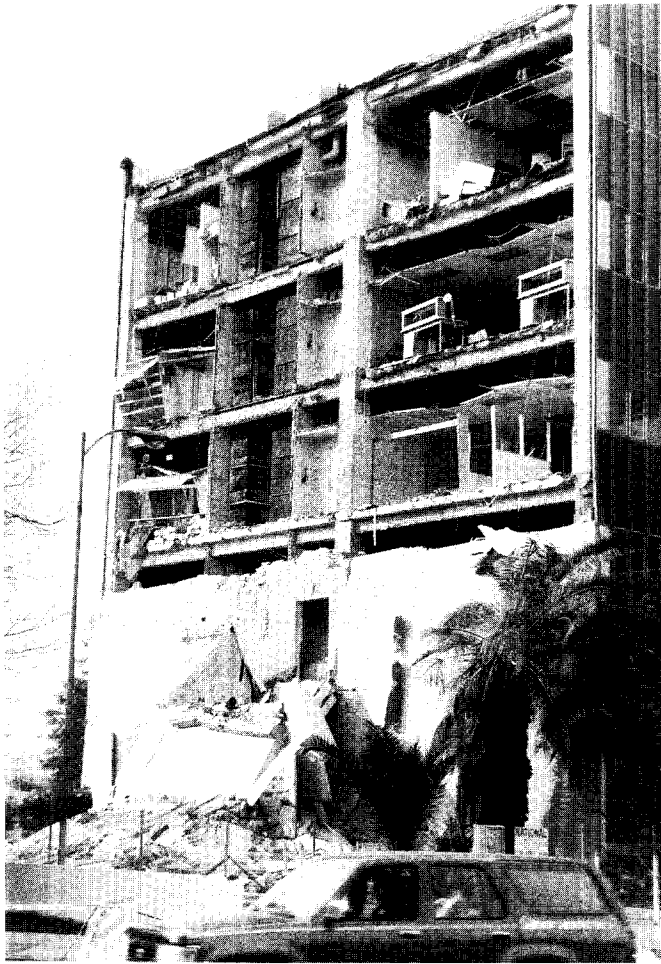
A five-story steel and concrete office building occupied by the Digital Equipment Corporation on Sherman Way lost the enclosing masonry end wall and stair tower (fig. 3.49) on the east side of the building. The corresponding wall on the west side of the building was damaged, but remained standing. The masonry facade did not continue to the ground, but was supported on a steel angle at the level of the second-story floor. On the west side of the building, this wall was crushed at the toe (fig. 3.50). On the east side of the building, the entire wall came off the supporting angle. The connections between the wall and the building frame appeared to be minimal (fig. 3.51). Other than these end walls, the building performed well. In the longitudinal direction, only a few panes of glass were broken on the first story.

Figure 3.49. The east end wall and stair tower of a five-story apparently steel-framed office building on Sherman Way in Reseda collapsed. The enclosing masonry wall became detached from the structure and slid to the ground, with the upper stories remaining intact. The doorway opening in the wall, shown here resting at about the second story level, originally provided access from the top story to the stair tower.

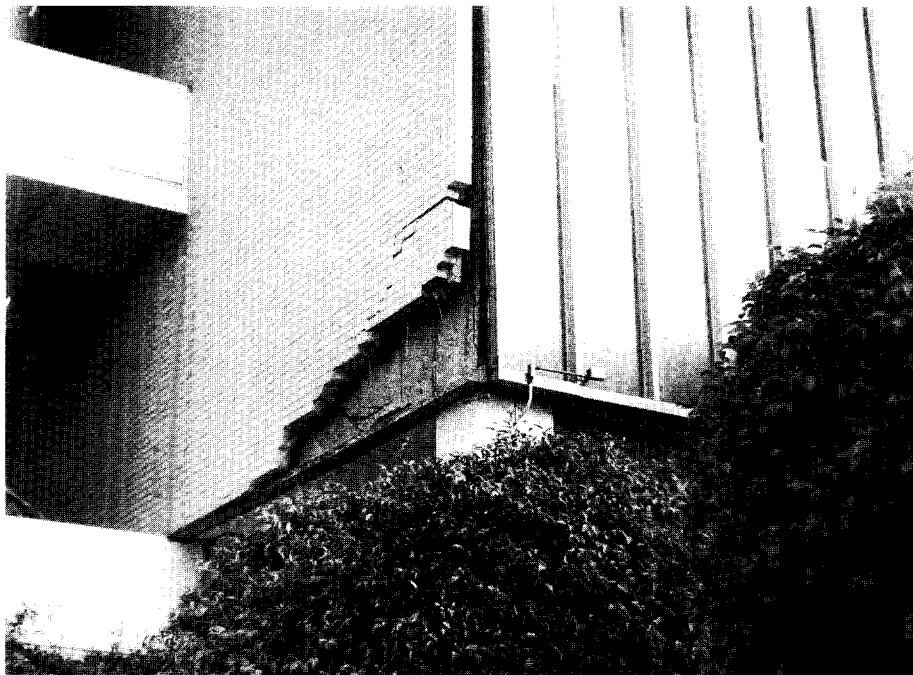
Figure 3.50. The similar west wall of was damaged, but did not peel away from the structure. This close up of the interface between the first and second stories shows that the masonry facade is supported on a steel angle. At the west end of the building, the facade was crushed at the toe where it is supported by the angle.
