# **1994 Northridge Earthquake Performance of Structures, Lifelines, and Fire Protection Systems**

Diana Todd  
Nicholas Carino  
Riley M. Chung  
H. S. Lew  
Andrew W. Taylor  
William D. Walton  
James D. Cooper  
Roland Nimis

Building and Fire Research Laboratory  
National Institute of Standards and Technology  
Gaithersburg, MD 20899-0001

May 1994

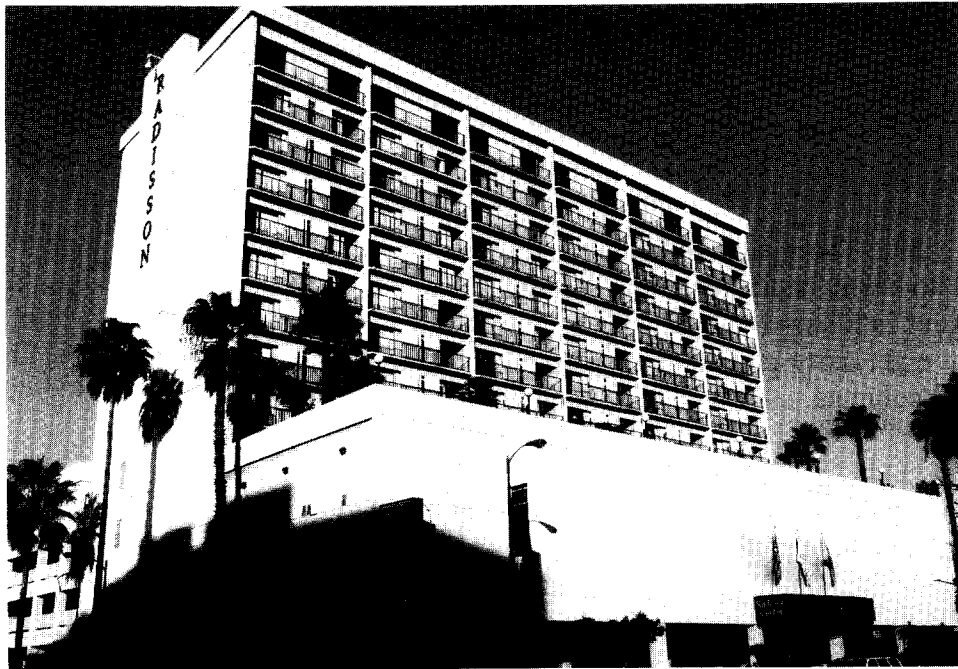
Figure 3.56. The columns supporting the three-story appendage at the front of the Radisson Hotel had serious shear cracks and related spalling.

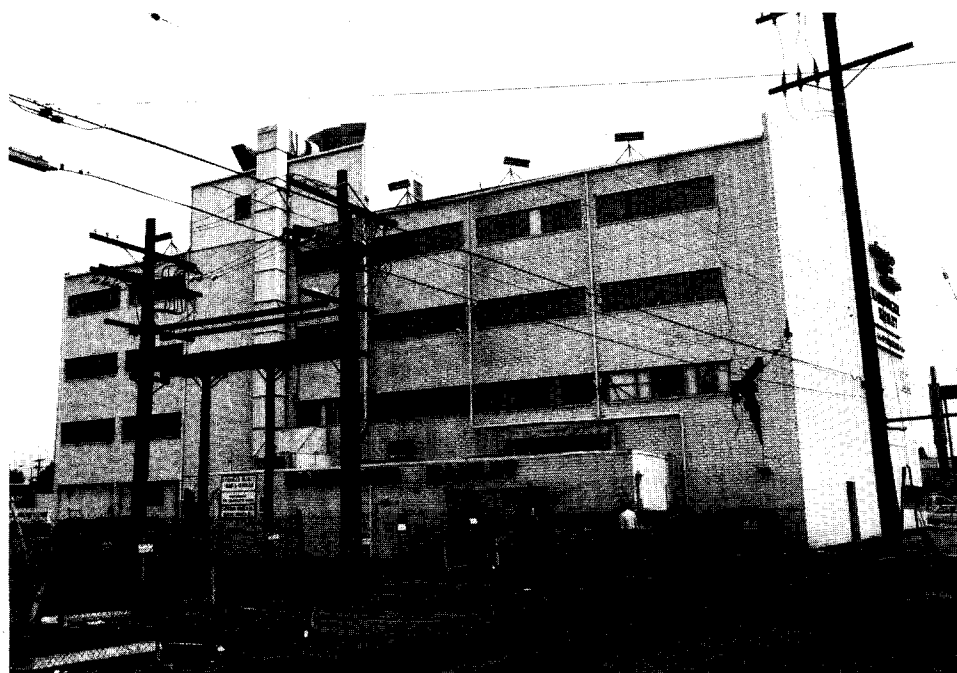
A four-story steel frame structure located at the intersection of Moorpark Street and Cedros Avenue in Sherman Oaks was shaken seriously during the earthquake (fig. 3.58). The exterior reinforced masonry wall was cracked in many places, particularly at the second floor level (fig. 3.59). The evidence of large ground shaking in the Sherman Oaks area was also seen by serious lateral displacements of single family houses and three-story apartment buildings from their foundation. In fact, a strong-motion instrument station in Tarzana located only a few kilometers away from this general area recorded the largest acceleration in this earthquake (1.82g horizontal, 1.18g vertical).

Figure 3.58. The reinforced masonry facade of this steel-framed building in Sherman Oaks was badly damaged.

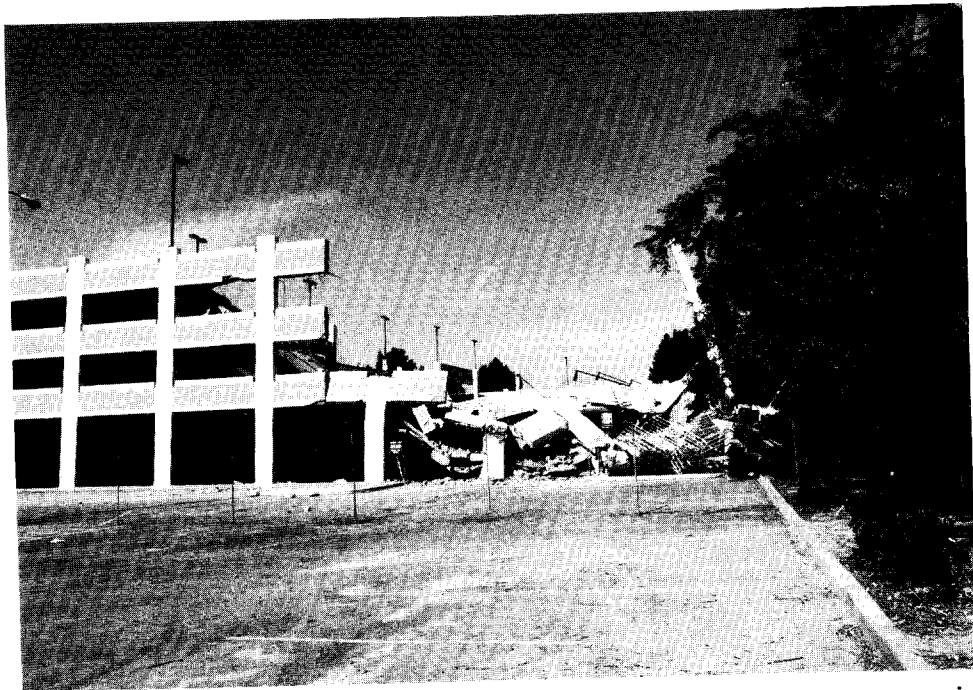
The collapse apparently started at the interior of the building. The exterior perimeter frame was pulled over towards the center of the structure (fig. 3.60), suggesting that interior beams had lost their vertical support, causing the floor plates to collapse and pull the exterior walls in with them. While some interior columns had collapsed, others were left intact, jutting up above the fallen floor slabs (fig. 3.61).

Figure 3.61. Some interior columns of the Northridge campus parking garage remained standing.

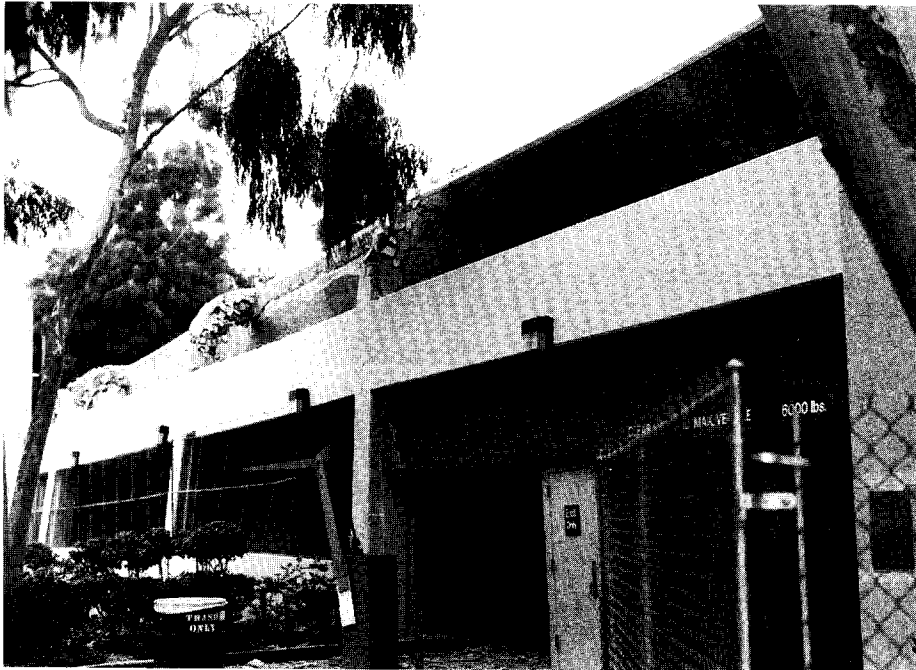
The five-level parking garage at the Kaiser Permanente medical complex on Cadillac Avenue in West Los Angeles experienced a similar collapse. All four facades were pulled inward, suggesting that an interior failure precipitated the damage (fig. 3.62). This garage was a post-tensioned cast-in-place concrete structure with shear walls providing the lateral-force resisting system at the east and west ends, and moment frames at the north and south perimeter. The shear walls were cracked horizontally throughout their height due to the out-of-plane bending (fig. 3.63). There was minor diagonal cracking, suggesting that the lateral load was not fully transmitted to the shear walls. The stair towers remained standing. Typically, these towers are structurally isolated from the post-tensioned slab to minimize potential deformations in the towers due to creep and shrinkage in the post-tensioned slabs.

Figure 3.62. The cast-in-place concrete parking garage at the Kaiser Permanente Hospital complex in West Los Angeles collapsed in on itself. The moment frame that provided lateral resistance on the south face of the structure could not resist the out-of-plane forces apparently caused by the collapse of interior elements.

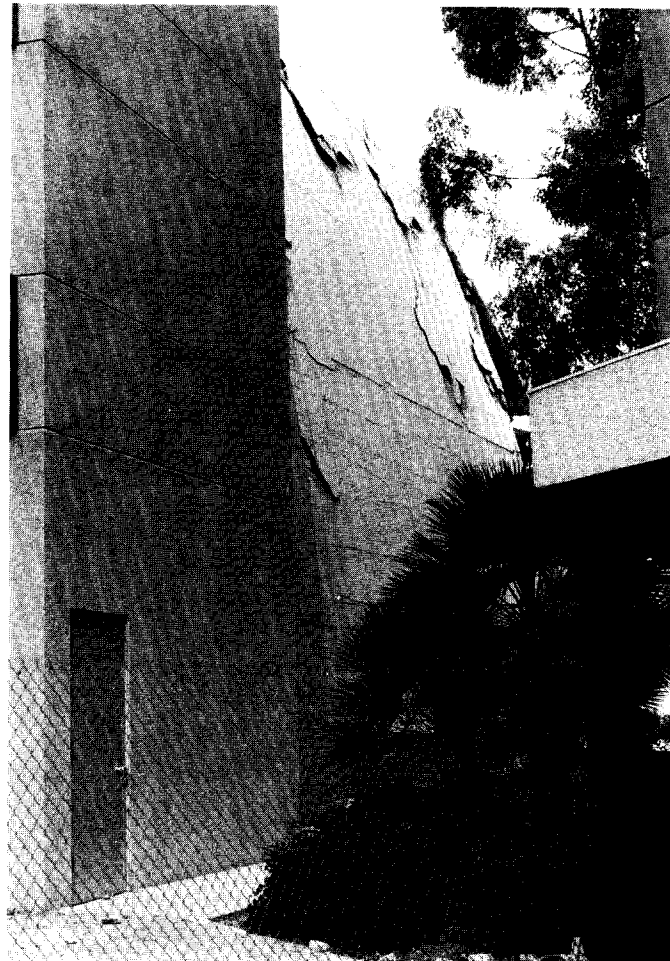
Figure 3.63. At the east and west faces of the Kaiser Permanente Hospital parking garage, shear walls made up the lateral force resisting system. Both walls had horizontal cracks caused by the out-of-plane bending when the walls were pulled inward. Neither wall had major diagonal cracking, suggesting that the lateral load was never fully delivered to the walls. The stair towers remained erect. The east wall and stair tower are shown here.

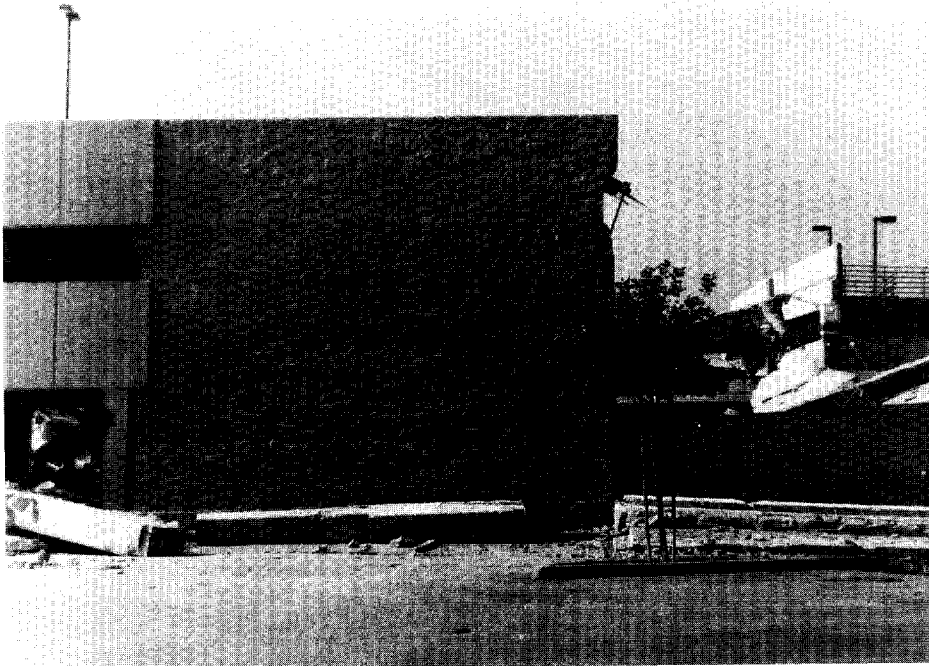
At the Northridge Fashion Center, three parking structures suffered damage. A large three-level concrete garage at the south end of the site, approximately 10 years old, suffered an almost complete collapse. The largely pre-cast concrete structure had intermittent shear walls which remained standing (fig. 3.66). The lack of diagonal cracks in these walls suggests that, like the walls at the Kaiser Permanente garage, they were never fully loaded. A similar, but smaller, precast garage at the north end of the Northridge Fashion Center also partially collapsed (fig. 3.68). At the east end of the site, an older two-level cast-in-place concrete garage showed

Figure 3.66. At the Northridge Fashion Center, major portions of the three-level south parking garage collapsed. The garage was precast concrete with intermittent shear walls. Most of the shear walls remained standing, largely undamaged, indicating that the lateral load was not adequately transmitted to these walls.

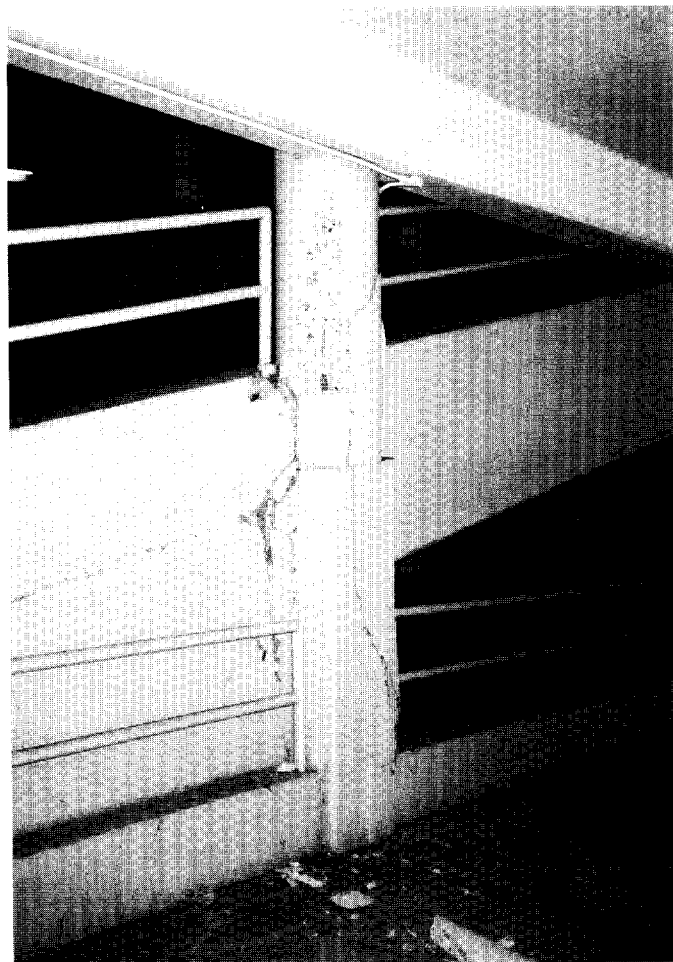
Common types of damage in other parking garages included shear-failure in unintentional short columns created by ramps or split-level decks (fig. 3.67) and collapsed decks caused by inverted-T's or concrete planks pulling off supports (fig. 3.68).

Figure 3.67. In parking garages, ramps can cause unintentionally shortened columns, which are vulnerable to damage, as shown here.

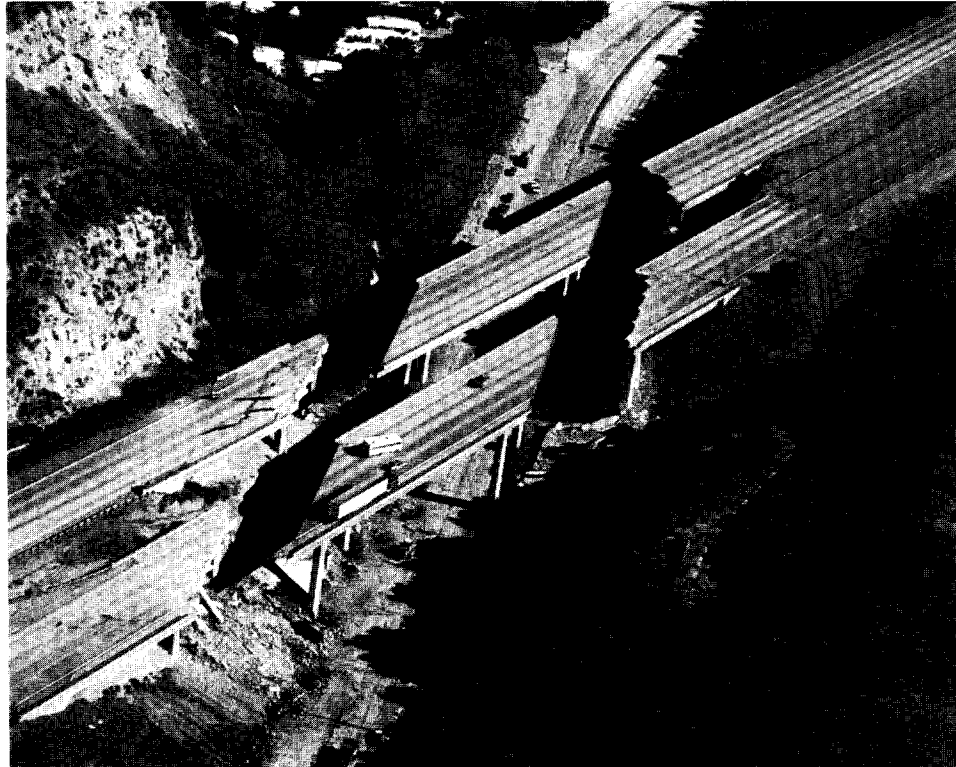
This bridge was designed in 1964 and constructed in 1967. It carries Interstate 5 over Gavin Canyon, about 3 km (2 mi) north of the intersection of Interstate 5 and State Route 14. An aerial photograph of the damaged bridge, after demolition had begun, is shown in figure 4.2, and a ground level view is shown in figure 4.3. Schematic structural drawings are shown in figures 4.4 and 4.5. The structure consists of two parallel bridges, with about a 66 degree skew alignment. Each bridge is composed of five spans. Each bridge has four two-pier bents, and there is a structural hinge near each of the two center bents (figs. 4.3 and 4.4). The superstructure consists of reinforced concrete box girders, and the central portion (between hinges) is post-tensioned. The bridge survived the 1971 San Fernando earthquake with virtually no damage. In 1974, the hinges were retrofitted with cable restrainers, as shown in figure 4.5. The seat length at the hinges is 200 mm (8 in), which by current design standards would be considered inadequate, especially for a structure of this size and flexibility.

Despite the presence of cable restrainers at the hinges, failure of three of the four end spans of the bridge was apparently initiated by the spans falling off the hinge seats. The fourth end span, at the far western corner of the bridge, partially came off its hinge seat but did not collapse, as indicated in figure 4.4. After support was lost at the hinges, a triangular portion of three of the end spans collapsed, as shown in figure 4.4. Demolition of the remaining portions of the end spans was carried out very soon after the earthquake, as shown in figure 4.2. It is likely that the skewed alignment of the bridge was an important contributing factor in this failure. The skewed alignment permitted rotation of the superstructure in a counter-clockwise direction, when viewed from above. The tall, flexible piers of the two center bents would have offered relatively little resistance to rotation in a horizontal plane. (EERC reconnaissance team members noted cracking patterns at the bases of the piers, which may have been evidence of such rotation [5]). Rotation of the superstructure would have resulted in differential displacements at the hinges, and eventually unseating of the end spans at the hinges. Demolition of the bridge was completed a few days after the earthquake.

Figure 4.2. Aerial view of the bridges at Gavin Canyon, looking to the east, showing appearance of the four end spans shortly after demolition had begun.

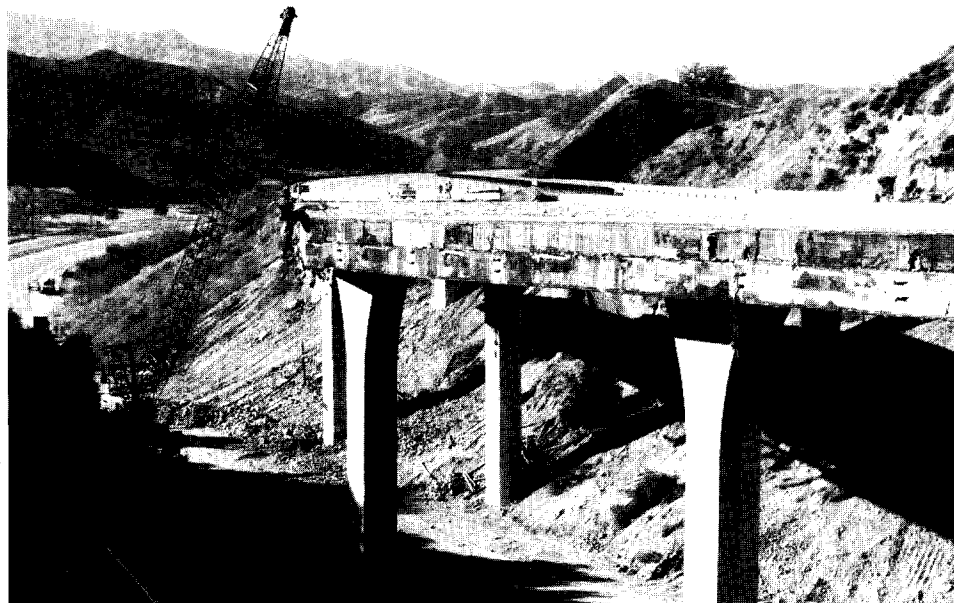
Figure 4.3. Ground level view of the southbound bridge at Gavin Canyon, looking to the northwest, showing the hinge bearing seat near Bent 3.

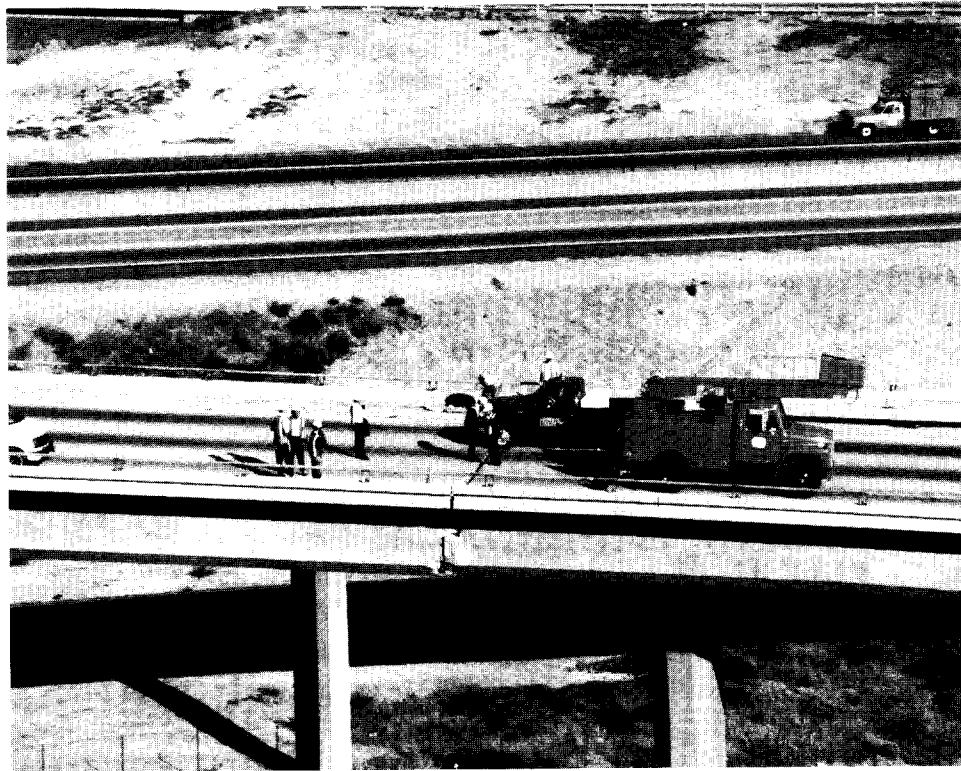
Figure 4.7. Example of pounding and offset at a hinge in the SR14/I5 interchange.

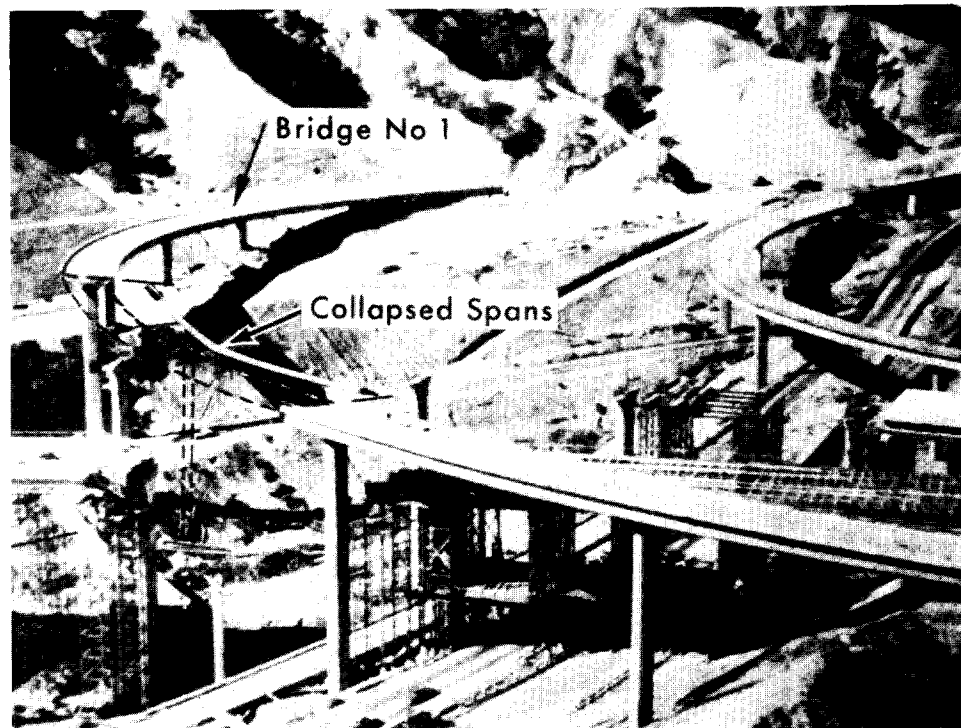
This interchange was designed in 1968 and was under construction in 1971 when portions were damaged by the San Fernando earthquake. At that time, one of the completed ramps in the interchange collapsed, and two ramps which were under construction were damaged. The portion which collapsed in 1971 was the South Connector Overcrossing, connecting southbound I5 with eastbound SR14. A photograph of the collapsed ramp, taken in 1971, is shown in figure 4.8. This ramp was later rebuilt, with improved pier reinforcement, and it suffered no significant damage in the Northridge earthquake. The damaged portions of the other two ramps under construction in 1971 were repaired in place, but not strengthened; the portions not yet constructed were completed with limited seismic upgrading. Both of the ramps which partially collapsed in the Northridge earthquake were under construction at the time of the 1971 earthquake.

Figure 4.8. SR14/I5 interchange after the 1971 San Fernando earthquake. View looking to the west, showing collapsed South Connector Overcrossing.

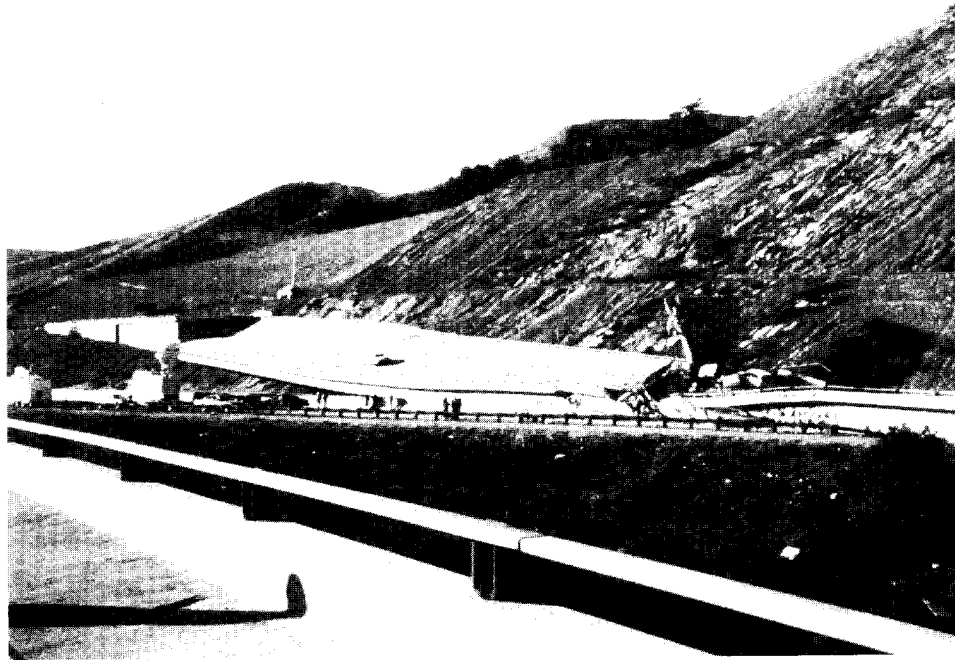
This ramp was designed in 1968 and constructed in 1971. Plan and elevation views of this ramp are shown in figure 4.9. The structure consists of multiple-cell concrete box girders, most of which are post-tensioned, supported on single pier bents with flared tops. The portion of the ramp which collapsed was between Abutment 1 and the hinge located near Pier 4. A ground-level view of the collapsed span is shown in figure 4.11, and a view of damaged Pier 3 is shown in figure 4.12. The mode of failure of this ramp has not yet conclusively been determined, but the following scenario appears likely. Because Pier 2 was the shortest and stiffest pier in the structure, it probably attracted a large share of the horizontal seismic forces. The reinforcing details of the pier, shown in figure 4.10, indicate that the pier contained quantities of lateral reinforcement which would be considered inadequate by current standards. Thus it is likely that Pier 2 was damaged and collapsed, pulling the superstructure off the seat at Abutment 1<sup>2</sup>. It was reported that Pier 2 had completely disintegrated in the collapse. This observation is consistent with the conjecture that the pier was initially severely damaged in shear, and was then so badly weakened that it was crushed in compression. Following the collapse of Pier 2, a failure of the superstructure was initiated by excessive shear and negative bending moment at Pier 3. The superstructure sheared off on either side of Pier 3, leaving the pier standing nearly intact, as shown in figure 4.12. The span between Piers 3 and 4 then collapsed, pulling the superstructure off the hinge seat near Pier 4.

Figure 4.11. Overview of the collapse of the SR14/I5 Separation and Overhead, Ramp C, looking to the south at Abutment 1. Pier 3 can be seen at the right of the photograph (Photo courtesy of EERC).

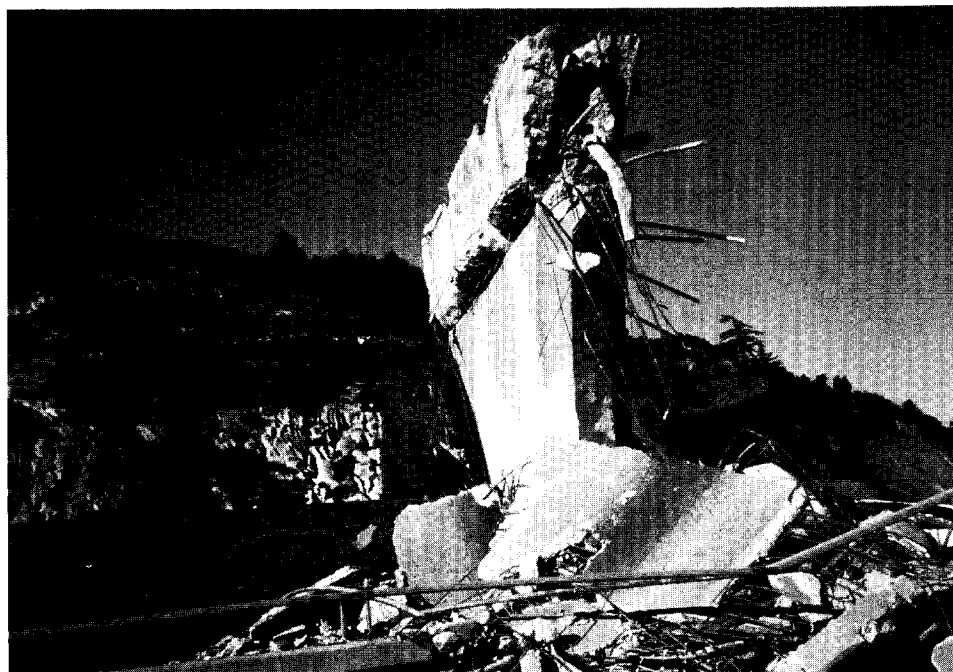
Figure 4.12. Damage at Pier 3 of the SR14/I5 Separation and Overhead, Ramp C, looking to the west (Photo courtesy of EERC).

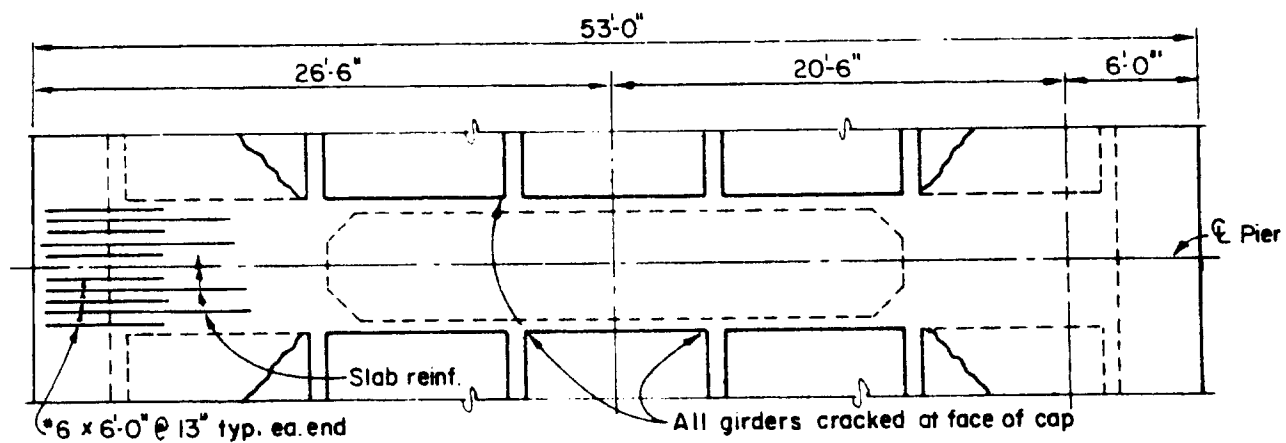
When the 1971 San Fernando earthquake occurred this ramp was under construction. Piers 2 and 3 had already been completed, and the bottom soffit and webs of the box girder between Abutment 1 and the hinge near Pier 4 had been cast and were resting on falsework. Settlement and shifting of the falsework resulted in damage to the parts of the ramp already constructed. After the San Fernando earthquake investigators noted cracking in the caps of Piers 2 and 3, consisting of cracks in the soffit slabs radiating 45 degrees from the pier corners, and vertical cracks in the box girder webs at the face of the pier cap, as shown in figure 4.13 [23]. It is not known how these cracks were treated in the repair work following the 1971 earthquake, or whether they were a contributing factor in the Northridge earthquake failure.

Figure 4.13. Cracking reported at Piers 2 and 3 following the 1971 San Fernando earthquake (reproduced from "The San Fernando Earthquake: Field Investigation of Bridge Damage," State of California, 1971).

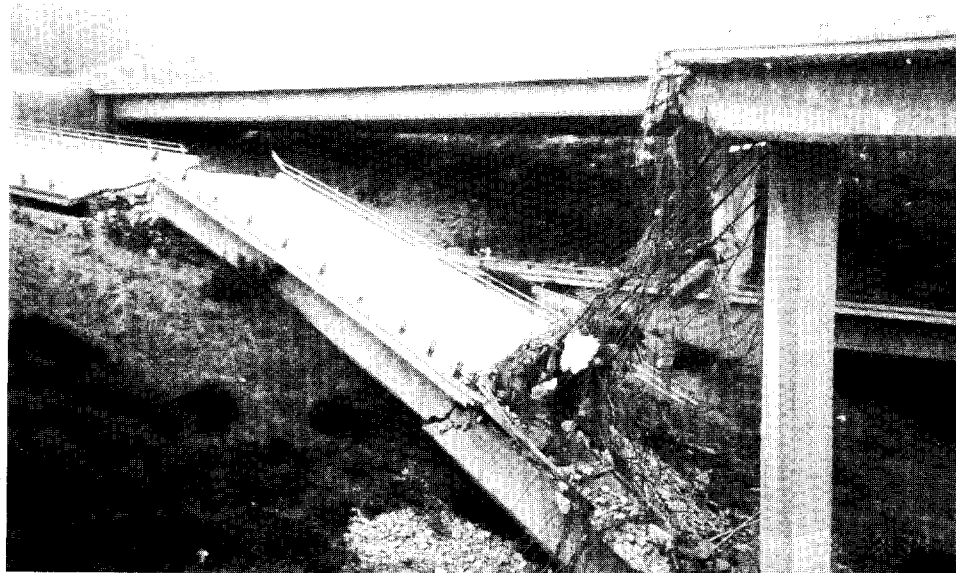
The collapse in the Northridge earthquake appears to have been initiated by the failure of Pier 2. After Pier 2 failed, the simply supported span between Abutment 1 and the hinge near Pier 2 collapsed, and, as shown in figure 4.15, the superstructure failed near Pier 3 due to a large negative moment. Pier 2 completely disintegrated, as shown in figure 4.16. This is the shortest pier in the structure, so it is likely that it attracted a high level of lateral force, was damaged in shear, and finally collapsed in compression. Pier 10 is similar in height to Pier 1, but the quantities of lateral reinforcement in Pier 10 are greater than those in Pier 1, as shown in figure 4.18. This is because Pier 2 had already been completed, but Pier 10 had not yet been constructed, when the 1971 earthquake occurred. Following the 1971 earthquake the plans for Pier 10 were revised to provide increased lateral reinforcement, as shown in figure 4.18.

Figure 4.14. Collapsed portion of the SR14/I5 North Connector Overcrossing, looking east. Pier 2 was at the left, near the broken hinge on the ground (Photo courtesy of EERC).

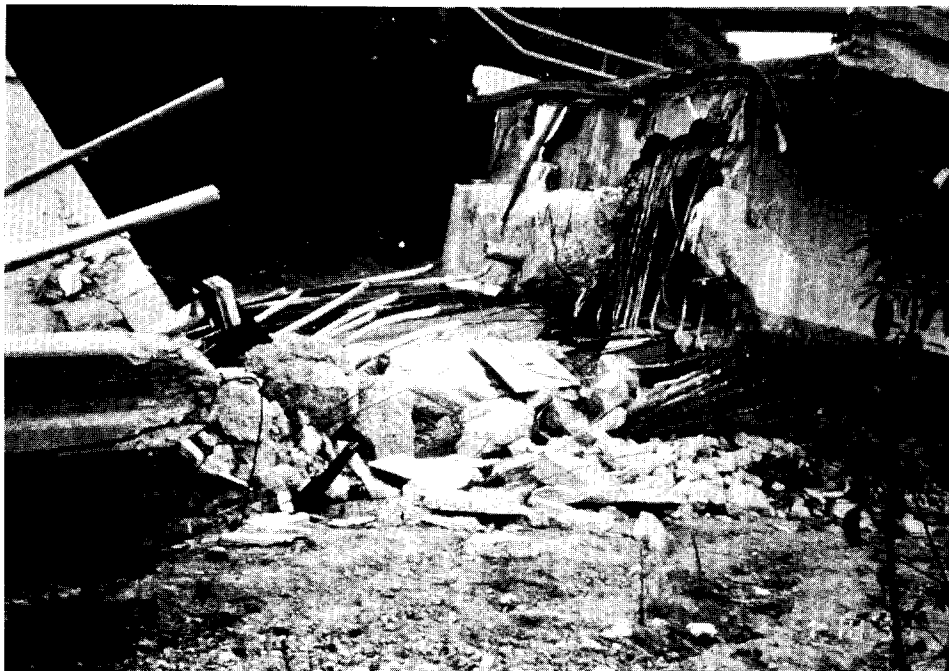
Figure 4.16. View of crushed Pier 2 and the hinge near Pier 2 (Photo courtesy EERC).

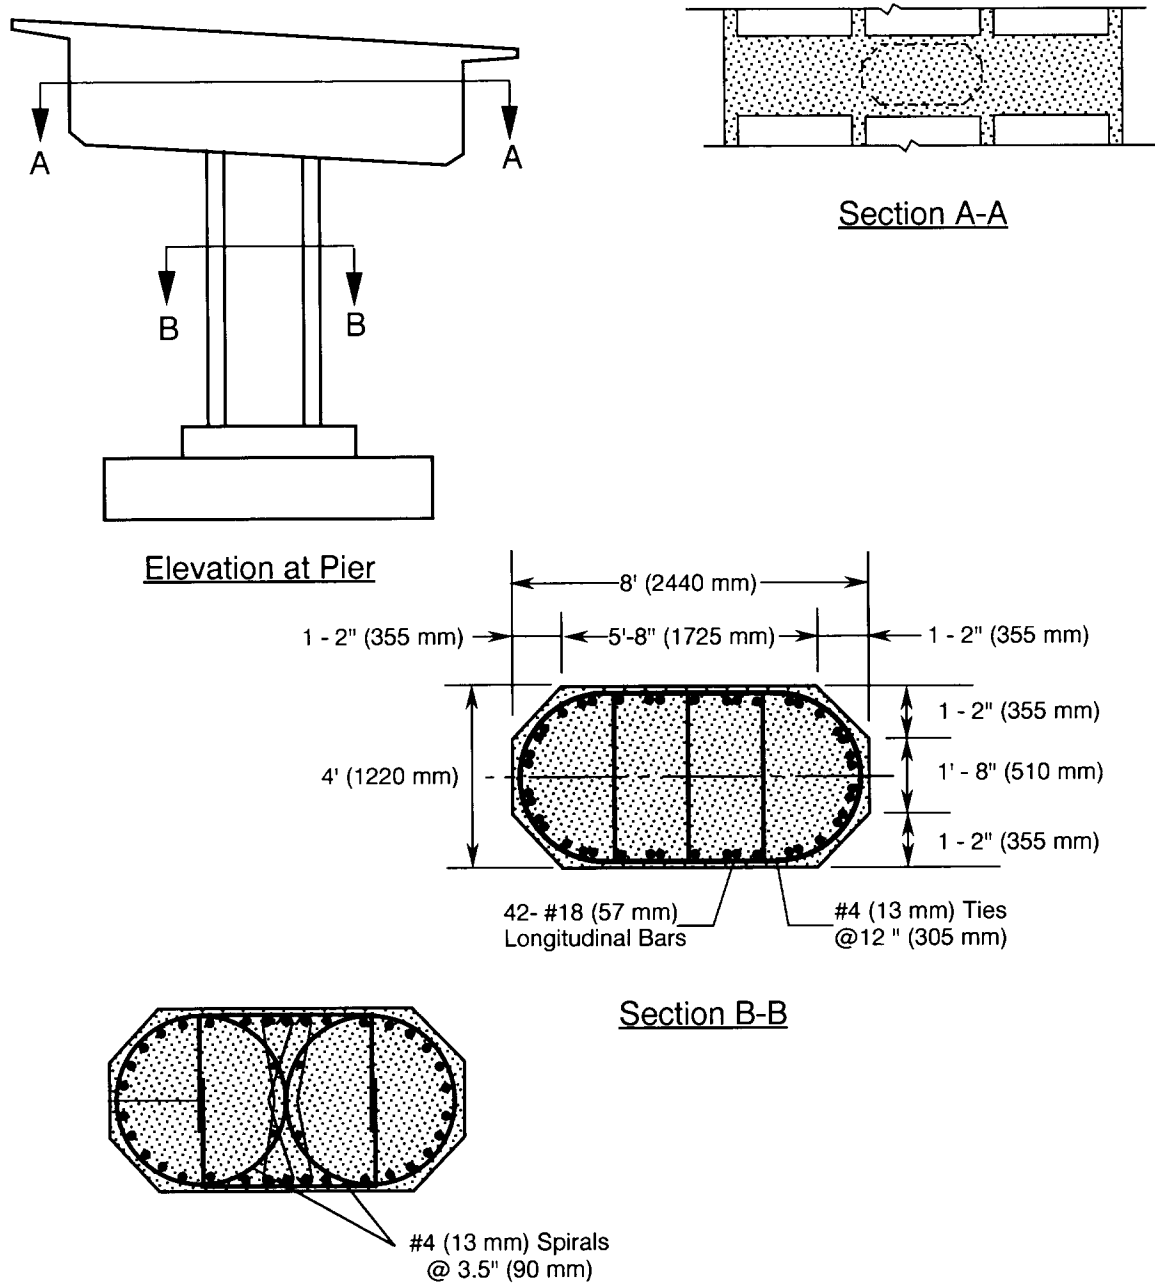
Figure 4.18. Reinforcement details for Pier 2 of the SR14/I5 North Connector Overcrossing, Ramp M.

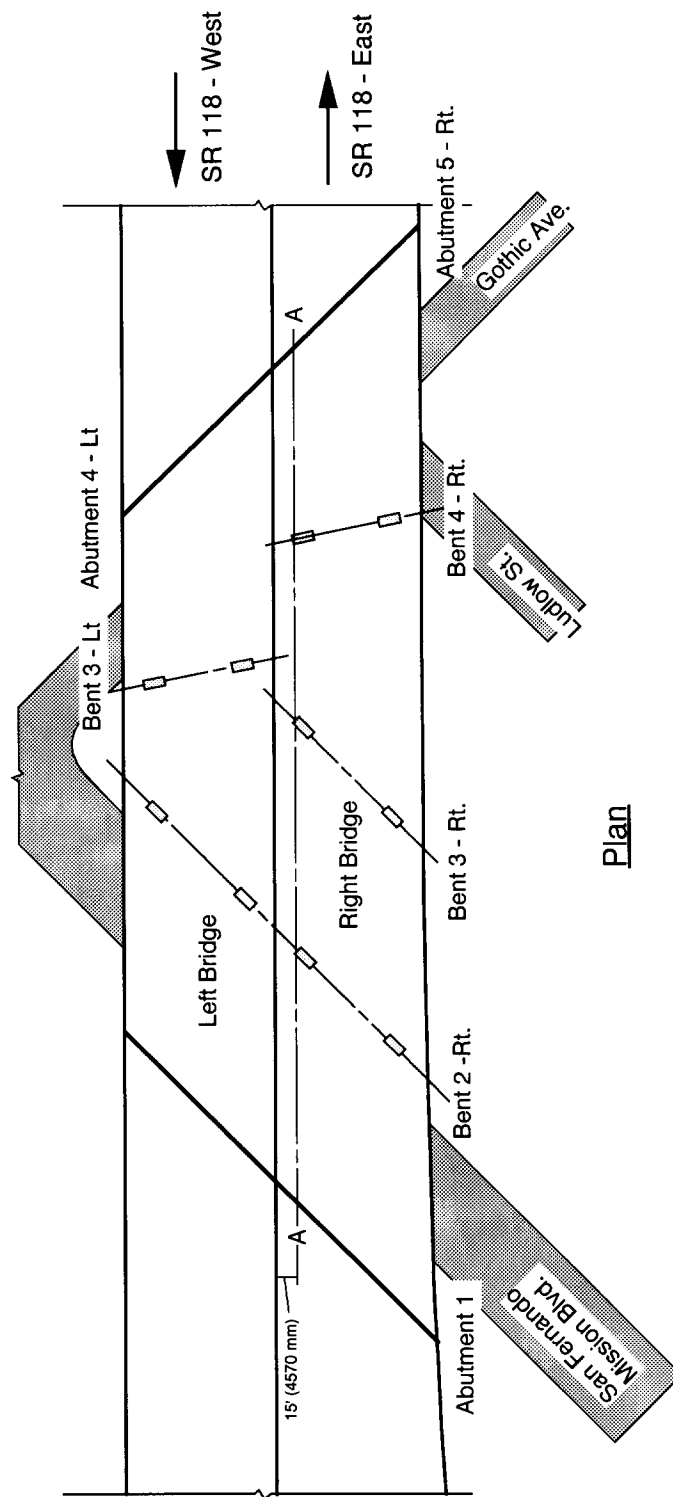
The first important feature of the bridge is its irregular geometry. Figure 4.23 shows that the plan shape of the bridge is a trapezoid. Thus, because of the orientations of the abutments, the structure was constrained to move in only one lateral direction during the earthquake, roughly to the southwest. Indeed, figures 4.21 and 4.22 show that the superstructure moved in this direction, creating a diagonal shear failures in many of the piers. There is also a highly irregular placement of piers, dictated in part by the trapezoidal plan shape of the bridge, and in part by right-of-way restrictions. The irregular plan shape and placement of piers created asymmetric stiffness and mass distributions, which undoubtedly lead to some piers being more heavily loaded than others during the earthquake. Detailed analyses will be required to determine how lateral earthquake loads were distributed among the piers.

Figure 4.23. Plan and elevation views of the SR118 Mission-Gothic Undercrossing.

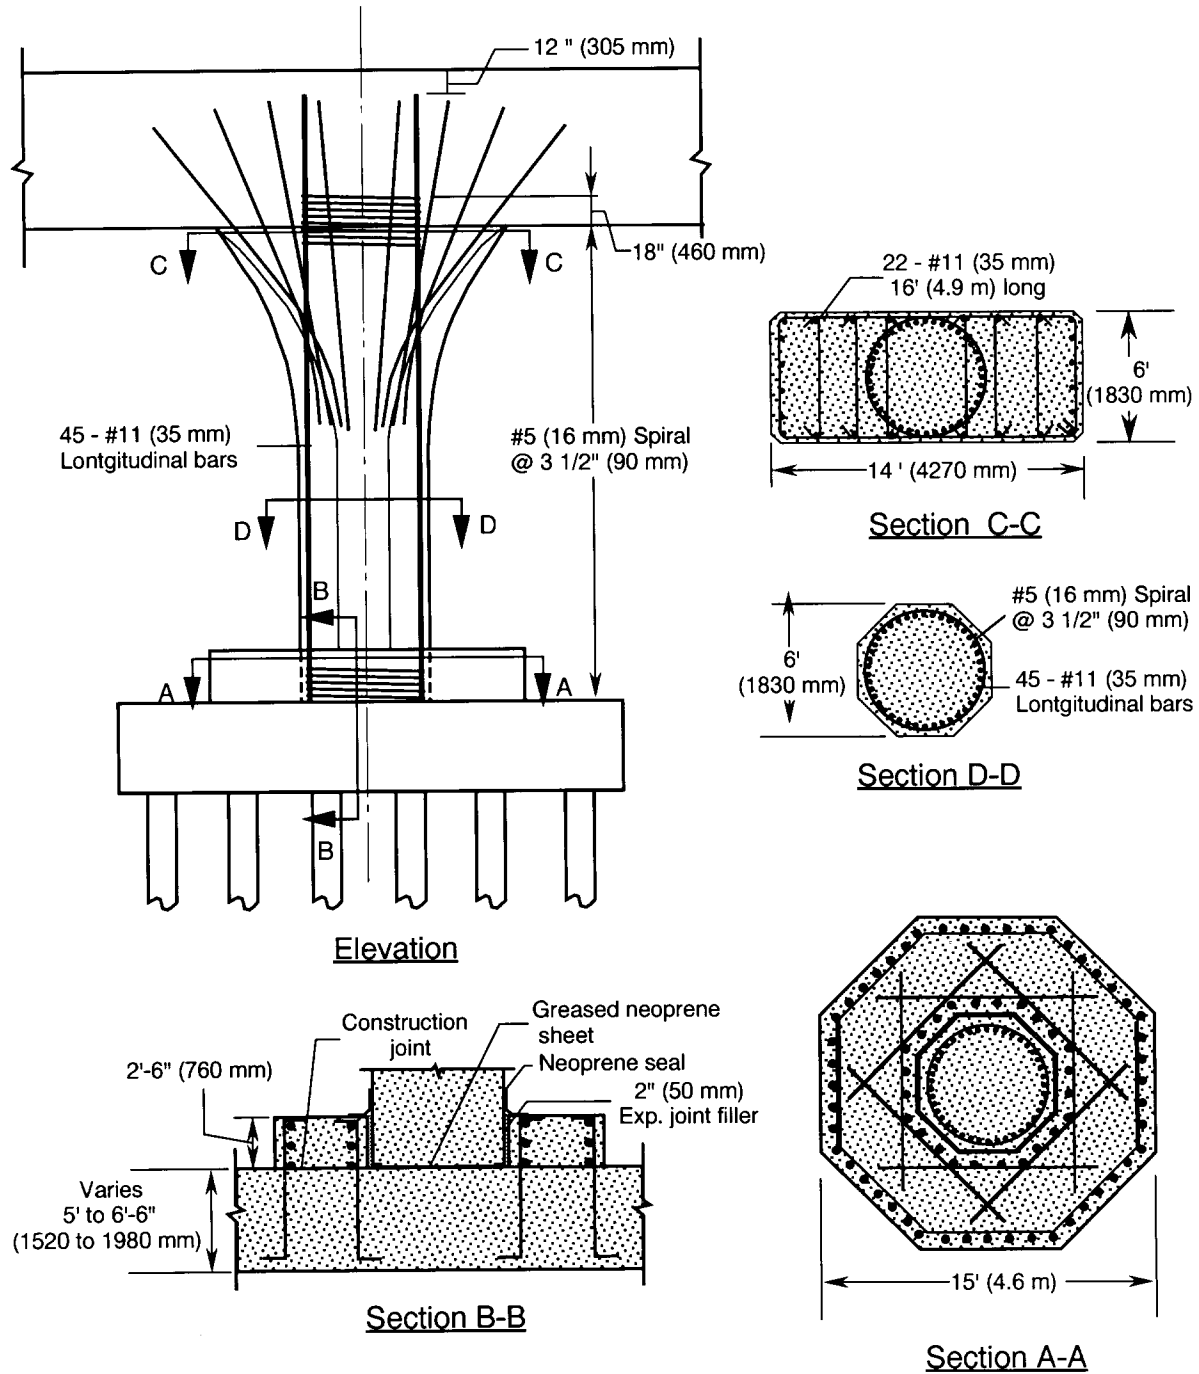
The second, and perhaps more important, feature of this bridge is the geometry of the bridge piers. Pier details are shown in figure 4.24. The piers were all relatively short, roughly 7200 mm (24 ft) tall by 1800 mm (6 ft) across, making an aspect ratio of only 4:1. However the piers also featured architectural flares at the tops, roughly 3600 mm (12 ft) tall. These flares were intended to be non-structural features of the piers. It was believed that the flares would spall or otherwise deteriorate during earthquake loading so that they would not contribute to the bending stiffness of the piers. However, it is clear that in actual performance the flares created a zone of added stiffness, reducing the aspect ratio of the piers to approximately 3:1. Thus the piers were very stiff laterally, and were dominated by shear rather than bending. The detail at the footing/pier interface was also somewhat unusual for this bridge. Figure 4.24, section B-B, shows that the base of the pier rested inside a collar at the top of the pier footing. This detail was intended to permit free translation of the pier base during post-tensioning operations of the superstructure, before the collar was cast. The detail also had the effect of creating a hinge at the pier base. It is not immediately apparent whether this hinge improved or worsened the seismic performance of the bridge, although for a given lateral force the bending moments at the tops of the piers were greater than if the hinges at the bases of the piers had not been present.

The likely failure mode of the bridge was that the piers initially suffered severe shear damage, followed by crushing of a number of piers in compression. The structure may also have shifted to the southwest, as constrained by the geometry of the abutments. Although unseating at Abutment 5 did occur, this was probably a secondary effect, as the seat lengths were generous by current standards. Rather, failure was probably initiated by damage to the piers. In this case the failure of piers has important theoretical implications, as the piers of this bridge contained quantities of lateral reinforcement similar to those required by current seismic design standards. Therefore, further research will be required to determine why the pier reinforcement was inadequate in this case.

Figure 4.24. Pier details for the SR118 Mission-Gothic Undercrossing.

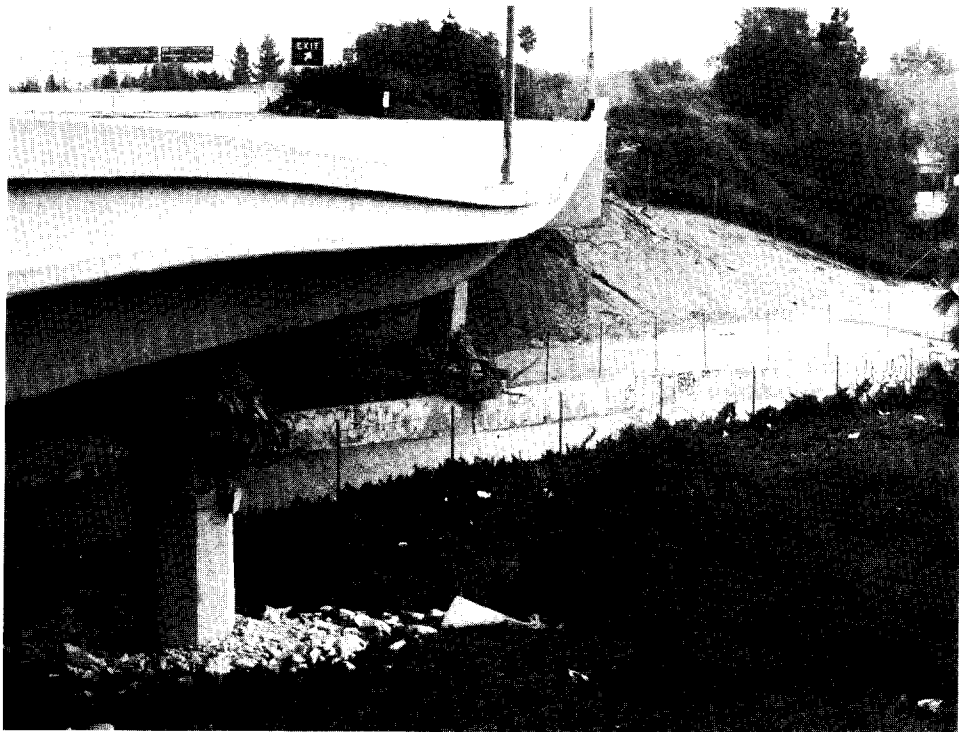
All ten of the piers in Bent 3 failed in combined shear and compression near their bases, as shown by figures 4.27 and 4.28. In Bent 2, Piers on the south side of the span failed near their top end, as shown in the left foreground of figure 4.26, and the damage became progressively less for piers to the north in Bent 2. The farthest north piers in Bent 2 showed relatively little damage - only diagonal shear cracks near the base, with no spalled concrete. This uneven distribution of damage to piers was probably caused by the asymmetric plan geometry of the bridge, as shown in figure 4.29.

Figure 4.26. Ground-level view of State Route 118 at Bull Creek Canyon Channel, looking along the south edge, towards the east.

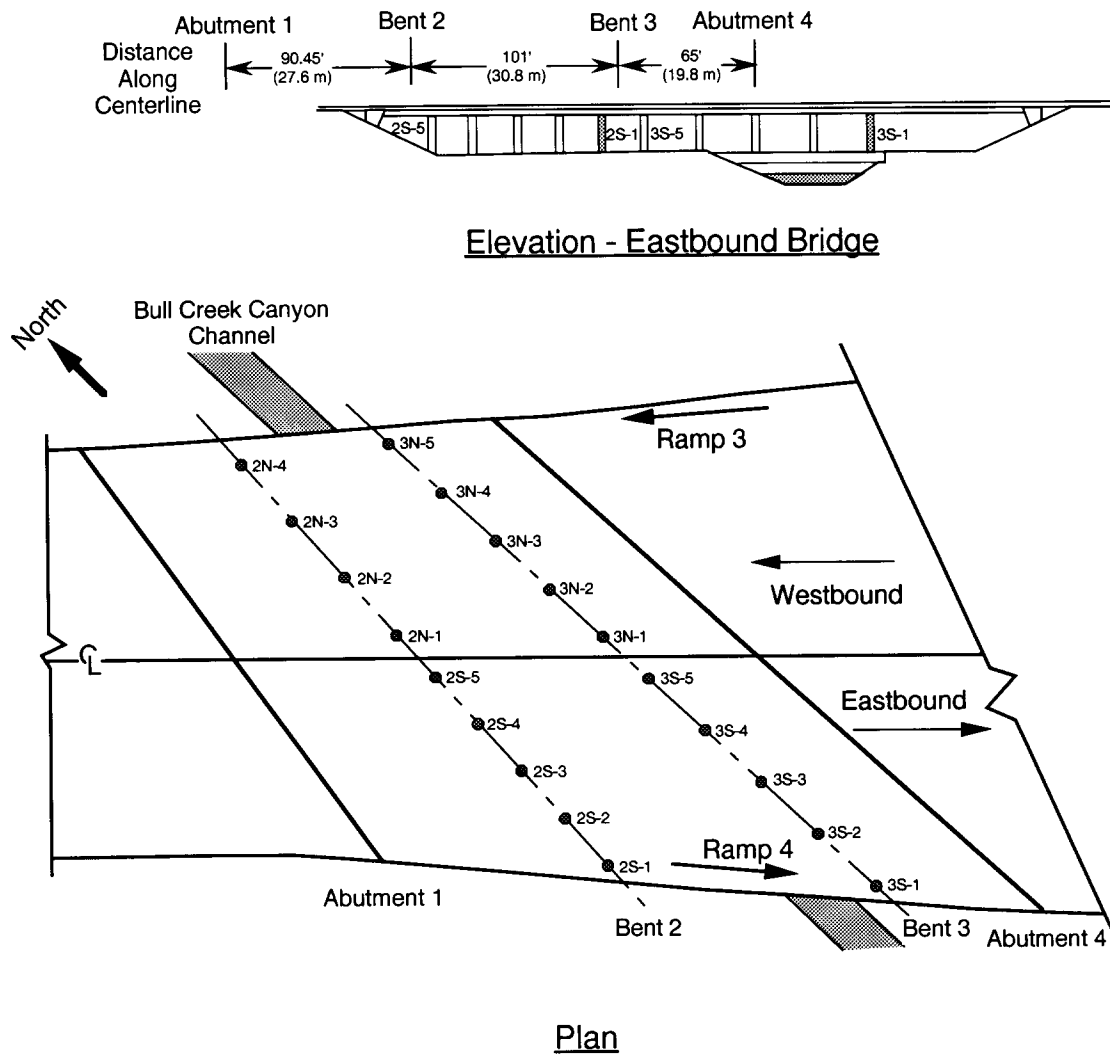
Figure 4.29. Plan and elevation views of State Route 118 at Bull Creek Canyon Channel.

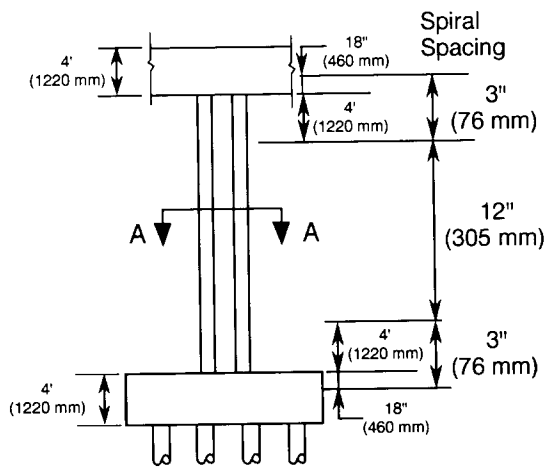
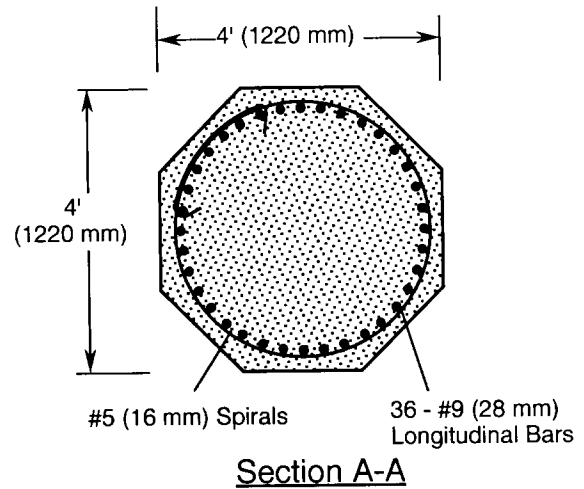
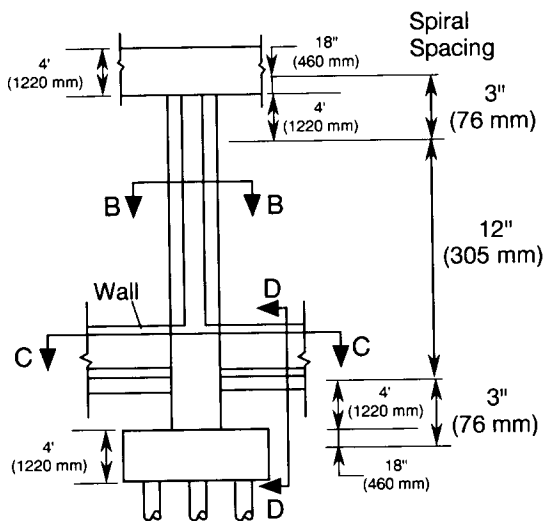
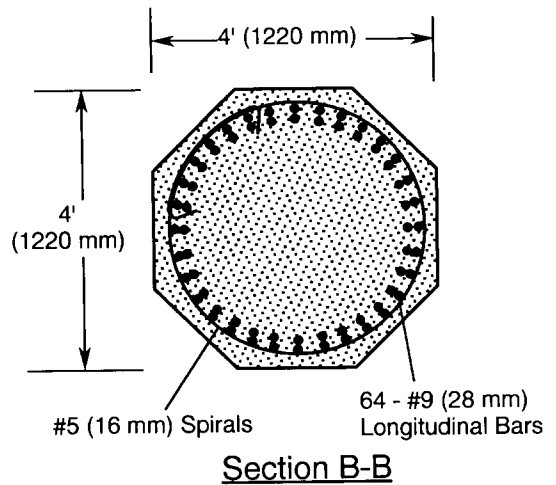
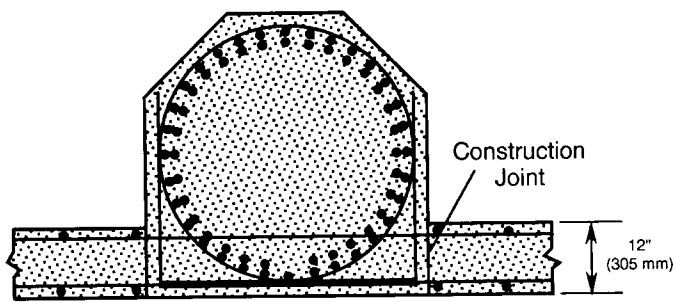
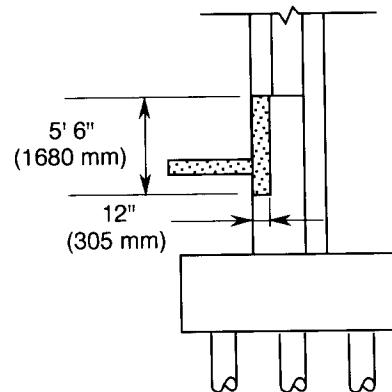
The confining reinforcement in the piers, shown in figure 4.30, is inadequate by current standards. Spiral confining hoops were spaced at 76 mm (3 in) near the top and bottom of each pier (presumably to provide confinement in potential plastic hinge regions), but the spacing was 305 mm (12 in) over most of the pier height. All pier failures occurred in the zone of wide spiral spacing. Another factor contributing to pier failure was that the effective lengths of the piers were much shorter than the distance between the footings and the girder soffit. The lengths of piers varied between roughly 6000 and 9100 mm (20 and 30 ft). In Bent 2, the effective pier lengths were decreased roughly one-third by compacted backfill soil above the pier footings. In Bent 3, the pier lengths were also decreased roughly one-third, but by a reinforced concrete channel liner wall, which was cast abutting the piers (fig. 4.30, section C-C). The shortened effective pier length resulted in stiffer piers, which were more susceptible to shear-dominated failure than bending-dominated failure.

Figure 4.30. Pier details for State Route 118 at Bull Creek Canyon Channel.
