# **1994 Northridge Earthquake Performance of Structures, Lifelines, and Fire Protection Systems**

Diana Todd  
Nicholas Carino  
Riley M. Chung  
H. S. Lew  
Andrew W. Taylor  
William D. Walton  
James D. Cooper  
Roland Nimis

Building and Fire Research Laboratory  
National Institute of Standards and Technology  
Gaithersburg, MD 20899-0001

May 1994

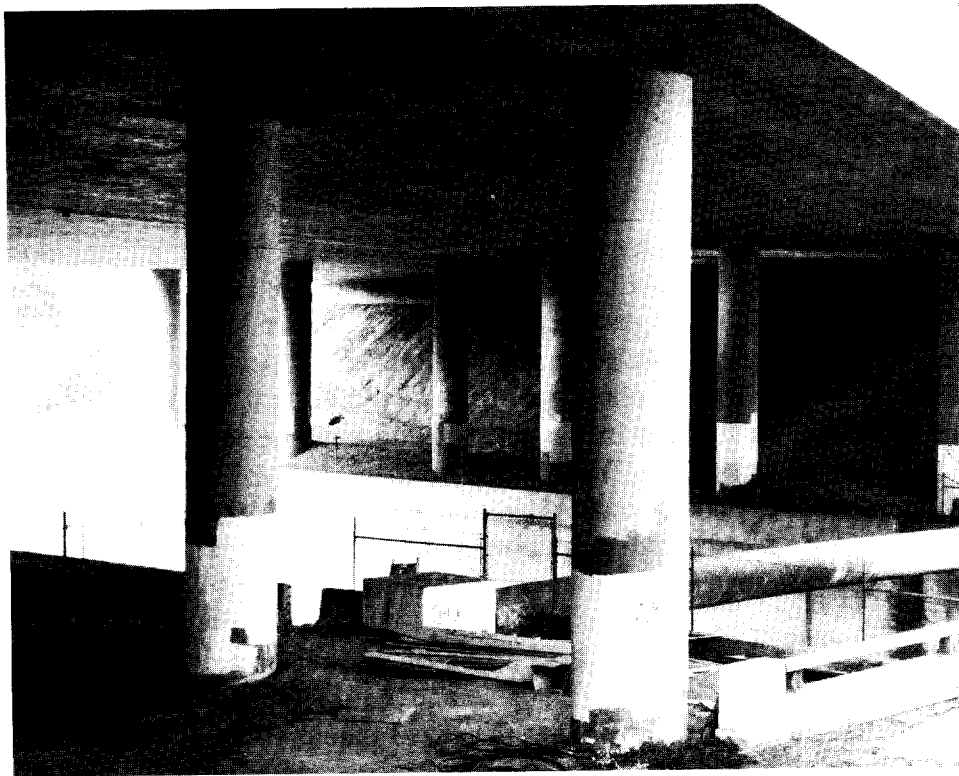
Between the two bridges which collapsed, I10 passes over Ballona Creek. Figure 4.33 is a view looking toward the southwest of the spans over the creek. There was essentially no damage to the supporting piers. Adjacent to the bridge over Ballona Creek, there is a westbound ramp which exits from I10 to Cadillac Ave. A portion of this ramp is supported by single piers which have been retrofitted with steel jackets, as shown in figure 4.34. No damage was noted to these retrofitted piers. The Cadillac Ave. ramp represents the only case known to the authors where undamaged retrofitted piers were located close to major collapse sites. However, because the retrofitted Cadillac Ave. ramp piers were immediately adjacent to an older, non-retrofitted multispan bridge which was undamaged (the Ballona Creek overpass), it is not known whether the Cadillac Ave. ramp piers were subjected to the same levels of lateral forces as piers at the two collapse sites at La Cienega-Venice and Fairfax-Washington.

Figure 4.33. I10 Bridge over Ballona Creek, looking to the southwest.

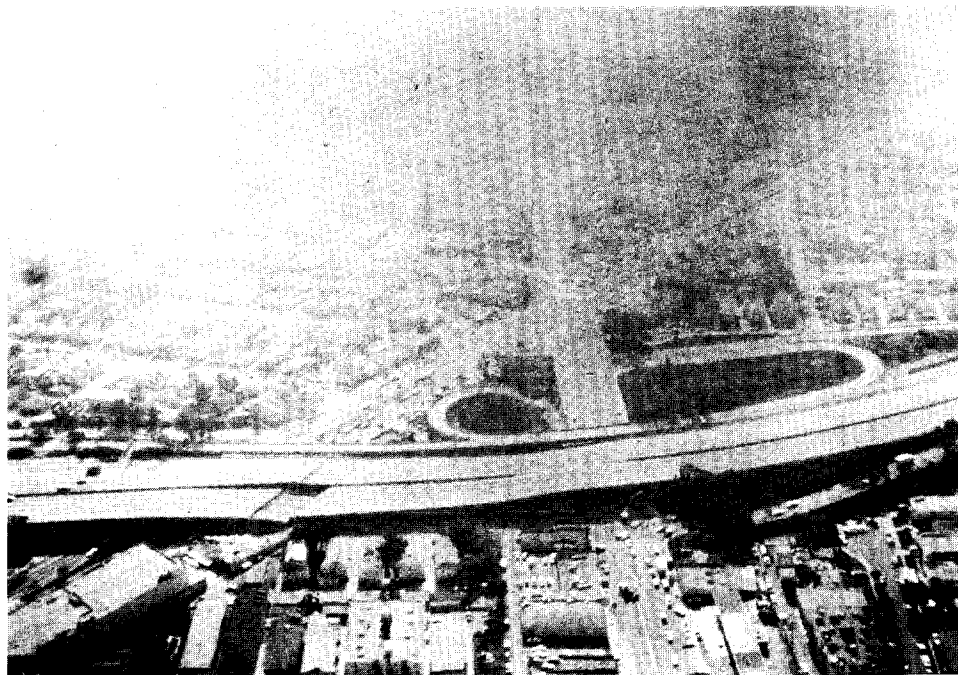
Figure 4.35 is an aerial view of I10 where it passes over La Cienega Blvd. and Venice Blvd. The view is toward the south, and Venice Blvd. is the diagonal street on the left side of the photograph. The portion of the westbound lane which collapsed to ground level can be seen. However, there was extensive damage to most of the supporting piers of the eastbound and westbound lanes.

Figure 4.35. Aerial view (looking south) of I10 Separation at La Cienega Blvd. and Venice Blvd., (Photo courtesy of FHWA).

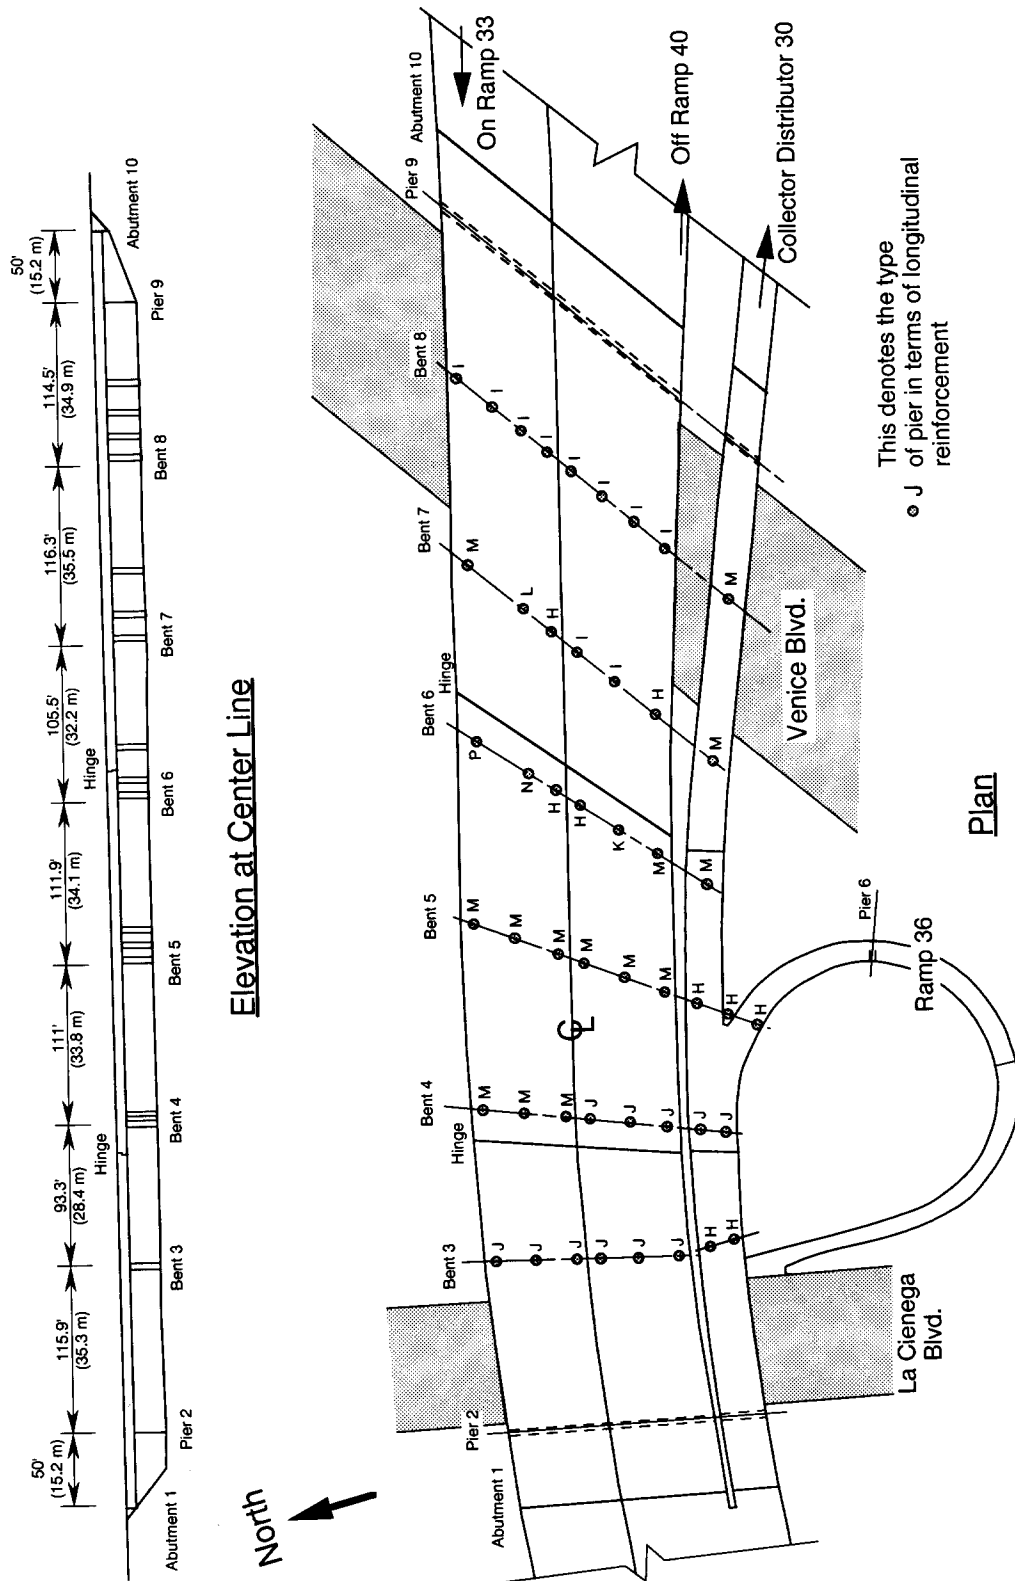
Figure 4.36 shows elevation and plan views of the nine-span bridge structure. Solid wall piers provided support adjacent to the abutments, and the remainder of the supports were multiple-pier bents. Two expansion joints (hinges) were provided as shown. Bents 3 to 7 included three supporting piers for each lane, while Bent 8 had four piers per lane. The exit ramp to La Cienega Blvd. and the eastbound collector-distributor did not collapse. Figure 4.37 shows the pier details. The piers had circular cross sections with a diameter of 1220 mm (4 ft), and the longitudinal reinforcement consisted of #11 (35 mm) or #18 (57 mm) deformed bars. The different pier reinforcement configurations were identified by pier "types" as shown in figure 4.37. These pier types are indicated in the plan shown in figure 4.36. The lateral reinforcement consisted of #4 bars (13 mm) at 305 mm (12 in) vertical spacing.

Figure 4.36. Elevation and plan of I10 Separation at La Cienega Blvd. and Venice Blvd.

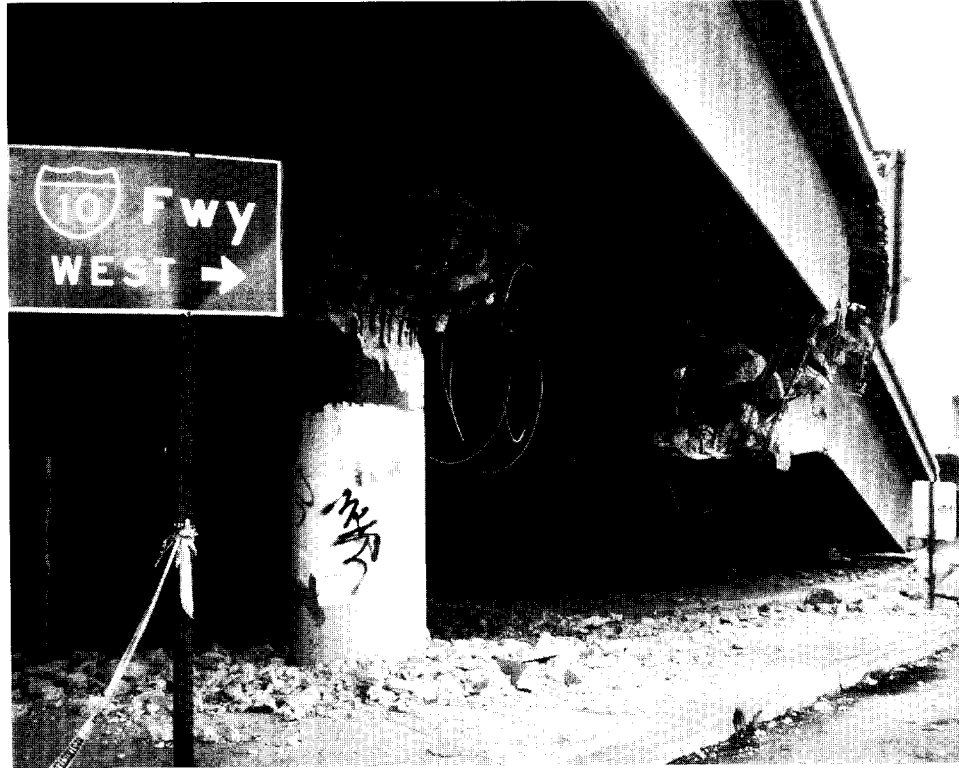
Figure 4.38 is a ground-level view of the portion of the westbound lane that collapsed to the ground at the hinge located between Bents 7 and 6. The pier in the foreground is the northernmost pier of Bent 7. It is seen that there was extensive column shortening due to the failure of the lateral reinforcement to provide adequate confinement of the core concrete. Fractured lateral reinforcement can be seen to the right of the failed portion of the pier. Figure 4.39 shows the other two piers of Bent 7 which supported the westbound lane. Extensive failure and column shortening is evident. The concrete block wall behind the piers is part of a storage building that was constructed beneath the bridge structure. The storage building extended from

Figure 4.38. Collapsed westbound lane of I10 at Venice Blvd.; pier of Bent 7 in foreground.

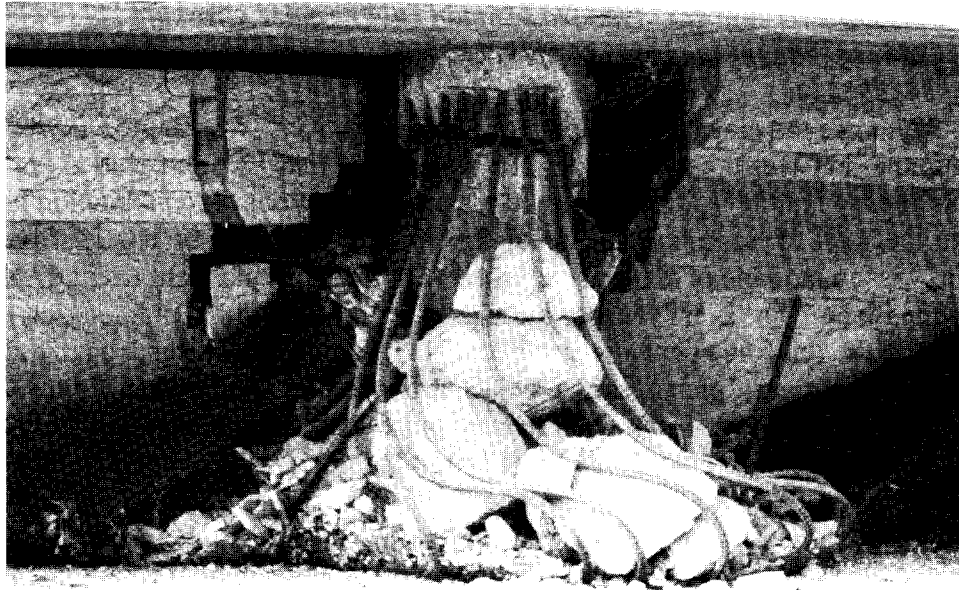
Figure 4.40 shows the northernmost pier of Bent 6, located just to the west of the hinge. This pier totally disintegrated, but the storage building prevented the roadway from collapsing to the ground. Figure 4.41 shows the southernmost pier supporting the eastbound lane at Bent 3. The top of the pier is severely damaged and it is likely that the storage building prevented the total collapse of the roadway.

Figure 4.40. Northernmost pier of Bent 6 supporting westbound lane of I10 (west of Venice Blvd.).

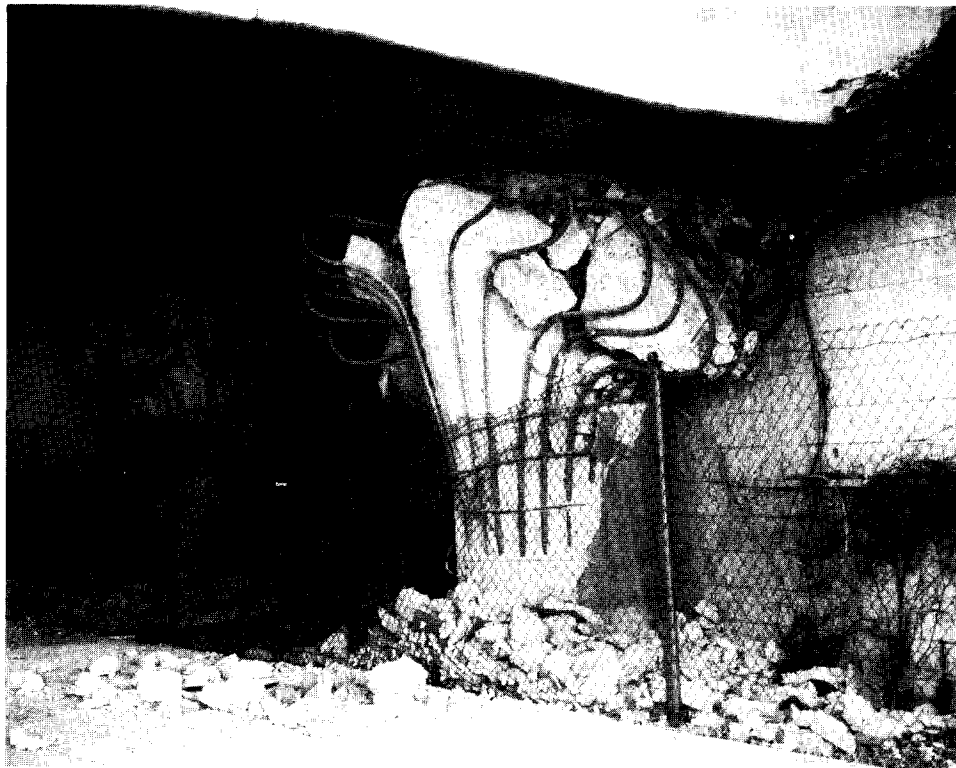
Figure 4.41. Piers of Bent 3 supporting eastbound lane of I10 at La Cienega Blvd.

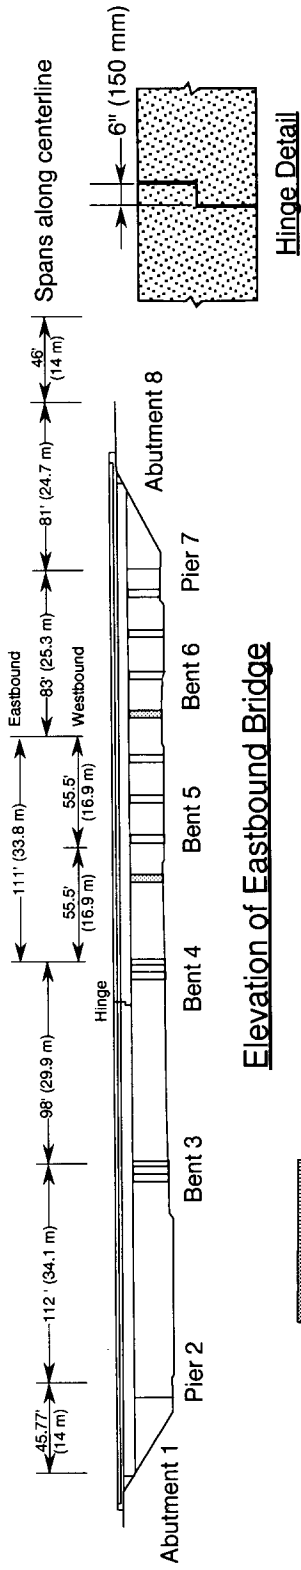
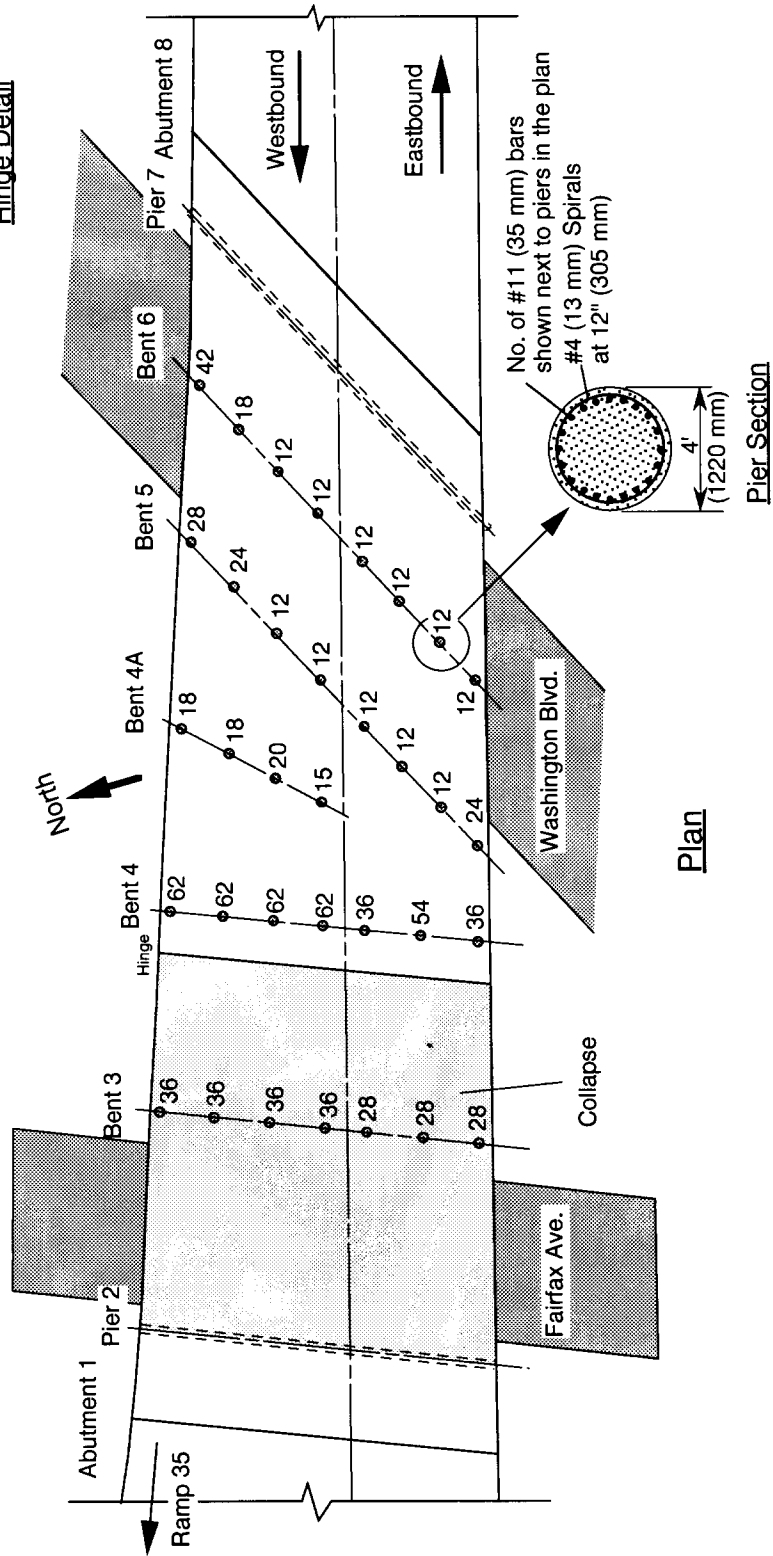
The earthquake caused partial collapse of two spans of the eastbound and westbound lanes on either side of Bent 3 (fig. 4.42). When the reconnaissance team arrived at the site, the collapsed spans had been completely removed and workmen were preparing to open up traffic on Fairfax Ave. Hence it was not possible to examine the collapsed structure. Conversations with Caltrans engineers at the site revealed that the piers in Bent 3 had failed and caused the girders to sag at this location. However, cable restrainers at the hinge west of Bent 4 prevented the girders from falling off of the hinge seats (fig. 4.43). Figure 4.44 is a photograph provided by EERC which shows the westbound lane of I10 over Fairfax Ave. It can be seen that the piers in Bent 3 shortened and caused the girder to sag. It can also be seen that the span to the west of Pier 2 lifted off of the abutment. Figure 4.45 is a close up view of one of the piers in Bent 3. The failure mode is similar to that observed at Venice Blvd. and La Cienega Blvd. When the piers were subjected to lateral ground motions, the lateral reinforcement was not able to adequately confine the core concrete. As a result of lateral load damage, there was a loss of axial load capacity and the piers shortened under the action of the vertical loads. As mentioned, the piers at Bent 4 had considerably more longitudinal reinforcement than the other piers. Examination of the piers in Bent 4 revealed varying degrees of diagonal cracking and spalling of the concrete cover. At the time of the site visit, these piers were surrounded with wooden shoring as a precautionary measure during the demolition of the collapsed spans.

Figure 4.42. Elevation and plan of I10 at the Fairfax Ave./Washington Blvd. Undercrossing.

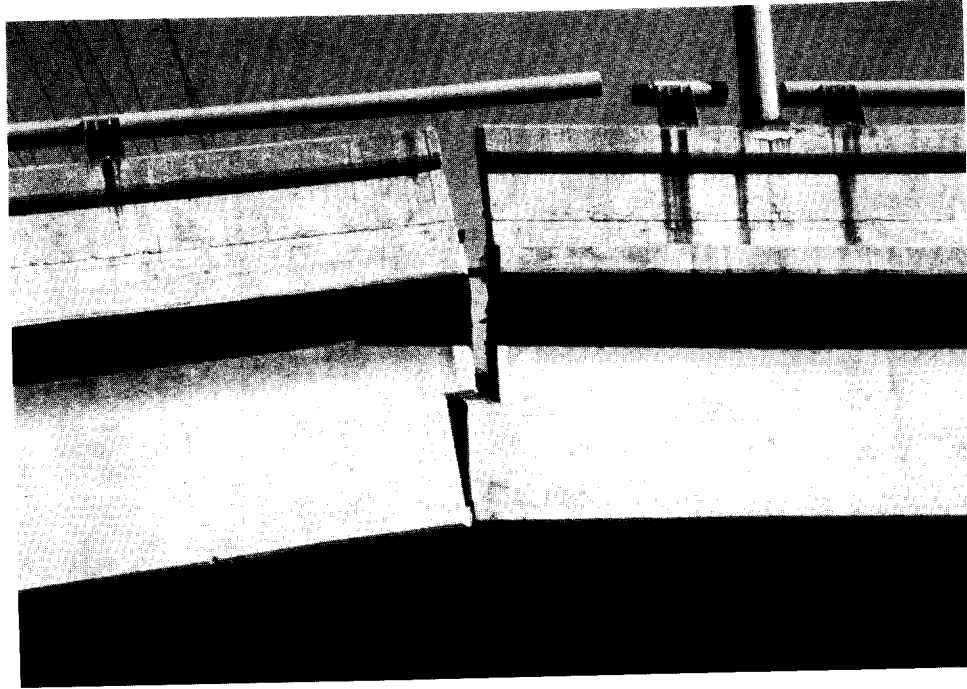
Figure 4.43. Hinge adjacent to Bent 4 of I 10 at Fairfax Ave.; cable restrainers prevented loss of support (Photo courtesy of EERC).

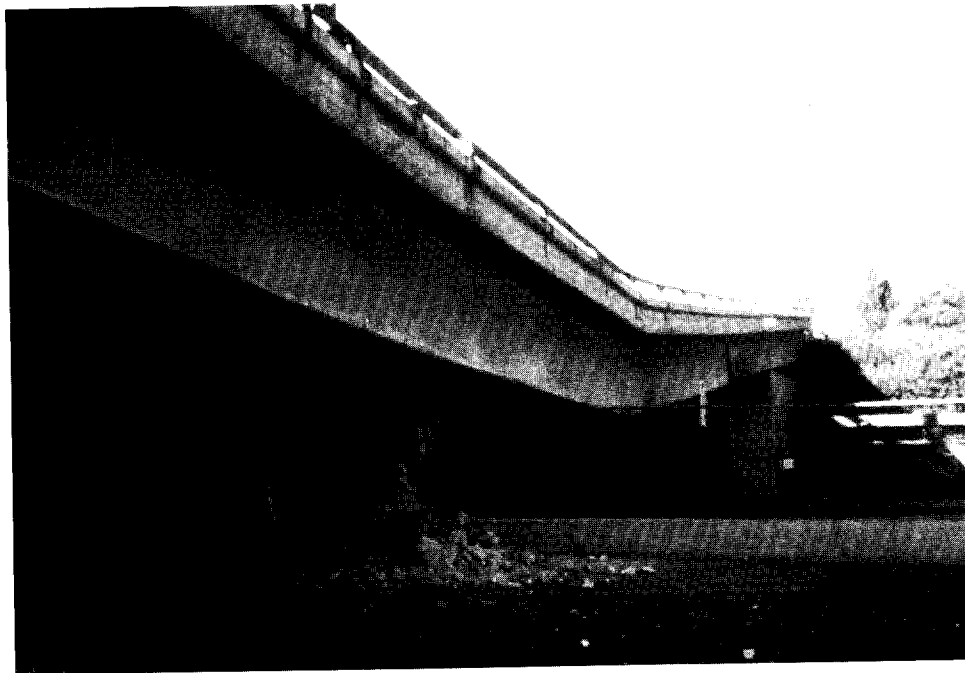
Figure 4.44. View of collapsed span of I10 over Fairfax Ave.; note rotation of girder over Pier 2 (Photo courtesy of EERC).

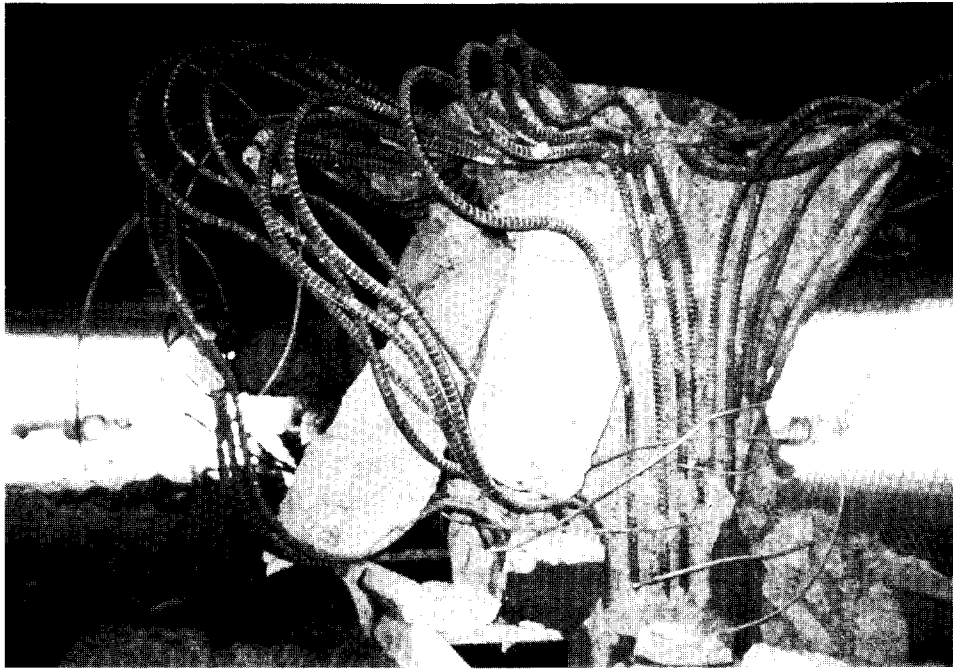
Figure 4.45. Failed column in Bent 3 of I10 at Fairfax Ave. (Photo courtesy of EERC).

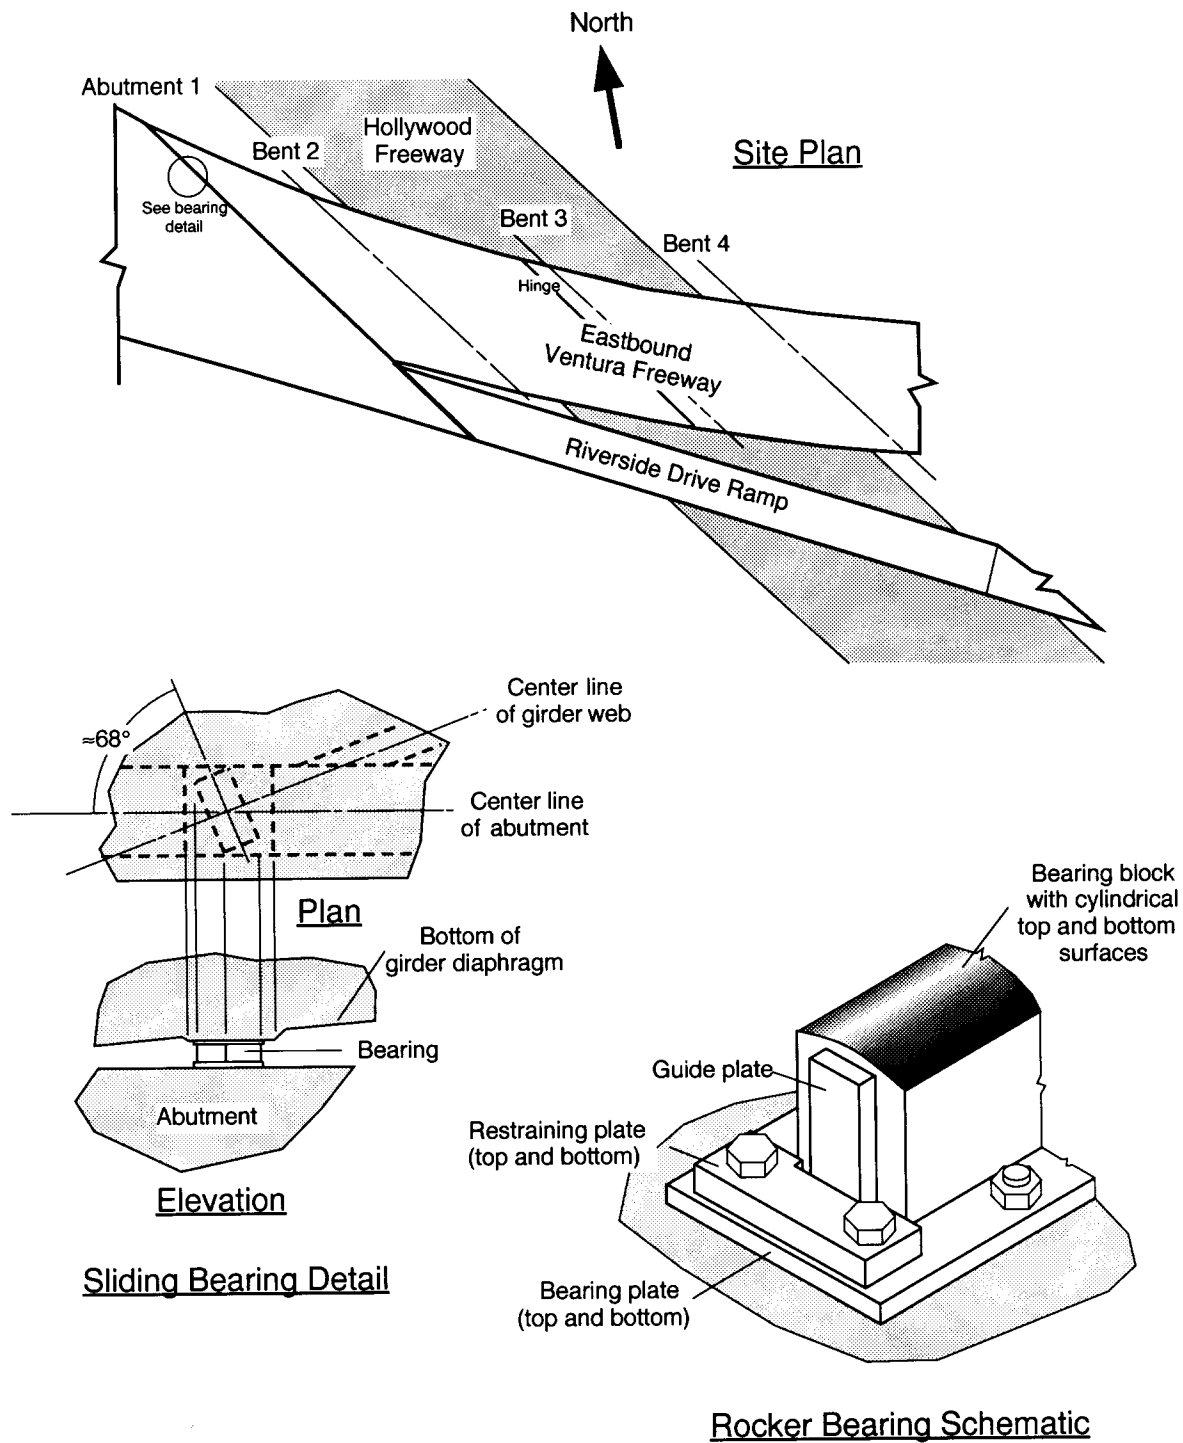
Figure 4.46 shows a simplified plan of the eastbound lane of the Ventura Freeway and the Riverside Drive ramp. Figure 4.47 is a ground level view of the eastbound lane as seen from the northbound lane of the Hollywood Freeway. At Abutment 1 (fig. 4.46), bearing supports are provided at the locations of the webs in the box girder. As shown in figure 4.46, the longitudinal axes of the bearings are aligned at right angles to the longitudinal axes of the girder webs. The four bearings on the north side of the eastbound lane of Ventura Freeway are of the sliding-type. Figure 4.48 shows the type of damage that was observed at these locations. Apparently, the dynamic frictional resistance of the bearing resulted in forces sufficient to spall off the shell of the abutment. The remainder of the bearings supporting the eastbound lane and the Riverside Drive ramp are of the rocker type. Figure 4.46 shows a schematic of this type of bearing. A steel bearing block with cylindrical surfaces is located between steel plates set into the abutment and girder end diaphragm. The blocks are kept in position with a system of guide plates and restraining plates as shown in figure 4.46. All of the rocker bearings showed some type of earthquake damage. The bolts for the restraining plates were sheared off at many locations, and the sheared bolt heads were found at distances of up to several meters from their original position. Some of the bearing blocks were skewed from their original positions (fig. 4.49). In one case, the bearing block had tipped over resulting in a complete loss of support at that location (fig. 4.50).

Figure 4.46. Eastbound lane of Ventura Freeway crossing over Hollywood Freeway; site plan and bearing details.

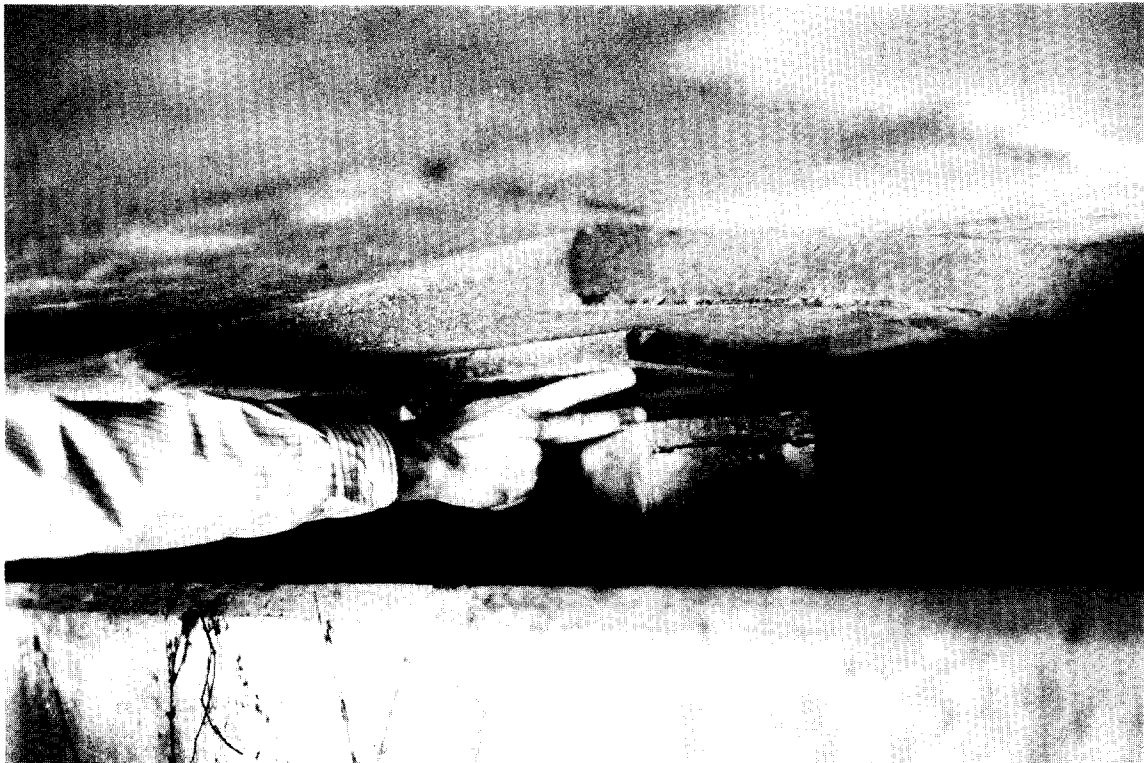
These observations highlight the unsuitability of rocker-type bearings to withstand the effects of seismic deformations. Because of redundancy, the failure of one bearing may not result in serious damage to the supported girder. However, multiple bearing failures could drastically alter the forces in the girder, and these forces could exceed the girder capacity.

Figure 4.50. Bearing block tipped over at this location resulting in loss of support to girder.

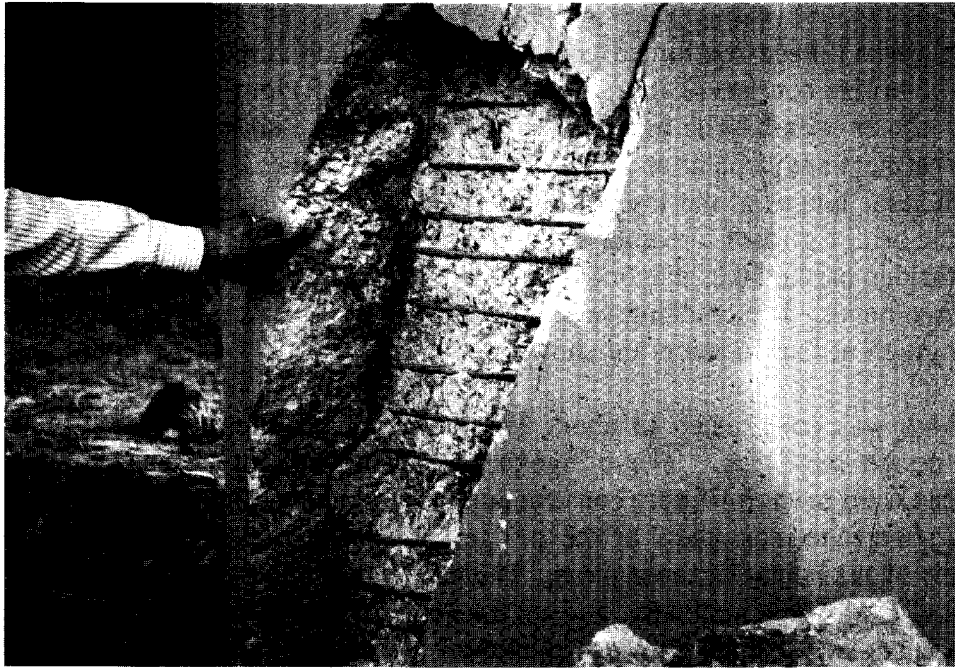
This is a long, curved ramp structure with piers of varying height. The last pier before the west abutment, adjacent to Sharp Avenue, exhibited severe shear cracking. This was one of the shortest and stiffest piers in the structure, so it probably attracted large lateral forces. Damage to the pier is shown in figures 4.51 and 4.52. Note that when the photos in figures 4.51 and 4.52 were taken the loose cover concrete had been removed by Caltrans workers to inspect damage to the core. It appeared that cracks extended into the core of the pier. The pier is octagonal in cross section, measuring 2440 mm (8 ft) across, and has a flared section at the top. Longitudinal reinforcement consists of 64 #11 (36 mm) bars (EERC 1994). This pier contains high levels of shear reinforcement: #4 (13 mm) spirals spaced at 89 mm (3.5 in). Damage to the abutment just to the west of this pier was also observed. This damage was apparently due to pounding between the superstructure and the abutment.

Figure 4.52. Close-up view of the westernmost pier at the Interstate 5, State Route 118, Southwest Connector, looking to the southeast. Loose cover concrete has been removed by Caltrans.

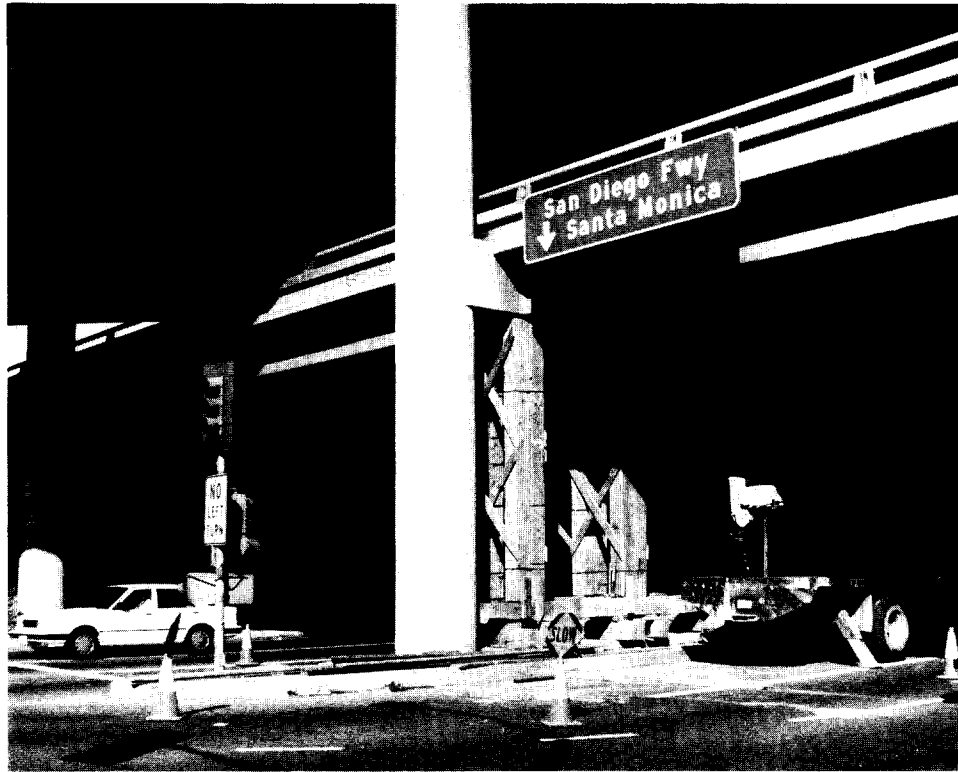
The damage observed in the Northridge earthquake possibly arose from three factors. First, the joint regions where cracking occurred are not as heavily reinforced as they would be under current design standards. Second, the structural hinges at the bases of most outrigger piers tended to increase the moments imposed on the outrigger joints. Third, the Jefferson Blvd. Undercrossing shares piers with the SR90 ramp above, as shown schematically in figure 4.55. The upper SR90 structure is more flexible than the lower Jefferson Blvd. Undercrossing, possibly resulting in further concentrations of moments at the outrigger joints.

Figure 4.53. Overview of the outrigger joint at the SR90/I405 interchange, Jefferson Boulevard Undercrossing, center bent, west side, looking to the north.

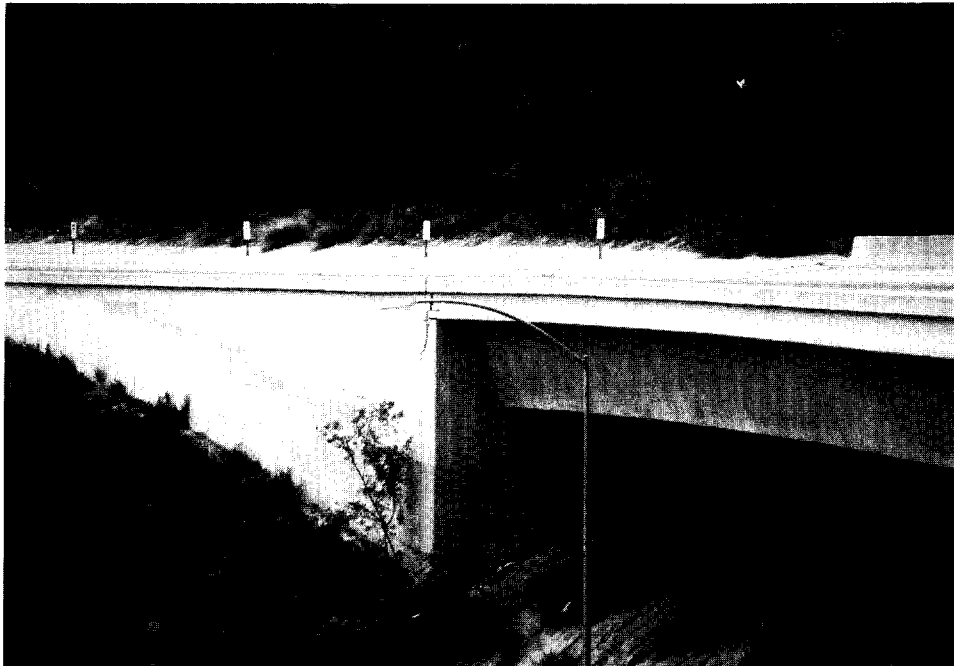
In the Northridge earthquake, bridge abutment damage ranged from minor settlement of backfill soil at the approaches, to cracking of wing walls, to permanent displacement of the entire abutment. For example, at the intersection of State Route 118 and Interstate 210, there was damage to the abutment at the east end of the long elevated structure connecting eastbound SR118 with northbound I210. An overview of the abutment is shown in figure 4.56, and a close-up of some of the abutment sidewall cracking is shown in figure 4.57. At the interchange of US101, SR134 and SR170, at the Riverside Drive Offramp Overcrossing (Caltrans bridge No. 53-1493S, described above) the abutments at both ends of the offramp exhibited severe cracking in the wing walls. Damage to concrete abutment piles was reported [5] at the Las Virgenes Overcrossing on US101 (Caltrans bridge No. 53-1442). There were many other cases of bridge abutment damage observed by the reconnaissance team, and reported by other investigators, which are too numerous to list here.

Figure 4.56. Overview of abutment at the east end of the ramp connecting eastbound SR118 with northbound I210.

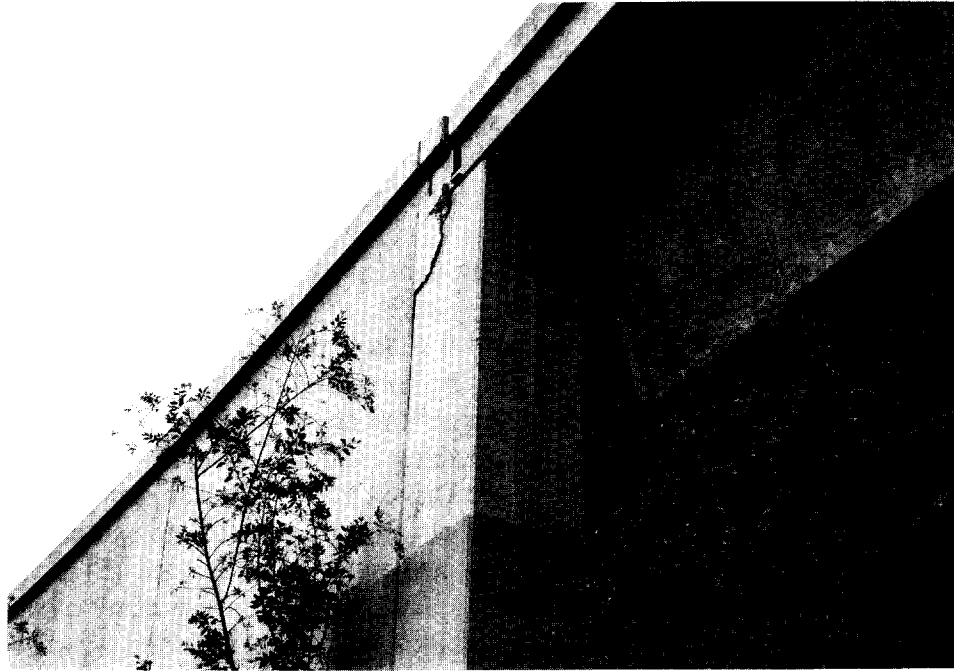
Figure 4.57. Close-up of abutment wall cracking at the east end of the ramp connecting eastbound SR118 with northbound I210.

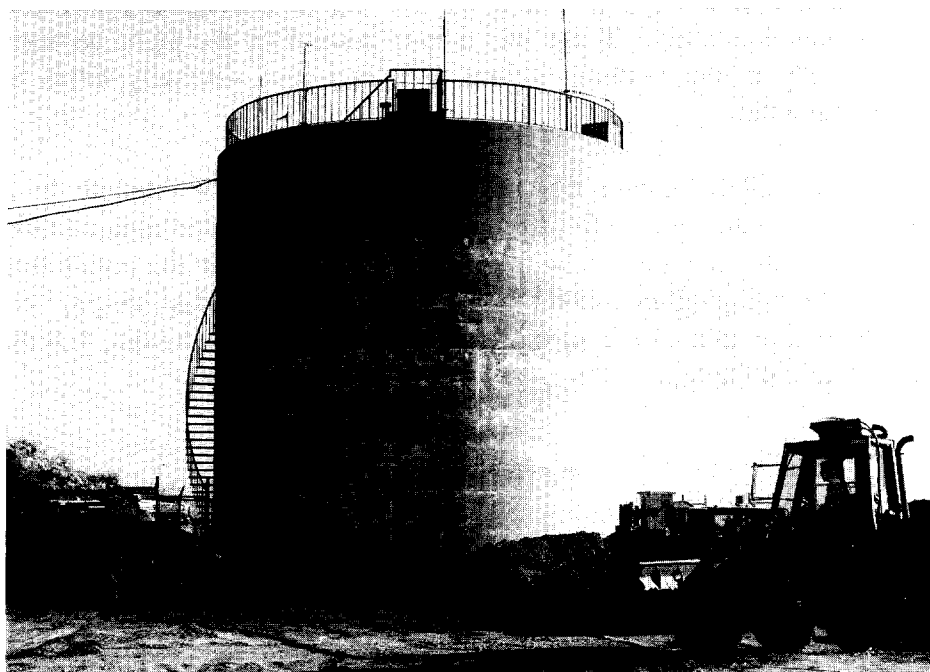
The reinforced concrete relief tank (surge chamber) on top of the hill appeared to perform well through the earthquake--no damage was observed (fig. 5.2). A steel pipe brings water up from the canyon below (fig. 5.3). The pipe is supported on concrete saddles built along the mountain slope. At a few places, the pipe separated from the saddles creating 50 to 80 mm (2 to 3 in) gaps. In at least one location, the pipe crashed vertically into the saddle. At two other locations, the pipe sections bulged 80 mm and 150 mm (3 and 6 in), however, no rupture or leakage was noticed. The ruptured section of the 2.1-m pipe is located near the hilltop. The two sections where the rupture occurred were connected using a mechanical coupling system (fig. 5.4). The pipe sections were connected by eight pairs of restrainer rods 35 mm (1-3/8 in) in diameter and 2.2 m (7 ft) long. The rods were attached to brackets, which were welded to the pipes. These welds broke during the earthquake (fig. 5.5) and resulted in the separation of the two pipe sections.

Figure 5.2. The reinforced concrete surge tank at Terminal Hill performed well during the earthquake--no damage was observed.

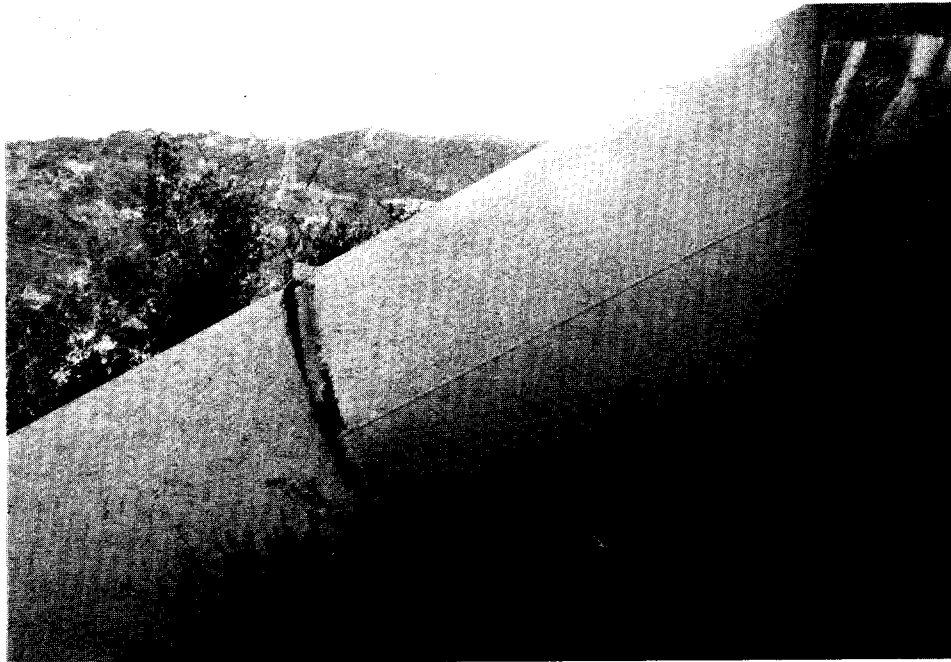
Figure 5.3. The steel pipeline at Terminal Hill separated from its supporting saddle at **several** places and pipe sections bulged at other locations along the alignment.

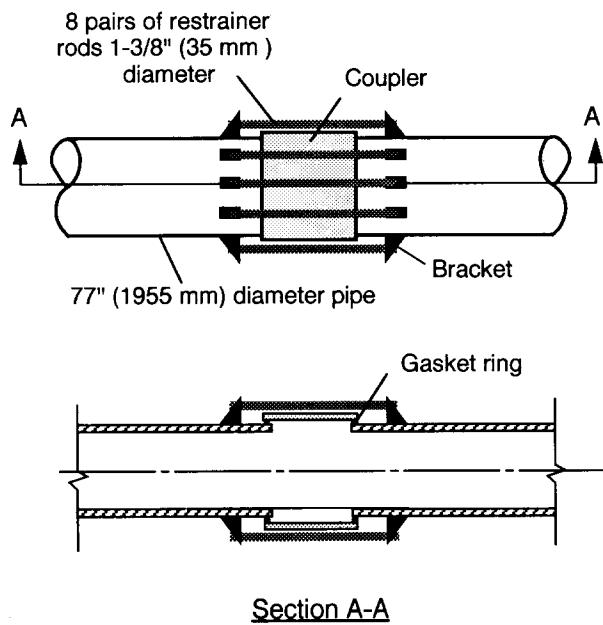
Figure 5.4. Schematic drawing of connection of the two steel pipe sections which were pulled apart during the earthquake.

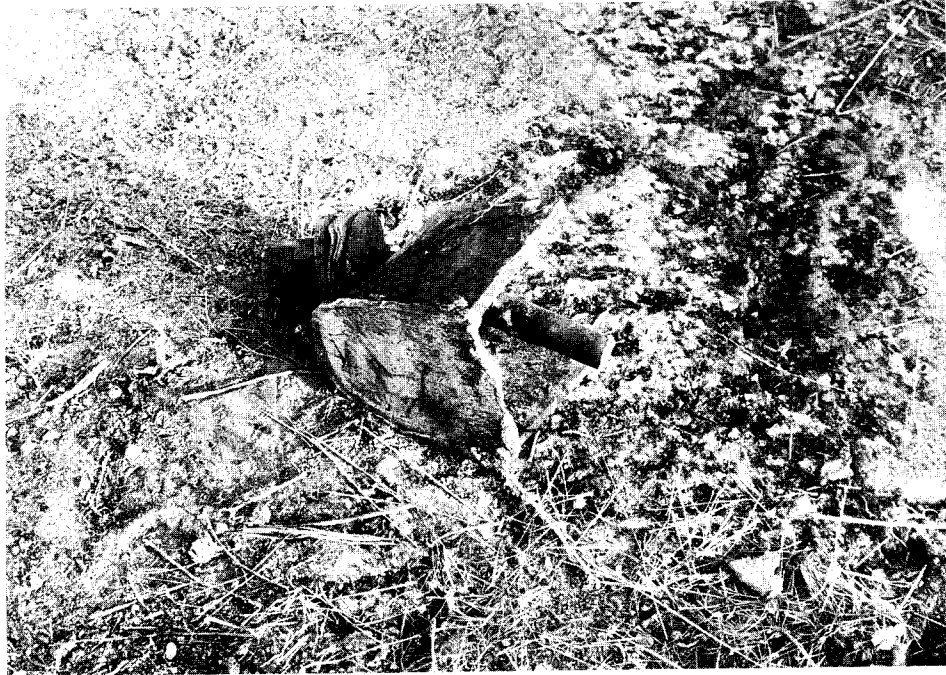
Figure 5.5. Welds of the restrainer brackets broke as the result of strong shaking.

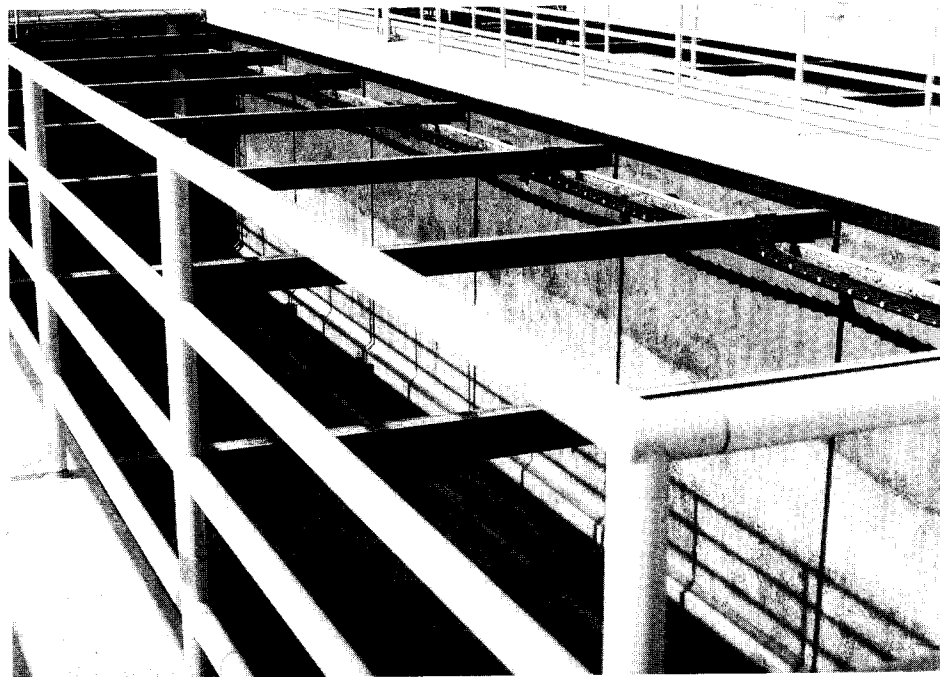
Figure 5.6. Undamaged clarifier tank at the Tillman Water Reclamation Plant.

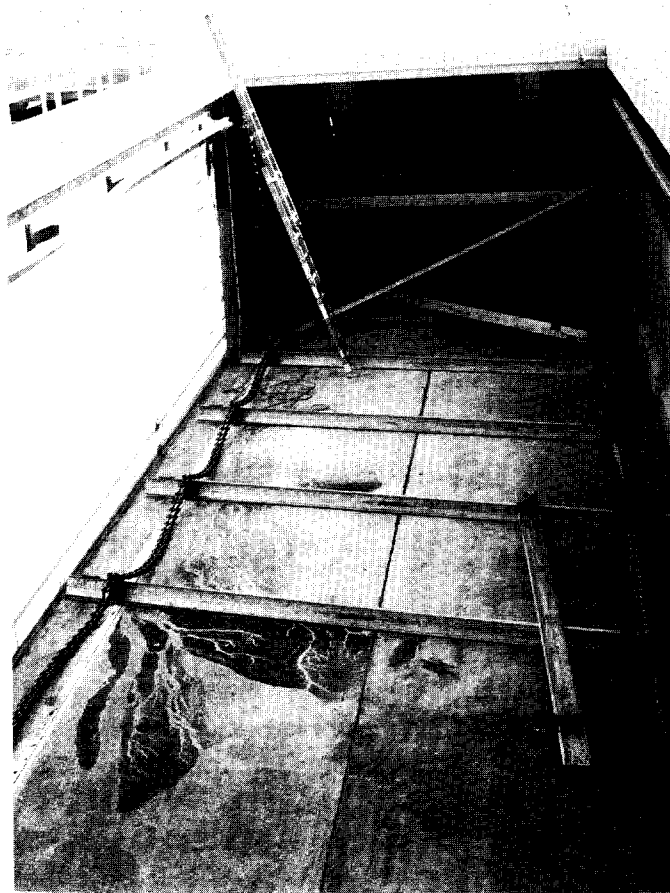
The earthquake resulted in damage to five out of twenty-two final clarifier tanks built in 1991 as part of the Phase II expansion. Twenty-two Phase I tanks built in 1983 were not damaged. Figure 5.6 shows a typical undamaged final clarifier tank. The scrapers are supported by railings attached to the walls with brackets. Chains are used to move the scrapers. All these components were made of plastic in the Phase II construction, whereas the brackets were made of metal and railings and sludge scrapers were made of redwood in the Phase I construction. Pins about 10 mm (3/8 in) in diameter and 19 mm (3/4 in) long connected the brackets to the railings. In the tanks where there was damage, it is suspected that the pins dislodged due to wave action in the tank and the railing became displaced. This caused jamming of the chain movement, which disabled the system (fig. 5.7).

Figure 5.7. A damaged sludge scraper in a clarifier tank at the Tillman Water Reclamation Plant.

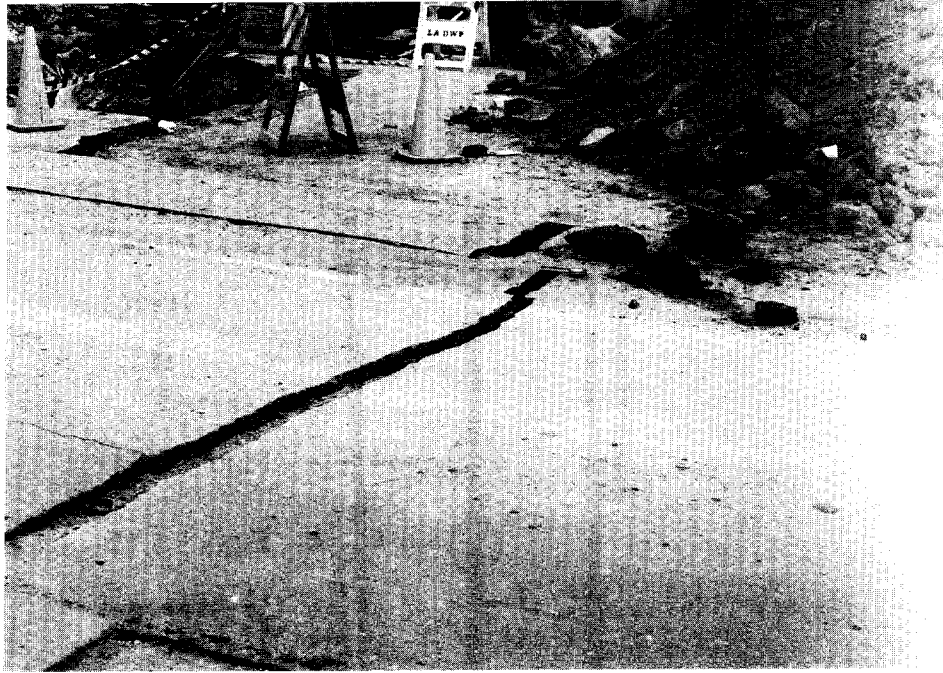
The rupture of a 0.6-m (22-in) gas main occurred along Balboa Boulevard between Rinaldi Street to the south and Lorillard Street to the north (fig. 5.8). Along this stretch, compressional ground failures occurred between Rinaldi Street and Halsey Street, and extensional ground failures occurred between Bircher Street and Halsey Street. Ground extension at this location is prominently exhibited by the transverse cracks in the pavement as shown in figure 5.9. Further, lateral spreading of 25 to 100 mm (1 to 4 in) toward the west was observed along the sidewalk on the west side of Balboa Boulevard north of Halsey Street, whereas no lateral spreading was observed on the east side of Balboa Boulevard.

Figure 5.9. Ground extension at the gas fire site on Balboa Boulevard can be seen by the transverse cracks in the pavement.
