# **1994 Northridge Earthquake Performance of Structures, Lifelines, and Fire Protection Systems**

Diana Todd  
Nicholas Carino  
Riley M. Chung  
H. S. Lew  
Andrew W. Taylor  
William D. Walton  
James D. Cooper  
Roland Nimis

Building and Fire Research Laboratory  
National Institute of Standards and Technology  
Gaithersburg, MD 20899-0001

May 1994

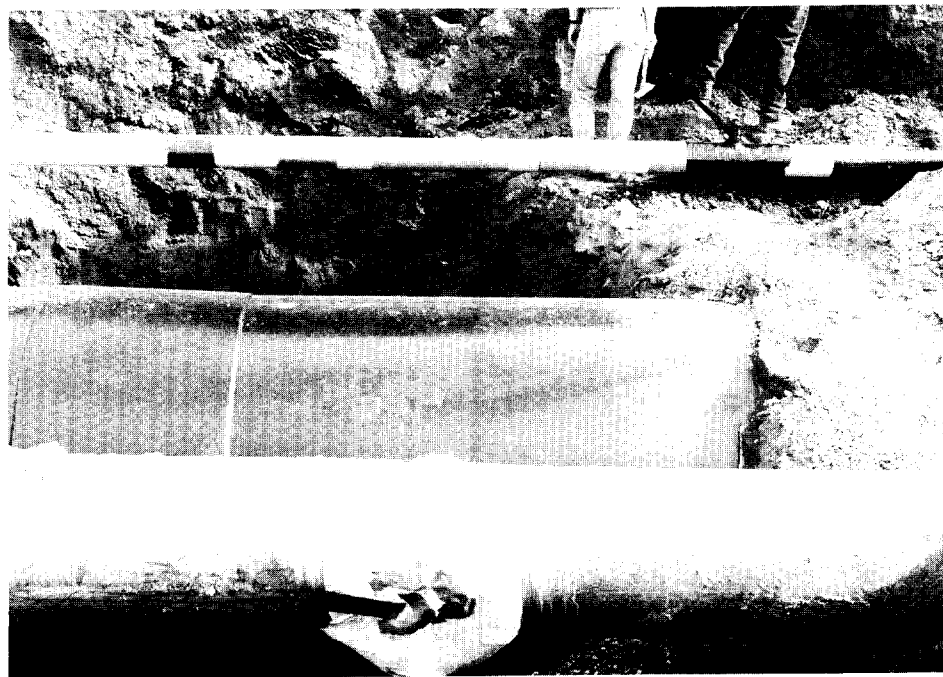
Three pipelines ruptured as the result of ground contraction; a 150-mm (6-in) gas distribution line, the 1.8-m (68-in) Rinaldi trunk water line, and a 0.6-m (22-in) gas main (fig. 5.10). The Rinaldi trunk line was of post-1971 construction, and the gas main was of 1930 vintage. These pipes showed a shortening of 125 to 150 mm (5 to 6 in).

Figure 5.10. Ground contraction along Balboa Boulevard caused the rupture of a gas distribution line (top), the Rinaldi trunk 1.8-m (68 in) water main (center), and a gas main (bottom). The pipes were being repaired at the time this photograph was taken.

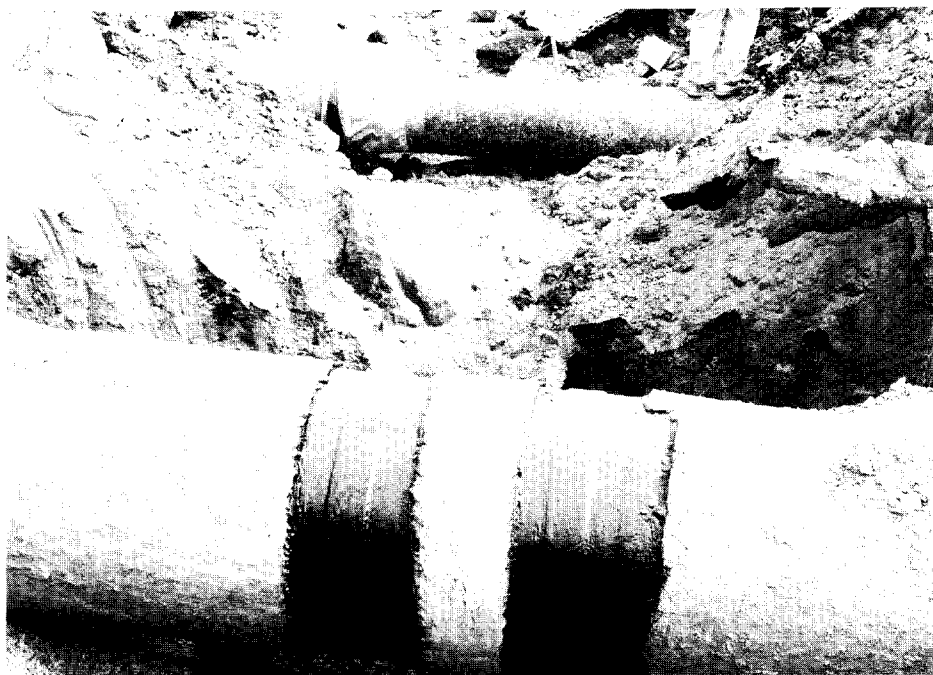
About one block north, the ground extension caused rupture of the same 0.6-m (22-in) gas main and a 1.2-m (48-in) water main (fig. 5.11). These pipes were pulled apart as the result of the ground extension. The rupture of the gas main caused a major fire at the site that destroyed five houses (figs. 5.12 and 5.13). The loss of both water mains at this location and the difficult access to the site due to the fire and street flooding made fire fighting difficult.

Figure 5.11. Ground extension along Balboa Boulevard resulted in the rupture of the same gas main shown in figure 5.10 (top) and a 1.2-m (48 in) water main (bottom). The rupture of the gas main here caused a major fire that engulfed five houses.

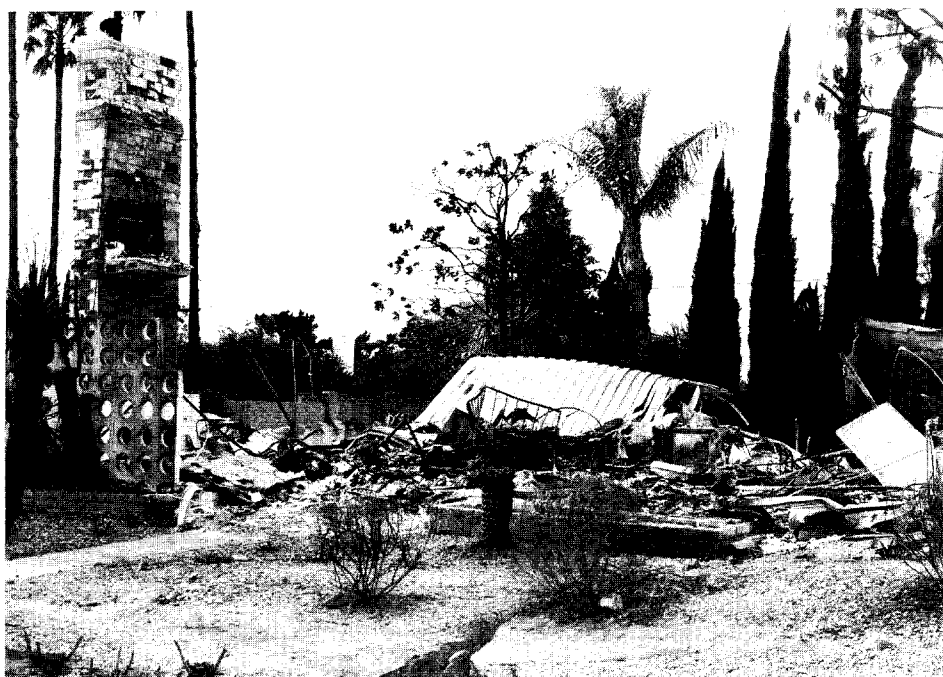
Figure 5.12. Houses destroyed by a fire resulting from the rupture of the 0.6-m gas main along Balboa Boulevard.

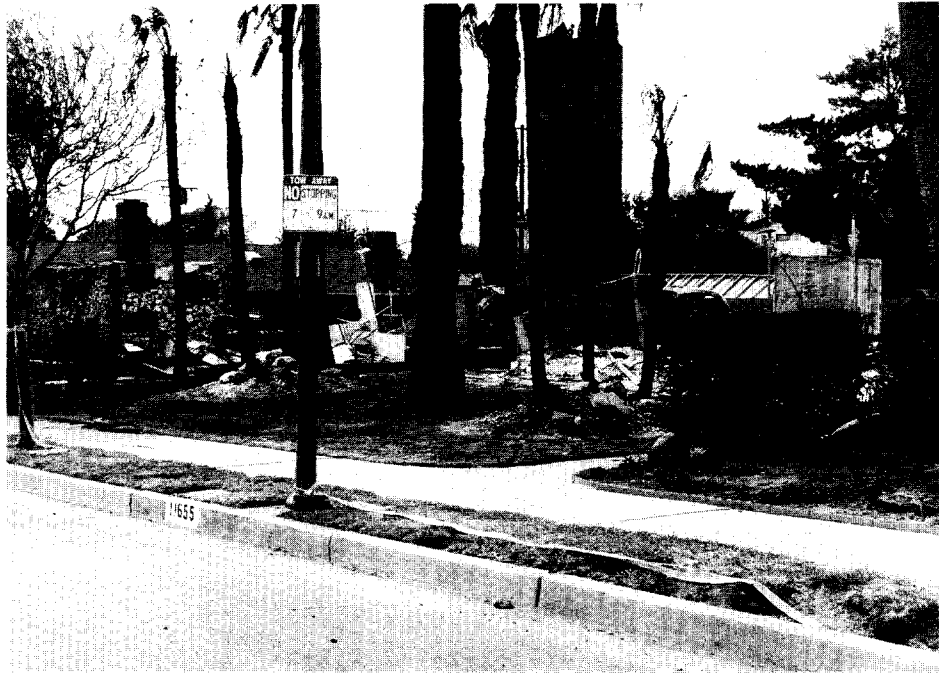
Figure 5.13. Houses destroyed by a fire resulting from the rupture of the 0.6-m gas main along Balboa Boulevard.

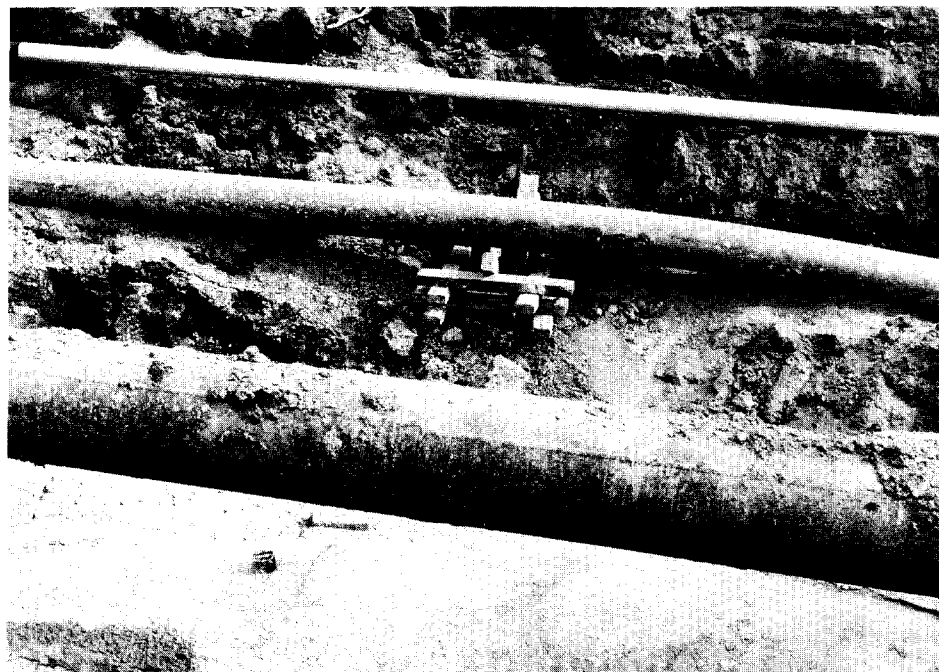
An excavated section just north of the fire site revealed some additional underground lines (fig. 5.14). The 460-mm (18-in) crude oil line in the middle of the photo performed well. The 150-mm (6-in) gas distribution line shown at the top of the photo is a replaced section.

Figure 5.14. Some of the buried pipelines located near the intersection of Balboa Boulevard and Bircher Street showing the potential hazard of co-location of lifeline systems. At this site are three water lines (two of them main lines); three gas lines; two sewers; one crude oil line; overhead power, telephone, and cable TV lines; the street lighting system; and the street itself.

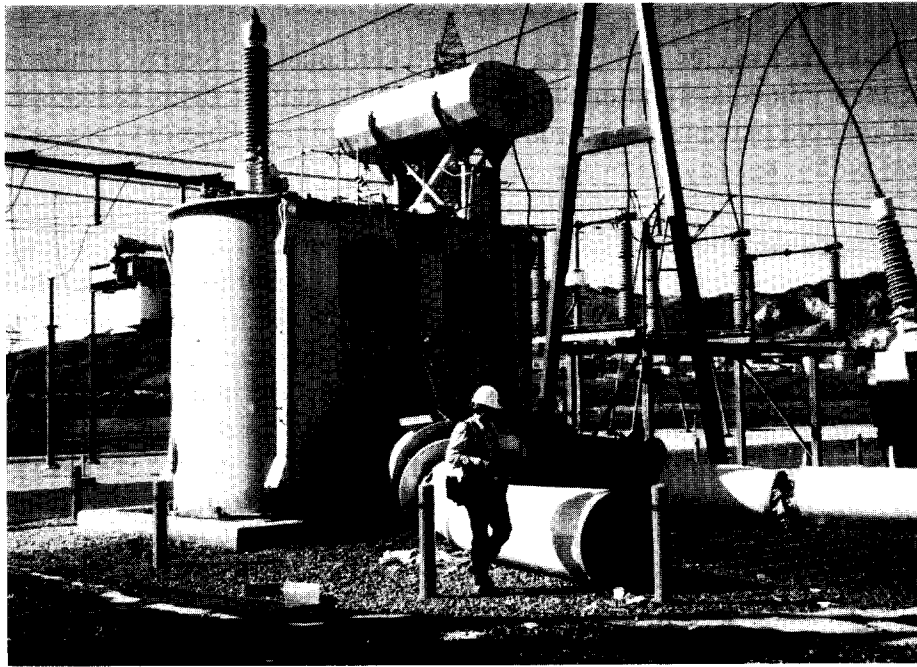
Some transmission towers suffered significant damage, many as the result of foundation failure. Damage to several high voltage substations near the epicenter, such as Sylmar, Pardee, and Rinaldi, led to the widespread power outage in the Los Angeles basin, as well as isolated outages throughout seven western states (fig. 5.15). As happened during the 1971 San Fernando earthquake, porcelain elements of 230-kV and 500-kV equipment suffered the most damage (fig. 5.16). This highlights the urgent need for developing new earthquake-resistant materials to replace porcelain, which is very brittle. Furthermore, most of the 230-kV circuit switchers, similar to those at the Sylmar substation shown in figure 5.17, were damaged. However, none were damaged during the 1971 earthquake, a possible indication of much stronger ground shaking by the Northridge earthquake. Most of the capacitor banks, similar to those in the background in figure 5.17, performed well in this earthquake, whereas most collapsed during the 1971 quake. Better performance of the capacitor banks is the result of stricter seismic requirements in equipment qualification and in installation practices.

Figure 5.15. Damage to DC equipment at several high voltage substations, such as this one at Sylmar, led to widespread power outages in the Los Angeles area as well as isolated outages throughout seven western states. (Photo courtesy of Edward Matsuda, Pacific Gas and Electric Company.)

- Improved methods for avoiding damage to high voltage substations should be developed. New materials are needed to replace the brittle porcelain insulators. Better switch systems should be developed and installed to prevent blackouts. Failures of foundations for transmission towers should be thoroughly investigated.

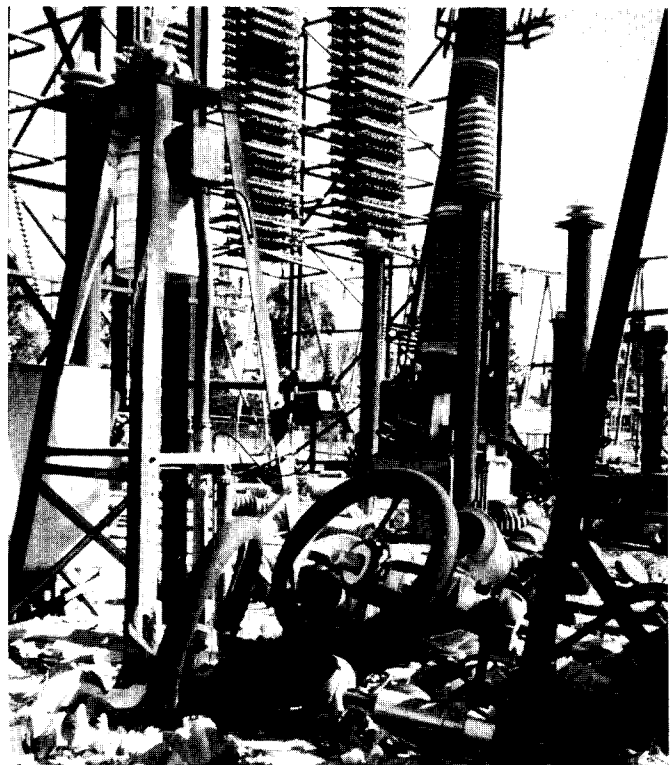
Figure 5.16. Porcelain is an integral part of high voltage electrical equipment due to insulation requirements and is also the most vulnerable to damage during strong earthquake shaking. (Photo courtesy of Edward Matsuda, Pacific Gas and Electric Company.)

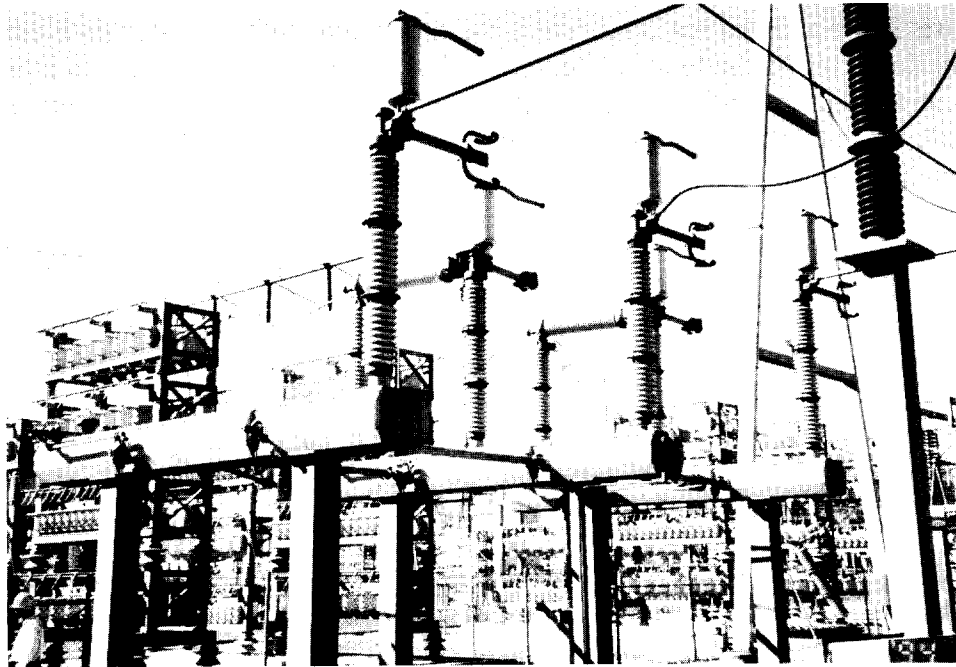
Figure 5.17. Most of the 230-kV circuit switchers (in the forefront) at the Sylmar substation were damaged. Most of the capacitor banks (in the background) performed well in this earthquake, whereas most collapsed during the 1971 quake. (Photo courtesy of Edward Matsuda of Pacific Gas and Electric Company.)

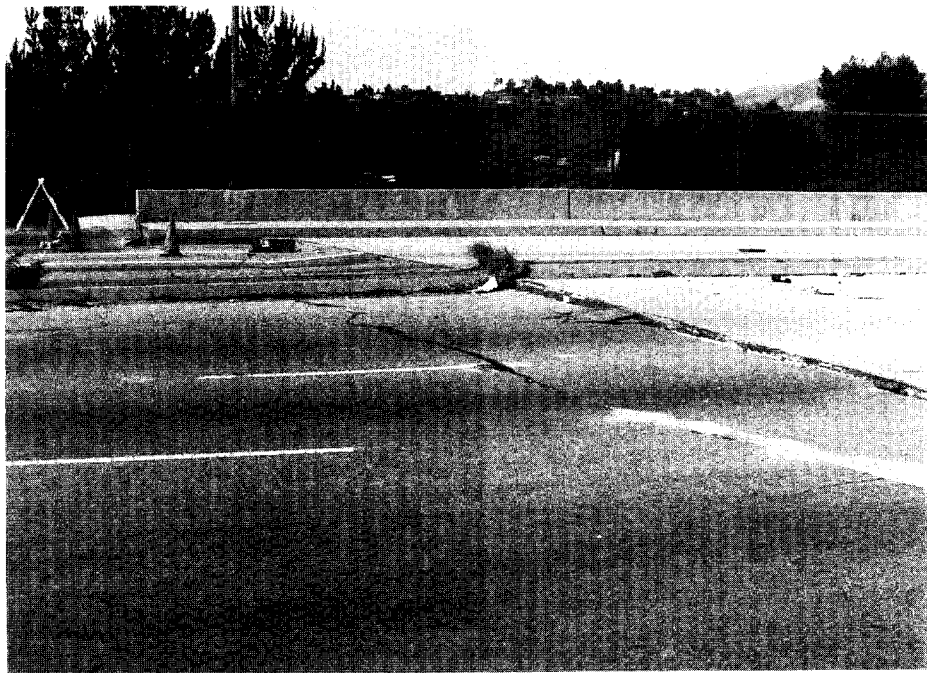
Strong ground shaking and lateral movement of subgrade materials resulted in numerous ruptures of asphalt pavement and concrete sidewalks in the epicentral area (figs. 5.19 and 5.20). In some instances, local traffic was interrupted temporarily until these cracks were repaired. In most cases, damage was minor and local traffic was not interrupted. The south approach of Balboa Boulevard at SR118 caved in because of loss of abutment fill due to a water main break (fig. 5.21). This bridge was closed for traffic due to some structural damage to the piers and the loss of the south abutment fill, as described in chapter 4.

Figure 5.20. Transverse cracks in pavement near the intersection of Balboa Boulevard and SR118.

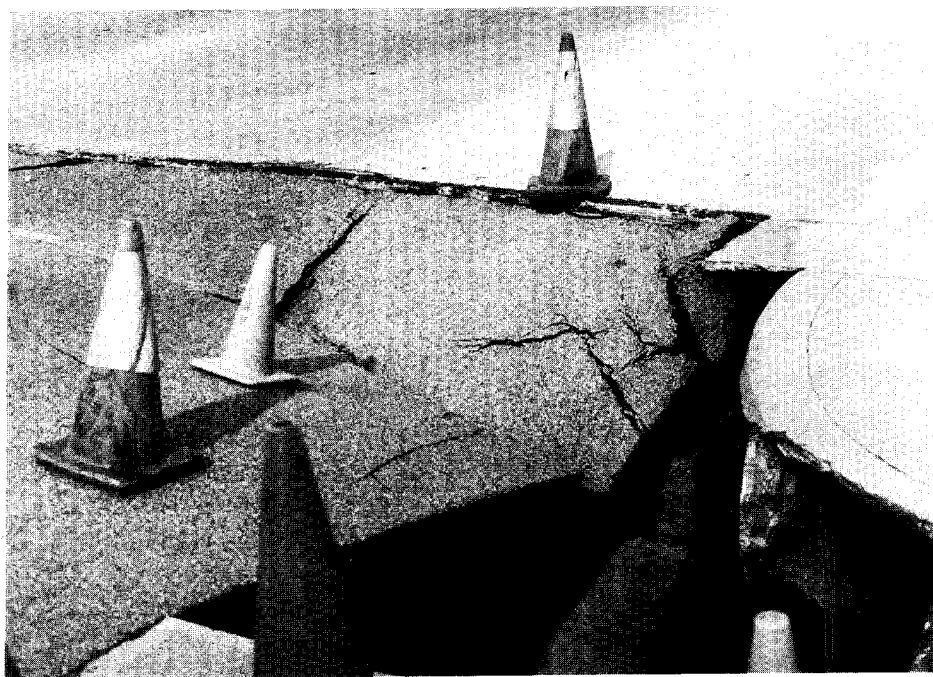
Figure 5.21. The approach of Balboa Boulevard at SR118 caved in due to the loss of the abutment fill because of a water main break.

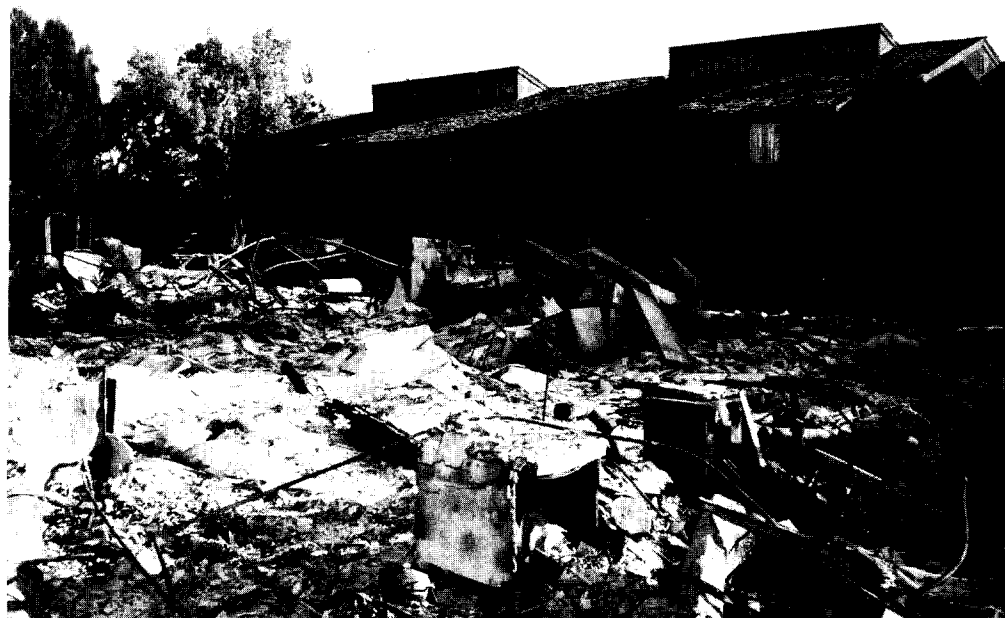
Figure 6.6. Multi-family residential building destroyed by fire.

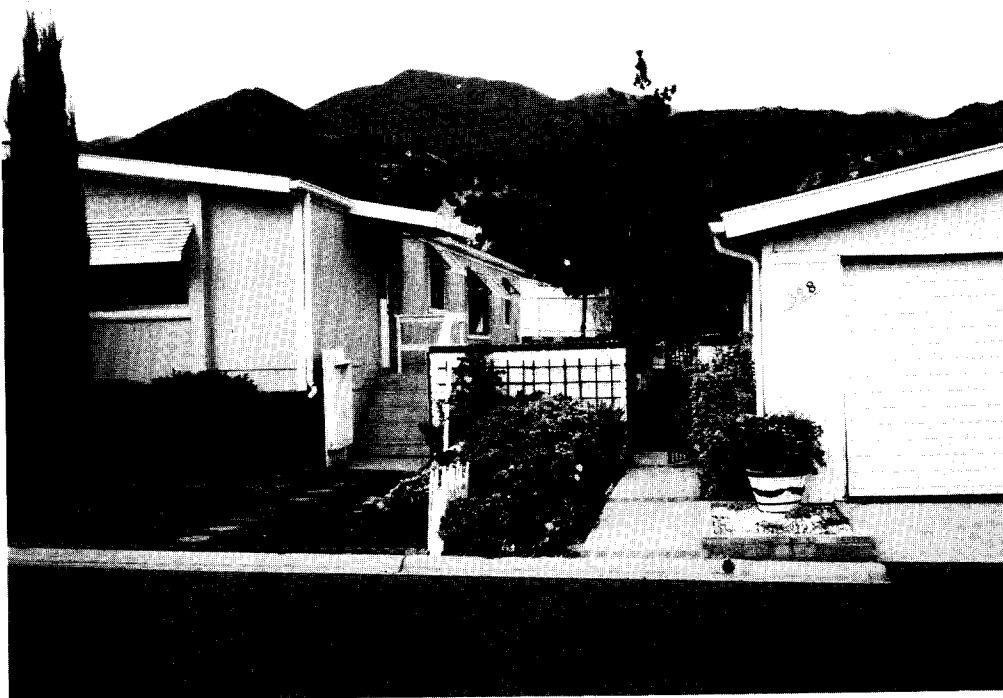
Building-to-building fire spread was limited to three manufactured housing developments (mobile home parks). Figure 6.8 shows the typical spacing between units in one of these developments. Figure 6.9 shows an area of the development destroyed by fire. Observations made at this development indicate that the method of unit-to-unit fire spread was primarily through windows. Once a unit became completely involved in fire, the thermal radiation was sufficient to cause the breakage of windows in an adjacent unit or to ignite combustibles within the unit directly through the windows. The fire department reported low water pressure in the area which combined with multiple independent fires and limited resources hindered fire fighting operations. The fire spread was stopped either by separation such as roads and open areas or by fire fighting operations.

Figure 6.8. Typical unit spacing in a manufactured housing development.

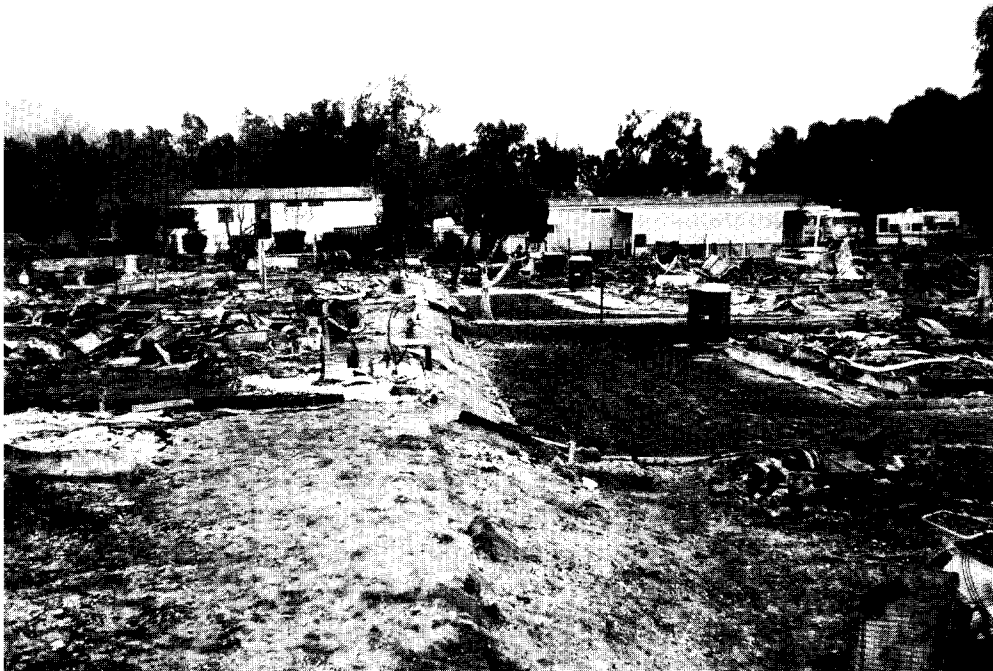
Figure 6.9. Impact of a multiple unit fire in a manufactured housing development.

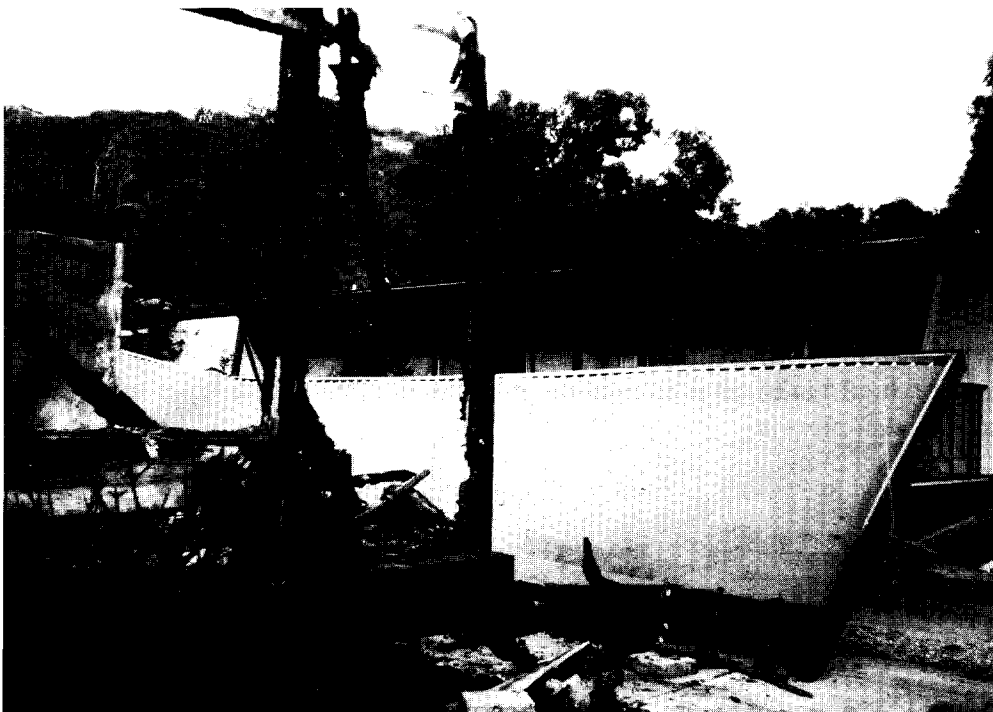
A unique aspect of the construction of these manufactured units played a role in limiting fire spread and assisting fire department actions. As the units burned from the inside, the carport roofs collapsed from the building side, coming to rest on the outside supporting columns. In this way the carport roofs formed fire breaks as shown in figure 6.10. Although these roofs would not necessarily have survived the fire by themselves, they reduced the fire exposure on adjacent units and thus enhanced fire fighting operations.

Figure 6.10. Collapsed roof which acted as a fire break in a manufactured housing development.
