NIST NCSTAR 2: Vol. I

# Report of the Technical Investigation of The Station Nightclub Fire

June 2005

A fire occurred on the night of Feb. 20, 2003, in The Station nightclub at 211 Cowesett Avenue, West Warwick, Rhode Island. A band that was on the platform that night, during its performance, used pyrotechnics that ignited polyurethane foam insulation lining the walls and ceiling of the platform. The fire spread quickly along the walls and ceiling area over the dance floor. Smoke was visible in the exit doorways in a little more than one minute, and flames were observed breaking through a portion of the roof in less than five minutes. Egress from the nightclub, which was not equipped with sprinklers, was hampered by crowding at the main entrance to the building. One hundred people lost their lives in the fire. On Feb. 27, 2003, under the authority of the National Construction Safety Team (NCST) Act, the National Institute of Standards and Technology (NIST) established a National Construction Safety Team to determine the likely technical cause or causes of the building failure that led to the high number of casualties in that fire. This report documents the procedures, findings,

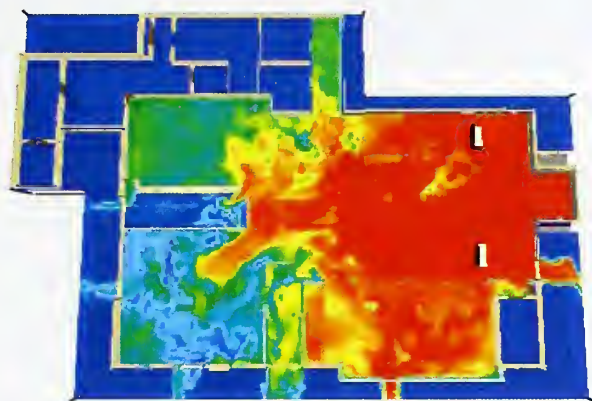
the full-scale nightclub, and to measure the temperature, heat flux, and gaseous products. In less than 90 seconds after ignition of foam at the corner of the reconstructed drummer's alcove, conditions in the middle of the room (5.5 m, or 18 ft, away) at head height (1.5 m, or 5 ft, above the floor) were found to be lethal.

**Temperatures 1.5 m (5 ft) above floor 90 seconds after ignition, calculated from computer simulation of full-scale nightclub fire.**

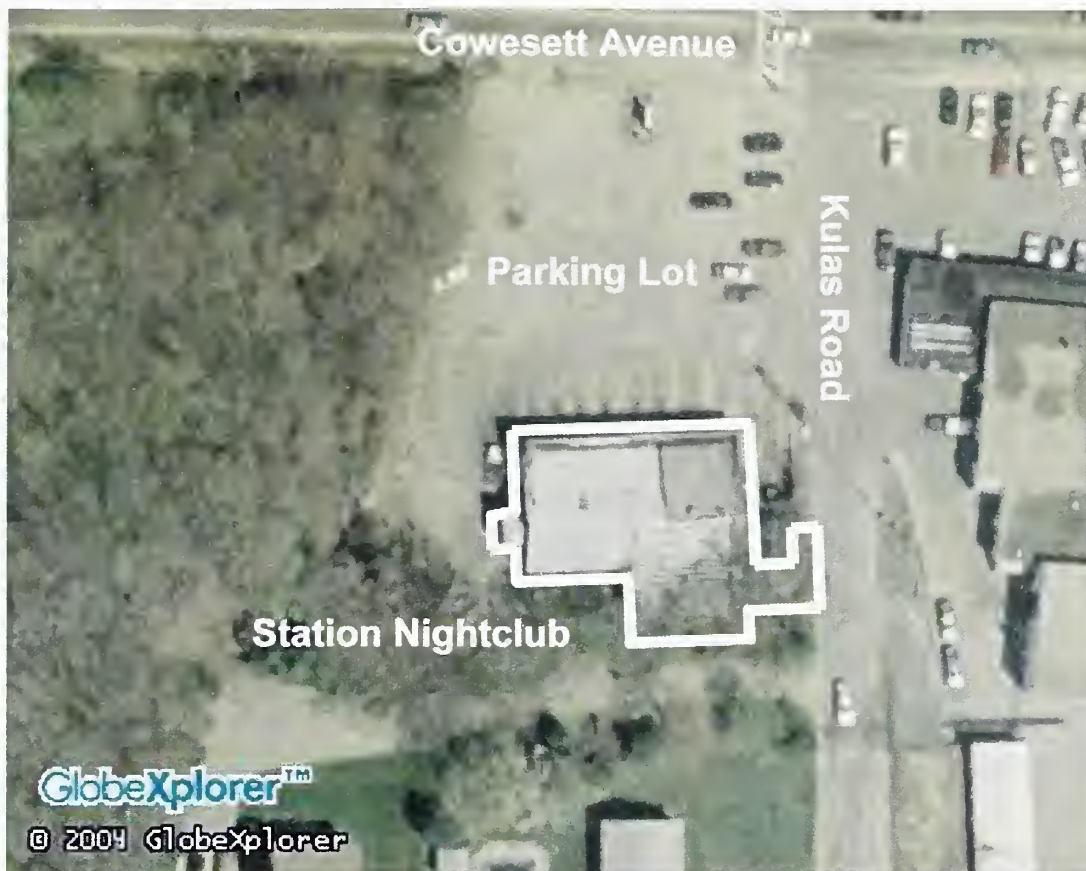
Figure 1-1. General orientation of building and site [2]

The Station nightclub was located at 211 Cowesett Avenue, West Warwick, Rhode Island. It was a single-story wood frame building with a footprint of about 412 m<sup>2</sup> (4484 ft<sup>2</sup>) and a small basement under the main bar room. Figure 1-1 is a photograph of the building on its lot. The north-facing front door of the nightclub was set back about 42 m (140 ft) from Cowesett Avenue, a three-lane, two way street that runs east-to-west. Kulas Road is two lanes wide and runs along the east side of the building, about 10 m (33 ft) east of the side bar exit. There was no direct street access to the building from either the west or south sides. Parking for over 100 cars was provided in the front and to the west side of the building.

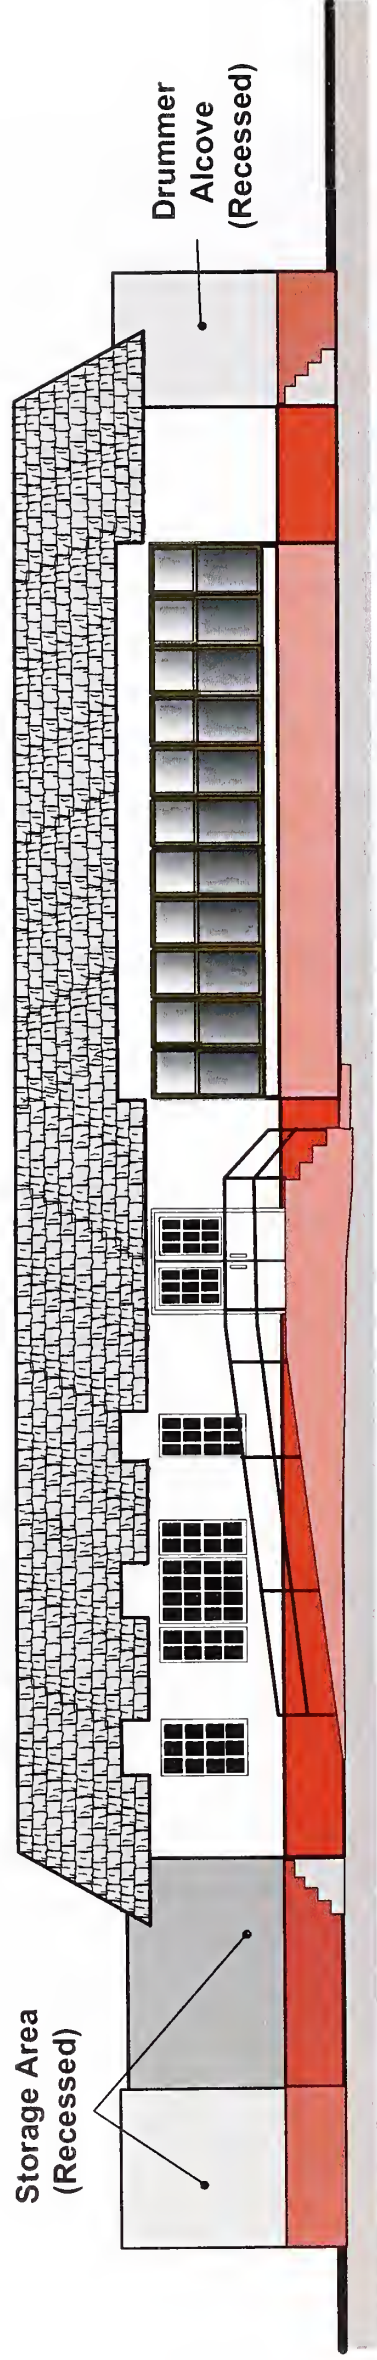
Figure 1-3 is a sketch showing the north side of the building approximately as it looked on February 20, 2003. Note the windows on the left which are in the main bar area, the windows on the right in the sunroom/poolroom, the ramp and stairs leading from the main entrance in front, and the stairways leading from side exits on the west and east of the building. Inside the double doors of the main entrance is a vestibule with a single doorway. Figures 1-4a and 1-4b are photographs of the north side and north west corner of the building as they looked within a year or two of the February 20, 2003 fire. The external walls were primarily covered with painted wood shingles or panels above a concrete foundation. The roof was flat with a wood shingle façade along the front and sides, as seen in the photographs.

Figure 1-3. Sketch of the north side of The Station nightclub locating the main entrance, front stairway/ramp, windows in the main bar area (left), sunroom/pool room (right), and exit stairs from the east and west sides

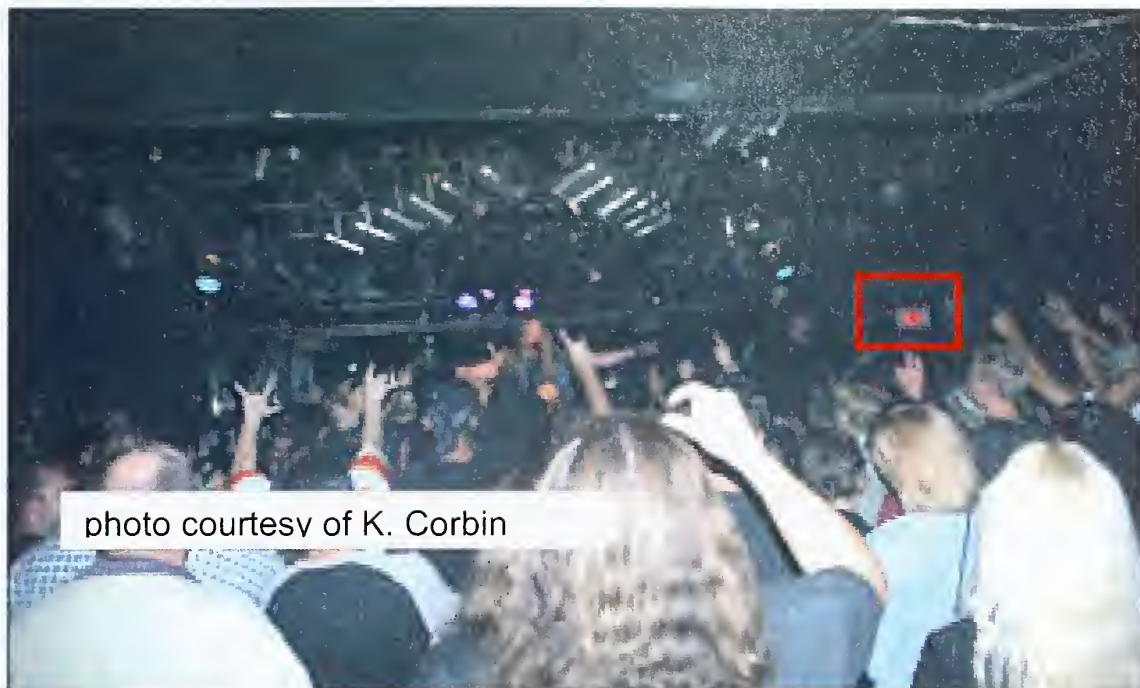
Figures 1-6a and 1-6b show different views inside the nightclub, highlighting the exit doors next to the platform and the exit from the main bar area.

**Figure 1-6a. View of inside of nightclub showing exit sign above door near platform [13]**

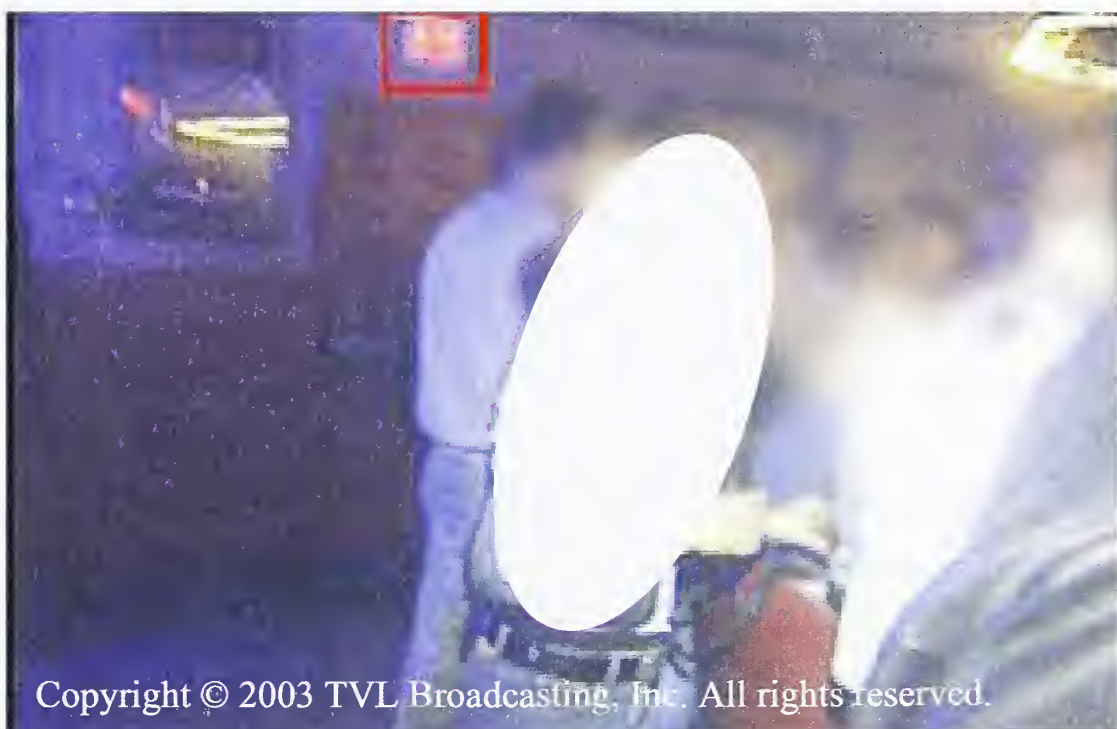
**Figure 1-6b. View of inside of nightclub showing exit sign above door in main bar area [4]**

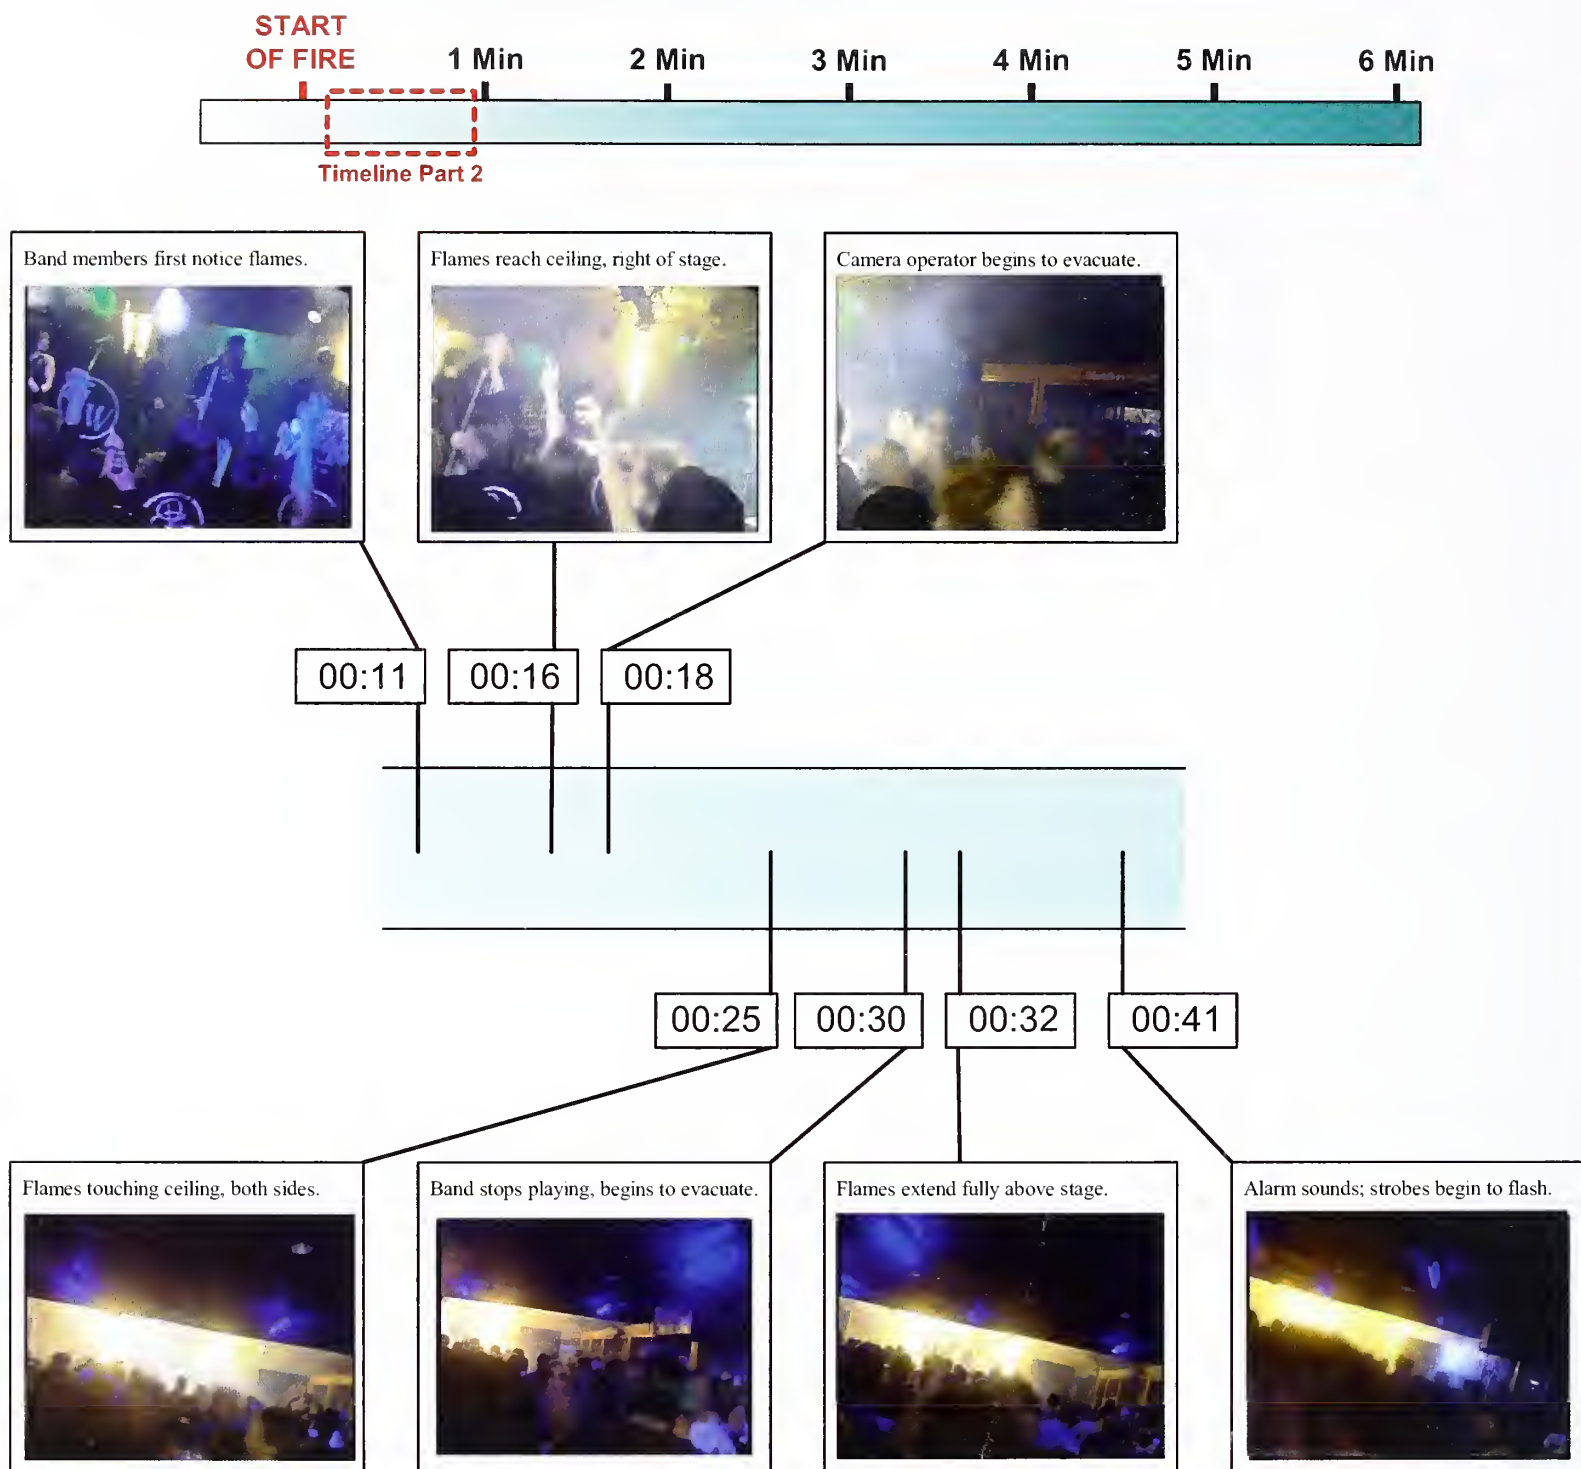
Figure 2-2b. Evacuation Timeline (10 seconds to 50 seconds after ignition). Video stills copyright © 2003 TVL Broadcasting, Inc. All rights reserved.

recognize the fire danger at 24 seconds. Around the time the band stopped playing (30 seconds fire time), the bulk of the crowd had begun the evacuation process. At 41 seconds the fire alarm could be heard and the strobe seen on the video. (See Fig. 2-2b.)

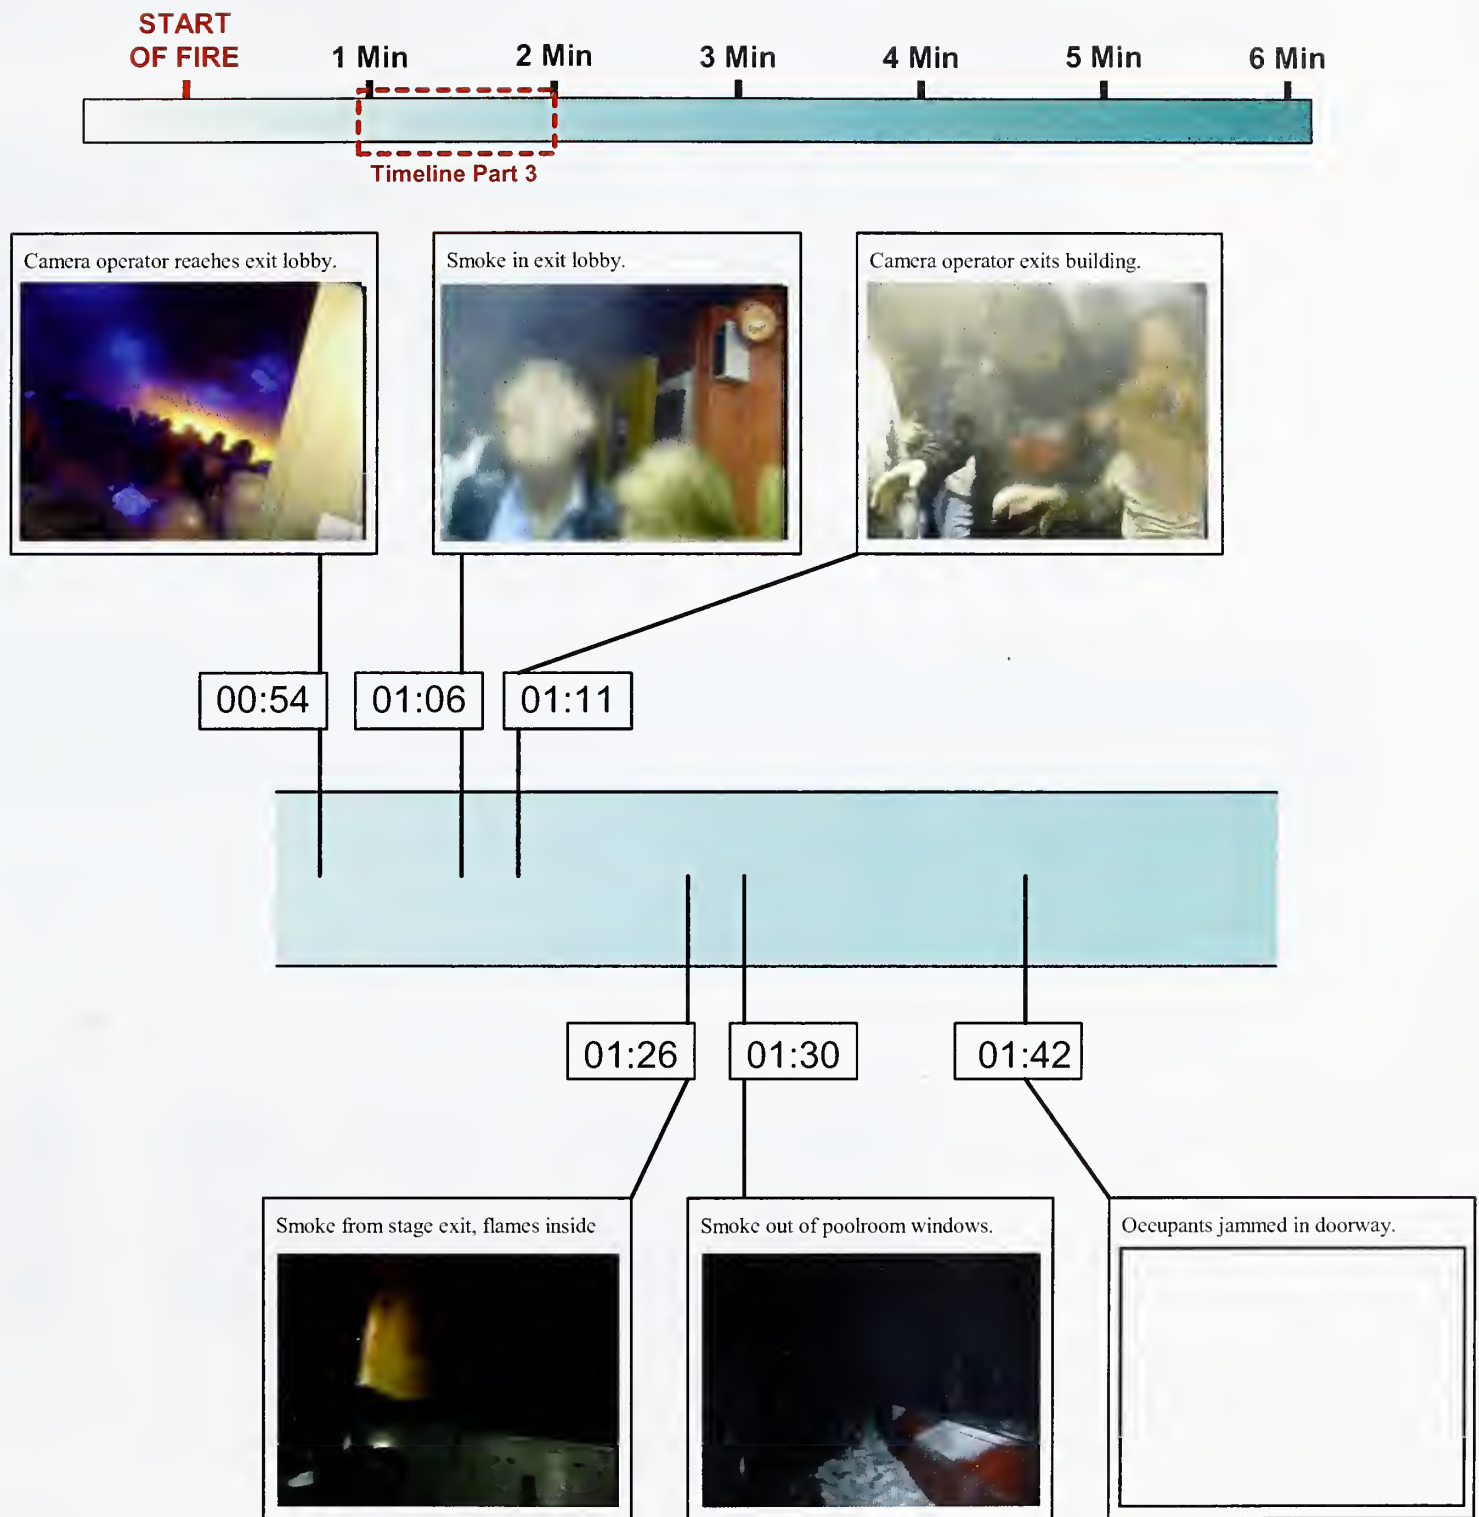
**Figure 2-2c. Incident Timeline (50 seconds to 2 minutes after ignition). Video stills copyright © 2003 TVL Broadcasting, Inc. All rights reserved.**

The videographer made his way to the exit lobby while continuing to capture the movement of the crowd leaving the area around the dance floor. As seen in Fig. 2-2c, he exited the building at 1 minute 11 seconds (fire time) along with a steady stream of occupants. Sometime estimated to be around 1 minute 30 seconds after ignition of the foam, the front exit became blocked with people, and occupants could be seen breaking windows and escaping from the poolroom/sunroom. The result of the crowd crush at the front exit was captured on the video at 1 minute 42 seconds (Fig. 2-2c). The latest time recorded for an occupant escaping from inside the main bar (through a window) was at 4 minutes 8 seconds; however, people stuck in the front entrance are seen in the video to have escaped as late as 5-1/2 minutes into the fire, just before the fire department ran its first hose line (Fig. 2-2d). (One patron claimed to have been pulled from the bottom of the pile by a firefighter considerably later, but this has not been confirmed by the NIST investigation.)

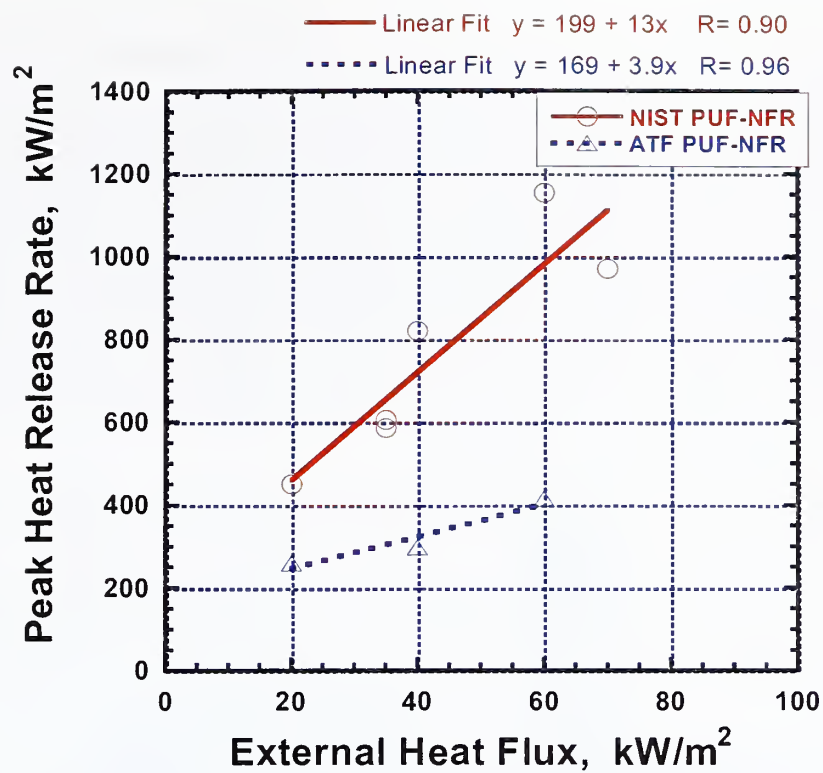
tested by ATF. A plot of the peak heat release rate as a function of incident radiation is shown in Fig. 4-2a, comparing the NIST results to the ATF measurements. As expected, the peak heat release rate increases about linearly with imposed heat flux.

Figure 4-2a. Peak heat release rate versus external heat flux for different polyurethane foams tested at NIST and ATF.

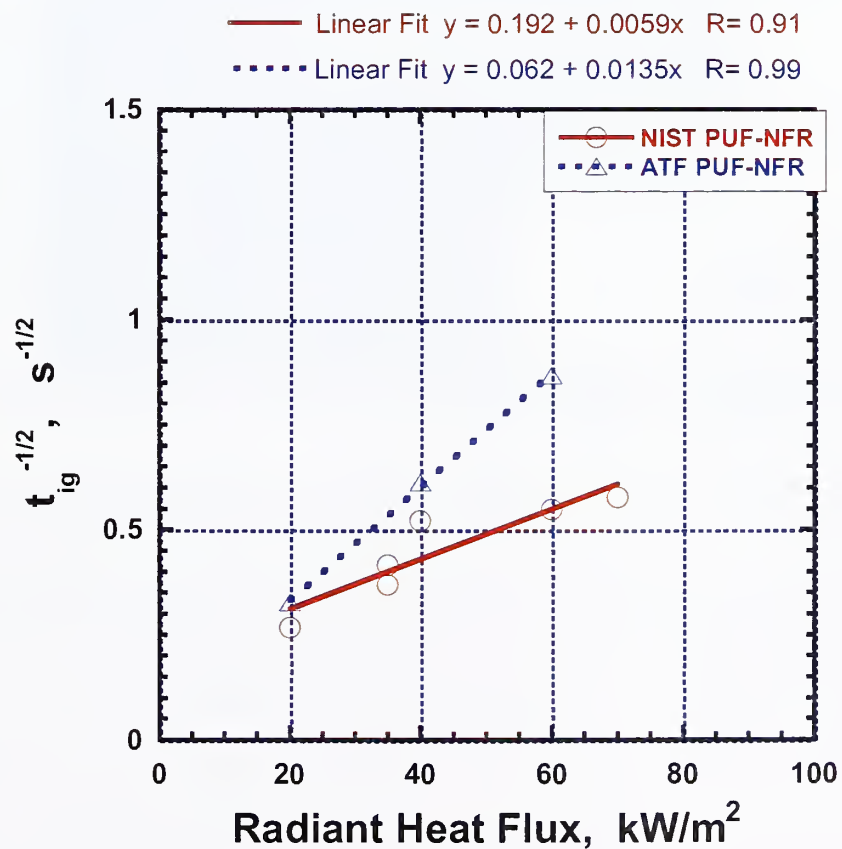
Figure 4-2b. Time to sustained ignition versus external heat flux for different polyurethane foams tested at NIST and ATF.

The precise reasons why the polyether foam tested by ATF differed from the behavior of the foams tested by NIST are not clear. (NIST did not have access to the foam from the fire scene tested by ATF.) However, the shorter time necessary for ignition of the ATF foam suggests that the effective value of  $k_{pc}$  was less. It is possible that the behaviors were influenced by the different molecular structure, additives, or manufacturing processes. It is also not clear under what conditions the foam had been stored in the basement of the nightclub or whether it had always been stored in the basement, nor what impact aging or water from fire fighting operations may have had on the foam. Using the properties of either foam, the fire is predicted to spread rapidly, with the foam acting as an ignition source for the wood layer underneath. The contribution from the foam to the total heat release in the fire was much less than from the wood, once the wood was ignited by the burning foam.

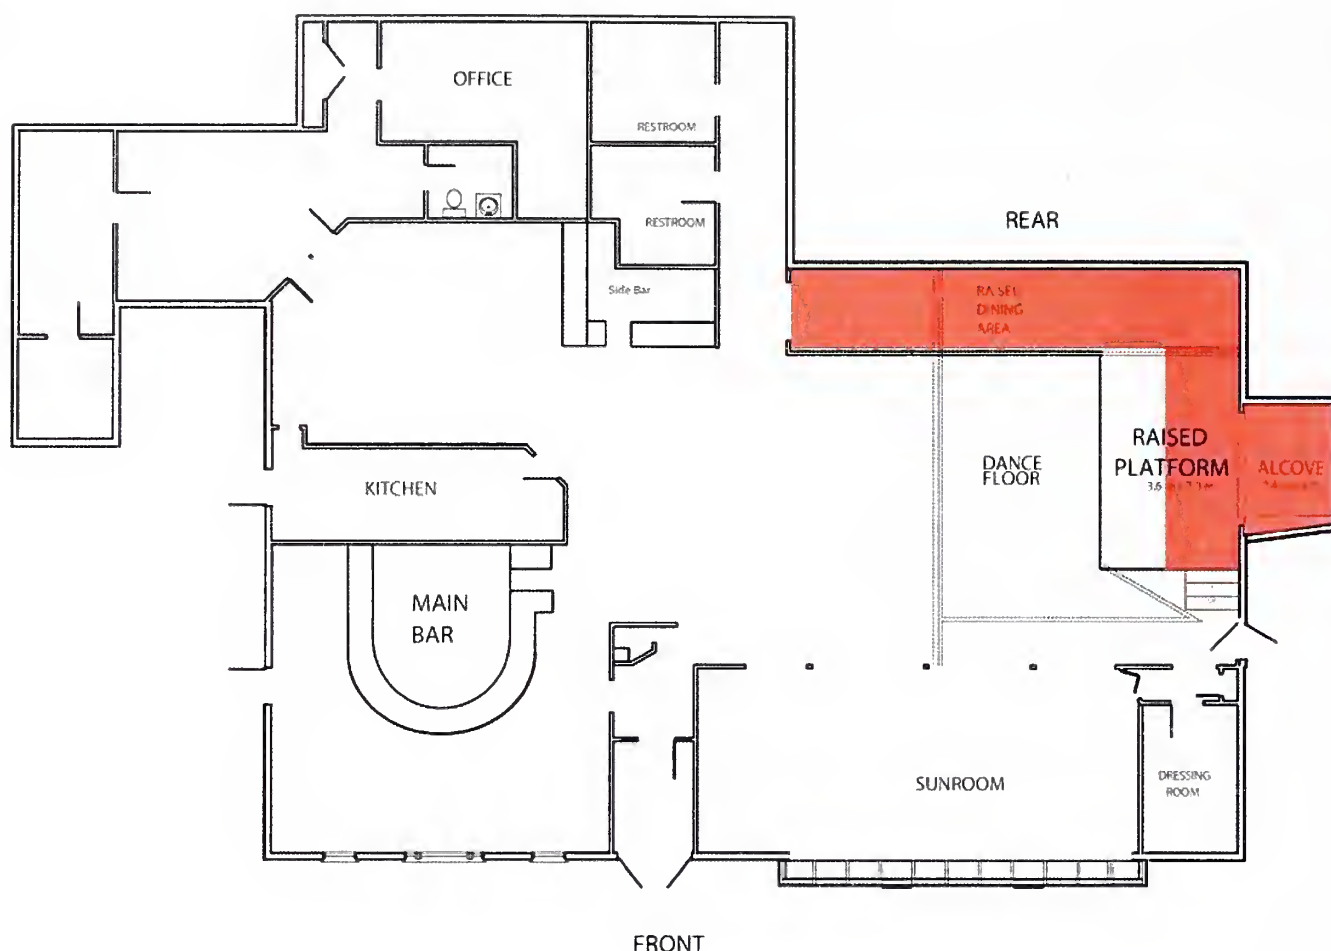
Carpet flooring had been installed in the nightclub on the elevated section along the rear wall and around the platform area. (Figure 4-5). Interior photographs of the nightclub did not provide sufficient information to identify the specific brand or type of carpeting.

**Figure 4-5. Portion of Nightclub with Carpeting.**

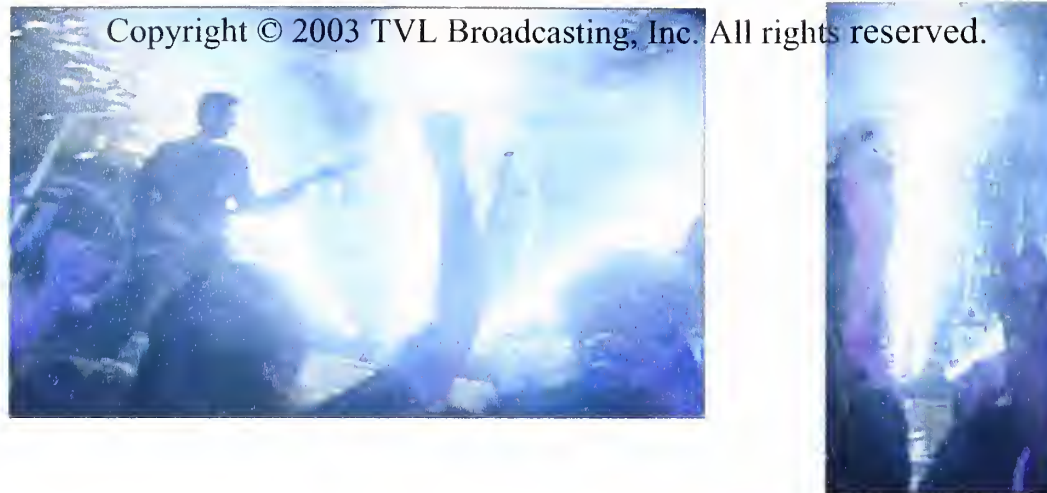
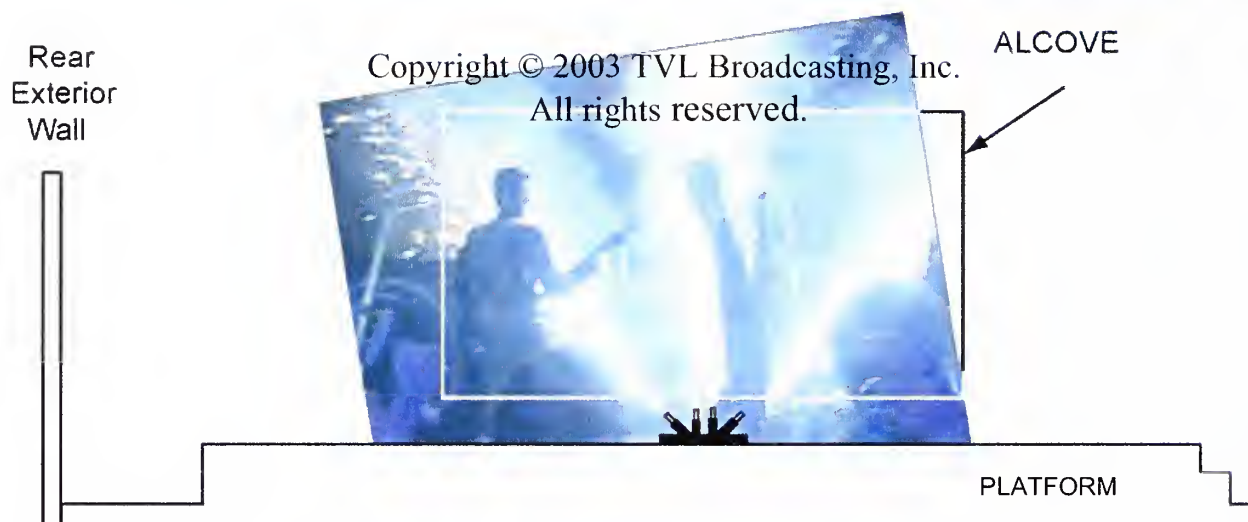
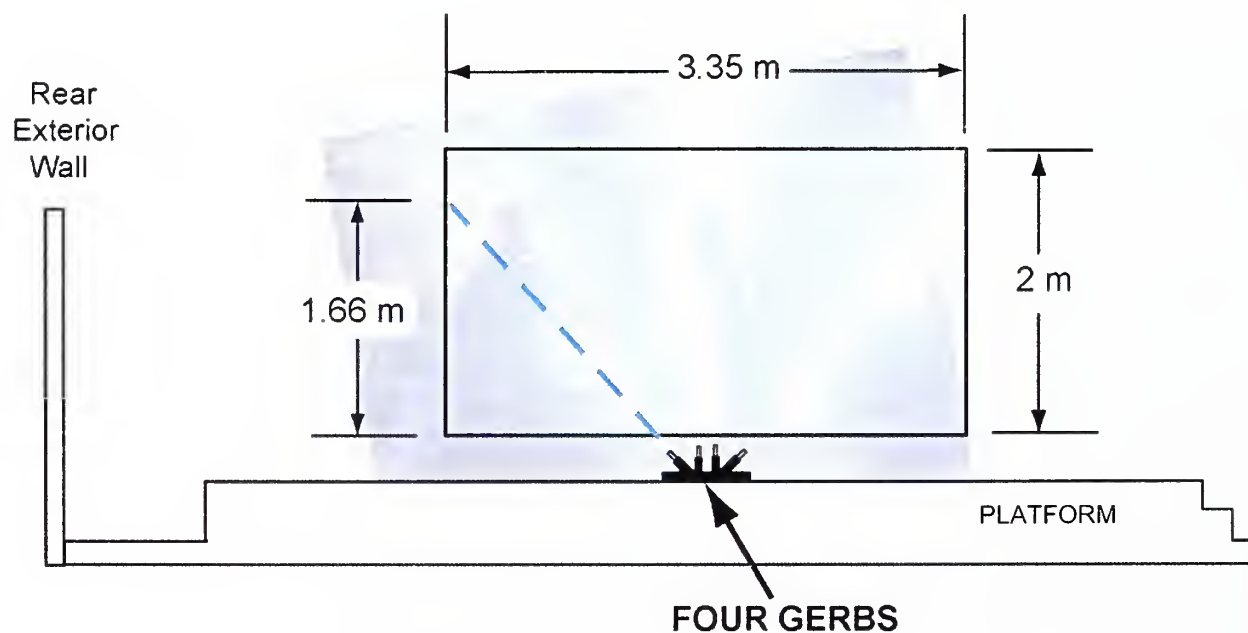
**Figure 4-10. Pyrotechnics (15 x 15 gerbs) positioned on nightclub platform.**  
 Video image copyright © 2003 TVL Broadcasting, Inc. All rights reserved.

The video recorded in the nightclub demonstrates that there were four gerbs positioned in front of the alcove. The two vertical gerbs were spaced about 0.1 m (4 in) apart and the two 45 degree gerbs were each positioned about 0.25 m (10 in) outside the vertical gerbs. This arrangement placed the tip of the 45 degree gerbs approximately 1.21 m (4 ft) from each of the side walls of the alcove. The spray of hot sparks would have impinged on a foam covered wall from about that distance.

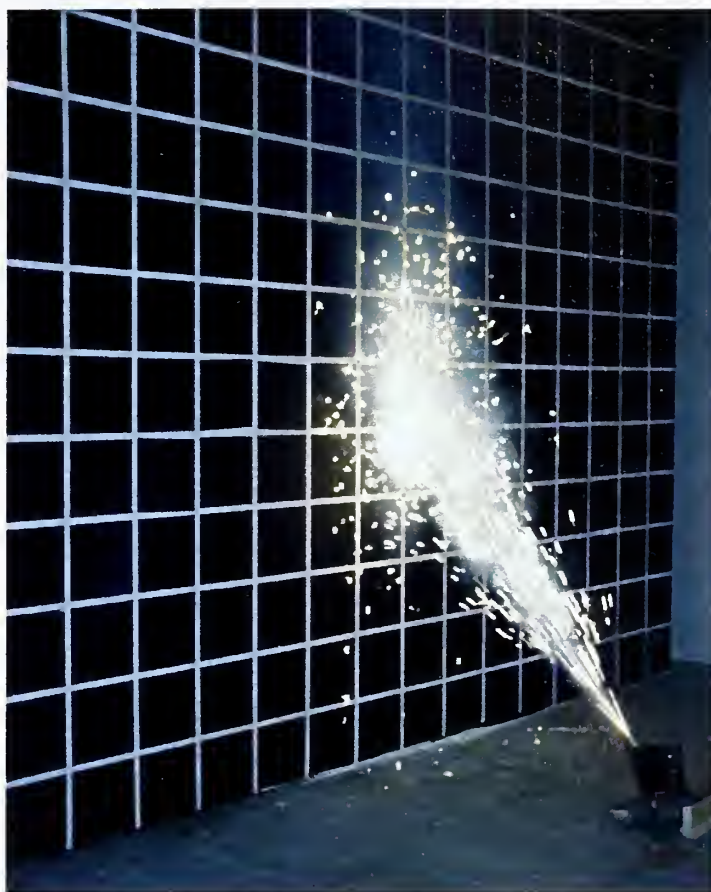
**Figure 4-11. Single Gerb at 45 degrees and in a Plane Perpendicular to Wall.**

In order to simulate this arrangement, a single gerb which was angled at 45 degrees was discharged against (and in a plane perpendicular to) the wall from a distance of 1.22 m (4 ft). A single 1.22 m (4 ft) by 2.44 m (8 ft) sheet of non-fire retardant polyurethane foam (PUF-NFR-B) was stapled to the gypsum board wall. A single gerb was positioned at a 45 degree angle so that the tip of the gerb was 1.22 m (4 ft) from the wall surface. The tip of the gerb was located 0.3 m (1 ft) above the floor. While temperature data were collected during the gerb discharge, the heat flux gauges were removed to prevent damage from dripping and burning plastic.

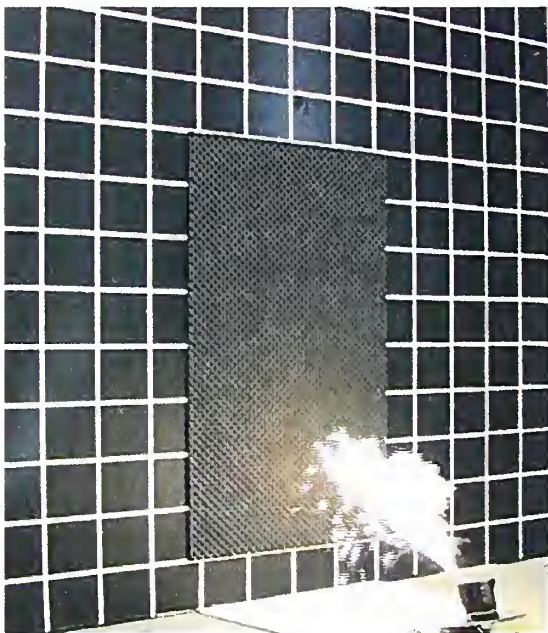
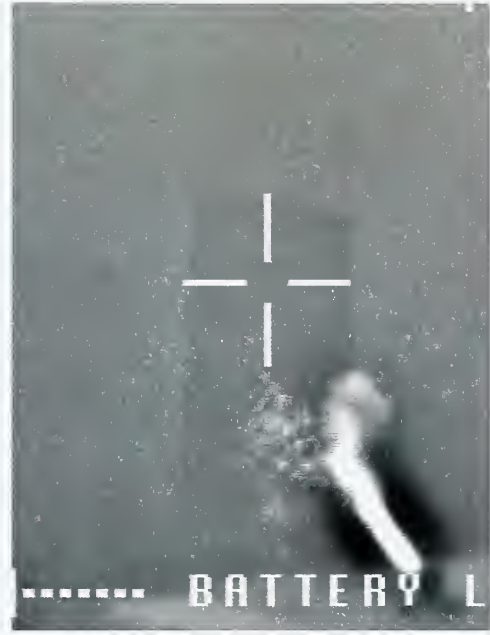
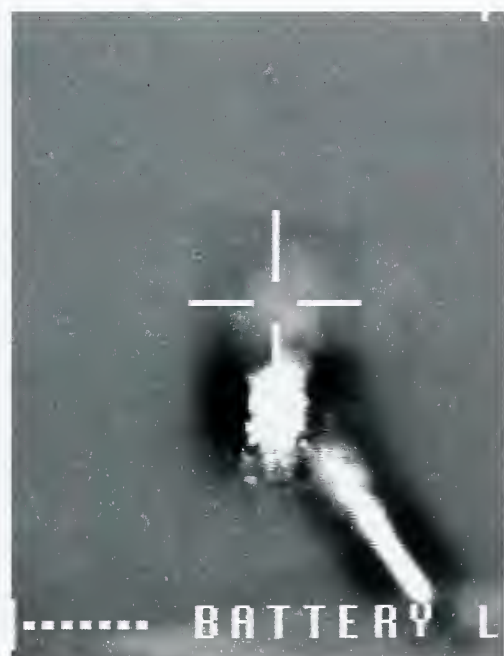
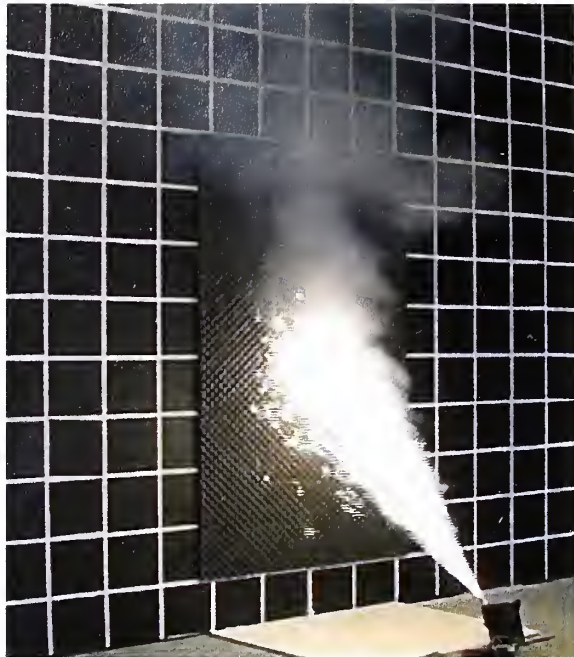
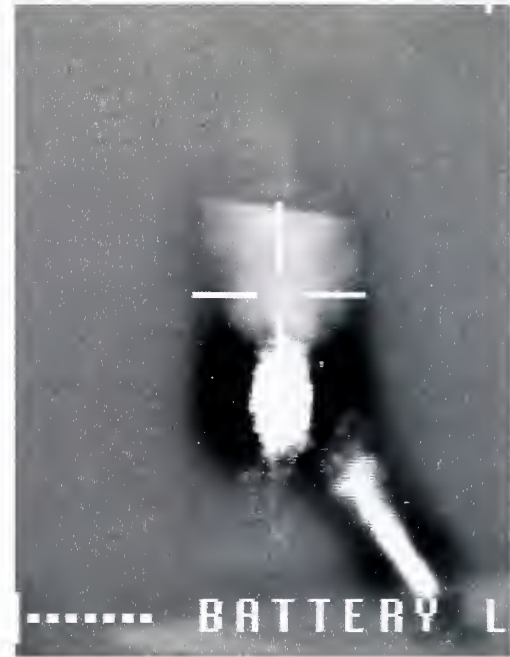
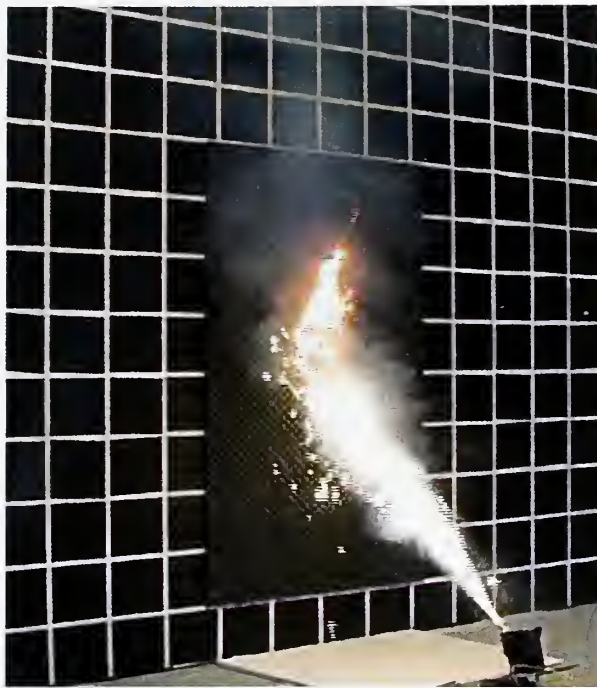
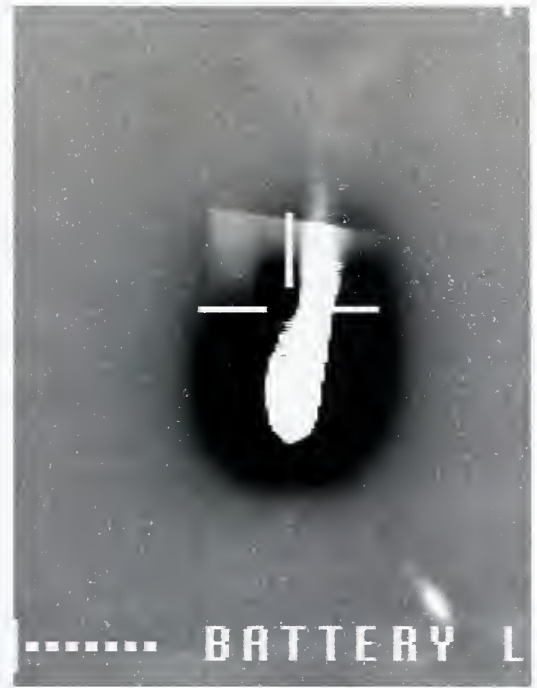
Still images were captured from the video recorded by the standard video and IR camera. For gerbs that were positioned at 45 degrees in a plane parallel to the wall, pairs of visible and infrared images are shown for times from 0 seconds to 30 seconds in Figure 4-13a through 4-13h. The visible images demonstrate that the gerb discharged a spray of white sparks for 15 seconds. The spray of hot sparks impacted the wall between 0.91 m (3 ft) and 1.5 m (5 ft) above the floor. Within 2 seconds after ignition, a thermal pattern (white area in IR image) developed on the wall. This area of increased temperature was oval in shape with a horizontal width of 0.3 m (1 ft) and a vertical dimension of 0.61 m (2ft). A similarly sized and positioned thermal pattern was also seen at 5 seconds into the discharge. The edges of the thermal pattern appeared fuzzy or diffuse. At 10 seconds after ignition, this thermal pattern had sharper edges and a black “haloing” appeared around the pattern. This haloing or shadowing has been observed under laboratory conditions in the presence of a significant thermal gradient. BST detectors measure relative levels of infrared radiation and are AC-coupled. The AC-coupling can cause a "black halo" or shadowing effect that increases as the relative radiation difference between an object and its surroundings increases unless a DC restoration process is included in the signal output circuitry. This would be consistent with the foam burning before  $t = 10$  seconds. Although not clearly seen in the standard video camera, flames were observed on the right hand side of the hot spark pattern at 9 seconds. By 15 seconds a well defined and hot thermal plume was observed in the IR image. Gas temperatures are plotted versus time in Appendix F, Figs. F-16a and F-16b.

**Figure 4-13b. Standard and Infrared Video Images of Gerb Discharge onto a Non-fire Retarded Polyurethane Foam Sheet on Gypsum Board Wall at  $t = 0.5$  seconds.**

**Figure 4-13c. Standard and Infrared Video Images of Gerb Discharge onto a Non-fire Retarded Polyurethane Foam Sheet on Gypsum Board Wall at  $t = 1$  second.**

**Figure4-13d. Standard and Infrared Video Images of Gerb Discharge onto a Non-fire Retarded Polyurethane Foam Sheet on Gypsum Board Wall at  $t = 2$  seconds.**

**Figure 4-13e. Standard and Infrared Video Images of Gerb Discharge onto a Non-fire Retarded Polyurethane Foam Sheet on Gypsum Board Wall at  $t = 5$  seconds.**

**Figure 4-13f. Standard and Infrared Video Images of Gerb Discharge onto a Non-fire Retarded Polyurethane Foam Sheet on Gypsum Board Wall at  $t = 10$  seconds.**

**Figure 4-13g. Standard and Infrared Video Images of Gerb Discharge onto a Non-fire Retarded Polyurethane Foam Sheet on Gypsum Board Wall at  $t = 15$  seconds.**

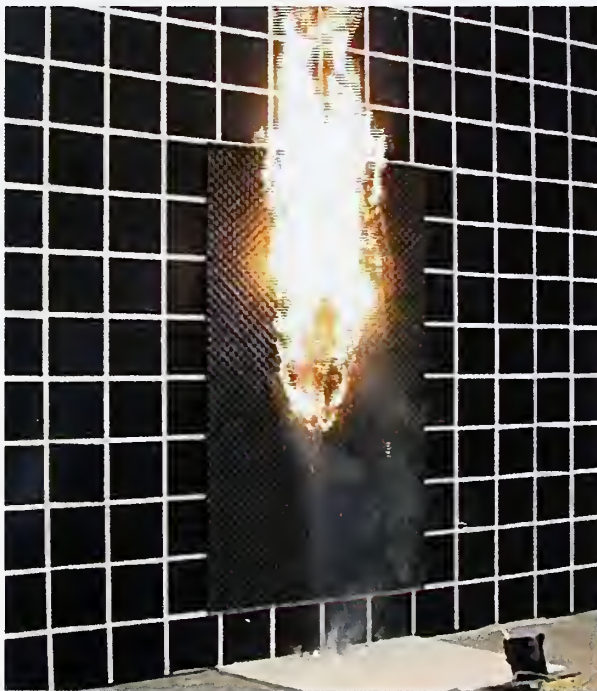
**Figure 4-13h. Standard and Infrared Video Images of Gerb Discharge onto a Non-fire Retarded Polyurethane Foam Sheet on Gypsum Board Wall at  $t = 30$  seconds.**

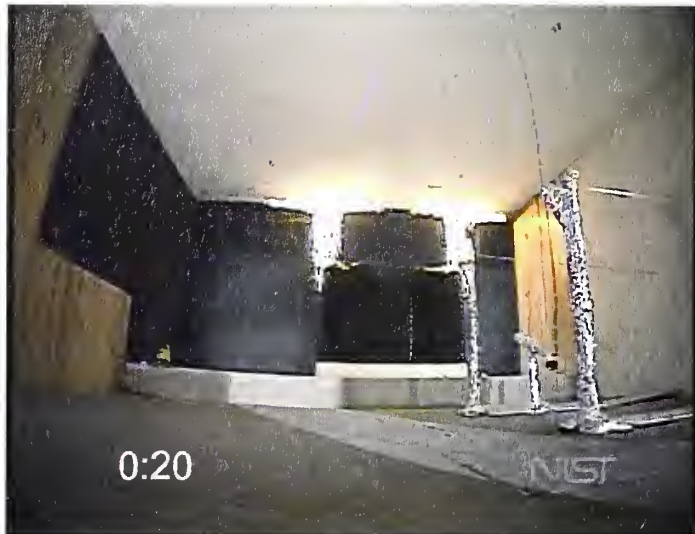
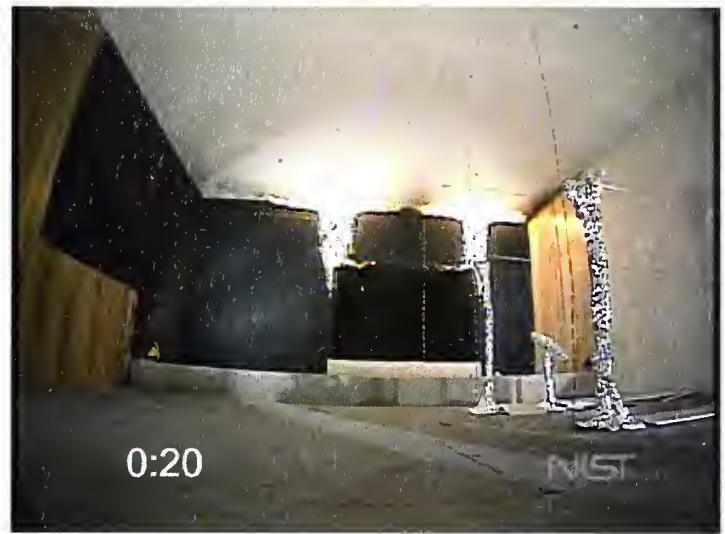
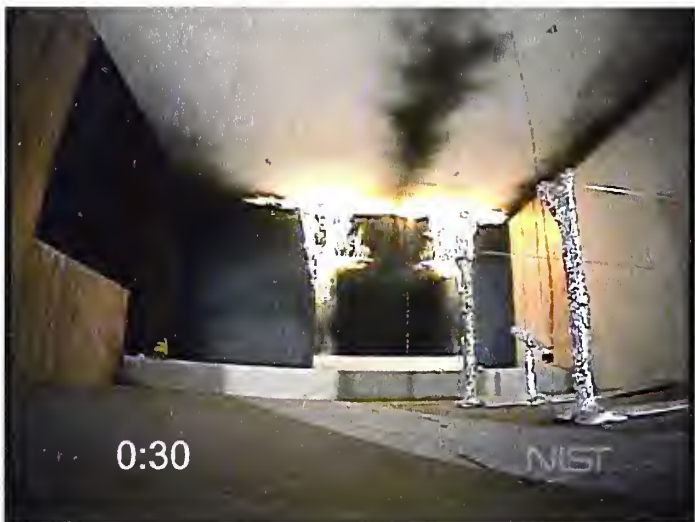
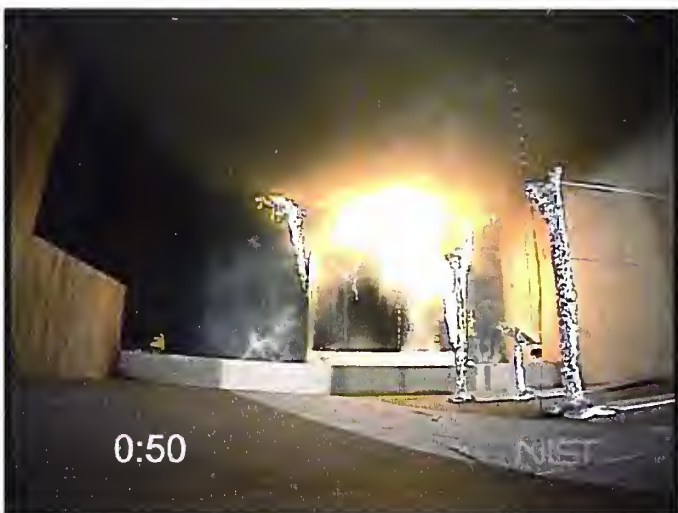
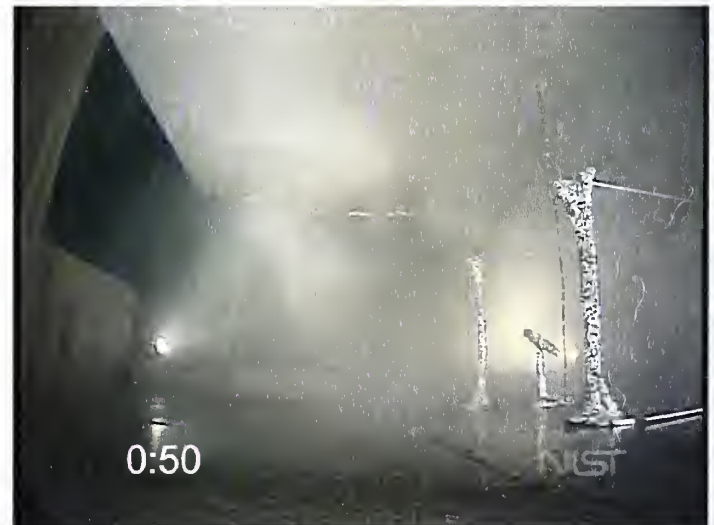
The succession of video frames on the left of Fig. 4-20 show how rapidly the fire spreads during the first 50 seconds, compared to how quickly the fire is controlled with sprinklers in the frames along the right. The first sprinkler activates on the right of the platform 24 seconds after ignition. By 30 seconds the sprinkler above the platform on the left and the sprinkler in the alcove have activated.

**Figure 4-20. Still frames taken from video of full-scale mock-up experiments. Time after ignition is indicated in lower left of each frame. Left column: unsprinklered; right column: sprinklered (first head activates at 24 seconds)**

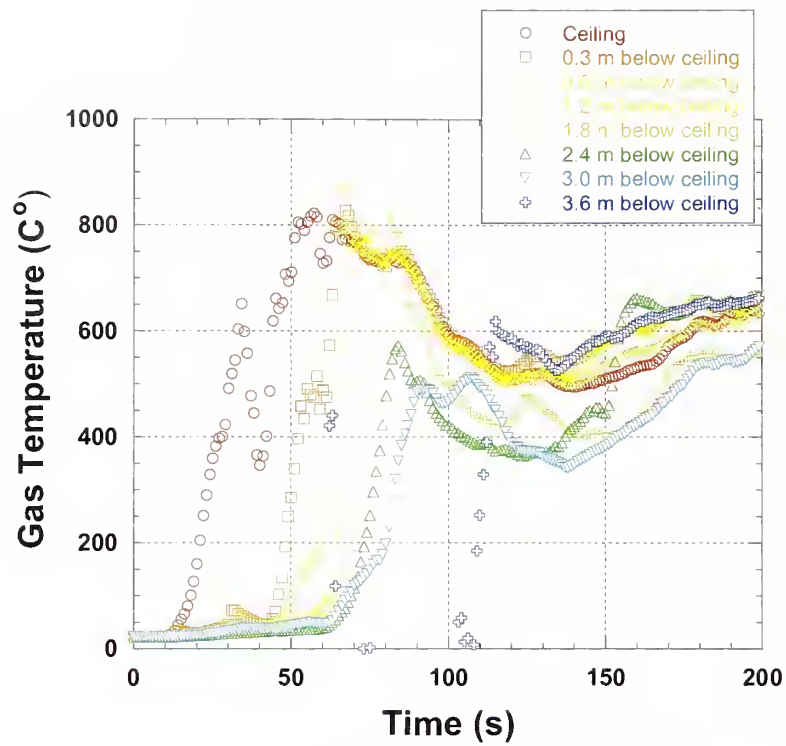
Figure 4-22. Temperatures versus Time for Unsprinklered Mockup Test. Thermocouples positioned on Platform (Location B) from ceiling to platform floor.

For the unsprinklered case, the temperature at the ceiling measured at location B (Fig. 4-22) began to increase within 10 seconds of ignition and continued to increase to over 800 °C in approximately 50 seconds. In less than 60 seconds, the temperature exceeded 50 °C at 1.4 m (4.5 ft) above the floor (2.4 m below the ceiling). The hot gases began to form an upper layer and the layer began to descend; in just over 110 seconds, the temperature at the floor of the platform had increased to over 600 °C.
