NIST NCSTAR 2: Vol. I

# Report of the Technical Investigation of The Station Nightclub Fire

June 2005

A fire occurred on the night of Feb. 20, 2003, in The Station nightclub at 211 Cowesett Avenue, West Warwick, Rhode Island. A band that was on the platform that night, during its performance, used pyrotechnics that ignited polyurethane foam insulation lining the walls and ceiling of the platform. The fire spread quickly along the walls and ceiling area over the dance floor. Smoke was visible in the exit doorways in a little more than one minute, and flames were observed breaking through a portion of the roof in less than five minutes. Egress from the nightclub, which was not equipped with sprinklers, was hampered by crowding at the main entrance to the building. One hundred people lost their lives in the fire. On Feb. 27, 2003, under the authority of the National Construction Safety Team (NCST) Act, the National Institute of Standards and Technology (NIST) established a National Construction Safety Team to determine the likely technical cause or causes of the building failure that led to the high number of casualties in that fire. This report documents the procedures, findings,

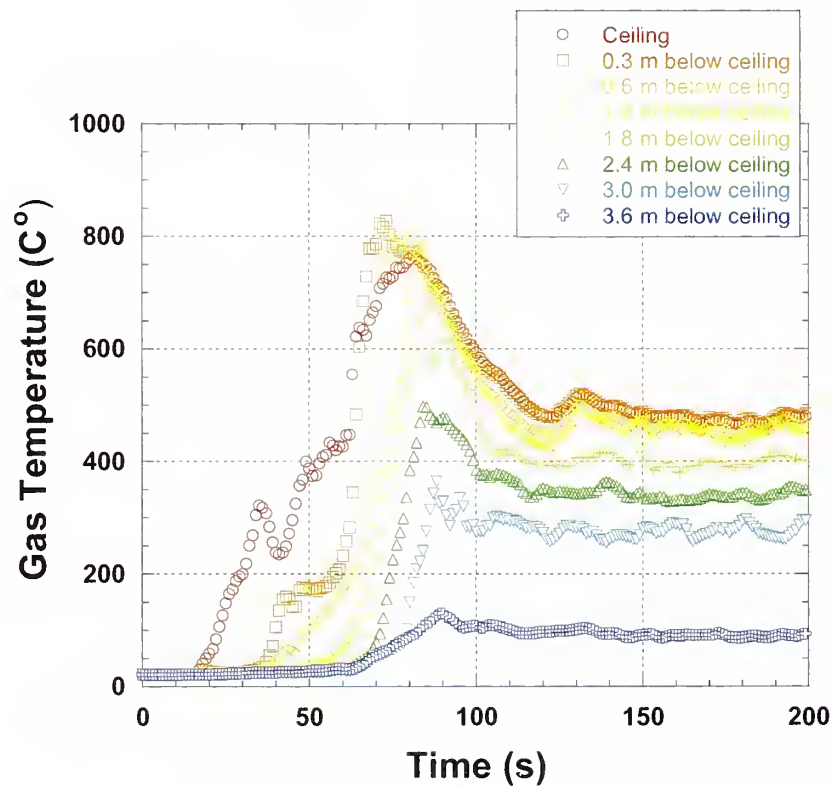
Figure 4-23. Temperatures versus Time for Unsprinklered Mockup Test. Thermocouples positioned on Main Floor (Location C) from ceiling to floor.

The thermocouple array at location C was installed 6.7 m from the foam covered platform wall, 3 m further away from the platform wall than the thermocouples at location B. The temperatures required about 15 seconds longer to begin increasing than those measured at location B, and required approximately 70 seconds to reach peak temperatures of 800 °C. From Fig. 4-23 one can see that the temperatures at 3.6 m below the ceiling did not begin to increase until 60 seconds after ignition and then the temperatures reached peak values of approximately 100 °C in 90 s. The temperatures at location C exceeded 50 °C at the 1.4 m (4.5 ft) above the floor (2.4 m below the ceiling) elevation in less than 70 seconds.

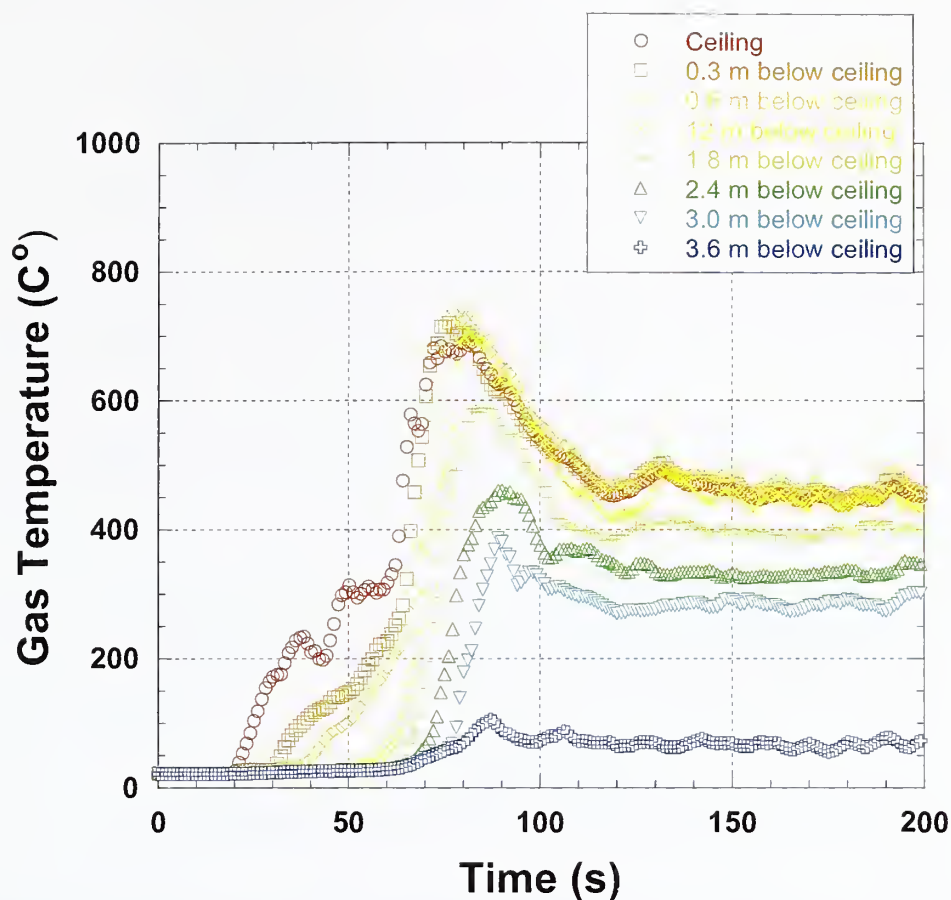
**Figure 4-24. Temperatures versus Time for Unsprinklered Mockup Test. Thermocouples positioned on Main Floor (Location D) from ceiling to floor.**

The thermocouple array at location D was installed 8.5 m from the foam covered platform wall, an additional 1.8 m further away from the platform wall than the thermocouples at location C. The temperatures began to rise in about 20 seconds (see Fig. 4-24), and required approximately 80 seconds to reach peak temperatures of 700 °C. The temperatures at 3.6 m below the ceiling did not begin to increase until 70 seconds after ignition and reached peak values of approximately 100 °C in 90 s. The temperatures near the floor at location D were about the same as the values recorded at the floor on the platform, Location C.

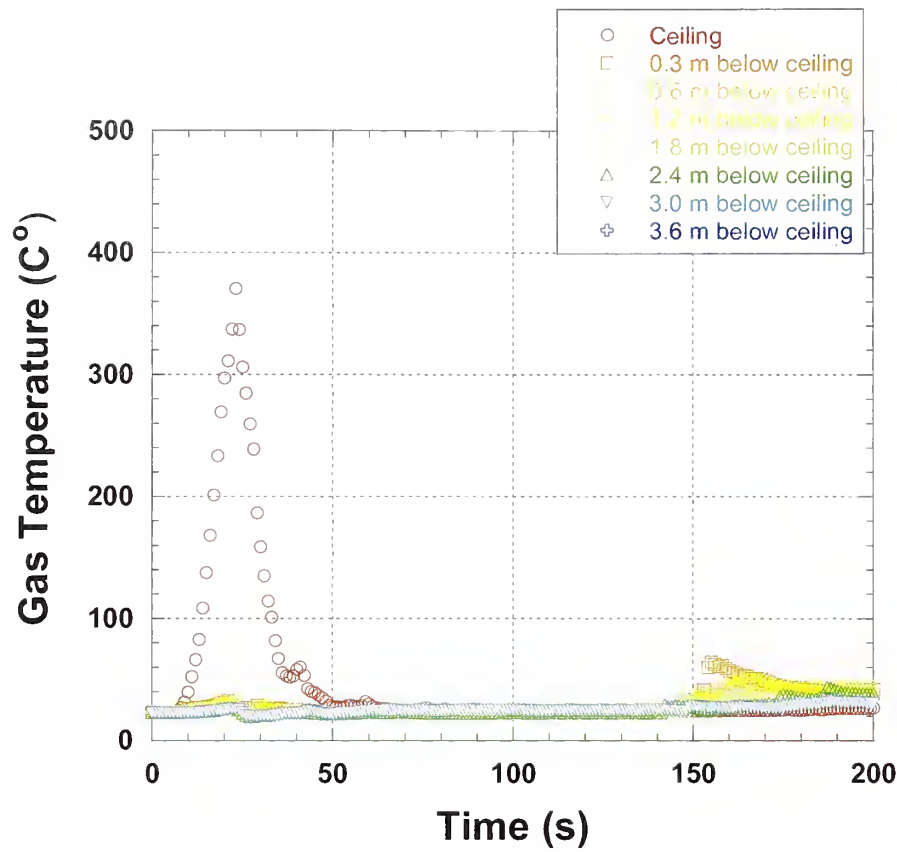
Figure 4-25. Temperatures versus Time for Sprinklered Mockup Test. Thermocouples positioned on Platform (Location B) from ceiling to platform floor.

For the sprinklered test burn, the ceiling thermocouple at location B (on the platform) recorded a peak temperature of 380 °C about 20 seconds after ignition, as can be seen in Fig. 4-25. When the sprinkler activated, the ceiling temperature quickly decreased, dropping to about 20 °C within 40 seconds of ignition. The activation of the sprinklers caused the other thermocouples at lower elevations to record near ambient temperatures throughout the test burn.

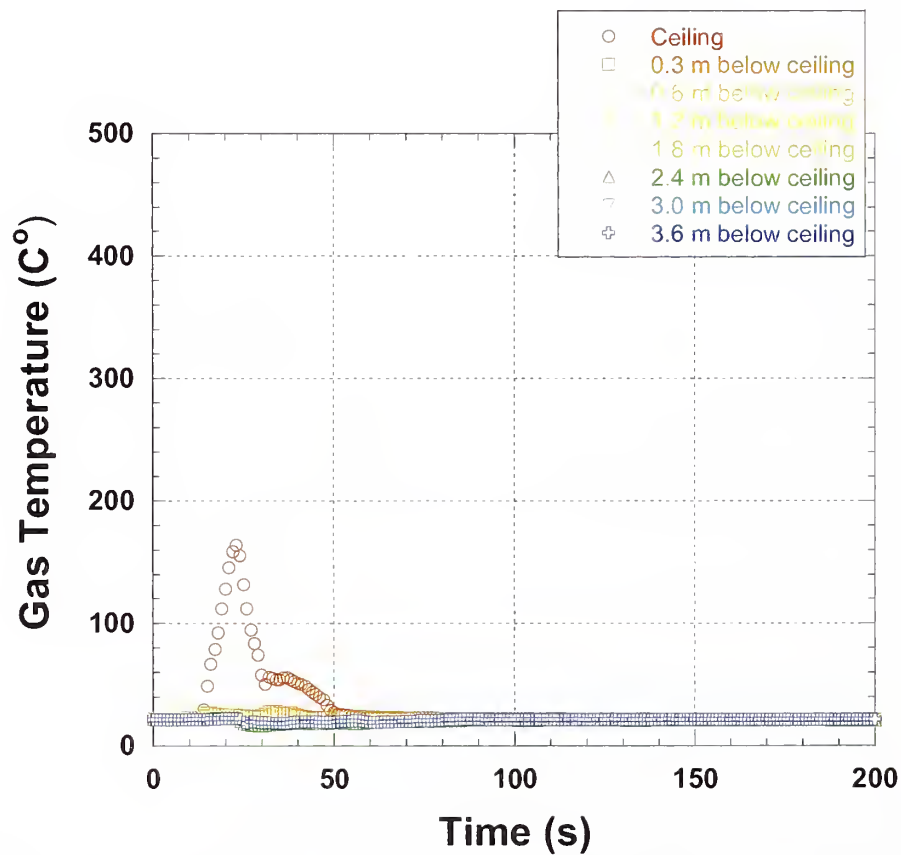
Figure 4- 26. Temperatures versus Time for Sprinklered Mockup Test. Thermocouples positioned on Main Floor (Location C) from ceiling to floor.

At location C (Fig. 4-26), the ceiling temperatures reached a peak temperature of 170 °C in about 20 seconds and declined to near ambient temperatures within 60 seconds. For location D (Fig. 4-27), the ceiling temperatures reached a peak temperature of 130 °C in about 20 seconds and declined to near ambient temperatures within 60 seconds. Thermocouples at lower elevations for both locations appeared to remain at near ambient temperatures throughout the test.

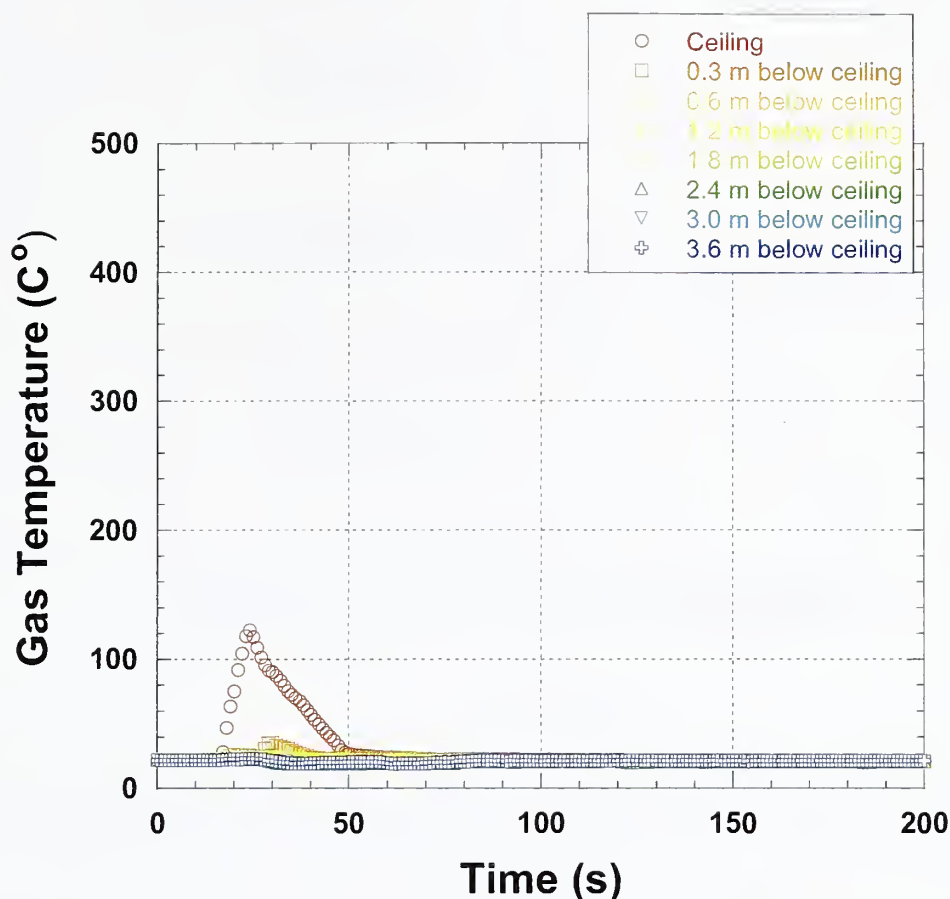
**Figure 4-27. Temperatures versus Time for Sprinklered Mockup Test. Thermocouples positioned on Main Floor (Location D) from ceiling to floor.**

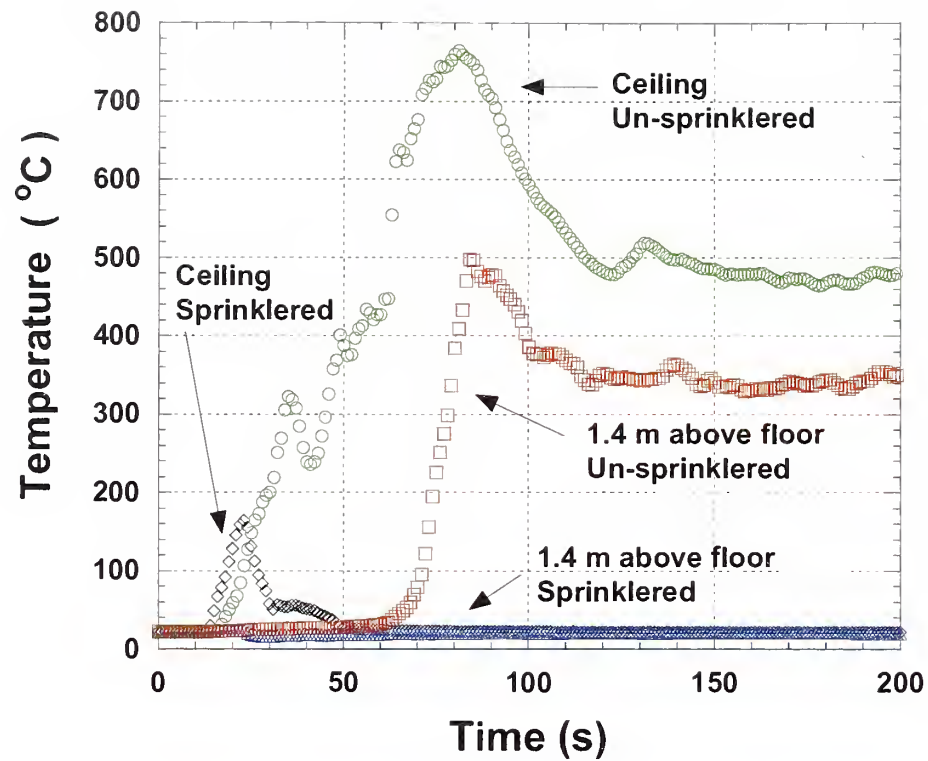
The comparison between the temperatures at the ceiling and 1.4 m above the floor for the sprinklered and unsprinklered experimental data is striking, as demonstrated in Fig. 4-28a for location C and Fig. 4-28b for location D. At 25 seconds, the temperatures at the ceiling were about 175 °C at location C and 125 °C at location D for both experiments, indicative of the fire being properly replicated up to the point when the sprinkler activated. During the next 25 seconds the temperatures throughout the compartment returned to close to ambient conditions in the sprinklered compartment. This compared to a continuing rapid rise in temperatures for the unsprinklered compartment, which reached ceiling temperatures in excess of 300 °C at 50 seconds, and peaks of 700 °C plus in the following 25 seconds. Peak temperatures of 400 °C to 500 °C were reached 1.4 m above the floor for the unsprinklered test; temperatures did not rise at all for the sprinklered compartment at this location.

Figure 4-28a. Temperatures versus Time for Unsprinklered and Sprinklered Mockup Test. Thermocouples positioned on Main Floor (Location C) at ceiling and 1.4 m (4.5 ft) above floor.

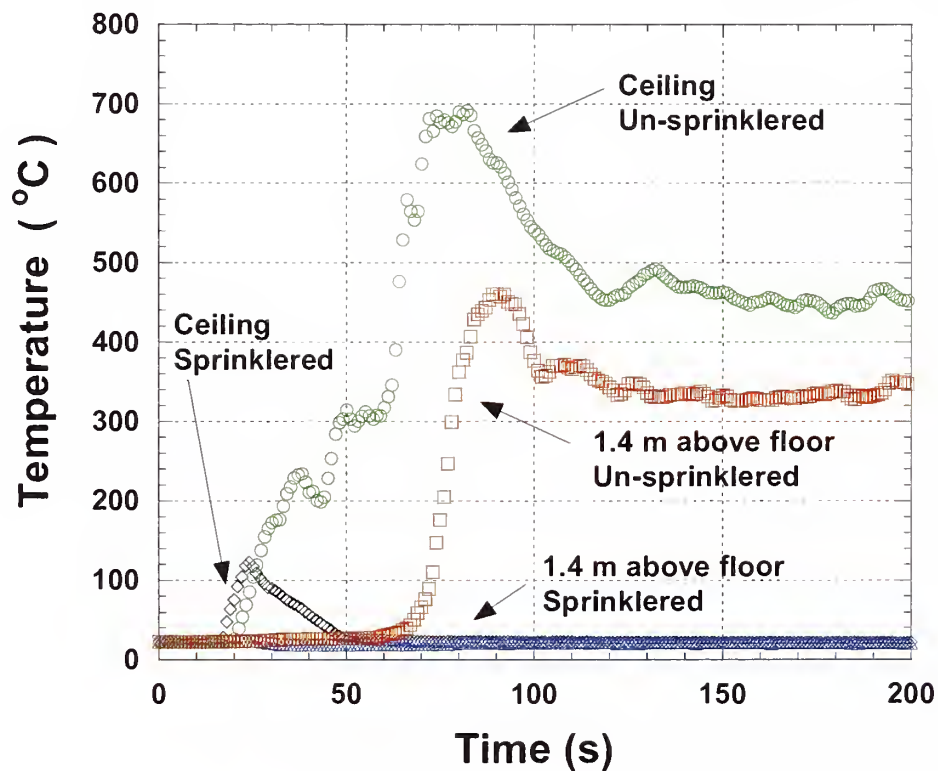
Figure 4-28b. Temperatures versus Time for Unsprinklered and Sprinklered Mockup Test. Thermocouples positioned on Main Floor (Location D) at ceiling and 1.4 m (4.5 ft) above floor.

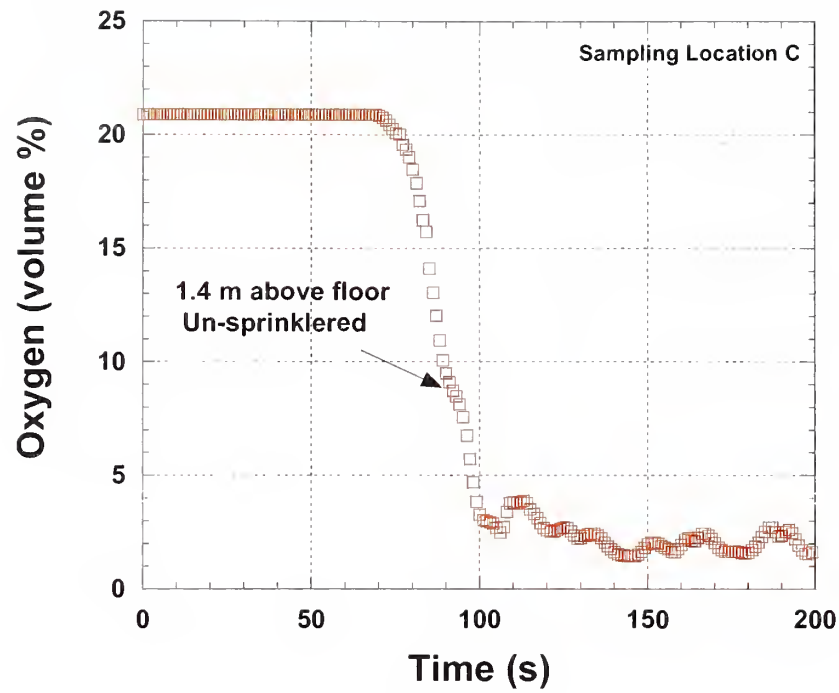
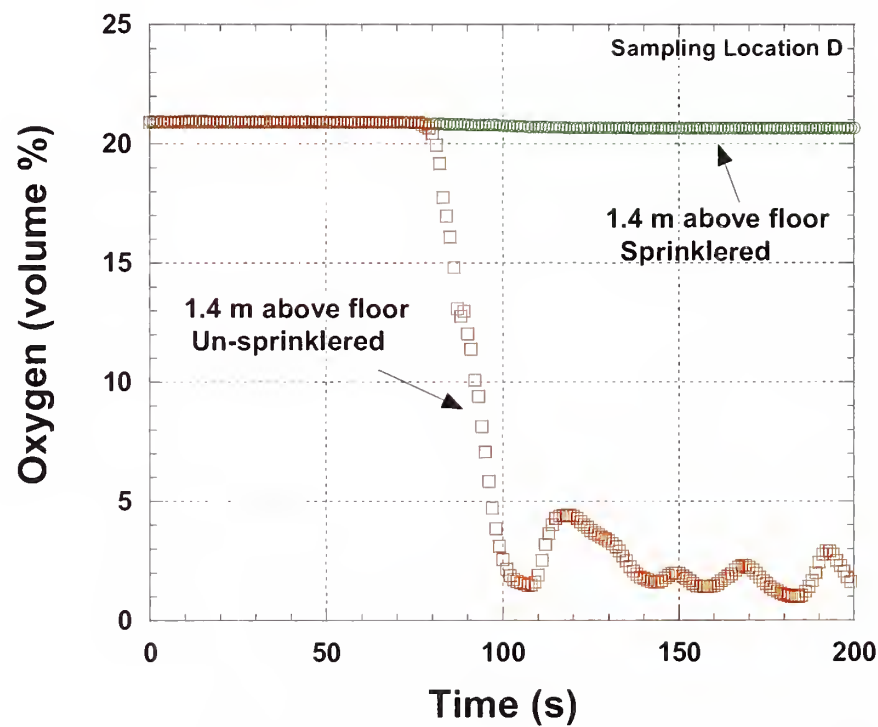
Figure 4- 30. Oxygen Volume Fraction vs Time for Unsprinklered and Sprinklered Mockup Test. Gas Sampling probe positioned on Main Floor (Location C) at 1.4 m (4.5 ft) above floor.

Figure 4-31. Oxygen Volume Fraction vs Time for Unsprinklered Mockup Test. Gas Sampling probe positioned on Main Floor (Location D) at 1.4 m (4.5 ft) above floor.

Gas volume fractions versus time are plotted for the unsprinklered and sprinklered tests in Figures 4-30 through 4-35 for O<sub>2</sub>, CO and HCN. (Additional gas volume fractions measurements are discussed in Appendix G.) At both locations C and D, oxygen volume fractions did not begin to drop at the 1.4 m elevation until 70 seconds to 80 seconds after ignition for the unsprinklered mock-up experiments. At both locations, the oxygen volume fractions descended to less than 4 % in less than 100 seconds, then fluctuated between 1 % and 4 % . During the sprinklered test burns, the oxygen mole fraction at location D did not appear to drop much below ambient oxygen levels. (A malfunctioning oxygen analyzer prevented the oxygen concentrations from being monitored at location D during the sprinklered burns.)

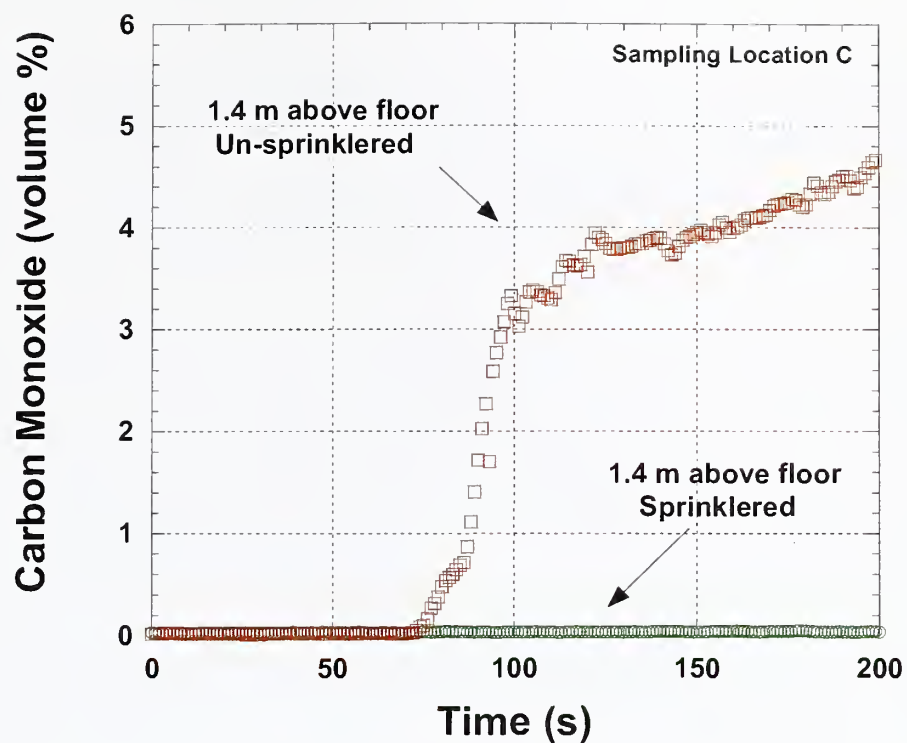
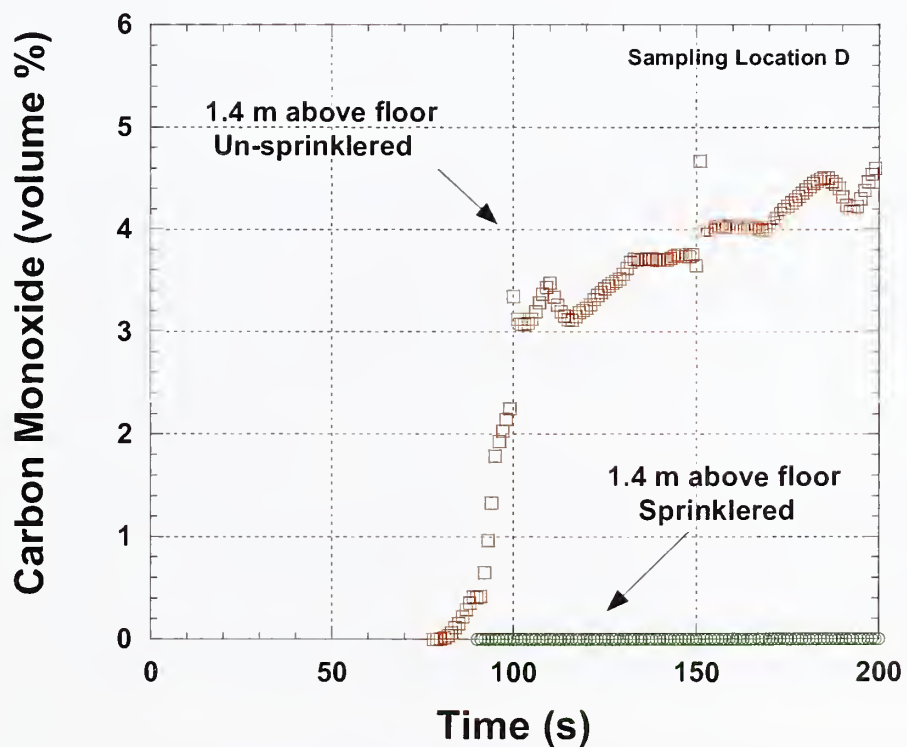
Figure 4-32. Carbon Monoxide Volume Fraction vs Time for Unsprinklered and Sprinklered Mockup Test. Gas Sampling probe positioned on Main Floor (Location C) at 1.4 m (4.5 ft) above floor.

Figure 4-33. Carbon Monoxide Volume Fraction vs Time for Unsprinklered and Sprinklered Mockup Test. Gas Sampling probe positioned on Main Floor (Location D) at 1.4 m (4.5 ft) above floor.

At both locations C and D, volume fractions of carbon monoxide at the 1.4 m elevation did not begin to increase until 70 seconds to 80 seconds after ignition for the unsprinklered mock-up experiments, but then increased to 3 % in the next 20 seconds to 30 seconds and reached 4.5 % by 200 seconds after ignition. During the sprinklered test burns, the carbon monoxide concentration at neither location C nor location D appeared to increase much above ambient levels.

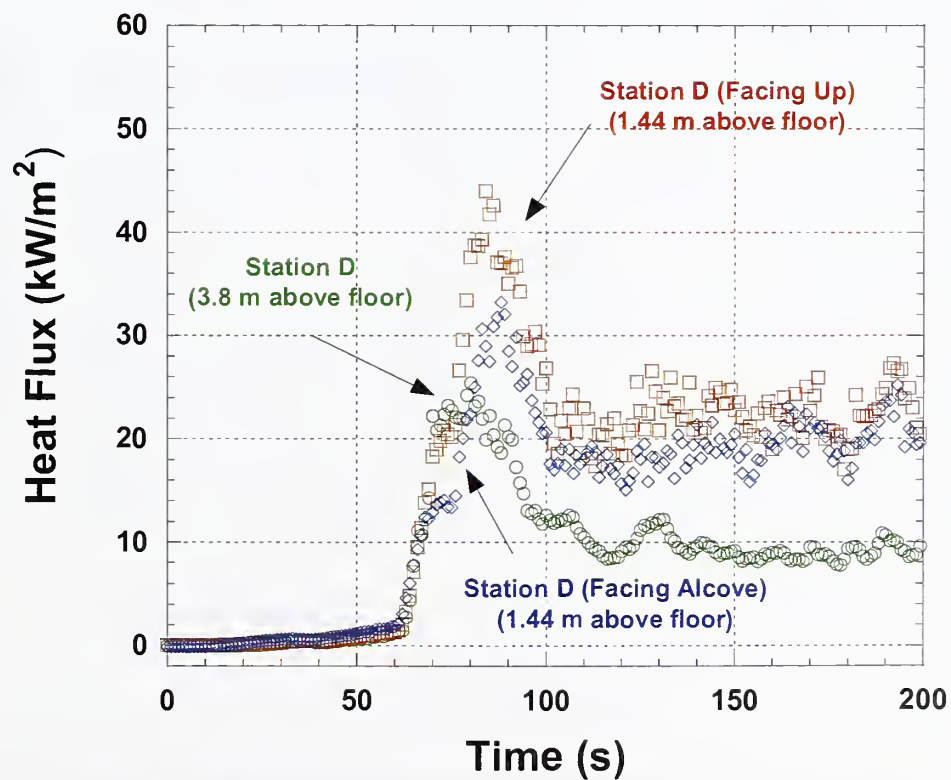
For the unsprinklered compartment test, the output of the thermal radiation and total heat fluxes for the radiometer and heat flux gauges at locations C and D are shown in Fig. 4-37 and Fig 4-38. At location C, peak fluxes in excess of 50 kW/m<sup>2</sup> were reached about 70 seconds after ignition. Peak fluxes at location D were about 20 % lower than location C. At 100 seconds after ignition, radiation and heat flux at

location C and the heat flux at location D decreased significantly to  $20 \text{ kW/m}^2$  and appeared to remain relatively constant at both locations. The radiometer in the ceiling at location D dropped to  $10 \text{ kW/m}^2$  before becoming relatively steady. (Additional plots of heat flux are shown and discussed in App. G.)

Figure 4- 37. Heat Fluxes versus time for unsprinklered mockup test. Radiometer positioned flush with ceiling (3.8 m above floor); heat flux gauges facing up (1.44 m above floor), and facing alcove (1.44 m above floor) at sampling location C.

Figure 4- 38. Heat fluxes versus time for unsprinklered mockup test. Radiometer positioned flush with ceiling (3.8 m above floor); heat flux gauges facing up (1.44 m above floor), and facing alcove (1.44 m above floor) at sampling location D.

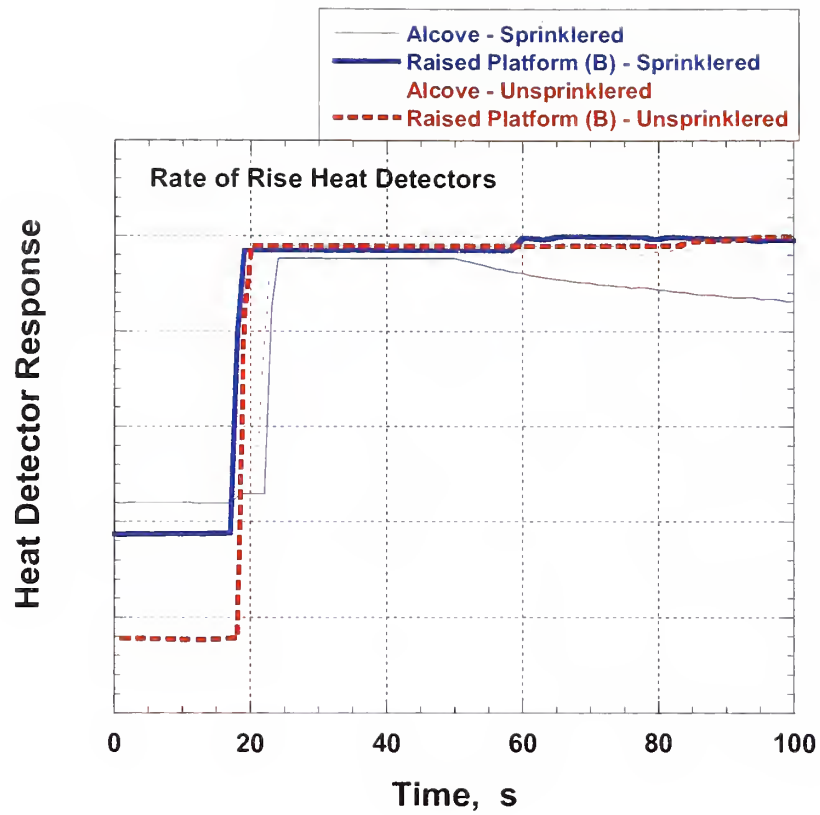
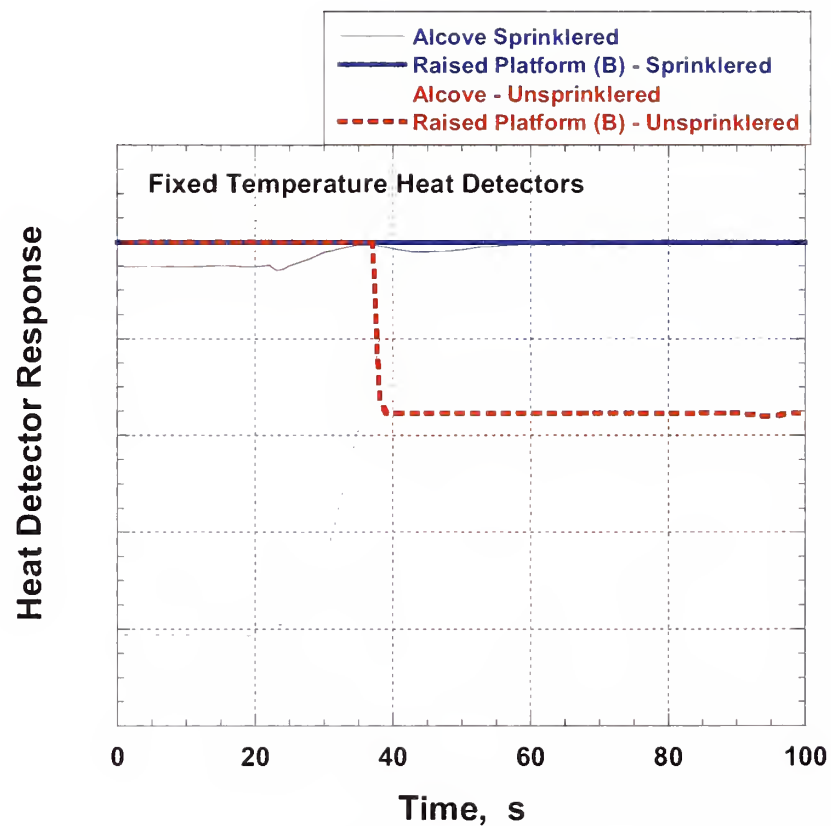
The responses of rate of rise heat detectors and fixed temperature detectors are plotted in Fig. 4-39 and Fig. 4-40, respectively. For both unsprinklered and sprinklered test burns, each of the rate of rise detectors activated in less than 20 seconds. Only in the unsprinklered experiments did the fixed temperature detectors activate. The fixed temperature detector in the alcove activated in about 20 seconds while the fixed temperature detector above the platform required almost 40 seconds to respond.

Figure 4- 39. Response of Rate of Rise Heat Detectors versus Time for Unsprinklered and Sprinklered Mockup. Detectors located in Alcove and at Location B.

Figure 4- 40. Response of Fixed Temperature Heat Detectors versus Time for Unsprinklered and Sprinklered Mockup. Detectors located in Alcove and at Location B.

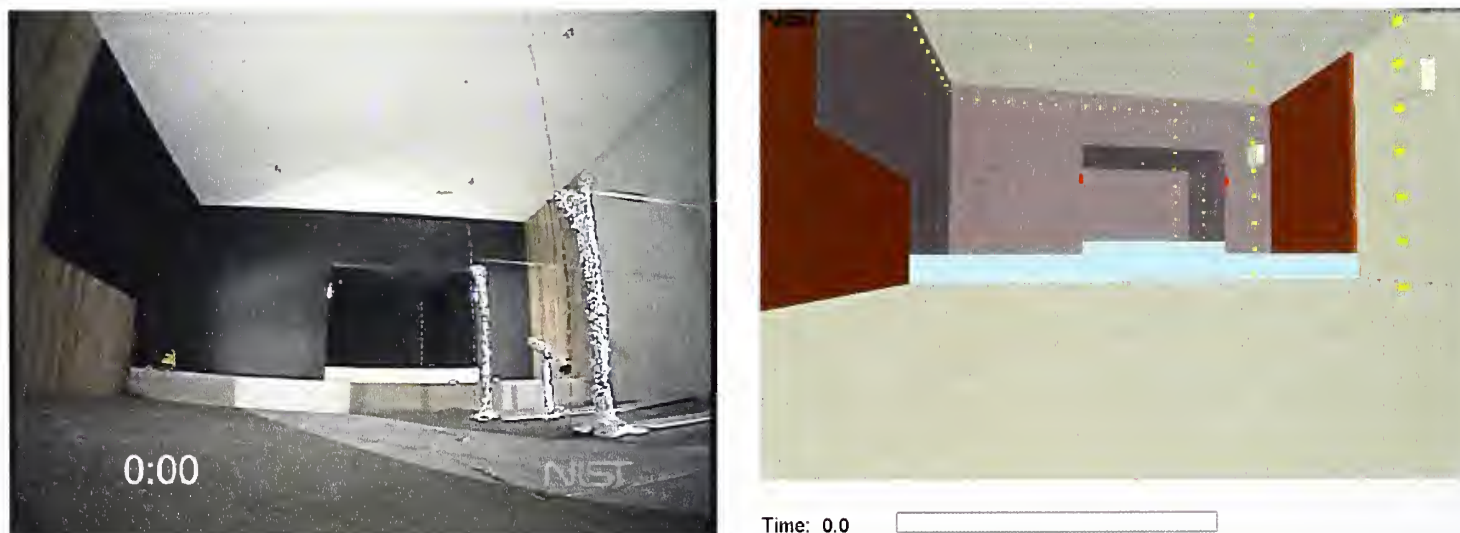
Figure 5-2. Ignition at the corners of the drummer's alcove,  $t = 0$  second.

Figure 5-2 shows the experiment and the simulation at the time of ignition. The video frame on the left shows the foam covered walls, the wood paneling, and the carpeted platform. Gypsum board covered the ceiling, floor and the remaining wall areas that were not covered with wood paneling or foam. Some of the instrumentation can be seen in the foreground of the video frame. In the image from the simulation, on the right, the comparable interior finishes can be seen. The instrumentation in the right figures is represented by colored dots. The thermocouples appear as yellow dots in evenly spaced arrays. The light gray blocks represent the locations of the heat flux sensors and the gas sampling locations, which were installed at approximately 1.5 m (5 ft) above the floor.

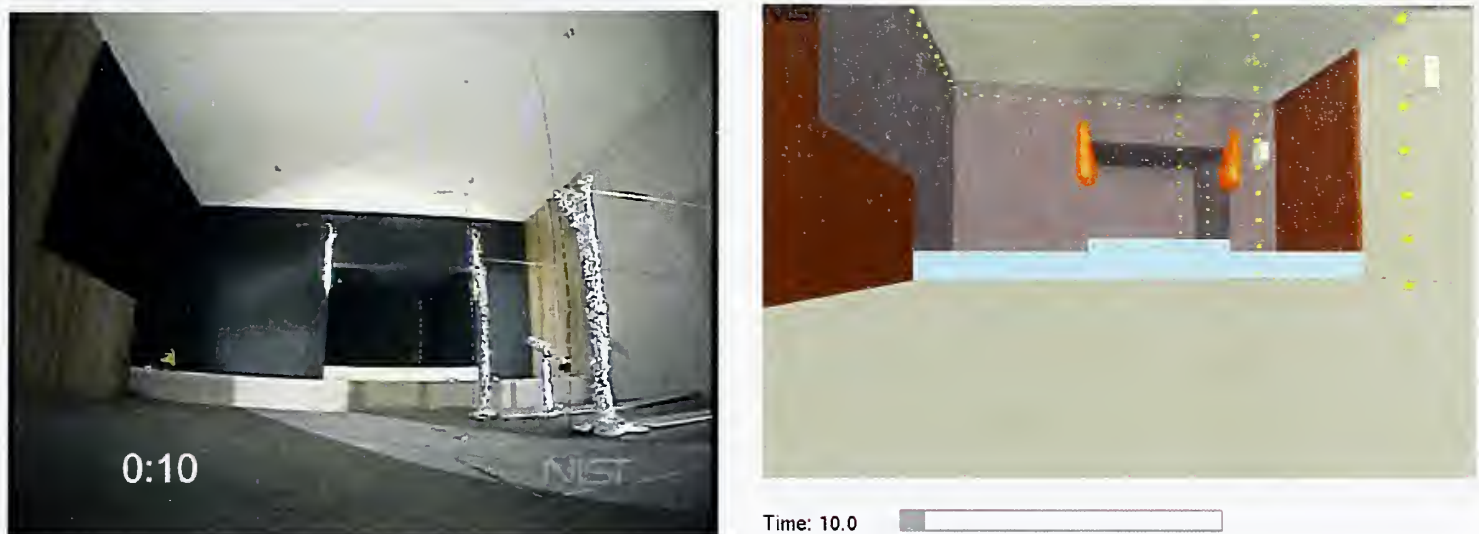
**Figure 5-3. Flames spreading toward ceiling,  $t = 10$  seconds after ignition.**

Figure 5-3 compares the fire development at 10 seconds after ignition. A flame is shown on both corners where the platform wall intersects with the drummer's alcove. In the case of FDS, the area that appears to be involved with flames is based on the stoichiometric mixture fraction, where there is the ideal mixture of fuel and oxygen for a robust flame to exist. The heat release rate per unit volume represented by the simulated flames is  $285.5 \text{ kW/m}^3$ . The flames in the simulation appear wider due to the grid resolution, which is 100 mm (4 in) throughout the room.

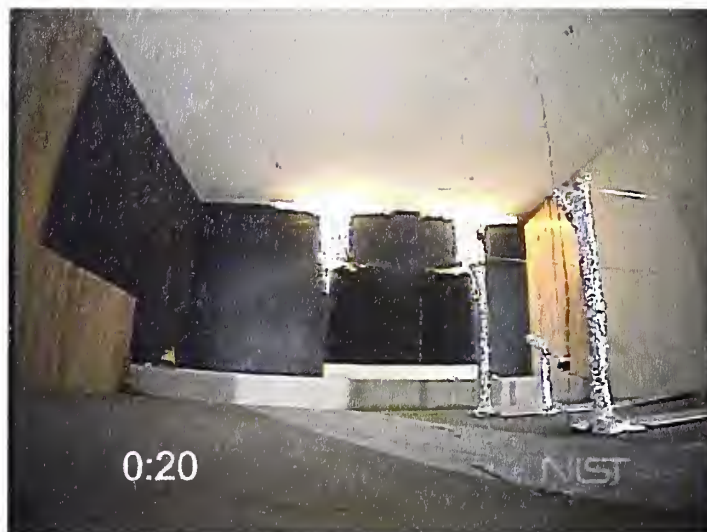
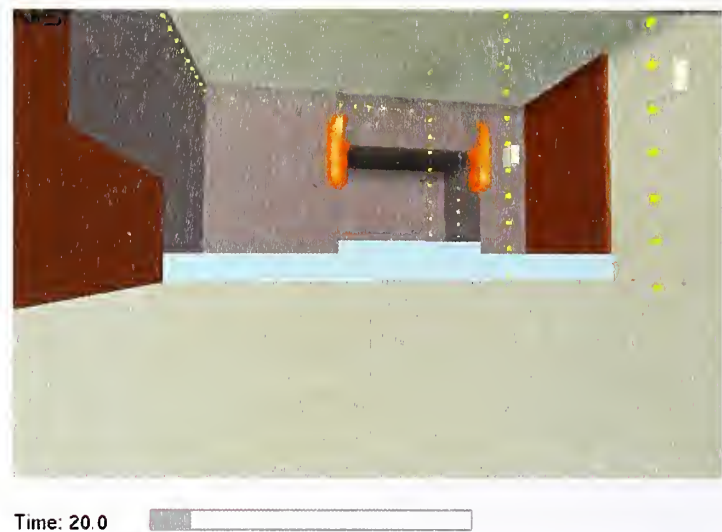
The video frame to the left in Figure 5-4 shows flames 20 seconds after ignition growing vertically and impinging on the ceiling. The simulated flames on the right, however, have not yet reached the ceiling. As noted above, the simulated flame is constrained to grow in 100 mm (4 in) increments, both vertically and laterally. This may account for the wider flame and the accompanying redistribution of energy that would reduce the propensity for rapid vertical flame spread. Light smoke can be seen in both images along the ceiling of the alcove, with light wisps of smoke along the ceiling above the platform.

**Figure 5-4. Flames impinging on ceiling,  $t = 20$  seconds after ignition.**

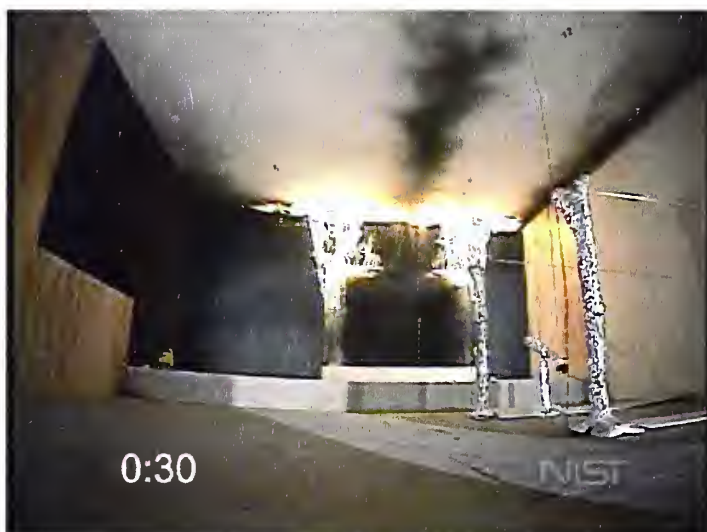
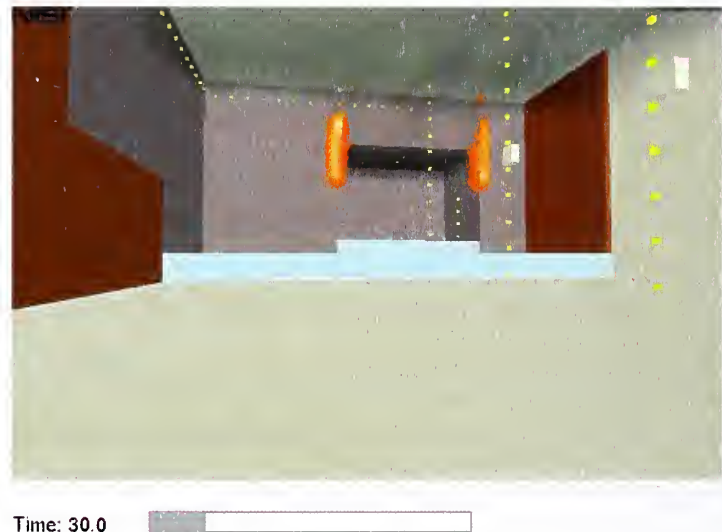
**Figure 5-5. Visible smoke spreading across ceiling,  $t = 30$  seconds after ignition.**

Figure 5-5 shows an increased amount of smoke flow across the ceiling at 30 seconds after ignition. The actual fire continues to grow at a faster rate than the simulated flames. In the video frame on the left the flames have formed twin V-patterns on each side of the alcove and the flames are spreading across the alcove ceiling. Notice the light smoke that is coming up from the carpeting below the two fire plumes. This is the result of foam melting and the burning foam droplets falling to the floor. This mode of flame spread is not accounted for within the FDS model. At 40 seconds after ignition, the video frame in Figure 5-6 shows areas of the foam on the platform wall have burned out (note the dark area directly above the point of ignition on the left side of the alcove). The actual flame fronts have continued to spread and into the alcove, where fire is visible on portions of the side walls and the ceiling of the alcove. The flames simulated with FDS have also grown, although at a slower rate. Both of the simulated flames have impinged on the ceiling.

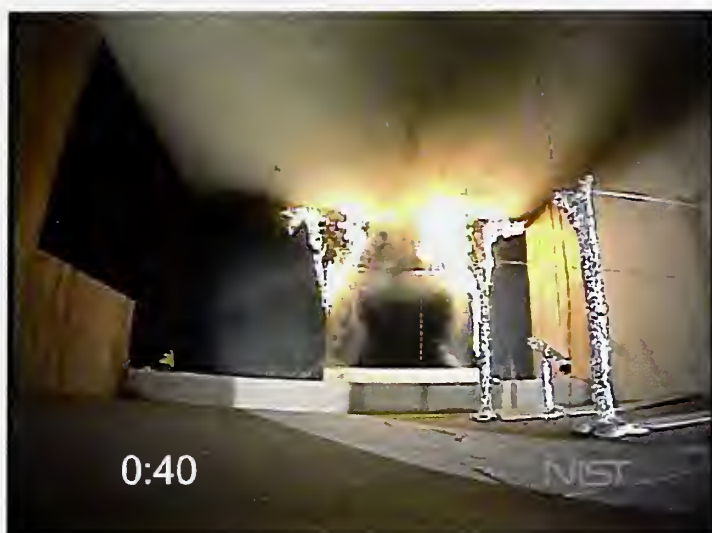
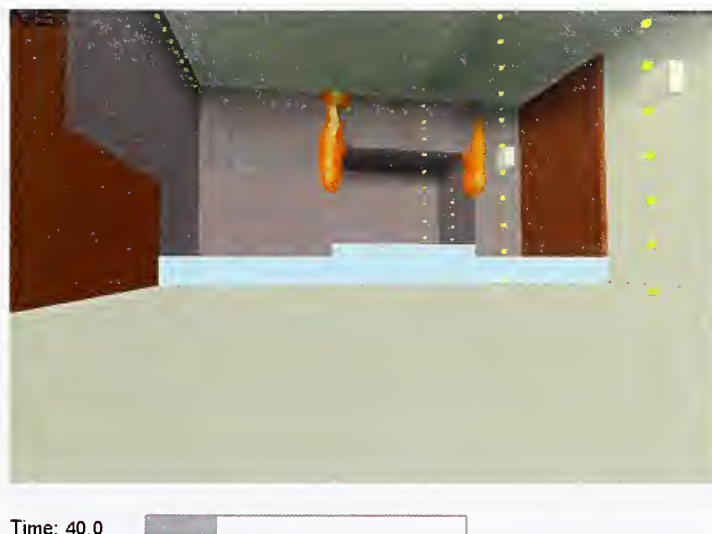
**Figure 5-6. Flames continue to spread into alcove,  $t = 40$  seconds after ignition.**

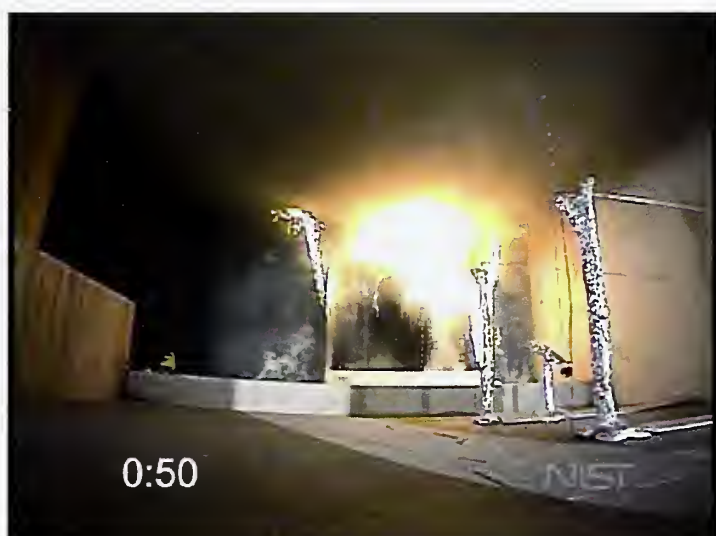
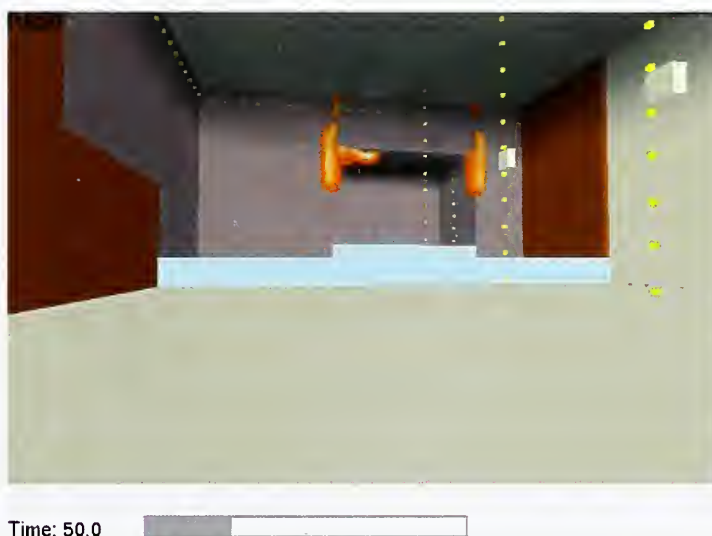
**Figure 5-7. Ceiling of alcove fully involved in fire,  $t = 50$  seconds after ignition.**

Figure 5-7, has images captured at 50 seconds after ignition. In the experiment, it appears that the entire ceiling of the alcove is burning, as well as the area of the platform wall above the opening to the alcove. There is also more smoke from drop-down of the burning foam onto the carpet, both in the alcove and on the platform. In the simulation, the flames have moved into the alcove and are spreading across the ceiling. In both images, the smoke or hot gas layer has developed across the ceiling of the enclosure.

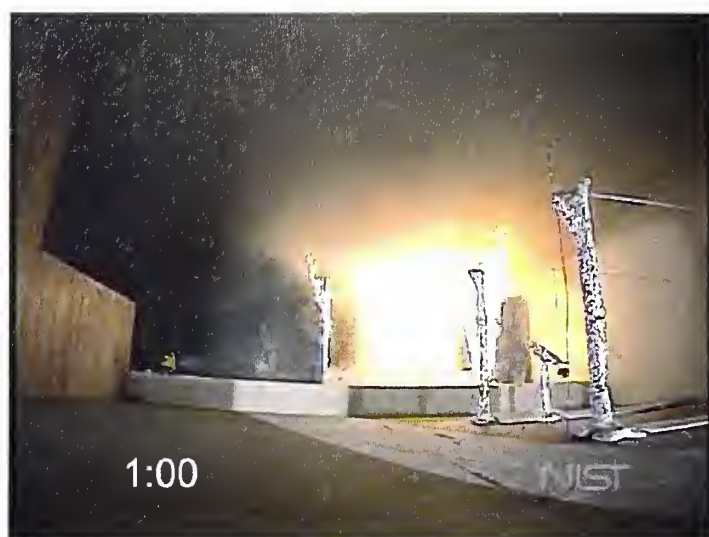
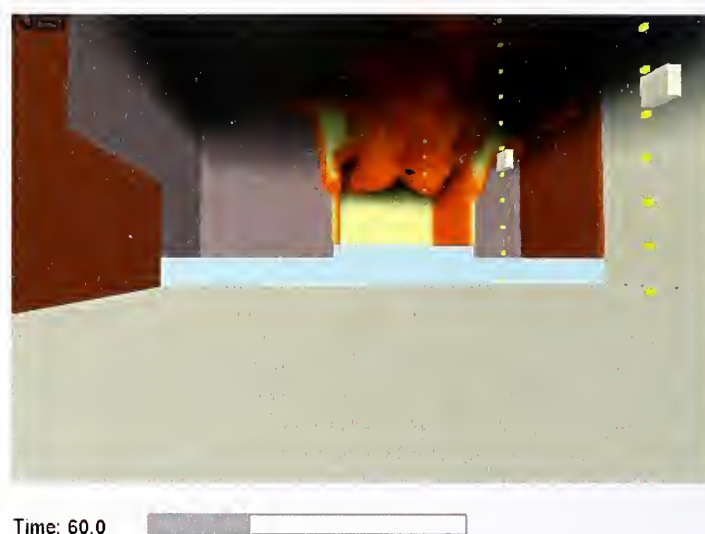
In Figure 5-8, the ceiling and the walls of the alcove have become fully involved with fire in both of the images. At 60 seconds after ignition, flashover has already occurred in the experiment and flashover is about to occur in the simulation. In both cases, flames are extending out of the alcove across the ceiling and the smoke layer has become thicker and darker.

**Figure 5-8. Flashover has occurred in alcove area,  $t = 60$  seconds after ignition.**

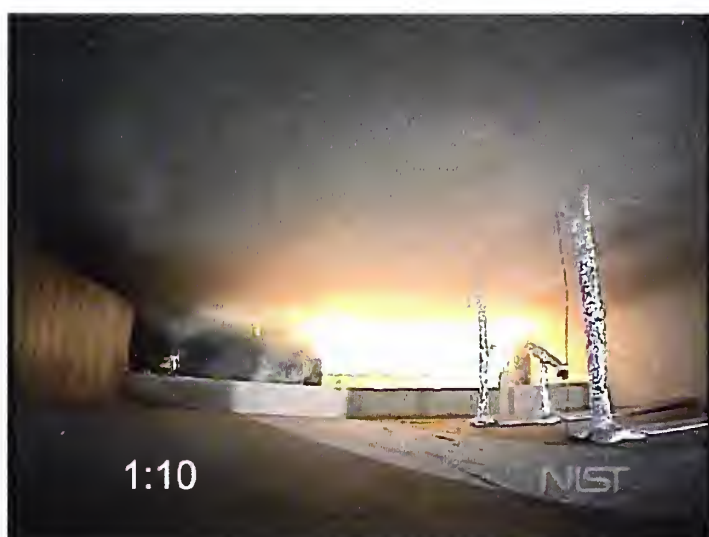
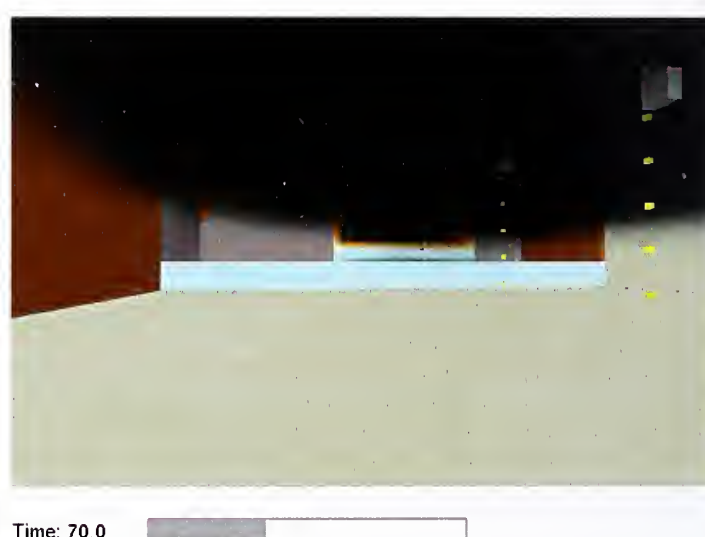
**Figure 5-9. Smoke layer has dropped to 1.5 m above floor,  $t = 70$  seconds after ignition.**

The images in Figure 5-9 show a significant increase in the amount of the smoke in the enclosure. The smoke layer has descended to within 1.5 m (5 ft) of the floor. The flames have spread along the wall behind the platform and can be seen at the lower edge of the smoke layer in both the video frame and the image from the simulation. The smoke in the experiment appears lighter in color than it actually is due to light that is being reflected from floor level halogen lights that were used to improve the visibility for the video cameras.

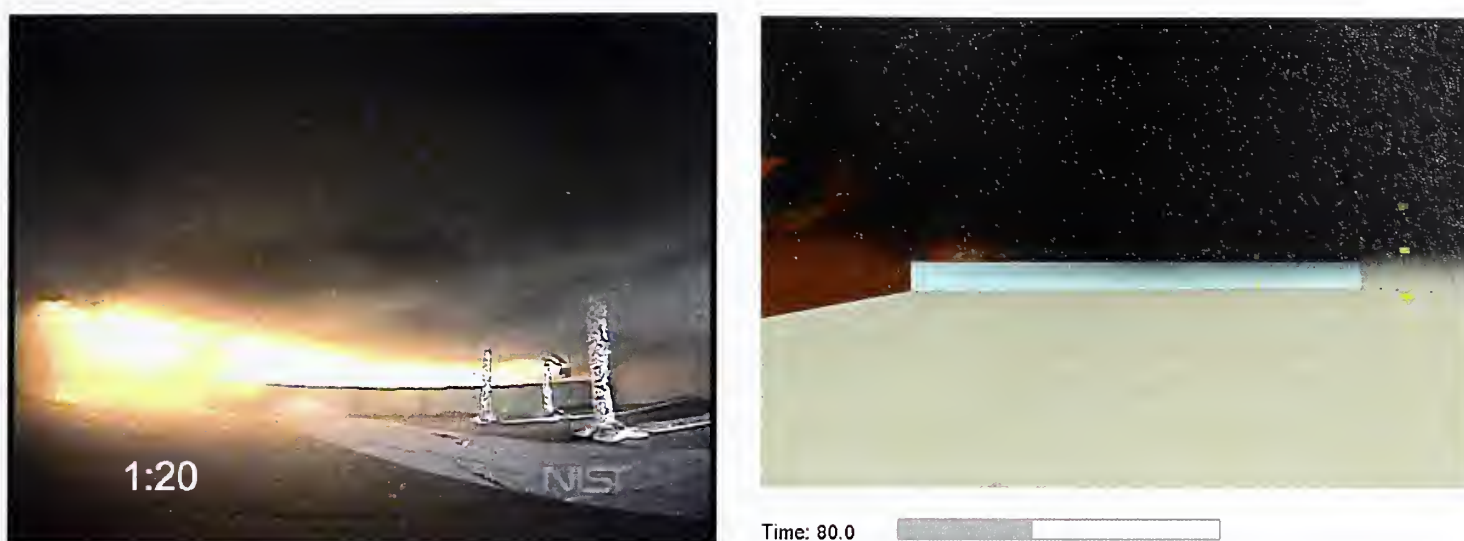
The fire continues to grow in both the experiment and the simulation as shown in Figure 5-10. The smoke layer has continued to descend. The interface height of the smoke layer is approximately 0.75 m (2.5 ft) above the floor at 80 seconds after ignition for both the experiment and the simulation. Both images also show the flame extension on the left wall of the enclosure. The upper portion of the left wall near the platform had foam installed over the paneling.

**Figure 5-10. Fire continues to spread,  $t = 80$  seconds after ignition.**

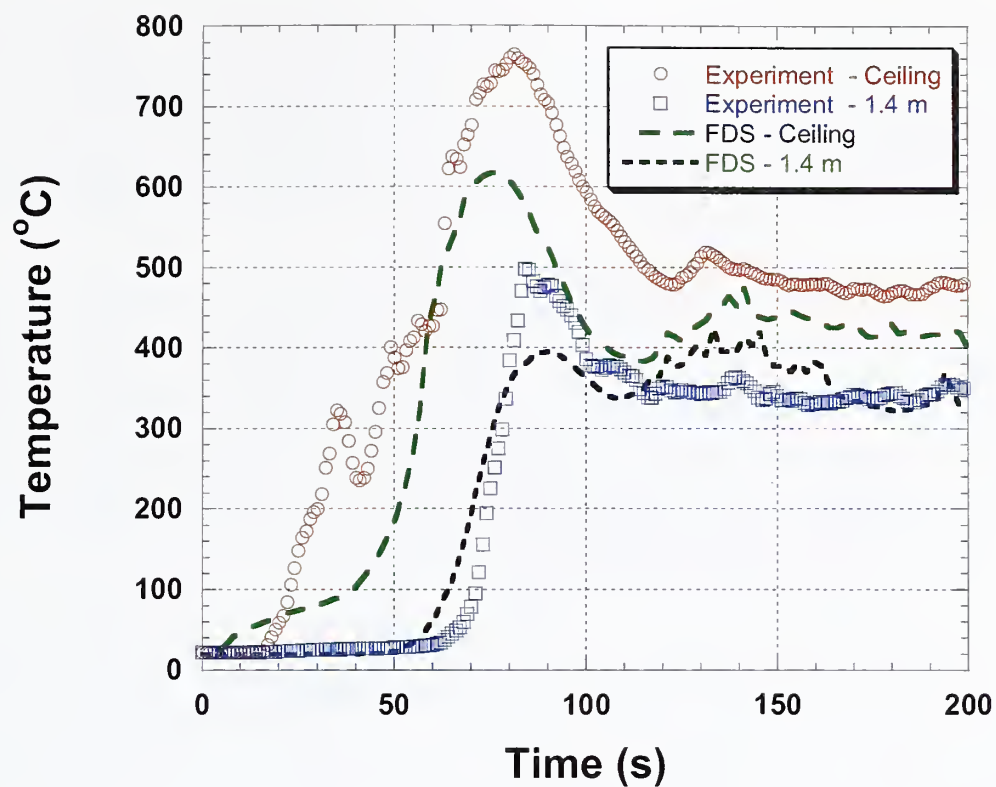
**Figure 5-13. Temperature comparison between the un-sprinklered fire experiment and the FDS simulation at Station C.**

Figure 5-13 is a comparison of the temperatures predicted and measured 25 mm below the ceiling and 1.4 m above the floor at the thermocouple array located at Station C (4.25 m west of the door opening or 1.7 m from the platform). The FDS output has been smoothed by applying a Stineman function (a geometric weight applied to the current point  $\pm 10\%$  of the data range). The temperature data show reasonable agreement with the predictions, including an overshoot followed by a leveling off as the fire reaches a ventilation limit. The temperatures near the ceiling increase faster in the test; conversely, the lower level temperatures increase at a slower rate in the test.

Note that, unlike the heat release rate, the temperature measurements respond to the local environment within a second; hence, the experimental temperatures and FDS predictions can be compared directly. Initially, the experimental measurements near the ceiling increase more rapidly than predicted. This is probably due to the strong transverse temperature gradients associated with the ceiling jets created early in the fire (see Fig. 5-5), where small differences in position between the experiment and simulation can have a large change in temperature. The simulated thermocouple temperatures are temperatures averaged over the grid cell volume(s) that they are associated with, which results in differences in positions between the experimental point measurement and the FDS output. The peak temperatures for the experiment and the simulation occur within 5 seconds of each other.
