NIST NCSTAR 2: Vol. I

# Report of the Technical Investigation of The Station Nightclub Fire

June 2005

A fire occurred on the night of Feb. 20, 2003, in The Station nightclub at 211 Cowesett Avenue, West Warwick, Rhode Island. A band that was on the platform that night, during its performance, used pyrotechnics that ignited polyurethane foam insulation lining the walls and ceiling of the platform. The fire spread quickly along the walls and ceiling area over the dance floor. Smoke was visible in the exit doorways in a little more than one minute, and flames were observed breaking through a portion of the roof in less than five minutes. Egress from the nightclub, which was not equipped with sprinklers, was hampered by crowding at the main entrance to the building. One hundred people lost their lives in the fire. On Feb. 27, 2003, under the authority of the National Construction Safety Team (NCST) Act, the National Institute of Standards and Technology (NIST) established a National Construction Safety Team to determine the likely technical cause or causes of the building failure that led to the high number of casualties in that fire. This report documents the procedures, findings,

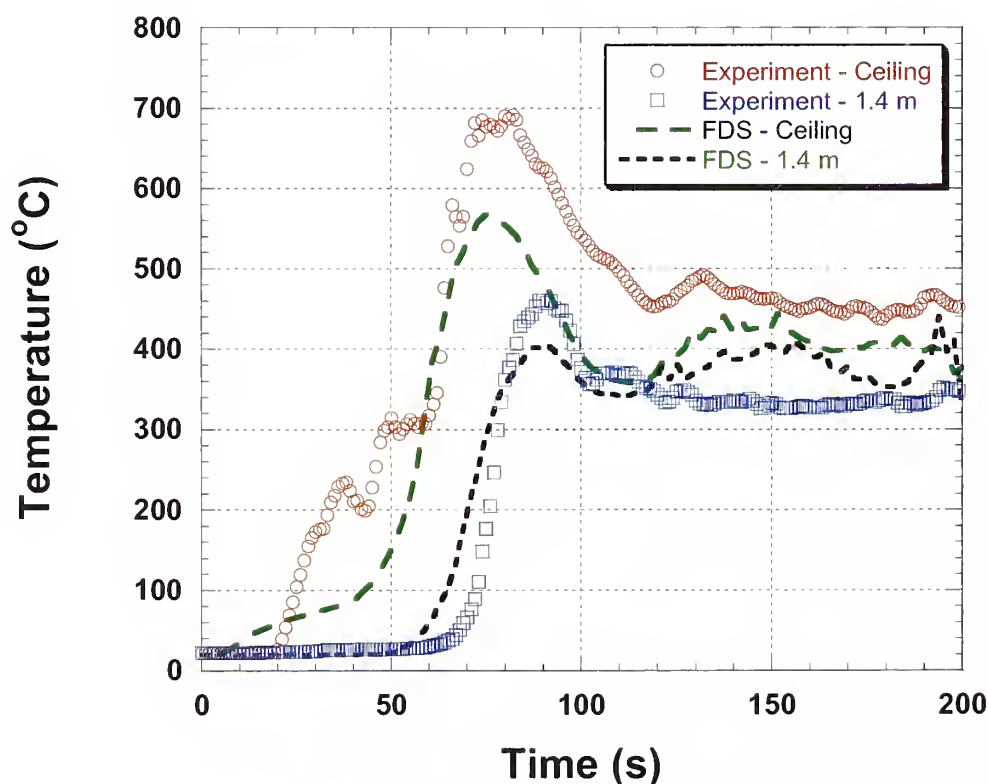
Figure 5-14 is a comparison of the temperatures predicted and measured 25 mm below the ceiling and 1.4 m above the floor at the thermocouple array located at Station D (2.35 m west of the door opening). Similar to the previous figure, the temperature data show reasonable agreement with the predictions. The trends are also similar and both of the measured temperatures and the predictions exhibit a reduction in peak temperatures relative to the values from Station C that is located approximately 2 m closer to the platform.

**Figure 5-14. Temperature comparison between the un-sprinklered fire experiment and the FDS simulation at Station D.**

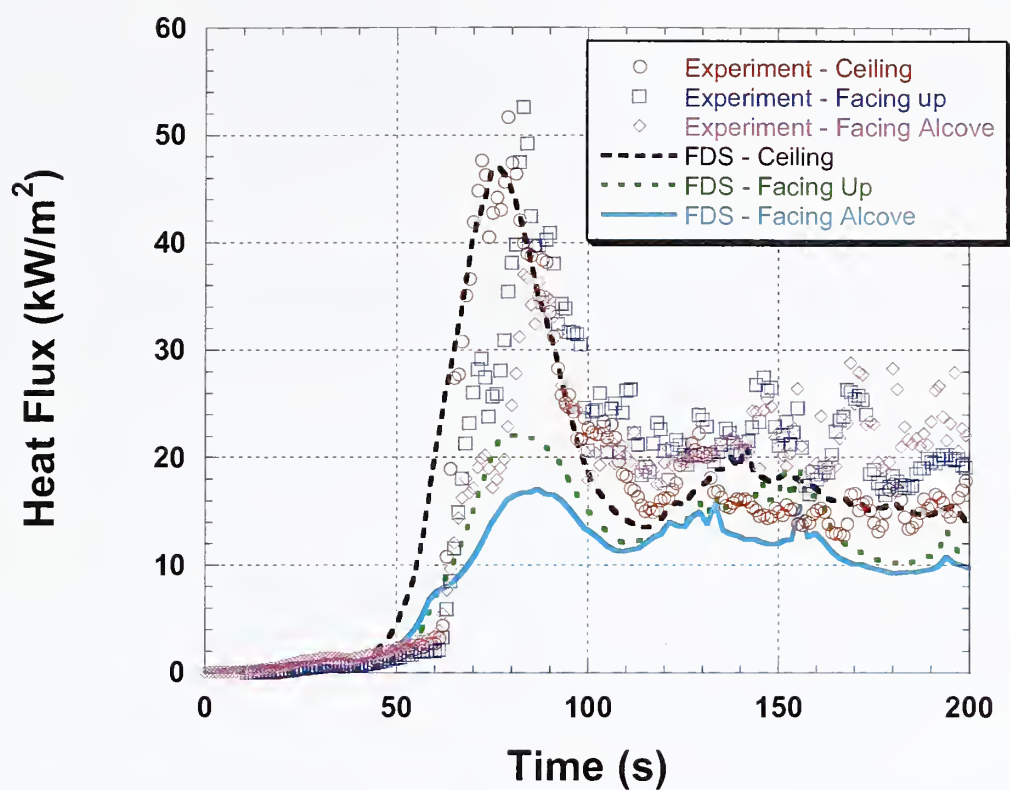
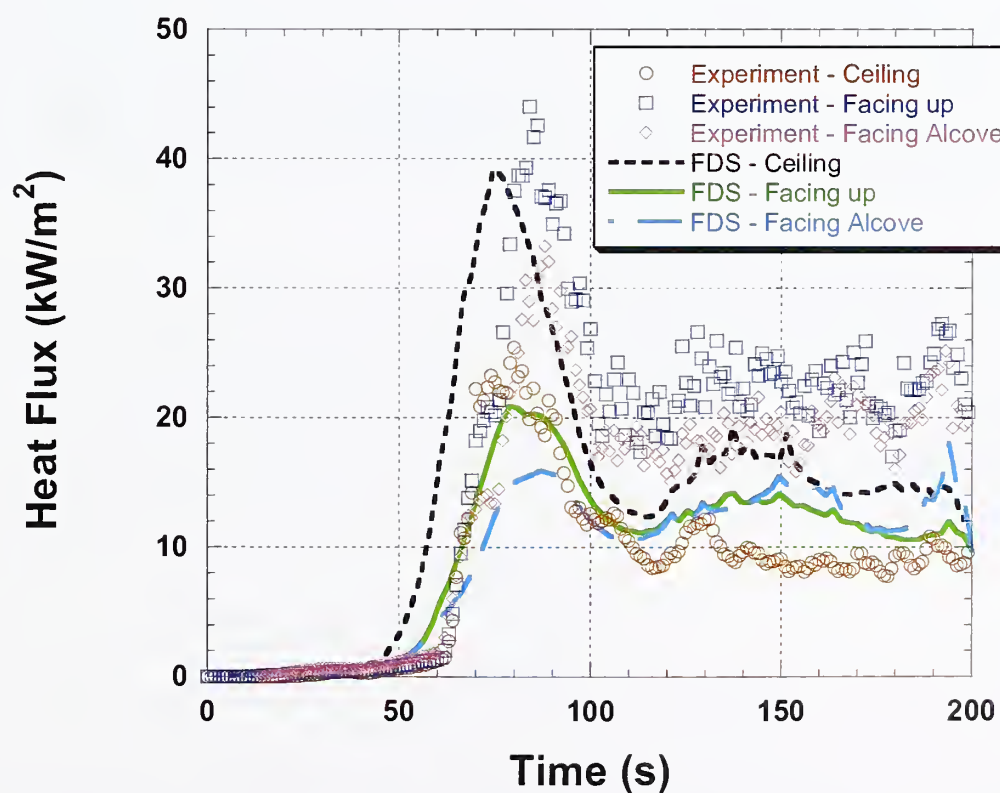
Figures 5-15 and 5-16 present the heat flux measurements taken at Stations C and D respectively. There were three total heat flux sensors at each position: one installed at ceiling level with the sensor aimed at the floor; and two sensors installed at approximately 1.5 m (5 ft) above the floor with one aimed at the ceiling and the other aimed toward the platform end of the enclosure. In both cases, the predictions follow the trends of the measured heat flux. Better agreement in terms of magnitude occurs at the ceiling level. The predicted heat fluxes 1.5 m above the floor are low by almost 50 % when compared with three out of four measurements.

Figure 5-15. Heat flux comparison between the un-sprinklered fire experiment and the FDS simulation at Station C

Figure 5-16. Heat flux comparison between the un-sprinklered fire experiment and the FDS simulation at Station D.

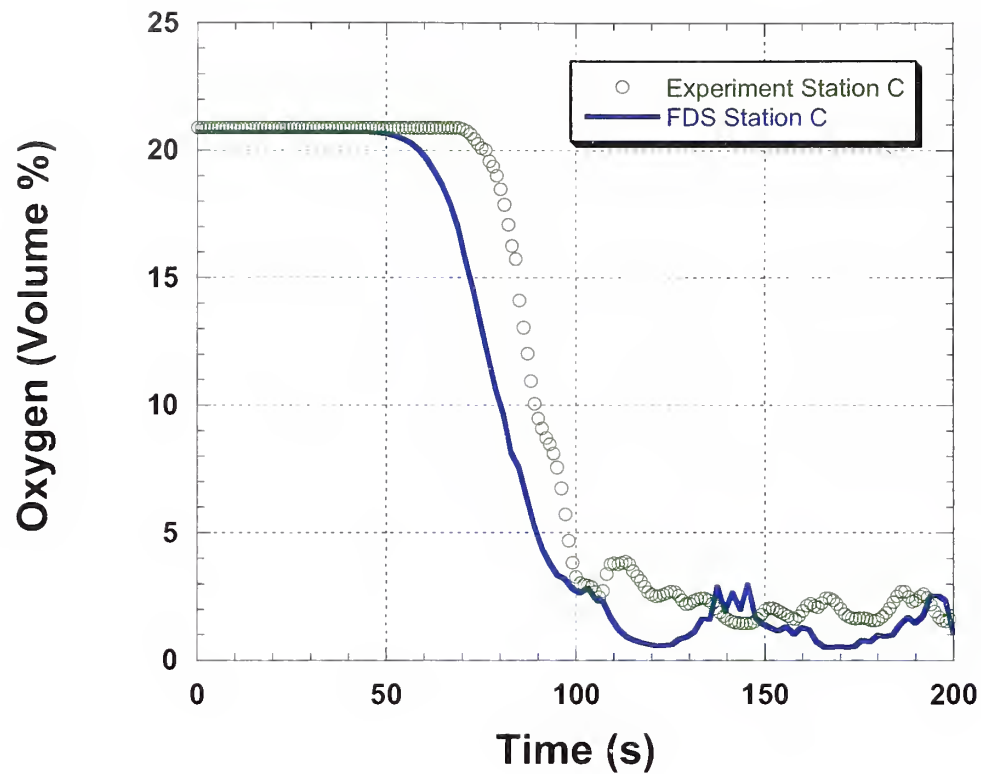
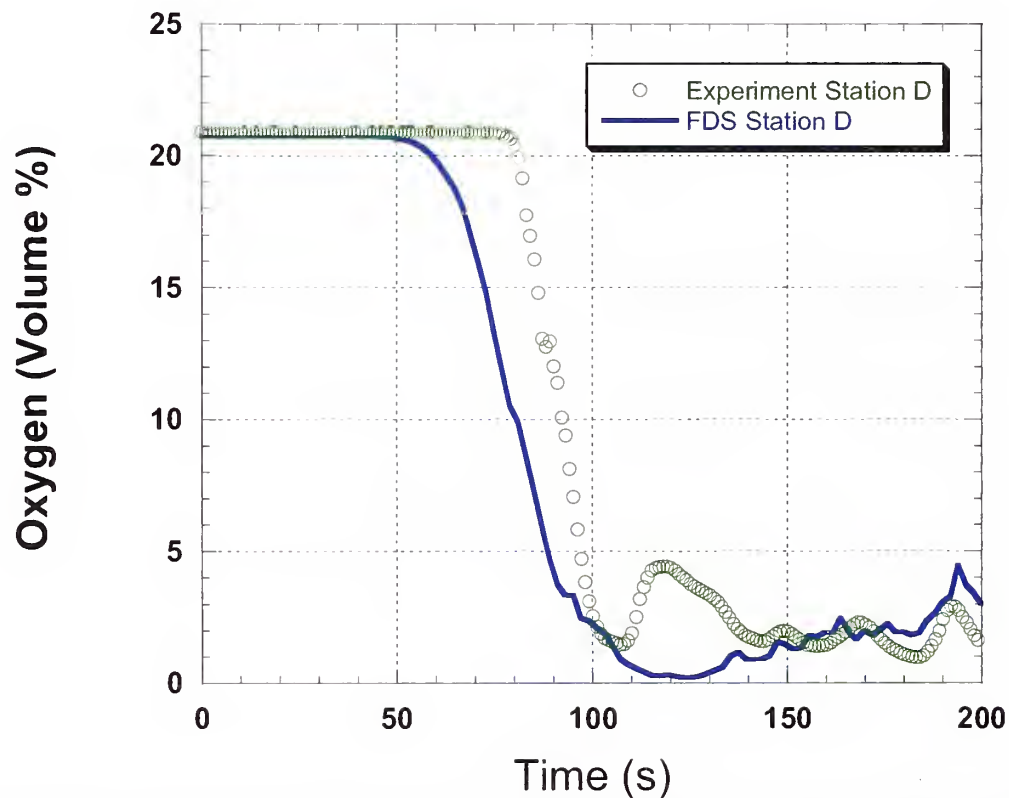
Figures 5-17 and 5-18 represent the oxygen volume fraction comparisons between the measurements at Stations C and D and the predicted values from FDS. The measurements and the predictions were positioned at 1.5 m (5 ft) above the floor. The oxygen levels predicted by FDS dropped sooner but slightly less rapidly than the experimental measurements; both reached the same low value of about two percent, confirming that the fire was close to ventilation-limited at this point.

Figure 5-17. Oxygen volume fraction comparison between the un-sprinklered fire experiment and the FDS model at approximately 1.5 m above the floor at Station C.

Figure 5-18. Oxygen volume fraction comparison between the un-sprinklered fire experiment and the FDS model at approximately 1.5 m above the floor at Station D.

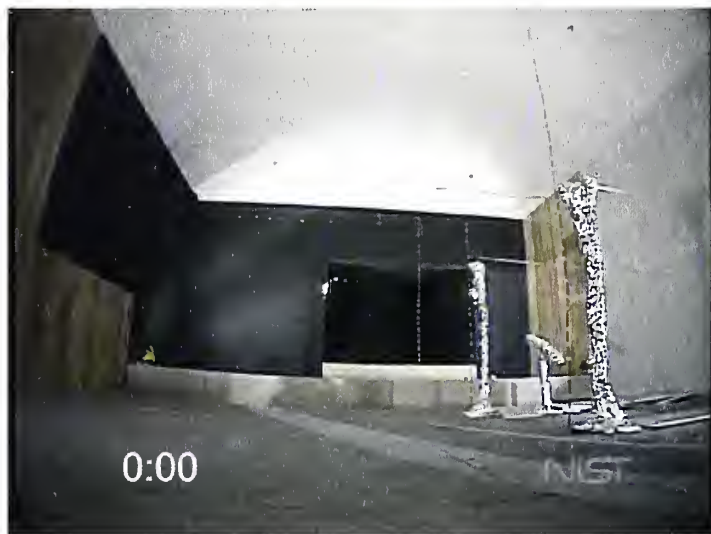
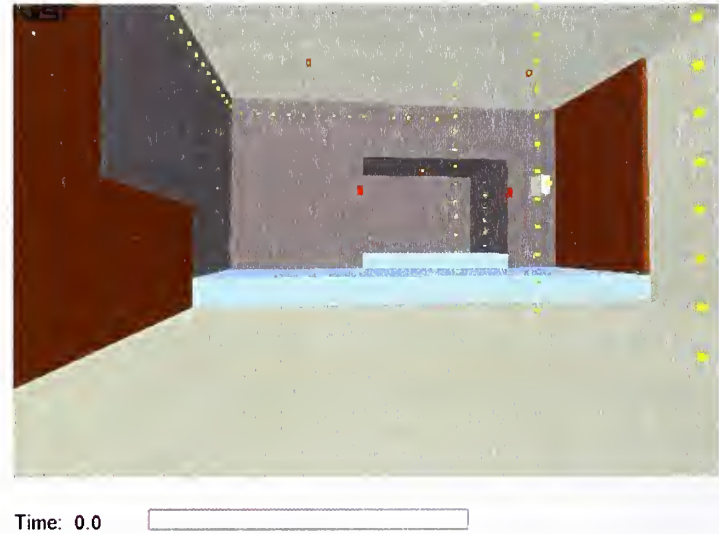
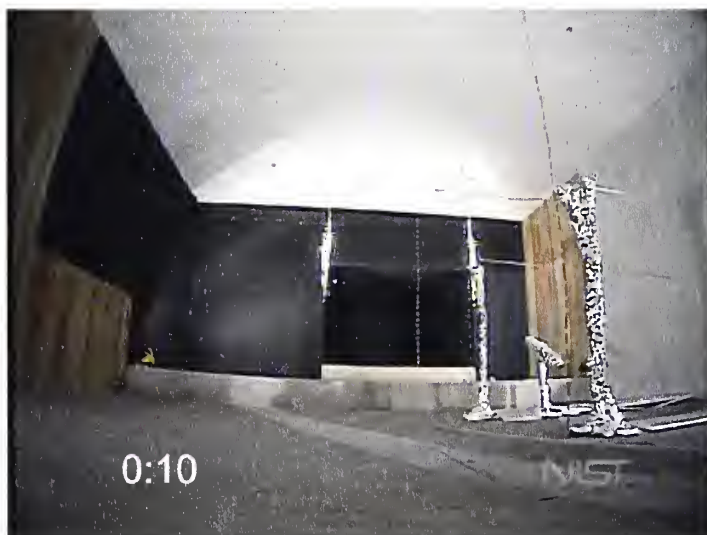
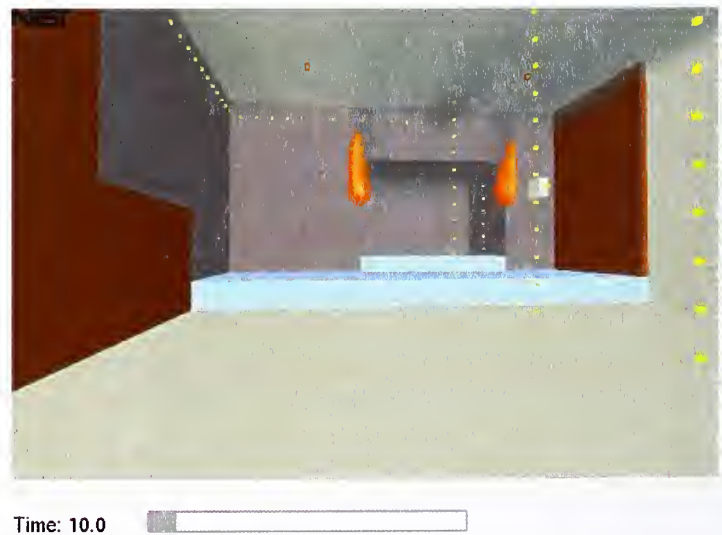
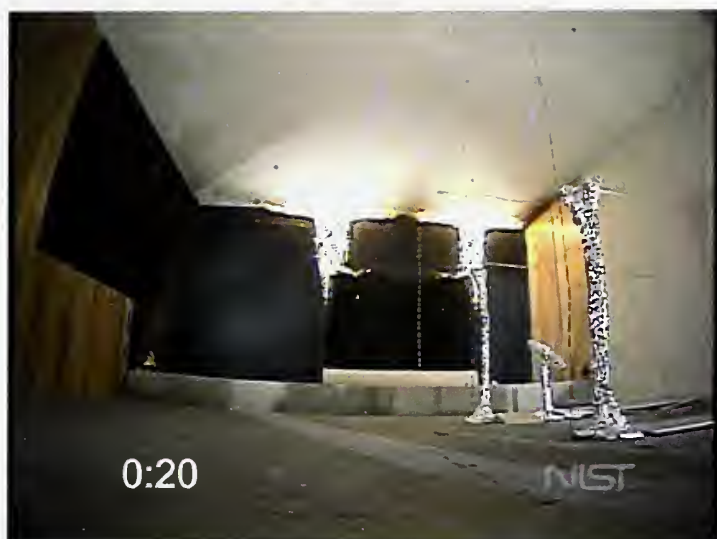
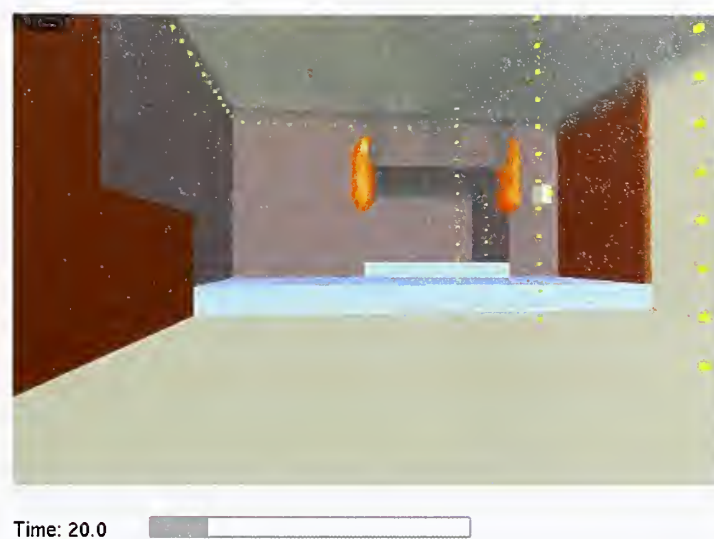
**Figure 5-19. Ignition at the corners of the alcove,  $t = 0$  seconds.**

**Figure 5-20. Flames spreading toward ceiling,  $t = 10$  seconds after ignition.**

**Figure 5-21. Flames impinging on ceiling,  $t = 20$  seconds after ignition.**

sprinkler activation. Figures 5-19 through 5-21 show a very similar progression in fire growth as the unsprinklered case for both the experiment and the FDS simulation between ignition and 20 seconds after ignition. Figure 5-22 was captured at 25 seconds after ignition, approximately 1 second after the first sprinkler activated in both the experiment and the simulation. With the experiment, the impact of the sprinkler can be seen as the fire on the right side of the platform wall is suppressed. In FDS the flame height on the right side of the alcove can be seen to be reduced.

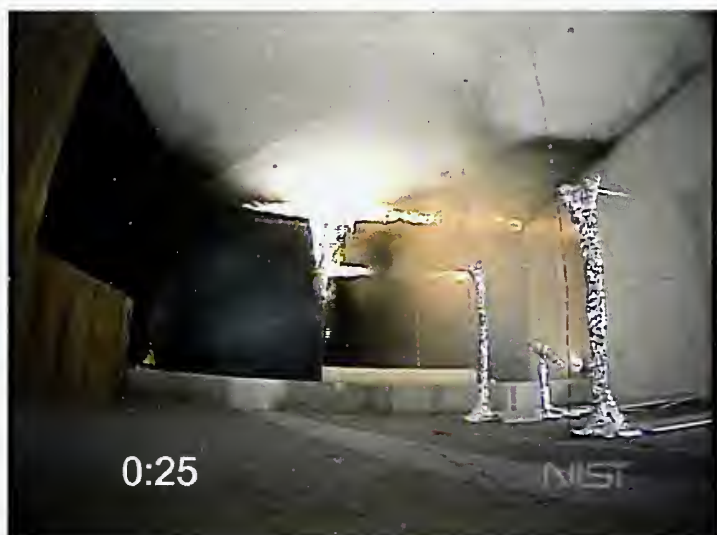
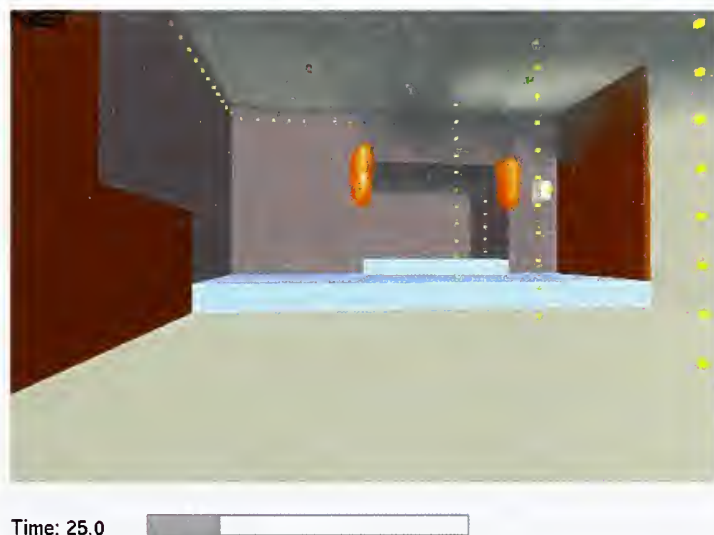
**Figure 5-22. Initial sprinkler operating,  $t = 25$  seconds after ignition.**

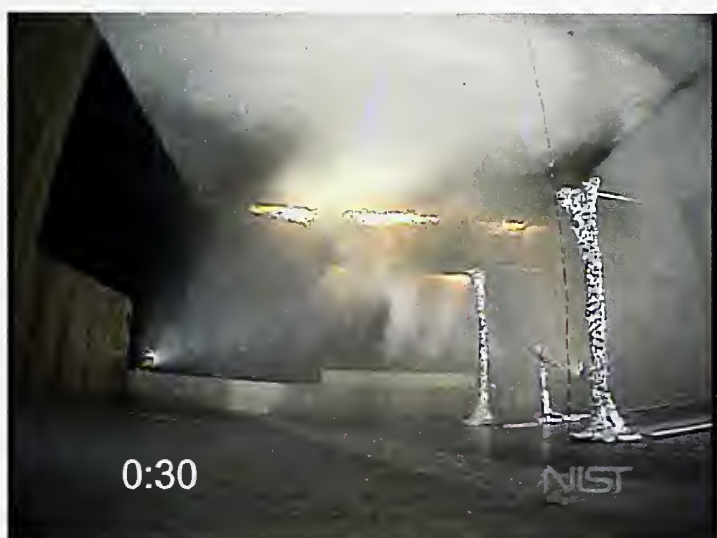
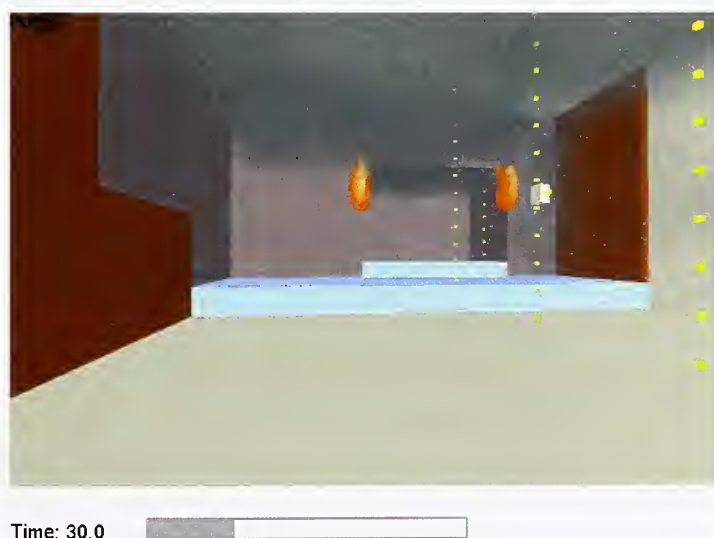
**Figure 5-23. Third sprinkler operating in experiment,  $t = 30$  seconds after ignition.**

By 30 seconds (see Fig. 5-23) the effect of both of the sprinklers above the platform operating as well as the sprinkler in the alcove is apparent. Burning continues at the intersection of the platform wall and the ceiling. This area is above where the water spray is hitting the wall. Also notice the flames on the ceiling of the alcove. This area is shielded from the water spray of the two sprinklers. The smoke being pushed out of the alcove is due to the activation of the sprinkler on the ceiling of the alcove. In the simulation, only one sprinkler is operating at this time. The fire growth on the right side of the alcove has been limited by the single sprinkler.

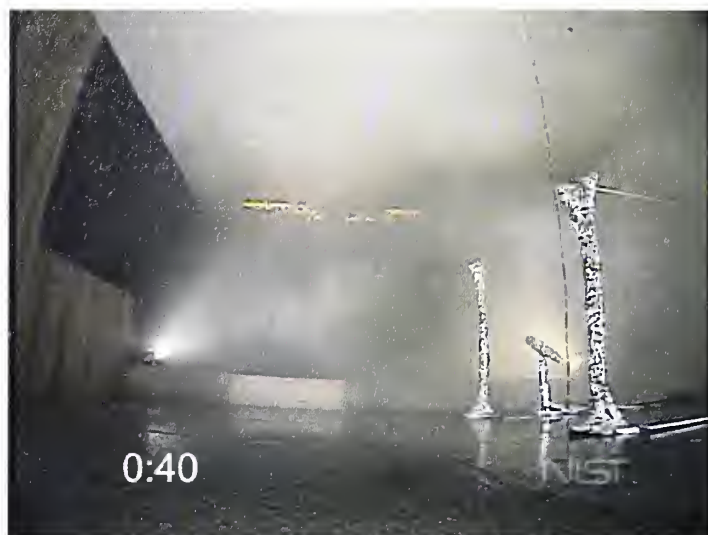
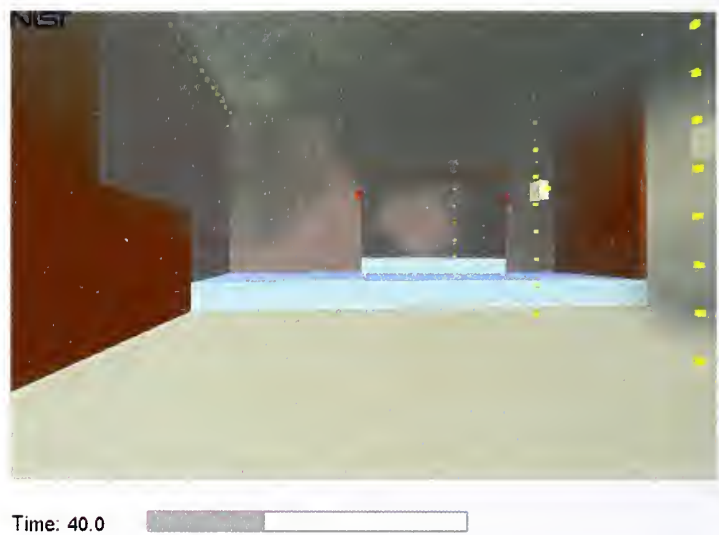
Figure 5-24. Suppression with three sprinklers operating in each case,  $t = 40$  seconds after ignition.

By 40 seconds after ignition, three sprinklers in the experiment and in the simulation have activated. The video frame in Figure 5-24 shows that the fire in the alcove has been suppressed and that the burning above the water line on the platform wall continues. With three sprinklers operating in FDS, the water spray is significantly reducing the visible flames. The flames on the platform wall have been suppressed. However, there are still flames visible at the intersections of the alcove ceiling and the alcove walls on both sides of the alcove. These areas are shielded from the water spray of the sprinklers over the platform and they are above the water impact line from the sprinkler in the alcove.

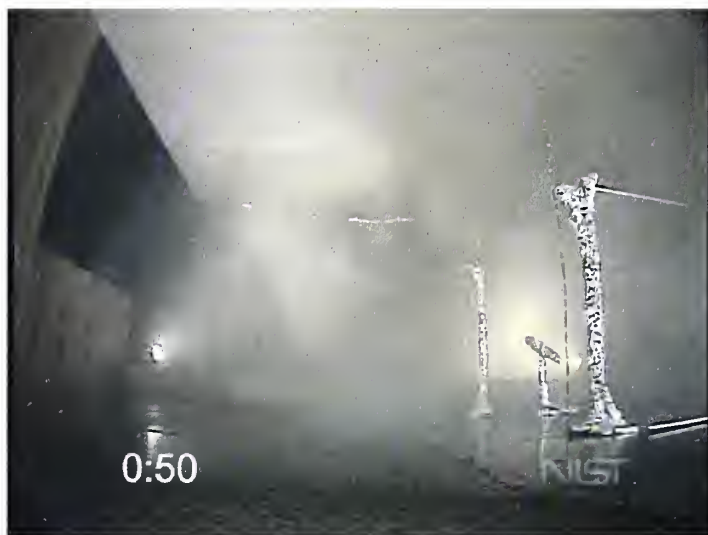
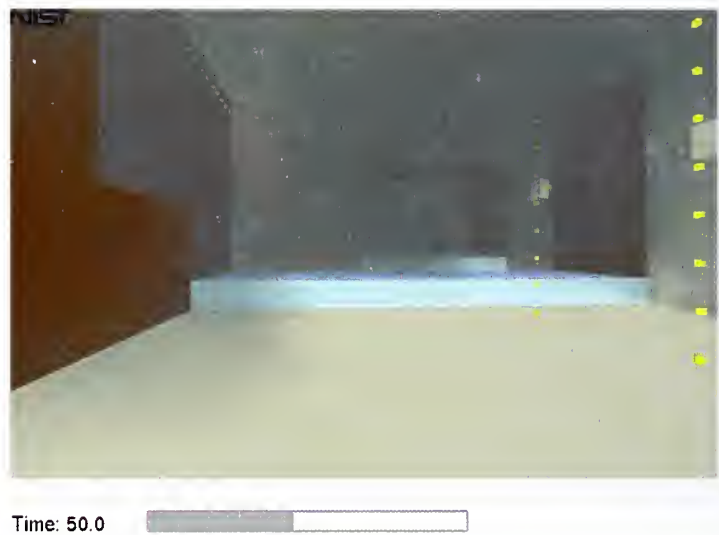
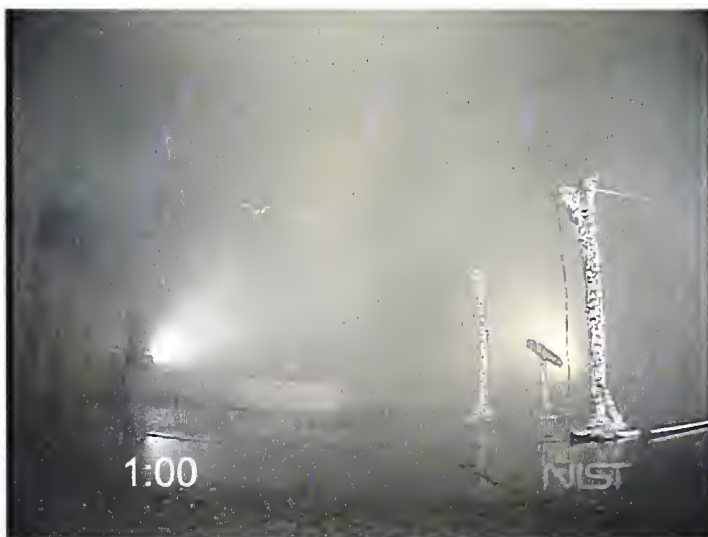
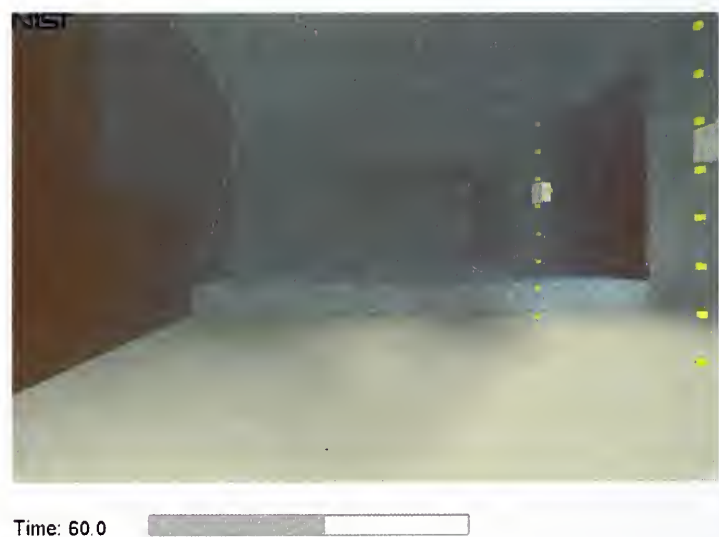
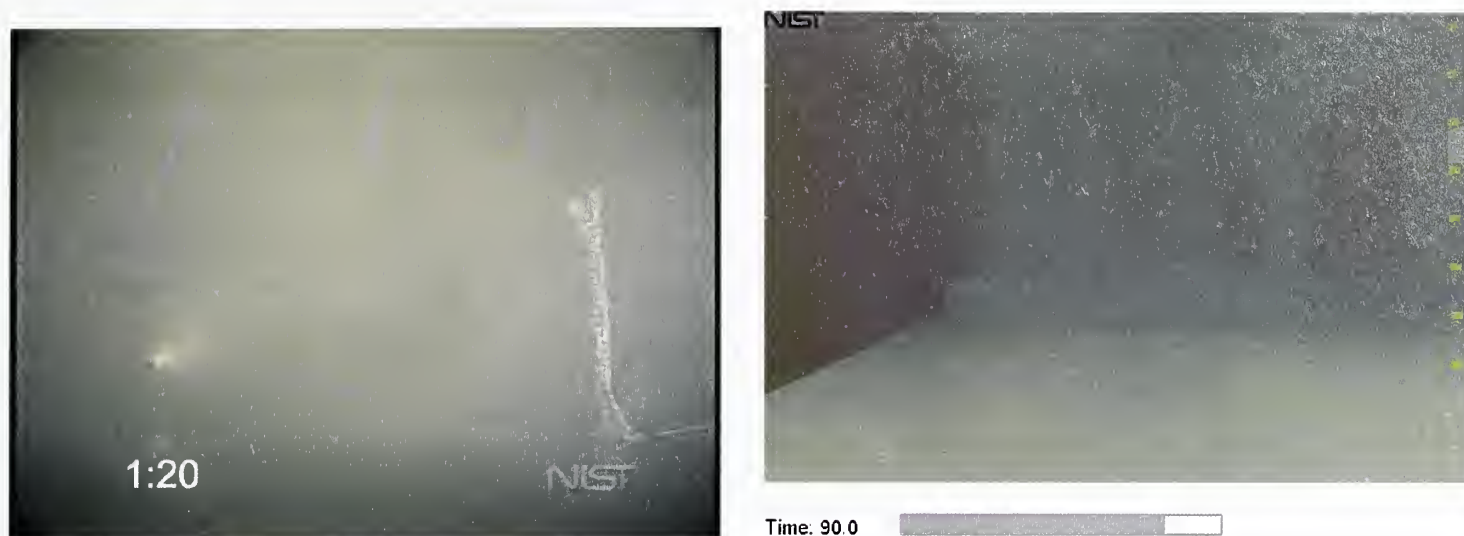
Figure 5-25. Fire suppression continues in both the experiment and the simulation,  $t = 50$  seconds after ignition.

Figure 5-26. Fire controlled in both cases,  $t = 60$  seconds after ignition.

**Figure 5-27. Fire controlled in both cases,  $t = 90$  seconds after ignition.**

Figures 5-25 through 5-27 show continued fire suppression for both the experiment and the simulation. In both cases some flames exist in the ceiling area of the alcove. But clearly the rate of fire growth and the resulting hazard development has been reduced significantly when compared with the unsprinklered case.

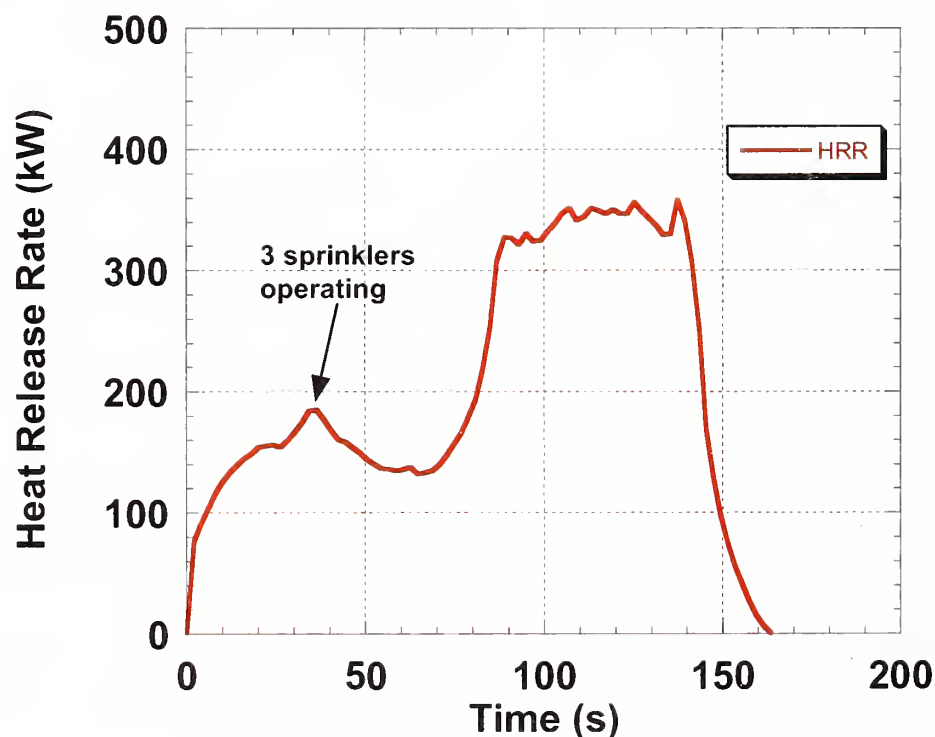
Figure 5-28 shows the FDS predicted heat release rate for the sprinklered enclosure. The experiment failed to produce enough combustion gases for the oxygen depletion calorimeter to measure a heat release rate. This was due to the rapid sprinkler activation, the effective fire suppression and the large volume of the enclosure. This graph demonstrates that in the simulation the fire grew after the activation of the third sprinkler (all were operating by 36 seconds). The decrease in HRR at approximately 140 seconds is when the shielded (dry) foam on the alcove ceiling burns itself out. In the experiment, foam above the line of water impact on the walls and the ceiling continued to burn after sprinkler activation as was shown in Figures 5-24 through 5-26.

Figure 5-28. FDS predicted heat release rate for the sprinklered case.

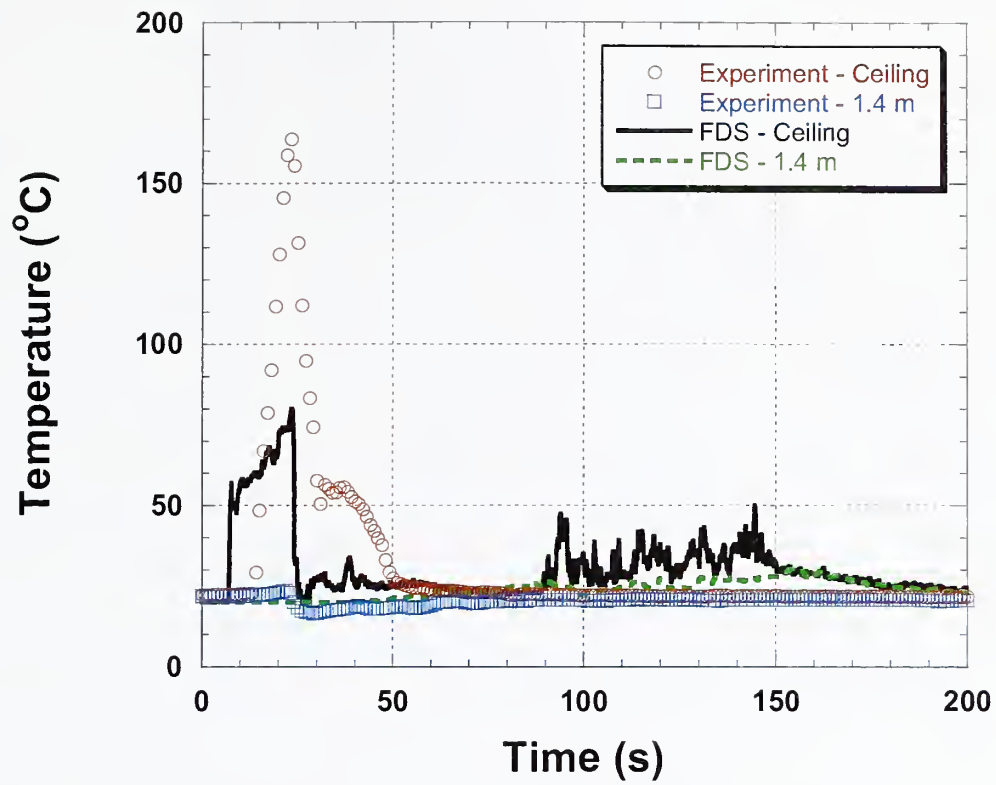
The comparison of the temperatures at Stations C and D are shown in Figures 5-29 and 5-30. In both cases FDS under predicts the temperatures near the ceiling. The FDS predictions in these two graphs have not been smoothed in order to show that the peak values near the ceiling are very close to the sprinkler activation temperature of 74 °C. Typically the temperature of the fire gases surrounding a sprinkler at the time of activation is approximately twice the listed temperature.

Figure 5-29. Temperature comparison between the sprinklered fire experiment and the FDS simulation at Station C.

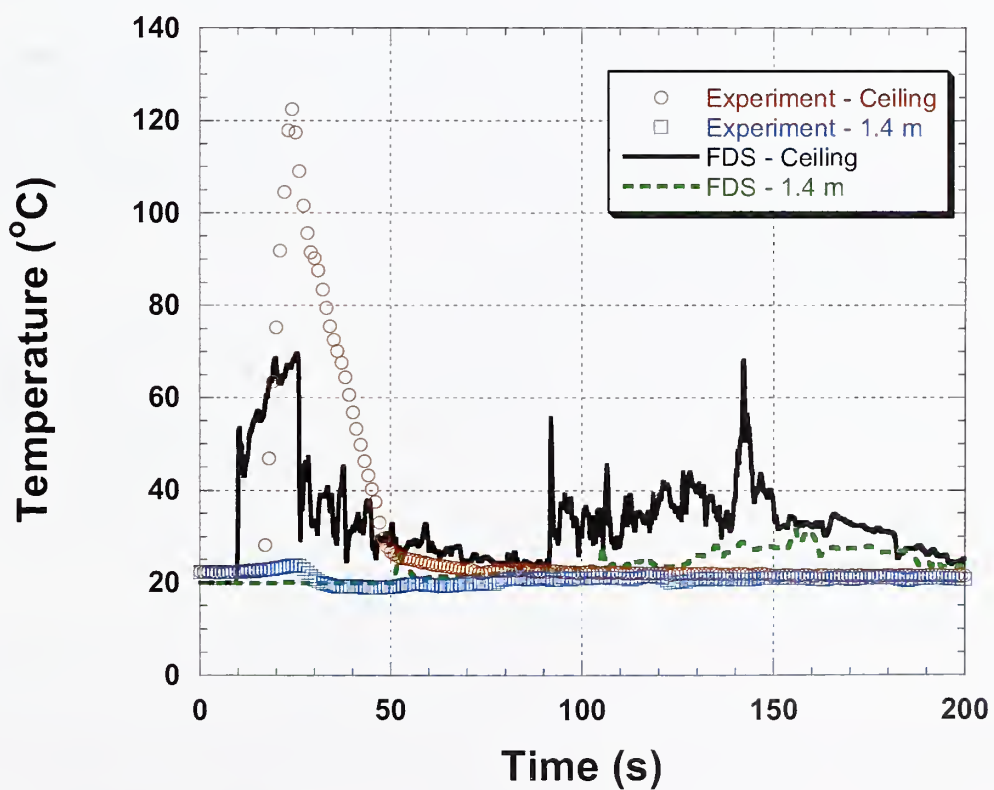
Figure 5-30. Temperature comparison between the sprinklered fire experiment and the FDS simulation at Station D.

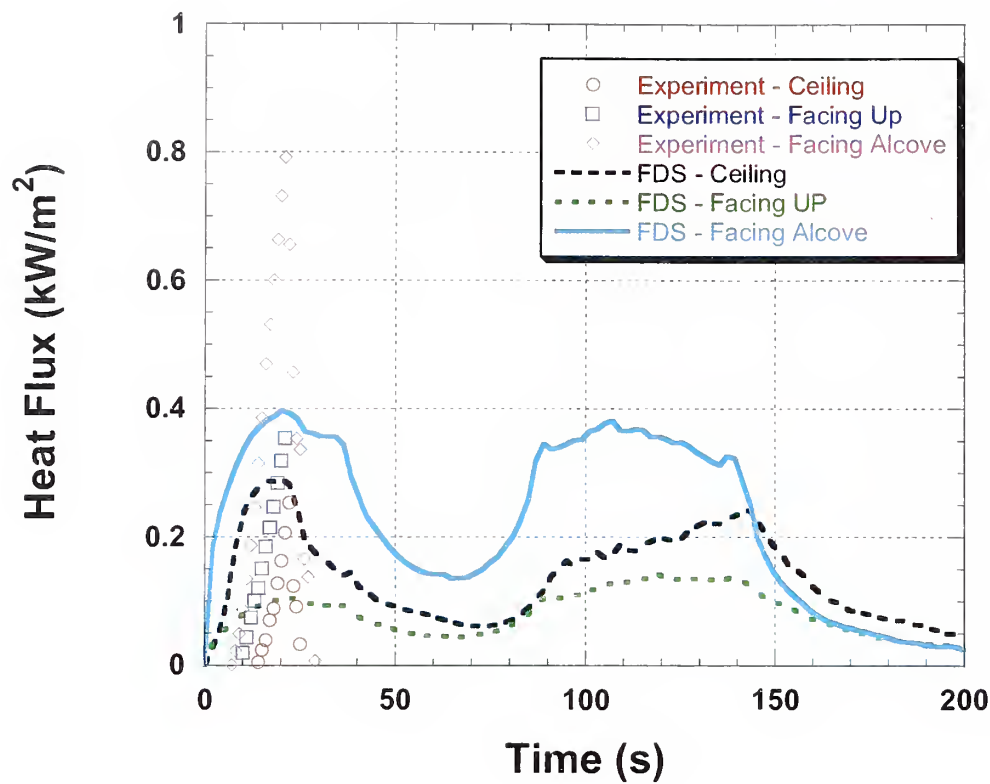
**Figure 5-31. Heat flux comparison between the sprinklered fire experiment and the FDS simulation at Station C.**

The comparison of the measured heat flux with the calculated heat flux is shown in Figures 5-31 and 5-32. Due to the limited fire growth and significant cooling by the water all of the heat flux values are less than  $1 \text{ kW/m}^2$ . One notable difference between the experiment and the simulation is after the sprinklers activate in the experiment, the measured heat flux goes to zero, while in the simulation small values heat flux energy continue to be shown.

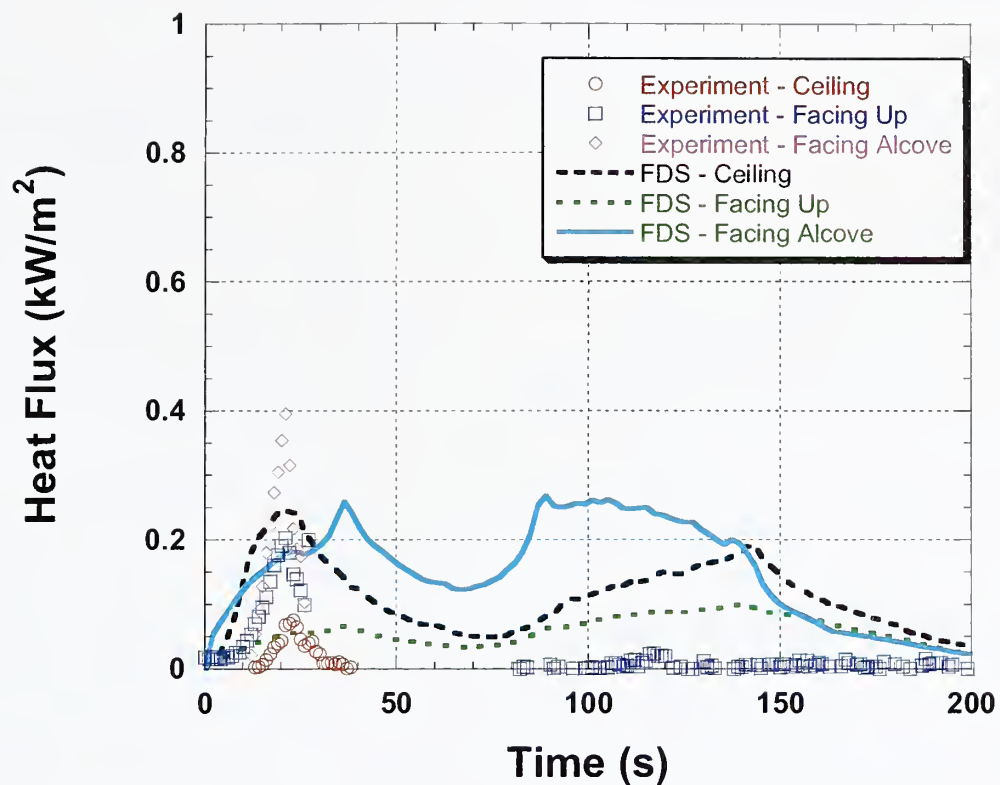
Figure 5-32. Heat flux comparison between the sprinklered fire experiment and the FDS simulation at Station D.

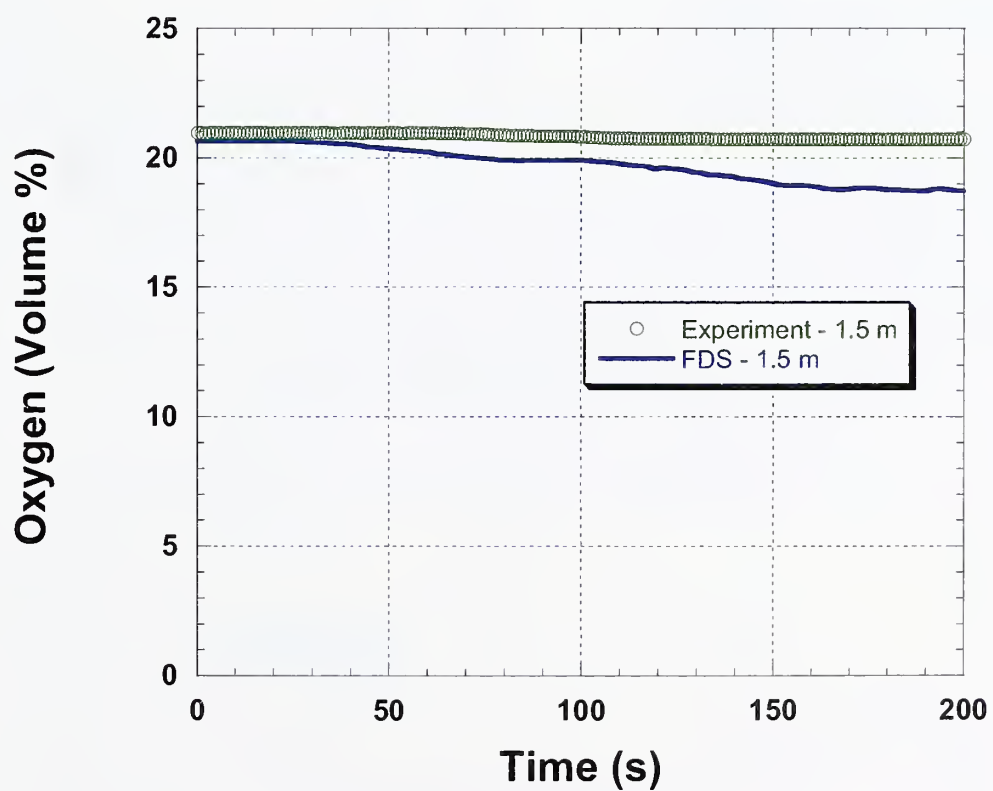
Figure 5-33 exhibits the comparison of the measured and predicted oxygen concentrations at Station C. The measured oxygen concentration shows only a slight decrease during the 200 seconds, while the simulation shows a decrease of approximately 2 percent. This may be due to the continued burning of the foam along the ceiling of the alcove that is taking place in the simulation of the experiment.

Figure 33. Oxygen volume fraction comparison between the sprinklered fire experiment and the FDS simulation at approximately 1.5 m above the floor at Station C.

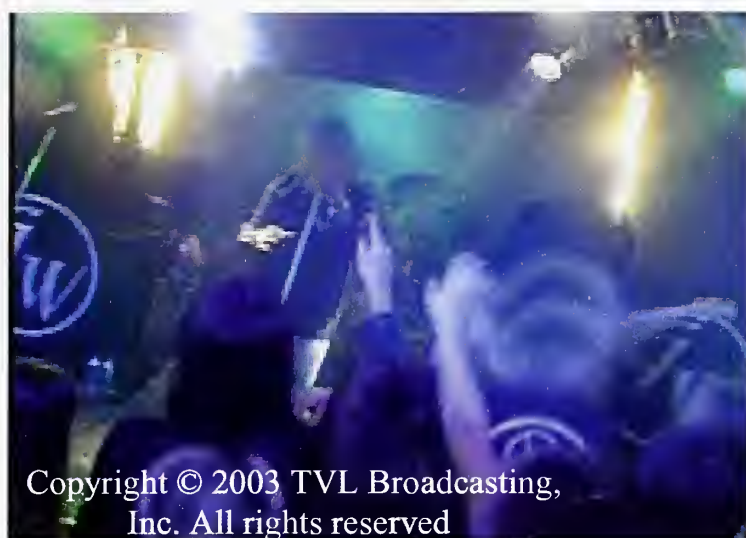
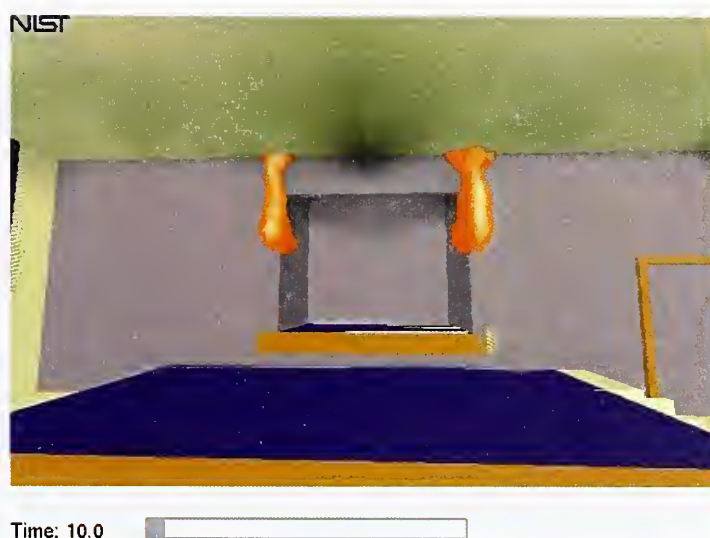
The images from the video in Figures 5-43 and 5-44 capture the initial state of the fires on each side of the platform shortly after the gerb discharge had stopped. At 10 seconds after ignition, the fire can be seen burning on two surfaces at each of the corners; this is also considered in the simulation with the placement of the ignition vents on both sides of the corner. In both the simulation and the actual incident the flames impinge on the ceiling within 20 seconds after ignition.

**Figure 5-43. Initial growth of fire on foam at corner of the alcove (10 seconds)**

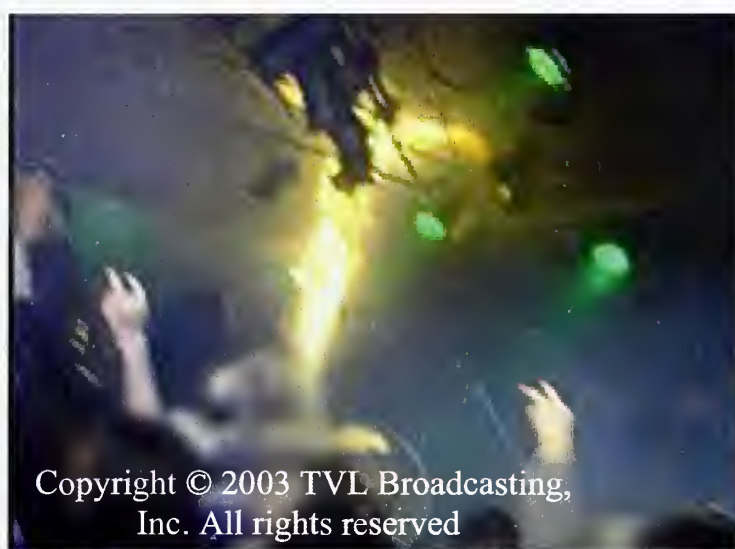
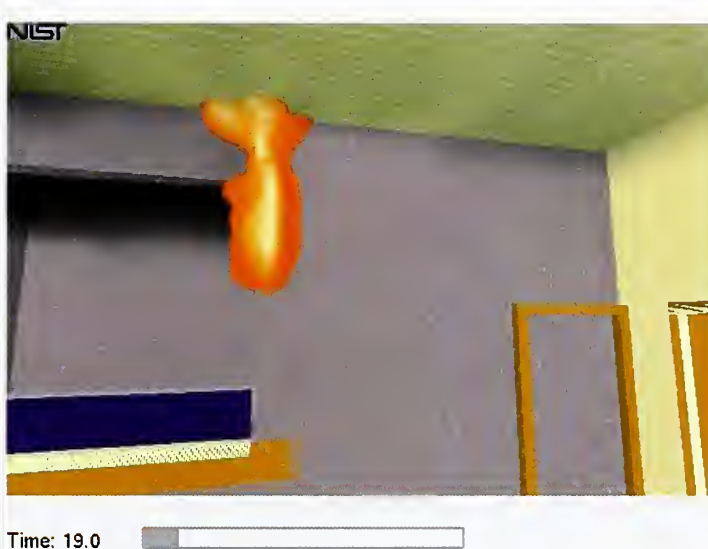
**Figure 5-44. Flames impinging on ceiling (19 seconds)**

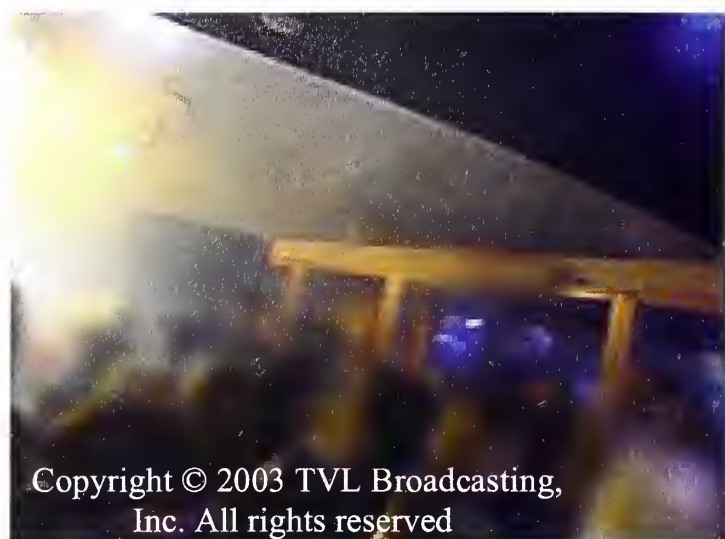
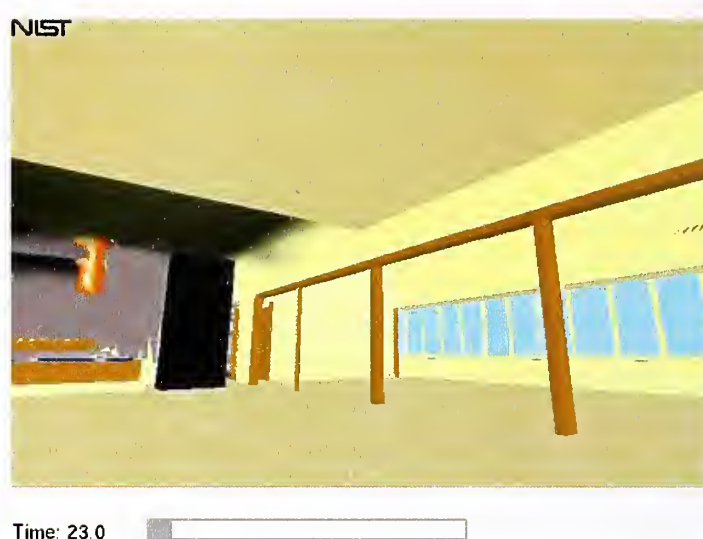
At 23 seconds after ignition, Figure 5-45, the videographer has begun to move toward the exit as have many in the crowd. Notice that many people are still facing the platform. The fire continued to grow and smoke has collected in the raised ceiling area over the dance floor. The smoke filling can be seen in the image from the simulation. (Note the black rectangular image on the floor is representative of the speaker cabinet, whereas the boundaries of the smoke layer are irregular.) At 53 seconds after ignition, the flames have grown and spread along the platform wall and into the alcove as shown in video image in Figure 5-46. In addition, the smoke is spreading across the lower level ceiling area toward the main exit. The flames have spread in the simulation as well and smoke is beginning to spill over from the dance floor area towards the exits and the main bar room, although it takes a few more seconds into the simulation for this to occur. Again the black rectangular objects on the floor are representative of speaker cabinets (near the platform) and the sound and lighting board (left side).

**Figure 5-45. Videographer backing away from platform (23 seconds)**

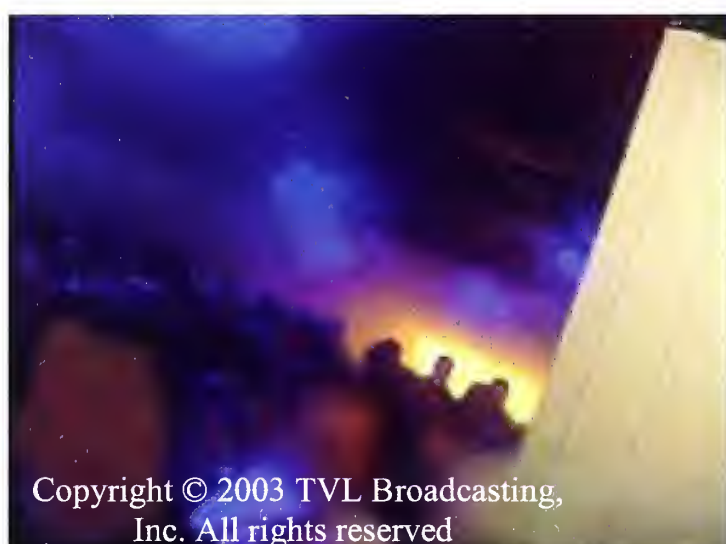
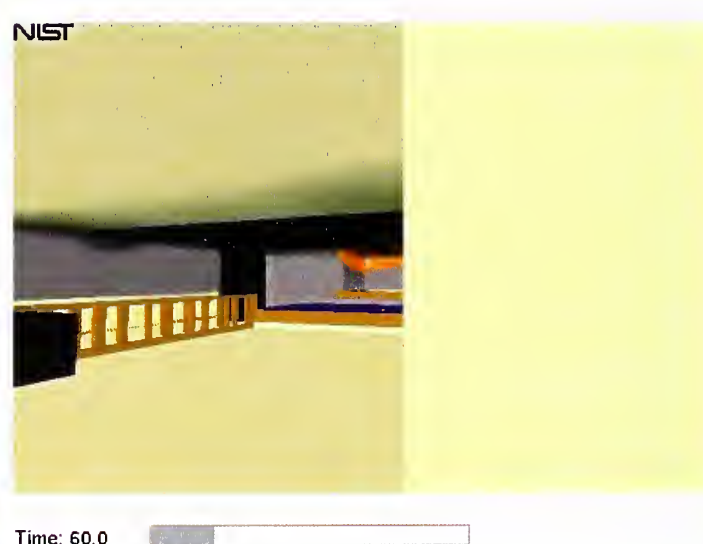
**Figure 5-46. Smoke beginning to roll across ceiling (video 53 seconds, simulation 60 seconds)**

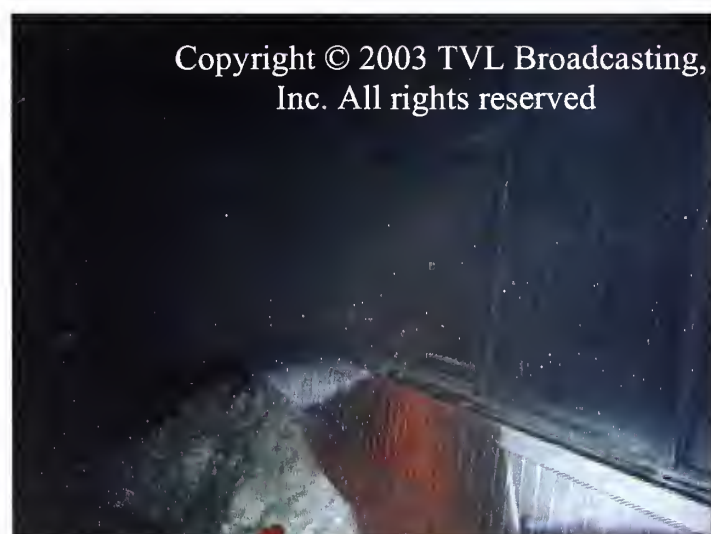
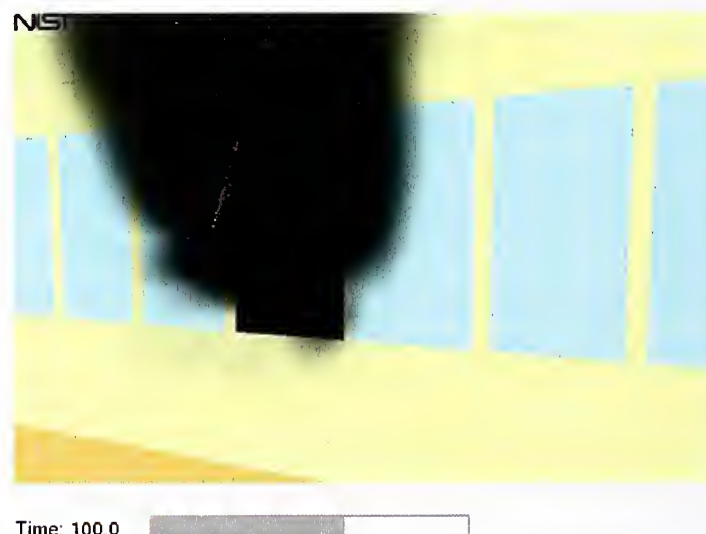
The videographer had exited the nightclub at approximately 70 seconds and headed toward the stage door. He then returns toward the main entrance and attempts to pass between the nightclub and the bus when he encounters a plume of black smoke pushing out of one of the window vents in the sunroom. The image from the simulation also shows a similar view. At approximately 110 seconds after ignition, smoke is flowing from the main entrance; the image from the simulation is given in Figure 5-48. The model did not account for people blocking the air flow into the doorway.

**Figure 5-47. Smoke billowing outside from broken sunroom window (100 seconds)**
