NIST NCSTAR 2: Vol. I

# Report of the Technical Investigation of The Station Nightclub Fire

June 2005

A fire occurred on the night of Feb. 20, 2003, in The Station nightclub at 211 Cowesett Avenue, West Warwick, Rhode Island. A band that was on the platform that night, during its performance, used pyrotechnics that ignited polyurethane foam insulation lining the walls and ceiling of the platform. The fire spread quickly along the walls and ceiling area over the dance floor. Smoke was visible in the exit doorways in a little more than one minute, and flames were observed breaking through a portion of the roof in less than five minutes. Egress from the nightclub, which was not equipped with sprinklers, was hampered by crowding at the main entrance to the building. One hundred people lost their lives in the fire. On Feb. 27, 2003, under the authority of the National Construction Safety Team (NCST) Act, the National Institute of Standards and Technology (NIST) established a National Construction Safety Team to determine the likely technical cause or causes of the building failure that led to the high number of casualties in that fire. This report documents the procedures, findings,

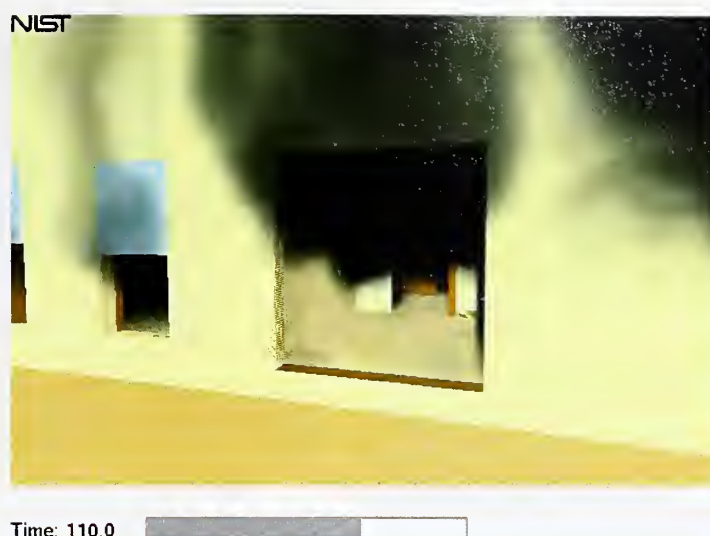
The videographer had exited the nightclub at approximately 70 seconds and headed toward the stage door. He then returns toward the main entrance and attempts to pass between the nightclub and the bus when he encounters a plume of black smoke pushing out of one of the window vents in the sunroom. The image from the simulation also shows a similar view. At approximately 110 seconds after ignition, smoke is flowing from the main entrance; the image from the simulation is given in Figure 5-48. The model did not account for people blocking the air flow into the doorway.

**Figure 5-48. Light smoke emanating from front door of nightclub (110 seconds)**

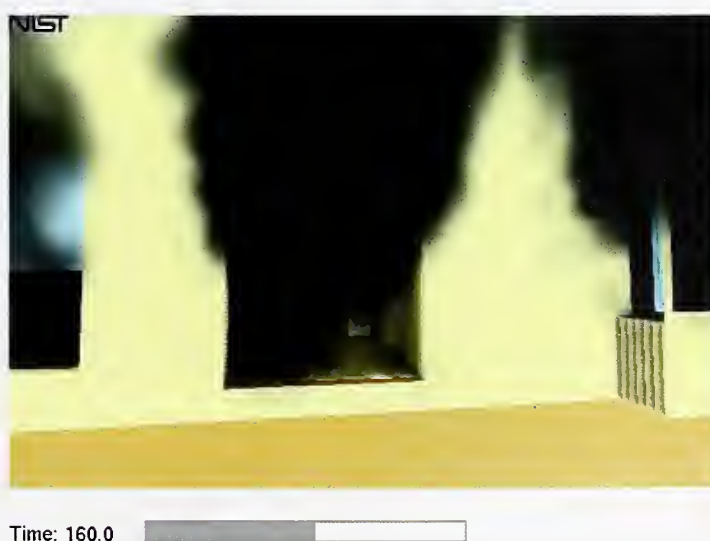
The Smokeview image in Figure 5-49 shows the smoke flow from the front door at 160 seconds after ignition in the simulation. In Figure 5-50, the simulated smoke flow from the main bar room windows is shown. More smoke is coming from the center window than the two side windows because the upper and lower portions of the center window have been removed while only the lower portion of the side windows are open in the simulation.

**Figure 5-49. Heavy smoke leaving front door and open main bar window (160 seconds)**

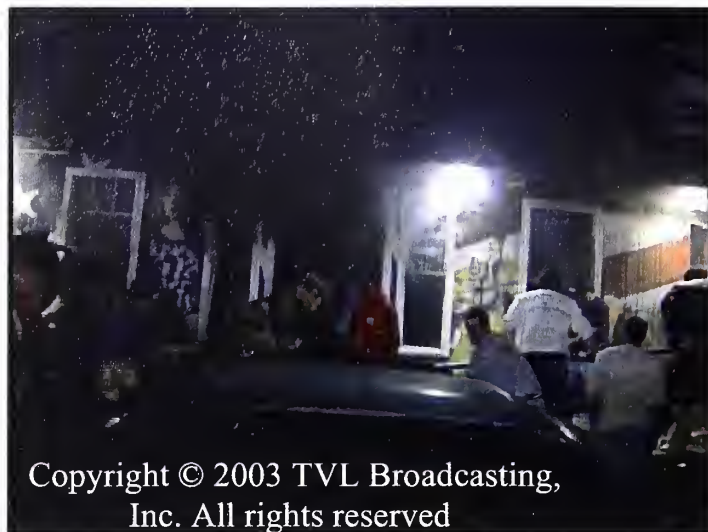
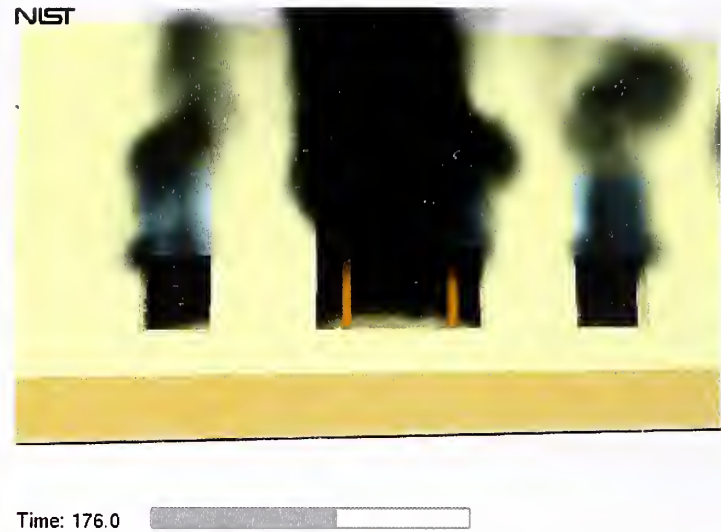
**Figure 5-50. View of smoke plumes from front windows of horseshoe bar area (176 seconds)**

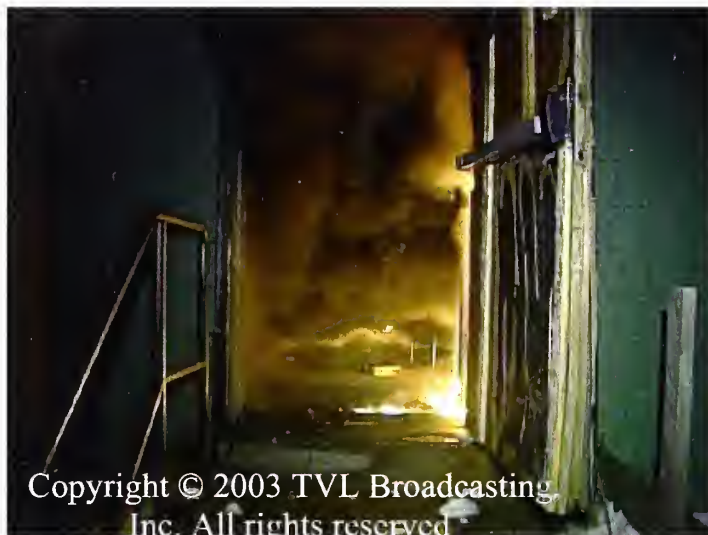
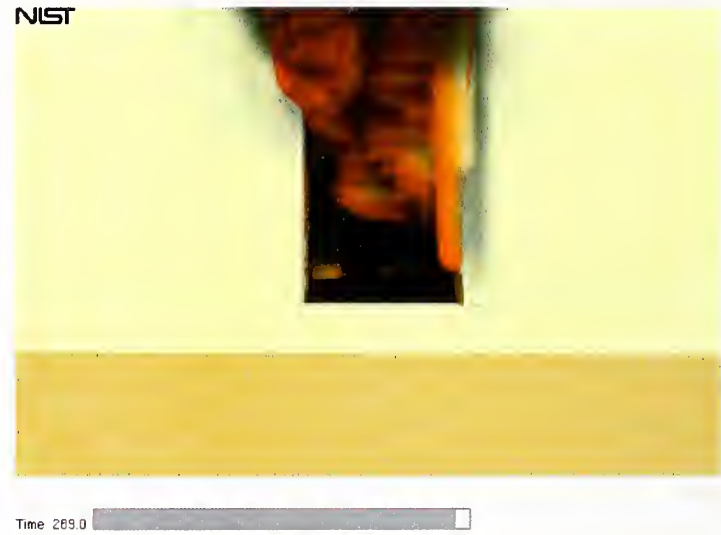
The videographer moves around to the stage door again. The view inside the open door at approximately 289 seconds after ignition is shown in Figure 5-51. The image from the simulation agrees with the video image on the level of combustion products in the doorway. However without a comparison to the temperature in the doorway, the mixture fraction alone would indicate that more flames are in the area of the stage doorway than can be seen in the video image. The videographer continues around to the backside of the nightclub, at 300 seconds after ignition flames are coming through a small portion of the back wall (south wall) of the dance floor area and smoke is leaking from the bathroom hallway wall. The videographer moved toward the front of the nightclub again, at 309 seconds flames can be seen in the area of the front door. It takes another 25 seconds before he is in a position to record the images of the flames coming from the sunroom windows and the main door. The simulation stops at 300 seconds after ignition, short of the time that the entire nightclub reaches flashover conditions.

**Figure 5-51. Looking into stage door exit (289 seconds)**

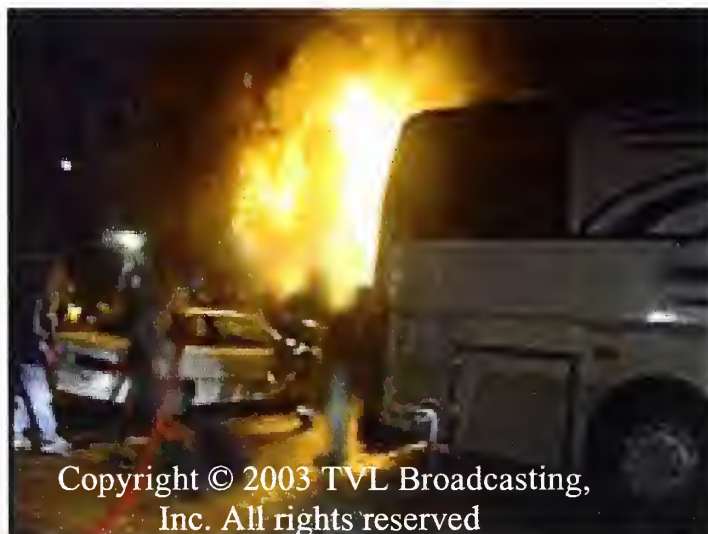
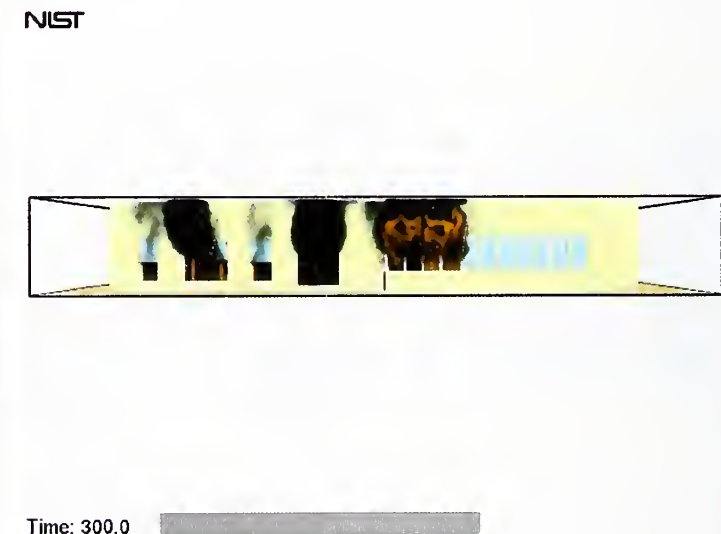
**Figure 5-52. Flames breaking through front door and sunroom windows (337 seconds video, 300 seconds simulation)**

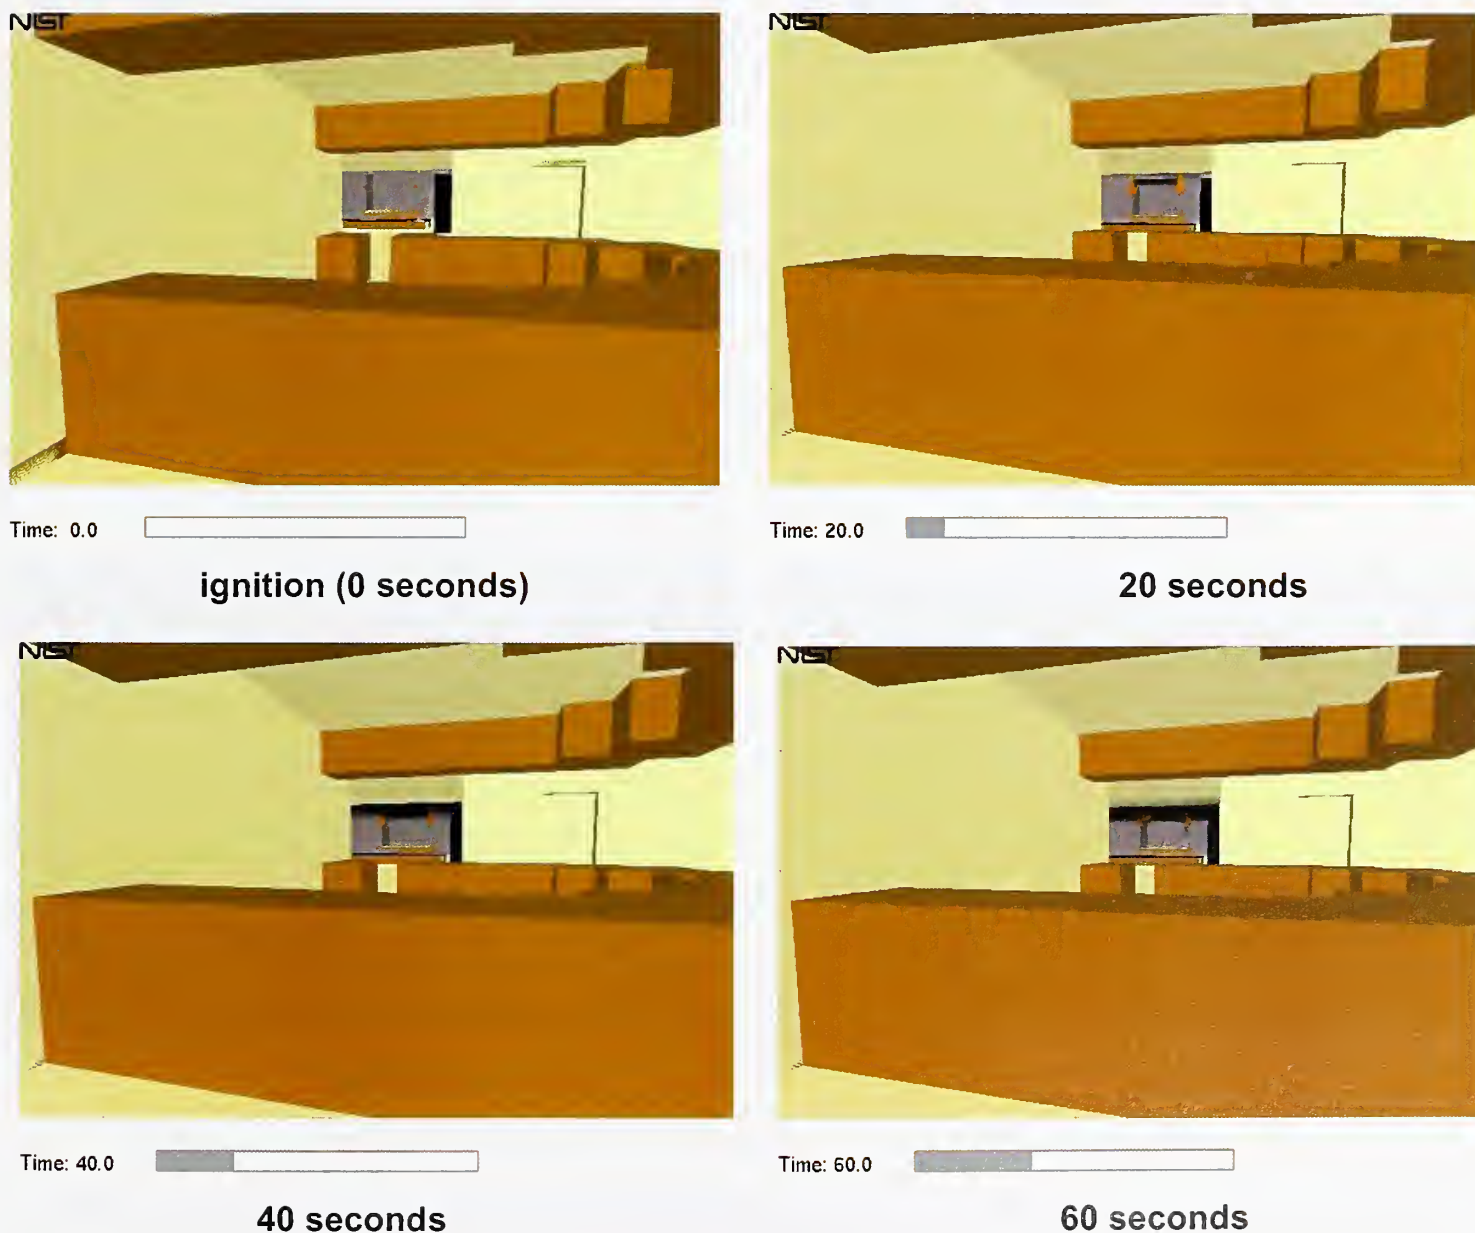
Smokeyview images were rendered at certain time intervals from the view looking through the far side of the main bar to the platform area. (See Figures 5-53a,b.) This allowed for the conditions to be observed at several key locations: the platform area, the entrance to the main exit way and the main bar area. Many of the occupants traveled this path as either they were able to exit or were overcome by the conditions prior to being able to do so. The fire developed quickly in the platform area as the foam burned and resulted in the alcove becoming fully developed with fire. Once that occurred the flames involved the entire rear wall and spread toward the main entrance, generating large amounts of smoke. At 70 seconds after ignition, the smoke can be seen in the area of the main entrance to the nightclub. This is consistent with the WPRI video. As the videographer leaves the nightclub, at approximately 70 seconds after ignition, smoke is flowing over the heads of people in the main entry foyer. However, even 80 seconds after ignition visibility remained high in the main bar room. This changed suddenly as the smoke and hot gases that were spilling out of the now-filled raised ceiling above the dance floor quickly spread to the main bar room. Based on the FDS simulation, within another 20 seconds, 100 seconds after ignition visibility was impaired, and remained so throughout the rest of the 300 seconds simulation. Flames can be seen in the last three images of Figure 5-53b as the surfaces in the main bar area began to burn.

**Figure 5-53a. View of fire from beyond horseshoe bar, looking at platform (0 - 60 seconds)**

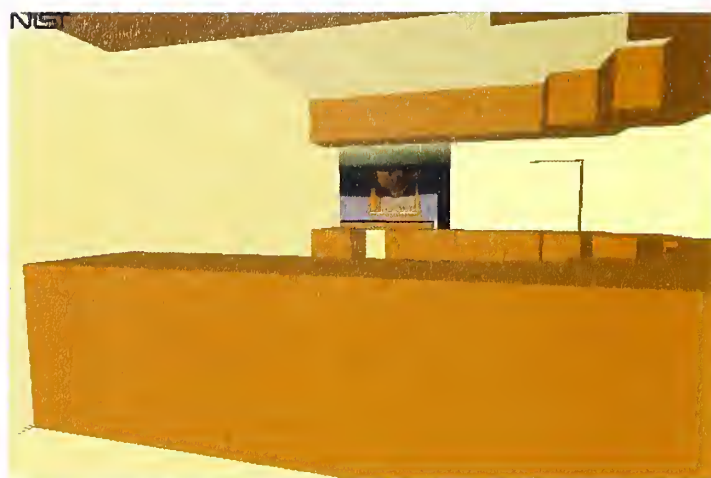
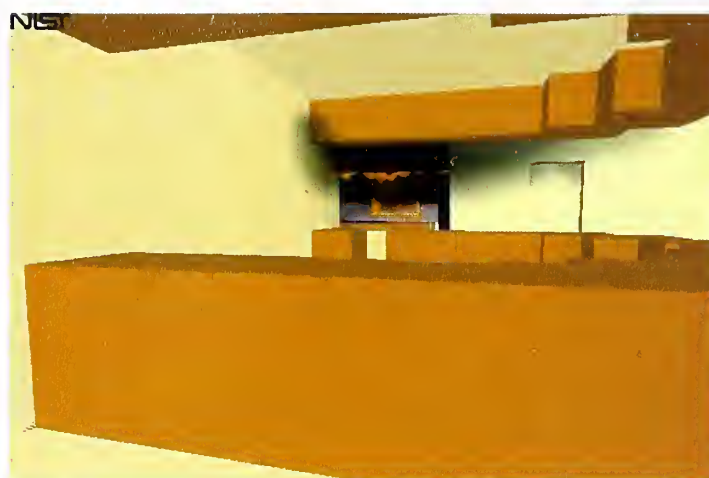
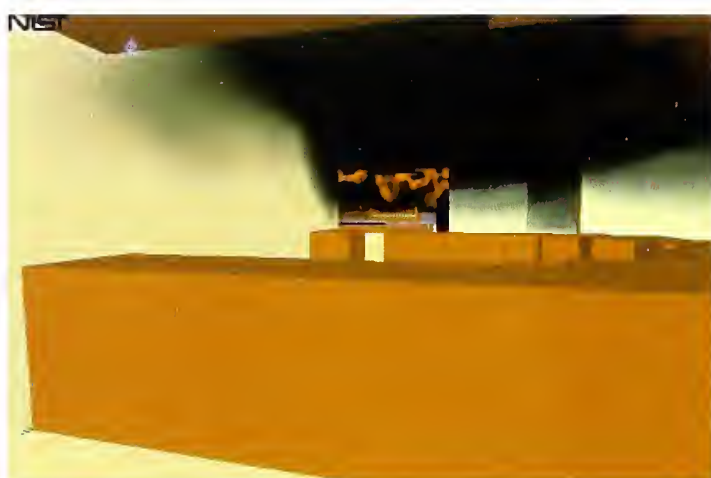
**Figure 5-53b. View of fire from beyond horseshoe bar, looking at platform (85 - 250 seconds)**

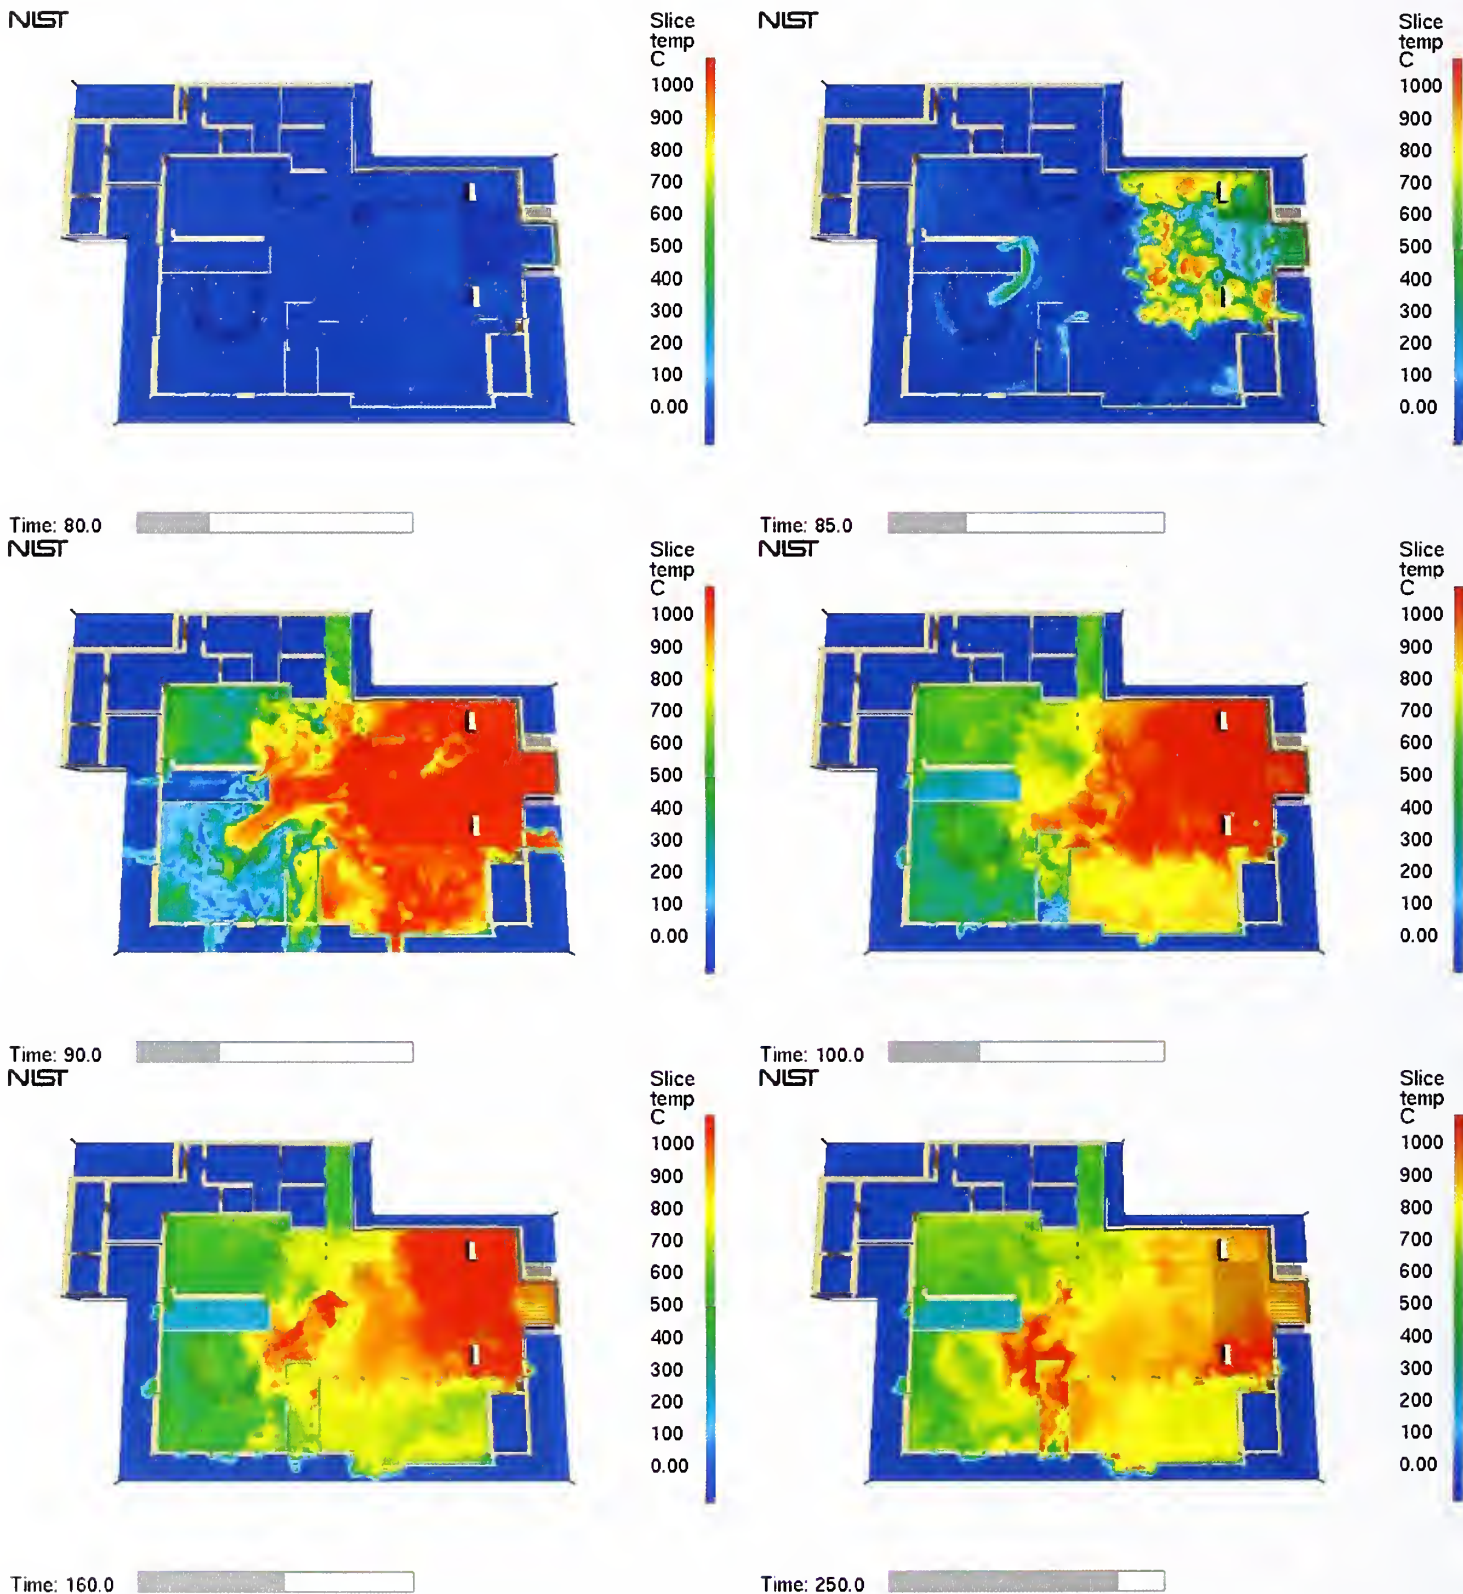
Figure 5-55. Temperatures at 1.5 m (5 ft) above the floor, 80 seconds to 250 seconds

Temperatures increase dramatically shortly after the alcove area reaches flashover conditions at approximately 65 seconds and then the platform area becomes fully involved in flames. The first two images in Figure 5-55 show the temperatures at 1.5 m (5 ft) above the floor at 80 and 85 seconds. Within that 5 second time interval the simulation predicts that dance floor area of the nightclub would have become untenable due to temperature. By 100 seconds after ignition, the simulation shows a large portion of the structure had become untenable due to temperature at the 1.5 m (5 ft) level. Figure 5-55 continues with the presentation of simulation temperature results from 160 seconds to 250 seconds after ignition. During this time interval temperatures continue to remain in the untenable range throughout the simulated nightclub, with the exception of areas that are considered closed off from the hot gas flow such as the

bathrooms, office and storage areas. These areas were assumed to be separated from the rest of the nightclub by closed doors, so they were modeled without a path for the gases to enter the spaces, hence they appear to remain in the tenable range. The kitchen area has an open door from the dart room and an open door that exits to the outside. The hot gas flow goes directly from the dart room to the exit doorway. This leaves the kitchen at a cooler temperature than the surrounding rooms.

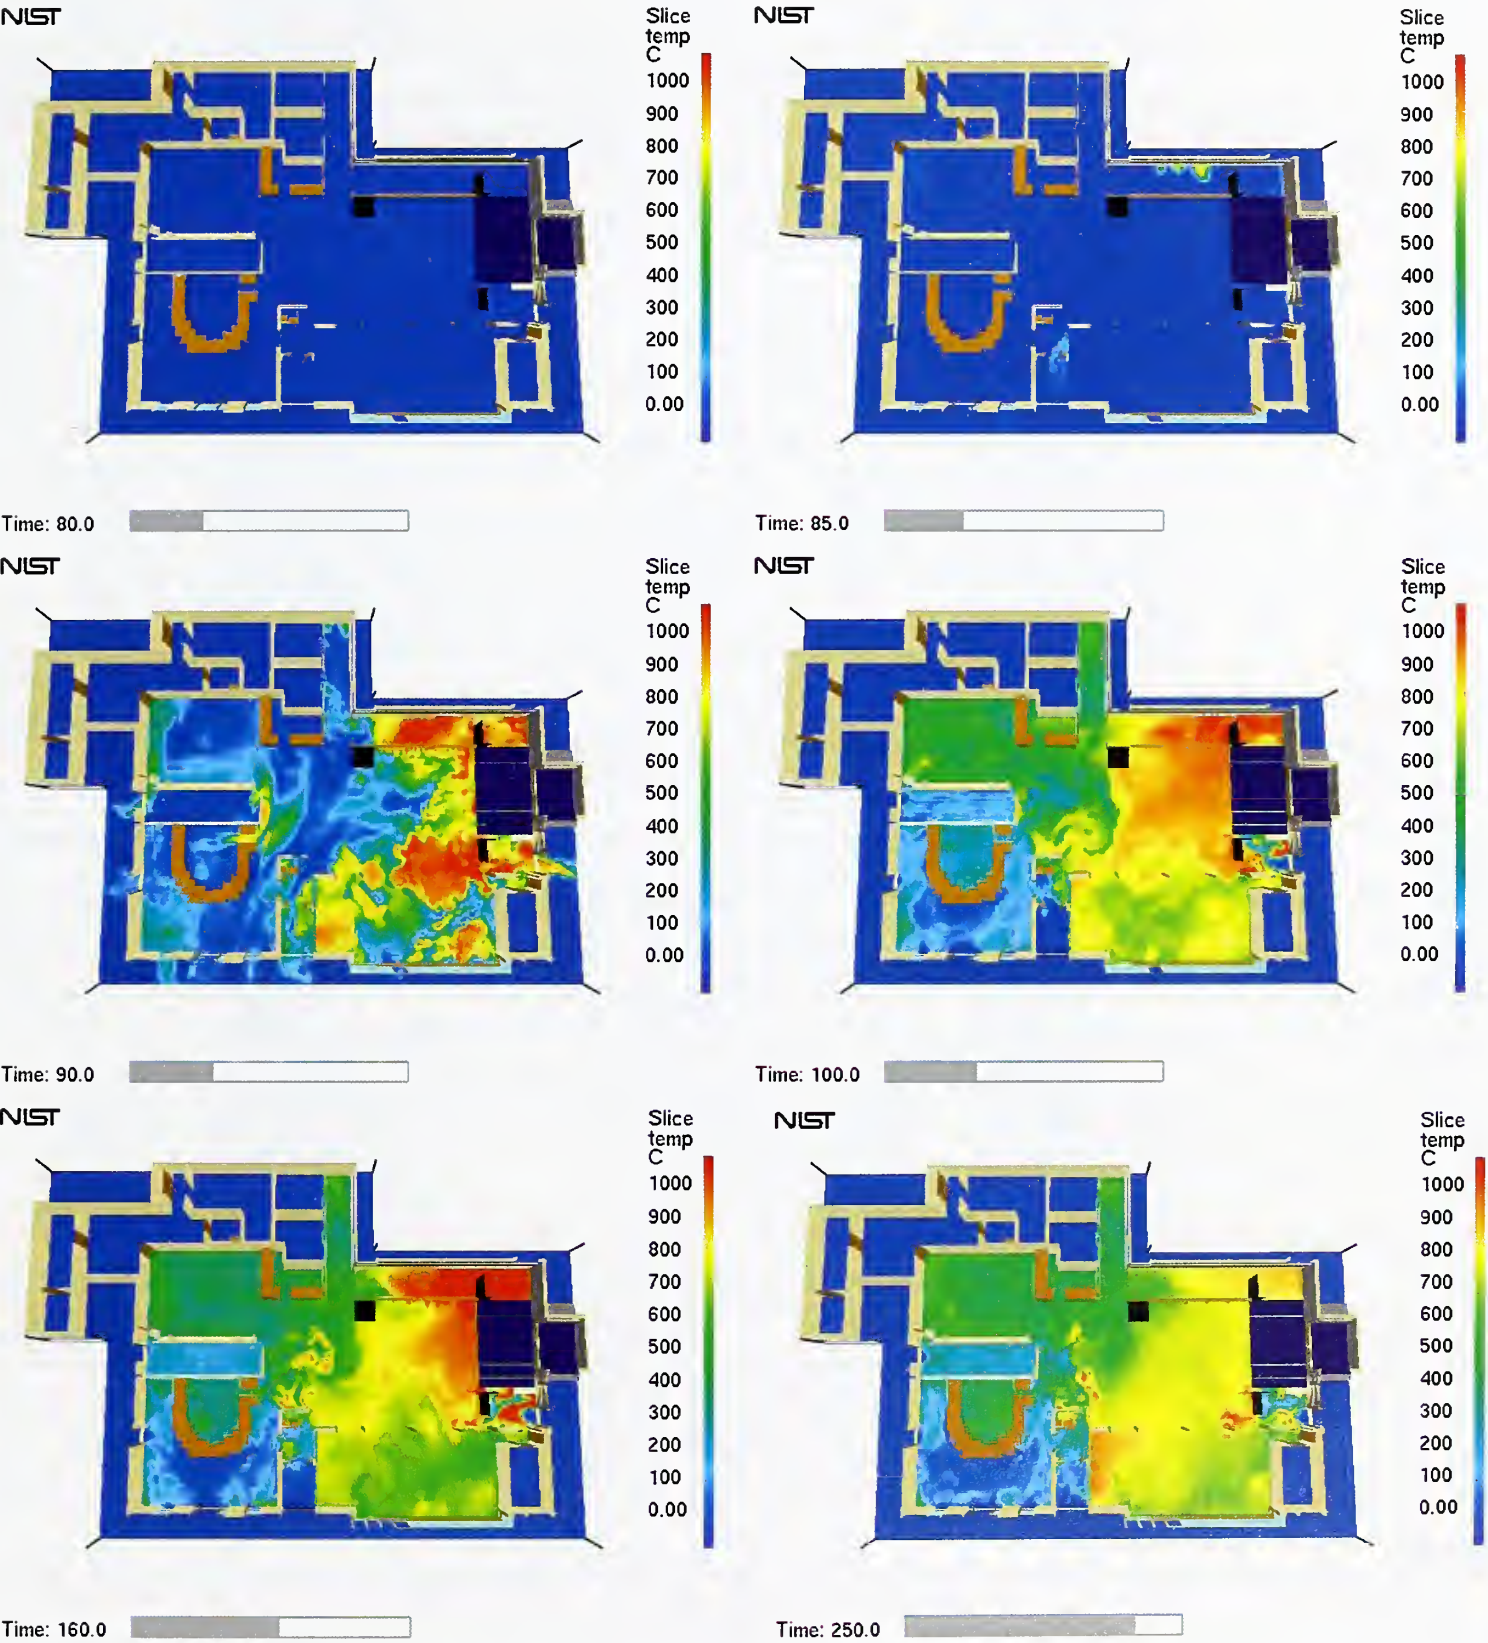
Figure 5-56. Temperatures at 0.6 m (2 ft) above the floor, 80 seconds to 250 seconds

At the 0.6 m (2 ft) height above the floor conditions remain tenable for a longer period of time than at the higher elevation. Figure 5-56 contains images captured at the same time intervals as in the previous figure. One can see that the dance floor and adjacent areas reach untenable temperatures in the simulation within 90 seconds after ignition. The sunroom and dart room areas are predicted to reach untenable temperatures within another 10 seconds.

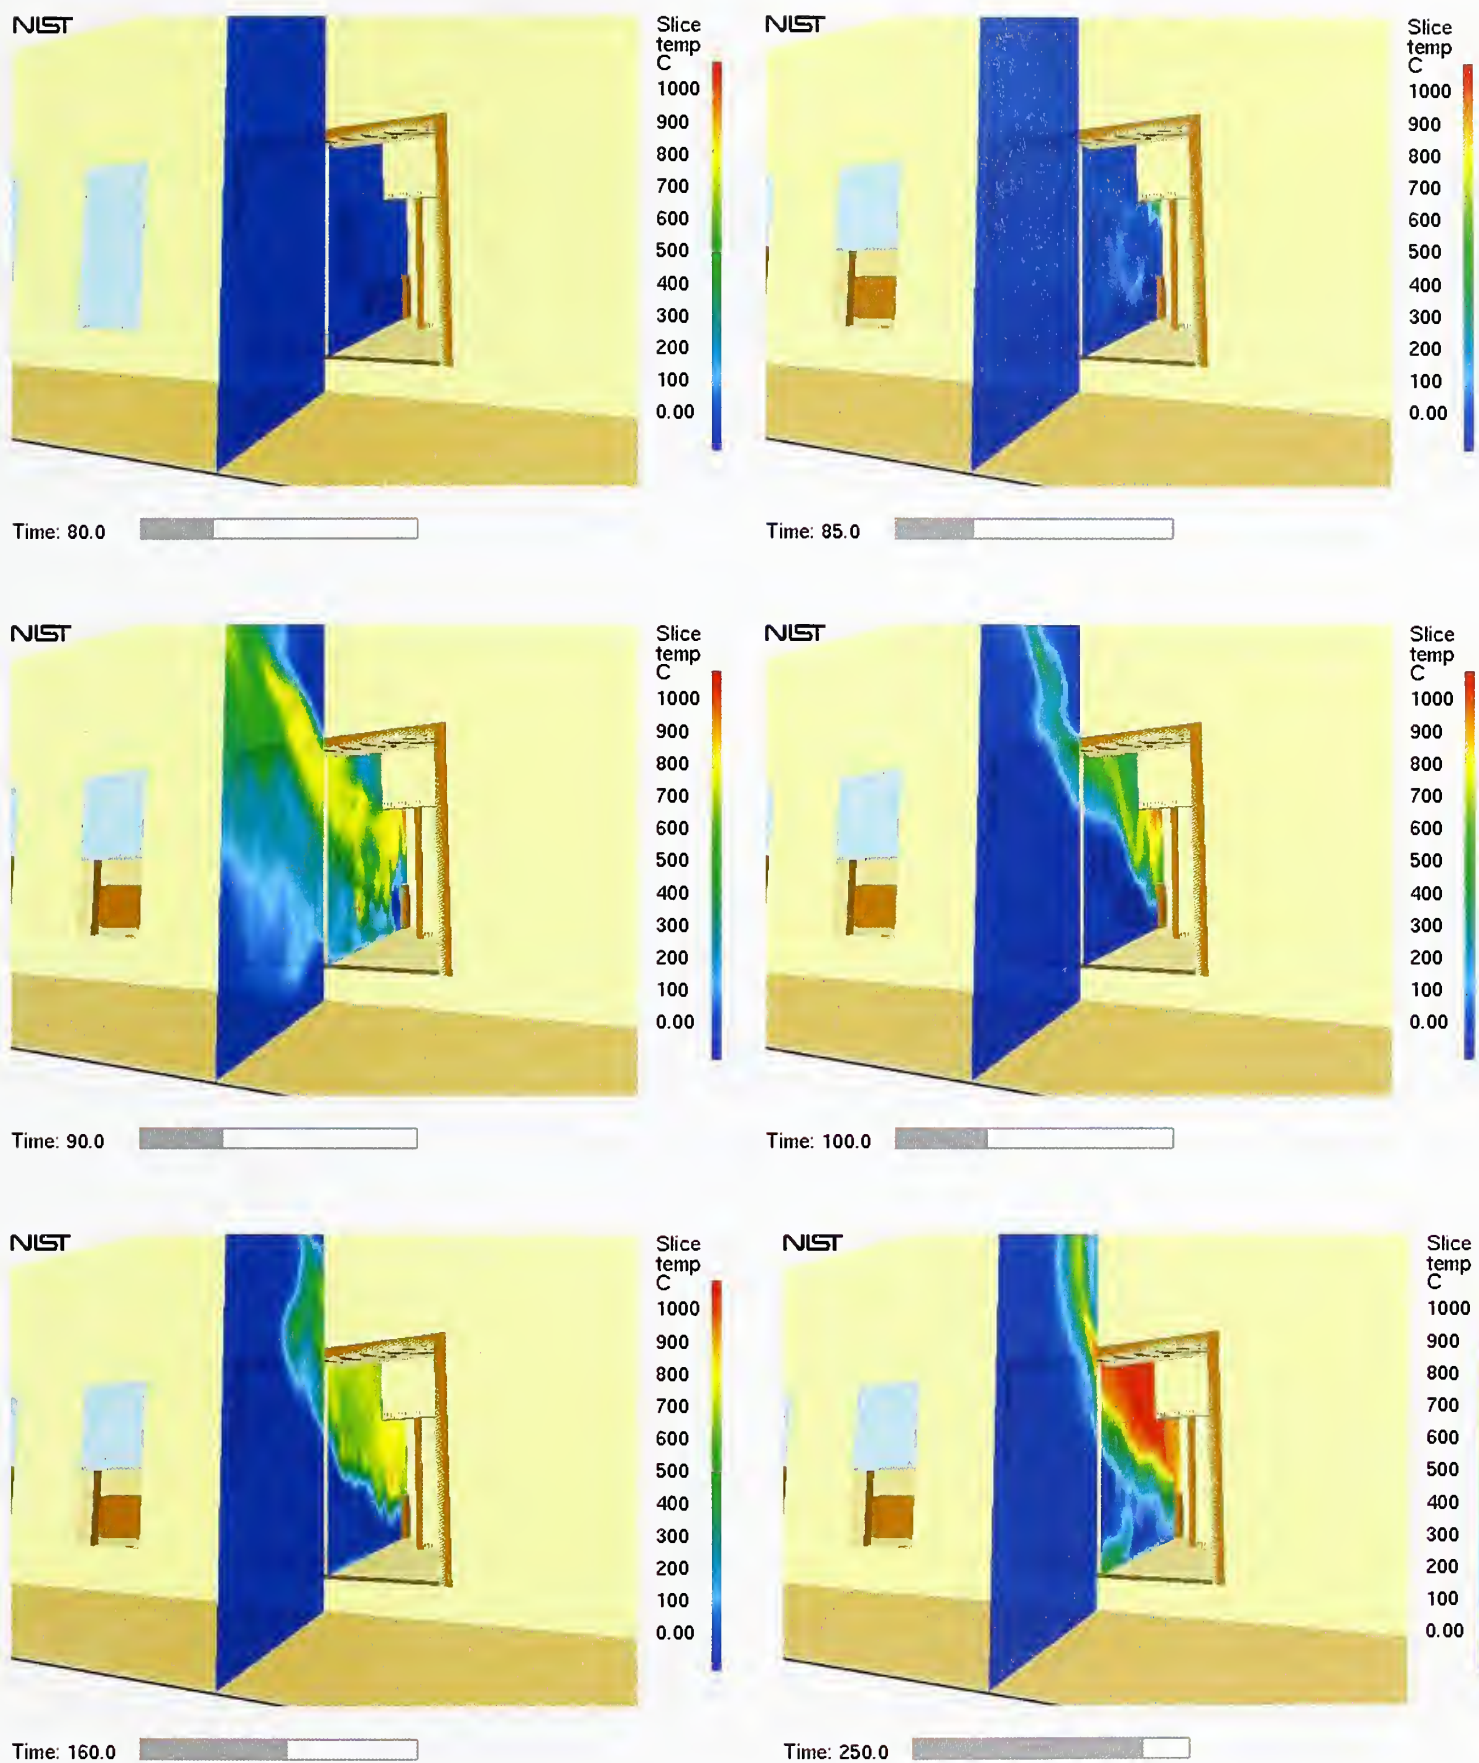
**Figure 5-57. Temperature profile through the center of the entry foyer, 80 seconds to 250 seconds**

Figure 5-57 shows the temperature predictions for the plane of data that is centered along the axis of the entry foyer. Temperatures just inside the front door, near the floor remain below the tenable limit because of the fresh air being drawn in through the doorway. This region of tenability decreases in a triangular orientation as the entranceway goes into the structure and gets smaller as the simulation continues. This simulation does not account for the occupants that accumulated in the doorway. Thirty-one victims were located in this area.

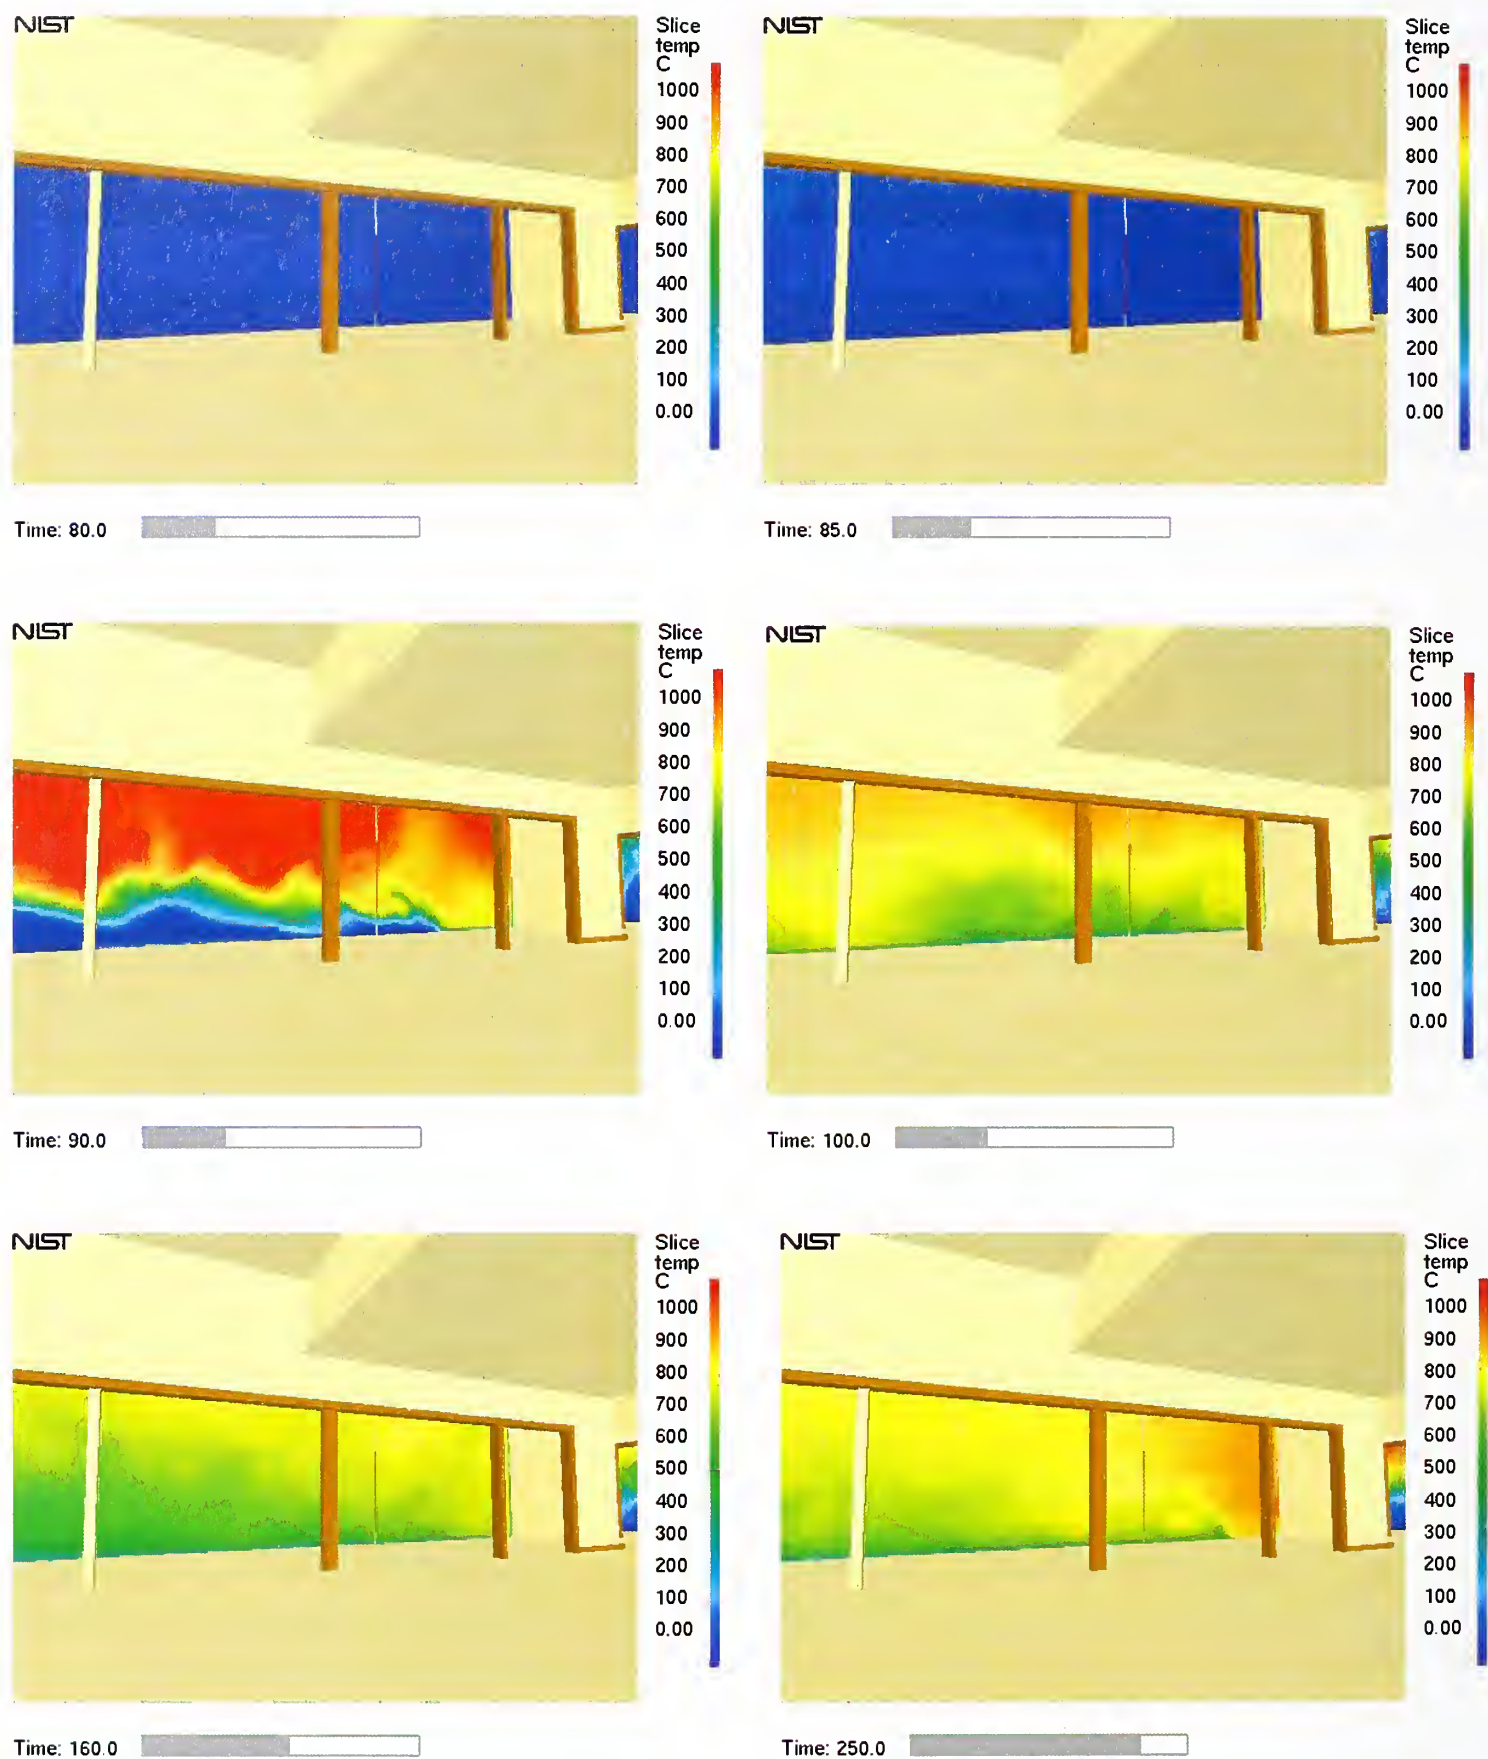
Figure 5-58. Temperature profile through the center of the sunroom, 80 seconds to 250 seconds

The area in the end of the sunroom adjacent to the entranceway was also a location that many victims were found. A vertical temperature slice through this area, shown Figures 5-58a and 5-58b, suggests that these victims did not have much time before the heat overcame them. Temperatures exceeded the 120 °C (248 °F) tenable threshold within 90 seconds after ignition. The simulation indicates that this change was rapid and extreme with temperatures in the upper portion of the space increasing from ambient conditions to flame temperatures on the order of 1000 °C (1830 °F) within 10 seconds. After the initial energy release due to the burning polyurethane foam (90 seconds), the predicted temperature decreased, but remained in the untenable range throughout the remainder of the simulation. Figure 5-58b shows that the temperatures increased again to 900 °C (1650 °F) at 250 seconds after ignition. The opening of portions of the bay windows between 78 seconds and 120 seconds after ignition had a minimal impact on reducing the temperatures in this part of the building. Eighteen victims were located in this area.

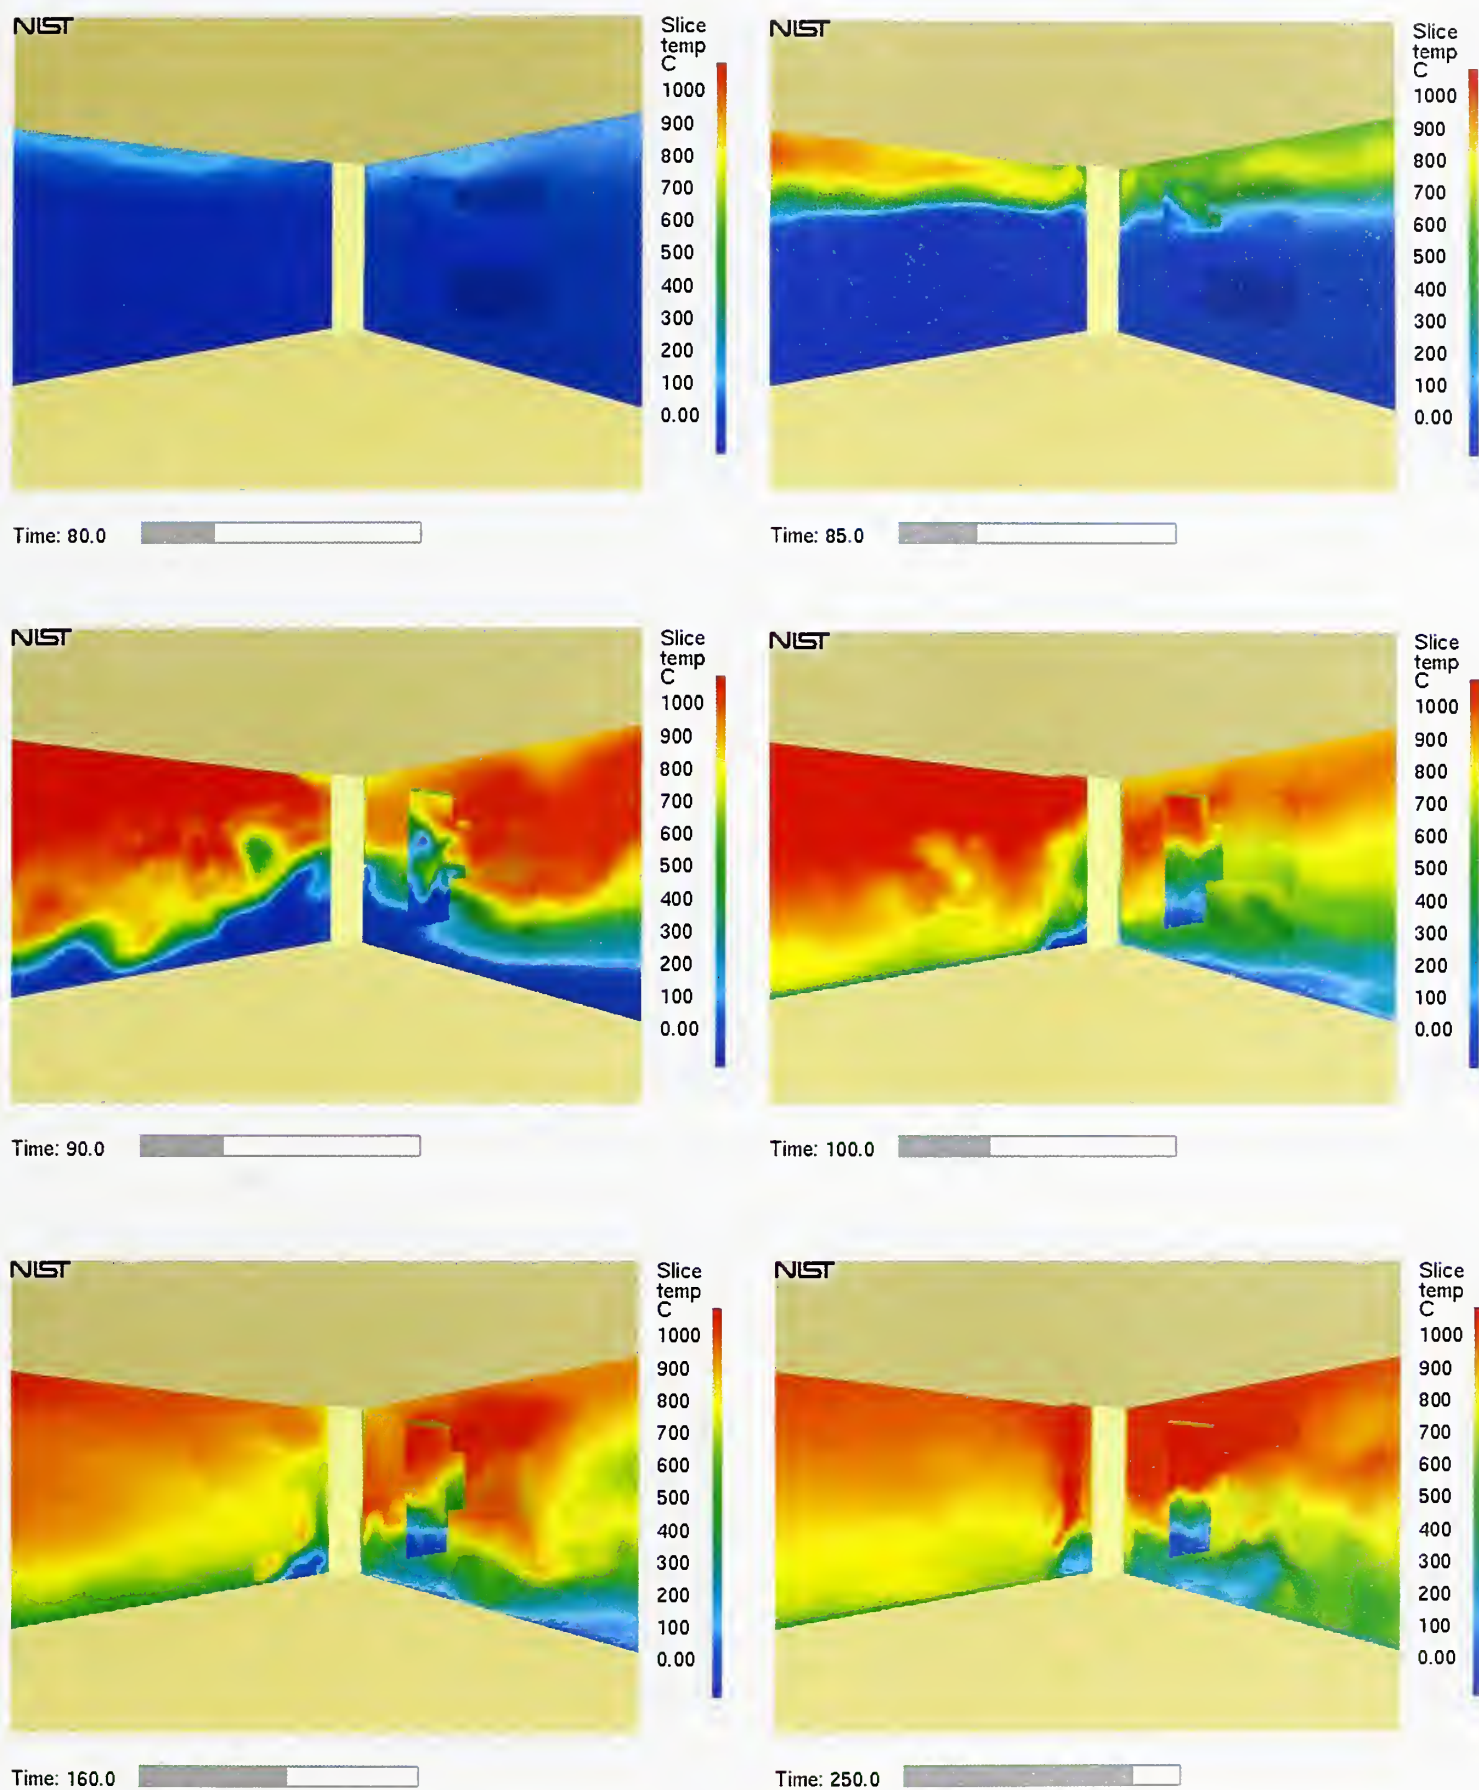
Figure 5-59. Temperature profiles approaching main entry foyer, 80 seconds to 250 seconds

Figure 5-59 depicts the temperatures in the approaches to the main entry foyer. The vertical temperature slices cover the area at the end of the entrance foyer and next to the ticket booth. The view is from the dance floor area looking toward the main entrance (front door). What appears to be a pillar in between the intersection of the two vertical slices is a portion of the wall that separates the sunroom from the main entry foyer. The images demonstrate that temperatures were untenable outside of the entranceway and that if the occupants were not able to make it into the area of cool air coming in from the front doorway, they did not have a chance of survival. Temperatures near the floor exceeded 400 °C (750 °F) within 100 seconds of ignition. Nine victims were located in this area.
