NIST NCSTAR 2: Vol. I

# Report of the Technical Investigation of The Station Nightclub Fire

June 2005

A fire occurred on the night of Feb. 20, 2003, in The Station nightclub at 211 Cowesett Avenue, West Warwick, Rhode Island. A band that was on the platform that night, during its performance, used pyrotechnics that ignited polyurethane foam insulation lining the walls and ceiling of the platform. The fire spread quickly along the walls and ceiling area over the dance floor. Smoke was visible in the exit doorways in a little more than one minute, and flames were observed breaking through a portion of the roof in less than five minutes. Egress from the nightclub, which was not equipped with sprinklers, was hampered by crowding at the main entrance to the building. One hundred people lost their lives in the fire. On Feb. 27, 2003, under the authority of the National Construction Safety Team (NCST) Act, the National Institute of Standards and Technology (NIST) established a National Construction Safety Team to determine the likely technical cause or causes of the building failure that led to the high number of casualties in that fire. This report documents the procedures, findings,

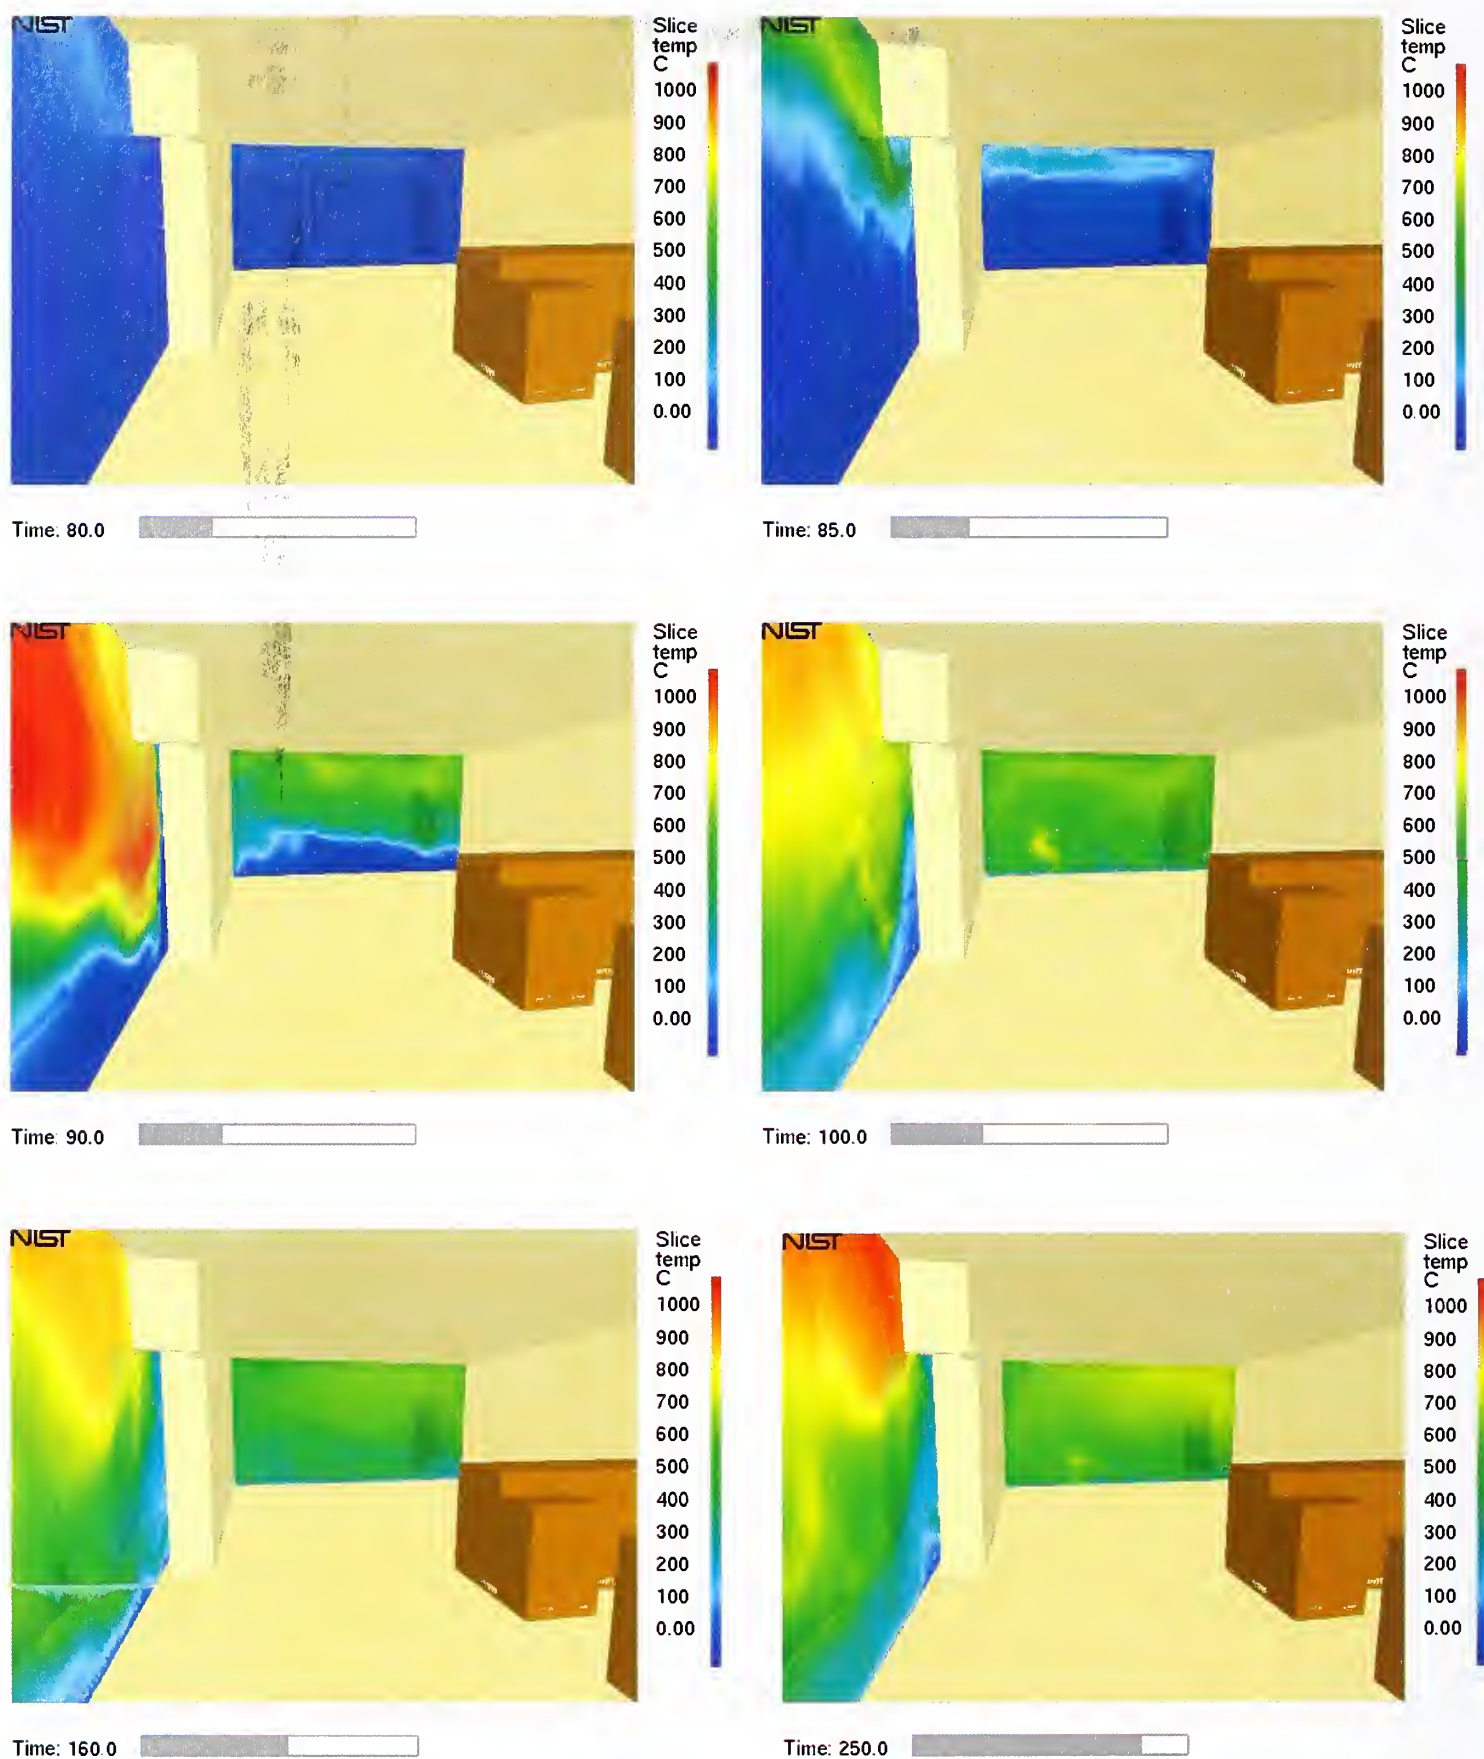
Figure 5-60. Temperature profiles in the dart room, 80 seconds to 250 seconds

The area of the nightclub with the side bar and the dart room is shown in the simulated images with vertical temperature slices bounding the area to the north (toward the main entrance) and to the east (toward the storage/office area entrance). Figure 5-60 shows the rapid change in thermal conditions between 80 seconds and 90 seconds after ignition. As in other parts of the nightclub simulation this significant increase in temperature was due to the burning of the polyurethane foam. Temperatures near the floor ranged from 200 °C (390 °F) to 600 °C (1110 °F) at 100 seconds. The figure indicates that the temperatures remained in the untenable range throughout the rest of the simulation. In the incident, nine victims were found in this area.

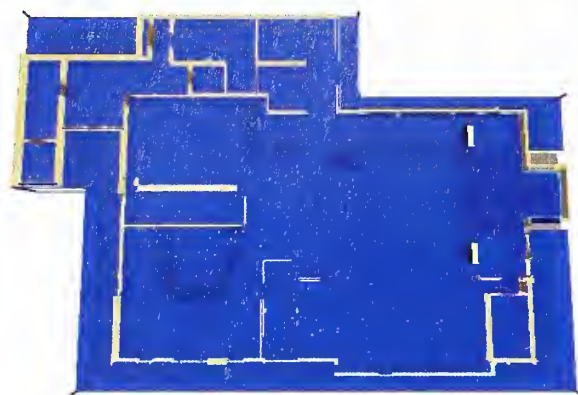
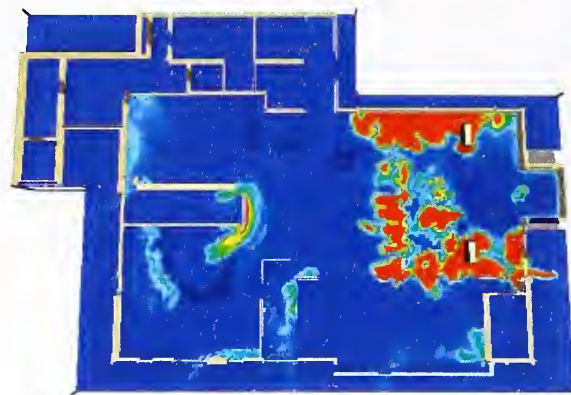
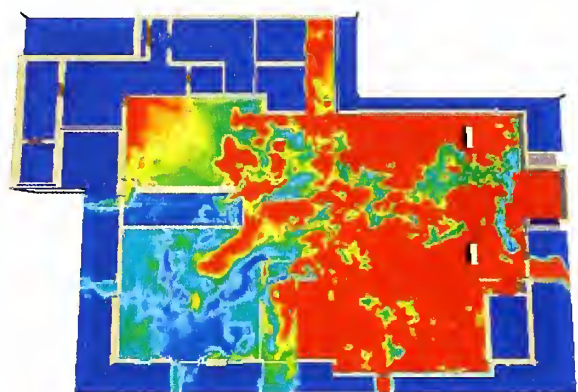
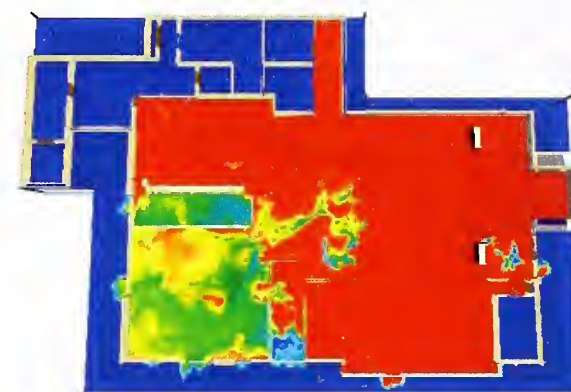
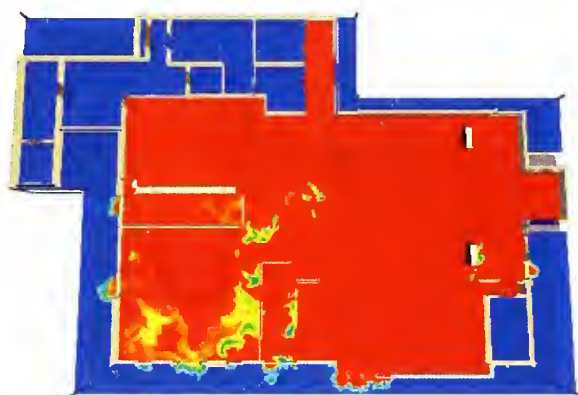
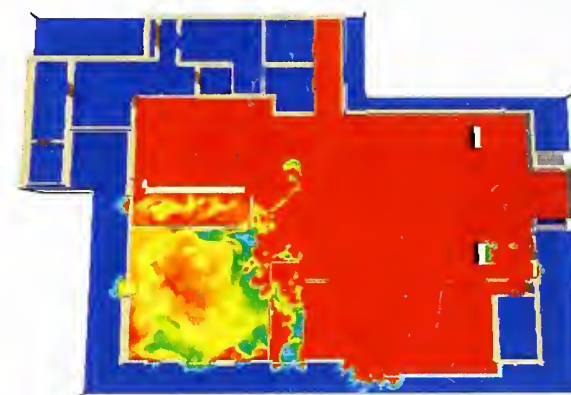
Figure 5-61. Oxygen volume fractions at 1.5 m (5 ft) above the floor, 80 seconds to 250 seconds

Just as the temperature levels rose rapidly after the platform area became fully involved in flames, the oxygen levels drop proportionally. As shown by the three dimensional smoke output in the previous section, the smoke spreads quickly through the structure. The first four images in Figure 5-61 range from 80 seconds after ignition to 100 seconds after ignition. This sequence has the most dramatic changes in oxygen concentration. Beyond 100 seconds the entire structure is untenable at the 1.5 m (5 ft) height. Tenability exists for the longest duration in the main bar area. Most of the building, including the platform and dance floor areas, the dart room, the main entry foyer and the main bar room, is shown by the simulation to be significantly depleted of oxygen to less than two percent.

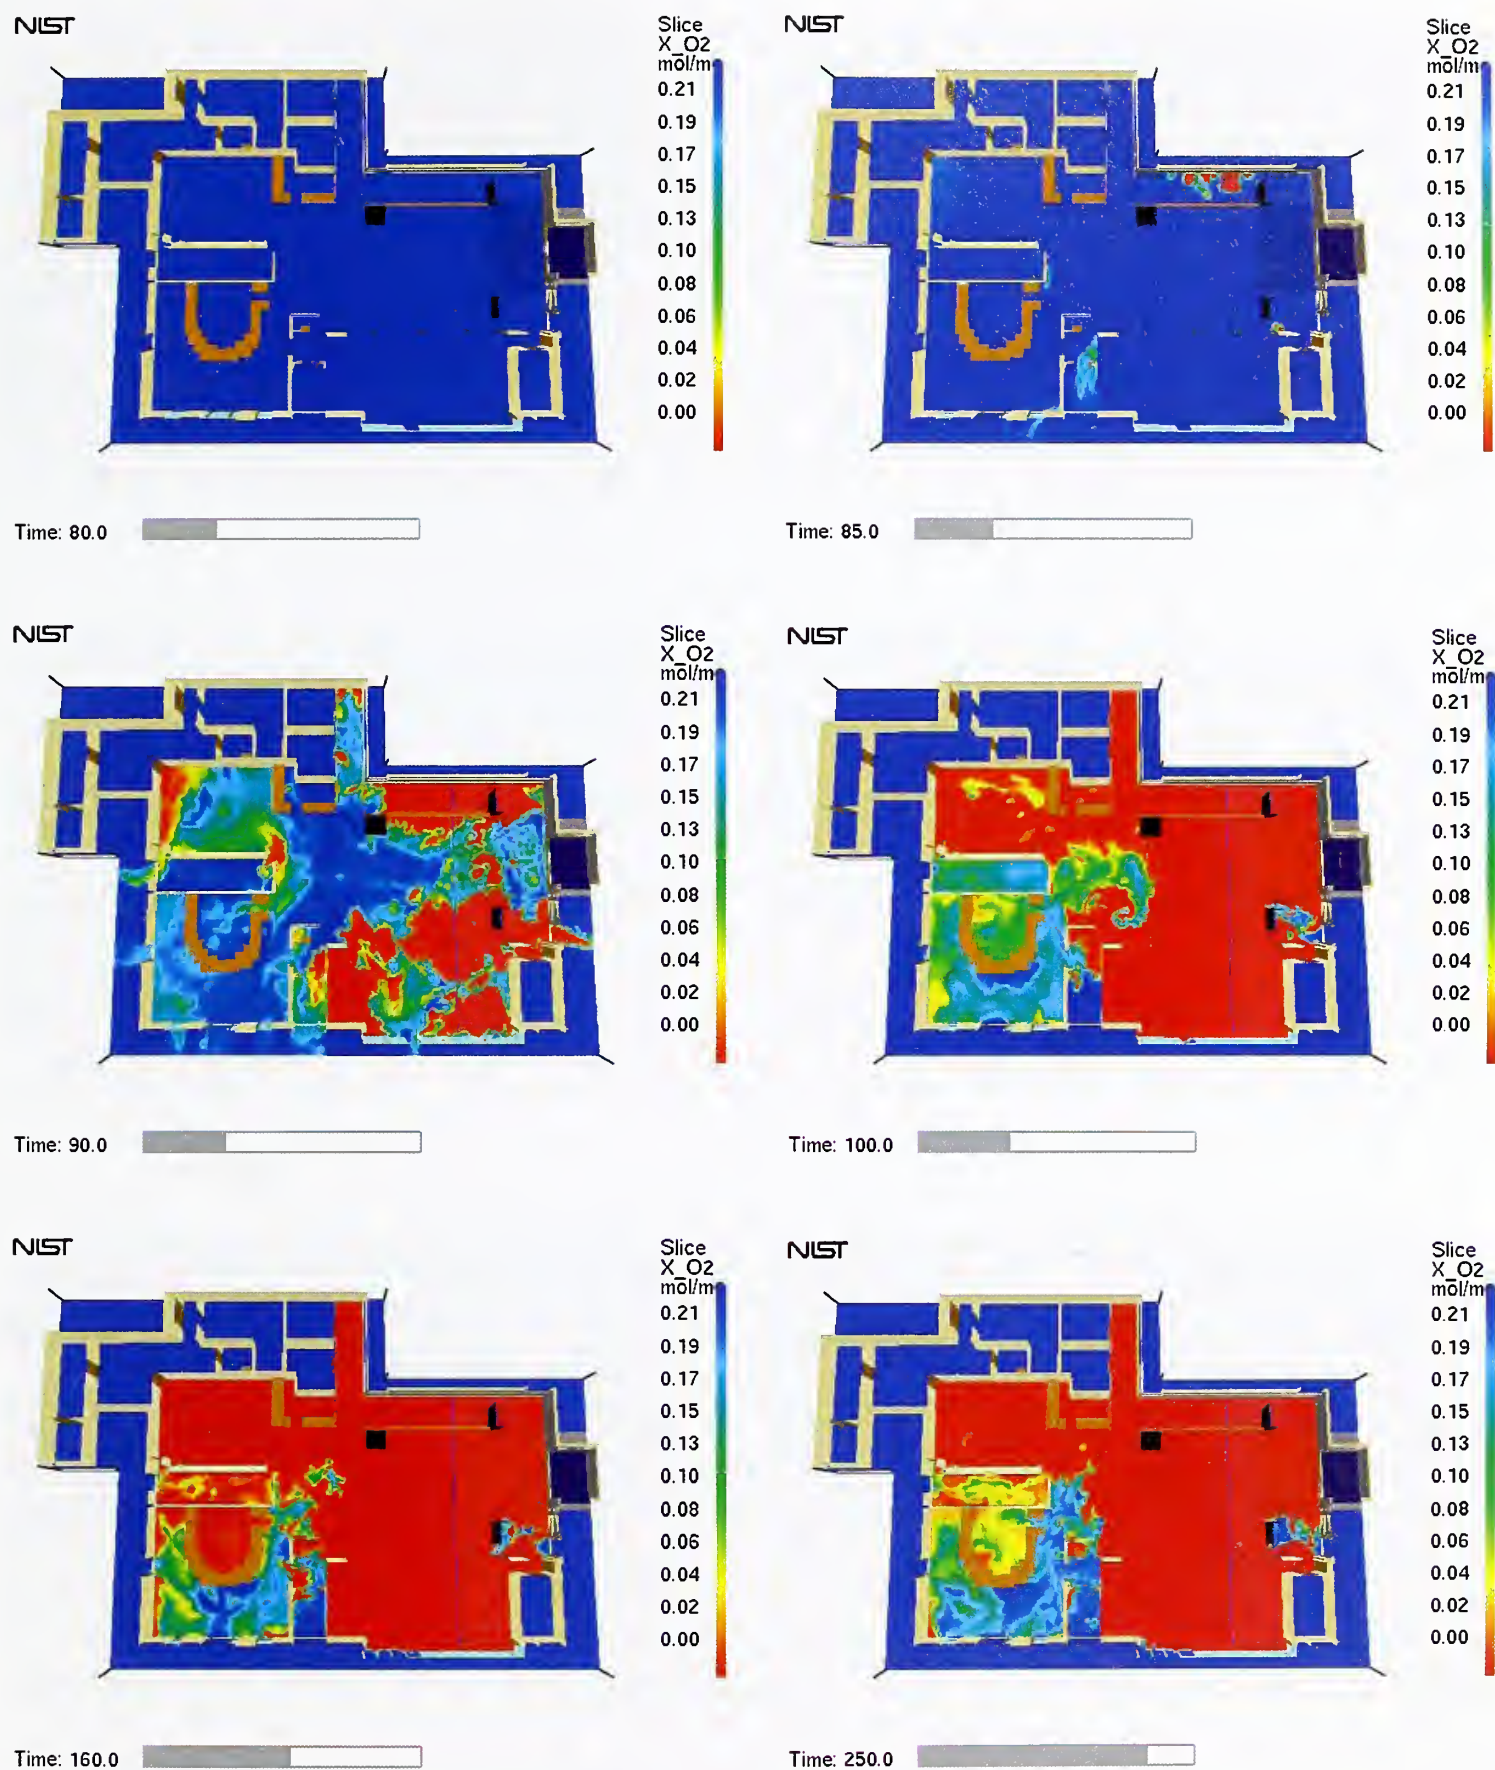
Figure 5-62. Oxygen volume fractions at 0.6 m (2 ft) above the floor, 80 seconds to 250 seconds

Figure 5-62 shows the predicted oxygen volume fraction 0.6 m (2 ft) above the floor, beginning at 80 seconds after ignition through 250 seconds after ignition. At this lower level it is apparent that tenability is also not likely in any area other than the main bar area and the entranceway right inside the front door. The opening of the windows at the front of the main bar room creates a more tenable atmosphere, probably saving the lives of occupants as they can be seen being pulled from the windows in the WPRI video. Occupants that stayed low in the main bar area had a better chance of survival.

The images in later in Figure 5-62, once again, show a rapid decrease in tenable conditions due to oxygen depletion throughout most of the simulated nightclub with the exception of the main bar room and the main entry foyer. Due to the open doors and windows in these areas, the simulation indicates that sufficient fresh air was drawn in to maintain a level of tenability with respect to oxygen in the areas adjacent to the open windows and the main entry way. This trend is shown to continue through the end of the simulation. In the WPRI video, the last person recorded being assisted through a window from the main bar room occurs at 250 seconds after ignition. This is consistent with the predicted oxygen concentrations near the windows.

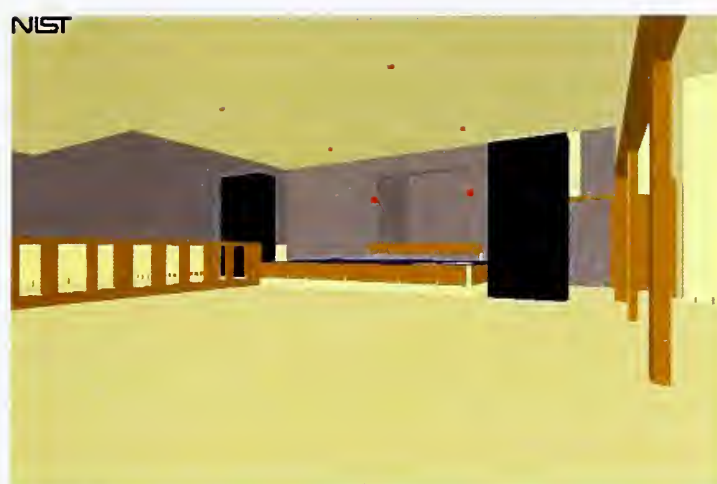
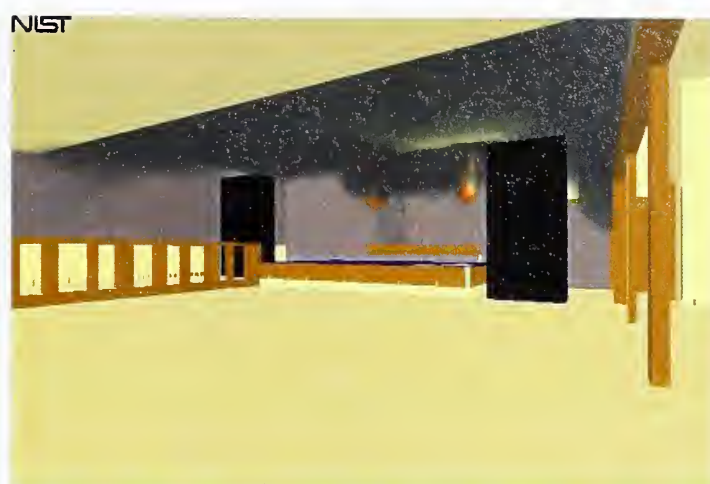
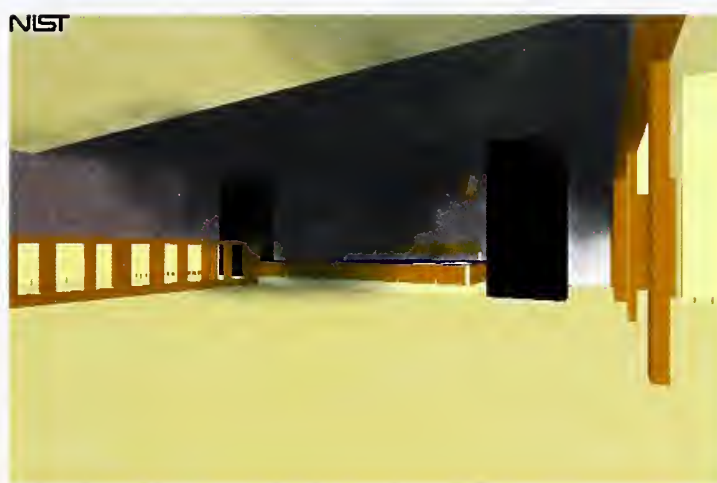
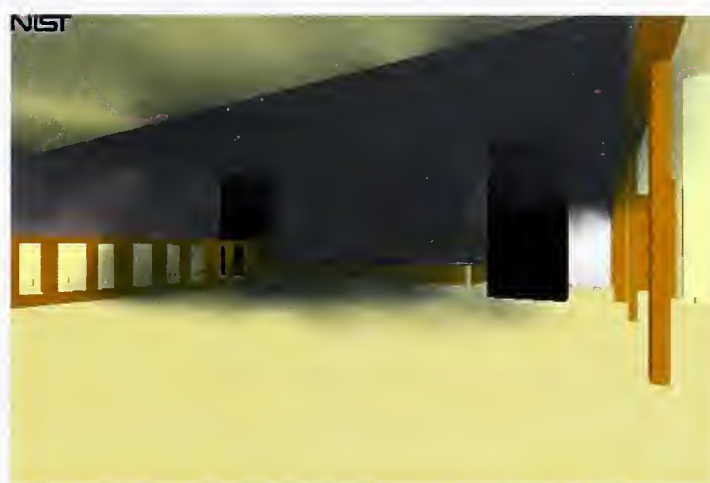
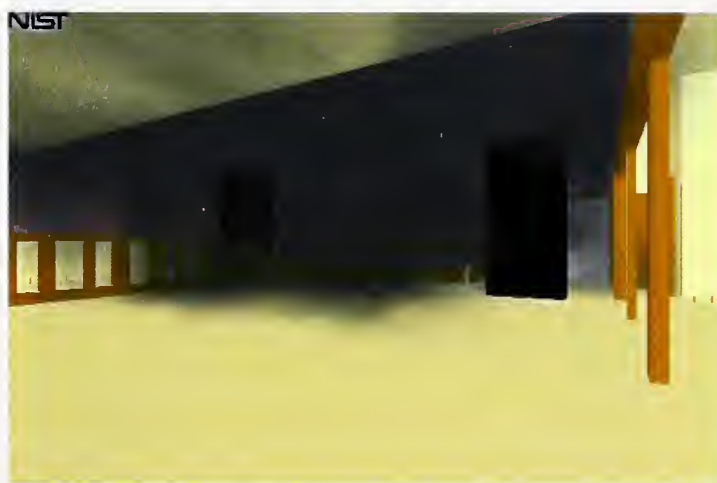
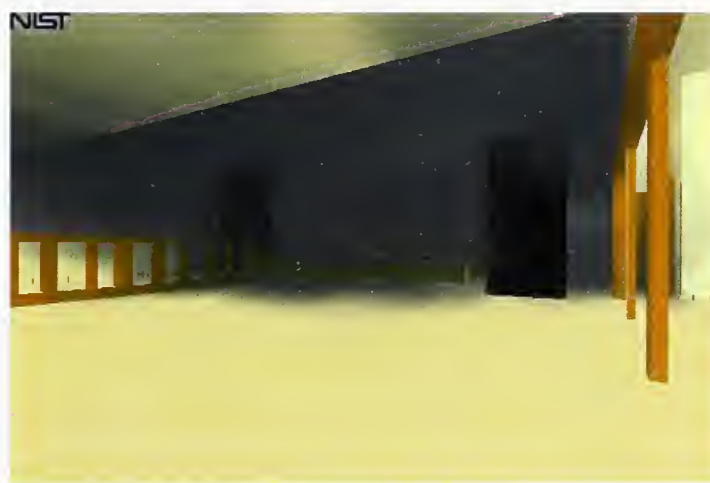
**Figure 5-63a. Simulation of nightclub with sprinklers, 0 seconds to 60 seconds**

Figures 5-63a and 5-63b are rendered from Smokeview to examine the flame and smoke spread and the effect of the sprinklers. The images begin at ignition or  $t = 0$  seconds and continue until 100 seconds after ignition. The first image in Figure 5-63a shows the two sprinklers over the platform area and the two sprinklers over the dance floor as small red dots along the ceiling. The larger red areas on the platform walls represent the location of the ignition burners. The sprinkler located on the ceiling of the alcove is hidden from view. The second image rendered at 20 seconds shows smoke being pushed away at the first sprinkler, which activated at 16 seconds after ignition. By 30 seconds after ignition, three of the sprinklers had been activated. This caused some of the smoke to be pushed down to the floor. The two sprinklers over the dance floor area did not activate during the simulation. Figure 5-63b has images from 70 seconds to 150 seconds after ignition. During this period the fire was significantly suppressed. The series of images show the smoke dispersing. The fire was extinguished fully at approximately 114 seconds. The smoke continued to spread and is diluted by fresh air entering the area.

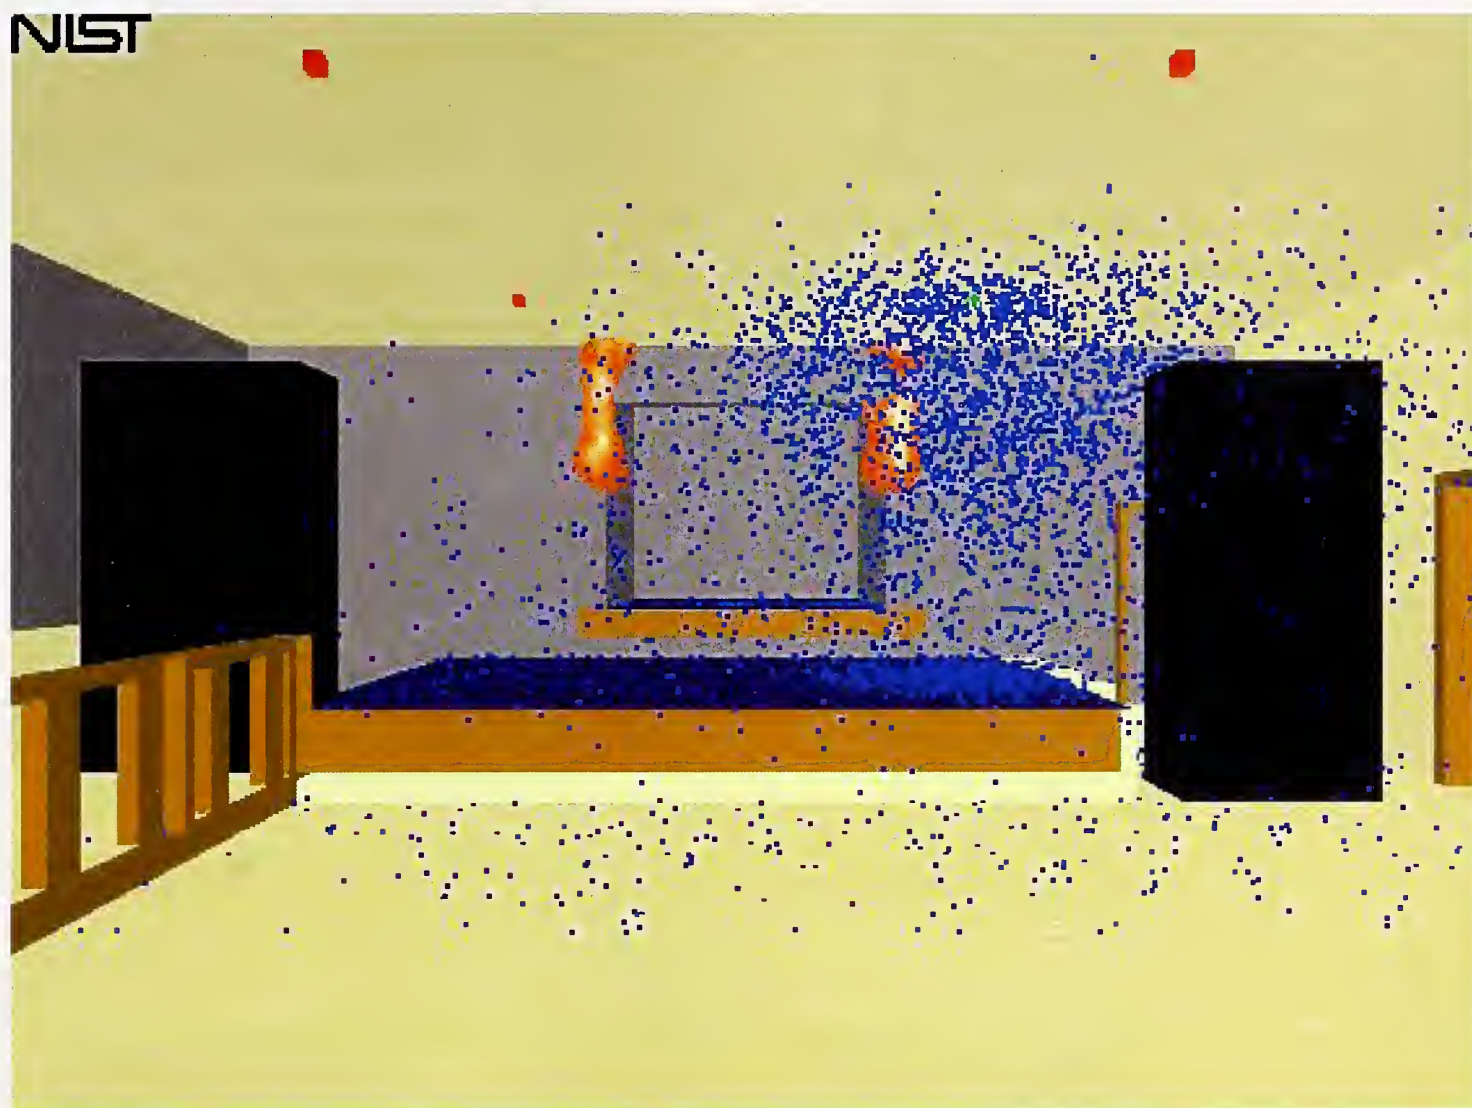
**Figure 5-64. Simulation of northwest sprinkler activation 18 seconds after ignition, showing water flow with smoke "turned off."**

Figure 5-64 provides another means of looking at the simulation. This image, rendered at 2 seconds after the first sprinkler activated, includes the visualization of the sprinkler droplets but does not include the visualization of the smoke. Notice that the activated sprinkler has changed color from red to green.

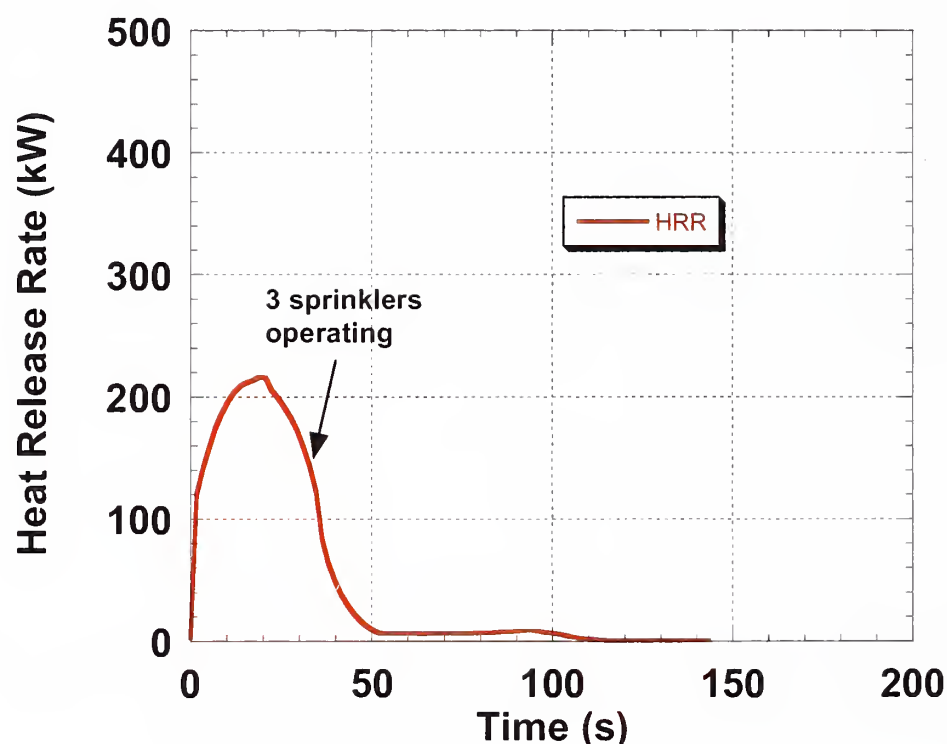
**Figure 5-65. FDS predicted heat release rate for the sprinklered case.**

Figure 5-65 shows the FDS predicted heat release rate for the sprinklered simulation. The heat release rate reached its maximum of approximately 220 kW at 20 seconds. This heat release rate quickly declined as the three sprinklers activated and suppressed the fire.

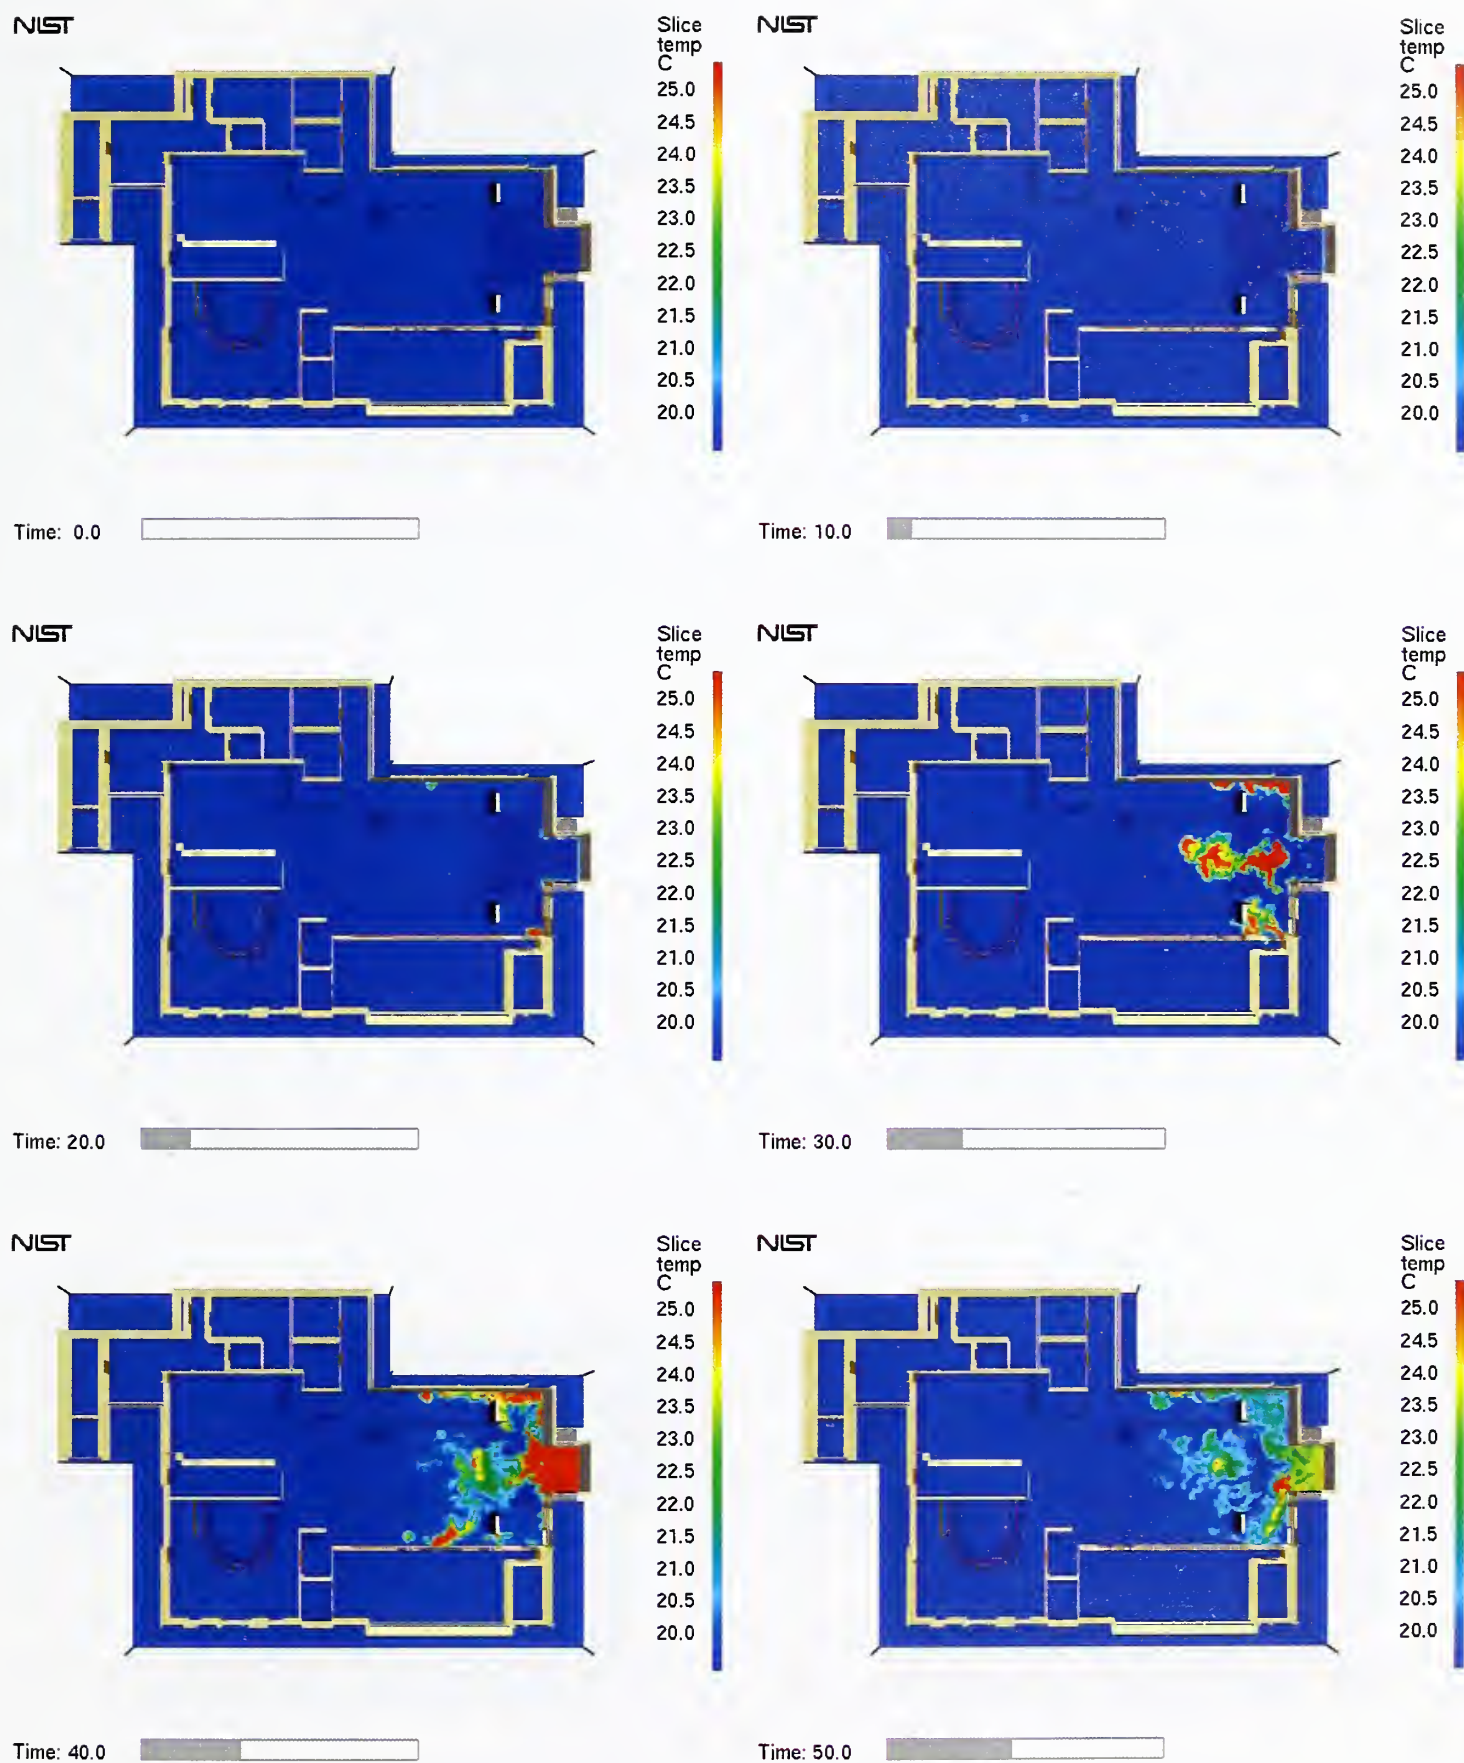
Figure 5-66a. Temperatures at 1.5 m (5 ft) above the floor, 0 seconds to 50 seconds

Isothermal plots are shown in Figures 5-66a and 5-66b to assess the tenability conditions based on temperatures that were predicted during the simulation of the fire. The figures show horizontal isothermal images 1.5 m (5 ft) above the floor from the time of ignition ( $t = 0$ ) to 100 seconds at 10 second intervals, and an image at 150 seconds. Due to the rapid activation of the sprinklers (three sprinklers were operating by 30 seconds after ignition), the temperatures at the 1.5 m (5 ft) level remain well below the temperature tenability threshold of 120 °C (248 °F) [6].

The comparison between the temperatures 1.5 m (5 ft) above the floor in the non-sprinklered simulation (Figure 5-55) and in the sprinklered configuration (Figs. 5-66a and 5-66b) show dramatically different thermal conditions. (Note the large difference in color scales.) During the non-sprinklered simulation temperatures exceeded 1000 °C (1830 °F) in the platform and dance floor areas, and in the main bar room they exceeded 500 °C (930 °F) within 100 seconds. In the sprinklered simulation, the temperature exceeds 25 °C at head height only near the platform; following sprinkler activation around 20 seconds, the thermal environment remains close to ambient up until the time the fire is fully extinguished at 120 seconds.

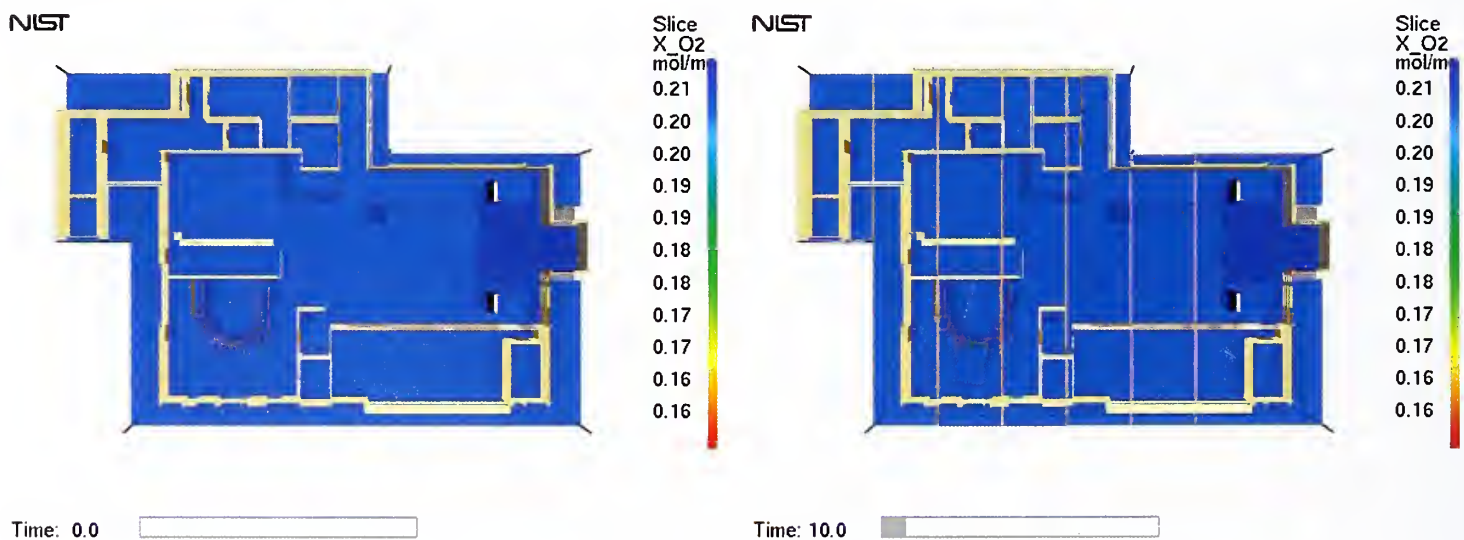
Figure 5.67a. Oxygen volume fractions at 1.5 m (5 ft) above the floor, 0 seconds and 10 seconds

Oxygen volume fractions were also examined in the sprinklered simulation to assess the tenability conditions that existed during the evolution of the fire. Horizontal slices were taken at the 1.5 m (5 ft) level with the roof removed to examine the structure as a whole. The analysis utilized a volume fraction of 0.12 as the oxygen tenability threshold [6]. Based on that oxygen limit, Figures 5-67a and 5-67b demonstrate that the atmosphere remained tenable during the entire duration of the simulation. In contrast, the non-sprinklered simulation predicted oxygen levels below 0.12 at the 1.5 m (5 ft) elevation throughout the building at 100 seconds after ignition and then continuing at untenable concentrations during the remainder of the simulation.

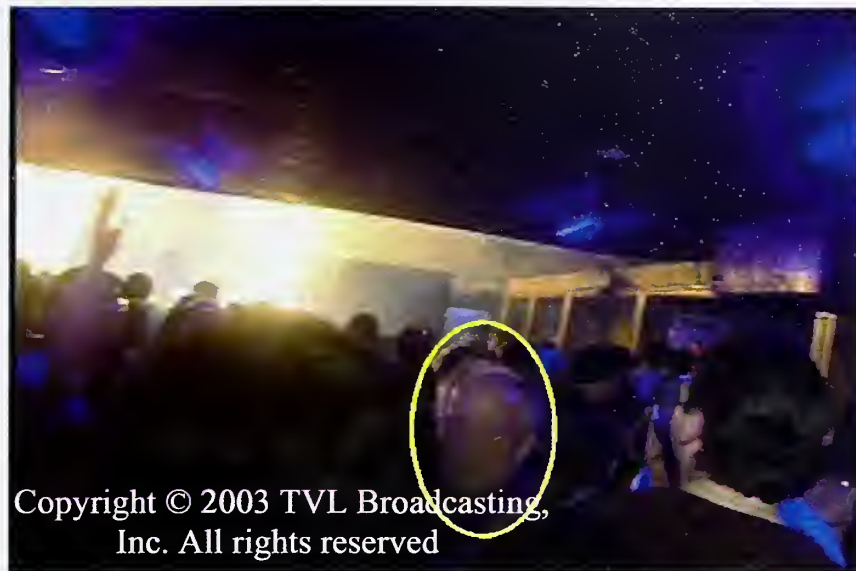
**Figure 6-1. Occupant at Start of Evacuation [2]**

Efforts were made to track individuals from their location in the club when the fire ignited until they had evacuated. One male occupant, shown facing the camera in Figure 6-1, was tracked through evacuation. The time of this still frame is 0:06:51 video time (0:00:29 fire time). The occupant's face has been blurred in the figures below in order to preserve his anonymity; his facial features were not critical for the identification analysis.

After the ignition of the fire, the camera operator began reacting before most other occupants did. The camera captured the occupant shown in Figure 6-1 29 seconds after the ignition of the fire turning and beginning to move toward the door. At this point, the camera was approximately two rows of people behind this man (between him and the main exit). This occupant can be seen reaching and crossing the main exit at 0:07:31 video time (0:01:09 fire time), 39 seconds later, in Figure 6-2.

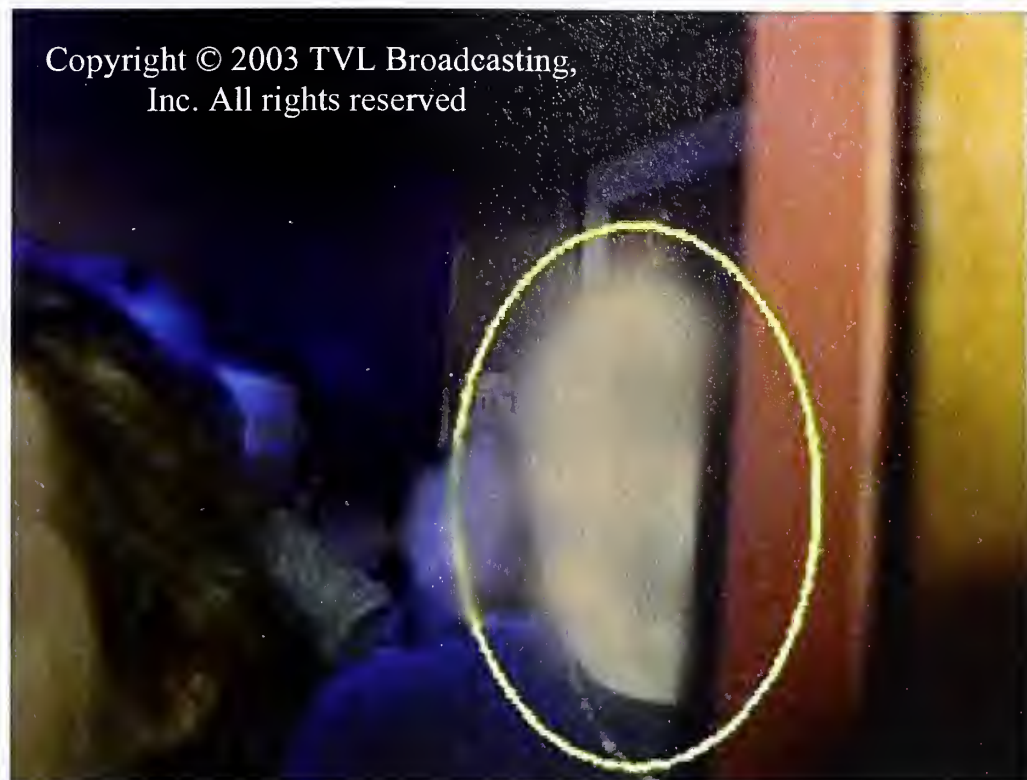
**Figure 6-4 Occupant Attempting to Evacuate [2]**

Forty-one seconds elapsed between Figure 6-4 (0:01:02 fire time) and when the occupant was first seen near the bottom of the pile. Because the camera operator moved to the side of the building immediately upon exiting through the main exit, it is not known when the individual shown in these figures reached the door and fell to that position.

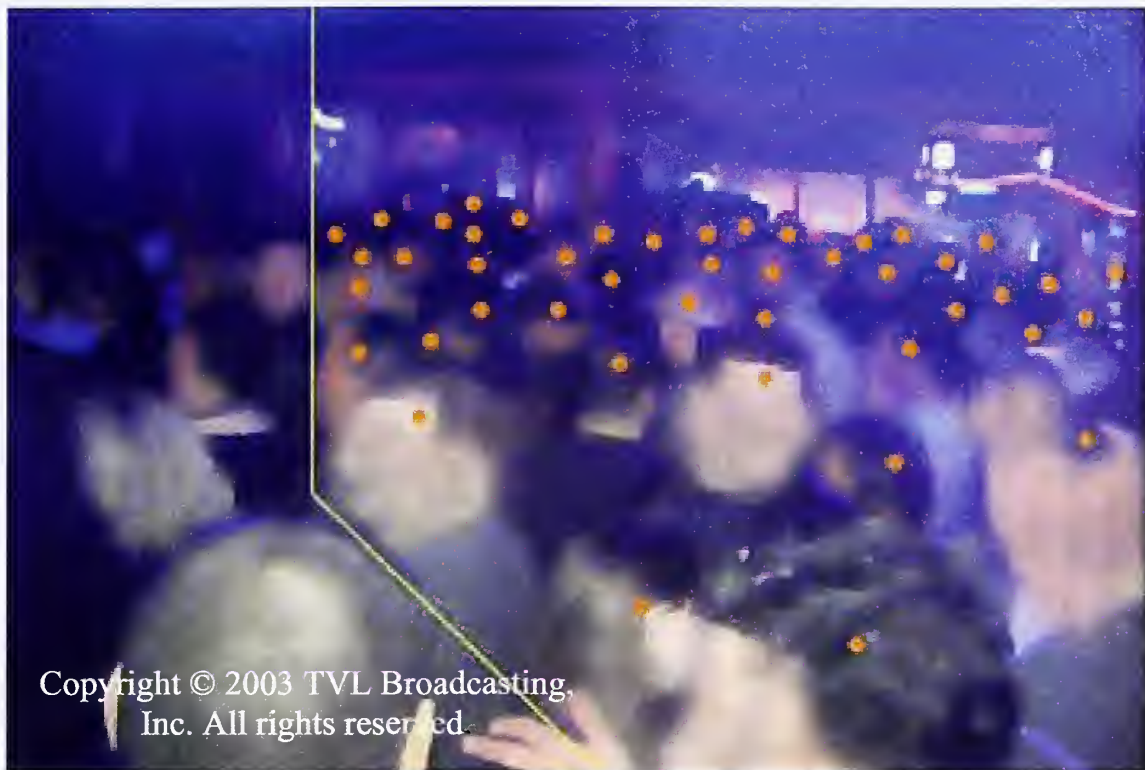
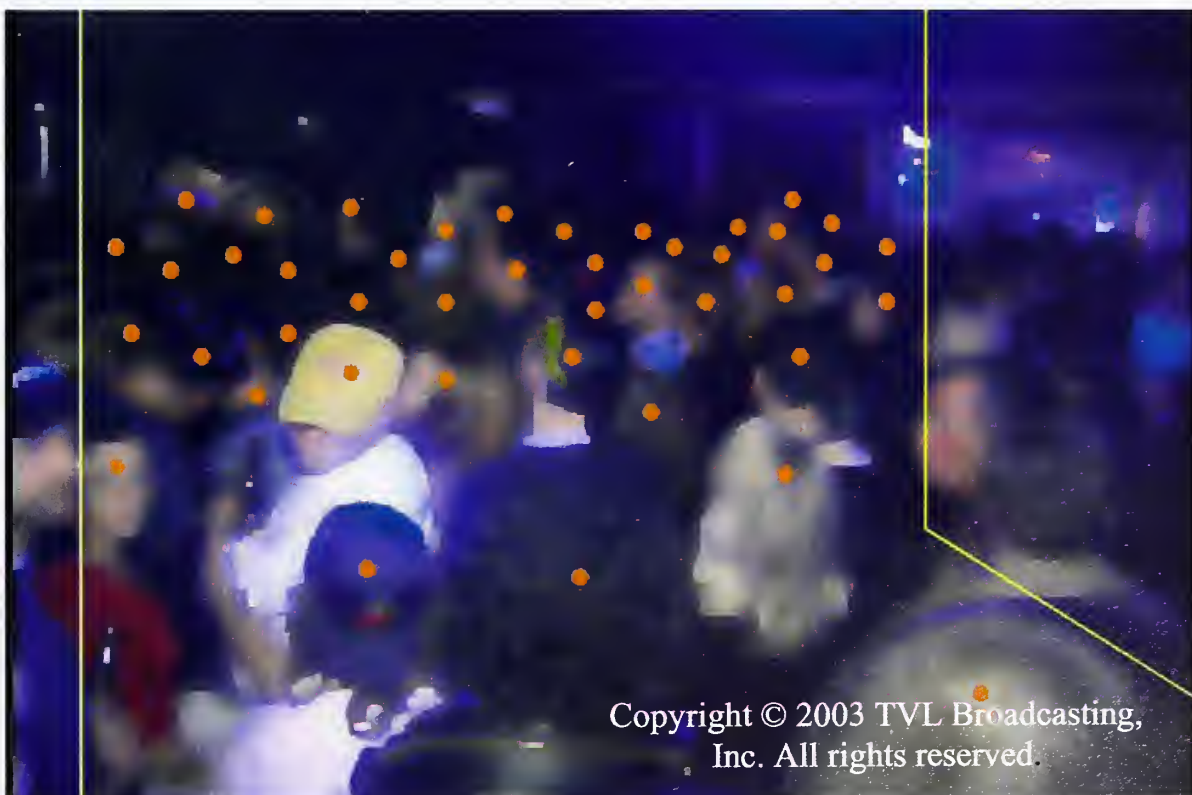
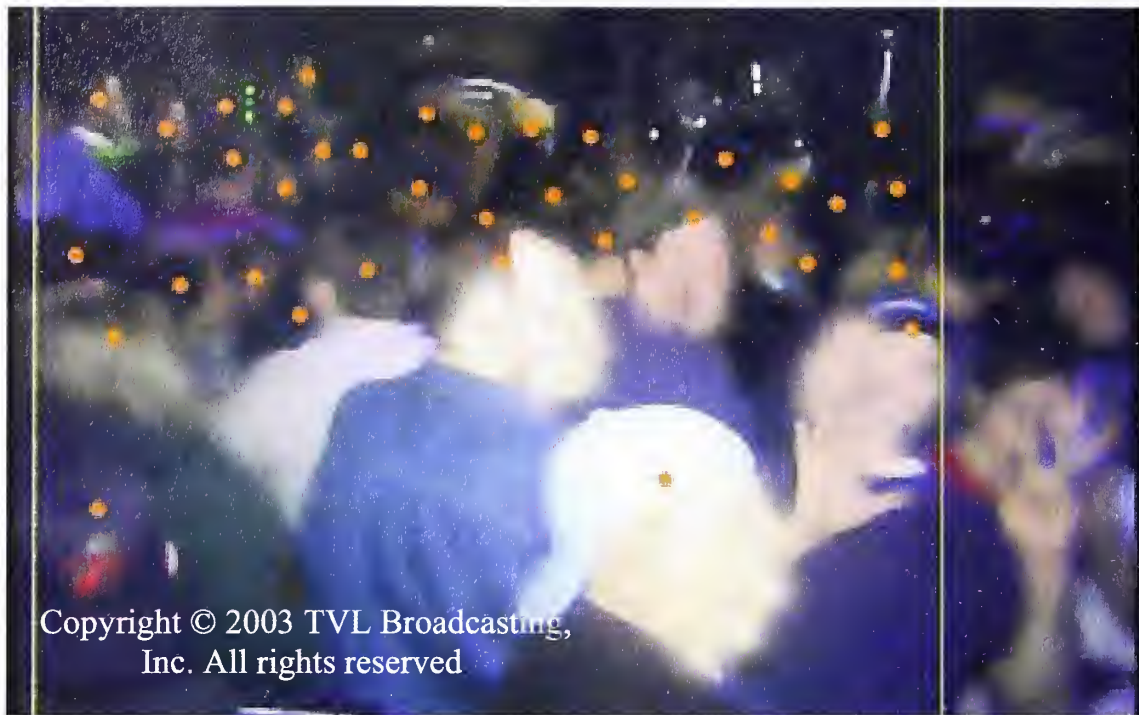
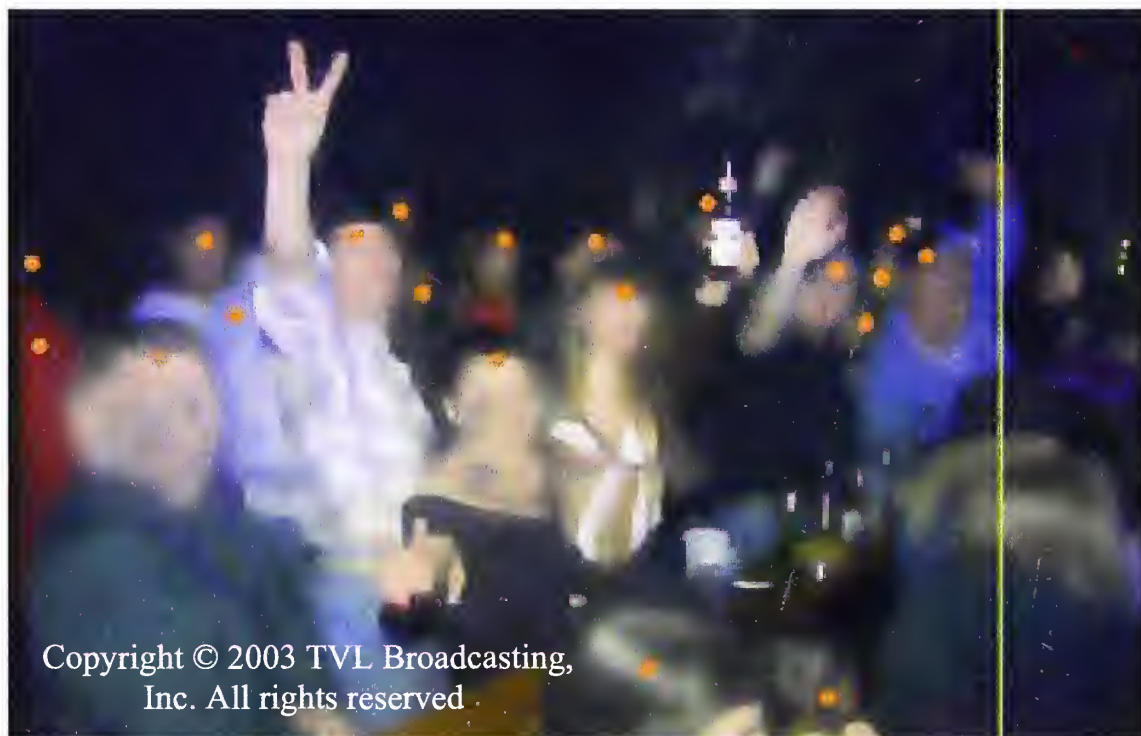
sequence in Figures 6-5 through 6-8 as the camera pans from right to left. The occupants shown in these still frames were counted in an effort to derive an approximate occupant load for the area shown. Orange dots have been used to represent counted occupants. The yellow lines in these Figures represent the boundaries where the frames overlap. A total of 144 occupants can be seen in these four figures. It is not clear at what time in relation to the start of the concert this video sequence was recorded. If it was recorded well before the main musical act, then it is likely that many occupants were located outside of the main platform viewing area at this time (i.e., many occupants may have been near one of the bars, in the pool room, or in the restrooms). Conversely, if this sequence was recorded immediately prior to the start of the primary musical act, then it is likely that the majority of the club's occupants would have moved towards the platform and into the performance assembly area. For these reasons it is not possible to extrapolate to a total building occupant load from this analysis. However, these figures can be helpful in estimating possible ranges of the number of occupants that may have been within the main platform viewing area.
