NIST NCSTAR 2: Vol. I

# Report of the Technical Investigation of The Station Nightclub Fire

June 2005

A fire occurred on the night of Feb. 20, 2003, in The Station nightclub at 211 Cowesett Avenue, West Warwick, Rhode Island. A band that was on the platform that night, during its performance, used pyrotechnics that ignited polyurethane foam insulation lining the walls and ceiling of the platform. The fire spread quickly along the walls and ceiling area over the dance floor. Smoke was visible in the exit doorways in a little more than one minute, and flames were observed breaking through a portion of the roof in less than five minutes. Egress from the nightclub, which was not equipped with sprinklers, was hampered by crowding at the main entrance to the building. One hundred people lost their lives in the fire. On Feb. 27, 2003, under the authority of the National Construction Safety Team (NCST) Act, the National Institute of Standards and Technology (NIST) established a National Construction Safety Team to determine the likely technical cause or causes of the building failure that led to the high number of casualties in that fire. This report documents the procedures, findings,

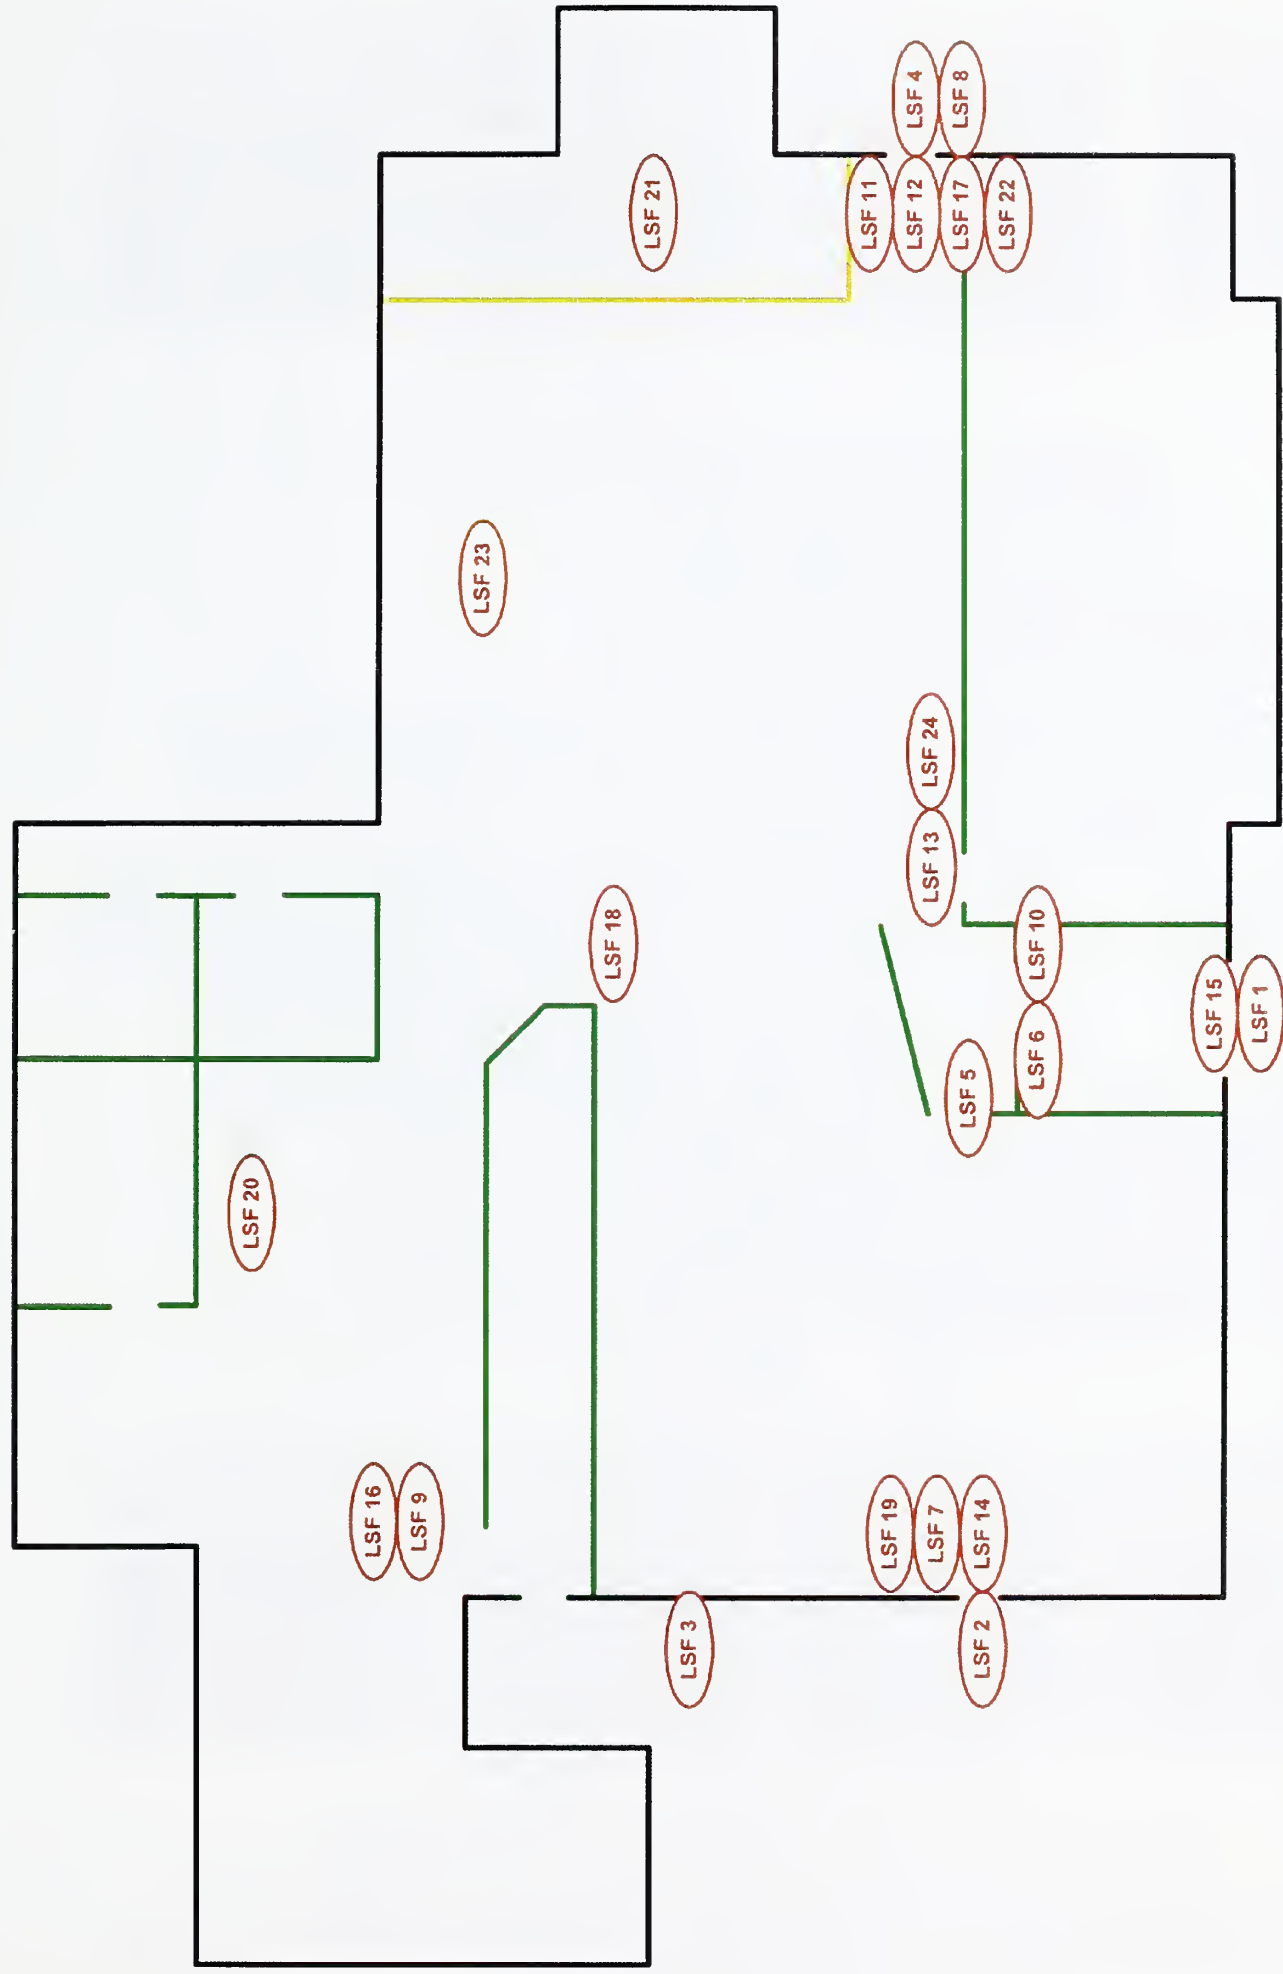
Figure 6-9. Locations of life safety features listed in Table 6-1.

Table 6-1 summarizes all identified life safety features within The Station prior to the fire. Refer to Figure 6-9 for the locations of these features within the building. Specific devices and features are shown in Figures 6-10 and 6-11, taken from video stills or photographs taken at the site on Feb. 22, 2003. (Large format copies of the photos are included in Appendix B.) Additional details, such as manufacturer names, model numbers, or other descriptions of the devices were not available.

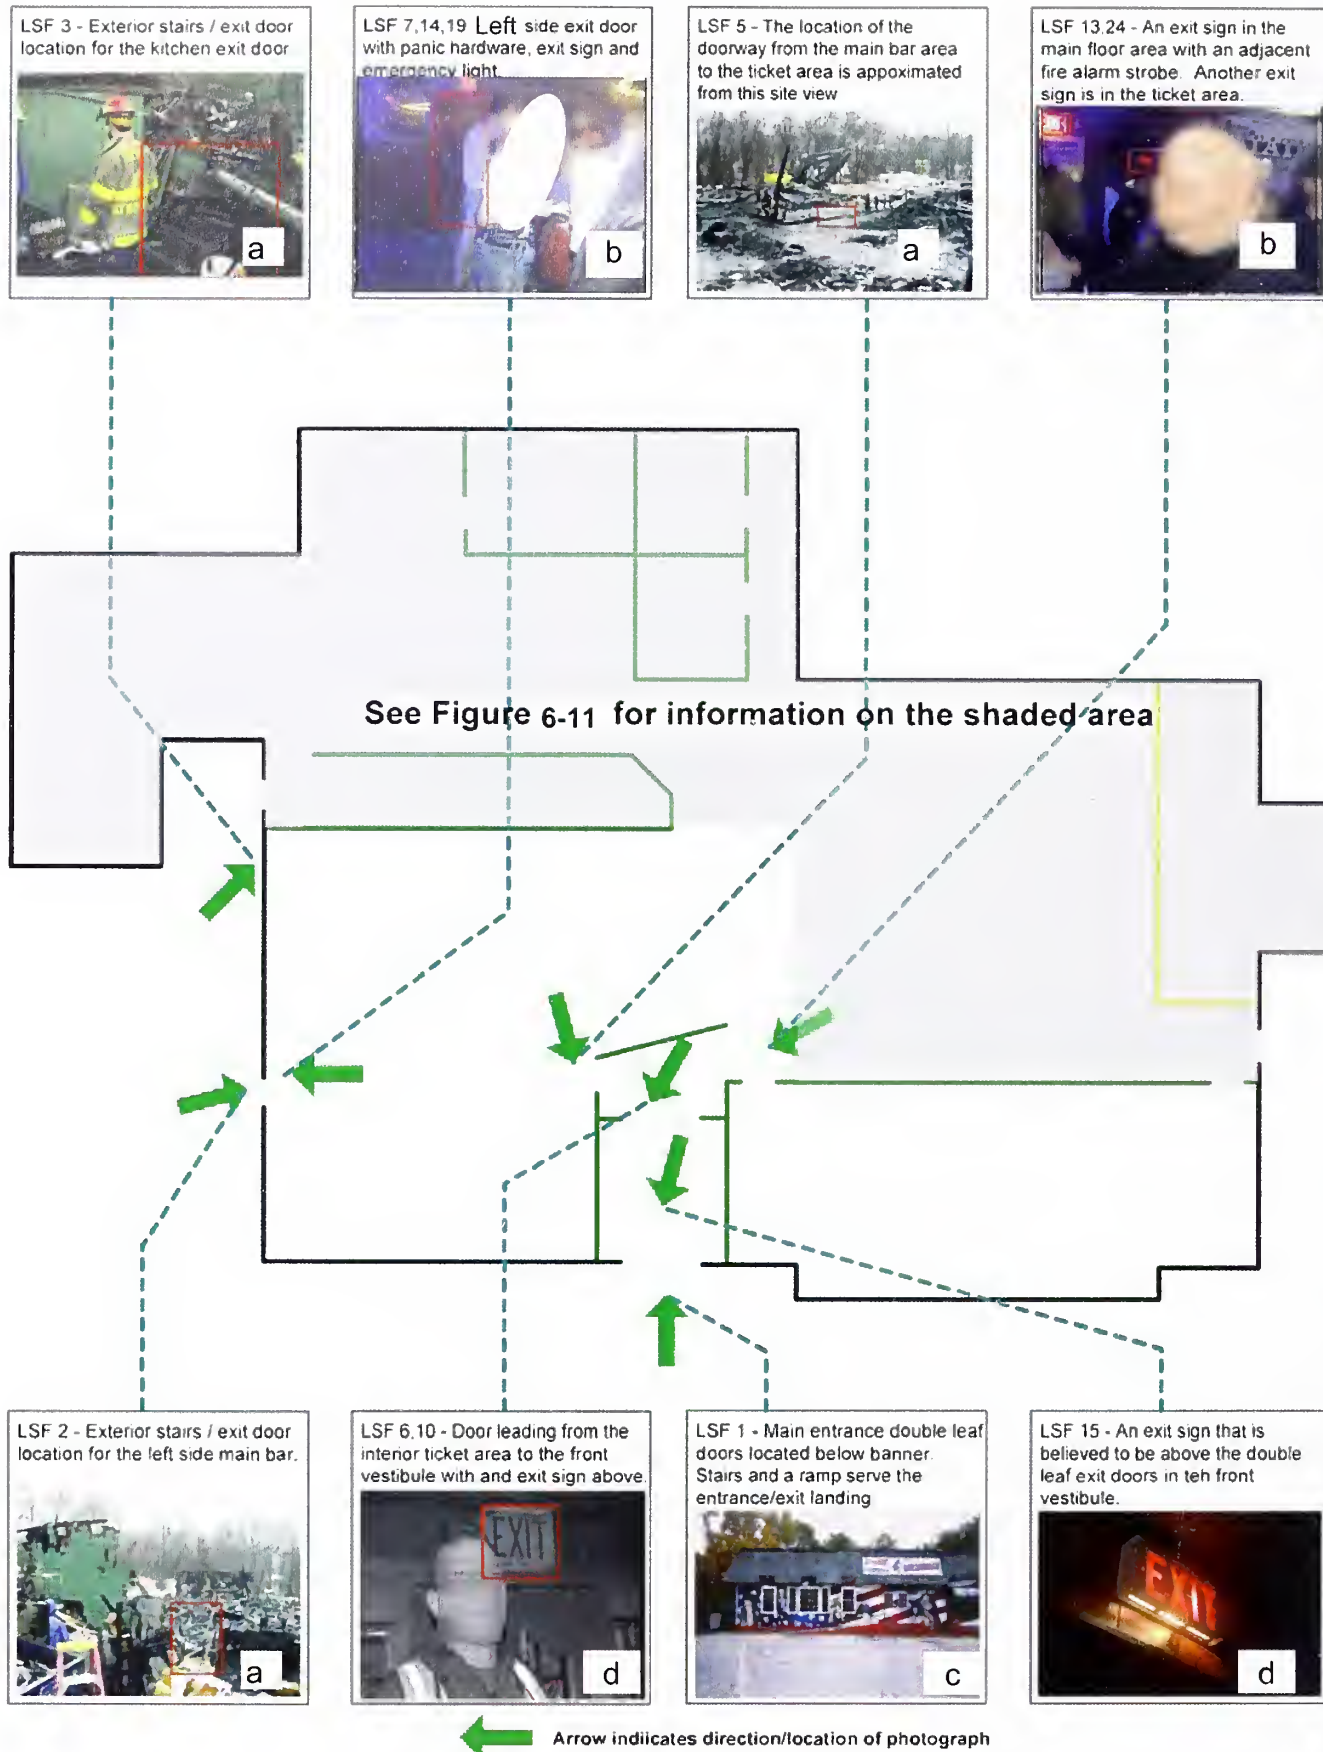
**Figure 6-10. Summary of Life Safety Features – Part 1**

Egress through the main entrance to the building was limited by a single interior door (LSF 6 in Figure 6-10) not the double doors that could be seen from outside the building.

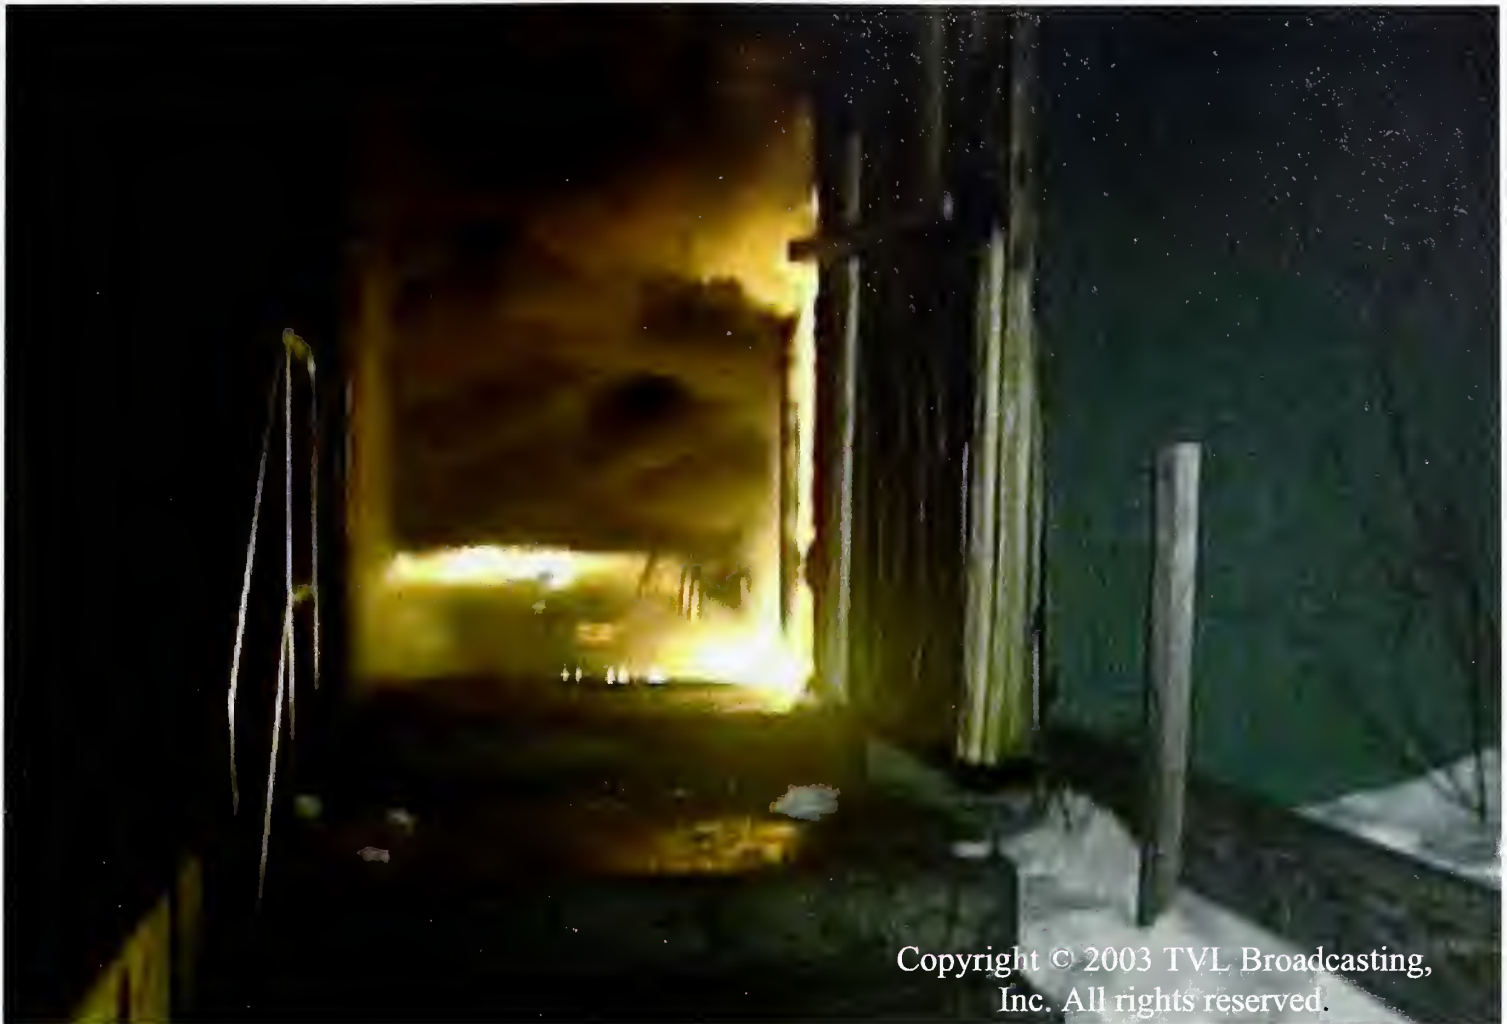
**Figure 6-13. Exit Door Near Platform [2]**

Several additional observations were made regarding the main exit vestibule area and the exit door near the platform. Figure 6-12 provides an approximate representation of the orientation and layout of the main exit vestibule area. It also shows the video evidence that was used to formulate this representation. The notes provided with this Figure give some additional observations related to this exit. Figure 6-13 shows the exit door located in the vicinity of the platform. Based upon this video still and other frames from this portion of the WPRI video, it appears that this exit included two doors:

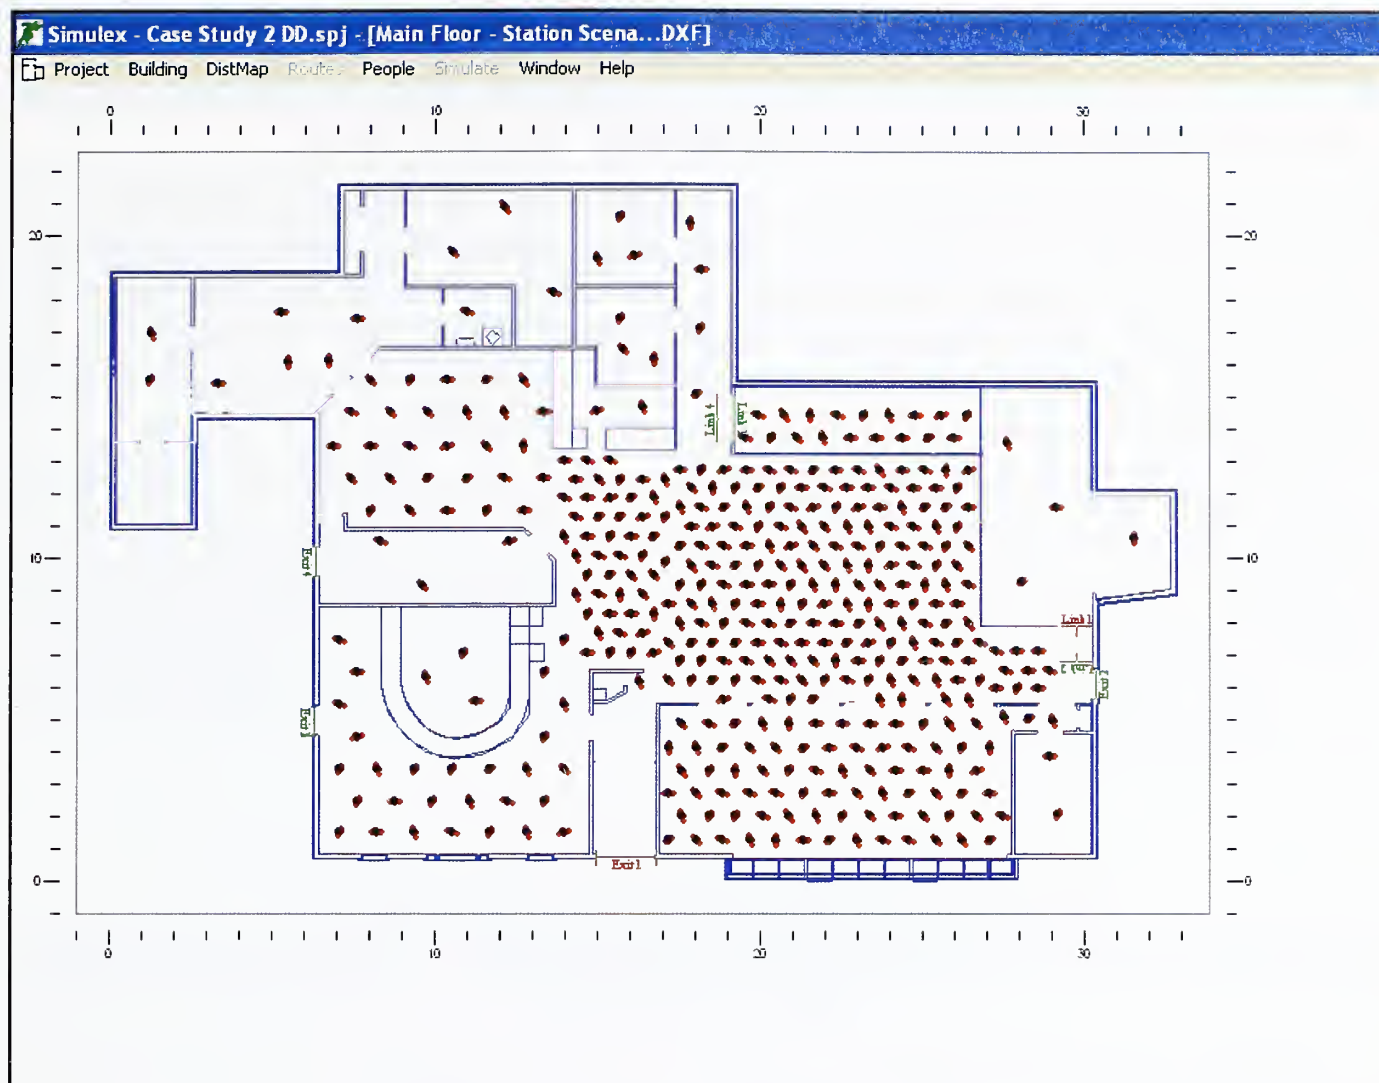
**Figure 6-15. Initial distribution of 420 simulated nightclub patrons and employees**

Scenario 3 investigated the impact of *doubling the width of the most restrictive element at the front entrance*. Figure 6-15 is one frame grabbed from the Simulex computer simulation indicating the initial population and distribution of patrons and employees. (This was typical of the initial conditions for all of the simulations.) The purpose was to see how this affected the evacuation time in the event that one of the other exits became blocked (e.g., due to construction, negligence or a criminal act). Simulex and

buildingEXODUS calculated a total egress exit time of 196 seconds  $\pm$  2 seconds, almost identical to the baseline case in scenario 1. The main difference in the outcome for scenario 3 was the larger number of occupants using the front entrance to escape, about 87 % of the total. Assuming that doubling the width of the restrictive front entrance would also have reduced the possibility for a crowd crush to develop, this change would bring the level of safety equivalent to what was implied by the current model codes.

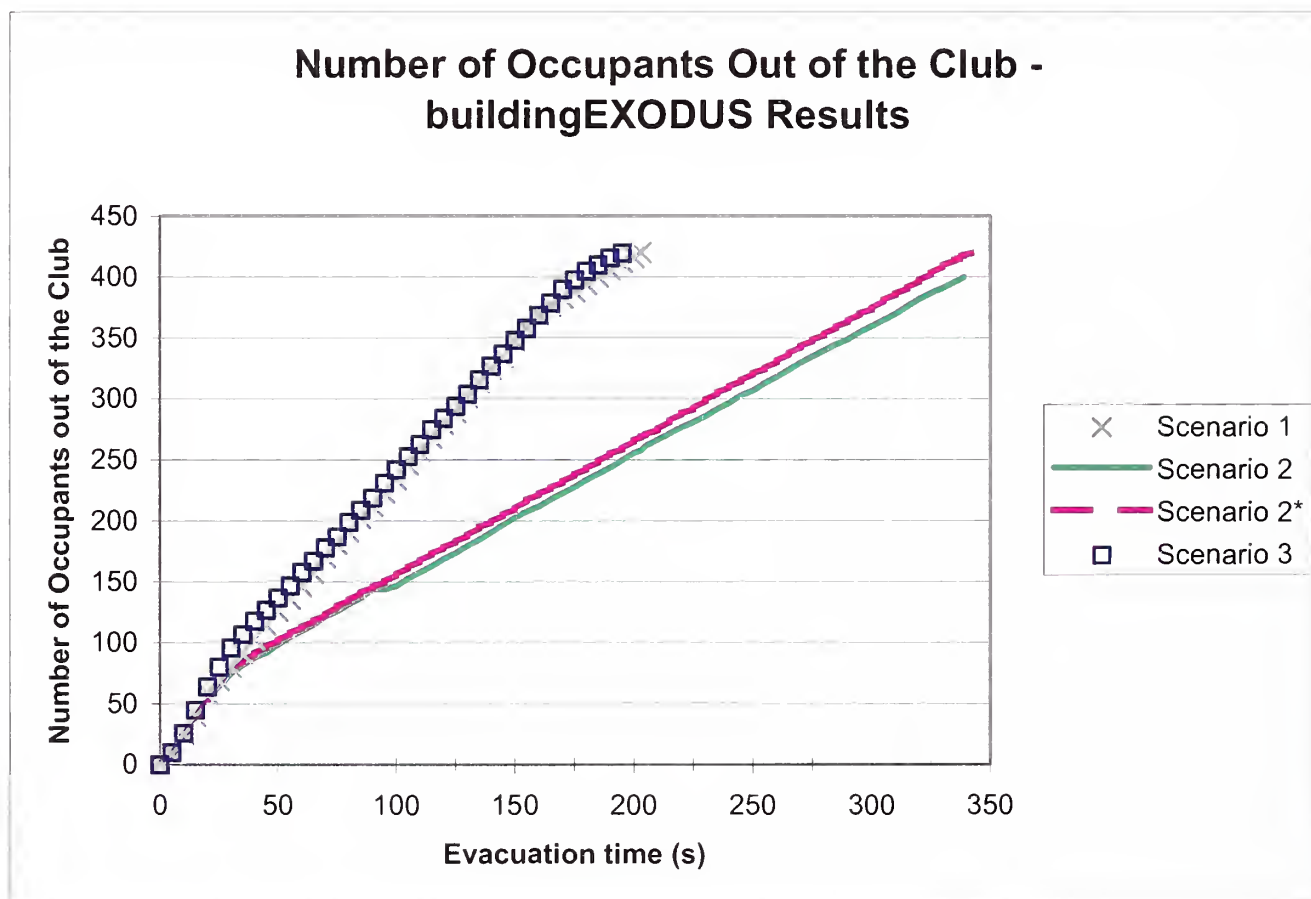
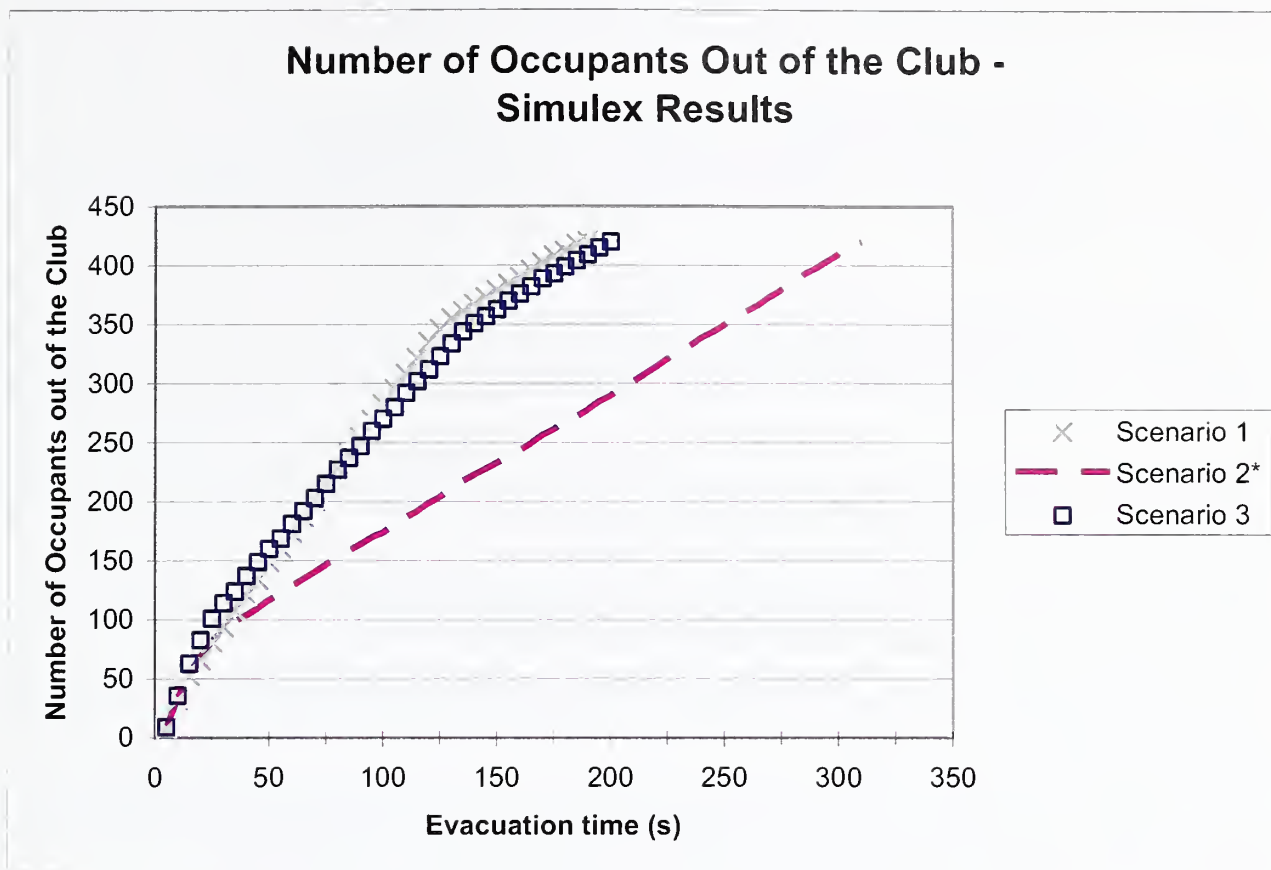
Figures 6-16 and 6-17 compare the cumulative population that was evacuated as a function of time for the scenarios described above, based upon the results of buildingEXODUS [39] and Simulex [37, 38] respectively. If one draws a vertical line up from the time scale at 90 seconds, the total number of people who remained in the nightclub at that time can be determined.

Ninety seconds had significance on Feb. 20 because that was about the time the front entrance became blocked and, according to the fire dynamics simulations, was a point where the conditions were becoming untenable throughout the building. The last column in Table 6-2 lists the population remaining for both the buildingEXODUS and Simulex simulations. Note that buildingEXODUS, when compared to Simulex, consistently provided a more conservative (i.e., a slower) rate of egress, which is consistent with the conservative flow rates chosen for the exit doors in buildingEXODUS.

Somewhere between 166 and 208 people were calculated to remain in the building 90 seconds after the fire began for the scenario in which the building met current national model code requirements. This number jumped to 271 for scenario 2, with the platform door blocked (recall that the front door remained open during the first 90 seconds). Doubling the entrance door width in scenario 3 brought the number of people remaining in the building 90 seconds into the fire back down to the range calculated for scenario 1. Finally, since the crowd-crush had not occurred prior to 90 seconds, the calculation for the 2\* scenario is essentially the same as for scenario 2.

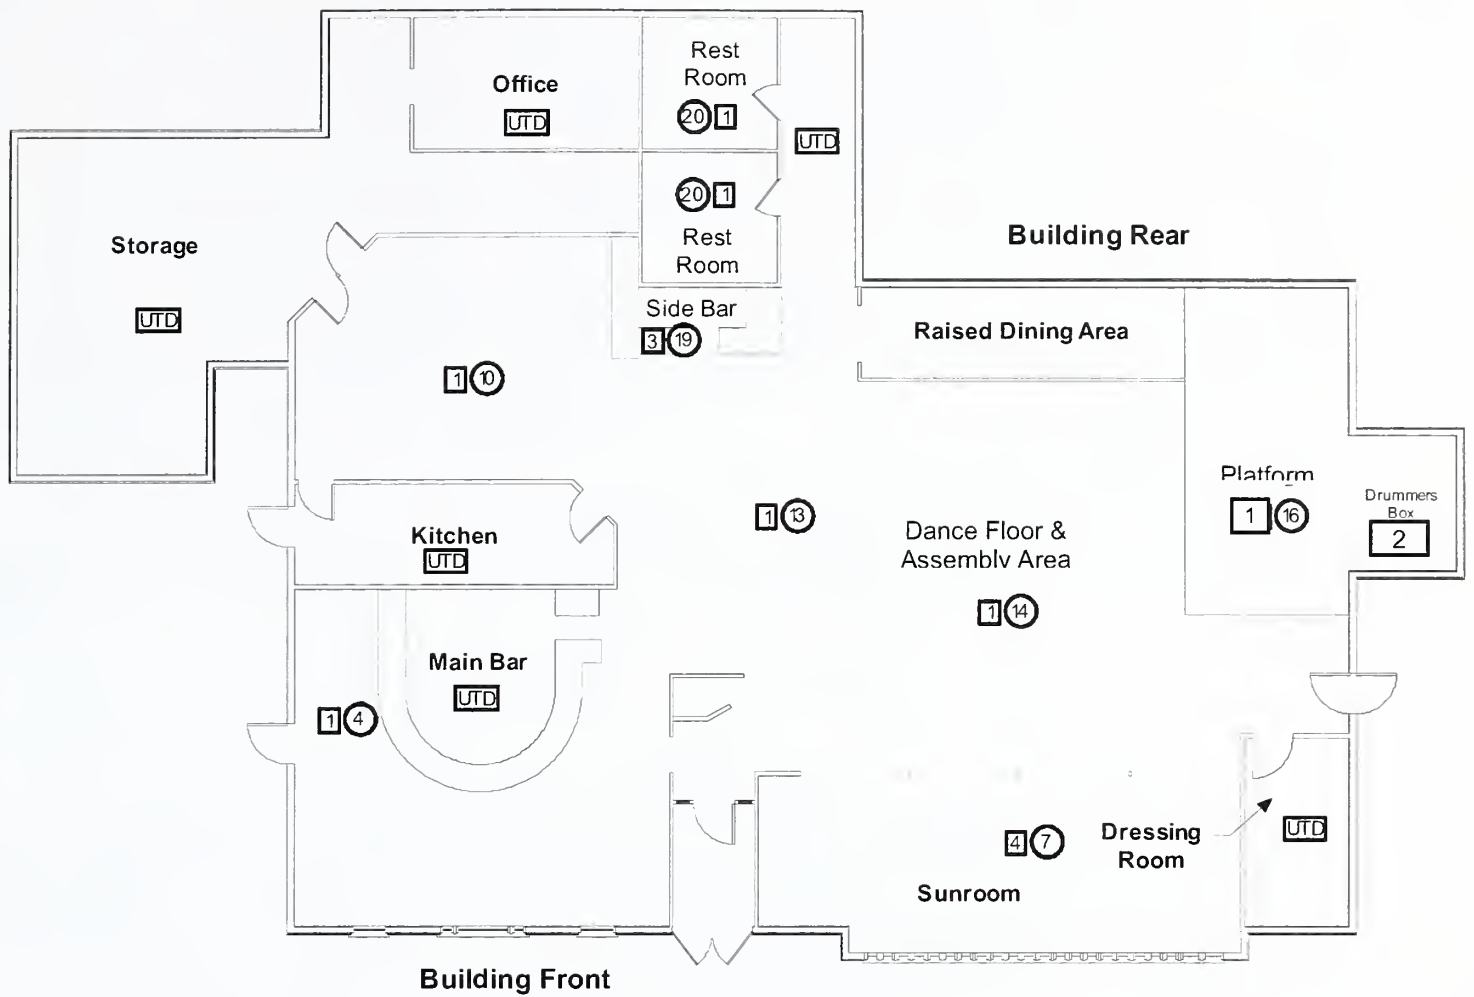
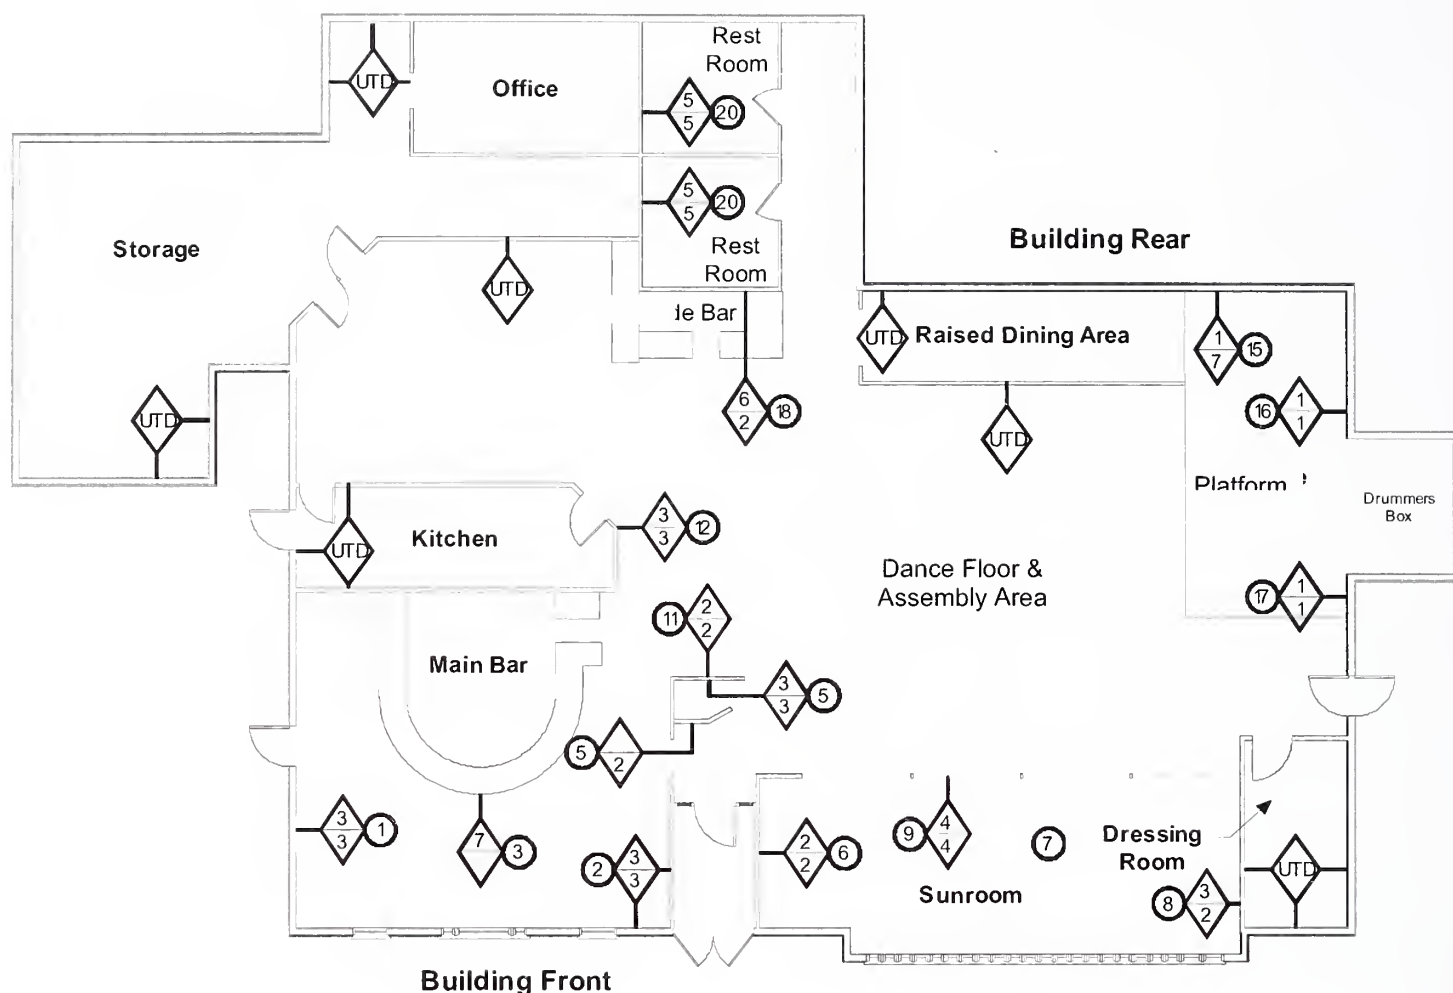
**Figure 7-1. Station Night Club Ceiling Interior Finish**

*Comment: As would be expected, the interior finish materials of the building varied greatly. The interior finish material was mapped and is shown in Figures 7-1 and 7-2. The interior wall finishes included wood paneling, bead board, painted gypsum, wafer board, and ceramic tile. Interior finishes were identified from photographic and video records. The finishes identified were estimates based on a video and photographs taken in the building. The finishes referred to as painted gypsum may be either gypsum wall board or plaster. Neither samples of products nor model and manufacture information were available. Accordingly, conclusions regarding flame spread ratings are based upon broad product categories. The ceramic tile and gypsum do not pose potential interior finish flame spread issues.*

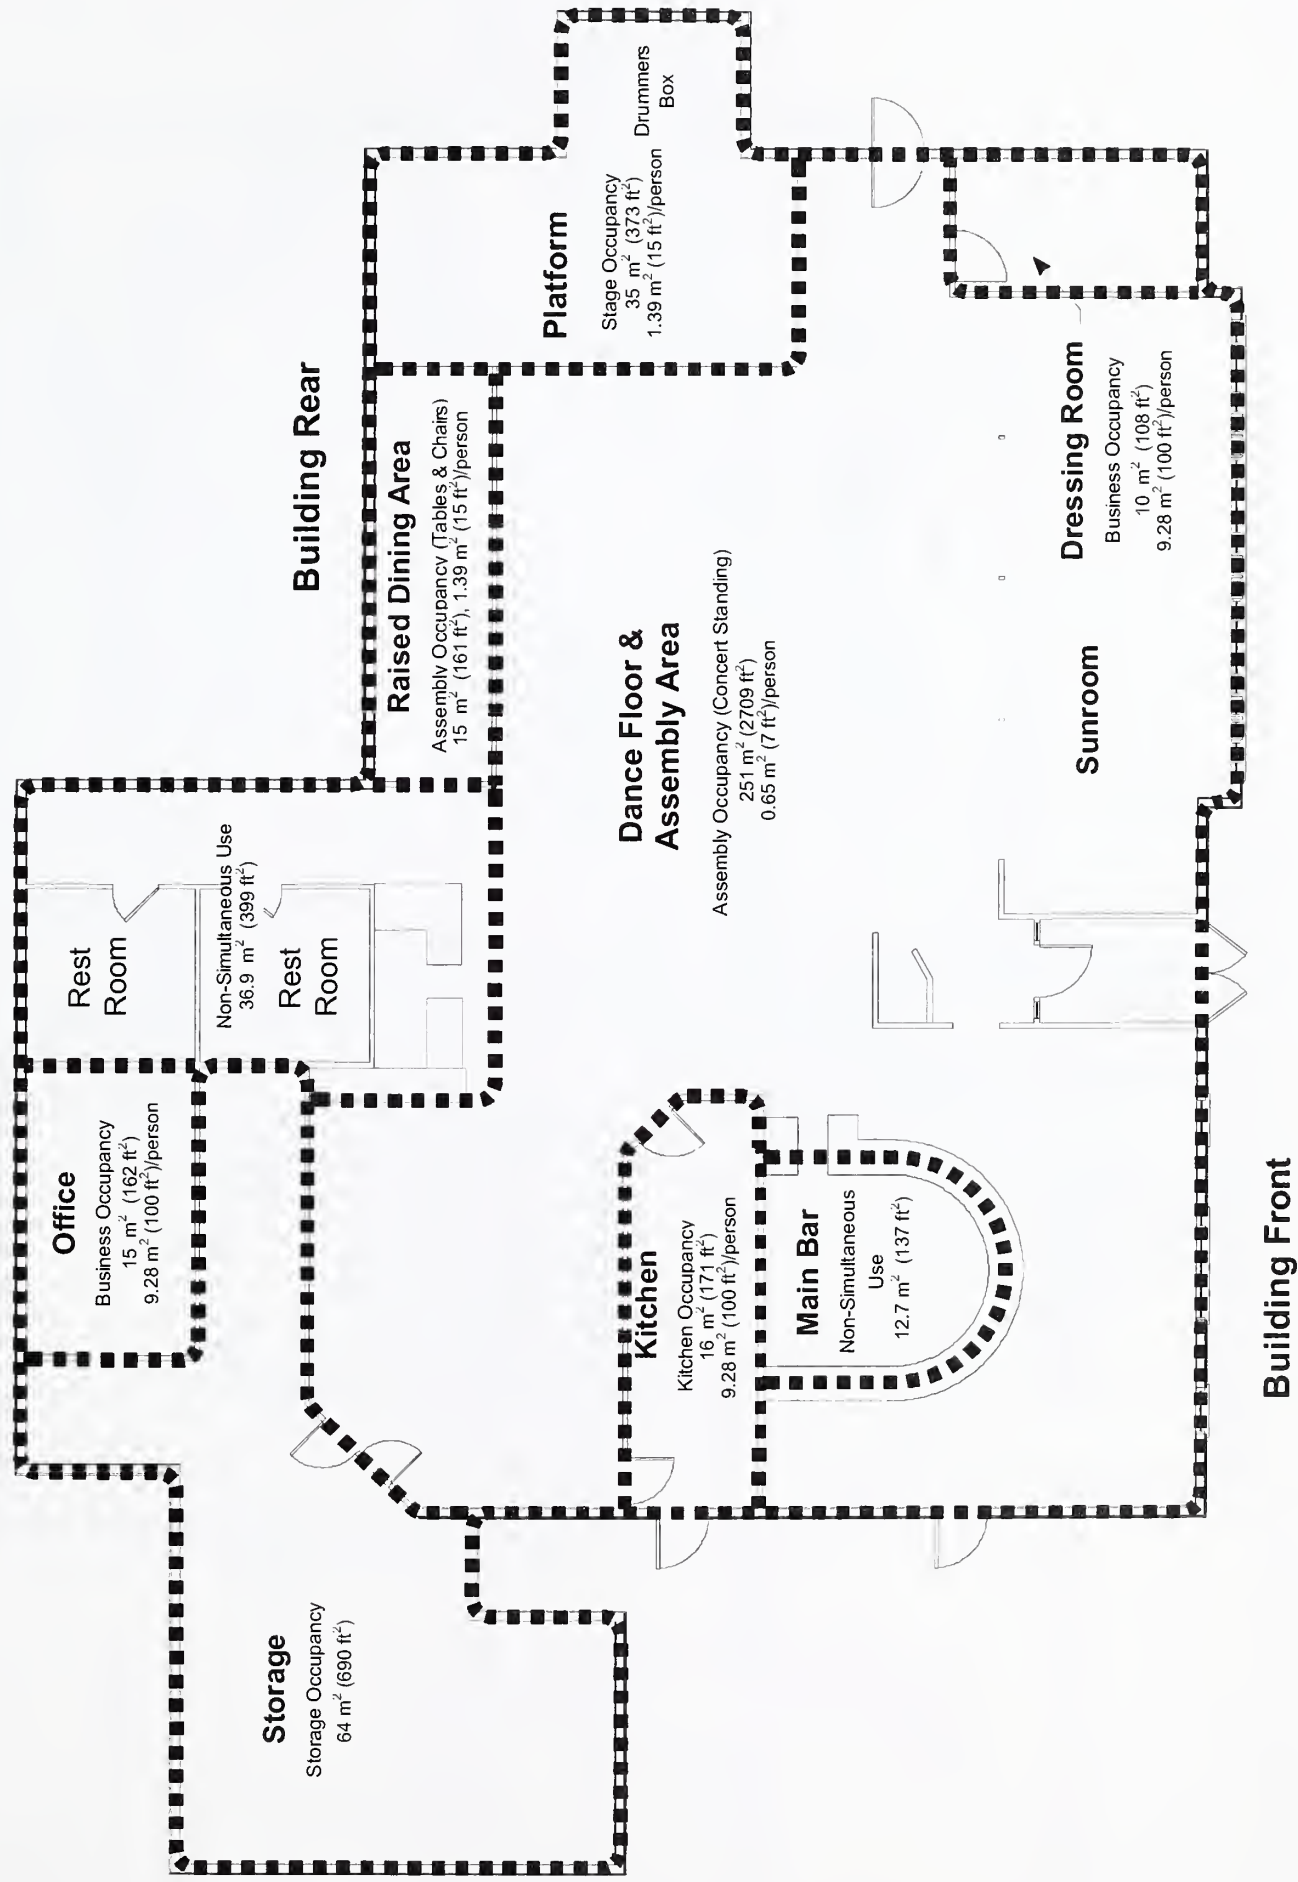
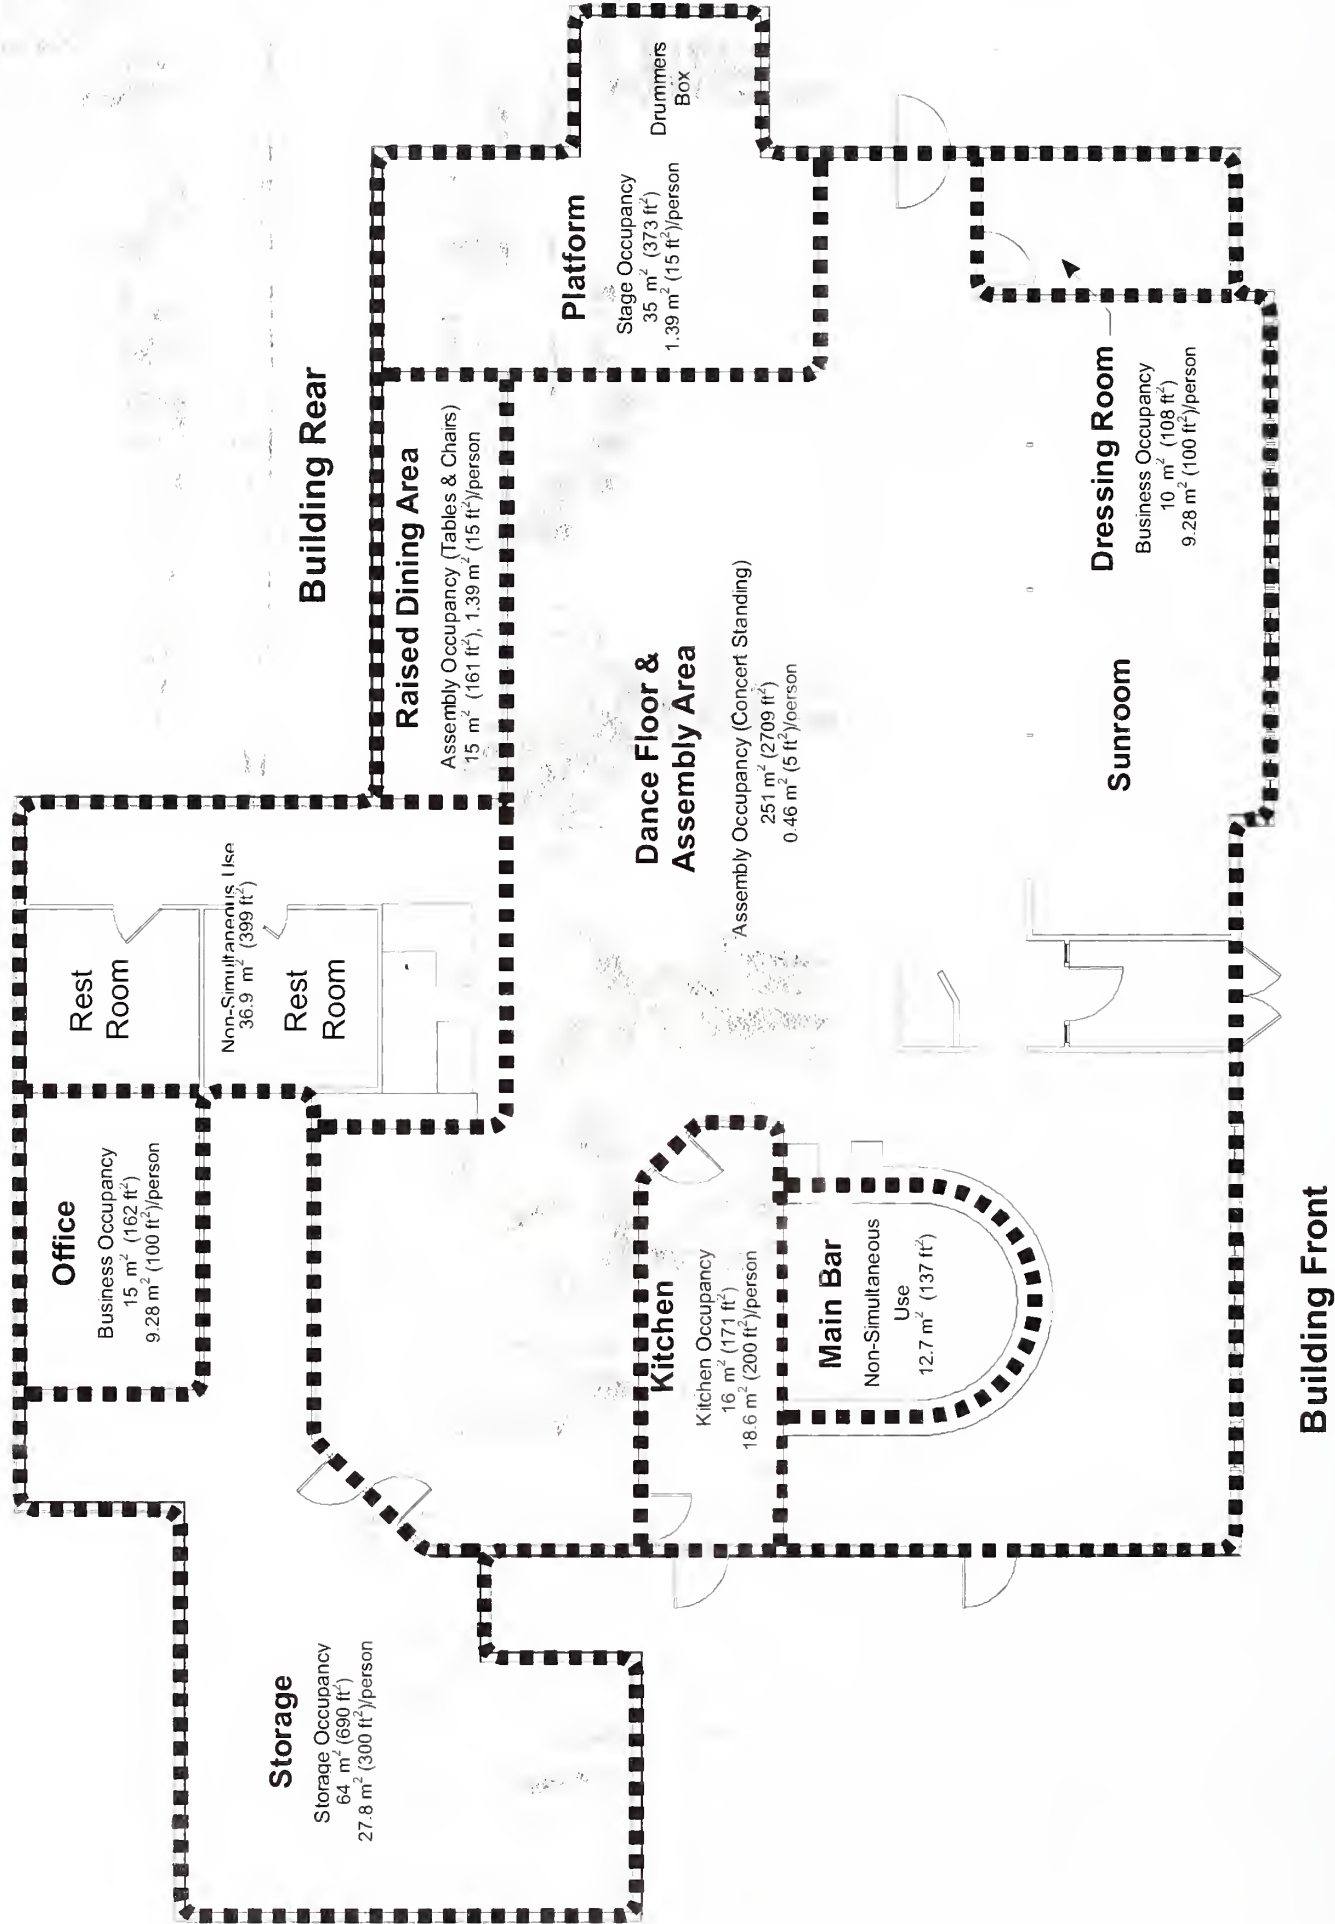
*Comment: Refer to Figure 7-3 and Figure 7-4 for the use of spaces within the Station as defined by the model codes. Based upon those uses, the maximum load for each space is computed in Table 7-4. The total maximum occupancy of a building similar to The Station, according to IBC,*

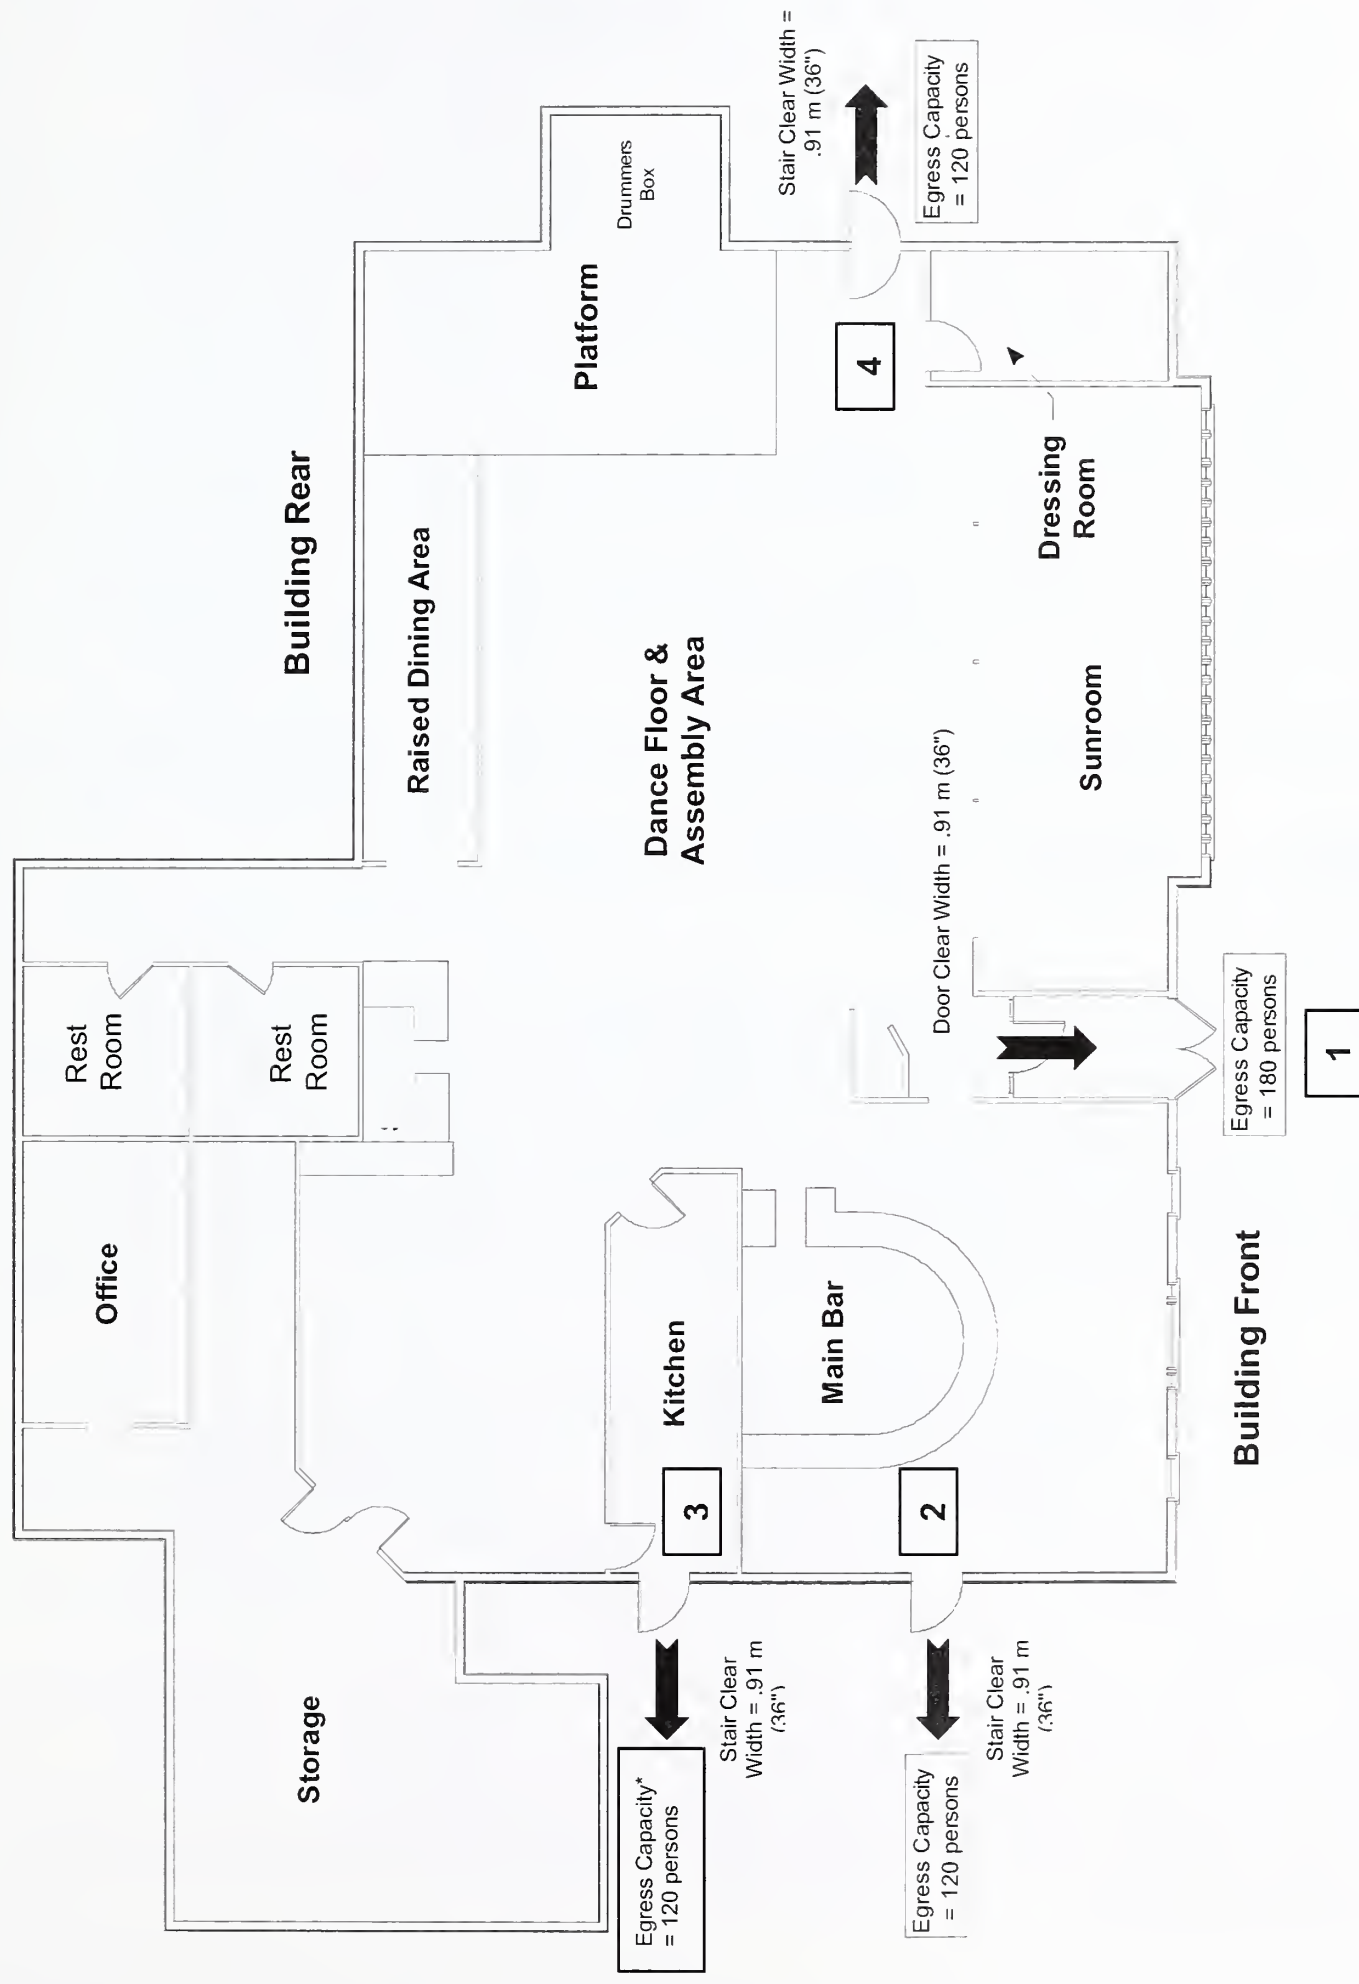
Figure 7-5. Station Nightclub Egress Capacity (\*Note that model codes exclude exiting through a kitchen when calculating occupancy limit.)

There were four exit routes from the building, as numbered in Figure 7-5: (1) the front main exit, (2) the main bar exit on the side, (3) the kitchen exit, and (4) the platform exit. The model codes govern their number, size, placement, and other details of design, as discussed in this section

*Comments: All doors exceeded the 0.81 m (32 in) minimum, and all door leaves swung in the direction of egress travel with the exception of the interior leaf at exit 4. (See Fig. 7-5.)*

*Comments: When viewed from the exterior, the right leaf of the front doors was not equipped with panic hardware. There was no visible hardware on either door. As of this writing, the type of hardware on the swinging door immediately inside the double exterior doors is undetermined. (See Fig. 7-5.)*

*See Table 7-6 and Figure 7-5 for capacities of each exit. As required by both model codes, the element with the smallest capacity in each path of egress was considered to be the limiting element. The limiting element dictated the capacity of each egress path. For the main entrance, exit 1, the interior 914 mm (36 in) door was the limiting element, resulting in a capacity of 180 persons for the main entrance exit. For exit 2, the side door out of the main bar area, the exterior stairs leading from the door were the limiting element, resulting in a capacity of 120 persons. Exit 3, from the kitchen, was also limited by an exterior stair; however, both codes prohibit egress by patrons through the kitchen (IBC §1013.2 and NFPA 5000 §11.5.2.1) Exit 4 adjacent to the platform had two doors installed on the same jam, one swinging in the direction of egress travel and one swinging opposing the direction of travel. Excluding the kitchen exit and including the exit adjacent to the platform, the occupancy limit based upon egress capacity would have been 420 according to both model codes. (See Table 7-6.)*
