NIST Special Publication 1000-5

June 2004
Progress Report on the
Federal Building and Fire Safety
Investigation of the
World Trade Center Disaster

Volume 4
Contains Appendices G, H, and I

Appendix H
Interim Report on Evolution of WTC Fires, Smoke, and Damage based on Image Analysis

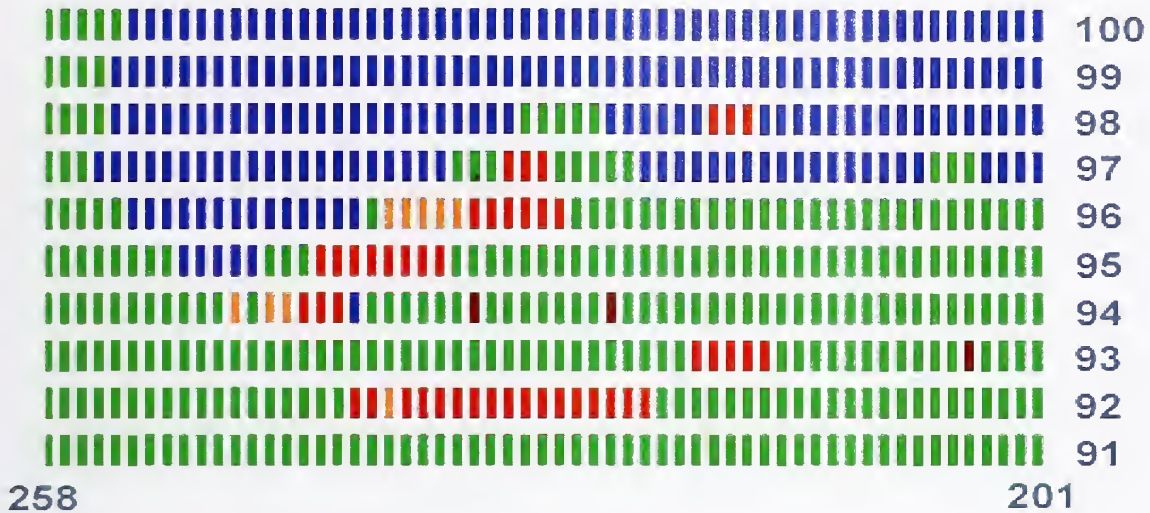
Figure H-10. A representation of fires for floors 91 to 100 on the east face of WTC 1 around 9:42 a.m. is shown. Results are taken from the Excel spreadsheet shown in Figure H-13. The color coding is based on the key shown. The color assignments are: 0-No fire, 1-Spot fire, 2-Fire visible inside, 3-External Flaming, and 9-Can't see.

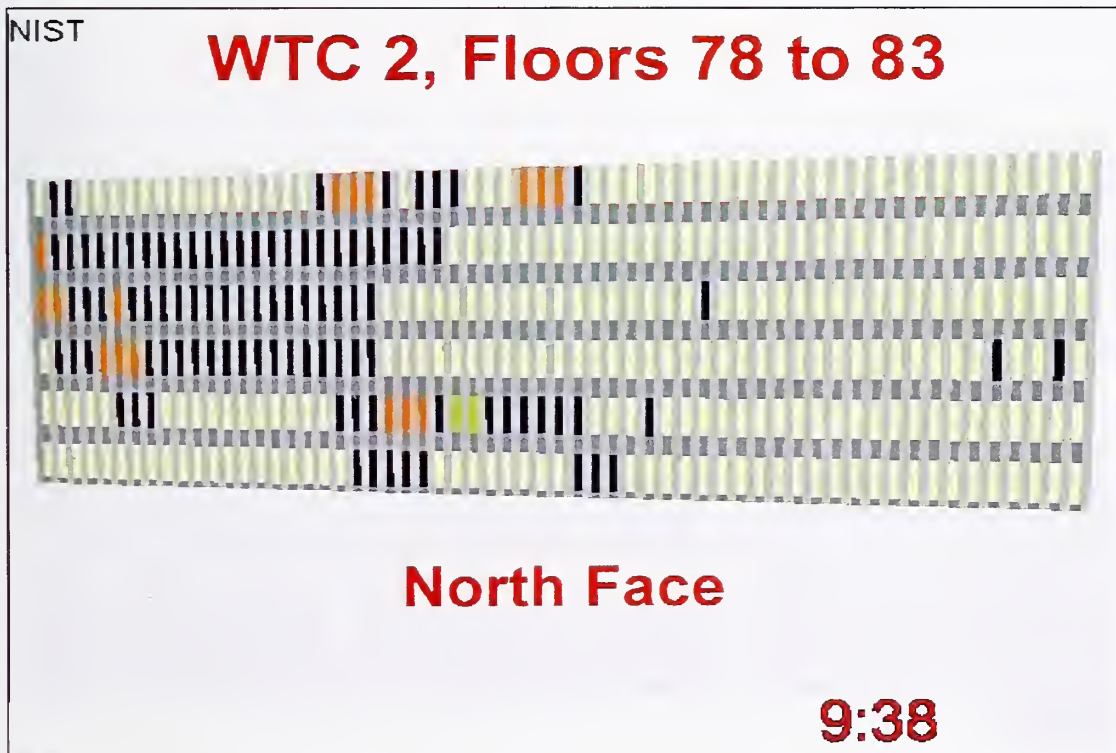
Figure H-11. A single frame from a time-dependent visualization generated by Smokeview is reproduced here. The frame is a three-dimensional representation of the condition of windows and fires on WTC 2 from the time the second tower was struck at 9:02:59 a.m. until it collapsed at 9:58:59 a.m. The color assignments are: - window in place, - missing window, - external flaming, - fire inside, and - spot fire.

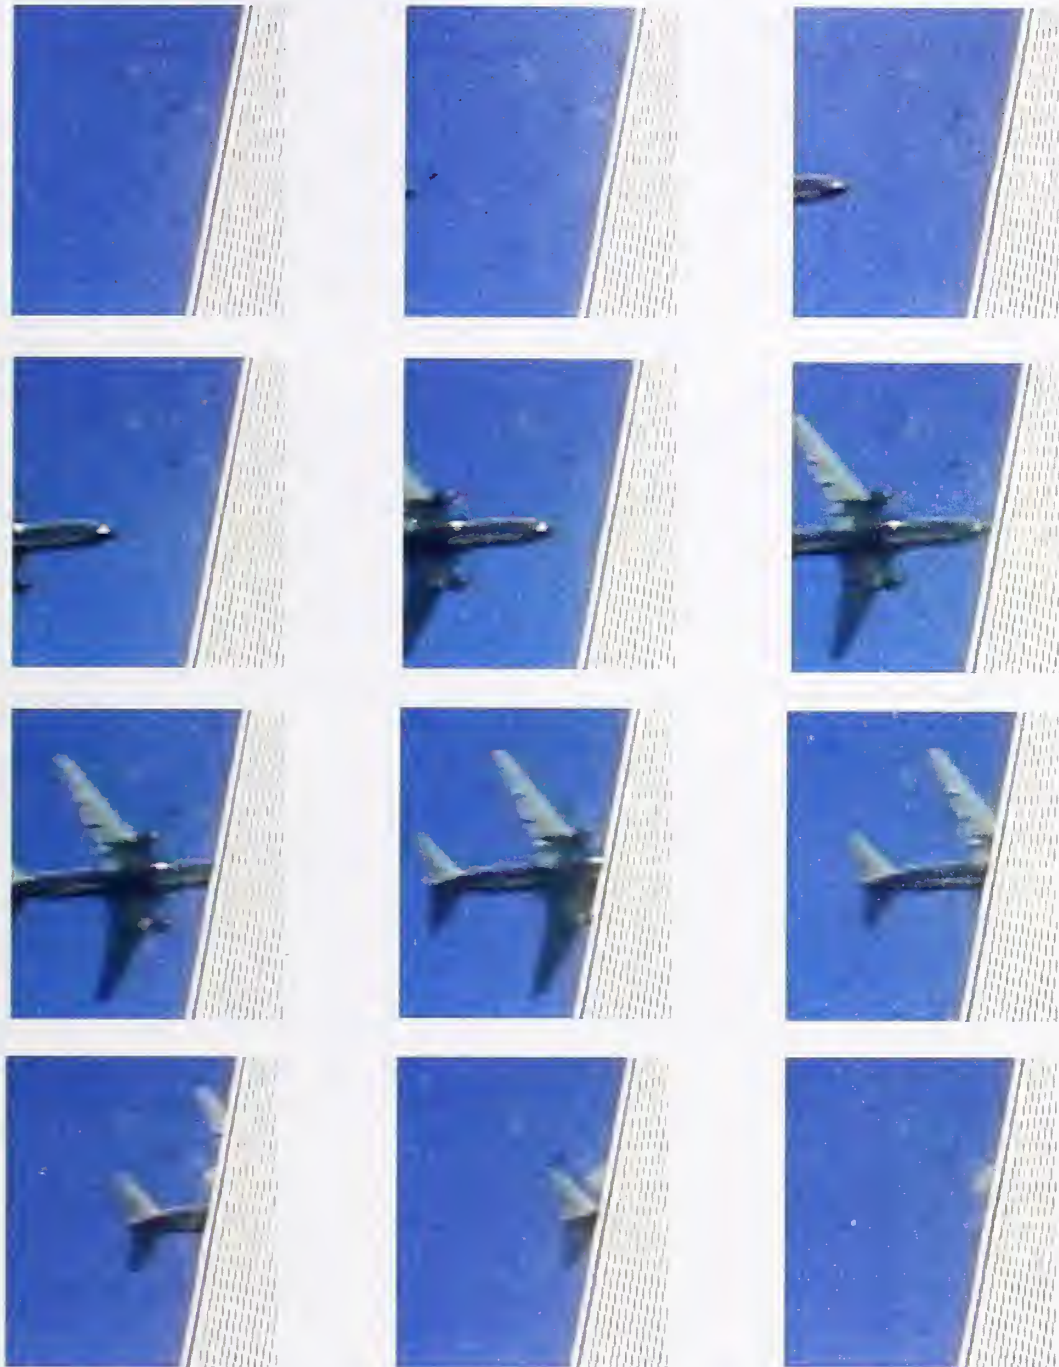
Figure H-15. Series of sequential cropped frames taken from a video shot on September 11, 2001, showing the plane approaching WTC 2. The frames, ordered from left to right and top to bottom, are separated by 33.3 ms.

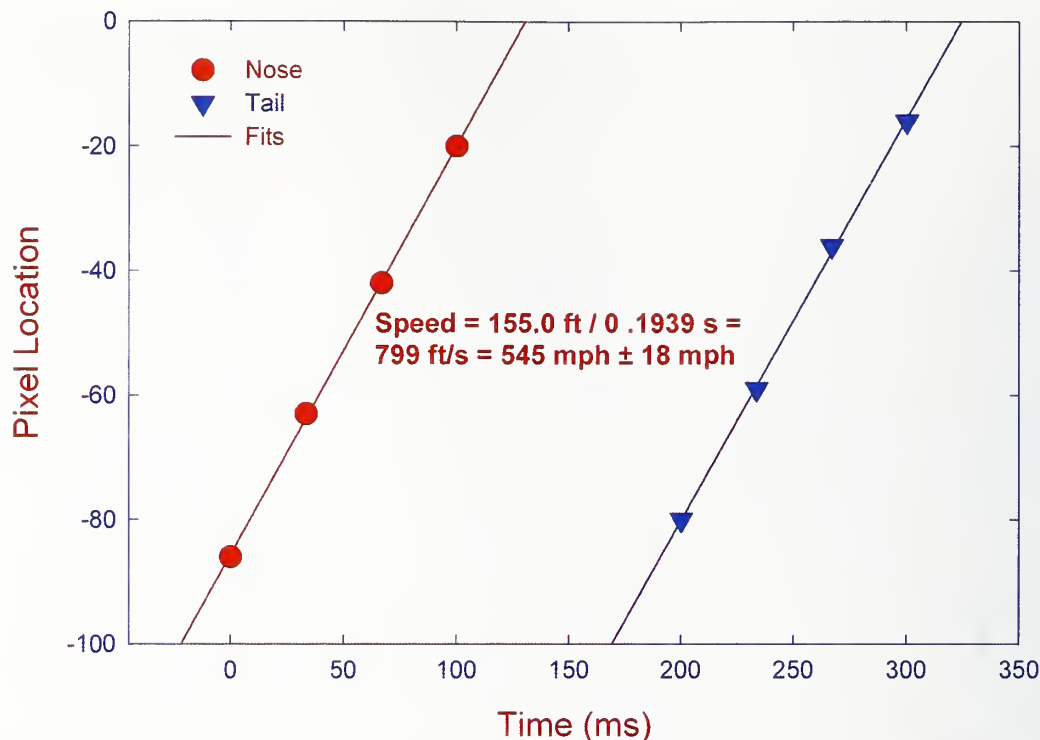
Figure H-16. Plots of pixel locations for the nose and tail of the plane that struck WTC 2 as a function of time taken from the images shown in Fig. H-15. Straight lines are the results of linear least squares curve fits to the data. Extrapolation of the lines to pixel 0 allows the time for the passage of the plane to be calculated.

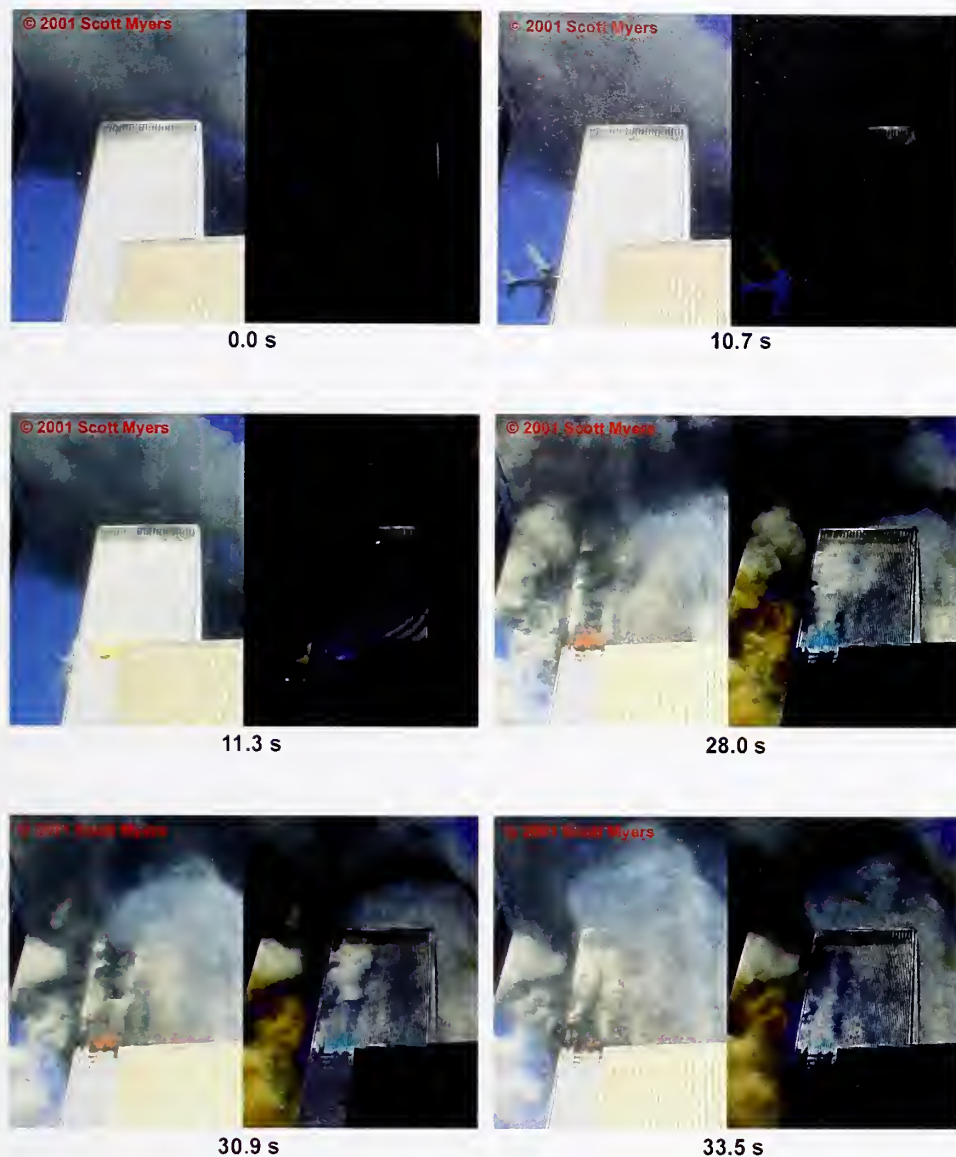
Figure H-17. Frames from a composite video are shown. The half frames on the left are taken from a video showing the plane strike on WTC 2, while the half frames on the right are generated by subtracting a frame recorded prior to the plane strike from all subsequent frames in the original video. Times refer to the period since the start of the difference video.

Following the plane strike, areas of the tower face above the strike floors become hidden by smoke, and it is difficult to see the moiré patterns in the difference frames. However, the area of the tower below the strike floors to the left of the building in the foreground continues to show a distinct difference pattern because it is not obscured by smoke. This pattern is apparent in the fifth frame (time = 30.9 seconds). On the other hand, frames 4 and 6 (times = 28.0 seconds and 33.5 seconds, respectively) have been chosen because they are near null points, and the area appears dark in the difference frame because the location of the building is essentially unchanged from its position before the plane struck. When the video is

played, the moiré patterns in this area of the tower face alternately appear and disappear in the difference video.

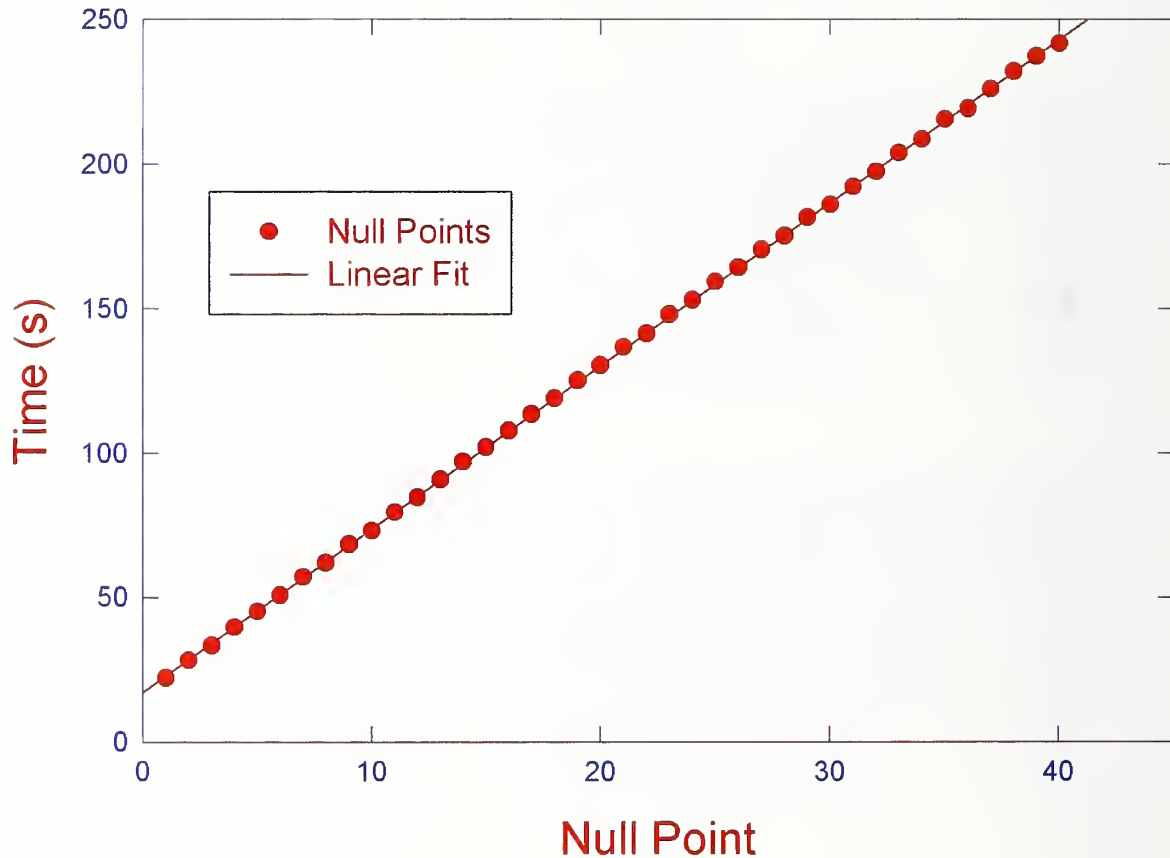
Because the absence of color is easiest to identify, it is straightforward to determine times when the null points occur in the difference image. Figure H-18 shows a plot of time versus null point number obtained from the difference video. The points fall on a straight line having a slope of 5.647 seconds \pm 0.008 seconds (95 percent confidence interval). Because the building passes through a null point twice during a single full oscillation, the period required for a single oscillation is 11.3 seconds.

Figure H-18. The time when null points are observed in the difference video following the plane strike on WTC 2 are plotted versus the null point number. The points fall on a very good straight line having a slope of 5.647 seconds \pm 0.008 seconds.

The measured oscillation period is consistent with measurements that are available from WTC 1 that yielded periods of 10.9 seconds in the east-west direction (averaged over a 9-year period that ended in 1993) and 11.6 seconds in the north-south direction (averaged over a 14-year period that also ended in 1993). The cores of the two towers were oriented perpendicular to each other so the motion monitored here should be comparable to the east-west direction of WTC 1.

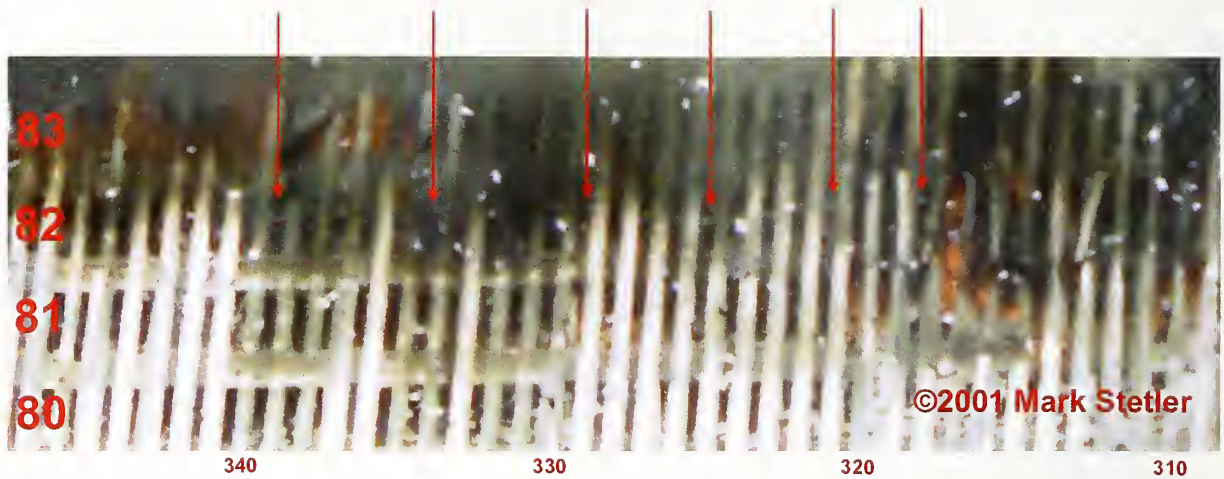
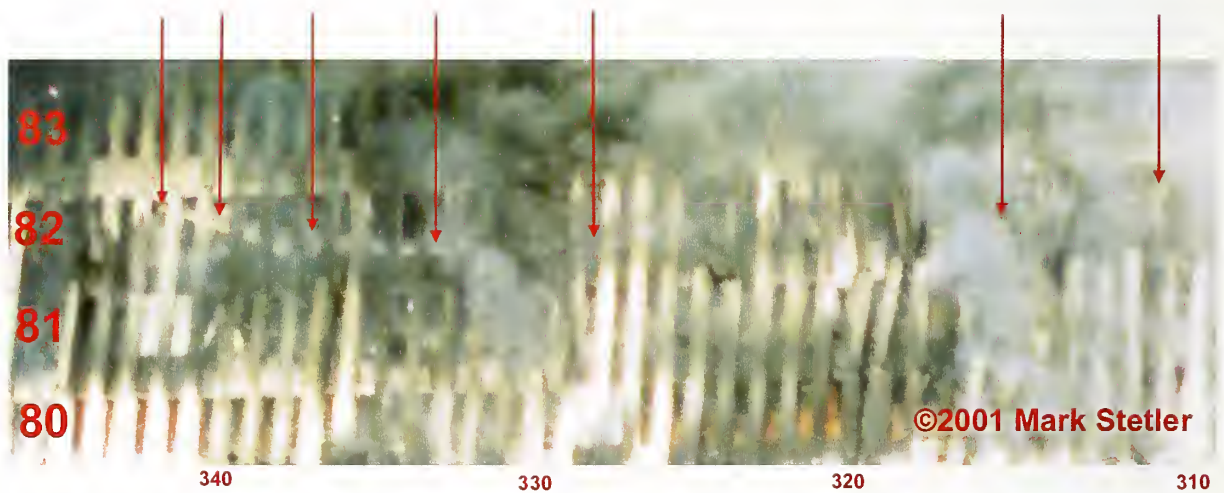
In the *May 2003 Investigation Progress Report* (NIST 2003), a photograph was shown in which there appeared to be a floor draped across a number of windows extending roughly from 310 to 342 across the east face of floor 82 of WTC 2. Figure H-22 compares an image taken shortly after the plane strike at 9:03 a.m. and one taken at 9:55 a.m. shortly before the tower collapsed. At the earlier time, the hanging object is already present, but is seen through the windows draped much higher on the floor 82. An interpretation consistent with these observations is that floor 83 along the east side of WTC 2 was partially collapsed over a significant fraction of its length by the passage of the plane through the building. At the later time the floor has sagged further. By reviewing a number of photographs and videos, it has been determined that the change in floor position occurred between 9:34 a.m. and 9:38 a.m.

Figure H-22. Images of the east face of WTC 2 taken shortly after the plane struck and shortly before the tower collapse are shown. An object that is most likely a floor can be seen through windows on floor 82 as indicated by the arrows. The object has dropped lower between the times the two photographs were taken.

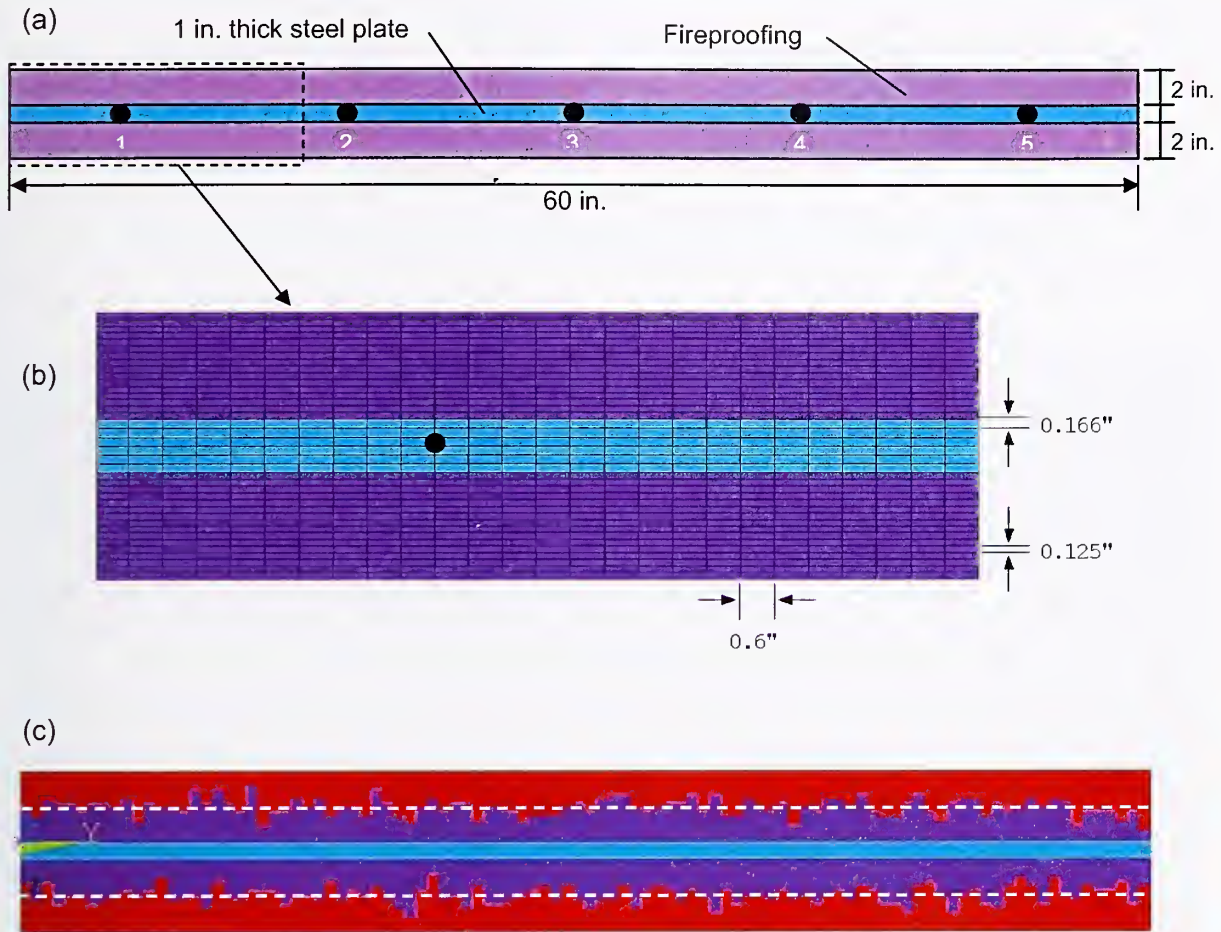
Figure I-1. Model used to study effects of fireproofing thickness and variability of thickness on steel temperature: (a) physical model used in analyses (points 1 to 5 are locations where temperatures are monitored), (b) finite element mesh used to represent physical model, and (c) finite element model to represent variable thickness of fireproofing (purple) (the elements in red represent material of high thermal conductivity).

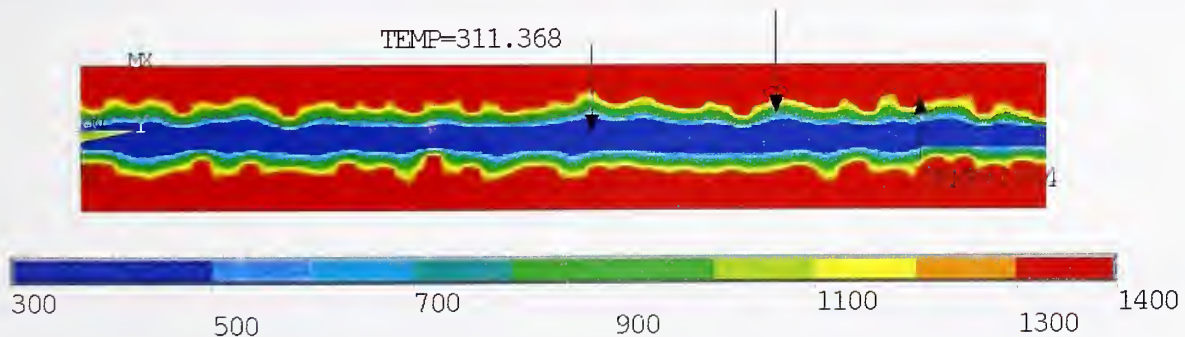
Figure I-2 shows temperature contours (in K) through the fireproofing and steel at 60 min after initial exposure for the model shown in Fig. I-1 (a). The fireproofing surface temperature is close to the gas temperature of 1,373 K, while the steel temperature is 311 K. If the fireproofing were of uniform thickness, the isotherms would be a series of lines parallel to the plate. It is seen that, when the thickness of fireproofing is variable, the isotherms follow the shape of the fireproofing surface contour. Thus, the temperature history at any point in the steel depends on the local thickness of the fireproofing.

Figure I-2. Temperature distribution after 1 h of exposure to gas temperature of 1,100 °C (1,373 K).

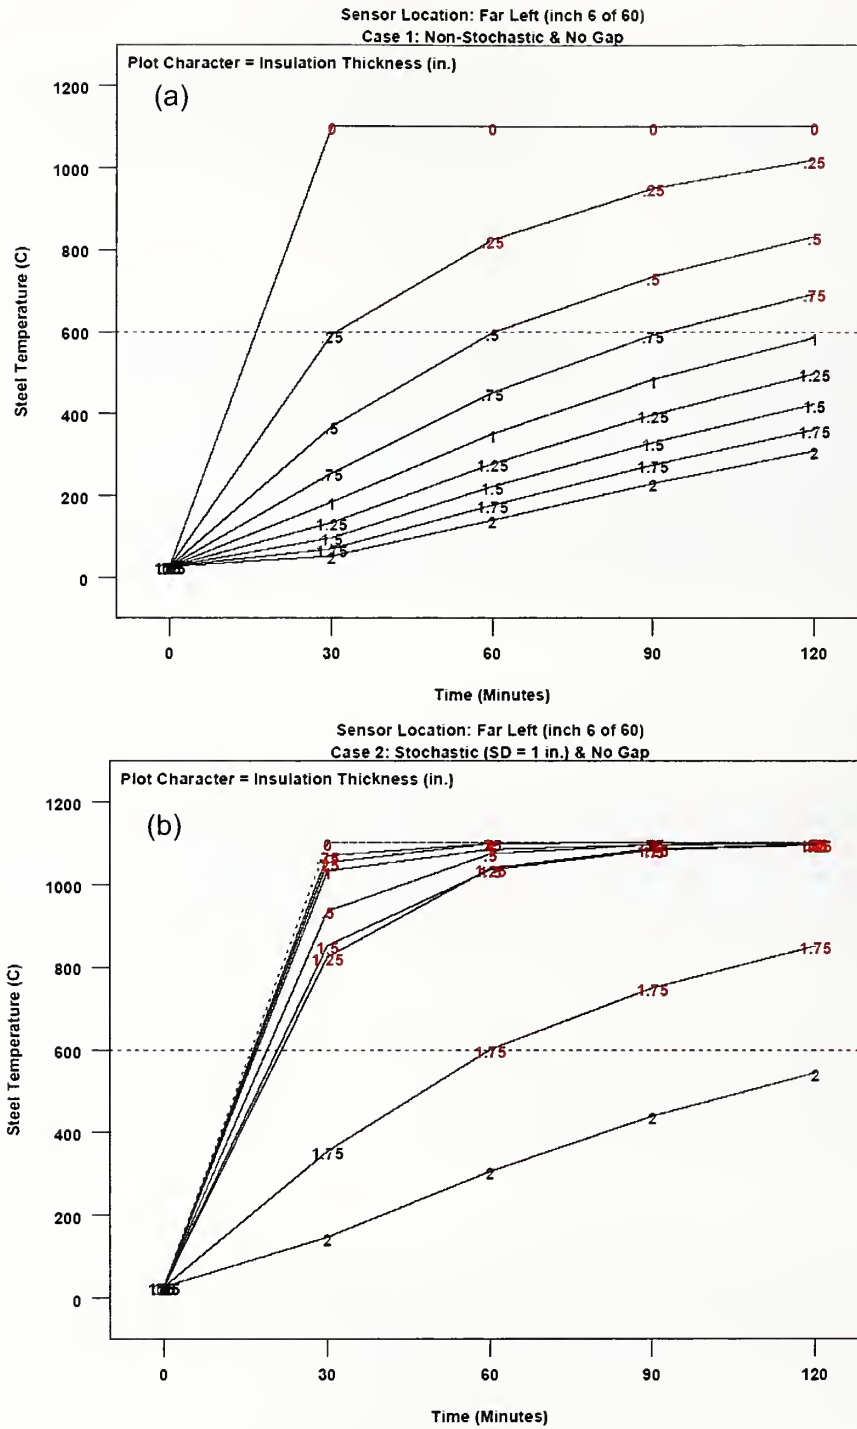
Figure I-3 shows the steel temperature at the far sensor #1 (6 in. from the end) as a function of time for various insulation thicknesses ranging from 0 in. to 2 in. (the thickness is indicated by the numbers on the curves). For the case in Fig. I-3 (a), the fireproofing is of uniform thickness, and for the cases in Fig. I-3 (b), the thickness varies with a standard deviation of 1 in. The time to reach a temperature of 600 °C is used as a measure of relative performance. It is seen that the presence of high variability in thickness has a detrimental effect of the protection provided by the fireproofing. For example, for a uniform thickness of 0.5 in., it takes about 60 min for the steel at point #1 to reach 600 °C; but when the standard deviation of the thickness is 1 in., the average thickness has to be 1.75 for the same level of thermal protection.

Figure I-3. Variation of steel temperature (at a point 6 in. from end of plate) with time for different average thicknesses of fireproofing (shown as numbers on the curves): (a) uniform thickness, and (b) variable thickness with a standard deviation of 1 in.

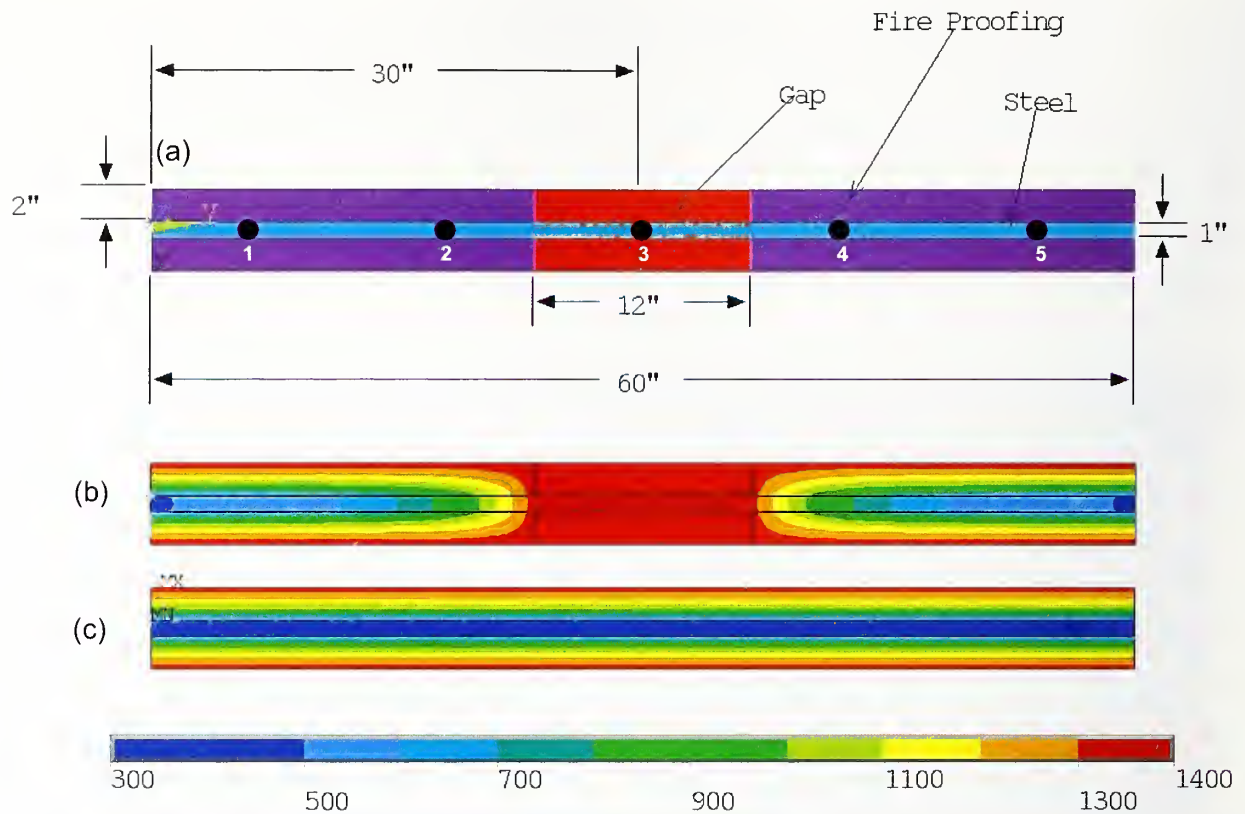
In addition to the effect of variation in thickness, it is important to understand the effect of missing fireproofing over a portion of a member. As an example, Fig. I-4 shows missing fireproofing from a diagonal of a bridging truss of the WTC towers floor system. Figure I-5 (a) shows an example of a numerical model with missing fireproofing. In this case, there is 12 in. of missing fireproofing on the steel plate, which is otherwise protected by 2 in. of uniform thickness fireproofing. Figure I-5 (b) shows the temperature contours (isotherms) at time 50 min. For comparison, Fig. I-5 (c) shows isotherms at the same time in a plate with no gap in the fireproofing. As expected, the bare steel at the missing fireproofing is at the gas temperature, but more importantly the “gap” in fireproofing leads to a “leakage” of heat into the interior steel.

Figure I-5. Effects of gap in fireproofing: (a) model of plate with fireproofing having 2 in. uniform thickness and 12 in. gap, (b) isotherms (K) at time = 50 min with 12 in. gap, and (c) isotherms without gap.

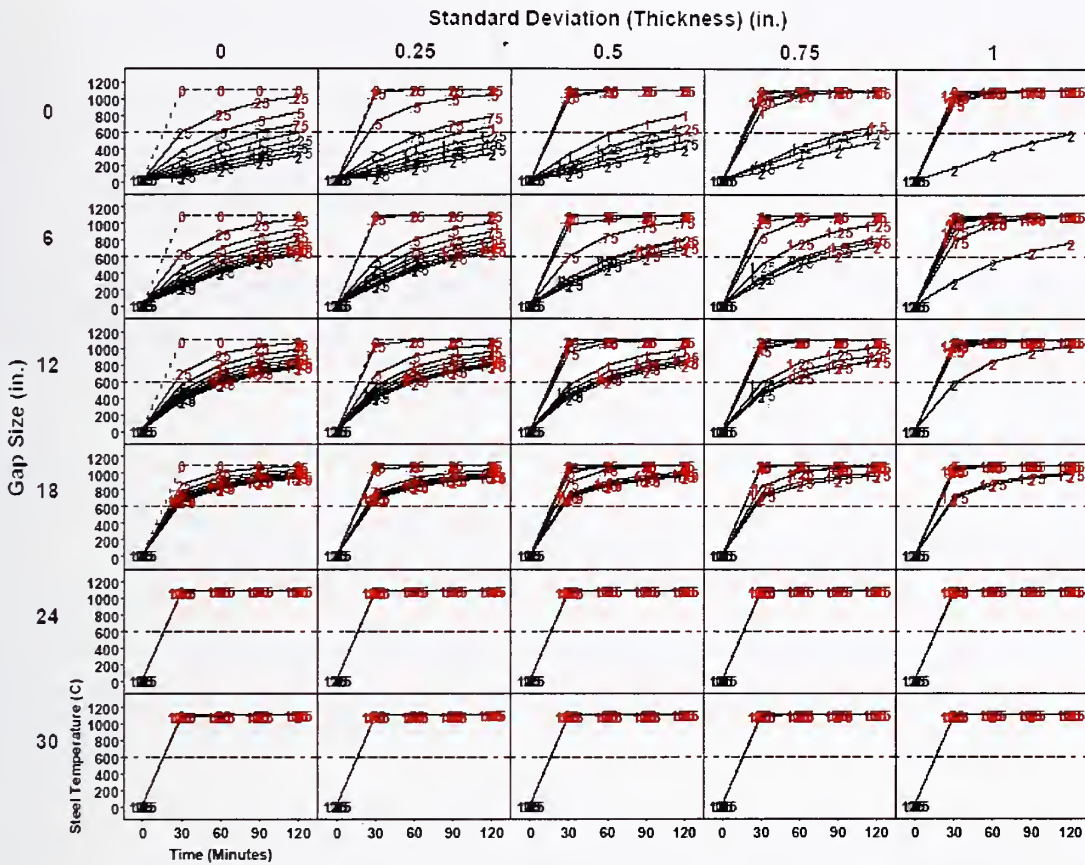
The results of the sensitivity study can be summarized in a series of plot matrices, which show the time histories of the steel temperature for different combinations of gap length and variability in fireproofing thickness. For example, Fig. I-6 shows the plot matrix for the temperature history at point #2 (18 in. from the end of the plate). Each plot contains a series of curves representing different average thickness of fireproofing, as in Fig. I-3. Each column of plots represents a constant value of thickness variability (standard deviation), and each row represents a constant gap length. The plot in the upper left corner represents the case of uniform thickness of fireproofing and no gap, which is the same plot as in Fig. I-3(a). (Note that for the case of uniform thickness and no gap, the steel temperature at any point in a cross section is the same along the length of the plate, as shown in Fig. I-5(c).) For gaps of 24 in. and 30 in., the temperature at point #2 rises rapidly because there is no fireproofing on the plate at that location. This explains the shapes of the curves in the two lower rows. In going from left to right in one of the top four rows it is seen that as variability of thickness increases, the time histories shift upward, thereby reducing the time to reach 600°C. This is the same observation as shown in Fig. I-3. Moving from the top to the bottom in any column shows the effects of increasing gap length. The effect of gap length depends, of course, on where the steel temperature is measured. At a point within the portion of steel that is bare, the temperature rises quickly. At points within the steel that are surrounded with fireproofing, the gap provides a path for heat flow, as shown in Fig. I-5 (b). As a result, points in the steel within the vicinity of the missing fireproofing will experience higher temperatures, as indicated by the rising trend of the curves in going downward from the top of a column in Fig. I-6. The National

Institute of Standards and Technology (NIST) does not have sufficient information to determine the frequency of occurrence of these gaps or their typical locations. Therefore, gaps in fireproofing will not be considered in the thermal modeling.

Figure I-6. Example of plot matrix from sensitivity study of the effects of missing fireproofing and variability of fireproofing thickness on steel temperature. Each graph is a temperature history of the steel at point #2 (see Fig. I-5) for different thicknesses of fireproofing.

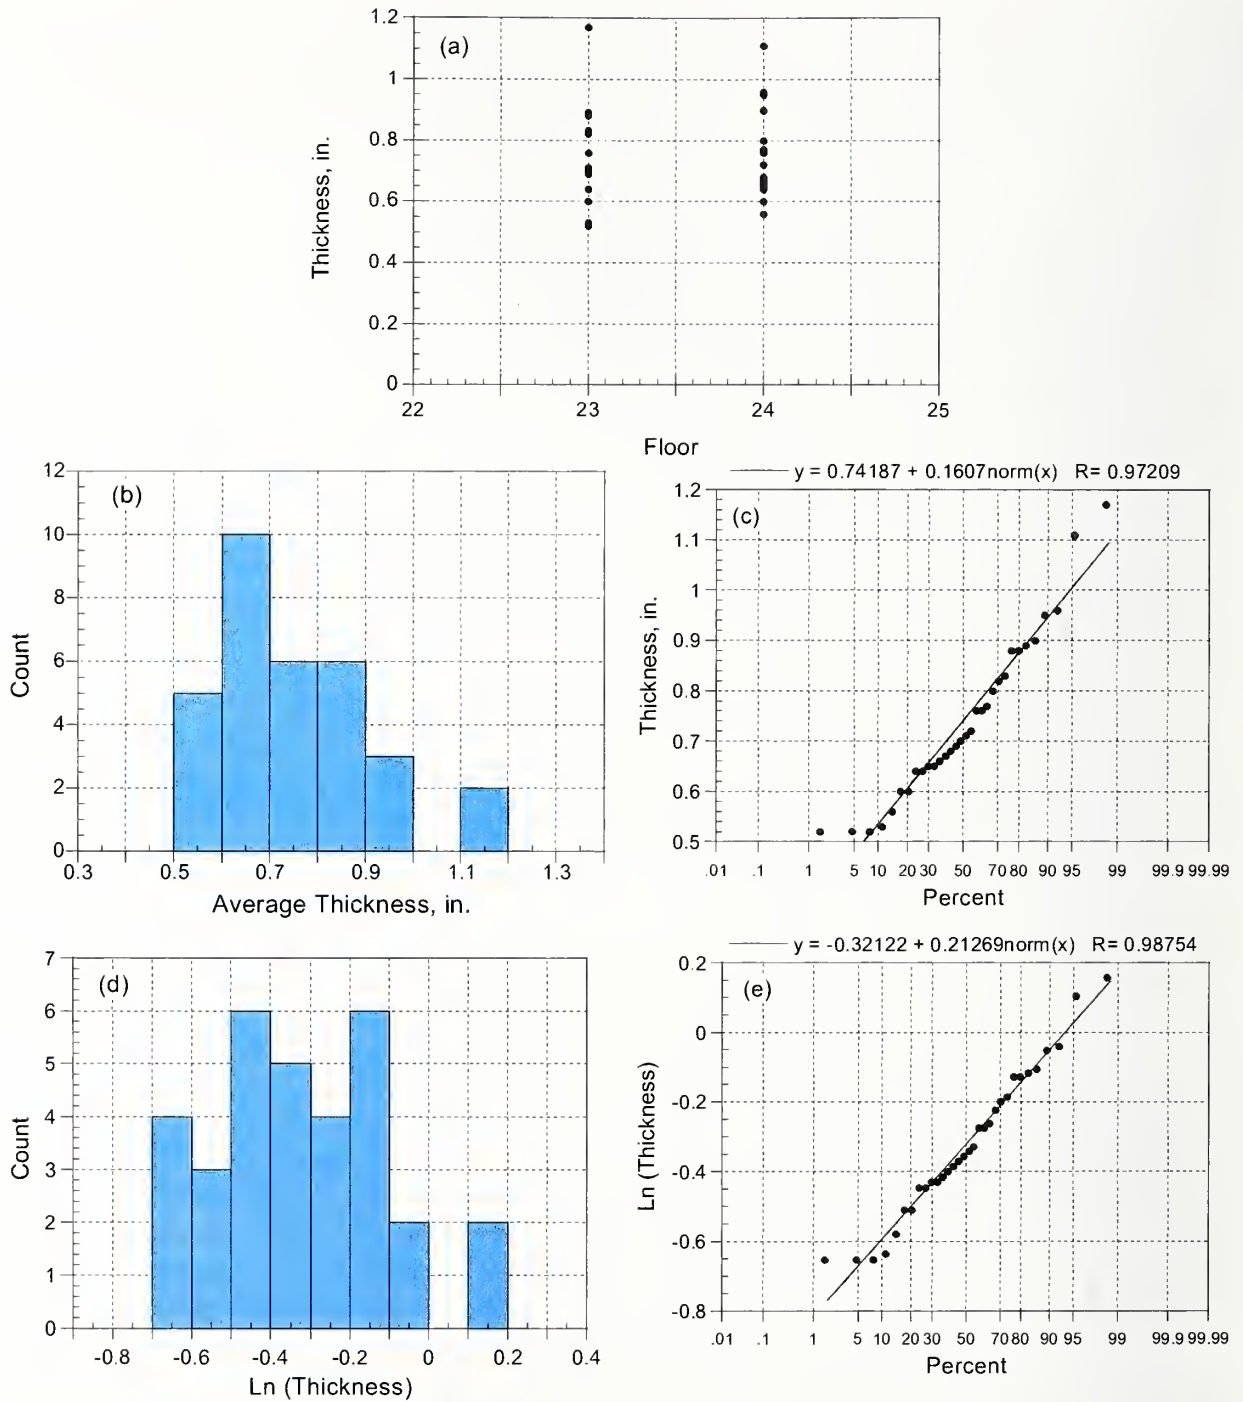
A lognormal distribution for the average thickness of the fireproofing on the non-upgraded floor trusses is explained as follows. It is expected that the thickness of fireproofing will be highly variable due to the difficulty in spraying the material on the relatively thin members. If the overall thickness is low and the variability is high, a normal distribution would require a fraction of the surfaces to have negative values of fireproofing. If the thickness distribution is lognormal, the thickness cannot be zero, and there is a low likelihood of having thickness close to zero. If the underlying distribution of fireproofing thickness is lognormal, the average thickness overestimates the thickness expected to be exceeded with 50 percent probability, and the median is the appropriate statistic for the 50 percentile value.

Figure I-7. (a) Dotplot of average thickness from floor trusses for floors 23 and 24, (b) histogram of average thickness, (c) normal probability plot of average thickness, (d) histogram of natural logarithm of average thickness, and (e) probability plot of natural logarithm of average thickness.

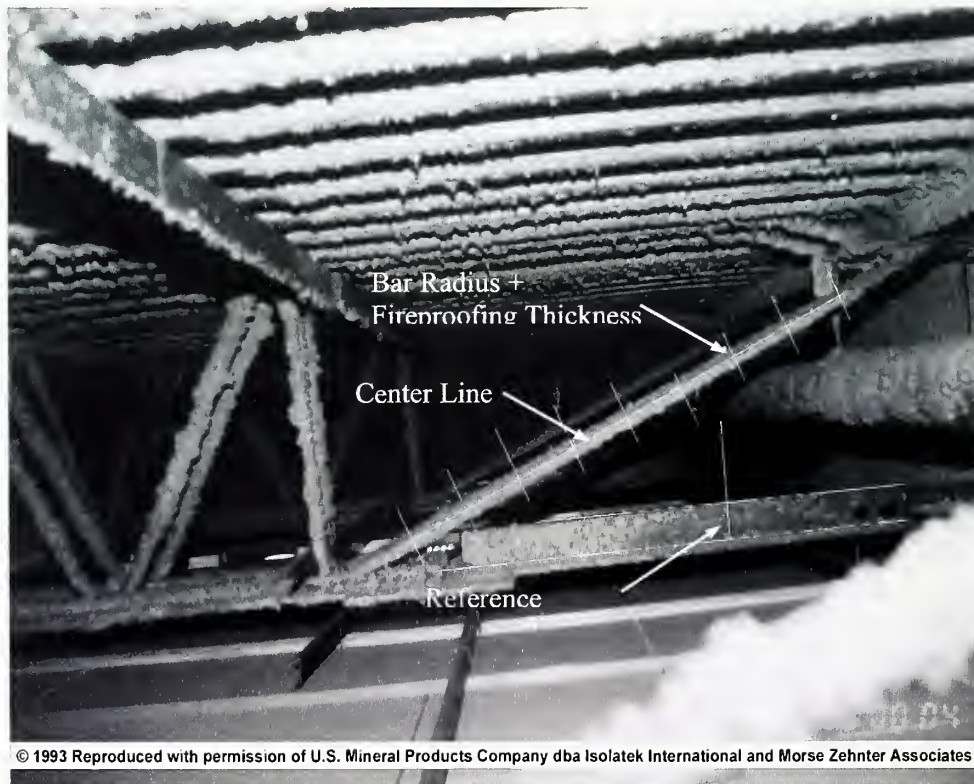
- Lines were drawn perpendicular to the “virtual” centerline. The number of pixels along the lines from the “virtual” centerline to the edge of the fireproofing was determined from the cursor positions indicated by the software. Measurements were made at regularly spaced intervals to avoid bias. Figure I-8 is an example of a series of measurements made on a strut.

Figure I-8. Example of measurement procedure used to estimate fireproofing thickness from photographs.

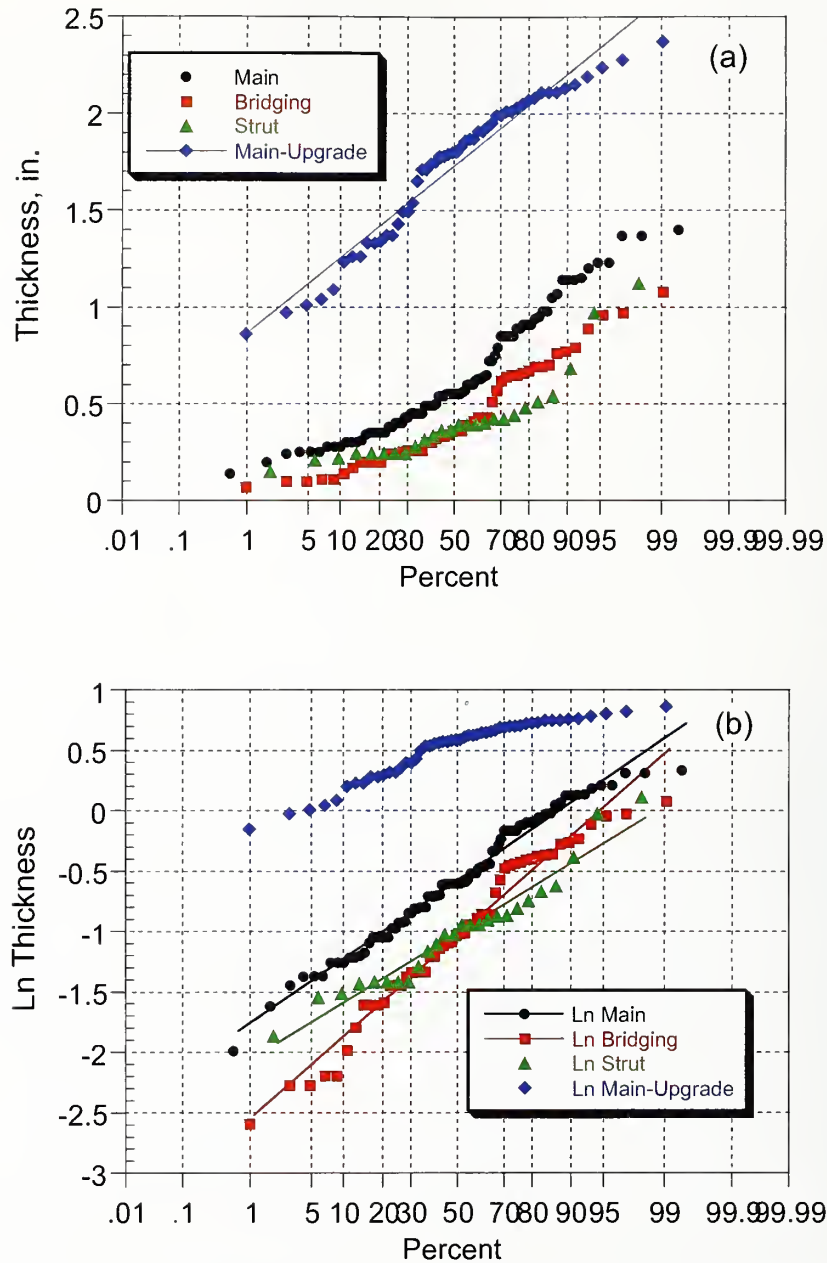
Figure I-9. (a) Normal probability plot of estimated fireproofing thickness based on photographs, and (b) normal probability plot of natural logarithms of thickness.

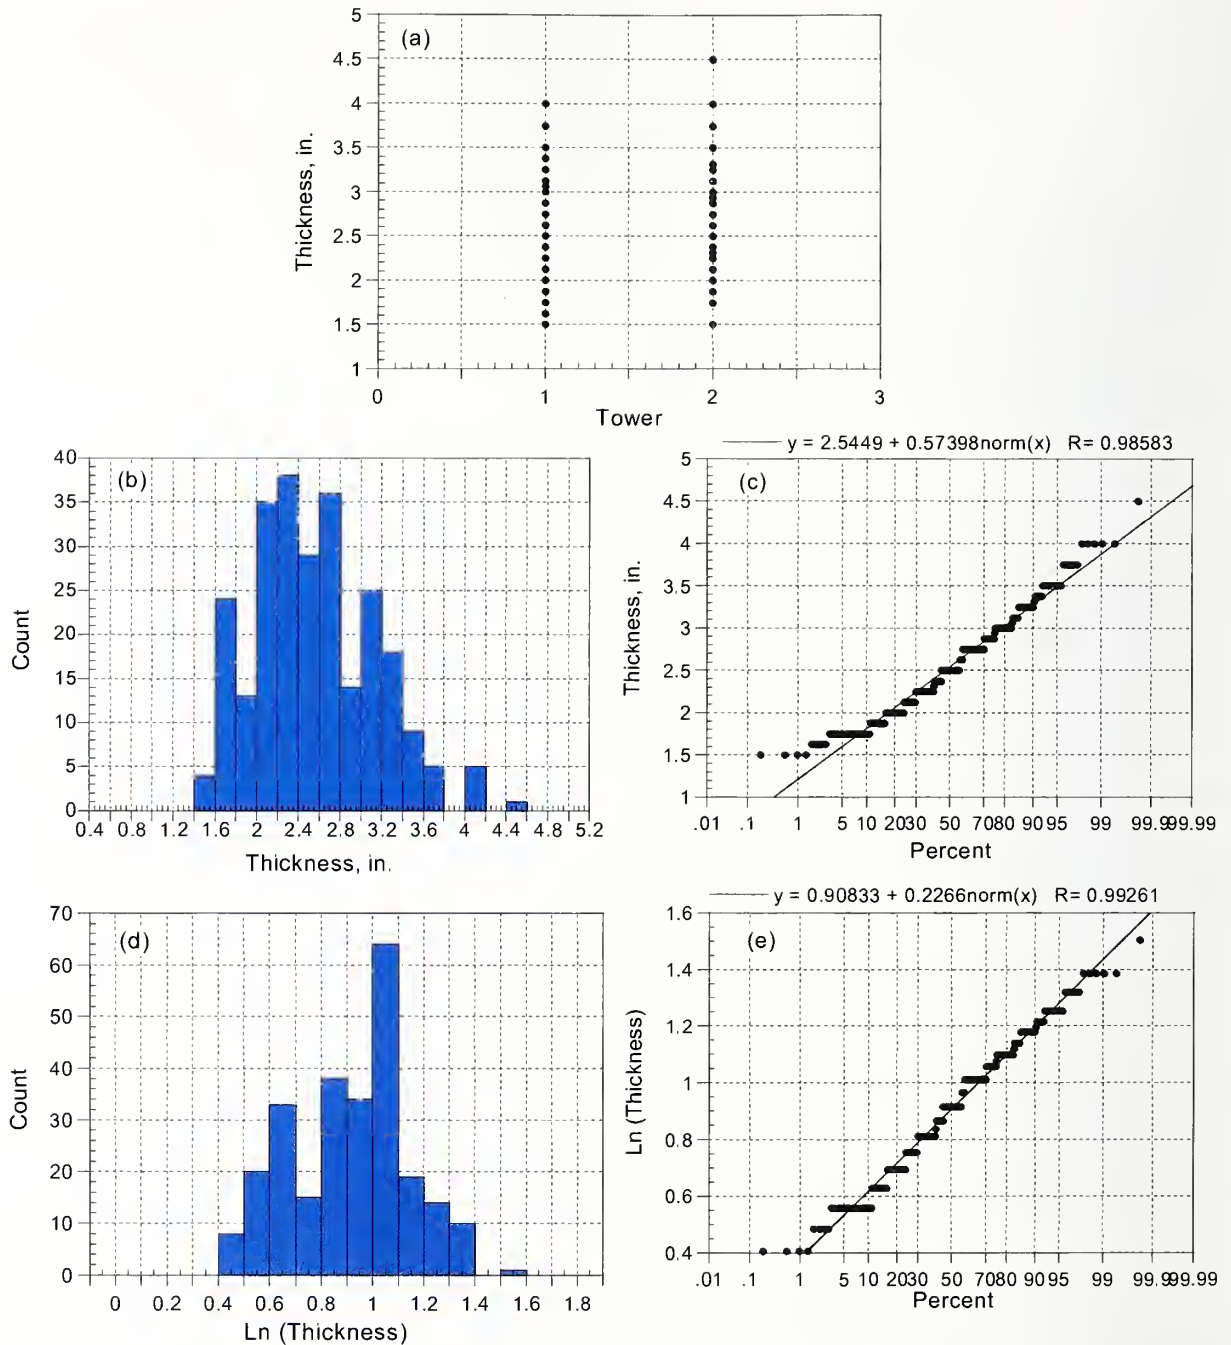
An analysis of the individual measurements was carried out to determine the underlying distribution for the measured thicknesses. Figure I-10 (a) is a dotplot of the individual measurements in WTC 1 (144 measurements) and in WTC 2 (112 measurements). It is observed that the central values and ranges

Figure I-10. (a) Dotplot of individual thickness measurements on floor trusses from Port Authority Construction Audit Reports, (b) histogram of thickness measurements, (c) normal probability plot of thickness measurements, (d) histogram of natural logarithms of thickness measurements, and (e) normal probability plot of natural logarithm of thickness measurements.

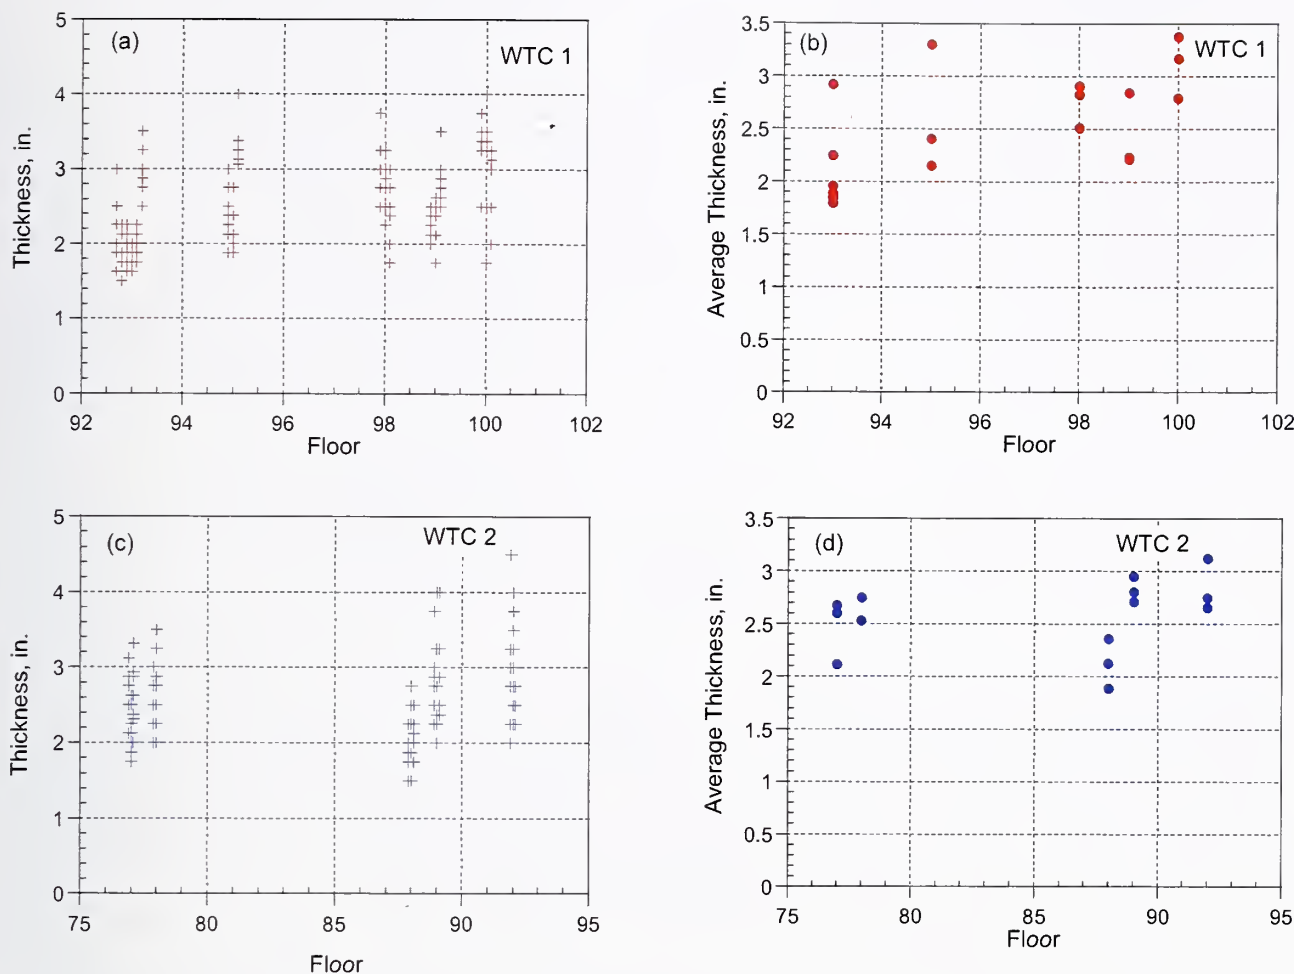
The overall standard deviation of 0.6 in. includes two contributions: (1) the variation of thickness at the cross section (within-truss variability), and (2) the variation of average thickness between trusses (between-truss variability). Figure I-11 shows these two components of the thickness variability for the two towers. Figures I-11 (a) and (c) show the within-truss variability, and Figs. I-11 (b) and (d) show the variation of average thickness of each truss. From analysis of variance, it was found that the within-truss standard deviation is 0.4 in., and the between-truss standard deviation is also 0.4 in. The within-truss standard deviation of 0.4 in. is similar to the standard deviation of the estimated individual thickness obtained from analysis of the photographs of upgraded main trusses.

Figure I-11. Fireproofing thickness on floor trusses in upgraded portions of WTC towers: (a) individual measurements in WTC 1, (b) average thickness in WTC 1, (c) individual measurements in WTC 2, and (d) average thickness in WTC 2.
