NIST Special Publication 1000-5

June 2004
Progress Report on the
Federal Building and Fire Safety
Investigation of the
World Trade Center Disaster

Volume 4
Contains Appendices G, H, and I

Appendix H
Interim Report on Evolution of WTC Fires, Smoke, and Damage based on Image Analysis

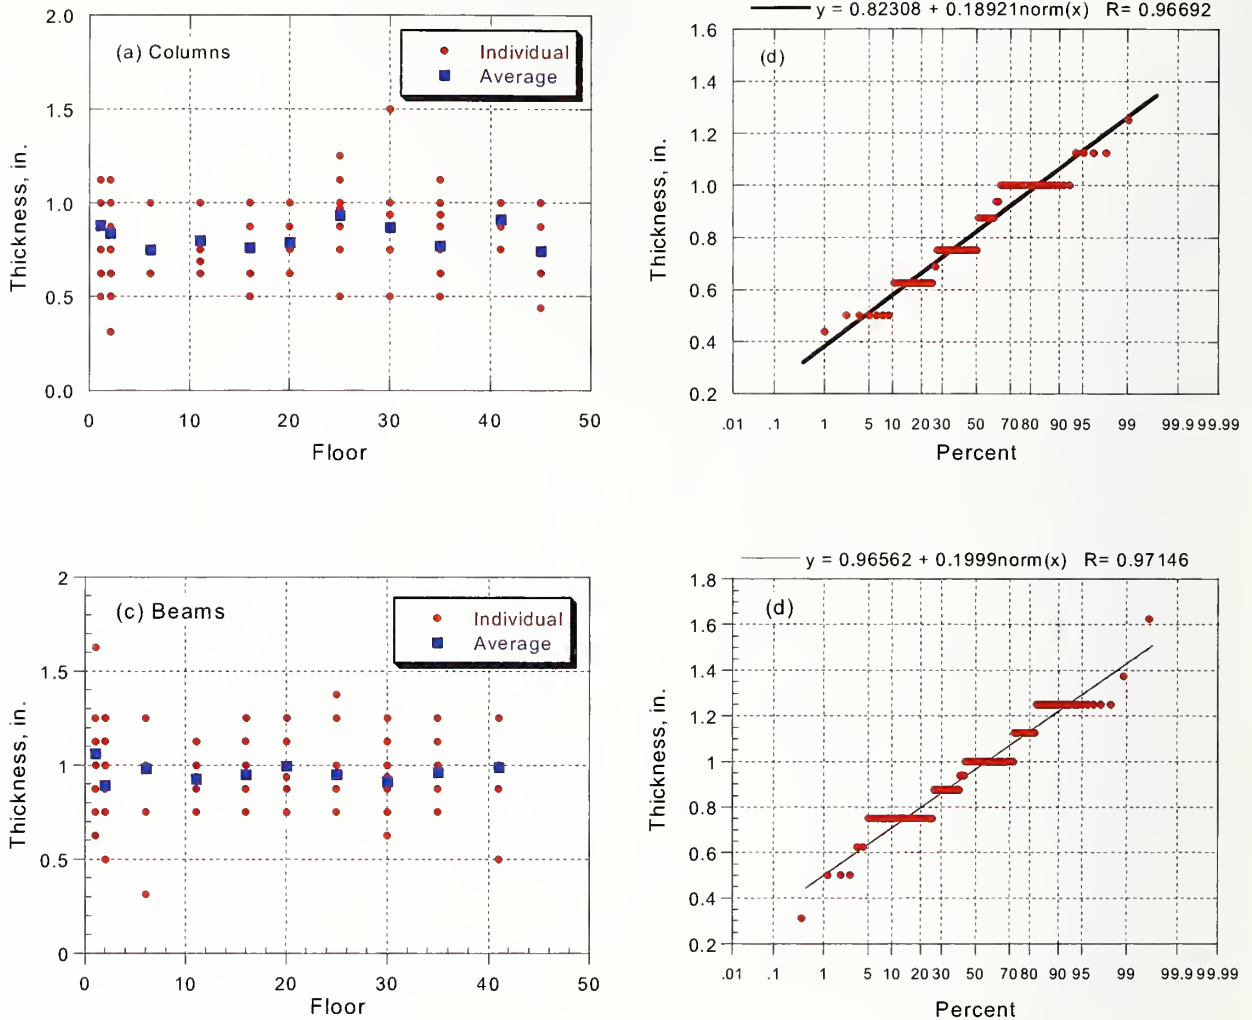
Figure I-12 (a) shows the individual and average fireproofing thickness on the core columns. Analysis of variance indicated no statistically significant differences among the average values and all data were pooled together. The average thickness for the columns is 0.82 in., the standard deviation is 0.20, and the coefficient of variation is 0.24. The information from the Port Authority indicated that the “minimum thickness required” for the columns was 0.5 in. Figure I-12 (b) is the normal probability plot of the individual thickness measurements. Because most of the thicknesses were reported to the nearest 1/8 in., the points are staggered instead of uniformly distributed. The plot, however, shows that the points follow a linear trend, and it appears that the thickness of the fireproofing on the core columns could be described by a normal distribution. Figures I-12 (c) and (d) shows the corresponding plots for the thickness of fireproofing on the beams. The average thickness for the beams is 0.97 in., the standard deviation is 0.21 in. and the coefficient of variation is 0.21. The information from the Port Authority indicated that the “minimum thickness required” for the beams was 0.75 in.

Figure I-12. (a) Individual and average thickness for core columns, (b) normal probability plot of individual measurements on columns, (c) individual and average thickness for core beams, and (d) normal probability plot of individual measurements on beams.

As might be expected, the variation in thickness of fireproofing for the beams and columns is lower than the variation observed in the floor trusses. The planar surfaces of the beams and columns result in more uniform application of the sprayed fireproofing than for the slender truss members. This results in reduced differences in the average thickness of fireproofing on different members and less variability within a member.

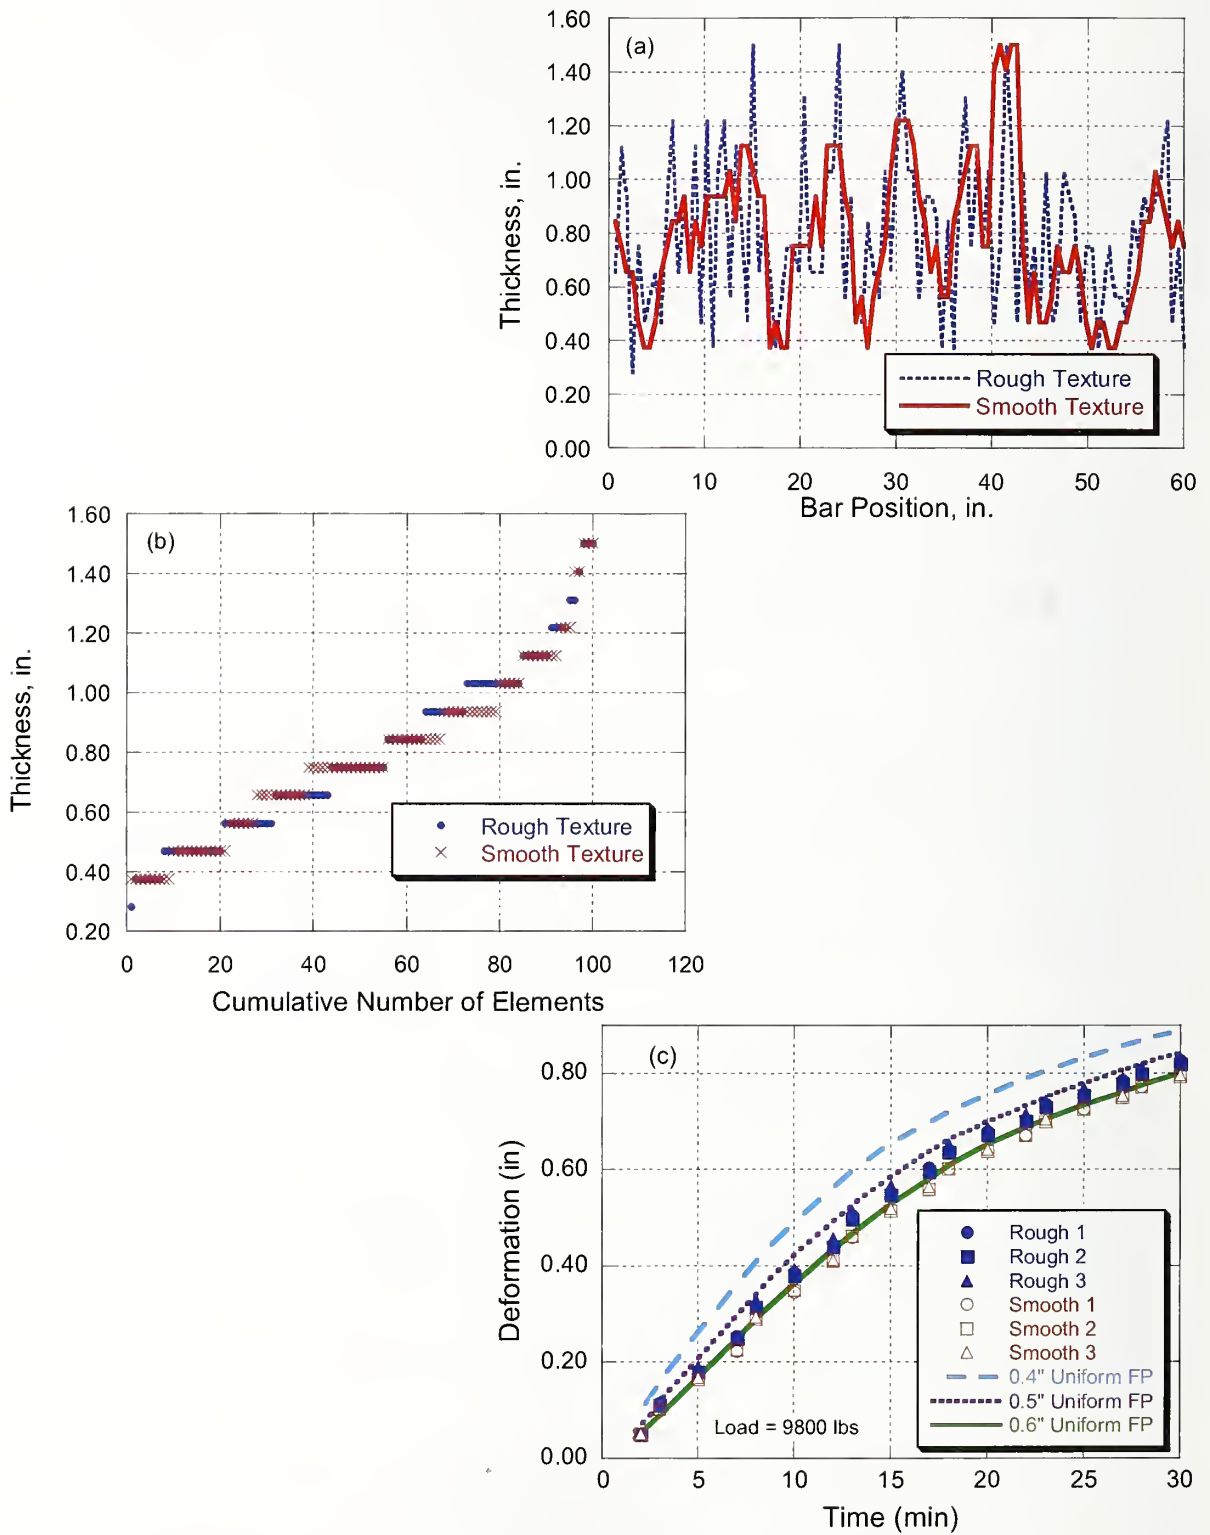
When the randomly selected thicknesses of each element were applied to the bar, it resulted in sudden changes in fireproofing thickness along the length of the bar. This resulted in a “rough” surface texture as shown by the dotted thickness profile in Fig. I-13 (a). It was felt that this rough texture (see also Fig. I-1 (c)) might not be representative of actual conditions, so an alternative approach was to use 5-point averaging to reduce the roughness of the fireproofing profile. The solid line in Fig. I-13 (b) shows such a “smooth” profile. The two profiles in Fig. I-13 (a) have approximately the same average value and standard deviation and have similar cumulative distribution of fireproofing thickness as shown in Fig. I-13 (b).

Figure I-13. (a) Randomly generated thickness profiles with average thickness of 0.75 in. and standard deviation of 0.3 in., (b) cumulative element size, and (c) deformation of 1 in. bar compared with deformation for uniform thickness of fireproofing.

Figure I–13 (c) shows that the “rough” texture reduces the effectiveness of the fireproofing by a small amount compared with the “smooth” texture. As noted above, it is believed that the “smooth” texture is more representative of the actual conditions. On the basis of these analyses, it is concluded that fireproofing with an average thickness of 0.75 in. and a standard deviation of 0.3 in. provides equivalent protection to 0.6 in. of uniform thickness.

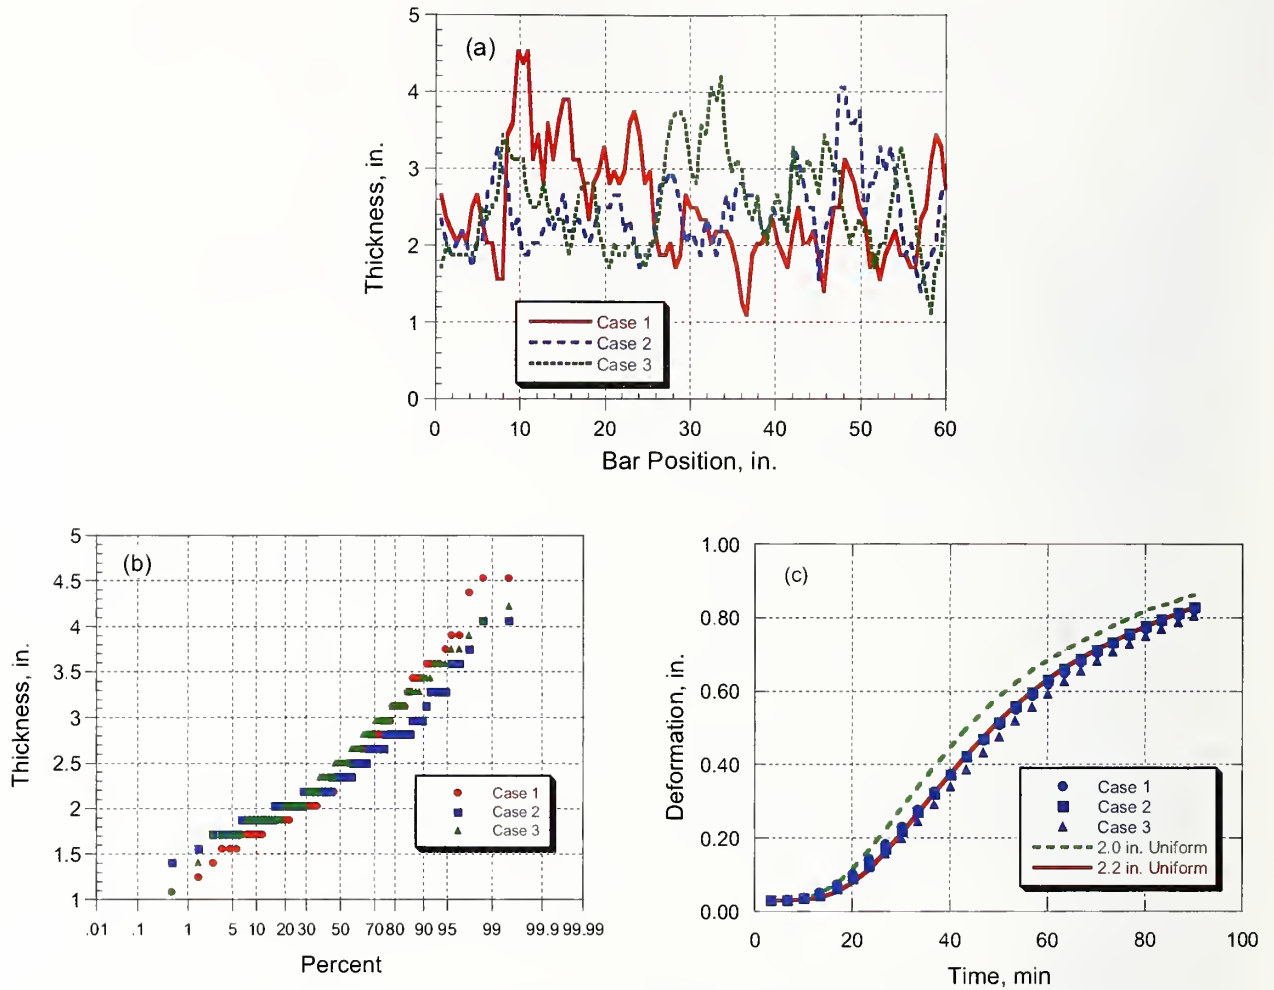
Figure I-14. (a) Randomly generated thickness profiles with average thickness of 2.5 in. and standard deviation of 0.6 in., (b) normal probability plots of thickness values, and (c) deformation of 1 in. bar compared with deformation for uniform thickness of fireproofing.

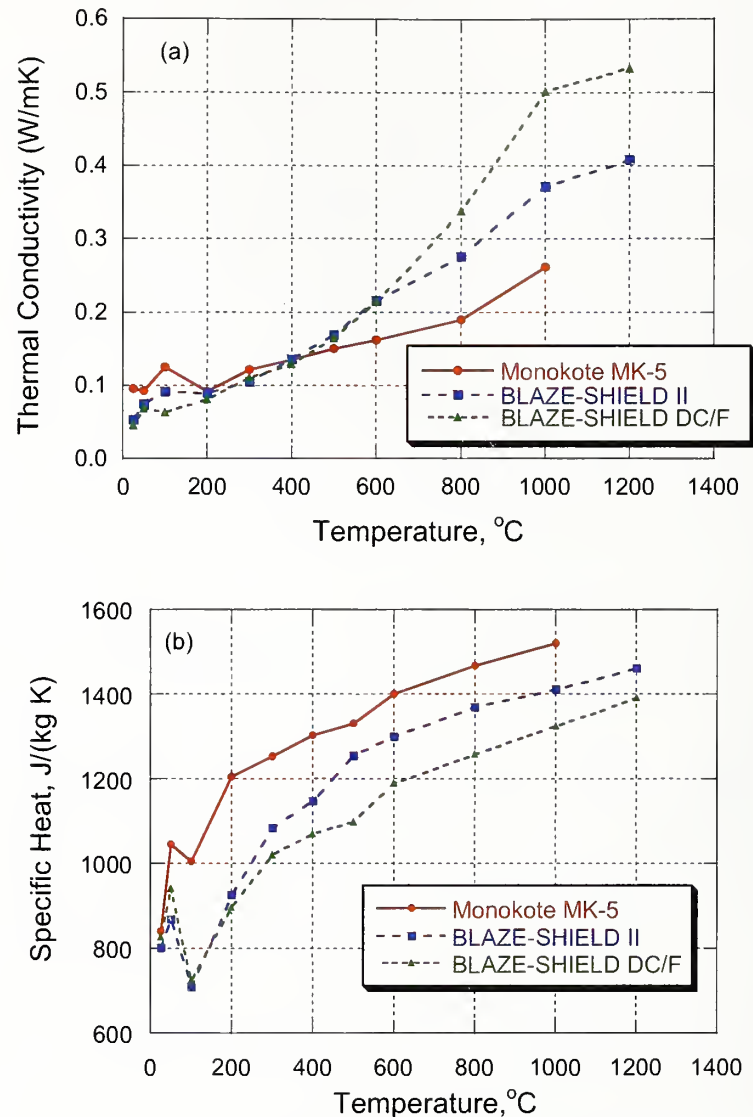
The thermal conductivity measurements were performed according to ASTM C 1113 Test Method for Thermal Conductivity of Refractories by Hot Wire (Platinum Resistance Thermometer Technique). This test method is based on heating two specimens with a platinum wire placed between them. The thin platinum wire serves not only as a heater, but also as a temperature sensor, since the variation of its electrical resistance during the test is converted into variation of temperature. Thermal conductivity is calculated based on the rate of temperature increase of the wire and power input. It was reported that substantial shrinkage during the measurements occurred for the three materials. The two MK-5 specimens shrunk, exposing the platinum wire positioned between them. For this reason, no thermal conductivity measurement could be performed for this material at 1,200 °C. Figure I-15 (a) shows preliminary results for thermal conductivity as a function of temperature. The results show similar trends of increased thermal conductivity with increasing temperature; however, the Monokote MK-5 specimens had a different behavior than CAFCO BLAZE-SHIELD Type DC/F and Type II at temperatures above 500 °C.

Figure I-15. Preliminary test results: (a) thermal conductivity as a function of temperature, and (b) specific heat as a function of temperature.

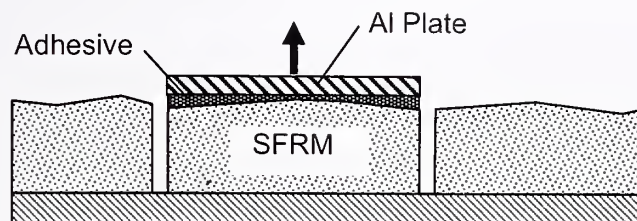
Figure I-16. Pull-off test of SFRM applied to steel plate.

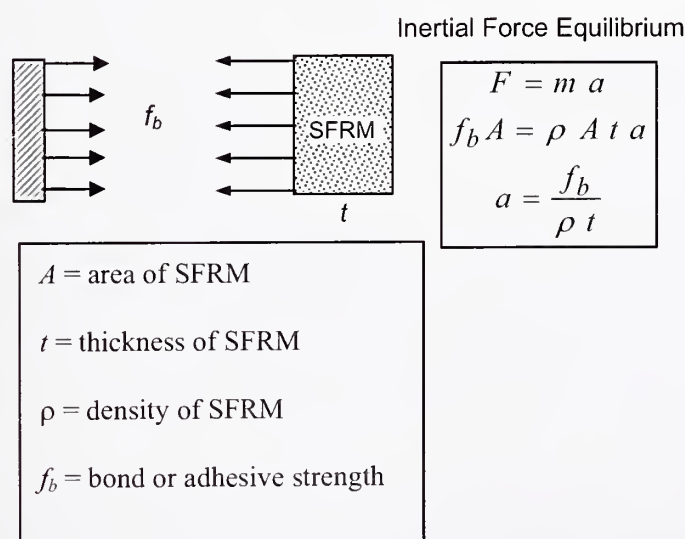
Figure I-17, shows the free body of the fireproofing being acted upon by its inertial force and the adhesive force. The acceleration to dislodge the SFRM is:

Figure I-17. Derivation of acceleration to dislodge SFRM from planar substrate.

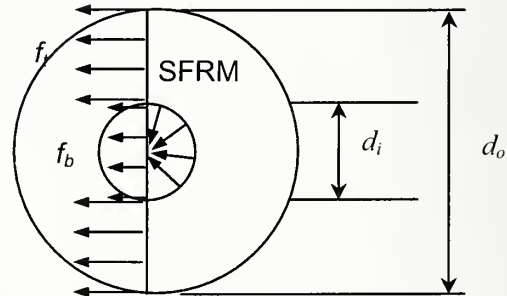
Figure I-18. Derivation of acceleration to dislodge SFRM surrounding a round bar.
