# NATIONAL BUREAU OF STANDARDS REPORT

by  
J. W. Ryan and W. W. Sander

Fire Endurance Tests of Prefabricated Exterior Wall Panels

Test Report No. T010219-53; 673286

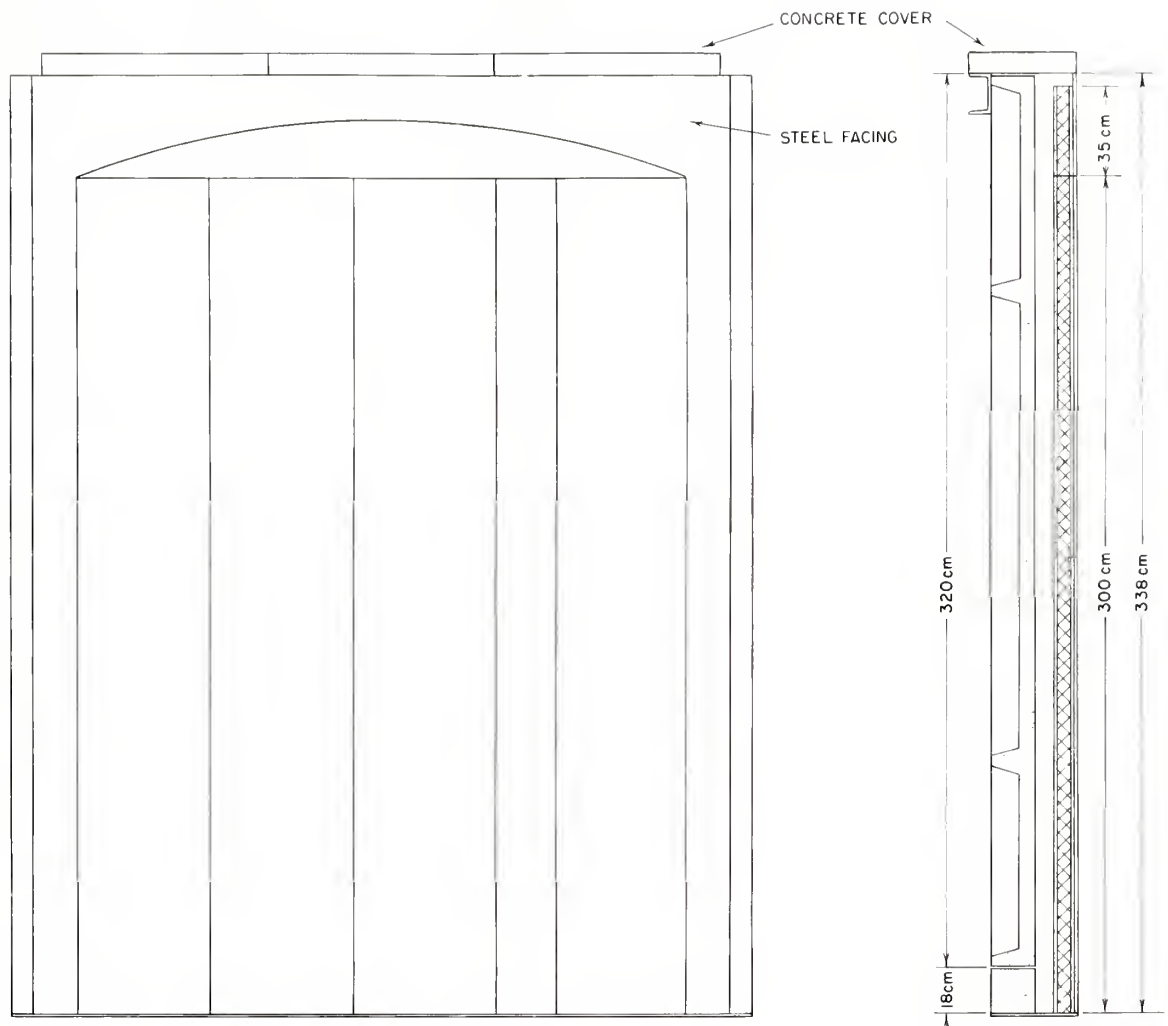
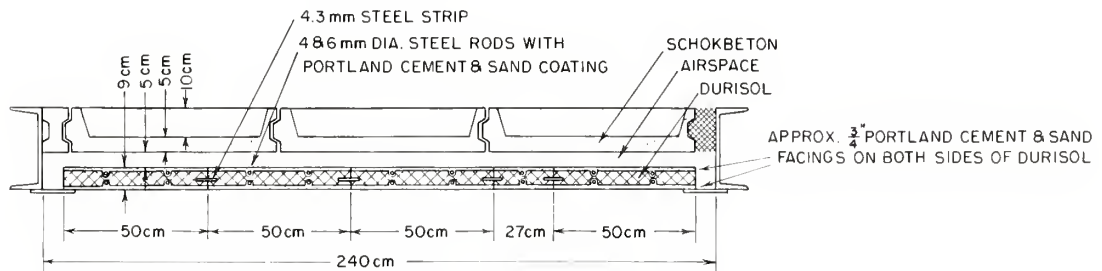
FIG. 1 CONSTRUCTION DETAILS OF TEST PANEL NO. 1

Test 1. A hollow wall with an air space of about 2 in. (5 cm) between the inner and outer faces. The outer face consisted of precast high density concrete channel slabs with transverse ribs. Each slab was 10 ft. 6 in. (320 cm) high, 2 ft. 5 in. (75 cm) wide, about 2 in. (5 cm) thick through the web and about 5.5 in. (15 cm) thick through the channel flanges and transverse ribs. The exterior sides of the flanges were forced to fit the flanges of the adjoining slabs in a tongue-and-groove system. The slabs were cast in form on a shock table and shocked repeatedly to obtain the high density. The inner face consisted of a pressed board of wood shavings banded with portland cement which was coated on both sides with about 3/4 in. of a portland cement and sand mixture, giving an overall thickness of about 4 in. The total thickness of the test specimen was about 12 in. The details are shown in figure 1.

Test 1. The inner face would have to be replaced after a standard 2 hr. fire exposure or equivalent and the outer face panels should be patched but could be used as is.

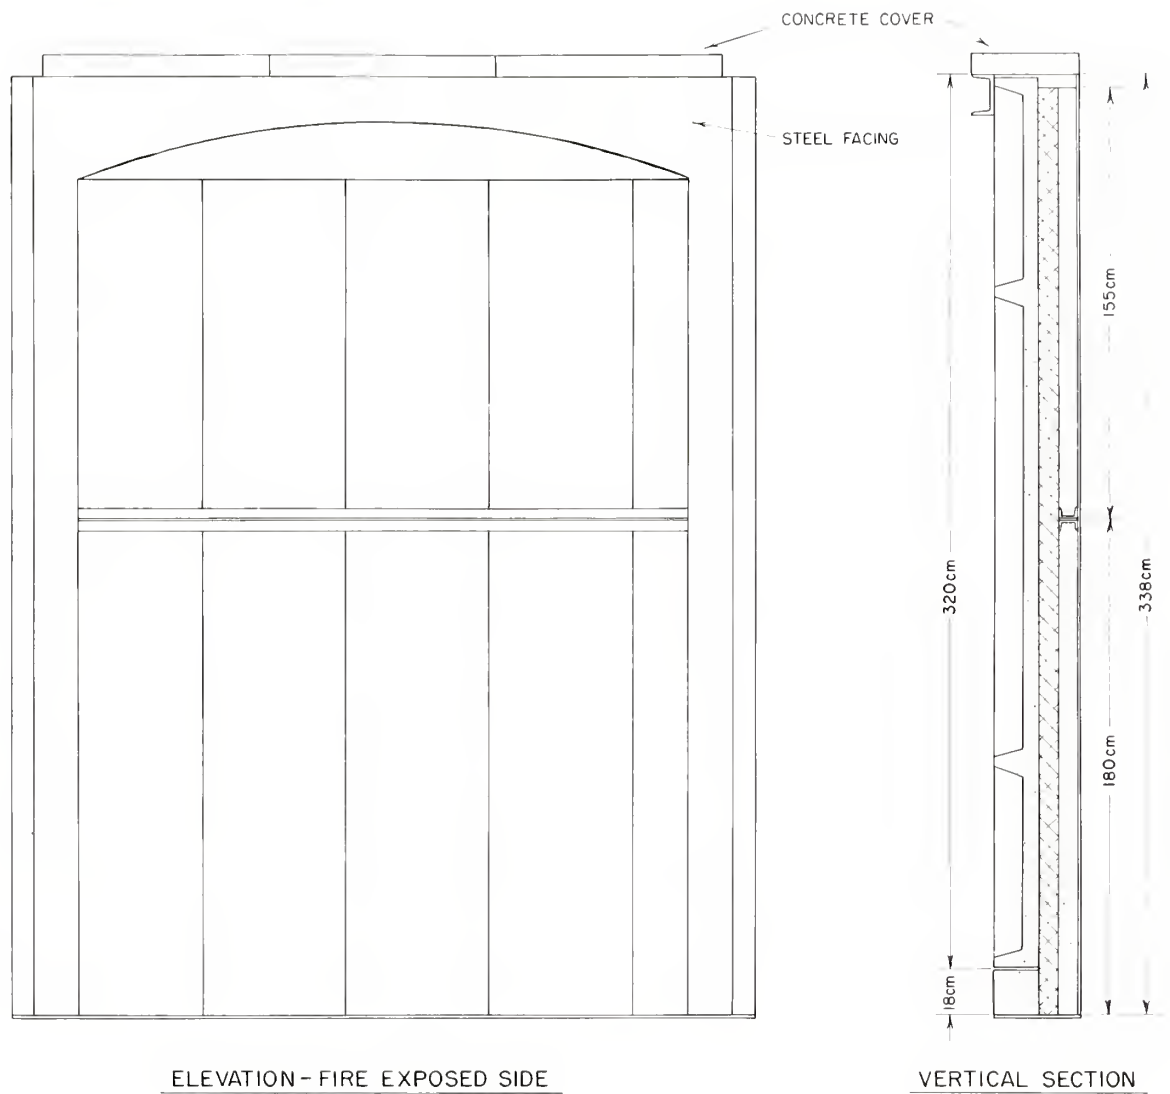
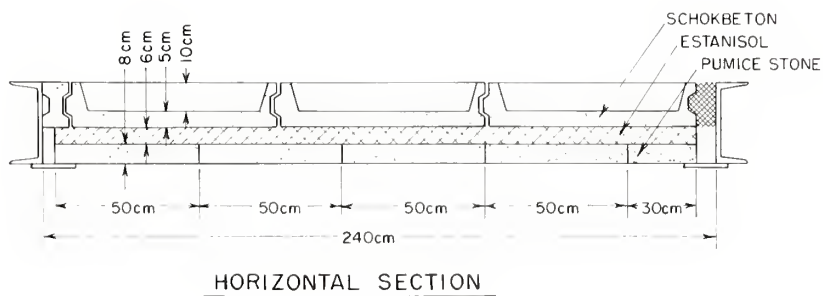
*FIG. 2 CONSTRUCTION DETAILS OF TEST PANEL NO.2*

Test 2. A sandwich wall with 2 in. of mineral wool insulation between the inner and outer faces. The outer face was of the same type materials and design as that in test 1. The inner face consisted of pumice concrete slabs 4 in. thick. The details are shown in figure 2.

Test 2. The inner face and the lateral wall panels between the faces would have to be replaced but the outer face panels would probably be maintained after a standard 3 hr. fire exposure, or its equivalent.

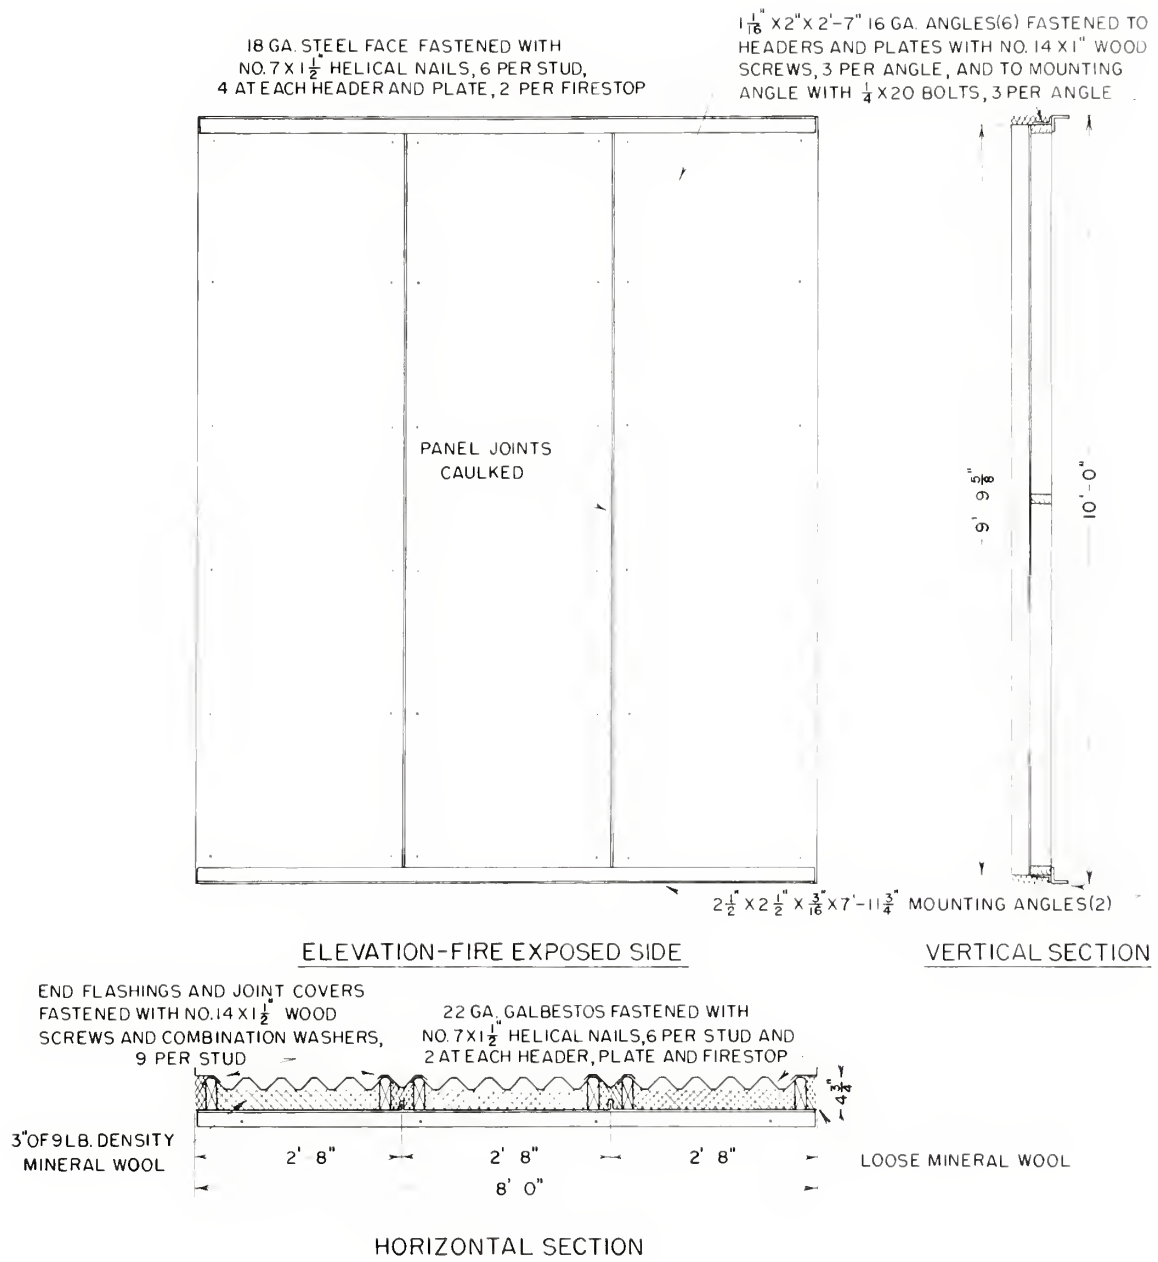
FIG. 3 CONSTRUCTION DETAILS OF TEST PANEL NO.3

Test 3. A wall consisting of three prefabricated panels, each of which was 7 ft. 11 3/4 in. high, 2 ft. 5 in. wide, and 4 3/4 in. thick, overall. Each panel consisted of a rectangular wooden frame to one face of which had been attached a sheet of 16 gage steel plate which projected on both sides of the frame and was bent to form interlocking joints with neighboring panels. The interior of the 3 in. deep wood frame had been filled with 9 lb./ft.<sup>3</sup> density mineral wool after which a corrugated sheet of 22 gage steel, coated with zinc, asbestos felt and a heavy asphaltic solution and aluminum painted on the outer side, had been attached to the other face of the frame. The mineral wool did not fill the 1 3/4 in. deep corrugations. The joints between panels in the interior or flat steel face were caulked and those in the exterior or corrugated face were stuffed with mineral wool and covered with full height 6 in. wide strips of the corrugated facing during erection. The details are shown in figure 3.

Test 3. The complete wall panels would have to be replaced after a 1 hr. standard fire exposure, or equivalent.

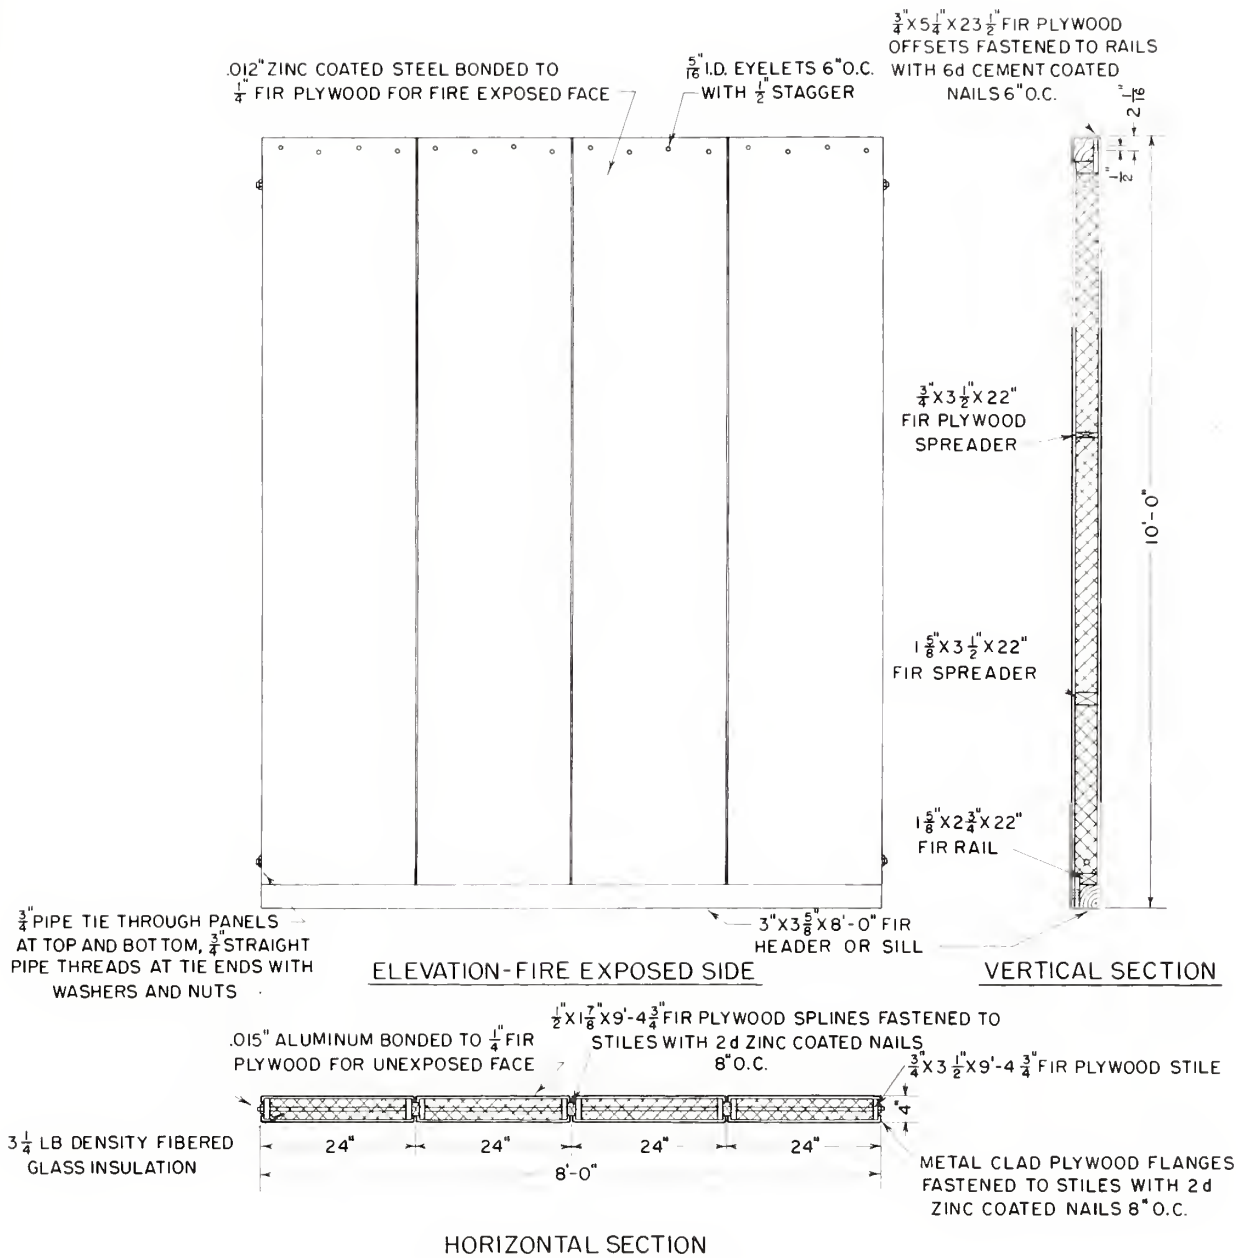
FIG. 4 CONSTRUCTION DETAILS OF TEST PANEL NO. 4

Test 4. A wall consisting of four prefabricated panels, each of which was 10 ft. high, 4 ft. wide, and  $\frac{1}{2}$  in. thick. Each panel consisted of a wood frame 9 ft.  $\frac{3}{4}$  in. high by 1 ft. 11 $\frac{1}{2}$  in. wide by  $\frac{3}{4}$  in. thick which had been faced on the interior side with  $\frac{1}{2}$  in. plywood clad with zinc coated steel and on the exterior side with  $\frac{1}{2}$  in. plywood clad with aluminum. The facings had been backed with asbestos paper and the space between facings filled with a glass fiber insulation. The interior face projected  $3\frac{5}{8}$  in. above the wood frame and the exterior face  $3\frac{5}{8}$  in. below, each backed with  $\frac{3}{4}$  in. additional plywood. These projecting lips had predrilled holes and eyelets for lag screws by which the panels were secured to 3 by 3  $\frac{5}{8}$  in. transverse sills at top and bottom during erection. All the surfaces of the wood components had been coated with a fire retardant paint except the metal clad faces of the plywood. The panels were tied together at erection by the sills and by  $\frac{3}{4}$  in. pipes which went through all four panels parallel to the faces near the top and bottom. The details are shown in figure 4.

Test 4. The complete wall panels would have to be replaced after a 3/4 hr. standard fire exposure, or equivalent.
