NISTIR 7661

Final Report on the Collapse of the Dallas Cowboys Indoor Practice Facility, May 2, 2009

January 2010

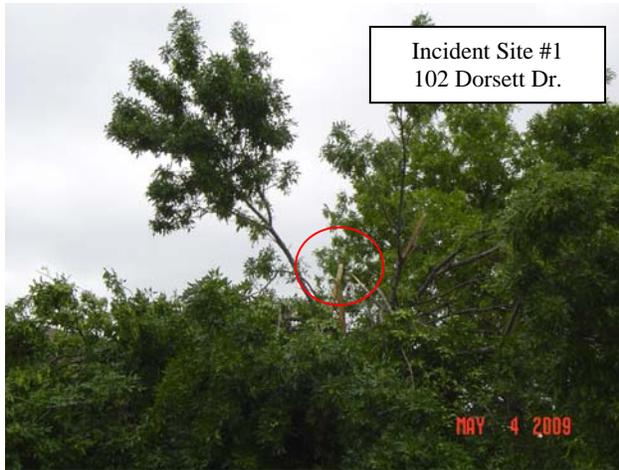
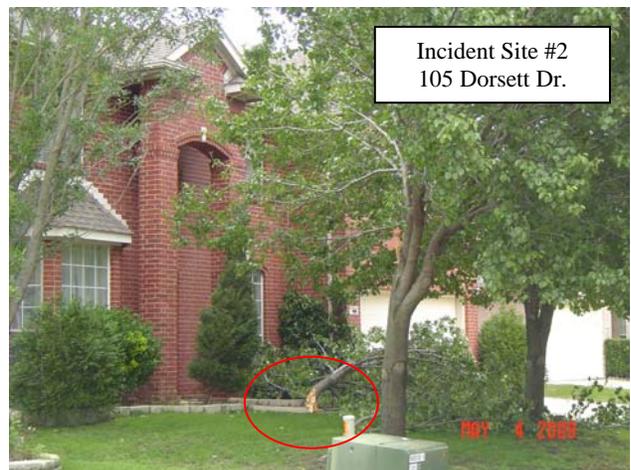
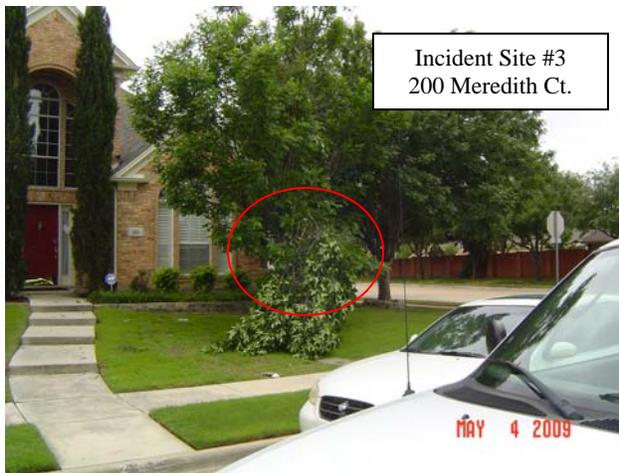
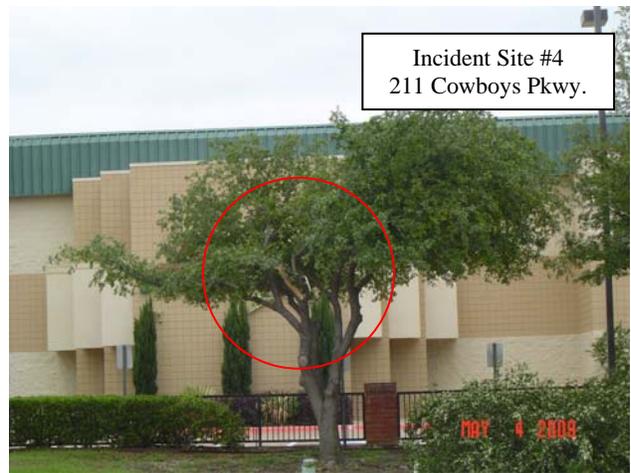
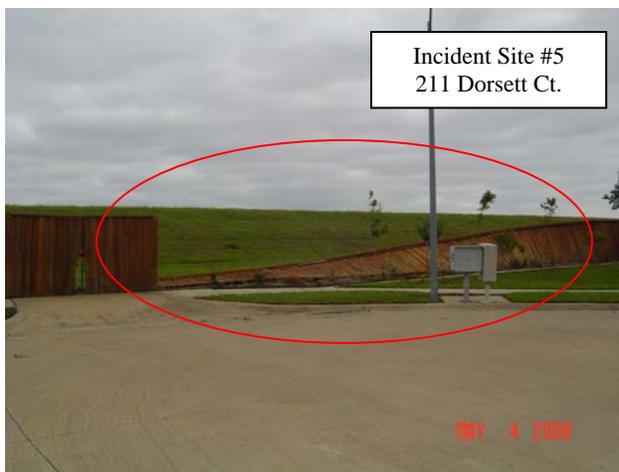
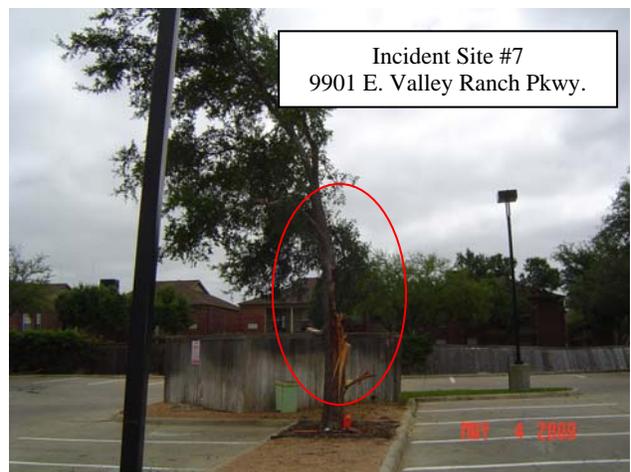
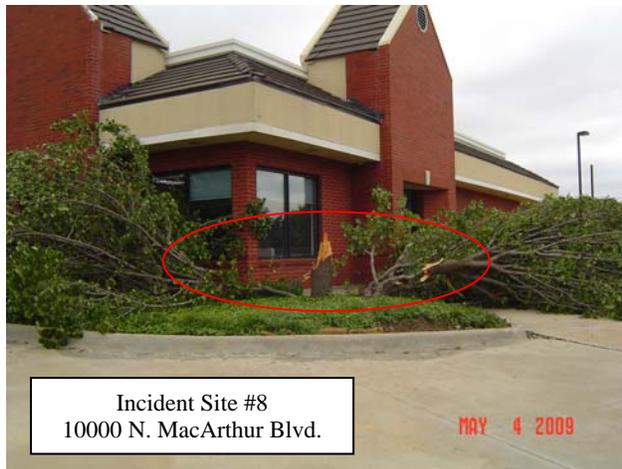
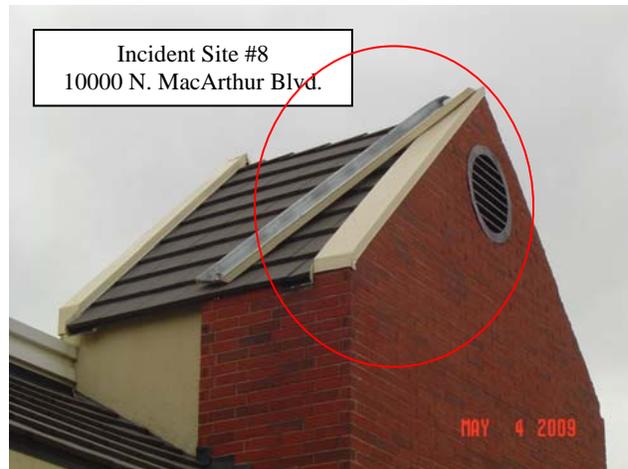
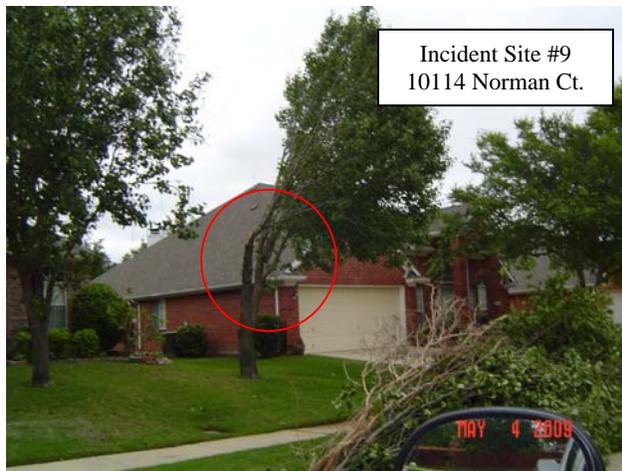
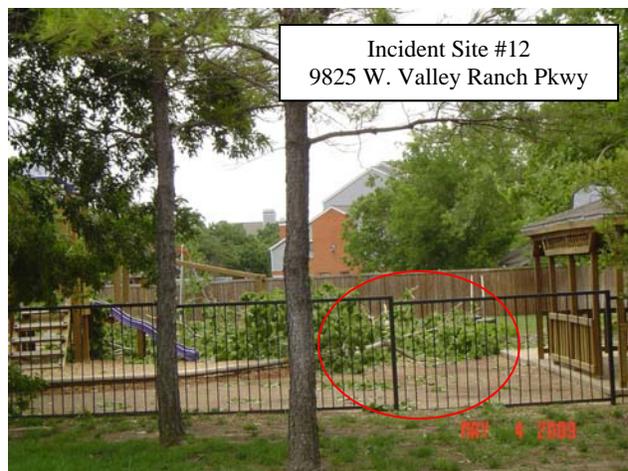
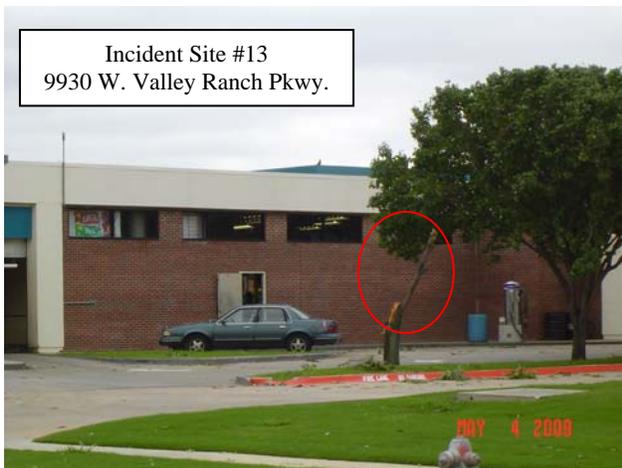
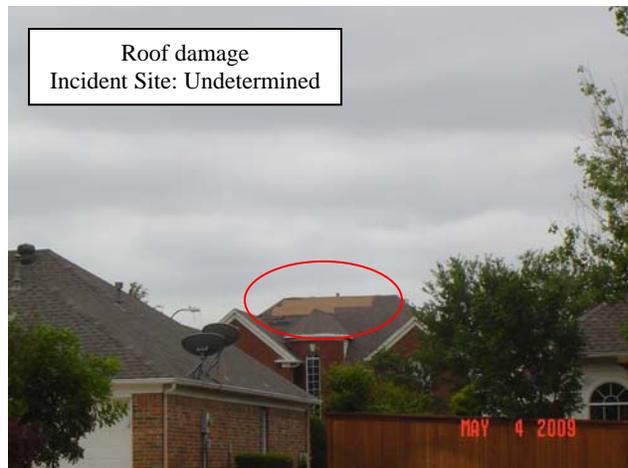
- No structural damage to residential or commercial structures in areas surrounding the practice facility
- Damage to surrounding neighborhoods limited mostly to broken tree limbs, with a few missing roof shingles at one house, and damaged flashing at another (see Figure 2–4)
- A general west-to-east pattern of damage to trees at locations on both east and west sides of the collapsed structure

**Figure 2-4 Wind damage to neighborhoods surrounding the practice facility
(Photo credit: City of Irving, Texas – used with permission)**

**Figure 2-4 (Cont'd) Wind damage to neighborhoods surrounding the practice facility
(Photo credit: City of Irving, Texas – used with permission)**

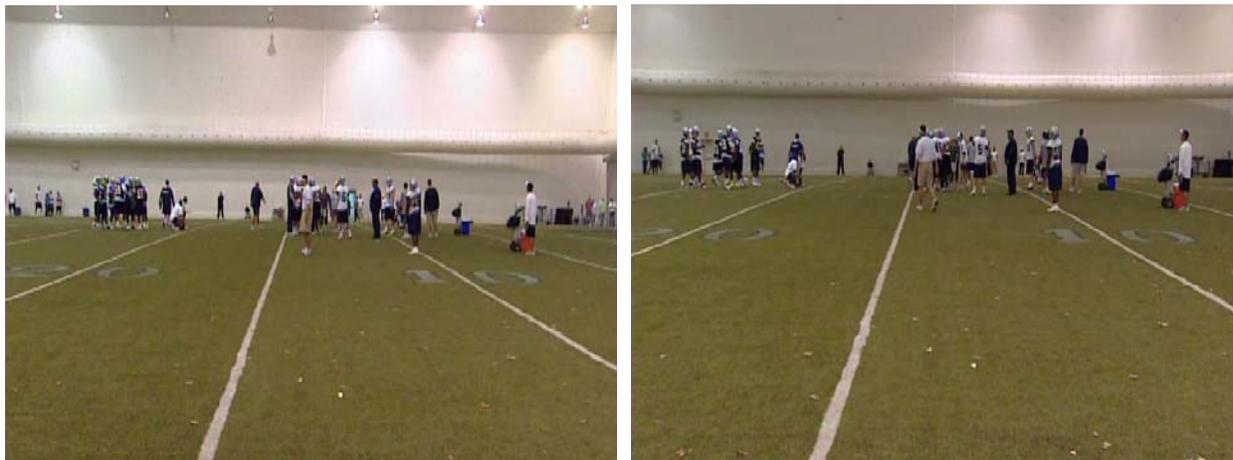
- Inner fabric liner appeared to move noticeably, as evidenced by the change in the shadows shown in Figure 3–1. The term “breathe” was used by the eyewitness (see Section 3.2).
- Lighting suspended from the steel frames swayed violently, as shown in Figure 3–2.
- A roll-up door on the south end came off its track and flapped in and out (see Figure 3–3).
- The south end wall appeared to sway toward the east and a personnel door came open.

**Figure 3–1 Two frames from the video showing motion of inner fabric liner
(Video credit: WFAA-TV – used with permission)**

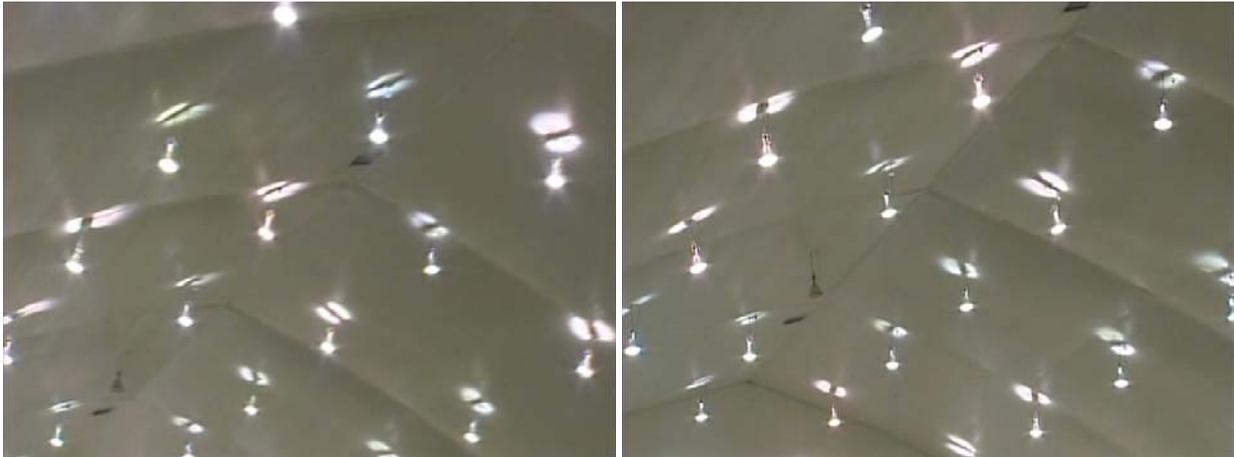
**Figure 3–2 Two frames from the video showing swaying of the lights
(Video credit: WFAA-TV – used with permission)**

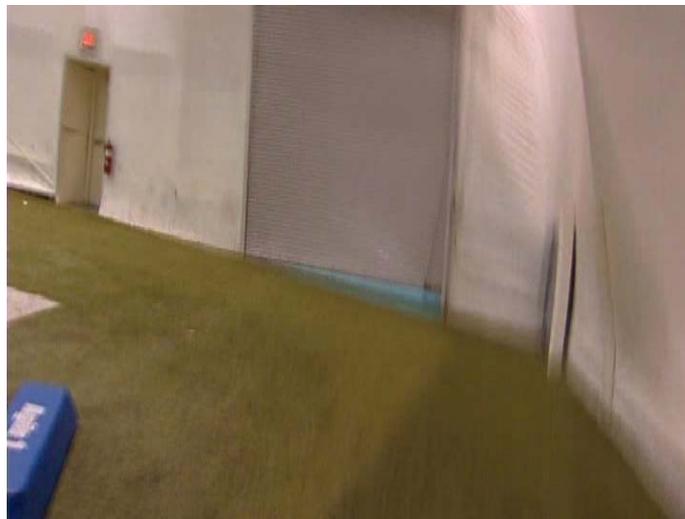
**Figure 3–3 Frame from the video showing opening of roll-up door
(Video credit: WFAA-TV – used with permission)**

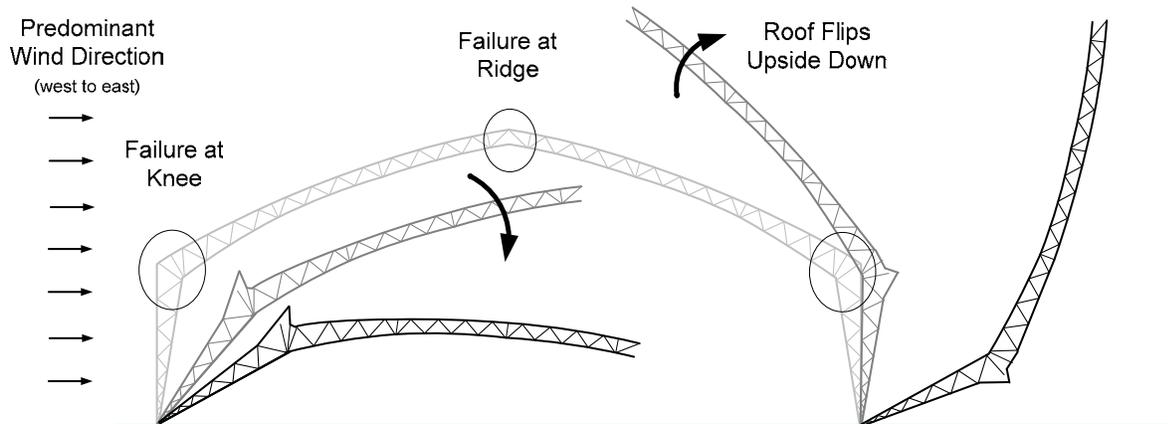
- Failure at the keystone and failure at the west knee allowed the west knee to straighten as the west leg rotated about its base toward the east.
- The west half of the roof collapsed downward, landing on the field.
- Failure at the keystone and failure at the east knee allowed the east knee to straighten as the east half of the structure rotated about its base toward the east.
- The east half of the roof rotated up and the east wall collapsed to the east, with the east half of the roof landing upside down.

Figure 3–5 Pattern of overall collapse of the southern portion of the structure

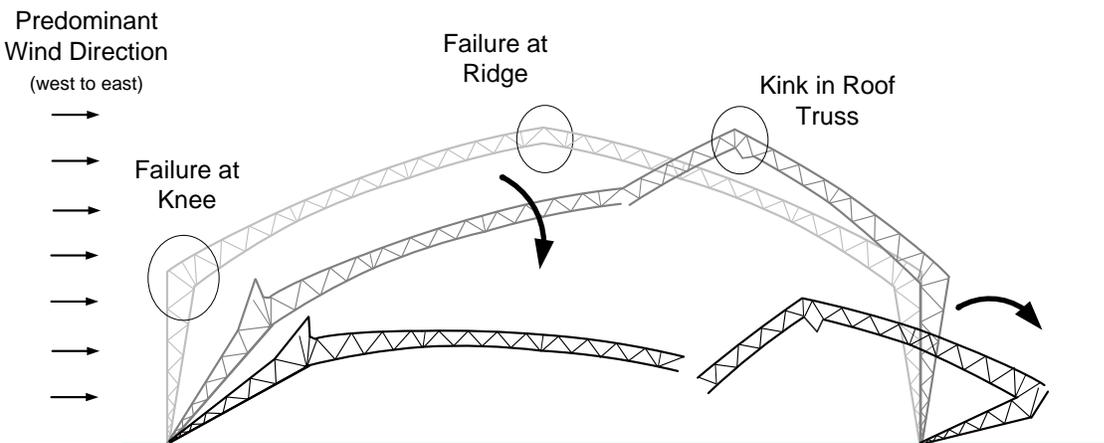
- Failure at the keystone and failure at the west knee allowed the west knee to straighten as the west leg rotated about its base toward the east.
- The west half of the roof collapsed downward landing on the field.
- The east half of the roof failed by buckling of the roof chords and, with failure at the knees, the east wall collapsed to the east as the east half of the roof collapsed downward onto the field.

Figure 3–6 Pattern of overall collapse of the northern portion of the structure

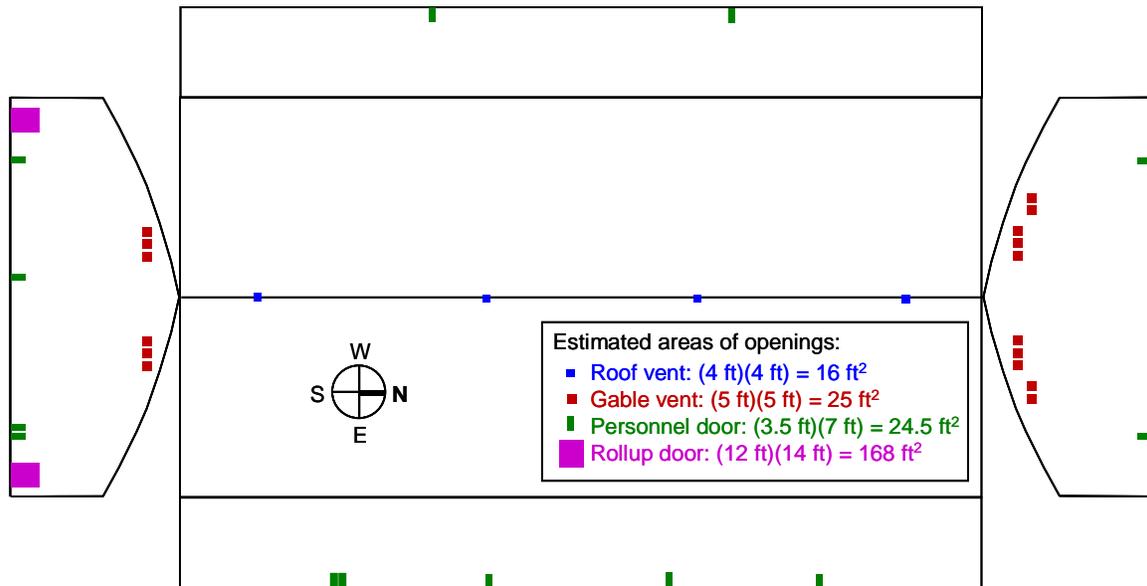
internal pressure build-up. As such, the structure is considered as enclosed for the purpose of internal pressure calculations.” However, in reality, there is no guarantee that this condition could be maintained. In addition, this structure is flexible and under design wind loading conditions, the structure deforms significantly (see Table 5–3), resulting in substantial distortions to the door framings that can cause the doors to fail to remain closed or latched during a wind storm (see Figure 3–3). Moreover, as is discussed in Section 4.2.2, a variety of circumstances could cause the fabric to tear, which could result in higher internal pressures during wind storms than those obtained if the fabric covering remained intact.

Figure 4–1 Openings in the building envelope

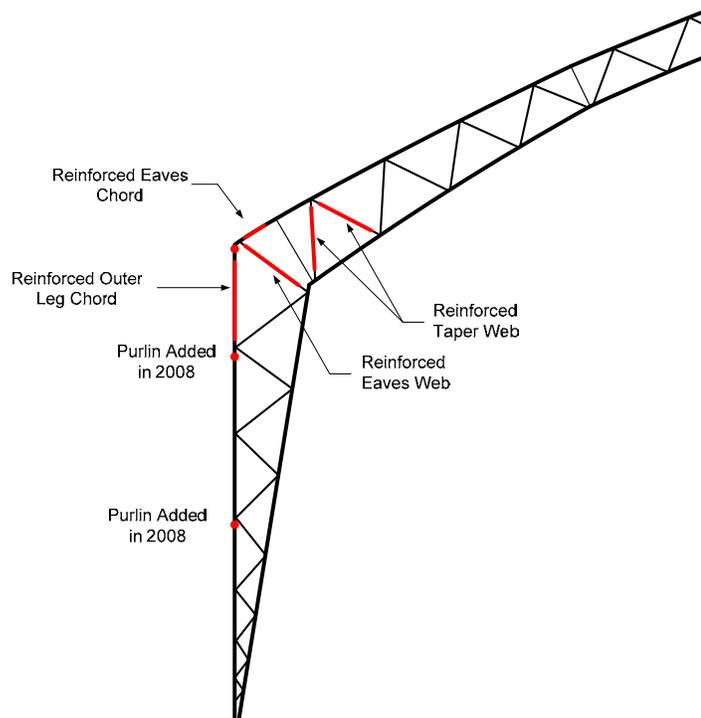
Figure 4–10 Reinforcement added in 2008

The structural frames supporting the fabric cover were designed and constructed in 2003. In 2008, the frames were reinforced by adding structural angles to selected chord members, rectangular structural tubes to the web members at the knees, and square structural tubes to two webs in the taper section. Figure 4–10 shows the locations of the reinforcement. All three reinforcing schemes can be seen in the photograph of one of the collapsed knees shown in Figure 4–11. Note that in many cases, the reinforcing detached from the original member during the collapse of the facility due to the failure of the screws used to attach the reinforcing.

1. The angles and both square and rectangular tubes were attached to the original members using self-tapping metal screws. The ability of such screws to fully mobilize the added member is not certain.
2. The added sections did not extend the entire length of the member to which they were attached. Thus, the critical section for tension yielding, tension rupture, flexural failure, shear failure, or compressive yielding was the original section; the only effect of the reinforcement would be to increase the buckling capacity.
3. The addition of reinforcement shifted the centroid of the composite section and therefore the reinforced sections were no longer concentrically loaded. This eccentricity would tend to reduce the effectiveness of the reinforcement.

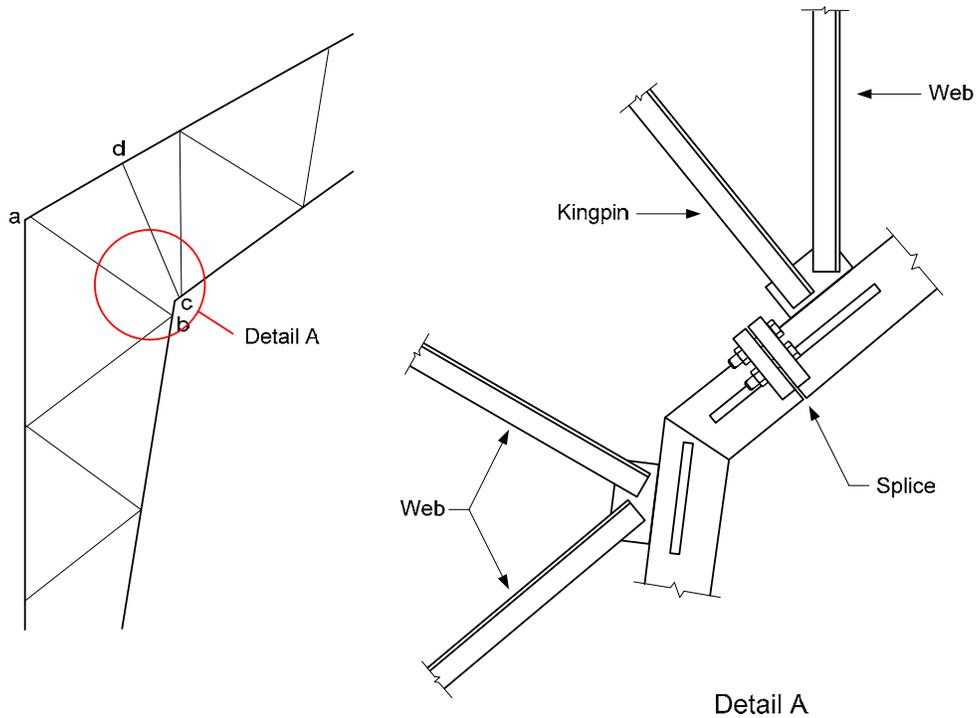
Figure 4–12 Schematic of inner knee

At the knees, however, the centroidal axes of the load-carrying members did not intersect at a common point. Indeed, as seen in Figure 4–12, the panel defined by points **a**, **b**, **c**, and **d** did not contain a web member. The result of this design detail is that large bending moments and shears are produced in the chord members in this region (see Chapter 5). According to the design documents, these bending moments and shear forces were not considered in the original 2003 design or the 2008 upgrade. In Chapter 5, DCRs are presented for (1) moment-axial interaction, (2) axial force only, and (3) shear forces only (Section 5.2).

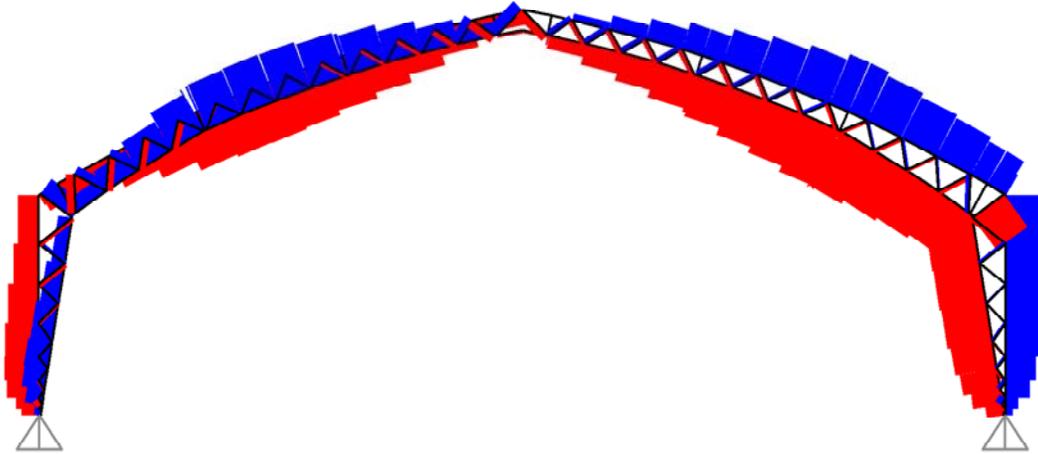
Figure 5–4 Axial forces under load combination $1.2 D + 1.6 W_4$
(Red: compression; blue: tension; wind from left)

The most critical wind load case, i.e., that which produced the largest DCRs in the frame, was found to be case W_4 above, with wind normal to the ridge, positive pressure on the windward roof, and negative internal pressure. The most critical load combination for this case was combination C_2 . Sample analysis results from this critical load combination ($1.2 D + 1.6 W_4$) are presented in Figure 5–4 through Figure 5–7. Axial forces are shown in Figure 5–4, bending moments are shown in Figure 5–5, shear forces are shown in Figure 5–6, and deflections are shown in Figure 5–7. The wind direction is from the left in these figures. Figure 5–4 shows large compressive axial forces in the inner chord on the leeward side of

the frame, particularly near the knee and near the splice between the taper section and the straight section of the roof truss. Figure 5–5 and Figure 5–6 show large bending moments and shear forces in the inner and outer chords near the connection eccentricities at the knee, particularly on the leeward side.

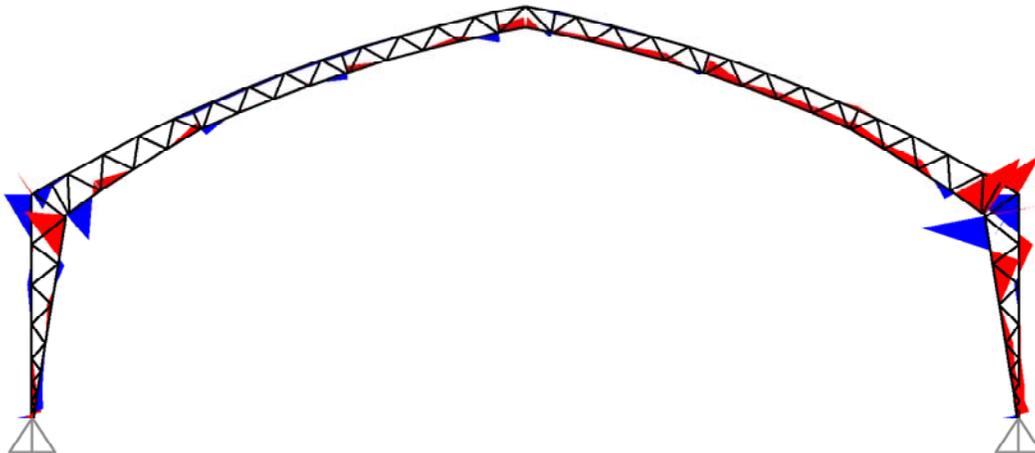
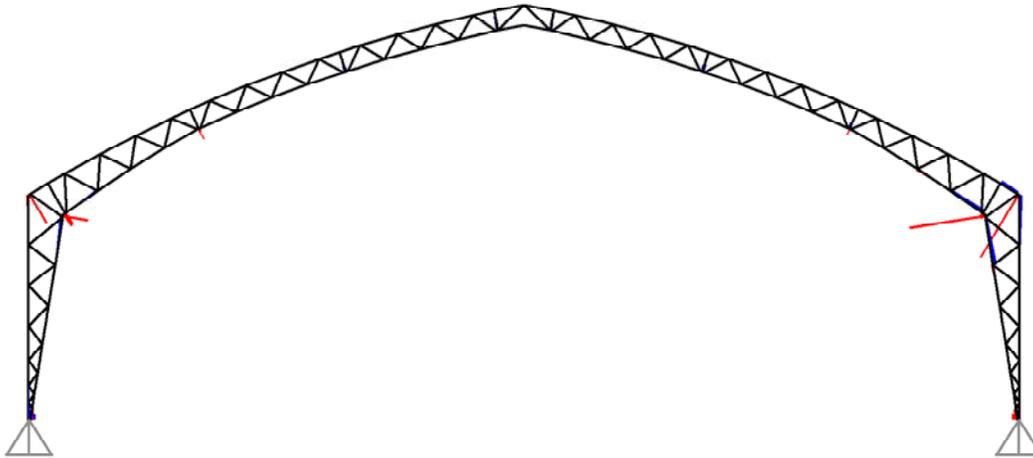
Figure 5–5 Bending moments under load combination $1.2 D + 1.6 W_4$
(Red: negative; blue: positive; wind from left)

Figure 5–6 Shear forces under load combination 1.2 D + 1.6 W₄
(Red: negative; blue: positive; wind direction is from the left)

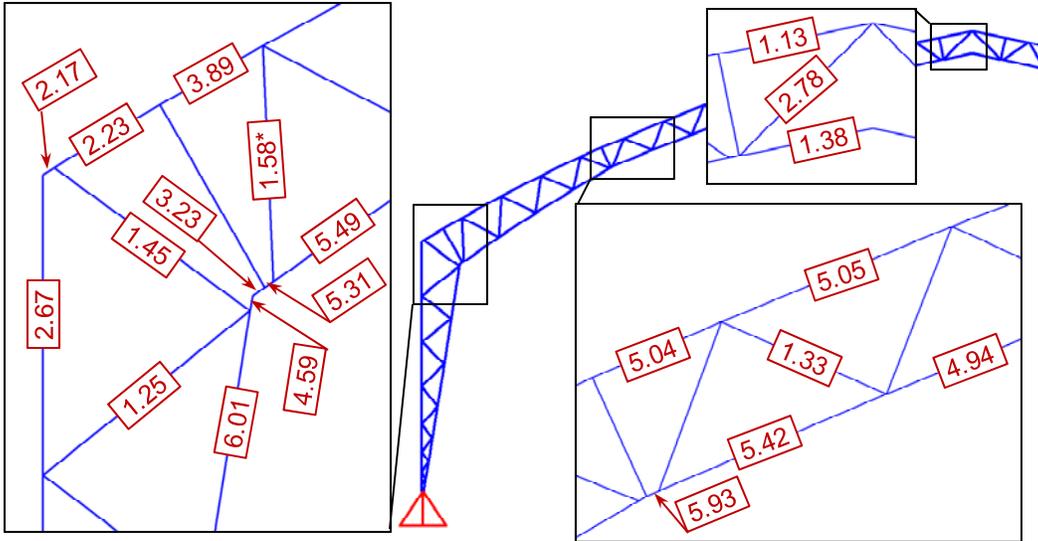
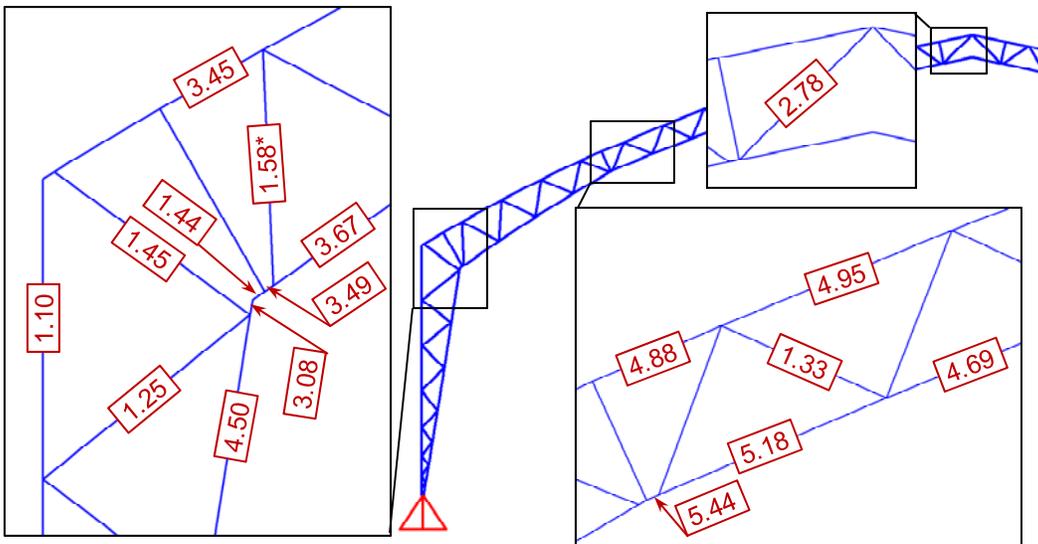
Figure 5–8 shows values of $DCR_{P/M}$ as large as 6.01, while Figure 5–9 shows values of DCR_P as large as 5.44, and Figure 5–10 shows two members with values of DCR_V exceeding 3.0. The difference between the $DCR_{P/M}$ values in Figure 5–8 and the DCR_P values in Figure 5–9 is attributable to bending moments produced primarily by connection eccentricities. The ratio of $DCR_{P/M}$ to DCR_P ranges from 1.02 to 2.43 for the various chord members shown, indicating that consideration of bending moments due to connection eccentricities can lead to increases up of to 143 % in DCRs. The large values of DCR_V in Figure 5–10 are also due to connection eccentricities, which require large shear forces to be carried directly through the inner and outer chord tubes at the knees. Although connection eccentricities were included in the structural analysis model used in the original 2003 design (Summit Structures 2003a), the design calculations indicate that the bending moments and shear forces resulting from these connection eccentricities were not considered in the design of the chord members.

Figure 5-8 Demand-capacity ratios for moment-axial interaction ($DCR_{P/M}$) under design wind load combinations C_1 and C_2 (Member Capacity Set B)

Figure 5-9 Demand-capacity ratios for axial force only (DCR_P) under design wind load combinations C_1 and C_2 (Member Capacity Set B)

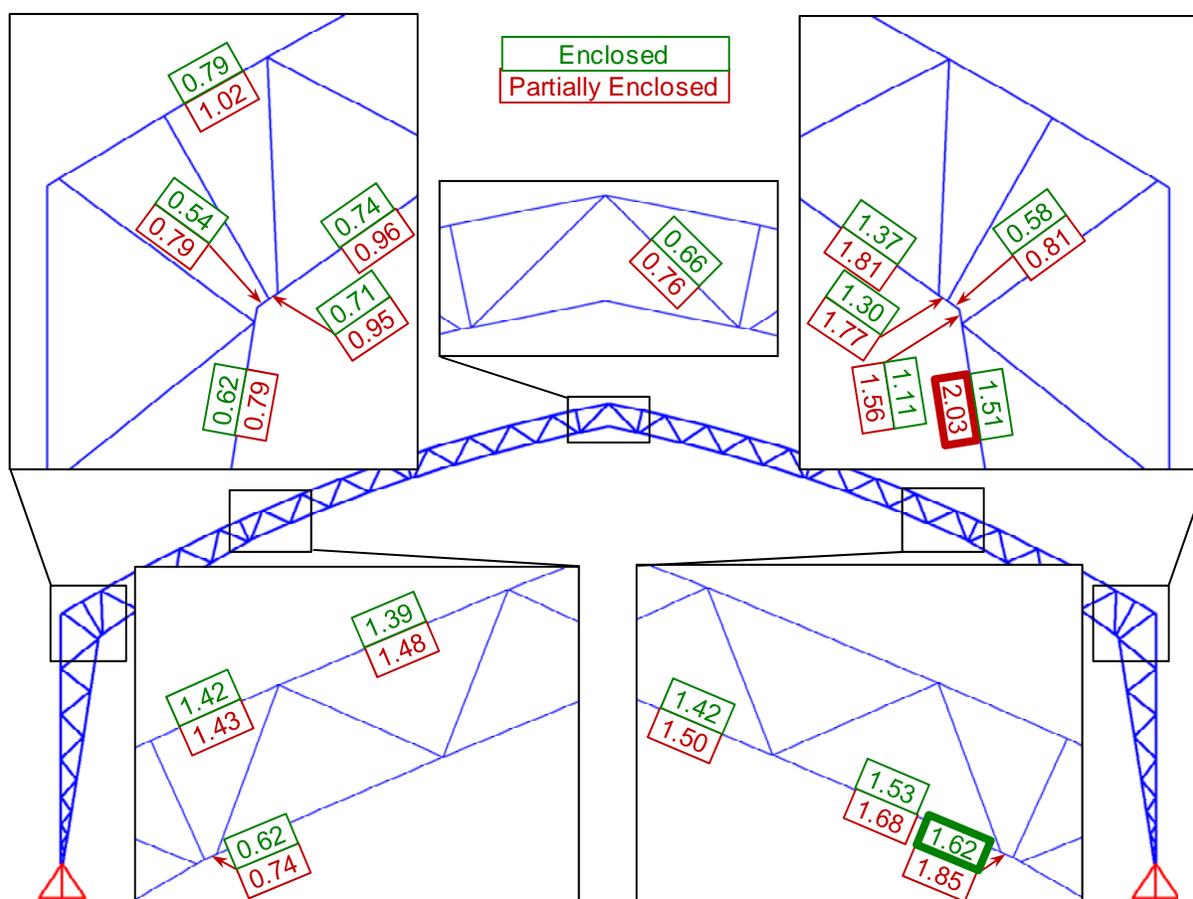
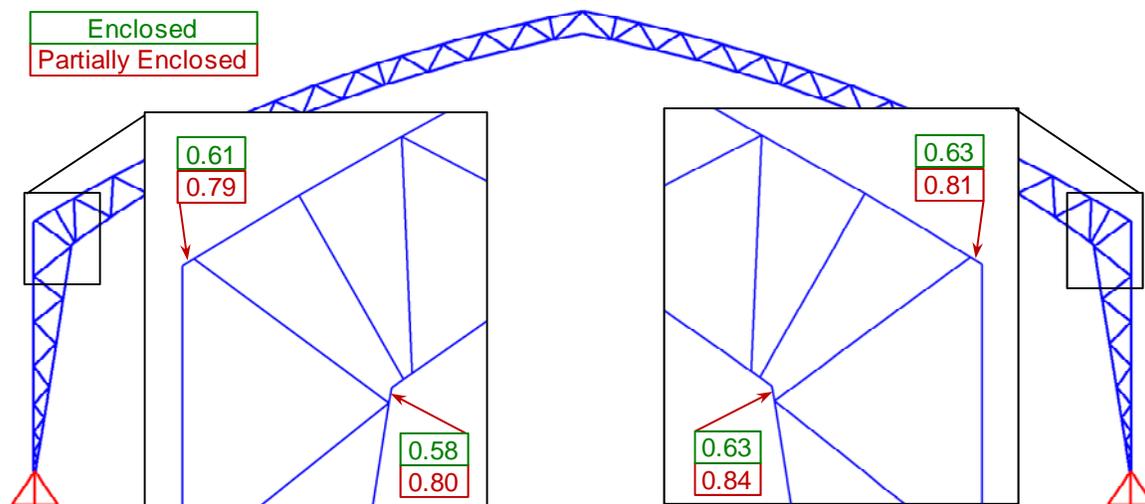
The largest values of $DCR_{P/M}$ are observed in the leg inner chord on the leeward side, with values as large as 1.62 for the enclosed condition and as large as 2.03 for the partially enclosed condition. For the enclosed condition, the largest value of $DCR_{P/M} = 1.62$ is observed in the straight inner chord 1 (see Figure 1–4) on the leeward side, and values as large as 1.51 are also observed in the inner chord at the leeward knee. For the partially enclosed condition, the largest value of $DCR_{P/M} = 2.03$ is observed in the inner chord at the leeward knee, and values as large as 1.85 are also observed in the straight inner chord 1 on the leeward side. Values of $DCR_{P/M}$ exceeding unity are observed in a number of other locations, including the straight outer chord 1 (see Figure 1–4) on the windward side and the windward knee region (only for the partially enclosed condition). These DCR values exceeding unity indicate that some members were not capable of resisting wind loads corresponding to an estimated wind speed of 60 mph normal to the ridge. The failures observed in the field (discussed in Chapter 3) are consistent with the locations in which large DCR values are observed in Figure 5–11 and Figure 5–12.

Figure 5–11 Unfactored $DCR_{P/M}$ values for 60 mph wind normal to ridge (wind from left)

Figure 5–12 Unfactored DCR_v values with 60 mph wind normal to ridge (wind from left)
