BUILDING SCIENCE SERIES 40

Engineering Aspects of the 1971 San Fernando Earthquake

This report presents the observations of the NBS on-site inspection team (most photographs in this report were taken by the team). The material presented herein is intended to serve as (1) a documentation of damage resulting from the earthquake and (2) as a source document for further studies, research, and recommendations. This is particularly important as necessary remedial work and restoration have resulted in the removal of evidence that is essential for studies and evaluations.

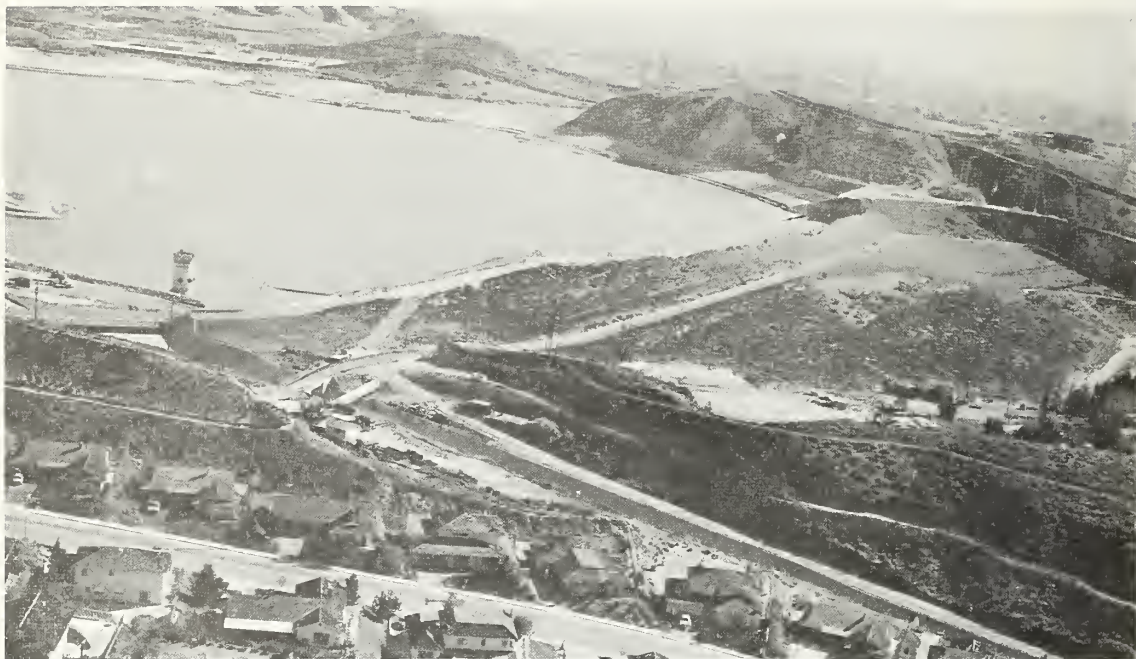
Aerial views of the Lower Van Norman Dam taken after several days of pumping to lower the level are given in figures 4.4, 4.5, 4.6 and 4.7. Figure 4.4 is a view of the Lower San Fernando Dam taken from downstream and clearly indicates the degree of collapse of the main fill over a great portion of the width of the dam. Water level was almost at the height of the lowered crest on the right side of the dam as viewed in this photo. Figure 4.5 is a similar photo taken from upstream and shows both the collapsed concrete liner and the large number of residences in the downstream flood plain. Figure 4.6 is taken from upstream and shows a relatively close-up view of the failure near the east abutment. Original height was at the level of the roadway on the crest. Figure 4.7 shows the degree of failure of the earth dam and the concrete liner.

Figure 4.4 Lower San Fernando Dam after lowering of water level.

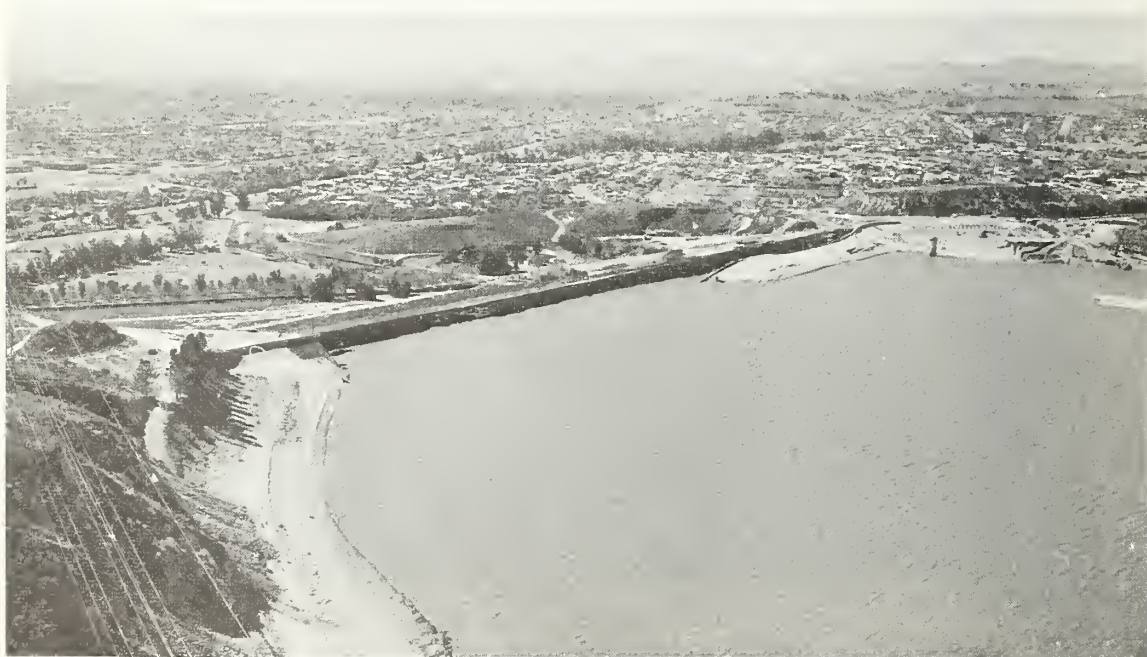
Figure 4.5 Lower San Fernando Dam and endangered residential area.

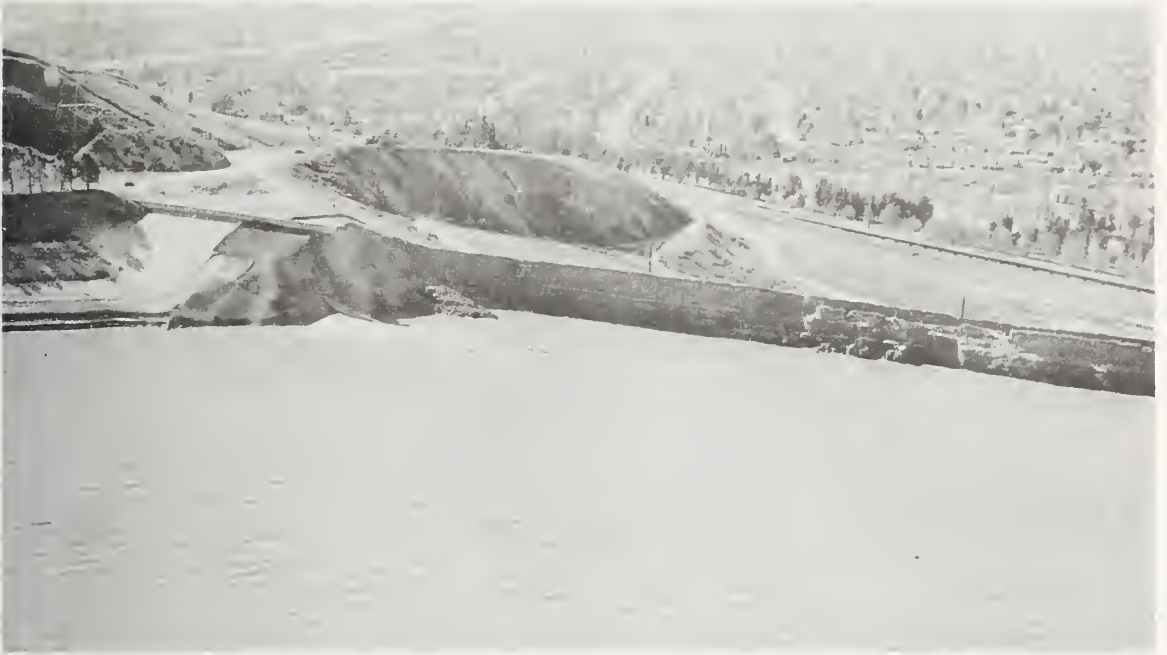
Figure 4.6 East abutment of Lower San Fernando Dam.

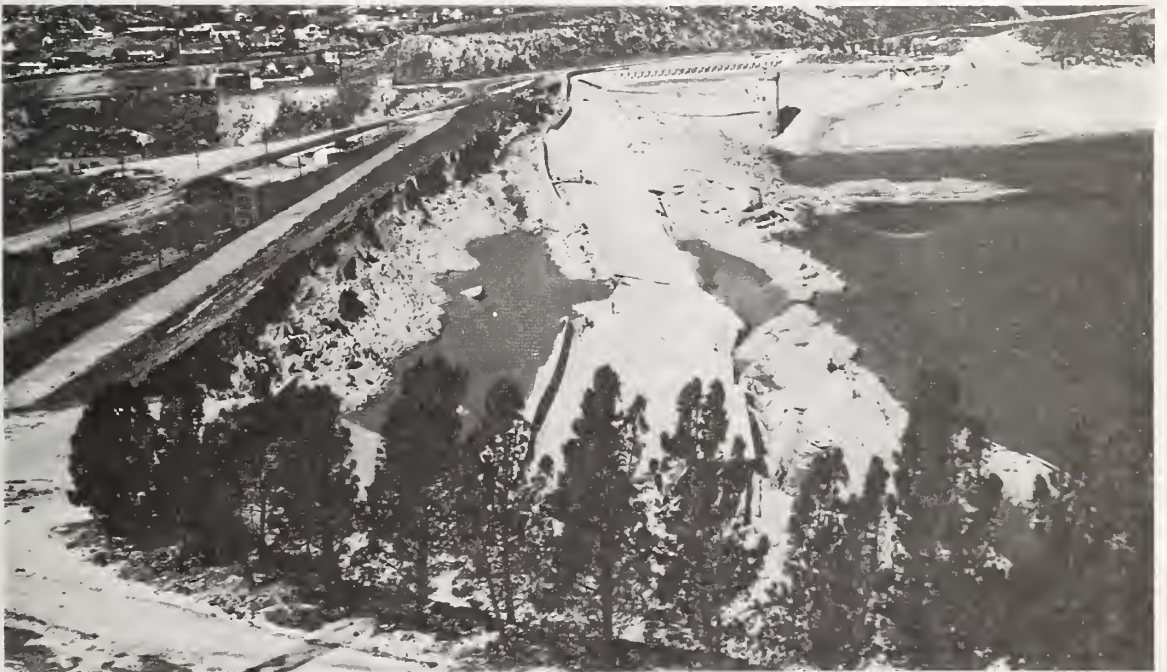
Figure 4.7 Collapsed liner of Lower San Fernando Dam.

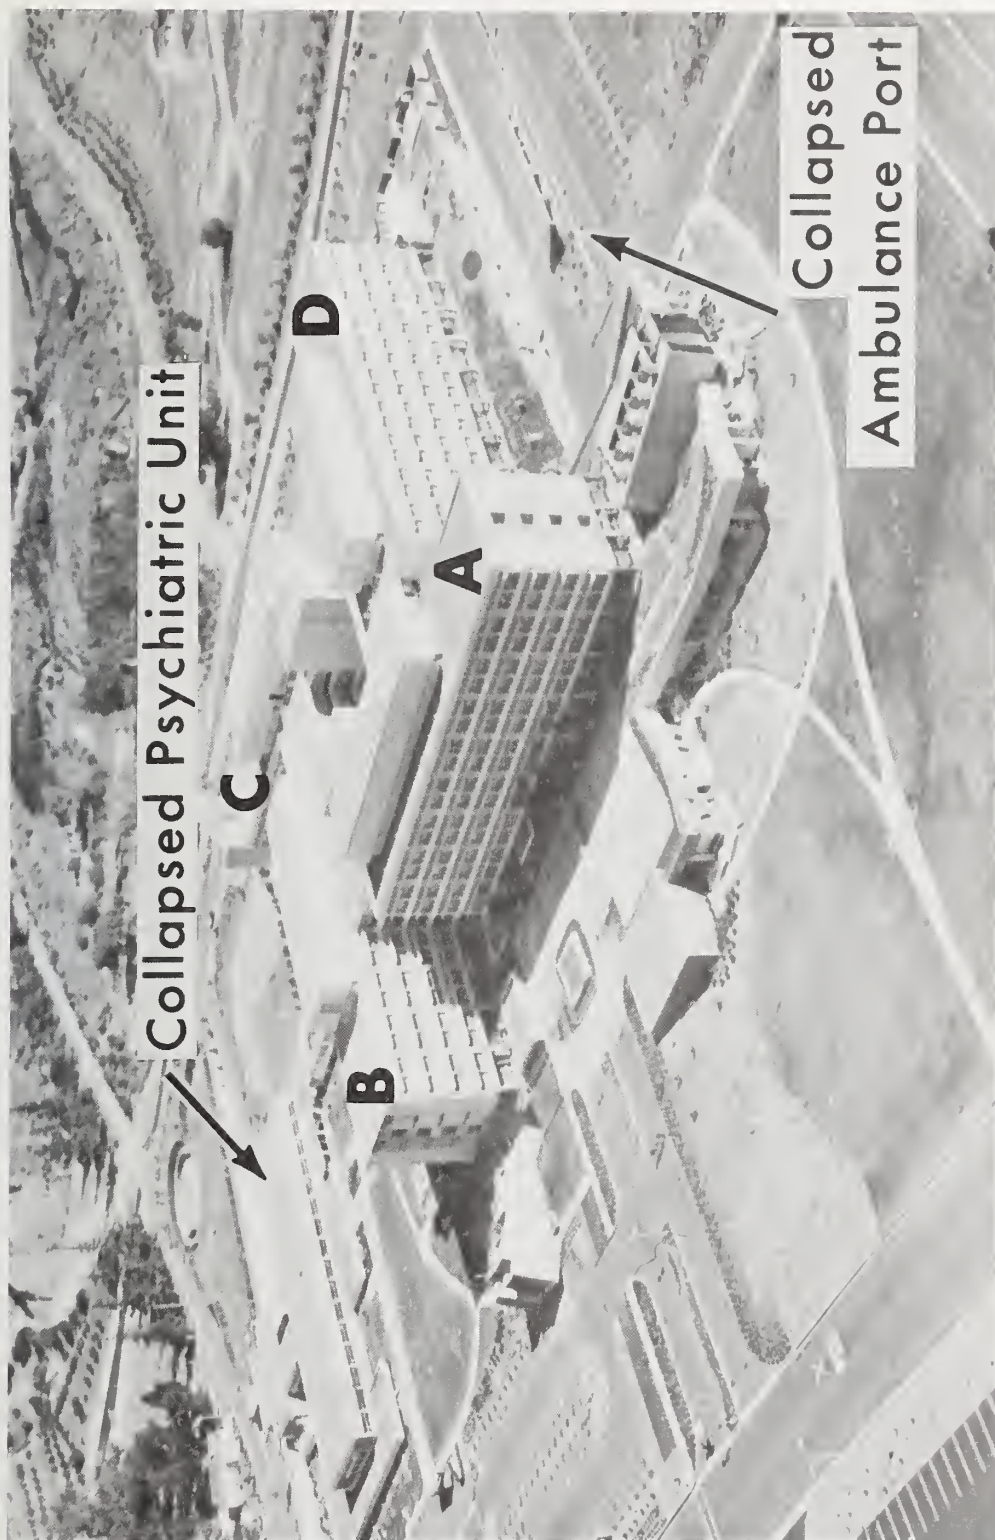
Figures 5.7 and 5.8 are photographs taken before and after the earthquake, similar to figures 5.5 and 5.6, except that the view is from the southwest. Note in figure 5.7 that the ground story is below grade on the north and most of the west sides. Close comparison of figures 5.7 and 5.8 will show that the first story of the psychiatric unit collapsed so that the building now appears to be one rather than two stories in height. Note also the collapsed ambulance port south of wing D.

Figure 5.8 Olive View Medical Center after the earthquake, as viewed from the southwest.

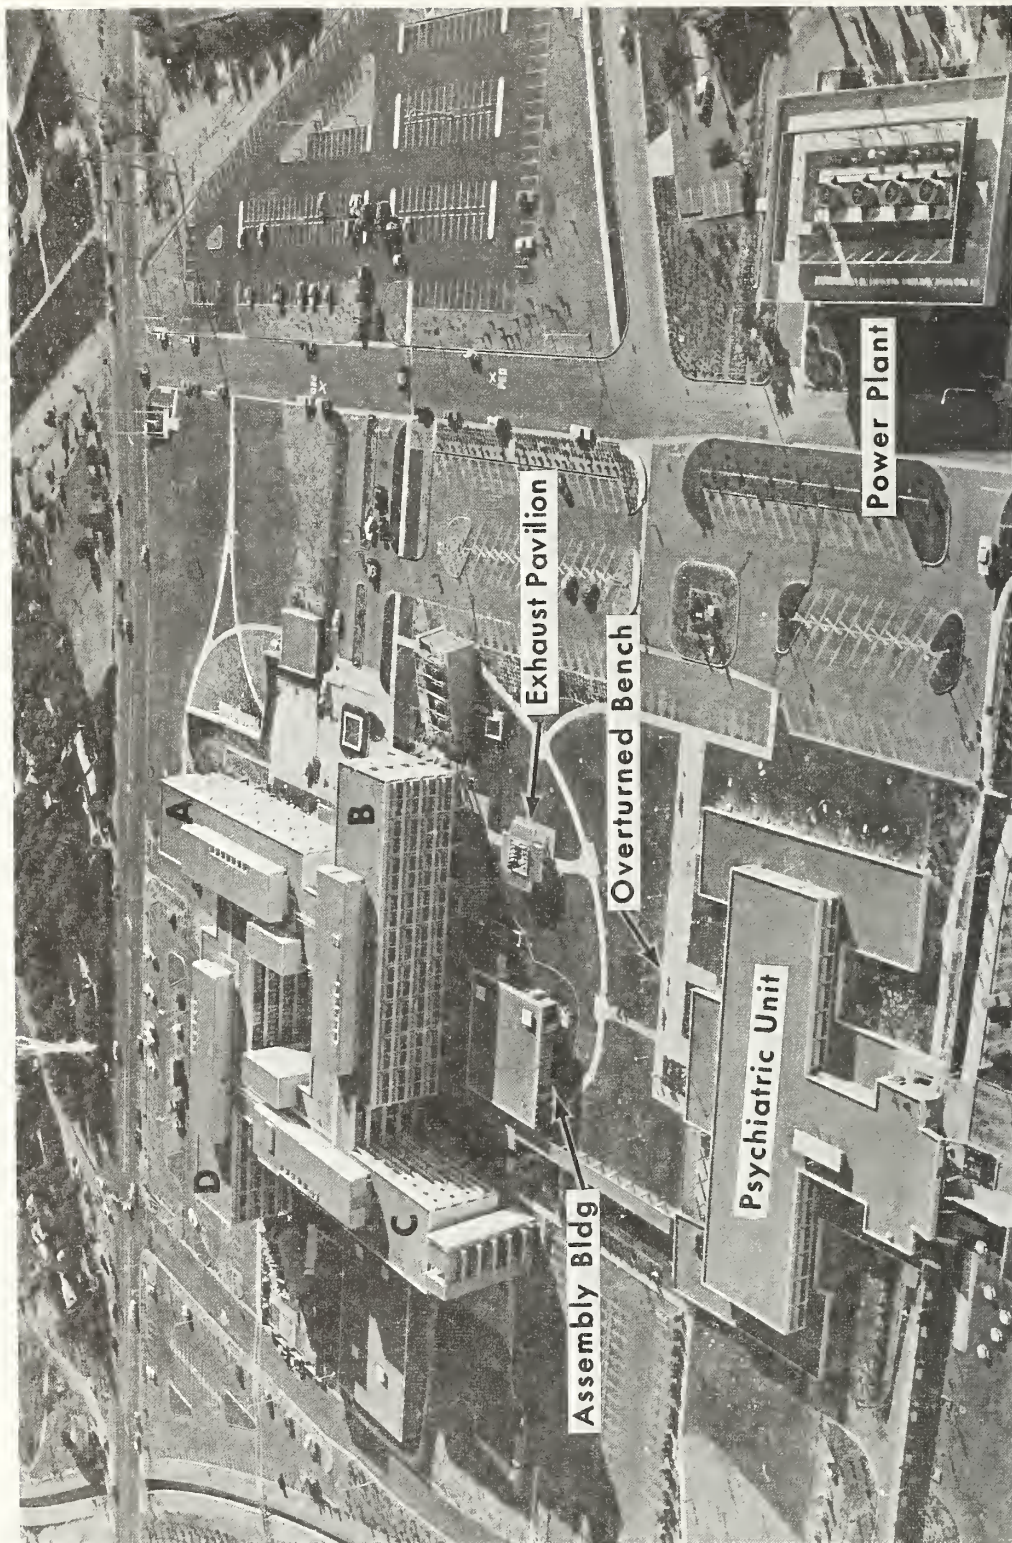
A photograph of the Medical Center as viewed from the north is shown in figure 5.9. The tipped stair tower at the end of wing C is clearly visible in this photograph. The psychiatric unit, the assembly building, the exhaust pavilion, and the power plant are also shown.

Figure 5.9 Olive View Medical Center as viewed from the north. The Psychiatric Unit which was originally a two-story structure collapsed and now appears to be a one-story building. (Los Angeles Times Photo)

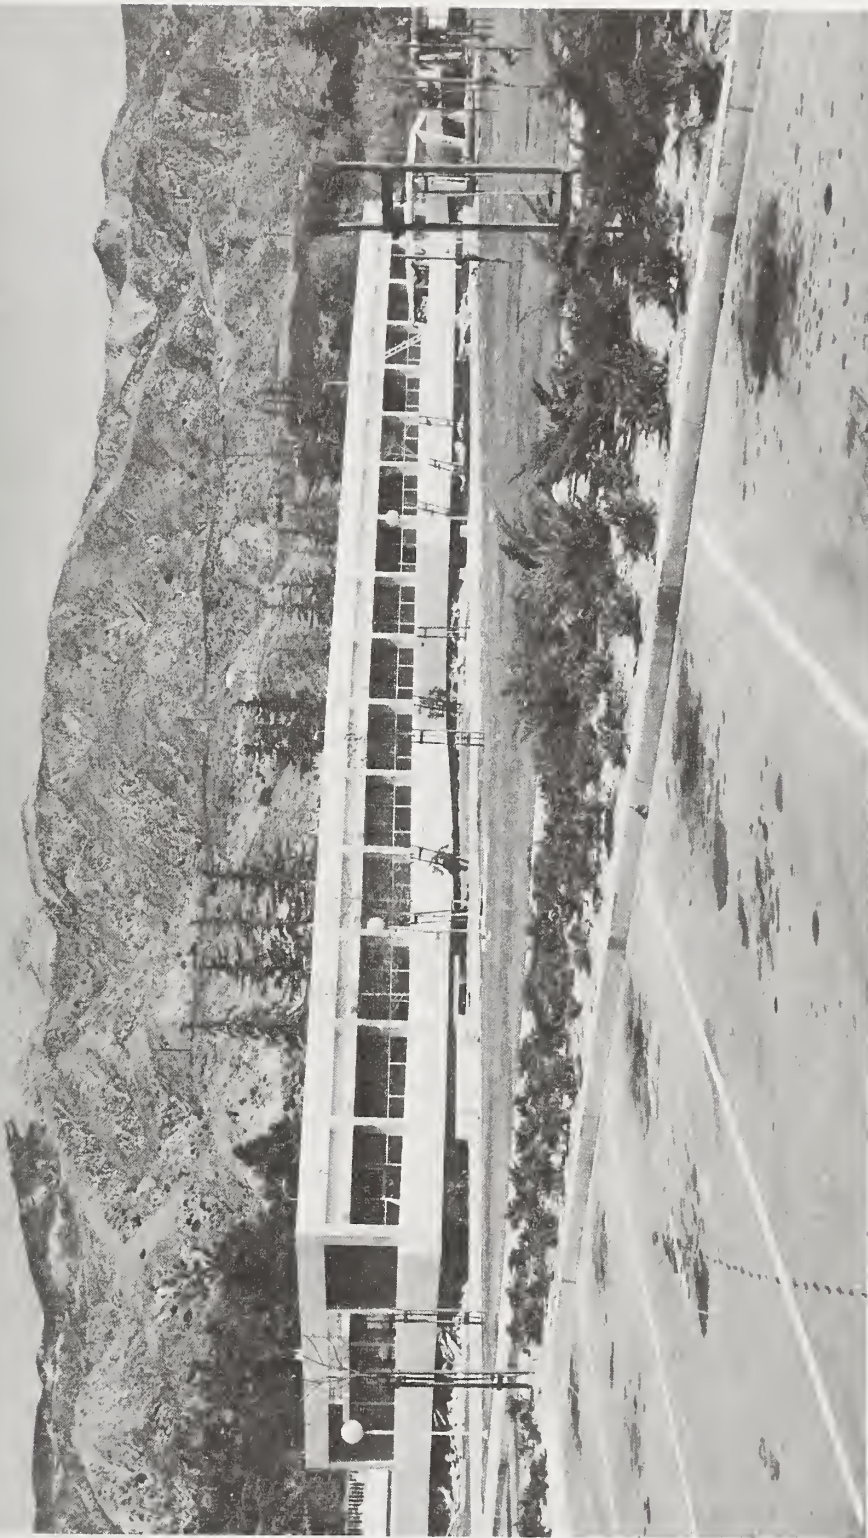
Psychiatric Unit - A photograph taken of the collapsed psychiatric unit, as viewed from the southwest, is shown in figure 5.10. As previously indicated and shown in figure 5.7, this was originally a two-story building. A plan view of the unit is shown in figure 5.11.

Figure 5.10 South and west elevations of the Psychiatric Unit. The ground story of this building was totally collapsed. What appears to be the ground floor was the first floor of this building.

The appearance of the structure after failure indicated that the columns shattered totally and pieces of lightweight concrete were hurled appreciable distances. All signs point to shear and compression failures which give virtually no ductility and so the advantages of nonlinear action and large amounts of damping in diminishing the magnitude of lateral forces are minimized.

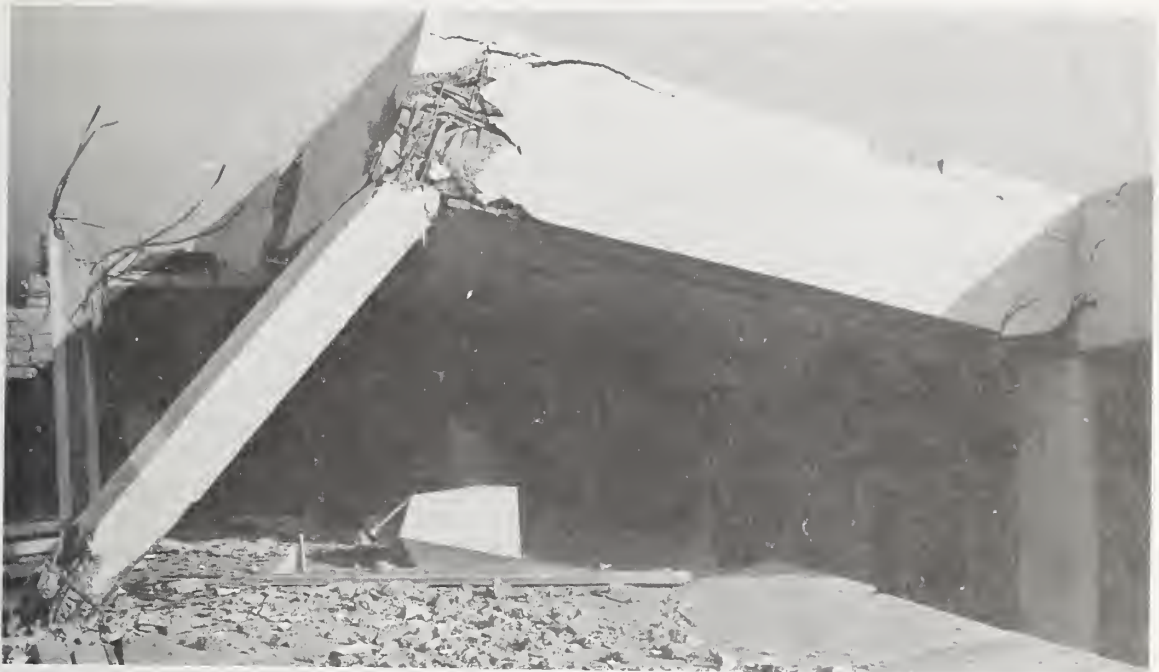
Figure 5.13 *Damage to the canopy at the front (north) entrance to the Psychiatric Unit.*

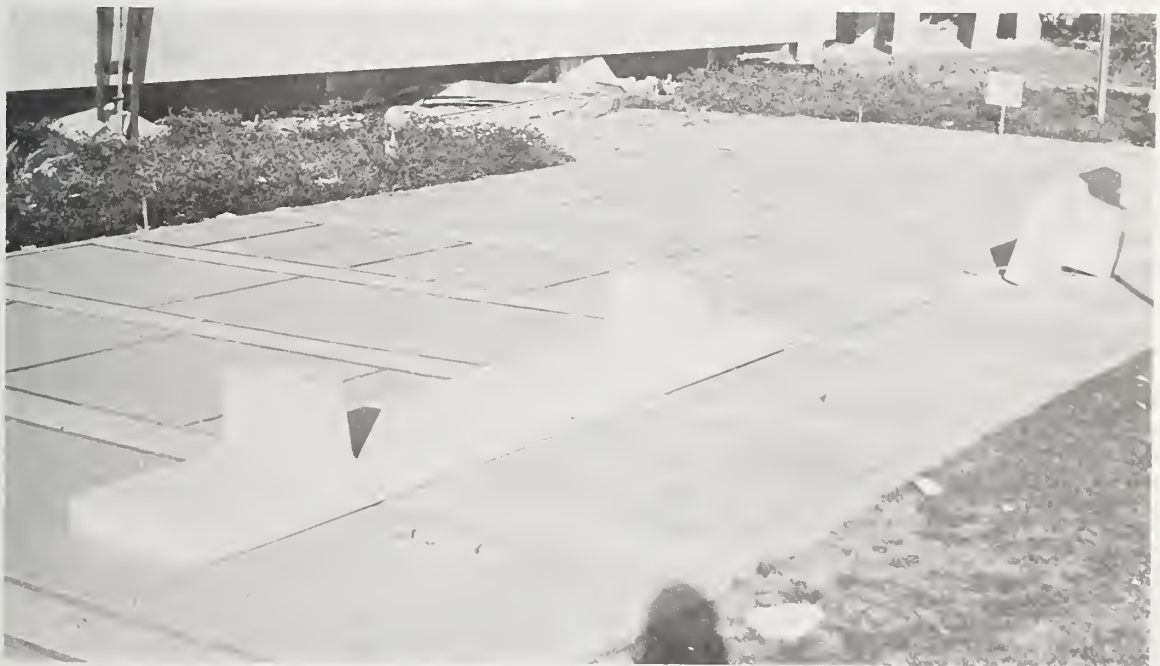
Evidence of ground motion is shown in the photograph of the west elevation of the psychiatric unit in figure 5.12. A close-up of the north entrance indicated in figure 5.12 is shown in figure 5.13. Figure 5.14 shows an overturned bench (see fig. 5.9 for location) which was bolted to the sidewalk, located south of the psychiatric unit. Calculations, which neglect the bolts, indicate that a horizontal ground acceleration of at least one-half gravity was required to overturn the bench. Similar calculations made on an overturned tombstone about three blocks south of Olive View indicated that a horizontal acceleration of one-half gravity or a horizontal acceleration of one-third gravity accompanied by a vertical acceleration of one-third gravity might have occurred in that general vicinity.

Figure 5.14 *This overturned concrete bench, which was bolted to the sidewalk, is located south of the Psychiatric Unit.*

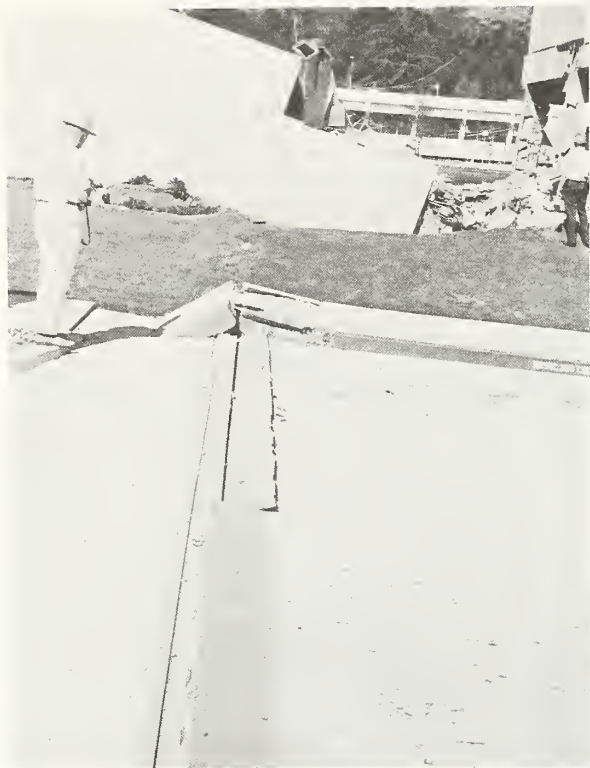
Figure 5.16 Compression ridge on the west side of the main building. A toppled stair tower is visible in the background.

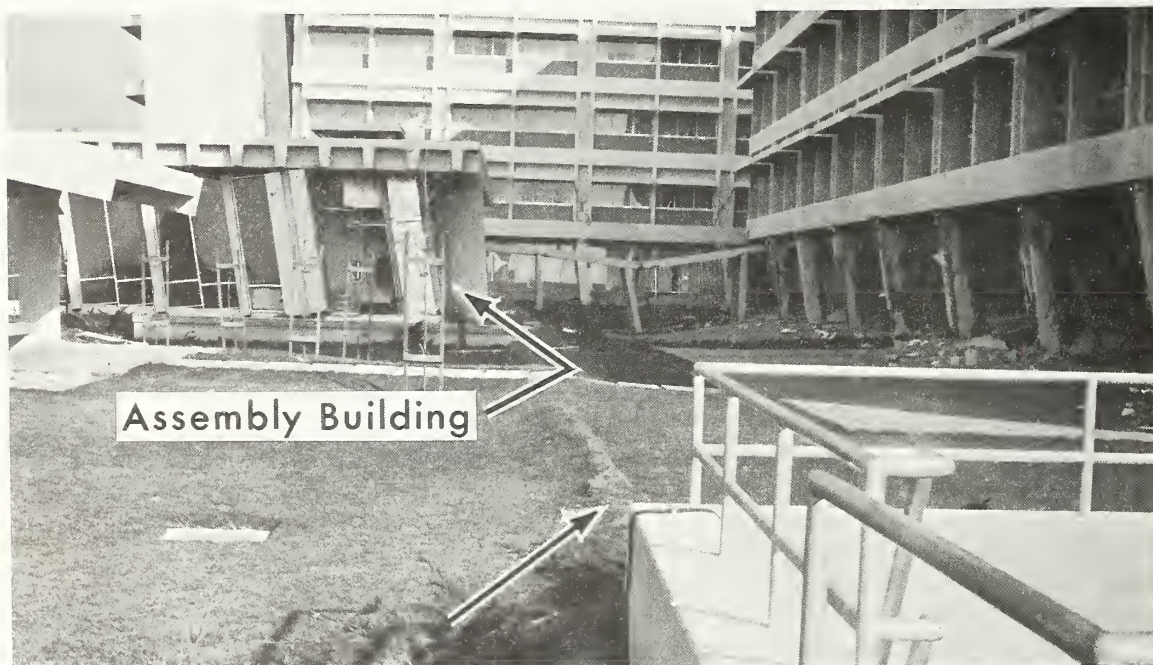
Figure 5.17 Compression ridge (arrow) on the north side of the main building.

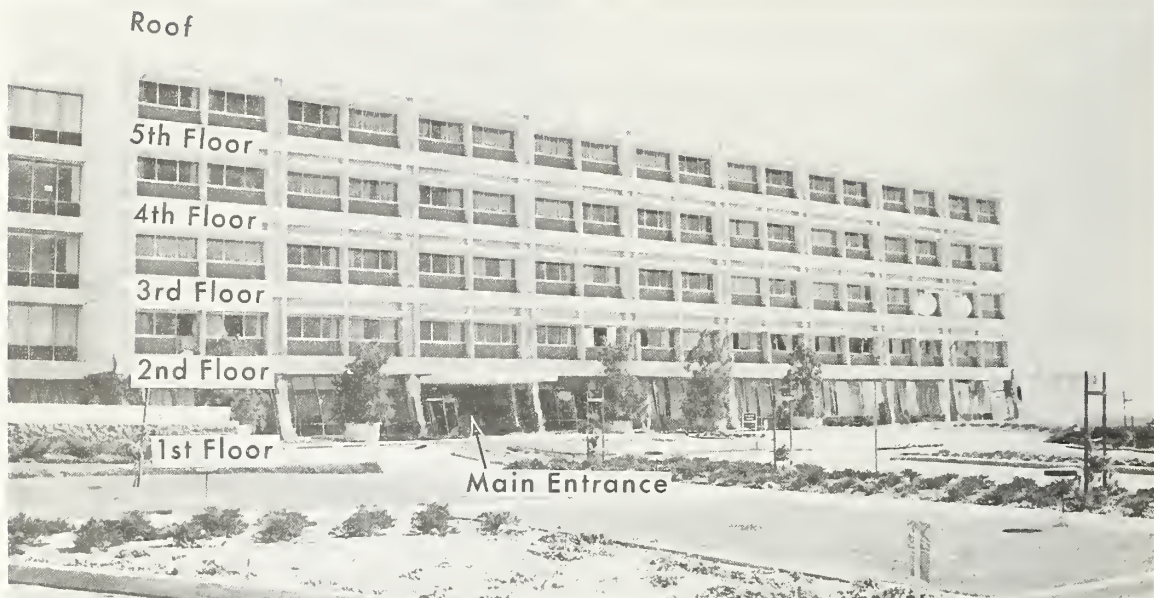
The west face of Wing A is shown in figure 5.18. This view shows the large lateral displacement of the wing to the north. Most of the displacement is in the first floor. This is shown clearly in the photograph of the main entrance in figure 5.19 (location shown in fig. 5.18).

Figure 5.18 West face of Wing A. Note the extensive damage at the first floor and the lateral displacement of the building to the north. Most glass was intact in windows above the third floor.

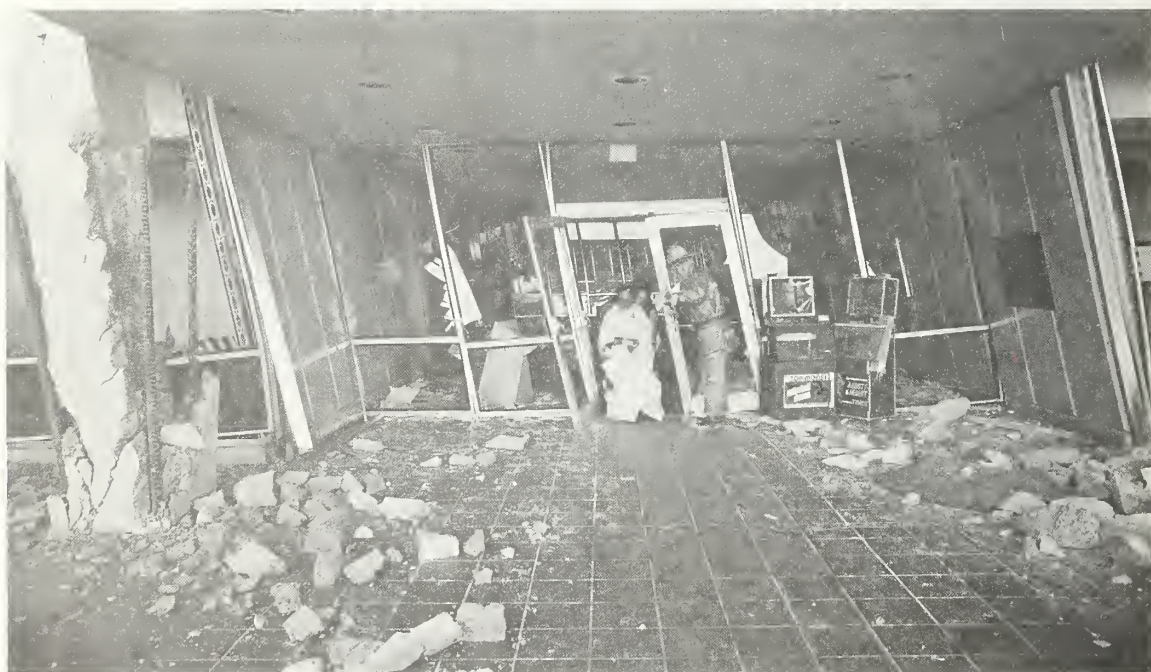
Figure 5.19 Patient evacuation through the main entrance of Wing A. (Los Angeles Times Photo)

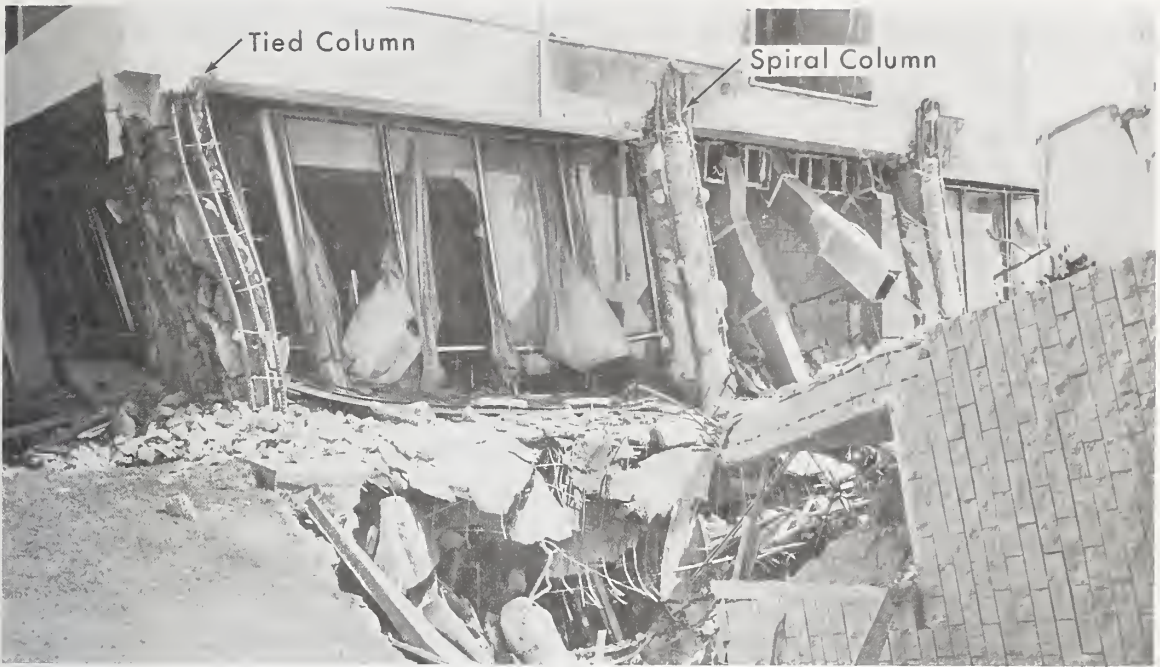
A typical first-story tied corner column is shown in figure 5.20. Note that this column was completely shattered and incapable of resisting load. Vertical bars in some similar columns actually fractured as shown in figure 5.21. On the other hand the spiral columns shown in figure 5.20, although having undergone tremendous lateral displacements, were still capable of carrying load. However, it is doubtful that they could have withstood much more strong ground motion.

The corner column in figure 5.20 had a design shear of 75 kips in the east-west direction and 108 kips for shear in the north-south direction for building code lateral force values. The L-shaped column has about 880 sq in of area and probably 800 sq in effective for shear. The tie spacing of No. 3 bars at 18 in is so large that the ties cannot count as shear reinforcement. This means the shear stresses in the north-south direction are approximately 135 psi and in the east-west direction 93 psi. These have a vector sum of approximately 160 psi. This shear stress would compare to the 1956 ACI allowable value (without a 33 percent overload allowance) of 90 psi, and 1963 ACI Code allowable value of approximately 80 psi for working stress and approximately 120 psi for the ultimate shear stress of 5000 psi concrete. This is based on the relatively low code acceleration coefficient of about 8 percent which was used in design. This indicates that this column was on the borderline of adequacy under the then existing Los Angeles County Code requirements and would be inadequate if biaxial shear effects are considered. There is no mention in the code of such biaxial shear effects. When the more restrictive 1963 ACI Code shear provisions are considered, the column would be clearly insufficient for the design lateral forces. Had the County Code been revised to include the 1963 ACI Code provision, additional lateral reinforcement would have been clearly required in this column.

Figure 5.20 West end of Wing B. Note the contorted column and the extent of the northward drift of the building. In the right foreground is the base of the toppled stair tower. Note that this stair tower has collapsed through the roof of the ground story.

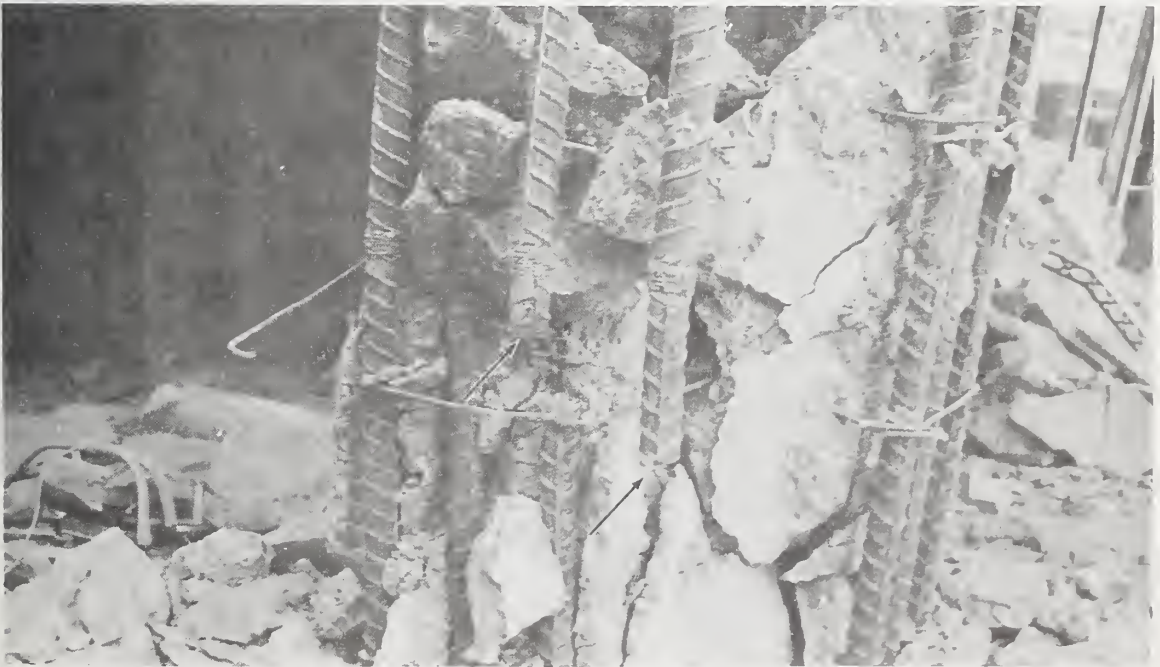
Figure 5.21 Close-up view of the first story column in the northeast corner of Wing B. Note the two fractured main reinforcing bars (arrows) and broken ties.

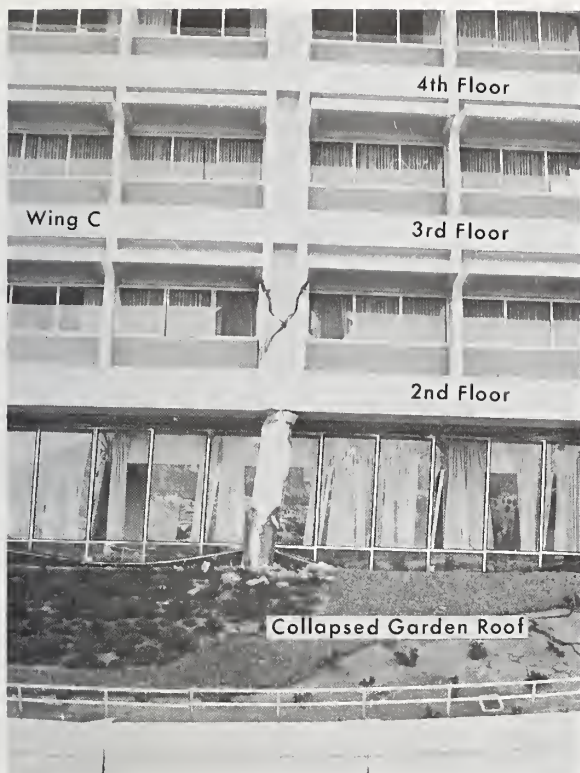
The east face of Wing C is shown in figure 5.22. Again the lateral displacement of the building to the north in the first floor can be seen. Note the diagonal cracking in the second-story C-shaped columns which indicates that the column was subjected to load reversal.

What appears to be an embankment in the foreground of figure 5.22 is actually a collapsed garden roof. This type of failure is shown more clearly in figure 5.23, the south face of Wing D. The garden roof which is an extension of the first floor, can be seen in its collapsed position. One hospital employee was killed at this location. Several protruding ground-story columns which originally supported the garden roof are indicated by arrows. A close-up view of one of the failed ground-story columns which originally supported the roof is shown in figure 5.24. A photograph of a ground-story column with the top completely stripped of reinforcement is shown in figure 5.25. The extensive column damage at the first floor is typical of column damage found at the first floor in all wings of the hospital.

Figure 5.22 A portion of the east face of Wing C. The collapse of the garden roof as well as the extensive damage of the first floor columns can be seen. Note the lateral displacement of the building to the north, in the first story and diagonal tension cracks in the second-story column.

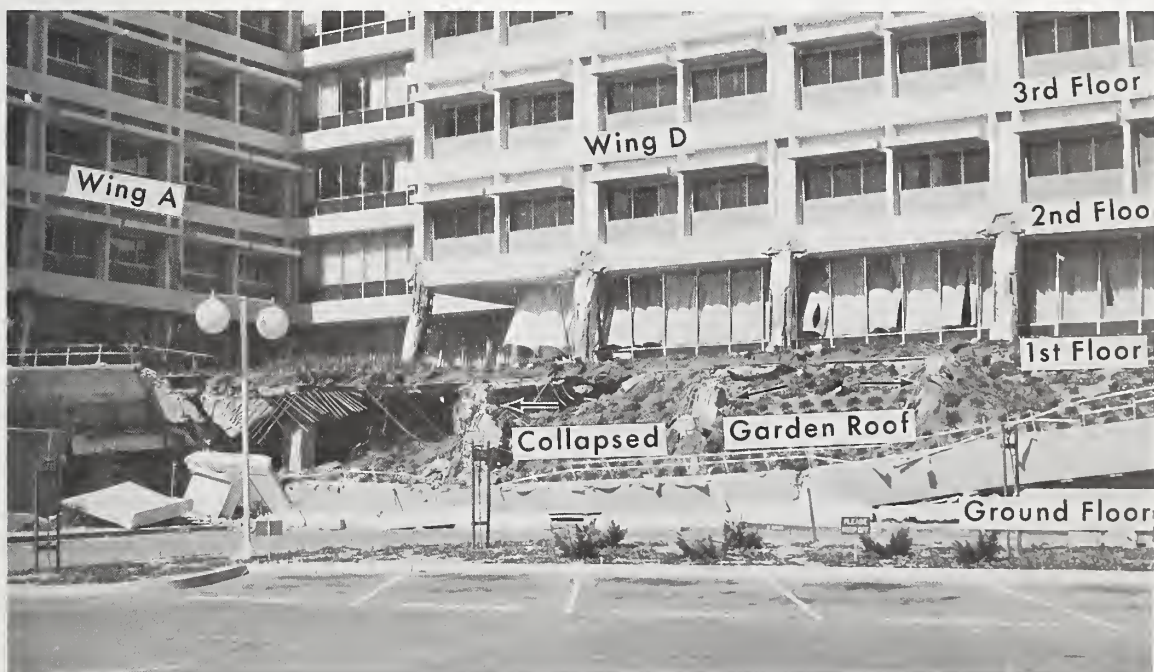
Figure 5.23 South face of Wing D. Note that the bulk of major damage suffered by the building is limited to the ground, first, and second floors.

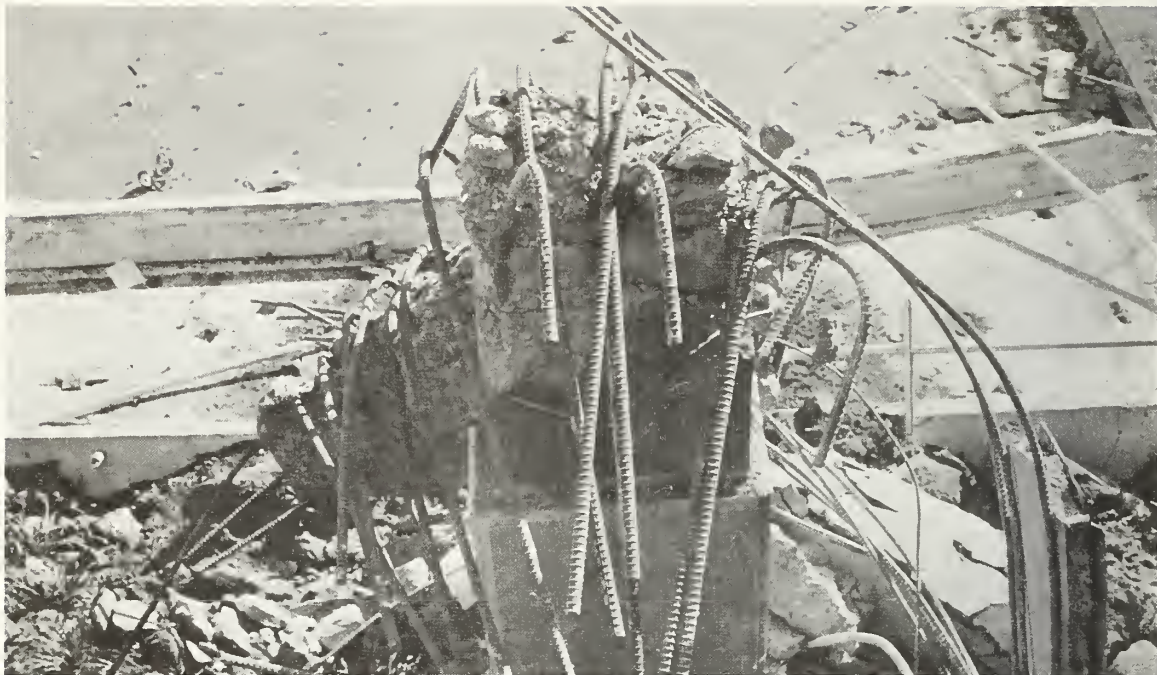
Figure 5.24 Close-up view (looking south) of one of the failed ground-story columns which originally supported the first-floor garden roof in front of Wing D. This is the same column seen in figure 5.23, the third from the right.

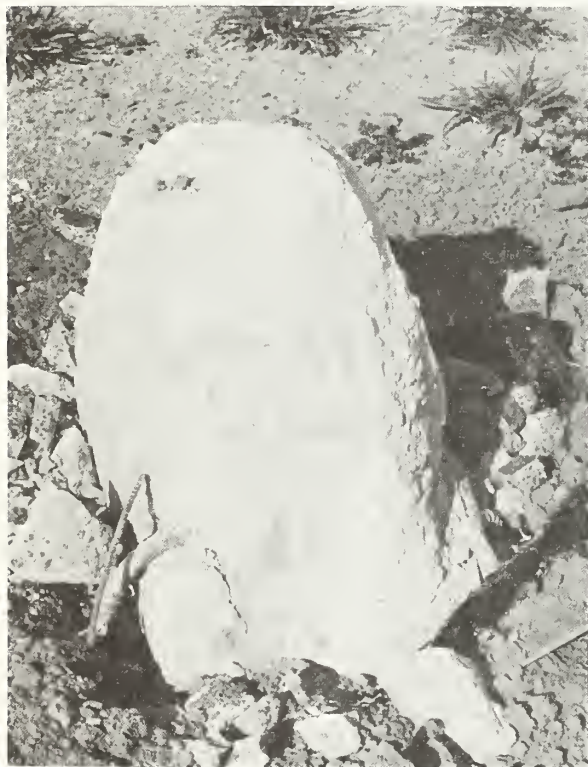
Figure 5.25 A column protruding through the garden roof at the far east end in front of Wing D. Note that in this failure the reinforcement has been completely peeled away from the upper end of the column.

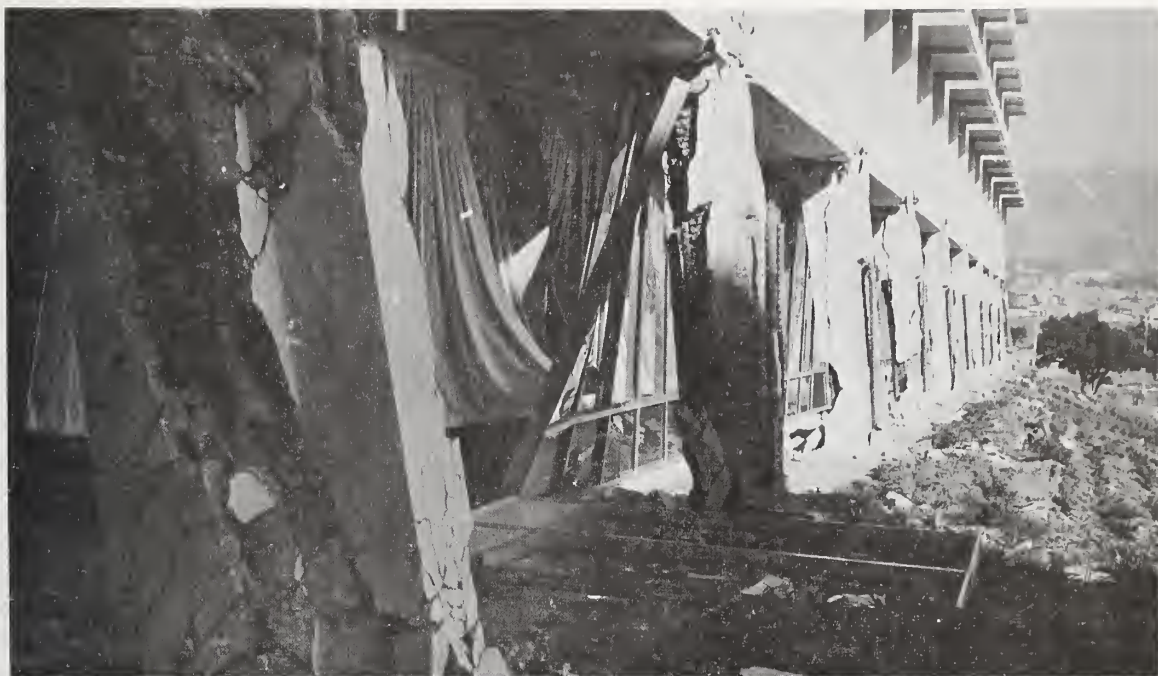
The south row of first-story columns in Wing D is shown in figure 5.26. The first column to the left is the L-shaped corner column. The remaining columns immediately visible to the right are spiral columns with a No. 18 bar in each corner running about two-thirds of the way up the column height. These bars, which are continued from the story below, have broken out of the column corners. These bars were not confined by spirals or ties, contrary to code requirements.

Figure 5.26 South row of first story columns, in Wing D; note the lack of ties on the corner bars which have broken out of the columns.

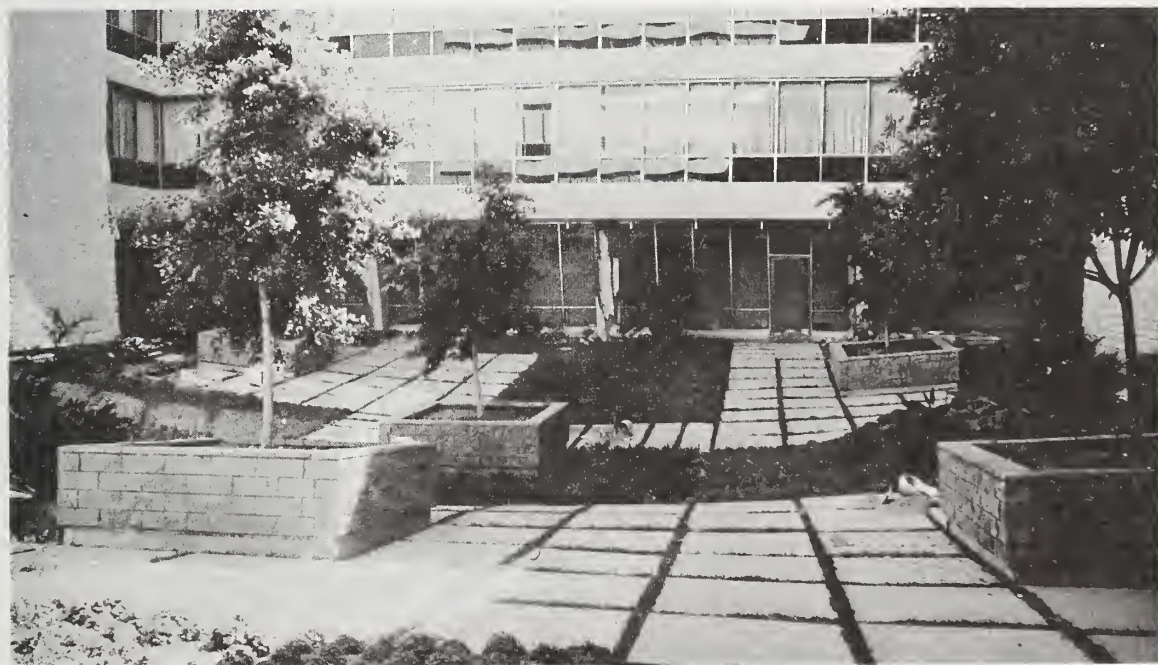
The enclosed first-floor court formed by the four hospital wings, is shown in figure 5.27. The sagging of the court was caused by failure of the ground-story columns. Other interior photographs are shown in figures 5.28, 5.29 and 5.30.

Figure 5.27 Enclosed court at the first floor level. The sagging court was caused by failure of the ground-story columns.

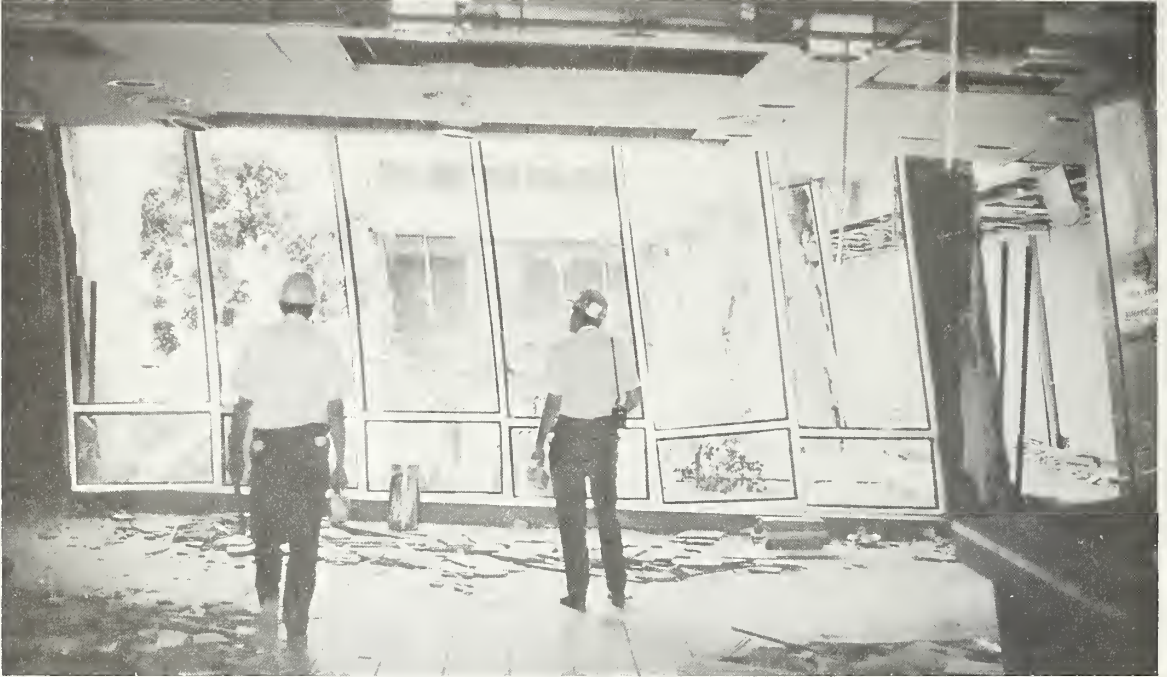
Figure 5.28 Damaged main lobby in Wing A. Note the window mullion distortion. The planted area seen through the window is a court enclosed by the four wings.

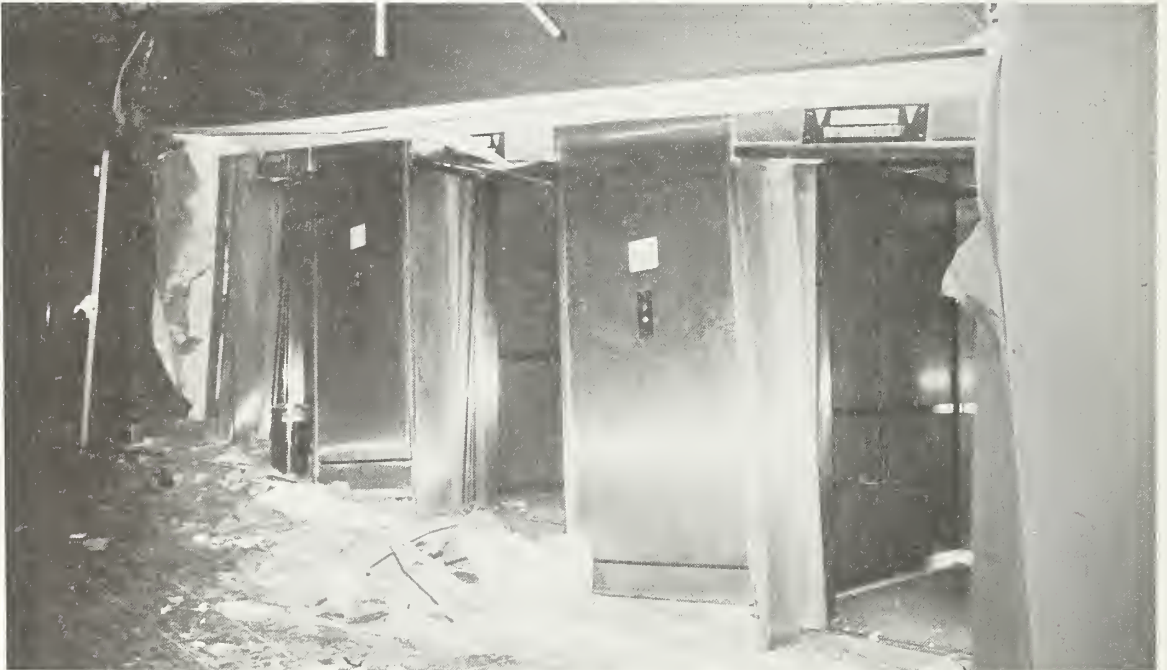
Figure 5.29 Damaged elevators in the Wing A lobby.

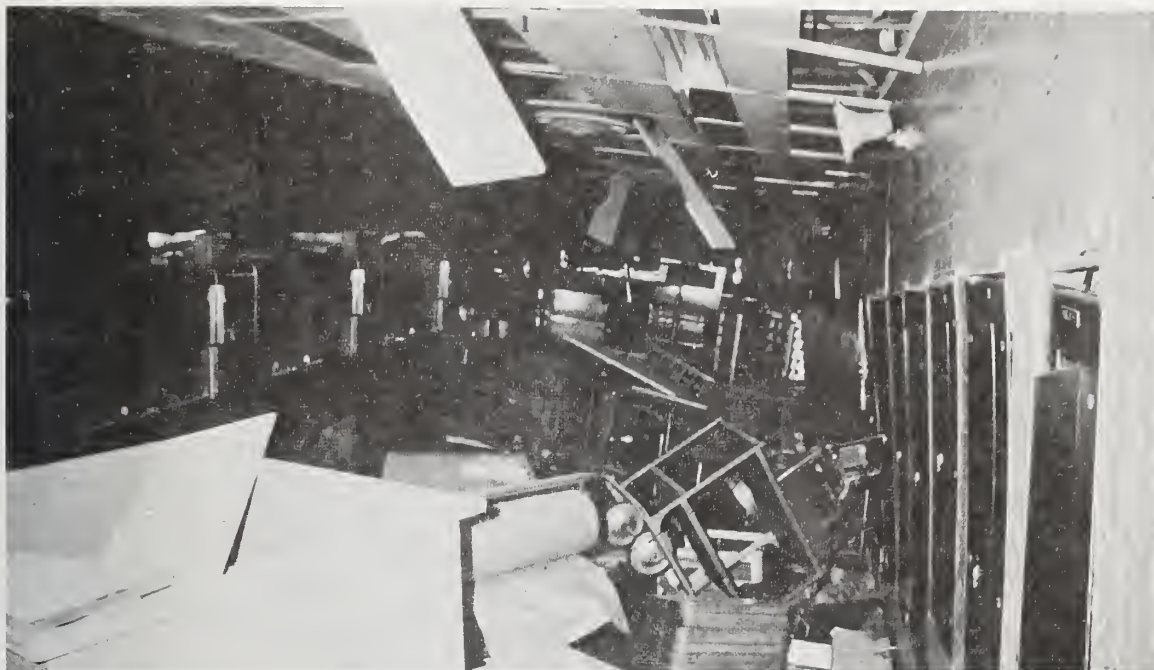
Figure 5.30 Violent shaking of the building left the ground floor hospital kitchen in shambles.
