BUILDING SCIENCE SERIES 40

Engineering Aspects of the 1971 San Fernando Earthquake

This report presents the observations of the NBS on-site inspection team (most photographs in this report were taken by the team). The material presented herein is intended to serve as (1) a documentation of damage resulting from the earthquake and (2) as a source document for further studies, research, and recommendations. This is particularly important as necessary remedial work and restoration have resulted in the removal of evidence that is essential for studies and evaluations.

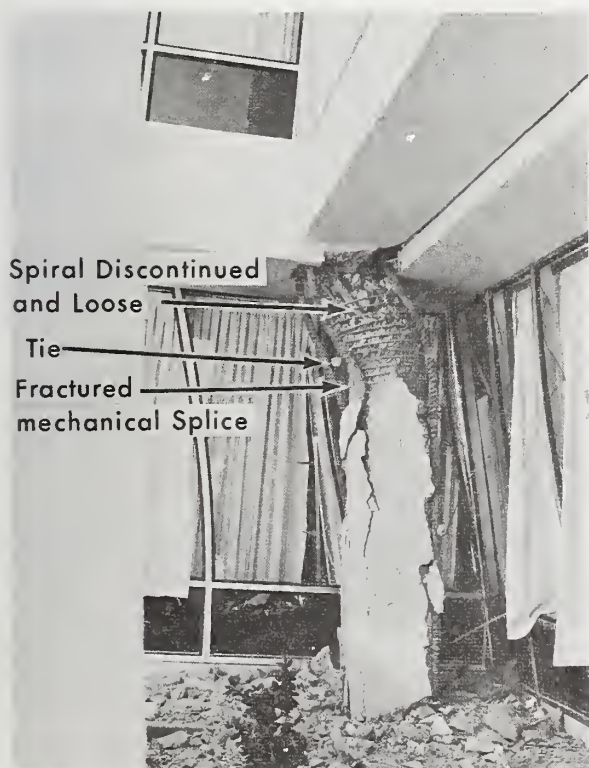
Figure 5.31 Damaged Spiral Column.

Several points are illustrated by the column shown in figure 5.31. A spiral column is basically more ductile than a tied column, but in lateral motion this ductility can only be achieved if ductility exists at the column-to-beam connection. In the connection shown, two things happened-

(1) the spiral stopped short of the connection, making it ineffective where it is needed most in lateral motion, (it should have been continued into the beam) and (2) the spiral unwound due to insufficient anchorage. Anchorage was intended to be achieved by lapping the spiral. This was not effective since the lap could not work once the covering concrete had broken away. Positive anchorage by hooks into the interior of the core is essential.

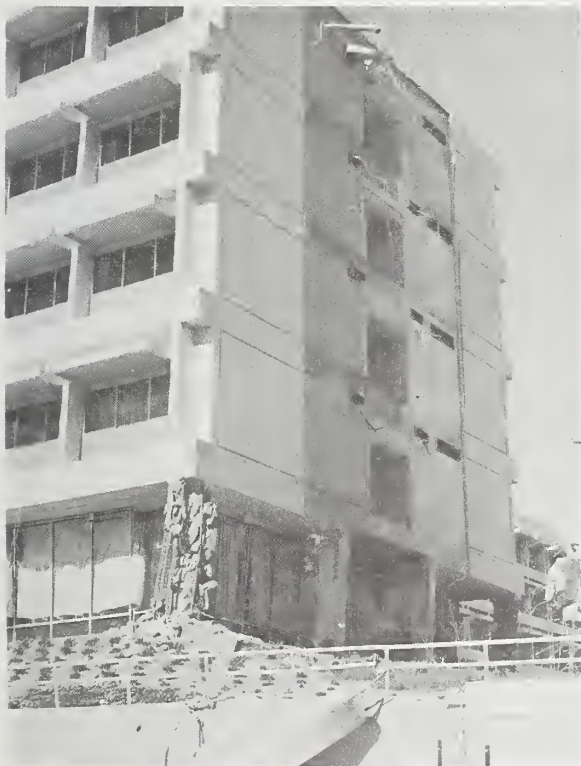
Stair towers A, B, and D overturned leaving the end of the wings exposed as shown in figure 5.33. Stair tower C, supported on footings, did not topple as is shown in figure 5.34. The overturning coefficient J was calculated as 0.557 and 0.656. Base shears were computed as 0.053 and 0.058 of the structure weight. Applying the J factor to the base shears means that the structure was designed for approximately 0.03 gravity when calculating overturning moment. All evidence indicates that accelerations at Olive View greatly exceeded this amount.

Figure 5.33 Wing D after stair tower overturned.

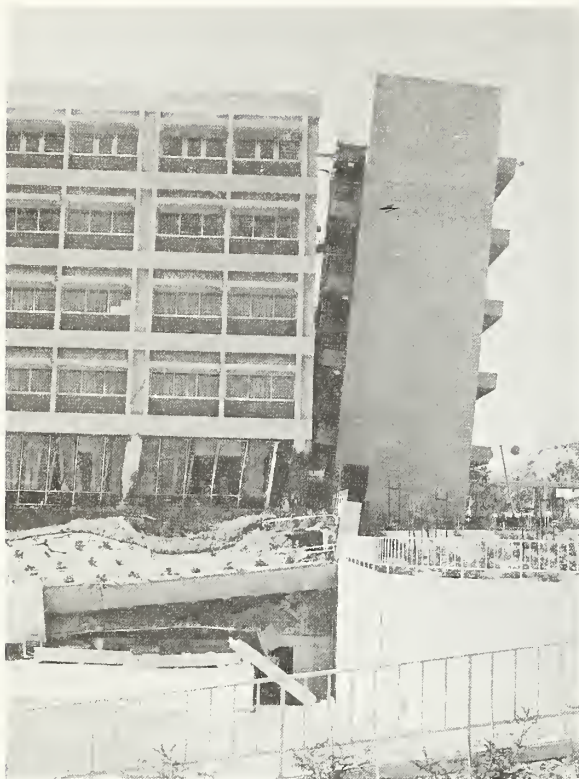
Figure 5.34 Tipped stair tower at the end of Wing C. This is the only stair tower that did not topple. This stair tower is supported directly on the foundation; whereas, the other three towers were supported on the ground-story columns.

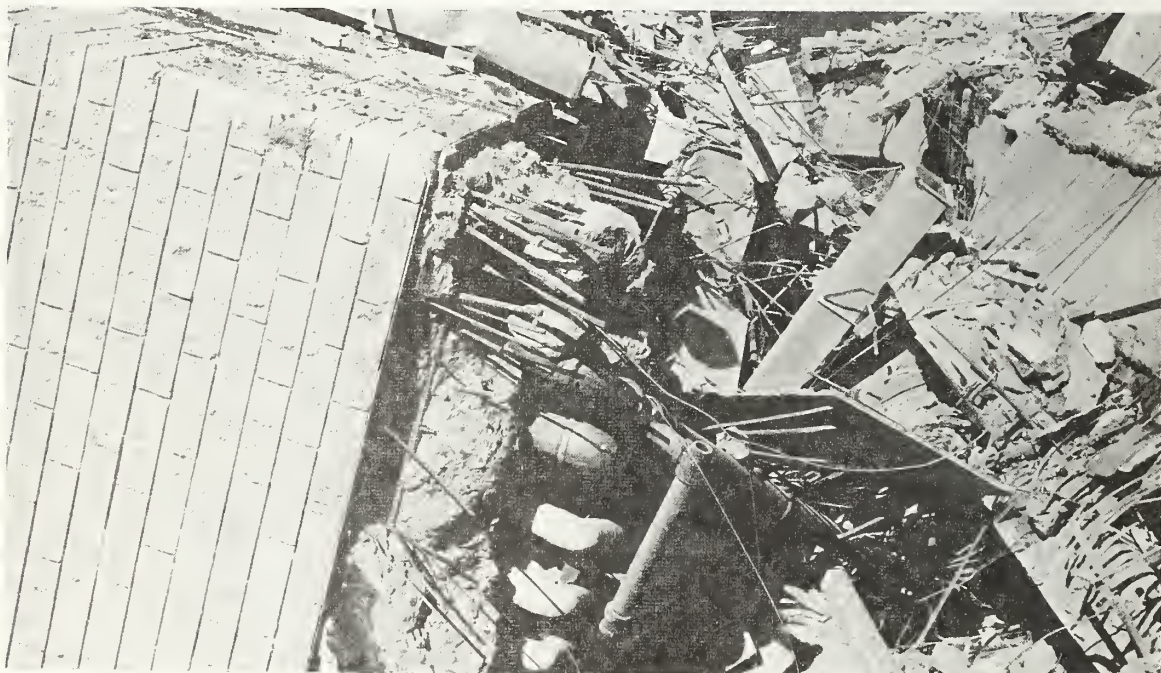
Figure 5.35 Base of stair tower B.

Examination of the base of stair tower B indicates bars which seemed to pull out of the first-floor slab (fig. 5.35). As previously indicated the stair tower walls were dowelled into the slab, which in turn was dowelled into supporting beams. These dowels were 36 in long (18 in into the walls and 18 in into the beams). The dowels matched the wall reinforcement which was usually No. 4 bars. This means that the overturning moment was resisted by No. 4 bars embedded 18 in. This is not adequate anchorage for such an important tensile tie under these load conditions.

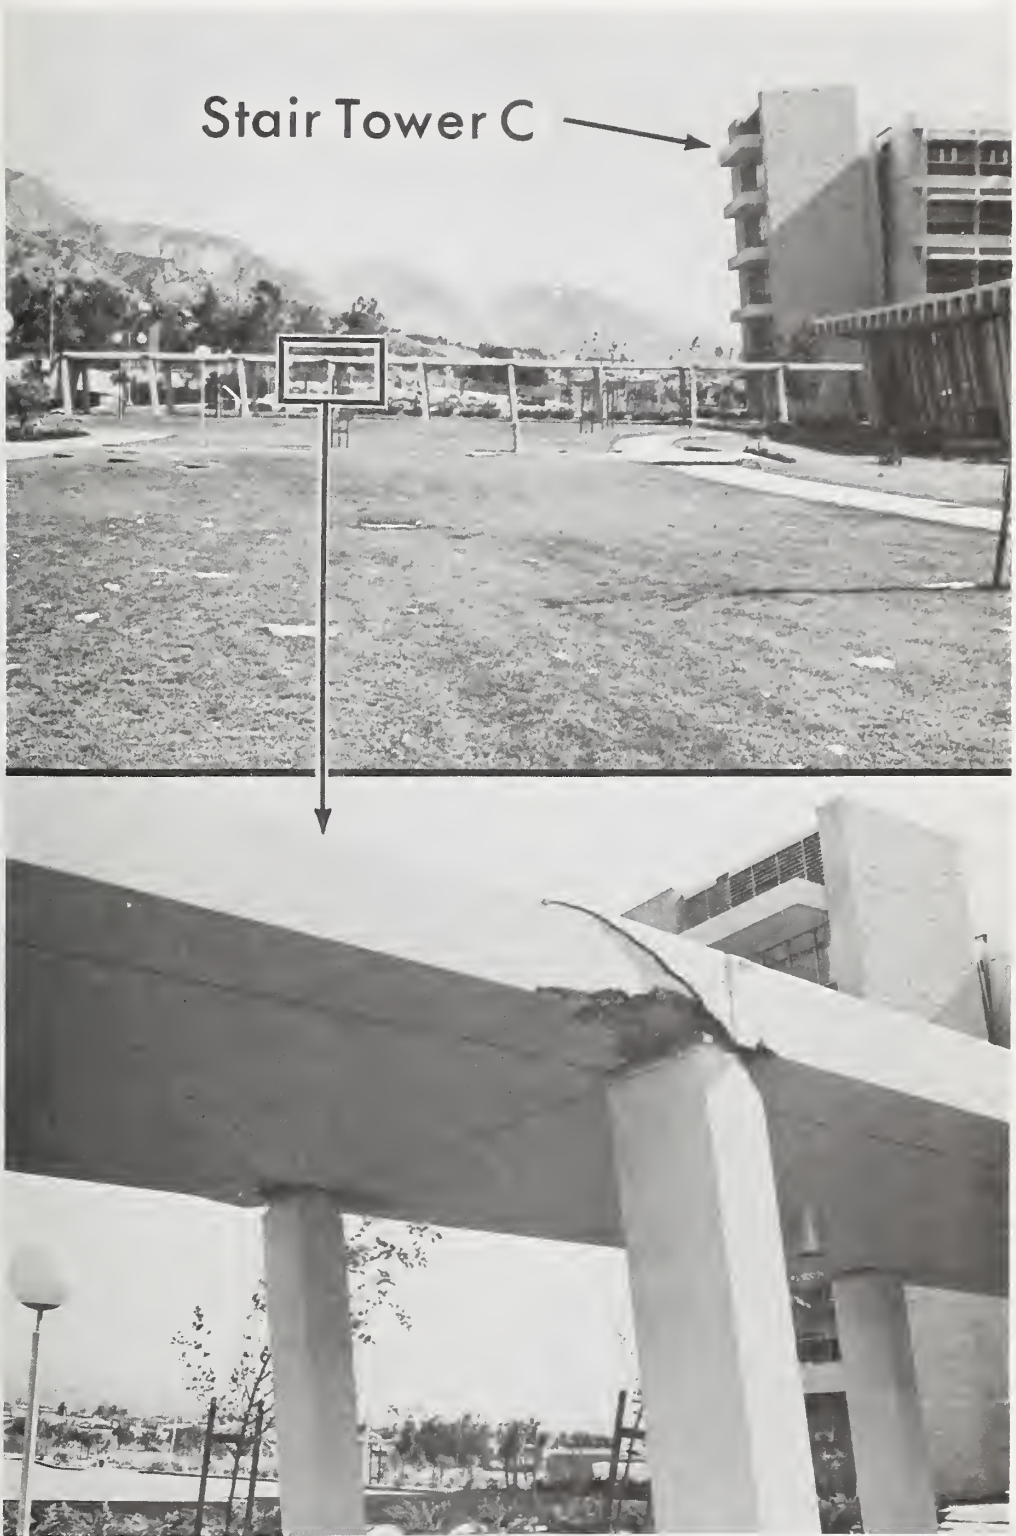
Figure 5.36 Walkway Canopy.

Canopy from Main Building to Psychiatric Unit - The canopy connecting the main building to the psychiatric unit is shown in figure 5.36; this structure was severely damaged. The canopy roof was of lightweight concrete, supported on a pair of stone aggregate concrete columns spaced 9.5 ft across the width. This pair of columns was spaced at 15 ft along the canopy length except near the assembly building. In the latter location the spacing varied. The column

reinforcing bars extended only a few inches into the canopy slab and could not offer restraint due to bending at the top of the columns.

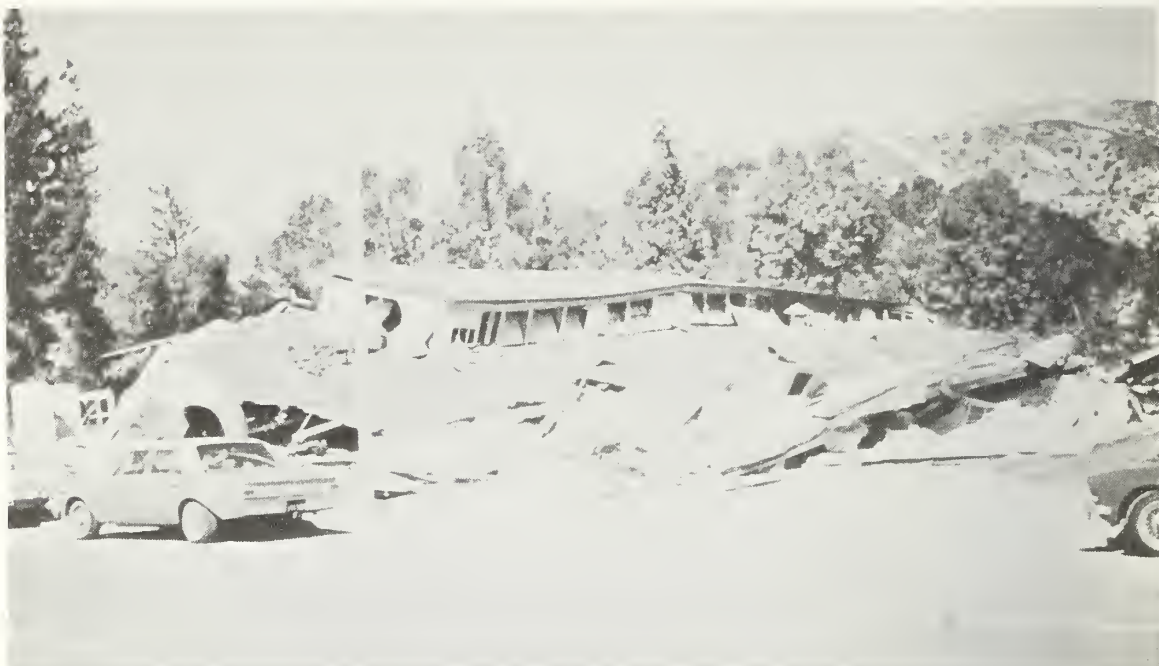
Old Buildings - There were a number of pre-1933 buildings in the old section of the Olive View complex. Many of these buildings were either totally collapsed or severely damaged. Figure 5.40a shows a completely collapsed old brick-wall building and figure 5.40b shows a severely damaged wood-frame house.

Figure 5.40a Totally collapsed old brick building at the old section of the Olive View Medical Center. The building was not designed to resist earthquake forces.

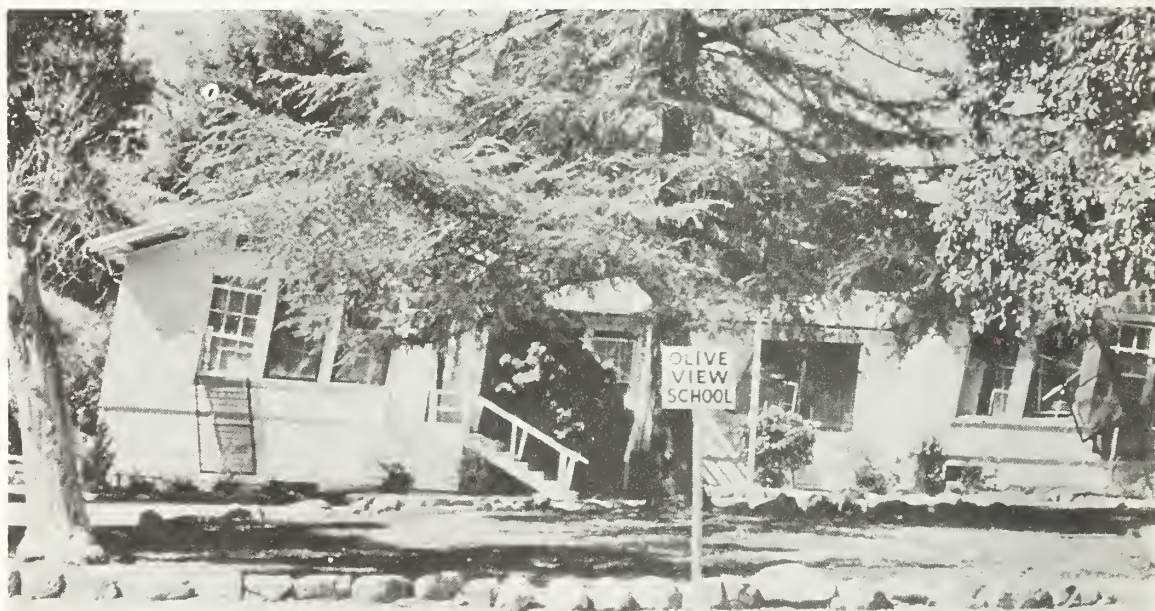
Figure 5.40b Severely damaged pre-1933 wood-frame structure at the old section of the Olive View Medical Center.

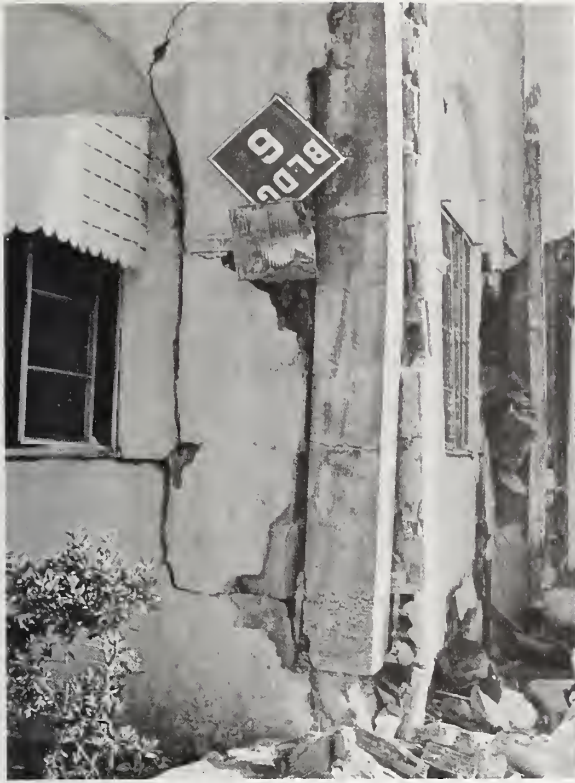
Figure 5.49 Detailed view of one of damaged reinforced concrete columns. Exterior walls were unreinforced clay tile and stucco.

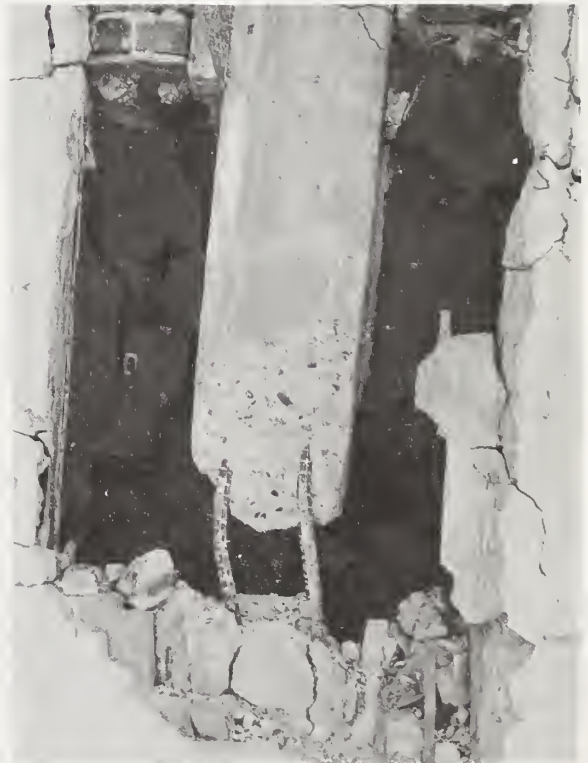
Figure 5.50 Close-up view of one of many damaged columns in Building 6. Note a lack of ties around the exposed square reinforcing bars.

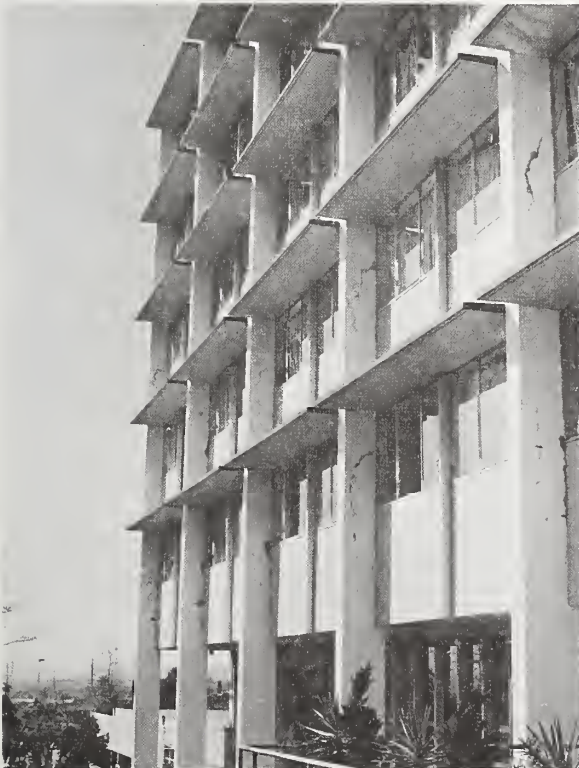
An aerial photo of the main building is shown in figure 5.56. The exterior columns on the north and south sides were extensively cracked, particularly in the third- and fourth-stories, as shown in figure 5.57. The concrete in the southeast fourth-story exterior column was crushed as shown in figure 5.58. Close-up views of this same column as viewed from inside are shown in figures 5.59 and 5.60 (note the splice of the column steel and the widely spaced ties).

Figure 5.57 Extensive column cracking is visible in the third and fourth stories of the south face.

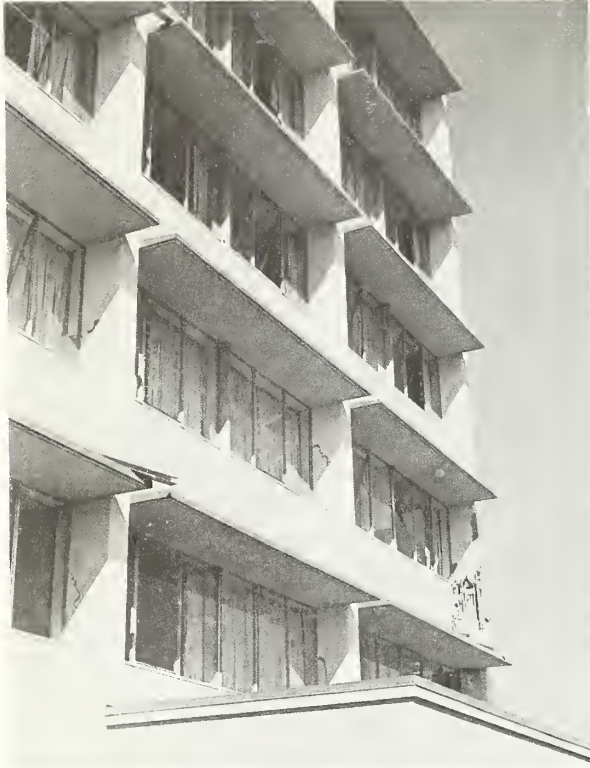
Figure 5.58 View of the failed column at the southeast corner of the fourth story.

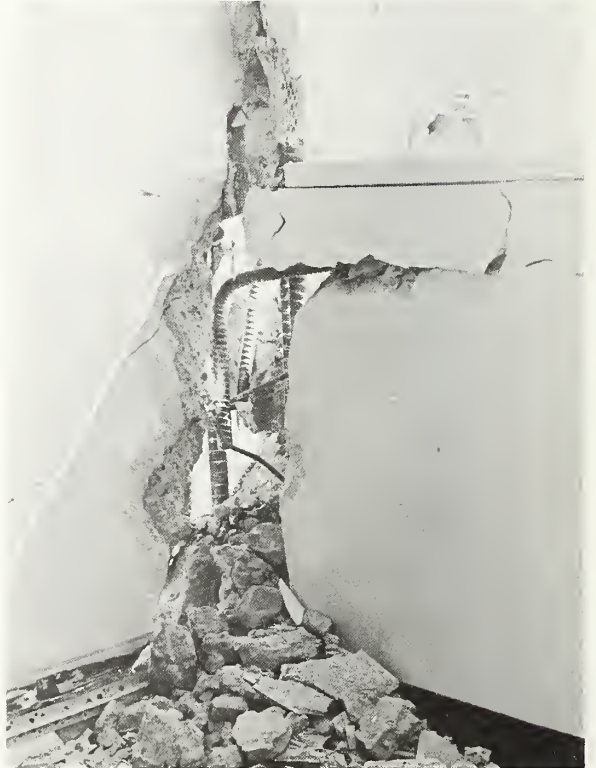
Figure 5.59 Damaged connection between the spandrel and shear wall on the southeast corner of the fourth floor.

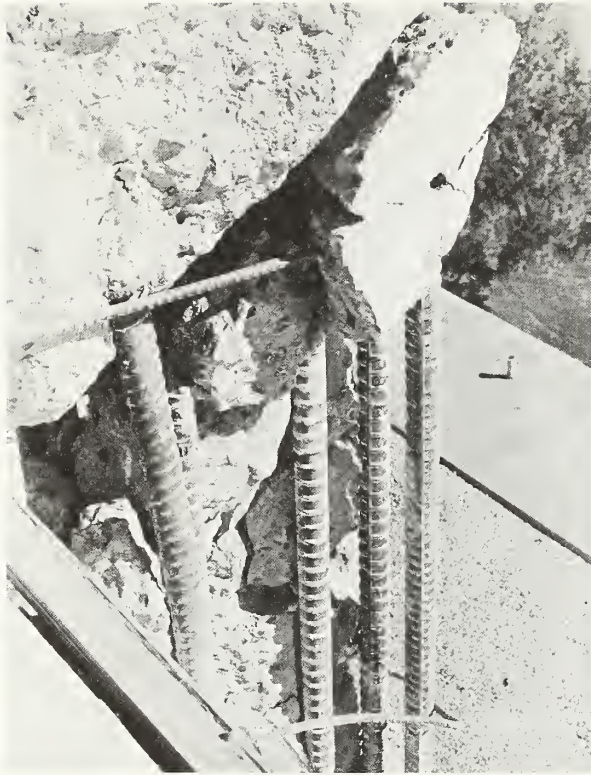
Figure 5.60 View of the reinforcement in the southeast corner fourth-floor column.

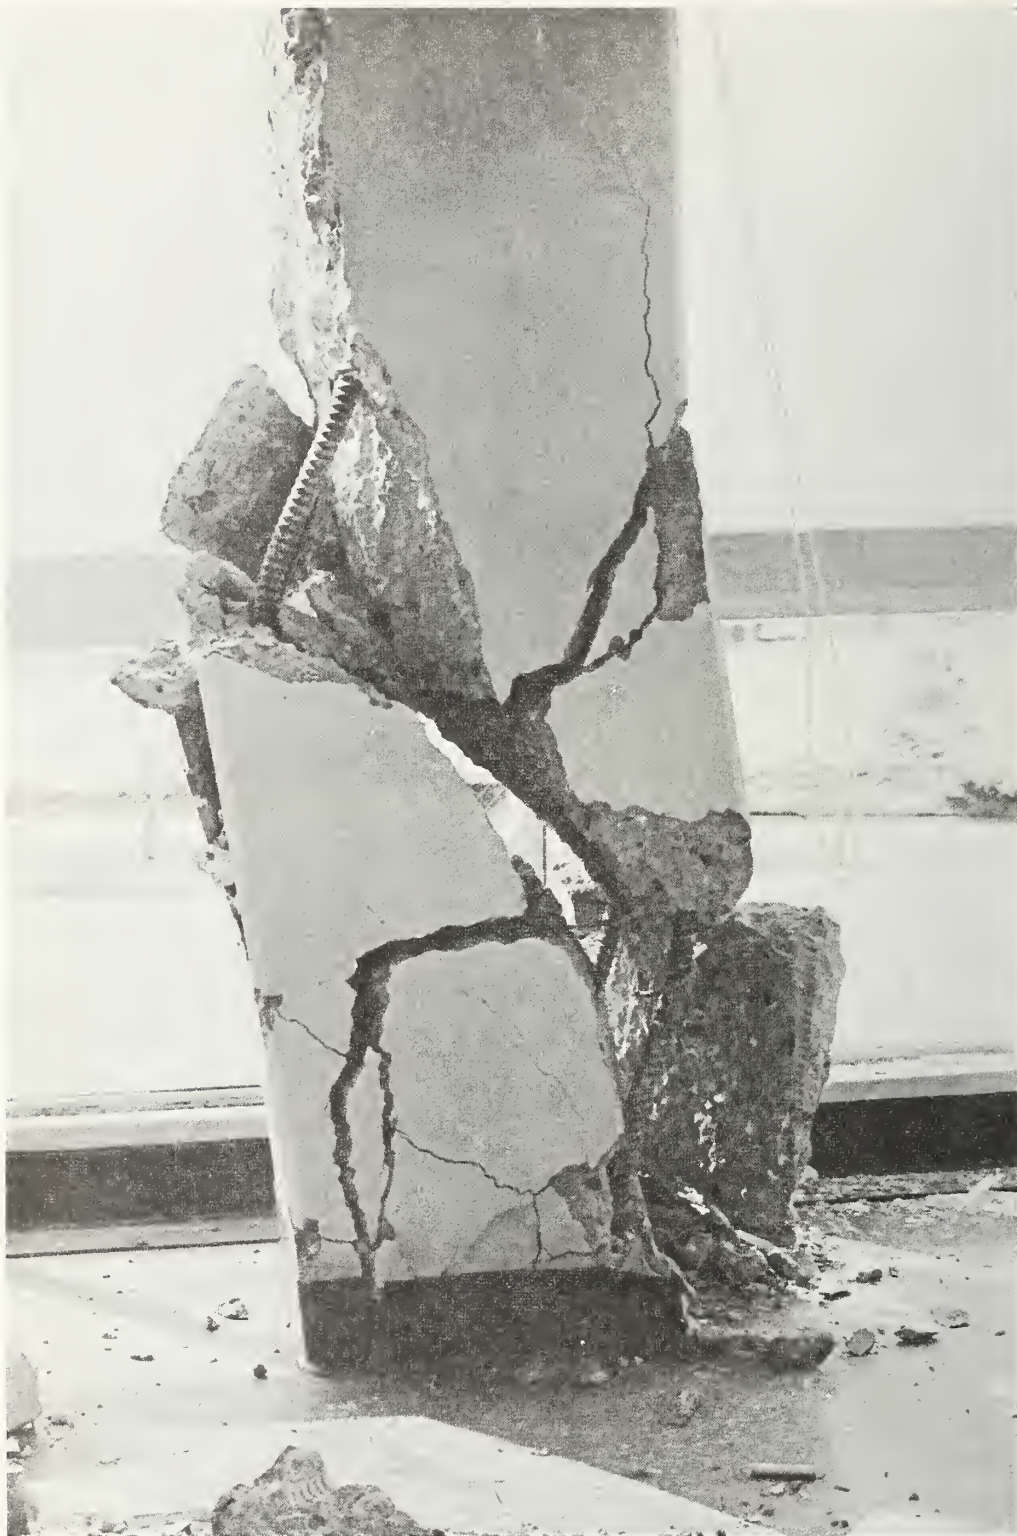
Figure 5.64 Reinforced concrete column at the west end of the third story.

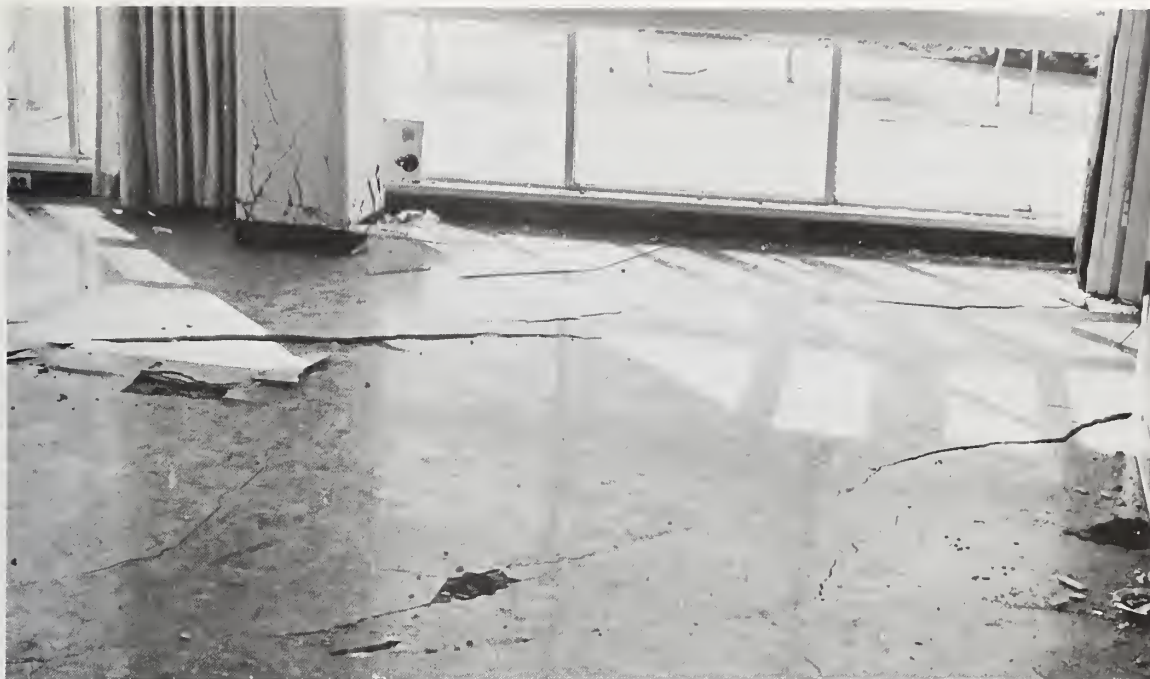
Figure 5.65 Floor damage at the west end of the third floor.

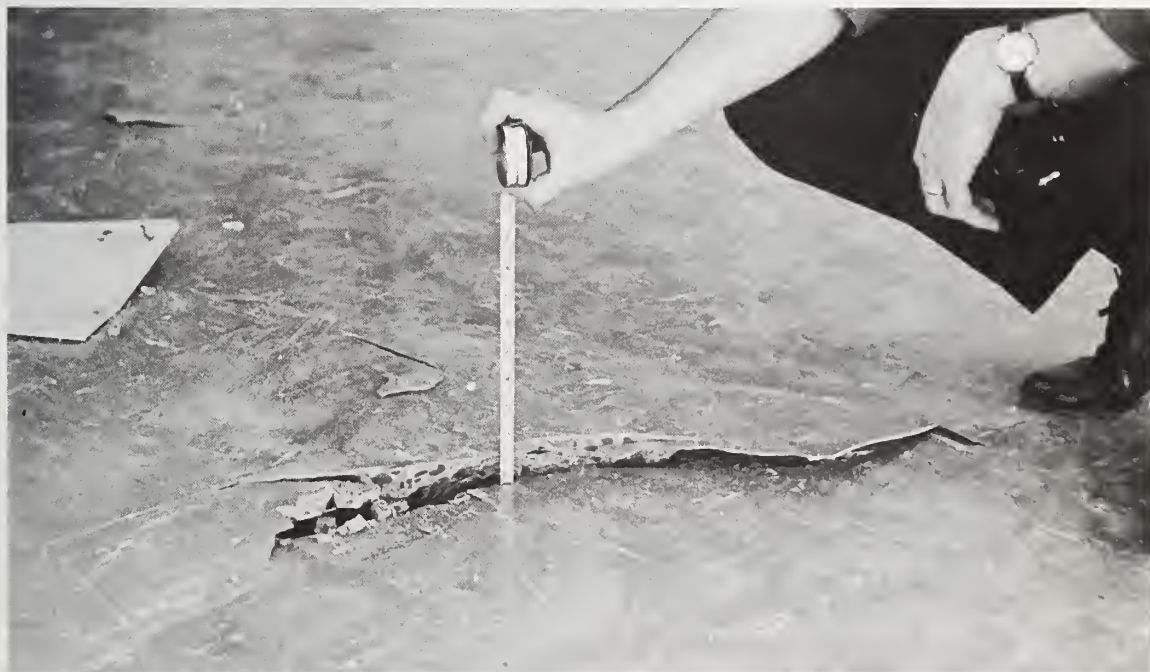
Figure 5.66 Floor cracking at the west end of the third floor. The floor is concrete pan-joist construction with a 3-in. slab.

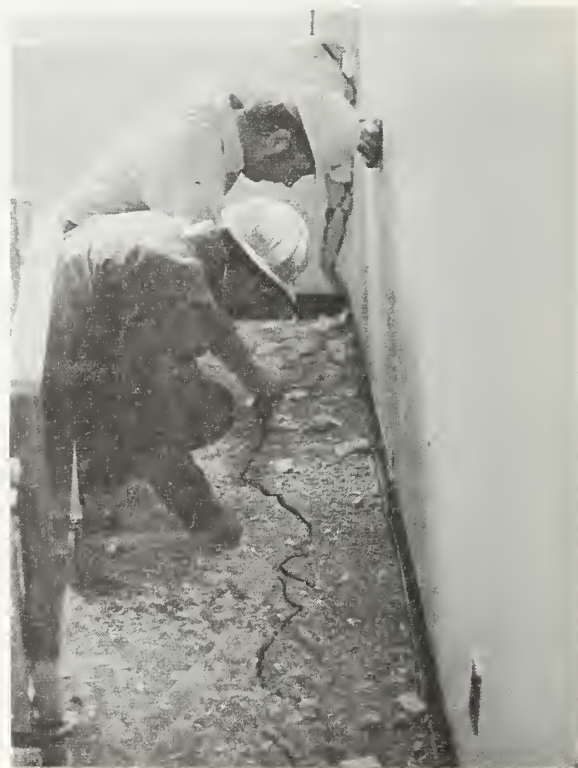
Figure 5.68 Damaged southwest corner room on the third floor. Note floor and spandrel cracking.

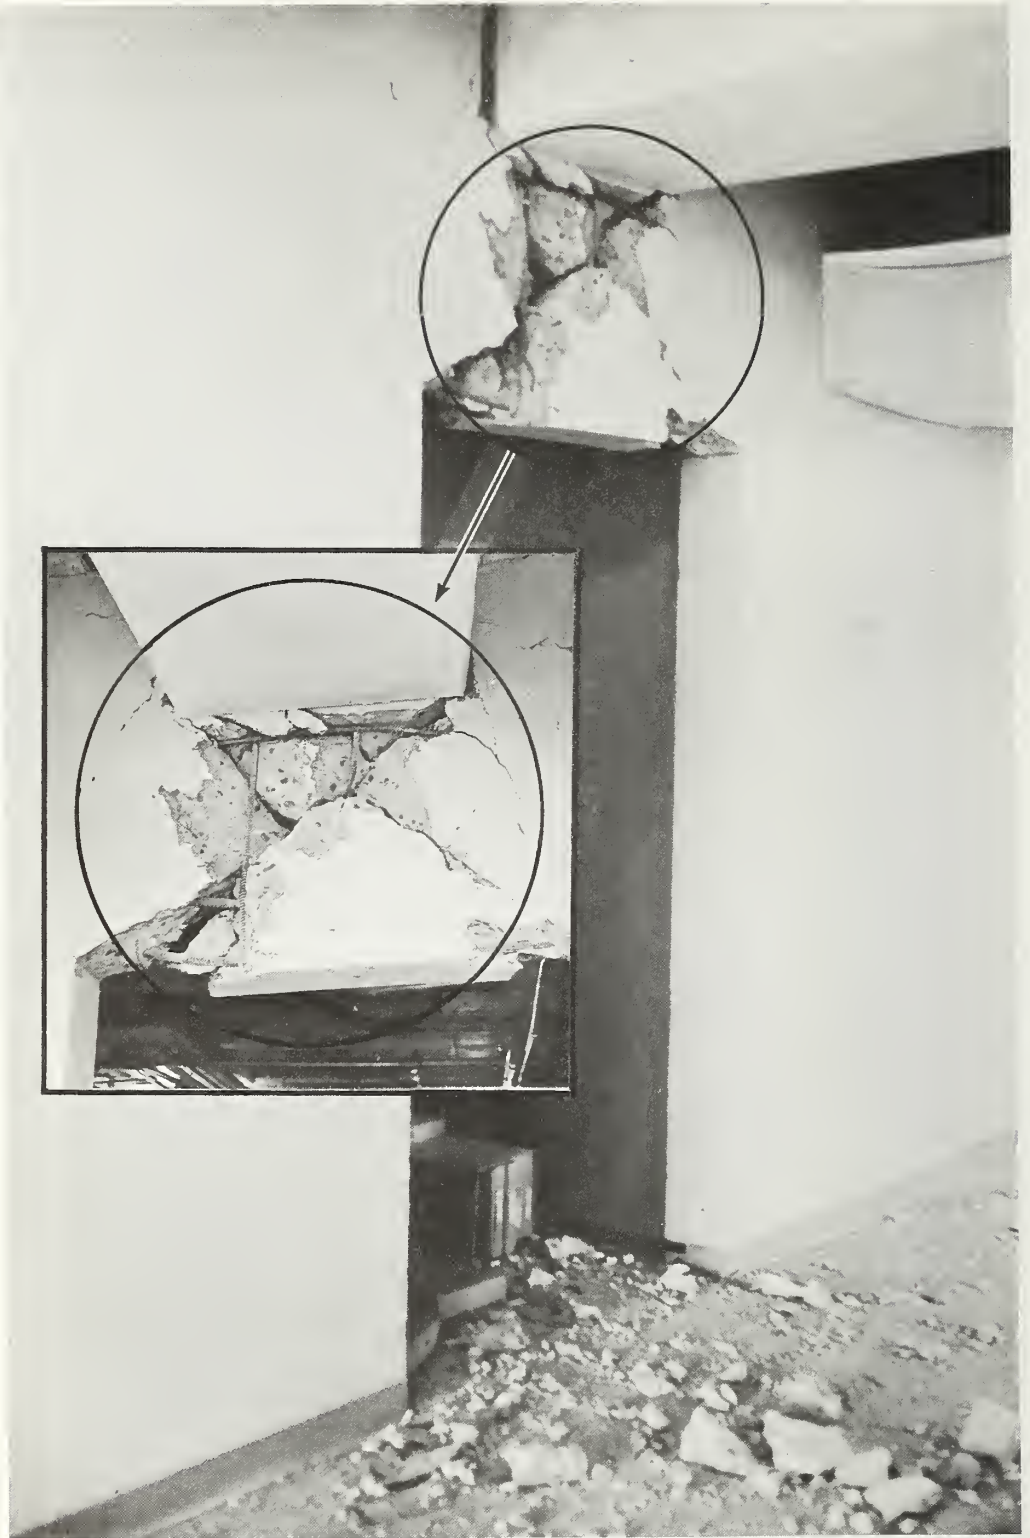
Figure 5.70 Beam over doorway near the west end of the seventh floor. A duct passes through an opening above the beam.

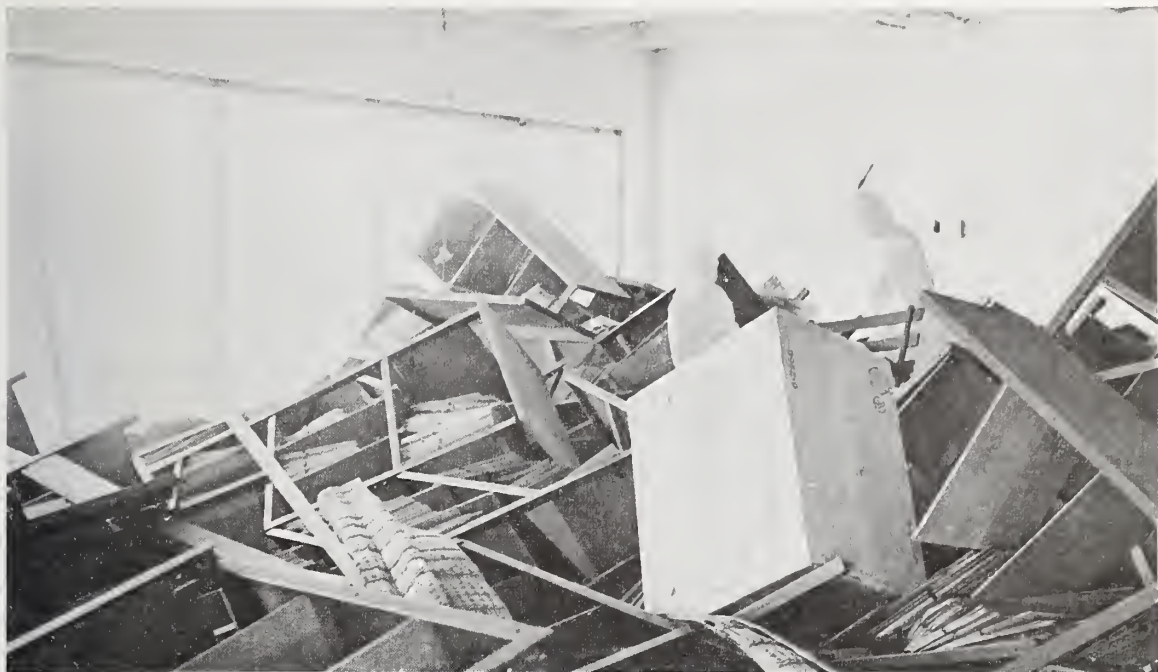
Figure 5.71 Shaking caused shelves to overturn on the seventh floor.

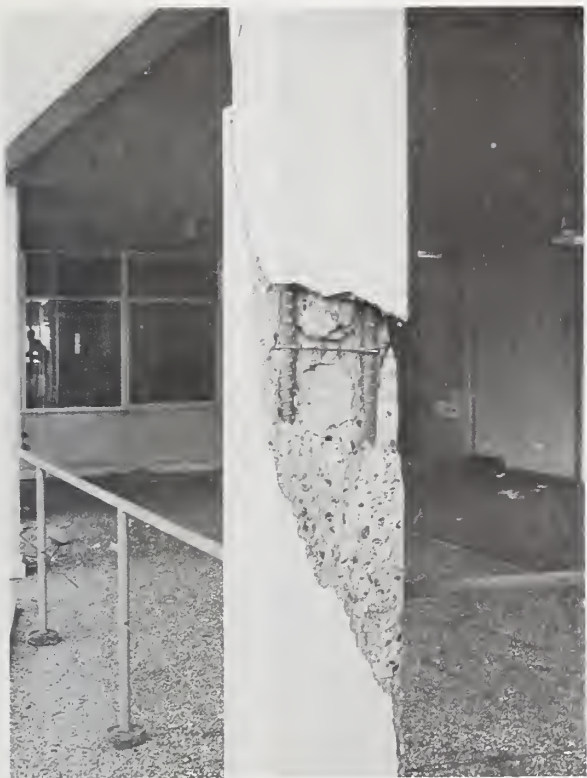
Figure 5.75 Close-up view of one of the columns shown in figure 5.74

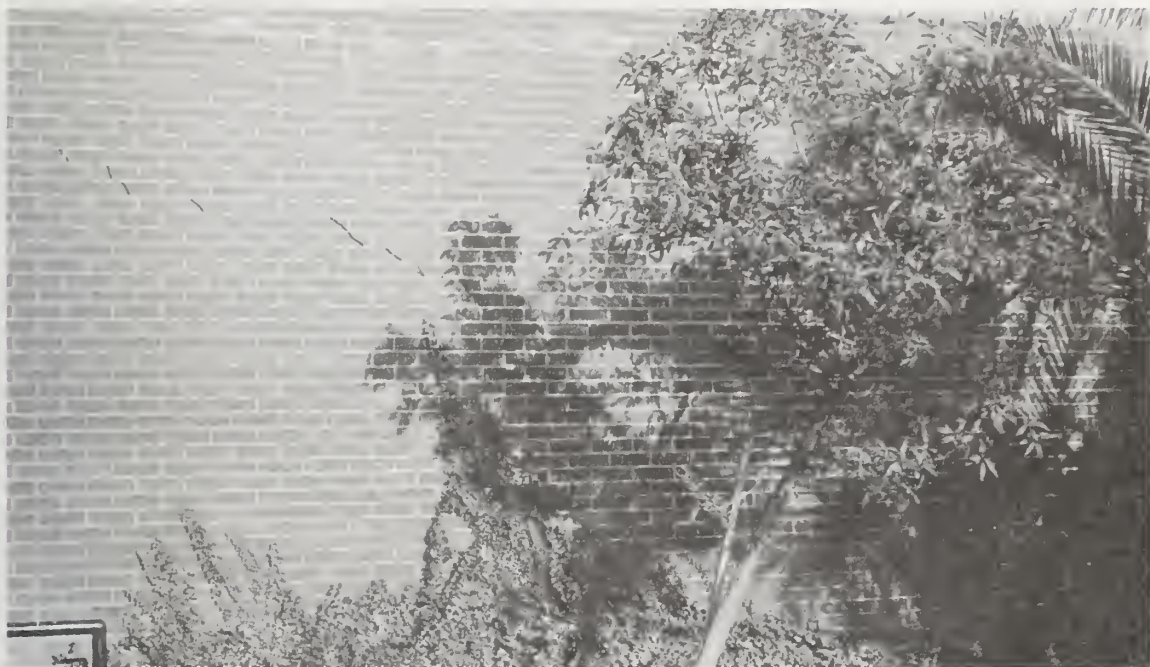
The building consists of three sections. The three story plus basement center section, the one- and two-story north section, and a one-story south section (figs. 5.77 and 5.78). A south elevation of the center section which shows the basement is shown in figure 5.79. A portion of the south section is barely visible behind the trees in the right of the figure. The reinforced brick wall behind the trees was cracked diagonally as shown in figure 5.80. This was the west wall of the cafeteria.

Figure 5.80 Reinforced brick masonry shear wall at west end of south section.

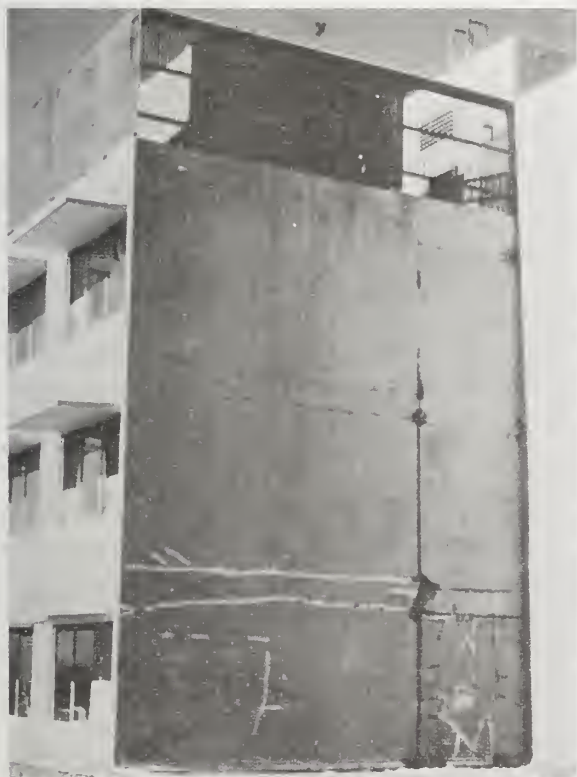
The east-end shear wall, a major load resisting element, was badly damaged as shown in figure 5.81. The portion of the walls outlined by a distinct rectangular crack pattern at each of three stories are referred to as "knockout panels" on the structural drawings. They were apparently provided for future expansion. An interior view of the first-story shear wall is shown in figure 5.82.

Figure 5.81 East-end shear wall of center section.

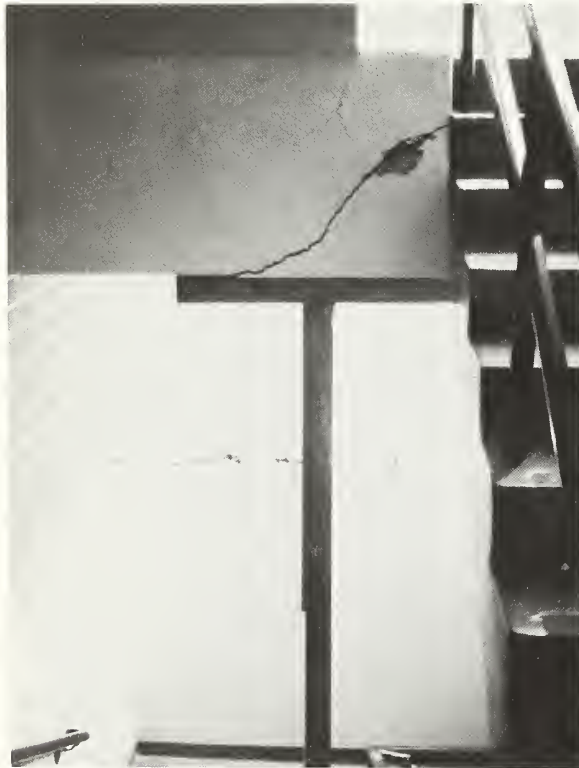
The stairwell shown in figure 5.83 was located at the east end of the center section and was damaged extensively. One of the two elevators (shown in figure 5.84) was badly distorted and inoperative. The second elevator was functioning.

Figure 5.83 Damaged reinforced concrete beam and walls in the stairwell at the east end of Pacoima Hospital.

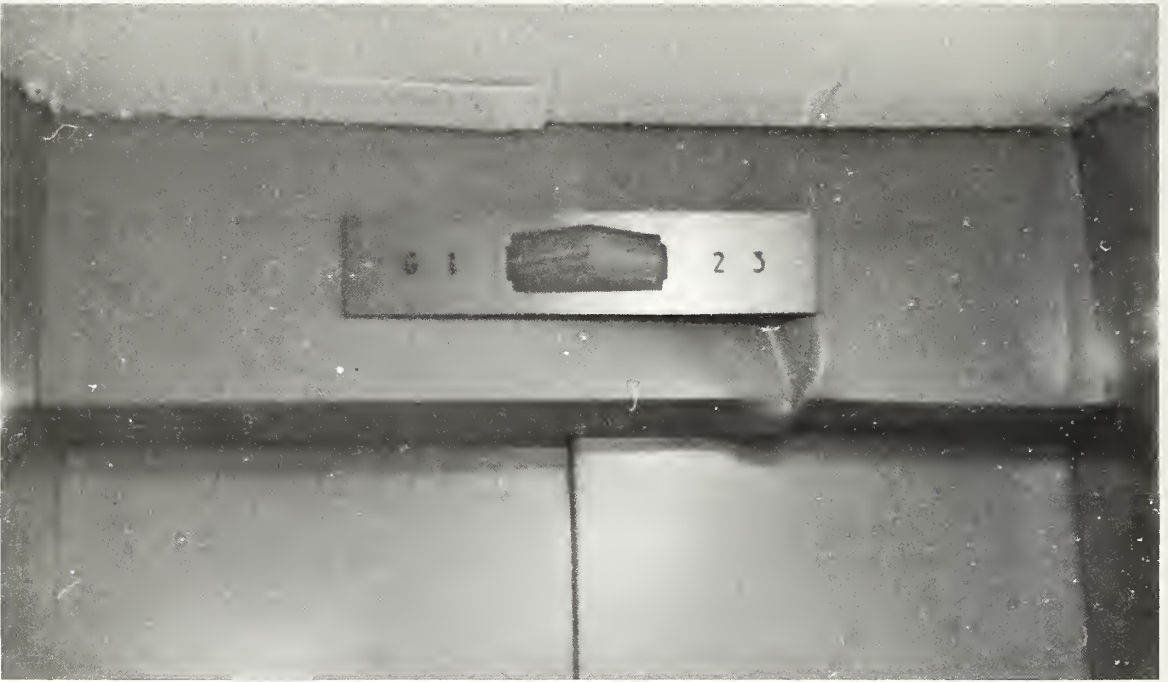
Figure 5.84 Buckled steel elevator door frame in the Pacoima Hospital.

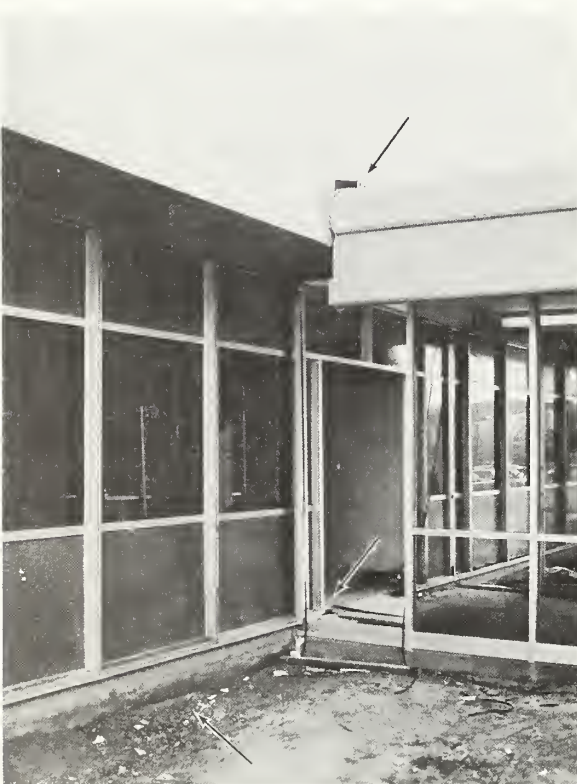
The walkway shown in figure 5.85 connected the north section with the mental health center. Relative movement shown seemed to indicate uplift of the main building. Further relative movement is shown in figure 5.86 which shows the north side of the north section. It was not certain at the time if the displacement was due to building uplift or soil settlement. Later reports indicated that the pile caps had "jumped" off the piles.

Figure 5.85 Connecting enclosed walkway between Pacoima Hospital (on the left) and the Mental Health Center. The structural damage and ground condition (arrows) appeared to indicate that the hospital building had experienced several inches of uplift.

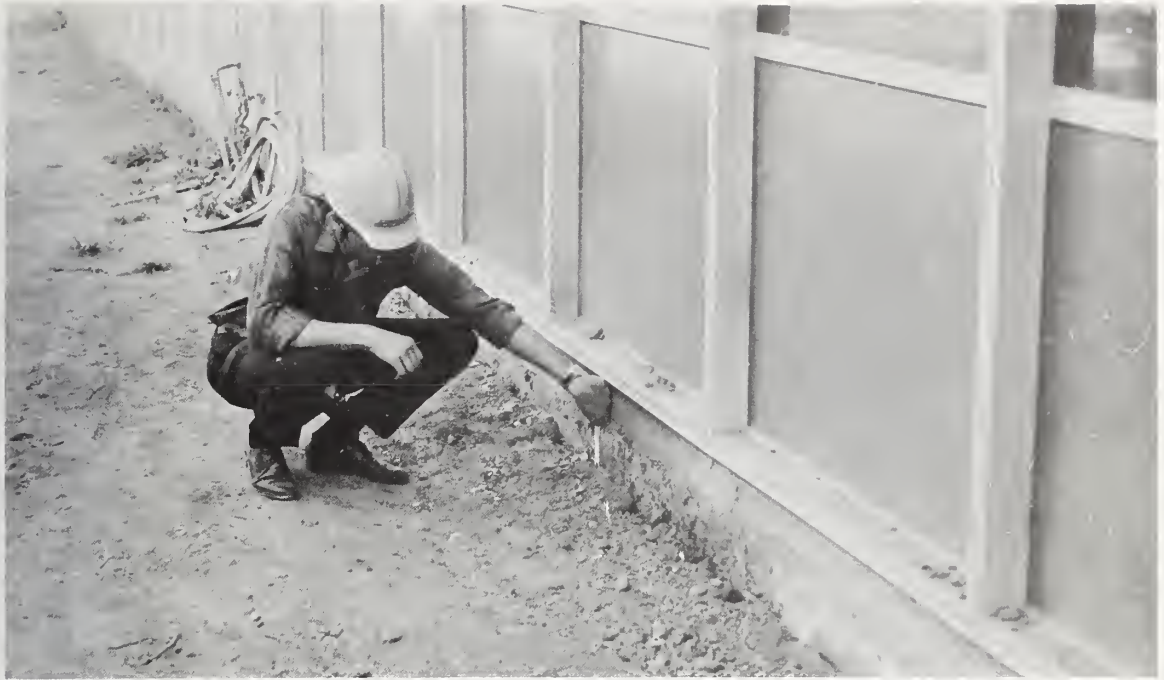
Figure 5.86 Relative movement between north section and ground.

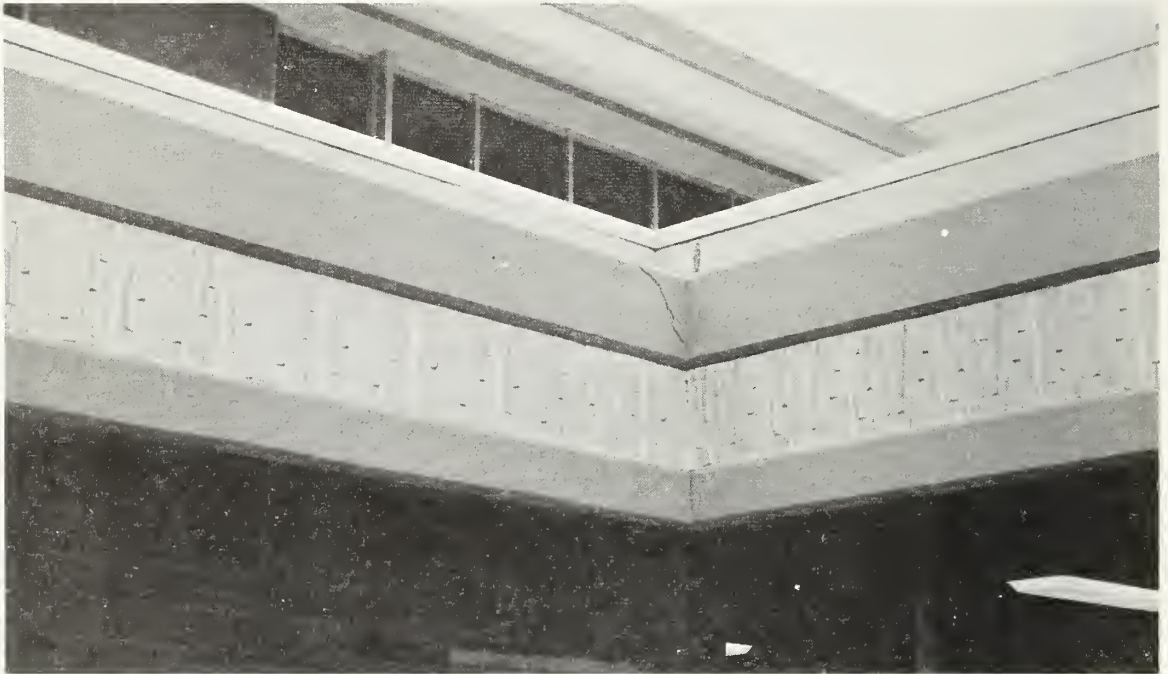
The west elevation of the new two-story mental health center is shown in figure 5.87. Interior finishing was being rapidly completed so that this reinforced brick masonry building could be used as a general purpose facility. Damage to shear walls and other structural elements was minor as indicated by the cracking shown in figure 5.88.

Figure 5.88 Cracking in exterior roof beams of the Mental Health Center.

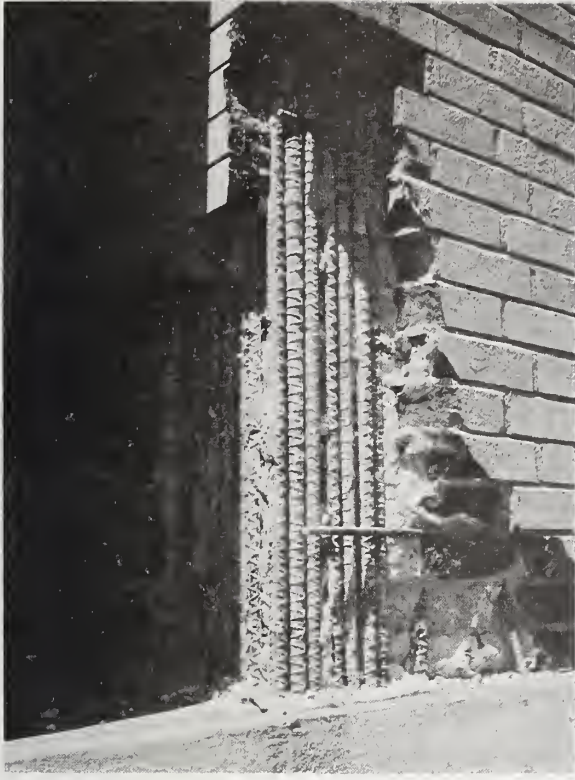
The aftershock of March 31 (refer to section 1.1) caused additional damage to the brick veneer. Although the magnitude of this aftershock was small (4.0 on the Richter scale), because the epicenter was only three and a half miles away from this structure, the resulting damage to the exterior cladding was considerably greater than that caused by the February 9 quake. During the aftershock large pieces of the brick veneer were spalled off from the wall, exposing the reinforcement in the shear wall (fig. 5.92). The building, however, remained in full use after both the February 9 earthquake and the March 31 aftershock.

Figure 5.92 Additional damage to brick veneer resulted from the March 31 after-shock, exposing the reinforcement in the shear wall.

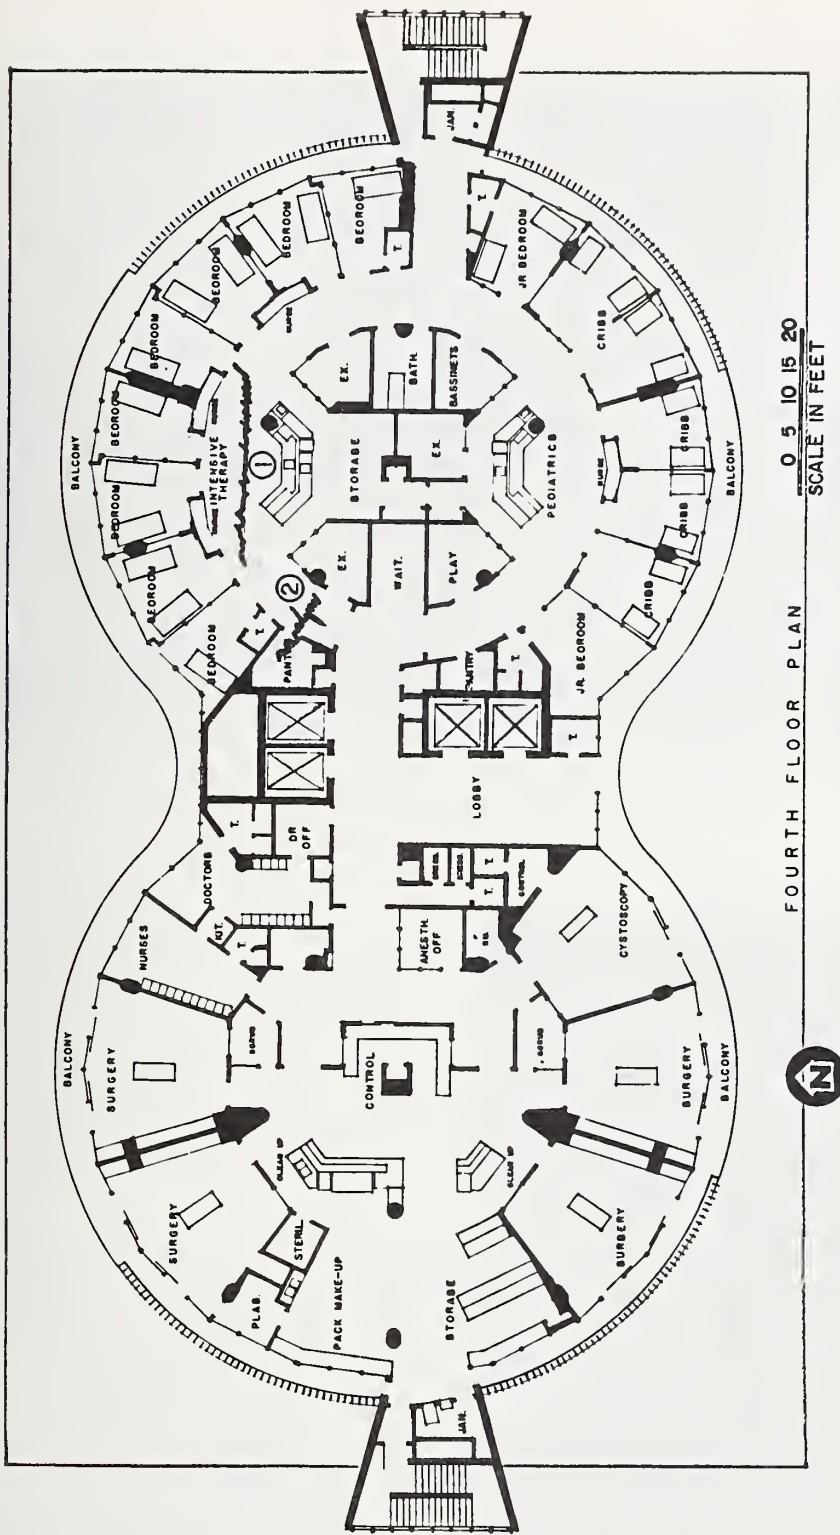
Figure 5.95 Fourth-floor plan, Kaiser Foundation Hospital. Outline of 3rd-story roof also shown.

There was severe cracking of the shear walls in the first, second, and third stories (fig. 5.96). The doors to the interior stairwell on the second and third floors were rendered inoperable due to the crushing of the spandrel beam in the shear wall (fig. 5.97). The fourth-floor slab, which is the transfer slab between the circular tower shear walls and the walls below, cracked and displaced vertically. There

- NOTES:
- ① LARGE CRACK IN SLAB (E-W)
 - ② CRACK IN FLOOR WITH 1" - OF VERTICAL DISPLACEMENT
