BUILDING SCIENCE SERIES 40

Engineering Aspects of the 1971 San Fernando Earthquake

This report presents the observations of the NBS on-site inspection team (most photographs in this report were taken by the team). The material presented herein is intended to serve as (1) a documentation of damage resulting from the earthquake and (2) as a source document for further studies, research, and recommendations. This is particularly important as necessary remedial work and restoration have resulted in the removal of evidence that is essential for studies and evaluations.

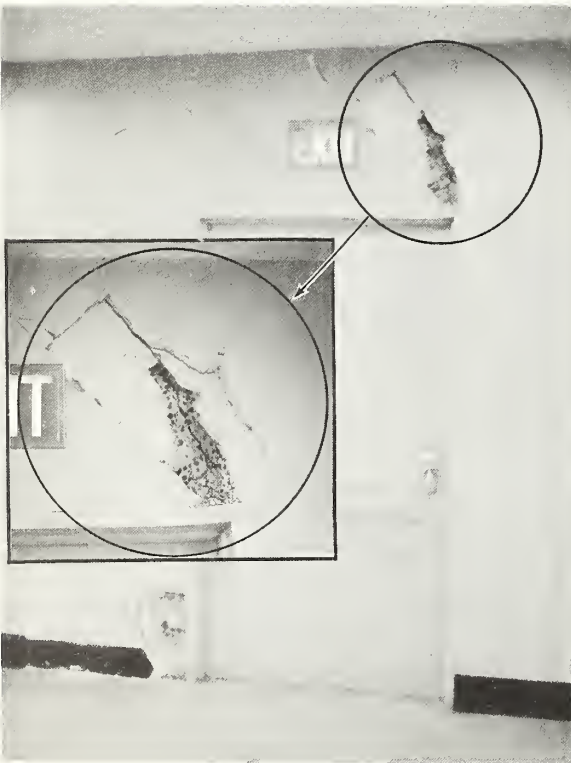
There was severe cracking of the shear walls in the first, second, and third stories (fig. 5.96). The doors to the interior stairwell on the second and third floors were rendered inoperable due to the crushing of the spandrel beam in the shear wall (fig. 5.97). The fourth-floor slab, which is the transfer slab between the circular tower shear walls and the walls below, cracked and displaced vertically. There

Figure 5.97 Second-floor door to interior stairwell. This door was jammed shut.

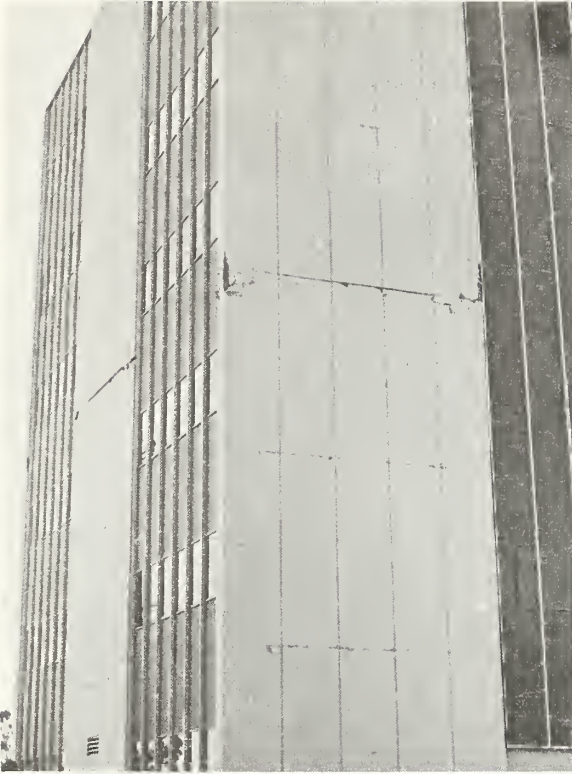
There was horizontal cracking at the construction joint at each floor level as shown in figure 5.100. This was particularly pronounced at the second, third, and fourth floors where concrete also spalled at the corners (figs. 5.101, 5.102, 5.103, and 5.104). Note the buckled vertical reinforcement in figure 5.104. These same shear walls were also cracked diagonally for the full height of the building (fig. 5.102). There was also extensive crushing at the base of the southeast shear wall as shown in figure 5.105.

Figure 5.100 View of the northeast corner. The north and east shear walls were cracked horizontally at the second through the sixth floors. Diagonal cracks were also present between floors.

The structure was repaired by attaching new 8-in gunite walls to the existing shear walls and providing additional floor-slab support by means of steel angles.

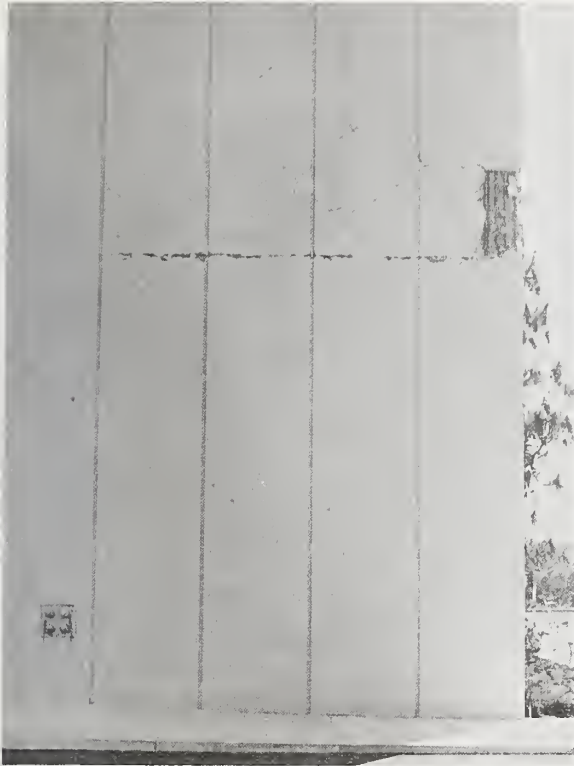
Figure 5.102 Diagonal cracking and spalling in the northwest corner shear wall.

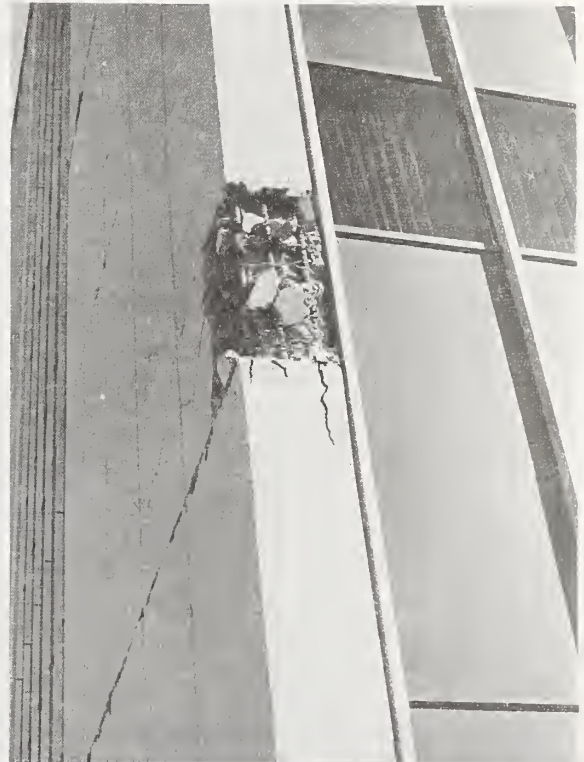
Figure 5.103 Close-up view of the spalled area of the shear wall shown in figure 5.102.

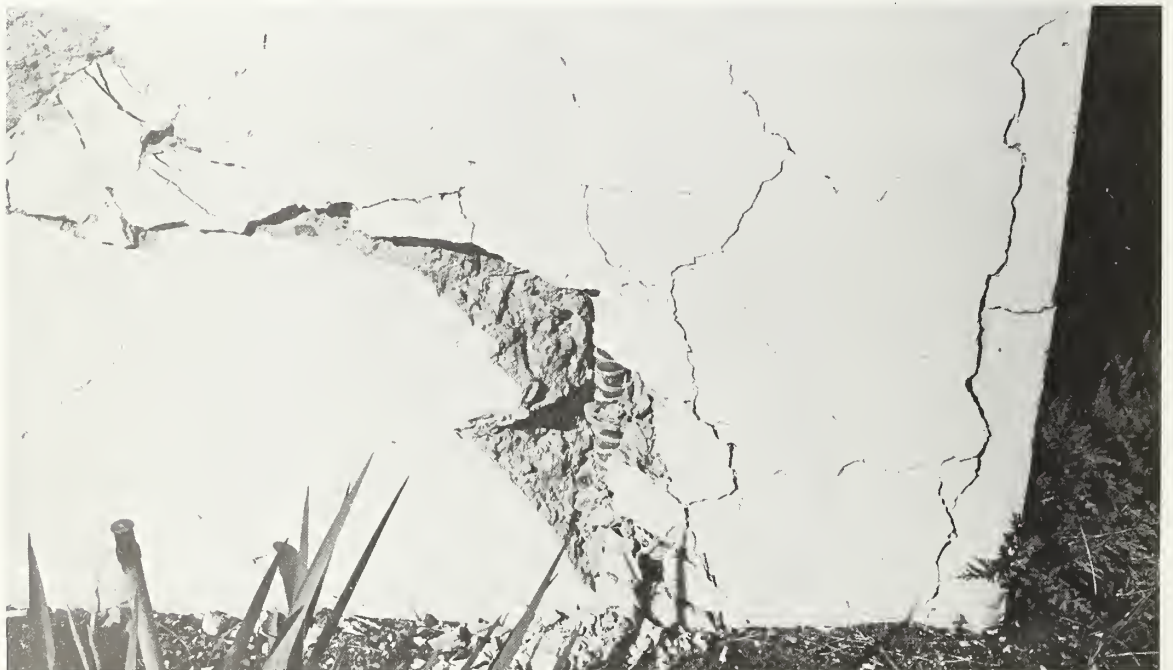
Figure 5.105 Cracking at the base of the southeast corner shear wall. Note the exposed reinforcing bar.

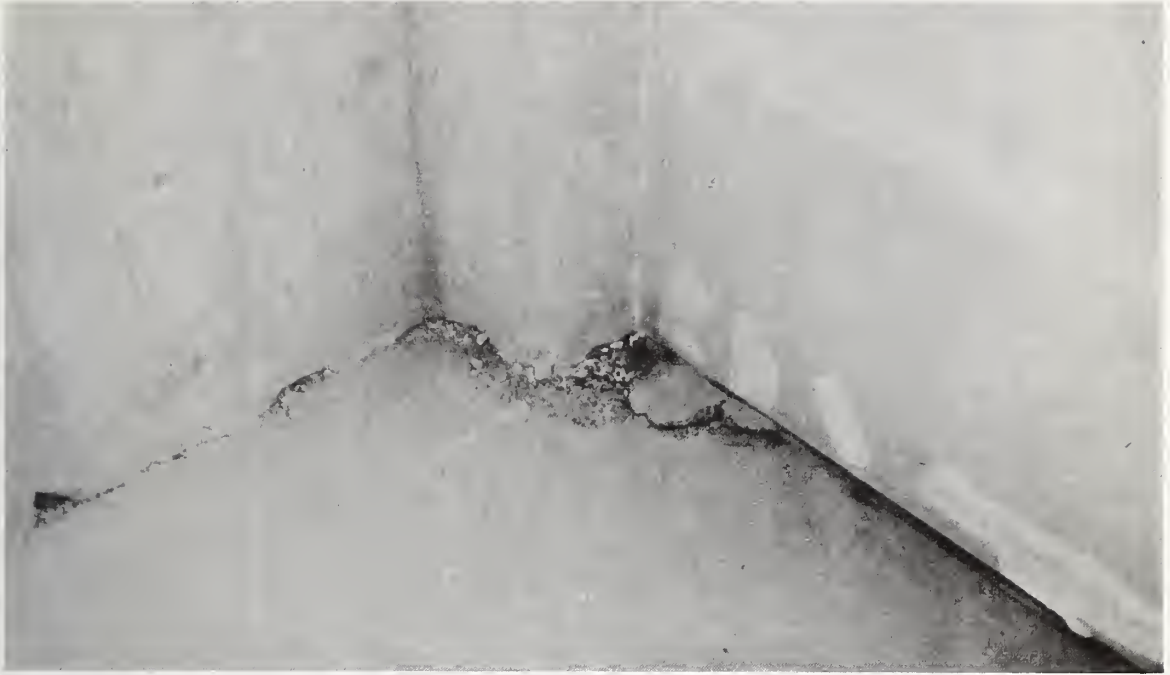
Interior damage consisted of horizontal cracking at the floor-to-wall joint of the third, fourth, and fifth floors (fig. 5.106). There were also damaged beam-column connections on these same floors (fig. 5.107). Some damage was also noted in the stairwell where the connections of metal stairs

Figure 5.106 Interior view of horizontal cracking at the northeast corner of the fourth floor.

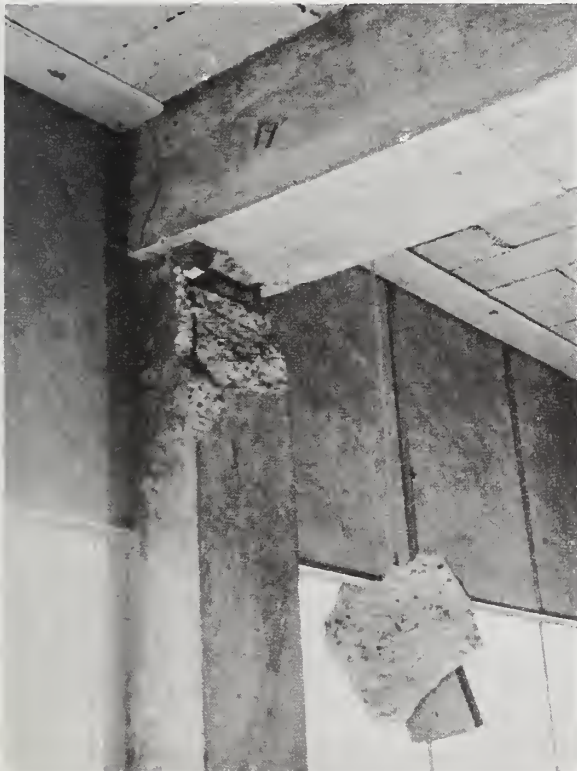
Figure 5.107 Damaged beam-column connection in the fourth story. The large piece of broken concrete is suspended by an electrical cable.

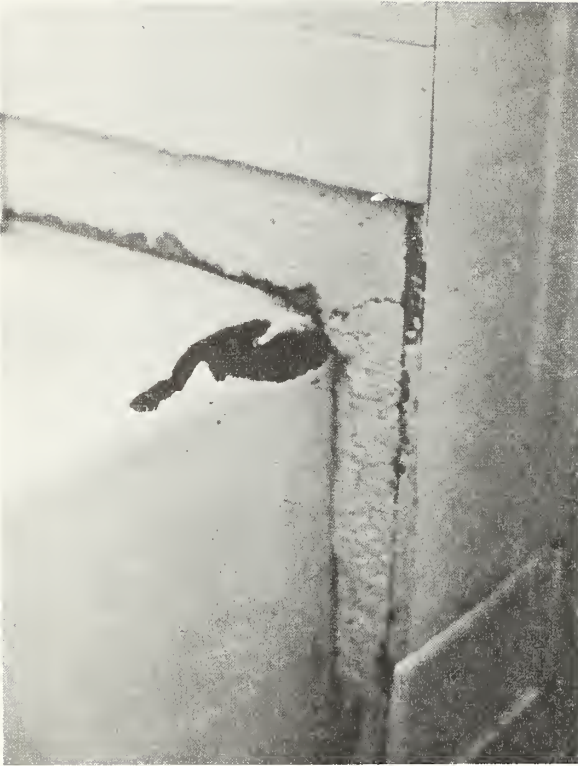
The most severe damage was to nonstructural elements such as plaster walls and plumbing fixtures. This damage is illustrated in figure 5.109. A cracked cast-iron bathtub which has already been removed from the building is shown in figure 5.110. This type of damage was greatest on the second, third, and fourth stories. This evidence together with the recorded accelerations suggest that this building underwent severe lateral deformation during the earthquake. There were apparently some cracks in the structural frame which were repaired with epoxy.

Figure 5.110 Cracked and chipped bathtub.

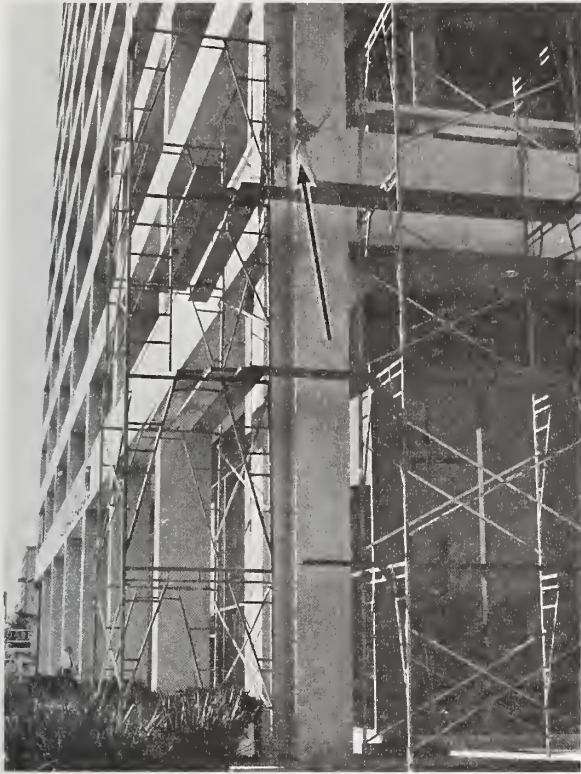
An elevation of the bank building is shown in figure 5.113. Principal structural damage was in the first-story columns, primarily at the second-floor beam-column connections as shown in figure 5.114. These columns were repaired with epoxy shortly after the earthquake as shown in figure 5.115. However, the initial attempt was not successful and two additional trials were made before the repair was considered to be acceptable.

Figure 5.114 View of cracked southeast column.

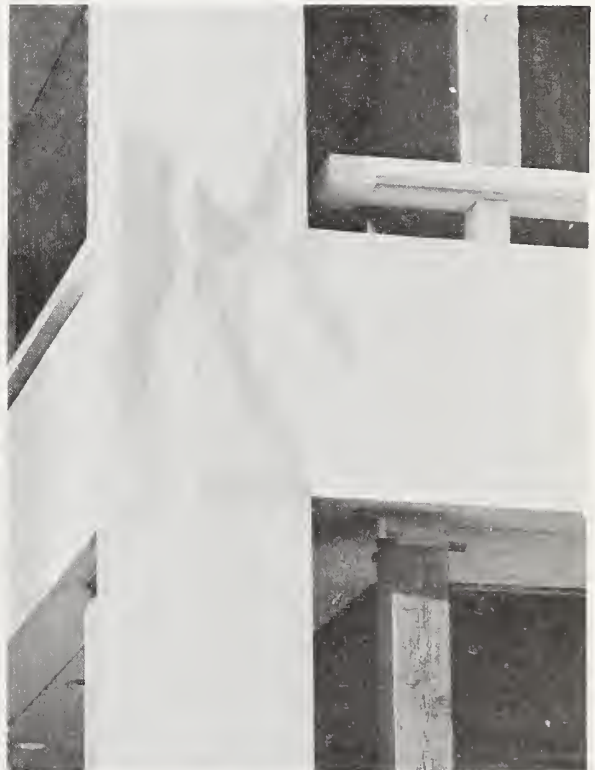
Figure 5.115 Cracked beam-column connections at the first floor were repaired with epoxy.

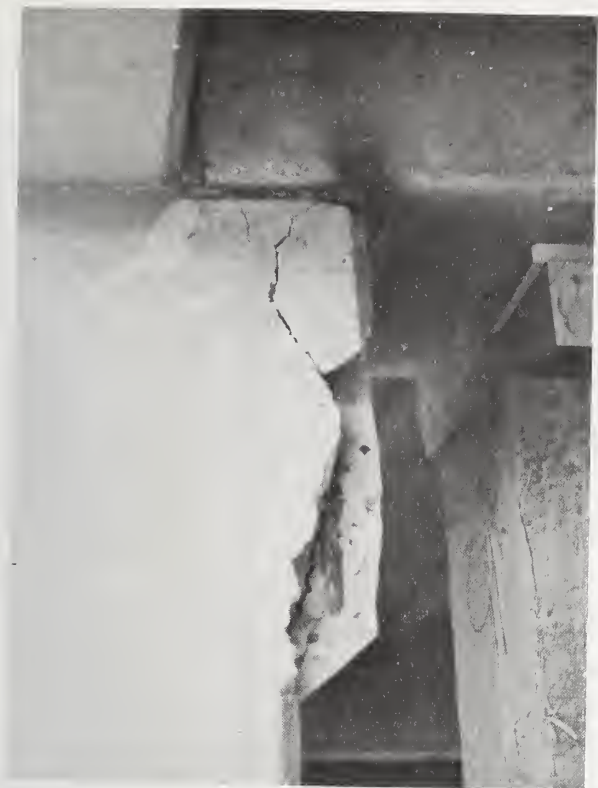
The parking garage located on the north side of the bank (see fig. 5.111) is shown in figure 5.116. The garage was constructed of precast pretensioned hollowcore planks with a cast-in-place topping supported on precast pretensioned girders. Columns are cast-in-place reinforced concrete. Most damage was limited to the columns which were cracked on the east-west faces as shown in figure 5.117. Concrete column corbels were also cracked as shown in figure 5.118.

Figure 5.118 Cracking of exterior column corbel.

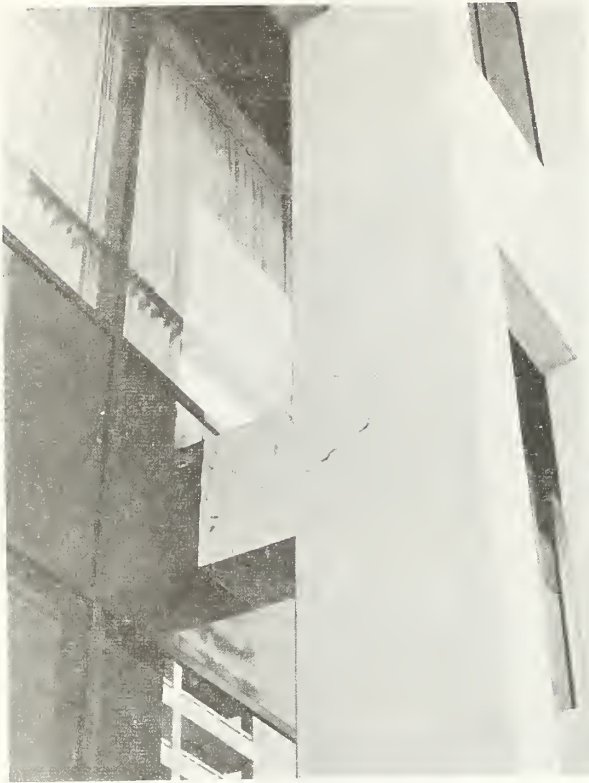
columns as shown in figure 5.121. This damage was being repaired with epoxy.

Figure 5.121 Cracking in a beam-column joint at the second floor level on the north face of the Bank of California building.

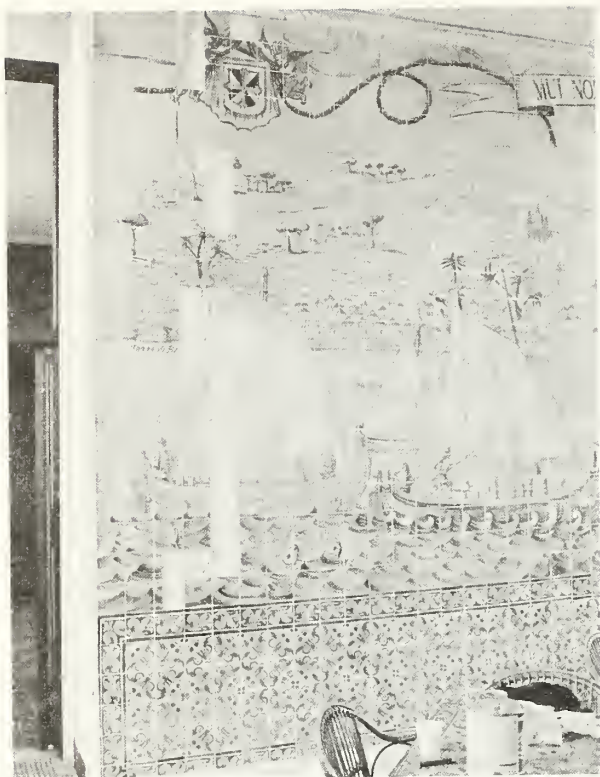
Figure 5.127 Cracked tile mural.

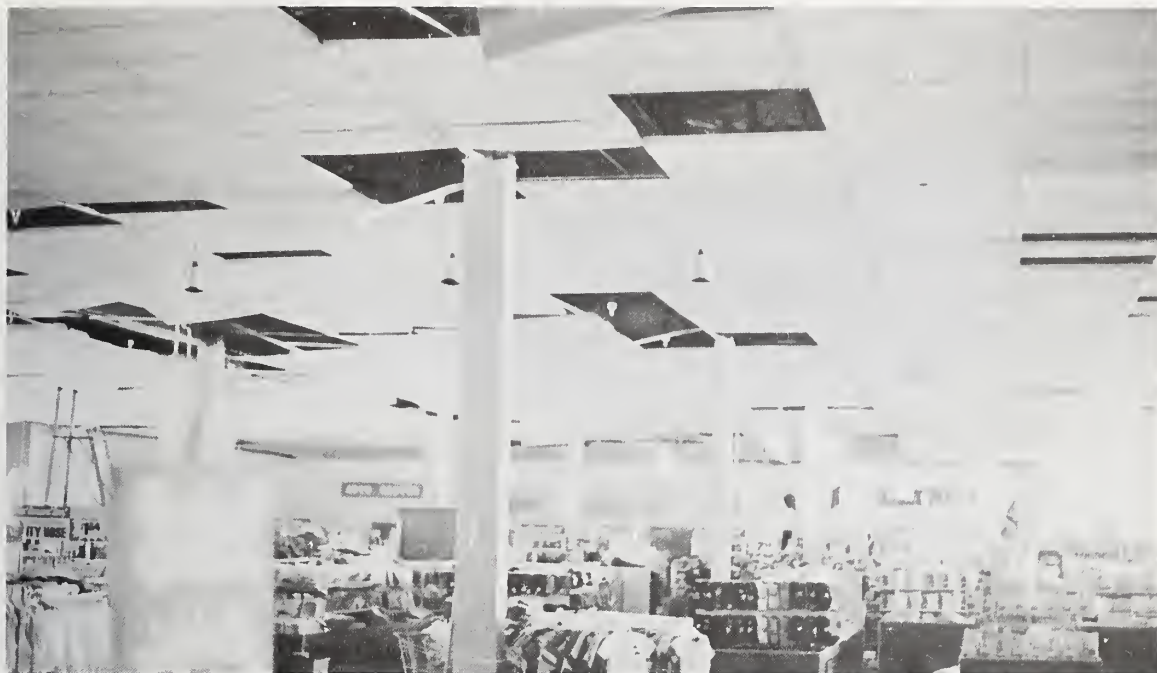
Other interior damage consisted of fallen suspended ceiling and merchandise thrown to the floor (fig. 5.130).

Figure 5.130 Interior view of Grants Department Store showing missing portions of suspended ceiling. Most of the merchandise which had been thrown to the floor had been picked up when this photograph was taken.

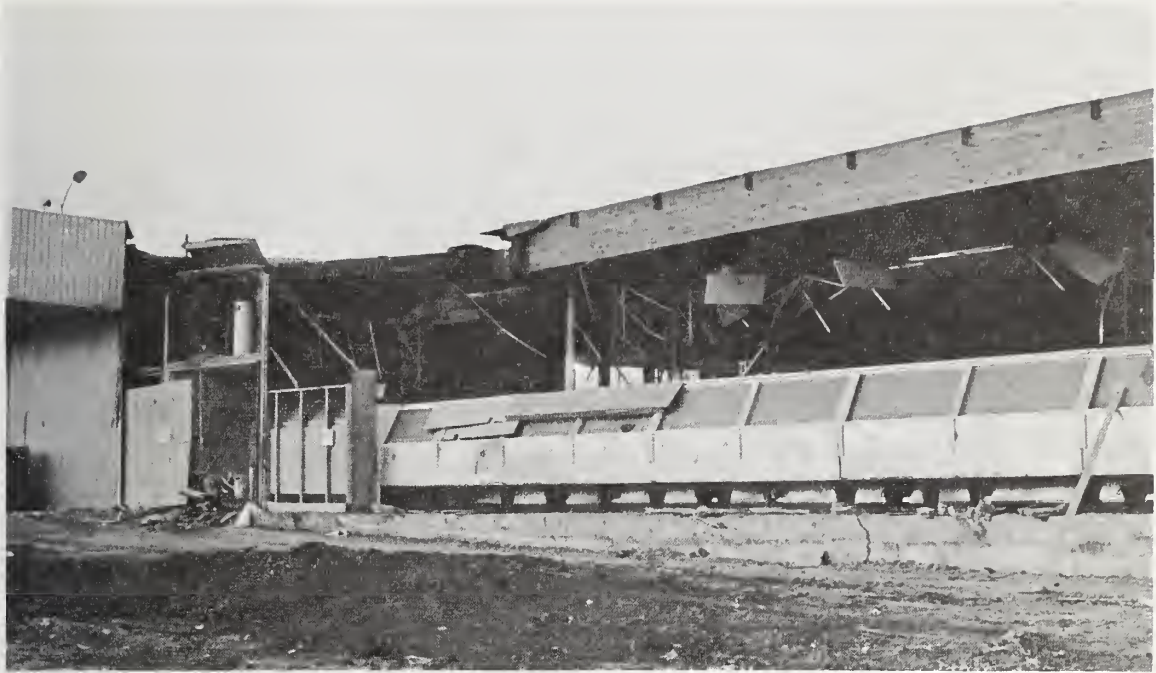
Grant's Department Store (location 2) except damage was more severe. At this site the masonry wall supporting wood beams fell outward, dropping beams to the ground. The laminated wood girder which supported one end of the roof beams is visible in figure 5.132.

*Figure 5.132 View of the Boy's Market looking east.
Most debris has been cleared.*

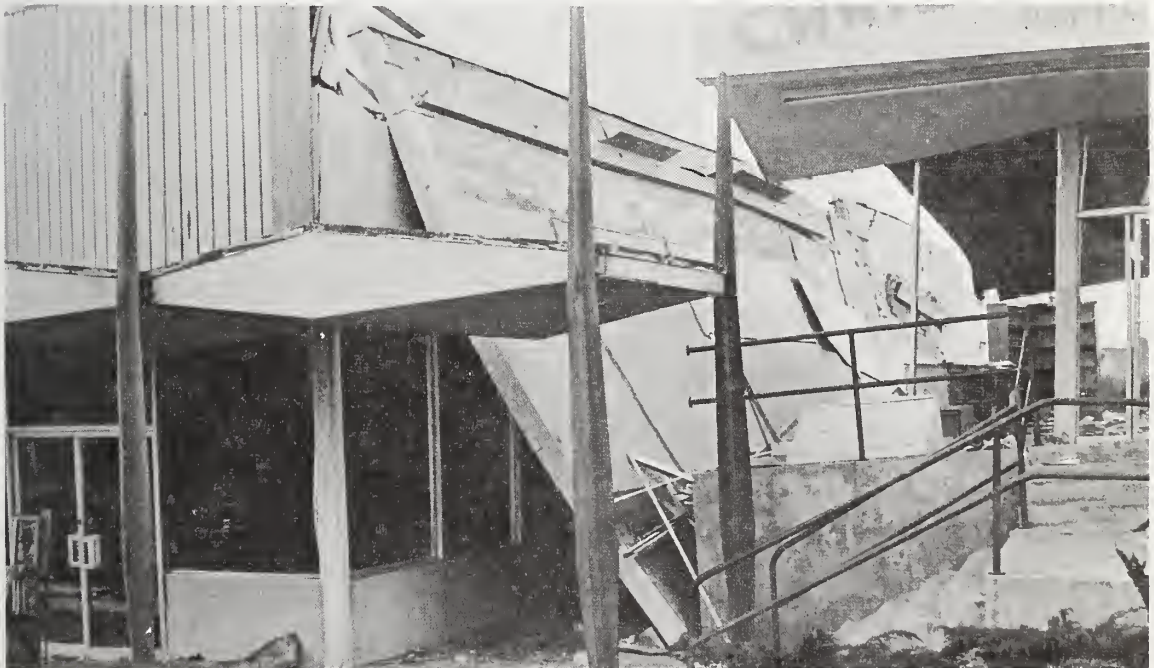
Another small store in the center was similarly damaged as shown in figure 5.133. Note that the reinforced brick masonry wall remained essentially intact even though it fell against an adjacent building. A view from the opposite end of the store is shown in figure 5.134. The laminated timber beam at the left spanned approximately 65 ft from a column at the front of the store to a rear masonry wall which also collapsed. Wood joists spanned from this beam to a wood ledger fastened to the wall on the right. Another view of this store is shown in figure 5.135.

*Figure 5.133 Collapsed side wall of a small store in the
shopping center.*

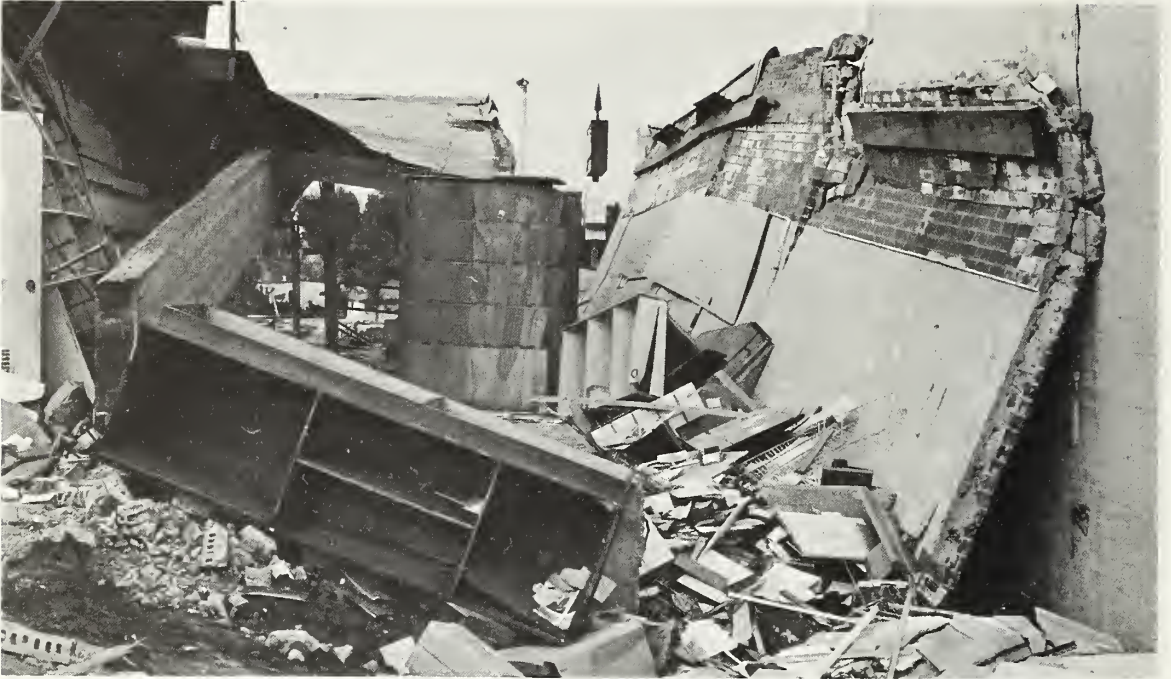
Figure 5.134 Collapsed side wall shown in figure 5.133 as viewed from the rear of the store.

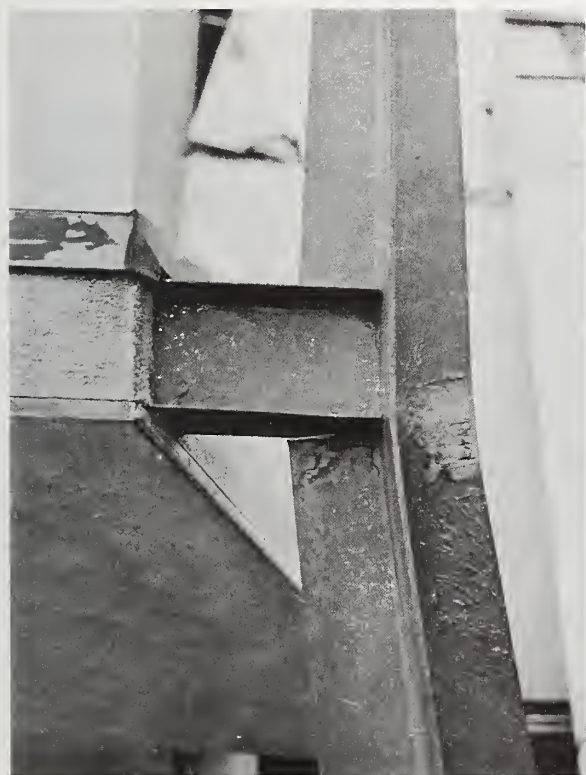
The construction of the southern portion of the center shown in figure 5.136 differed from that described above. This portion had a concrete canopy supported on a light steel frame and was severely racked during the earthquake. The destructiveness of ground shaking can be envisaged by extensive cracking in the parking lot pavement. Yielding and fracture of one of the support columns is shown in figure 5.137.

Figure 5.137 Yielded and fractured canopy support.

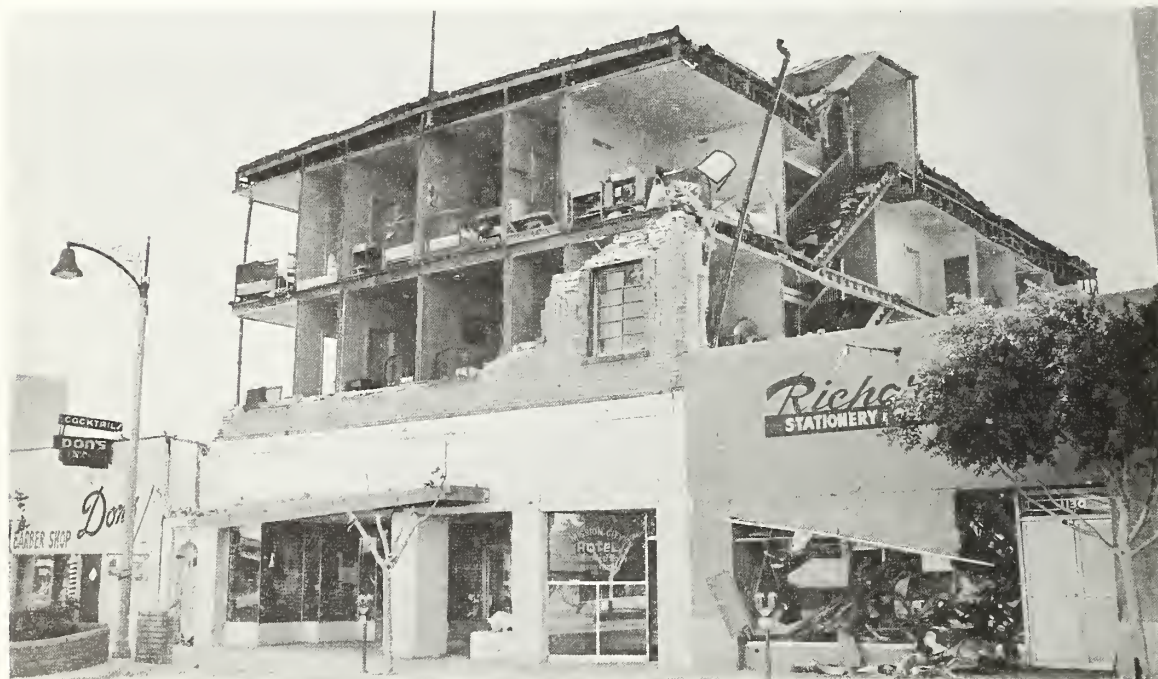
The hotel shown in figure 5.139 was severely damaged. The second story and roof are held up by interior partitions. One of the walls fell through the roof of the adjacent store causing severe interior damage (fig. 5.140). Fallen parapets, walls, and bricks were common as shown in figures 5.141, 5.142, and 5.143. The Kress store was severely damaged as shown in figures 5.144, 5.145, and 5.146. The diagonally cracked wall of Kress shown in figure 5.146 was common in other buildings in the mall as shown in figure 5.147.

Figure 5.139 Total collapse of brick masonry wall surrounding three-story wood frame building (Mission City Hotel).

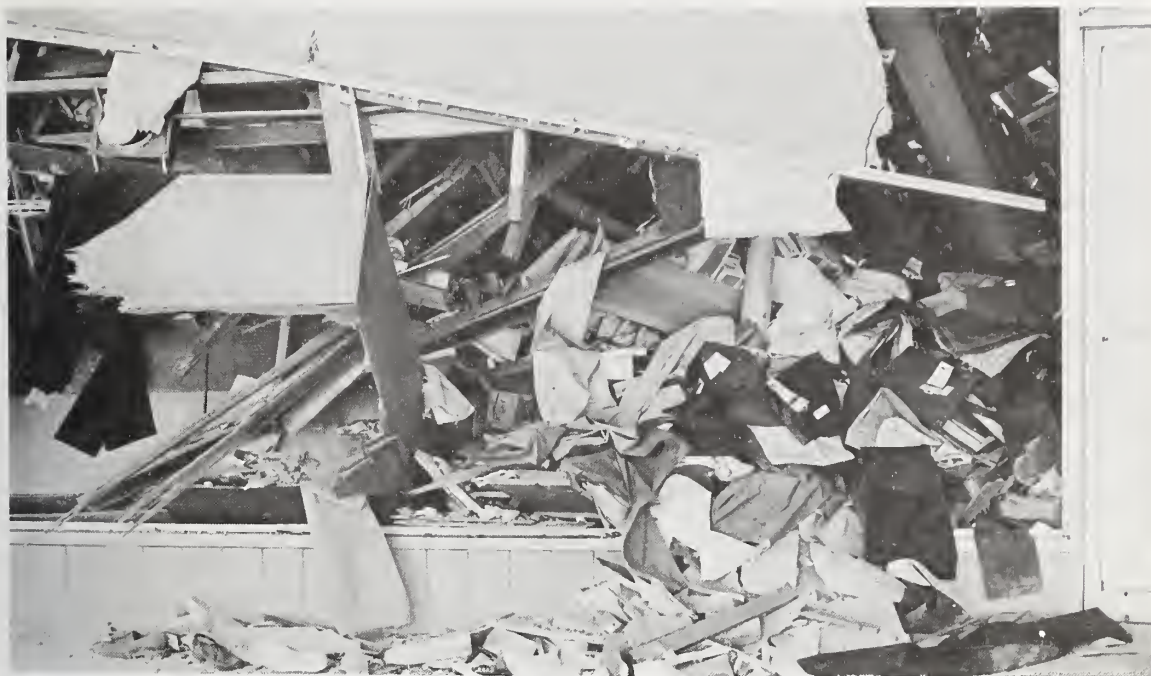
Figure 5.140 The wall of the building shown in figure 5.139 fell through the roof of this building.

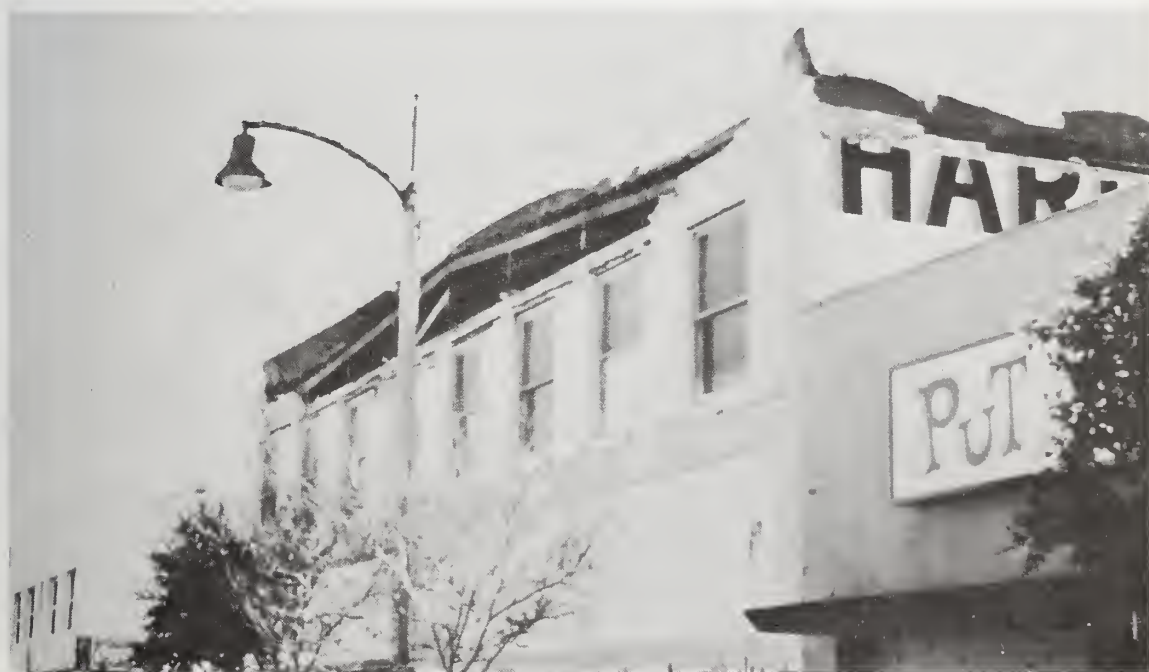
Figure 5.141 Damaged parapet and wall.

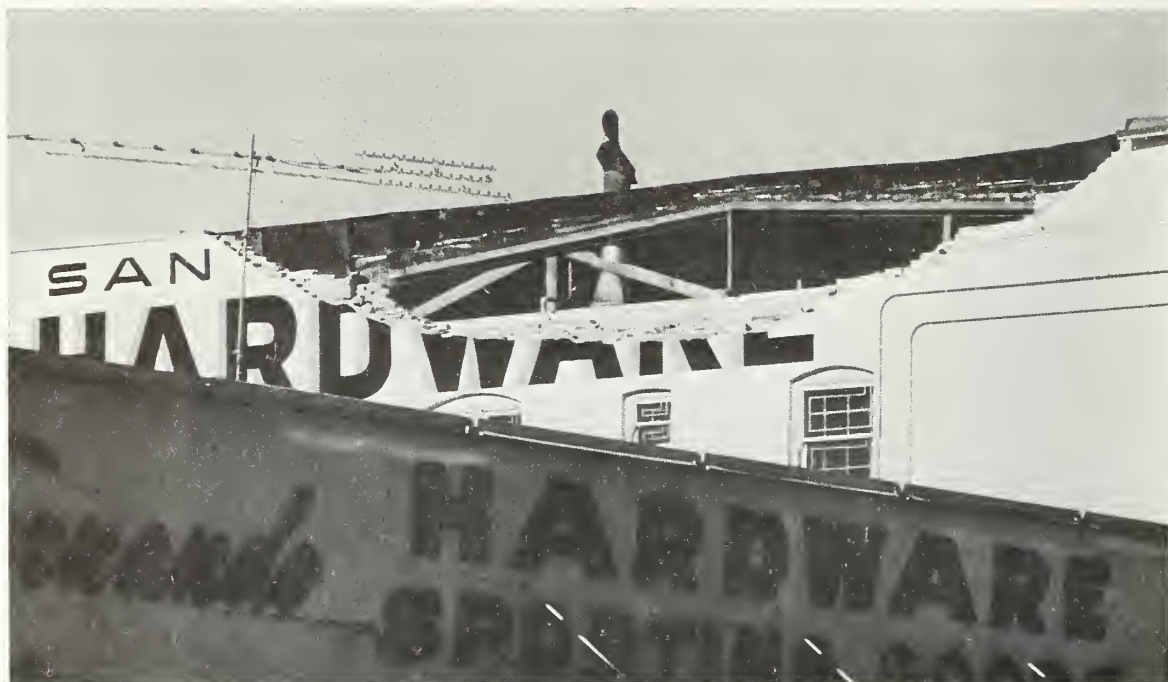
Figure 5.142 Damage to brick masonry parapet wall.

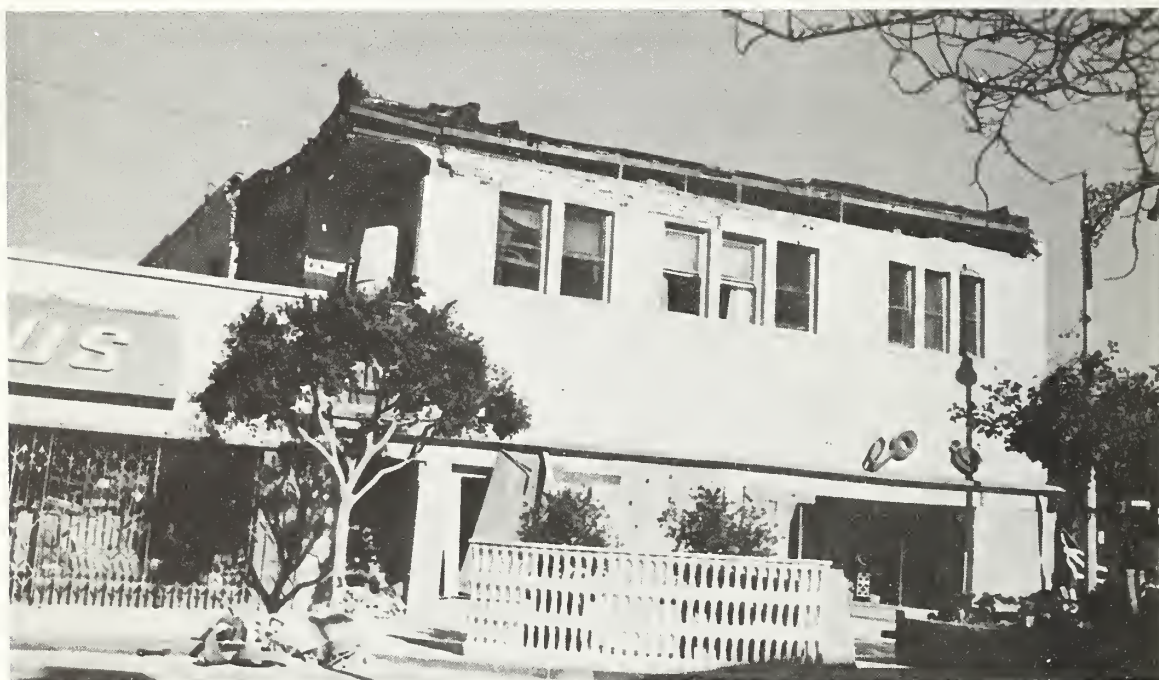
Figure 5.143 Collapsed wall and parapet.

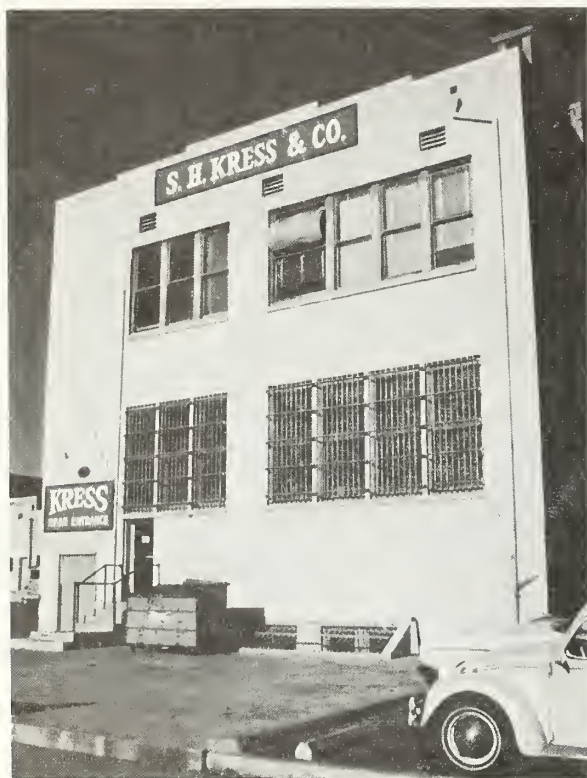
Figure 5.146 Diagonally cracked wall at Kress.

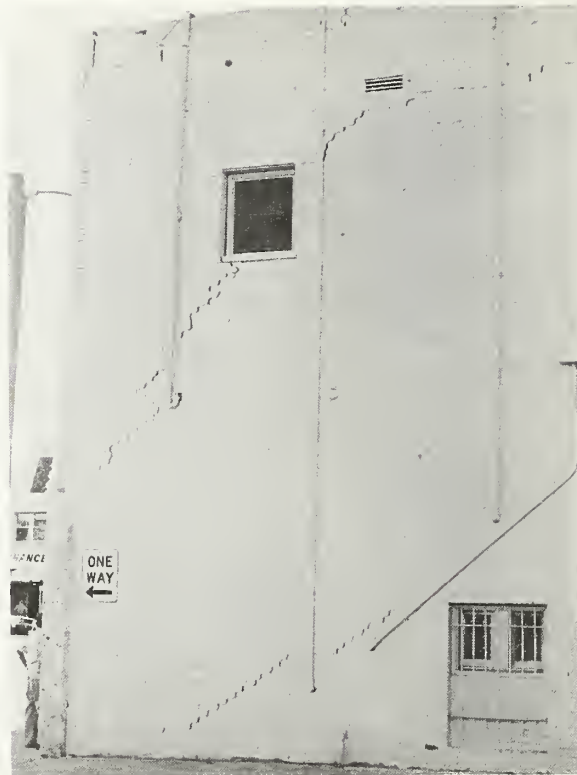
Figure 5.147 Typical diagonally cracked wall.

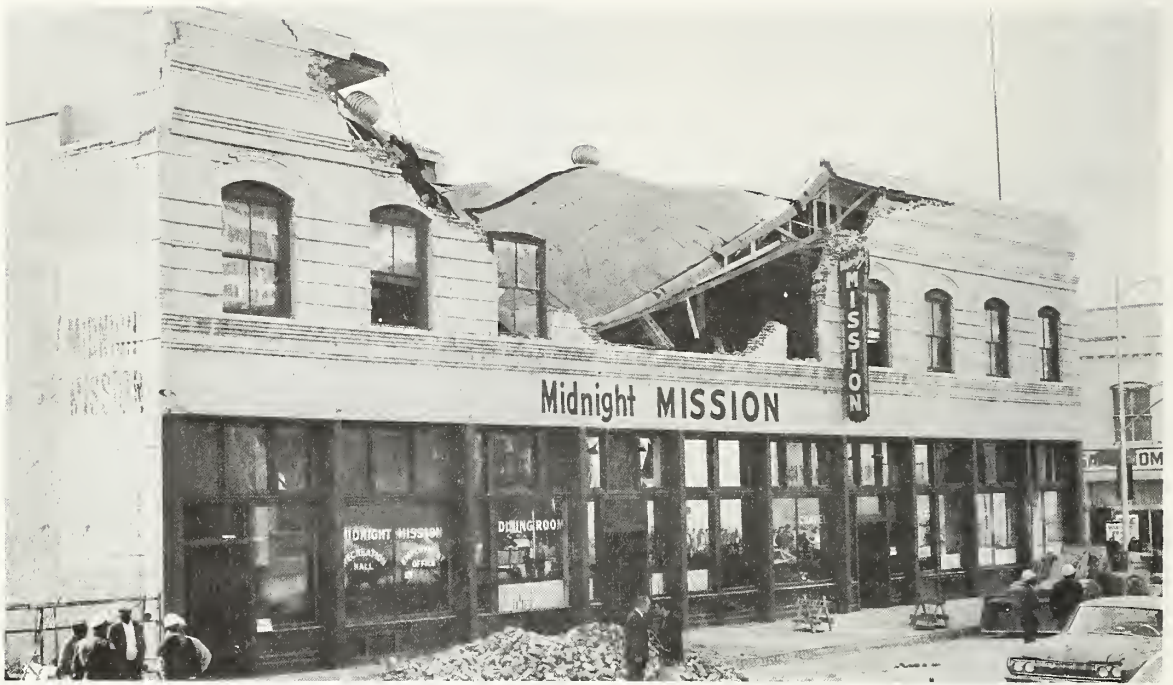
This damage, though severe, was not unexpected considering the type of construction. A similarly constructed building, the Midnight Mission, as far away as downtown Los Angeles was damaged as shown in figure 5.148. At this latter location one man was killed when he ran outside and was struck by falling masonry. Such falling objects are common and dangerous with the pre-1933 masonry construction. It is certainly not typical of modern reinforced masonry construction,

Figure 5.148 *Midnight Mission, 396 South Los Angeles Street, in downtown Los Angeles. This building, erected in 1896, provided shelter for about 200 men. One man was killed when he ran out of the front door and was struck by falling masonry. (Los Angeles Times Photo).*

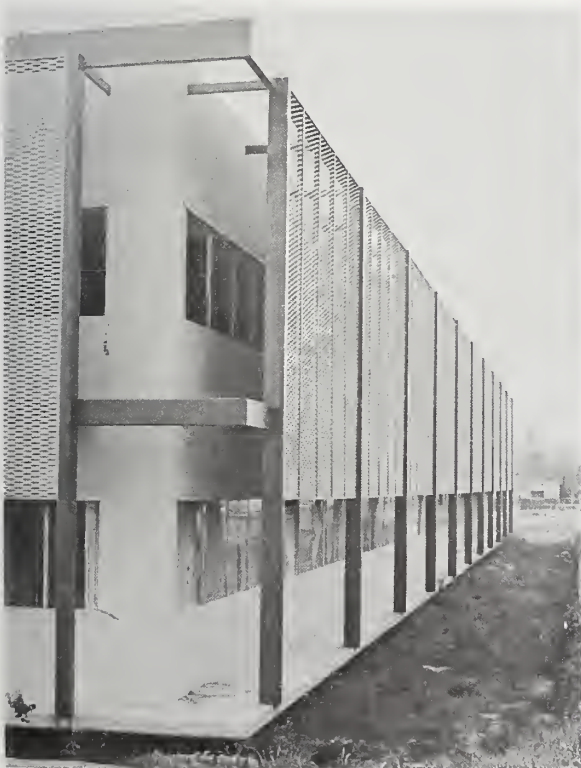
The Foothill Medical Center (see fig. 5.149 and fig. 5.150) is located on Van Nuys Boulevard at Dronfield Avenue, Pacoima. This structural steel frame building (about 65 ft by 200 ft in plan) had considerable glass breakage as shown in figure 5.151. There was also some damage to the stucco covered wood-frame exterior walls as shown in figures 5.151 and 5.152.

*Figure 5.151 East elevation
showing glass
breakage and
cracked exterior
walls.*

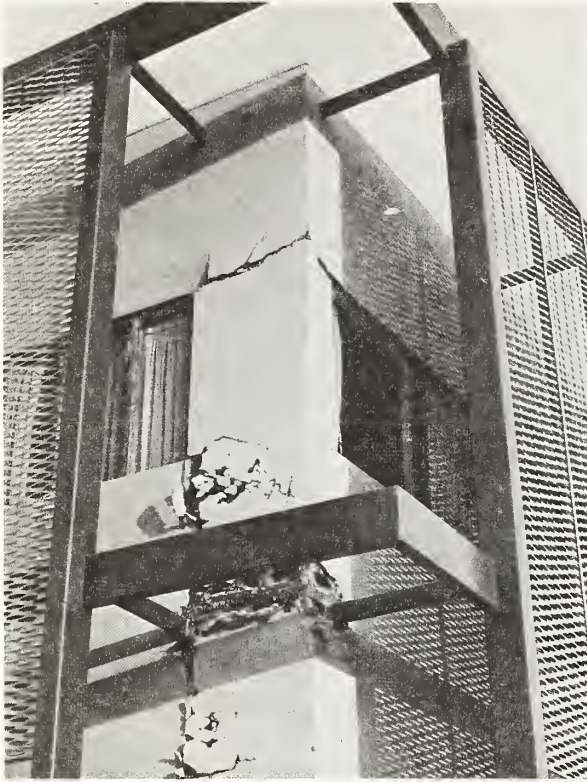
Figure 5.152 Corner damage to the stucco covered wood-frame exterior walls.

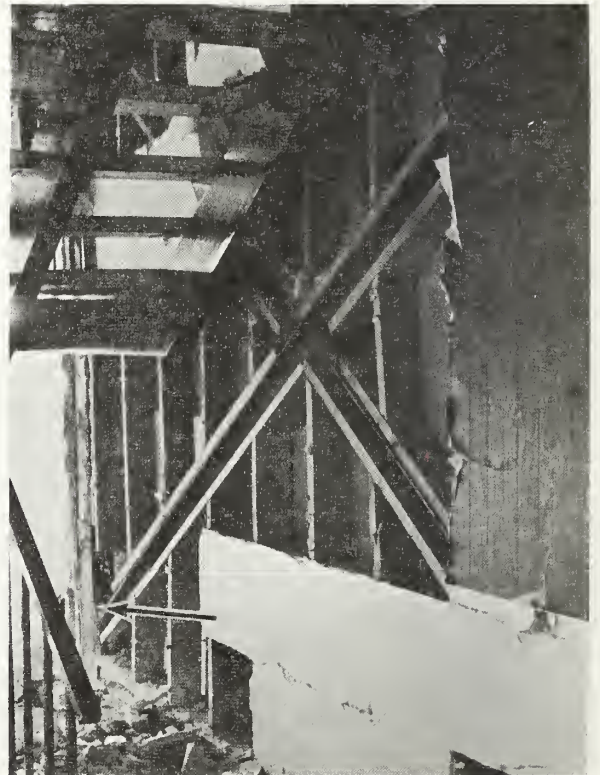
The wallboard had been removed near the entrance to examine the lateral bracing (fig. 5.153). While the bracing showed no evidence of damage, the exposure revealed local flange buckling of the steel column as indicated by the arrow. There was considerable damage to interior partitions and stairwells (fig. 5.154).

Figure 5.153 Interior view of lateral bracing. The arrows locates local flange buckling at the bottom of the steel column.

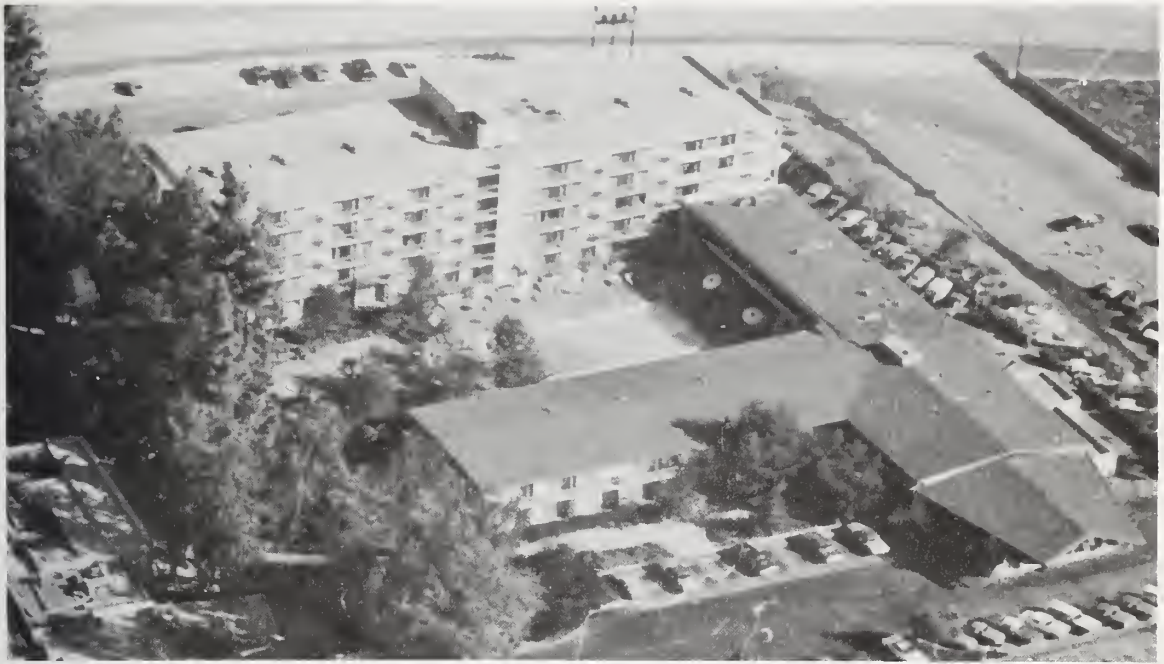
The nine-year old Sportsmen's Lodge Hotel shown in figure 5.156 is located on Ventura Boulevard near Coldwater Canyon Avenue. The complex consists of two buildings, one two-stories (60 ft x 170 ft) and one five-stories (68 ft x 240 ft) high. Construction is reinforced concrete masonry bearing wall and precast reinforced lightweight concrete slabs. This structure had only minor damage consisting of some cracked plaster and one broken window.

Figure 5.156 Aerial view of Sportsmen's Lodge Hotel.

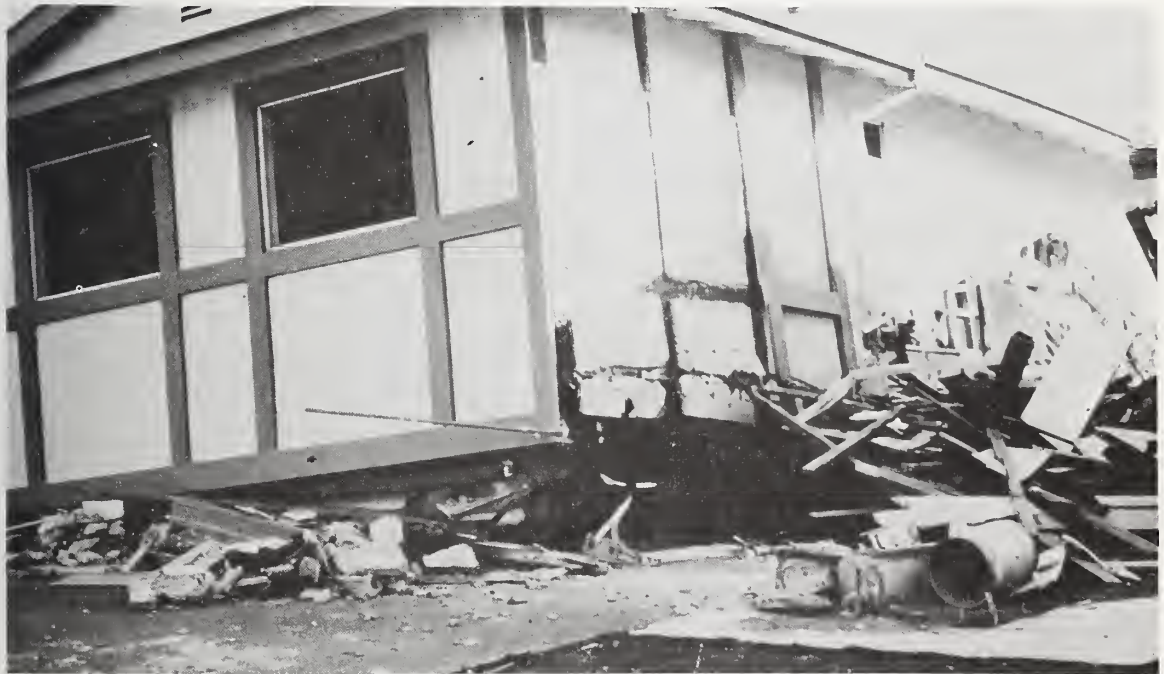
Split-level houses frequently collapsed as in the case of the house shown in figure 5.157 (map 3, location 5). This house was similar in appearance to the one shown in figure 5.158 which was not damaged. Other damaged split level houses (map 3, location 6) are shown in figures 5.159, 5.160, and 5.161. A similar house located slightly farther south (map 3, location 12) is shown in figure 5.162. In general, split-level or irregularly-shaped houses that were not adequately tied at the changes in roof or floor elevation were severely damaged either by collapse or at the junction of the wings (fig. 5.161). Collapse frequently occurred due to a wide open-space provided by the garage door in the end wall, which offered little lateral resistance (fig. 5.162).

Figure 5.157 Collapsed split-level residence at Fenton Avenue and Tyler Street.

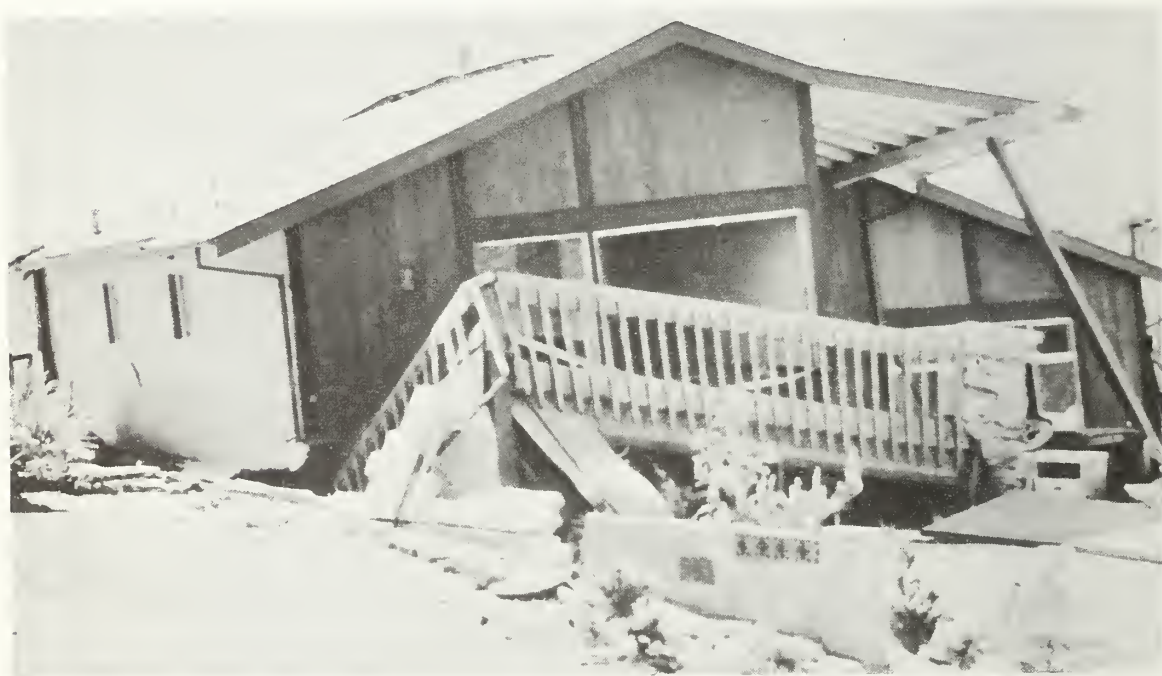
Figure 5.159 Collapsed split-level residence at Almetz Street and Leedy Avenue.
