BUILDING SCIENCE SERIES 40

Engineering Aspects of the 1971 San Fernando Earthquake

This report presents the observations of the NBS on-site inspection team (most photographs in this report were taken by the team). The material presented herein is intended to serve as (1) a documentation of damage resulting from the earthquake and (2) as a source document for further studies, research, and recommendations. This is particularly important as necessary remedial work and restoration have resulted in the removal of evidence that is essential for studies and evaluations.

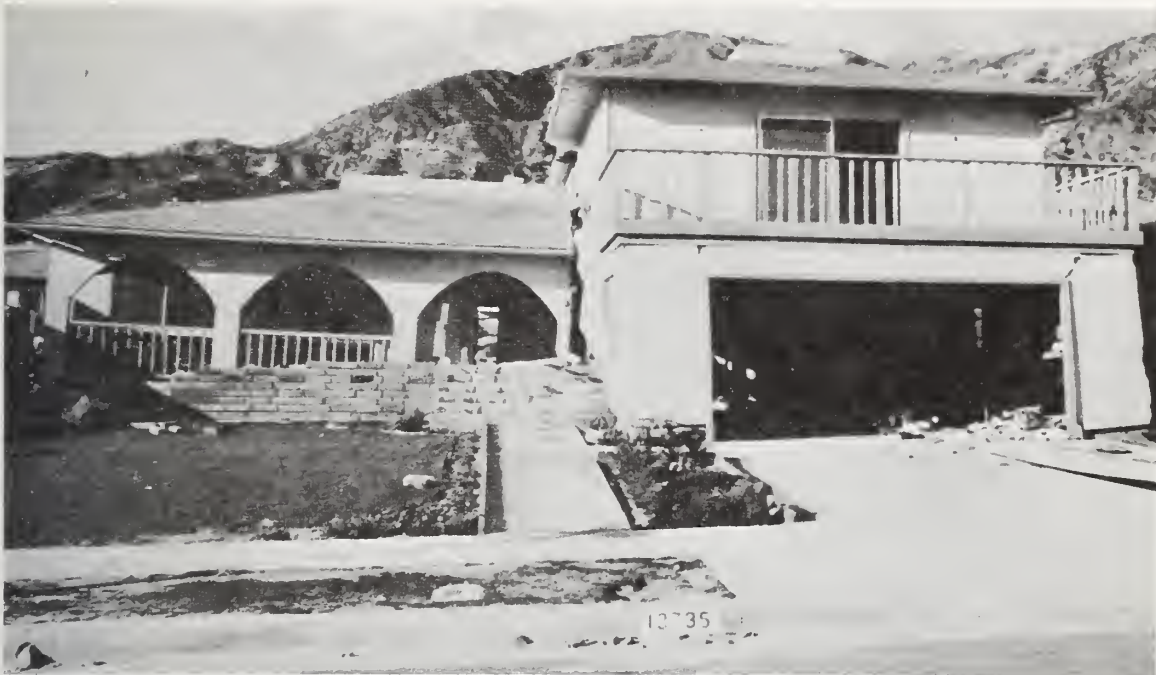
Figure 5.160 Damaged split-level residence at Aldergrove Street and Leedy Avenue.

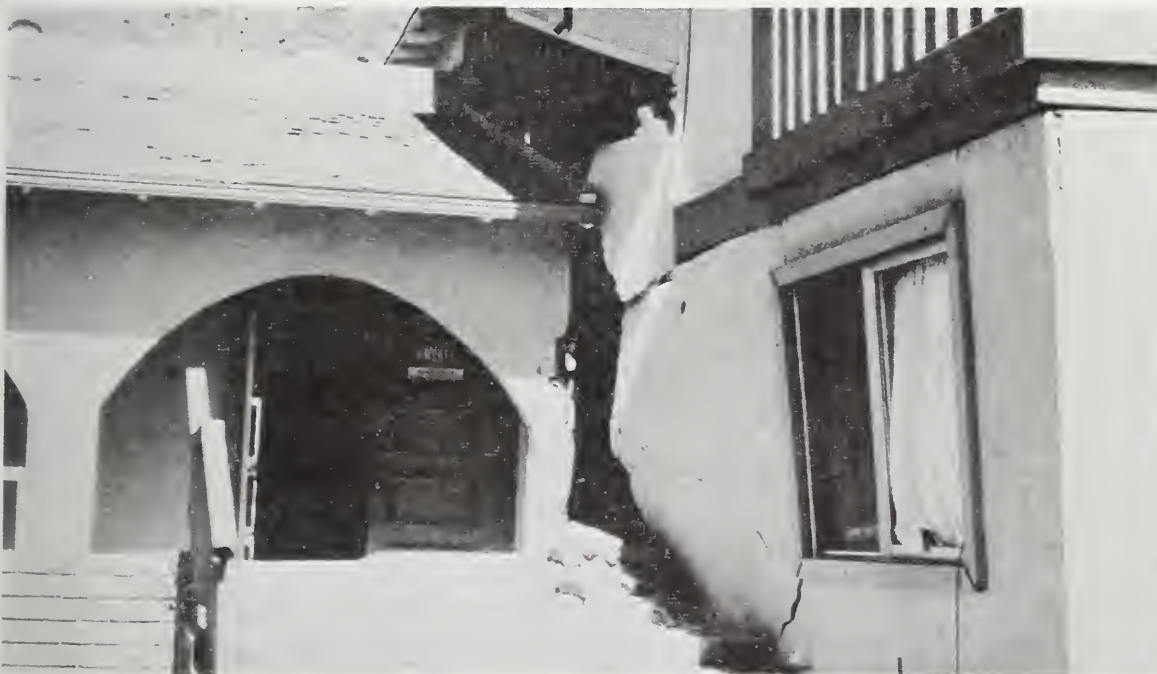
Figure 5.161 Closeup of damaged split-level residence shown in figure 5.160.

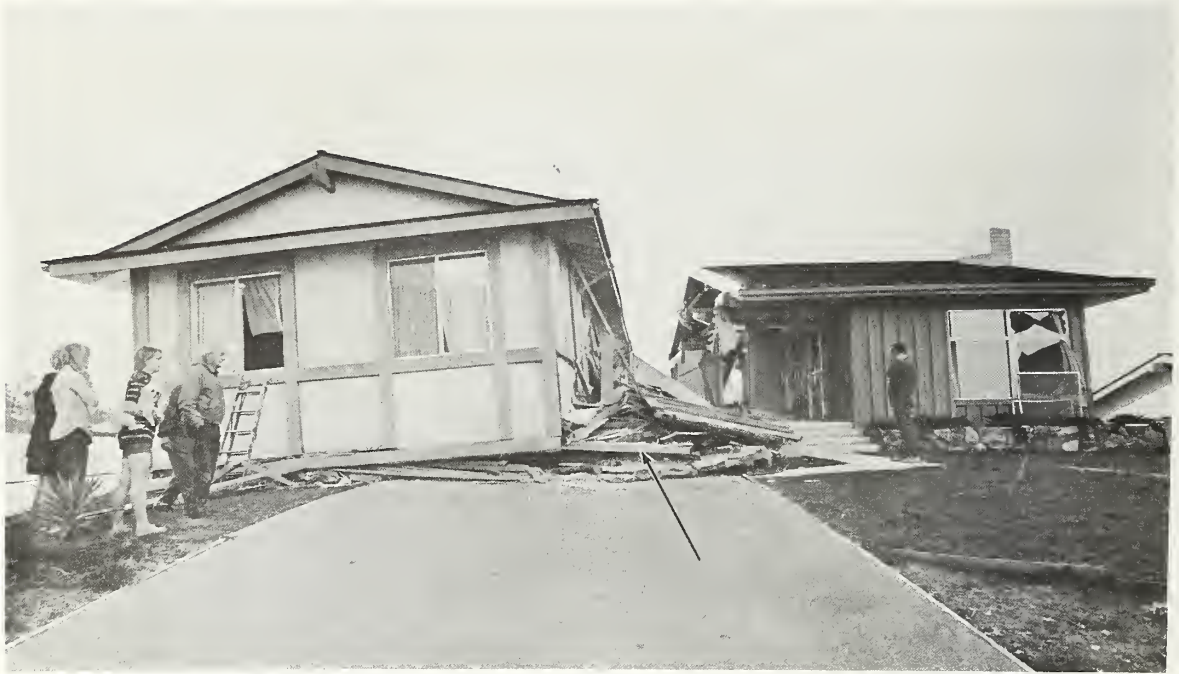
Split-level houses frequently collapsed as in the case of the house shown in figure 5.157 (map 3, location 5). This house was similar in appearance to the one shown in figure 5.158 which was not damaged. Other damaged split level houses (map 3, location 6) are shown in figures 5.159, 5.160, and 5.161. A similar house located slightly farther south (map 3, location 12) is shown in figure 5.162. In general, split-level or irregularly-shaped houses that were not adequately tied at the changes in roof or floor elevation were severely damaged either by collapse or at the junction of the wings (fig. 5.161). Collapse frequently occurred due to a wide open-space provided by the garage door in the end wall, which offered little lateral resistance (fig. 5.162).

Figure 5.162 Split-level residence, Sylmar. Note crushed car (arrow). (Los Angeles Times Photo).

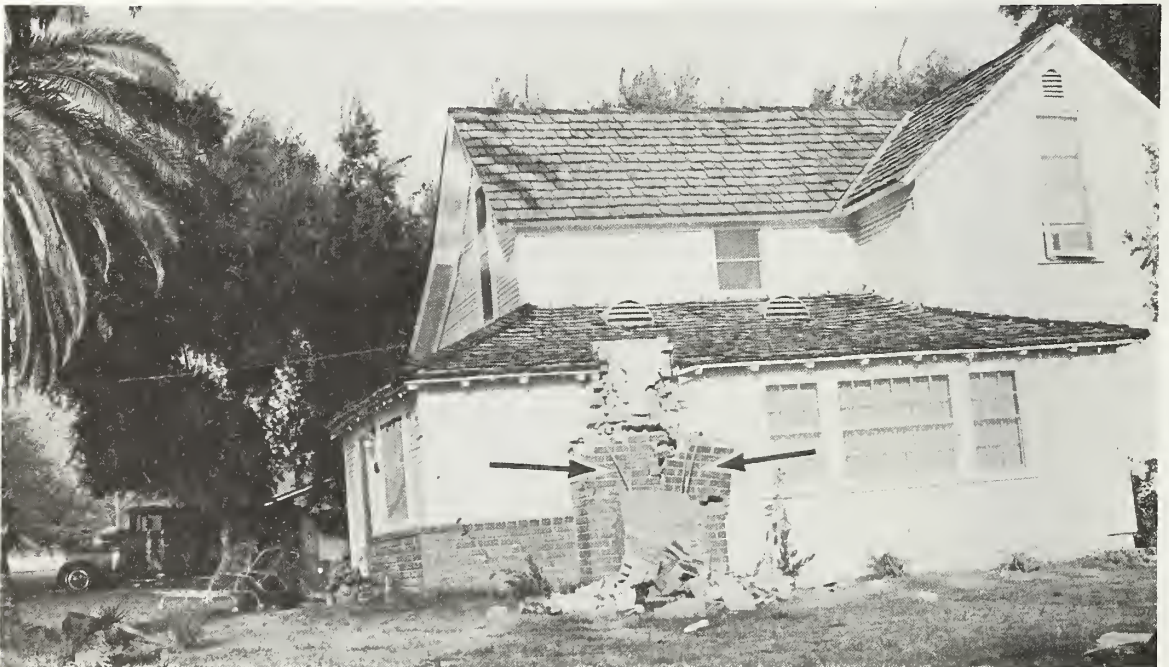
Masonry chimneys on many residences collapsed as shown shown in figure 5.163 (map 3, location 10). Leaning chimneys were not uncommon as shown in figure 5.164 (map 3, location 11) when they were properly reinforced but inadequately tied to the house. Note the collapsed masonry fence in front of the house.

Figure 5.163 Damaged reinforced brick masonry chimney (arrows indicate reinforcement).

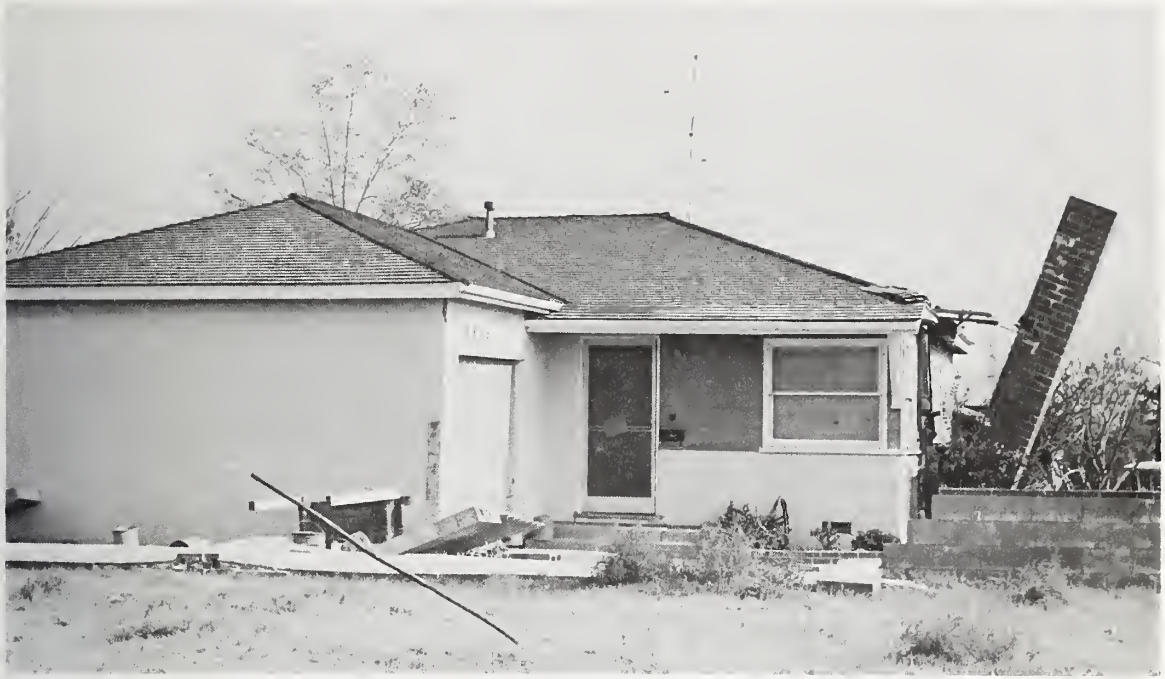
Figure 5.164 Leaning reinforced brick masonry chimney.

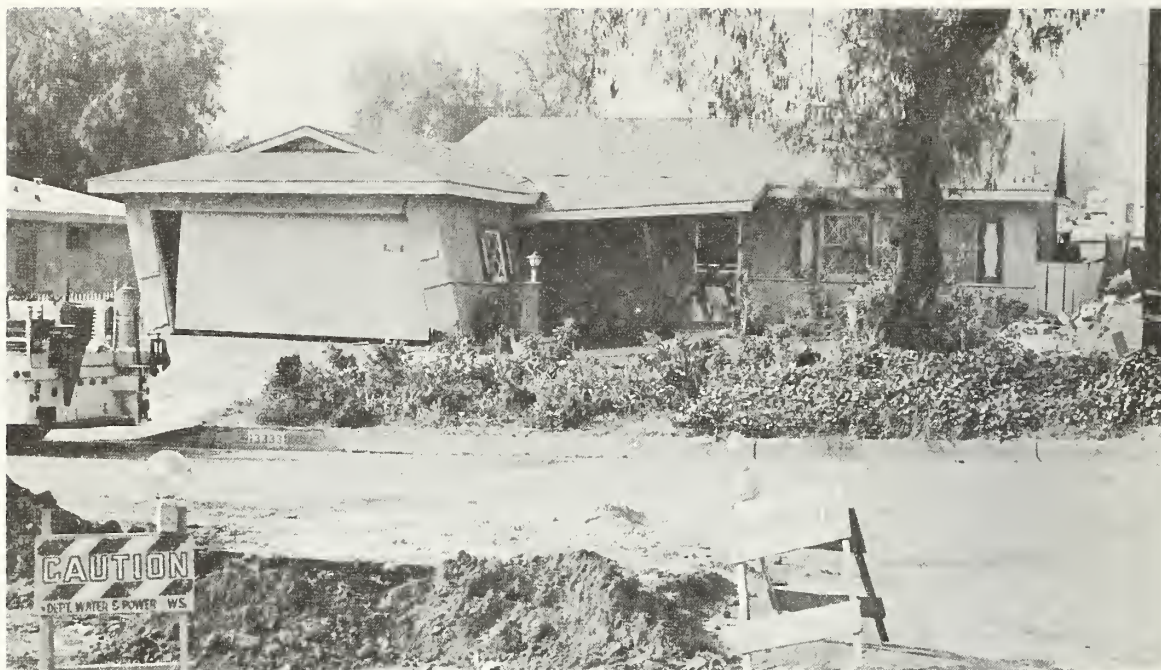
Figure 5.166 Damaged single family residence.

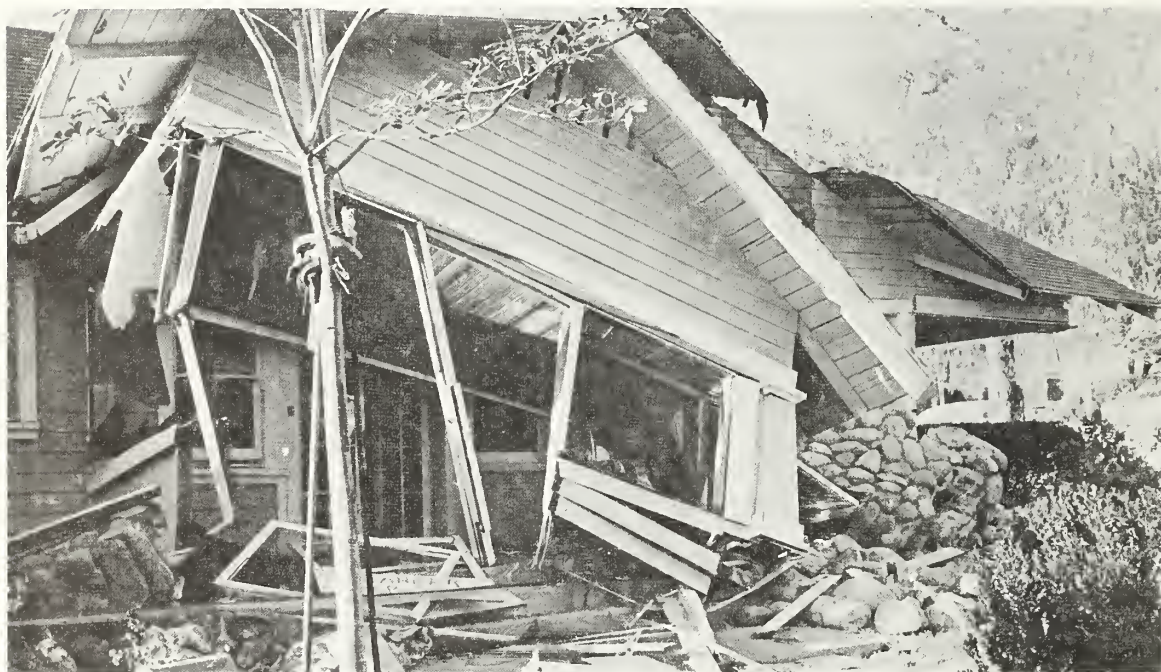
Figure 5.167 Destroyed wood-frame house.

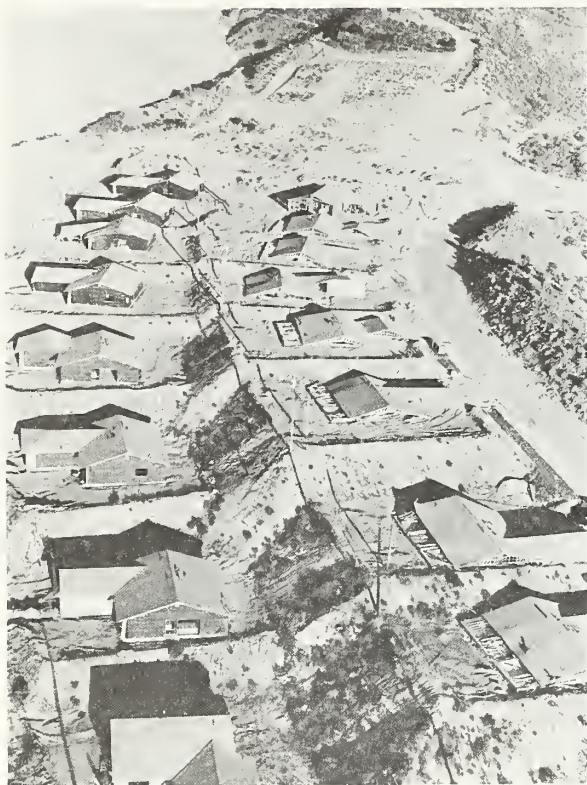
One group of partially completed residences located east of and adjacent to the San Fernando Veterans Hospital (map 3, location 8) was heavily damaged as shown in figure 5.168. The frames and roofs were essentially complete at the time of the earthquake. The walls of the houses on the left were covered with wire mesh and paper backing which was to be covered with stucco (in a few cases decorative plywood panels were also installed). This covering was essentially the only difference from the houses on the right which collapsed. It appears that a very nominal amount of material furnished considerable lateral support. (The house in the right rear background which did not collapse was apparently no different than those which did collapse. The reason it remained standing is not known.) A partially collapsed house is shown in figure 5.169.

Figure 5.168 Housing development under construction.

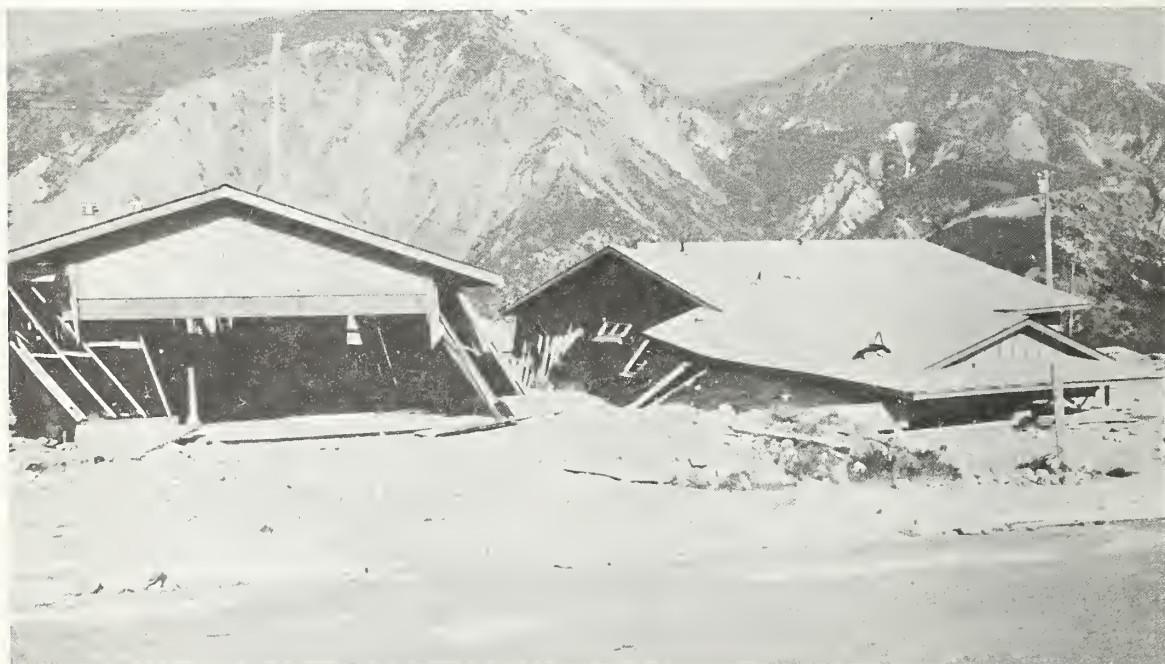
Figure 5.169 Partially collapsed houses under construction.

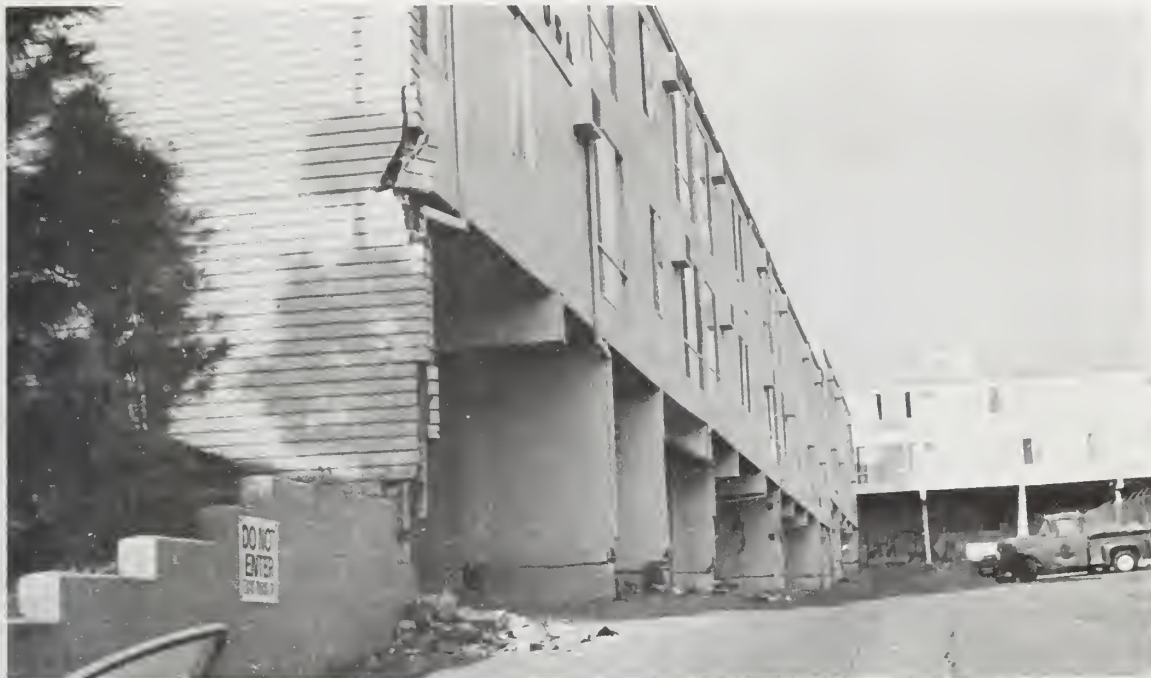
Apartments differ little in construction from houses. The "Friday USA" Apartments (map 3, location 14) suffered severe damage as shown in figure 5.170 due to little lateral resistance provided by large open-garage areas in the first floor. The Mardette Apartments (map 3, location 16) were similarly damaged as shown in figures 5.171 and 5.172. The wide open parking areas and entranceways provide little lateral resistance as in the case of split-level houses previously discussed.

Figure 5.170 Rear view of damaged three-story "Friday USA" apartment building.

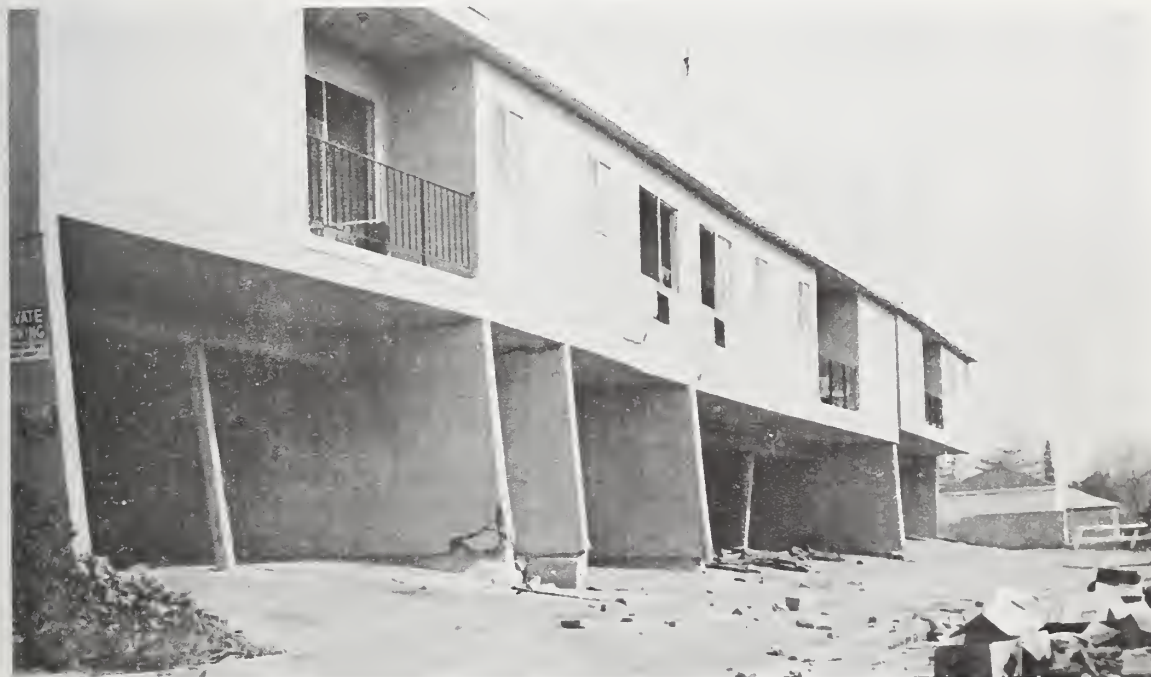
Figure 5.171 Rear view of damaged two-story Mardette apartment building.

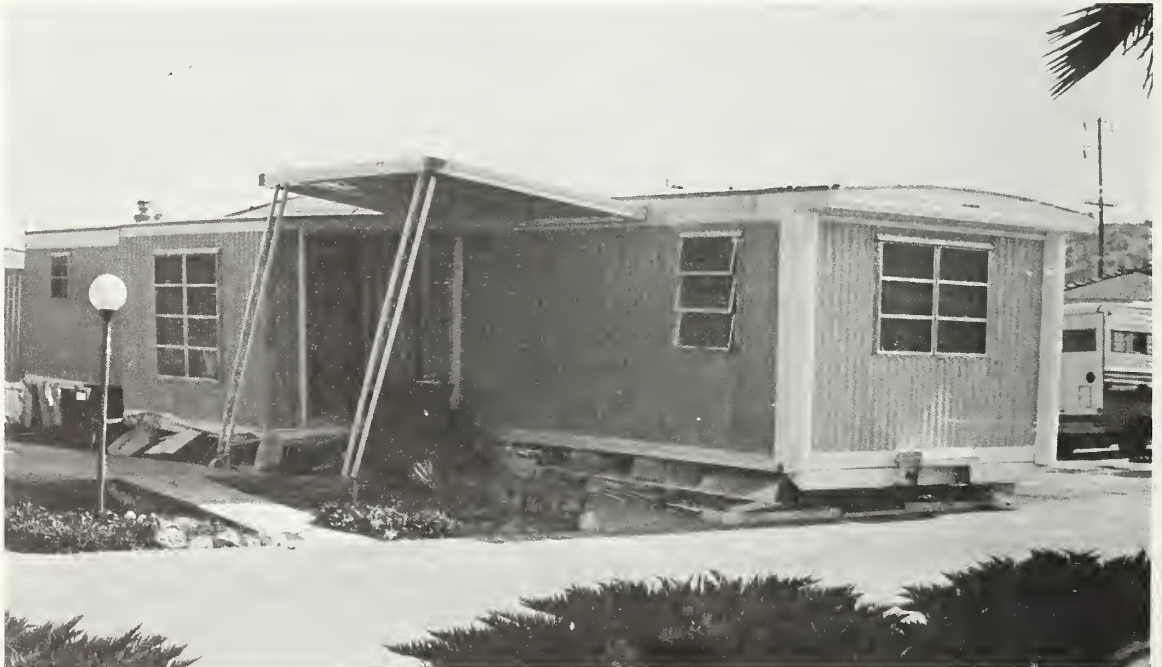
Typical damaged mobile homes are shown in figure 5.173 (map 2, location 1) and figure 5.174 (map 2, location 3). These homes are usually supported on small concrete or metal base supports. Metal curtain walls around the base were usually damaged when trailers moved sideways (there is little to resist lateral movement since these homes are usually not attached to the base supports). Frequently considerable damage was caused by the supports subsequently punching through the floor.

Figure 5.173 Mobile home (Soledad Canyon Road, Newhall) which was damaged when it fell off its small concrete and metal base supports.

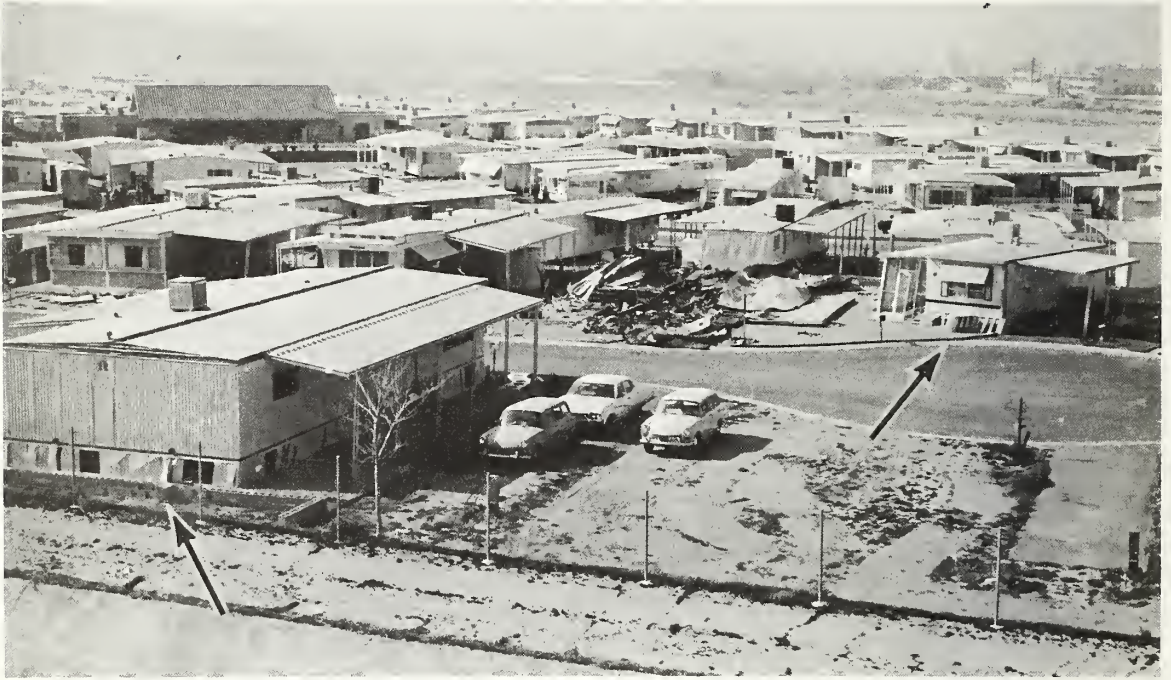
Figure 5.174 Mobile home park located along Sierra Highway 14 in Newhall. At the center of the figure are the remains of a home which was completely destroyed by fire. Note damaged metal curtain walls around the bases of the mobile homes (arrows).

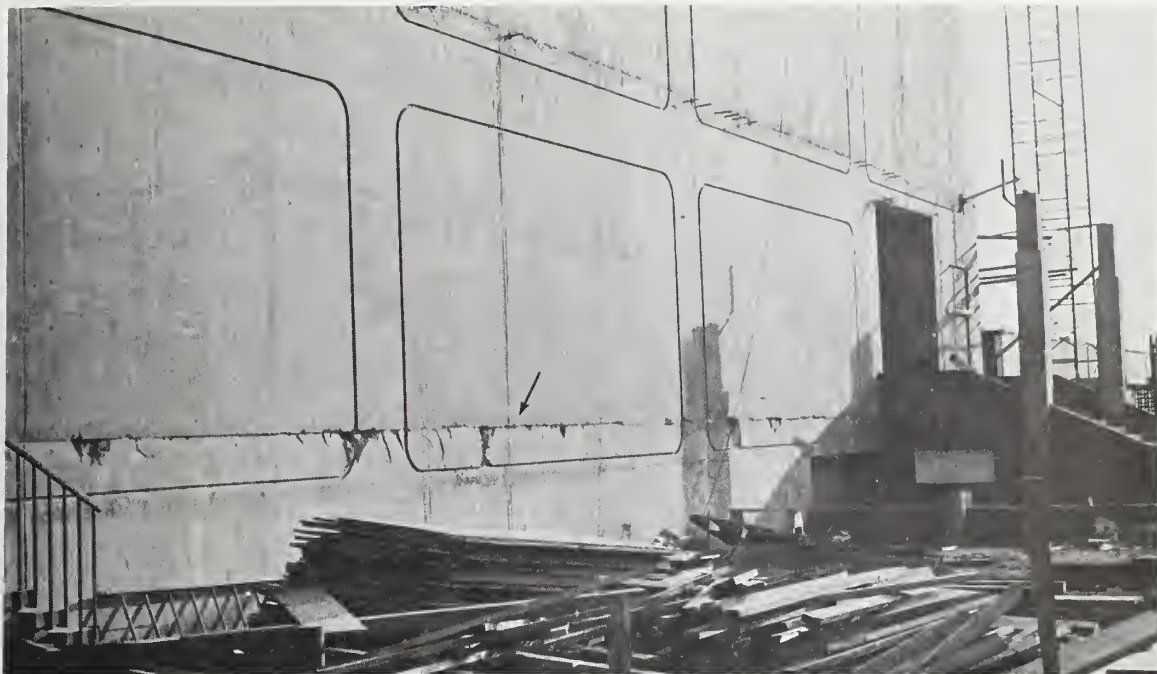
Damage noted on the building exterior consisted primarily of horizontal cracks and concrete spalling along the construction joints (fig. 5.176 and 5.177) and at the building corners (fig. 5.178). The penthouse free-standing cantilever concrete walls were only 12 hours old at the time of the earthquake but suffered no damage.

Figure 5.176 Horizontal crack along the construction joint at the base of the structure.

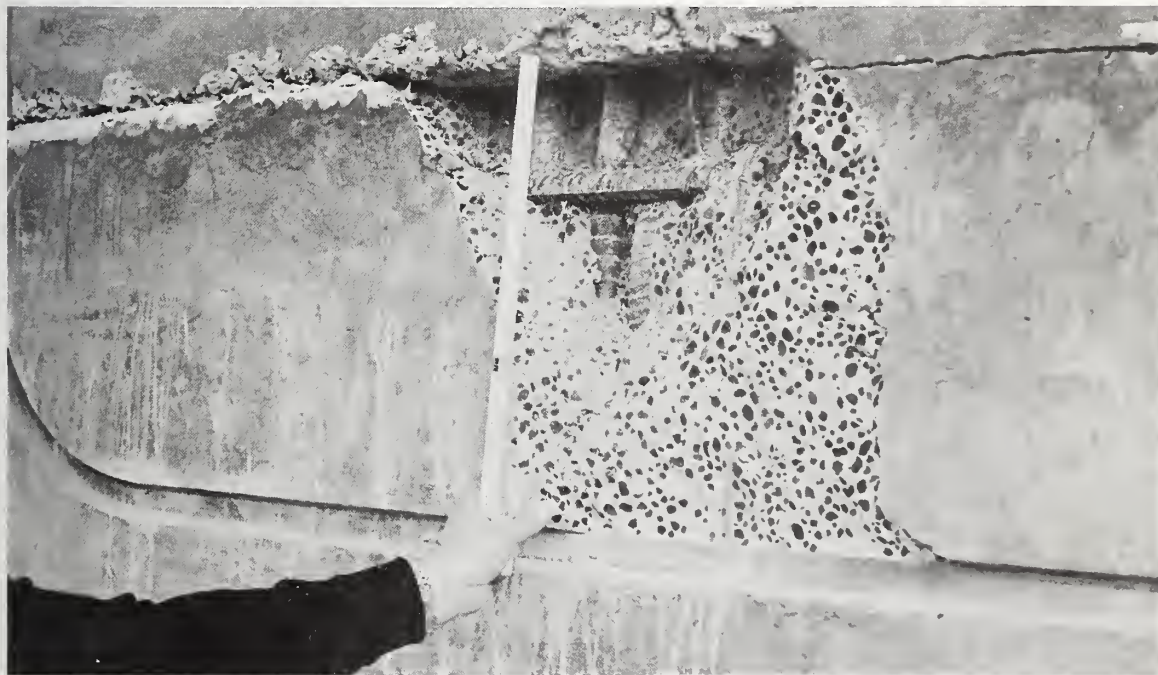
Figure 5.177 Damage to the exterior surface of the concrete wall along the construction joint.

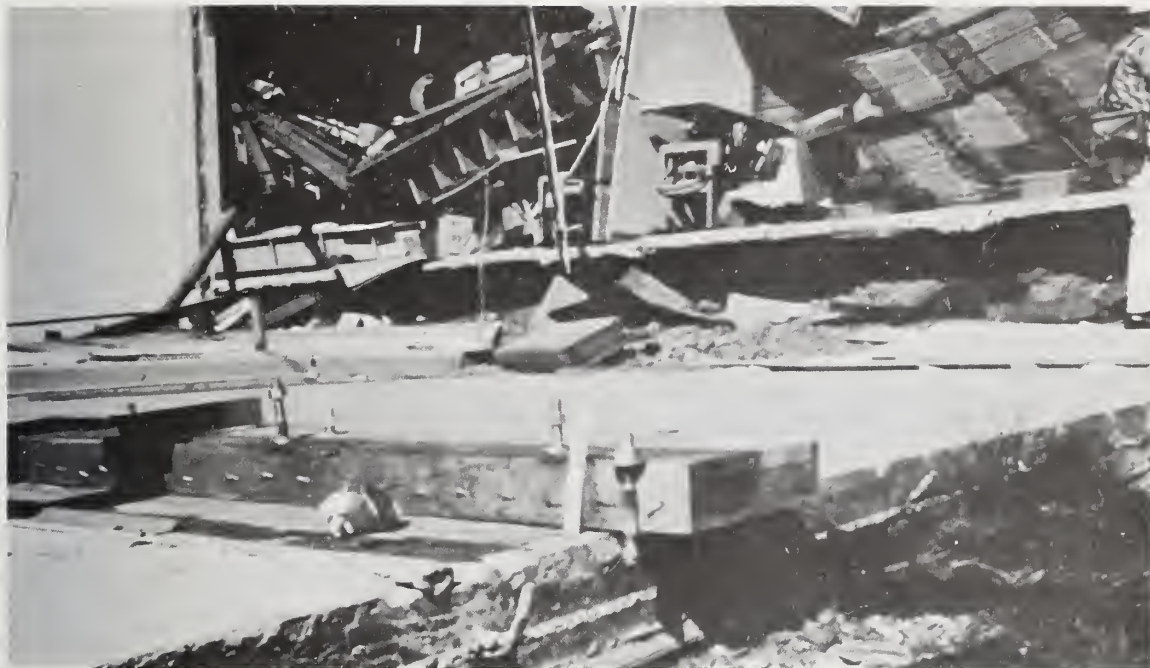
This industrial park comprised of some 30 small industrial buildings located at the northeast corner of the City of San Fernando. The complex was located in the region of strong ground motion with evidence of vertical ground displacement of as much as three feet. The primary cause of damage to many buildings, therefore, can be attributed to permanent ground displacement and faulting (see figs. 5.180 and 5.181).

Figure 5.181 Ground displacement caused separation of two walls.

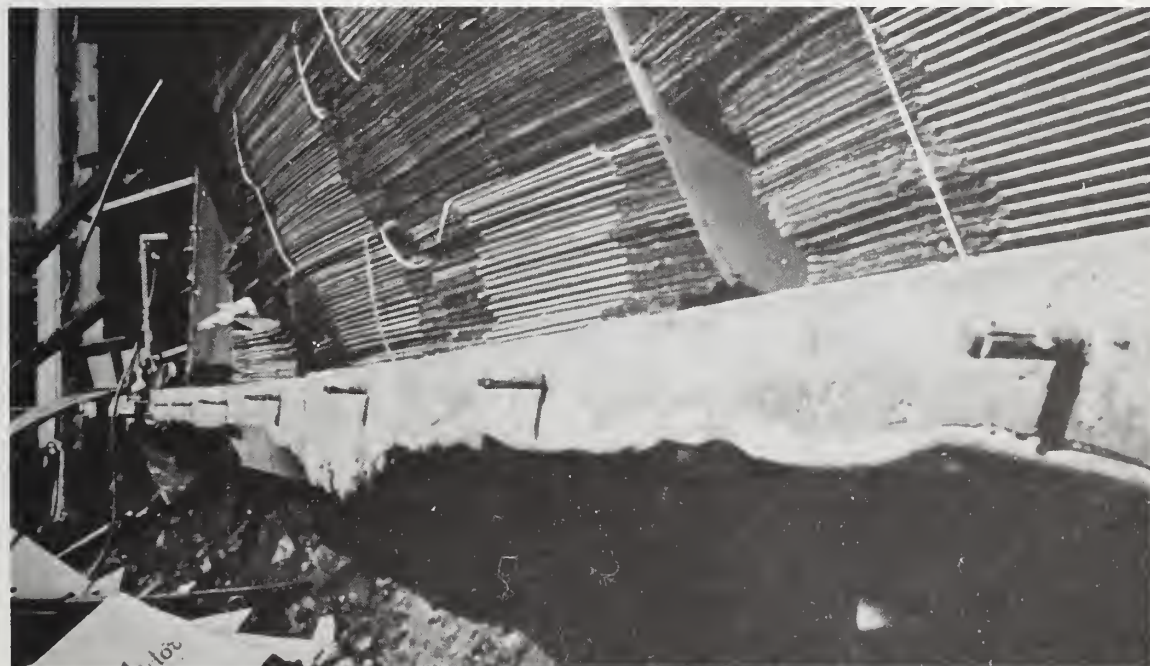
away from the roof and floor, thereby causing the roof to collapse. A typical failure is shown in figure 5.182.

Figure 5.182 The roof collapsed when the exterior wall pulled away.

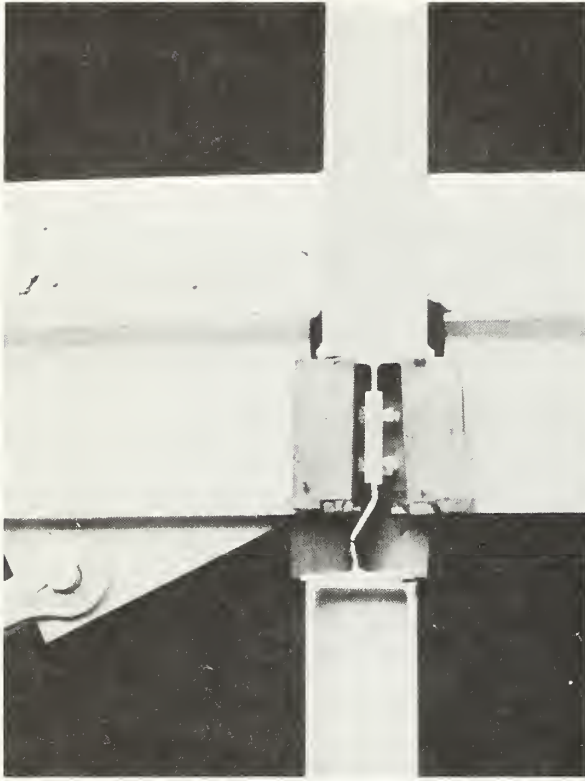
Damage to the structure was confined to web crippling of some of main floor beams to which diagonal braces were attached. Positions of damaged beams with respect to diagonal braces and a close-up view of a damaged beam are

Figure 5.185 Location of damaged floor beams (arrows).

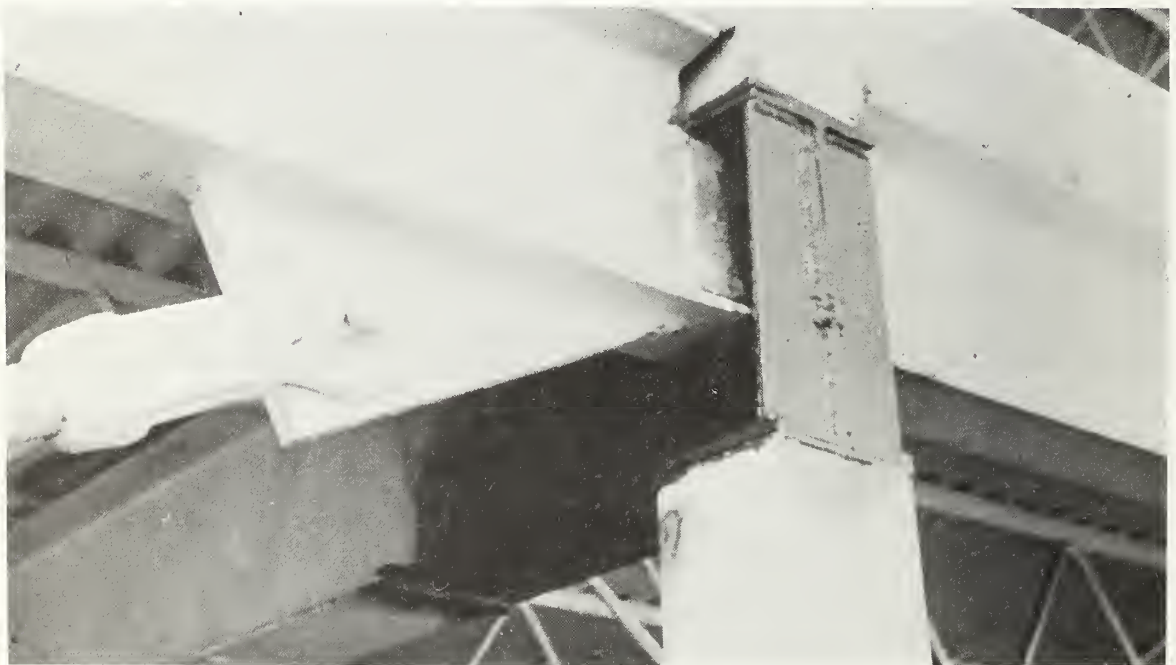
shown in figures 5.185 and 5.186. It is clear from these photographs that no vertical stiffeners were provided at the support. Figure 5.187 shows a typical repaired beam. Two vertical stiffeners were added to the beam and bottom half of the crippled web and the flange was replaced with a new section over the support. Initial installation of vertical stiffeners at a cost far less than the repair cost could have prevented the web from crippling.

Figure 5.186 Close-up of damaged floor beam. Wood blocks were used to provide temporary support.

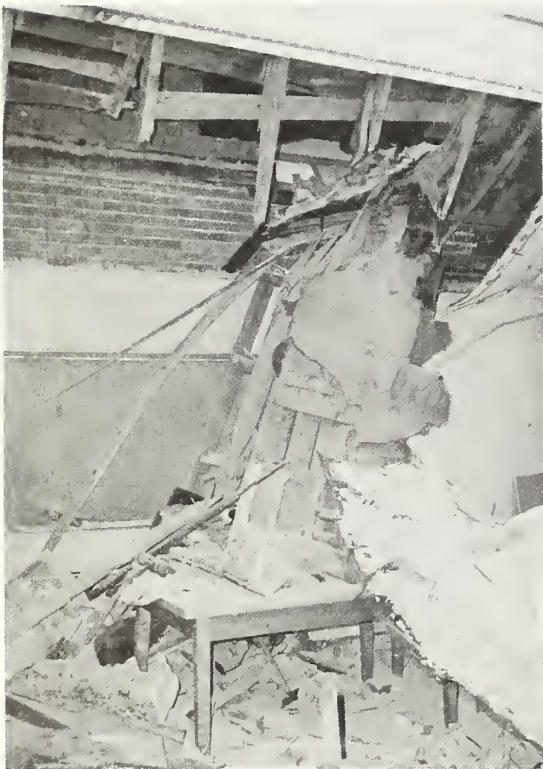
Figure 6.3 A portion of the parapet wall fell through the roof and came to rest on a table, Los Angeles High School.

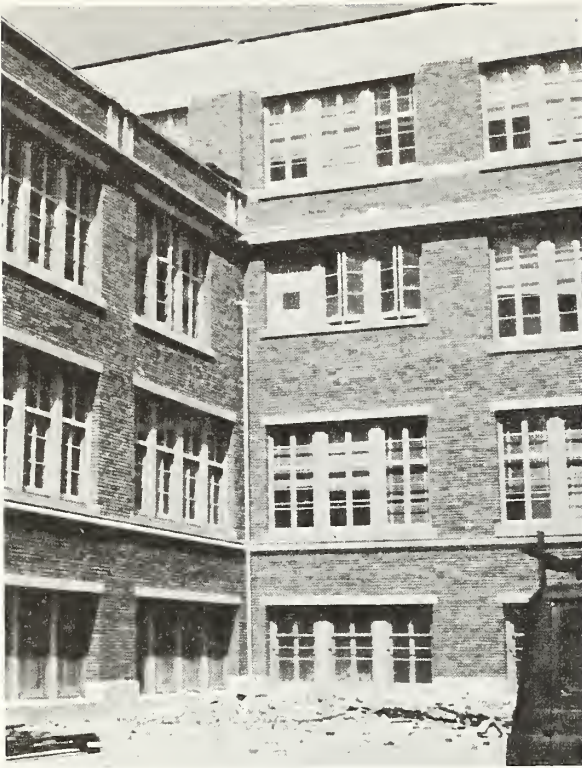
Figure 6.4 Brickwork fell from the parapet into the courtyard, Los Angeles High School.

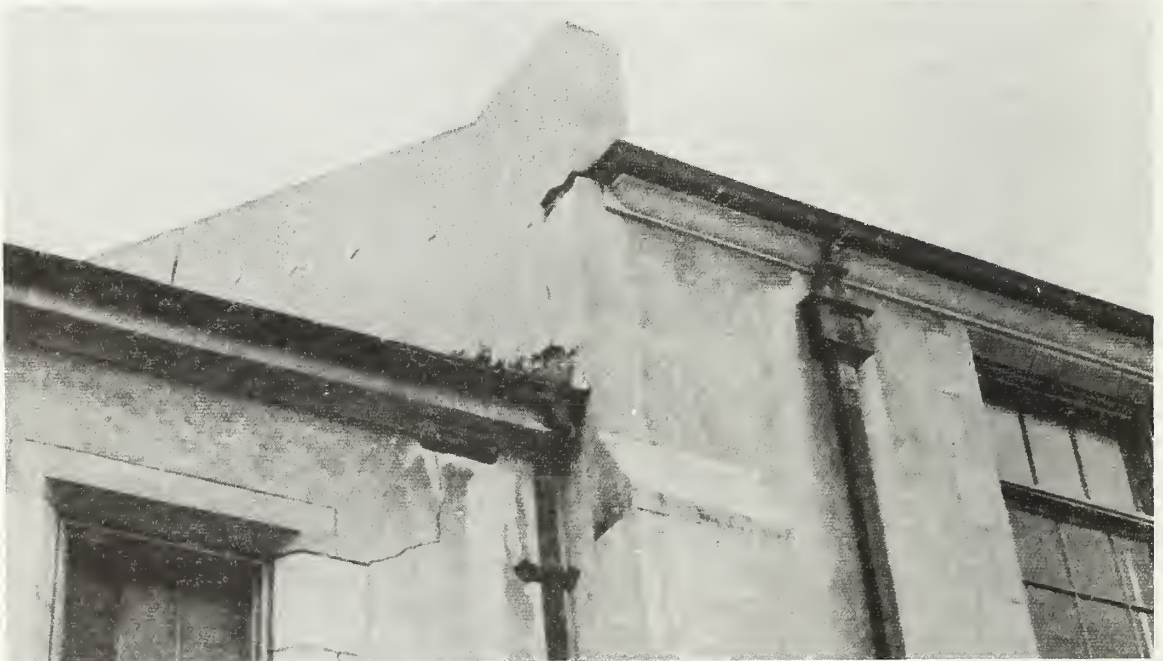
Figure 6.5 Brick walls sustained serious cracking, Morningside School Building #2.

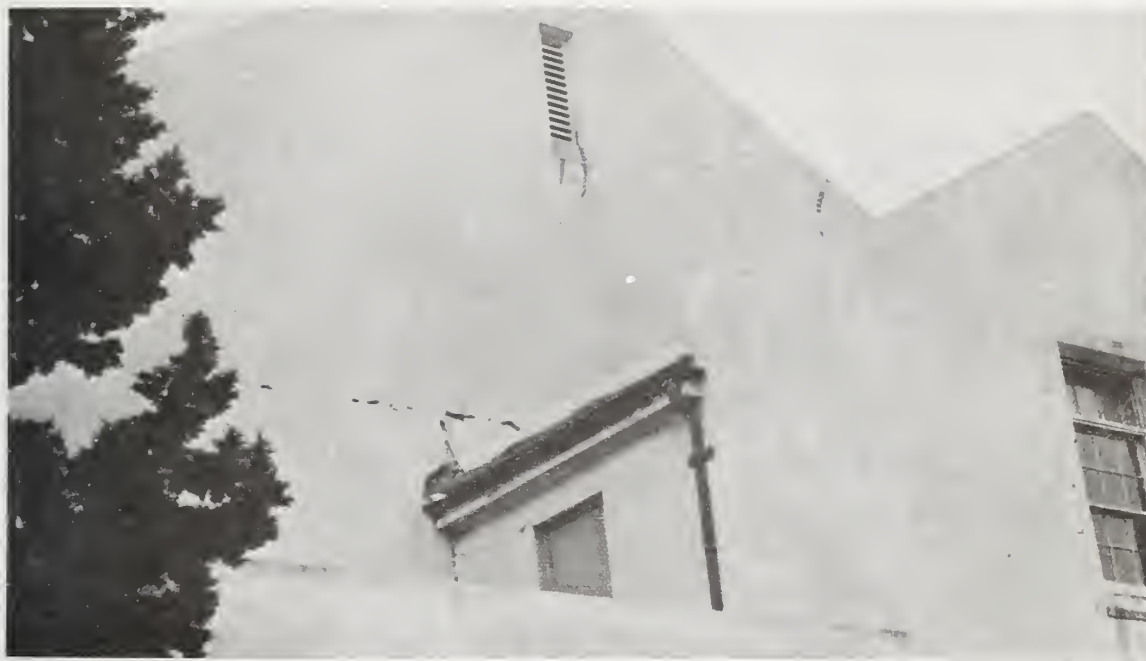
The structure was a two-story double loaded corridor classroom building 60-ft wide and 100-ft long with unreinforced brick bearing walls laid in lime mortar. The structure had a wood framed gable roof covered with heavy slate roofing, wood framed floors in the classrooms, and concrete slabs in the corridor. The walls were unreinforced brick with a concrete bond beam at the roof. The building rested on spread footings. The structure did not collapse, but sustained serious cracking of the brick walls (fig. 6.5), brick separated at the bond beam and was displaced at the gable end (fig. 6.6). The building has been abandoned and was demolished.

Figure 6.6 Brick wall was displaced at the gable end, Morningside School Building #2.

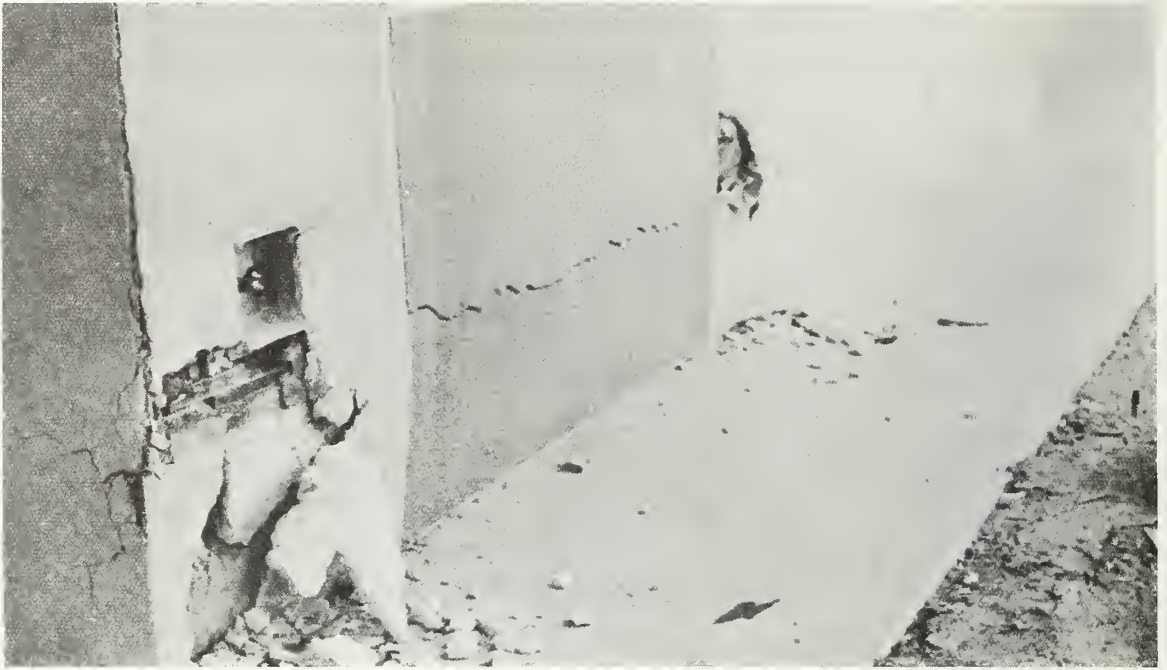
Figure 6.12 Displaced bearing wall, Van Gogh Street School.

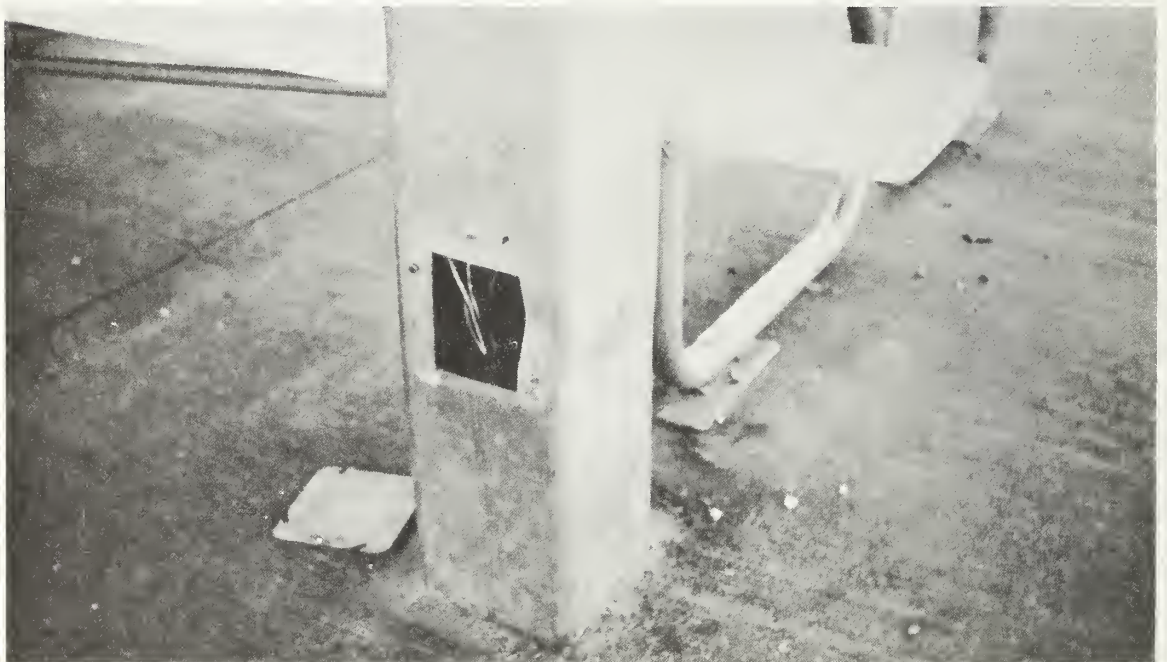
Figure 6.13 Lunch shelter columns were permanently bent at opening for electrical outlet box, Van Gogh Street School.

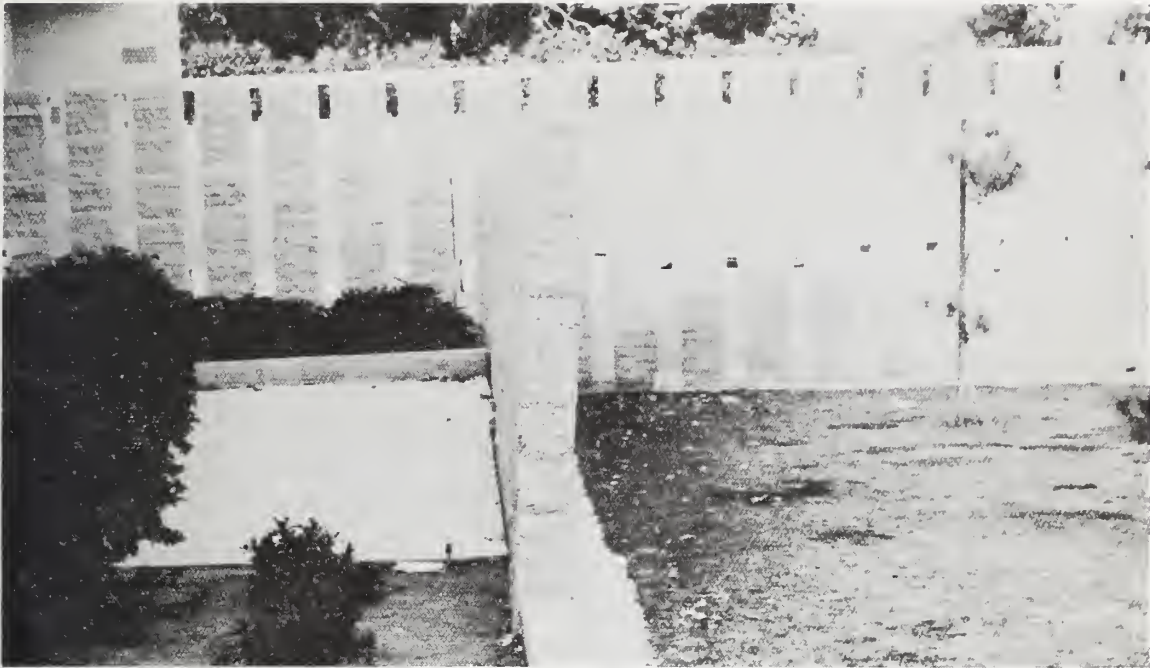
Figure 6.14 Cantilever concrete block garden wall leaned approximately ten degrees, Van Gogh Street School.

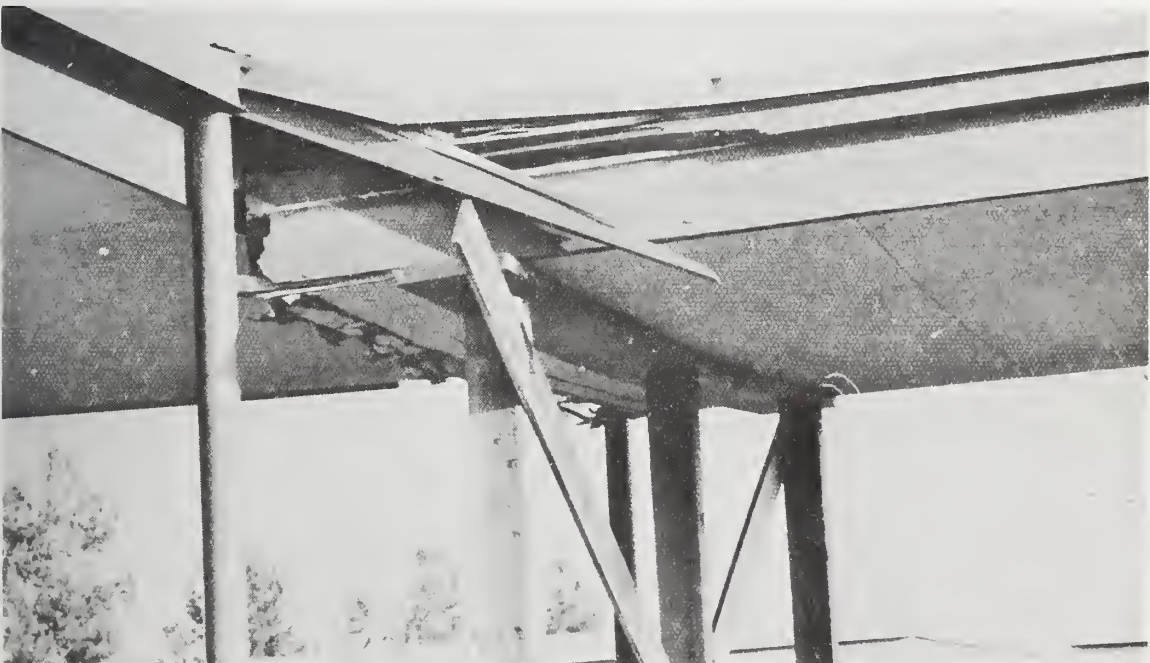
Principle structural damage was caused by the differential stiffness of the buildings and the covered arcades. The arcades pulled loose both from the buildings and from each other and distorted their supporting pipe columns (fig. 6.15 and 6.16). There was a slight spalling of the gymnasium prestressed-concrete roof member where a steel cross beam was attached to support gymnastic equipment (fig. 6.17). The ground under the gymnasium subsided approximately 1 1/2 in leaving a void beneath the slab on grade adjacent to the

Figure 6.15 Arcades pulled loose from each other at Sylmar High School.

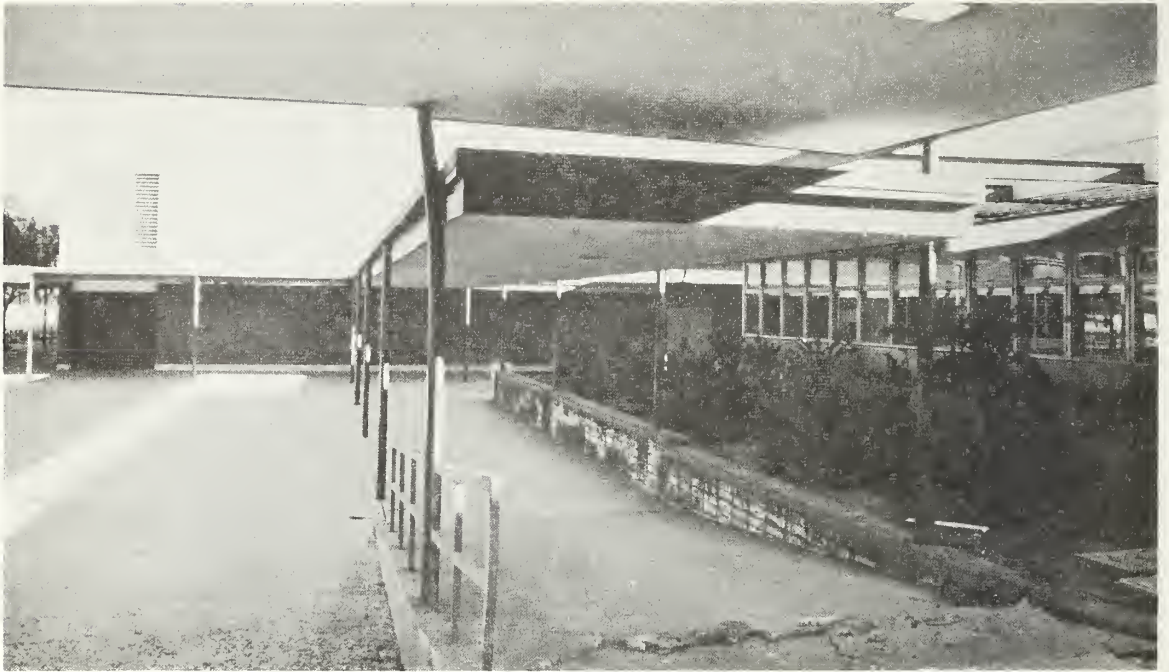
Figure 6.16 Distorted pipe columns at arcade, Sylmar High School.
