BUILDING SCIENCE SERIES 40

Engineering Aspects of the 1971 San Fernando Earthquake

This report presents the observations of the NBS on-site inspection team (most photographs in this report were taken by the team). The material presented herein is intended to serve as (1) a documentation of damage resulting from the earthquake and (2) as a source document for further studies, research, and recommendations. This is particularly important as necessary remedial work and restoration have resulted in the removal of evidence that is essential for studies and evaluations.

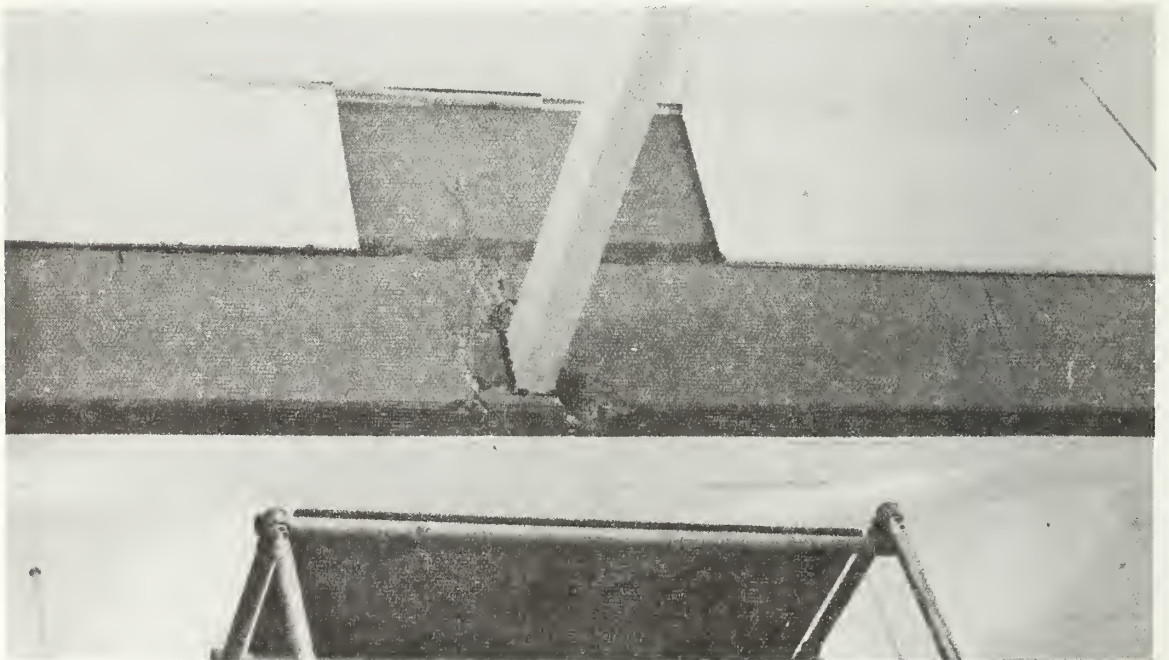
Figure 6.17 Spalled prestressed concrete roof member at gymnastic equipment support, Sylmar High School.

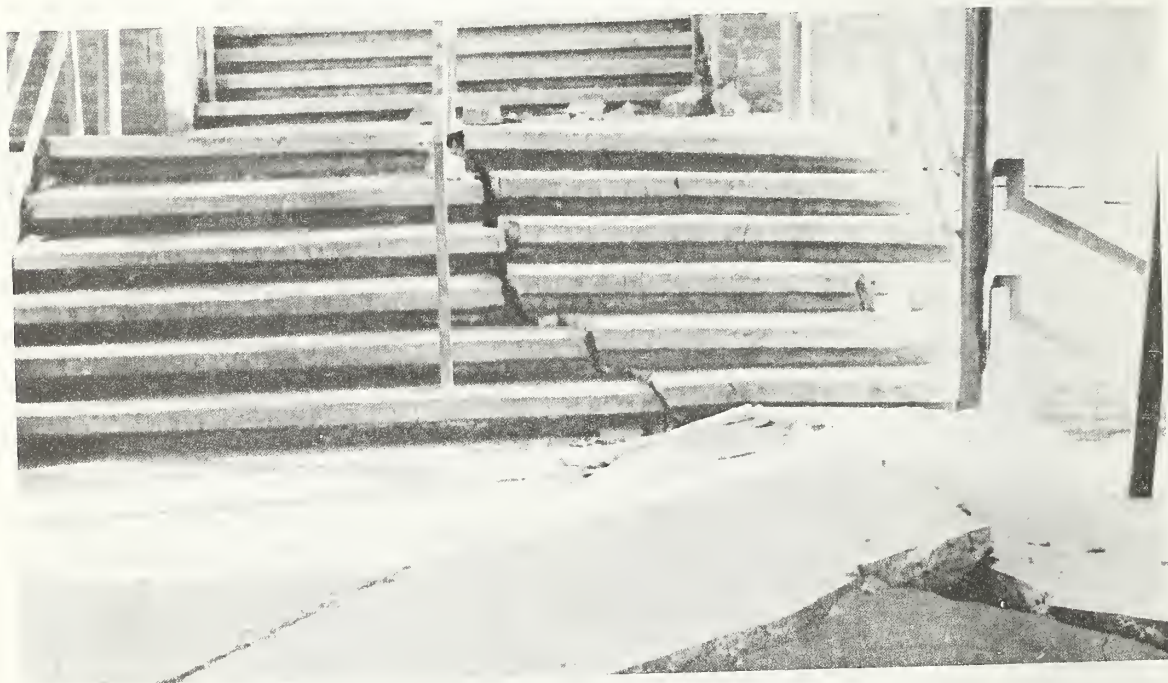
walls. The floor slab sagged down toward the middle of the room. The gymnasium walls which rested on piles did not subside. Slabs on grade were extensively cracked and buckled (fig. 6.18 and 6.19). The interior supporting piers for the structural floor in the kitchen were severely damaged and shoring was required to provide for safe occupancy. A reinforced grouted brick transformer vault, constructed partially below grade, was extensively damaged. There was considerable damage to lighting fixtures, acoustical ceilings, and plaster. The school is presently occupied.

Figure 6.18 Slabs on grade were extensively cracked and buckled, Sylmar High School.

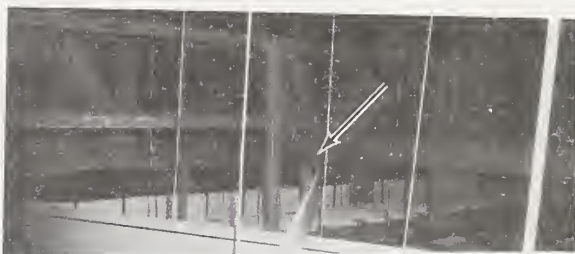
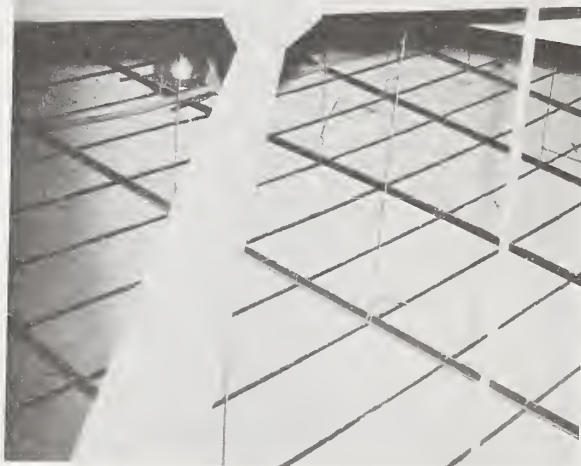
There was limited structural damage; in the gymnasium, the diagonal rods in the horizontal bracing system pulled out of clevises where oversized clevises were erroneously installed (fig. 6.20). In the auditorium several 5x3 angles in the horizontal bracing system buckled (fig. 6.21).

Figure 6.20 Horizontal bracing rod pulled out of clevis, San Fernando High School.

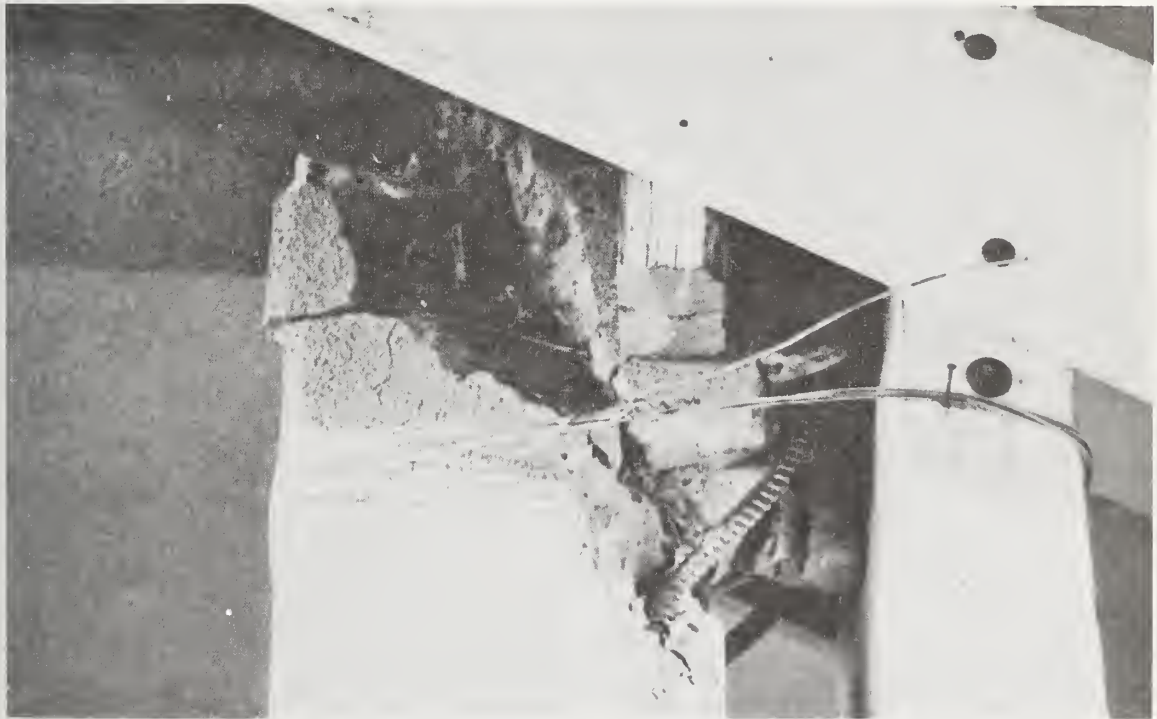
The major structural damage consisted of fracturing of four second-story columns of a two-story covered arcade (fig. 6.22 and 6.23). The concrete roof of the arcade was shored to prevent collapse. The longitudinal concrete wall in the classroom buildings, extending the full length of the buildings sustained some hairline diagonal cracks near both ends of the building. The cracking can be attributed to shrinkage stresses that existed prior to the earthquake. A concrete curb at the corner of the mechanical penthouse fractured under the steel column at the brace connection (fig. 6.24 and 6.25). Structural damage was minimal; however, a major loss of lighting fixtures constituted a real hazard. Approximately 1500 lighting fixture stems failed at the ceiling canopy or at the fixture. All fixtures have been reinstalled. There was nominal damage to acoustical ceiling tile. Electrical conduits were damaged at structural separation joints where they were rigidly connected to both sides (fig. 6.26). The earthquake aftershock of March 31, 1971, caused little additional damage. There were a few new plaster cracks, a few damaged ceiling tiles, and some additional flaking of concrete on the previously damaged arcade columns. It is possible that the aftershock could have caused collapse of the arcade if it had not been shored. The damaged arcade has been removed. The entire school is in use.

Figure 6.22 Fractured concrete at second-story covered arcade columns, Patrick Henry Jr. High School.

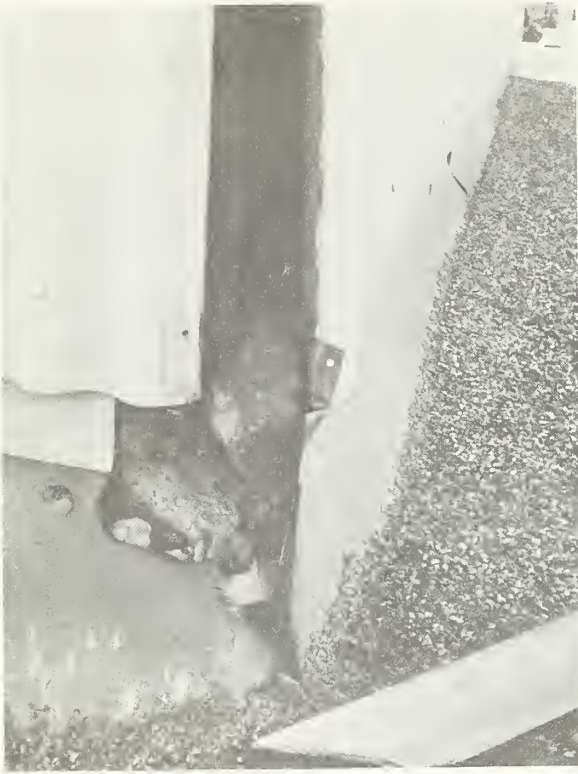
Figure 6.23 Close up of fractured concrete second-story covered arcade column, Patrick Henry Jr. High School.

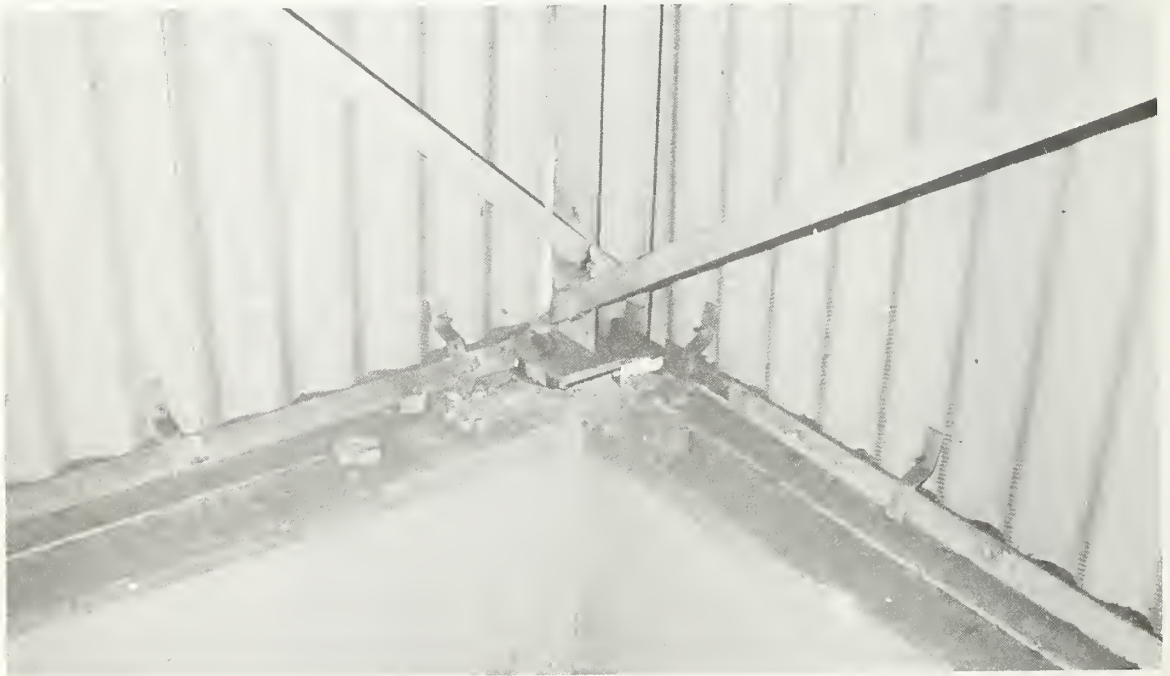
Figure 6.24 Corner of mechanical penthouse fractured under steel column (exterior view), Patrick Henry Jr. High School.

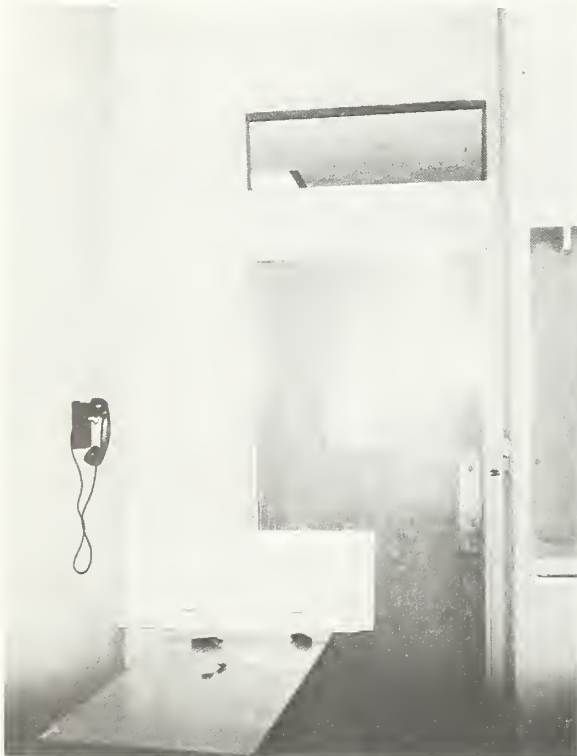
Figure 6.32 Cracked pier in north wall of administration wing, Crescenta Valley High School.

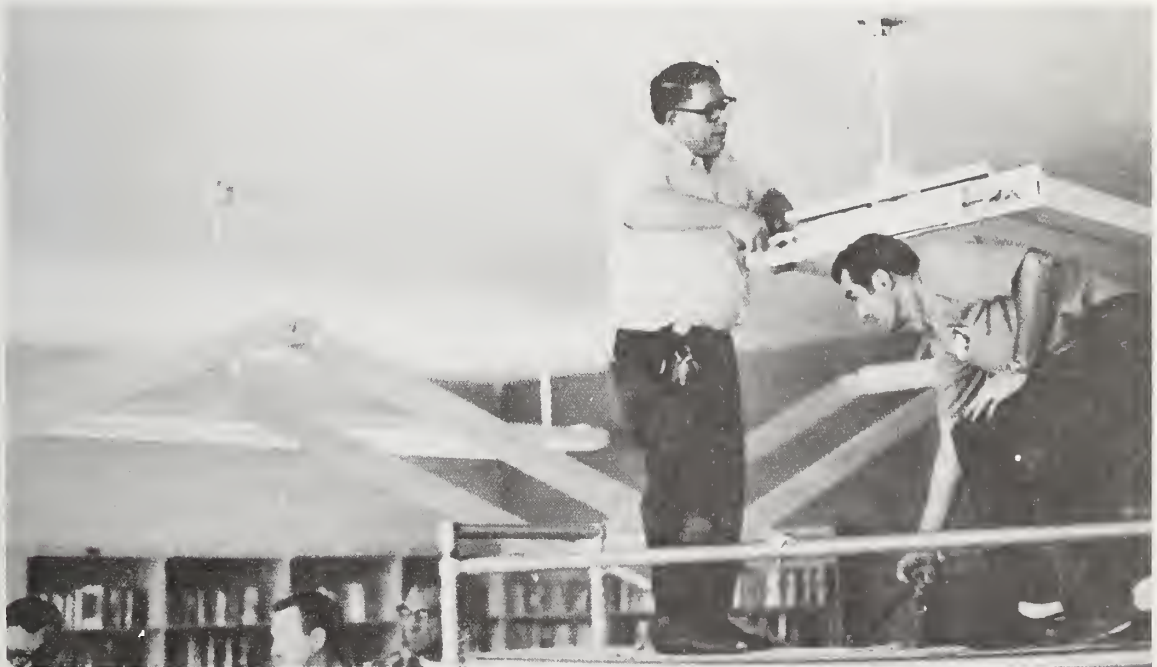
Figure 6.34 Flat steel bar braces concealed in transverse partitions, Clark Junior High School. Damage to partition caused by buckling of brace and striking the studs.

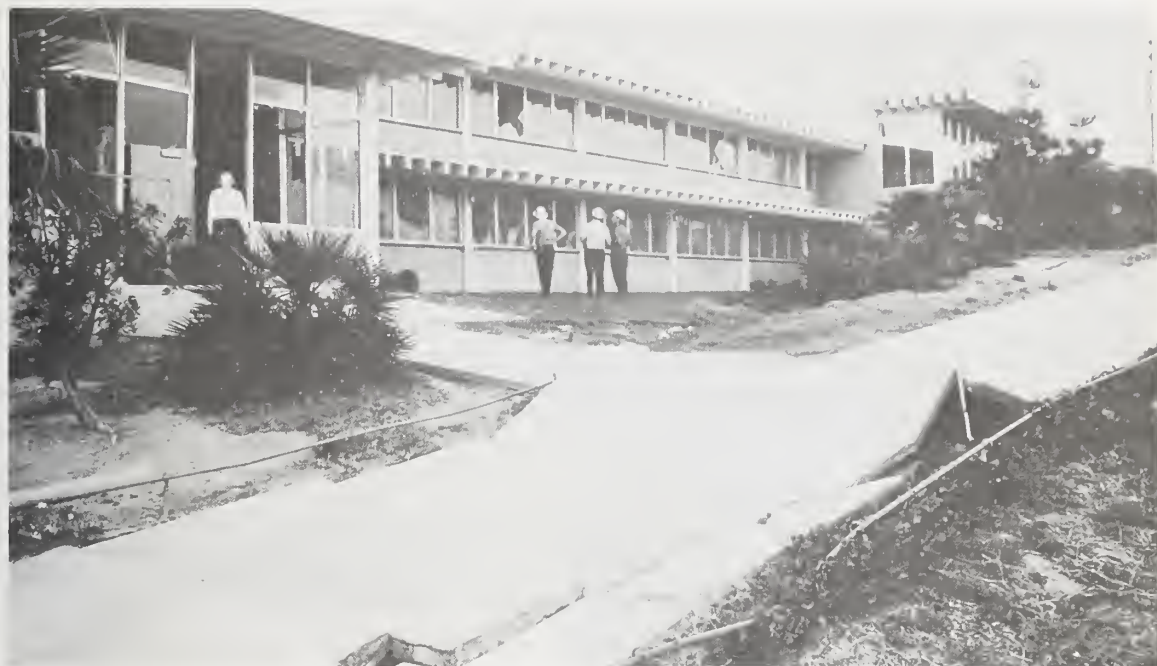
Clark Junior High School in La Crescenta was constructed in 1961. The school is located approximately eleven miles southeast of the City of San Fernando (location 13, fig. 6.1). The school has two-story brick bearing wall, double loaded, corridor classroom buildings. The roofs are poured gypsum on light steel framing; the second floor is concrete slab and joist; and the first floor is a concrete slab on grade. The upper-story intermediate transverse shear-resisting elements are flat-steel-bar diagonal braces concealed in the transverse partitions. The end transverse shear elements in the upper story and all of the elements in the lower story are reinforced grouted brick masonry. The buildings rest on spread footings. The major structural damage was caused by excessive elongation of the steel diagonal braces (fig. 6.34). This permitted the gypsum roof diaphragm to deflect excessively and thus greatly increased the bending stresses near the middle and the shearing stresses at the ends of the roof diaphragm. Cracks were noted in the roof diaphragm. The increased shears at the ends of the roof diaphragm also caused some minor cracking of the end brick shear walls. There was extensive nonstructural damage including damage of lighting fixtures (fig. 6.35) and cracked plaster partitions due to excessive drift of the top story. The school is in use.

Figure 6.35 Damage to lighting fixtures at Clark Junior High School.

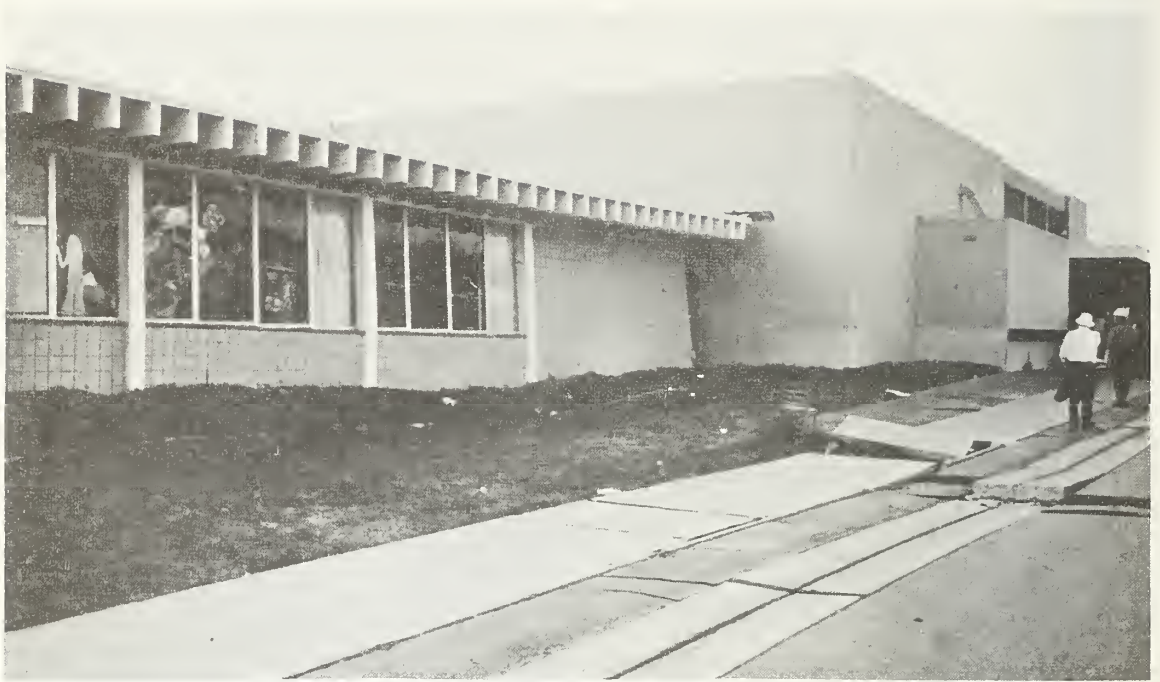
Figure 6.41 West wall of girls' school, Los Angeles County Juvenile Facility. Note displacement at left (north) end of building and severe ground rupture (see figure 6.48).

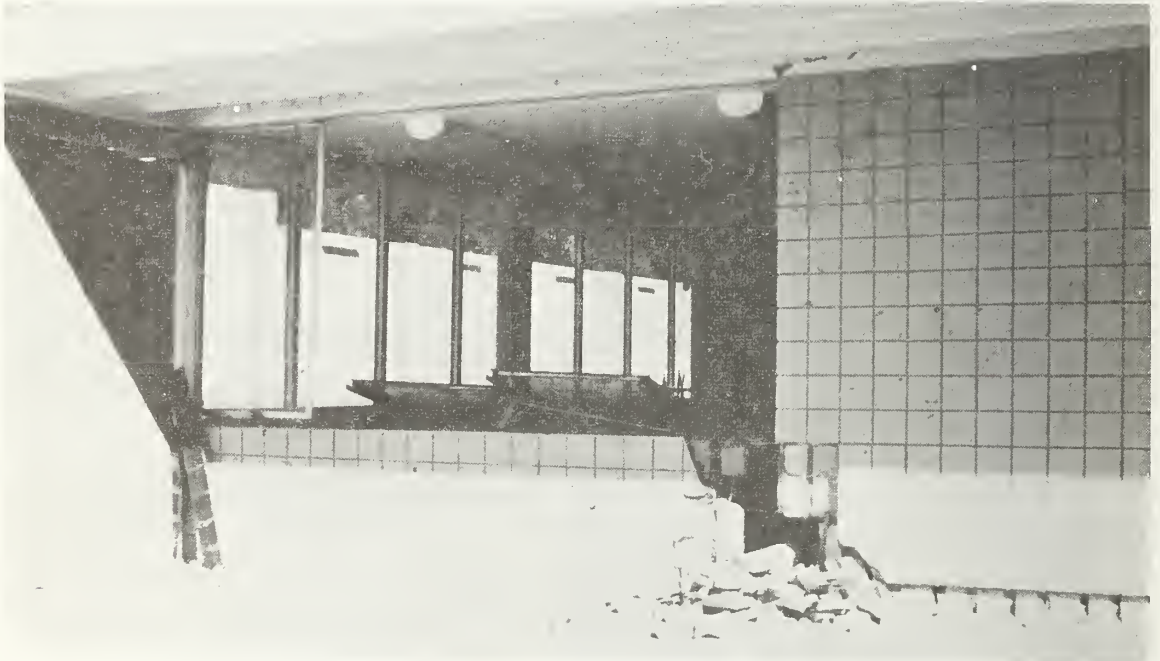
Figure 6.42 East wall of girls' school, Los Angeles County Juvenile Facility. Note distress at right (north) end adjacent to taller (cafeteria) building and ground rupture.

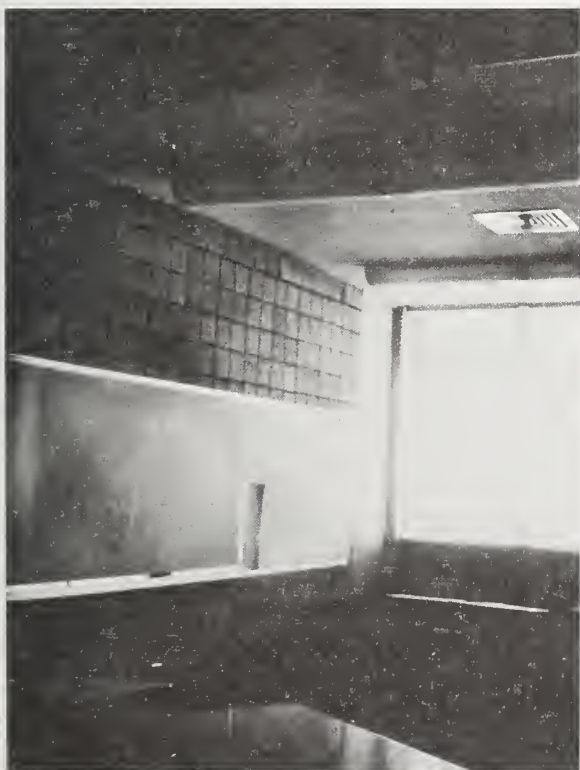
Figure 6.44 West classroom of boys' school, Los Angeles County Juvenile Facility. It appears the room would have been safe.

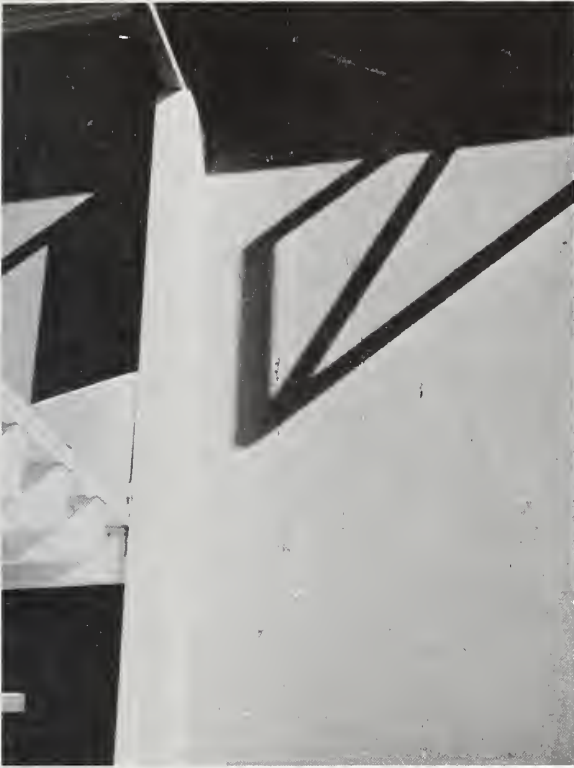
Figure 6.45 Displacement of concrete block at top of transverse partition, Los Angeles County Juvenile Facility.

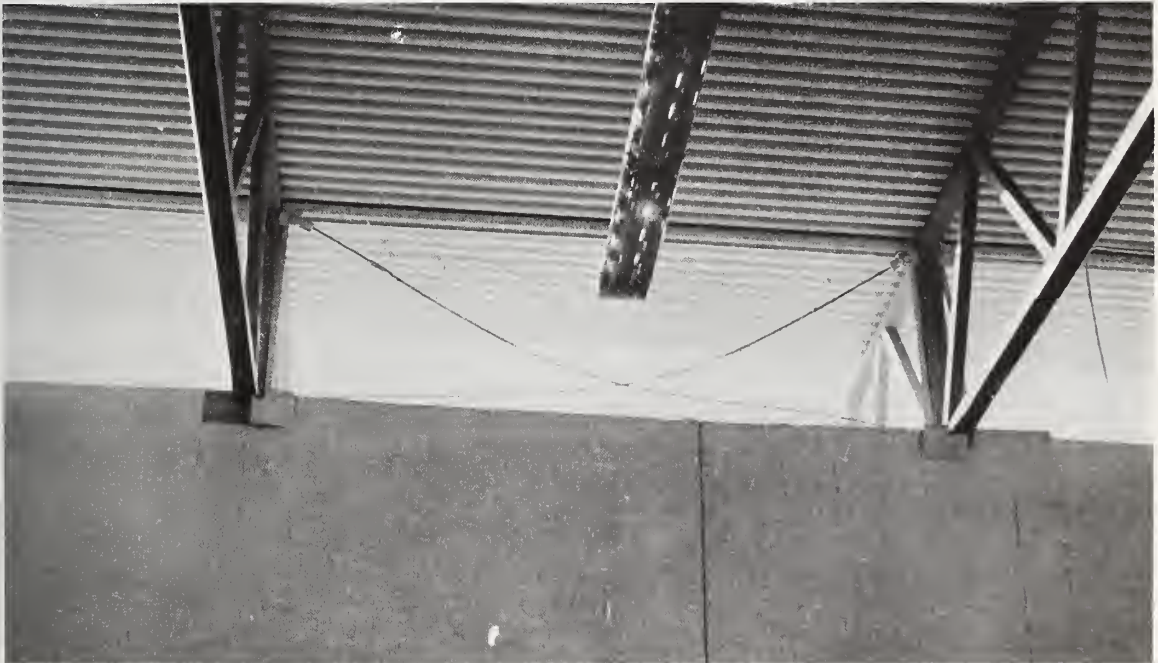
Figure 6.46 Cracked wall at junction of boys' school and gymnasium, Los Angeles County Juvenile Facility.

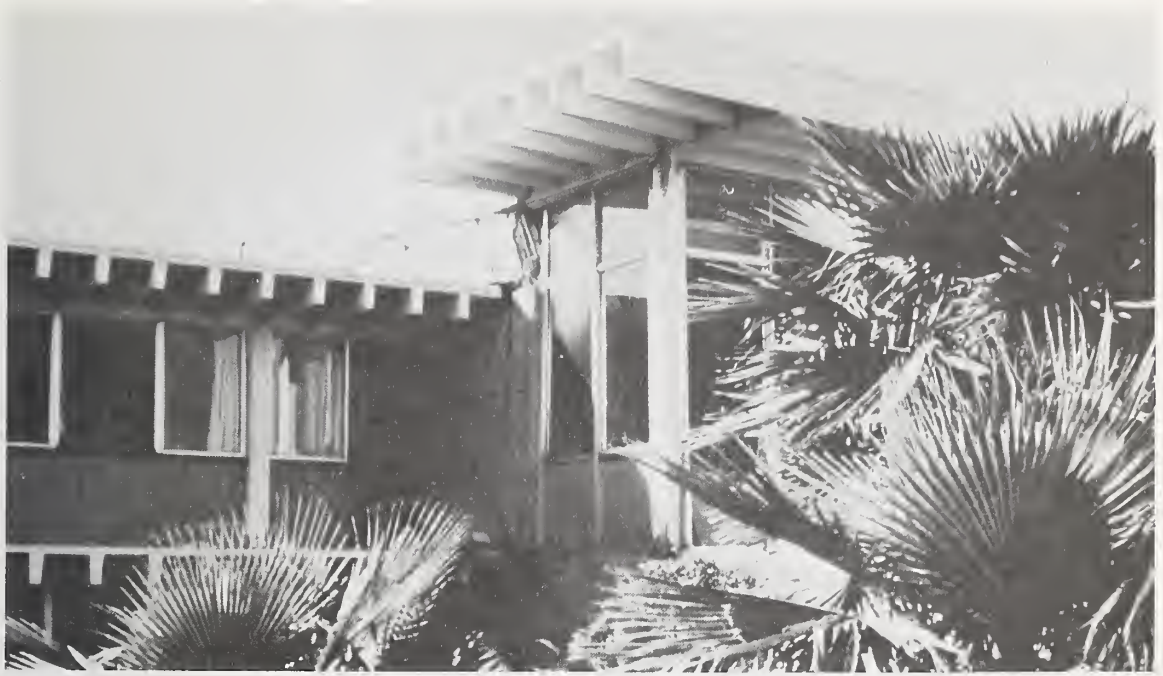
(fig. 6.47). There was damage to the portion of the girls' school adjacent to the cafeteria at a location of vertical ground fracture; however, the solidly grouted concrete block wall resisted the distortion (fig. 6.48), and prevented collapse. The floor was badly cracked in this area. There was minimal damage to the rest of the girls' school.

Figure 6.48 Damage to girls' school adjacent to cafeteria, Los Angeles County Juvenile Facility. The solidly grouted concrete block wall resisted the distortion.

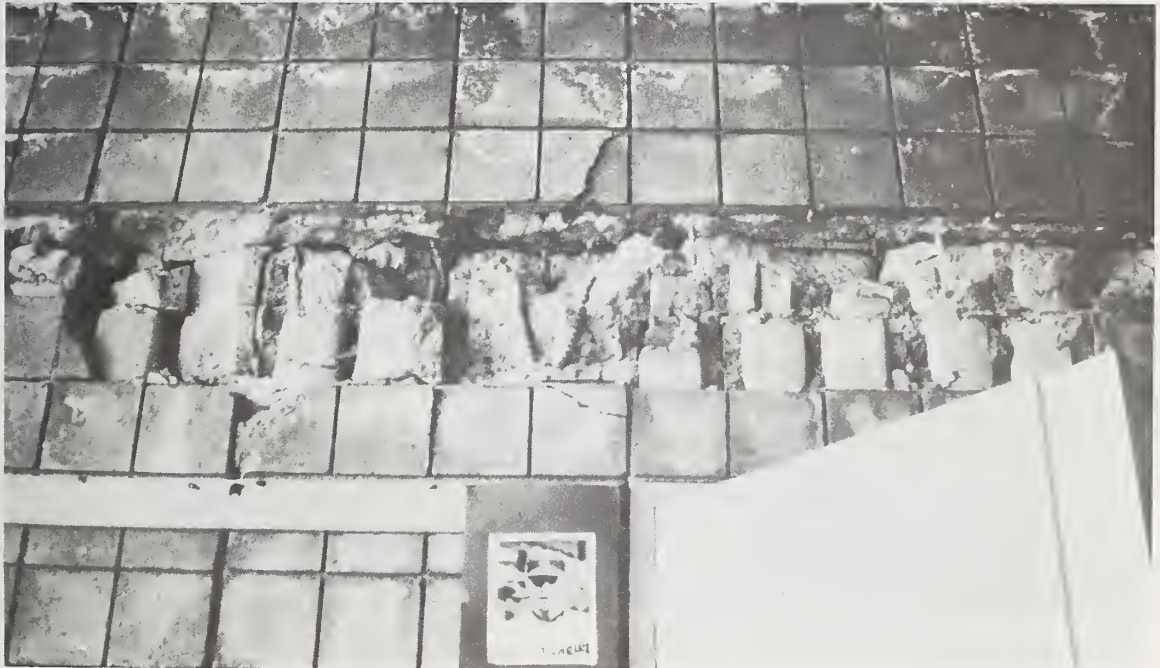
Major damage on other buildings consisted of shattering of walls at locations of change in roof elevations (fig. 6.49 and 6.50) and fracturing of concrete block walls constructed with "stacked bond", in which the horizontal reinforcing was concentrated only at the bond beam (fig. 6.51 and 6.52). The better behavior of the school buildings can be attributed to the more restrictive rules and regulations of the Field Act since the other factors (Architects, Engineers, Contractors and Inspectors) were the same for both types of buildings. The school buildings could be economically repaired; however, the entire facility has been vacated and may be abandoned.

Figure 6.49 Damage to wall at change in roof elevation (exterior), Los Angeles County Juvenile Facility.

Figure 6.50 Damage to wall at change in roof elevation (interior), Los Angeles County Juvenile Facility.

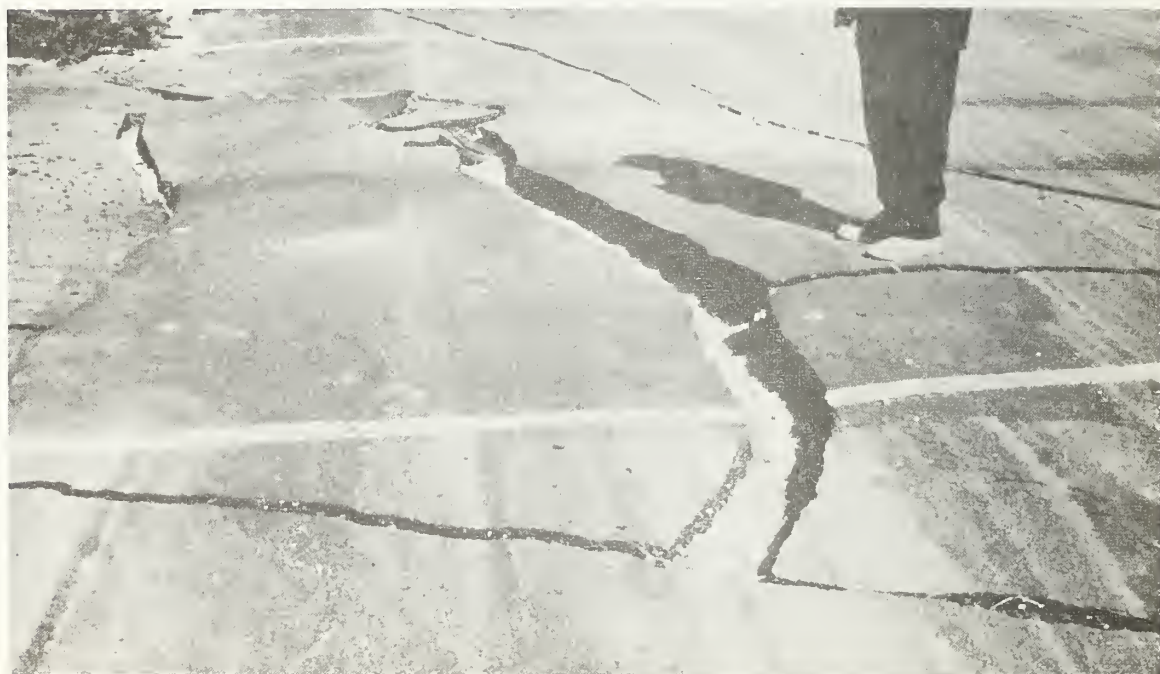
Camp Karl Holton, Los Angeles County Probation Camp, located in Little Tujunga Canyon was constructed in 1959. The camp is located in an area of extreme ground fracture (fig. 6.53 and 6.54) approximately four miles northeast of the City of San Fernando (location 16, fig. 6.1). This camp contains a group of single-story concrete block bearing wall buildings which include administration, service facilities, school, living quarters, and a recreation building. Construction consists of wood joists and roof sheathing, concrete block walls, and concrete slabs on grade. The buildings rest on spread footings. There is one wooden portable classroom building near the masonry school. A concrete block security wall surrounds the institution. Much of the perimeter security wall has fallen or is severely tilted (fig. 6.55). As previously noted, concrete block masonry for schools requires uniform distribution of horizontal and vertical reinforcement with all block cells fully grouted whereas for other structures horizontal reinforcement may be concentrated in the bond beam and only reinforced cells must be grouted.

Figure 6.53 Eight-inch vertical displacement in out-door recreation area, Camp Karl Holton.

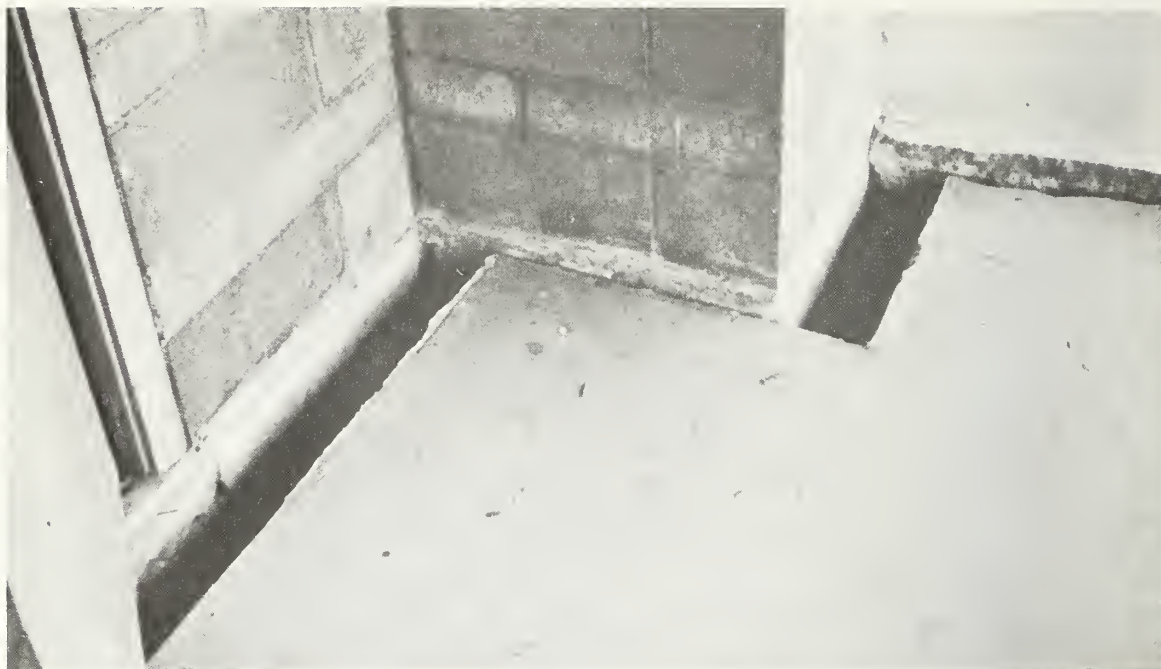
The recreation building suffered severe structural damage. The concrete block walls which were grouted only in the reinforced cells shattered and were displaced as much as four inches laterally at the base (fig. 6.56 and 6.57). The living unit was undergoing major alterations at the time of the earthquake. Thus, the damages sustained do not necessarily reflect the condition of the building. The vehicle storage building has a broken bottom chord at one gabled wooden roof truss, and the wood sheathing appears to be supporting the roof by plate action. Approximately six inches of vertical displacement between the masonry classroom building and the portable classroom building was noted (fig. 6.58). Either

Figure 6.56 Concrete block wall grouted only in vertically reinforced cells shattered, Camp Karl Holton.

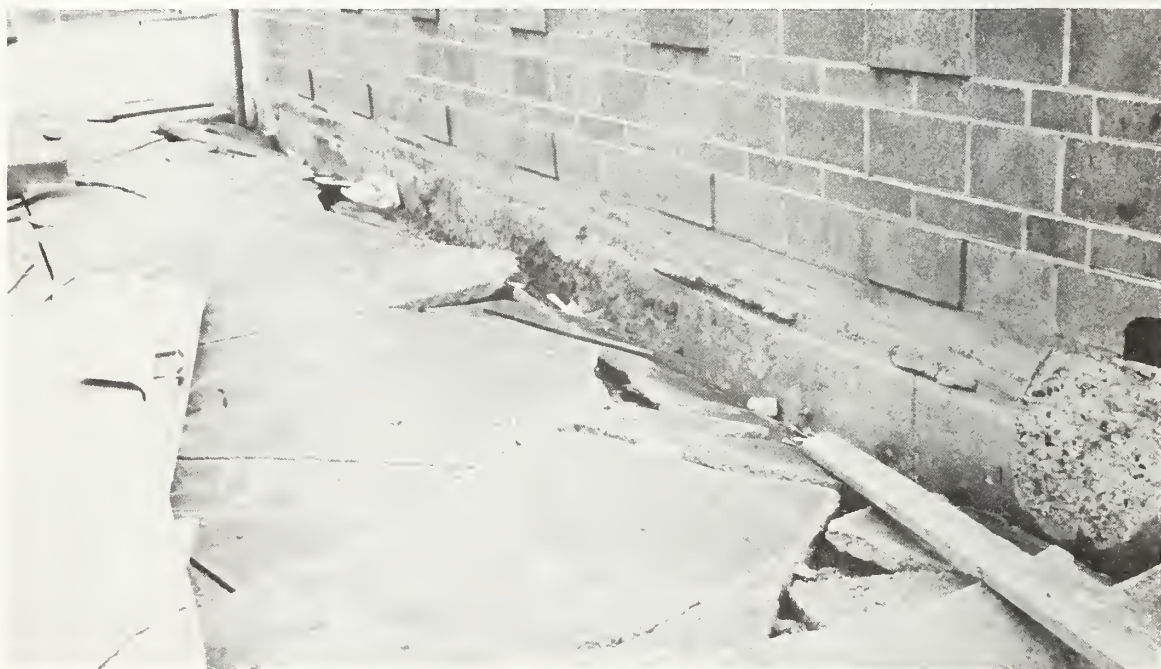
Figure 6.57 Recreation Building at Camp Karl Holton. Four-inch displacement between slab and wall.

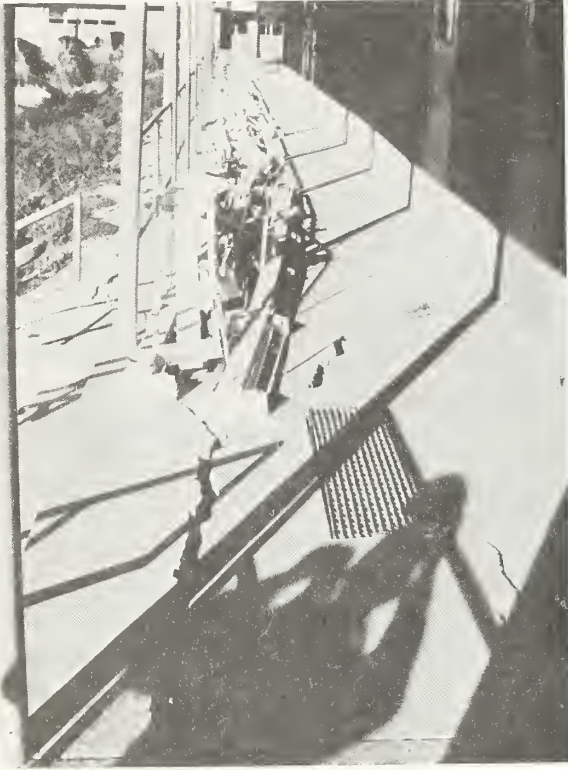
Figure 6.58 Approximately 6 inches of vertical displacement between masonry classroom building and the portable classroom building, Camp Karl Holton.

the portable building and the ground on which it is supported dropped or the adjacent area, together with the building thereon, was raised. The building remained intact although two covered arcade pipe columns were displaced a few inches at the base where the slab on grade pulled apart (fig. 6.59). The stem mounted lighting fixtures in all buildings were severely damaged and most fell to the floor (fig. 6.60). Damage to the portable classroom was minimal. A sheet metal foundation clip was distorted and an interior partition was offset a quarter of an inch at a joint in the wallboard. The classroom building could be used in its present condition if the light fixtures were reinstalled; however, the complex has been vacated pending a study of the disposition of the camp.

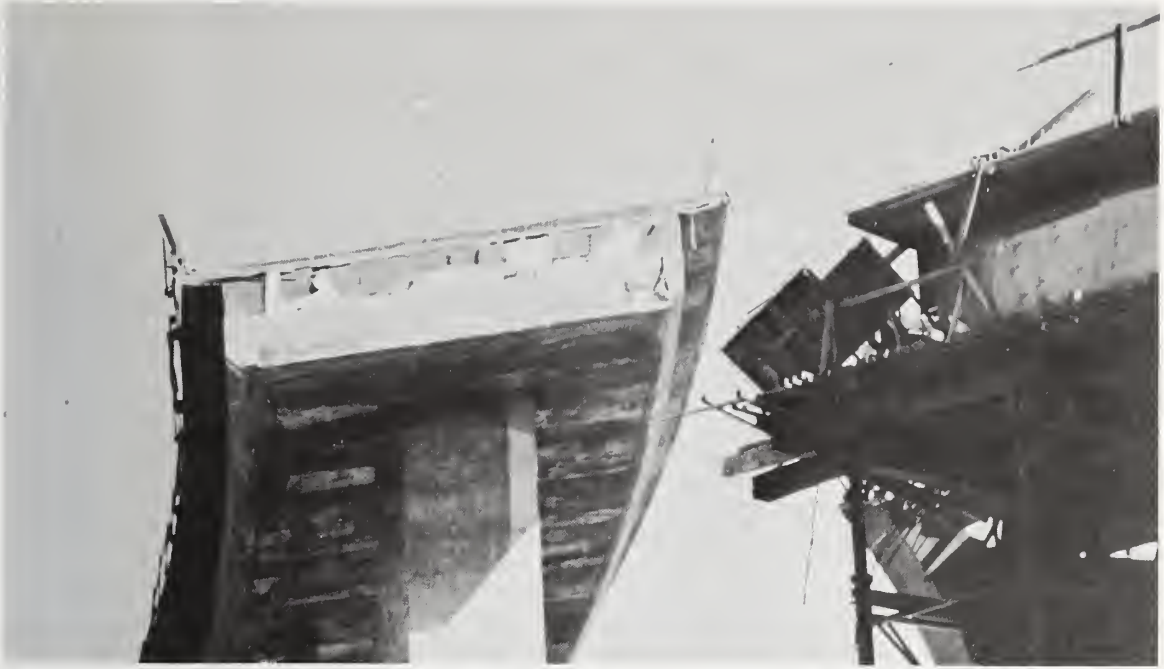
direction and 15 in the transverse direction. The slenderness of the column and the nature of the hinge seat can be seen in figure 7.5, which is a post-failure view of pier 5. Figure 7.6 shows the hinge cross section immediately adjacent to pier 3. Reference to the hinge detail as shown in figure 7.4 indicates that each web of the box girder rested on a 2-in thick by 10-in deep by 30-in wide elastomeric bearing pad and the center bay of the hinge seat had a 1-ft high raised shear key, which was approximately 5-ft 6-in wide. The raised cross section of this shear key is visible in figure 7.6. The only positive ties in the longitudinal direction were 1 1/2-in equalizing bolts, one of which was placed in the center of each of the three cells, parallel to the axis of the bridge.

Figure 7.6 Post-failure view of Pier 3 and hinge seat with shear key.

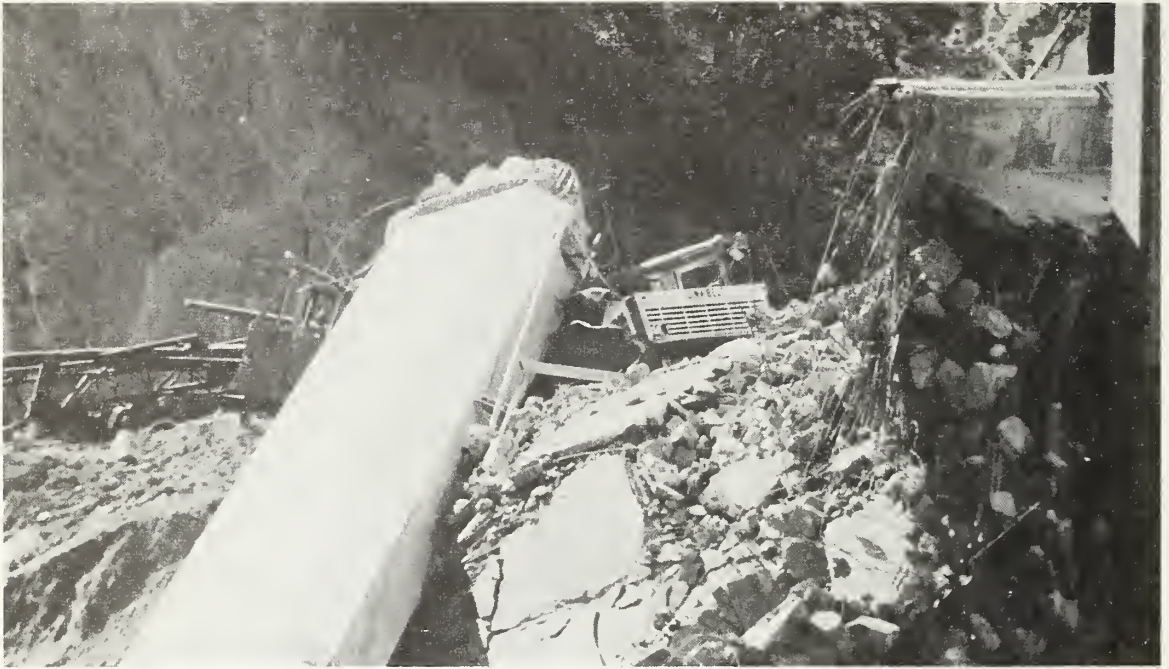
Figure 7.8 The top of Pier 5 and girder debris from the South Connector Overcrossing.

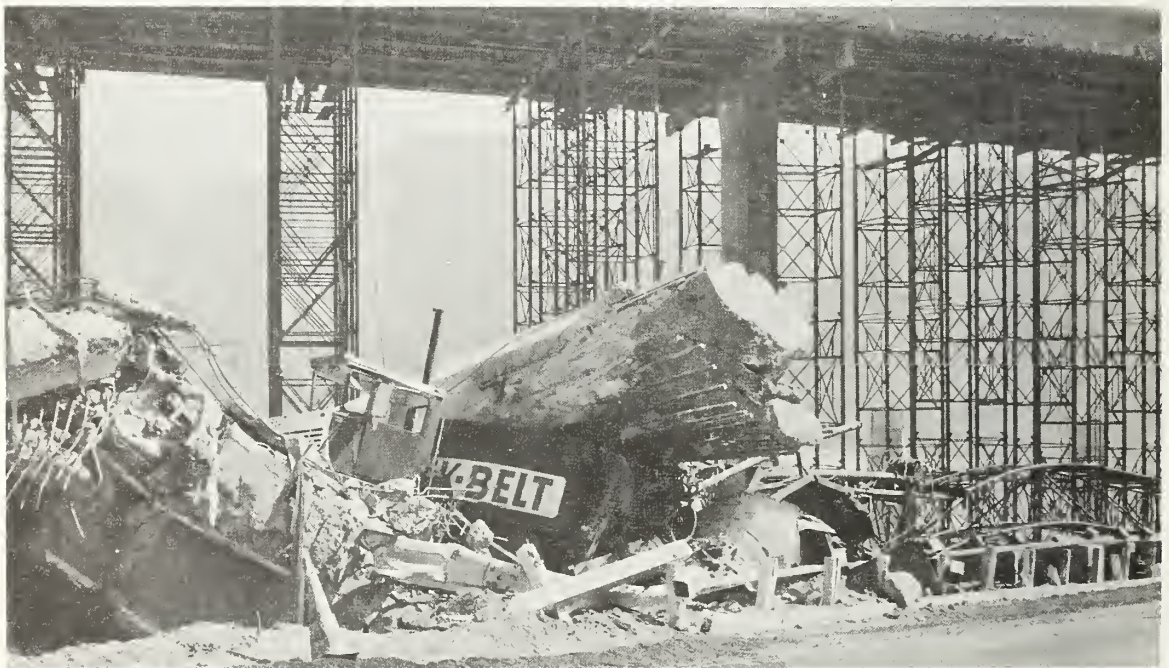
Figure 7.9 The top of Pier 5, which was embedded in the girder diaphragm, resting on the construction crane after collapse.

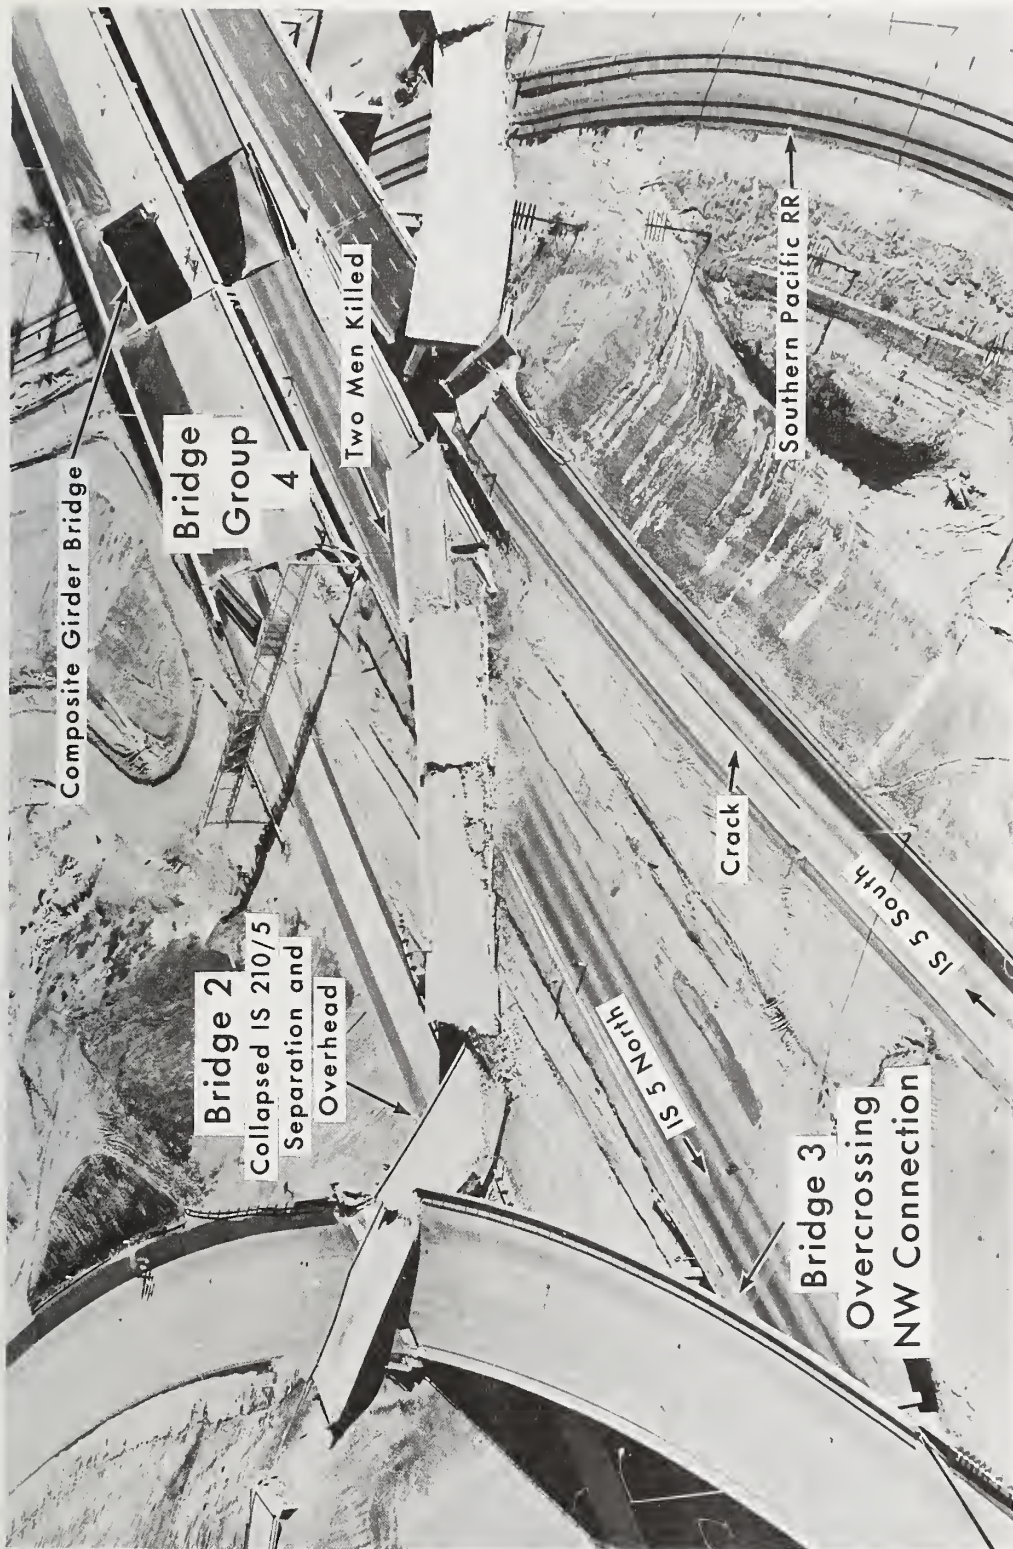
This complex interchange, much of which was completed and open to traffic, suffered extensive damage and must be almost completely rebuilt. Figure 7.10 is an aerial view of the freeway interchange looking north toward San Fernando Pass and Newhall. The collapsed IS 210/5 Separation and Overhead caused major damage to the Golden State Freeway (IS 5), the Foothill Freeway (IS 210), the San Fernando Road (which paralleled the railroad), and the Southern Pacific Railroad tracks. The collapse of the Separation and Overhead resulted in the loss of the lives of two men who were passing underneath it in a pickup truck. Additional detail can be seen in figure 7.11. In addition to the collapsed Separation and Overhead structure (Bridge 2), the Northwest Connector Overcrossing (Bridge 3) was severely damaged from the impact of Bridge 2 and must be removed and replaced. The series of essentially parallel spans carrying IS 5 South and IS 5 North, and the northbound truck routes over the Southern Pacific Railroad tracks and San Fernando Road (Bridge Group 4) were also destroyed. Some spans of this bridge group were impacted by the falling IS 210/5 Separation and Overhead, while one steel girder span collapsed by dropping off its bearings. This complex represented various types of bridges, including reinforced concrete box girders, precast prestressed I-beam girders, and concrete-steel composite girder bridges. Immediately to the east of this group, Bridge 5 (as shown in fig. 7.12) was a two span cast-in-place prestressed box girder with a longest span of 122 ft. It was supported by a single column bent founded on 16-in diameter cast-in-place drilled shaft piles. The structure suffered major column damage and was removed. Because of the need to rapidly remove the destroyed and damaged bridges in order to reopen the

Figure 7.11 View looking east of the collapsed Separation and Overhead (Los Angeles Times Photo).

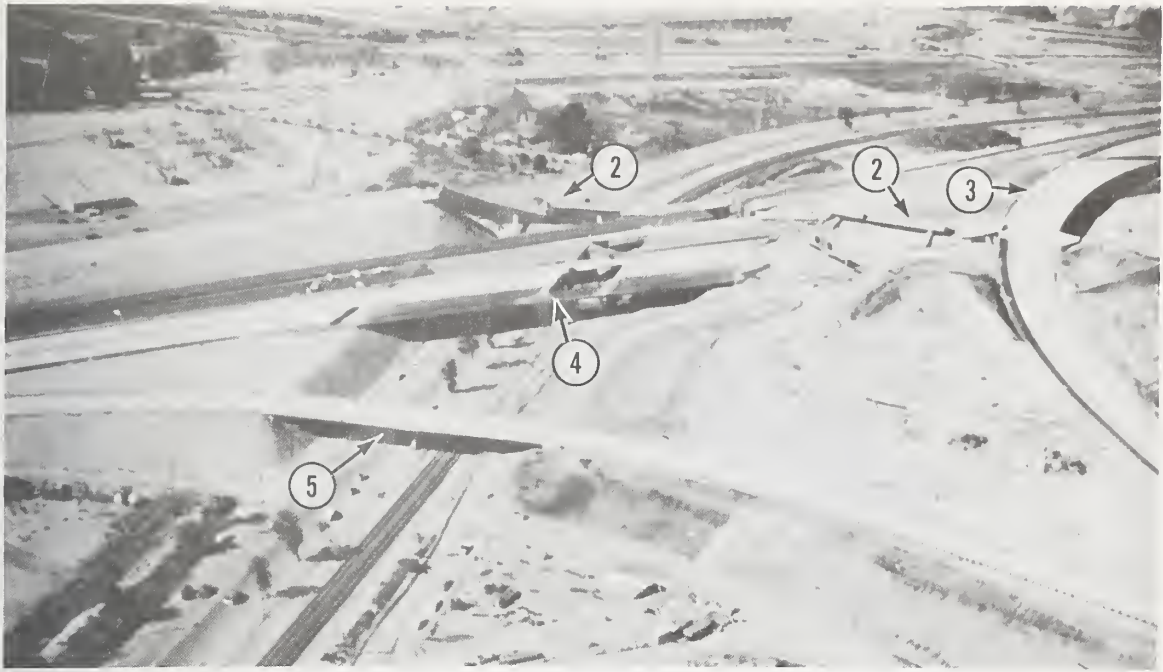
Figure 7.12 View looking northwest at the IS 5 and IS 210 interchange, showing Bridge group 4 and Bridge 5 immediately after the quake and before removal to restore railroad service.
