BUILDING SCIENCE SERIES 40

Engineering Aspects of the 1971 San Fernando Earthquake

This report presents the observations of the NBS on-site inspection team (most photographs in this report were taken by the team). The material presented herein is intended to serve as (1) a documentation of damage resulting from the earthquake and (2) as a source document for further studies, research, and recommendations. This is particularly important as necessary remedial work and restoration have resulted in the removal of evidence that is essential for studies and evaluations.

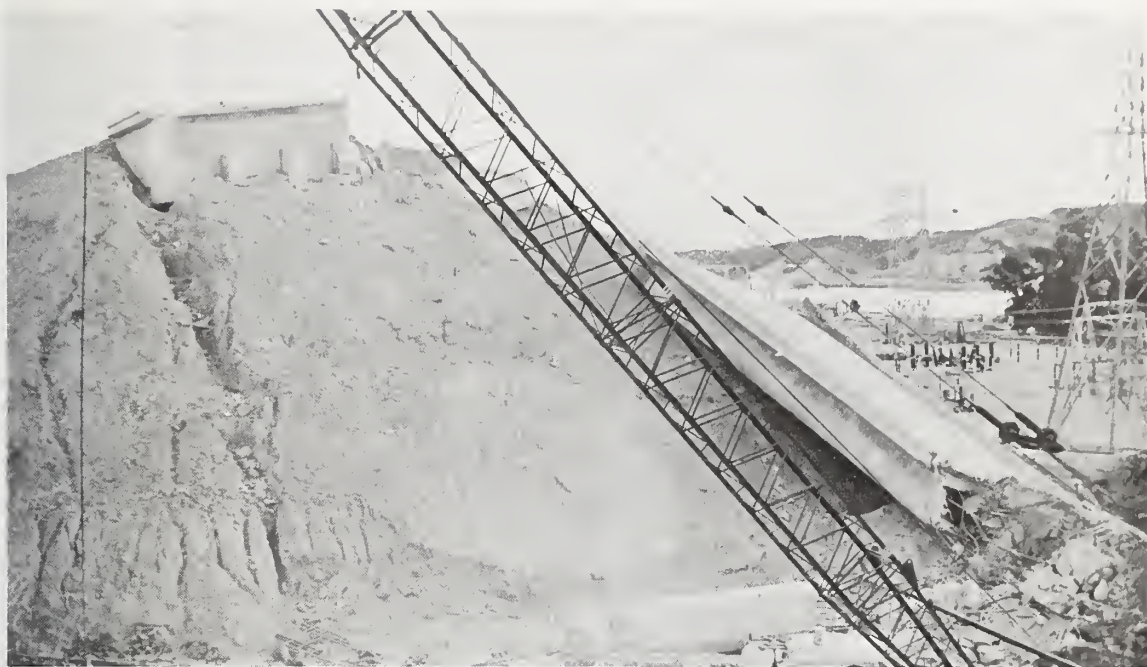
The collapsed IS 210/5 Separation and Overhead structure (Bridge 2) was a 7-span, nonprestressed, reinforced concrete box girder structure, carried on single column bents as shown in figure 7.14. This bridge was also curved in plan and had hinge details generally similar to those described previously for the bridge at the Palmdale interchange. The bridge was supported on elastomeric bearing pads on the pile-supported end abutments shown in the upper left of figure 7.15. A closeup of the abutment bearings at the north end is shown in figure 7.16. One of the elastomeric bearing pads can be seen lying next to the concrete bearing block. Another of these pads was found in a relatively undamaged state adhering to the under side of a box girder web after the girder had fallen approximately halfway down the slope. The appearance of the concrete pedestals in figure 7.16 indicates that the girders slid off the pedestals fairly rapidly.

Figure 7.15 East abutment of IS 210/5 Separation and Overhead structure.

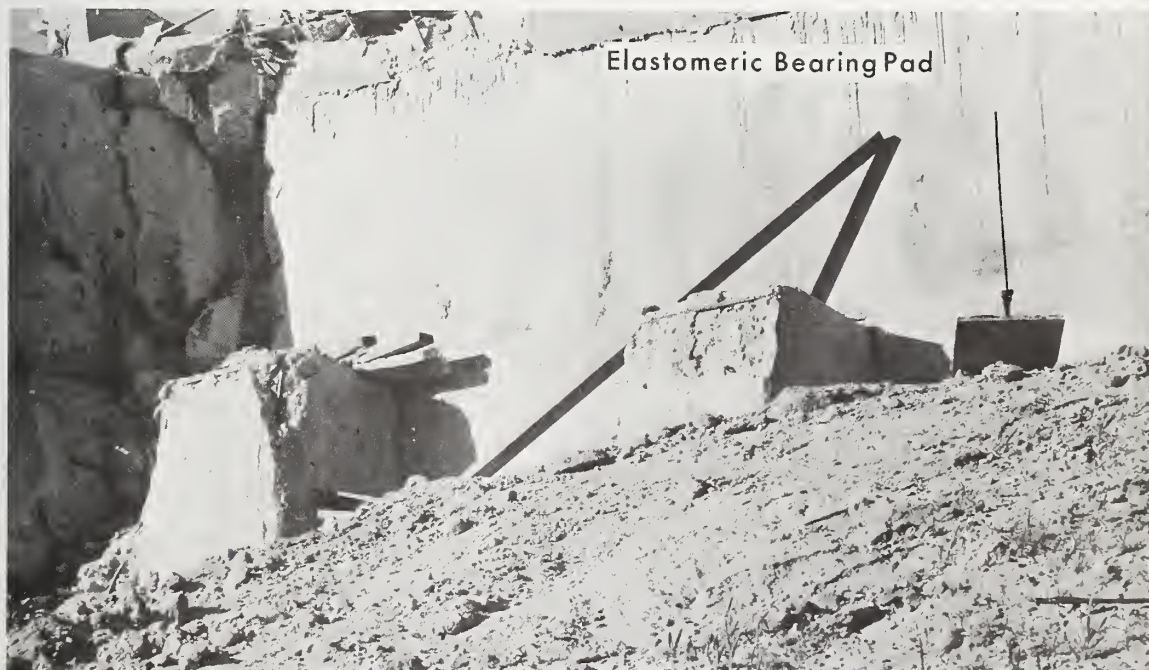
Figure 7.16 Close up of east abutment and elastomeric bearing pad.

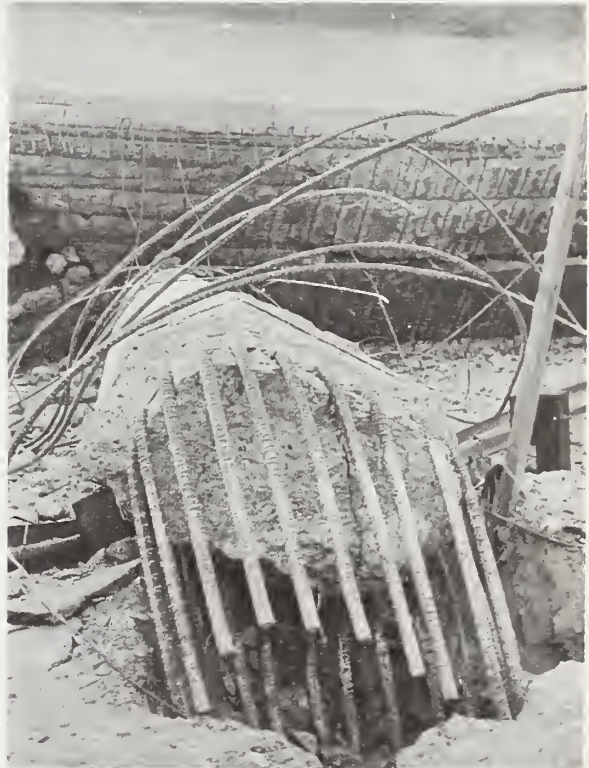
Figure 7.20 Base of the column which pulled out from the 6-ft diameter cast-in-place drilled shaft. Note the stripping of the reinforcement of the bottom of the girder in the background of the picture.

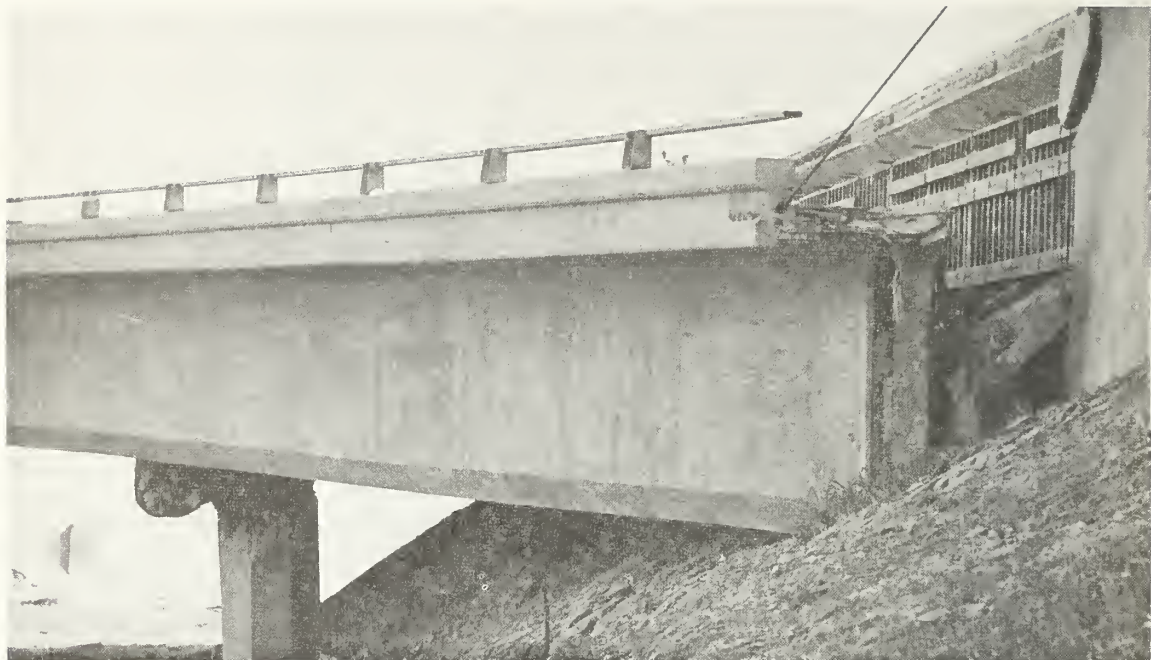
Figure 7.22 Abutment and pier damage at the western end of the Northwest Connector Overcrossing.

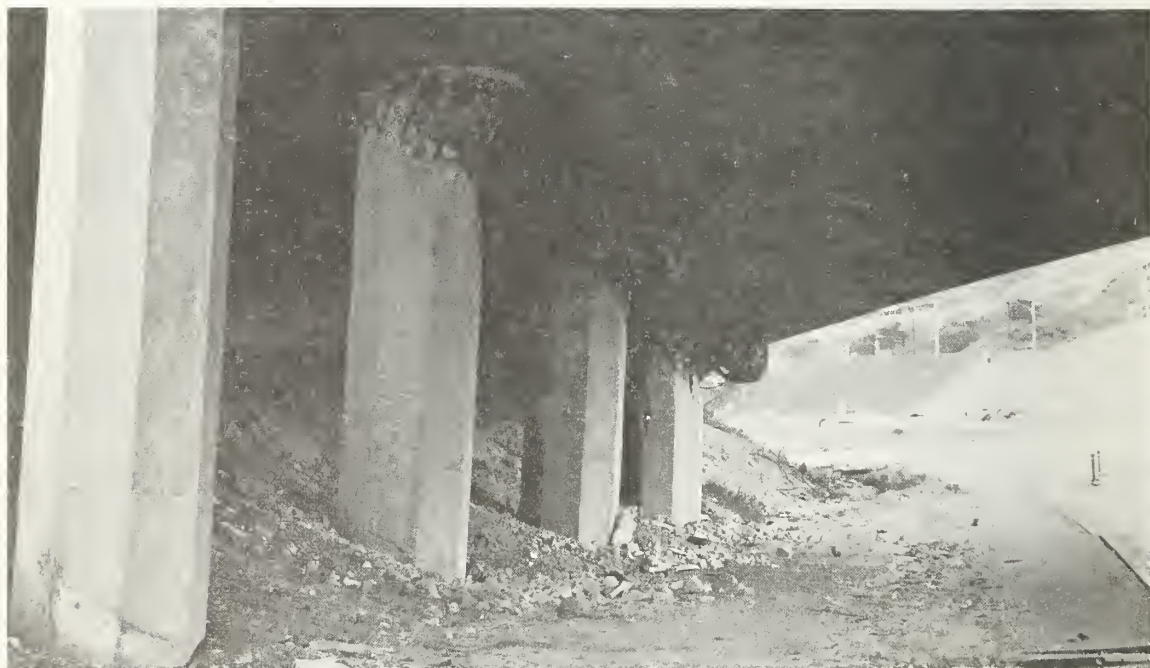
Figure 7.23 Spiral column failures in bent 2 at the west end of the Northwest Connector Overcrossing.

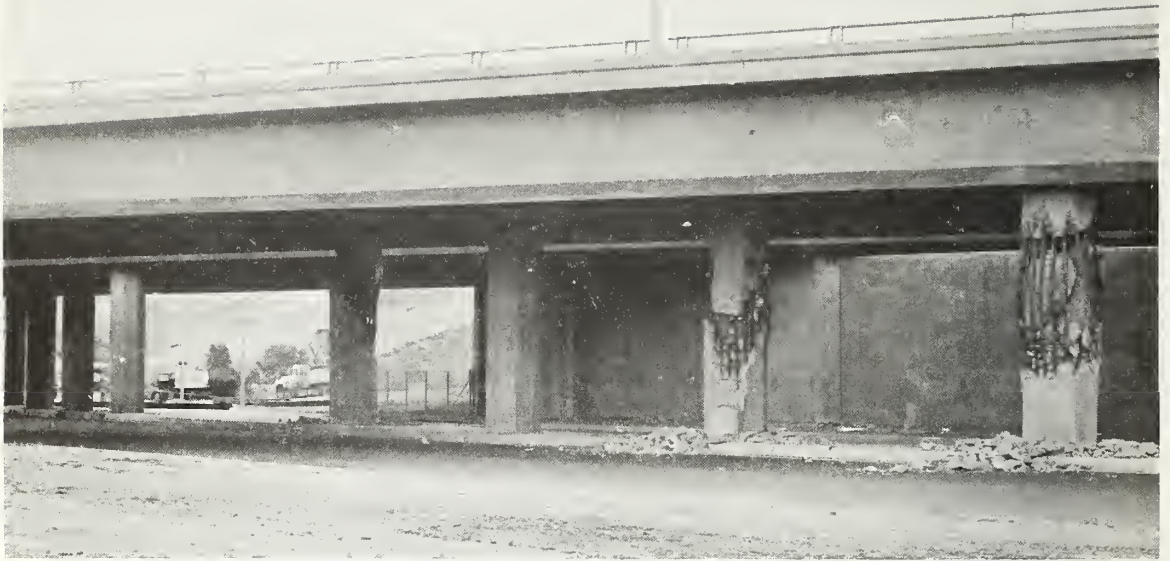
The major damages noted in this bridge was sustained by the southern or right bridge and were mostly in the columns and abutments, as can be seen in figure 7.26, which shows bent 3 of the right bridge in the foreground. The bridge had apparently twisted in a clockwise direction and it appeared that it had rotated about the third column from the right hand side of the photo, which is relatively undamaged. Severe damage was encountered in the other columns, as can be seen from the closeup in figure 7.27, which indicates complete destruction of the core concrete and buckling of the bars, as well as loss of the relatively light hoops provided. Note the hoops lying in the rubble in the foreground. The columns of bents 2 and 4 were set in a series of closure walls and movement could take place only at the top, so the damage to these columns was fairly well confined to the very top portion, as shown in figure 7.28. In spite of the massive damage to the support elements, the girders appeared to be in surprisingly sound shape, and visual examination did not indicate any appreciable evidences of concrete cracks large enough to indicate reinforcement yielding.

Figure 7.26 Column failures in bent 3 of Foothill Boulevard Undercrossing.

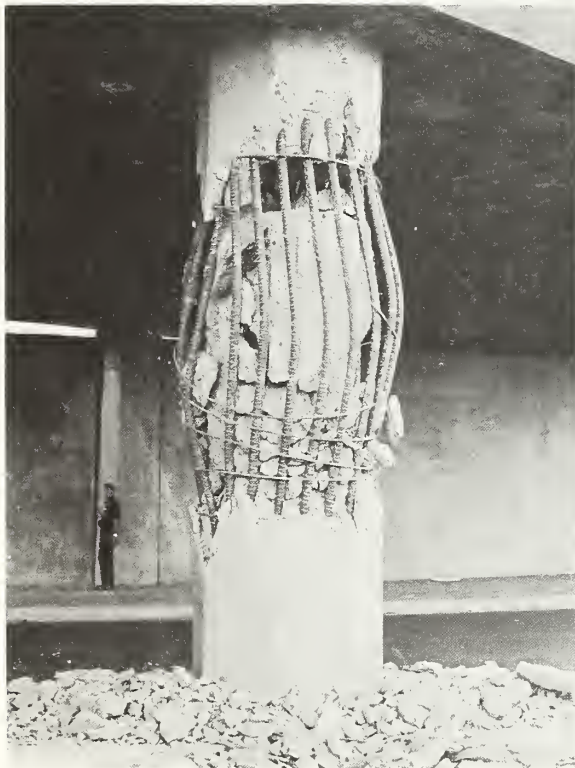
Figure 7.27 Close-up view of failure of a tied column in bent 3. Note hoops on ground in debris.

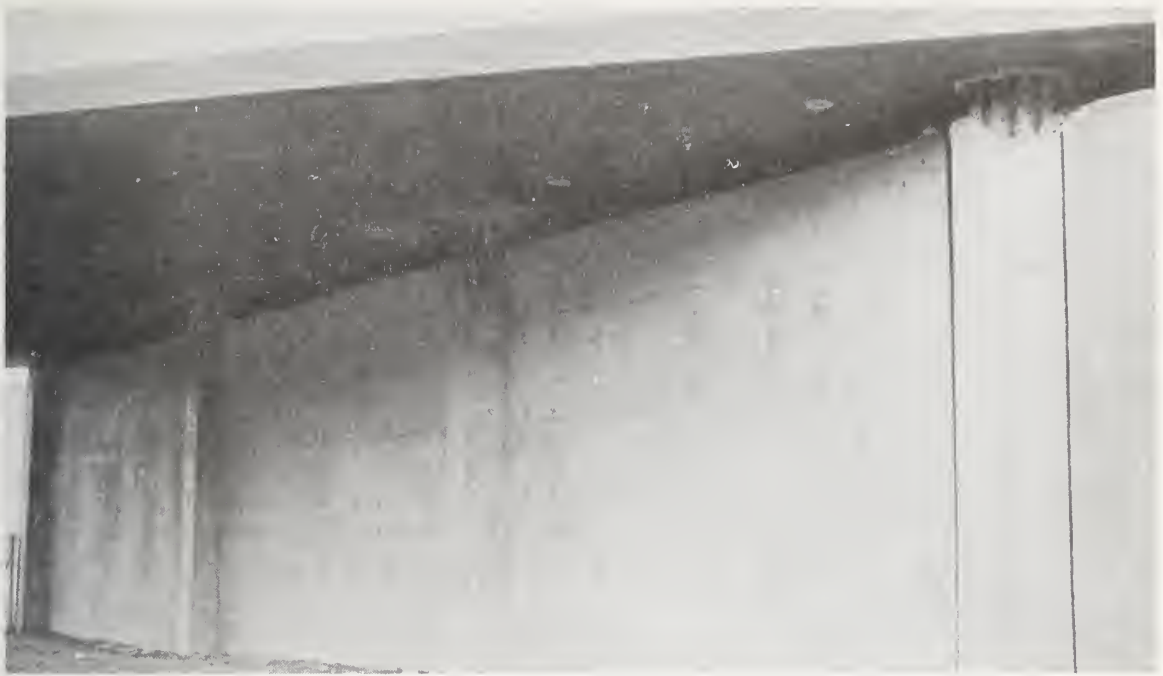
Figure 7.28 Damaged columns in bent 4 with 10-in closure wall which was separated from the columns by 1/2-in filled expansion joints.

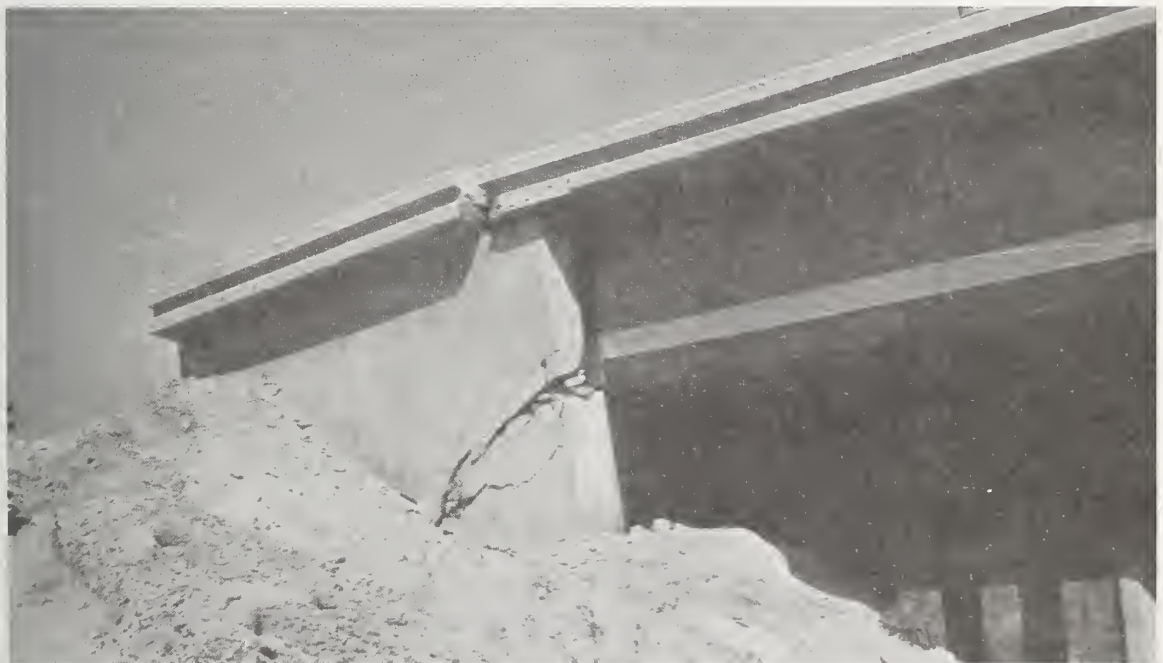
Throughout the remainder of the north San Fernando Valley, numerous bridges were damaged in a much less dramatic manner. A typical sight was extensive cracking in the abutments, similar to that shown in figure 7.29. In this case a major crack ran through the earth fill up to the bridge abutment, through the abutment and out the other side of the abutment. The bridge in this case was displaced

Figure 7.29 Typical abutment damage.

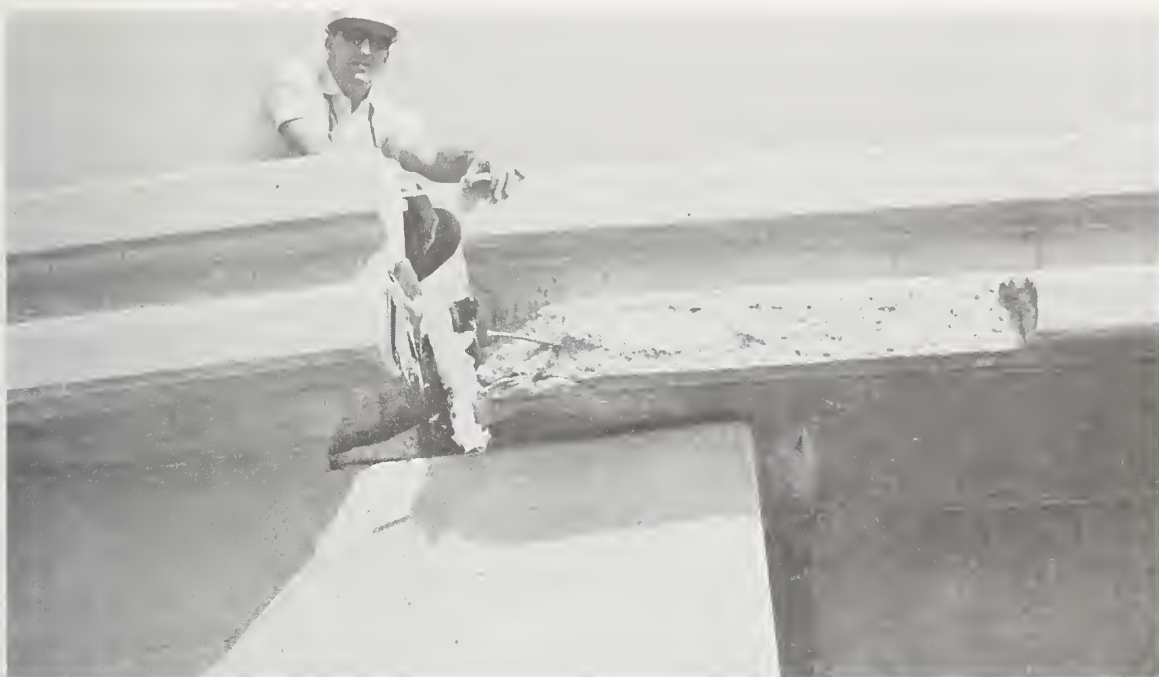
both longitudinally and transversely over 6 in, as can be seen in figure 7.30. This particular structure was a continuous reinforced concrete box girder bridge, located between the Palmdale and Foothill interchanges.

Figure 7.30 Longitudinal and transverse movement of cast-in-place box girders with respect to abutment sections.

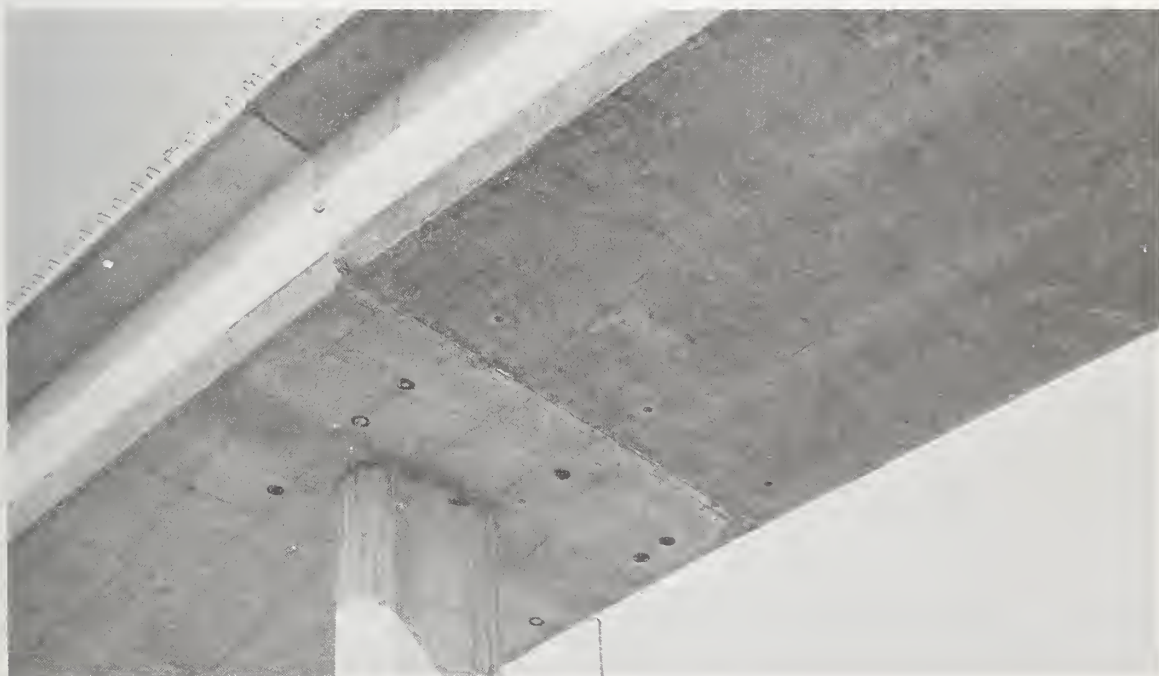
Bridges supported on tall, slender columns and piers seemed particularly susceptible to movement and bridges located several miles north of the Palmdale interchange indicated substantial movement at hinges, as shown in figure 7.31, and extensive butting of one section against another causing spalling as shown in figure 7.32. However, these damages can be classified as minor. Many of the bridges with heavy abutments came through with relatively light damage to concrete slope paving and no visible damage to the structure, as did the single span prestressed box girder bridge shown in figure 7.33. This bridge was located on the Foothill Freeway at Glenoaks Boulevard and is only a few blocks from Olive View Hospital.

Figure 7.31 Typical movement at a hinge joint of a slender box girder bridge.

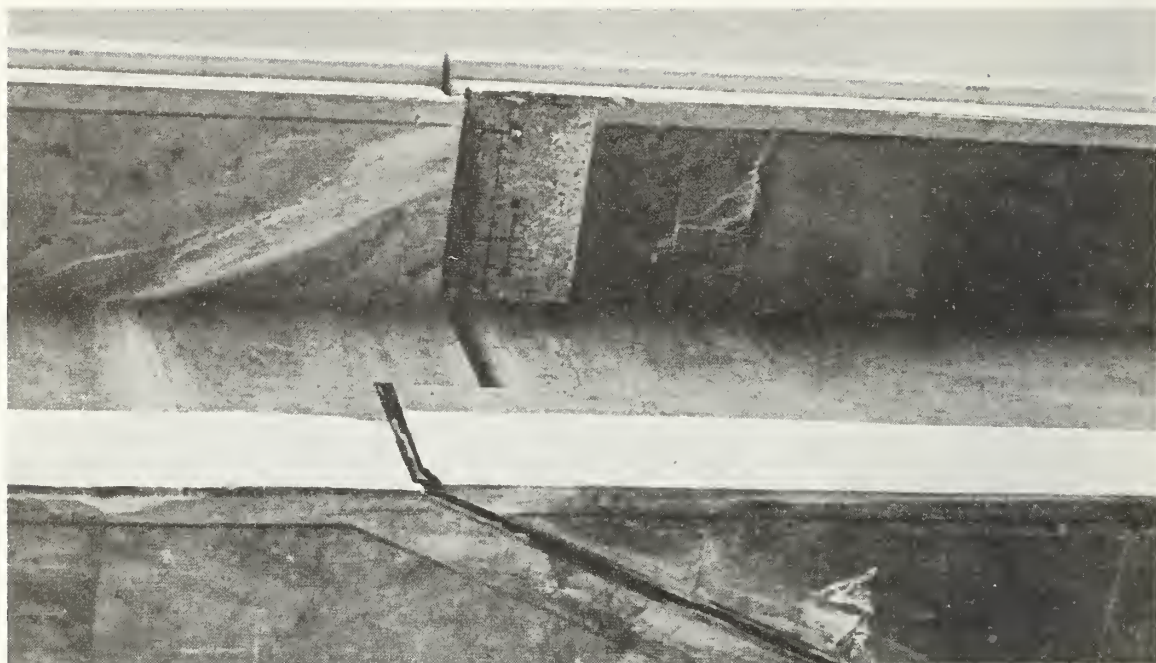
Figure 7.32 Typical movement and spalling at a joint in an elevated box girder bridge, caused by battering at the joints.

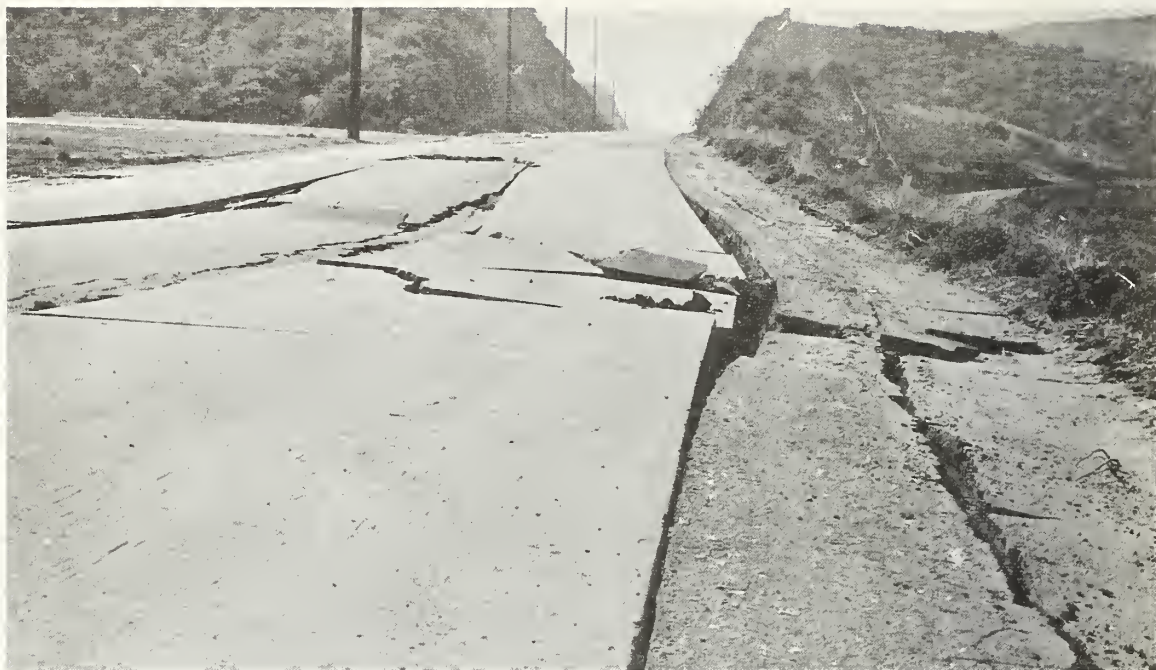
Figure 7.35 Road cave-in and ground cracks along Blucher Avenue along the eastern edge of the lower Van Norman Reservoir.

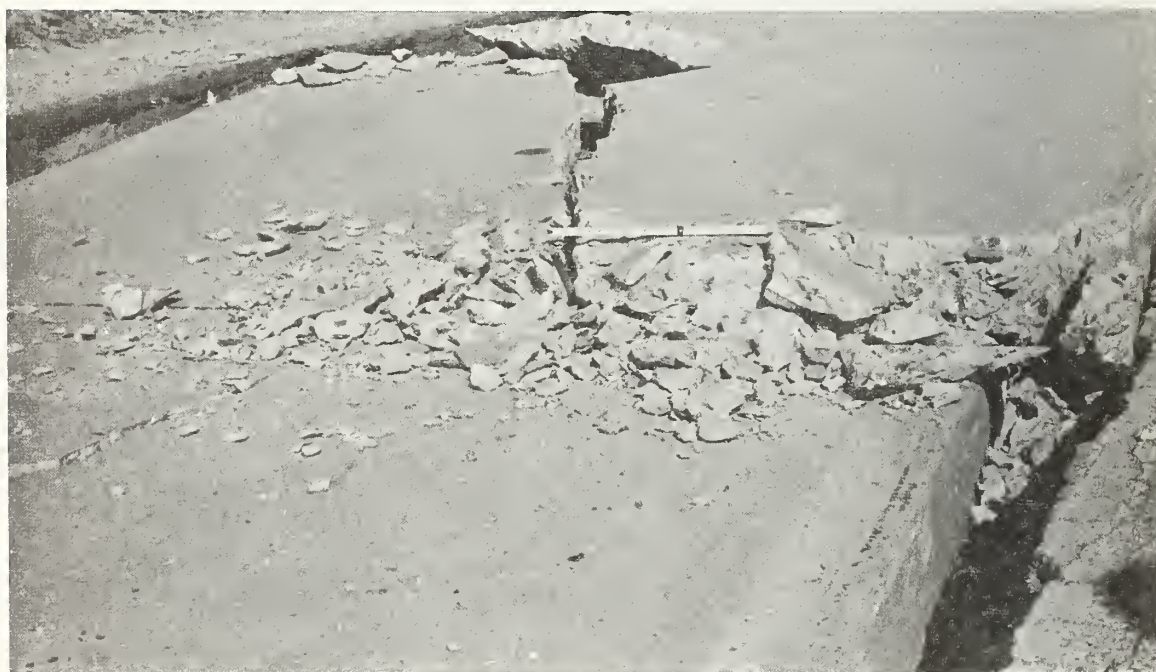
Figure 7.36 Concrete road slabs were crushed by the ground motion in this location.

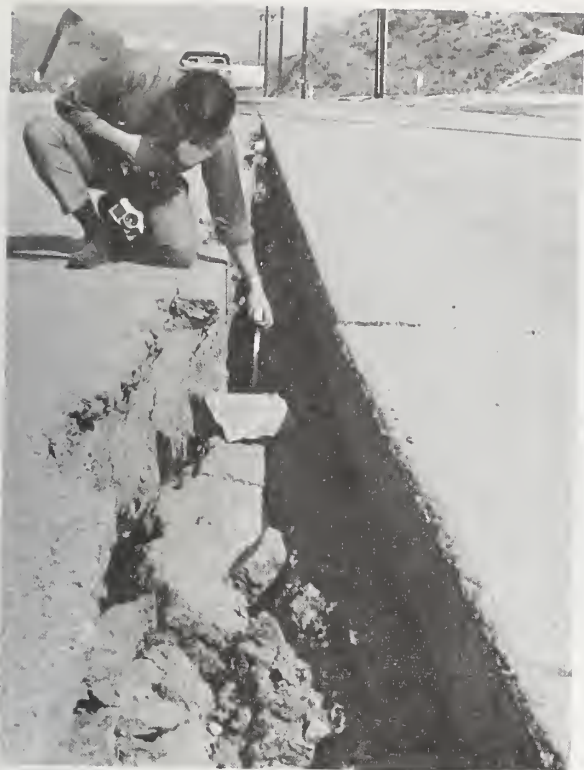
Figure 7.37 One of ground cracks along the road had a depth of at least 14 ft.

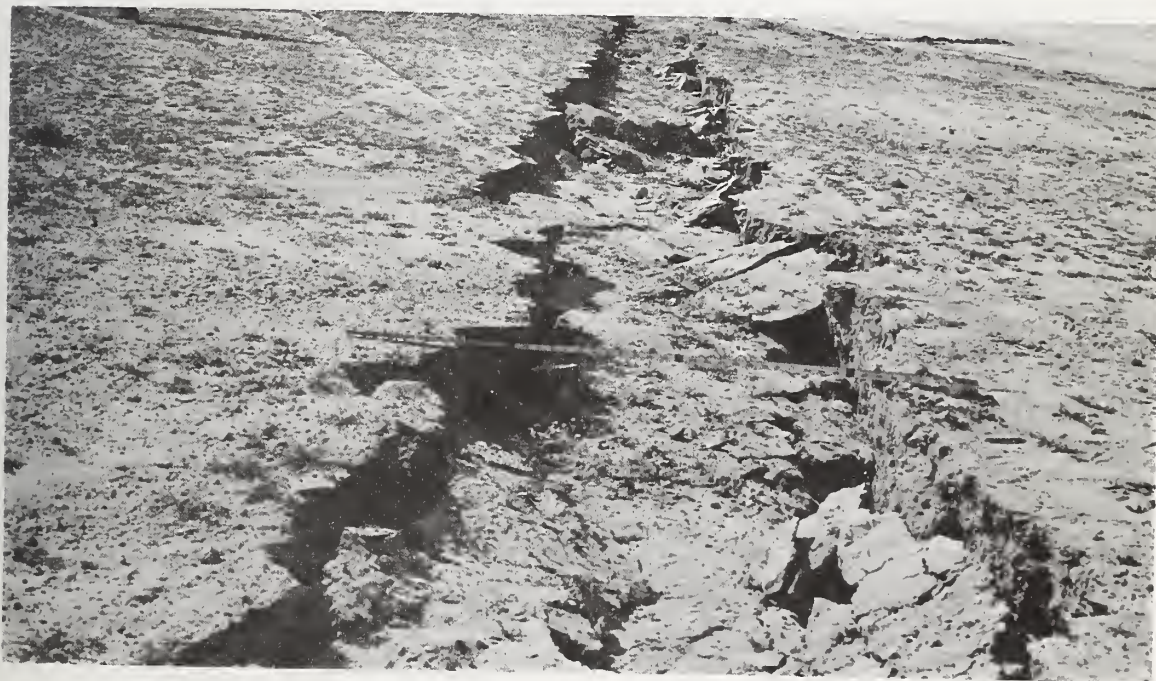
Figure 7.38 Ground cave-in (2-ft wide) near the damaged road slabs shown in figure 7.35.

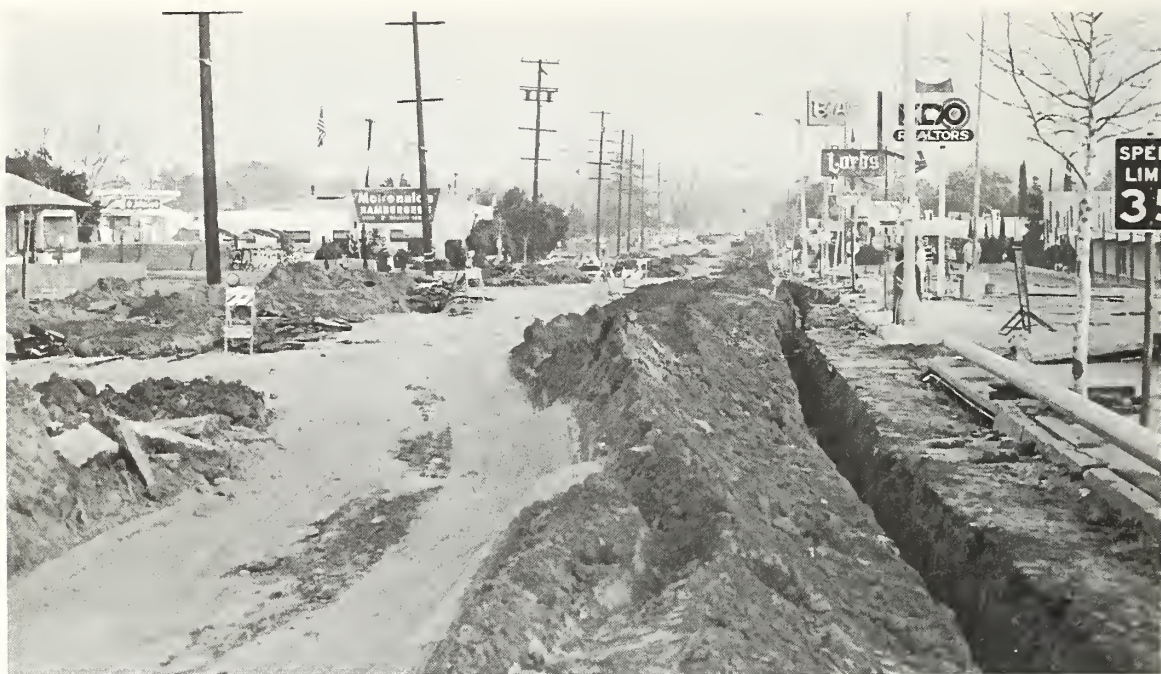
Figure 7.39 Broken gas, water, and sewer lines being repaired near intersection of Hubbard Avenue and Glenoaks Boulevard, San Fernando.

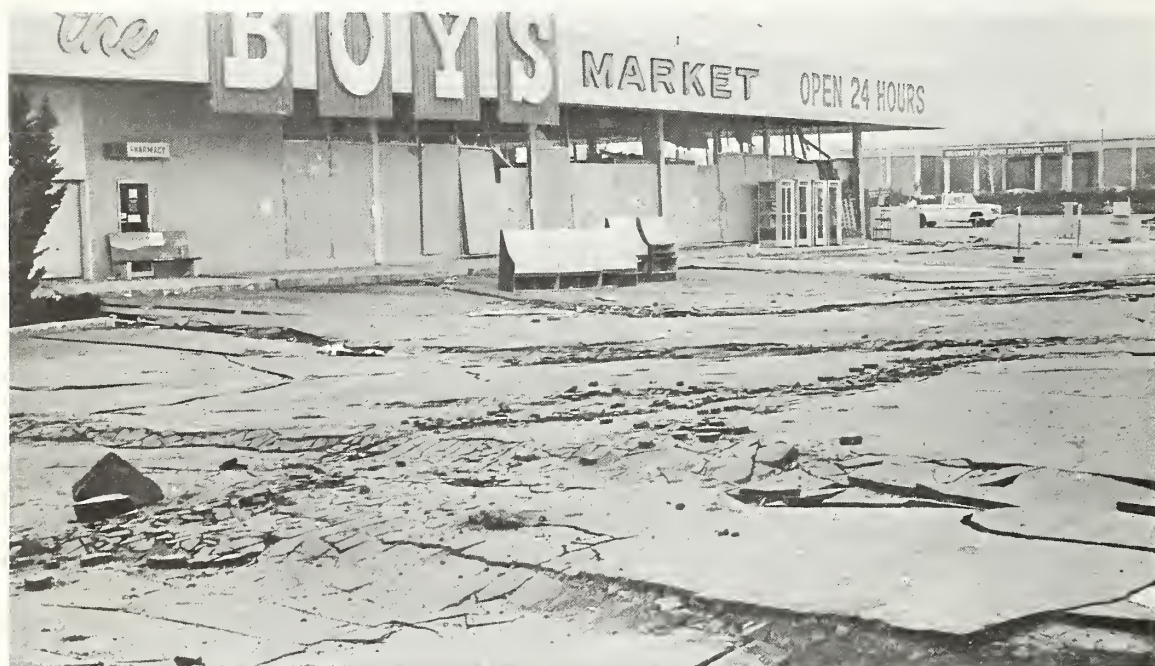
Figure 7.40 Considerable ground movement is evident in the parking lot of the shopping center at the corner of Hubbard Avenue and Glenoaks Boulevard.

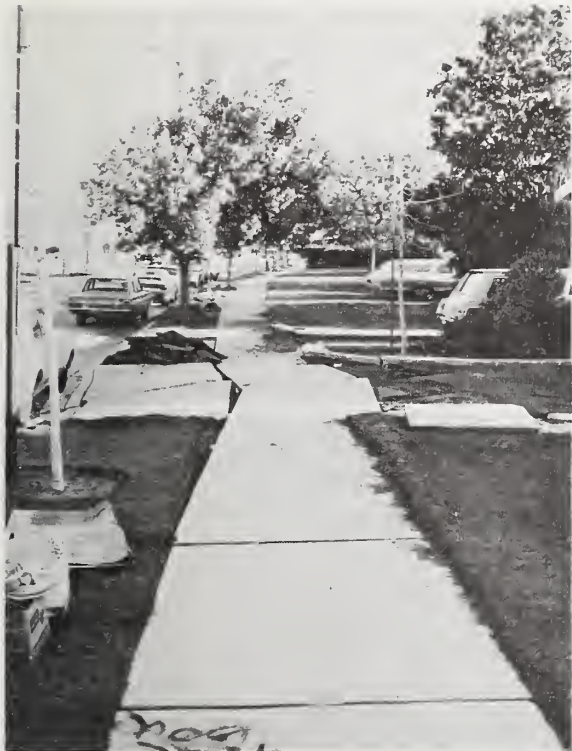
Figure 7.41 Sidewalk along Knox Street, near Orange Grove Avenue, San Fernando. Horizontal ground movement is clearly evident.

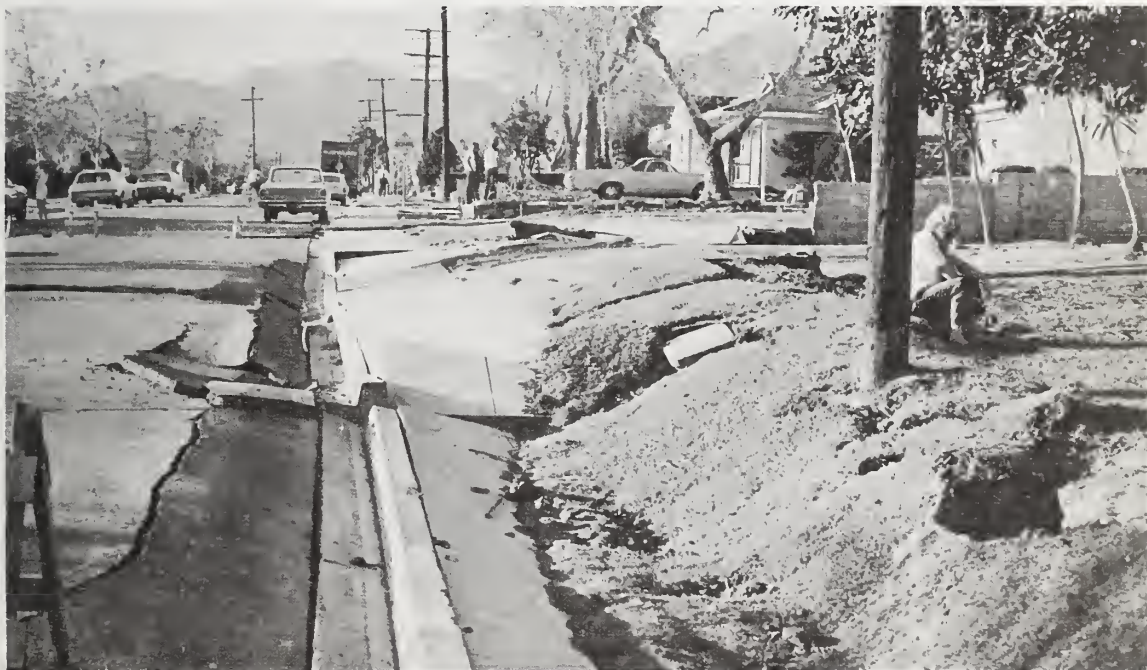
Figure 7.42 Damaged street and sidewalk along 8th Street, between Orange Grove Avenue and Fernmont Street, San Fernando.

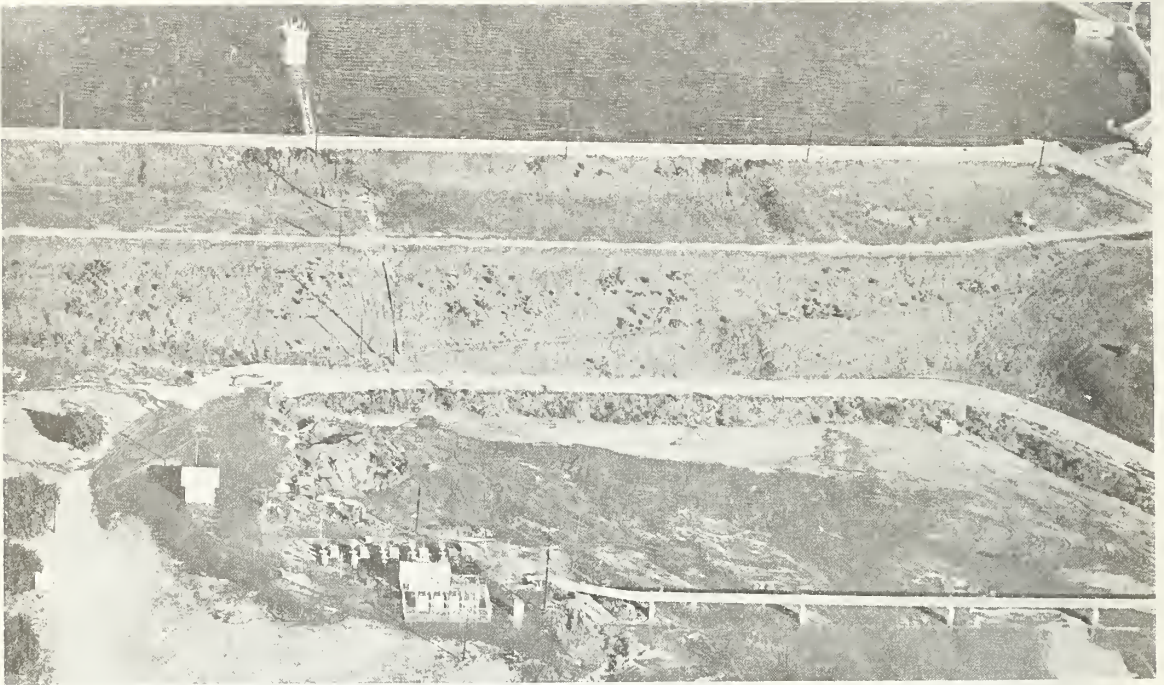
4. The Upper Van Norman Reservoir (location 9) with a capacity of 1800 acre-feet, was damaged. The Upper San Fernando dam, which was built in 1919-1921, is about 1200 ft in length along its axis and about 60 ft high. It settled about three feet and displaced laterally about five feet at the crest. However, the dam did not collapse and has been in use at about one-third capacity. Of the two intakes, the old one (Outlet No. 1) has cracked at the base; whereas, the new one (Outlet No. 2) did not sustain damage. Some water seepage appeared at the downstream side of the upper reservoir dam (fig. 8.3) as a result of damage in the drain system.

*Figure 8.3 Downstream face of the Upper San Fernando Dam.
Note the seepage at the foot of the dam.*

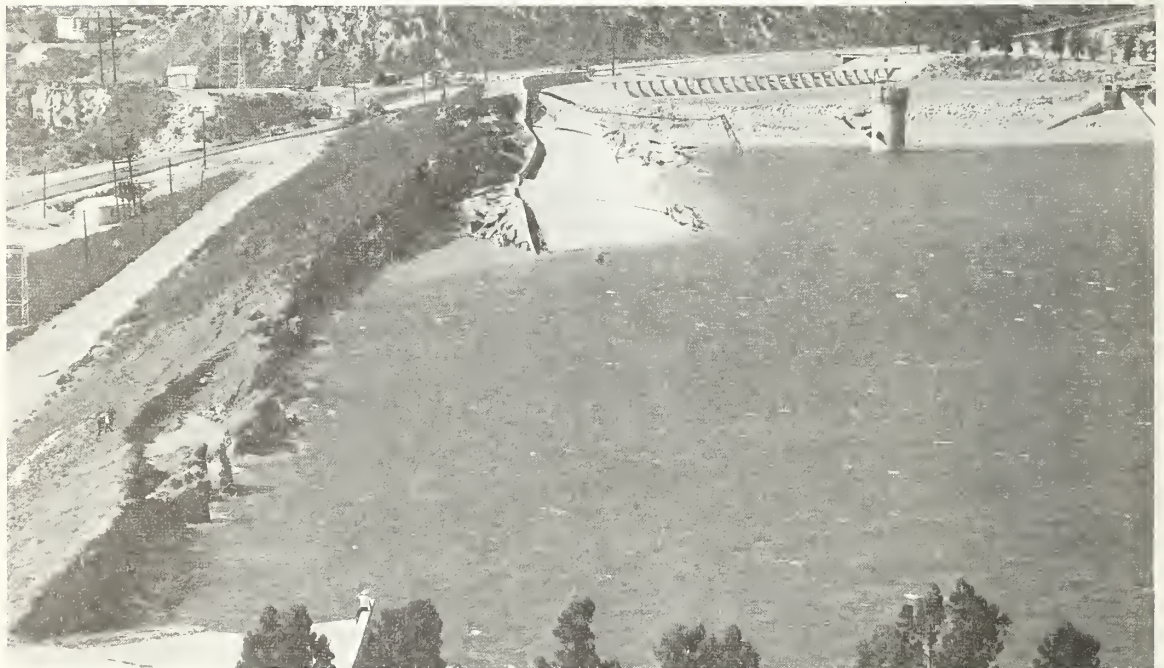
6. The Lower San Fernando Dam was severely damaged but did not collapse. It was built by the hydraulic fill method in 1913-1915 and raised and improved in 1930 and again in 1940. The reservoir can hold some 20,000 acre-feet of water at the water level of 1134 feet. At the time of the quake, the water level was 1110 feet, containing about 11,000 acre-feet. With this lower water level, although the crest of the dam collapsed during the quake (see fig. 8.4), the dam held back the water. With only a few feet of free-board to relieve the water pressure on the damaged dam, the water was immediately drained through the collapsed intake at a rate of 800 cubic feet per second (cfs) and discharged by 11 pumps at a rate of 190 cfs. The Lower Van Norman Reservoir is now out of service and is almost completely drained.

Figure 8.4 Collapsed crest of the Lower San Fernando Dam.

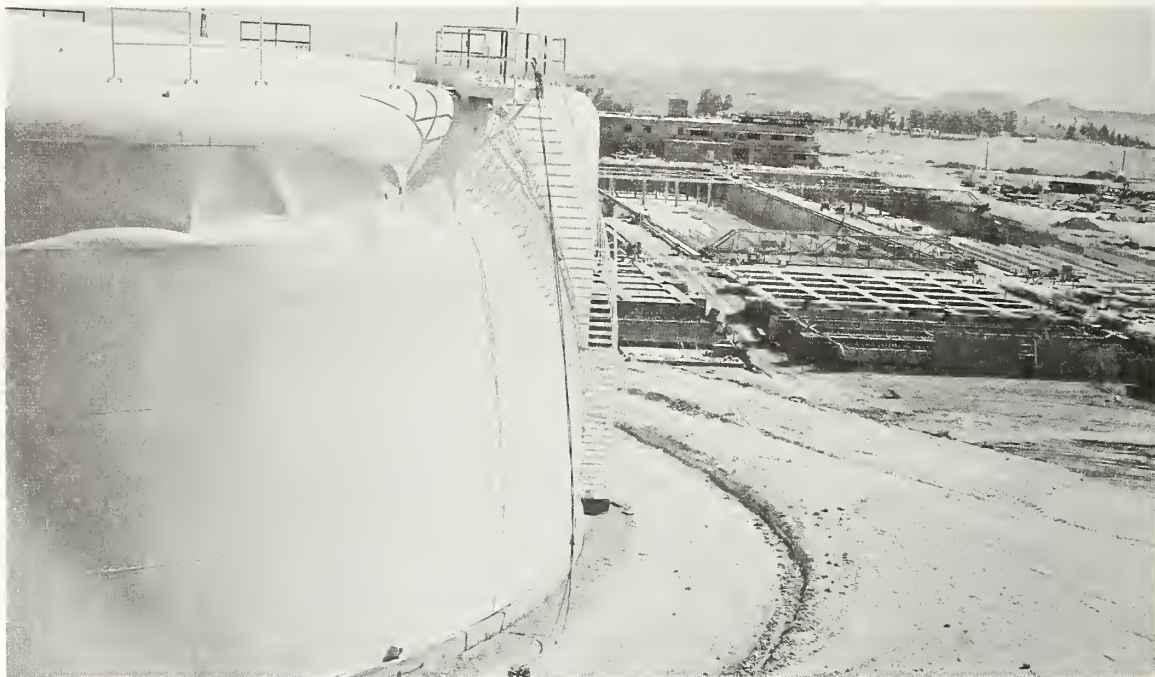
The intensity of ground movement at the Jensen Filtration Plant can be envisaged from the buckled 1.9-million-gallon water storage tank shown in figure 8.5. The tank, which was made of 3/8-in thick steel plate, was 30-ft high and 100-ft in diameter. This tank was located in the north-west area of the plant and was reported to be approximately one-half full at the time of the earthquake. Some of the anchor bolts, which held the tank to its foundation, were pulled out of their anchorage. The amount of pullout was, in general, greater on the north and south sides than the east and west sides. This indicates that some rocking motion of the tank occurred during the earthquake about an axis oriented in the east-west direction. The amount of uplift of the tank was greater on the south side than on the north side, as indicated by the amount of pull-out of the anchor bolts. The amount of pulled-out length was several inches on the

Figure 8.5 Buckled steel (3/8 in. thick) backwash tank at Joseph Jensen Filtration Plant.

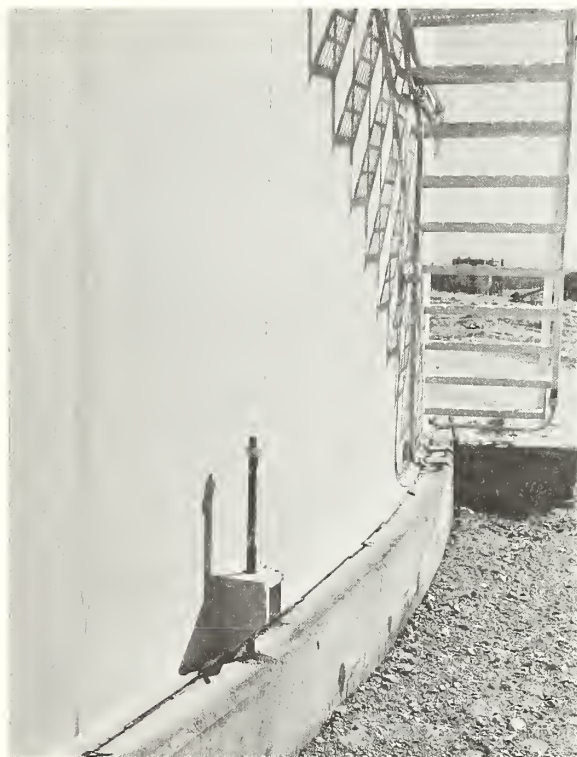
north side and as much as 19 inches on the south side (fig. 8.6). This difference in the amount of pull-out can possibly be explained by heavy machinery which was attached to the north side of the tank and apparently restrained the uplift.

Figure 8.6 Vertical Movement of tank pulled one-inch diameter anchor bolt out of concrete base.

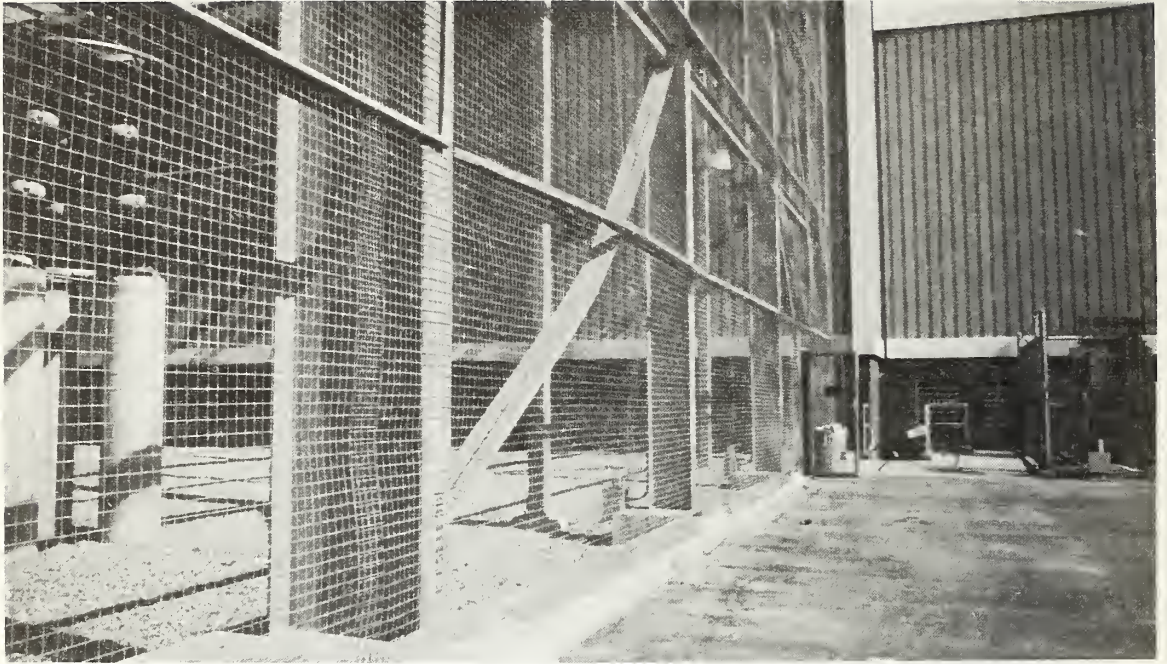
Figure 8.10 Buckled lateral bracing.

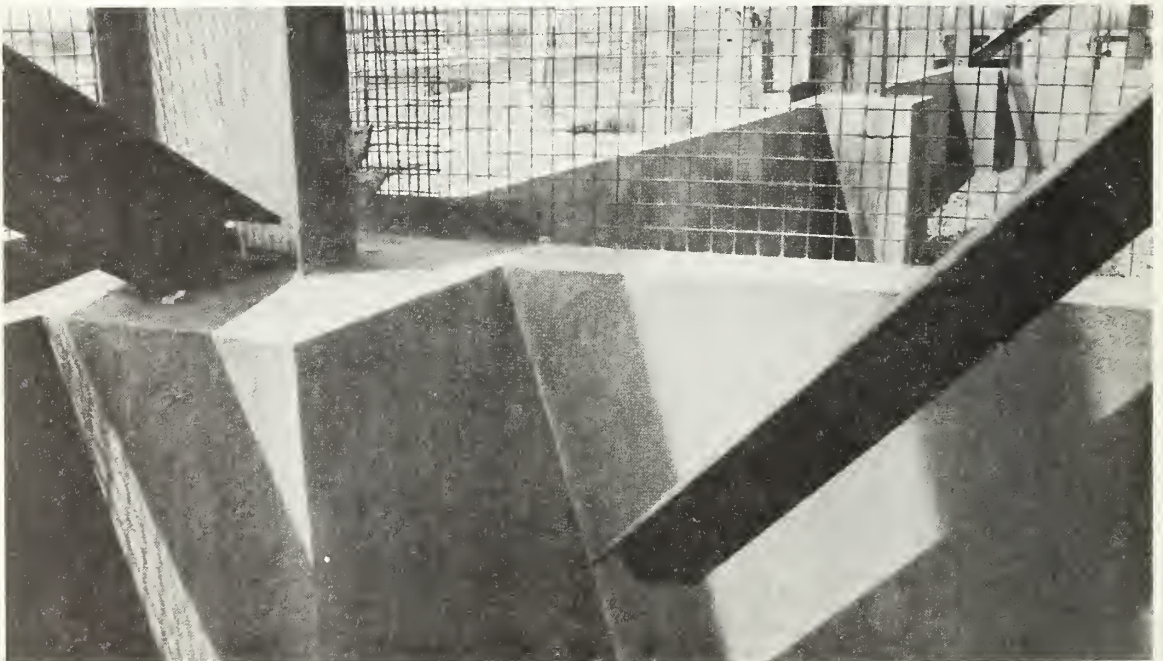
Figure 8.11 Fractured gusset plate.

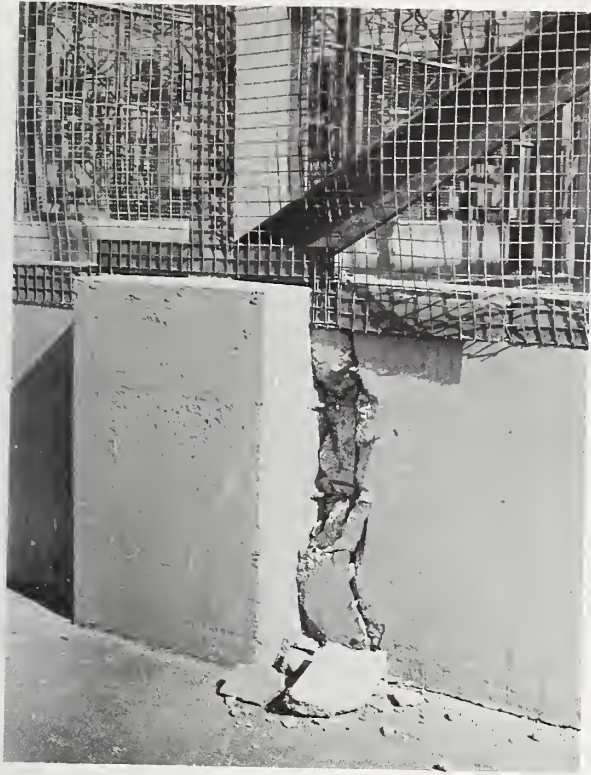
of these columns was damaged due to what appears to be independent movement that took place between the two sections of the building. The floor slab and the basement wall in this vicinity were also damaged. On the other hand, numerous damages were sustained by the bare steel frame structures over the transformer yards. Many braces were buckled, stretched, and broken at gusset plates (fig. 8.10 and 8.11). Some columns were bent and, in several places, cracks occurred between the column pedestal and the concrete wall which surrounded the yard (fig. 8.12).

Figure 8.12 Concrete spalling at one of the joints between a column pedestal and an enclosure wall surrounding the electrical transformer yard.

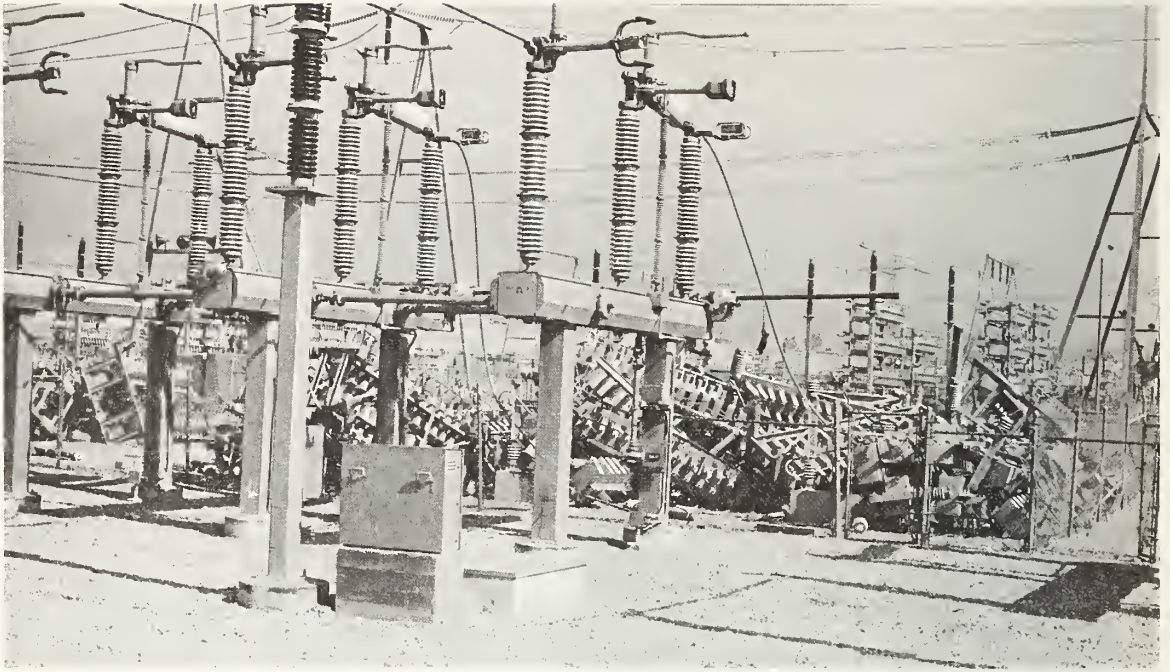
Much outdoor electrical equipment was supported on insulators, (fig. 8.13). Equipment collapsed due to failure of these insulators during the earthquake as shown in figure 8.14.

Figure 8.14 Destroyed electrical capacitor banks (in background) at Sylmar Converter Station.

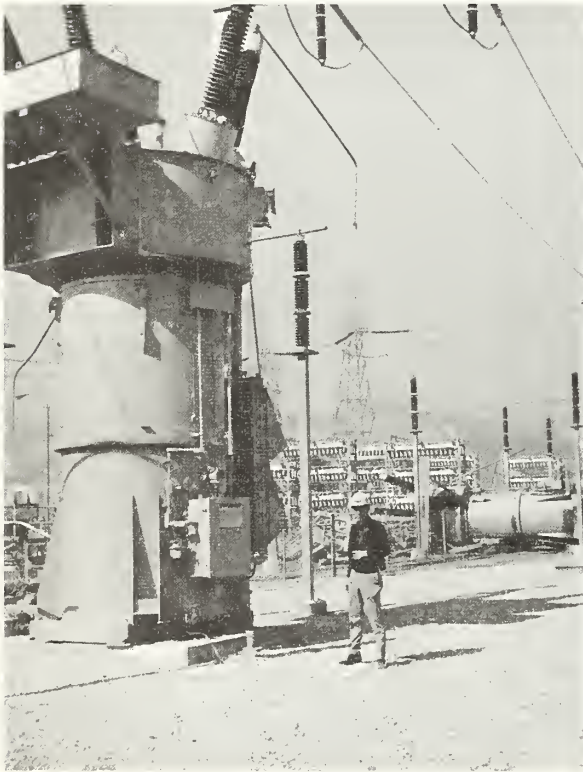
Several large oscillators were toppled and dislodged due to failure of their anchorage to the foundation pad (fig. 8.15). Each oscillator was attached to four 12-in by 12-in by 3/4-in anchor plates. Each of these plates was anchored to the concrete pad with four 1/2-in studs. A close examination showed that all studs were fractured at the base metal. Some fractured studs showed only partial fusion to the base anchor plate. The base steel plates and a concrete pad to which the plates were embedded are shown in figures 8.16 and 8.17, respectively. In figure 8.17 the broken studs are indicated by arrows.

*Figure 8.15 Toppled and dislodged oscillators.
(J. H. Rainer photo)*
