BUILDING SCIENCE SERIES 40

Engineering Aspects of the 1971 San Fernando Earthquake

This report presents the observations of the NBS on-site inspection team (most photographs in this report were taken by the team). The material presented herein is intended to serve as (1) a documentation of damage resulting from the earthquake and (2) as a source document for further studies, research, and recommendations. This is particularly important as necessary remedial work and restoration have resulted in the removal of evidence that is essential for studies and evaluations.

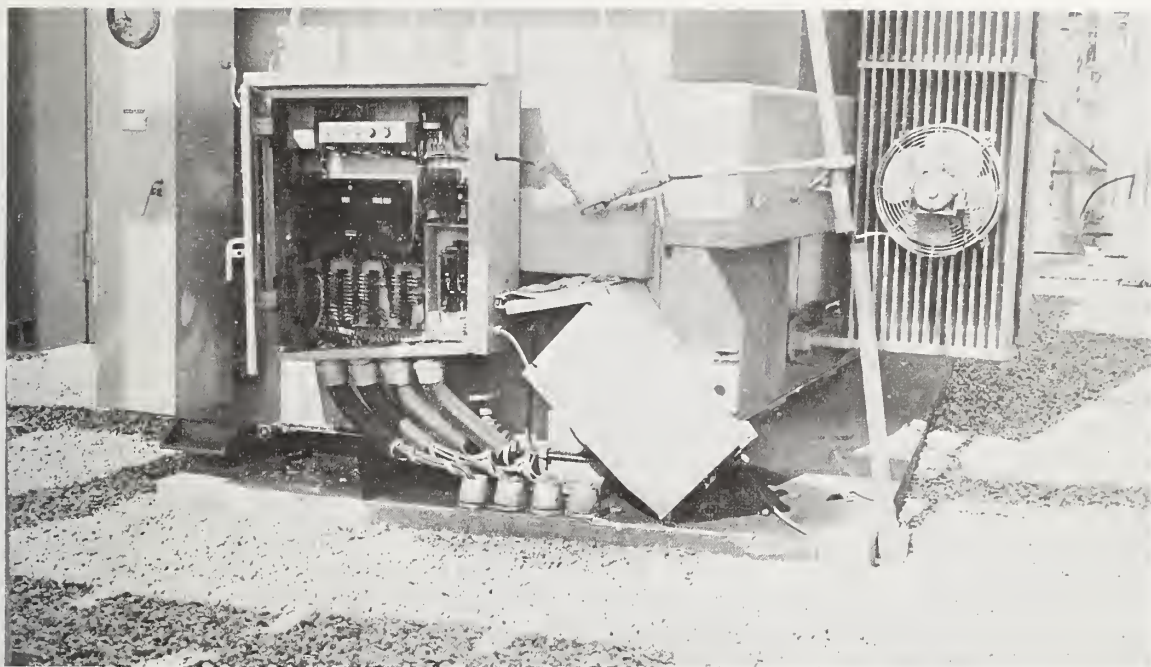
Numerous large transformers in the radio-shielded yards were moved laterally on their foundation slabs as anchor bolts were sheared off due to lateral forces. A typical example of such a failure is shown in figure 8.18.

Figure 8.18 Electrical transformer which moved laterally on its foundation slab.

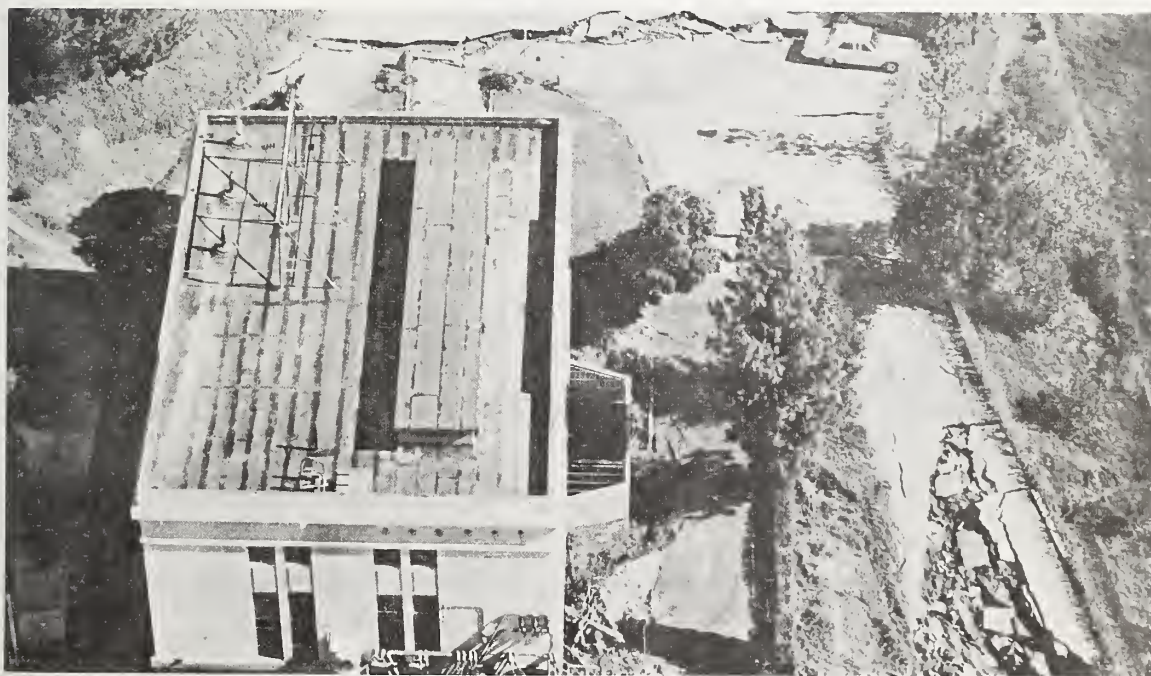
The power plant which is located just north of the Upper Van Norman Reservoir was dropped about three feet, thereby shearing off the end of the penstock and breaking the bypass gate. This station had a generating capacity of 6000 kilowatts and is out of service indefinitely. Severe ground failure around the plant is shown in figure 8.19.

Figure 8.19 Aerial view of the San Fernando Power Plant.

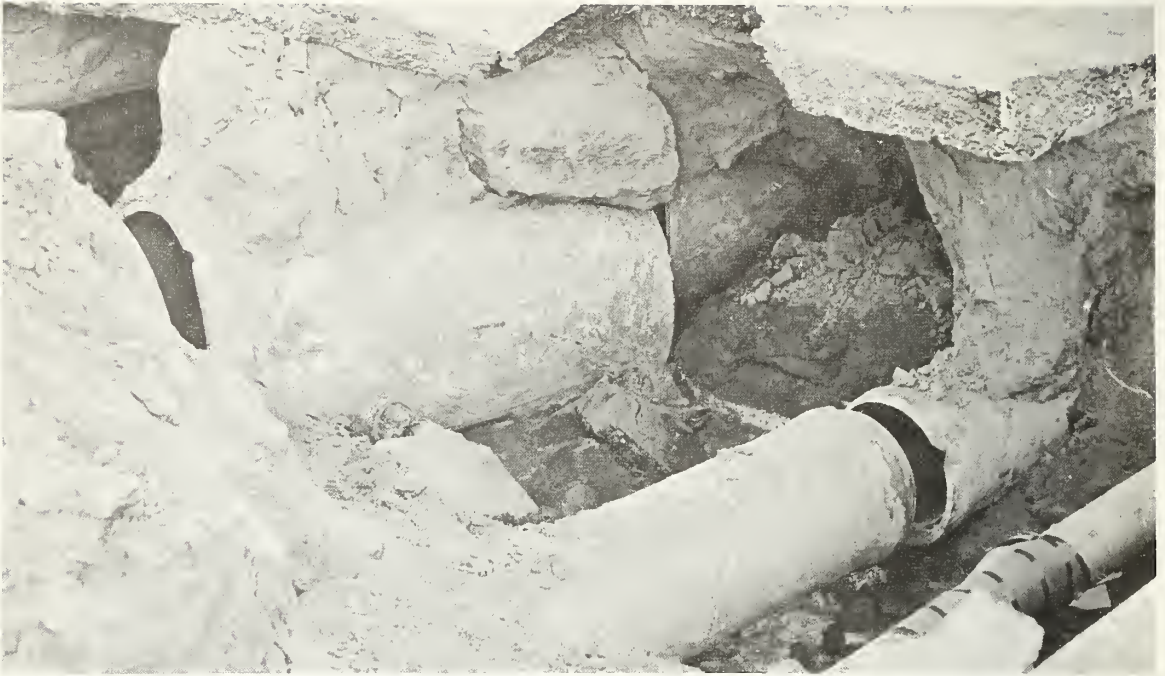
Many broken gas lines were flooded with water from broken water mains. The greatest damage of this type occurred in the northern corner of the City of San Fernando where, as shown in figure 8.21, ruptured gas, water, and sewer lines were buried adjacent to each other. Some 10 days after the quake, a problem of a similar nature occurred in the Sunland-Tujunga area, some 6 miles east of the City of San Fernando, where earthquake-loosened soil worked its way into the broken gas lines and filters in a regulator station. This disrupted gas service to about 10,000 customers for a period of up to one day, in the area bounded by Sherman Grove Avenue, Haynes Canyon Avenue, the San Gabriel Mountains and Verdugo Mountains (fig. 8.20, Area 2).

Figure 8.21 Close-up view of ruptured sewer, water, and gas lines.

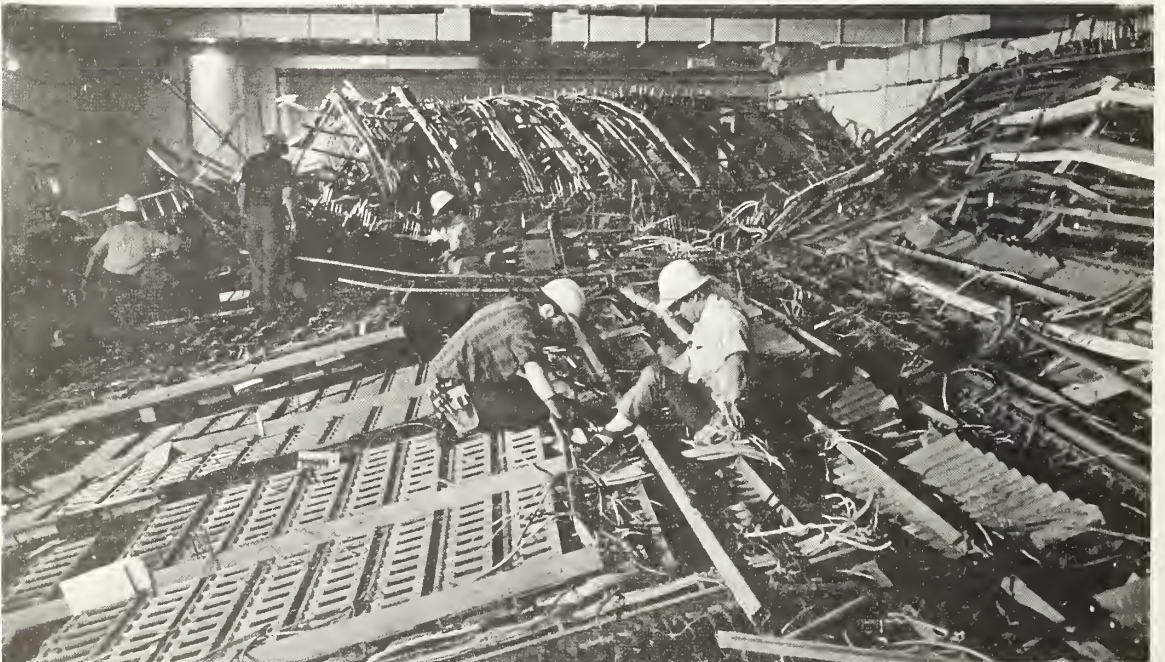
The equipment damage was concentrated at the Sylmar Central Office where all the switching equipment was rolled over (fig. 8.22). Loss of this central office left 9,500 Sylmar customers without telephone service.

Figure 8.22 Toppled and damaged telephone switching equipment at Sylmar Central Office of General Telephone Company.

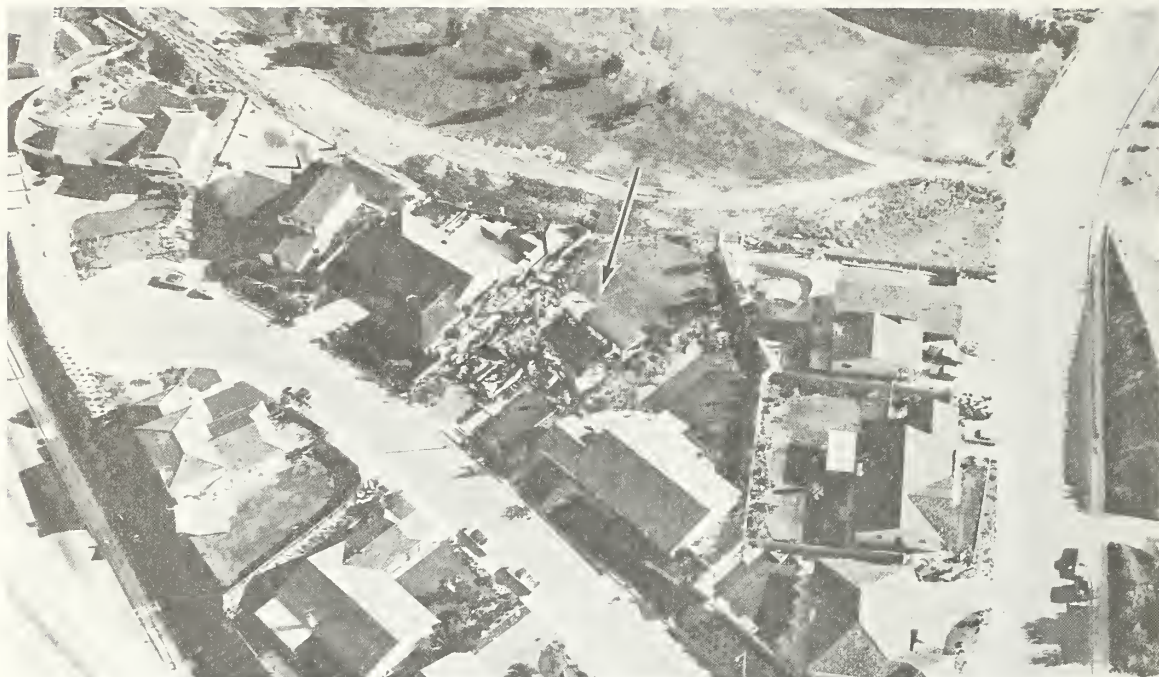
Figure 8.24 House in Knollwood area destroyed by fire.

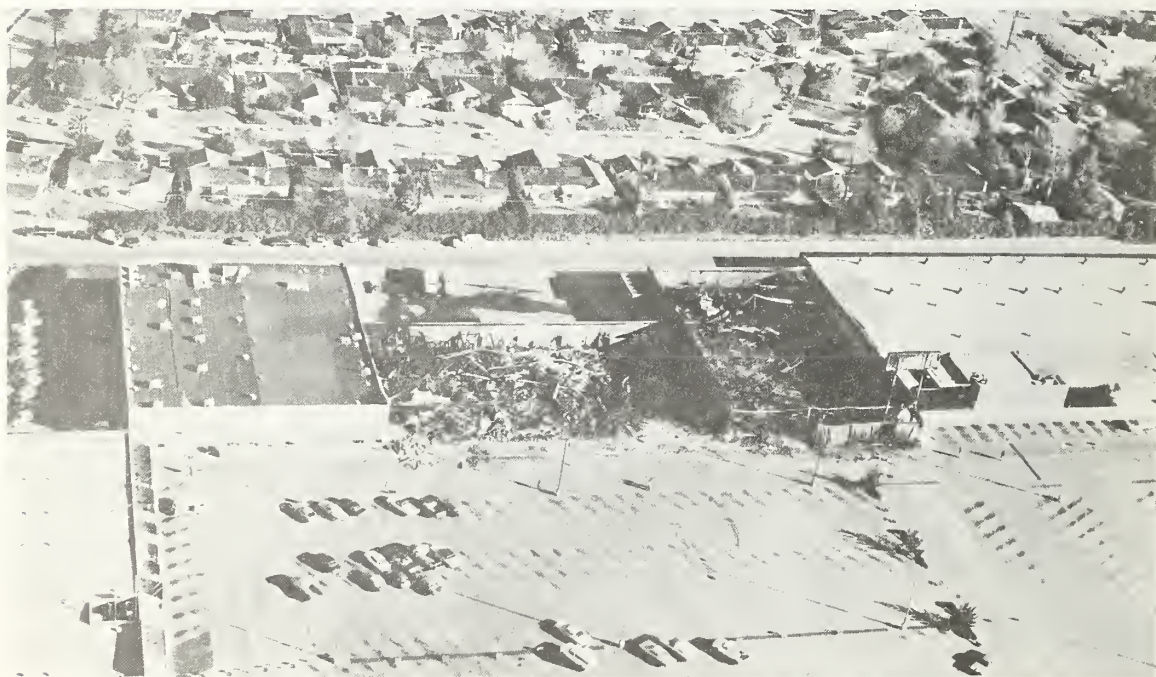
*Figure 8.25 Commercial buildings destroyed by fire
(Chatsworth Street and Zelzah Avenue,
Granda Hills).*

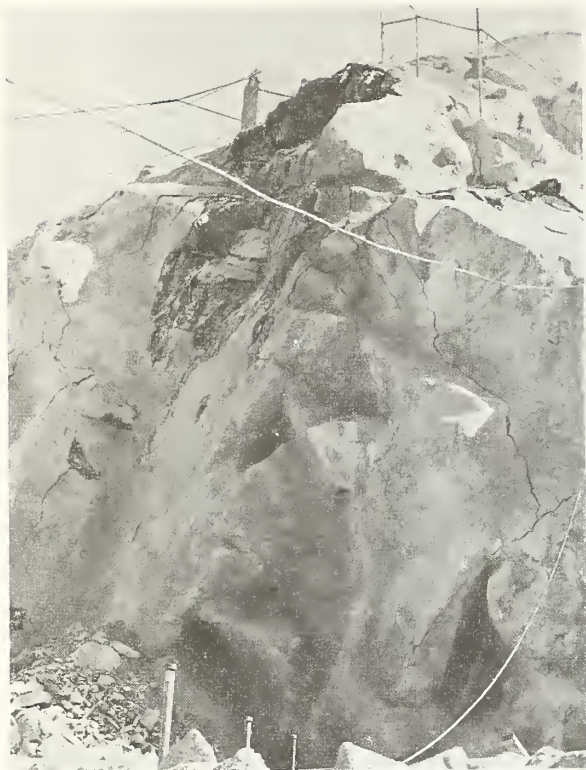
Dams - Pacoima Dam, built in 1928 as a 370 ft high concrete-arch structure, is the only major District dam in the Sylmar area (see fig. 8.26). Significant damage occurred to the gunite abutments (figs. 8.27 and 8.28), and massive rockslides occurred in the vicinity of the dam (fig. 8.29) [8.4]. Although damaged evaluation is not complete, preliminary reports indicate there was no structural damage to this dam. Water level behind the dam was low at the time of the earthquake.

Figure 8.27 Damage to gunite
left abutment,
Pacoima Dam.

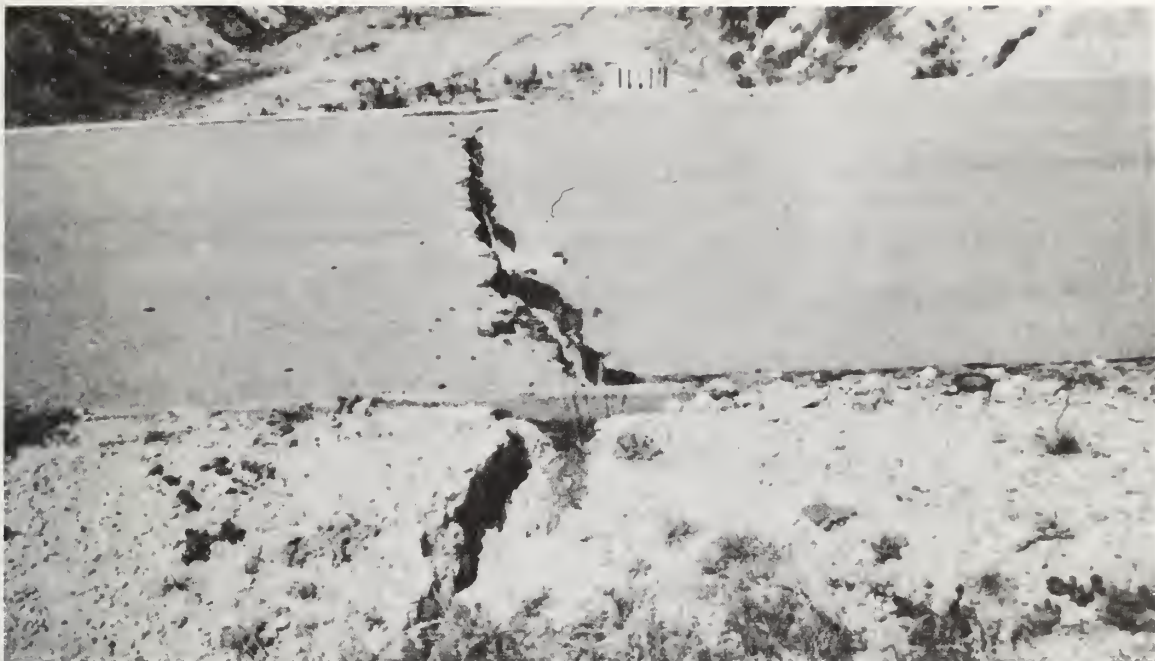
Debris Basin, there were cracks in the dam fill on both sides of the spillway (fig. 8.30) and in the facing slab parallel to the spillway invert (fig. 8.31). Hog Debris Basin and Sombrero Debris Basin also suffered similar damage.

Figure 8.30 Looking northwesterly toward basin showing crack in the pavement and a 2-inch vertical displacement of paved crest of dam (Stetson Debris Basin).

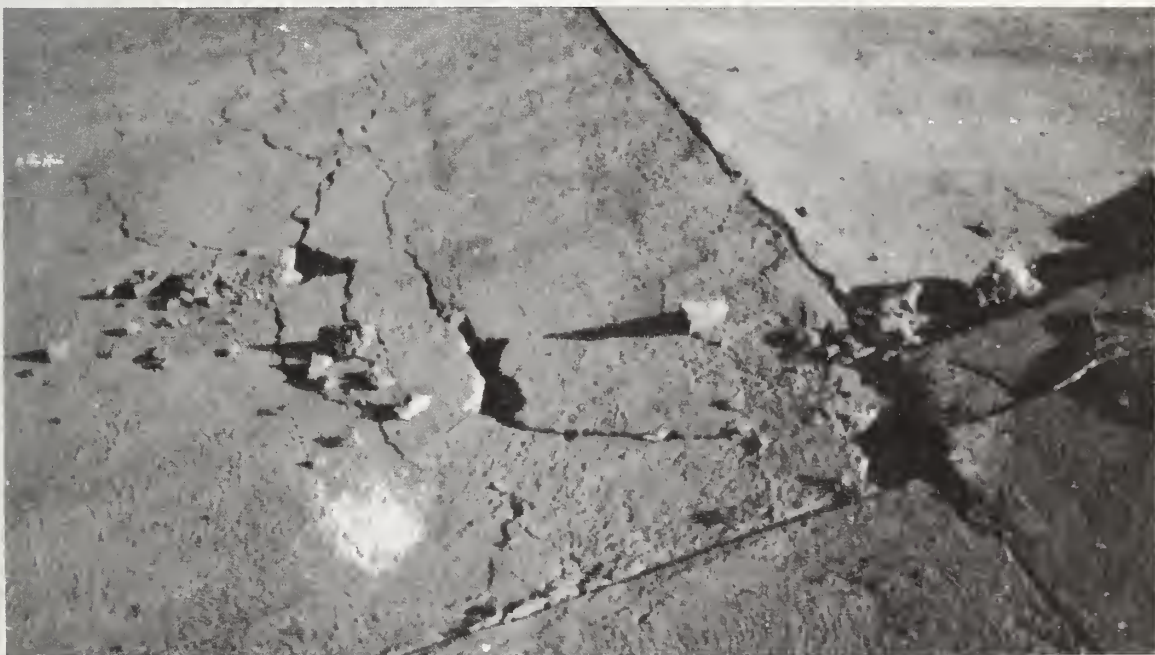
Figure 8.31 Looking easterly showing damage to facing slab; Stetson Debris Basin.

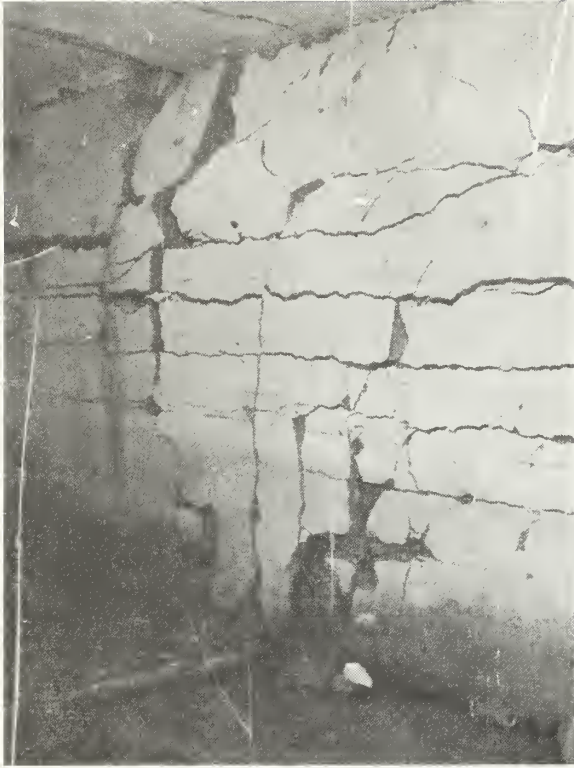
Channels - The Wilson Canyon Channel has a reinforced concrete box which was badly damaged (figs. 8.32 and 8.33). Concrete walls along the Lopez Canyon Channel were also badly damaged (figs. 8.34 and 8.35). Other channels which were damaged are the Mansfield Channel and the Pacoima Wash Channel.

Figure 8.32 Left wall buckled inward at station 45+10. Wilson Canyon Channel.

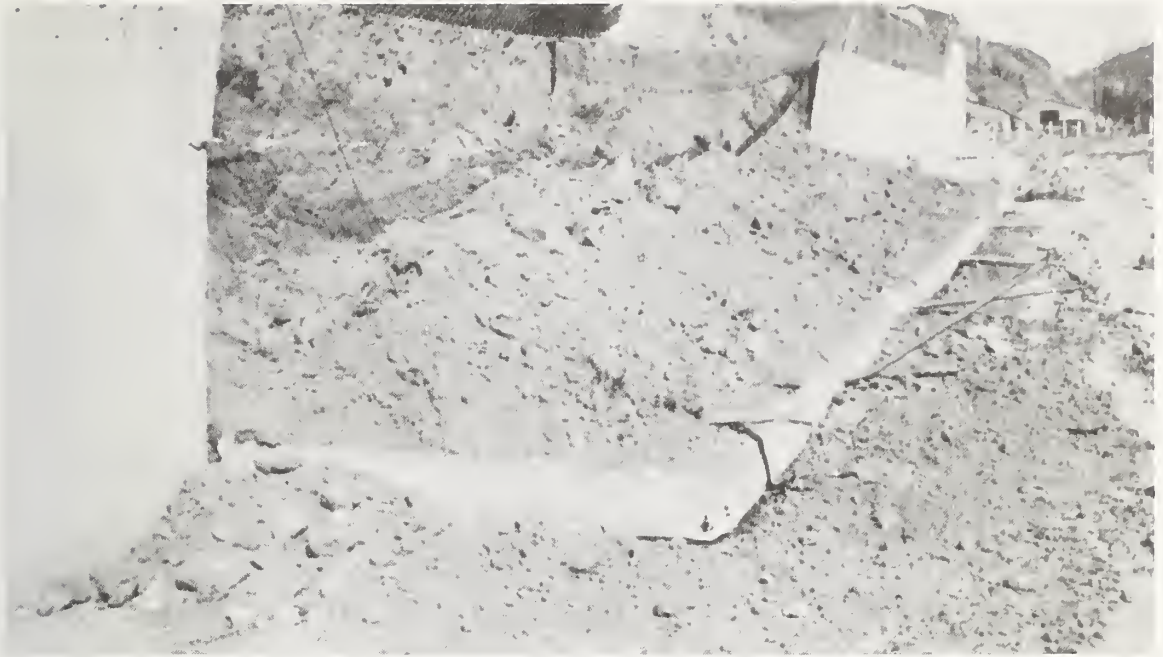
Figure 8.34 Lopez Canyon Channel. A 50-foot section of the wall has failed on the right bank. The 50-foot section adjacent upstream also shows severe structural damage.

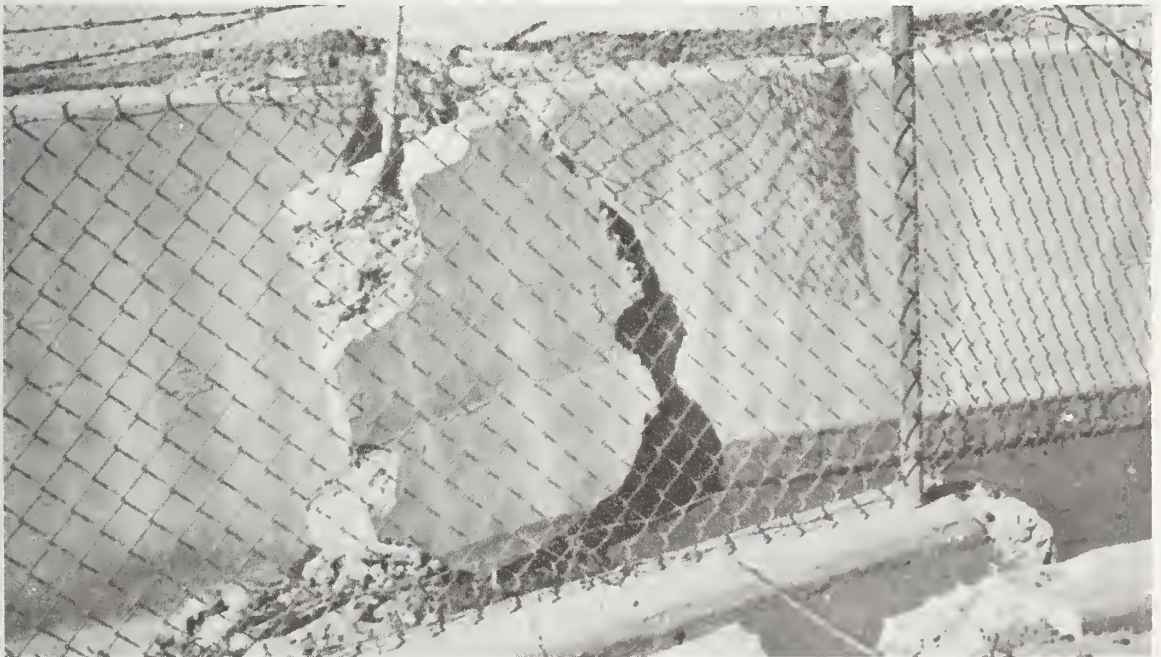
Figure 8.35 Lopez Canyon Channel. A 2-foot displacement of the channel had caused complete failure of the walls and invert, with the upstream portion moving over the downstream portion.
